(10) **Patent No.:** **US 11,592,051 B1**
(45) **Date of Patent:** **Feb. 28, 2023**

(54) **BOLT EXTENDER ARRANGEMENT**

A bolt extender includes a bottom portion defining internal threads and a multi-sided outer surface, an upper shoulder, and a threaded rod projecting upwardly from said upper shoulder.

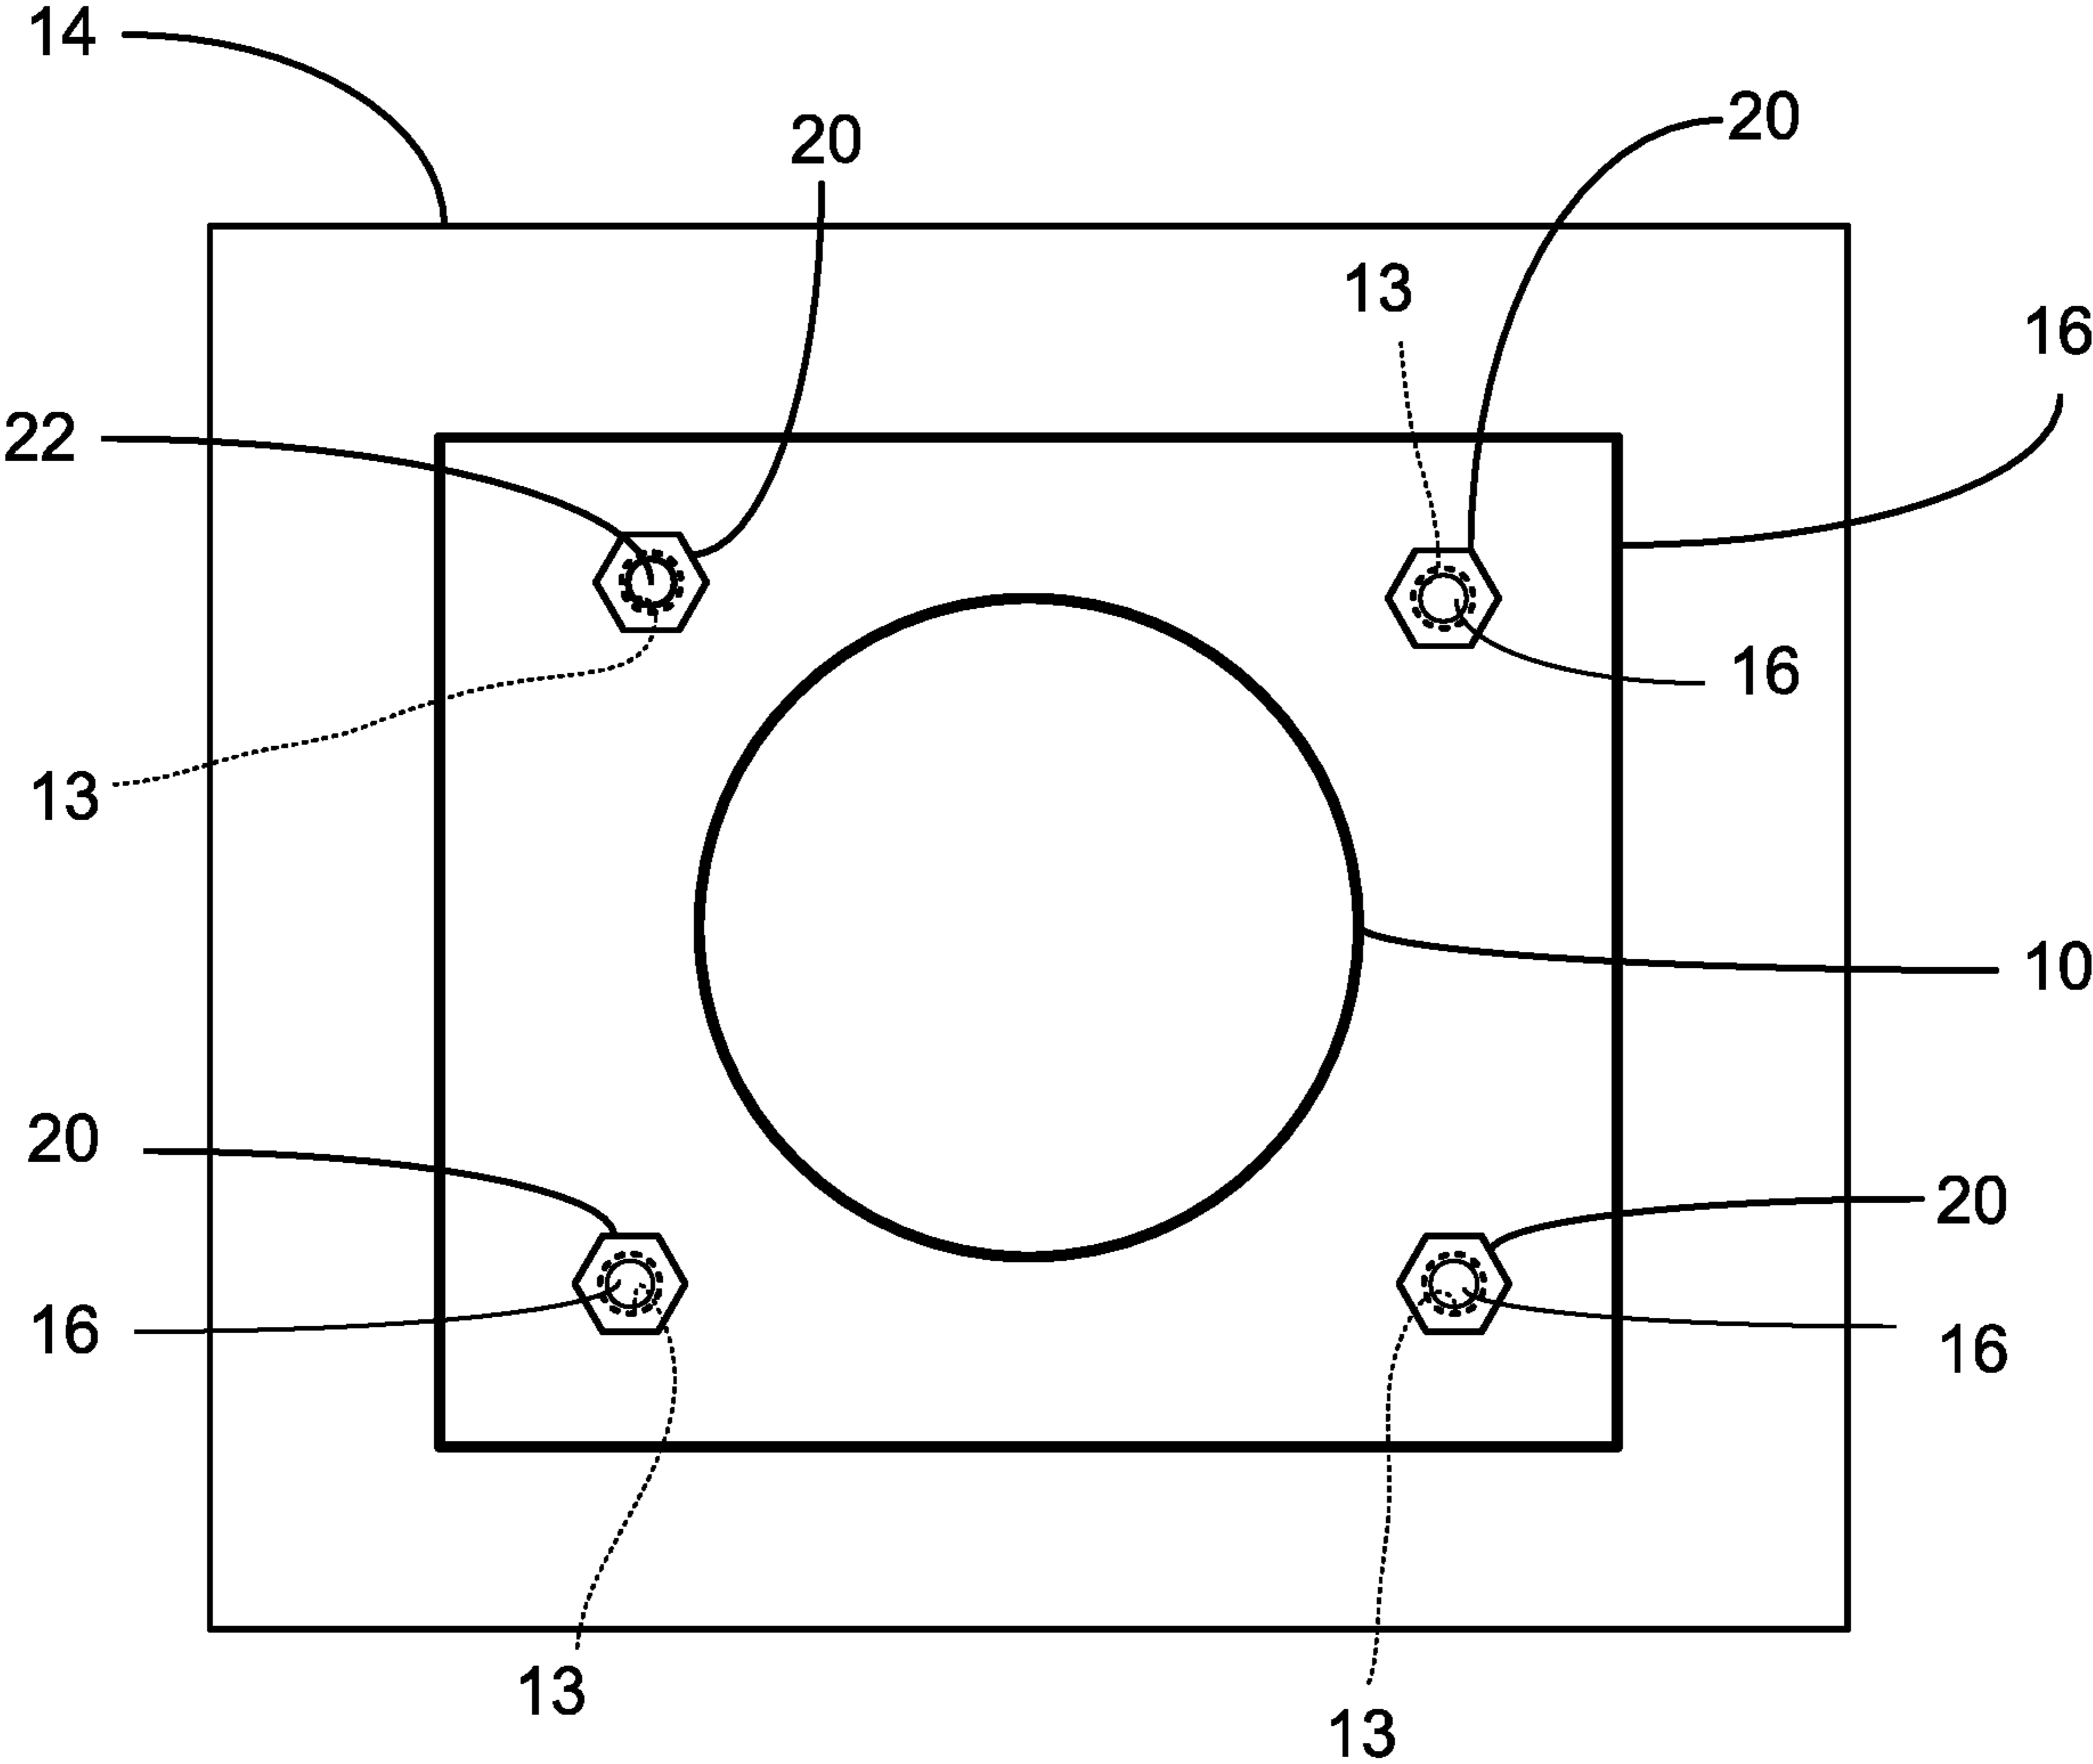
Fig 12

FIG. 12 is a plan view of the pole of FIG. 11, with the top, leftmost rod having been partially replaced and elongated by the bolt extender of FIGS. 7 and 8.
