# (10) Patent No.: US 11,644,626 B2

# (54) FIBER OPTIC INSPECTION TOOL WITH INTEGRATED CLEANING MECHANISM

(71) Applicant: Panduit Corp., Tinley Park, IL (US)

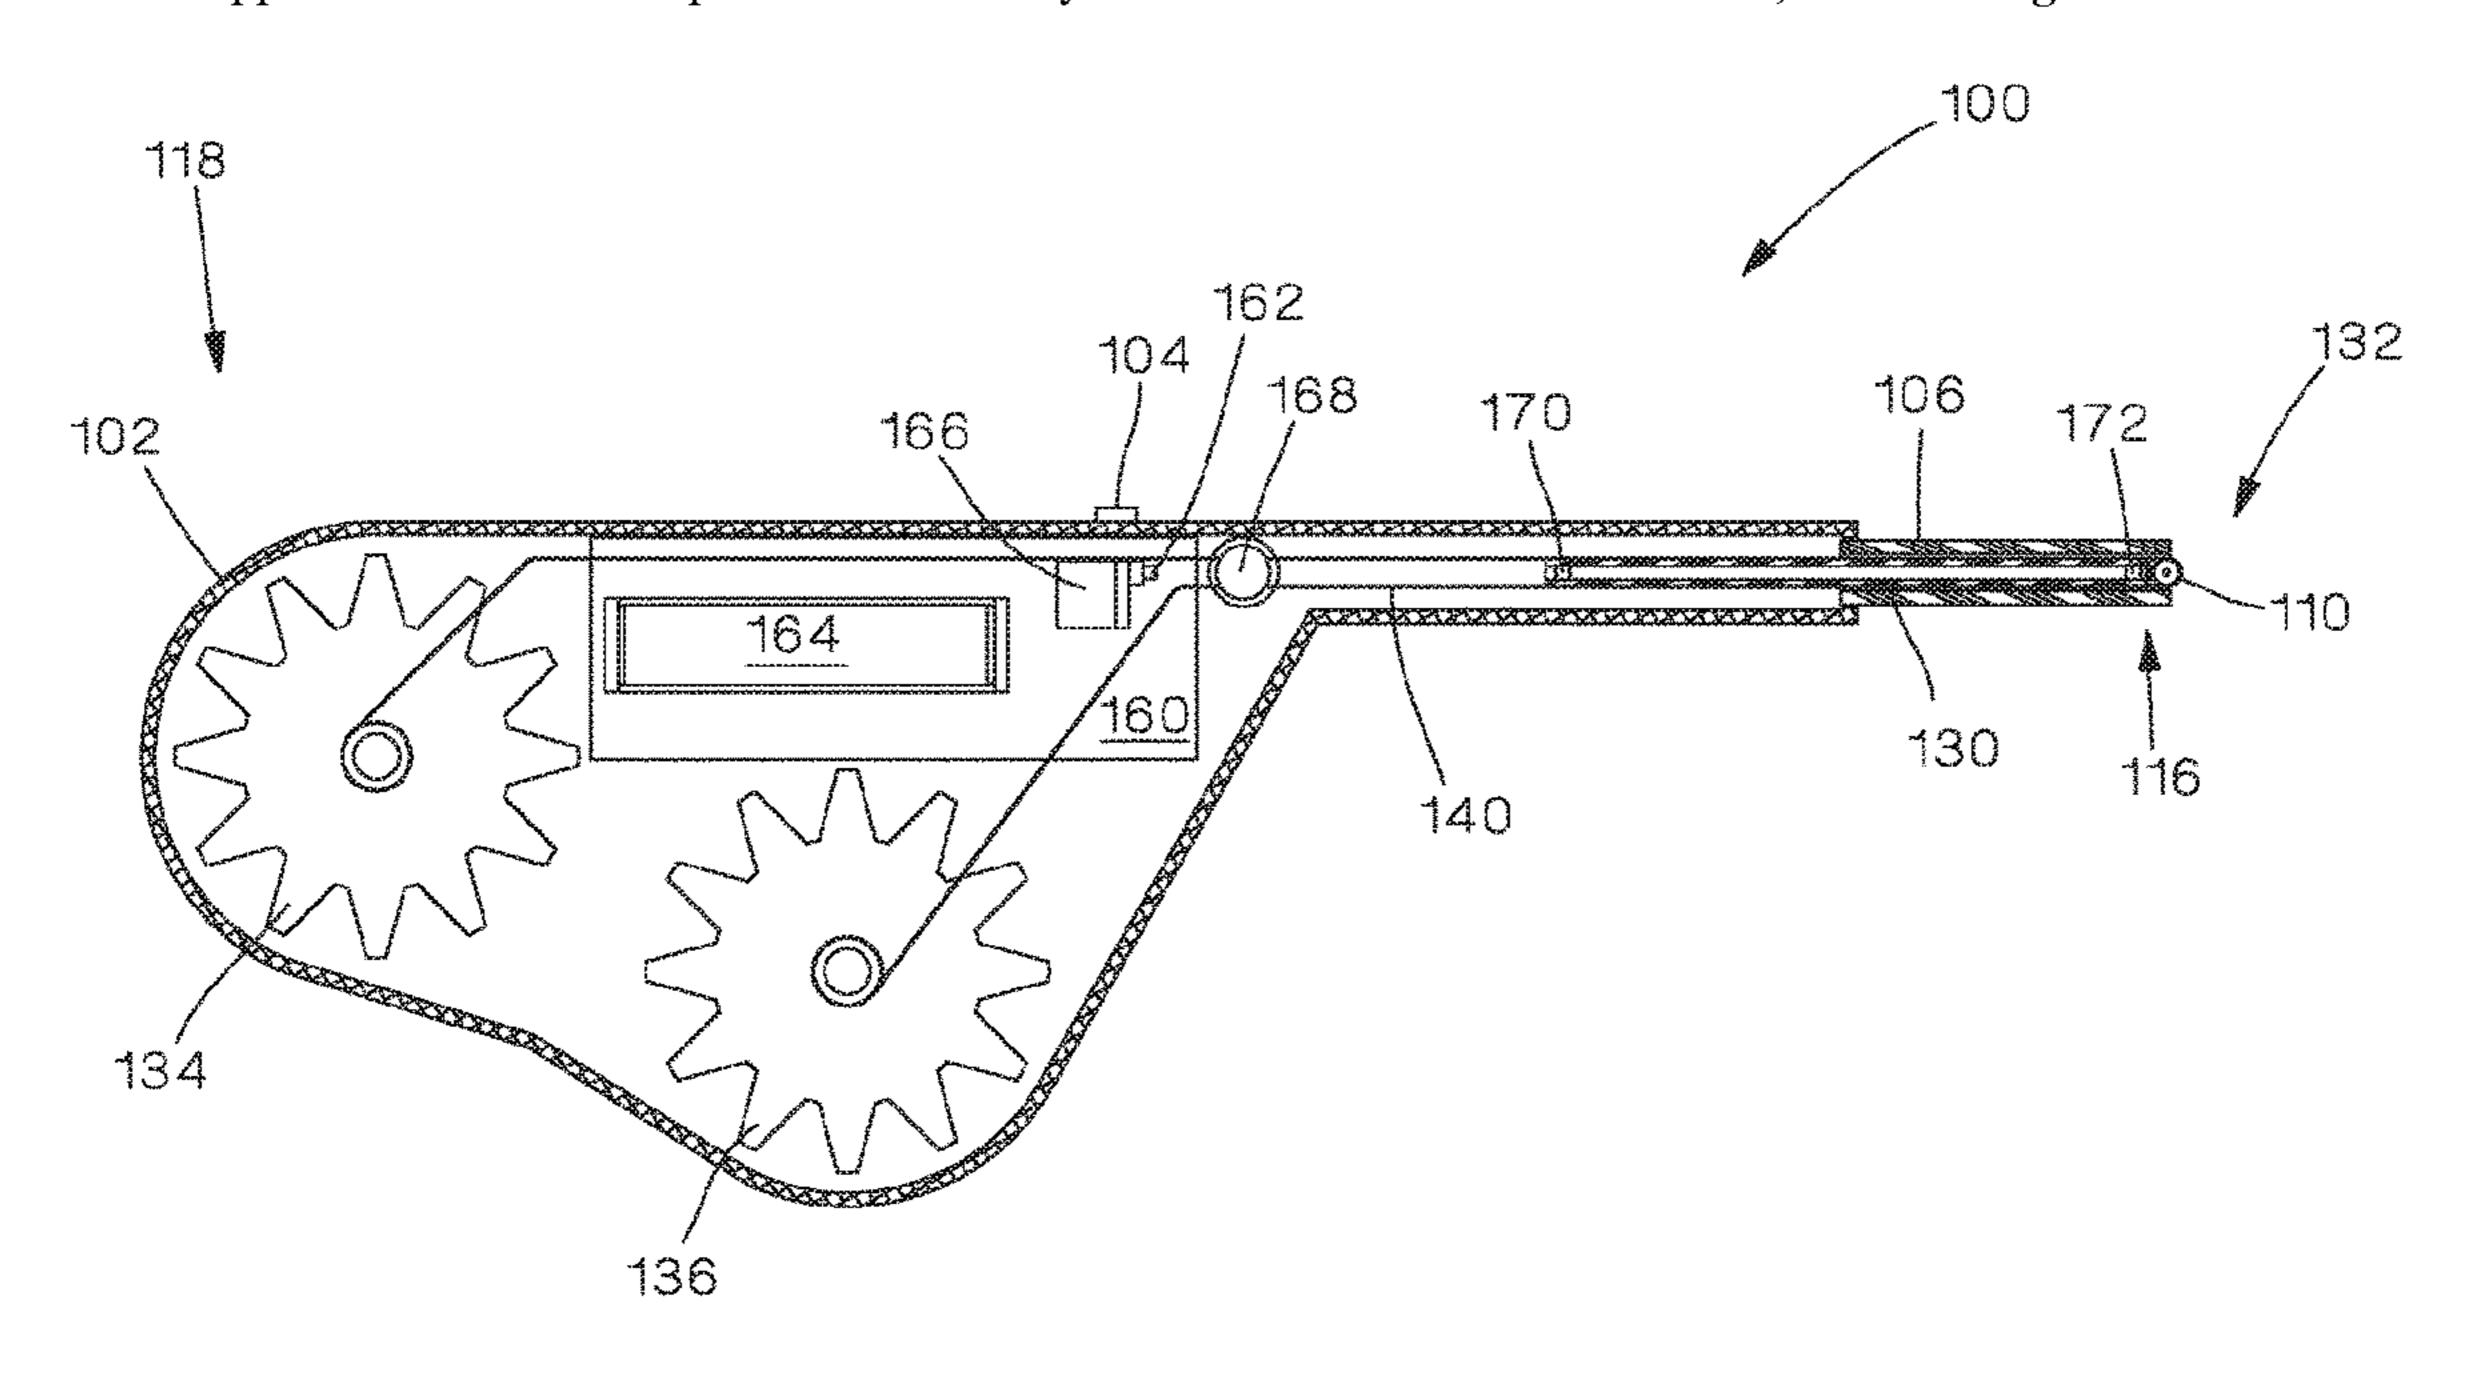
Various implementations of fiber optic inspection tools with integrated cleaning mechanisms are disclosed. The fiber optic inspection and cleaning tool includes a housing, a cleaning system and an imaging system. The cleaning system includes a pay-off reel, a take-up reel, a spindle and a cleaning tape that travels off the pay-off reel, around the spindle, and onto the take-up reel. The imaging system includes a camera and a light source. The camera, spindle, and cleaning tape are aligned along a visual axis. The pay-off reel, take-up reel, camera and light source are all located within the housing.

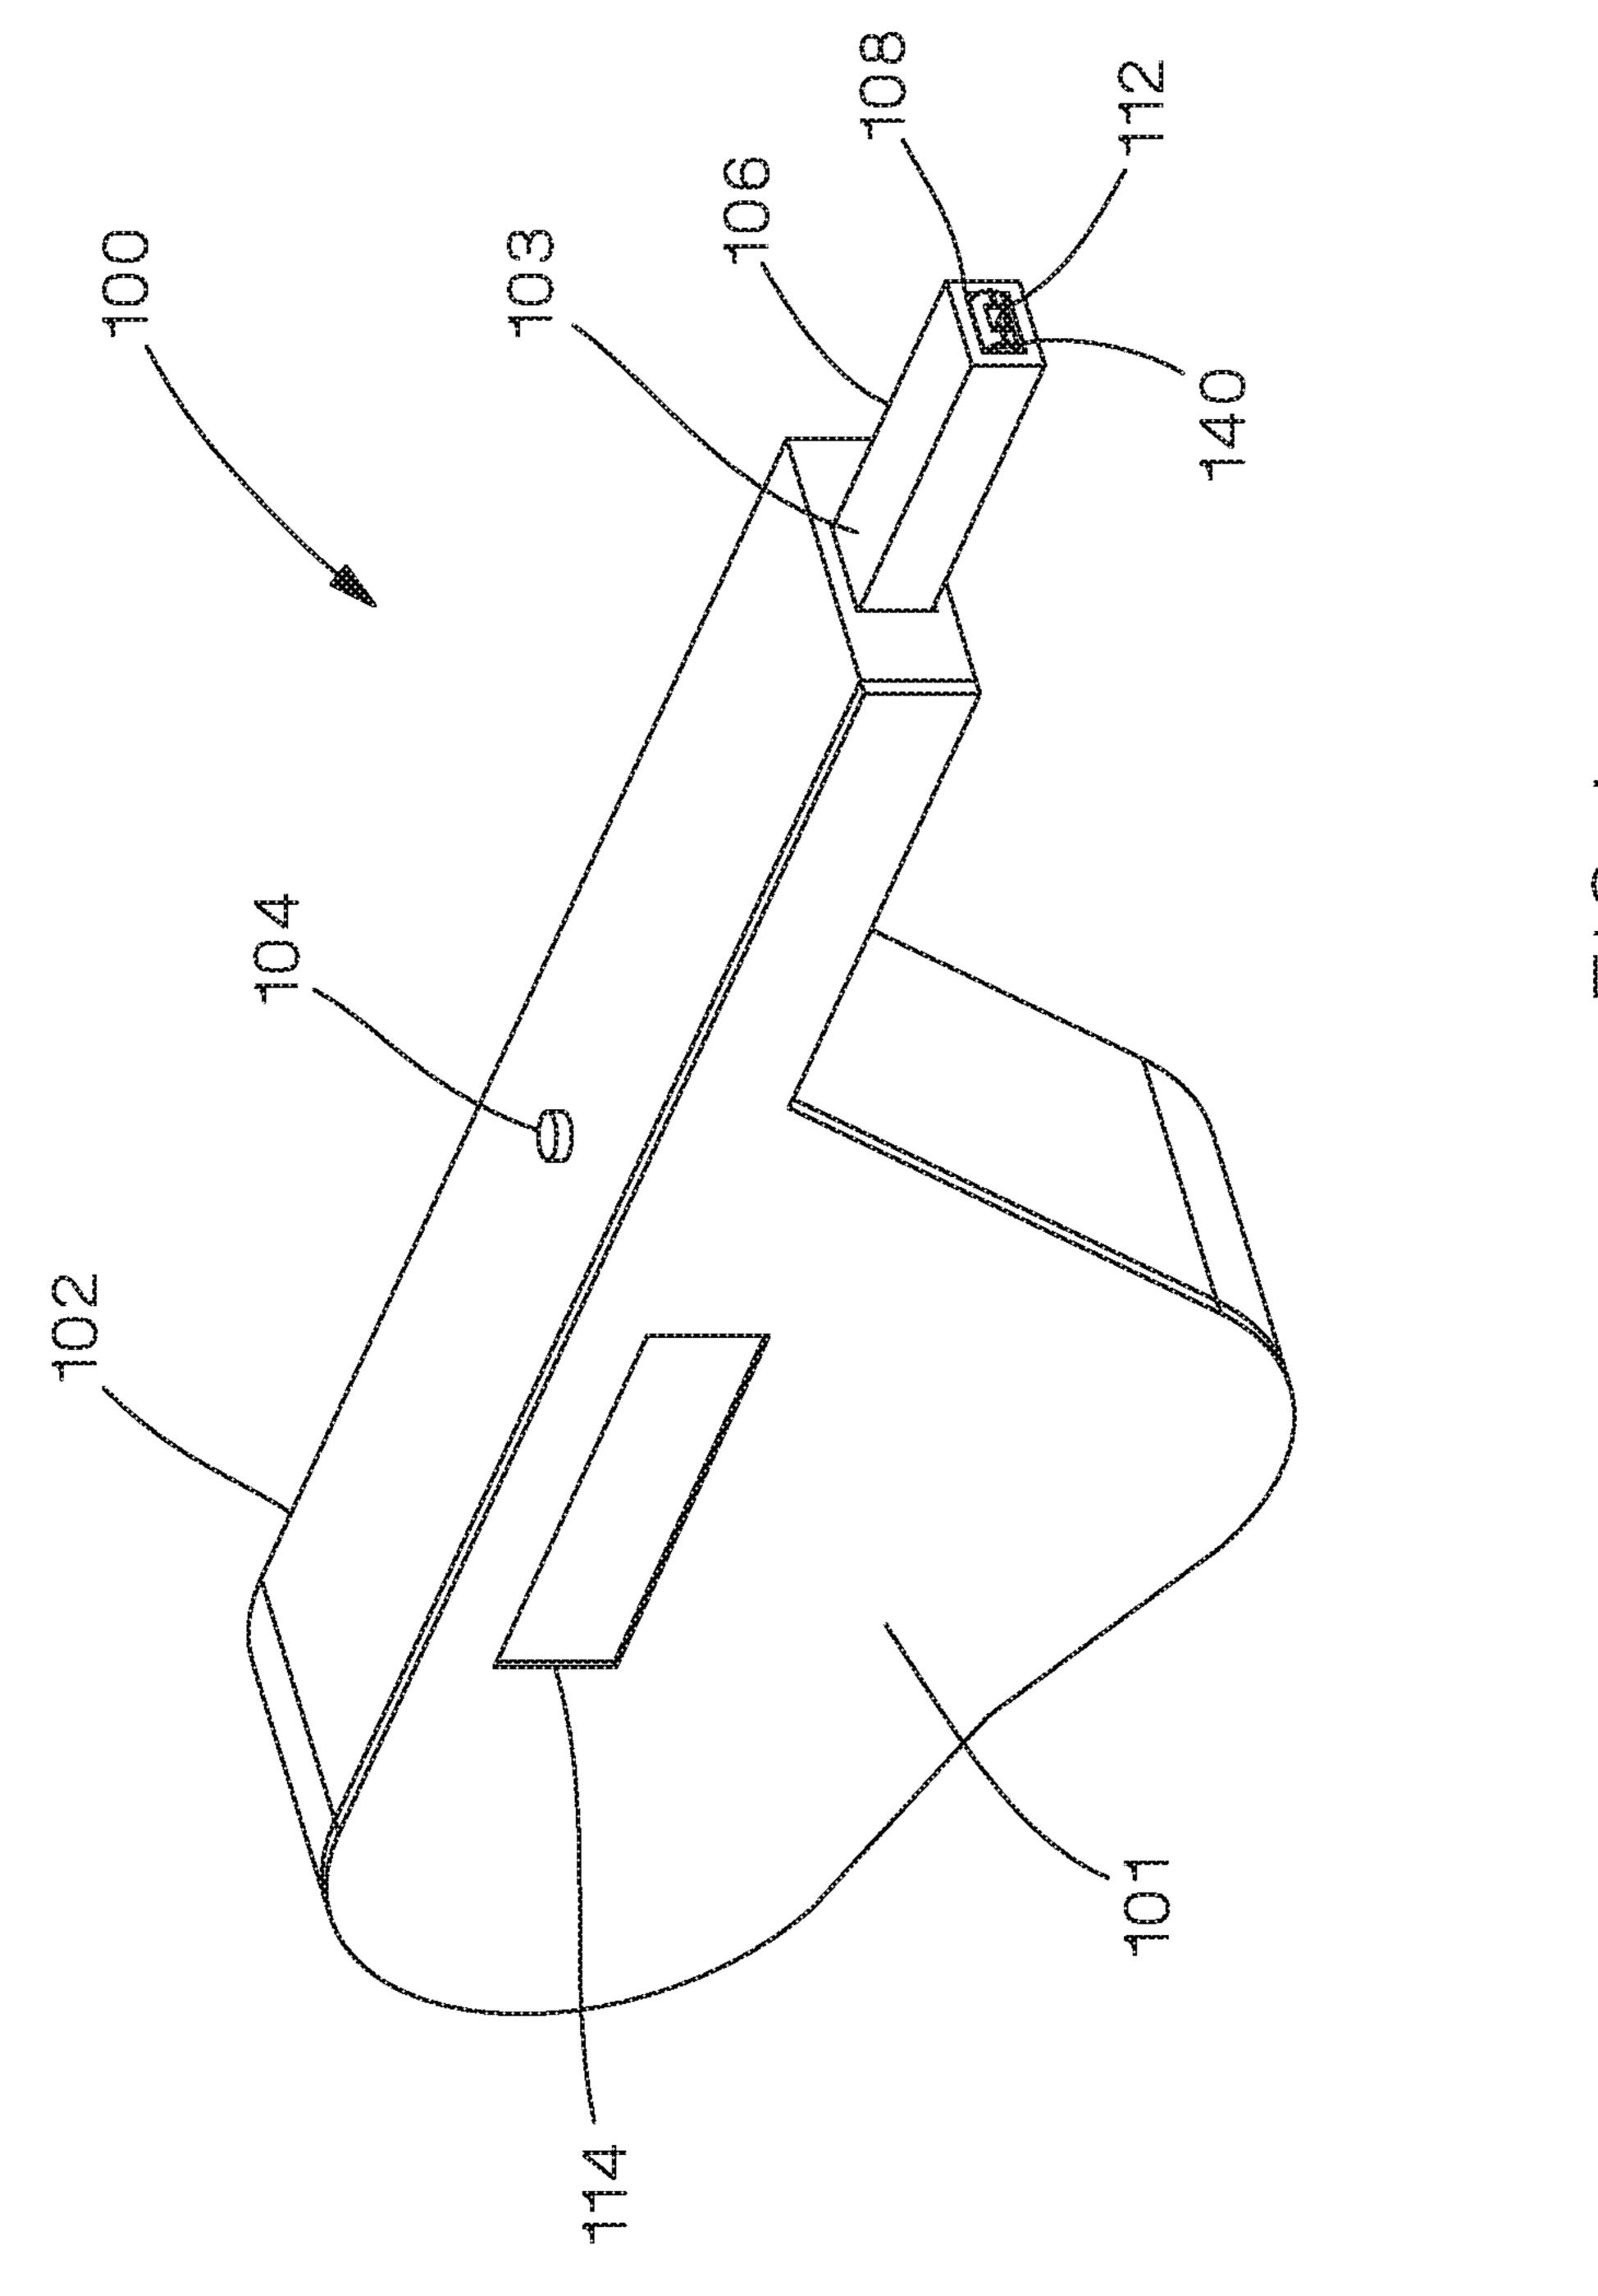
- FIG. 1 is a perspective view of a fiber optic inspection and cleaning tool, according to an embodiment of the present disclosure;
- FIG. 2 is a perspective view of the fiber optic inspection and cleaning tool shown in FIG. 1 having a side cover 50 removed to show at least some internal components included in the fiber optic inspection and cleaning tool;

FIGS. 1-11 disclose an exemplary fiber optic inspection and cleaning tool 100 according to an embodiment of the 10 present disclosure. The fiber optic inspection and cleaning tool 100 is configured to clean and inspect adapters 402, or an end-face 401 to a connector 400 that is behind such adapter 402, such as those in optical cassettes used in data centers or network patch panels.

The fiber optic inspection and cleaning tool 100 includes a housing 102, a left side cover 101, an indicator 104, a probe 106, a first aperture 108, a cleaning tape 140 surrounding a spindle 110 (seen in FIG. 2), a second aperture 112, and a third aperture 103. Optionally, the left side cover 20 101 includes a window 114, made from a transparent material such as glass or transparent polymer, to see the internal components and mechanisms of the fiber optic inspection and cleaning tool 100. The fiber optic inspection and cleaning tool 100 may also optionally include a communication 25 device for communicating with other devices wirelessly.

The housing 102 of the fiber optic inspection and cleaning tool 100 may be shaped and sized to be held in the hand of an installer. The probe 106 extends out from the third aperture 103, which is an opening in the housing 102. The 30 first aperture 108 is an opening within the probe 106. The first aperture exposes a spindle 110 and a cleaning tape 140 to the connector end-face 401 or adapter 402 that is positioned to be imaged and/or cleaned by the fiber optic an opening within the spindle 110.

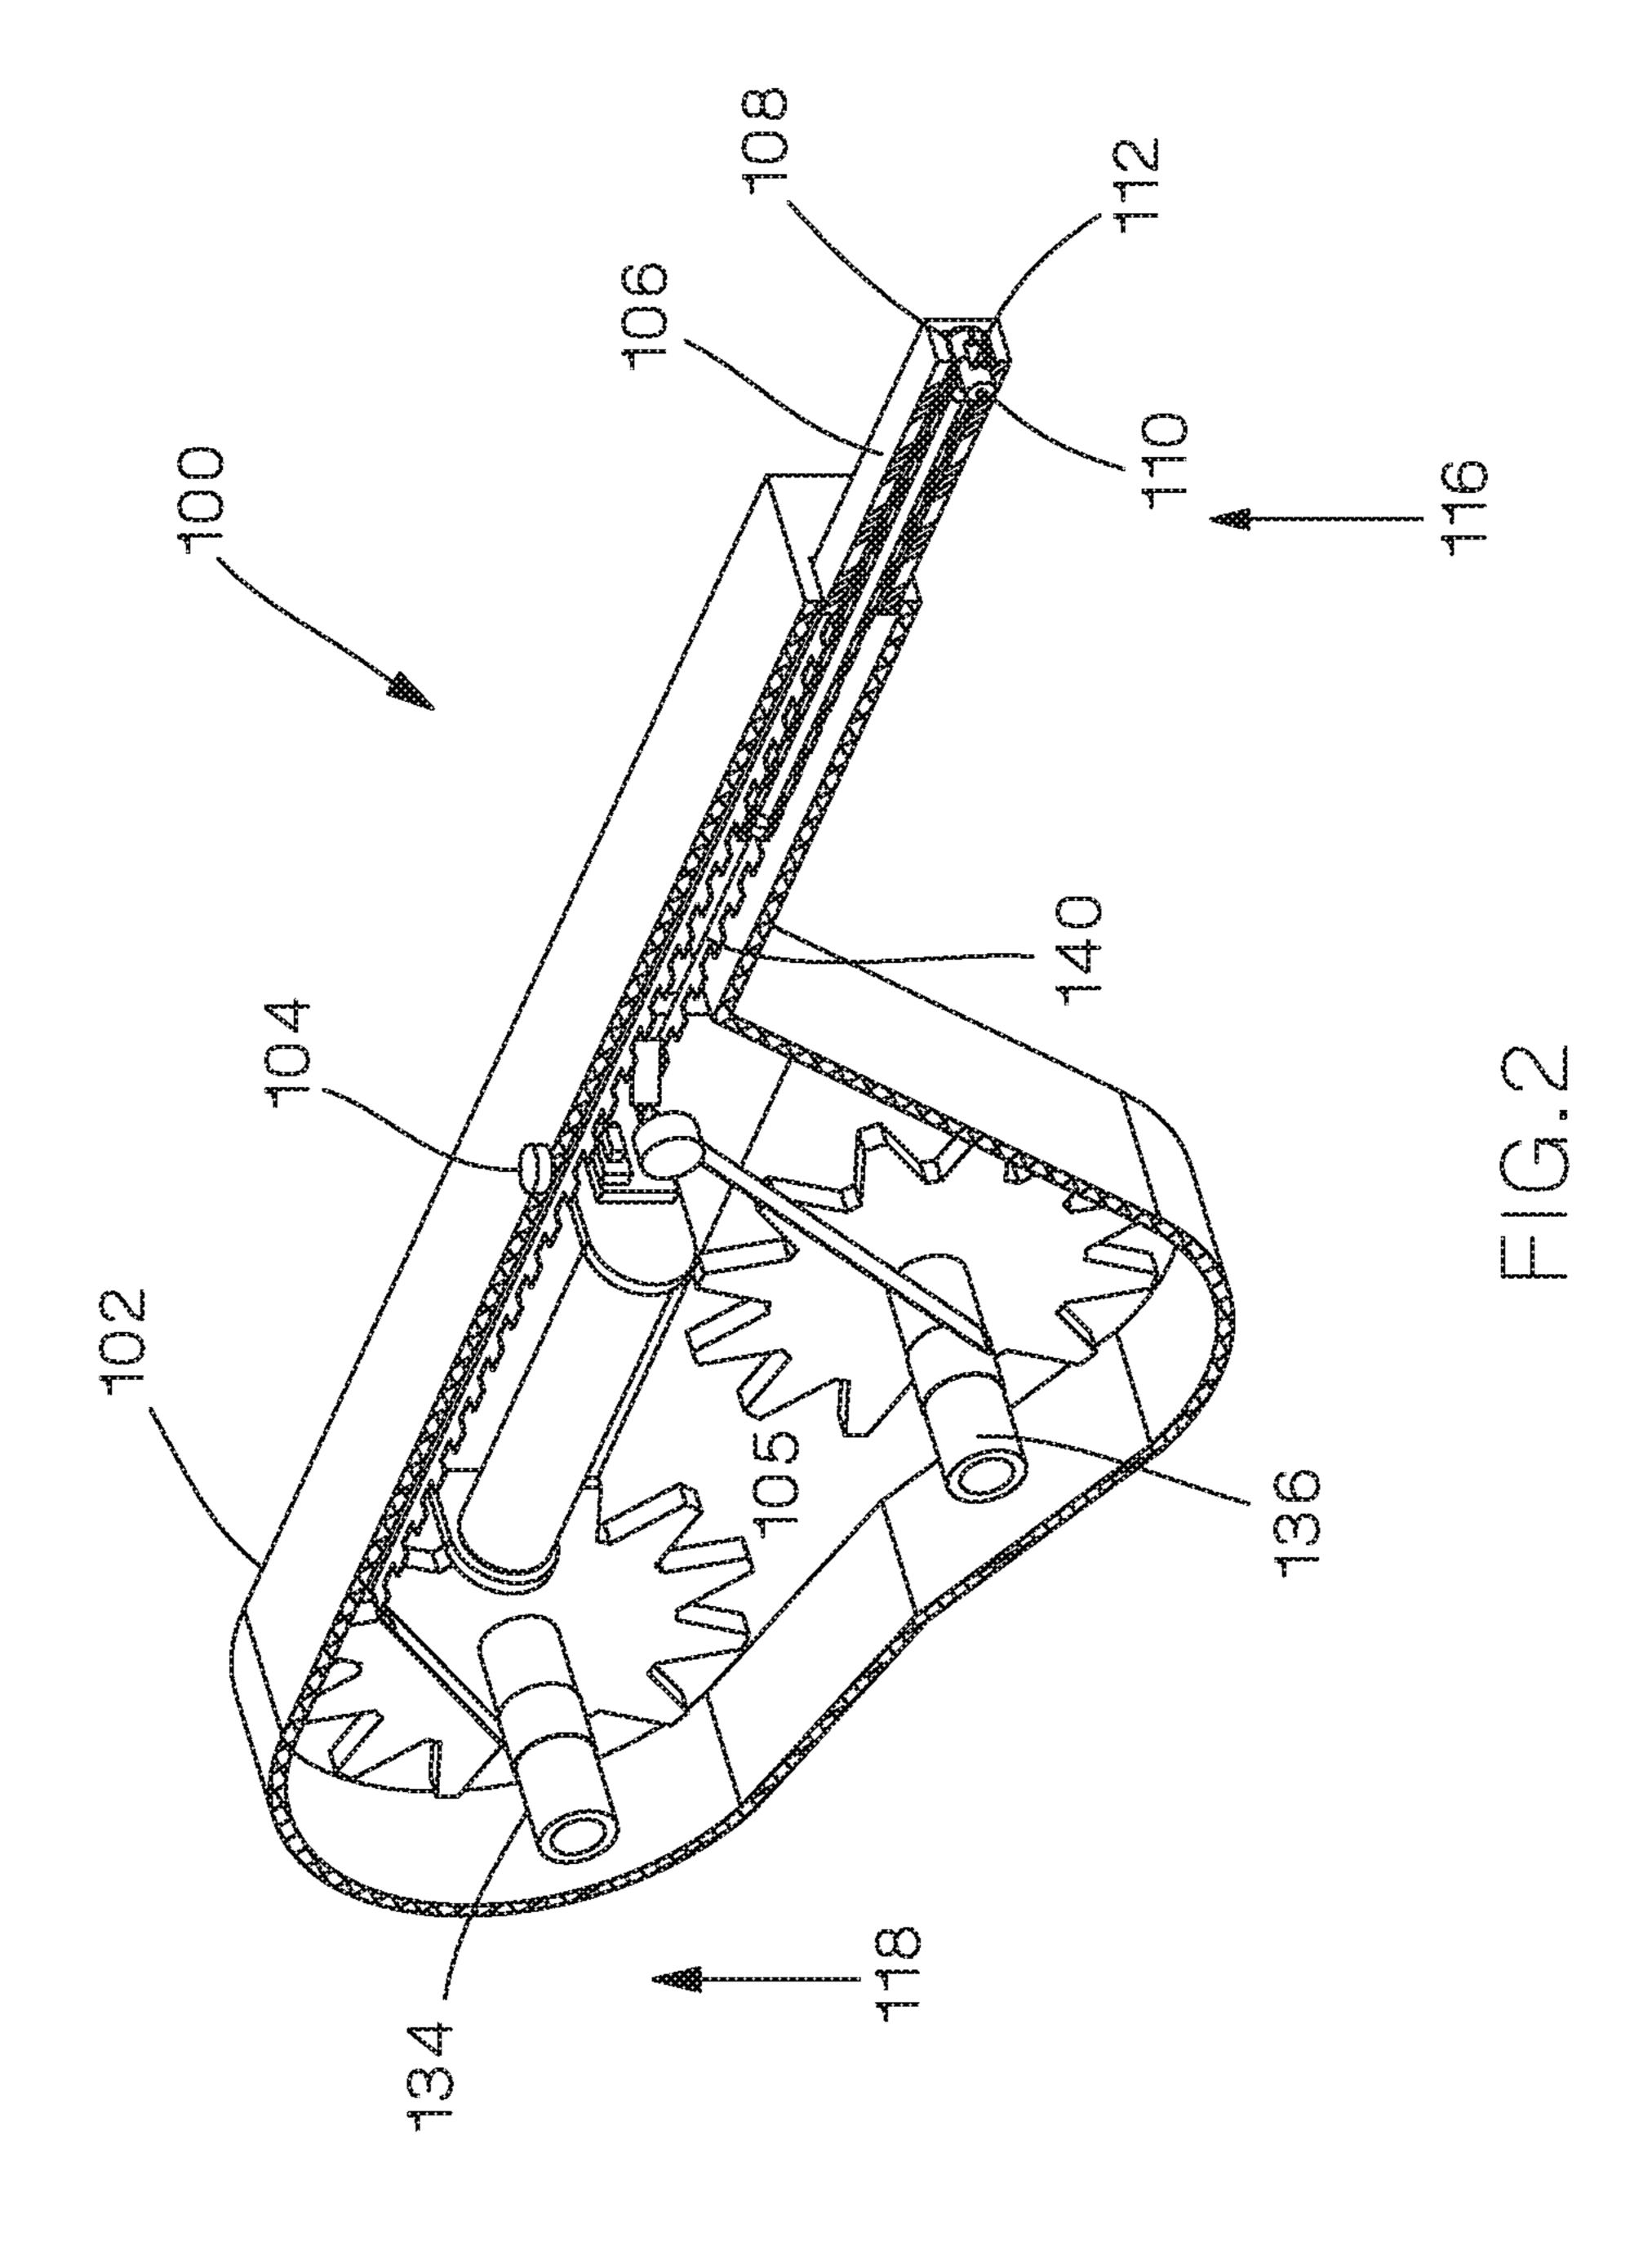
- FIG. 3 is a side view of the fiber optic inspection and cleaning tool shown in FIG. 2 having the side cover removed to show at least some of the internal components included in 55 the fiber optic inspection and cleaning tool;

FIG. 2 is a side view of the fiber optic inspection and cleaning tool 100 with the left side cover 101 removed to illustrate a view into the components and mechanisms within the housing 102. FIG. 3 is a side view of the fiber 40 optic inspection and cleaning tool 100 with the left side cover 101 removed to illustrate a view into the components and mechanisms within the housing 102. FIGS. 2 and 3 depict the fiber optic inspection and cleaning tool 100 having a front end 116, a back end 118, and a probe head 45 **132**. Additionally, within the housing **102** is a pay-off reel 134, a take-up reel 136, a right-side cover 105, and an imaging system 160. The cleaning tape 140 travels off the pay-off reel 134, around the spindle 110 and onto the take-up reel 136. The imaging system 160 includes a battery 164, an 50 imaging device 162, computing system 166, a light source 168, a first lens 170 and a second lens 172. The second lens 172 may be located towards the front end 116 of the fiber optic inspection and cleaning tool 100. The first lens 170 may be located between the second lens 172 and the imaging 55 device 162. Although only two lenses are shown in the figure, one or more optical surfaces may be placed in between those lenses to correct for chromatic, spherical or other types of aberrations. The same set of lenses, namely the first lens 170 and the second lens 172, direct the light 60 reflected from the connector 400 back to the imaging device 162. The imaging device 162 may include additional lenses or filters to improve the quality of the captured image.

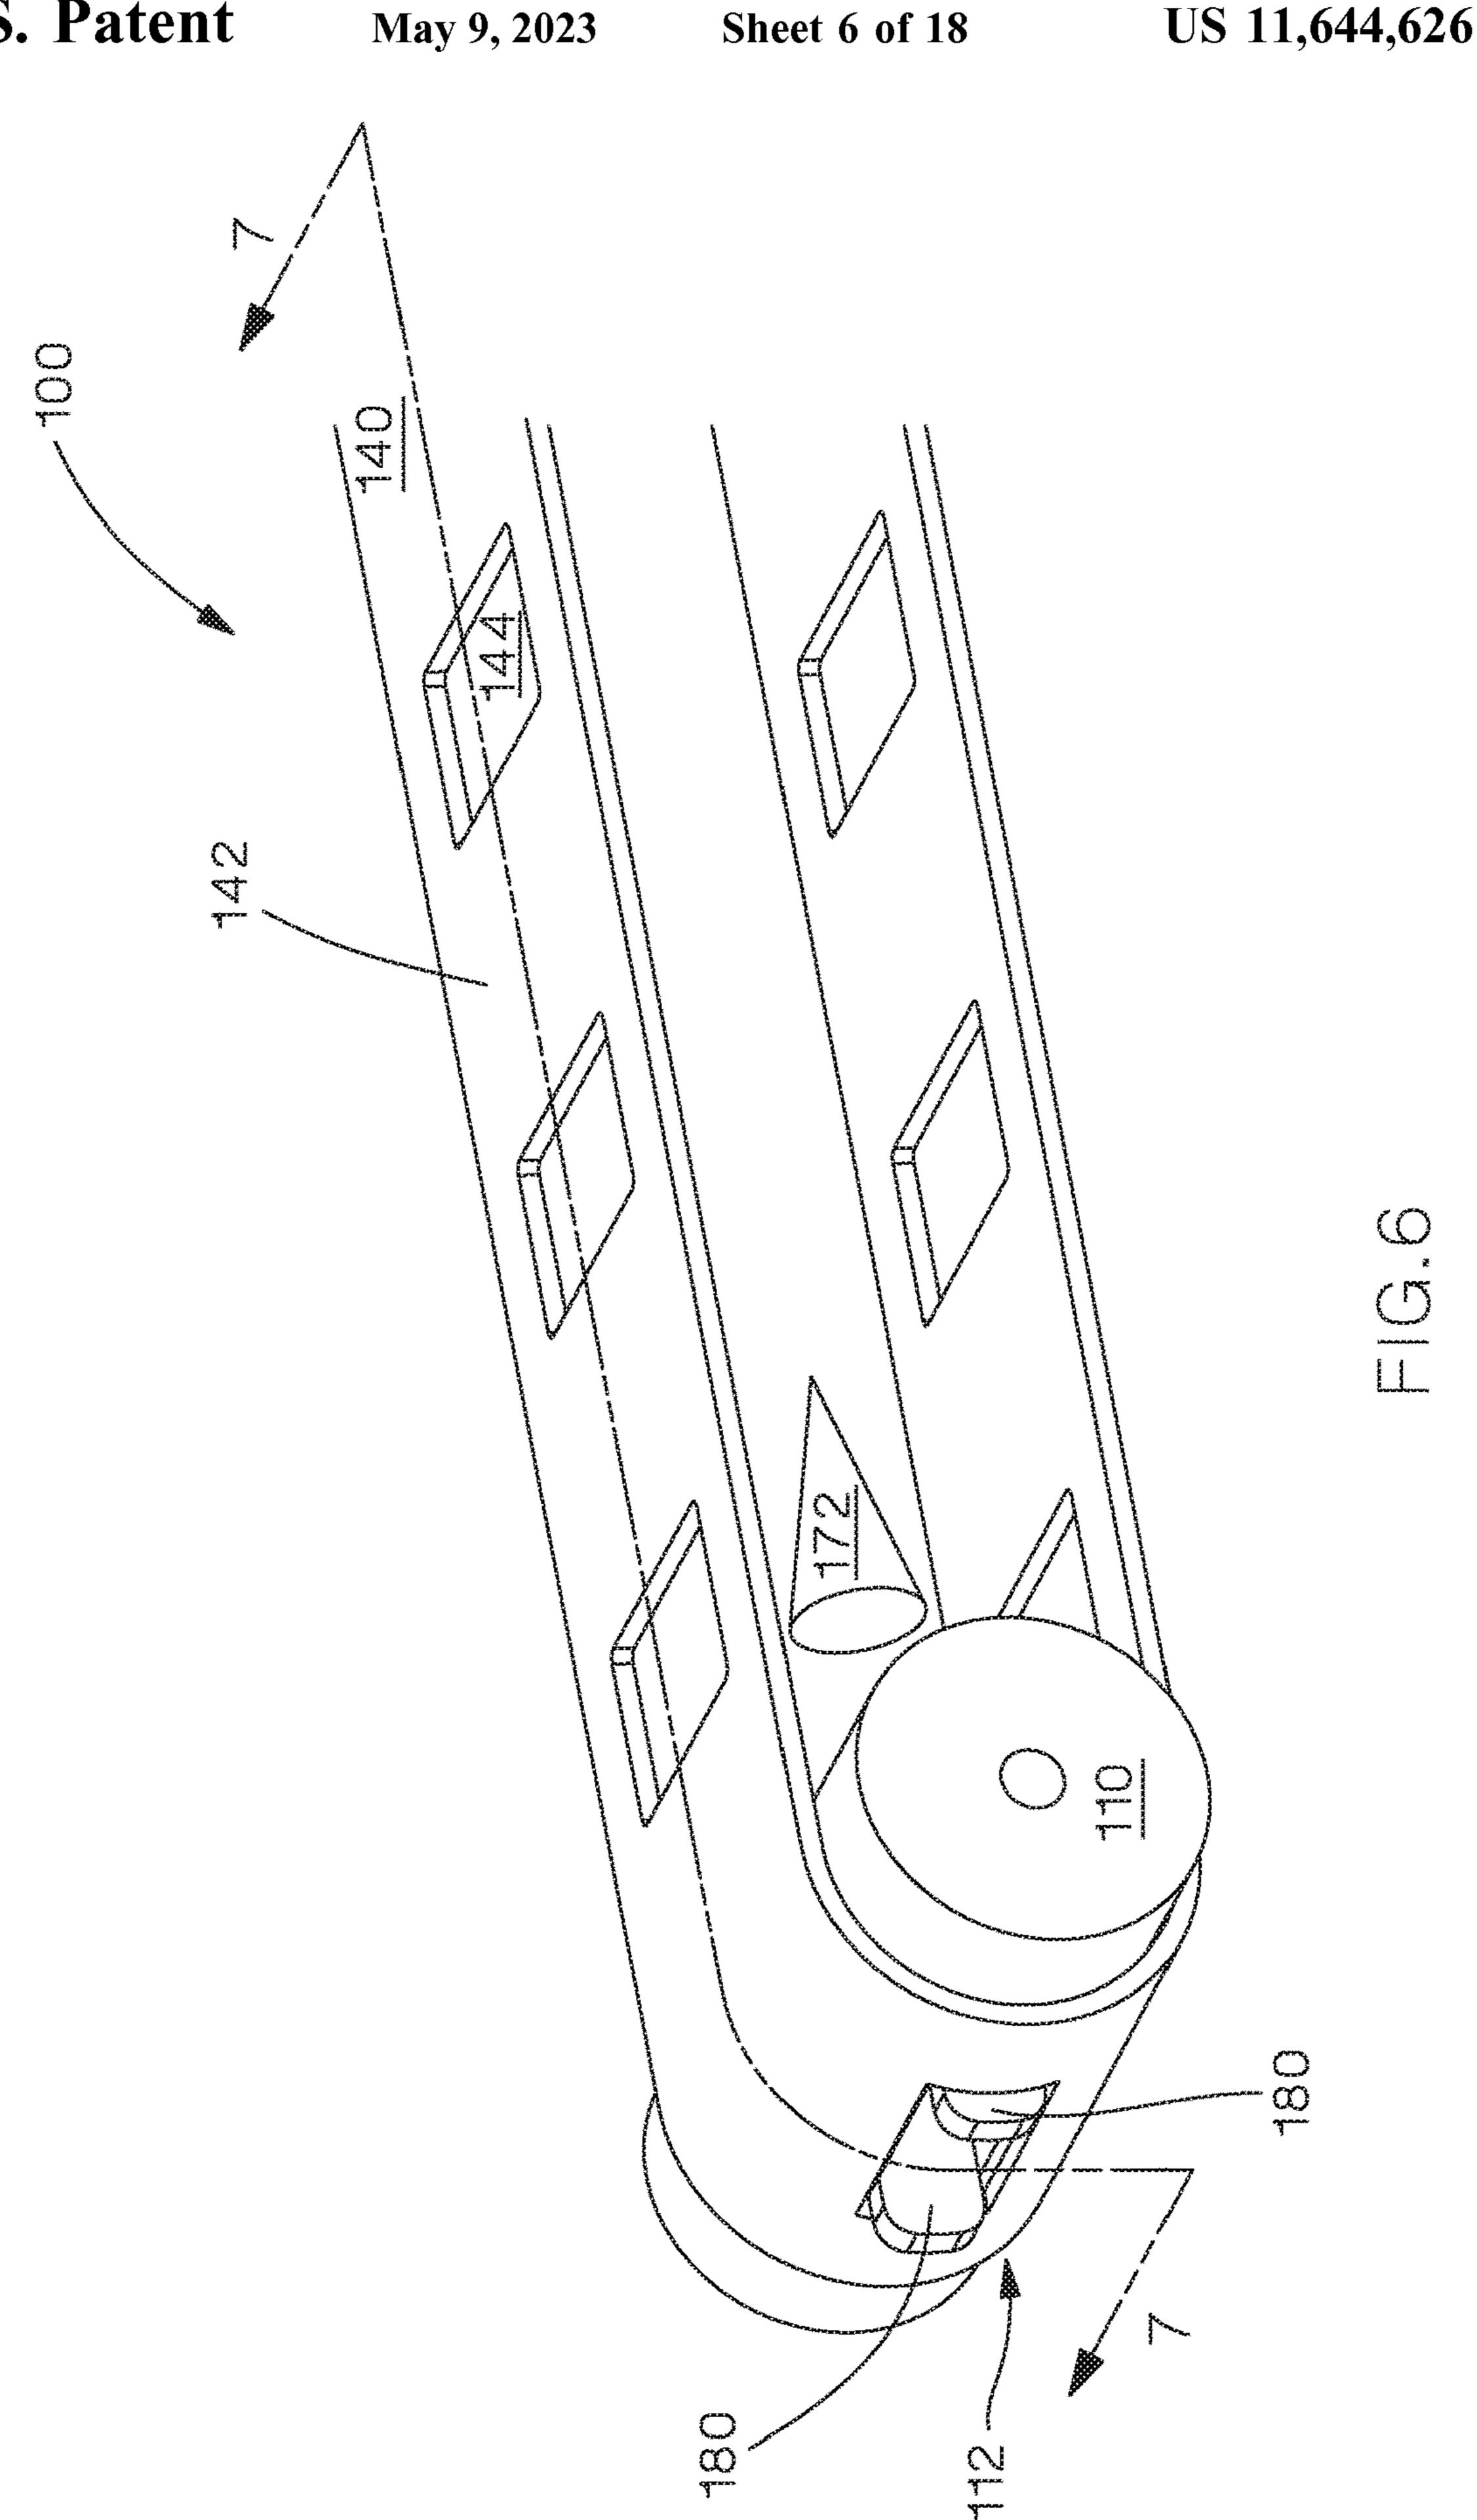
- FIG. 7 is a sectional view of the internal components of the fiber optic inspection and cleaning tool taken along line 7-7 shown in FIG. 6.
- FIG. 8 is a side view of the fiber optic inspection and cleaning tool shown in FIG. 1 having an imaging system removed, according to an embodiment of the present disclosure;

FIGS. 6 and 7 show the interaction of the spindle 110 with the segmented cleaning tape 140 of the fiber optic inspection and cleaning tool 100, where FIG. 7 shows a cross-sectional view of the fiber optic inspection and cleaning tool 100 taken along line 7-7 from FIG. 6. As the cleaning tape 140 advances to rotate around the spindle 110, the spindle 110 correspondingly rotates so that the spindle tabs 180 catch the windows 144 of the cleaning tape 140.

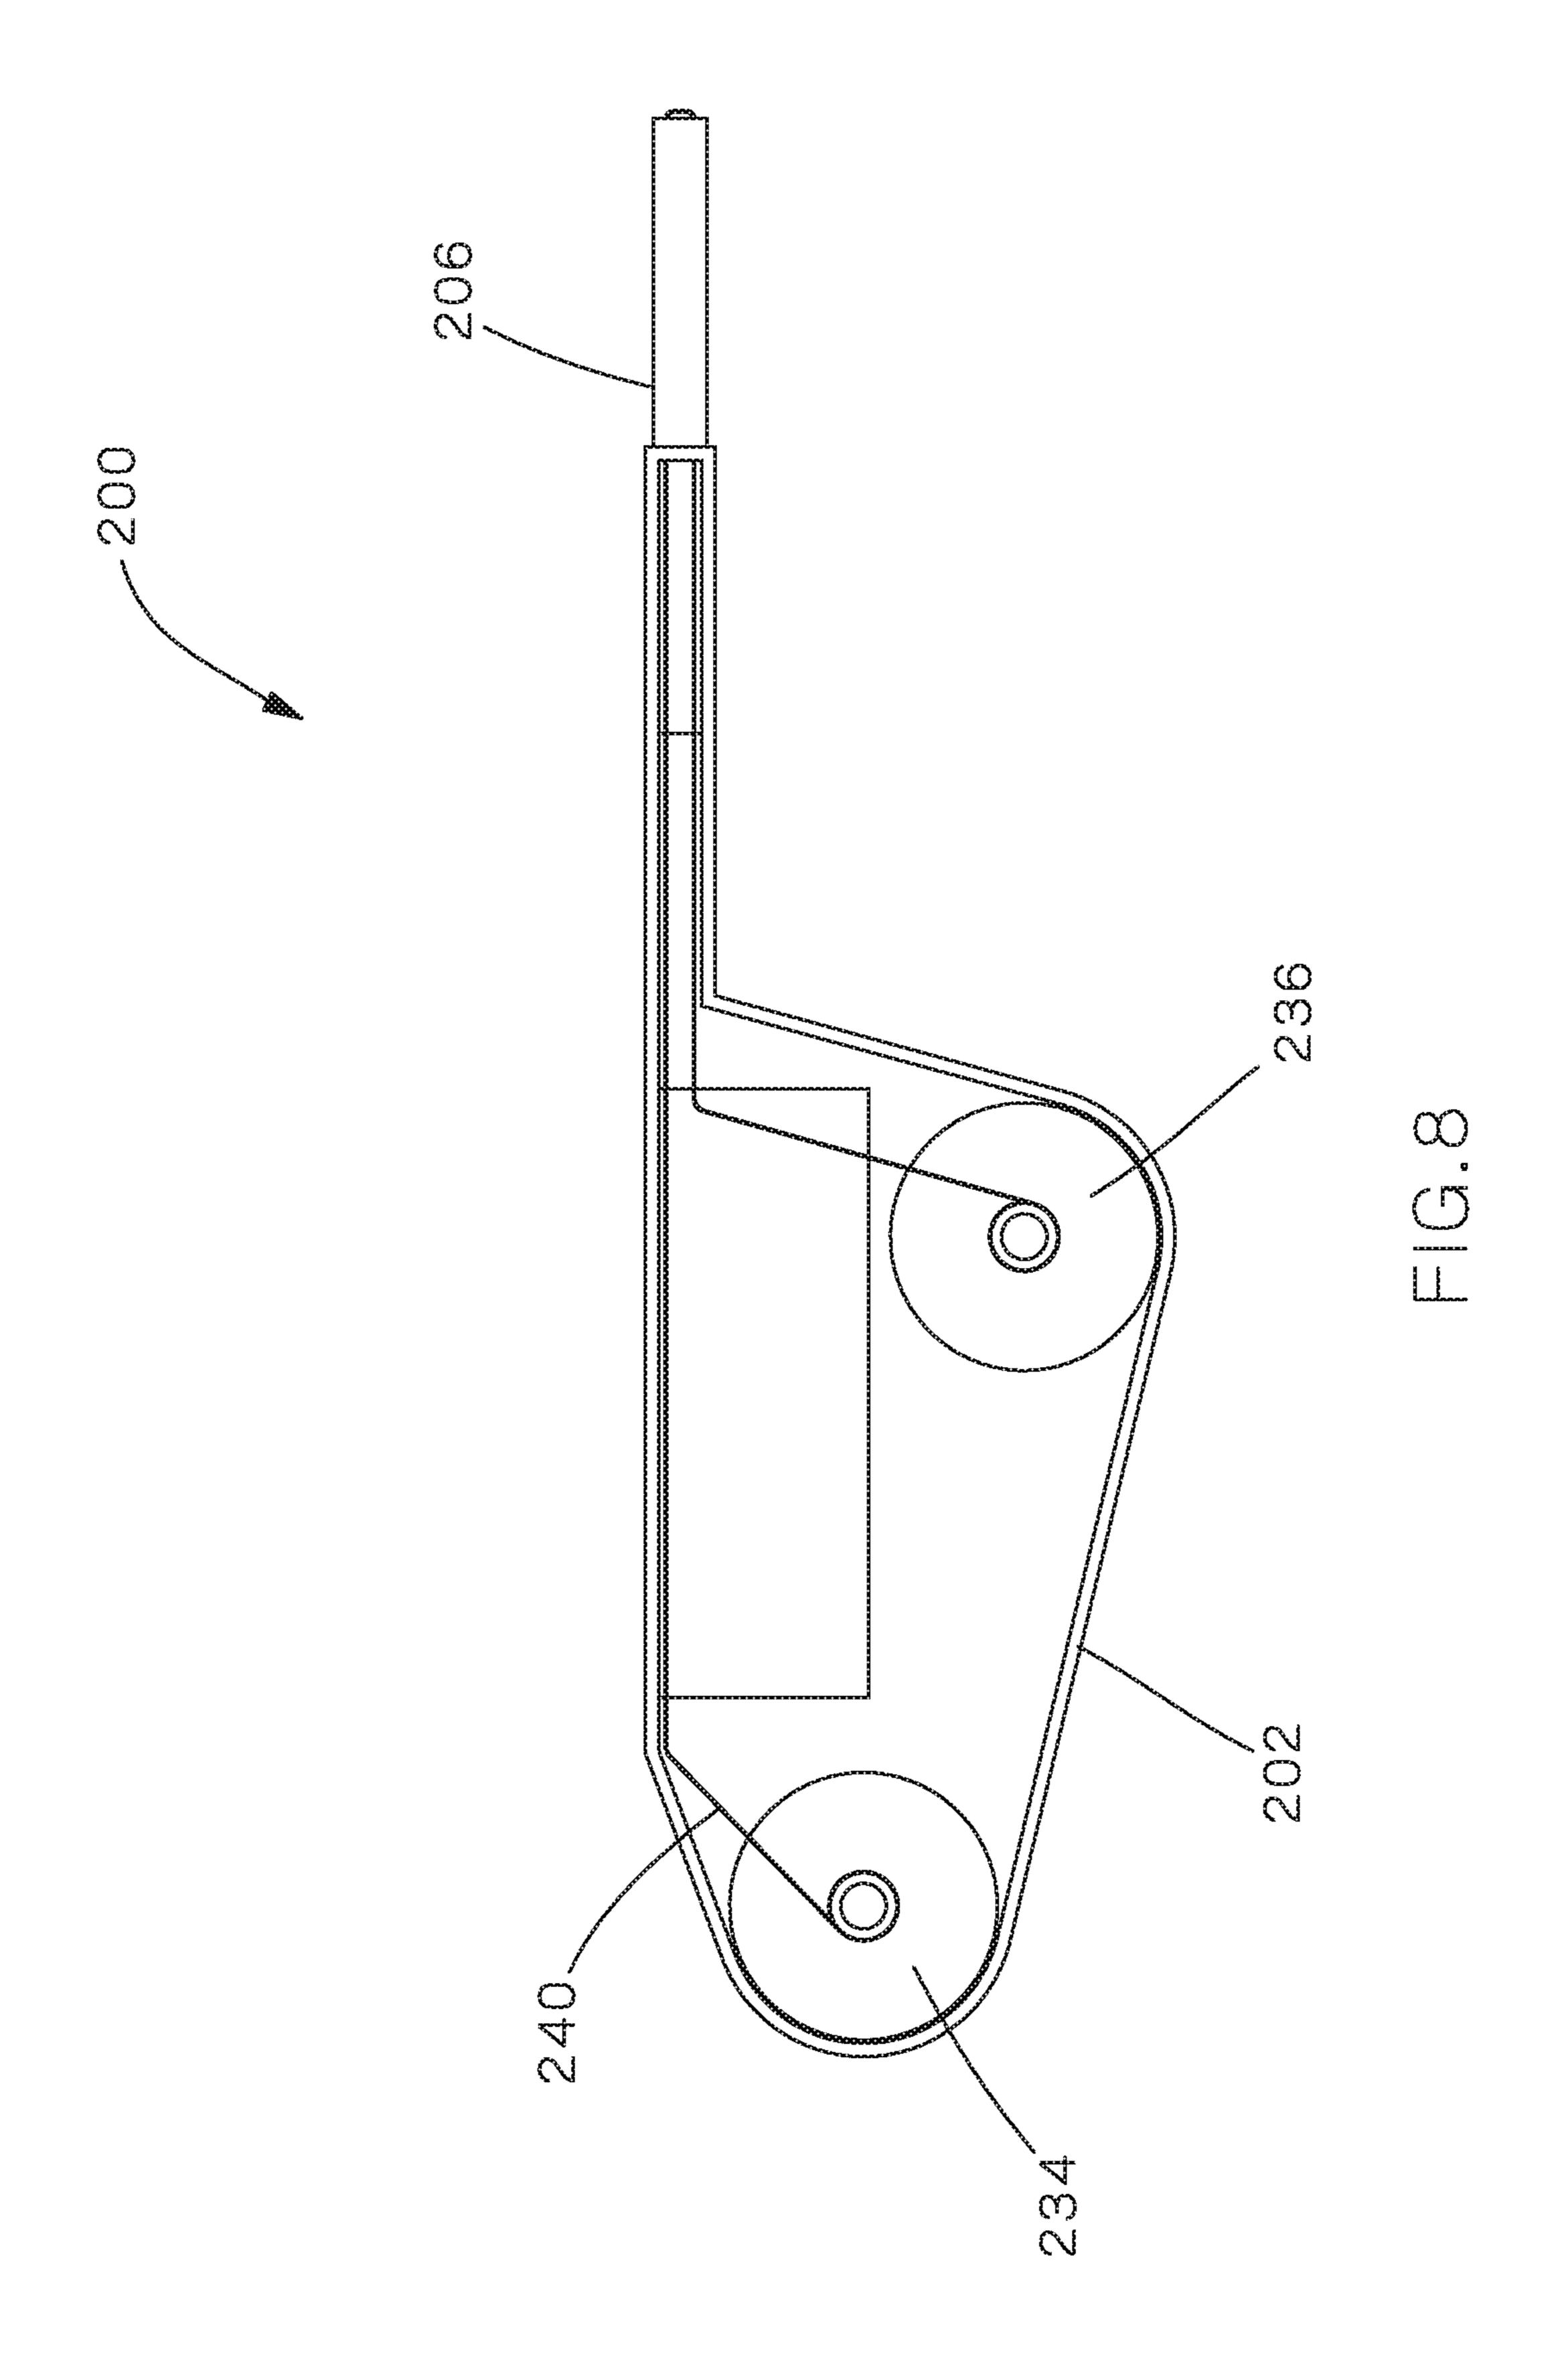
- FIG. 9 is a side view of the fiber optic inspection and cleaning tool shown in FIG. 7 with the imaging system included;
  - FIG. 10 is a front view of the fiber optic inspection and cleaning tool shown in FIG. 1 with a probe in an extended state;

FIGS. 8 and 9 depict an alternate embodiment where the most expensive components of a fiber optic inspection and cleaning tool 200 are detachable and reusable. FIG. 8 depicts all the components that may be discarded, such as a housing 202, a used tape 240, a pair of reels 234 and 236, and a probe 206. FIG. 9 depicts the reusable optical and electrical 30 components. The reusable components include an imaging system 260, internal structure 230 (housing lenses that are not depicted in FIG. 9), light source 268, and indicator 204. The imaging system 260 includes a battery 264, electronics/processors 266, and imaging device 262.
