# (10) Patent No.: US 11,644,626 B2

# (54) FIBER OPTIC INSPECTION TOOL WITH INTEGRATED CLEANING MECHANISM

(71) Applicant: Panduit Corp., Tinley Park, IL (US)

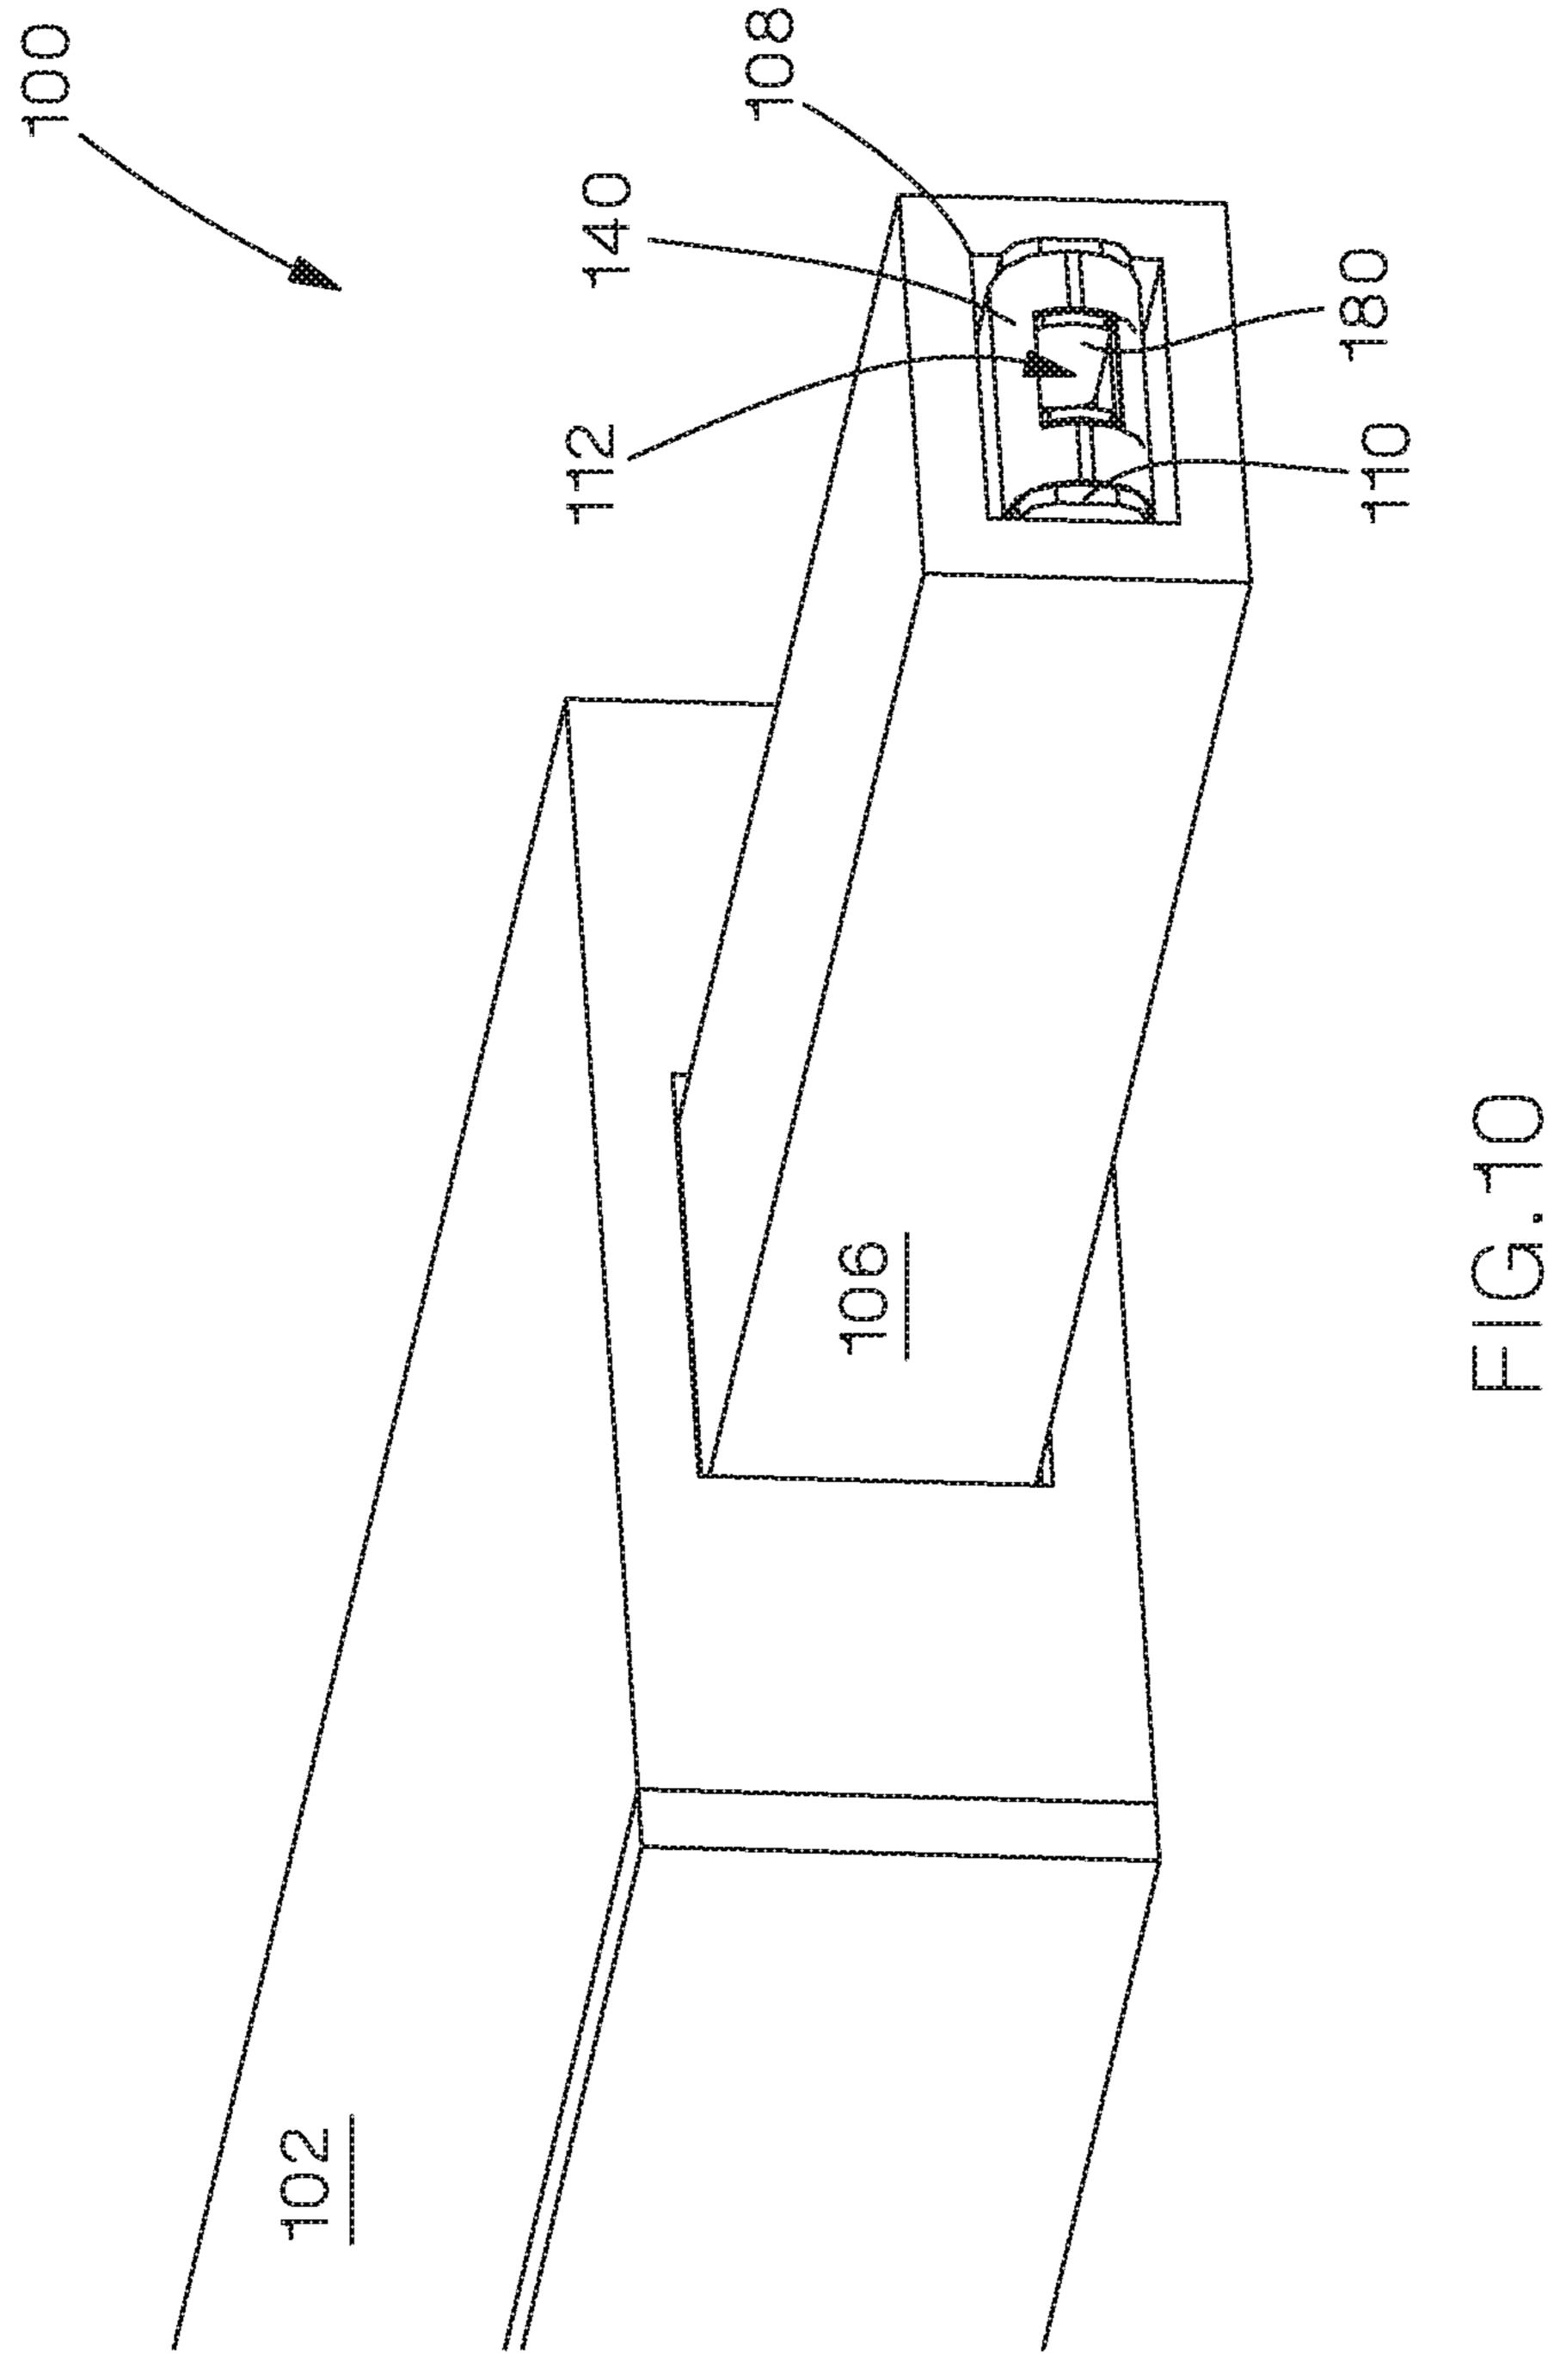
- FIG. 11 is a front view of the fiber optic inspection and cleaning tool shown in FIG. 1 with the probe in a retracted state;
  - FIG. 12 is a top down view of a fiber optic inspection and cleaning tool having a top cover removed to show at least some internal components, according to an alternative embodiment of the present disclosure;

In addition or alternatively, FIGS. 10 and 11 show a mechanism by which the cleaning tape 140 advances. FIG. 10 shows a perspective view of a portion of the front end 116 of the fiber optic inspection and cleaning tool 100 when the probe 106 is in an extended state. FIG. 11 shows a perspective view of a portion of the front end 116 of the fiber optic inspection and cleaning tool 100 when the probe 106 is in a retracted state. When the probe 106 is pressed against the adapter/connector under test, the probe 106 retreats into the housing 102, and causes the cleaning tape 140 to shift. The retreat of the probe 106 is shown in FIG. 11, however the movement of the cleaning tape 140 is not portrayed in FIG. 11.

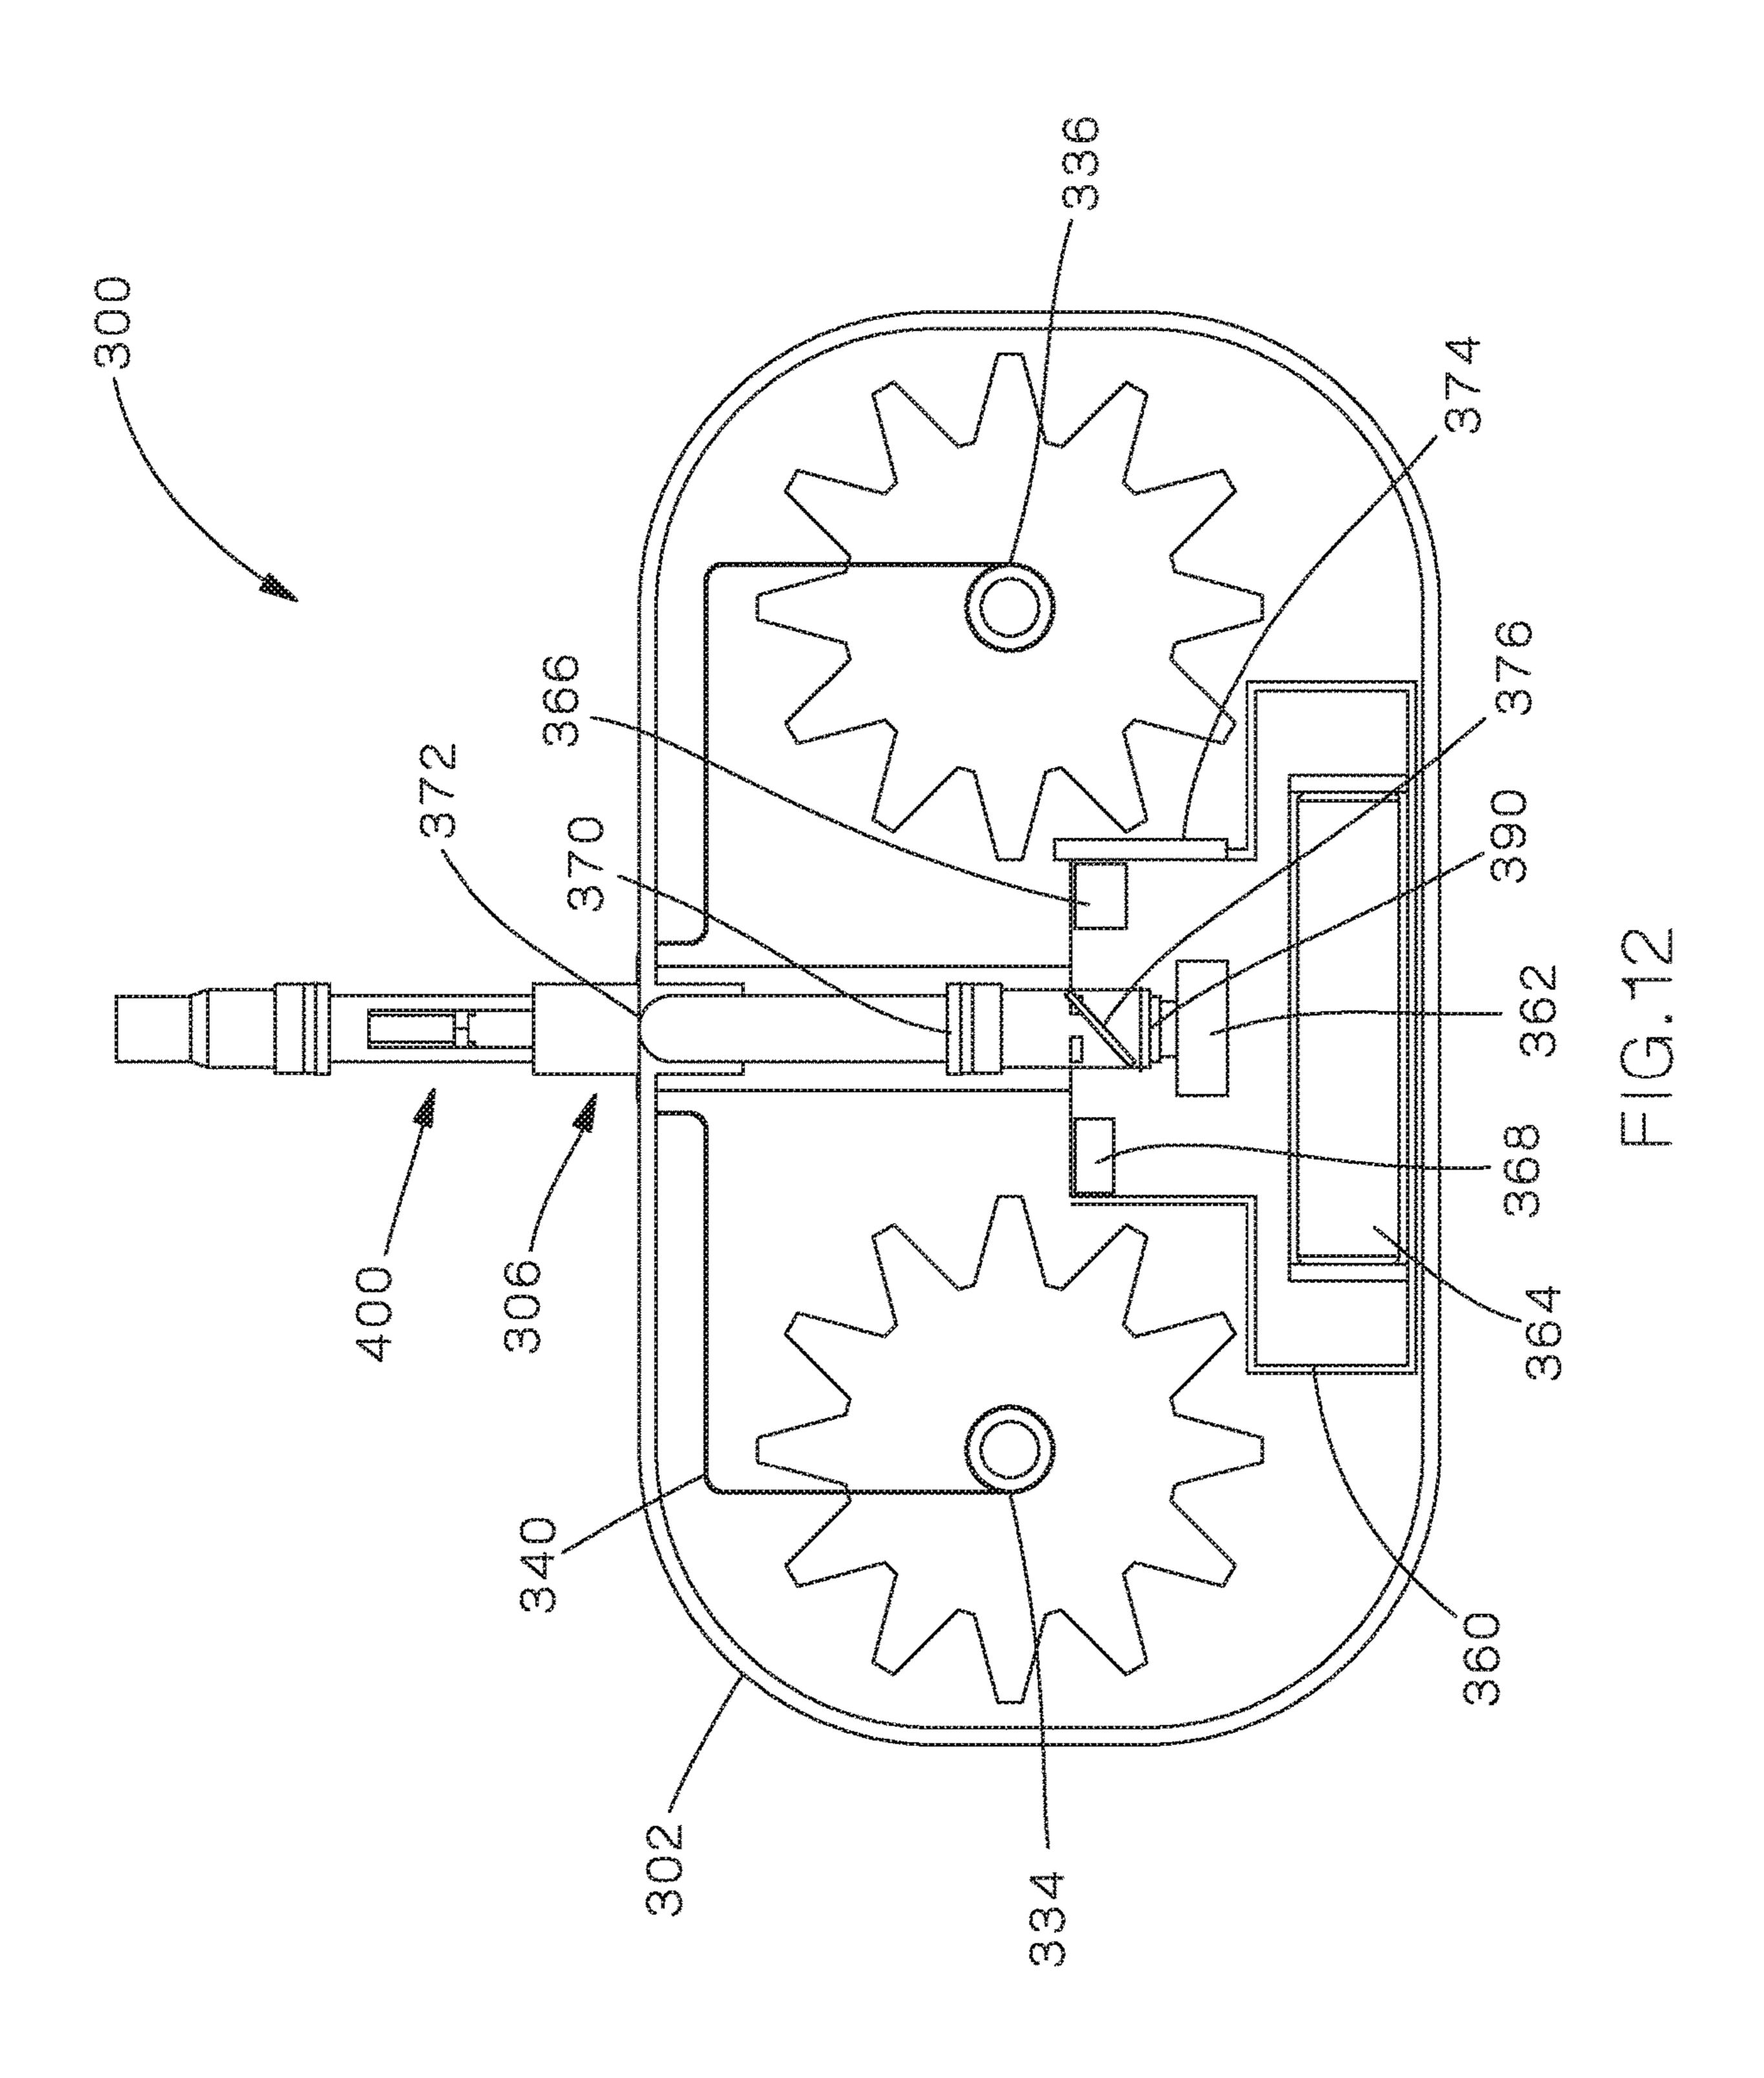
- FIG. 13 is a perspective view of the fiber optic inspection and cleaning tool shown in FIG. 12;
  - FIG. 14 is a side view of a fiber optic inspection and cleaning tool having a side housing removed to show at least some internal components, according to an alternative embodiment of the present disclosure;

FIGS. 12 and 13 disclose another exemplary fiber optic inspection and cleaning tool 300 according to an alternative embodiment of the present disclosure. The fiber optic inspection and cleaning tool 300 is used to clean and inspect connectors and connector end-faces, such as from connector 40 400, from patch cords, interconnects or cable trunks. The features and main functionalities of the fiber optic inspection and cleaning tool 300 are similar to those in the fiber optic inspection and cleaning tool 100.

The fiber optic inspection and cleaning tool **300** includes 45 a housing 302, an adapter 306, an imaging system 360, a pay-off reel 334, a take-up reel 336, and a cleaning tape 340. The imaging system 360 incudes a battery 364, a light source 368, an imaging device 362, a lens/filter 390, a first lens 370, a second lens 372, an absorber 374, electronics/ 50 processors 366, and a beam splitter 376. An adapter 306 is used in place of a probe in order to receive the connector 400. The cleaning tape 340 is similar to the cleaning tape **140** and includes windows to provide an opportunity for the camera to view the end face of the connector. A spindle 310 can be seen in FIG. 13 having a vertical configuration, rather than a horizontal configuration like spindle 110. Optionally, the fiber optic inspection and cleaning tool 300 may include an indicator (not shown). As noted above, the functionalities of each feature of the fiber optic inspection and cleaning tool 60 **300** are similar to the functionalities of the features of the fiber optic inspection and cleaning tool 100.

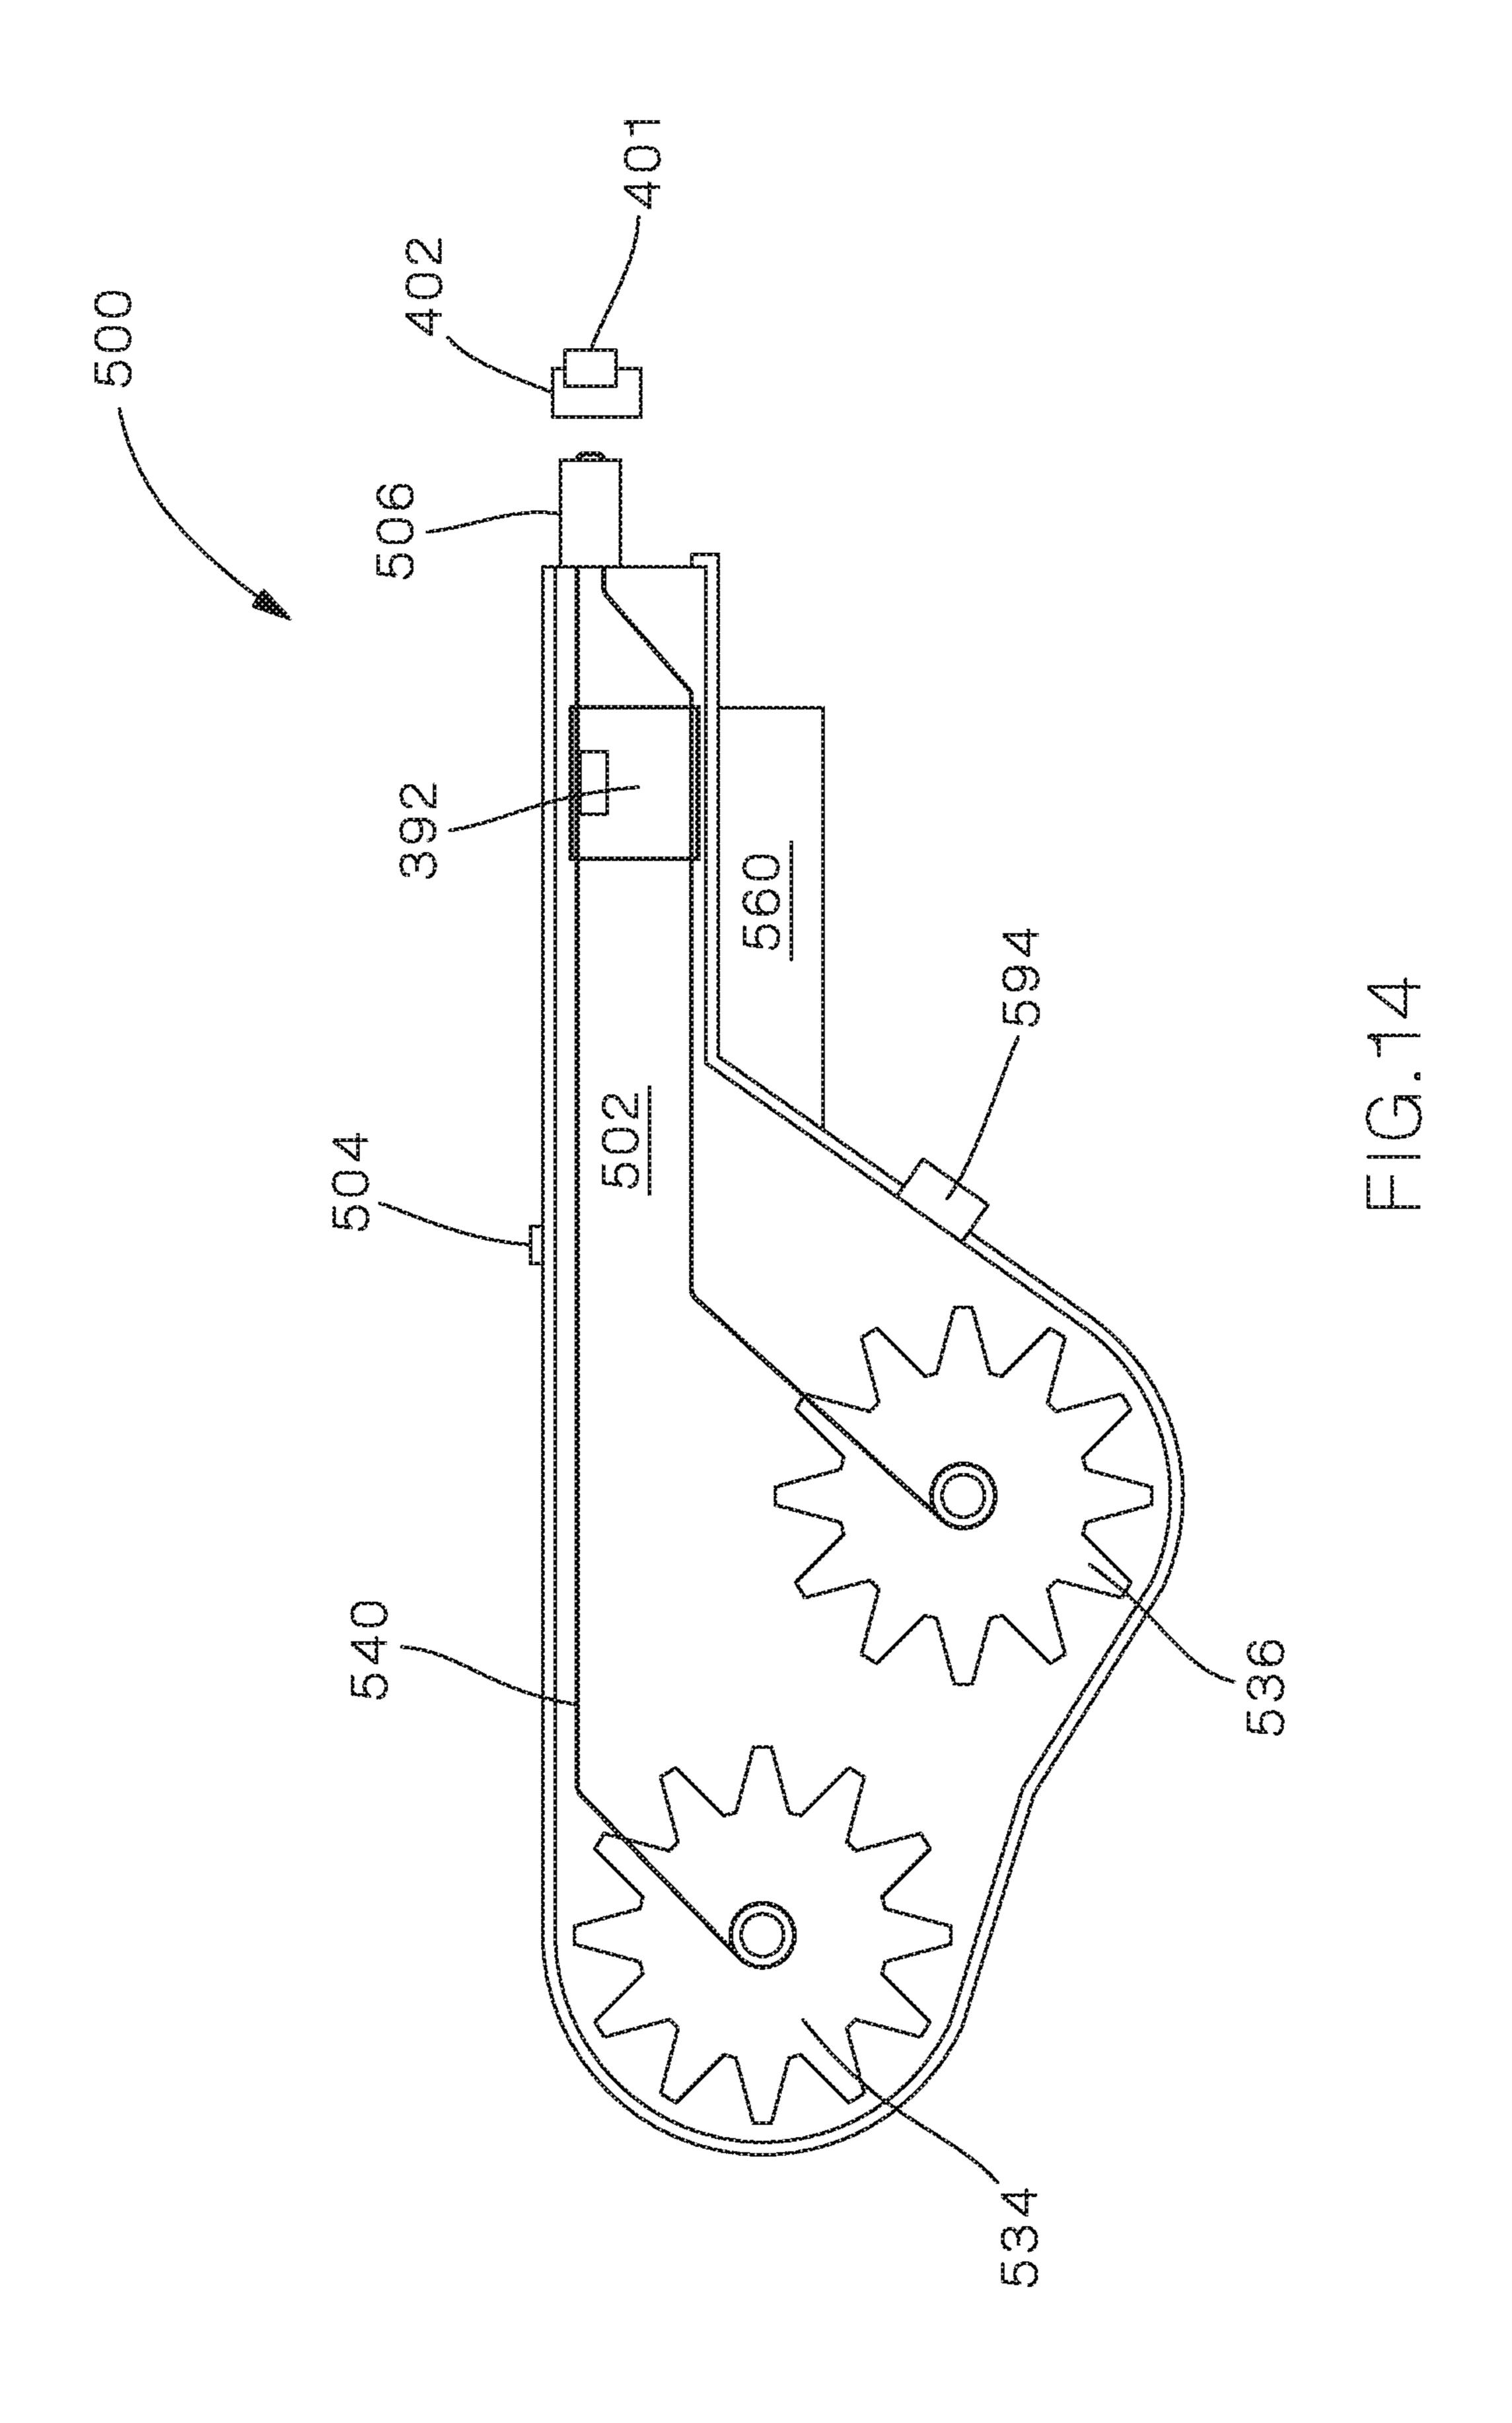
- FIG. 15 is a top view of a portion of the fiber optic inspection and cleaning tool shown in FIG. 14
  - FIG. 16 is a top view of an imaging system component of the fiber optic inspection and cleaning tool shown in FIG. 15;

FIGS. 15 and 16 are top views of a portion of the example fiber optic inspection and cleaning tool 500 demonstrating the configuration of imaging system **560**. FIG. **15** shows a view of the fiber optic inspection and cleaning tool 500 absent a top cover and the top portion of the cleaning tape **540** (the portion coming off pay-off reel **534**). What is shown in FIG. 15 is the portion of the cleaning tape 540 after it come off spindle 510 (seen in FIG. 17A) and is on its way to take-up reel **536**. FIG. **15** depicts the imaging system **560** connecting into the housing 502 between the probe 506 and the take-up reel 536. The imaging system 560 includes a battery 564, a light source 568, an imaging device 562, electronics/processors 566, a beam splitter 576, a light absorber 574, a mirror 594, and a lens 570. The lens 570 may include more than one lens. The battery **564** may be changed as needed. The cleaning tape **540** includes cleaning sections 542 and windows 544. FIG. 16 depicts an indicator 504 located toward the rear of the imaging system 560, located on top of the imaging system **560**. Alternatively, the indicator 504 may be located directly on the housing 502.

As can be seen from FIGS. 15 and 16, when viewed from above the imaging system **560** forms an "L" shape. An attachment section **596** is a portion of the imaging system **560** furthest away from the light source **568** in the direction the light travels (towards the housing **502**).

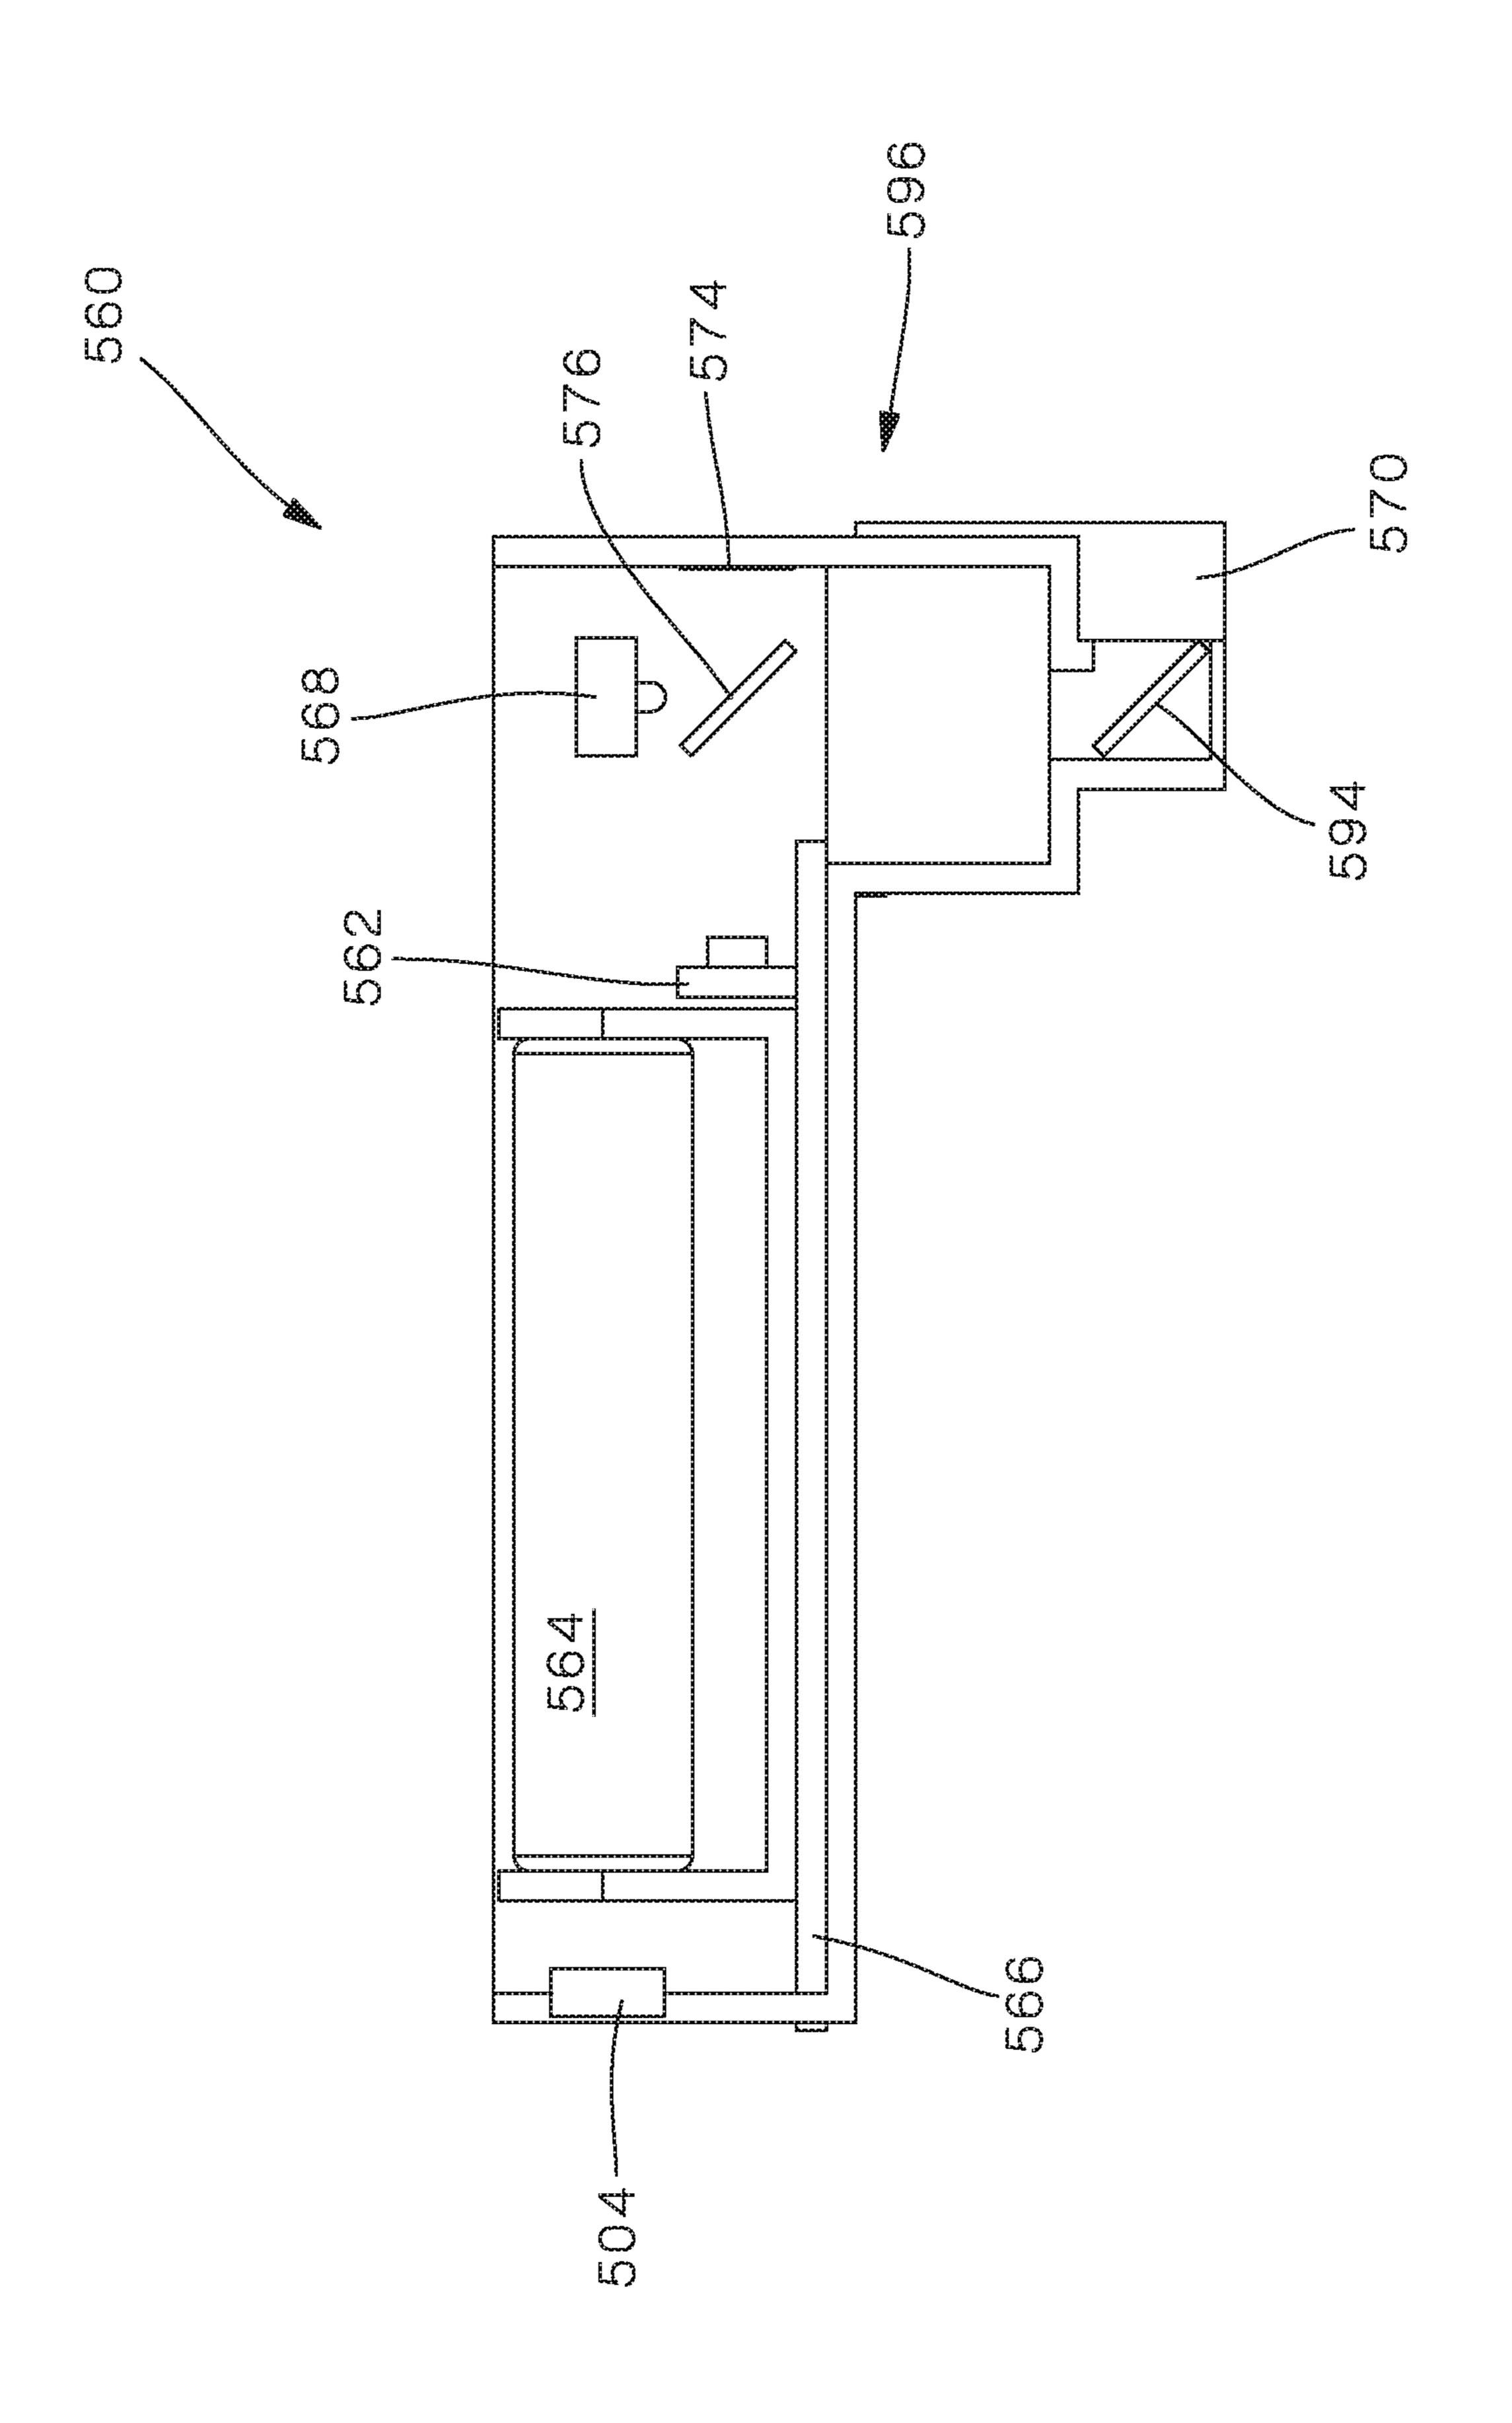
- FIG. 17A is a view showing the imaging system and cleaning system separated of the example fiber optic inspection and cleaning tool shown in FIG. 14; and

FIG. 17A is a view showing the imaging system and 40 cleaning system separated of the example fiber optic inspection and cleaning tool **500**, and FIG. **17**B is a view showing the integrated imaging system and cleaning system of the fiber optic inspection and cleaning tool 500. An arrow 598 in FIG. 17A shows the movement of the imaging system 560 45 in order to connect with the housing 502 of the cleaning portion of the fiber optic inspection and cleaning tool 500. As imaging system 560 connects with the housing 502, the attachment section 596 goes into attachment section 592, and lens 570 is in line with spindle 510 and tape 540.
