US011673336B2

(54) **CAMERA-BASED MONITORING SYSTEM FOR 3-DIMENSIONAL PRINTING**

(71) Applicant: **Impossible Objects, Inc.**, Northbrook, IL (US)

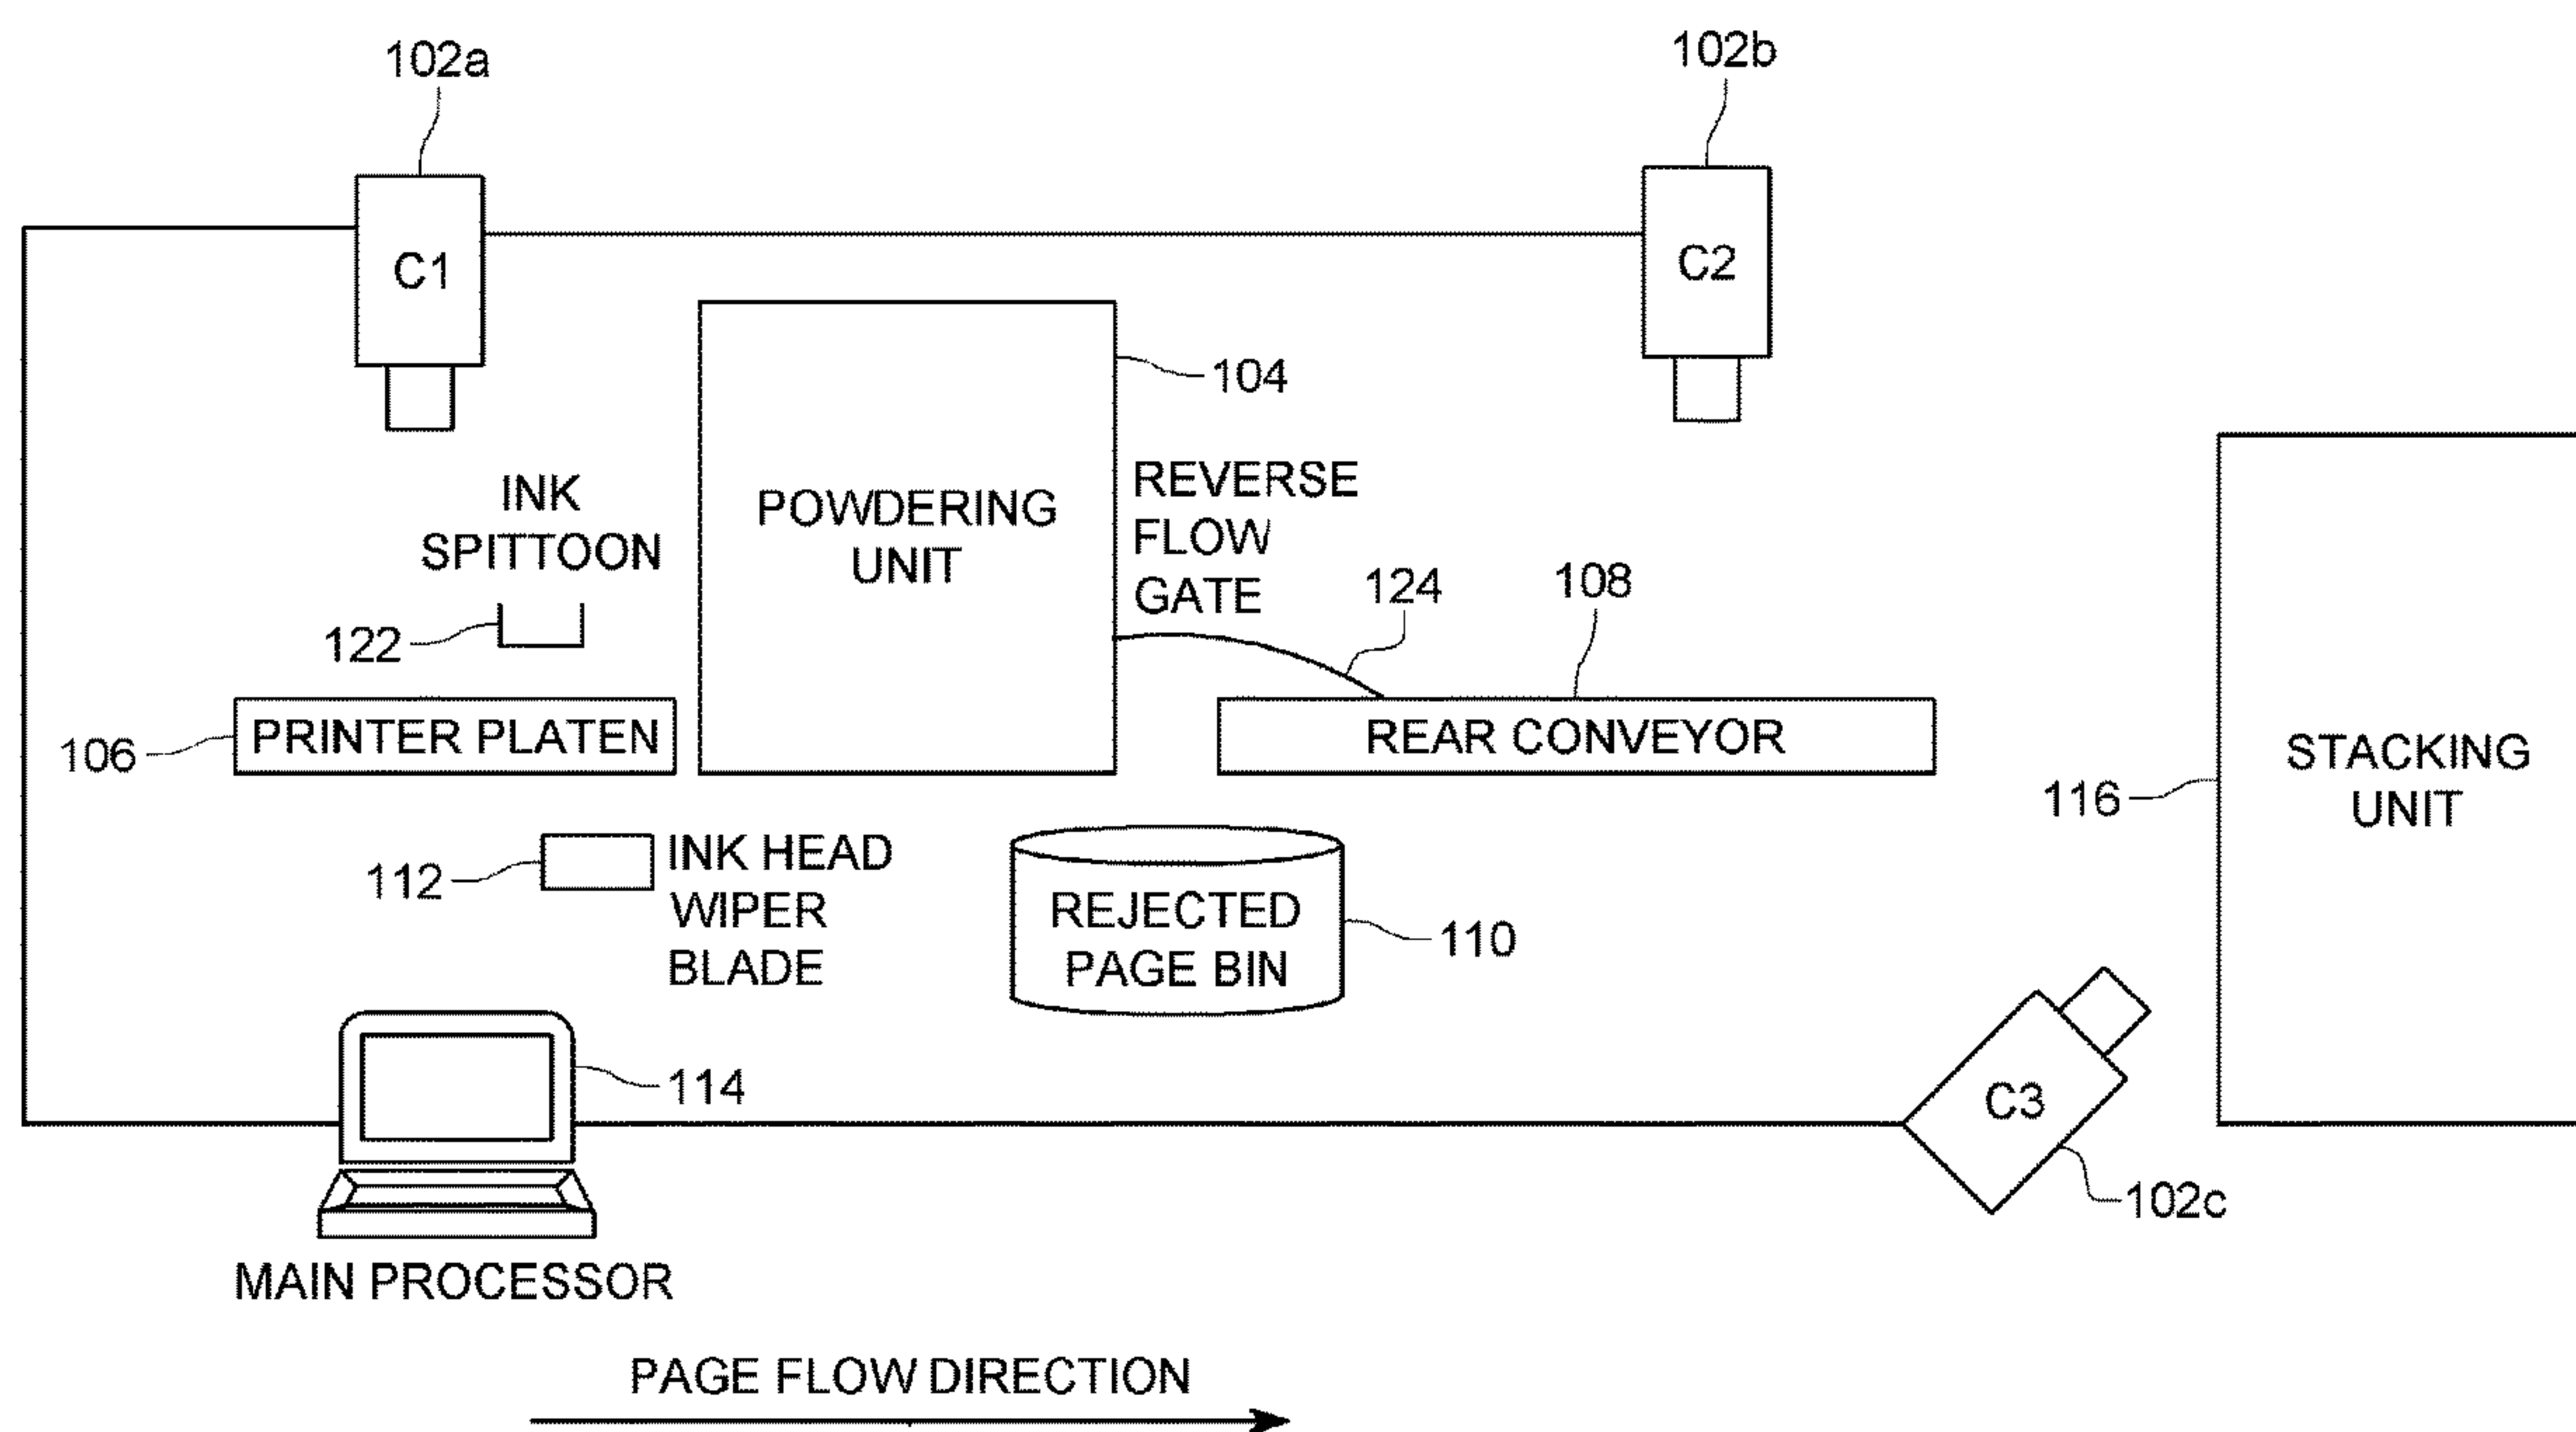
Fig. 1

FIG. 1 shows a portion of a typical CBAM process 10 including camera locations for the present invention.

FIG. 1 shows a stylized portion of a typical CBAM process. Substrate sheets are fed onto a printer platen **106** where they are to represent sections of the 3-D build object and printed with a fluid in the pattern of that section. An ink spittoon **122** and ink head wiper blade **112** are shown for completeness. Printed sheets are then transferred to a powdering unit **104** where they are flooded with powder. The powder adheres only to printed areas. A first camera **C1 102a** monitors the printing process. After excess powder is removed, powdered pages are transferred onto a rear conveyor **103** by a reverse flow gate **124** to be conveyed to a stacking unit **116** where they are stacked one on top of another. A second camera **C2 102b** monitors the rear conveyor, an a third camera **C3 102c** monitors the stacker. All three cameras feed video to a processor **114**. A rejected page bin **110** holds any rejected pages. These can be discarded, or manually analyzed.

A particular embodiment of the system has three camera-based monitors as shown in FIG. 1. These are independently running Raspberry Pi™ computers with camera module shields (i.e. daughter boards.) The Raspberry Pi's are installed in sealed cases (to prevent incursion of powder and fibers), provide lenses and set screws to adjust focus, have Ethernet interfaces and provide power to LED-based lighting attached and controlled by the Raspberry Pi. The monitoring software is written in the Python language and uses several libraries, such as PIL/Pillow, OpenCV (for image processing), NumPy, SciKit and SciKit-Learn. In addition to cameras, line scanners or other imaging devices can be used to capture high resolution image data.

The three monitoring systems show in FIG. 1 are as follows:

- 1) The Print Platen Monitor **C1 102a**  
This monitor observes page placement on the print platen. It can determine whether there is single page on the platen, whether the position and angle of the page are within

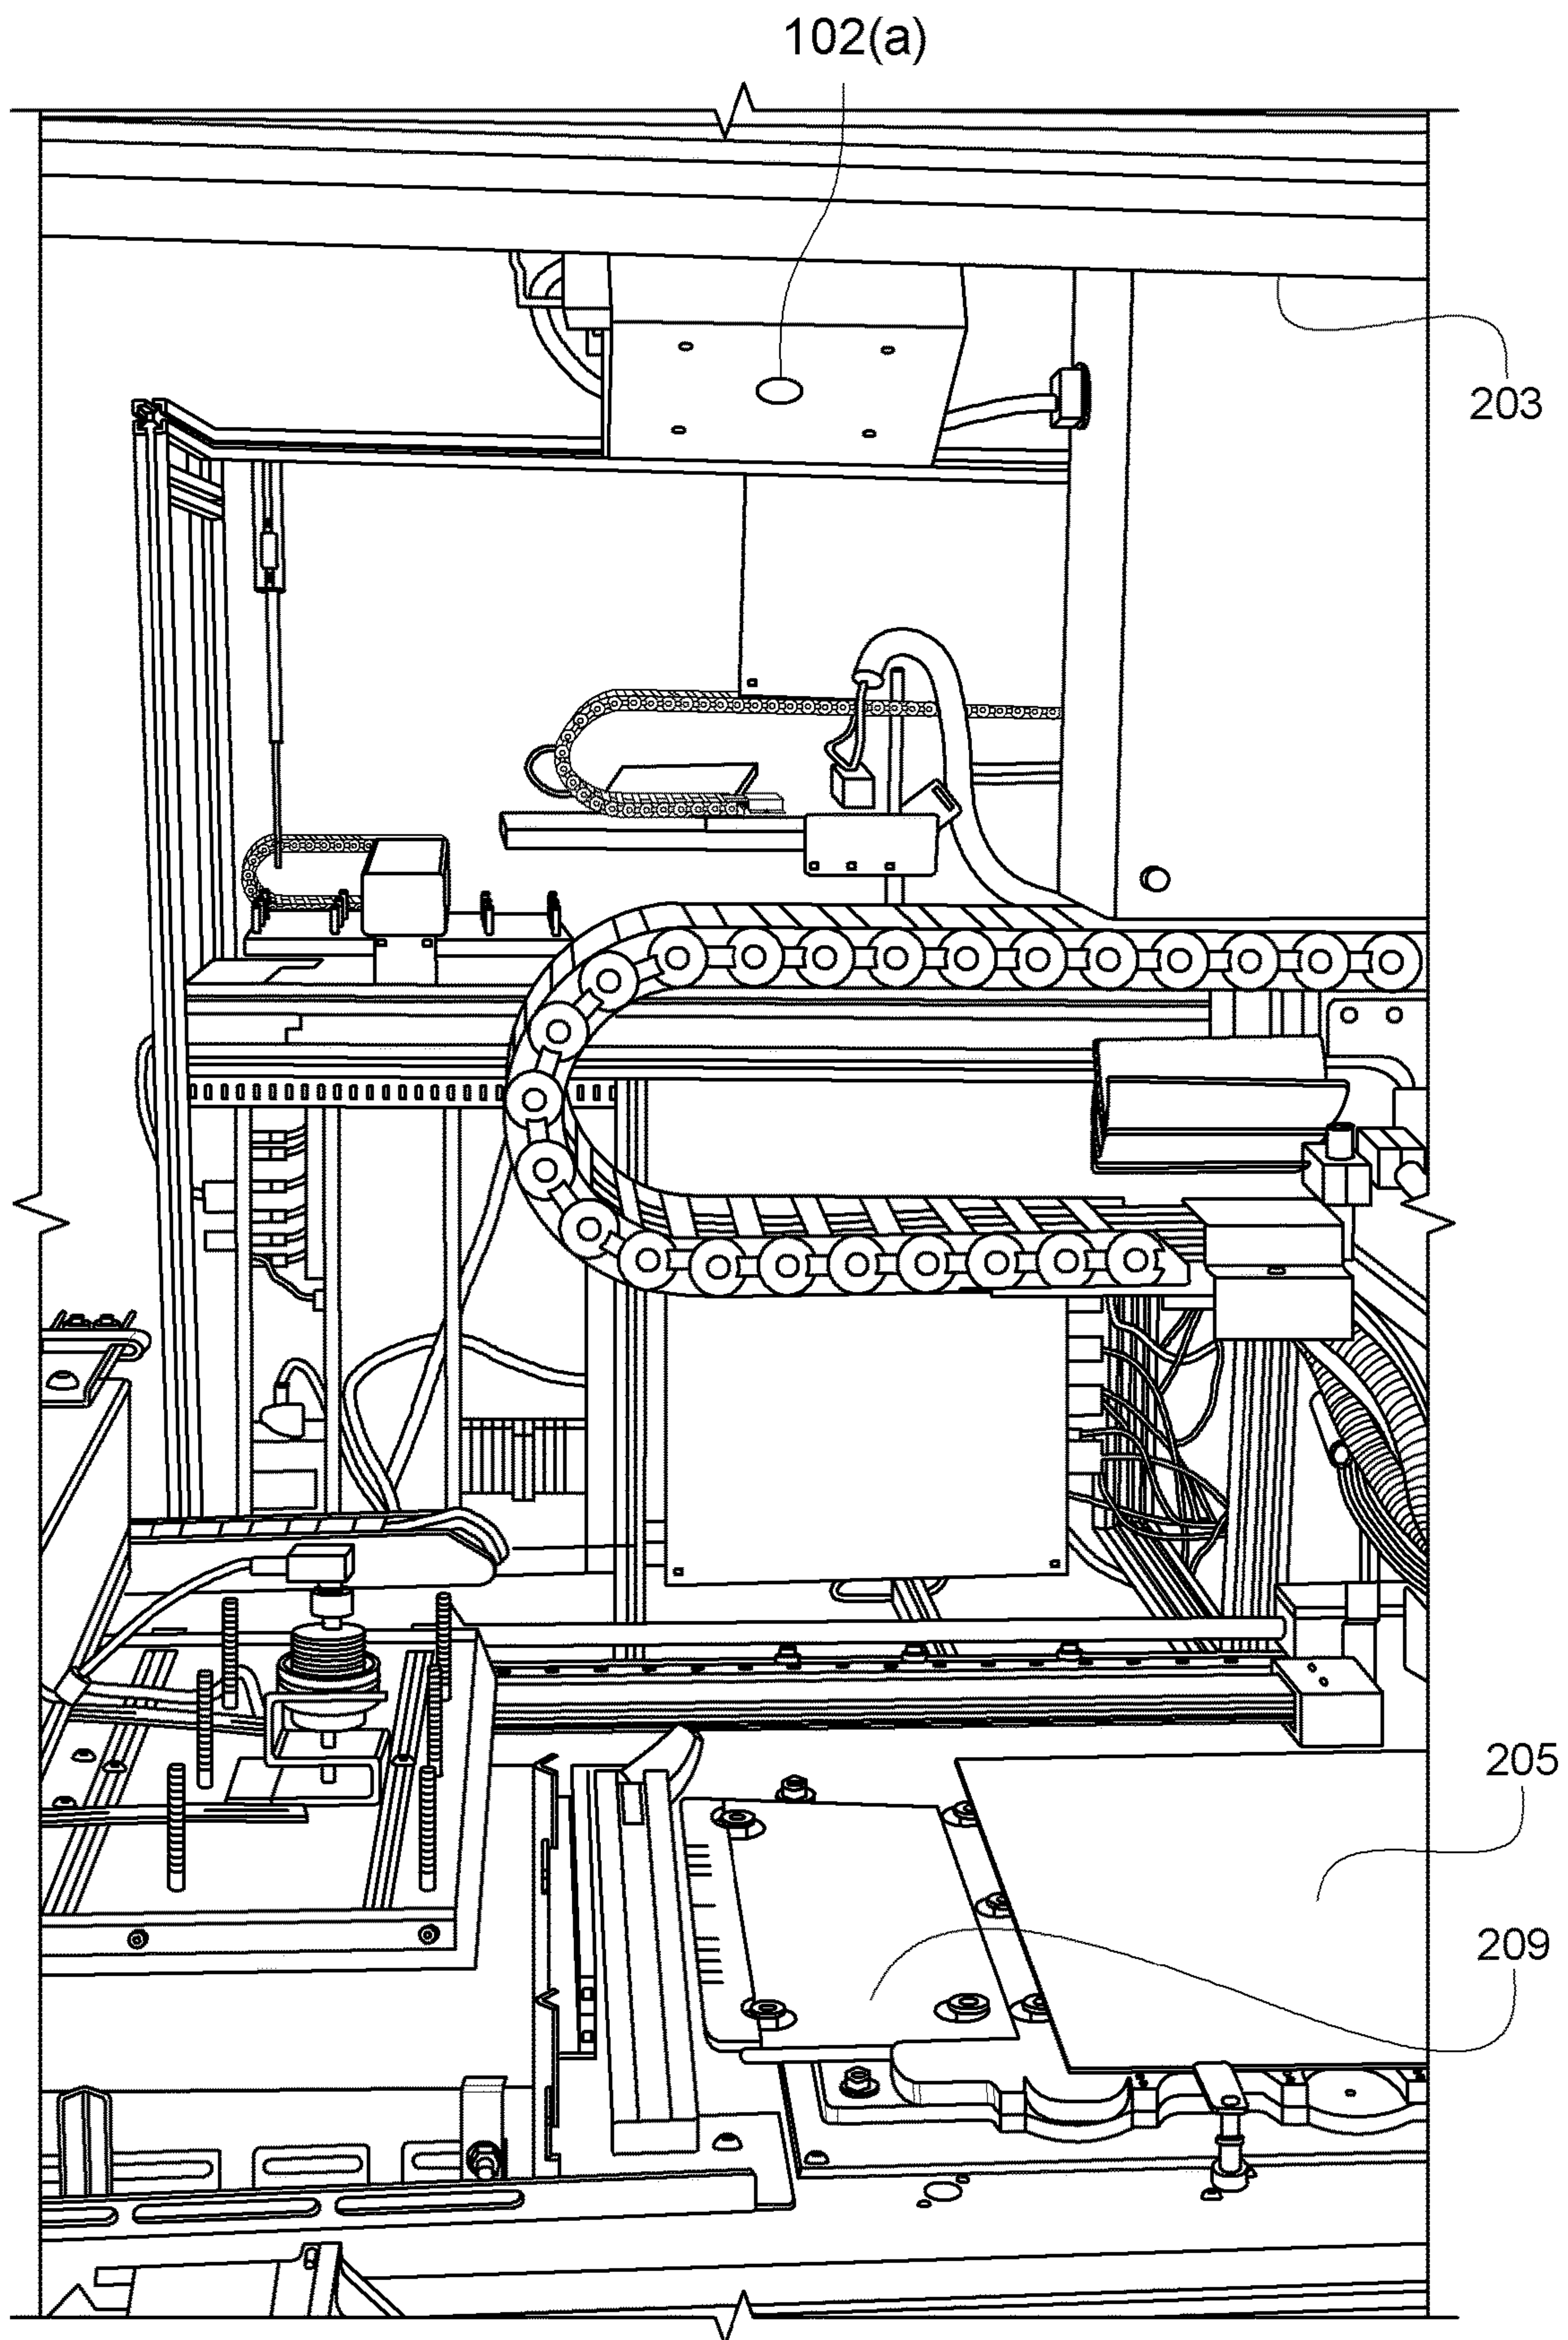
FIG. 2 shows a platen camera and lighting.

FIGS. 2-4 show detailed schematics of an embodiment of the apparatus and monitoring system. In FIG. 2, the print platen camera C1 102a can be seen at the top of the figure. Lighting 203 for the camera is also above the platen 209. A sheet 205 can also be seen resting on the platen.

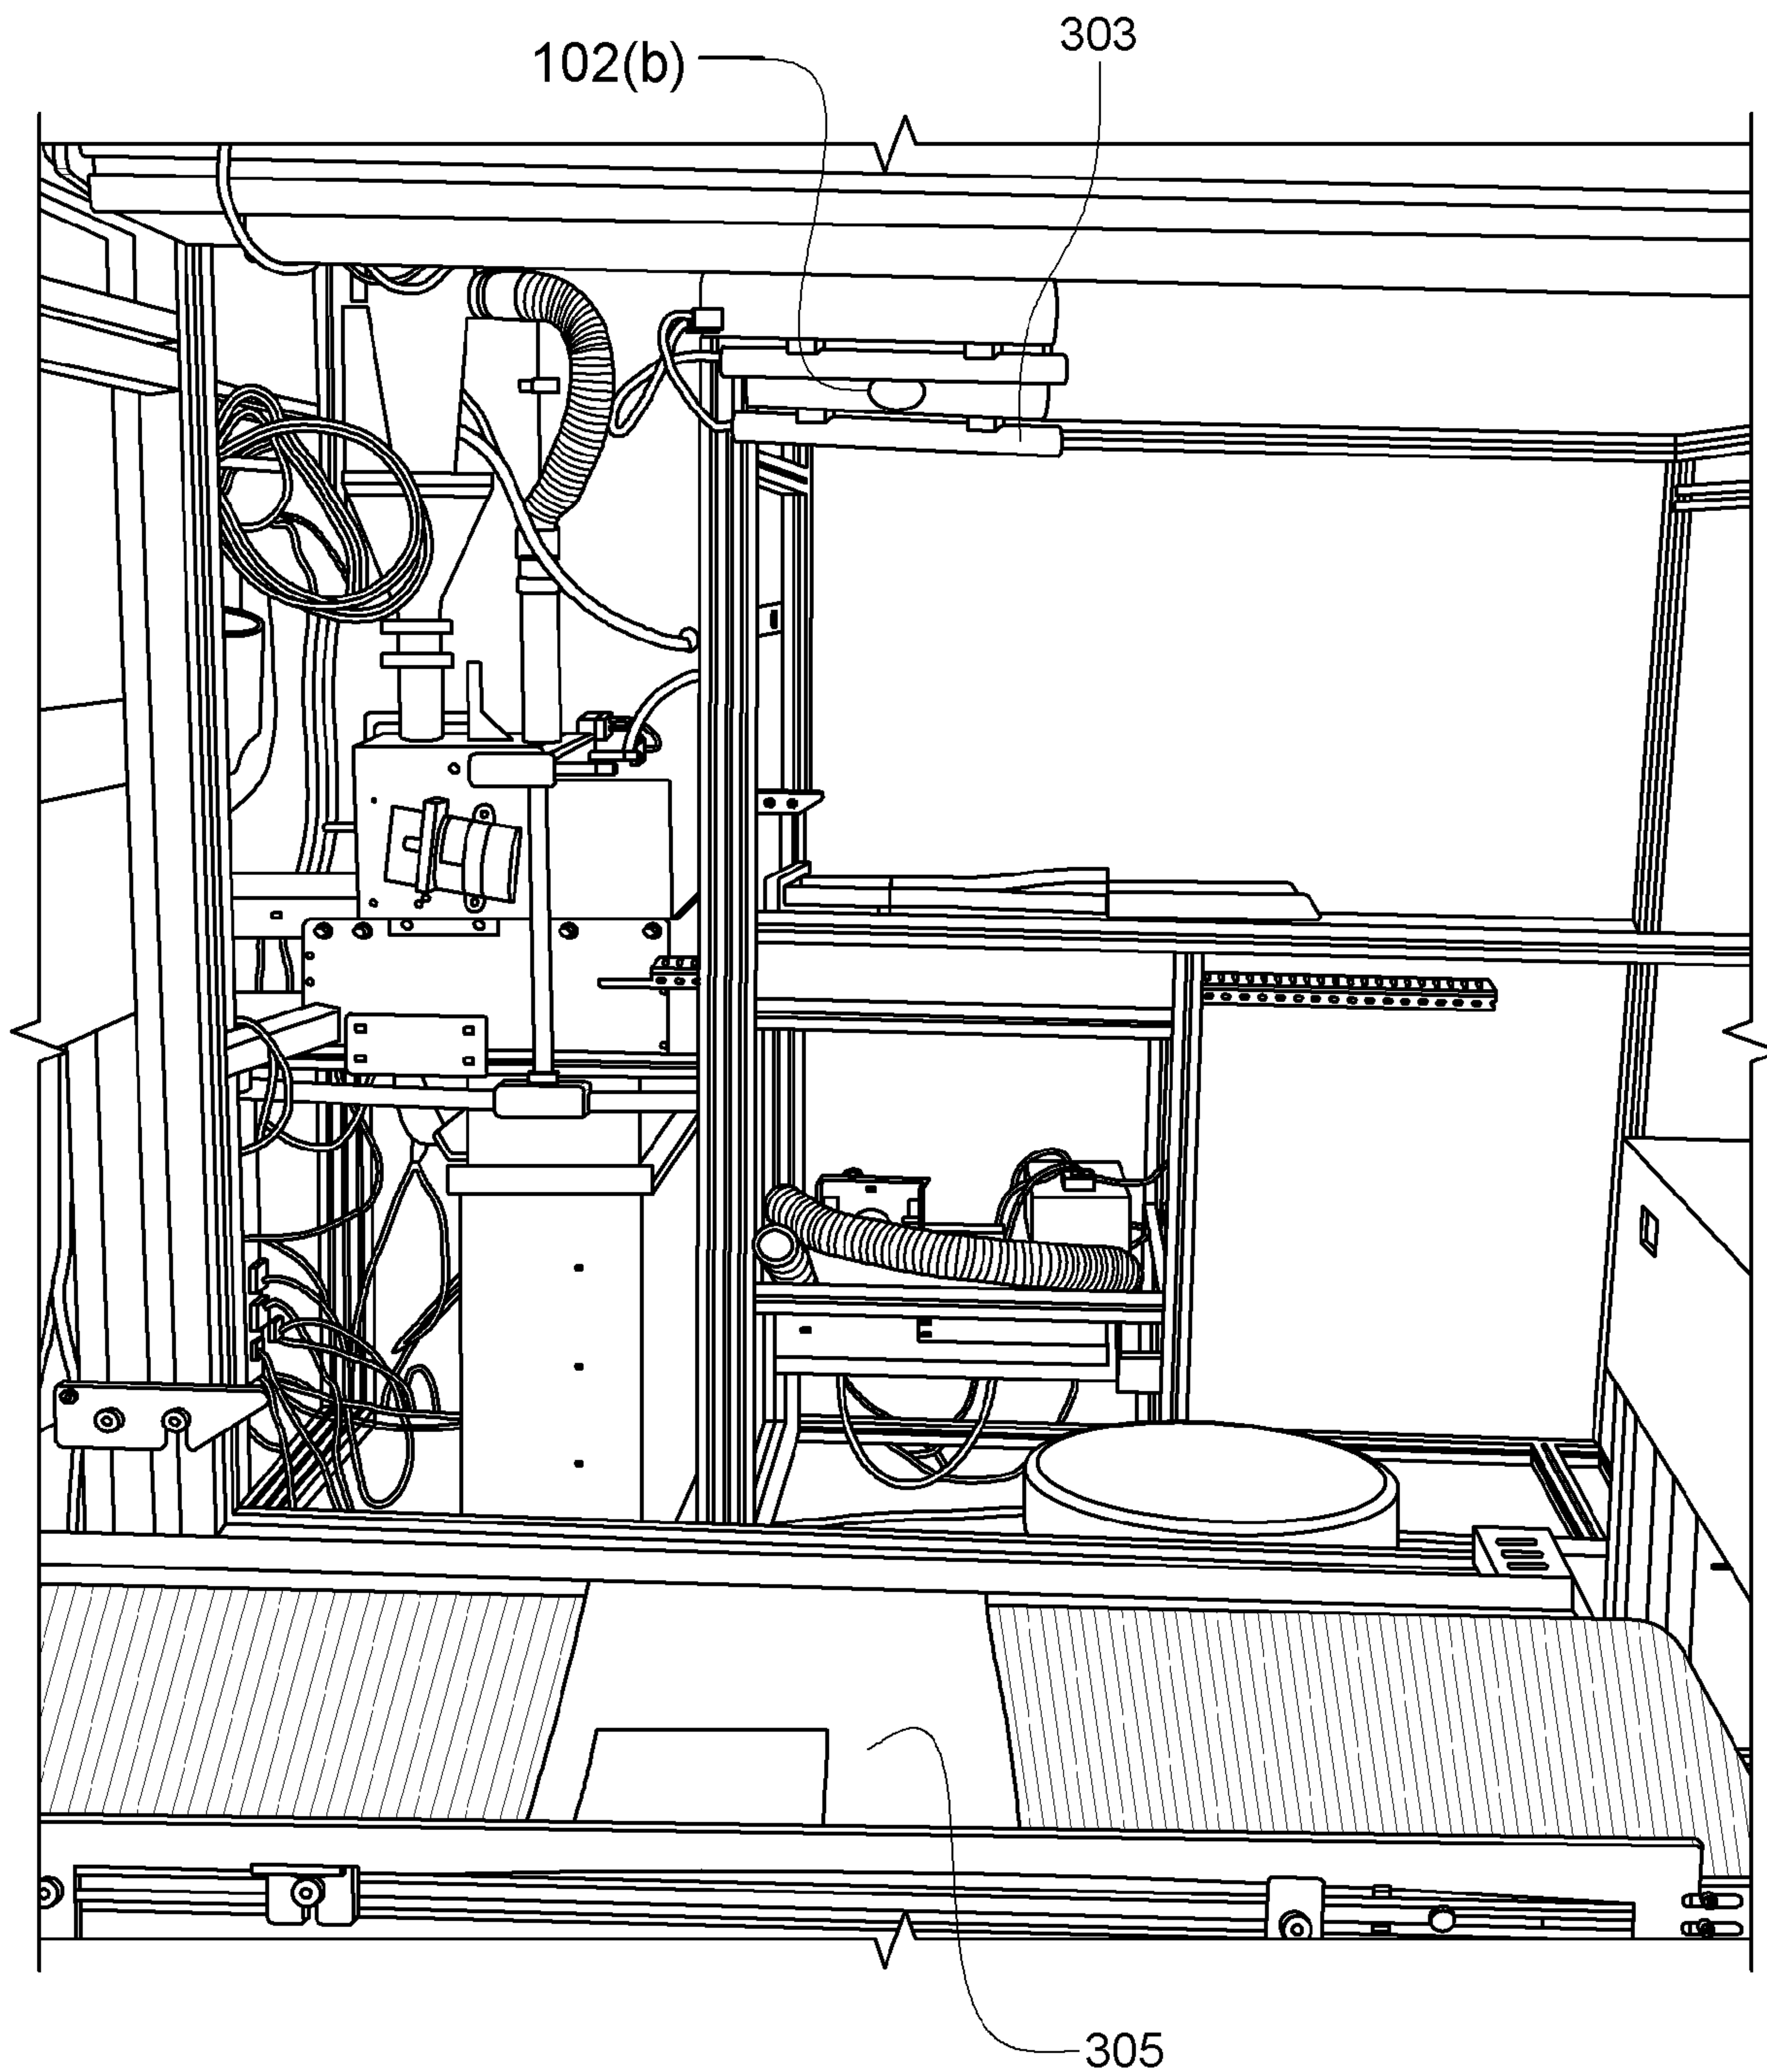
FIG. 3 shows a rear conveyor camera and lighting.

FIG. 3 shows the rear conveyor camera C2 102b. Lighting 303 for the rear conveyor camera can be seen near the camera.

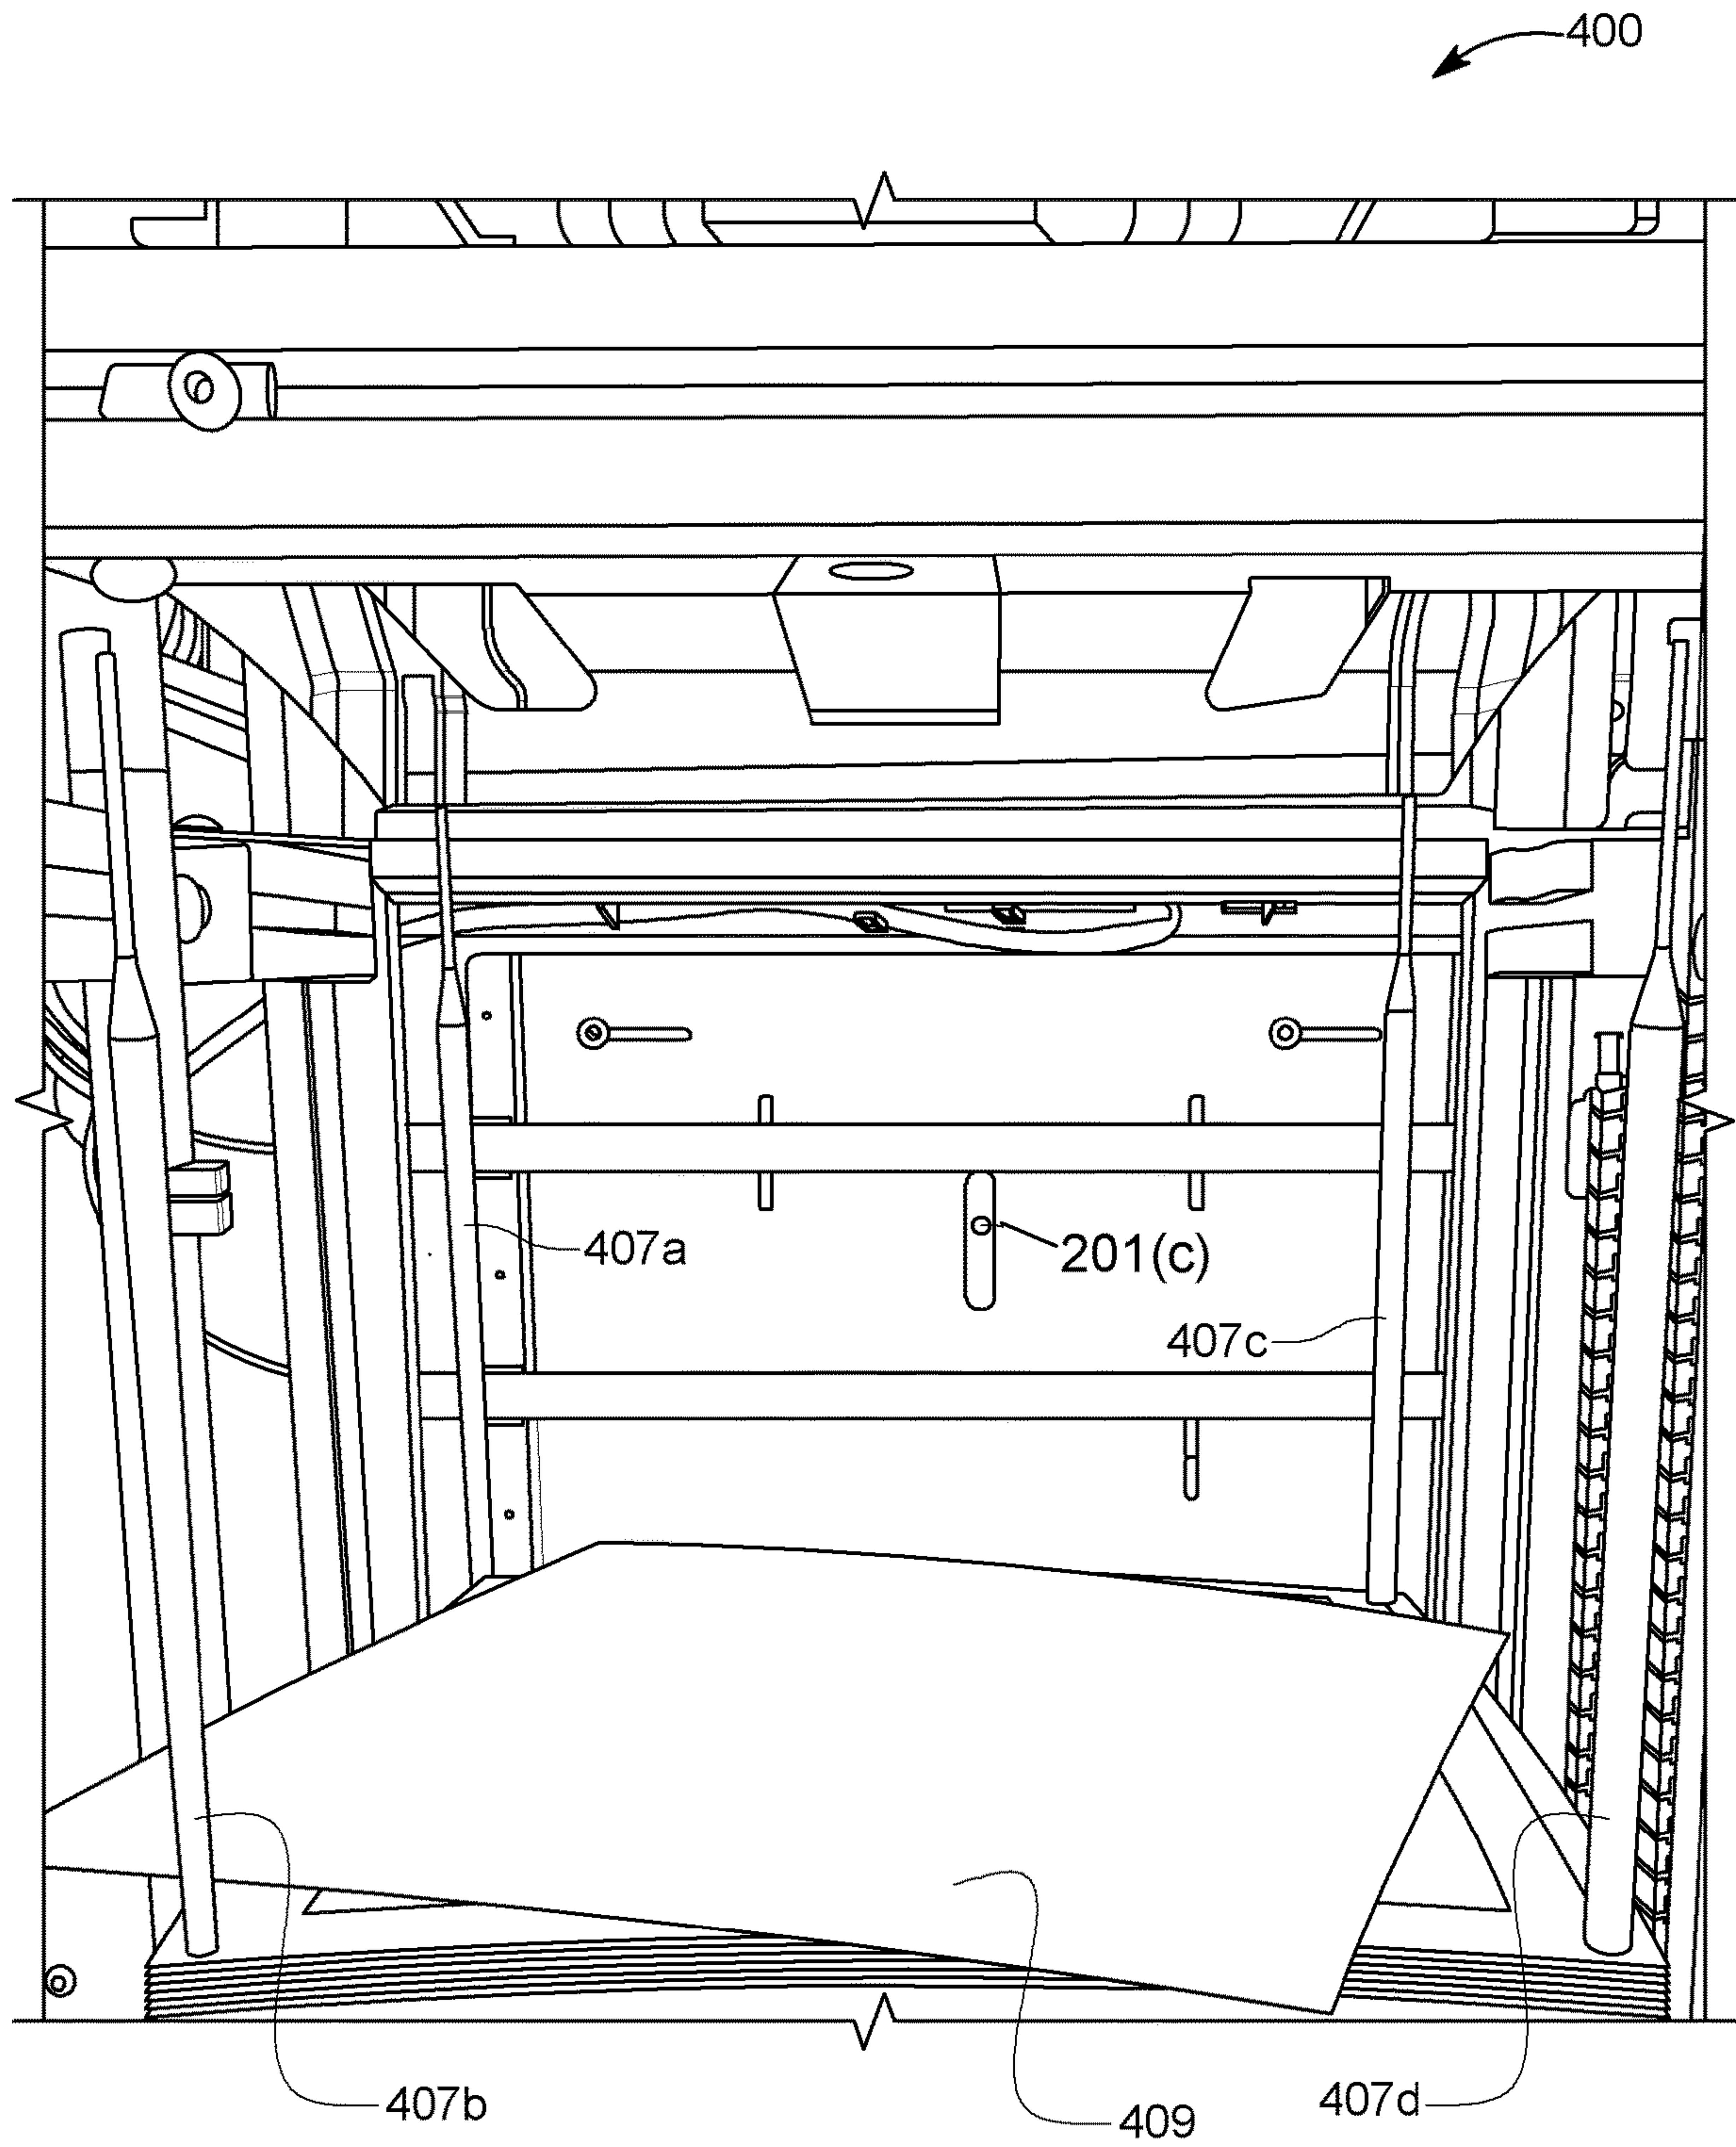
FIG. 4 shows a stacker camera and lighting.

FIG. 4 shows the stacker camera C3 102c, four registration pins 407a, b, c, d and a misaligned page 409.

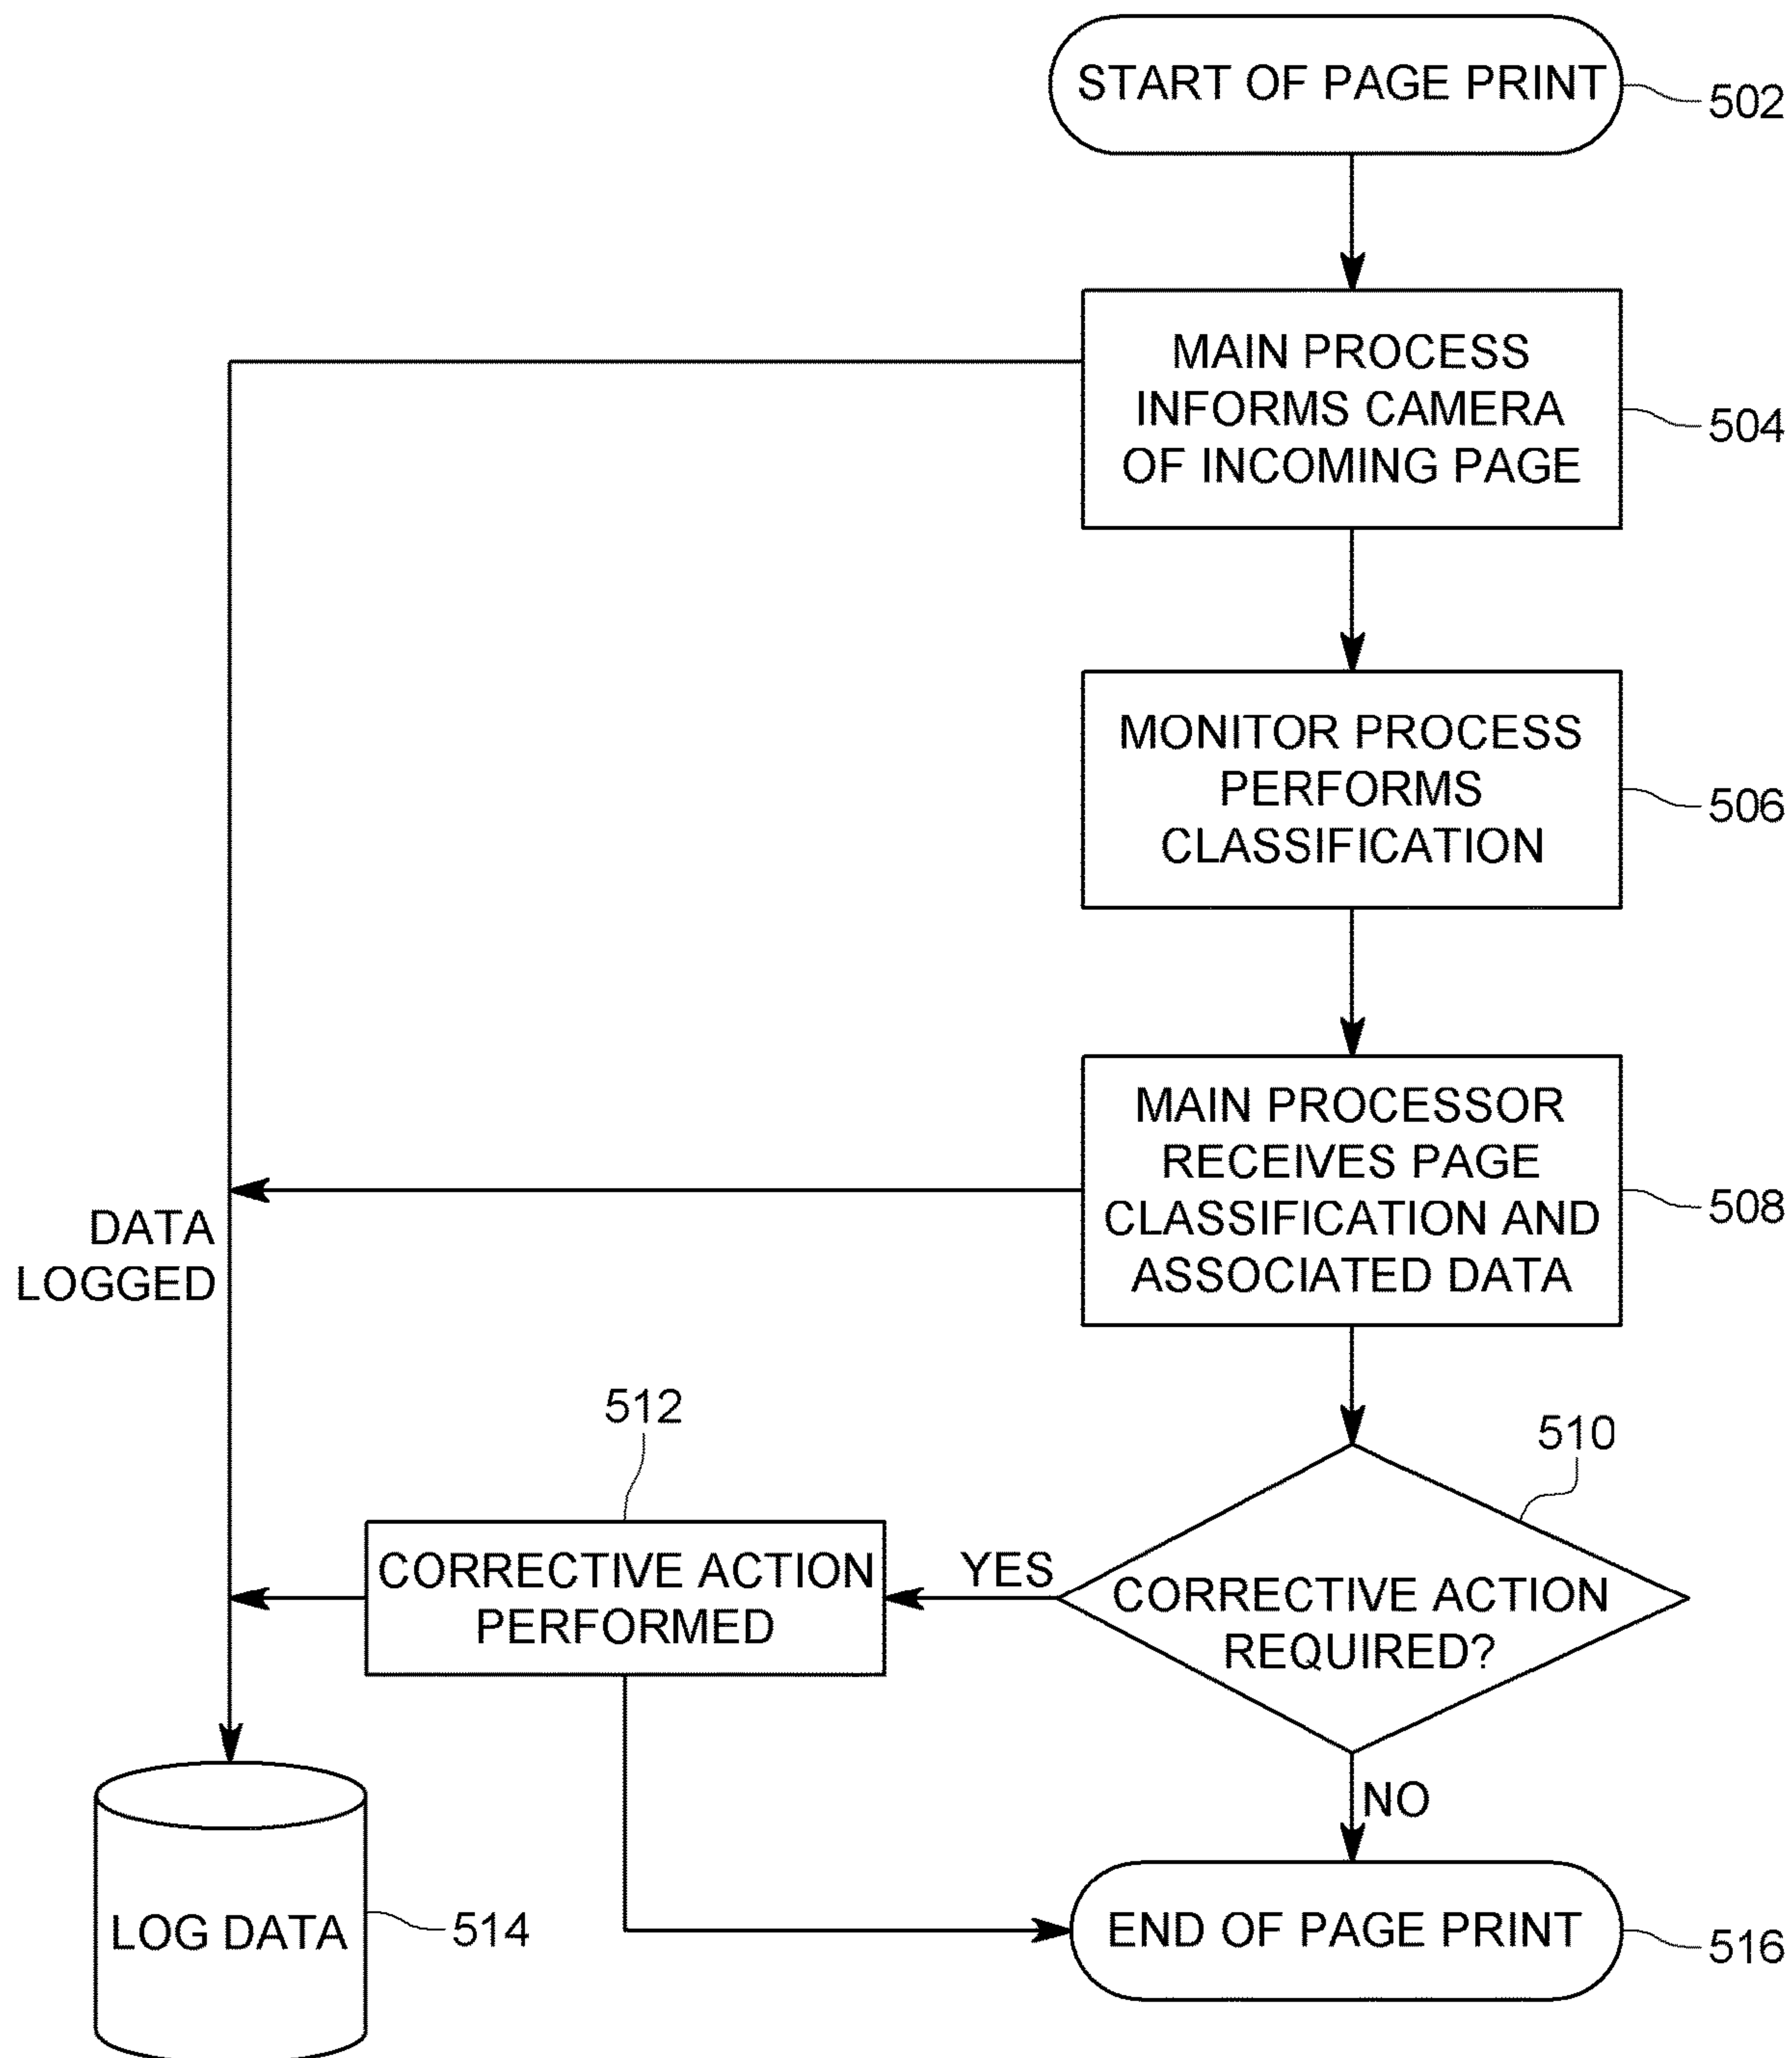
FIG. 5 is a flowchart of the general corrective print 15 process carried out using the print platen camera.

FIG. 5 is a flowchart of the general corrective print process carried out using the print platen camera C1 102a. At the start of print 502 the main process informs the camera unit of an incoming page 504. The camera sends images for analysis to the main processor (or an image processor) and image classification is performed 506. The main processor then receives the page classification 508 and makes a decision 510 whether the page is good, or whether corrective action is necessary (at least one of the required page parameters is out of tolerance). If the page is good, that is the end of that print cycle 516. If the page is bad, corrective action is performed 512. In all cases, data at each step is logged 514.
