US011673336B2

(54) **CAMERA-BASED MONITORING SYSTEM FOR 3-DIMENSIONAL PRINTING**

(71) Applicant: **Impossible Objects, Inc.**, Northbrook, IL (US)

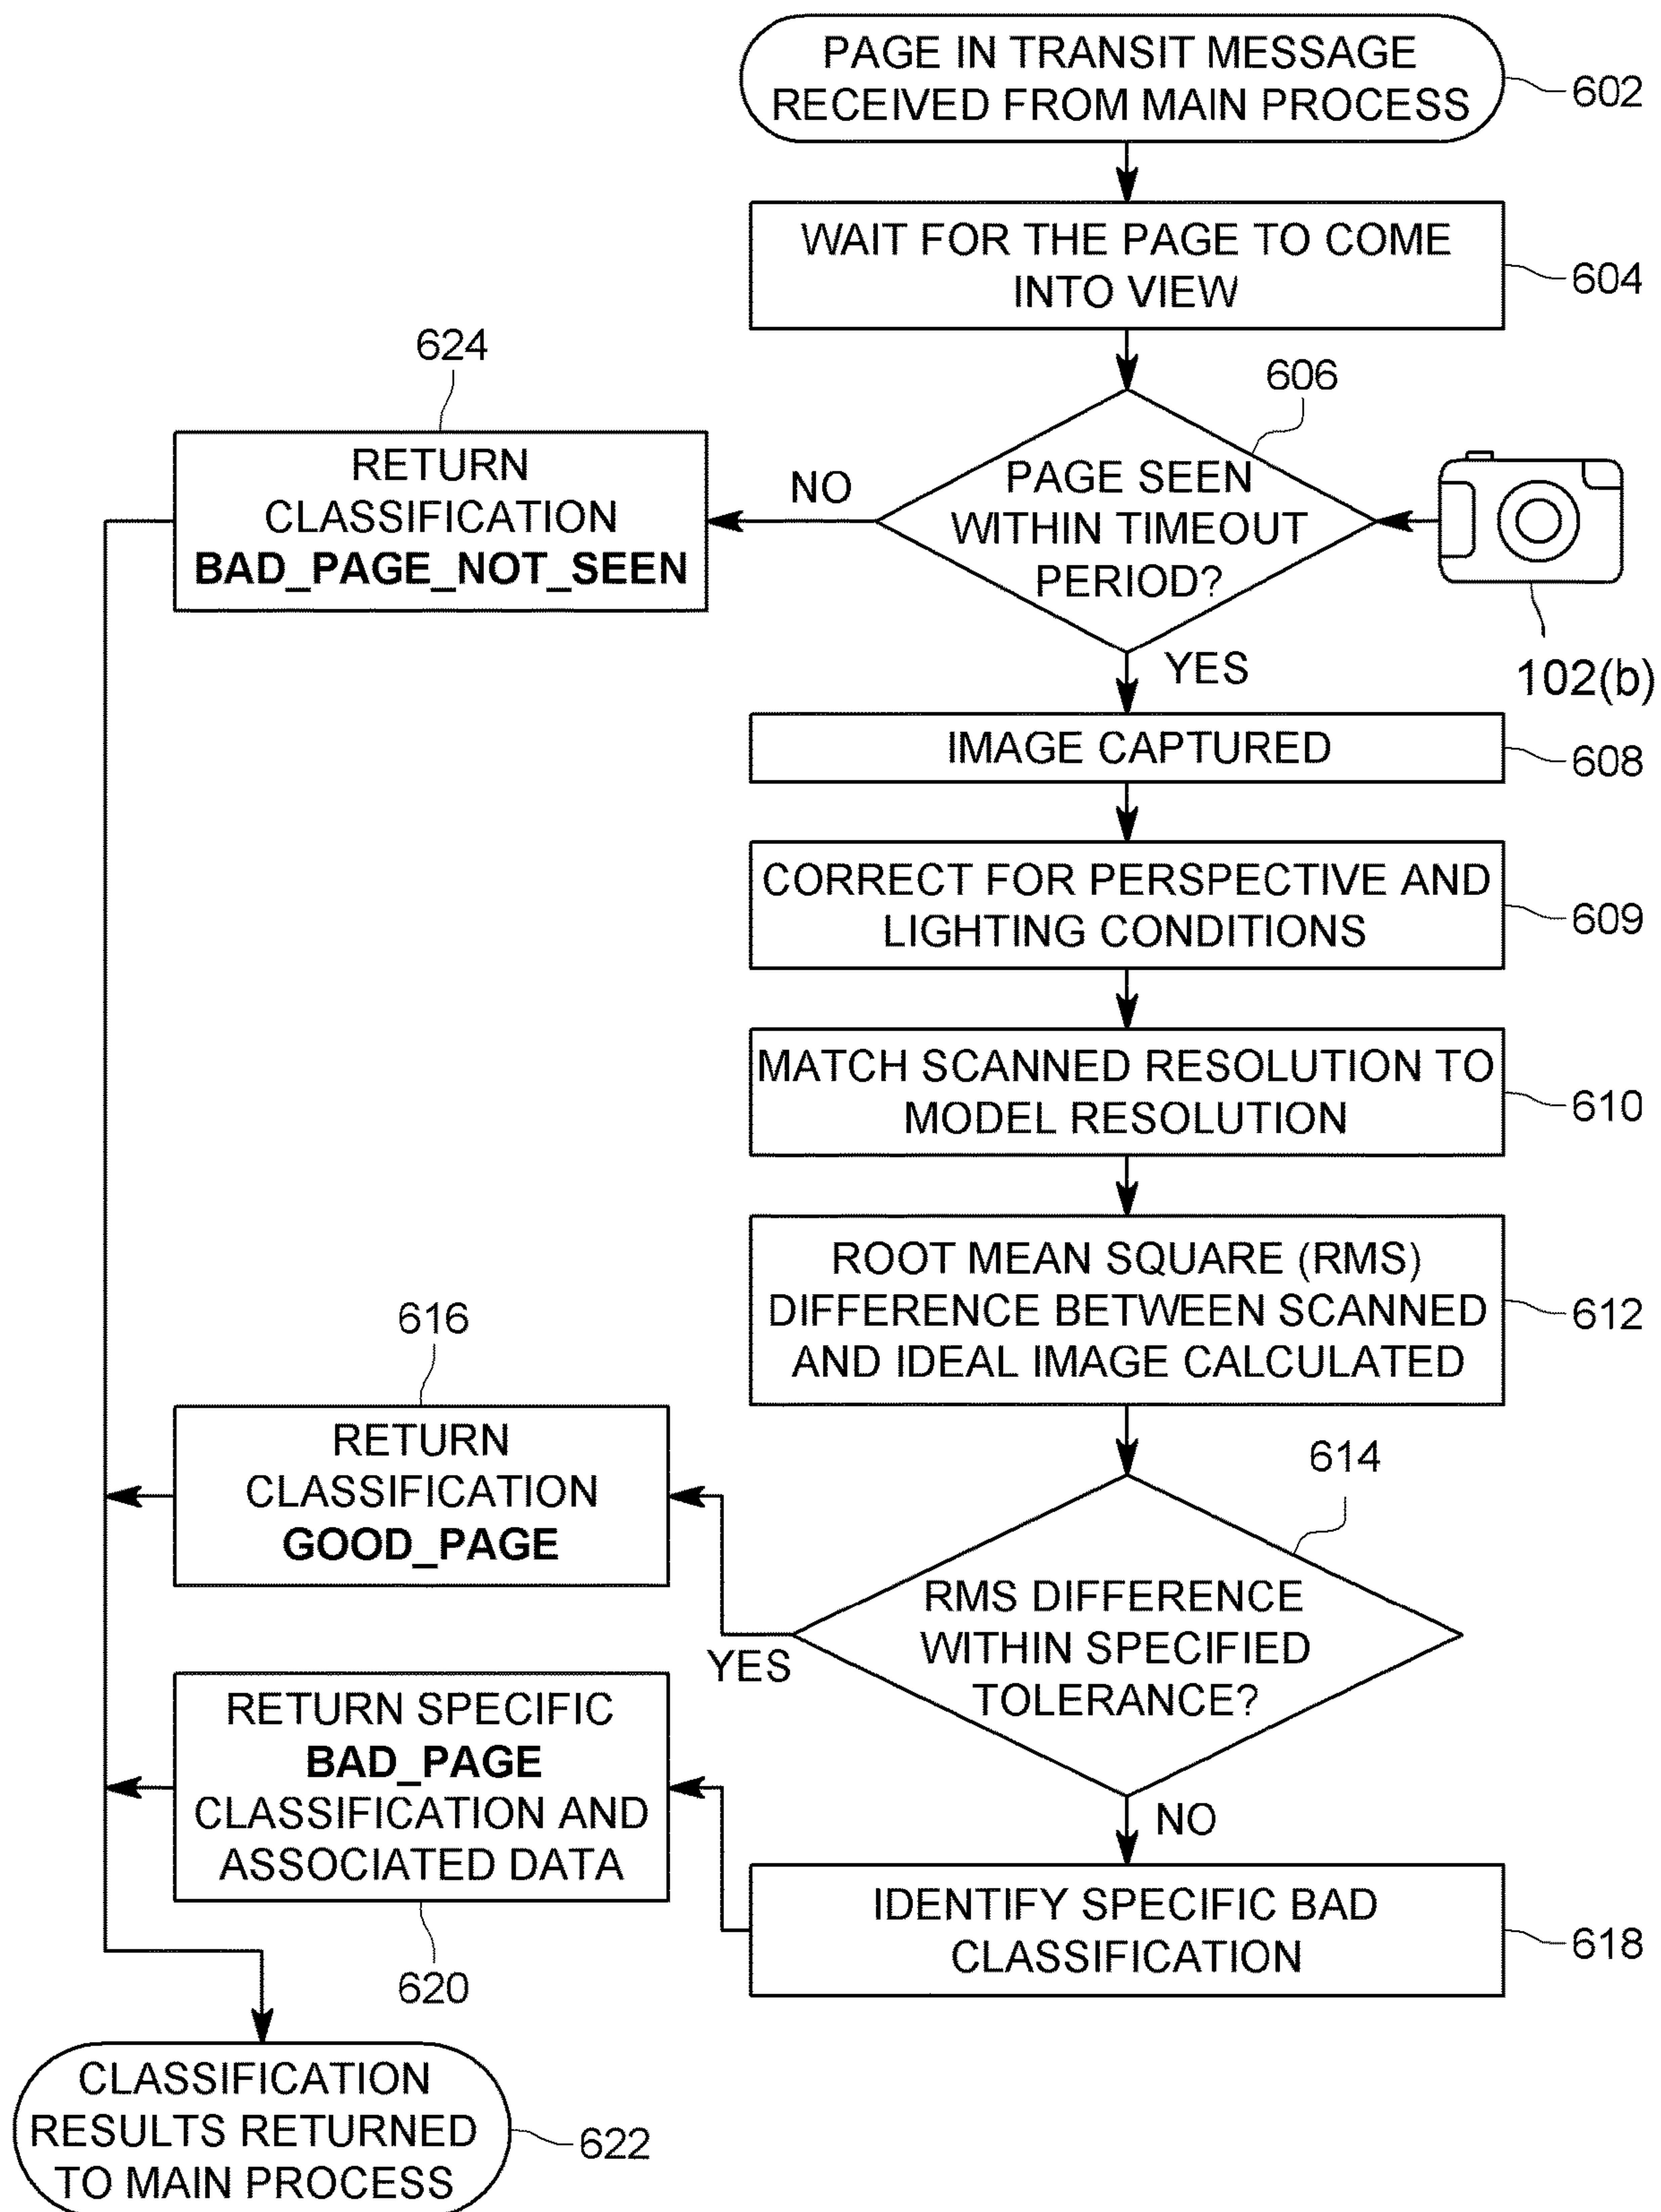
FIG. 6 is a flowchart of the post-powdering classification process.

FIG. 6 is a flowchart of the post-powdering classification process. A page-in-transit message is received 602 from the main process when a page has been printed and is on the rear conveyor. The system waits for the page to come into camera view 604 using the camera C2 102b. If the page is not detected within a predetermined timeout interval, a page-not-seen message is returned 624. If the page is detected, the page image is captured by the camera 608. Correction is made for perspective and lighting conditions 609. (As mentioned, not only perspective may be corrected, but any computational lens correction now or in the future known in the art may be used to pre-process and/or calibrate the optics system to prepare it for the classification algorithms.) A comparison is then made between the corrected scanned image and one or more stored model images 610. A root mean square (RMS) difference between the scanned image and the model is computed 612, and a determination is made as to the size of any RMS error between the two 614. If the powdered page is within tolerance, a good-page classification is returned 616. If the RMS error is too large, a specific

bad page classification is determined **618**. A bad-page classification and specific associated classification data is return **620**. In all cases, the classification results are returned to the main process **622**.

The use of Root Mean Square (RMS) difference is one of several techniques that can be used, and is shown in the figures as an example. Any separate monitor and associated classification system may use any image analysis techniques including, but not limited to RMS, neural network classification, and any form of artificial intelligence classification. In fact, any classifier or image analysis system now or in the future known in the art may suffice to perform the in/out of tolerance, error or parameter analysis. The object of the classification is to determine if the page is within tolerances for any number of separate parameters that many generally apply, or may be specific to a particular build.

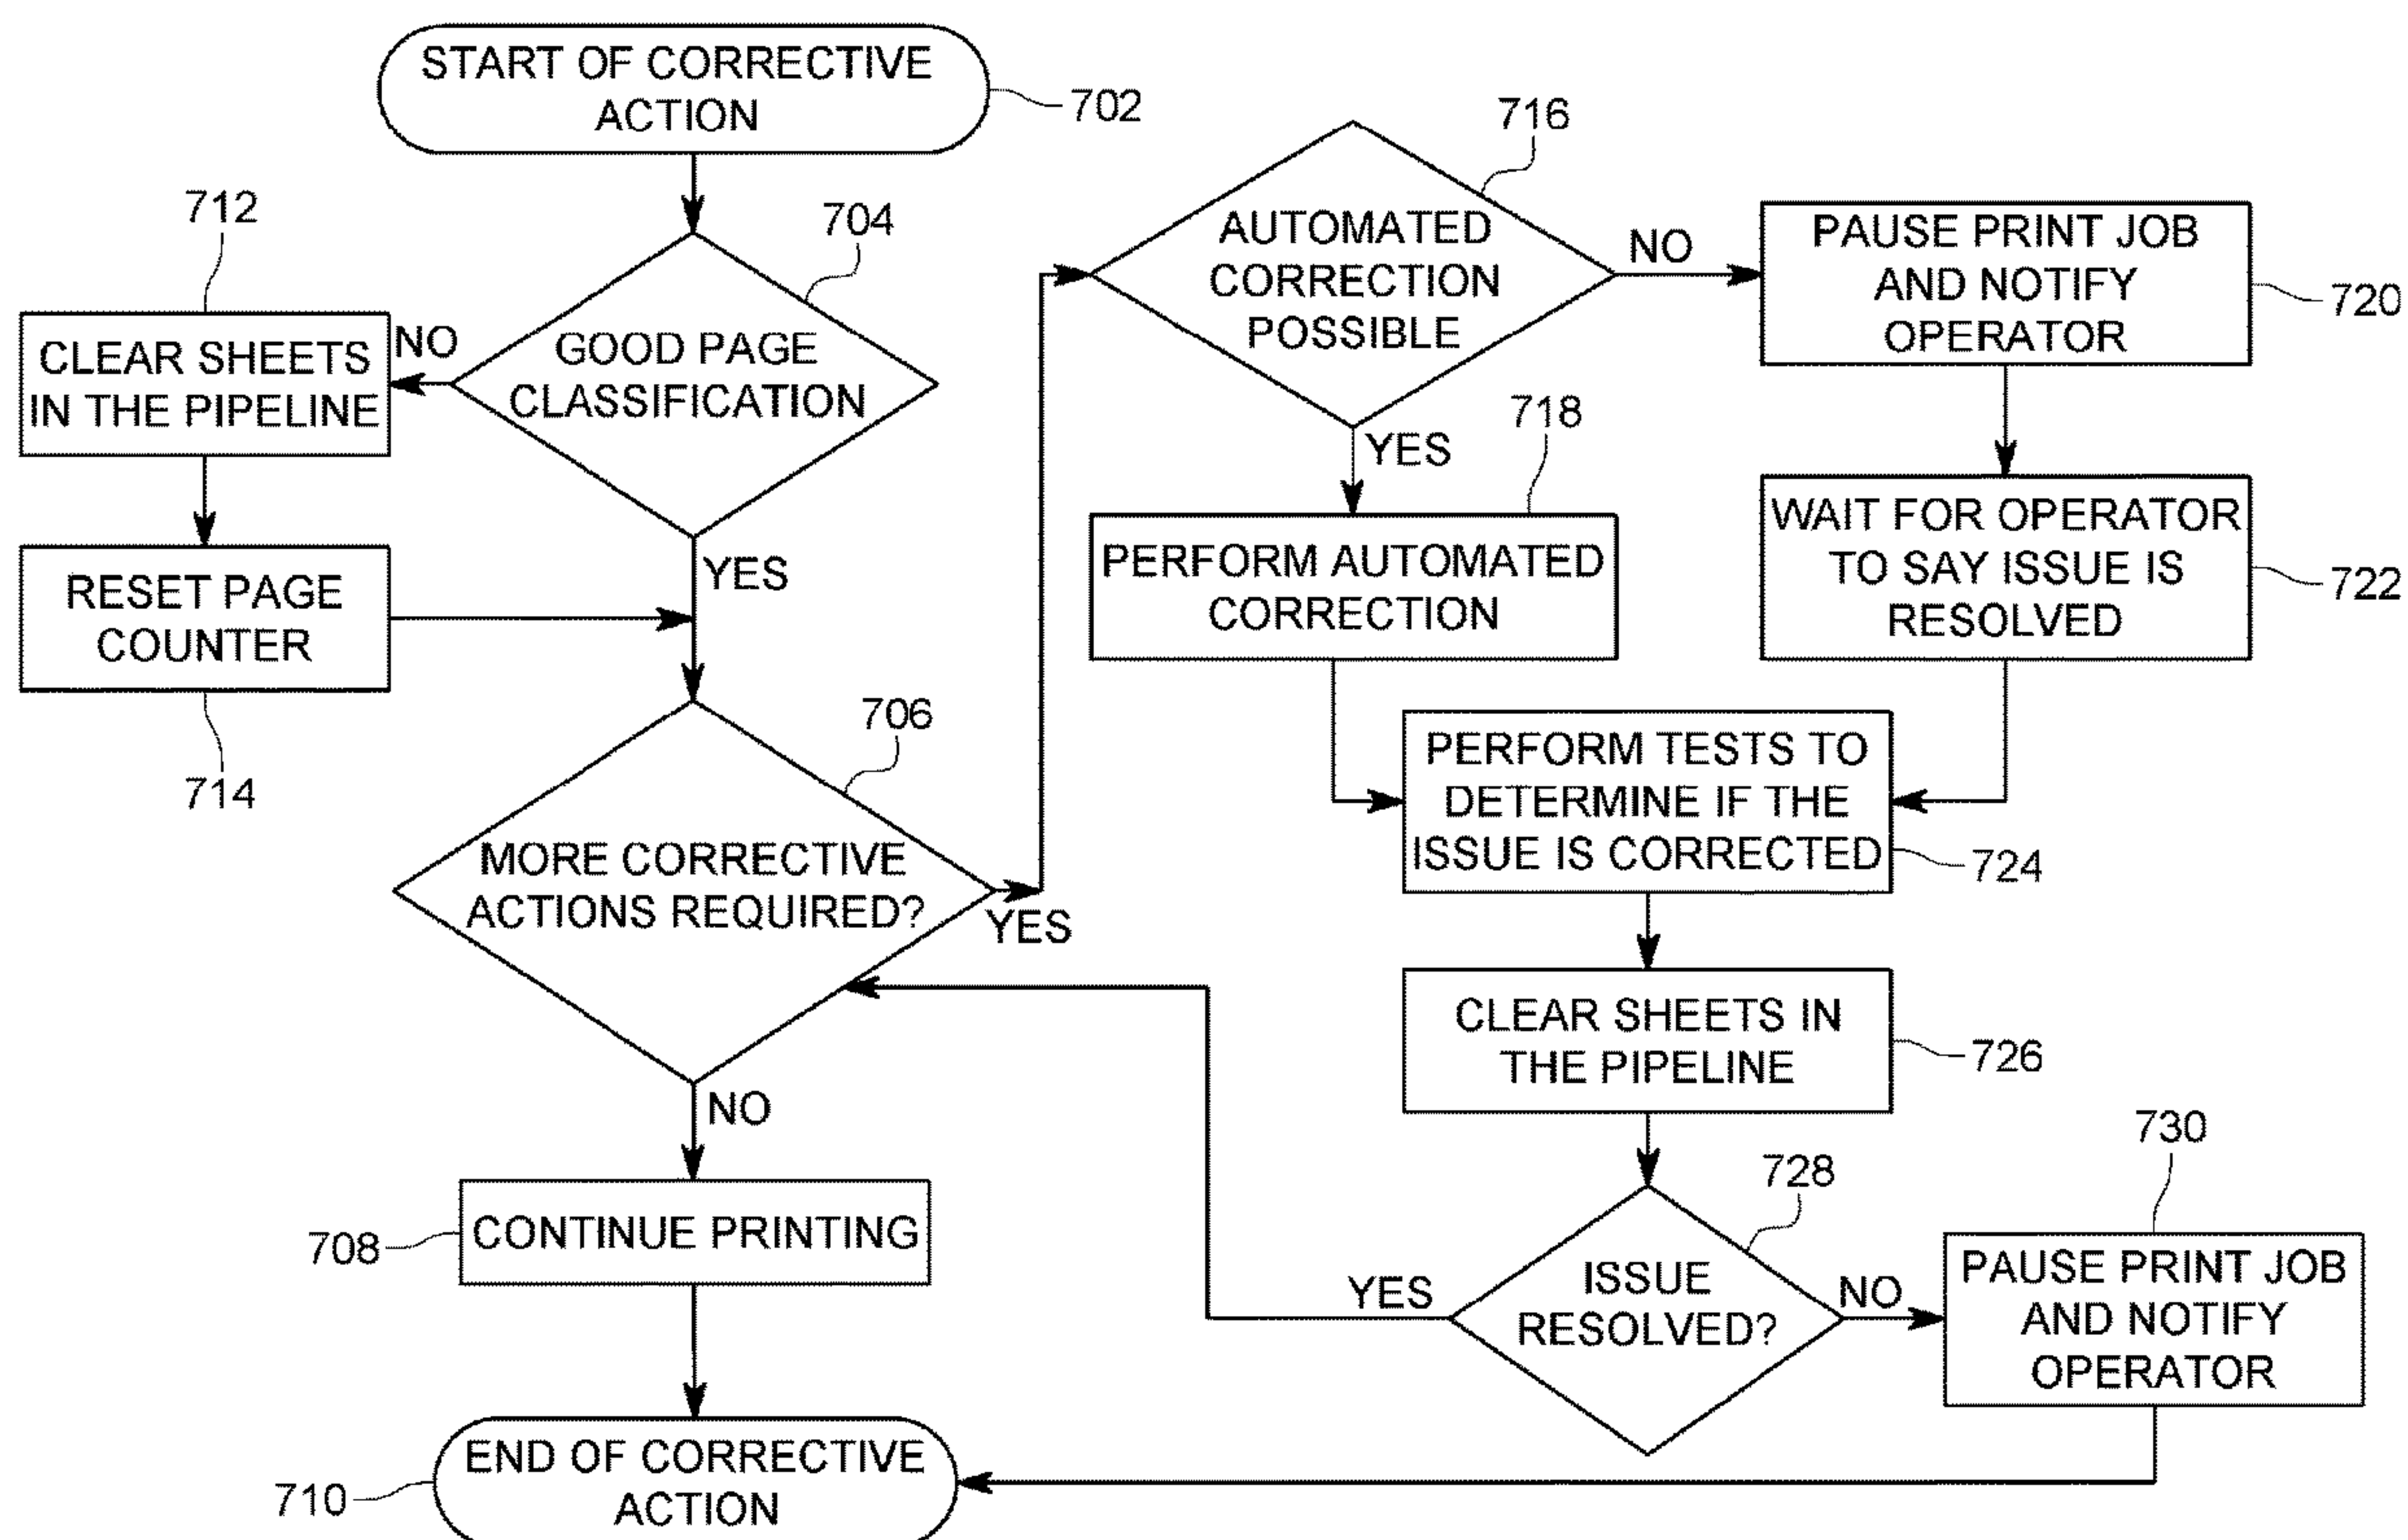
Fig. 7

FIG. 7 is a flowchart of the corrective action process.

FIG. 7 is a flowchart of corrective action. Corrective action starts **702** when a bad page is detected at any of the monitoring locations. If there is no good-page classification **704** sheets are cleared in the pipeline **712** and the page counter is reset **714**. A good-page classification skips these two steps. A determination is then made whether more corrective action is required **706**. If not, printing continues **708**, and that is the end of that corrective action cycle **710**. If, on the other hand, more corrective action is required, a determination of whether it can be done automatically is made **716**. If automated correction is possible, it is performed **718**. If not, the job is paused, and the operator is notified **720**. A wait is then made until the operator indicates the issue is resolved **722**. For either automated or manual corrective action, the next step is to run tests to see if the issue is truly resolved **724**. Test sheets cleared in the pipeline **728**, and a decision is made whether the issue is truly cleared **728**. If yes, it is determined if more (or other) corrective action is necessary **706**. If not, printing continues **708**, and the corrective action cycle terminates **710**. If so, the question of automatic verses manual correction is again determined **716**.
