(10) **Patent No.:** **US 11,703,412 B1**

(54) **SYSTEM AND METHOD FOR DETECTING SEWER LATERAL LEAKS**

Sewer line and lateral inspections are made in order to detect leaks and improper connections, using steam injected into a section of sewer line. Thermal imaging of the vicinity indicates leaks and illegal connections.

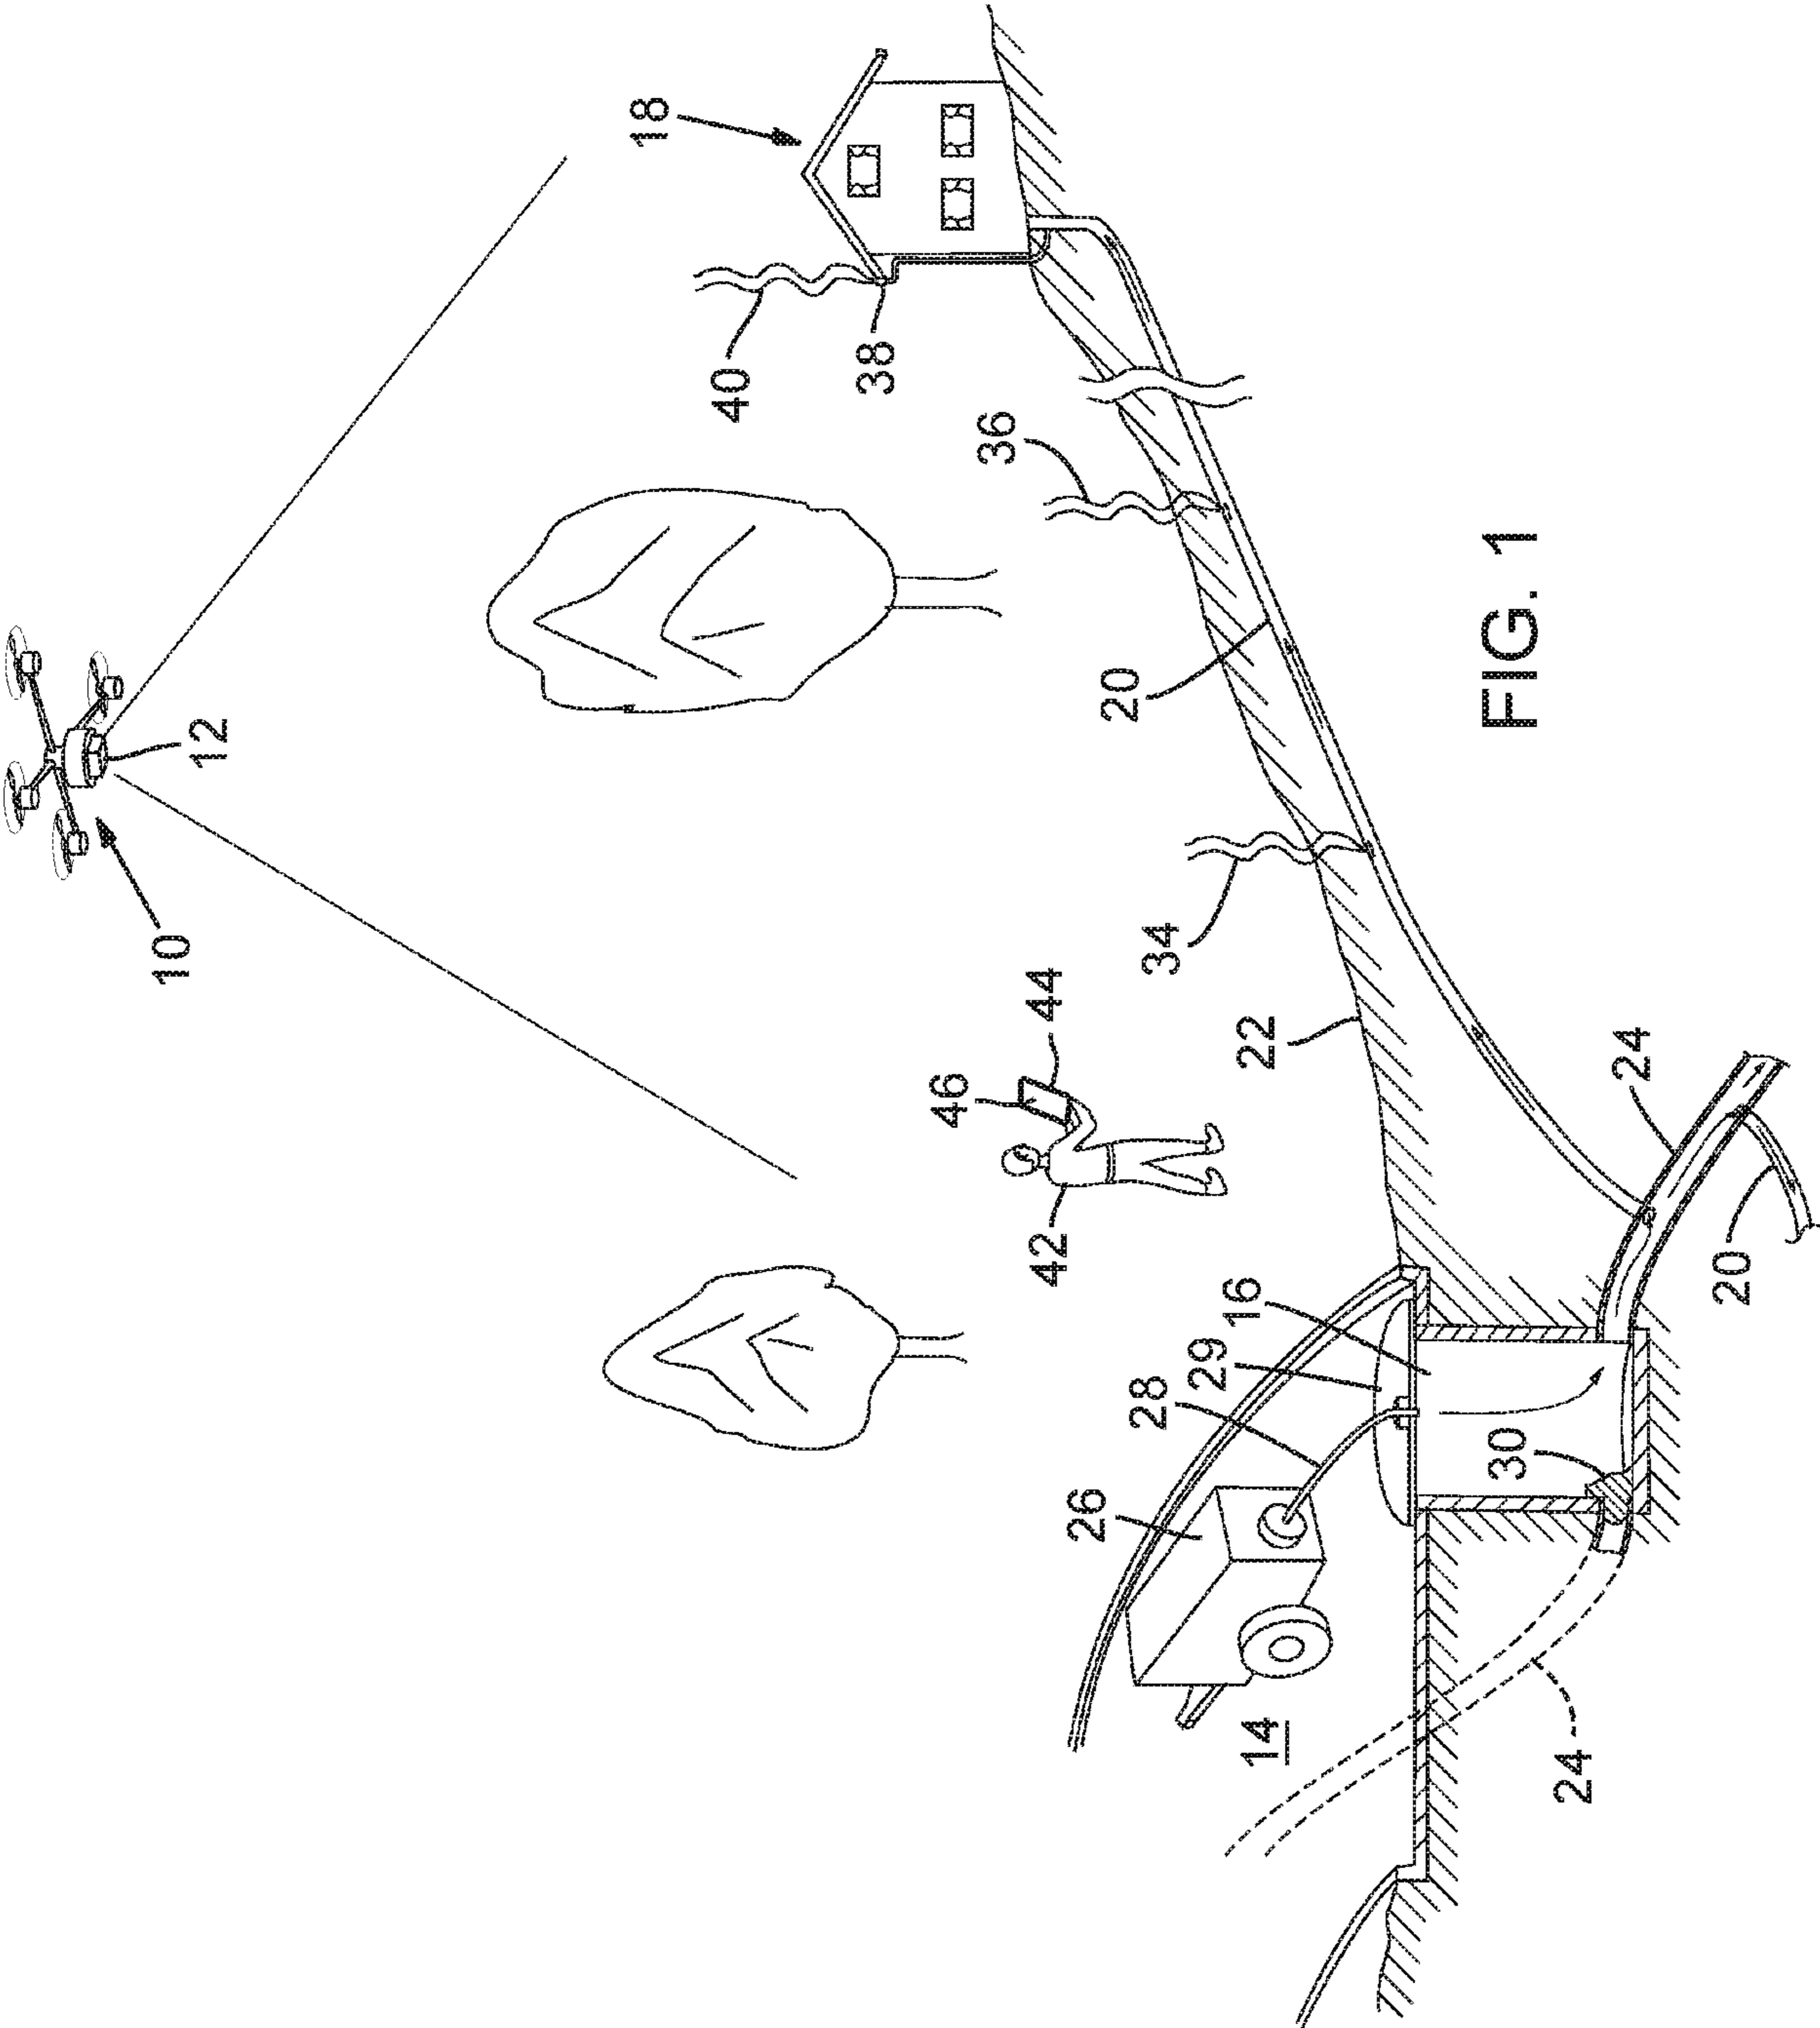
FIG. 1 is a schematic elevation view indicating the system and process of the invention, with a drone used to provide thermal images.

FIG. 1 shows schematically the method and system of the invention, in which a UAV or drone **10** has a thermal imaging camera **12** that takes overhead aerial thermal images of the landscape below, which includes a road **14** with a manhole **16**. A building is shown at **18**, which can be a residence, the building having a lateral sewer drain line **20** coming from the house and buried shallowly beneath the soil surface **22**, draining into the main sewer line **24**, although it could drain into the manhole **16**.

A boiler **26** is brought to the site, being a steam generator with a delivery hose **28**. Alternatively, a hot air blower could be used. The hose is connected to deliver steam into the section of main sewer line, with the laterals typically emptying into the main line between manholes. Steam can be directed into the manhole, using an adapter **29**, after the main line **24** has been temporarily blocked as needed. Blocks **30** are placed in the manhole at any other openings to the main line other than to the section of interest, and on the main line at the other end of the section, which is shown on the right in the drawing. Alternatively, the steam could be

FIG. 1 indicates that steam, or water vapor from the steam, seeps up through the soil at 34 and 36. Also, a rain litter or downspout 38 of the house is seen emitting steam or heat at 40. This indicates an illegal hookup to the sewer lateral 20.

An operator 42 holds a drone control 44 with a display screen 46. The device 44 controls the drone 10 flying over the scene, and also the drone's camera 12. The screen 46 displays an aerial image of the landscape in the vicinity of the manhole, the lateral and the house, with thermal imaging. Drone or camera movement may be needed to display all relevant areas. The images will indicate all features of the landscape, but will highlight areas of increased temperature, caused by the steam or heat emitted at leaks and from hookups.

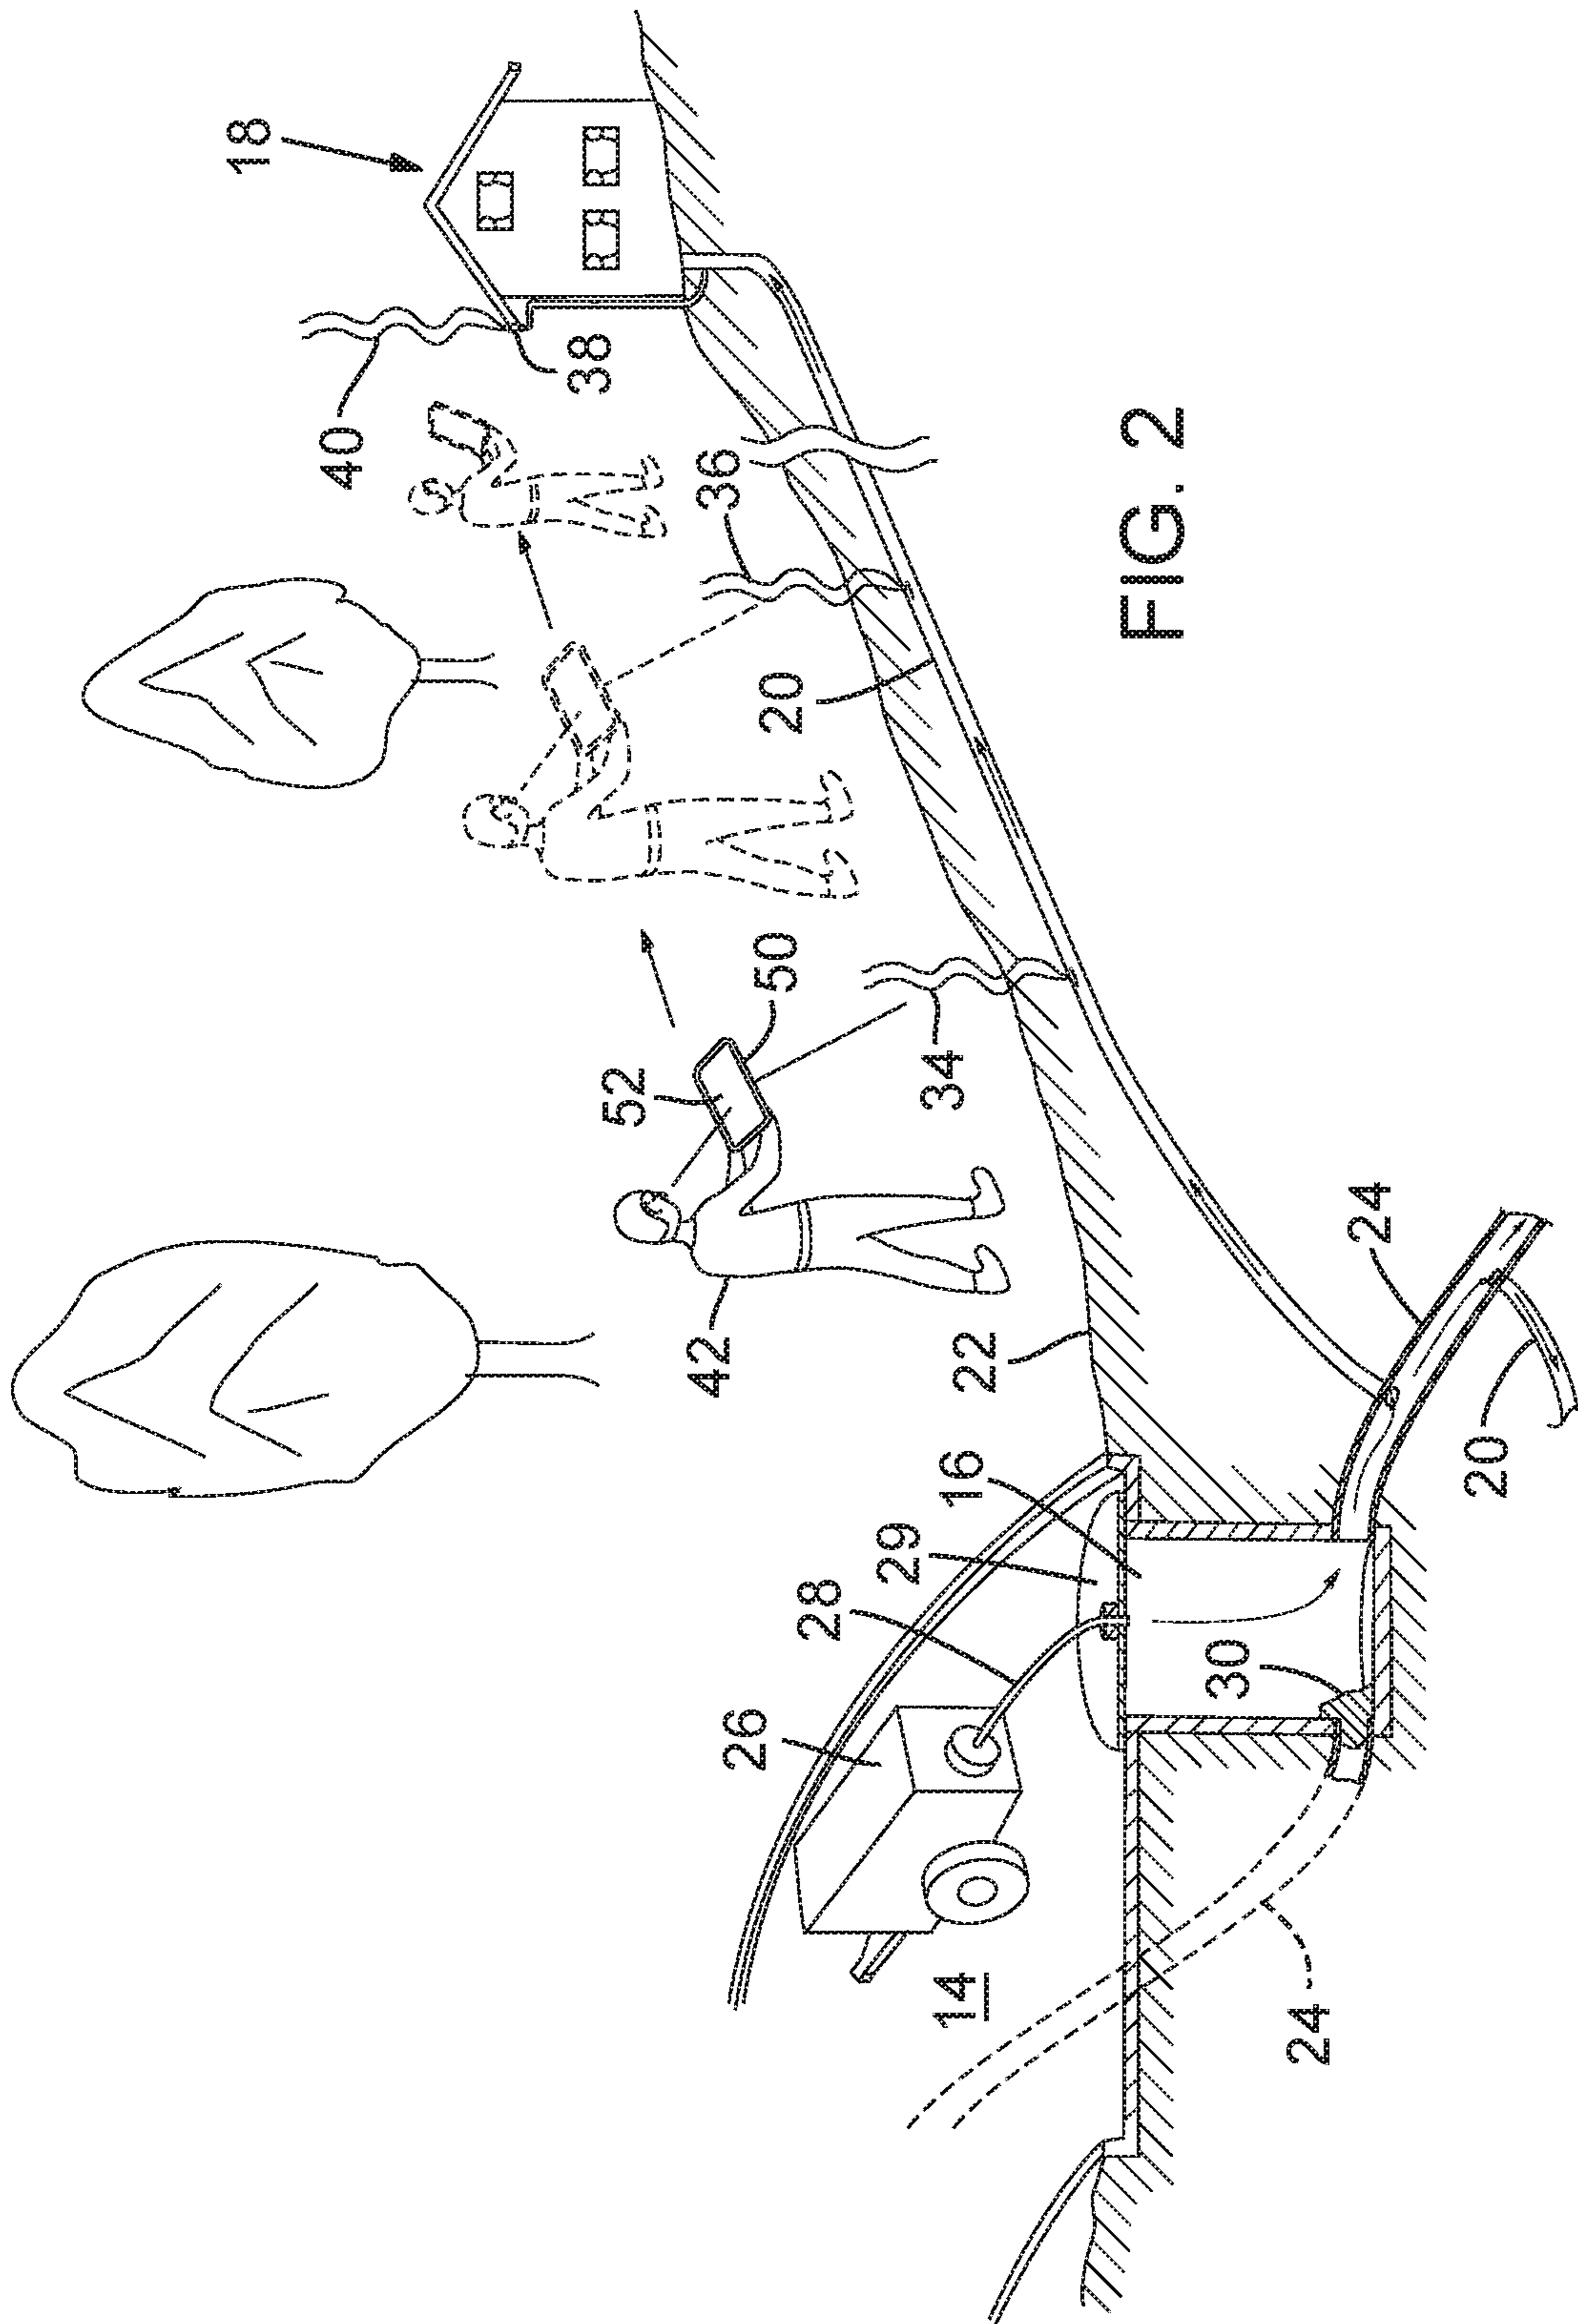
FIG. 2 is a schematic view similar to FIG. 1 but with an operator carrying a thermal imaging device, rather than use of a drone.

FIG. 2 shows a similar operation, but without the drone. The operator 42 has a hand-held thermal imaging or thermography device, indicated here as a housing 50 with a screen 52 that displays thermal images with a camera (not shown). The operator aims the camera along the landscape where the lateral is located, and can inspect the house 18 by aiming the camera and, if needed, bringing the camera closer. The system is similar to that described above, except that the inspector (or inspectors) is required to move to different locations in order to inspect a number of laterals and buildings. The drone is capable of imaging a much larger area and many more laterals and hookups.

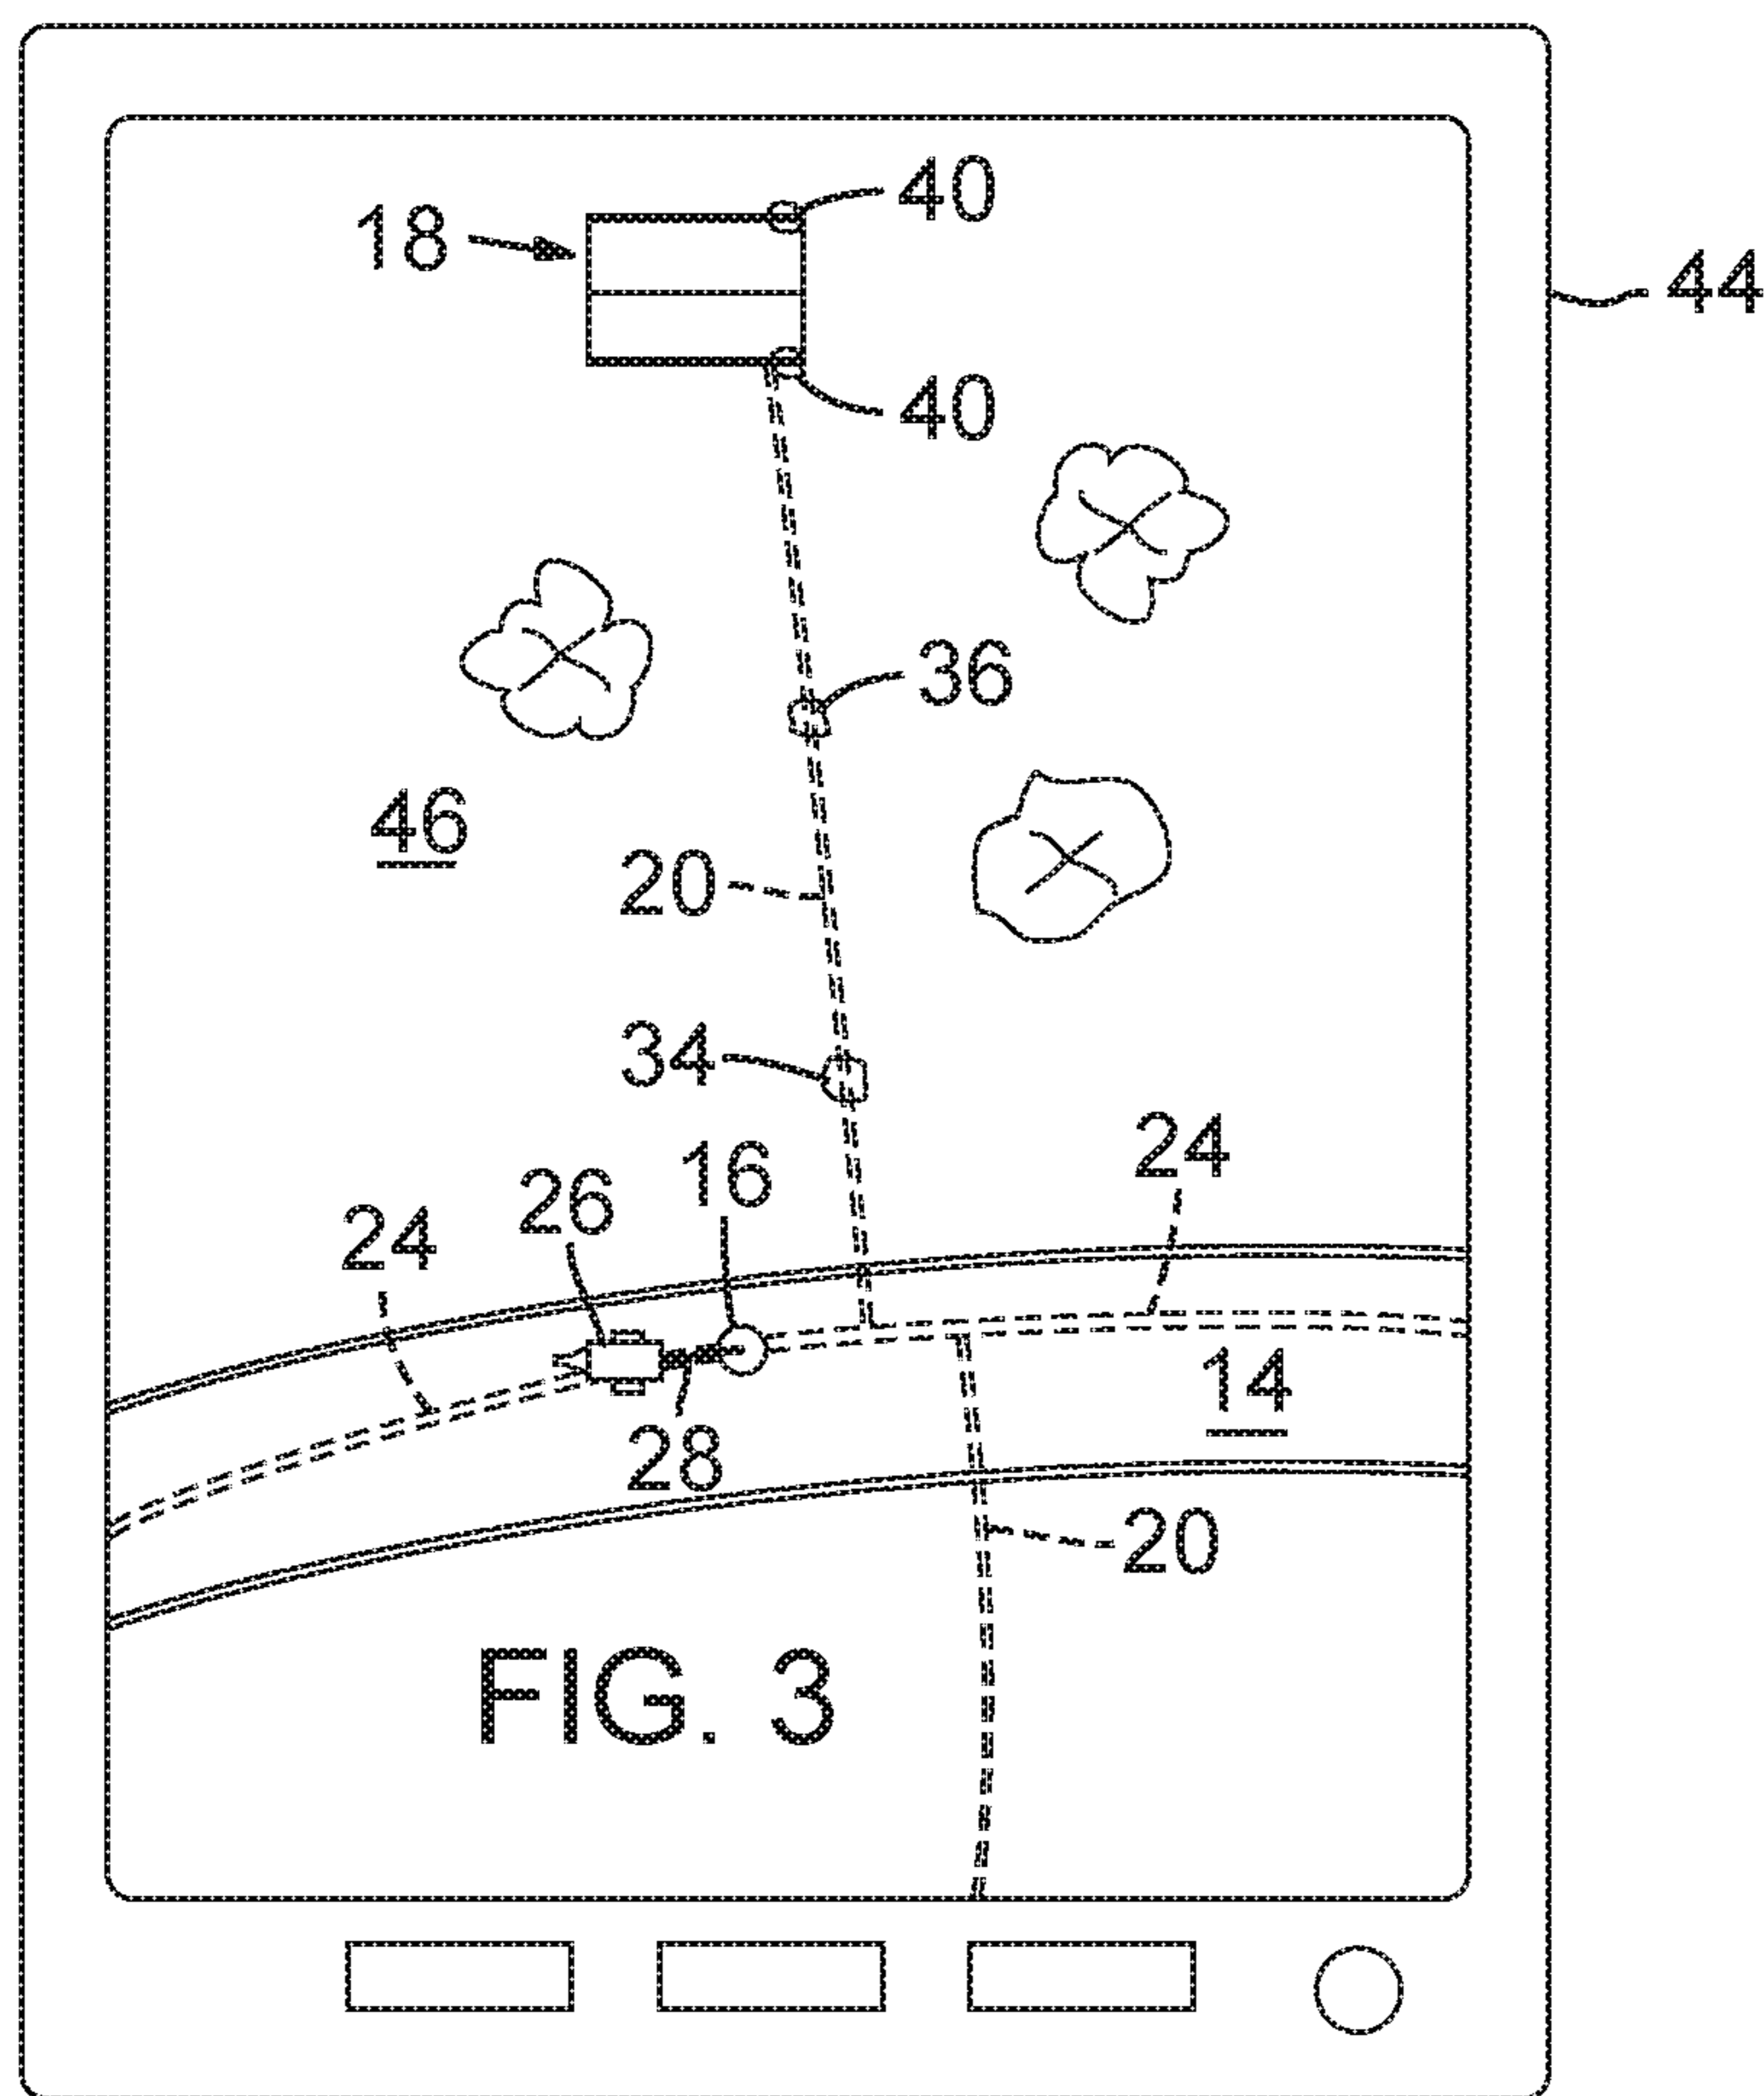
FIG. 3 is an example of a screen shot for a computer device displaying thermal images, particularly as imaged by a drone camera, and indicating steam escape locations.

FIG. 3 is a schematic indication of a screen display on the device 44 of FIG. 1. The screen 46 shows a thermal image, via infrared thermography or thermal video (still shots could be used if desired). The thermographic camera detects radiation in the infrared range of the spectrum and produces the thermogram. Typically areas of higher temperature are displayed with warmer, brighter colors, such as yellow, orange or red. Since infrared radiation is emitted by all objects with temperature above absolute zero, thermography will display the entire environment, whether visible to the eye or not, e.g. day or night. Variations in temperature are clearly displayed, and in the case of the example noted above, with lateral leaks at 34 and 36, these would typically be orange or red areas against a much darker background, such as blue or dark blue. The spectrum of displayed colors for particular temperature ranges can vary with different systems. The house 18 will typically show more heat than the natural environment, typically trees and vegetation. The house may show as light green or yellow. A steam emission, such as 38, will be shown as a higher temperature than the house itself, typically brighter than the surroundings.
