(10) **Patent No.:** **US 11,739,713 B2**
(45) **Date of Patent:** **Aug. 29, 2023**

(54) **FLUROELASTOMER EROSION COATING REPAIR**

(71) Applicant: **Raytheon Technologies Corporation**, Farmington, CT (US)

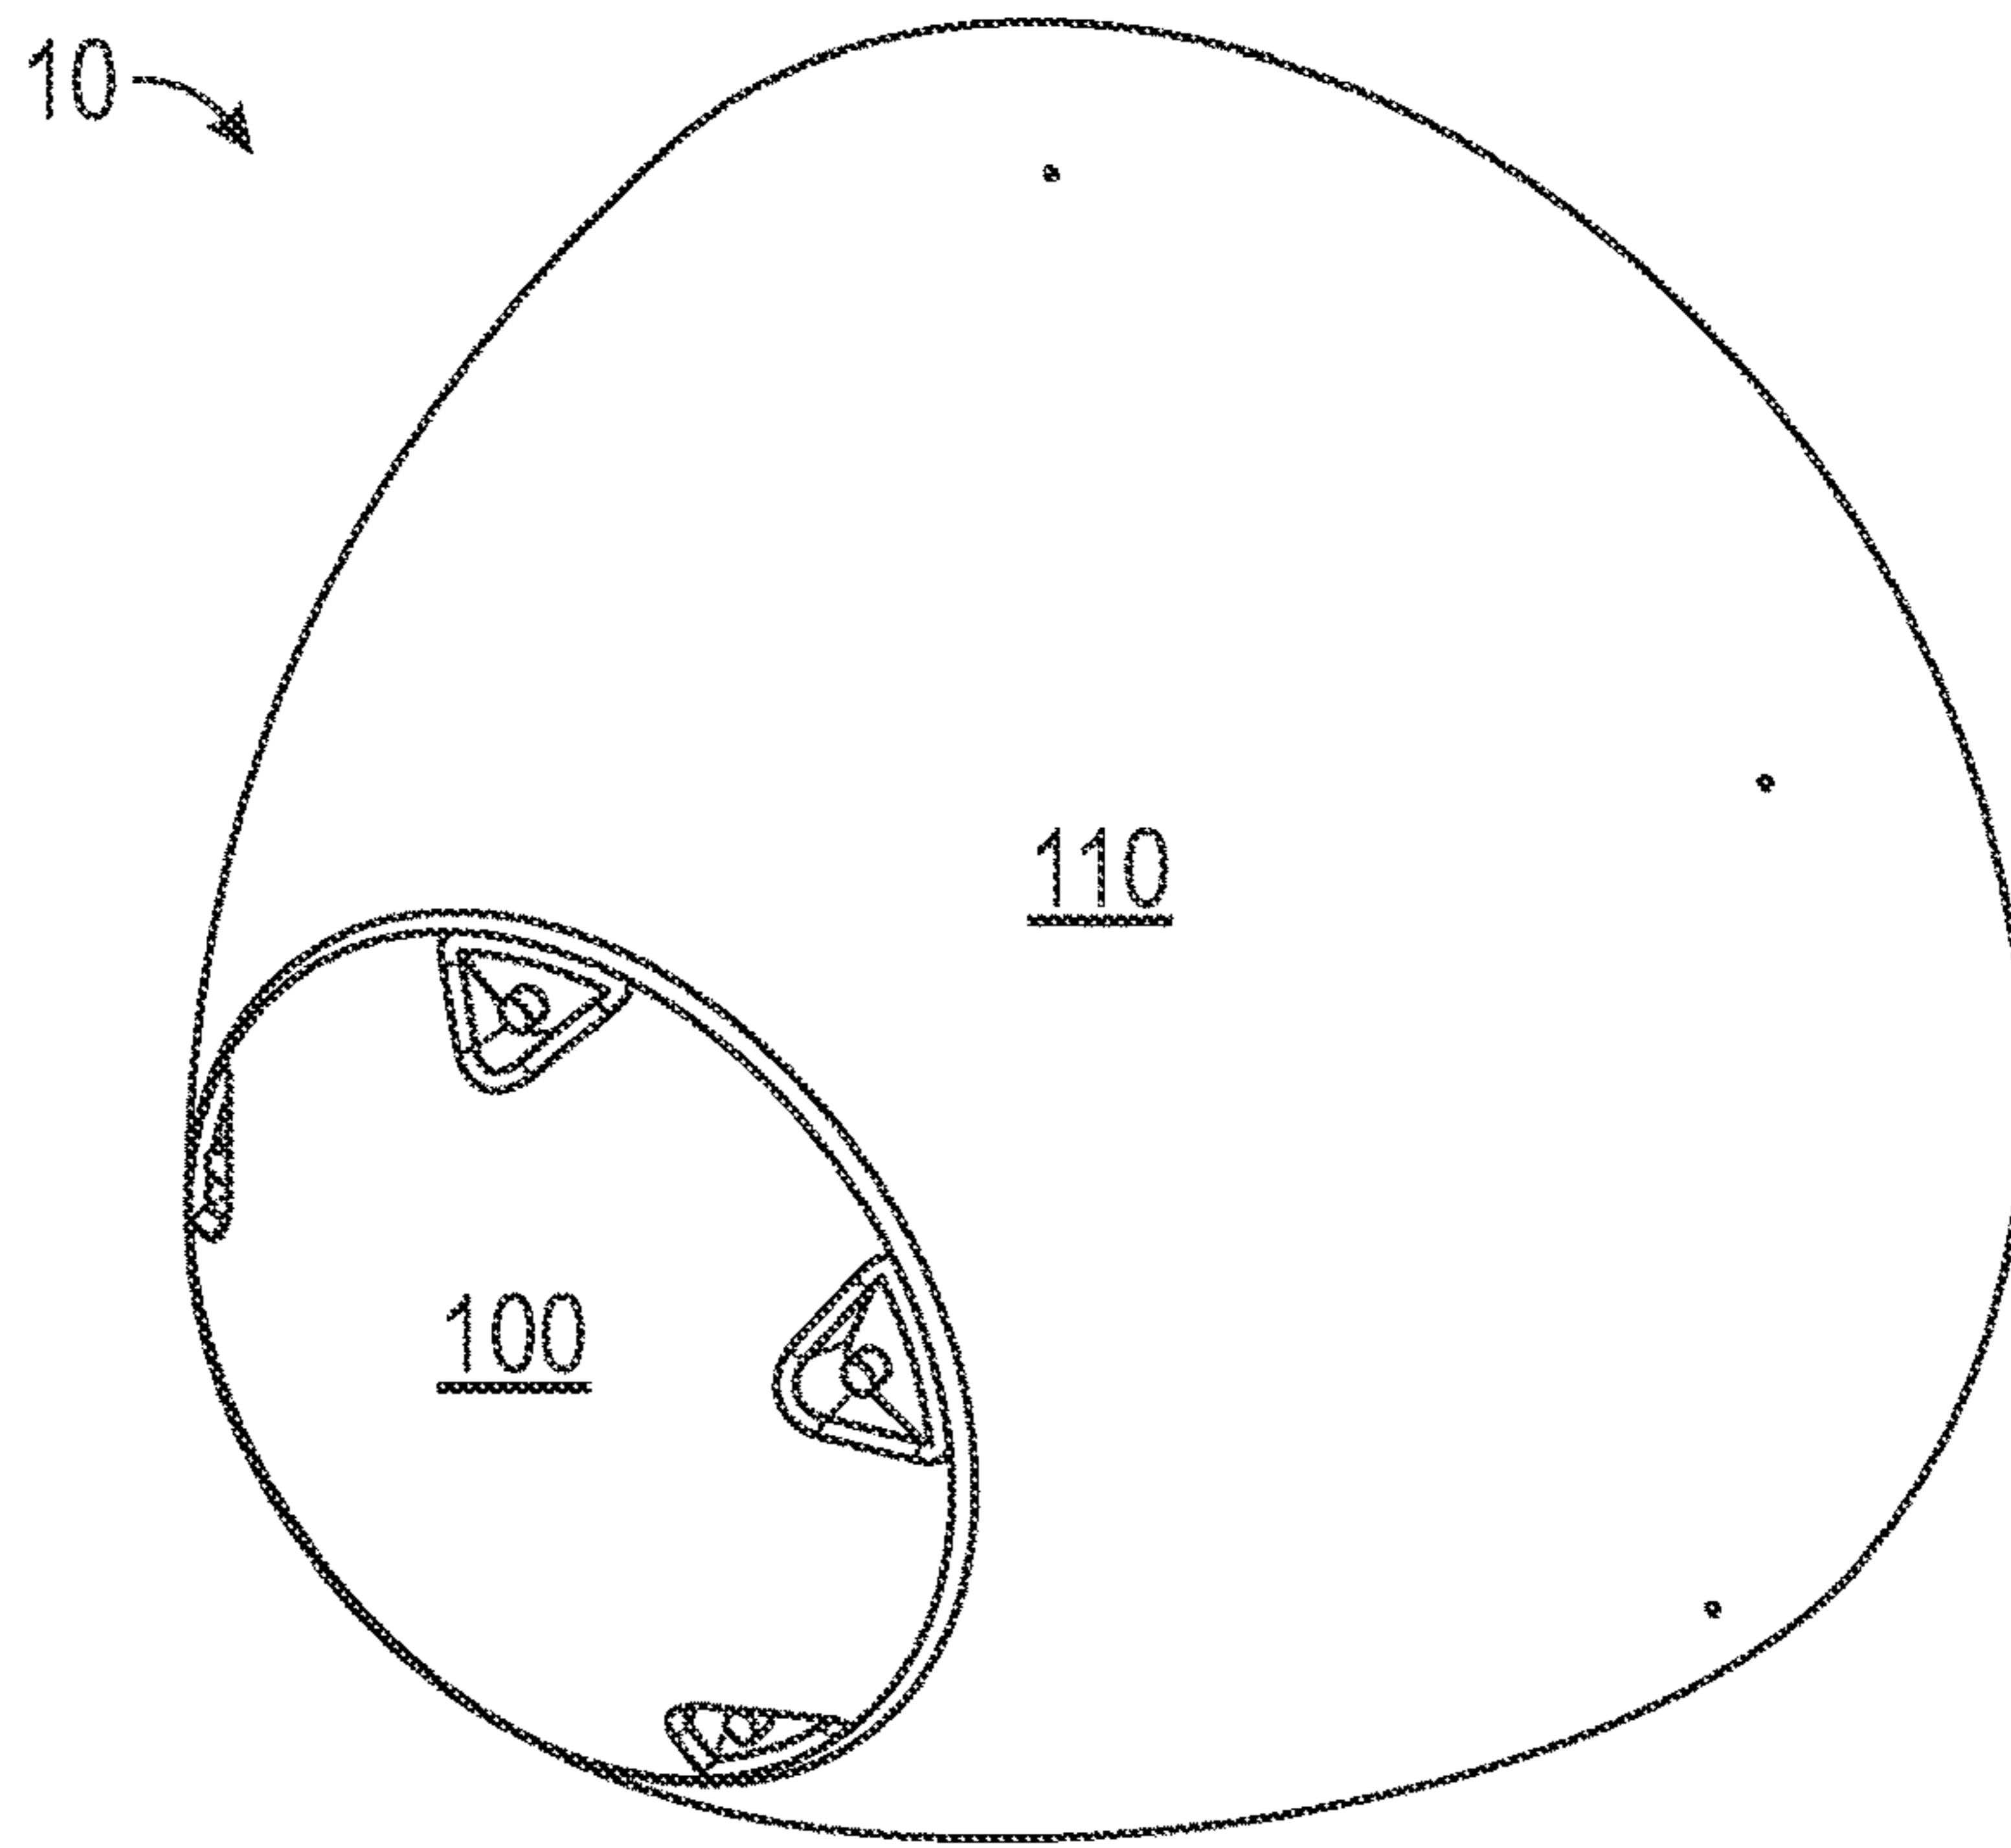
FIG. 1 shows an inlet cone for a gas turbine engine;

FIG. 1 shows an inlet cone for a gas turbine engine. The inlet cone 10 includes a forward cover 100 and a rear cone segment 110, both of which typically rotate with the fan, but may also be static in the airflow. The rear cone segment 110 is a truncated cone, with attachment flanges on the forward and aft extents. The forward flange (also referred to as the front attachment flange) is shown in FIG. 4 and is protected by the forward cover 100. The aft flange is not shown.

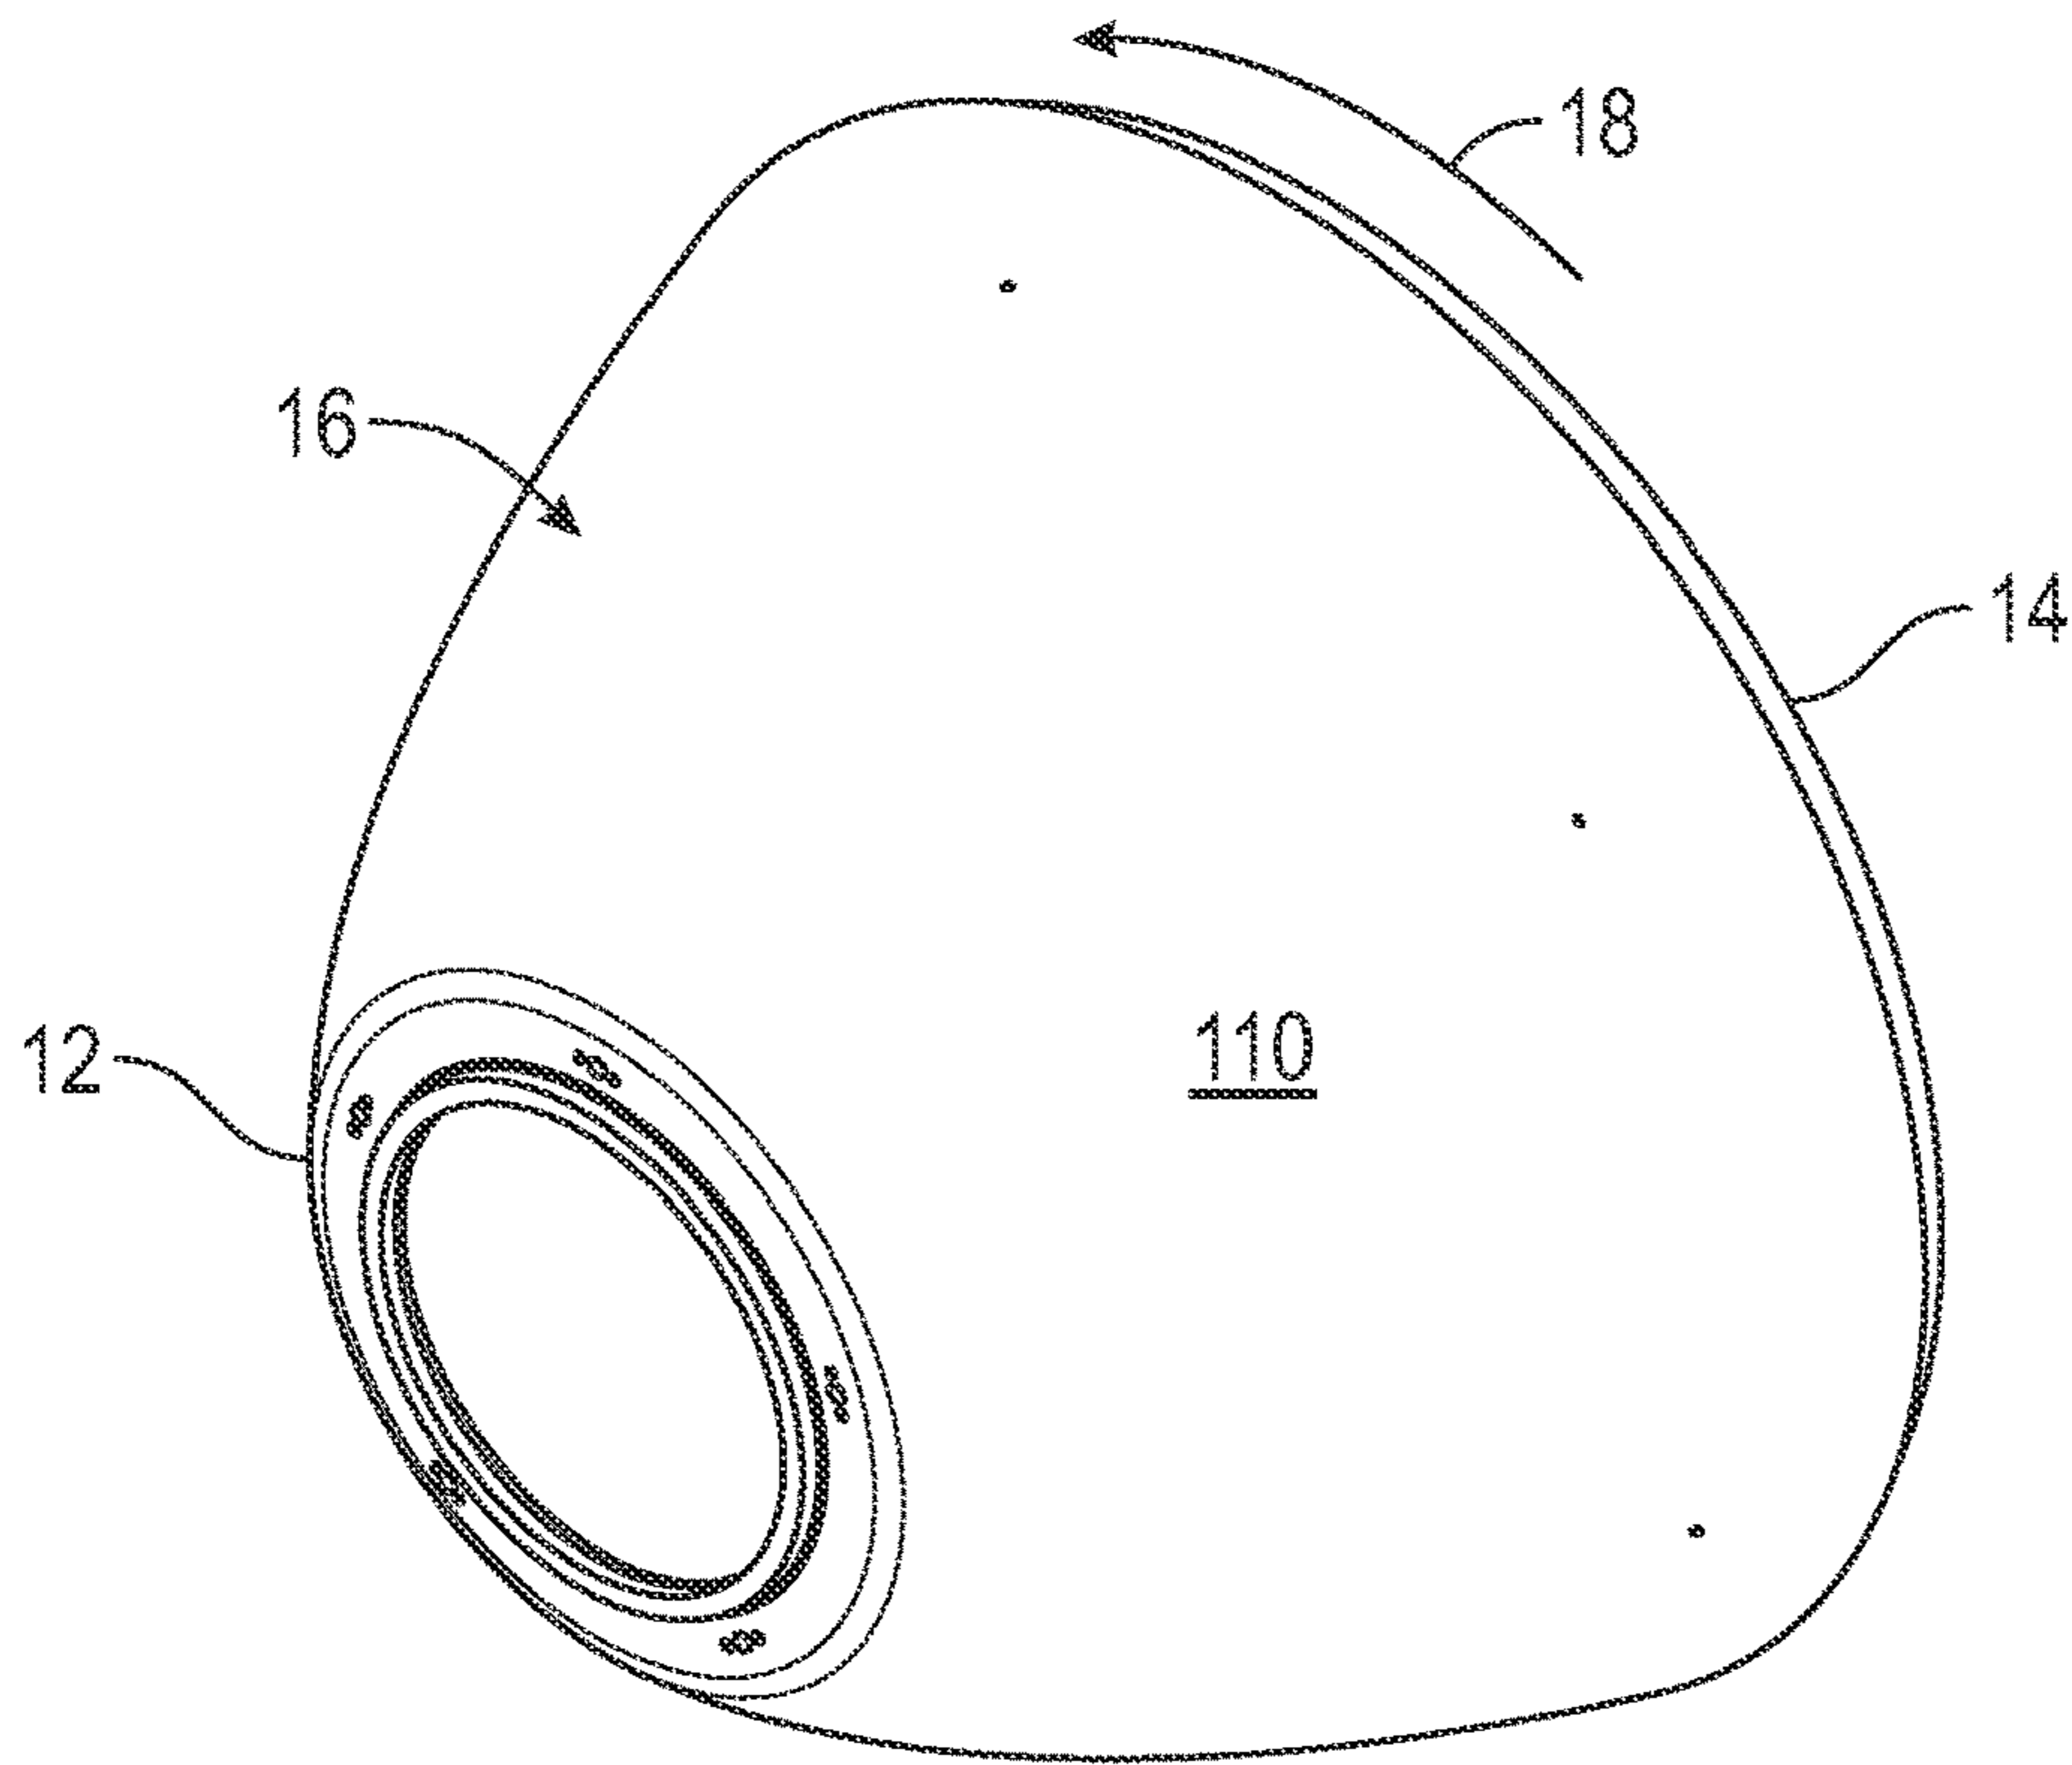
FIG. 2 shows a rear cone segment;

FIG. 2 shows rear cone segment 110 for a gas turbine engine. The rear cone segment 110 is rotatably mounted to the turbine engine in front of the fan blades and has a leading edge 12, a trailing edge 14, and an outer flow surface 16. The rear cone segment 110 has a direction of rotation 18.

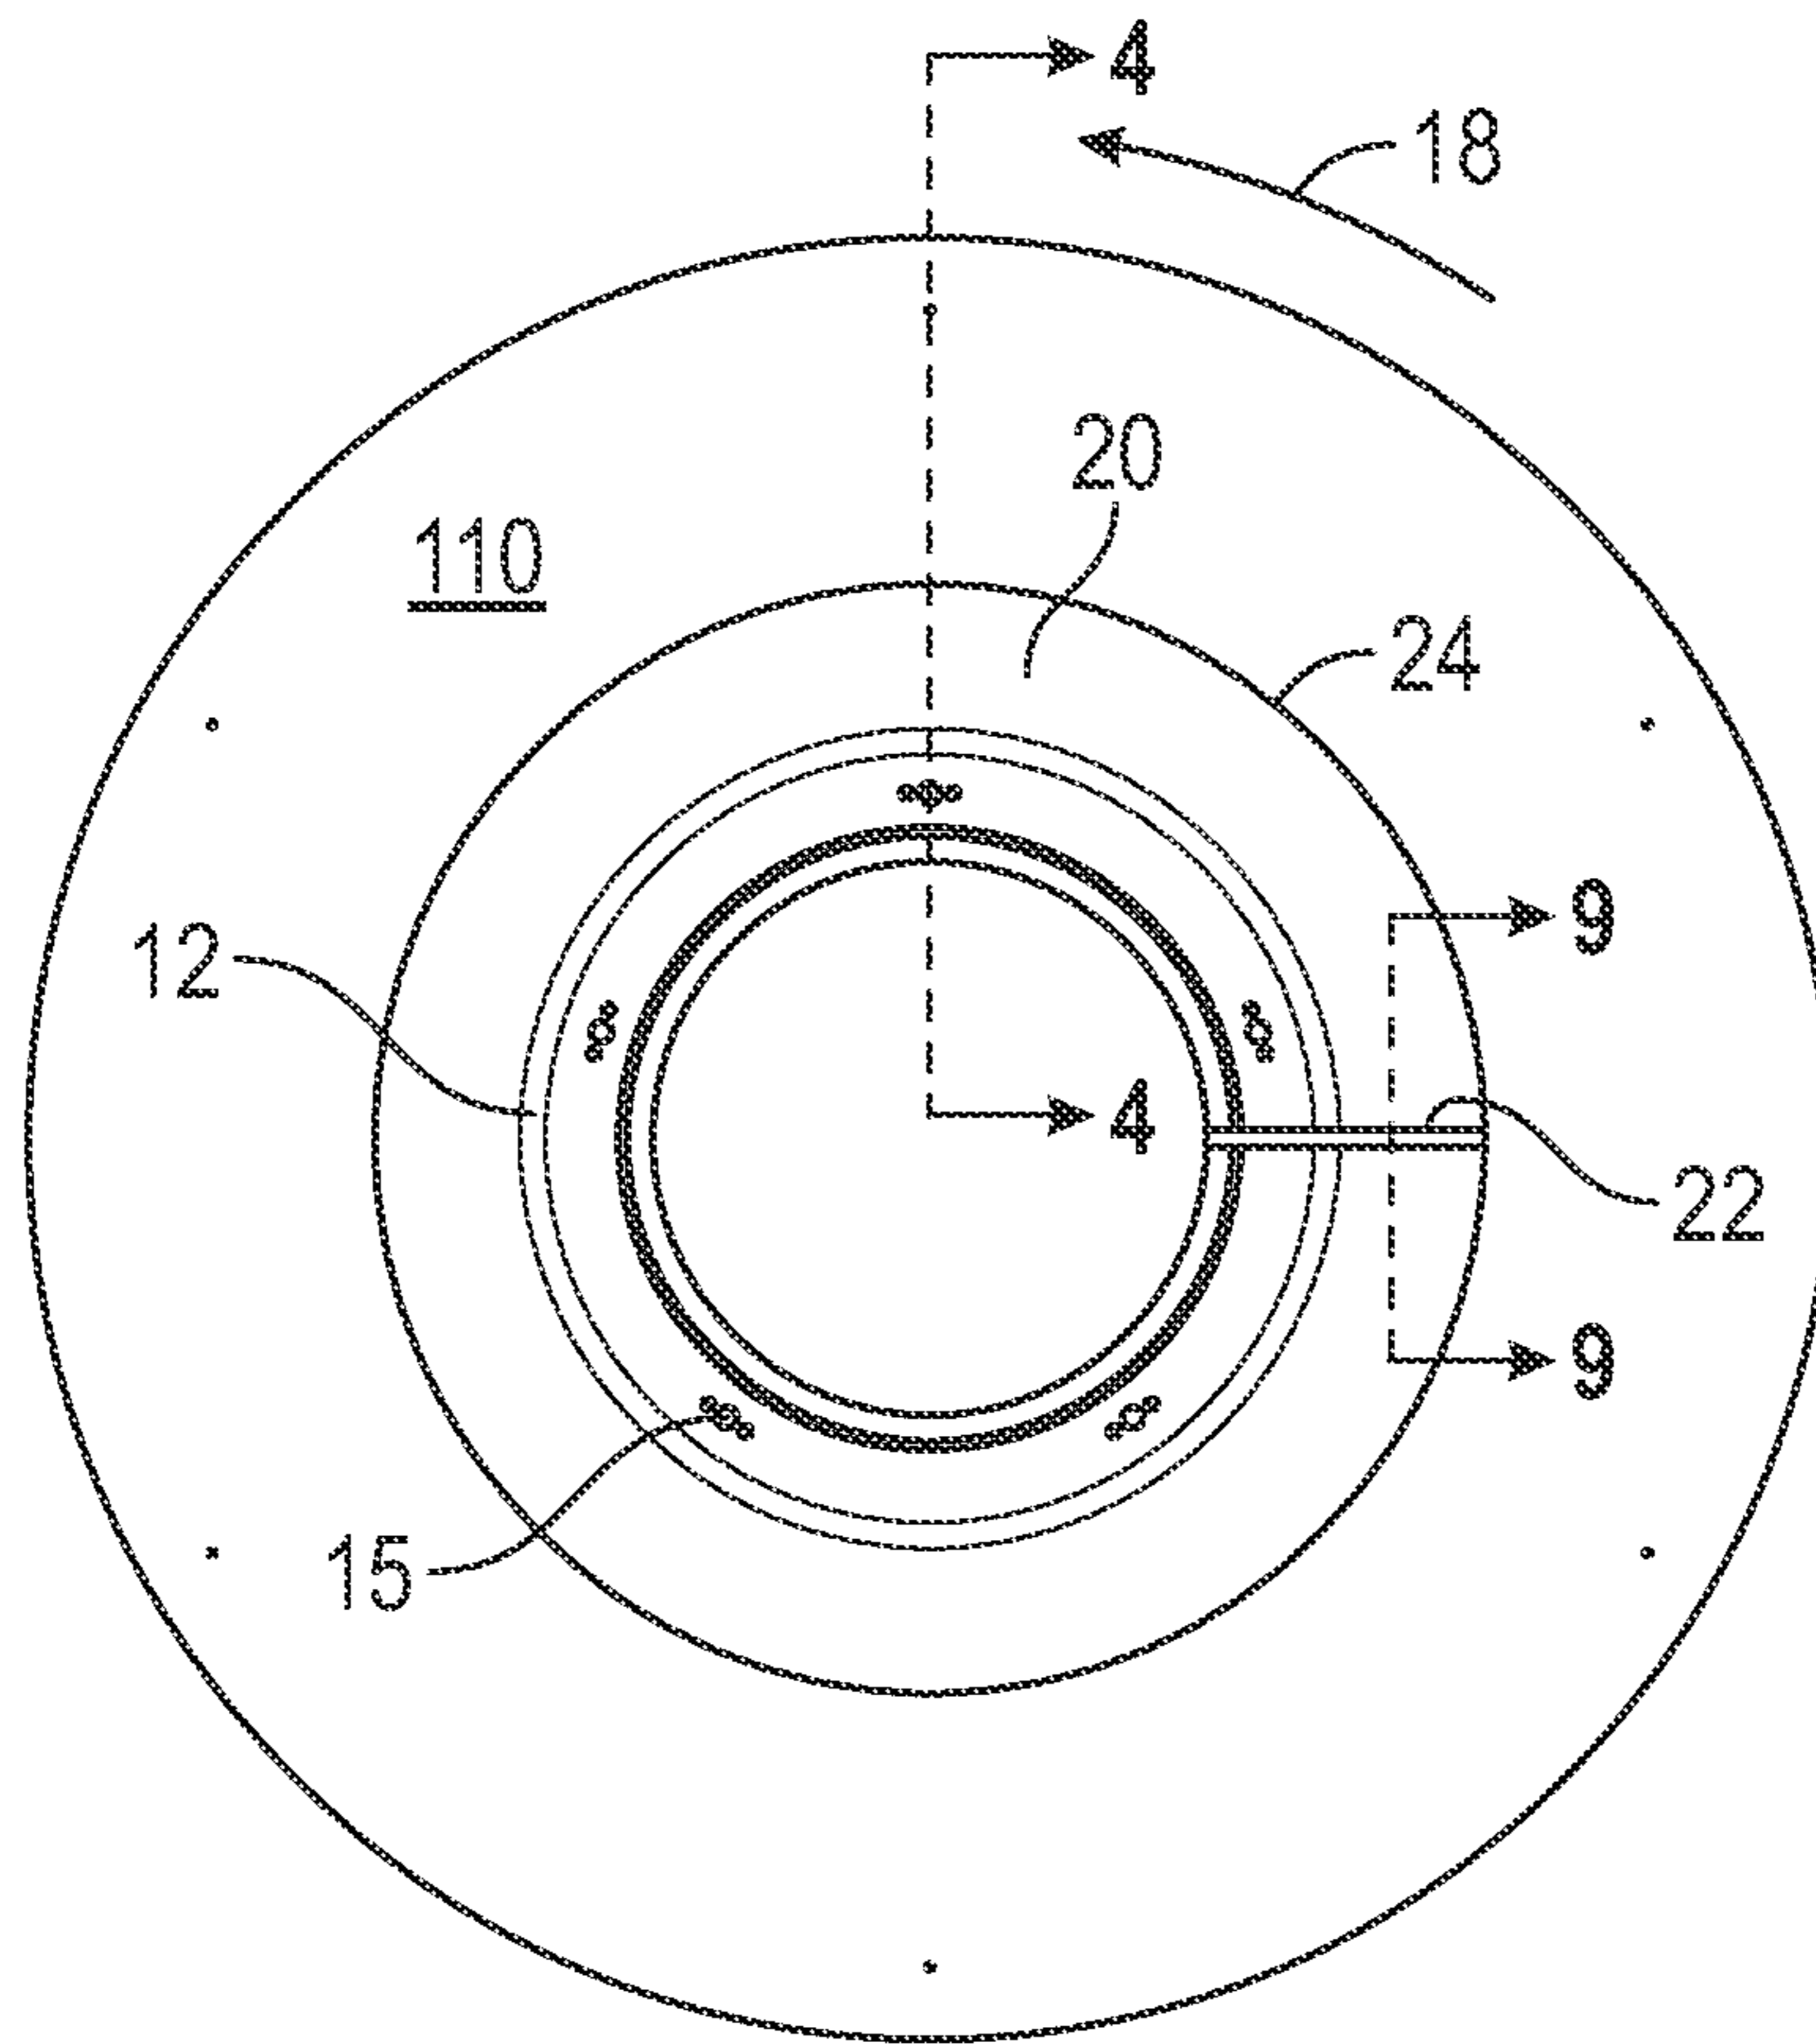
FIG. 3 is a front view of a rear cone segment;

FIG. 3 is a front view of rear cone segment 110. The rear cone segment 110 has attachment holes 15 for forward cover 100. Repair area 20 includes the attachment holes and a portion of the outer flow surface 16. Repair area 20 has an axial joint 22 and a circumferential joint 24. FIG. 2 also shows section line 4 and section line 9 which are shown in greater detail in FIG. 4 and FIG. 9 respectively.

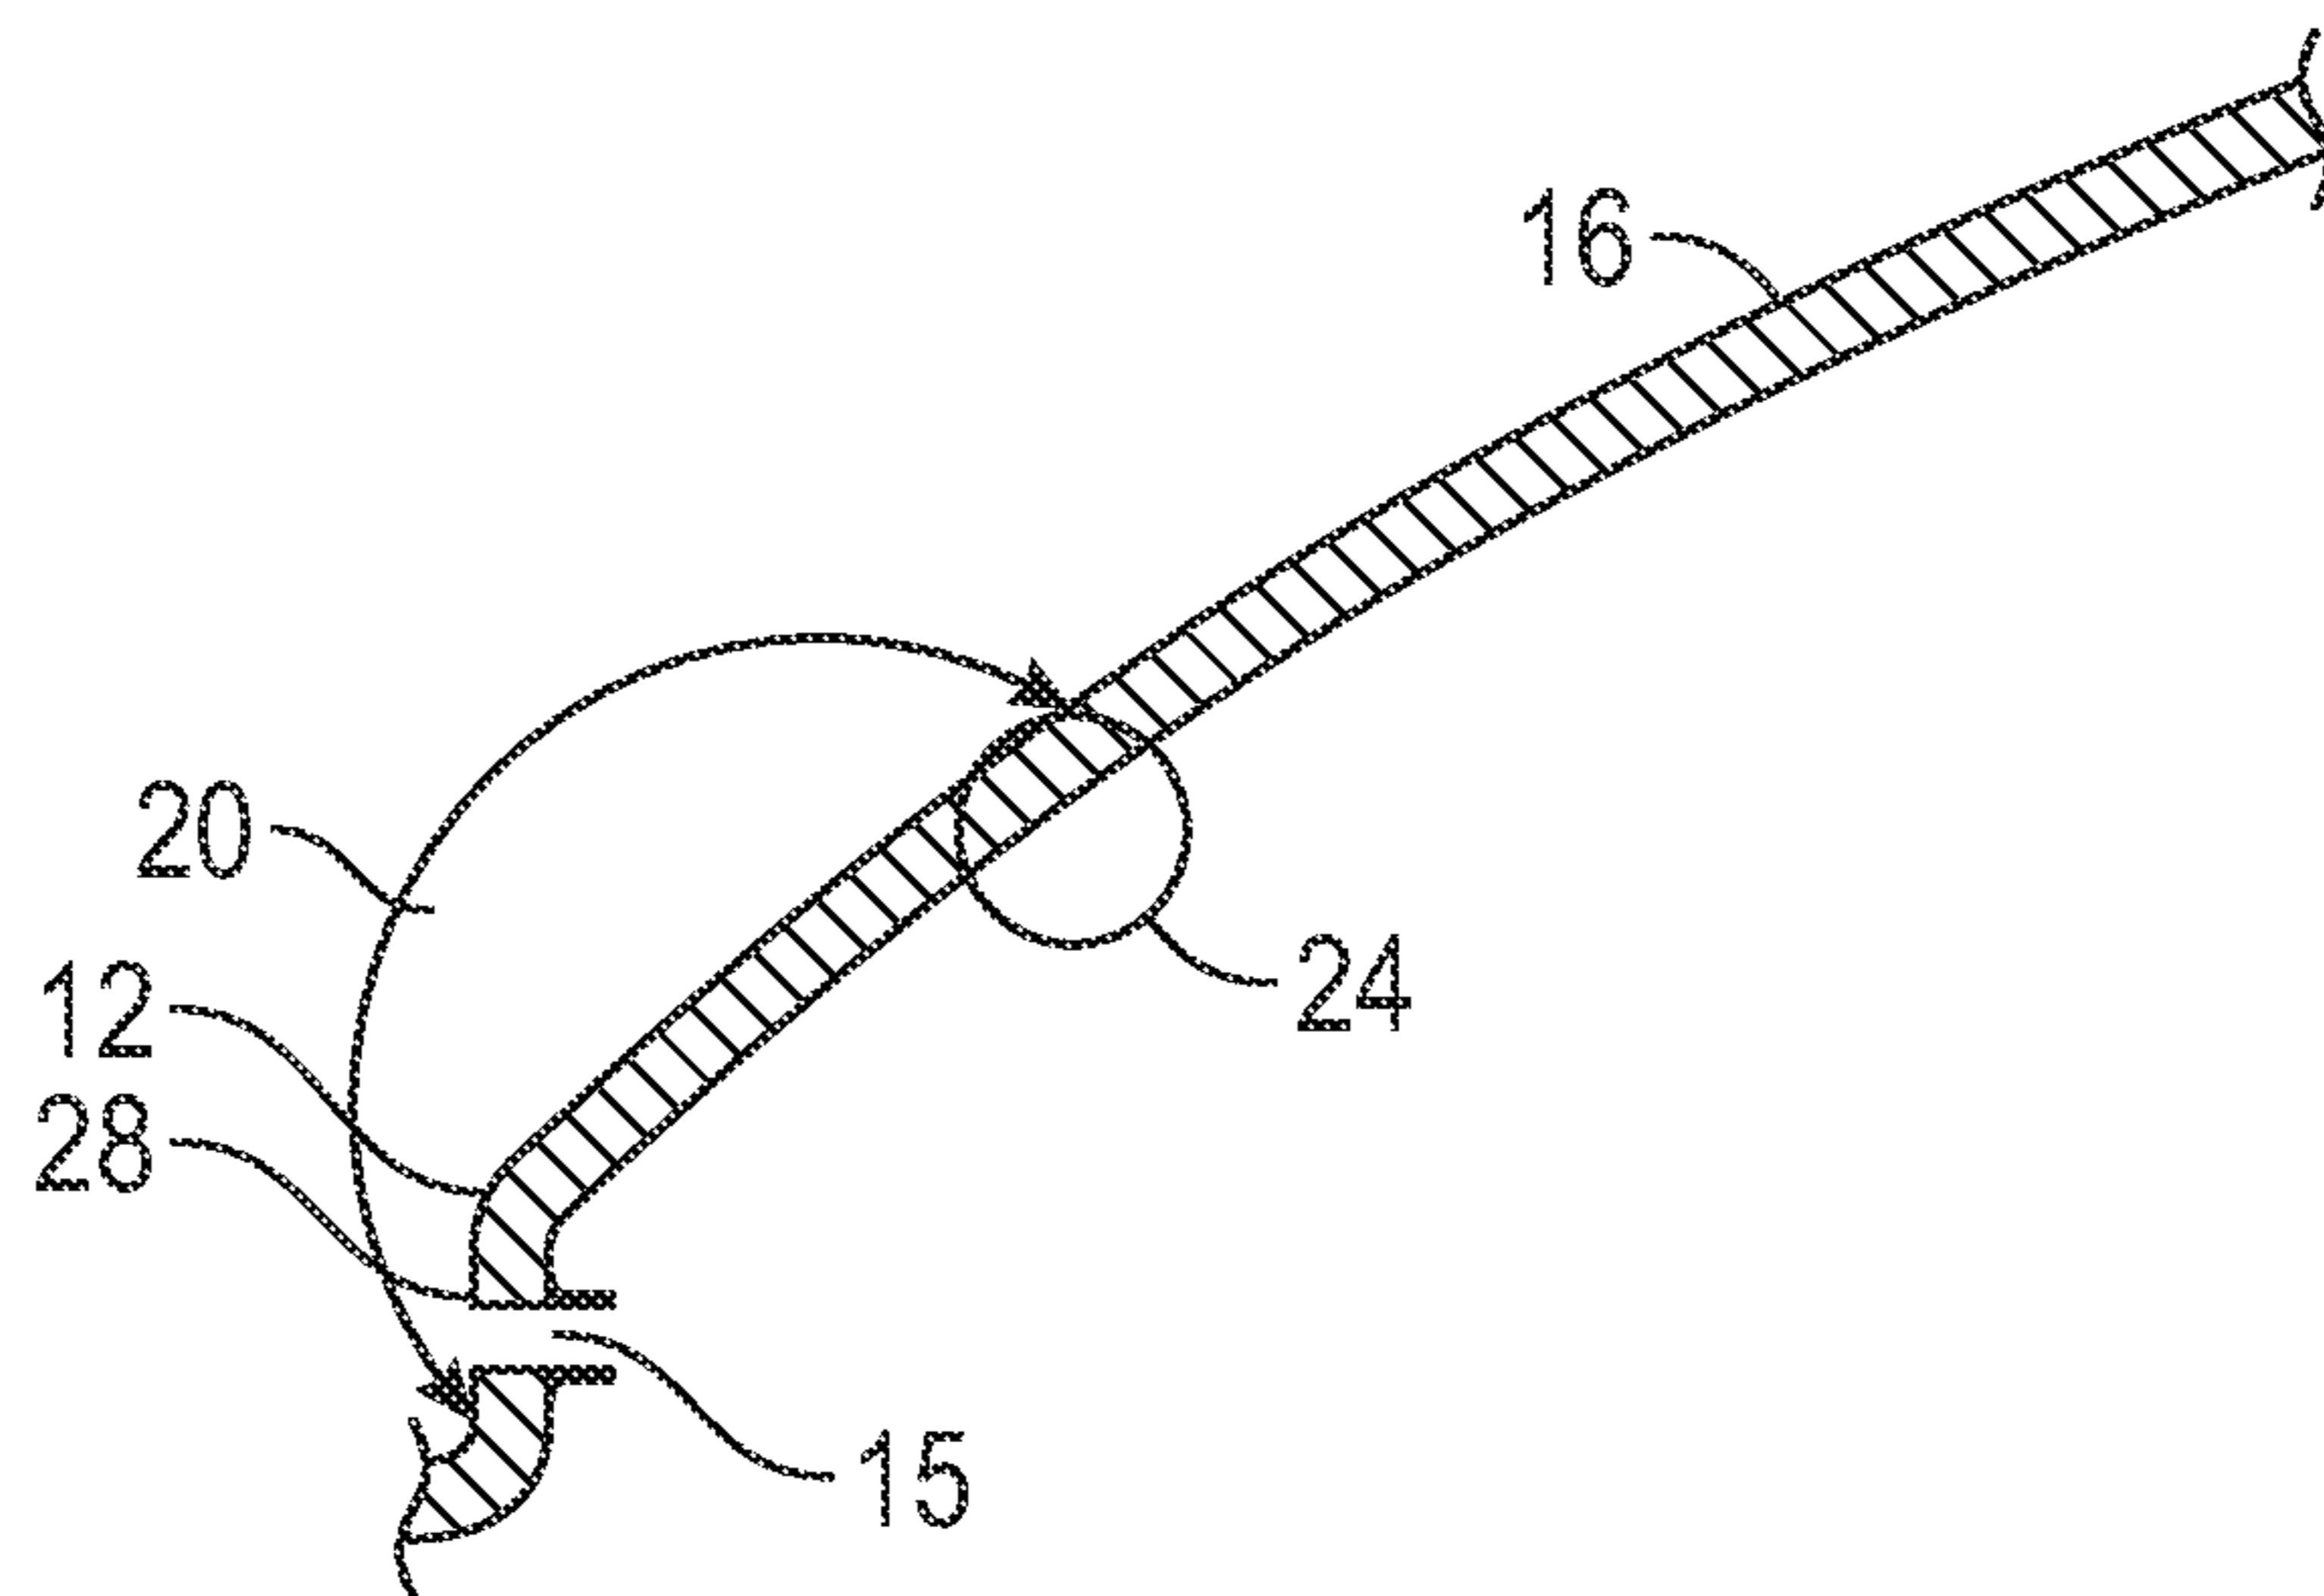
FIG. 4 shows a cross section of a repair area;

FIG. 4 shows a cross section of repair area 20 having a leading edge 12 and a forward flange 28. Forward flange 28 includes the attachment holes 15. Because the repair area includes the forward flange, airflow is prevented from getting under the forward edge of the repair material. An additional feature of having the repair area cover the forward flange is the mating part has a bolted interface that passes through the repair material, thus further securing the repair detail. The circumferential joint 24 is shown in greater detail in FIG. 10.

The existing fluoroelastomer coating is removed from the rear cone segment 110 to form repair area 20. The existing fluoroelastomer coating may be removed by mechanically by cutting it away with a blade, abrasive wiping, abrasive blasting, water jetting, or a combination thereof. Chemical softening of the existing fluoroelastomer coating may precede mechanical removal. Chemical softening includes contact with a solvent such as acetone, methyl ethyl ketone, or another solvent comprising a ketone. After the existing fluoroelastomer coating is removed the repair area may be cleaned, inspected, and prepared for bonding with the cured replacement erosion coating.

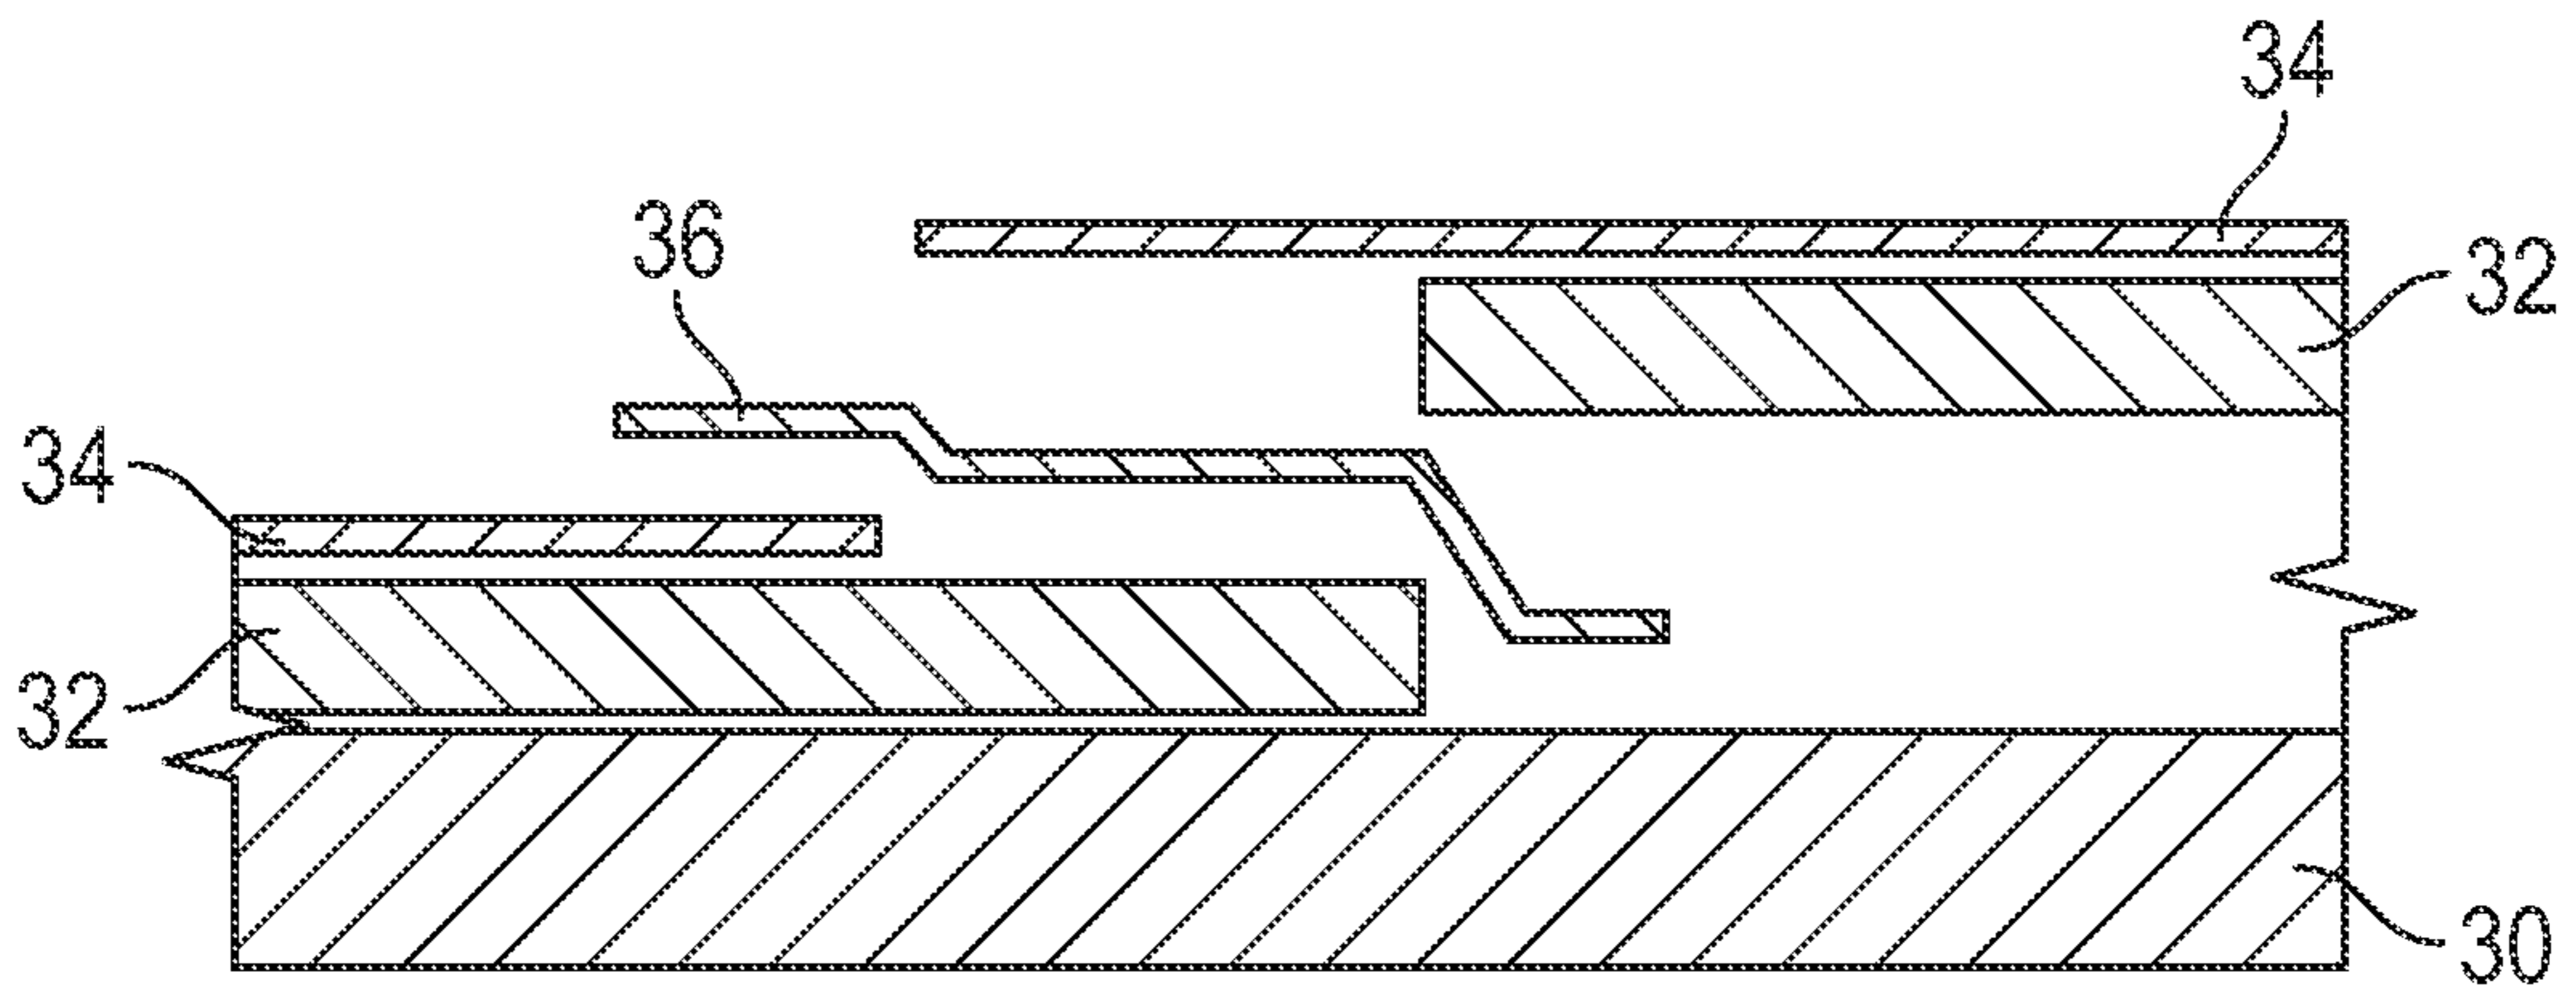
FIGS. 5 and 6 show a layout of an uncured replacement erosion coating;

FIG. 5 shows a mold having a concave surface 30, an uncured fluoroelastomer sheet 32 disposed on the mold with a first end of the uncured fluoroelastomer sheet located adjacent to one side of barrier film 36 and the second end of the uncured fluoroelastomer sheet 32 located next to the opposite side of barrier film 36. The fibrous reinforcement 34 is disposed on the uncured fluoroelastomer sheet with one end adjacent to one side of barrier film 36 and the other end of the fibrous reinforcement 34 located next to the opposite side of barrier film 36. The joint formed by the ends of the

uncured fluoroelastomer sheet does not align with the joint formed by the ends of the fibrous reinforcement **34**.

When using a mold with a concave surface, one end of a barrier film is applied to the mold surface. A sheet of uncured fluoroelastomer having a first end, a second end, a front edge and a back edge is used. The sheet of uncured fluoroelastomer is wrapped axially so the first end and second end are located axially and the front edge and back edge are located circumferentially. The sheet of uncured fluoroelastomer is placed on the mold surface so that the first end of the fluoroelastomer sheet is adjacent to one side of the barrier film and the second end of the fluoroelastomer sheet is adjacent to the other side of the barrier film. The free end of the barrier film extends beyond both ends of the fluoroelastomer sheet. A sheet of fibrous reinforcement is placed on the uncured elastomer so that the joint between the ends of the fibrous reinforcement do not align with the joint between the ends of the uncured elastomer. The barrier film is located between the ends of the uncured fluoroelastomer and between the ends of the fibrous reinforcement.

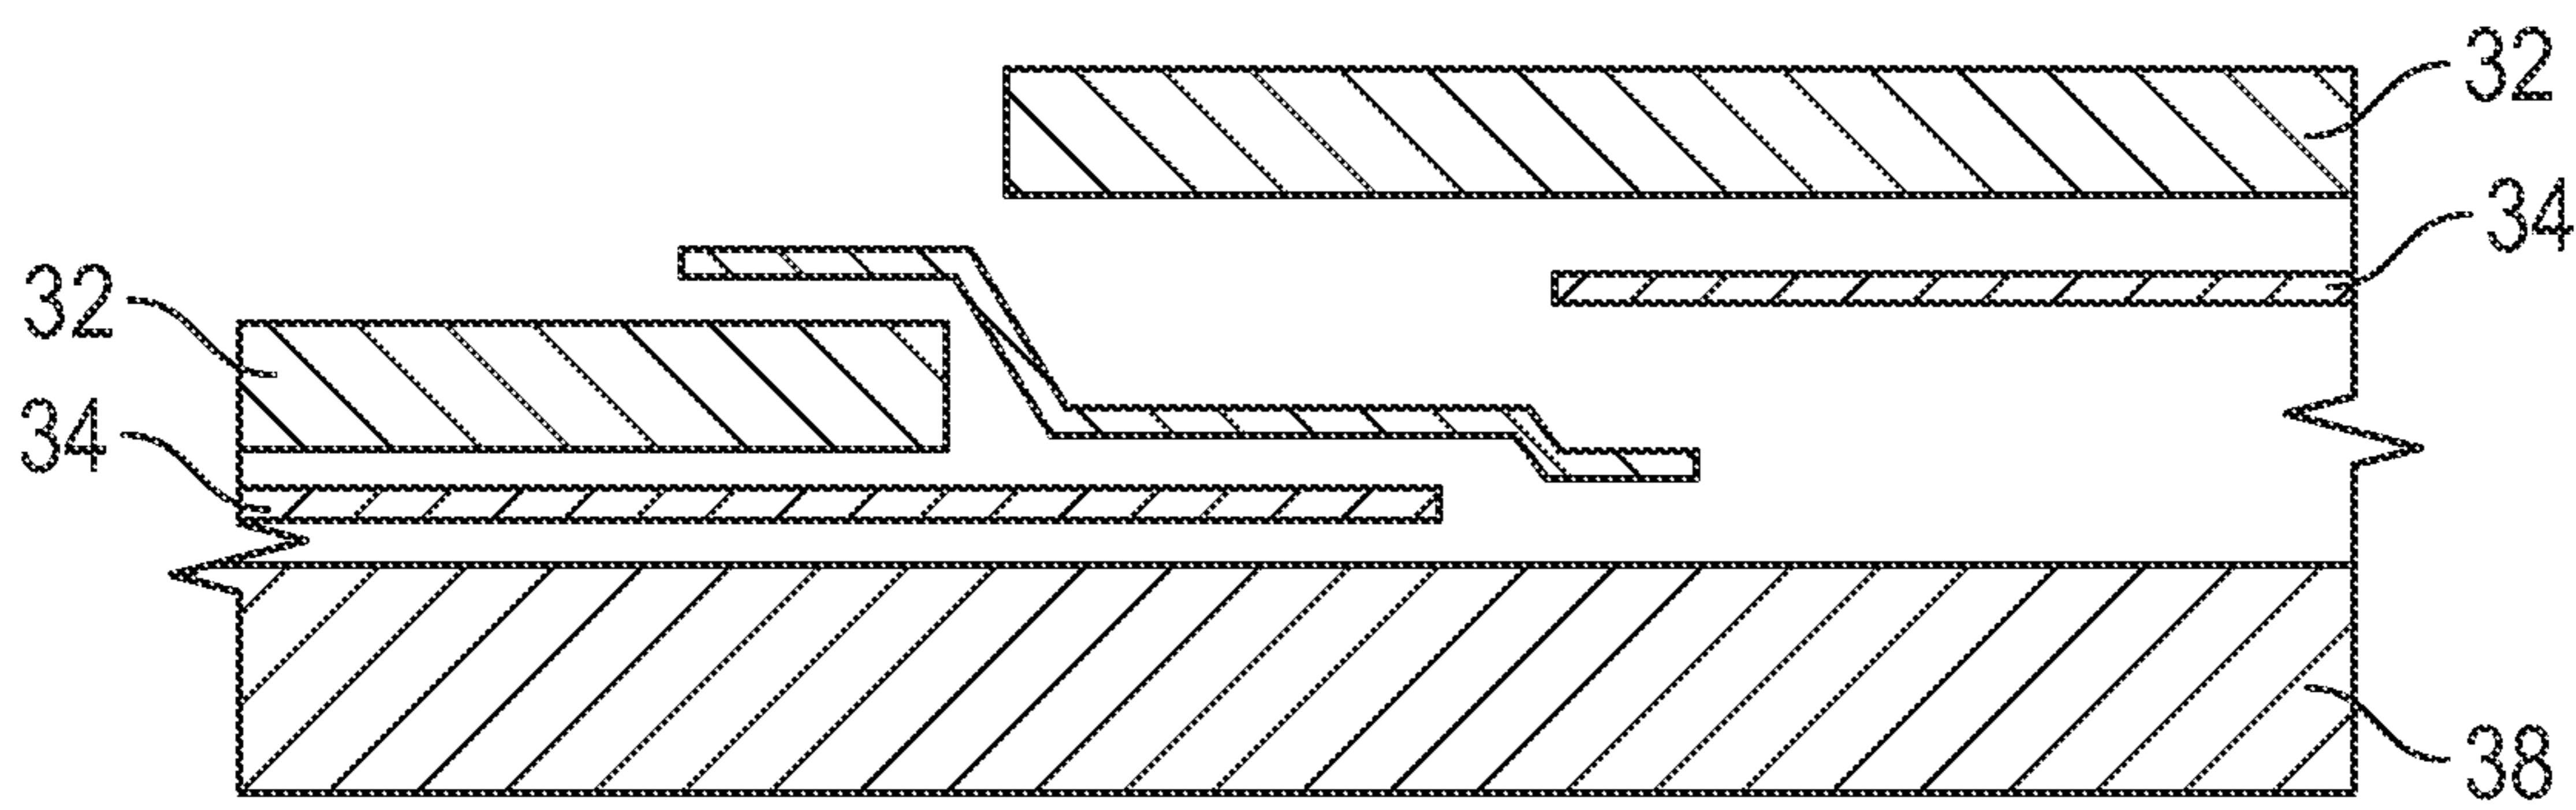
FIG. 6

When using a mold with a convex surface the order of the uncured fluoroelastomer and fibrous reinforcement are reversed. FIG. **6** shows a mold having a convex surface **38**, a fibrous reinforcement **34** disposed on the mold with a first end of the fibrous reinforcement **34** located adjacent to one side of barrier film **36** and the second end of the fibrous reinforcement **34** located next to the opposite side of barrier film **36**. The uncured fluoroelastomer sheet **32** is disposed on the fibrous reinforcement **34** with a first end adjacent to one side of barrier film **36** and the second end of the uncured fluoroelastomer sheet **32** located next to the opposite side of barrier film **36**. The joint formed by the ends of the uncured fluoroelastomer sheet **32** does not align with the joint formed by the ends of the fibrous reinforcement **34**.

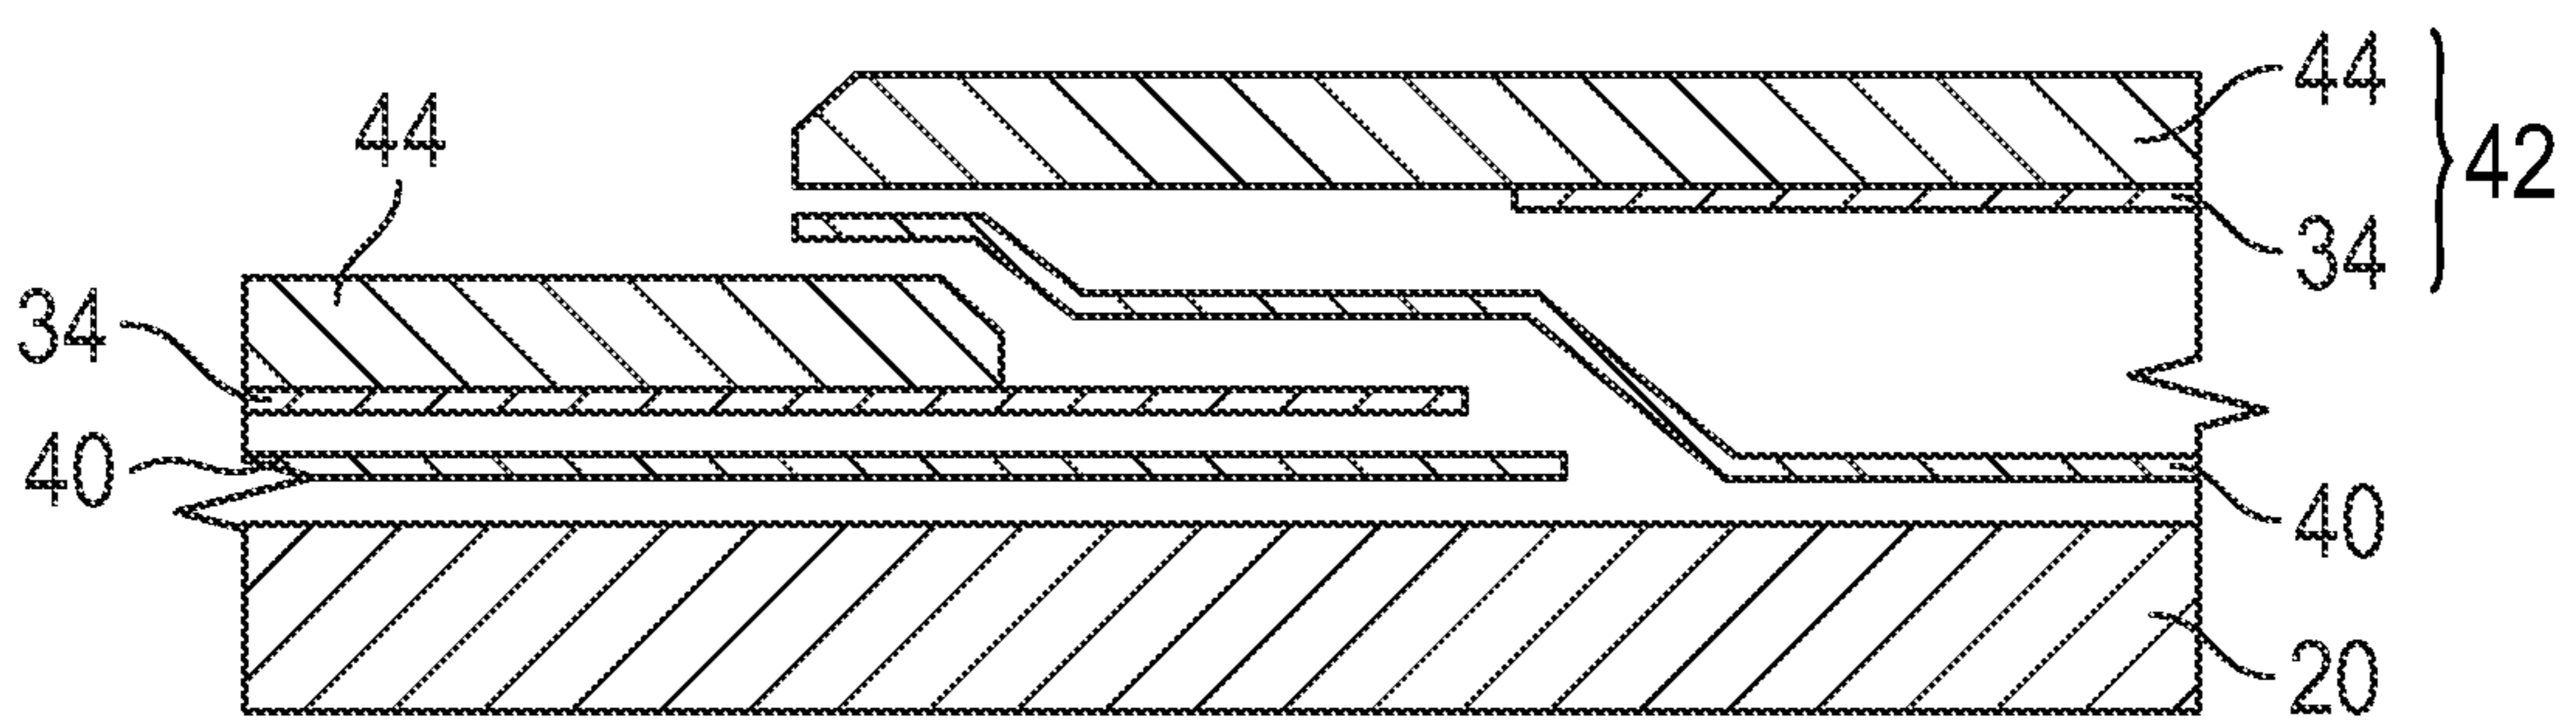
FIG. 7

FIGS. 7 and 8 show a cured replacement erosion coating located on a repair area;

FIGS. **7** and **8** show the cured replacement erosion coating **42** located on the repair area **20**. Adhesive **40** is located between the cured erosion coating and the repair area to bond the cured replacement erosion coating **42** to the repair area **20**. Cured replacement erosion coating **42** includes fibrous reinforcement **34** and cured fluoroelastomer **44**. FIG. **7** shows the ends of cured fluoroelastomer **44** overlapping.
