(10) **Patent No.:** **US 11,739,713 B2**
(45) **Date of Patent:** **Aug. 29, 2023**

(54) **FLUROELASTOMER EROSION COATING REPAIR**

(71) Applicant: **Raytheon Technologies Corporation**, Farmington, CT (US)

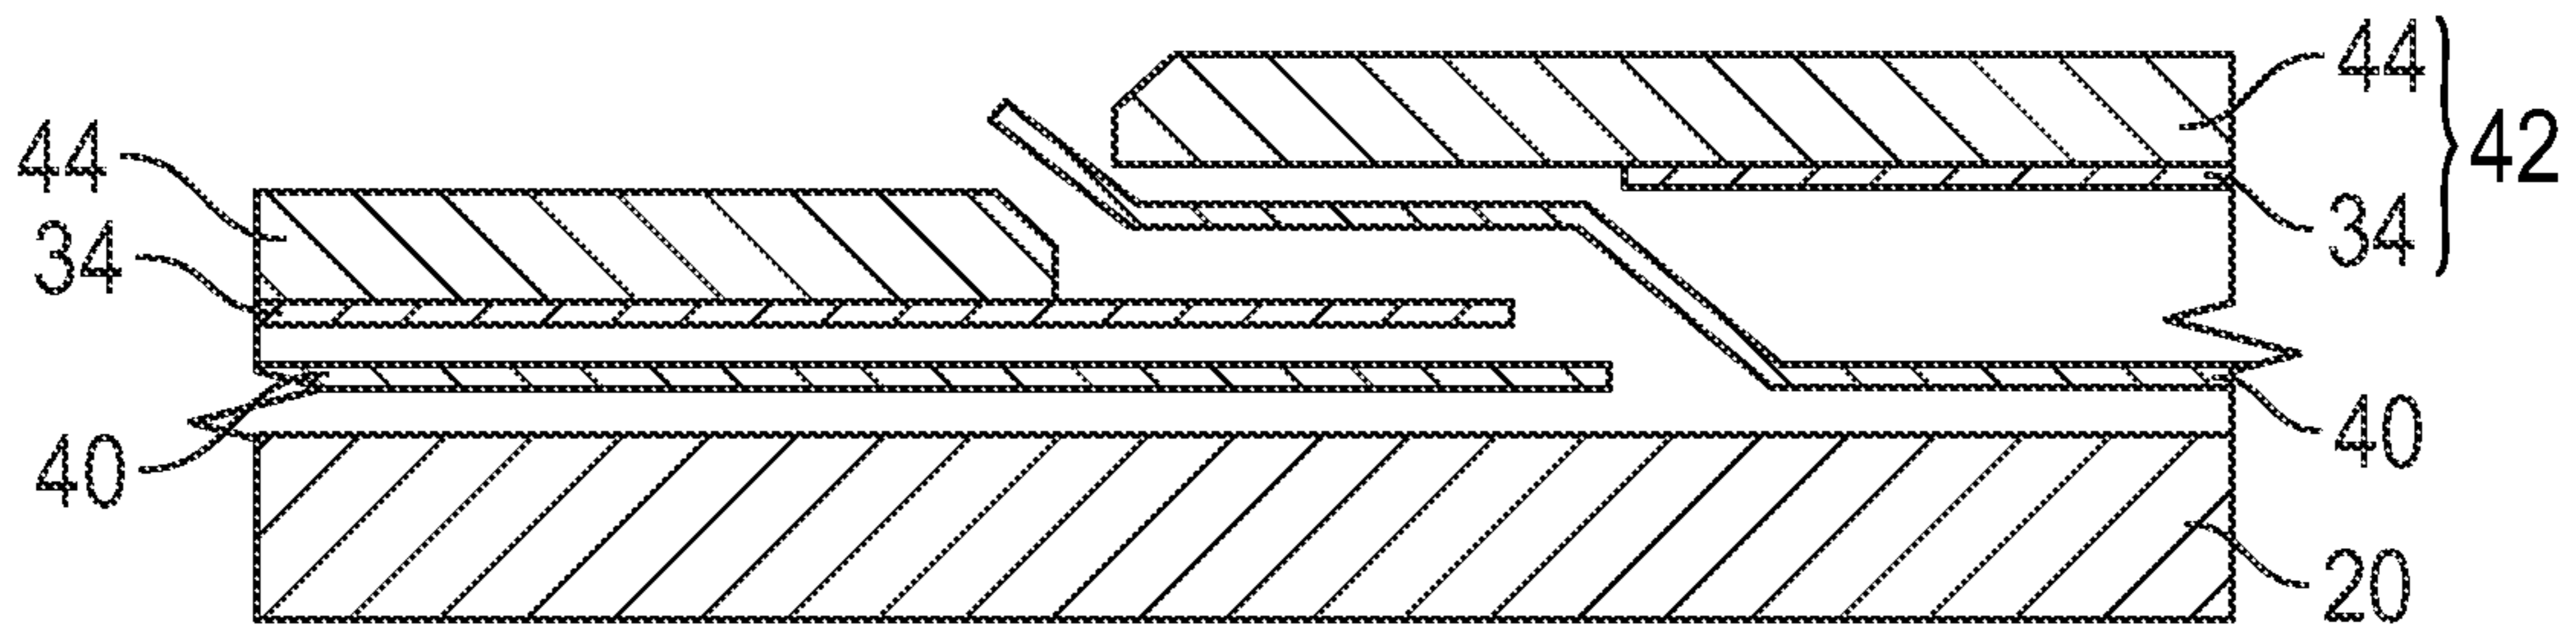
FIG. 8

FIGS. **7** and **8** show the cured replacement erosion coating **42** located on the repair area **20**. Adhesive **40** is located between the cured erosion coating and the repair area to bond the cured replacement erosion coating **42** to the repair area **20**. Cured replacement erosion coating **42** includes fibrous reinforcement **34** and cured fluoroelastomer **44**. FIG. **7** shows the ends of cured fluoroelastomer **44** overlapping.

The overlapping fluoroelastomer can be removed after the adhesive **40** has bonded the cured replacement erosion coating to the repair area. FIG. **8** shows the ends of cured fluoroelastomer **44** meeting without overlap.

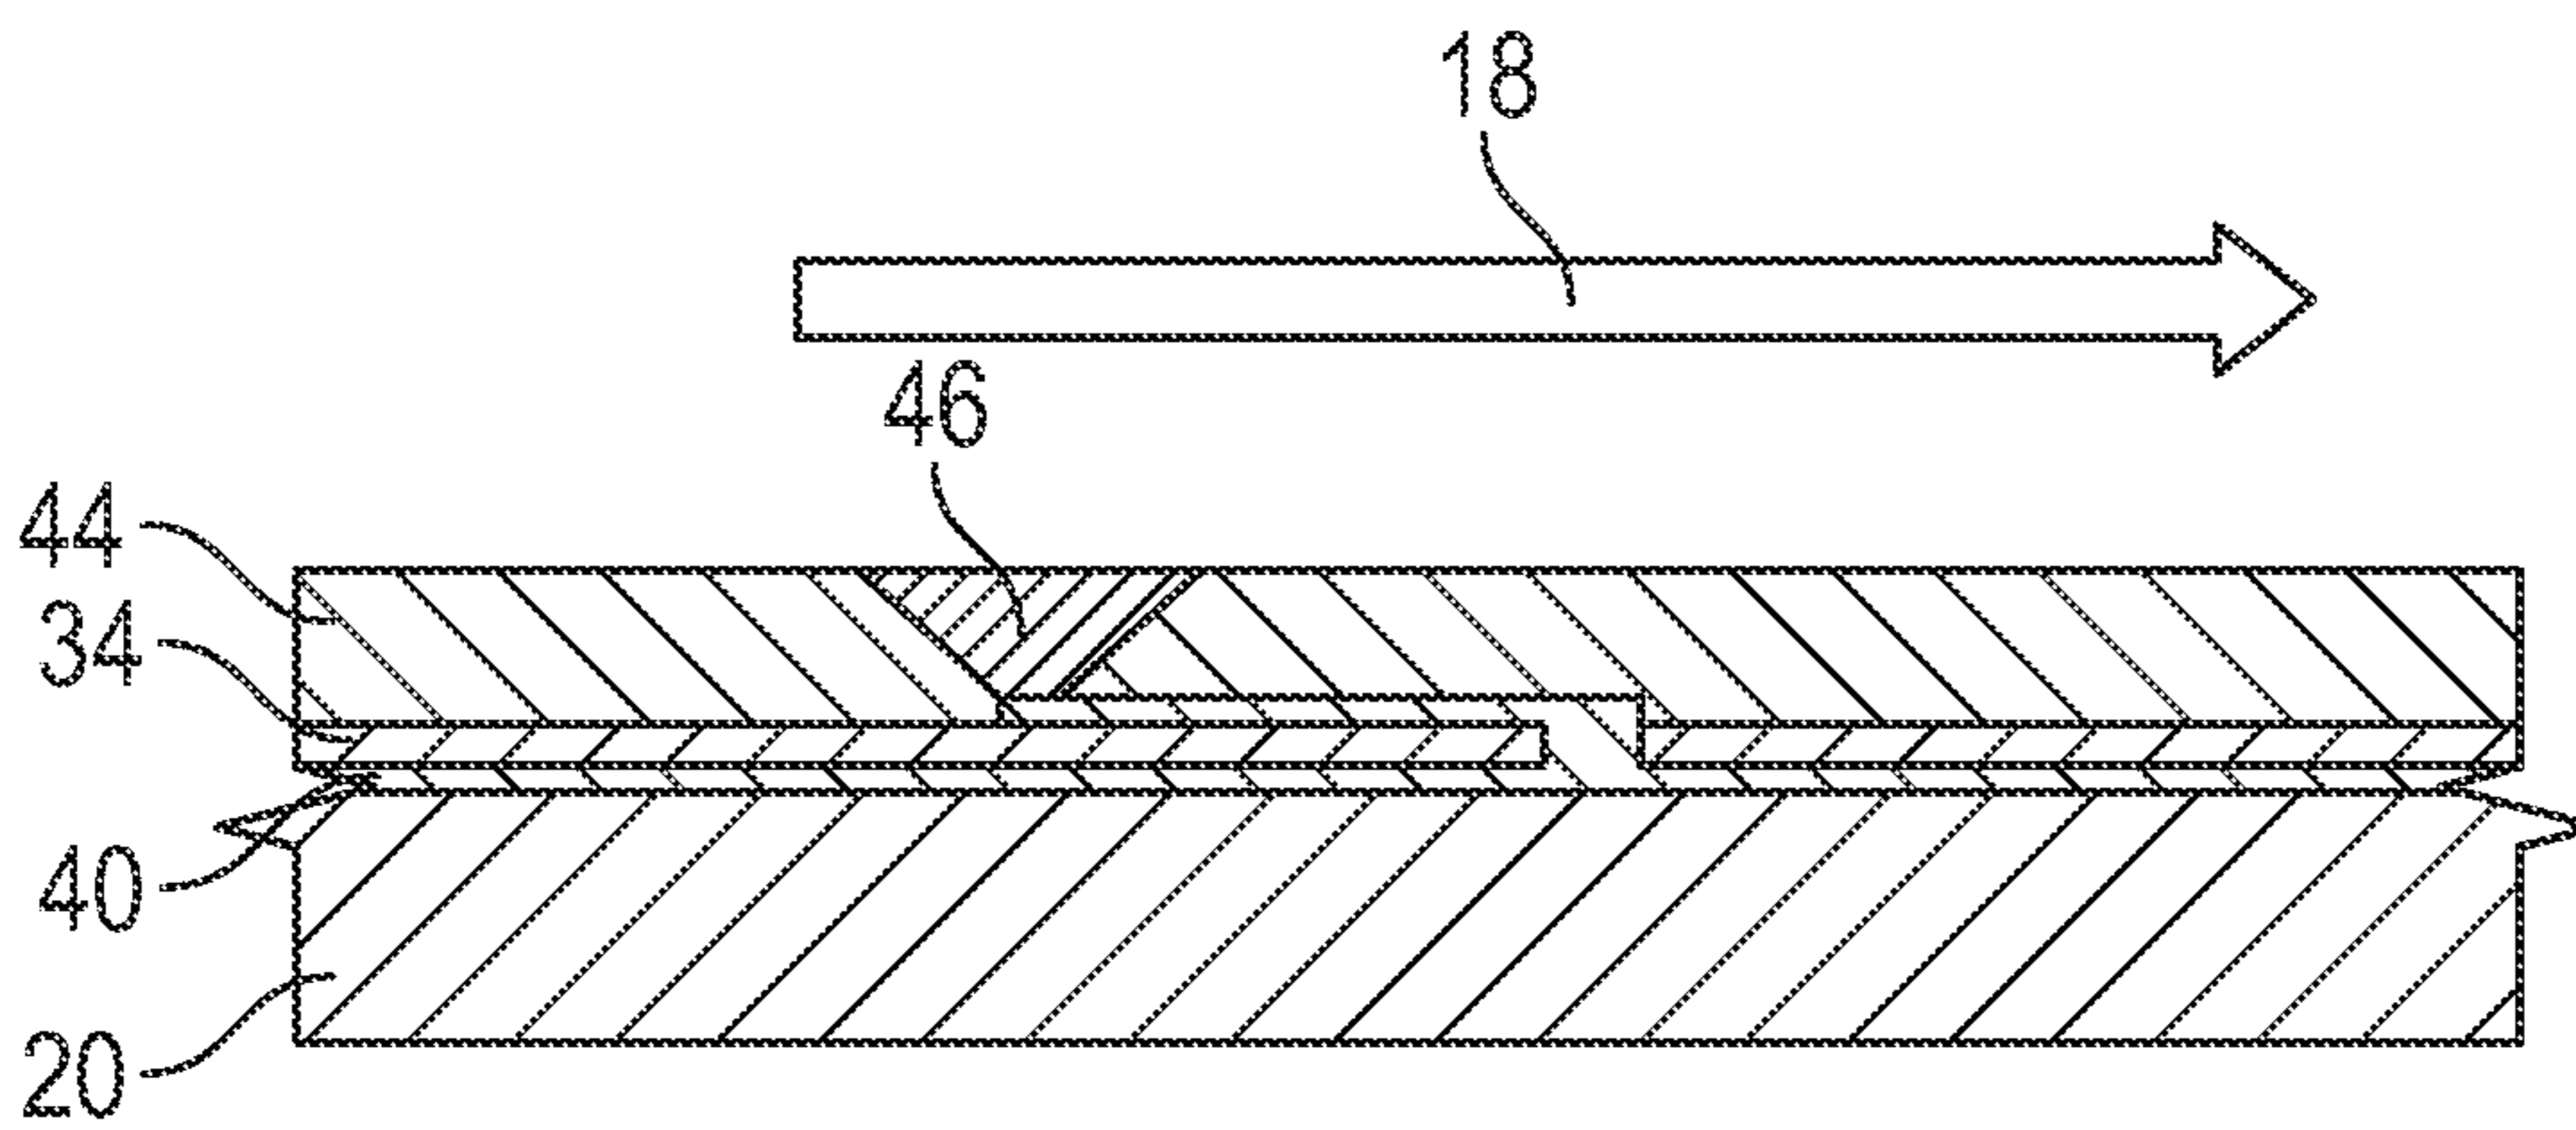
FIG. 9 shows a finished axial joint of the cured replacement erosion coating; and

FIG. **9** shows the finished axial joint. The joint between the ends of the cured fluoroelastomer **44** is sanded smooth and any excess adhesive is removed and liquid fluoroelastomer **46** is used to smooth and fill the gap where adhesive was removed. The liquid fluoroelastomer **46** is cured at a temperature less than the cure temperature of the adhesive. As can be seen from FIG. **9**, the prepared cured replacement erosion coating is located on the prepared repair area by wrapping the prepared cured replacement erosion coating around the rear cone segment **110** in a direction opposite to a direction of rotation.

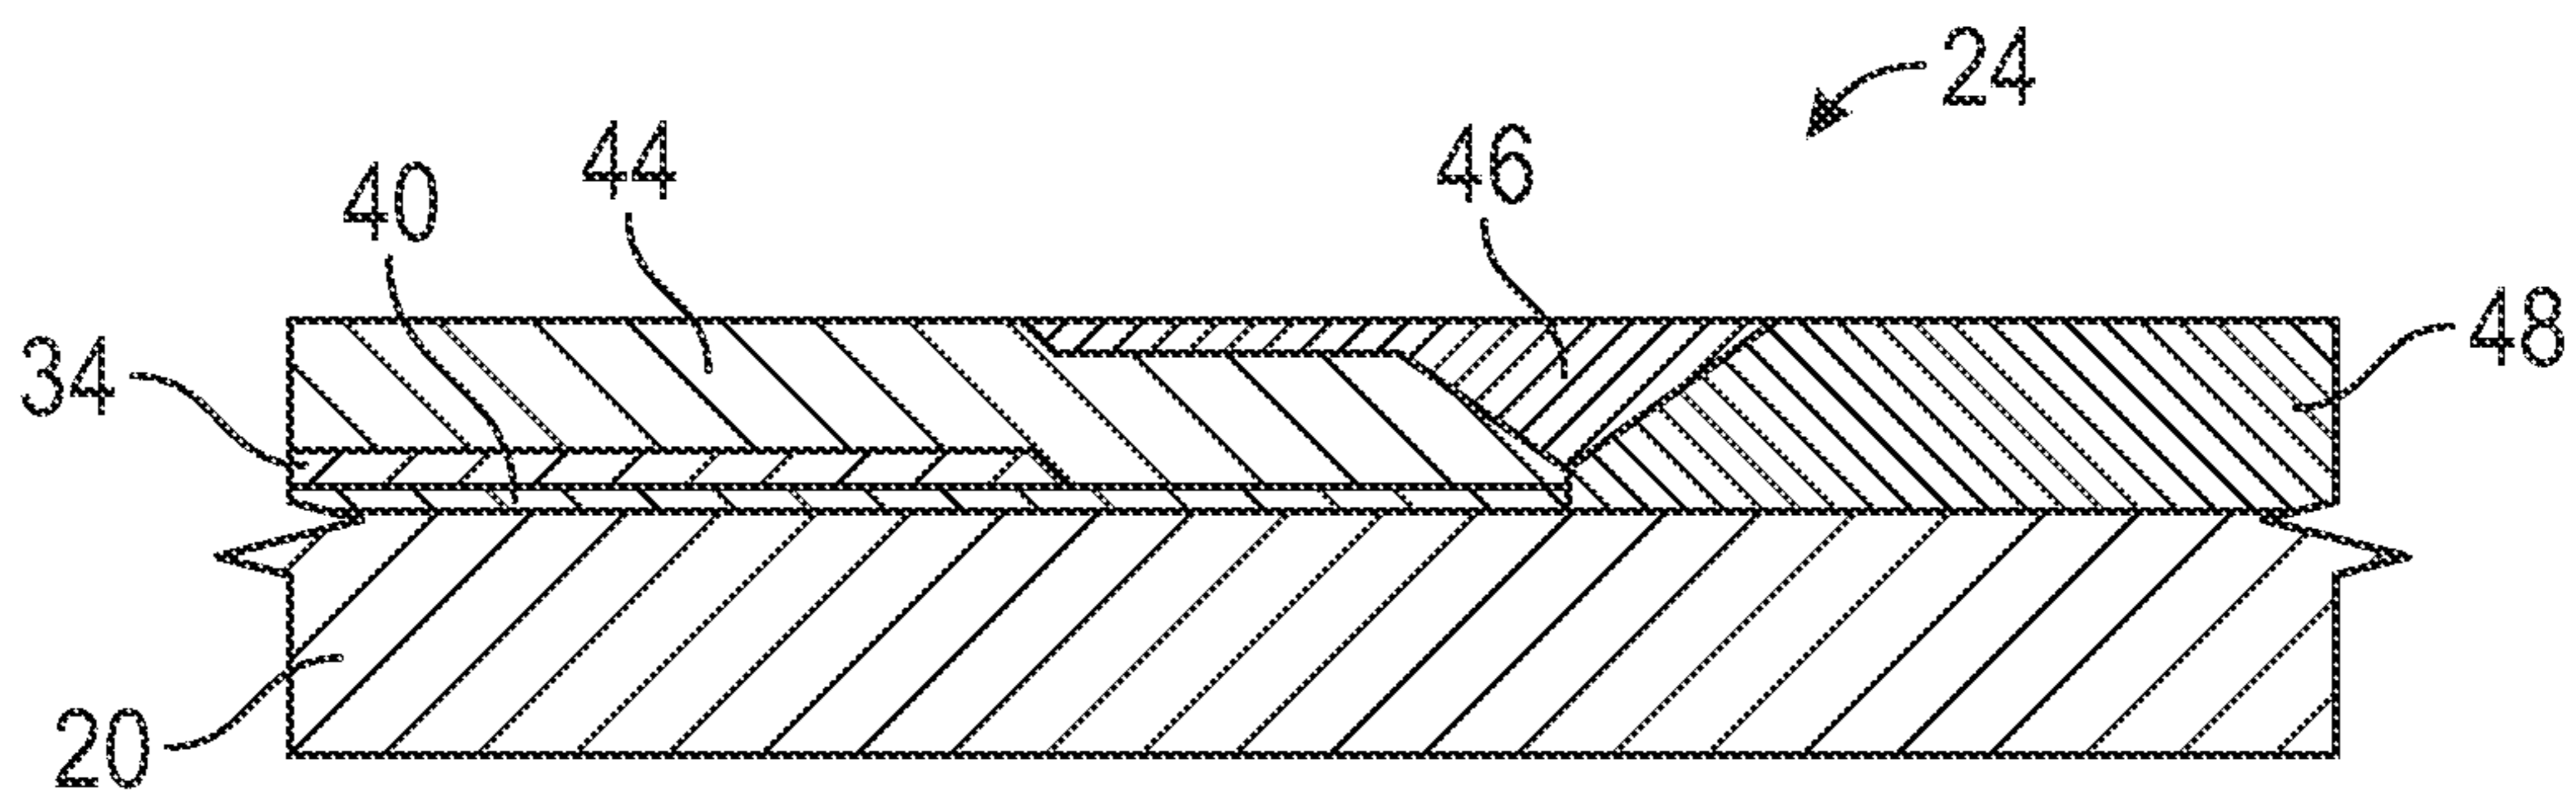
FIG. 10 shows the finished circumferential joint.

FIG. **10** shows the finished circumferential joint **24**. The cured fluoroelastomer **44** may overlap the original erosion coating when first located on the repair area. In the finished circumferential joint the cured fluoroelastomer may be sanded smooth and any excess adhesive is removed and any gap between the newly applied cured fluoroelastomer and the original erosion coating filled with second fluoroelastomer **46**, typically a liquid fluoroelastomer, which is cured. A gap may be the result of bonding tolerances or from removal of excess adhesive. The fibrous reinforcement does not contact the original erosion coating. The original erosion coating may consist of a fluoroelastomer.
