(10) **Patent No.:** **US 11,739,713 B2**  
(45) **Date of Patent:** **Aug. 29, 2023**

(54) **FLUOROELASTOMER EROSION COATING REPAIR**

(71) Applicant: **Raytheon Technologies Corporation**,  
Farmington, CT (US)

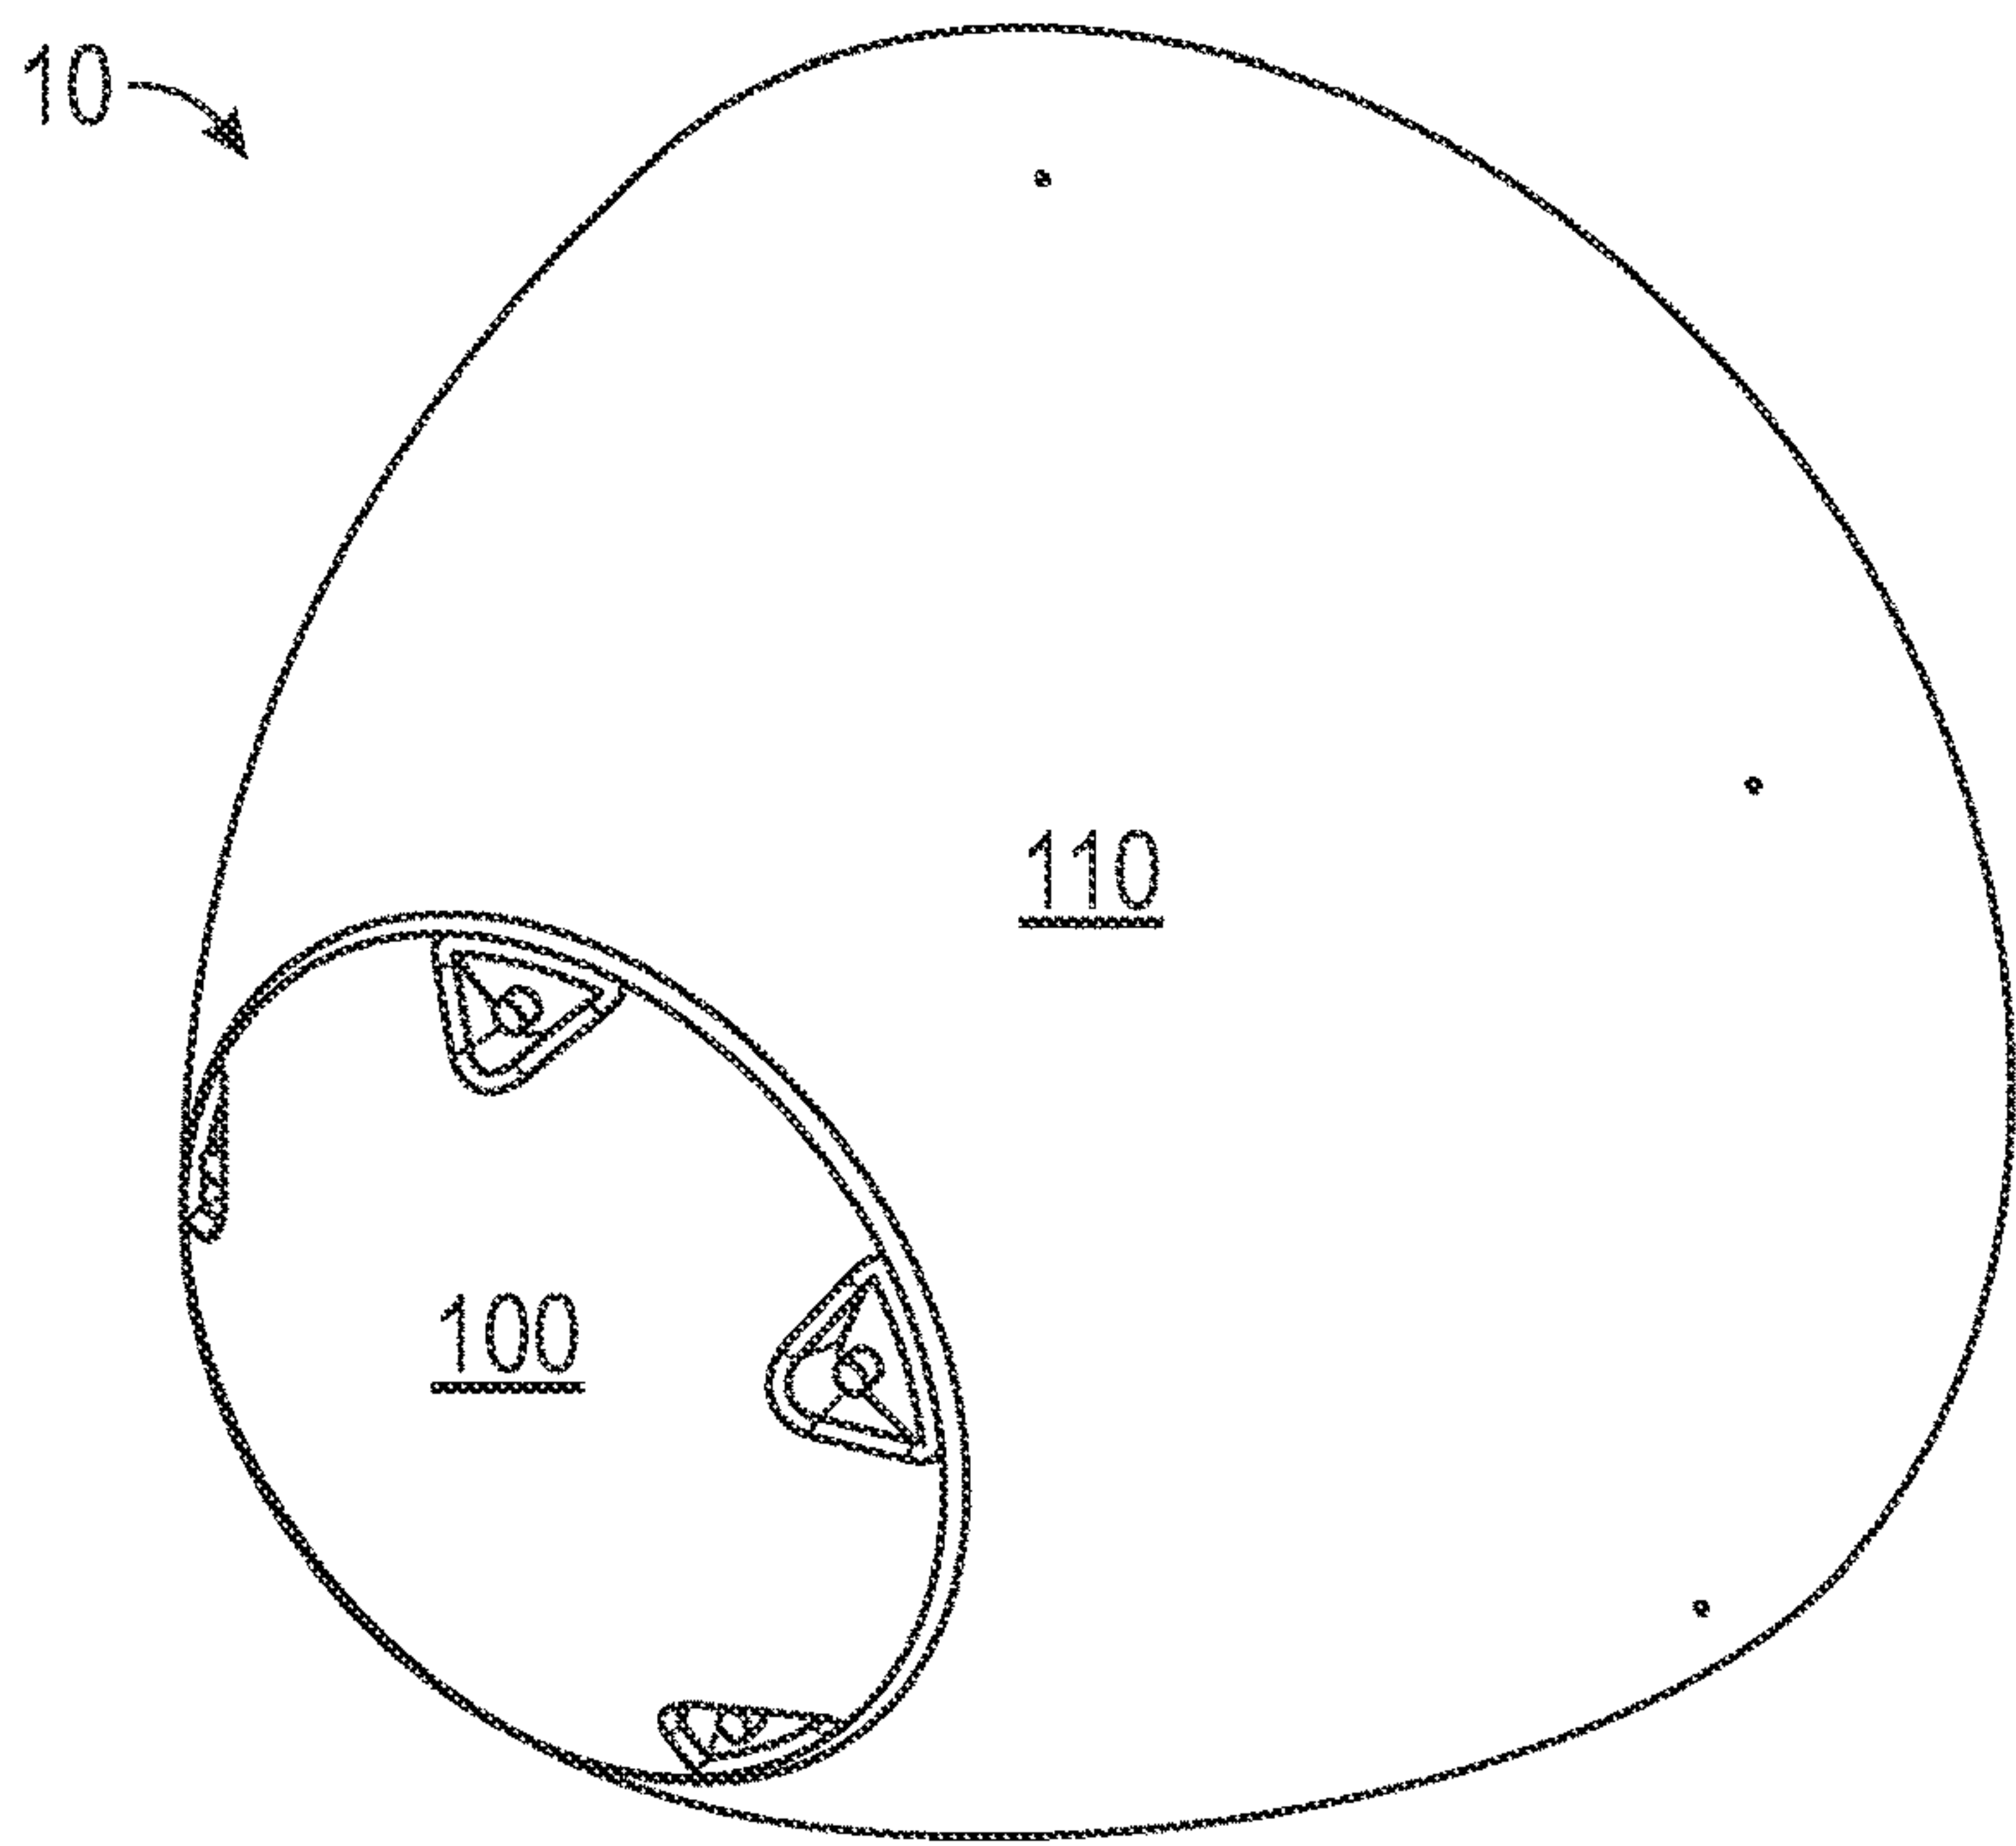
FIG. 1 shows an inlet cone for a gas turbine engine;

FIG. 1 shows an inlet cone for a gas turbine engine. The inlet cone 10 includes a forward cover 100 and a rear cone segment 110, both of which typically rotate with the fan, but may also be static in the airflow. The rear cone segment 110 is a truncated cone, with attachment flanges on the forward and aft extents. The forward flange (also referred to as the front attachment flange) is shown in FIG. 4 and is protected by the forward cover 100. The aft flange is not shown.

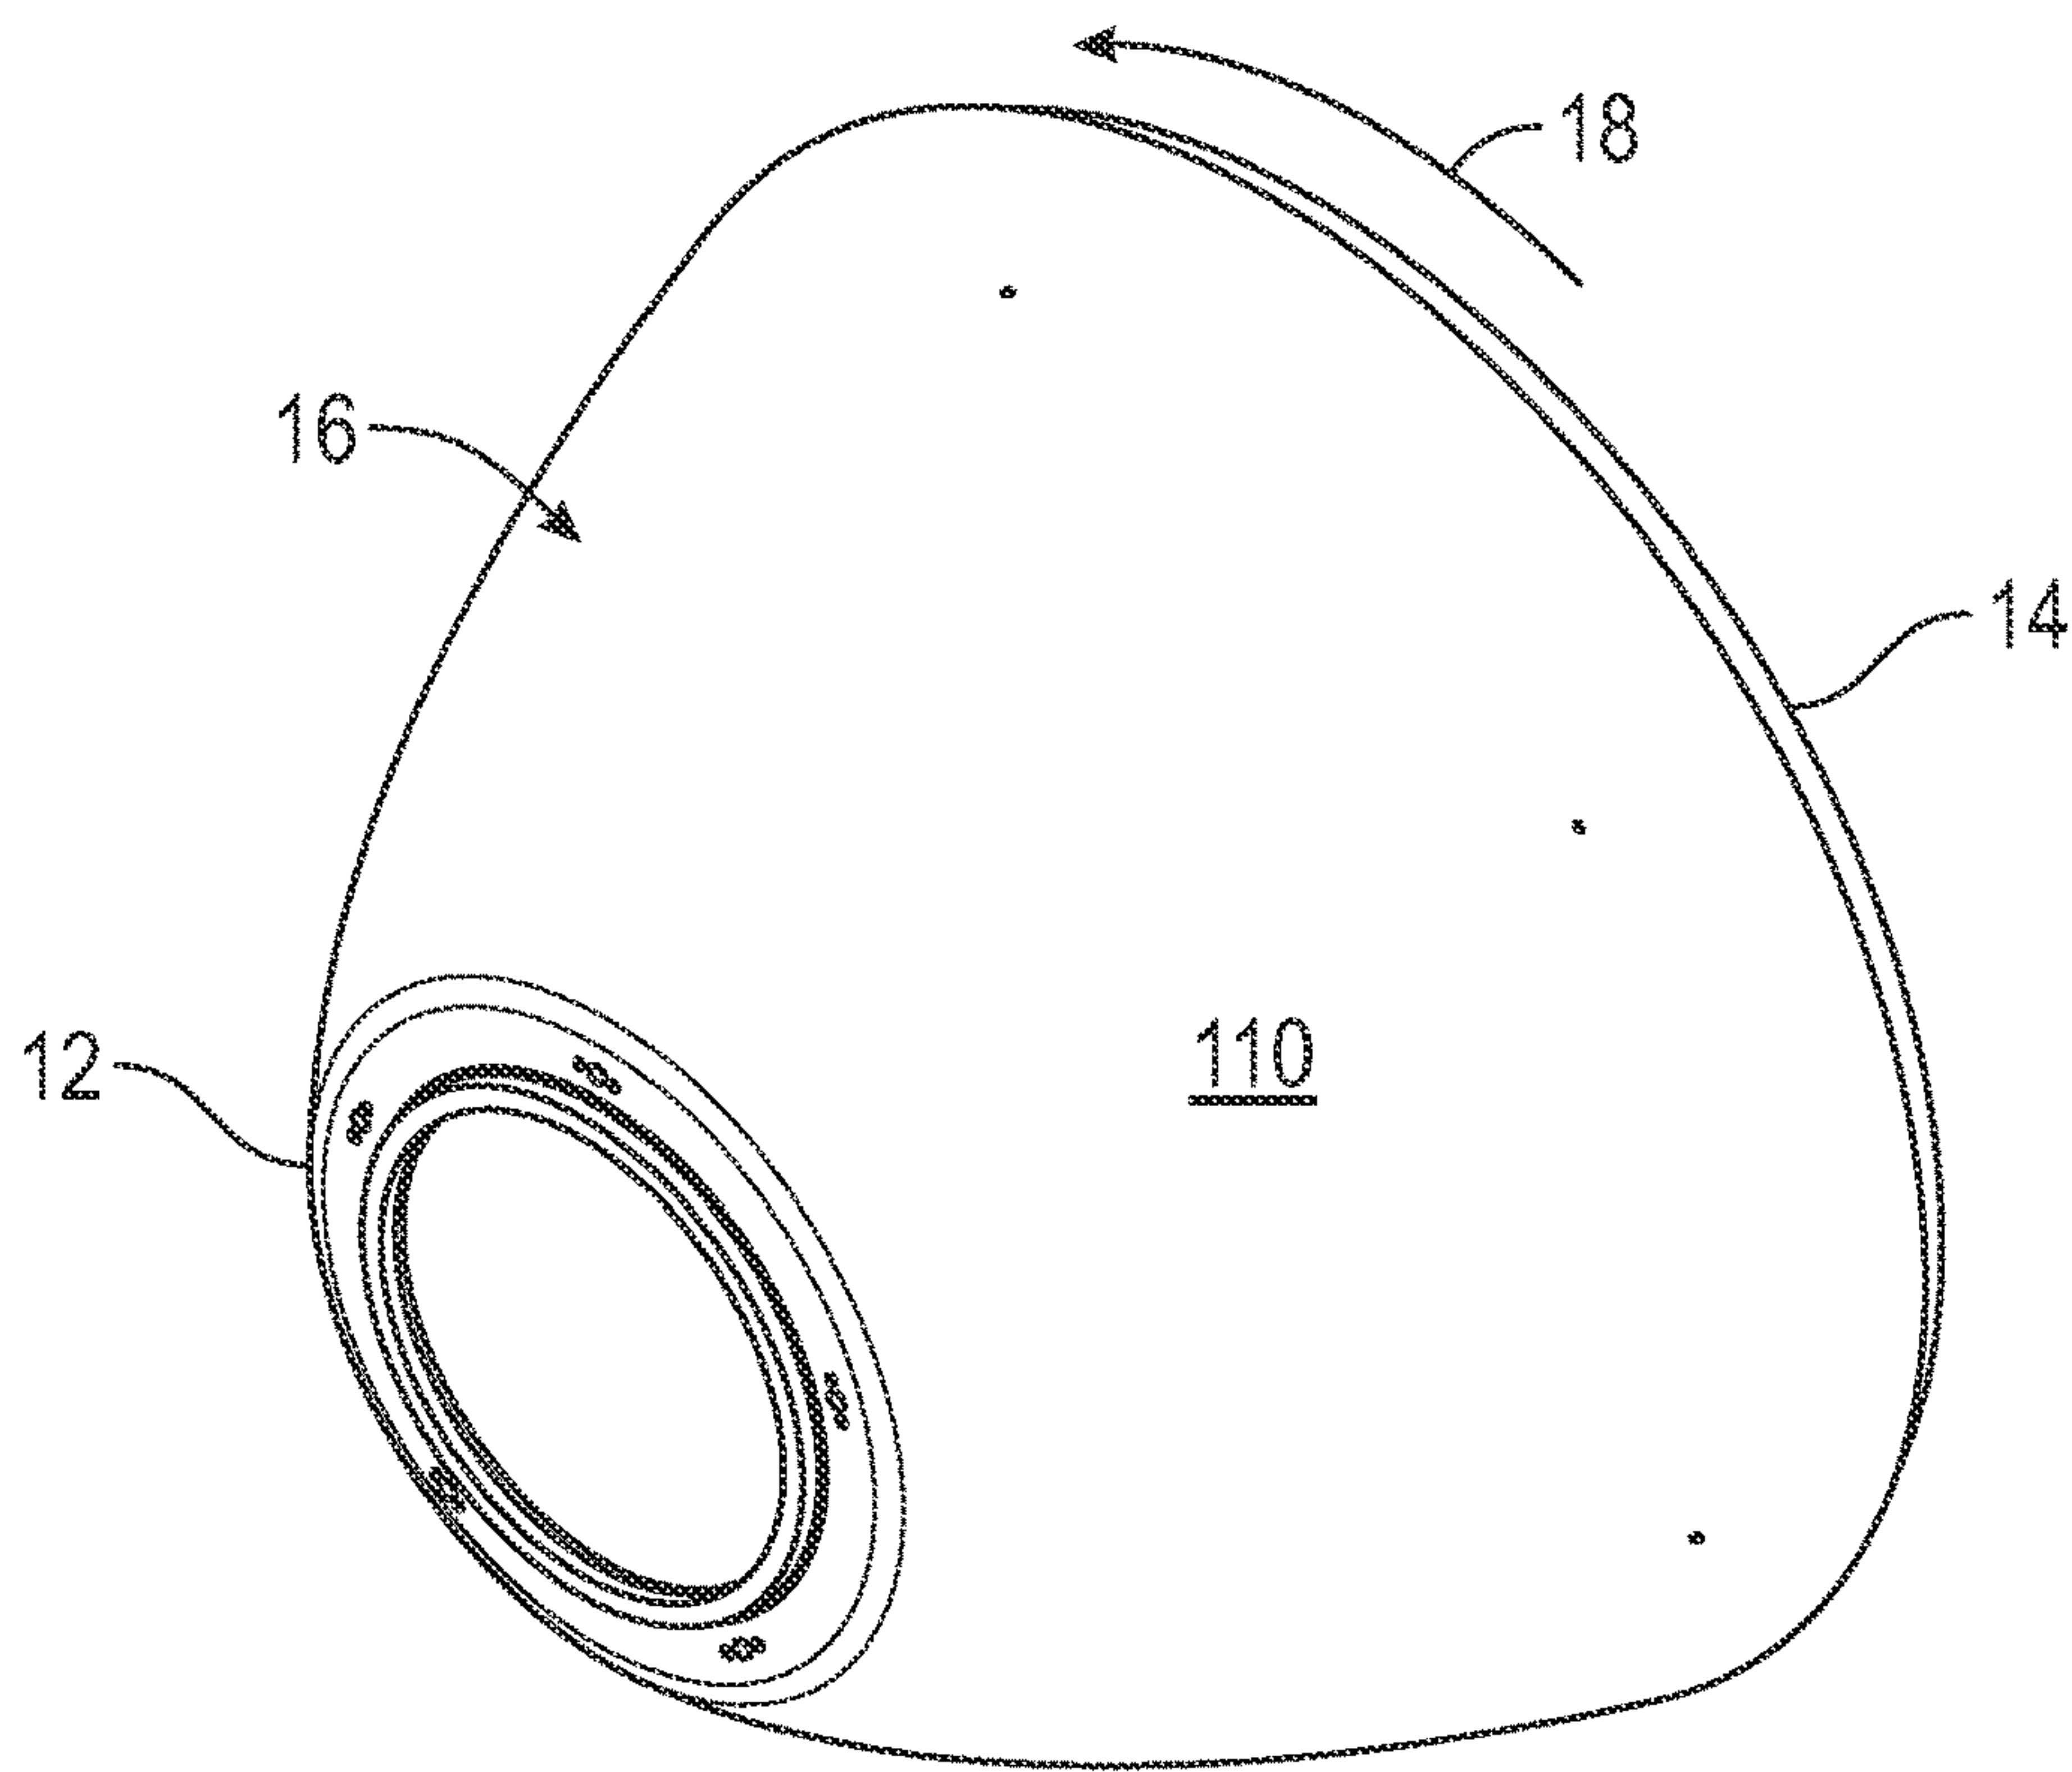
FIG. 2 shows a rear cone segment;

FIG. 2 shows rear cone segment 110 for a gas turbine engine. The rear cone segment 110 is rotatably mounted to the turbine engine in front of the fan blades and has a leading edge 12, a trailing edge 14, and an outer flow surface 16. The rear cone segment 110 has a direction of rotation 18.

FIG. 3 is a front view of rear cone segment 110. The rear cone segment 110 has attachment holes 15 for forward cover 100. Repair area 20 includes the attachment holes and a portion of the outer flow surface 16. Repair area 20 has an axial joint 22 and a circumferential joint 24. FIG. 2 also shows section line 4 and section line 9 which are shown in greater detail in FIG. 4 and FIG. 9 respectively.

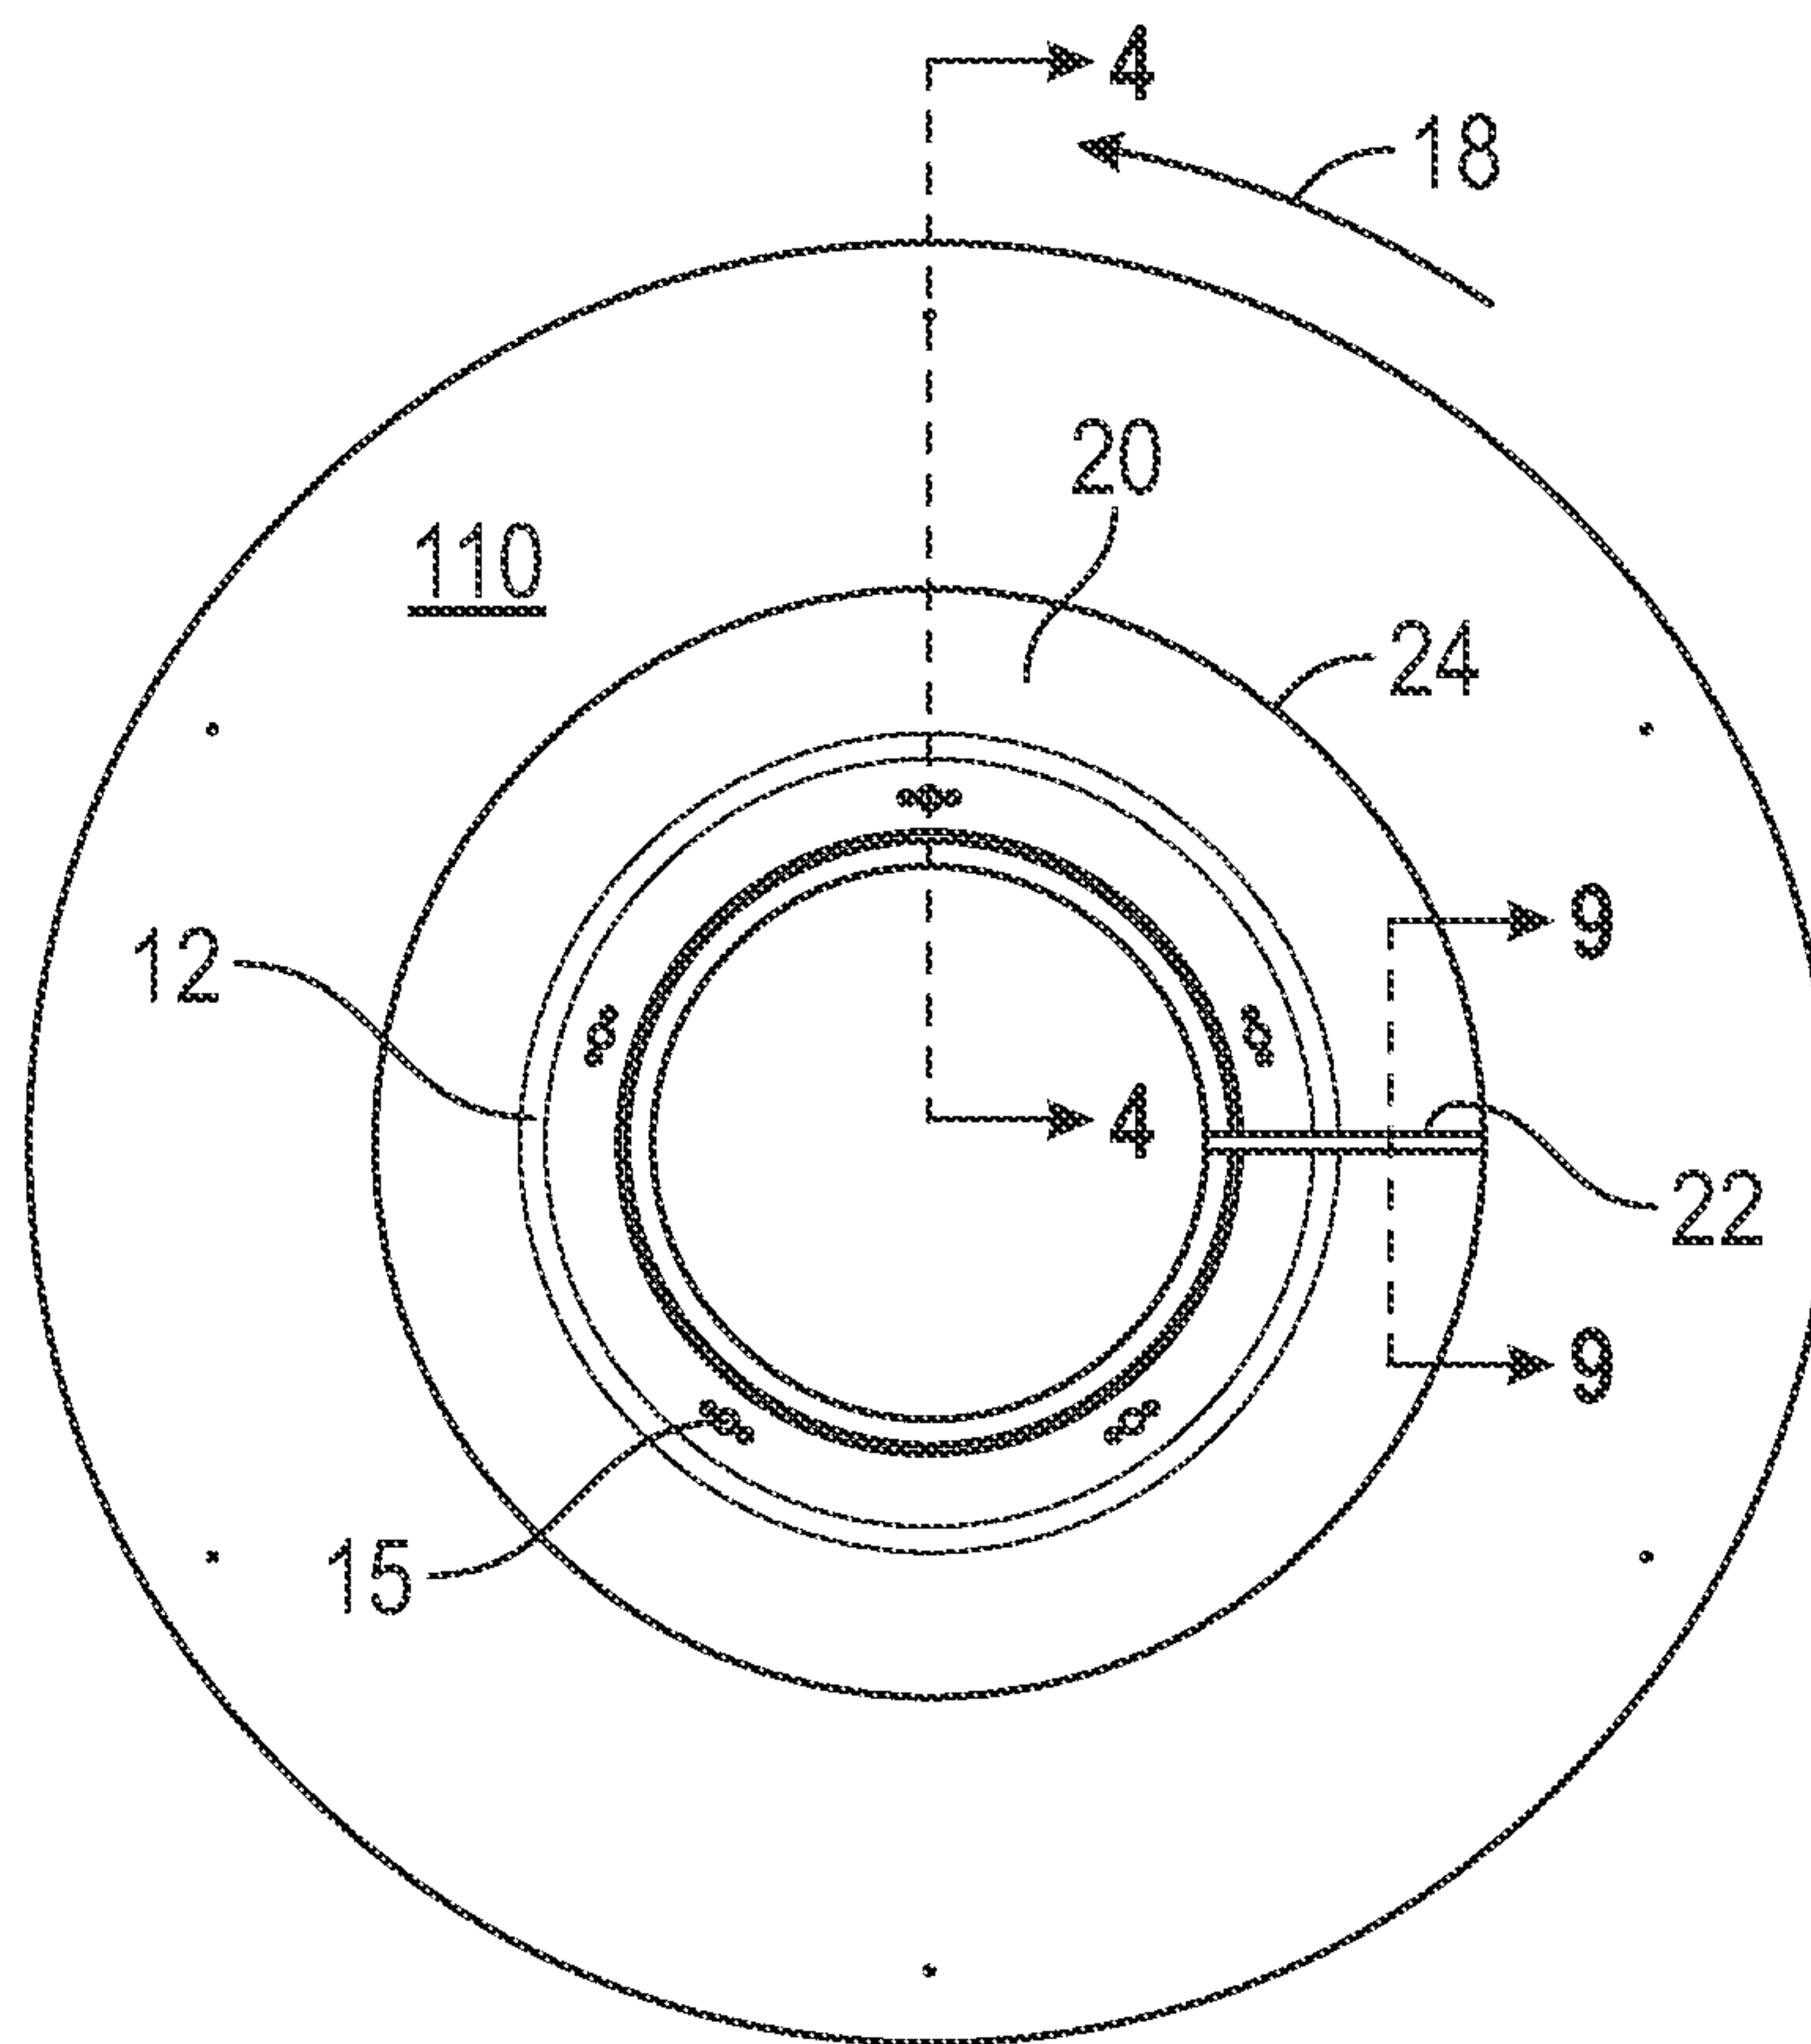
FIG. 3 is a front view of a rear cone segment;

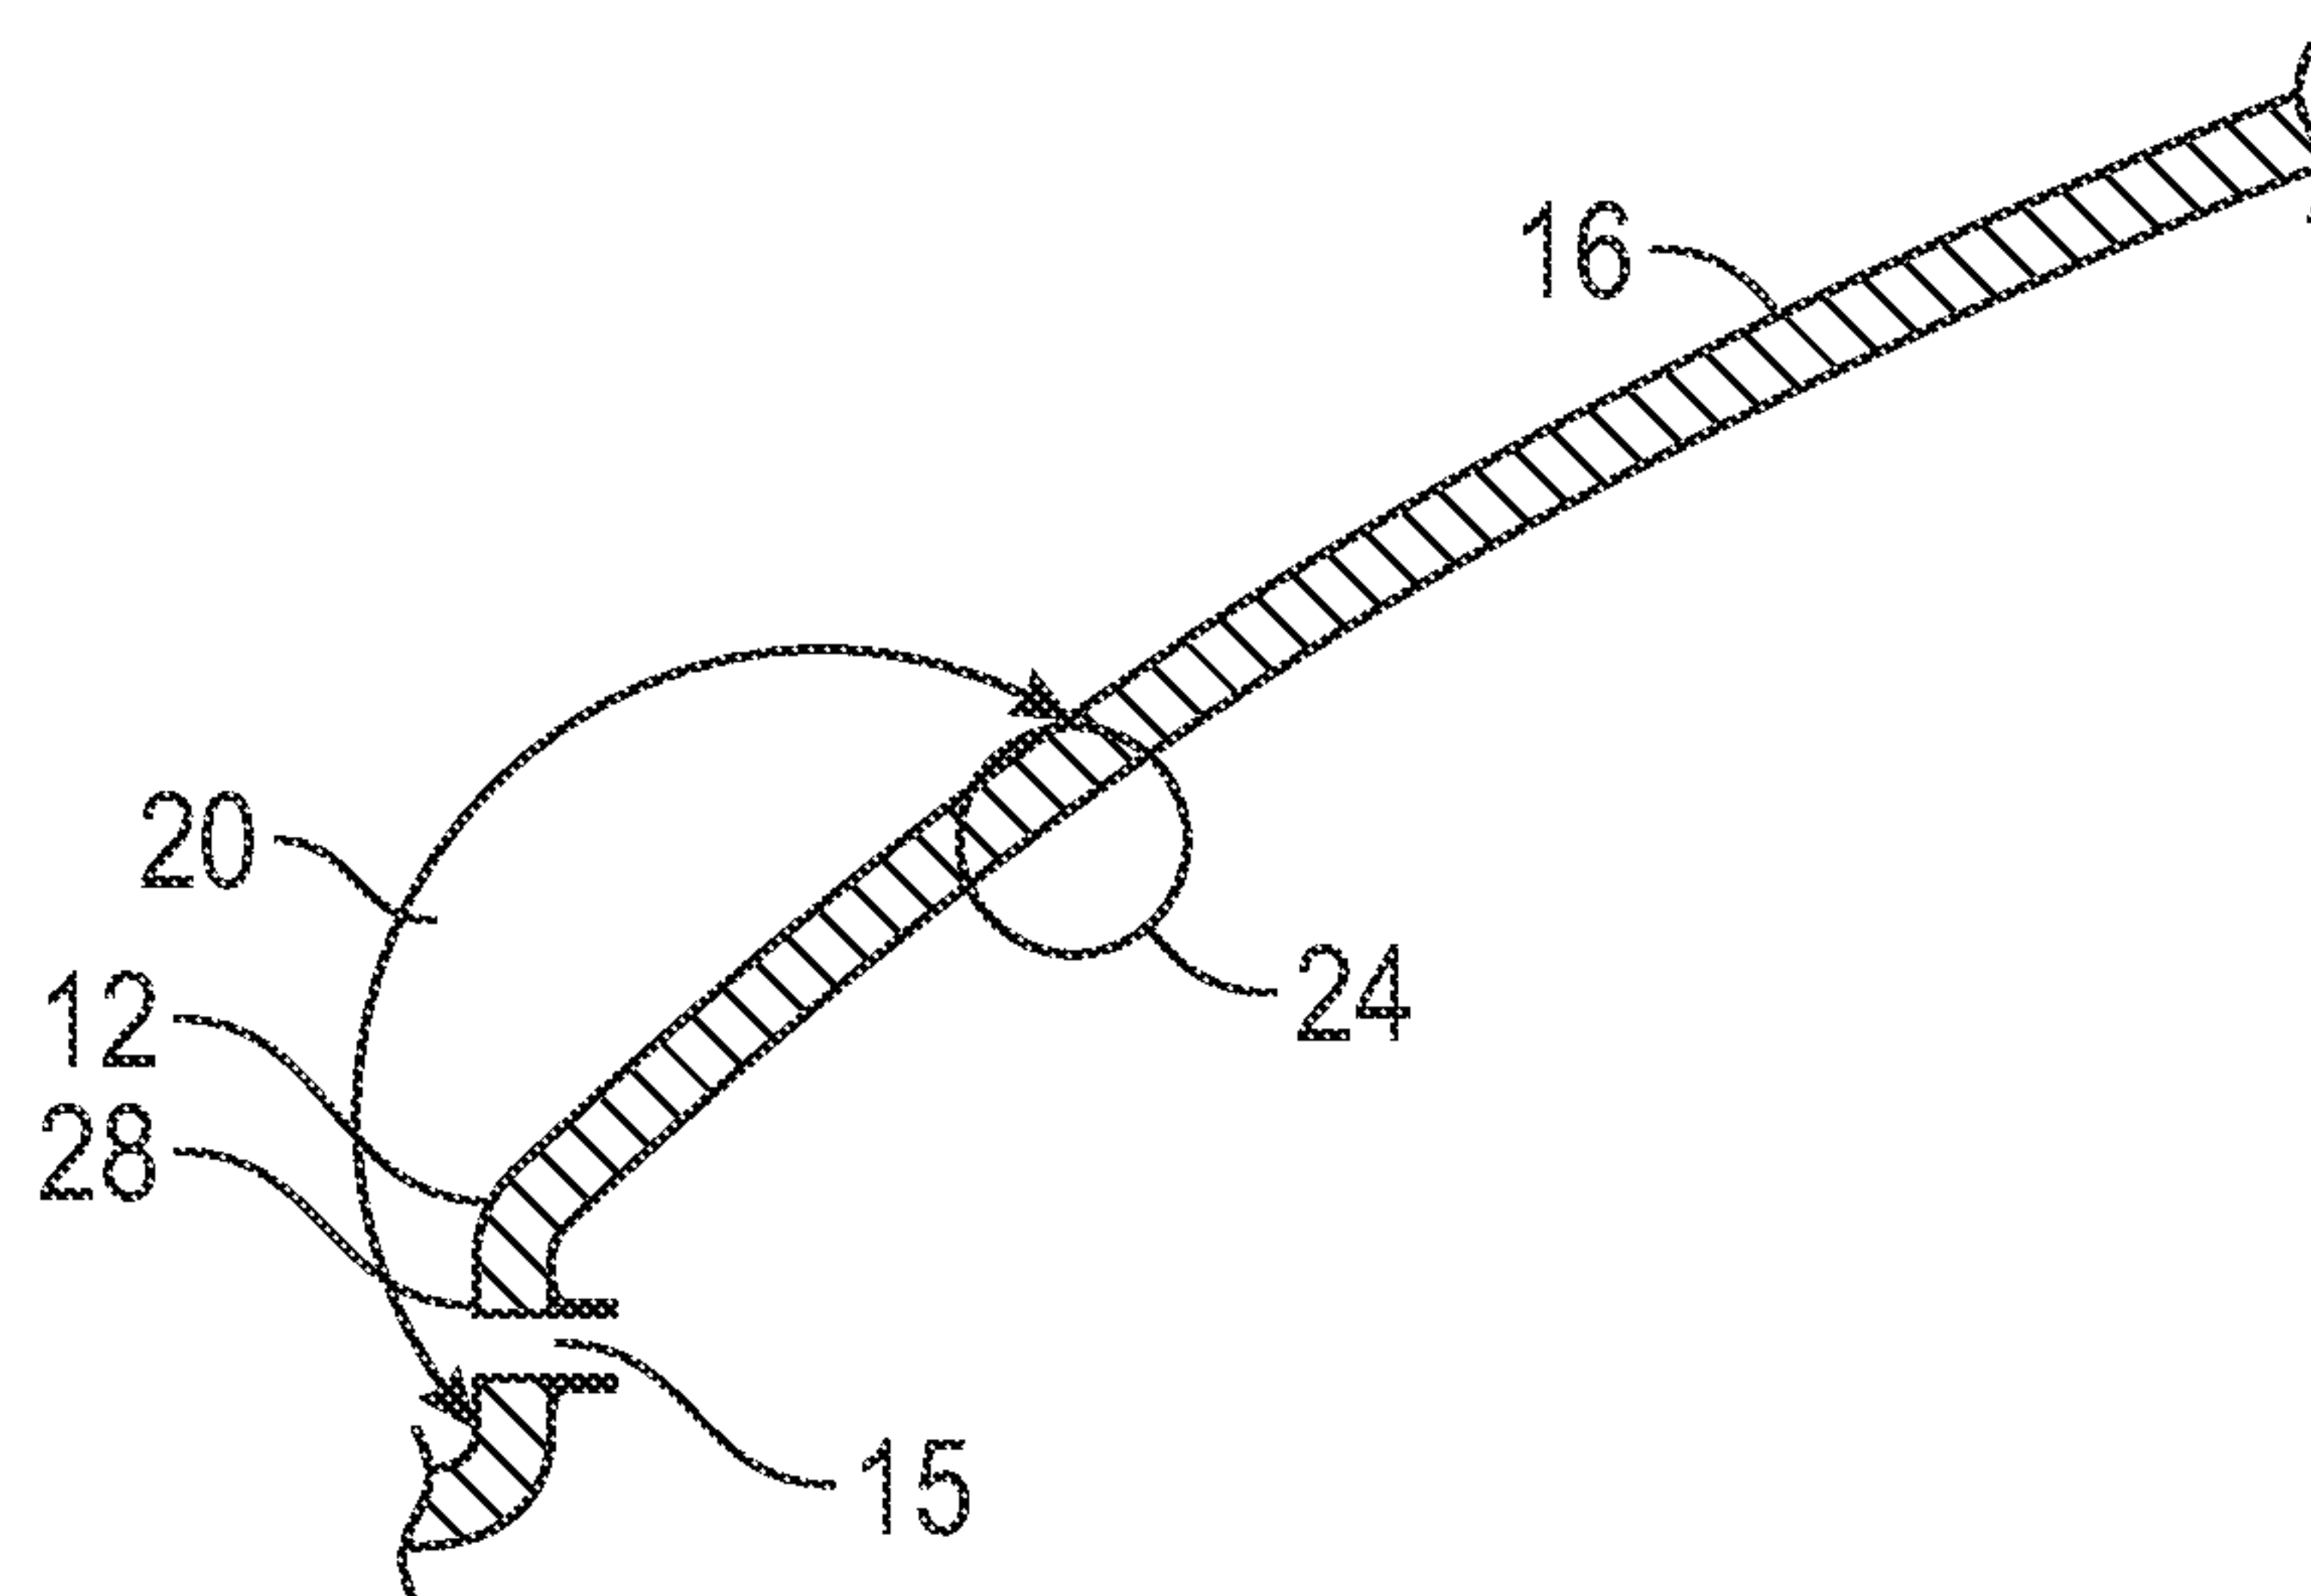
FIG. 4 shows a cross section of a repair area;

FIG. 4 shows a cross section of repair area 20 having a leading edge 12 and a forward flange 28. Forward flange 28 includes the attachment holes 15. Because the repair area includes the forward flange, airflow is prevented from getting under the forward edge of the repair material. An additional feature of having the repair area cover the forward flange is the mating part has a bolted interface that passes through the repair material, thus further securing the repair detail. The circumferential joint 24 is shown in greater detail in FIG. 10.

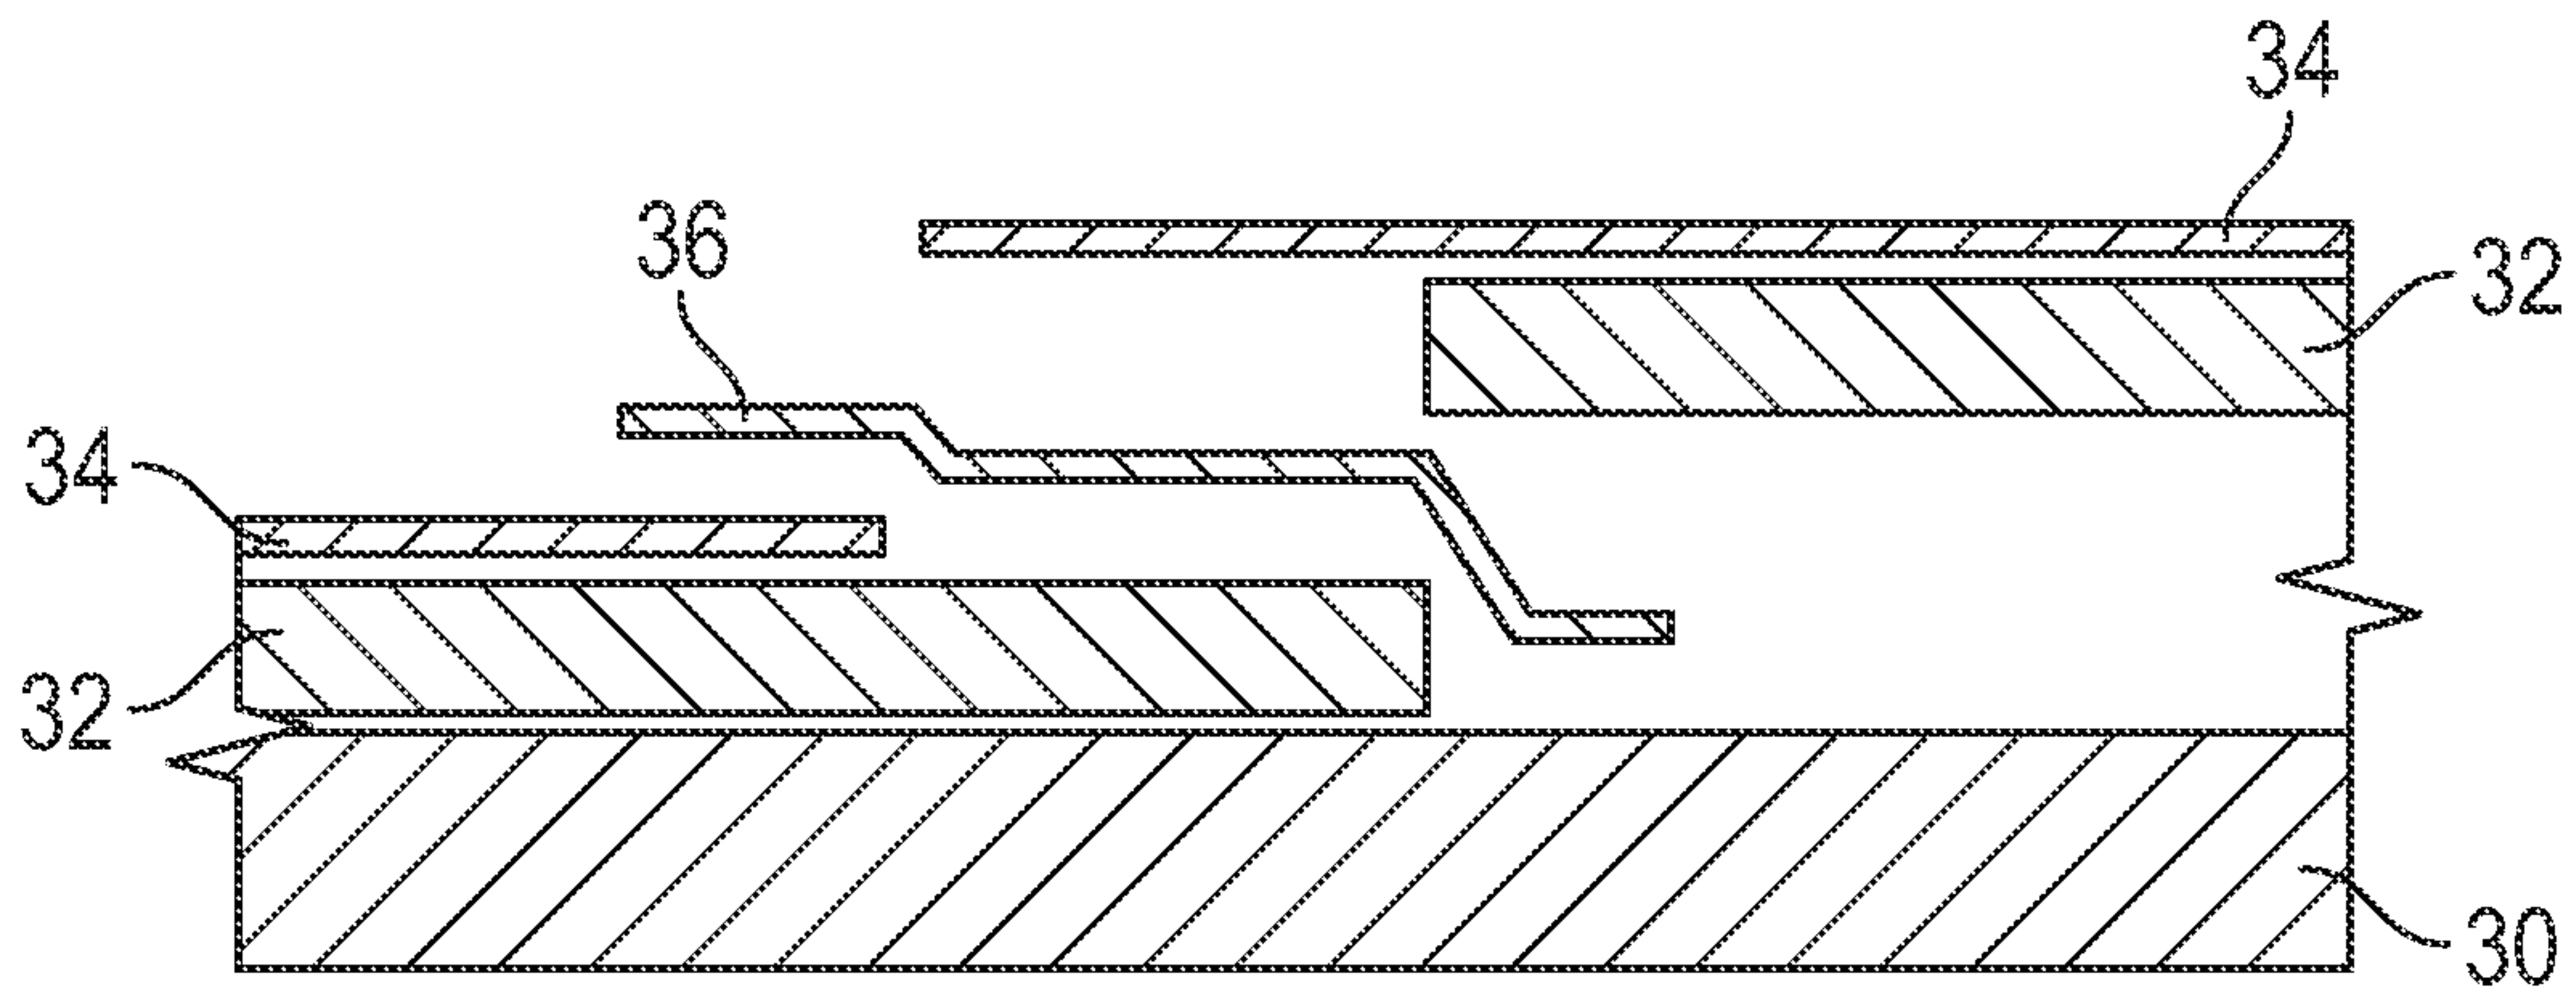
FIGS. 5 and 6 show a layup of an uncured replacement erosion coating;

FIG. 5 shows a mold having a concave surface 30, an uncured fluoroelastomer sheet 32 disposed on the mold with a first end of the uncured fluoroelastomer sheet located adjacent to one side of barrier film 36 and the second end of the uncured fluoroelastomer sheet 32 located next to the opposite side of barrier film 36. The fibrous reinforcement 34 is disposed on the uncured fluoroelastomer sheet with one end adjacent to one side of barrier film 36 and the other end of the fibrous reinforcement 34 located next to the opposite side of barrier film 36. The joint formed by the ends of the

uncured fluoroelastomer sheet does not align with the joint formed by the ends of the fibrous reinforcement **34**.

When using a mold with a concave surface, one end of a barrier film is applied to the mold surface. A sheet of uncured fluoroelastomer having a first end, a second end, a front edge and a back edge is used. The sheet of uncured fluoroelastomer is wrapped axially so the first end and second end are located axially and the front edge and back edge are located circumferentially. The sheet of uncured fluoroelastomer is placed on the mold surface so that the first end of the fluoroelastomer sheet is adjacent to one side of the barrier film and the second end of the fluoroelastomer sheet is adjacent to the other side of the barrier film. The free end of the barrier film extends beyond both ends of the fluoroelastomer sheet. A sheet of fibrous reinforcement is placed on the uncured elastomer so that the joint between the ends of the fibrous reinforcement do not align with the joint between the ends of the uncured elastomer. The barrier film is located between the ends of the uncured fluoroelastomer and between the ends of the fibrous reinforcement.

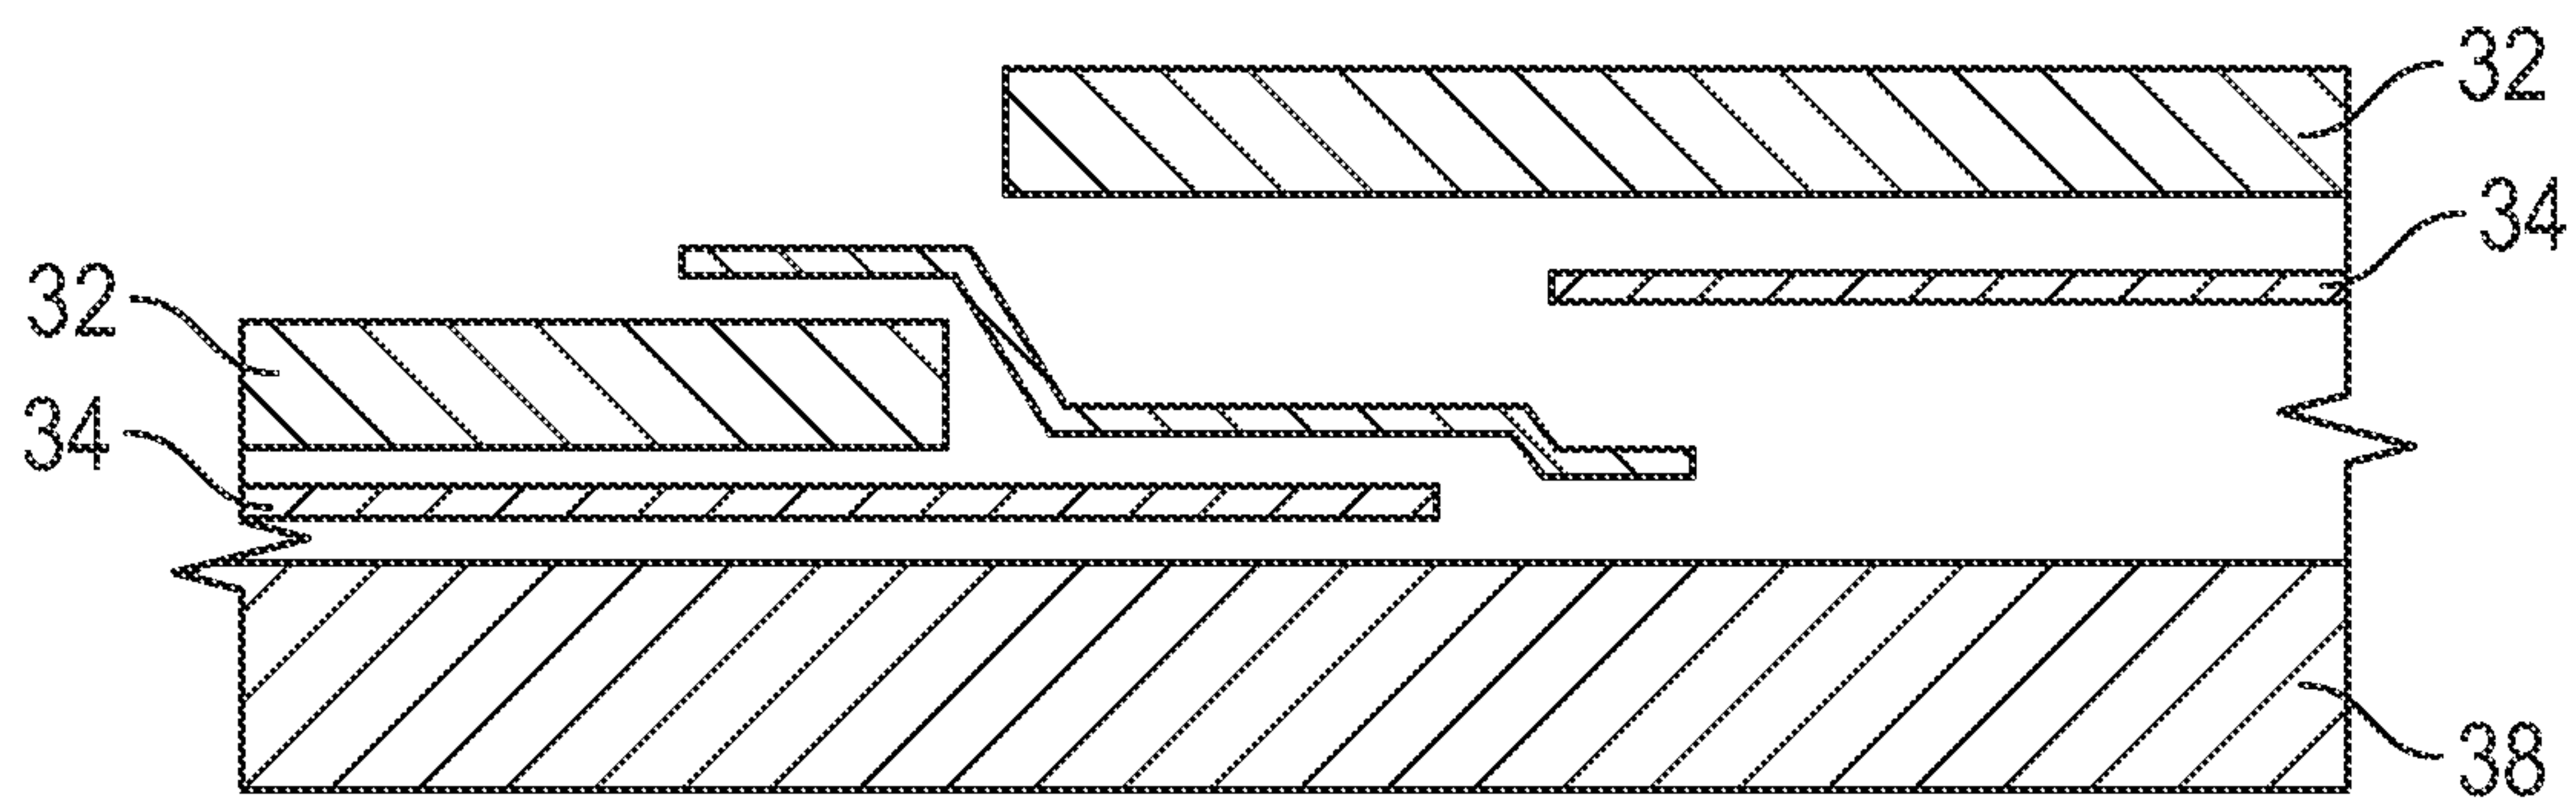
FIG. 6

When using a mold with a convex surface the order of the uncured fluoroelastomer and fibrous reinforcement are reversed. FIG. **6** shows a mold having a convex surface **38**, a fibrous reinforcement **34** disposed on the mold with a first end of the fibrous reinforcement **34** located adjacent to one side of barrier film **36** and the second end of the fibrous reinforcement **34** located next to the opposite side of barrier film **36**. The uncured fluoroelastomer sheet **32** is disposed on the fibrous reinforcement **34** with a first end adjacent to one side of barrier film **36** and the second end of the uncured fluoroelastomer sheet **32** located next to the opposite side of barrier film **36**. The joint formed by the ends of the uncured fluoroelastomer sheet **32** does not align with the joint formed by the ends of the fibrous reinforcement **34**.

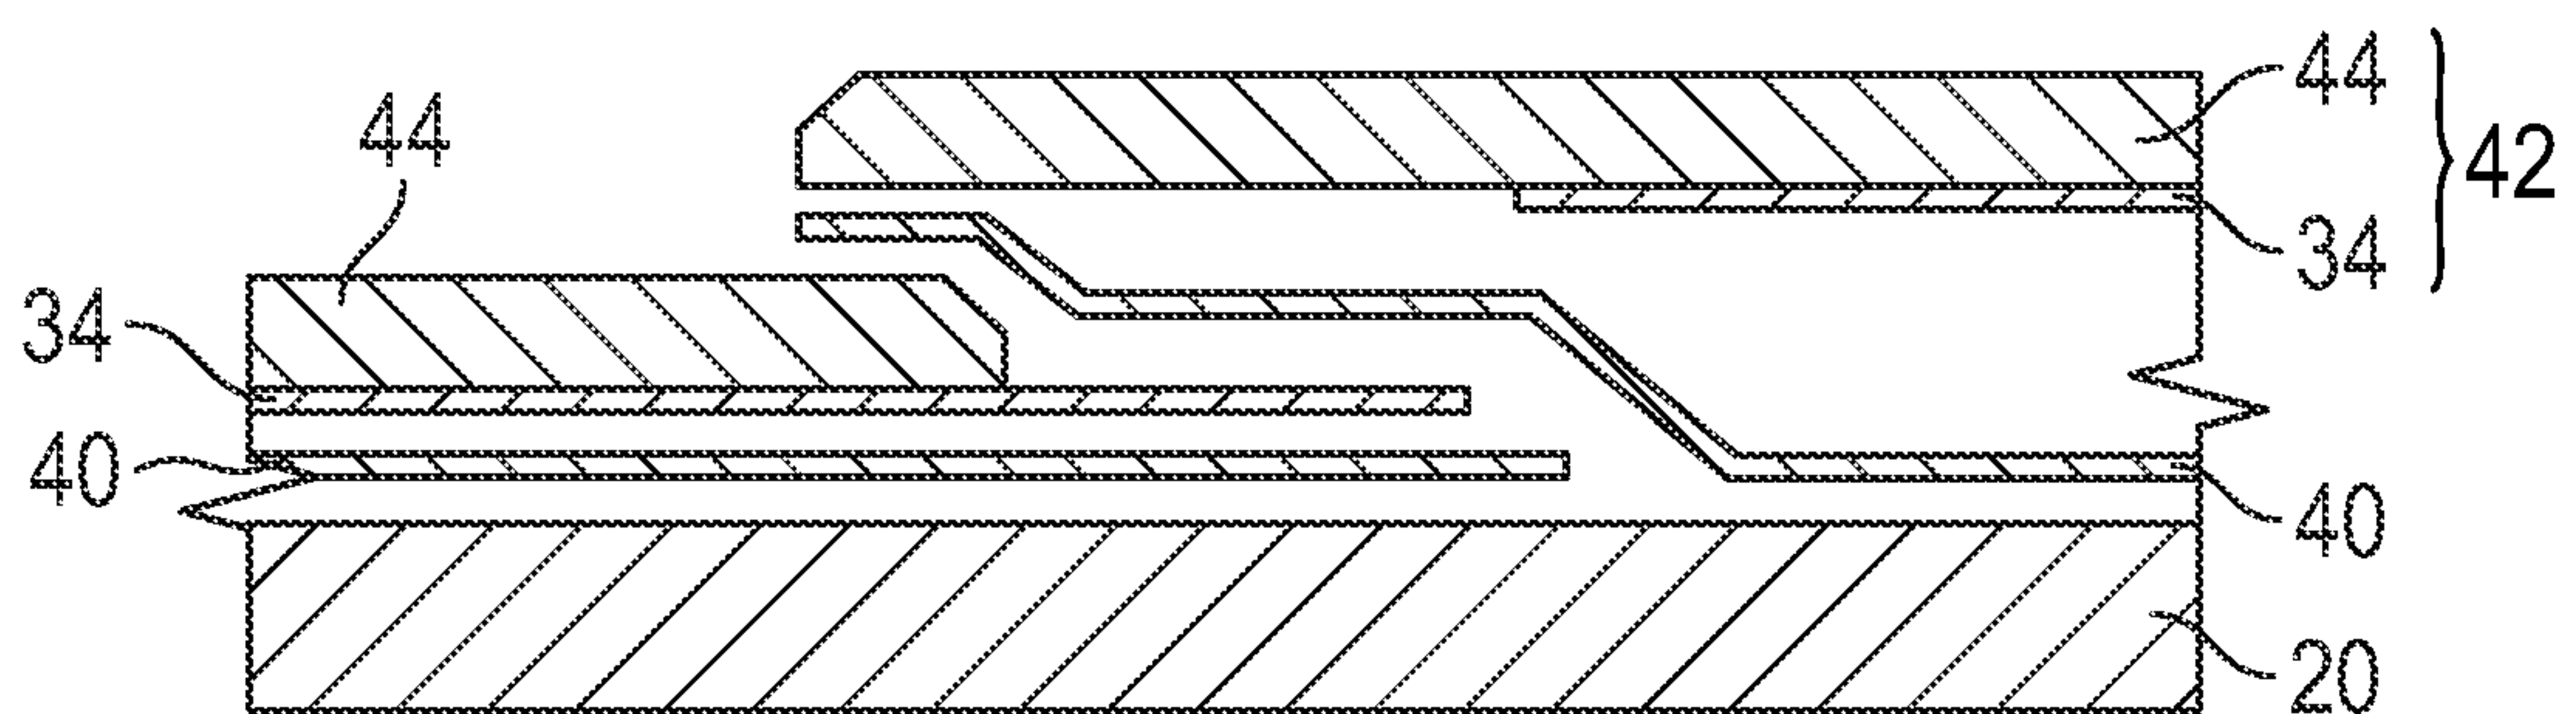
FIG. 7

FIGS. 7 and 8 show a cured replacement erosion coating located on a repair area;

FIGS. **7** and **8** show the cured replacement erosion coating **42** located on the repair area **20**. Adhesive **40** is located between the cured erosion coating and the repair area to bond the cured replacement erosion coating **42** to the repair area **20**. Cured replacement erosion coating **42** includes fibrous reinforcement **34** and cured fluoroelastomer **44**. FIG. **7** shows the ends of cured fluoroelastomer **44** overlapping.

The overlapping fluoroelastomer can be removed after the adhesive **40** has bonded the cured replacement erosion coating to the repair area. FIG. **8** shows the ends of cured fluoroelastomer **44** meeting without overlap.
