(10) **Patent No.:** **US 11,739,713 B2**  
(45) **Date of Patent:** **Aug. 29, 2023**

(54) **FLUOROELASTOMER EROSION COATING REPAIR**

(71) Applicant: **Raytheon Technologies Corporation**,  
Farmington, CT (US)

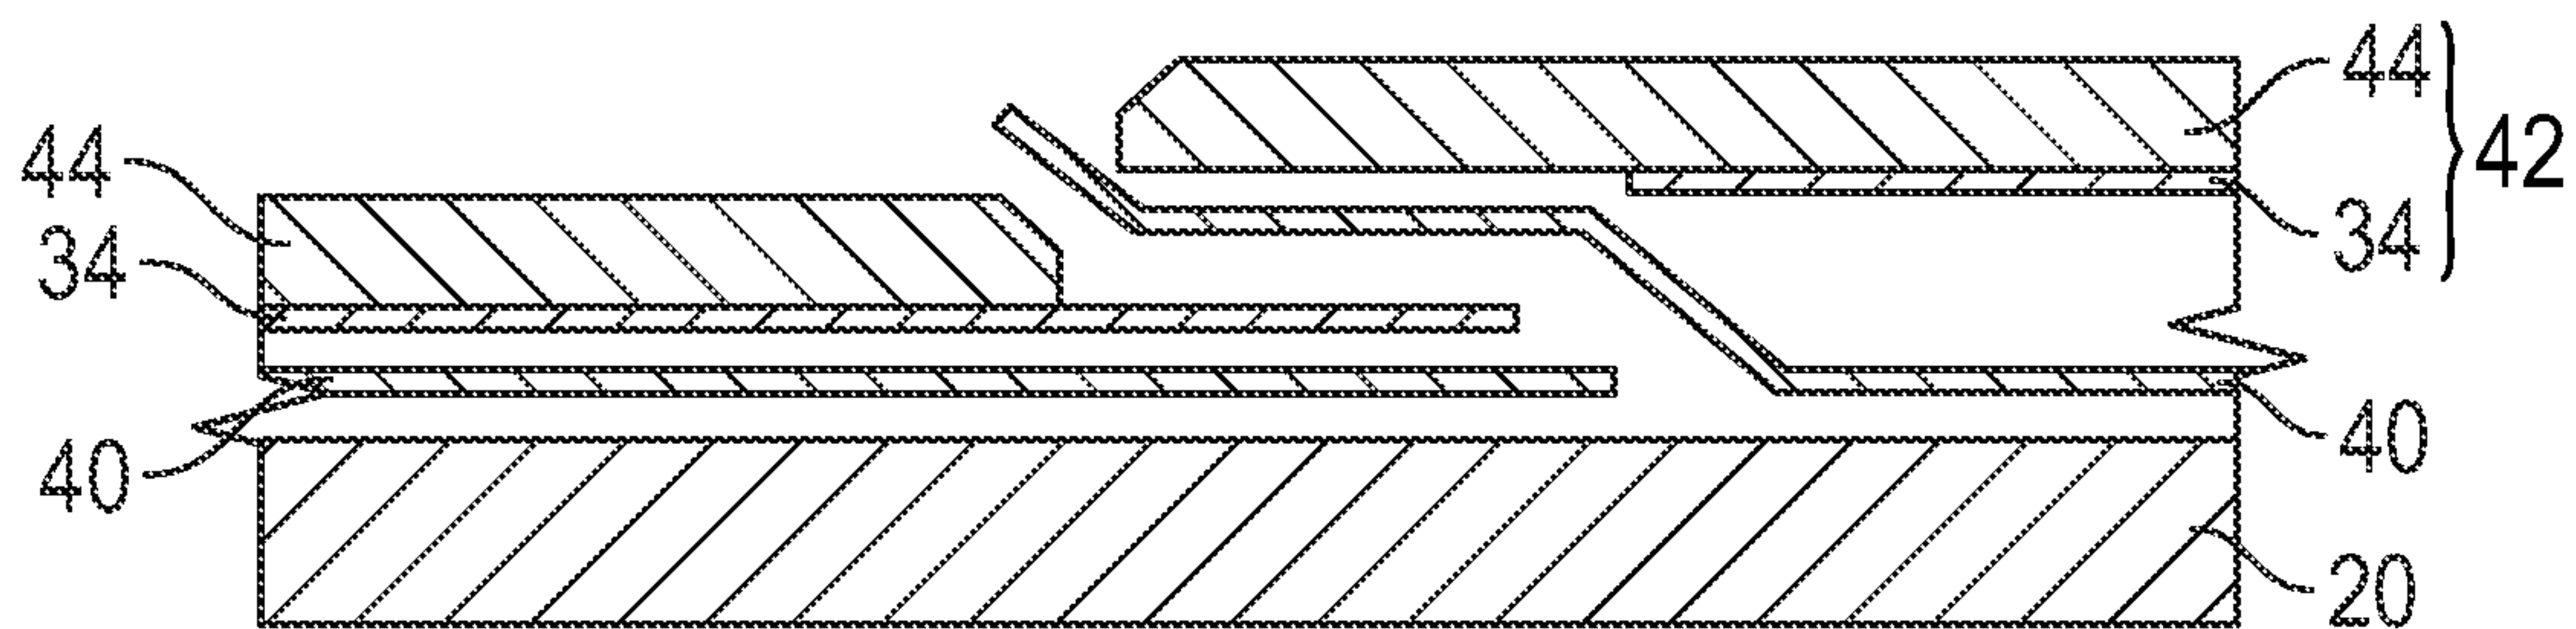
FIG. 8

FIGS. 7 and 8 show a cured replacement erosion coating located on a repair area;

FIGS. **7** and **8** show the cured replacement erosion coating **42** located on the repair area **20**. Adhesive **40** is located between the cured erosion coating and the repair area to bond the cured replacement erosion coating **42** to the repair area **20**. Cured replacement erosion coating **42** includes fibrous reinforcement **34** and cured fluoroelastomer **44**. FIG. **7** shows the ends of cured fluoroelastomer **44** overlapping.

The overlapping fluoroelastomer can be removed after the adhesive **40** has bonded the cured replacement erosion coating to the repair area. FIG. **8** shows the ends of cured fluoroelastomer **44** meeting without overlap.

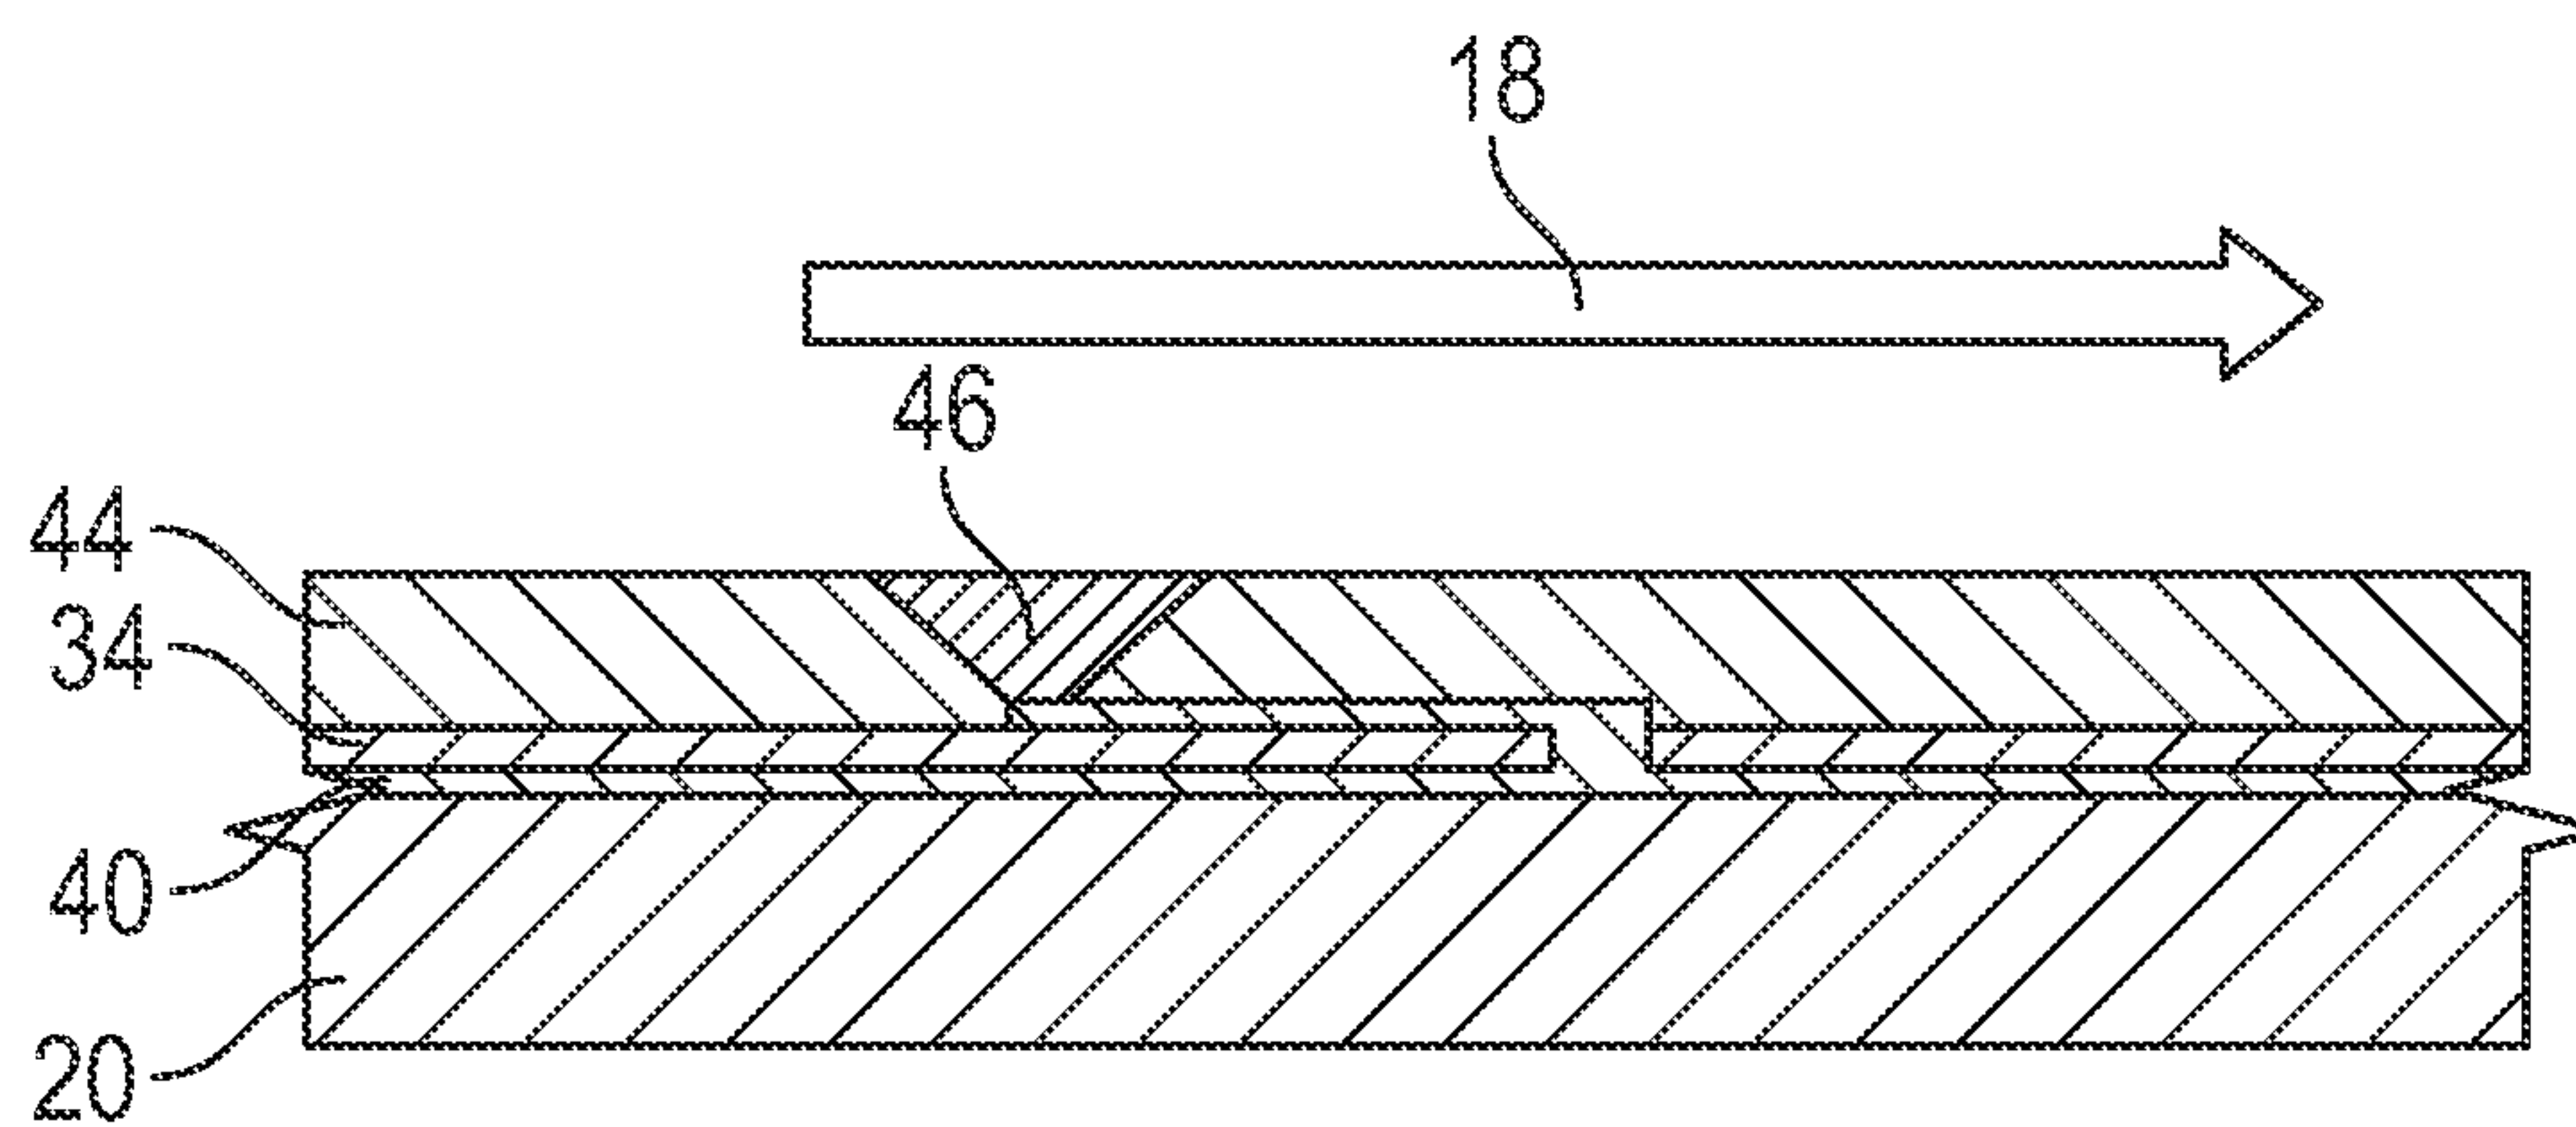
FIG. 9 shows a finished axial joint of the cured replacement erosion coating; and

FIG. **9** shows the finished axial joint. The joint between the ends of the cured fluoroelastomer **44** is sanded smooth and any excess adhesive is removed and liquid fluoroelastomer **46** is used to smooth and fill the gap where adhesive was removed. The liquid fluoroelastomer **46** is cured at a temperature less than the cure temperature of the adhesive. As can be seen from FIG. **9**, the prepared cured replacement erosion coating is located on the prepared repair area by wrapping the prepared cured replacement erosion coating around the rear cone segment **110** in a direction opposite to a direction of rotation.

FIG. 3 is a front view of rear cone segment 110. The rear cone segment 110 has attachment holes 15 for forward cover 100. Repair area 20 includes the attachment holes and a portion of the outer flow surface 16. Repair area 20 has an axial joint 22 and a circumferential joint 24. FIG. 2 also shows section line 4 and section line 9 which are shown in greater detail in FIG. 4 and FIG. 9 respectively.

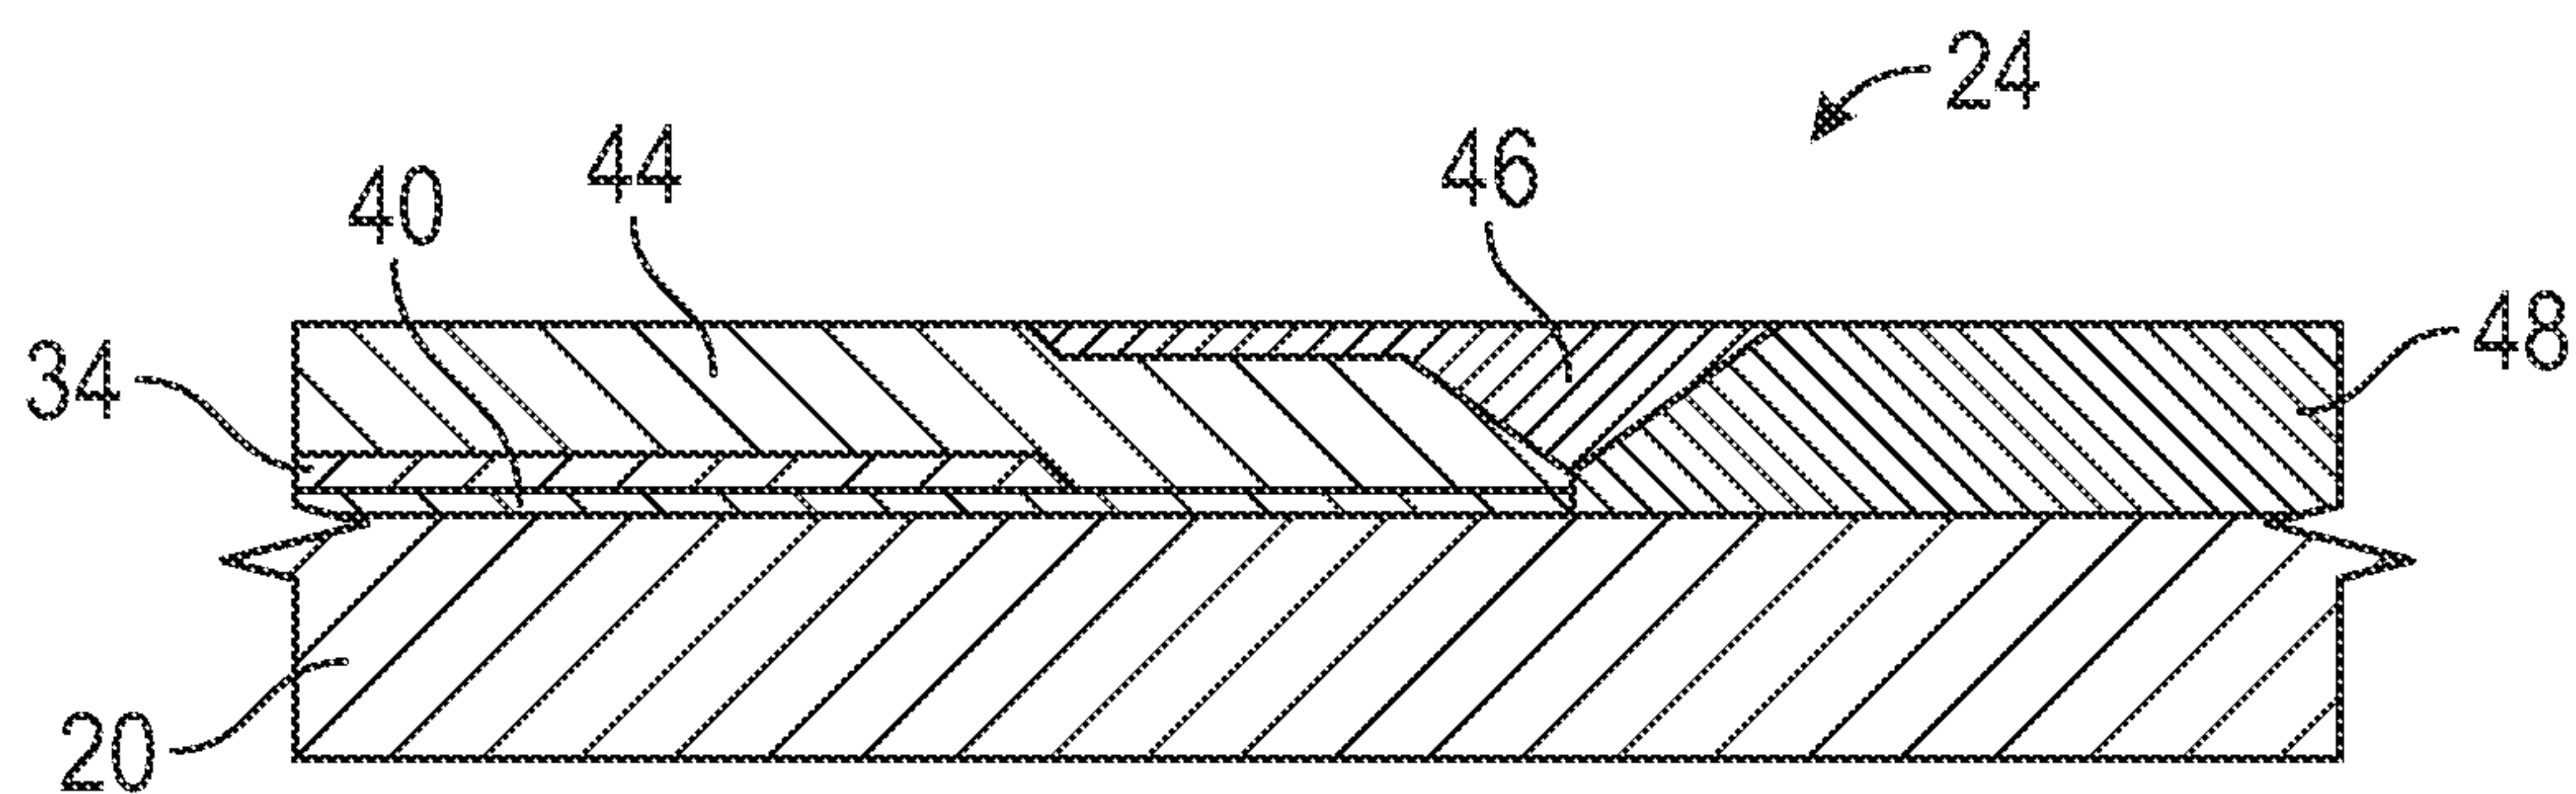
FIG. 10 shows the finished circumferential joint.

FIG. **10** shows the finished circumferential joint **24**. The cured fluoroelastomer **44** may overlap the original erosion coating when first located on the repair area. In the finished circumferential joint the cured fluoroelastomer may be sanded smooth and any excess adhesive is removed and any gap between the newly applied cured fluoroelastomer and the original erosion coating filled with second fluoroelastomer **46**, typically a liquid fluoroelastomer, which is cured. A gap may be the result of bonding tolerances or from removal of excess adhesive. The fibrous reinforcement does not contact the original erosion coating. The original erosion coating may consist of a fluoroelastomer.

FIG. 4 shows a cross section of repair area 20 having a leading edge 12 and a forward flange 28. Forward flange 28 includes the attachment holes 15. Because the repair area includes the forward flange, airflow is prevented from getting under the forward edge of the repair material. An additional feature of having the repair area cover the forward flange is the mating part has a bolted interface that passes through the repair material, thus further securing the repair detail. The circumferential joint 24 is shown in greater detail in FIG. 10.
