US011788293B2

(10) **Patent No.: US 11,788,293 B2**
(45) **Date of Patent: Oct. 17, 2023**

(54) **COMPOSITE SHIELD ROOFING SYSTEM**

(71) Applicant: **Brian Booth**, Quinlan, TX (US)

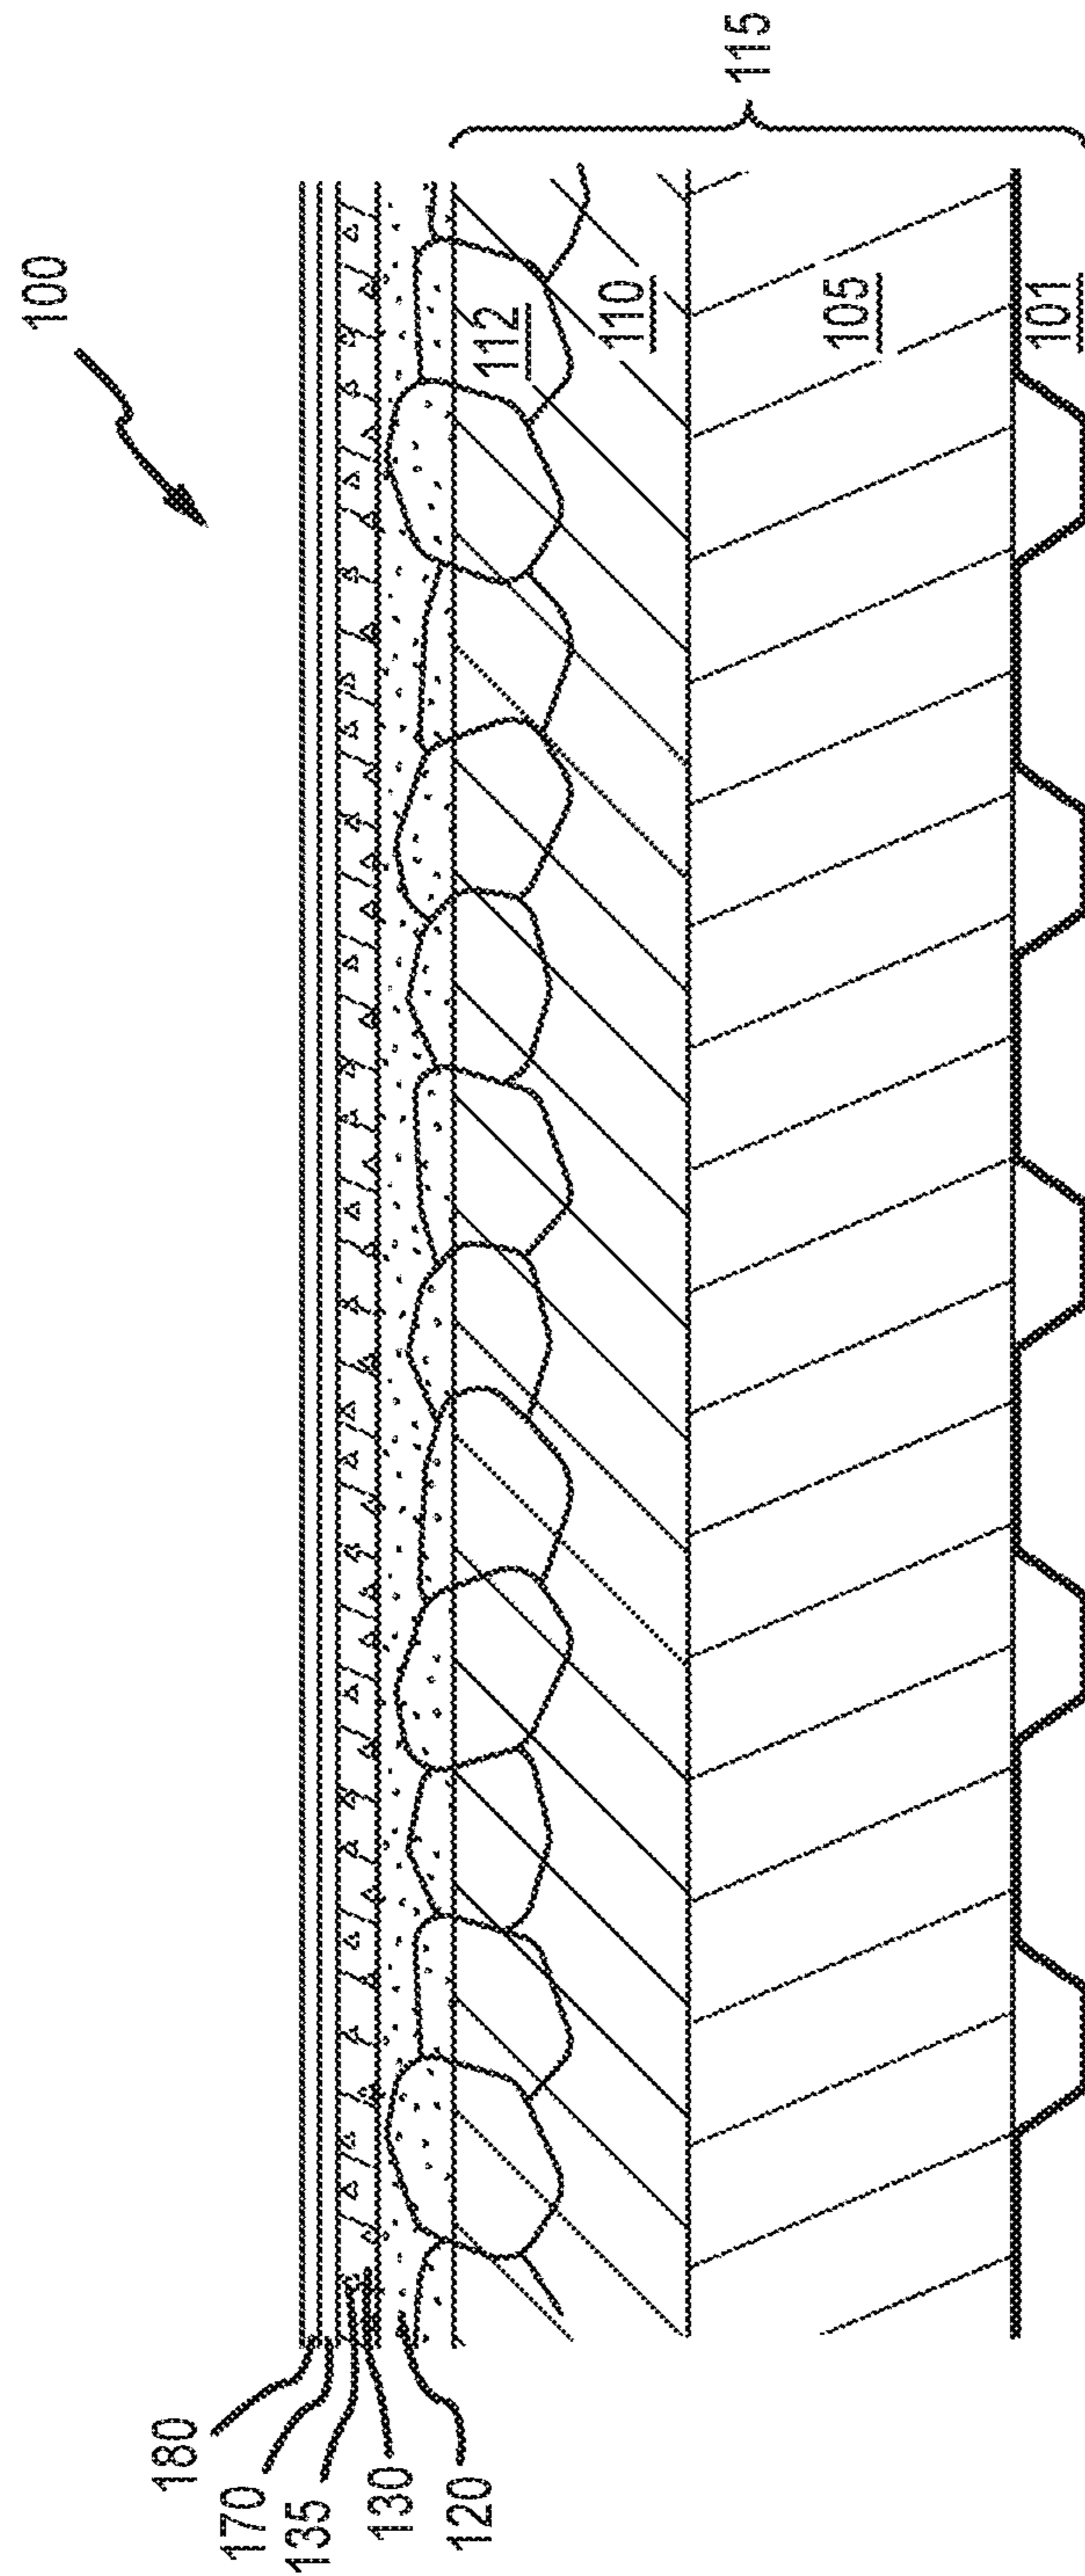
FIG.1

FIG. 1 is an illustration of a composite roofing system applied over a gravel built up surface according to an embodiment of the disclosure; and

Referring to FIG. 1, an embodiment of a composite roofing system **100** is applied over an existing gravel built up roofing surface **115**. As shown, the gravel built up roofing surface **115** includes a built up asphalt surface **110** that has been applied over insulation **105** previously layered over a metal decking **101**. In an embodiment, the gravel built up roofing surface **115** comprises gravel **112** embedded into the top coat of asphalt to create a flood coat that makes up the gravel built up roof surface **110** and which helps the gravel **112** stay in place. While commonly called by those of ordinary skill in the art as "gravel," and as will be referred to throughout the instant disclosure as "gravel," the gravel layer **112** is usually some sort of aggregate material such as pea gravel, slap, or mineral granules.

In various embodiments of the composite roofing system **100**, a first fluid application flood coat **120** of bentonite emulsion is applied over the prepared, pre-existing gravel built up roofing surface **115** at a rate of 15 gallons per 100 square feet. In an embodiment, the bentonite emulsion may be Western Colloid Asphalt Emulsion Roof Surfacing Product #298, or APOC® 300 Non-Fibered Asphalt Emulsion. As described herein, the bentonite emulsion may be applied to the gravel built up surface manually using a hand held spray device. Alternately, the bentonite emulsion may be applied mechanically or in various ways as known to those of ordinary skill in the art. Upon curing, the first flood coat **120** of bentonite emulsion will provide the roof with a waterproof surface. Normal curing time for the first flood

Referring to FIG. 1, the composite shield roofing system includes a second fluid application flood coat **130** of bentonite emulsion. The second flood coat **130** further includes approximately 3 to 6 pounds of chopped reinforced fiberglass **135** per 100 square feet. Similar to the first flood coat, the bentonite emulsion of the second flood coat is applied via a spraying device. However, the chopped reinforced fiberglass is pulled from a spool and sprayed out of a pneumatic gun to combine with the bentonite emulsion of the second flood coat in midair during application. The first flood coat of bentonite emulsion must be cured before a second flood coat is applied thereover.

In various embodiments, an asphalt primer layer **170** is applied over the second flood coat **130** once the second flood coat of bentonite emulsion and chopped reinforced fiberglass has cured. The asphalt primer layer **170** may be applied at a rate of one half ($\frac{1}{2}$) gallon per 100 square feet. Finally, after the asphalt primer layer **170** has cured, a top coat **180** is applied thereover. As those of ordinary skill in the art understand, the asphalt primer layer **170** should correspond with the type of top coat **180** applied. In an embodiment, the top coat may be a reflective top coat. In another embodiment, the top coat may be an Energy Star Rated reflective top coat.

Various embodiments of the disclosed composite roofing system allow for application of different top coats. The top coat **180** depends on a slope of the pre-existing gravel built up roofing surface. That is, if a slope of the pre-existing gravel built up surface **115** is at least one fourth ($\frac{1}{4}$) inch per one foot, the top coat **180** may be an elastomeric acrylic roof coating applied at a rate of four gallons per 100 square feet. Stated differently, there is a minimum slope factor for acrylic top coating. In an embodiment, the elastomeric acrylic roof coating may be one of Western Colloid ElastaHyde #720 ARC White Elastomeric Acrylic Coating, APOC® 247 Sun-Shield® White Reflective Roof Coating, or APOC® 264 FLASH N' SEAL® White Elastomeric Roof & Flashing Sealant. If an elastomeric acrylic roof top coat is applied, the asphalt primer layer corresponding thereto may be one of Western Colloid Product #970 A₂A Bonding Primer or APOC® 230 Elastocryl® Premium Acrylic Base Coating.

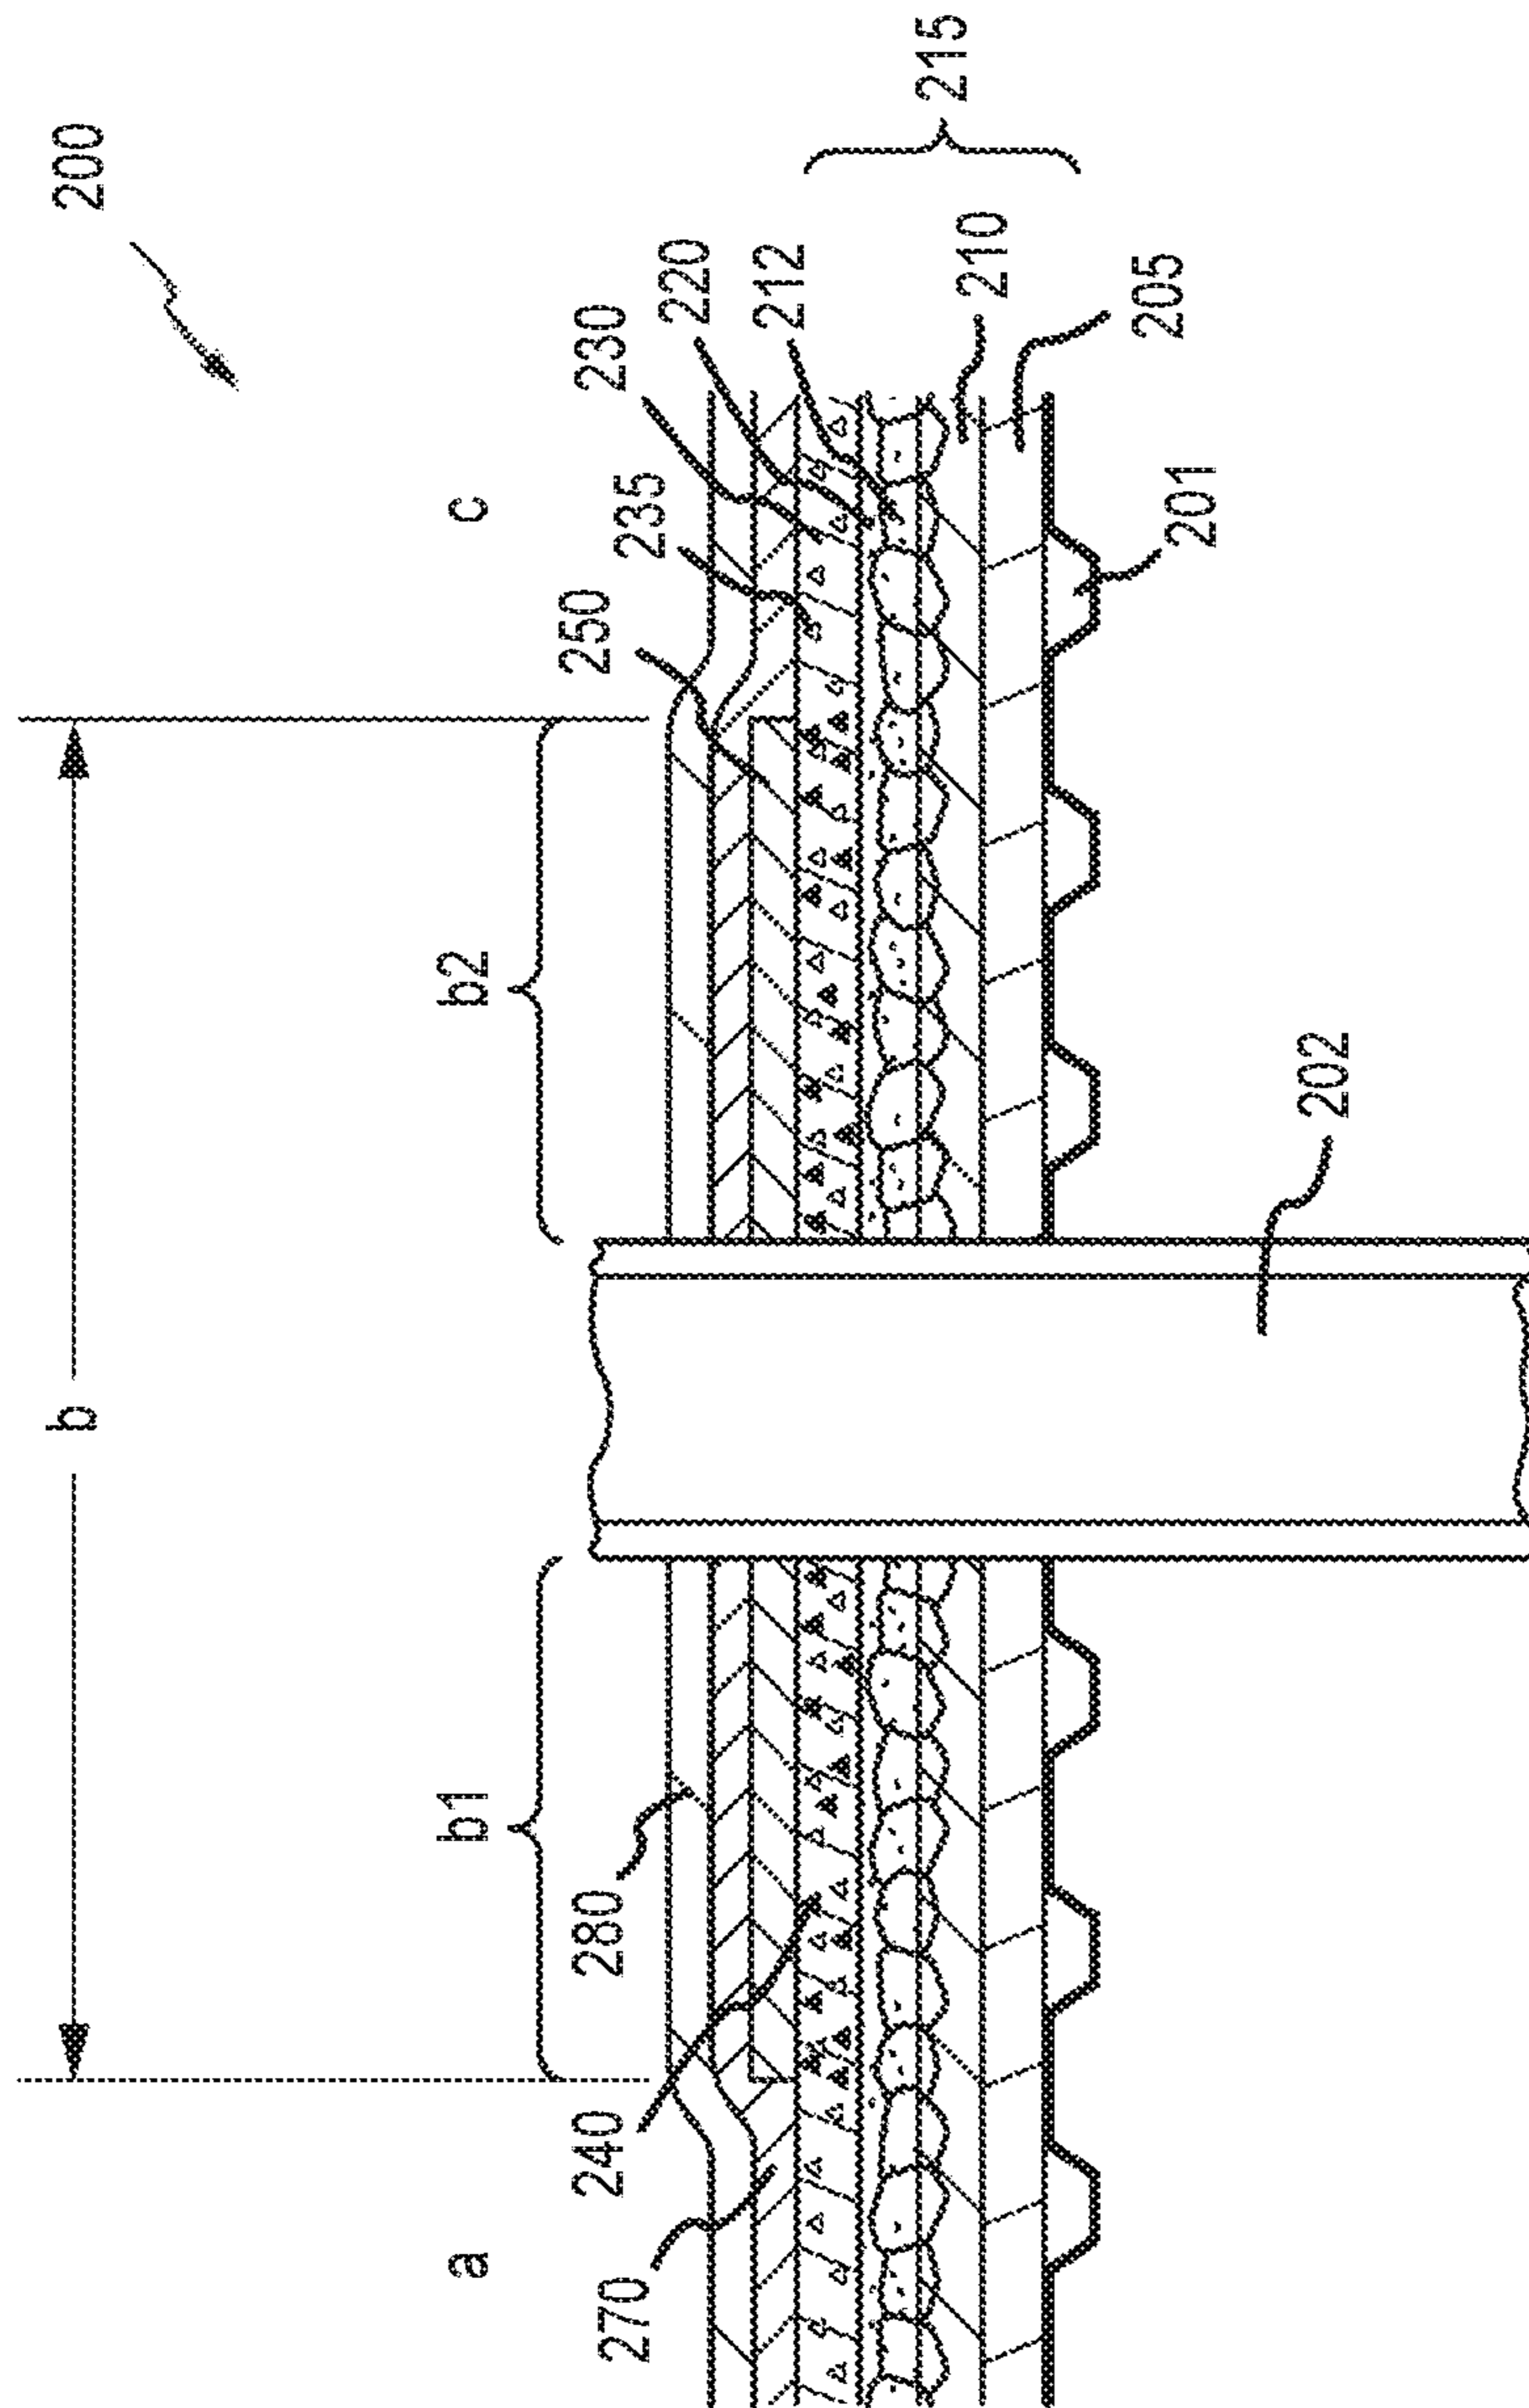
FIG. 2 is an illustration of a composite roofing system applied over a gravel built up surface having at least one penetration according to another embodiment of the disclosure.

Referring now to FIG. 2, the composite shield roofing system **200** may include a gravel built up surface **215** that has at least one roof top penetration **202** that penetrates at least one of a metal decking layer **201**, insulation layer **205**, and existing built up asphalt layer **210** having gravel **212**

As similar to FIG. 1, the pre-existing gravel built up roofing surface **215** is first prepared for fluid application of the composite roofing system. Then, a first fluid application flood coat of bentonite emulsion **220** is applied over the entire prepared pre-existing gravel built up roofing surface **215** at a rate of fifteen (15) gallons per 100 square feet and allowed to cure.

In an embodiment, a second fluid application flood coat of bentonite emulsion **230** is applied to the cured first flood coat—including areas ‘a’, ‘b’, and ‘c’ in FIG. 2, at a rate of 10 gallons per 100 square feet. In addition to the bentonite emulsion **230**, the second flood coat includes approximately 3 to 6 pounds of chopped reinforced fiberglass **235** per 100 square feet. Furthermore, in an area ‘b’ surrounding a roof top penetration—area ‘b’ includes areas b_1 and b_2 and does not include the area of the penetration itself as shown in FIG. 2, an additional approximately 3 to 6 pounds of chopped reinforced fiberglass per 100 square feet is added to the second flood coat. Stated differently, the second flood coat applied to the area surrounding a roof top penetration, includes a total of approximately 6 to 12 pounds of chopped reinforced fiberglass per 100 square feet.

In an embodiment, the chopped fiberglass layer **240** is applied to an area surrounding a roof top penetration that spans approximately 2 feet in each radial direction. That is, each of areas b_1 and b_2 will have a width of approximately 2 feet or measure a distance of approximately 2 feet from an outside perimeter or outside circumference (depending on the shape) of the roof top penetration. Thus, in various embodiments, regardless whether a roof top penetration comprises a roughly cylindrical shape (e.g. a drain pipe) or a more rectangular shape (e.g. a rectangular skylight), in a cross-sectional view of the roofing layers such as shown in FIG. 2, each of b_1 and b_2 will be approximately 2 feet wide.

In various embodiments, an elastic trowel grade mastic coating **250** is applied to the area around the at least one roof top penetration to ensure watertight integrity. The elastic trowel grade mastic coating **250** may be a white elastic trowel grade mastic coating and it may be applied after the second flood coat **230** having the 3 to 6 pounds of chopped reinforced fiberglass **235** therein and having the additional 3 to 6 pounds of chopped reinforced fiberglass **240** being added thereto has cured.

After the elastic trowel grade mastic coating **250** has dried or cured, an asphalt primer layer **270** is applied over the second flood coat **230** uniformly across the roofing surface.

In an embodiment, the asphalt primer layer **270** may be applied at a rate one half ($\frac{1}{2}$) gallon per 100 square feet. Finally, after the asphalt primer layer **170** has cured, a top coat **280** is applied thereover. As those of ordinary skill in the art understand, the asphalt primer layer **270** should correspond with the type of top coat **280** applied.

As discussed above in relation to FIG. 1, various embodiments of the disclosed composite roofing systems allow for application of different top coats. The top coat **280** depends on a slope of the pre-existing gravel built up roofing surface. That is, if a slope of the pre-existing gravel built up surface **215** is at least one fourth ($\frac{1}{4}$) inch per one foot, the top coat **280** may be an elastomeric acrylic roof coating applied at a rate of four (4) gallons per 100 square feet. Alternatively, if the slope of the pre-existing gravel built up surface **215** is less than one fourth ($\frac{1}{4}$) inch per one foot (for example, $\frac{1}{8}$ inch per one foot), the top coat **280** is a silicon roof coating applied at a rate of two gallons per 100 square feet.
