(10) **Patent No.:** **US 11,870,310 B2**  
(45) **Date of Patent:** **Jan. 9, 2024**

(54) **METHOD OF REPAIRING A HYDROGENERATOR**

(71) Applicant: **Electromechanical Engineering Associates, Inc.**, Monroeville, PA (US)

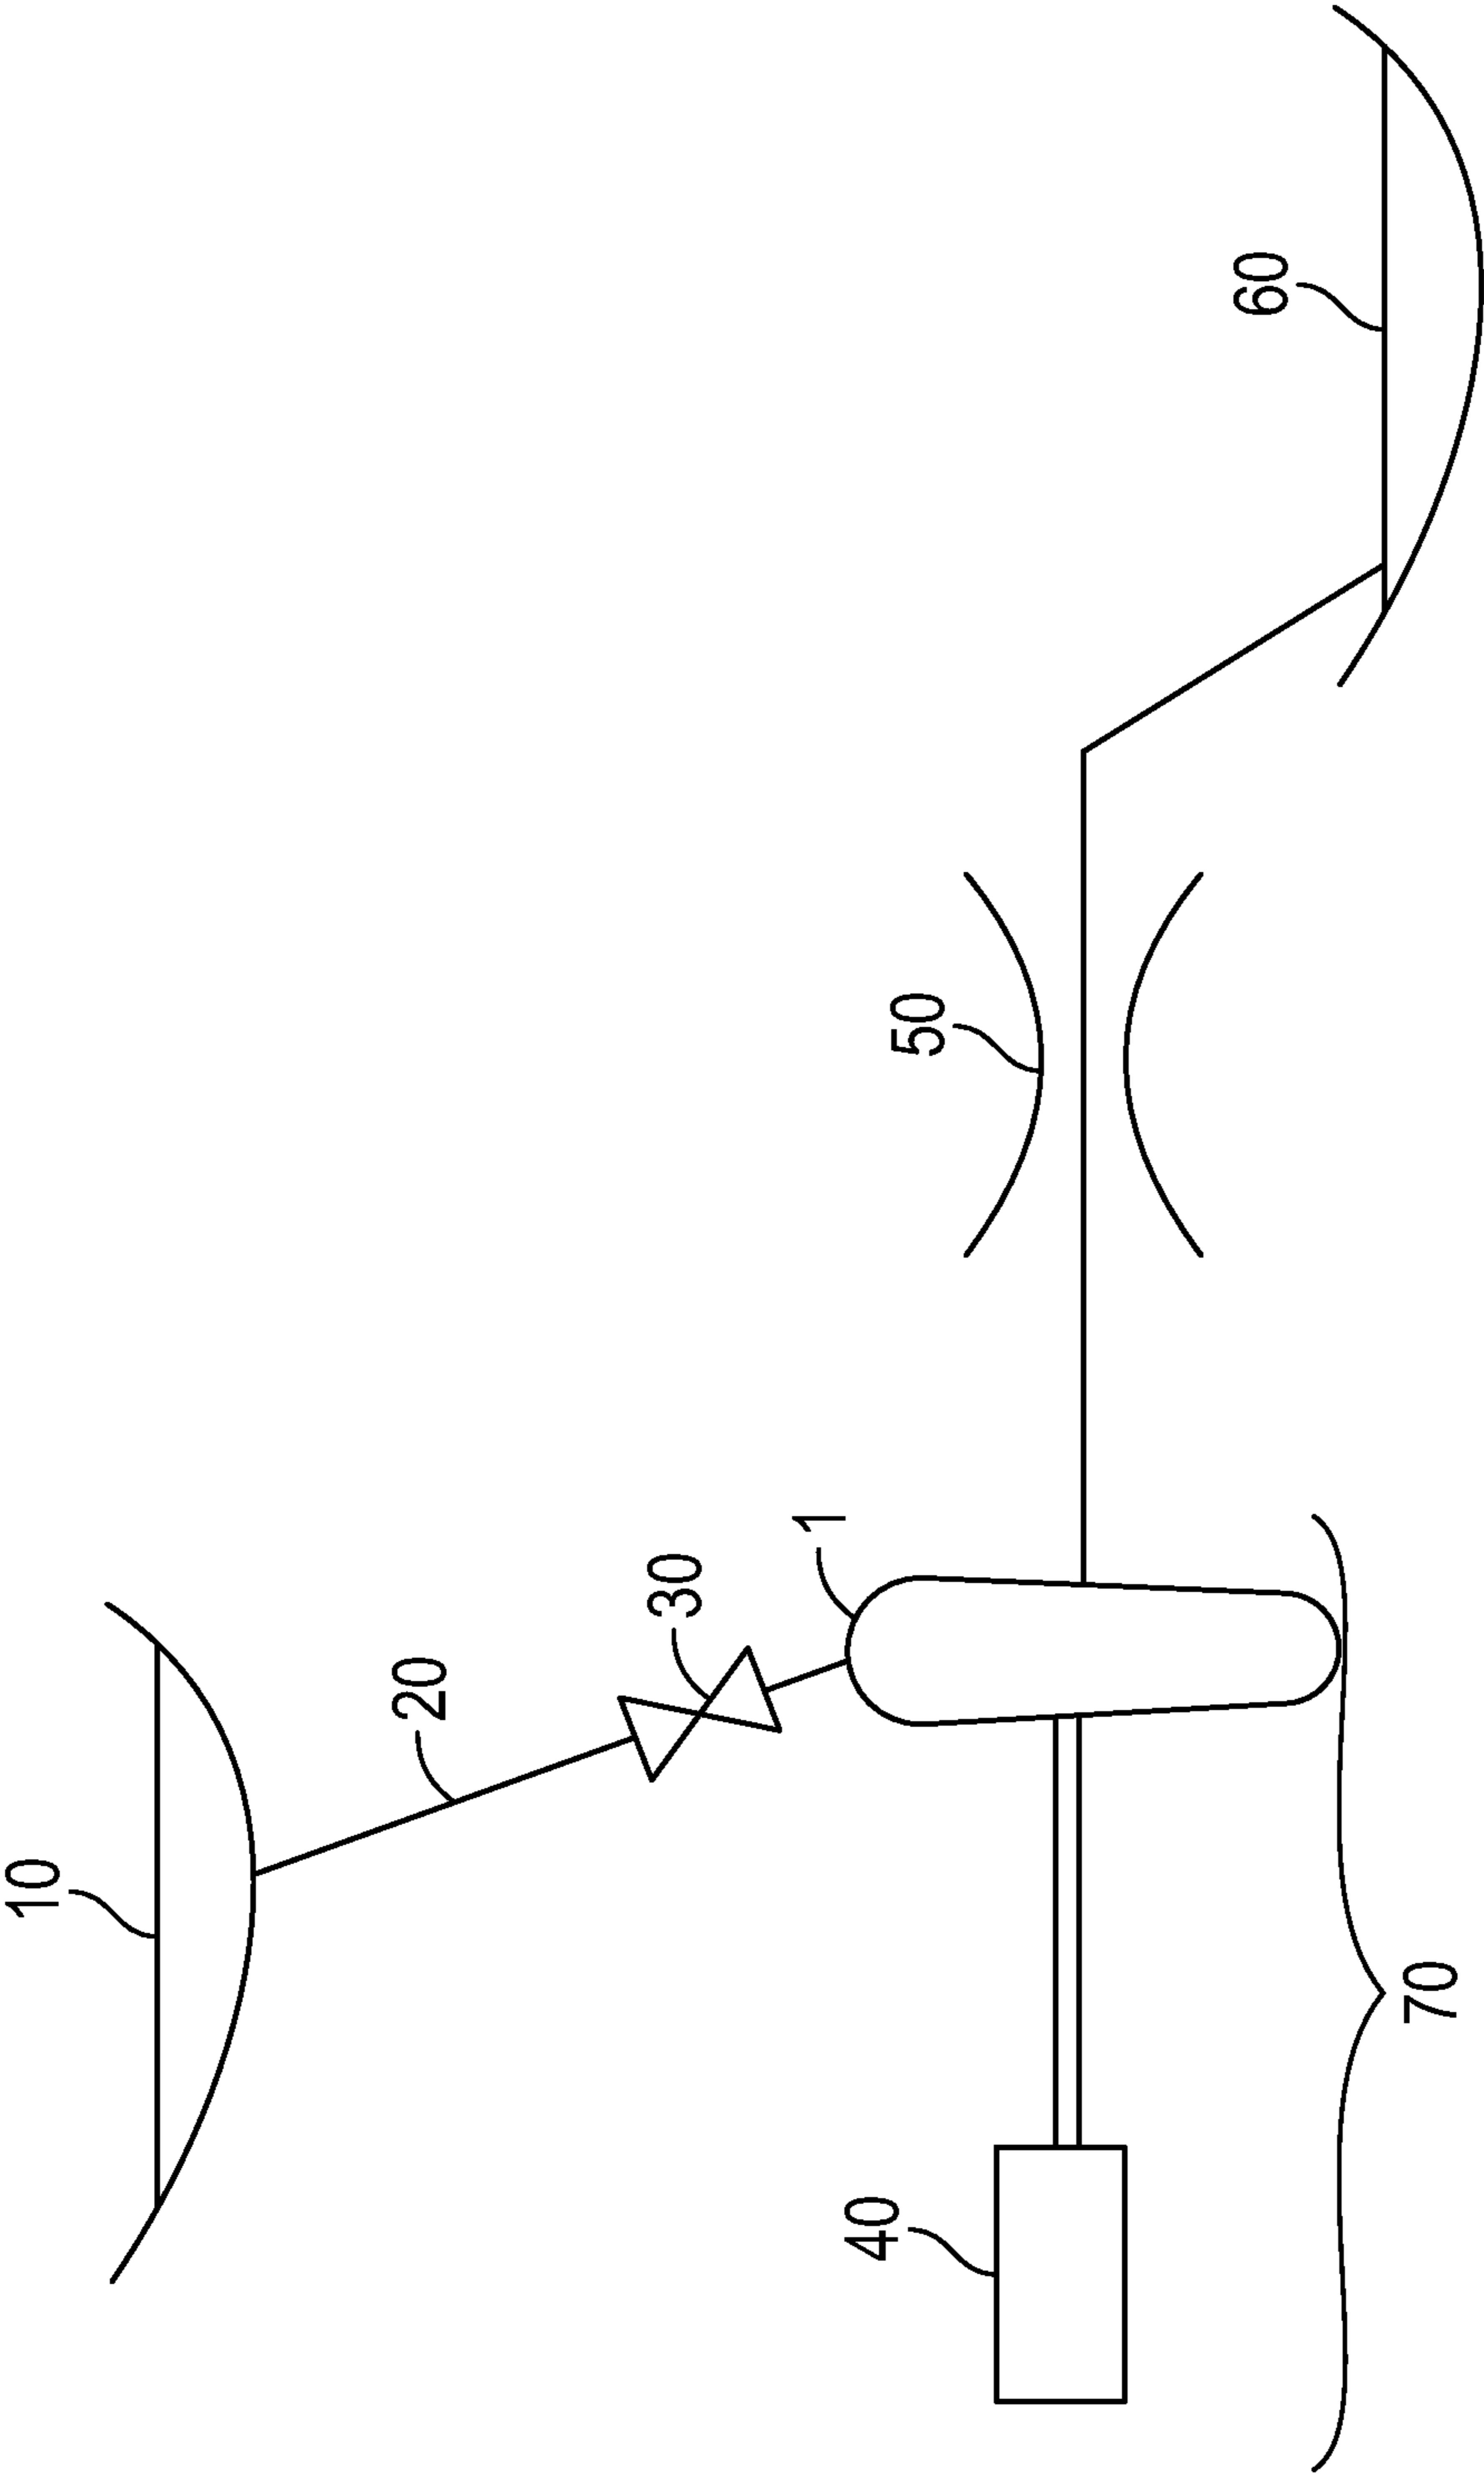
FIG. 1  
(Prior Art)

FIG. 1 illustrates a hydropower plant that includes an upper body of water 10 feeding a turbine 1 through a pressure line 20 via a shutoff element 30. The turbine 1 drives a generator 40 that generates electricity. The turbine 1 and the electric generator 40 together form a hydrogenerator (hydroelectric generator) 70.

FIG. 1 shows a possible hydropower plant;  
 FIG. 2 is a diagram of how a hydropower plant works;  
 FIGS. 3A, 3B, and 3C show a typical geometry and failure location of a rotor;

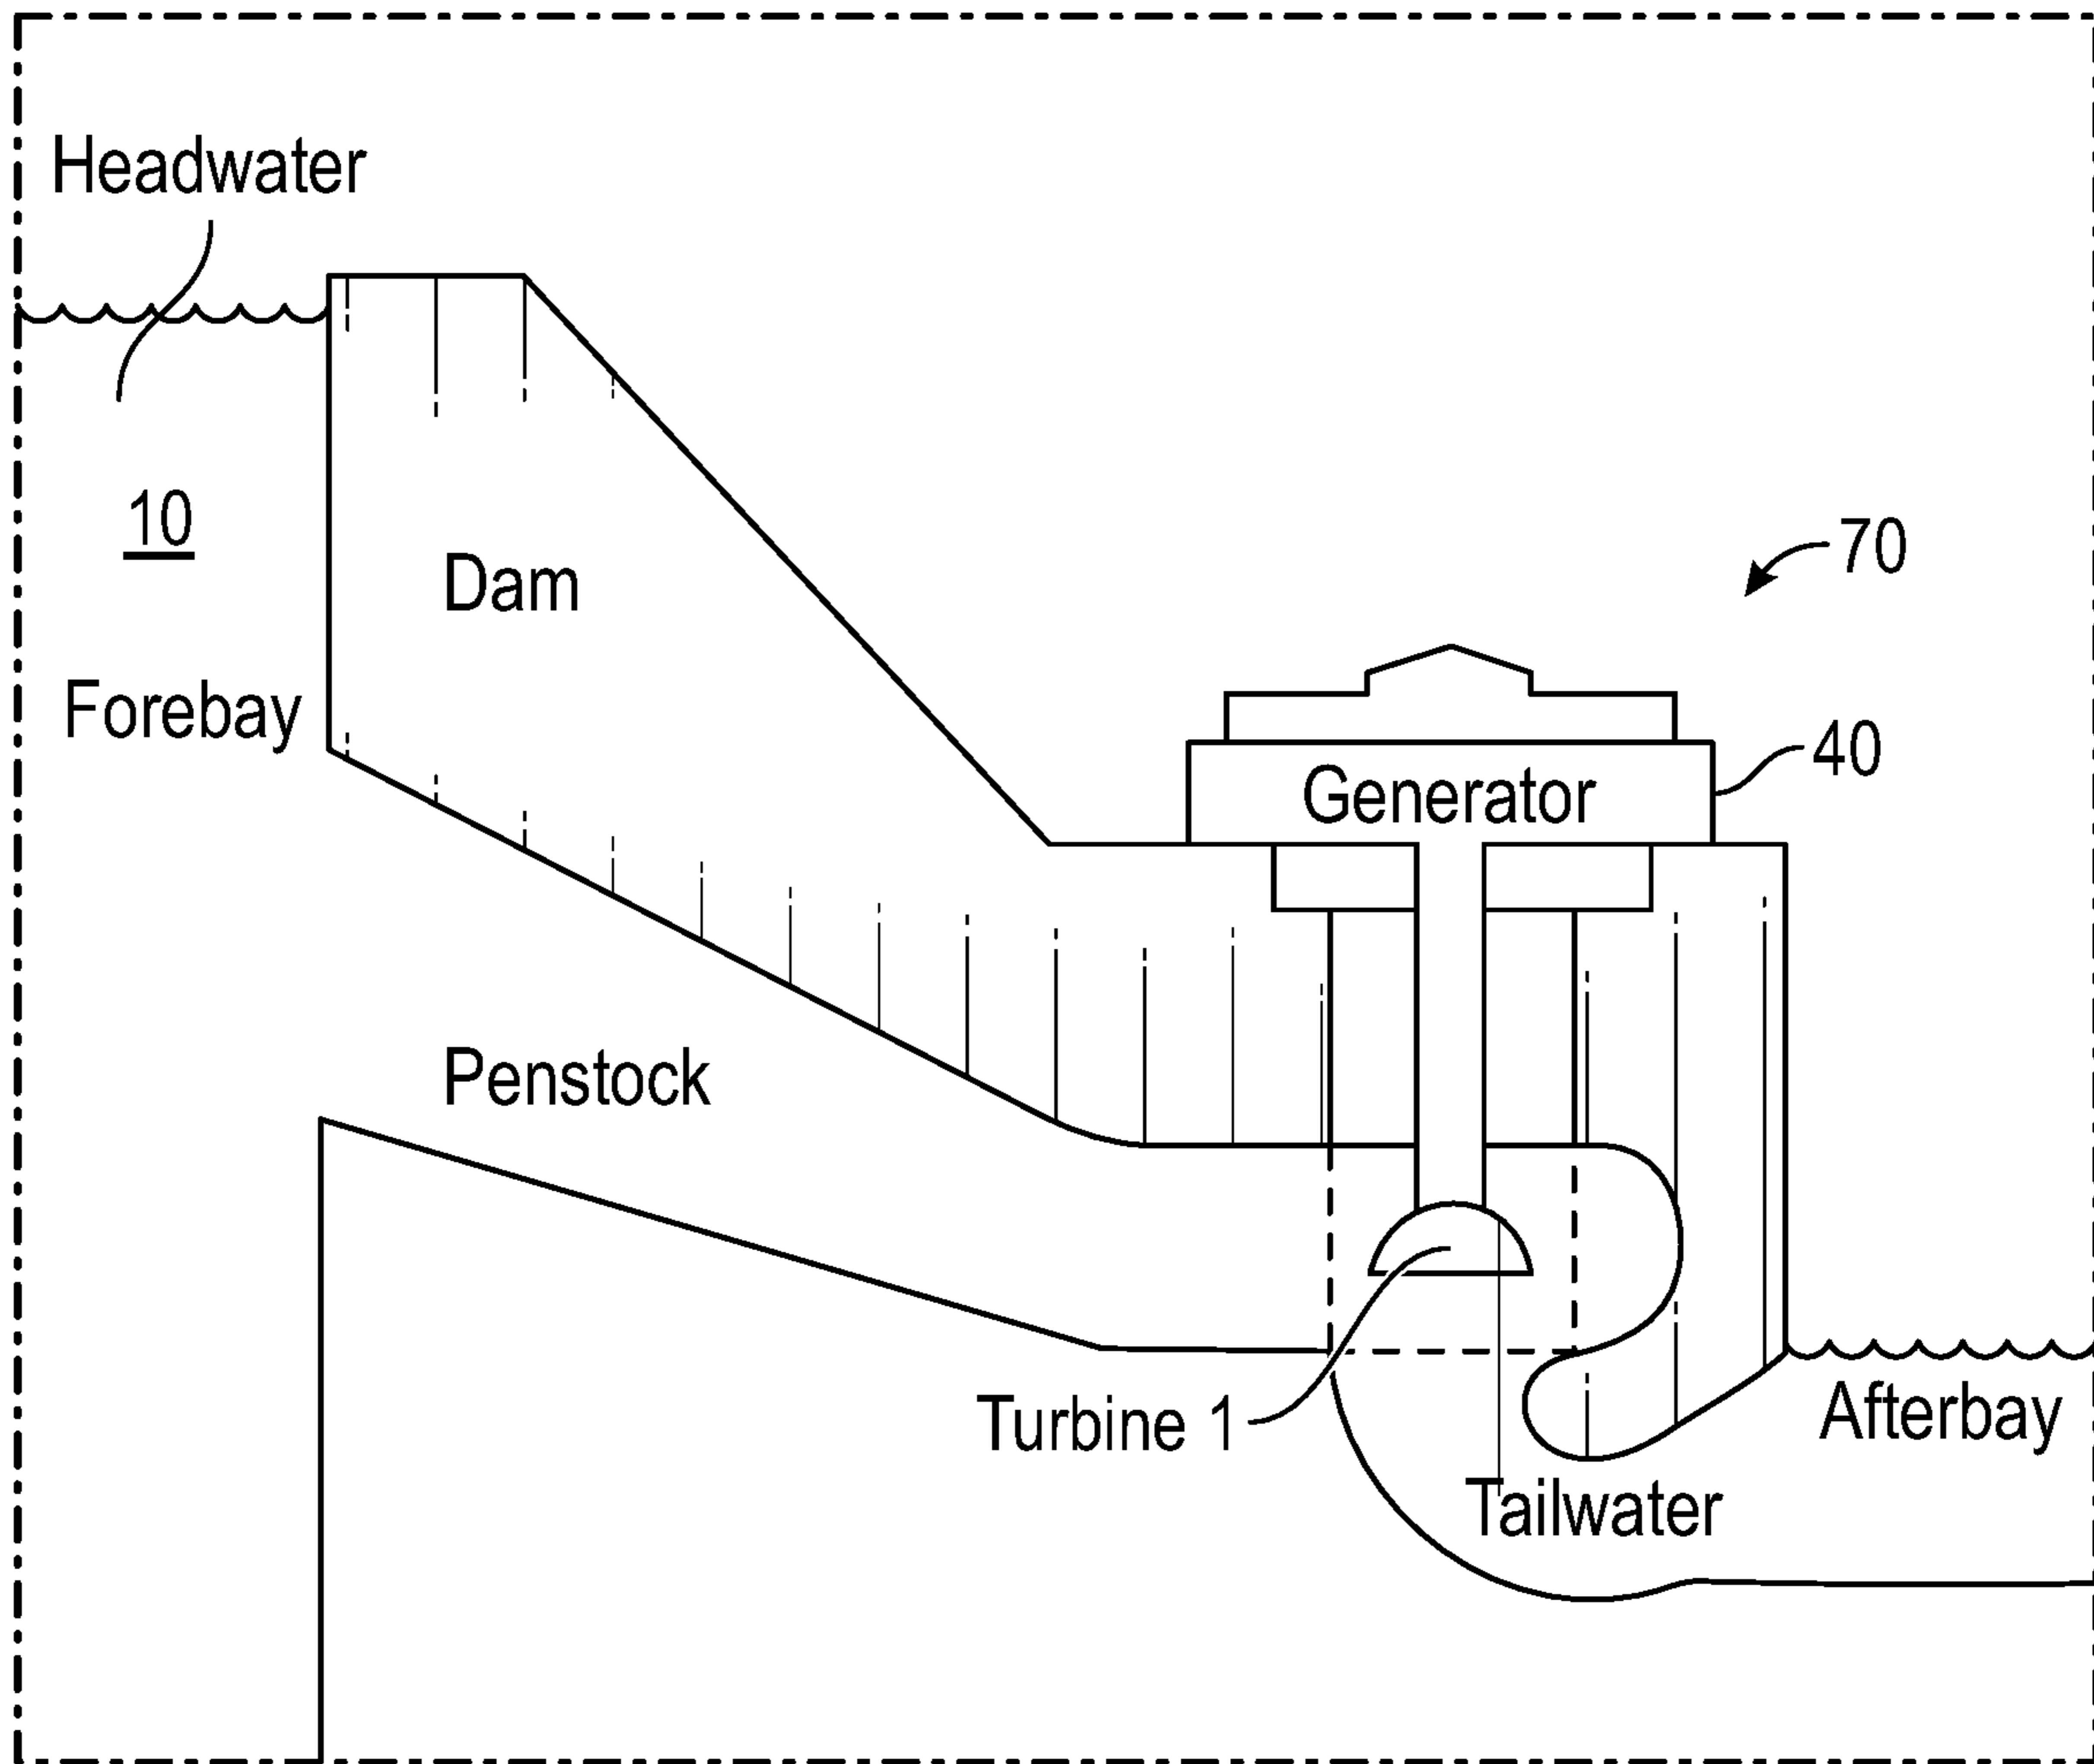
**FIG. 2**  
**(Prior Art)**

As shown in FIG. 2, a dam creates a reservoir forming the upper body of water 10. The reservoir has a "head" or height from which water flows. A pipe (penstock) carries the water from the reservoir to the hydrogenerator 70. The hydrogenerator 70 shown in FIG. 2 is a vertical hydrogenerator designed around a vertically mounted shaft assembly. Attached to the upper portion of the shaft assembly is a rotor 100 (see FIG. 3A) of the generator 40. Attached to the lower end of the shaft is the turbine 1. The turbine 1 has turbine blades driven by the fast-moving water from the penstock, something like a pinwheel in the wind. The turbine 1 drives the rotor 100 within a stator of the electric generator 70 to generate electricity.

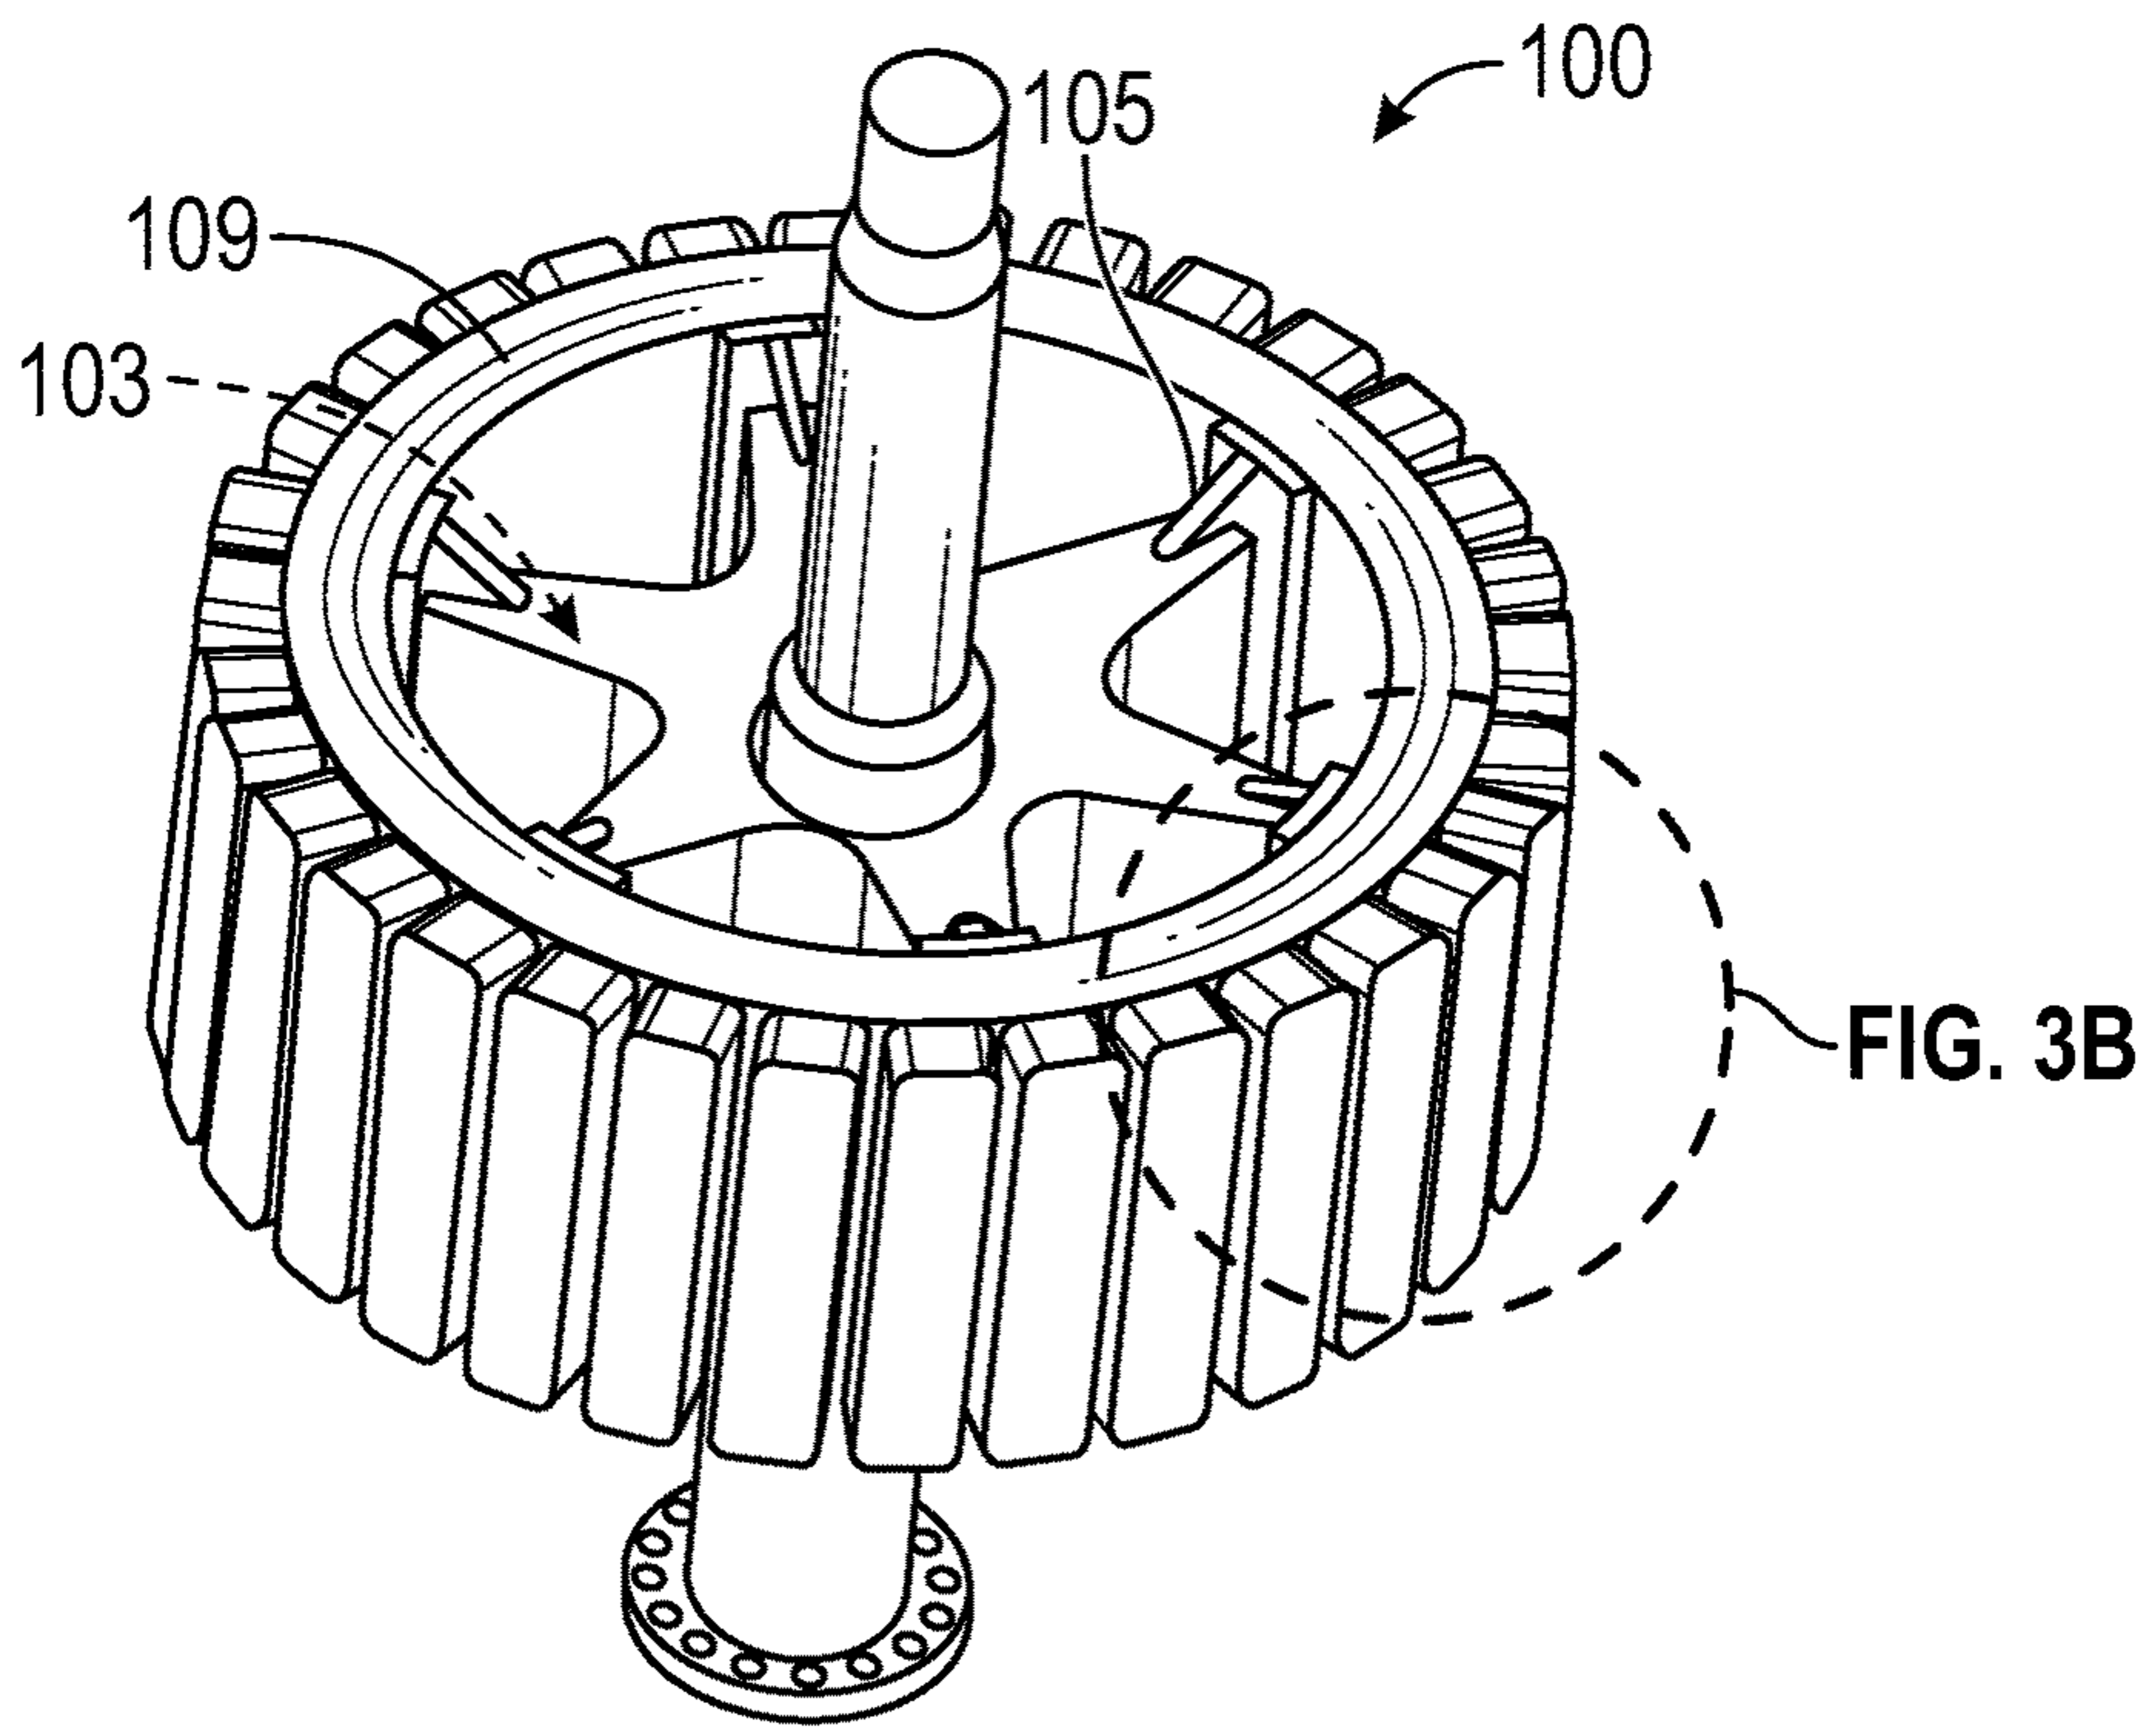
FIG. 3A  
(Prior Art)

FIG. 3A shows a rotor 100 of a typical electric generator 40, and FIG. 3B shows a cross-section of the circled portion of the rotor 100 in FIG. 3A. The rotor 100 includes a shaft 102 and a spider 103 attached to the shaft 102. The spider 103 supports a rim 108 surrounding the shaft 102. The rim 108 carries a number of poles 110 spaced along the outer circumference of the rim 108. When the poles 110 pass by poles in the stator during rotation of the rotor 100, the electric generator 70 generates electricity.

The illustrated spider 103 is a welded steel structure having six spider arms 104 with vertical posts 105 at their ends that support the rim 108. The rim 108 is a ring of laminated steel segments held together by solid steel end plates 109 at the top and bottom, and clamped together by bolts 130 (see FIG. 6) passing through the end plates and laminations. The rotor poles 110 in turn are supported by the rim 108 both radially, usually by dovetails, and axially by the rim 108.

FIG. 6 shows a thrust plate assembly having a thrust plate **122** used in an embodiment of the disclosed method for repairing the electric generator **40** shown in FIGS. 3A and 3C as having a fractured rim support ledge **106**.

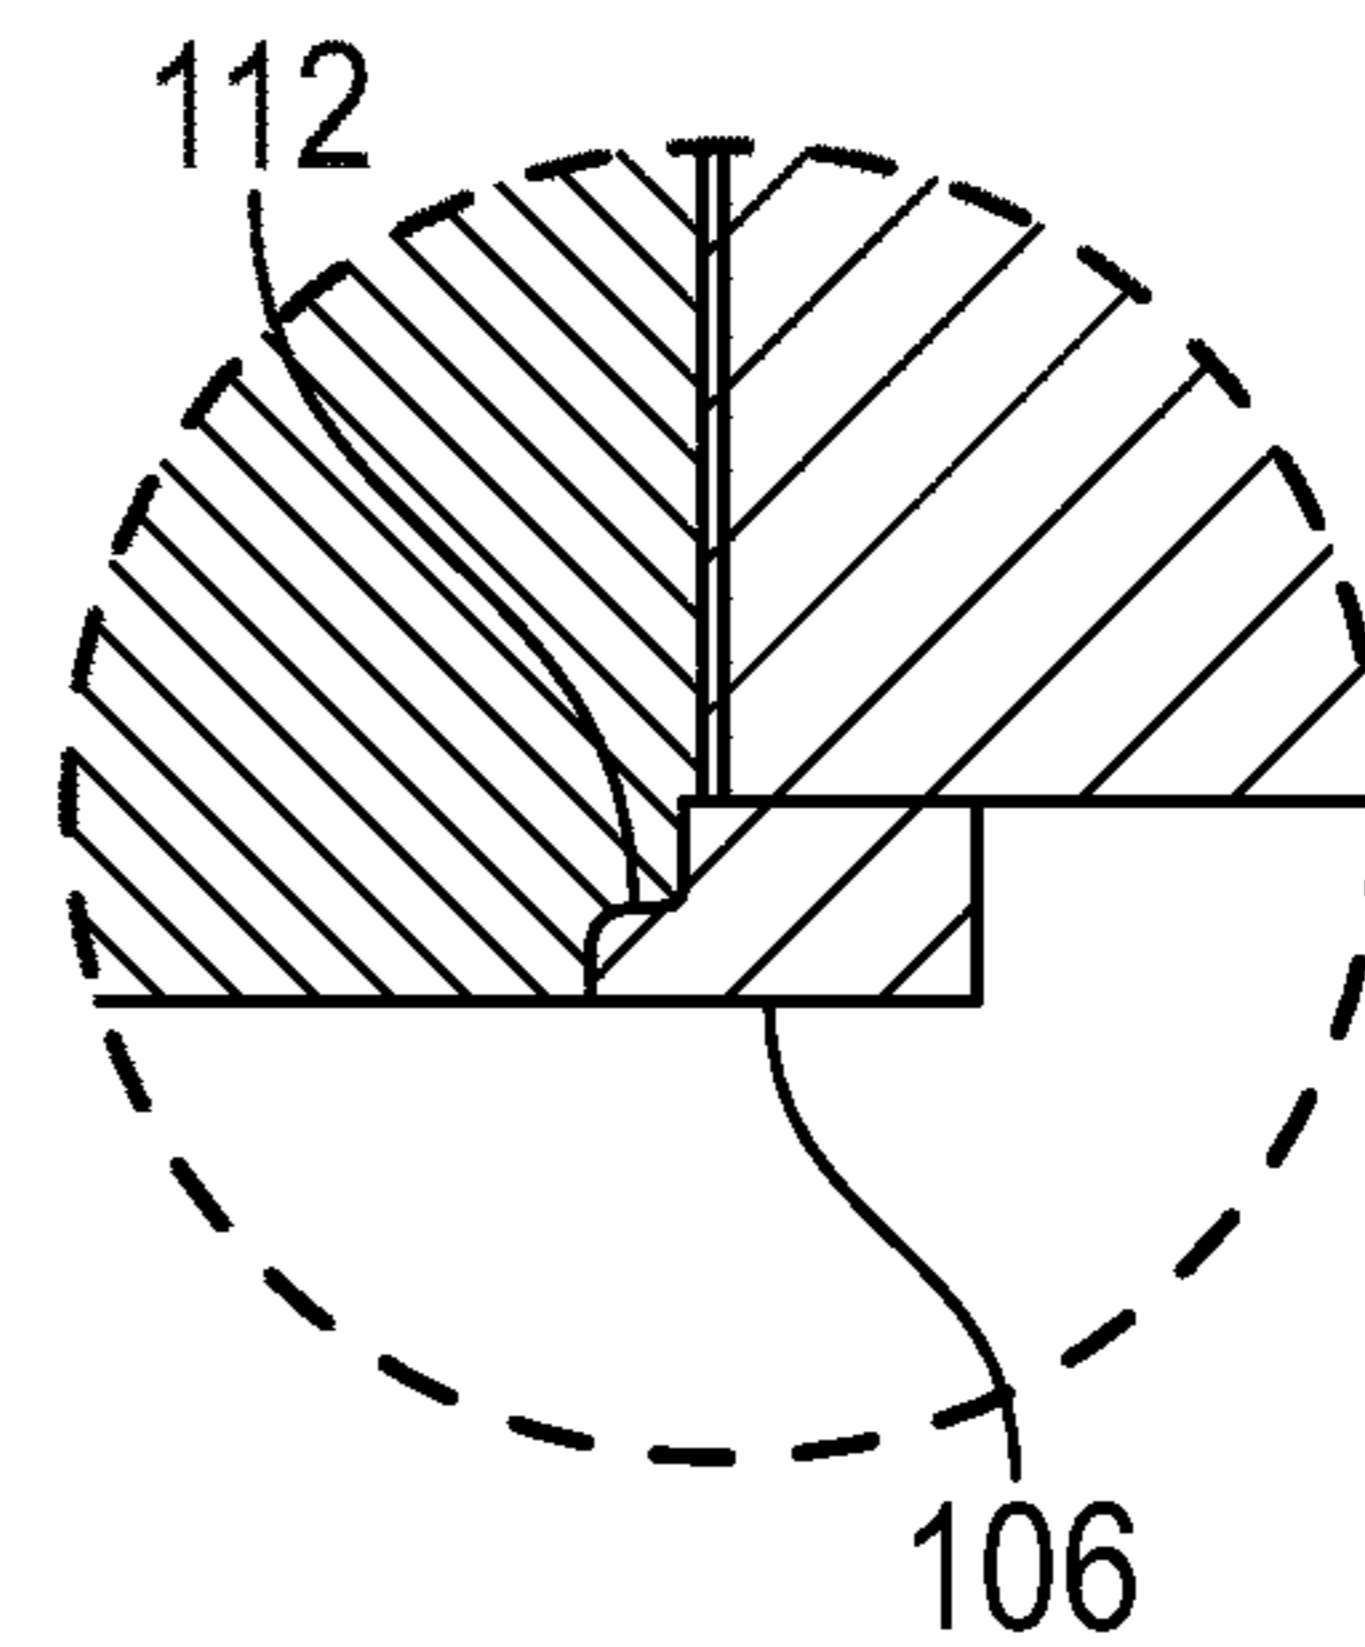
FIG. 3C  
(Prior Art)

vertical post 105 is provided with a rim support ledge 106 machined in the base of the vertical post. FIG. 3C shows a close-up view of a rim support ledge 106 machined in the base of the vertical post 105. In general, the rim 108 is supported on the rim support ledges 106, and is mounted on the spider arms 104 by a friction fit.

A common problem that occurs in the operation of the electric generator 40 is that wear occurs at the rim support ledge 106 generally due to friction between the rim 108 and the rim support ledge 106. Because of different operational forces and other factors, the rim 108 may move with respect to the rim support ledge 106, which can ultimately lead to damage, such as the fracture 112 of the rim support ledge 106 illustrated in FIG. 3C.

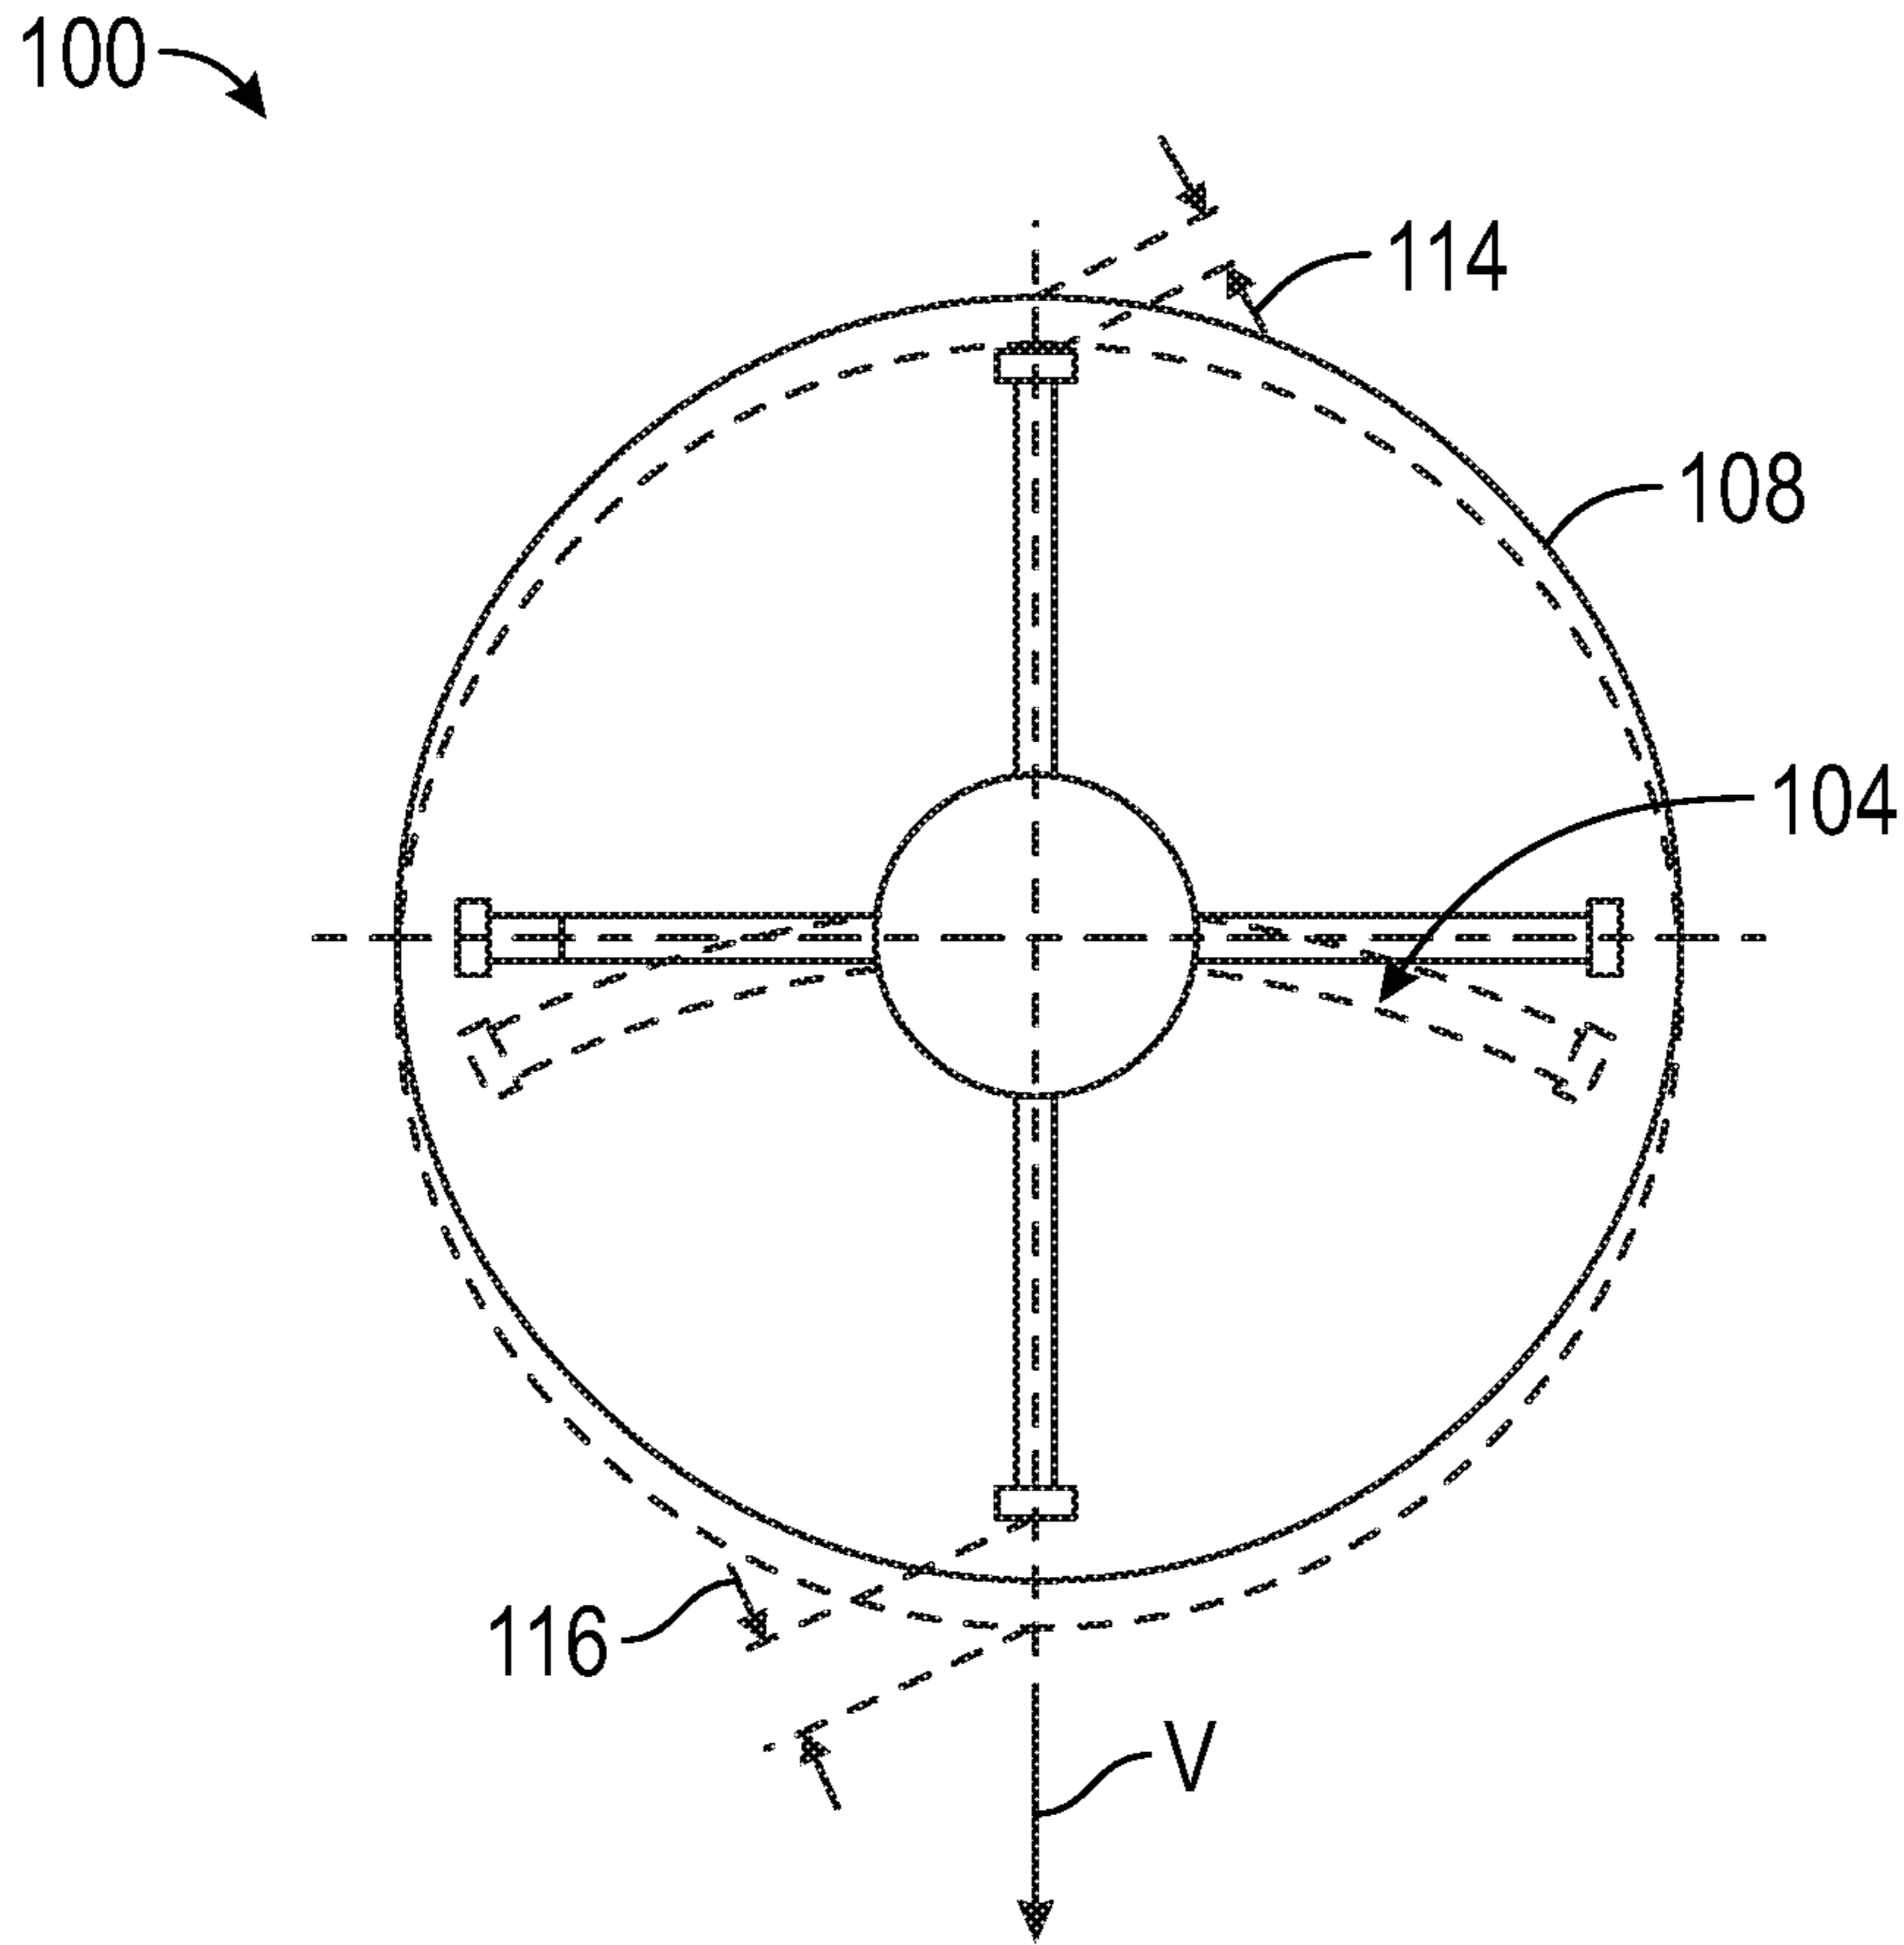
**FIG. 4**  
**(Prior Art)**

An unbalanced magnetic pole vector V on the rotor 100 is shown in FIG. 4. The clearance 114 at the top of FIG. 4 is shown as the clearance with the rim 108 concentric. The eccentricity 116 at the bottom of FIG. 4 is shown as clearance with the rim 108 eccentric. The magnetic forces distort the rim 108 during operation whereby, because of the rim's construction in layers, fretting or other wear occurs which ultimately leads to the failure of some part of the rotor structure which then must be repaired. The lateral flexibility of the spider arms 104 plus the loss of frictional interference between the rim 108 and the spider arms 104 permits the rim 108 to slide on the ledges 106 at each start, and also once per revolution, when exposed to an unbalanced magnetic pole. It is very difficult if not impossible to build a hydrogenerator which does not have an unbalance magnetic pole. Even the slightest unbalance will cause the components of the rotor to move with respect to one another and cause fretting if not other wear on the rotor.

FIG. 4 shows an unbalanced magnetic pole vector on a rotor;

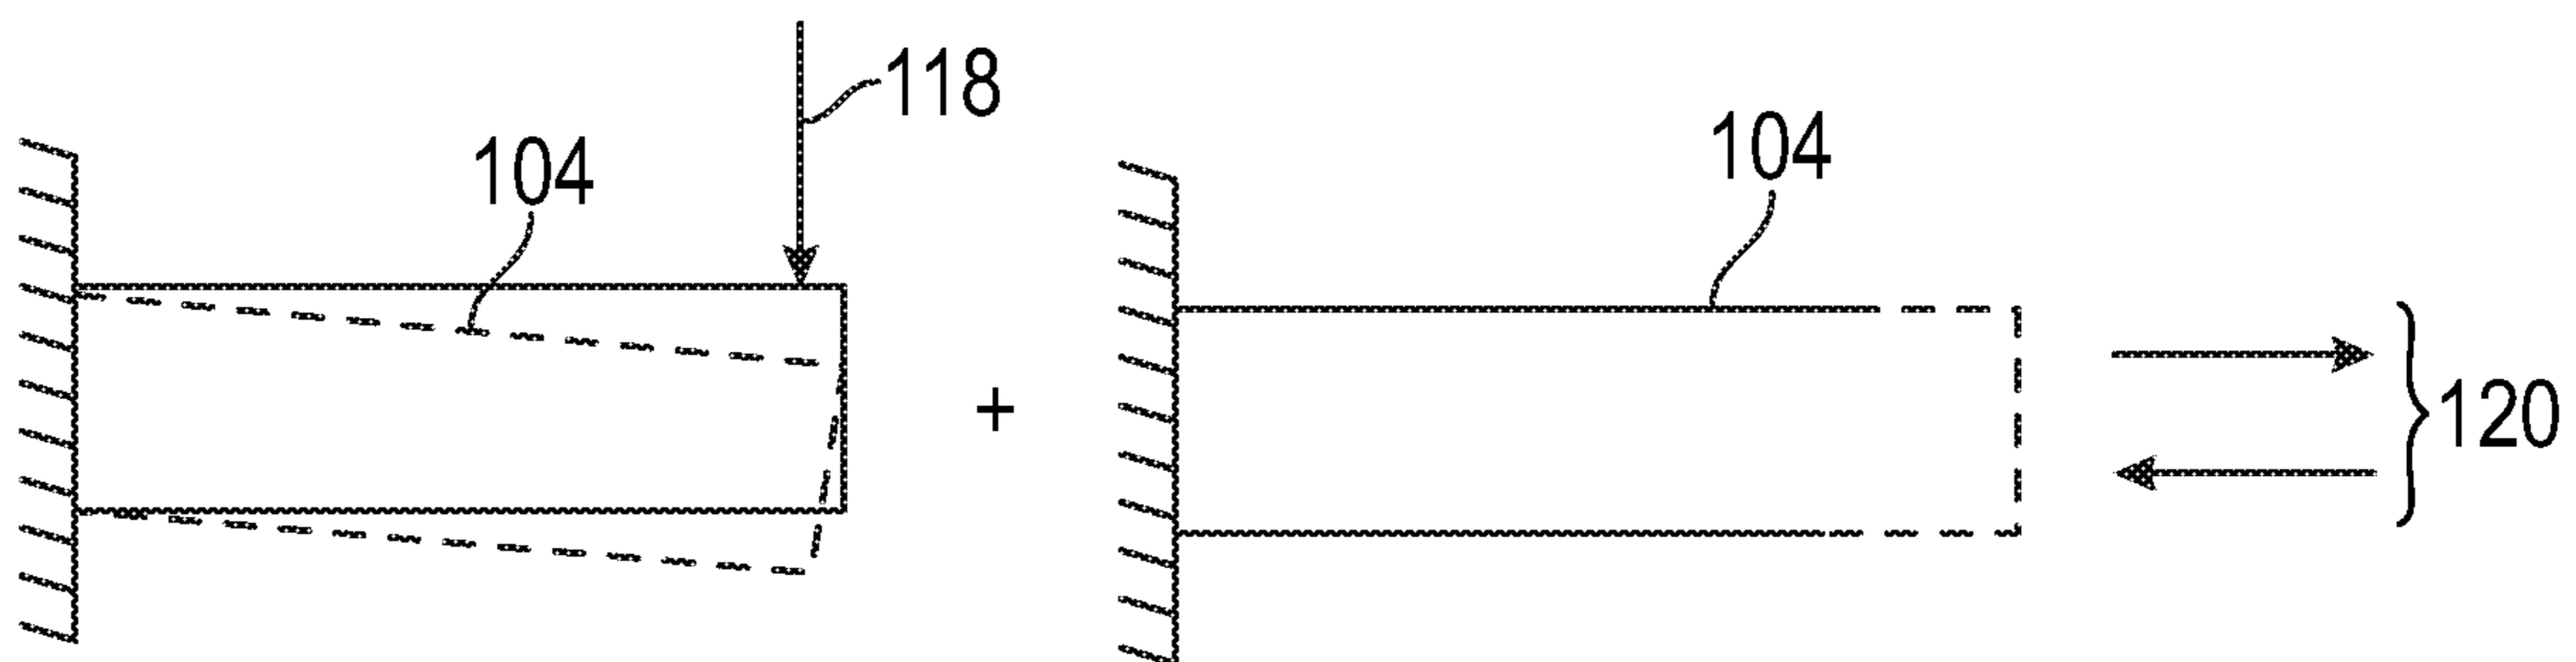
**FIG. 5A**  
**(Prior Art)**

FIG. 5A shows the force 118 of the dead weight of the rim 108 and the poles 110 pulling down on the spider arms 104. FIG. 5B shows the traction (friction) force 120 from sliding, which forces combine to cause wear during operation. The dead weight of the rim 108 and the poles 110 will act upon components of the hydroelectric generator 70. At each start and stop of the hydroelectric generator 70 there will be a centrifugal force on the generator rim 108, thereby causing the components thereof to move with respect to one another. The movement of the components with respect to one another will cause or contribute in causing the fretting or other damage to the components of the rotor 100, which will accelerate damage and the appearance of cracks in the structure of the rotor 100.

FIG. 5A shows the dead weight of the rim and the poles of a rotor, and FIG. 5B shows the traction (friction) force from sliding.
