(10) **Patent No.:** **US 11,870,310 B2**  
(45) **Date of Patent:** **Jan. 9, 2024**

(54) **METHOD OF REPAIRING A HYDROGENERATOR**

(71) Applicant: **Electromechanical Engineering Associates, Inc.**, Monroeville, PA (US)

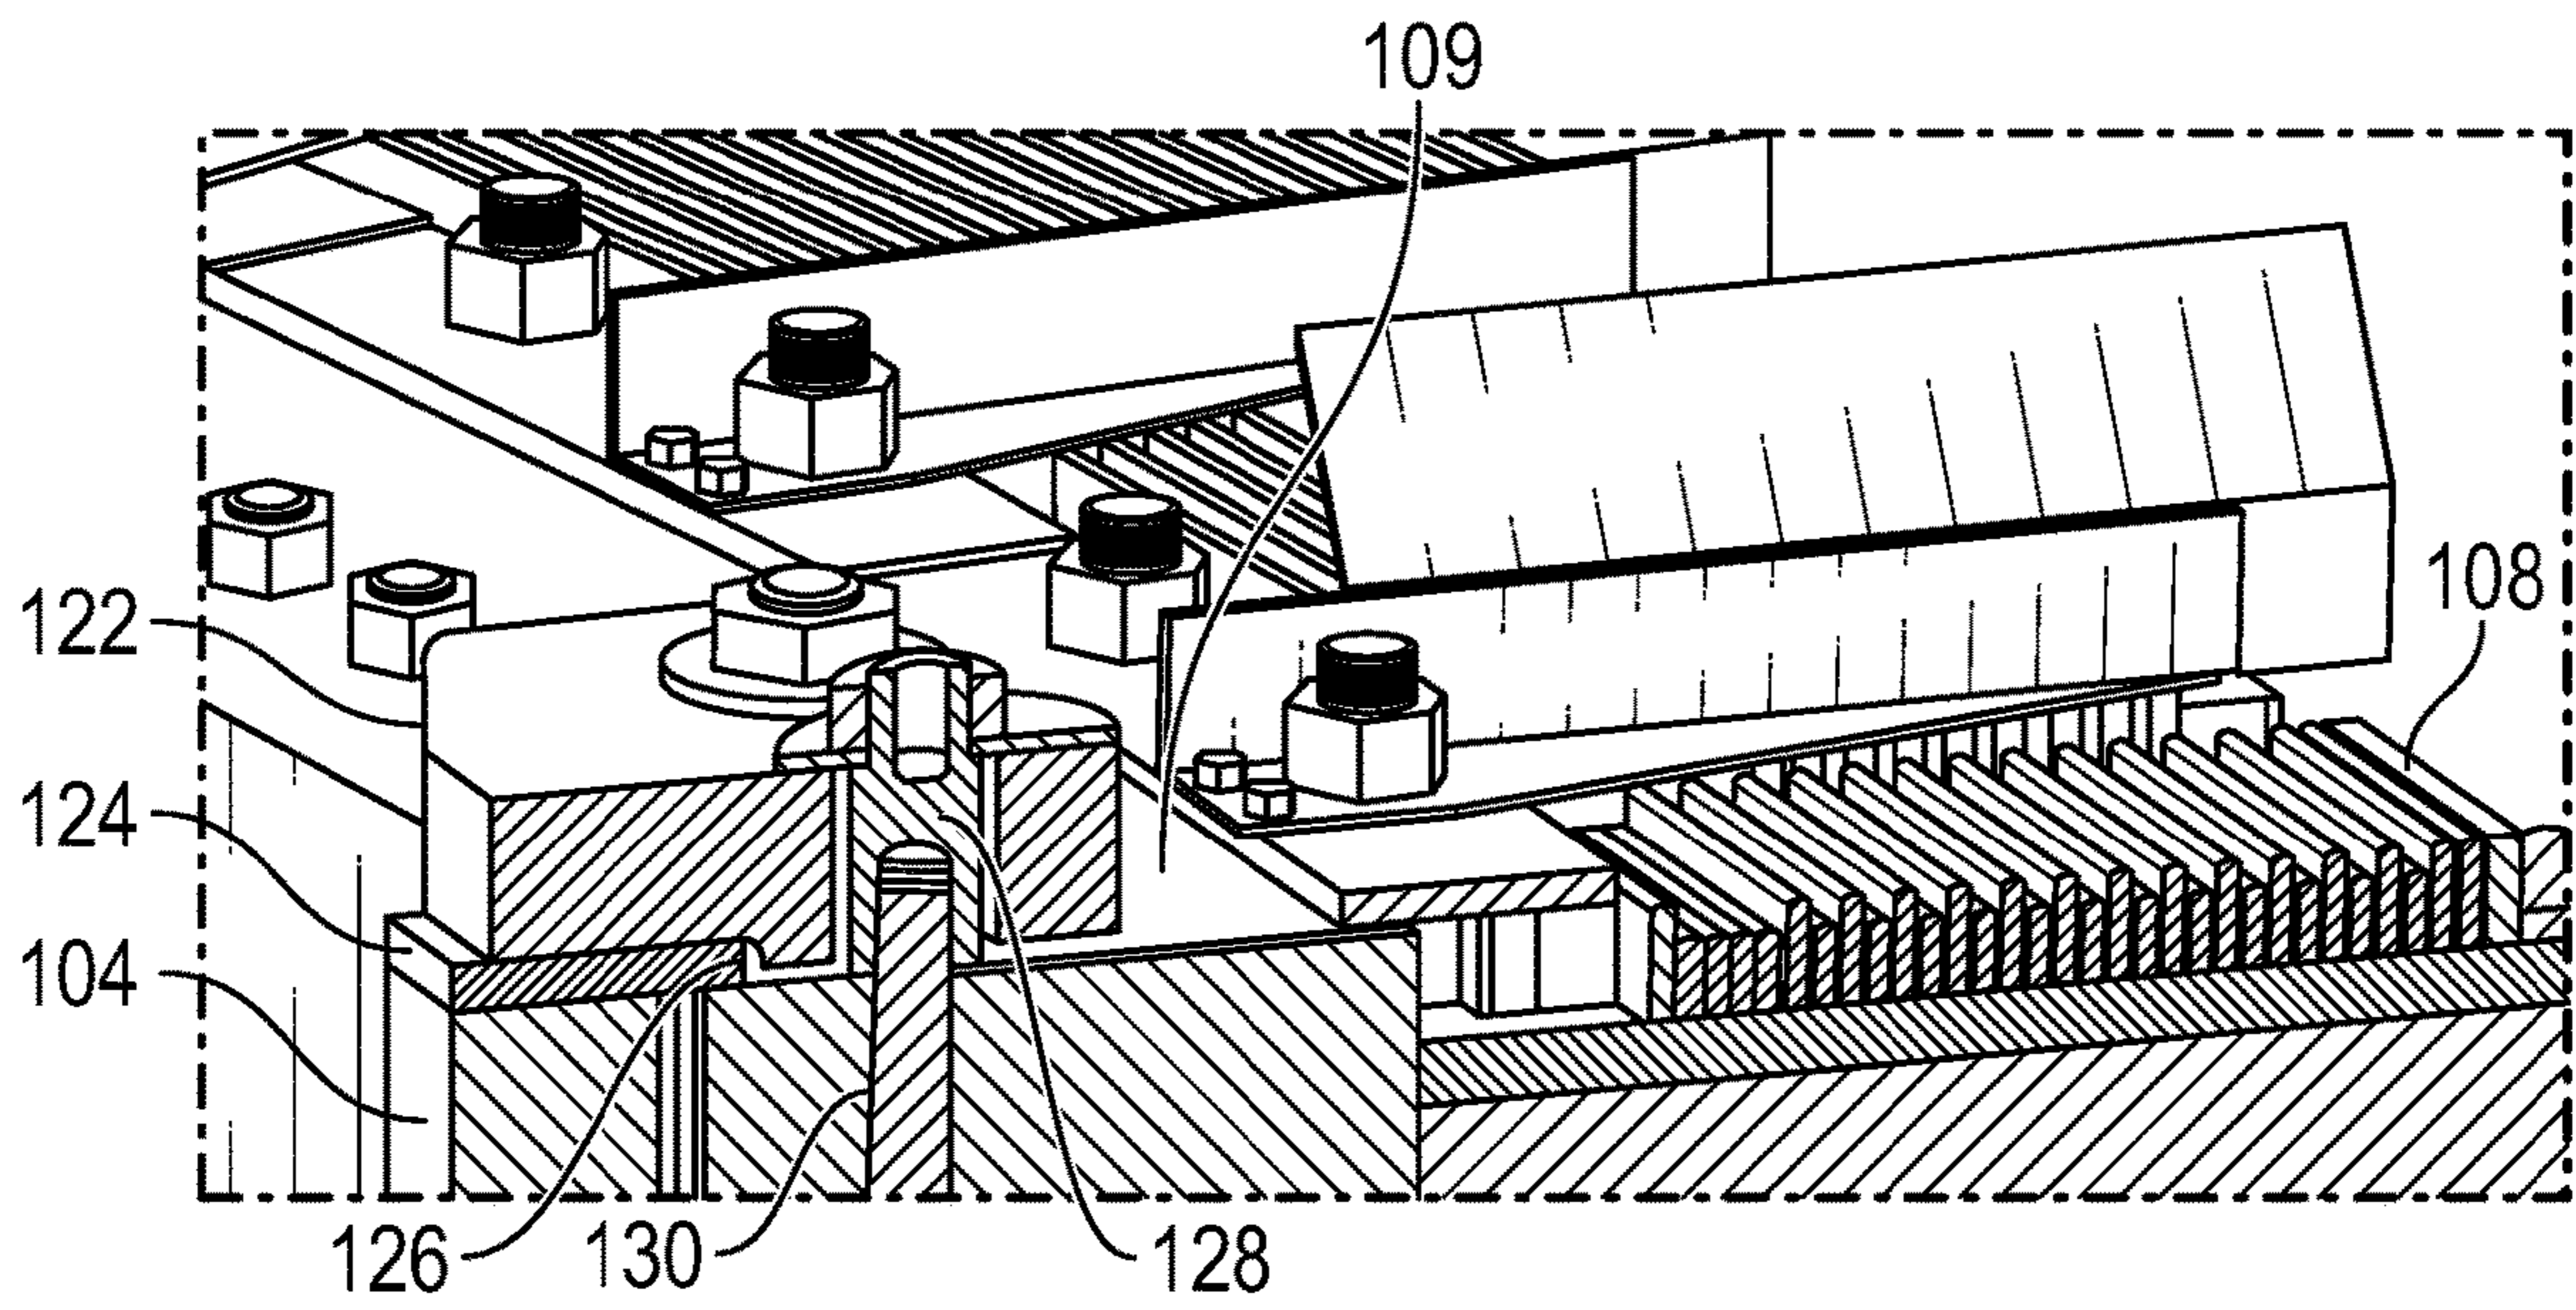
FIG. 6 shows a thrust plate assembly having a thrust plate **122** used in an embodiment of the disclosed method for repairing the electric generator **40** shown in FIGS. 3A and 3C as having a fractured rim support ledge **106**.

In general, in this embodiment a plurality of thrust plates **122** are located one at each of a corresponding spider arm **104**. The thrust plates **122** support the rim **108** from above on the spider arms **104**. In other words, instead of the weight of the rim **108** resting solely on the rim support ledges **106**, which one or more rim support ledges **106** are cracked or completely broken off, the weight of the rim **108** is supported by the thrust plates **122**, such that the rim **108** is, in a sense, hanging from the thrust plates **122**. The thrust plate **122** is spaced apart from the rim **108** itself.

In the illustrated embodiment a wear plate or sacrificial plate **124** is located in a recessed or stepped or shoulder portion **126** of the thrust plate **122** between the thrust plate **122** and the spider arm **104**. A portion of the wear plate **124** may or may not extend so as to be in contact with the top of the rim **108**. The spacing of the thrust plate **122** a distance from the rim **108** prevents frictional contact between the thrust plate **122** and the rim **108**, and thus prevents wear. Instead, the wear plate **124**, which is lubricated with a solid lubricant, experiences friction and wear.

As the wear plate **124** wears down, a sleeve bolt **128** can be tightened periodically to tighten the connection of the thrust plate **122**. In this manner, the life of the rotor **100** can be extended without extensive repairs or replacement.

FIGS. 6 and 7 show an embodiment of a thrust plate assembly for a hydrogenerator in place on the rotor shown in FIG. 3; and

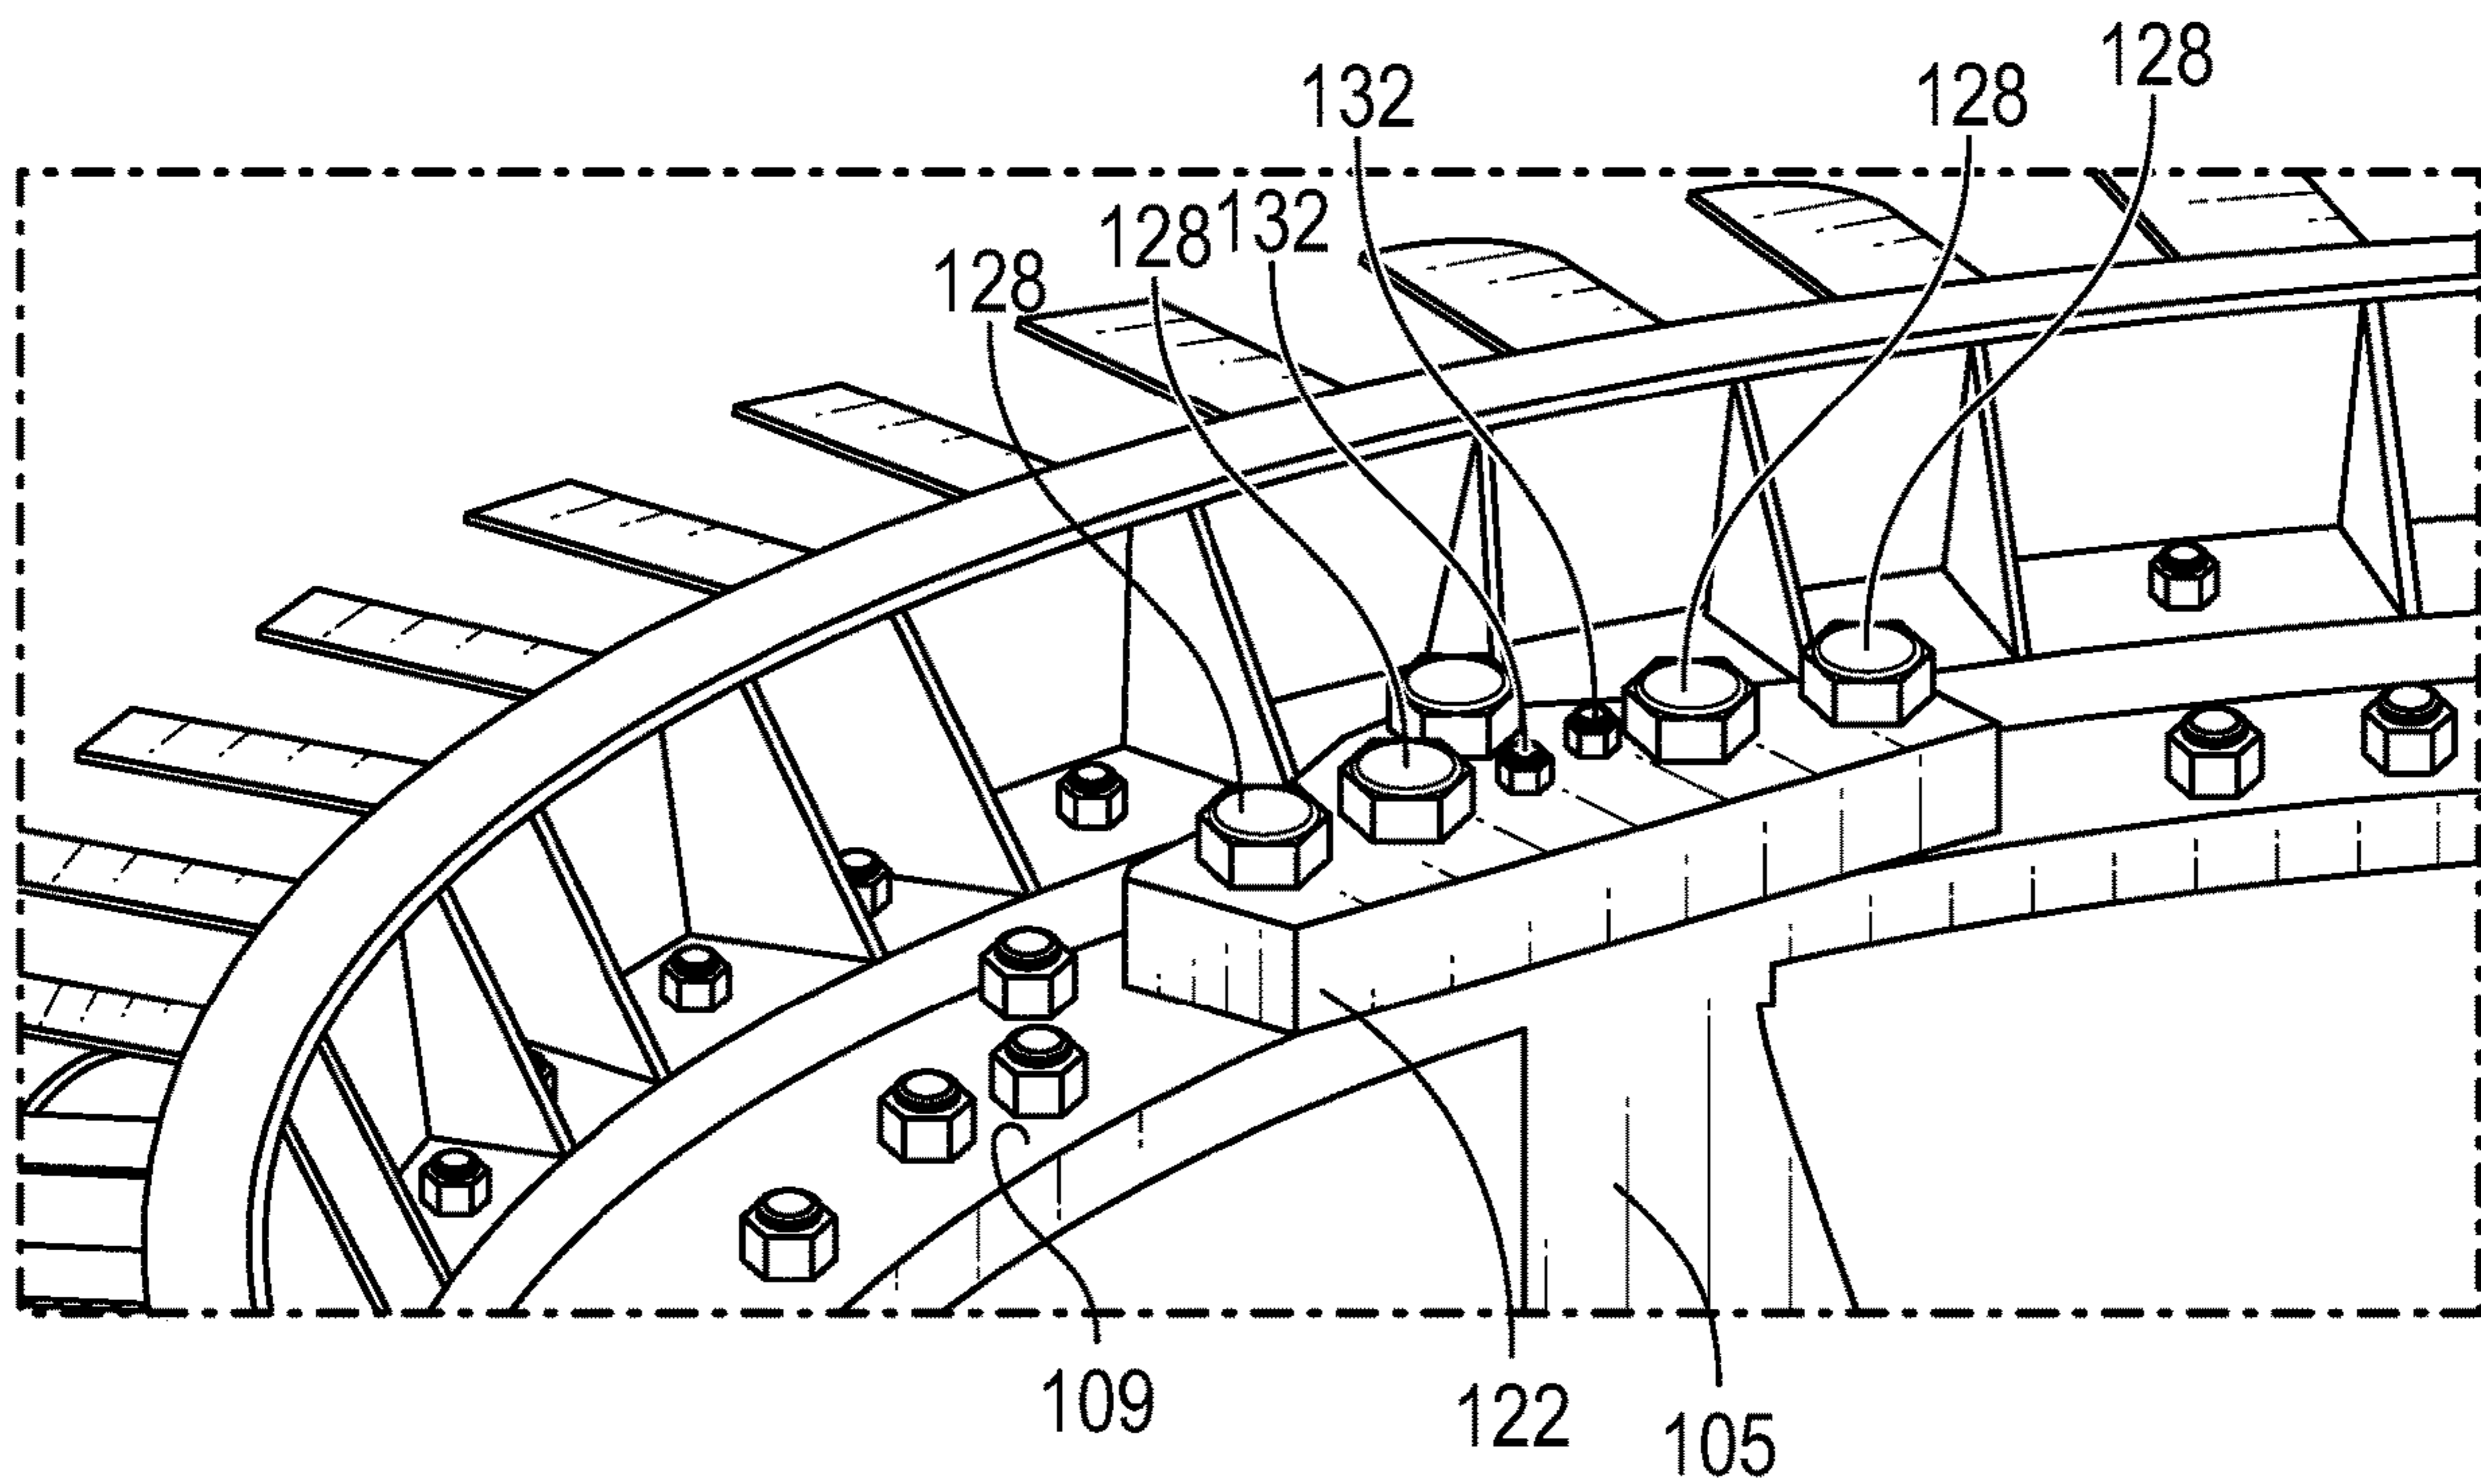
FIG. 7 illustrates mounting of a thrust plate **122** on the rim **108** adjacent to a spider arm vertical post **105**, and FIG. 8 illustrates the fasteners fastening the thrust plate **122** on the rim top plate **109**. The thrust plates **122** can be 3" (three inch) thick machined plates manufactured from ASTM A829 SAE **4140** with a minimum yield strength of 70 ksi, and a UTS not less than 118 ksi and a40% reduction in area. This provides strength while providing ductility and toughness for fatigue resistance. Each thrust plate **122** is affixed to the rim **108** with five sleeve bolts **128** that thread to the rim clamping studs **130** (see FIG. 6), and two 1.25" (one-and-one-quarter inch) alloy socket head cap screws **132**.

The sleeve bolts **128** are modeled for stress analysis as though a 2.75" (two- and three-quarters inch) Hex bolt with a suitable length of unthreaded shank were cut off, bored and tapped with 1.75"-5 UNC inside threads. The minimum tensile area of this configuration is slightly greater than that of the original stud. The sleeve bolts **128** are made from commercial Grade 5 bolts, and thus will be at least as strong as the rim studs **130**. The length below the heads will be 3" (three inches); then with the washers under the head, contact of the bottom of the shank with the rim top plate **109** will be avoided.

The two 1.25" (one-and-one-quarter inch) socket head cap screws **132** are used to resist localized bending due to the weight of the rim **108**. The design specification calls for a maximum of 1/3rd (one-third) of the rim weight to be carried by an individual thrust plate **122**. This is slightly over 33 tons for the illustrated rim, and though obviously could not be carried by all of the thrust plates **122**, could conceivably be carried by some of them. The rim top plate **109** must be drilled and tapped for the Helicoil thread insert corresponding to this thread.
