US011967056B2

(54) **SYSTEMS, METHODS AND APPARATUSES FOR DETECTING AND ANALYZING DEFECTS IN UNDERGROUND INFRASTRUCTURE SYSTEMS**

(71) Applicant: **INFRASTRUCTURE DL, LLC**,  
Dousman, WI (US)

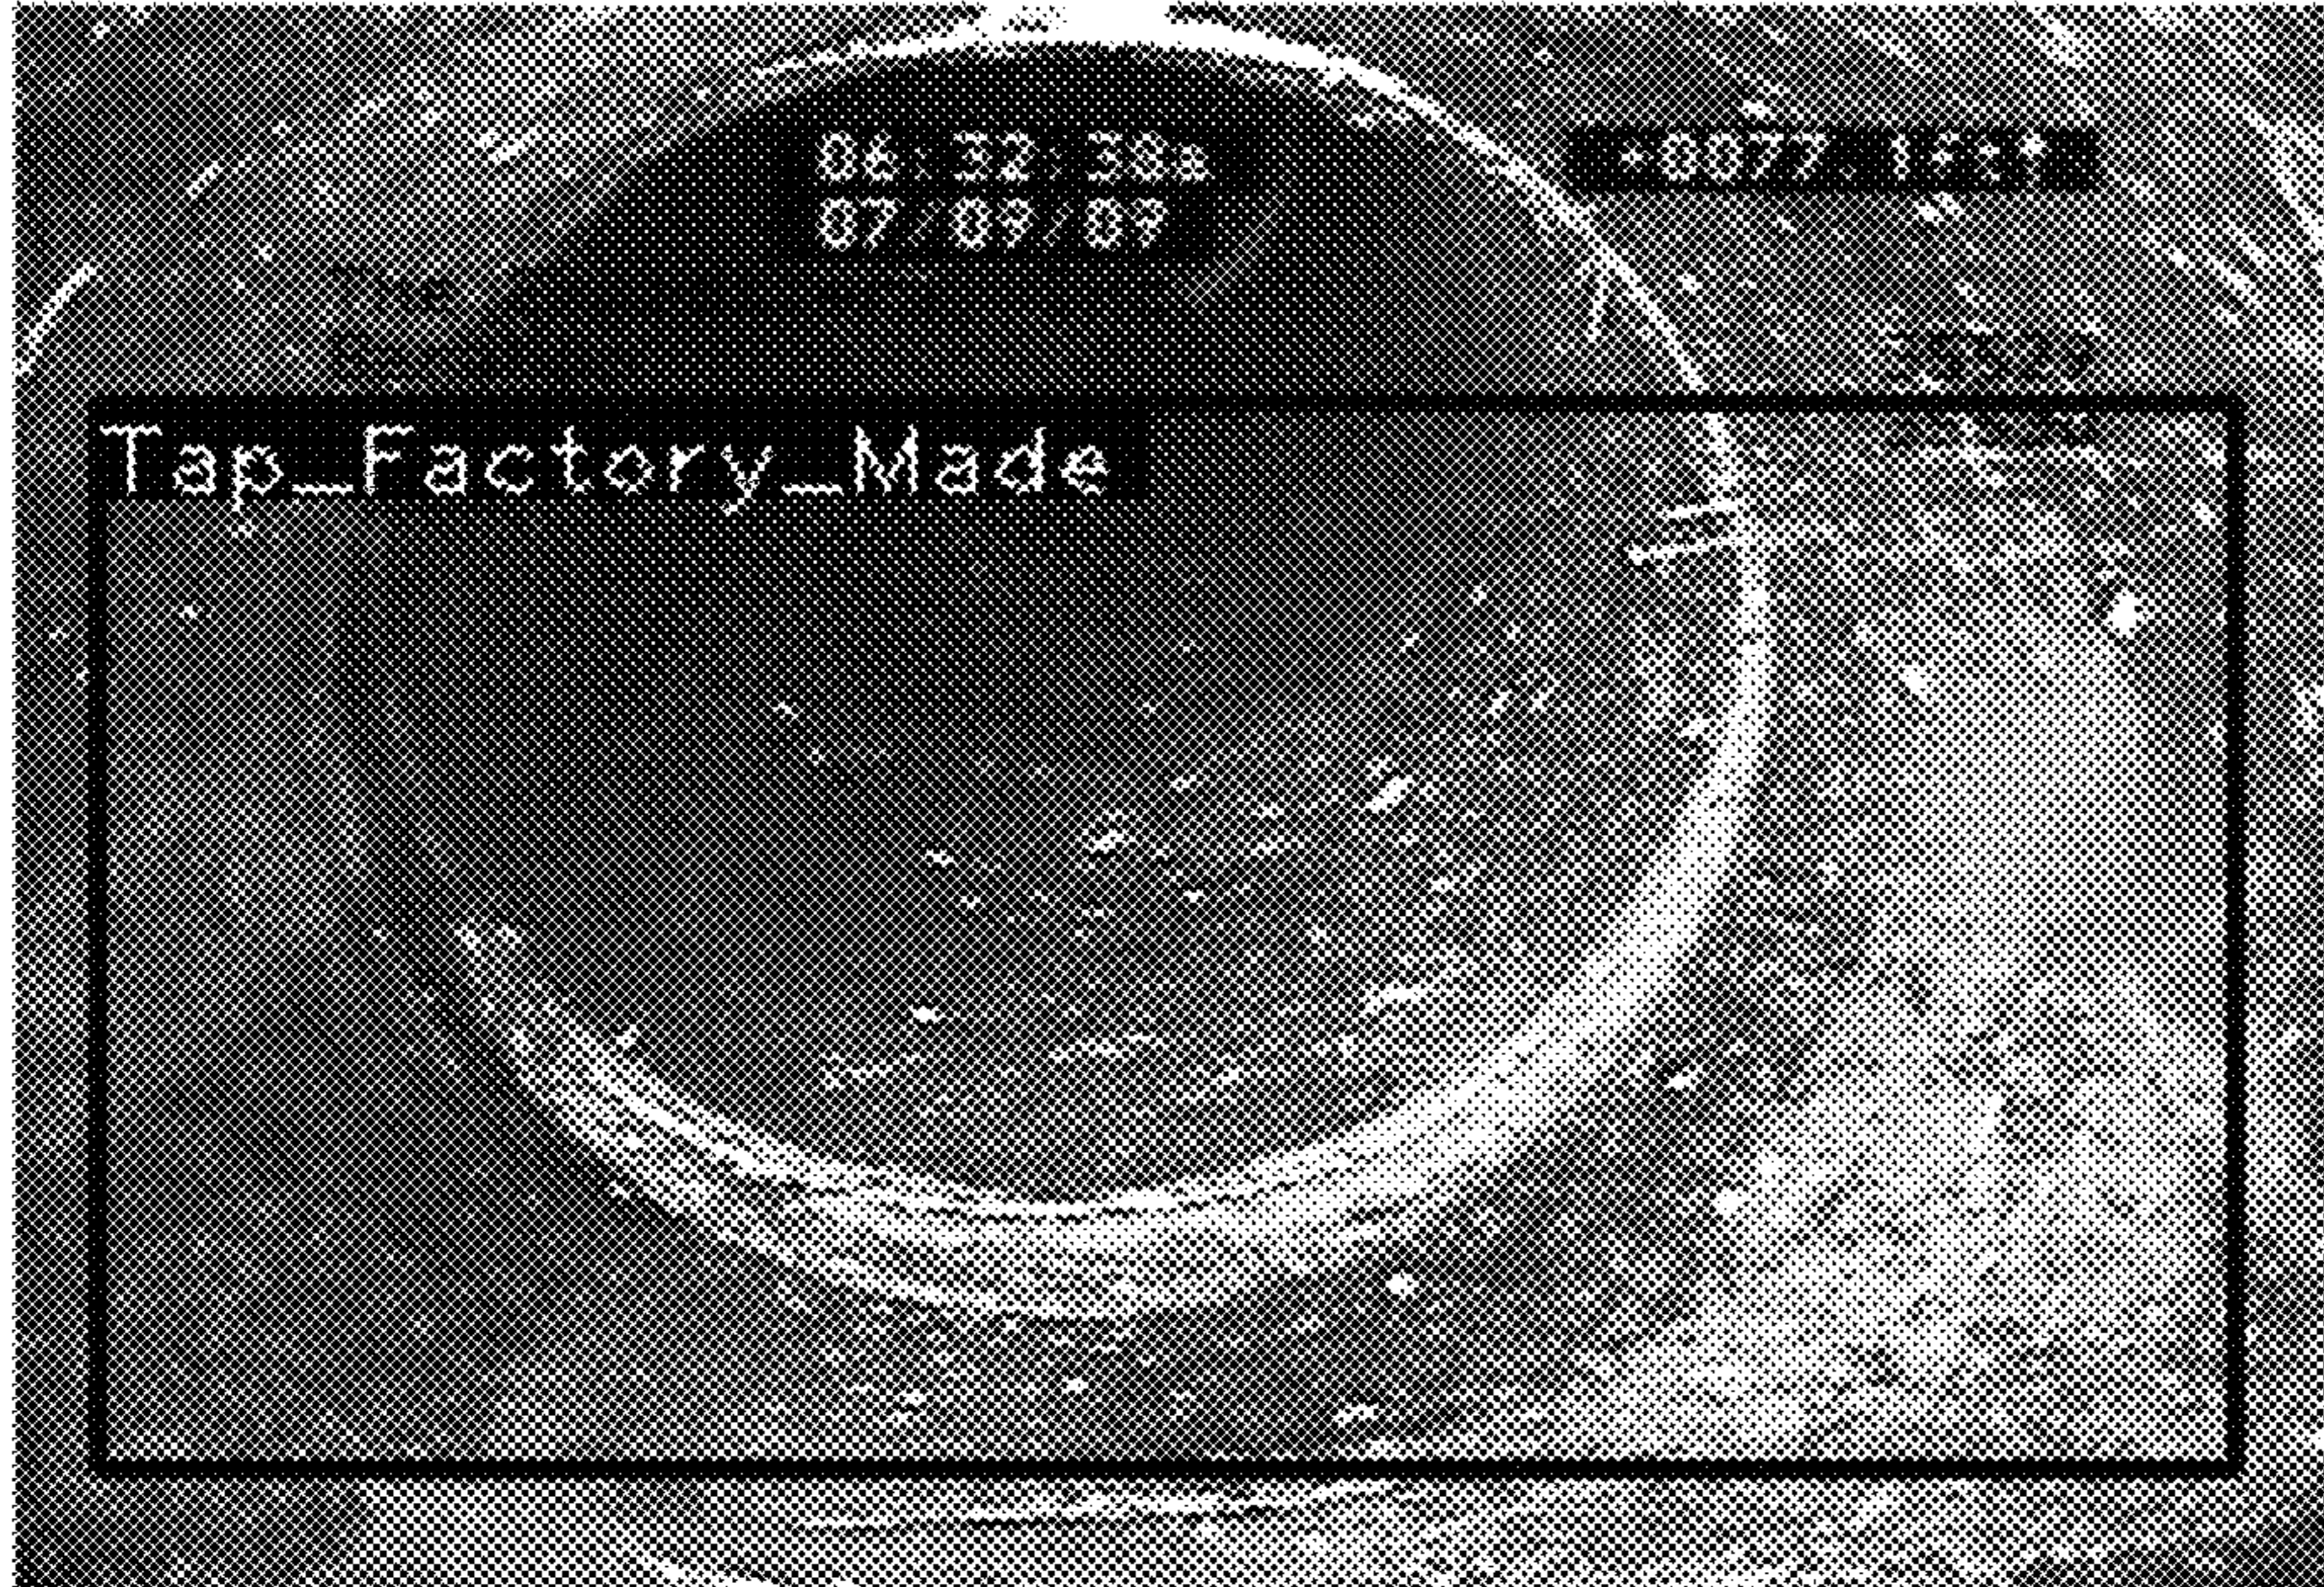
*Fig. 2*

FIG. 2 provides a camera view of a sewer pipe with a defect shown.

For example FIGS. 2-5 show various defects and bounding boxes within a sewer pipe taken from a video of the sewer pipe. FIG. 2 shows a frame and a bounding box of a sewer pipe having a factory made tap, for example a preformed pipe fitting built into the sewer during construction. Depending on the person reviewing the video, the tap may be viewed as a different type of defect, e.g. a break-in, and may be analyzed or assessed compared to a second person reviewing the video. The present invention provides a proper labeling and assessment of the area as a factory made tap, regardless of the person reviewing the video and removes potential mislabeling of the area or defect.

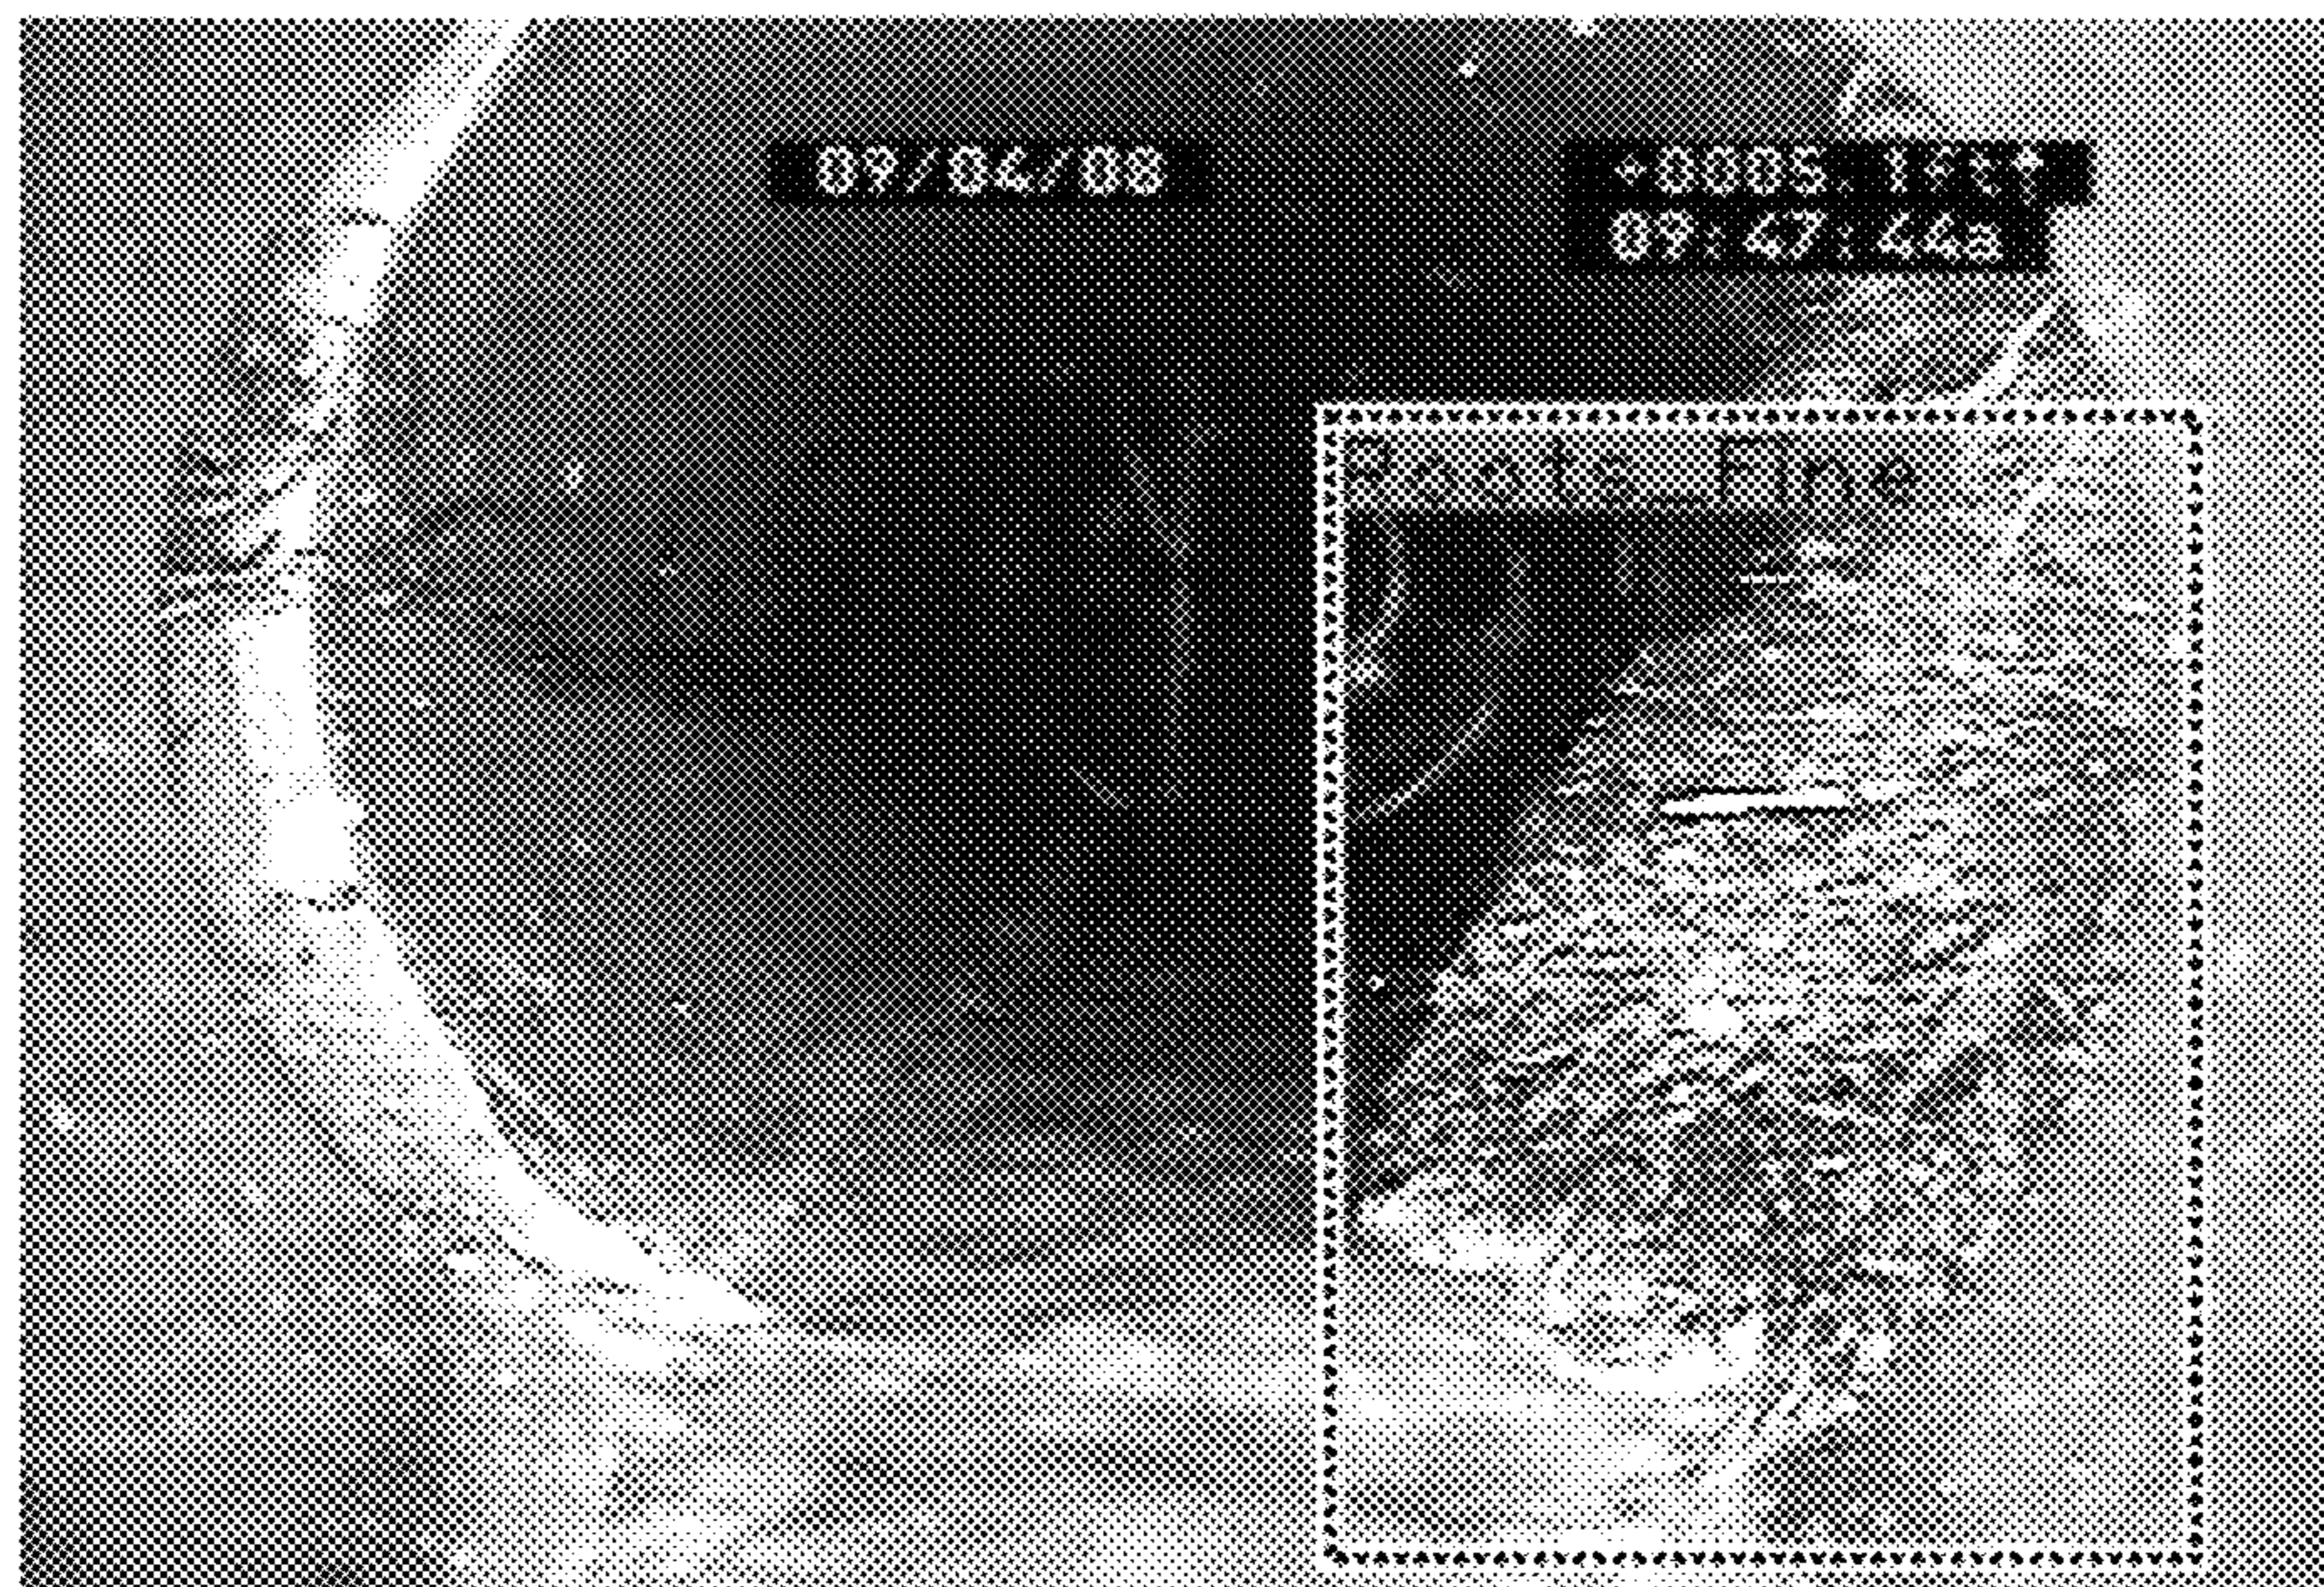
*Fig. 3*

FIG. 3 provides a camera view of a sewer pipe with a further defect shown.

Similarly, FIGS. 3-6 show roots encroaching within the sewer pipe. As noted from the captured bounding boxes, the defects range from root encroachment on the lower range of concern (fine) (FIGS. 3 and 4) to root encroachment of high concern (heavy ball of roots) (FIG. 6) and root encroachment of a level of concern in between (medium) (FIG. 5).

As discussed, personal observations may provide a different analysis than noted in the Figures. FIG. 3 may be perceived as being a more severe root encroachment than FIG. 5 from what is shown in the frame. The reviewer may incorrectly label FIG. 5 as "fine" and FIG. 3 as "medium". The review potentially would not have taken into account the potential length and overall area of the root encroachment may not be fully appreciated from the observation. The present invention addresses such omissions and incorrect analysis, as the method and process take out such subjective reviews.

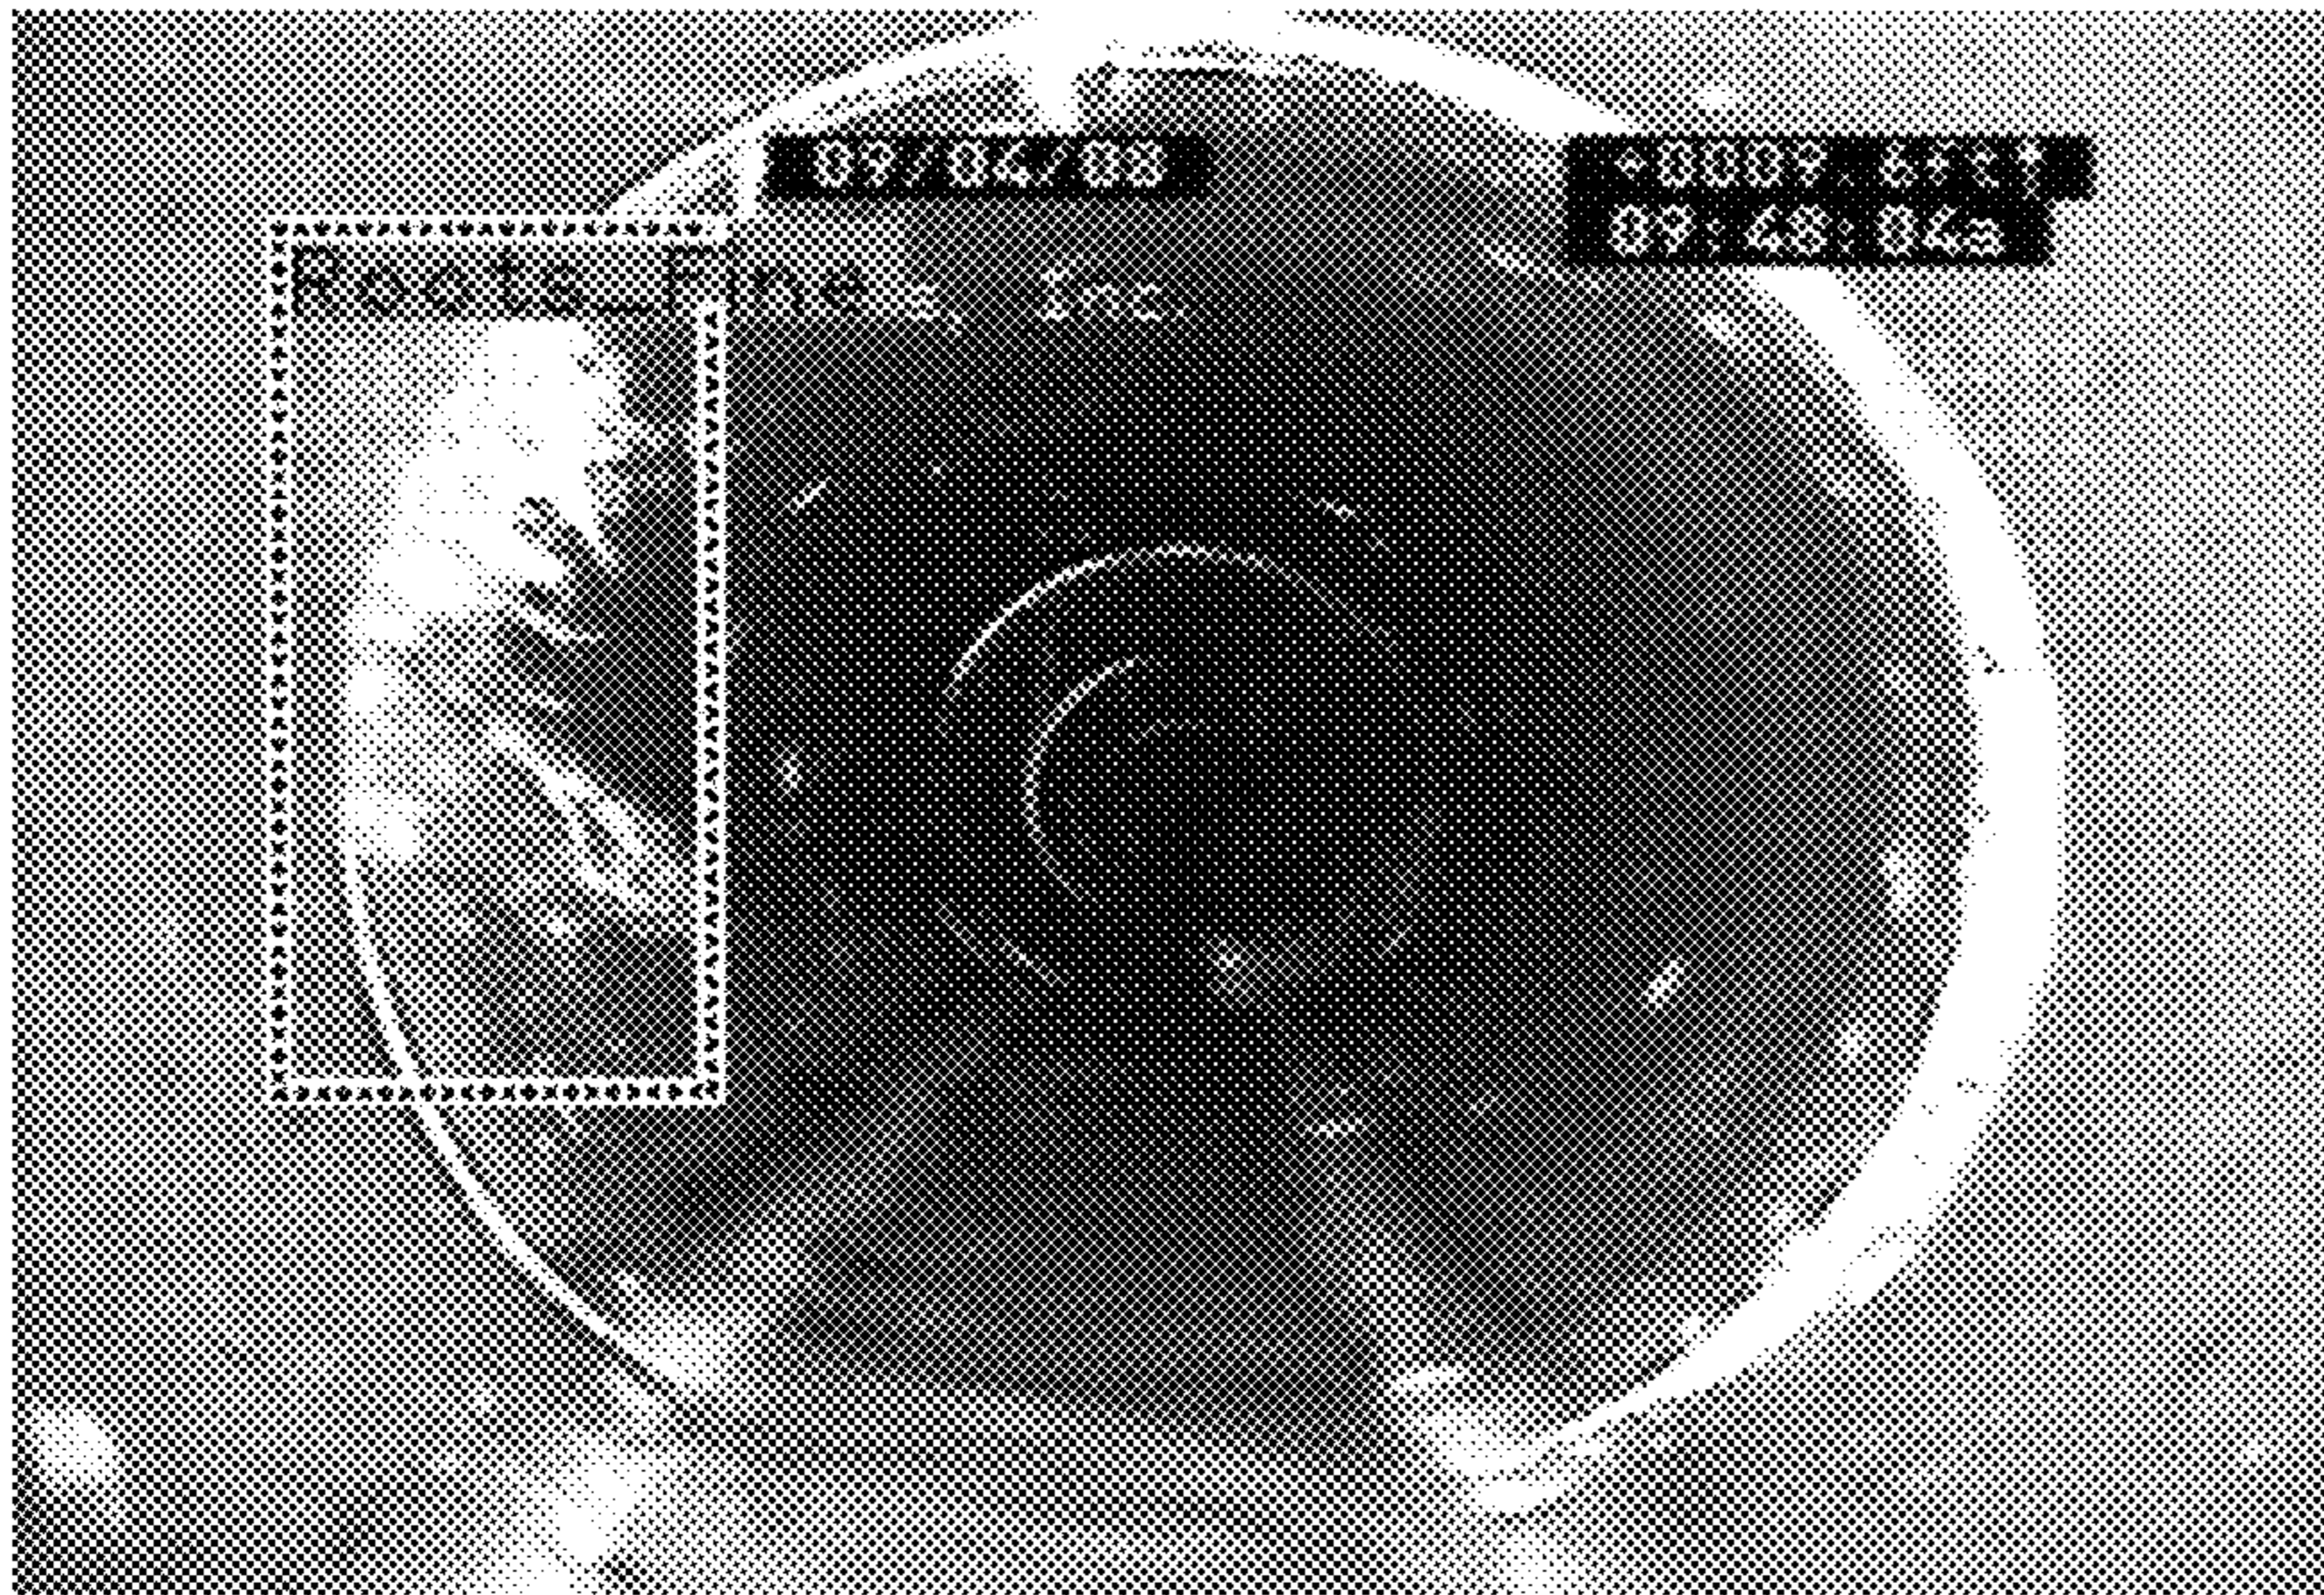
Fig. 4

FIG. 4 provides a camera view of a sewer pipe with another defect shown.

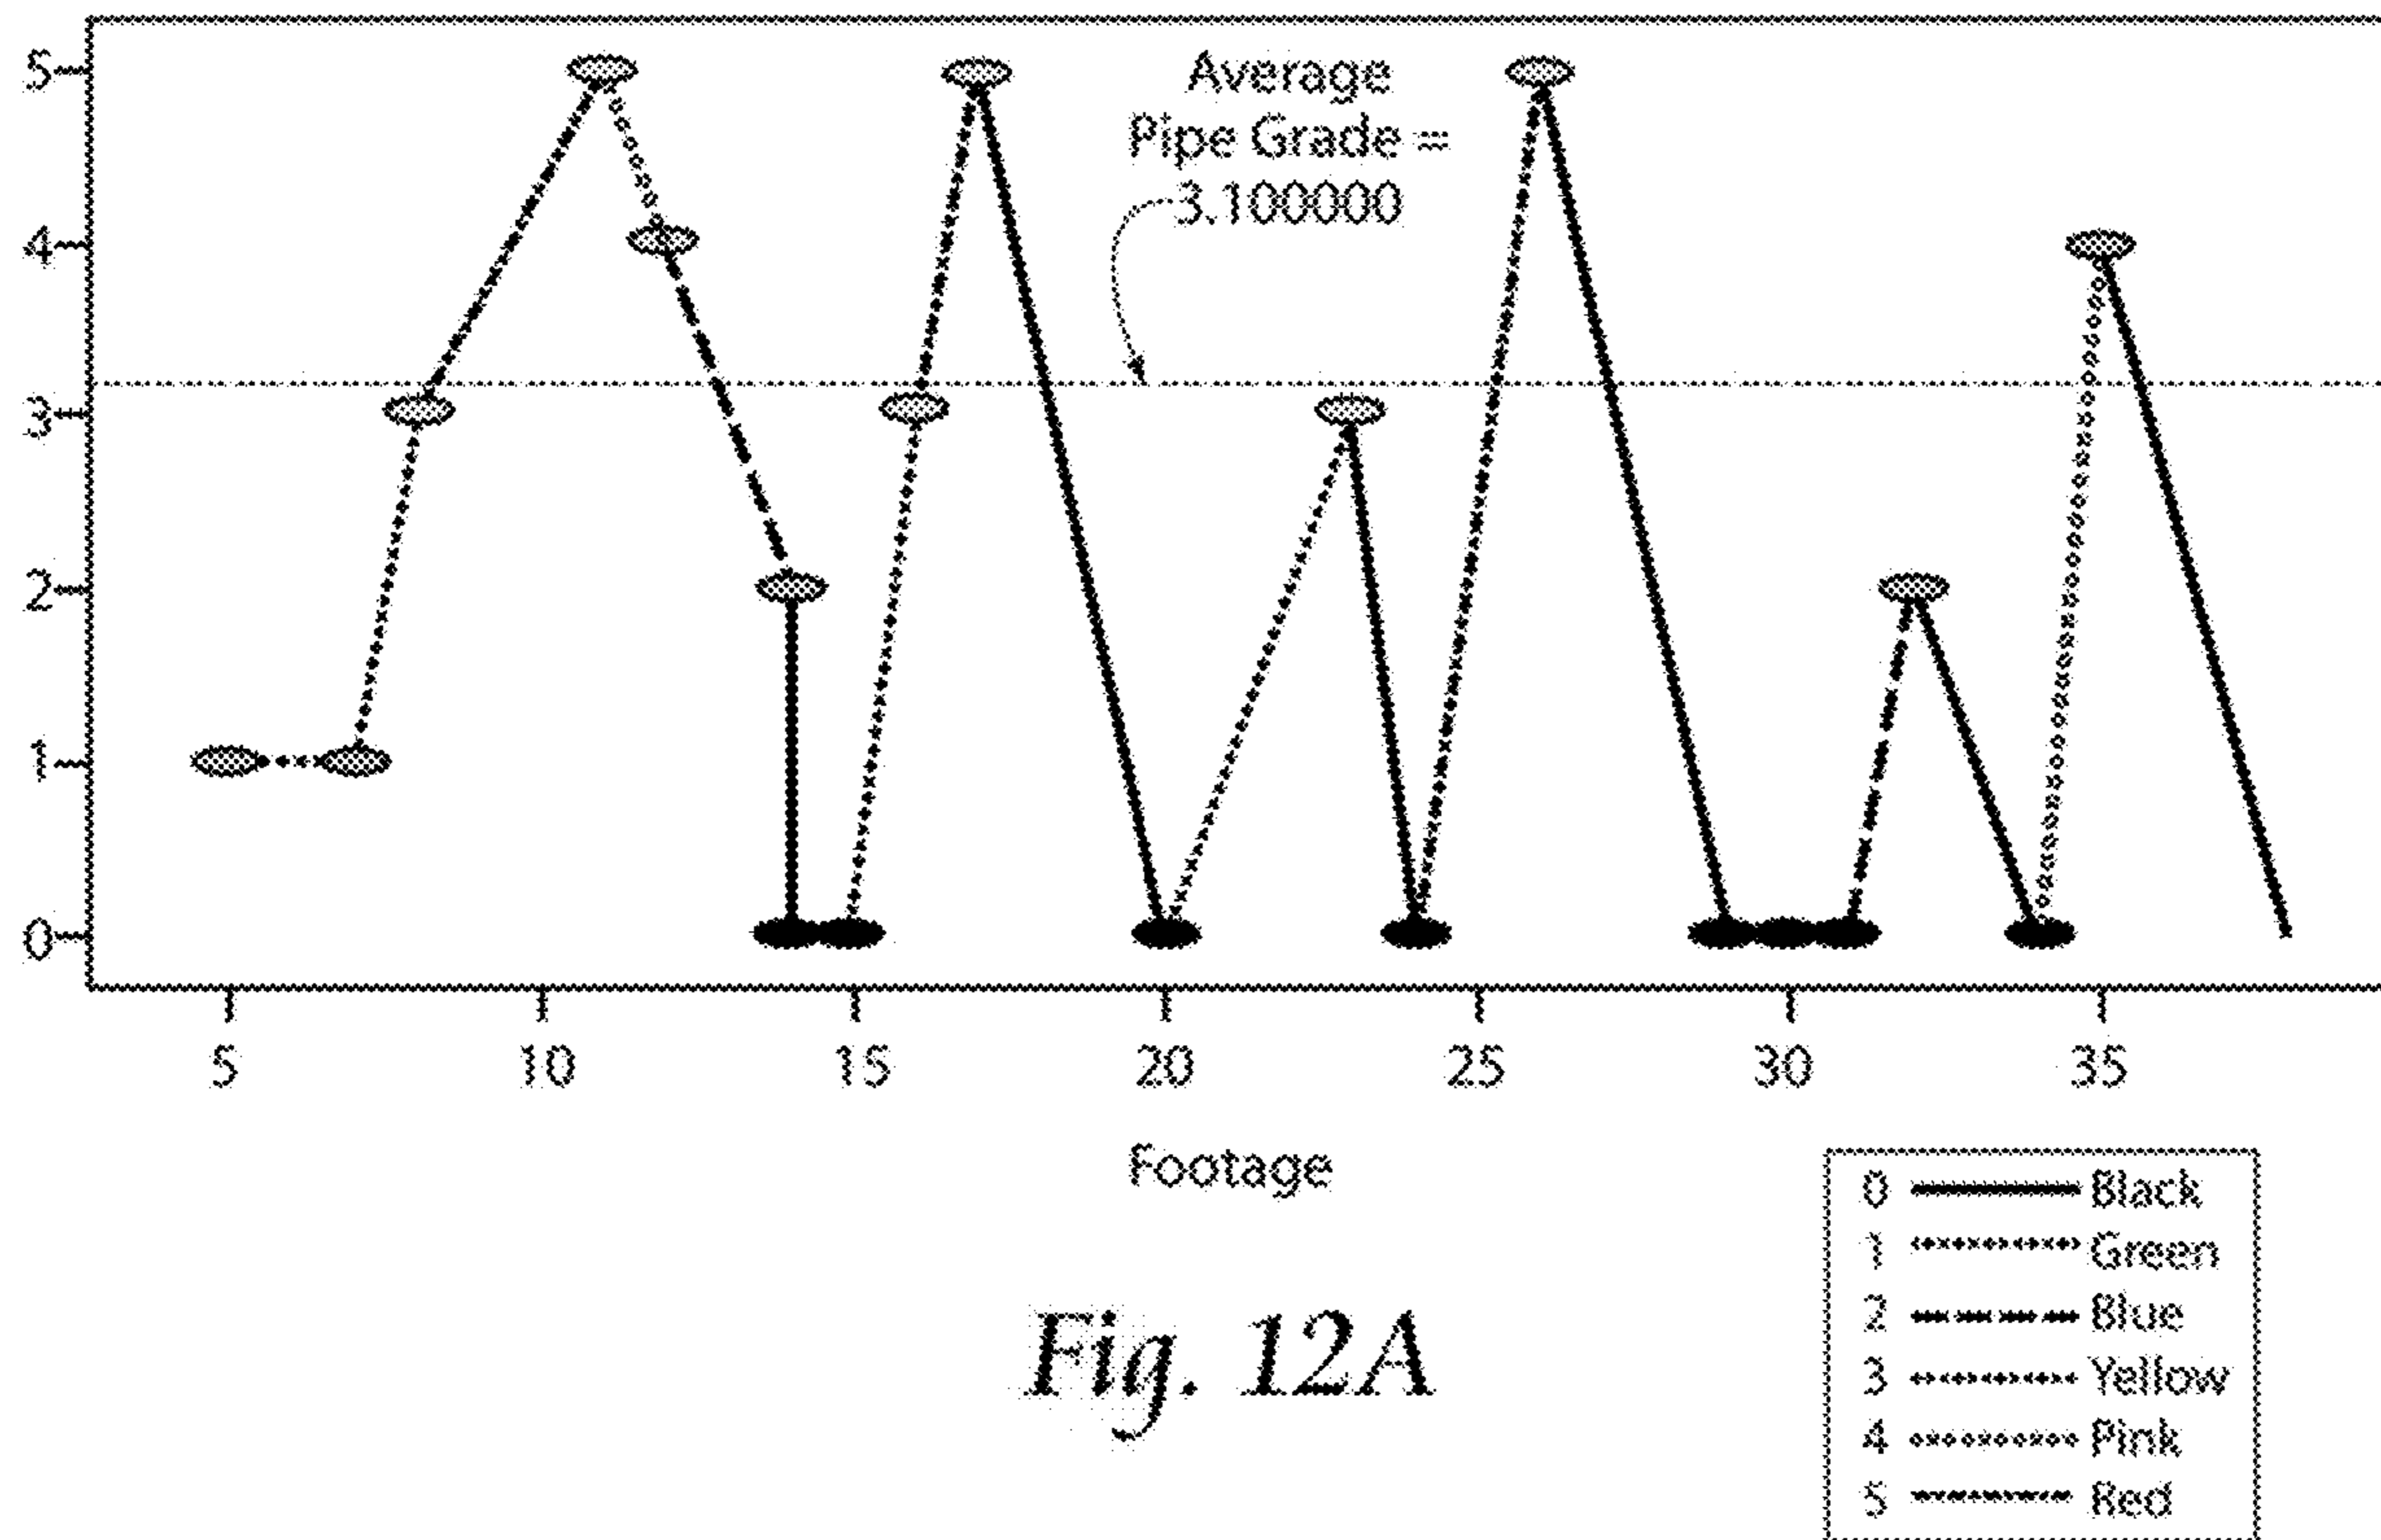
Fig. 12A

FIGS. 12A and 12B are graphs of the video footage analyzed in FIG. 11. The graph would likely accompany the spreadsheet in FIG. 11 and be used together with the spreadsheet. As noted above with respect to FIG. 10, the graphs and spreadsheets also give a rating from 0-5 for the severity of a defect, with a color code used as well (0=black, 1=green, 2=blue, 3=goldenrod (yellow), 4=magenta (pink), and 5=red). FIG. 12A plots the various defects noted in FIG. 11 with respect to the severity of the defect. For example, the plot point at five feet and a severity of 1 (green) corresponds to the first defect (roots fine) noted on the spreadsheet in FIG. 11. Likewise, the defect at eleven feet and severity of 5 (red) corresponds to a joint defect. FIG. 12A also graphs the overall average plot grade for the pipe (3.166, yellow). FIG. 12B correlated to the graph in FIG. 12A, showing where the laterals are located along the length of the sewer pipe. Together, the three Figures demonstrate provide an objective report that can be used in determining sewer pipe quality over time. When a future report is generated by the present invention for the same sewer pipe, the average pipe grade can be compared to determine how the grade has changed over time. An objective assessment is available, since there is a very high level of confidence that the comparison is an apples to apples comparison.
