(10) **Pub. No.: US 2003/0037436 A1**

(54) **METHOD FOR REPAIRING AN APERTURED GAS TURBINE COMPONENT**

METHOD FOR REPAIRING AN APERTURED GAS TURBINE COMPONENT

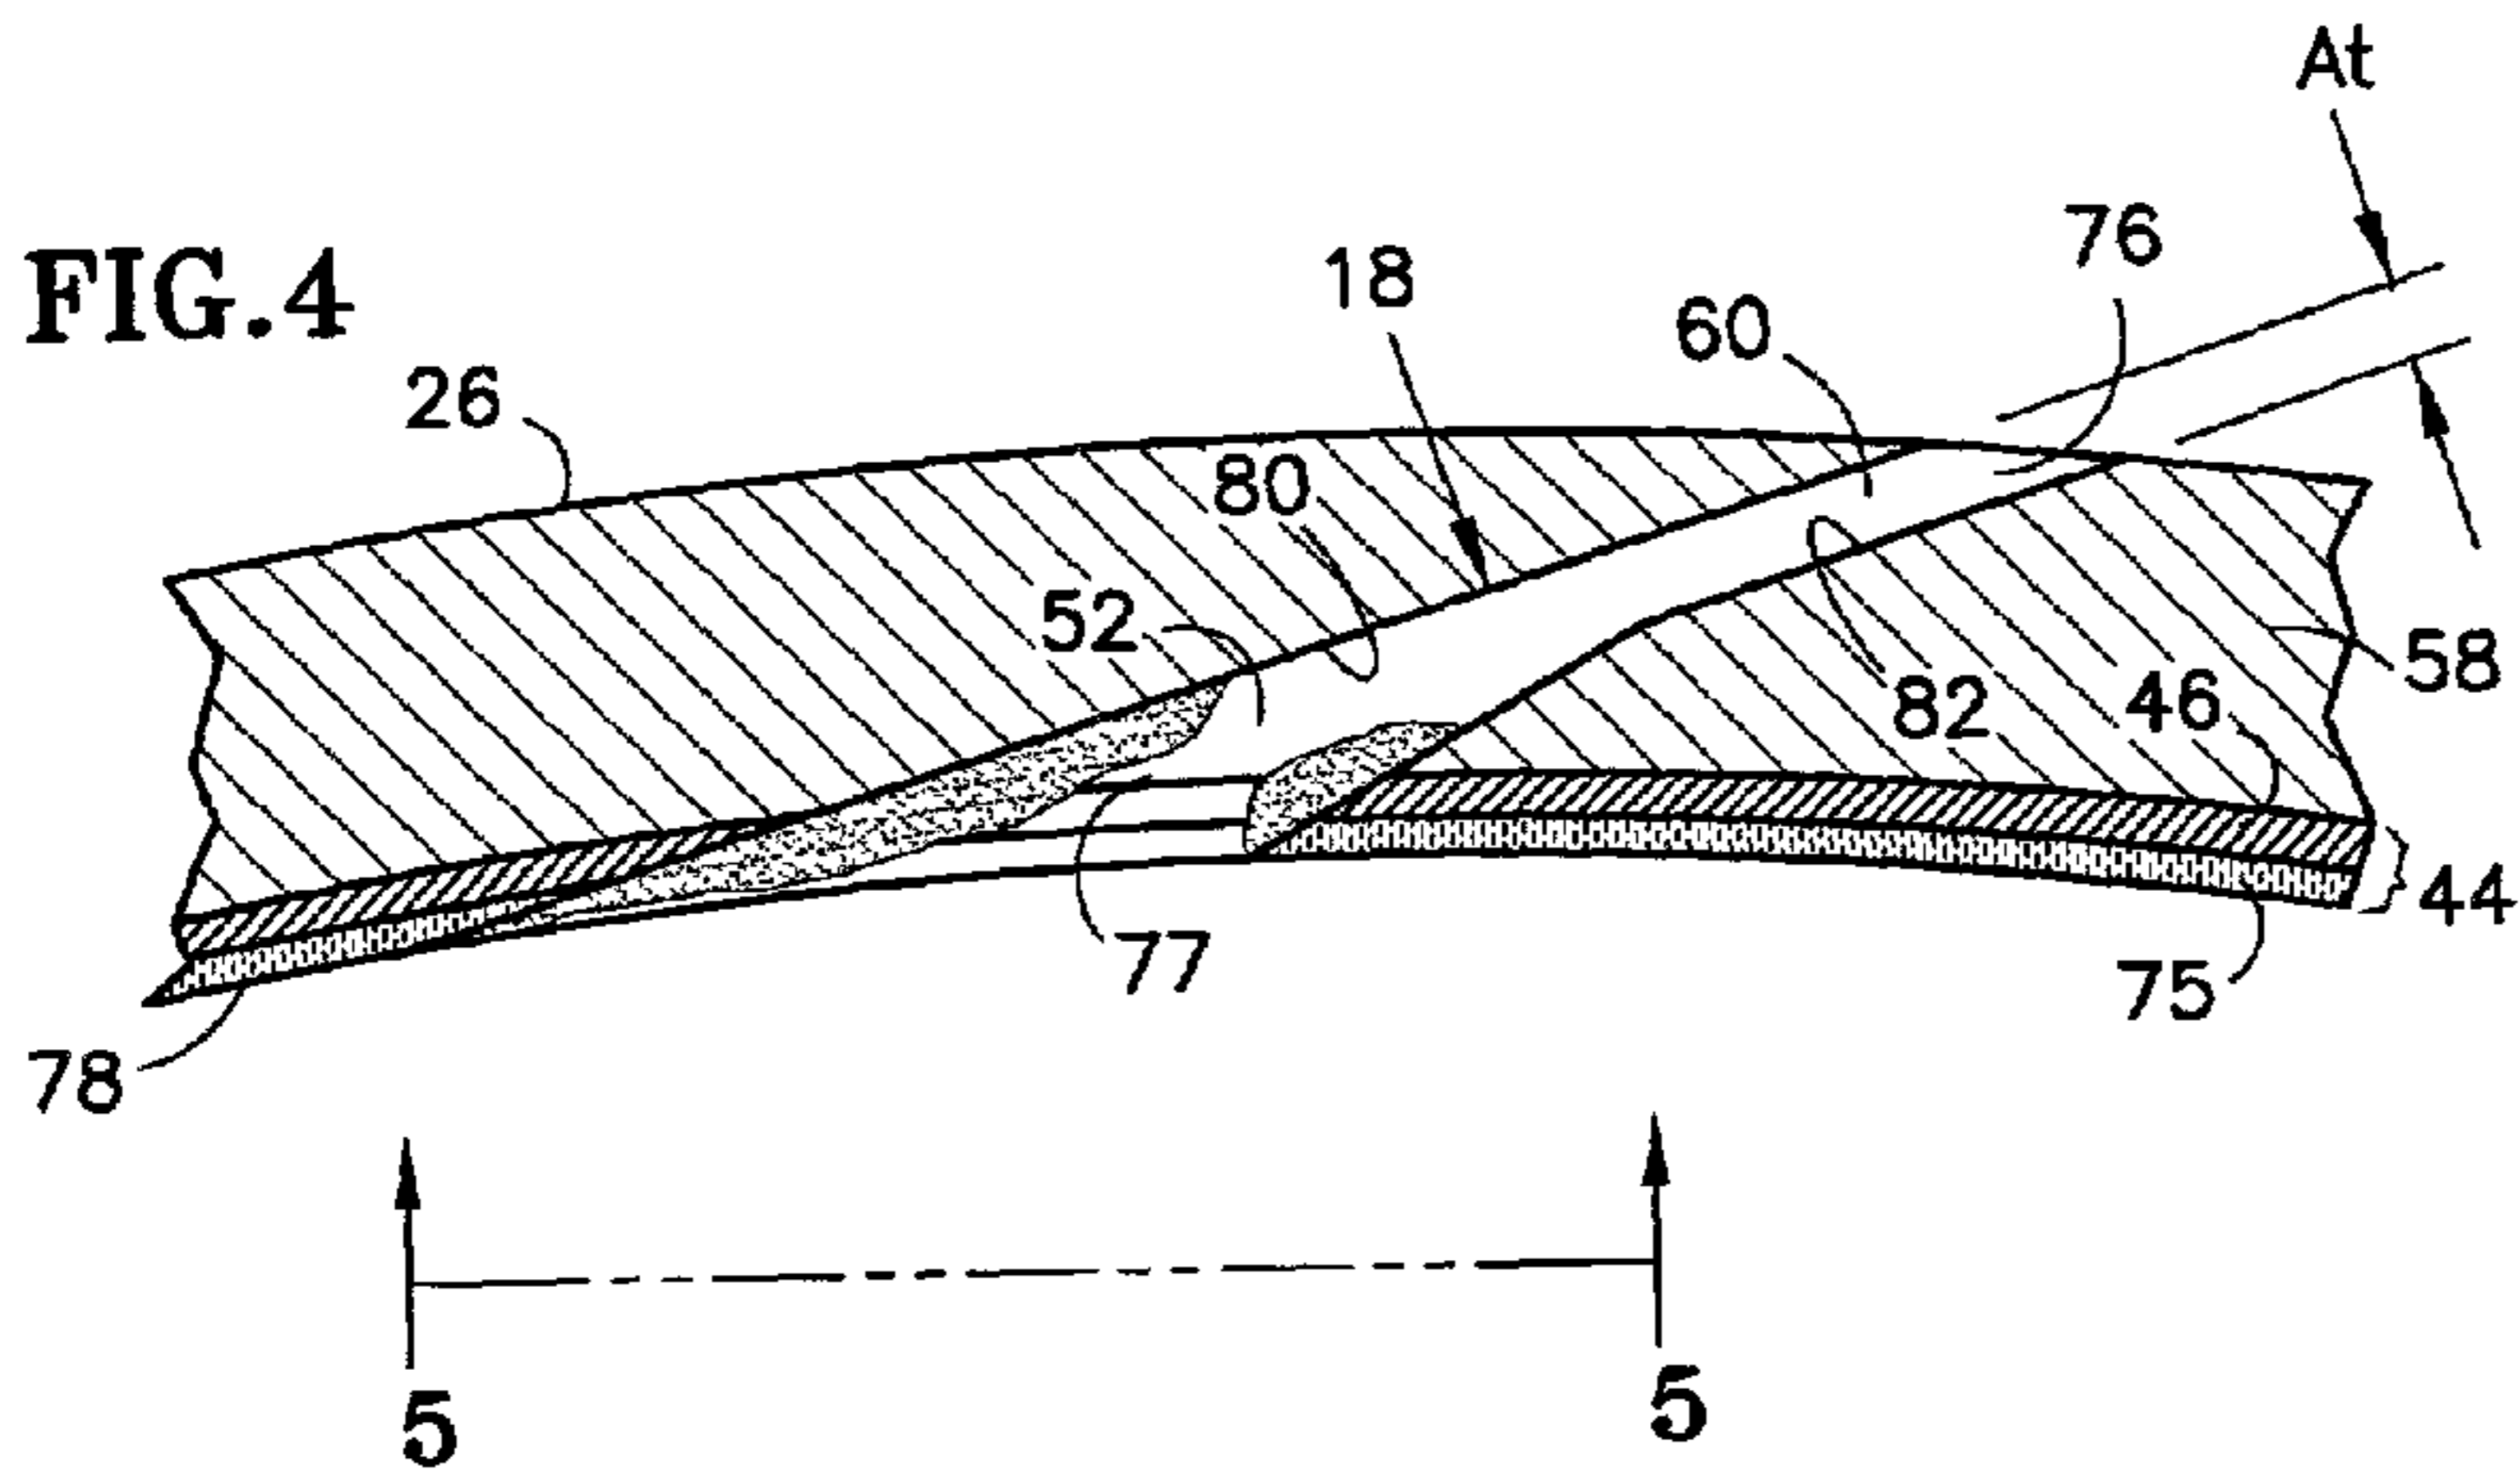
[0027] FIG. 4 is an enlarged cross-sectional view taken essentially in the direction 4-4 of FIG. 1 and illustrating the vane substrate, an existing protective coating applied to the substrate and a typical diffusion cooling hole extending through the substrate and the coating;

[0036] Referring to FIG. 4, a cross-sectional view of the wall thickness of the airfoil 12, and in particular the diffusion hole 18, is shown taken along the line 4-4 of FIG. 1. FIG. 5 shows a view taken essentially in the direction 5-5 of FIG. 4 showing the diffusion hole 18 prior to the repair of the present invention.

[0038] Referring now to FIGS. 1 and 4, it is noted that the vane 10 has a plurality of diffusion holes 18 which may have various geometries and predetermined air flow characteristics based on location within the vane 10. The representative diffusion hole 18, shown in FIG. 4, has a metering passage 60 in fluid communication with a diffusion passage (mouth) 52, each having a predetermined geometry. The metering passage 60 has an inlet 76 with a predetermined throat area, shown as A_t , where the throat area A_t provides a predetermined air flow requirement. Thus, the inlet 76 regulates cooling air flow into the diffusion holes 18 from the internal cavities 24. The diffusion passage 52 is axially diverging, nonregulatory and extends from the inlet 76 to an outlet 77 at the exterior surface 78 of the vane 10. The diffusion passage 52 facilitates the film cooling of the exterior surface 78 of the airfoil 12 as the cooling air exits from the diffusion passage 52 of the diffusion hole 18. The diffusion passage 52 also includes an inner shaped portion (inner diffuser portion) 80 while the metering passage 60 includes an inner metering portion 82.

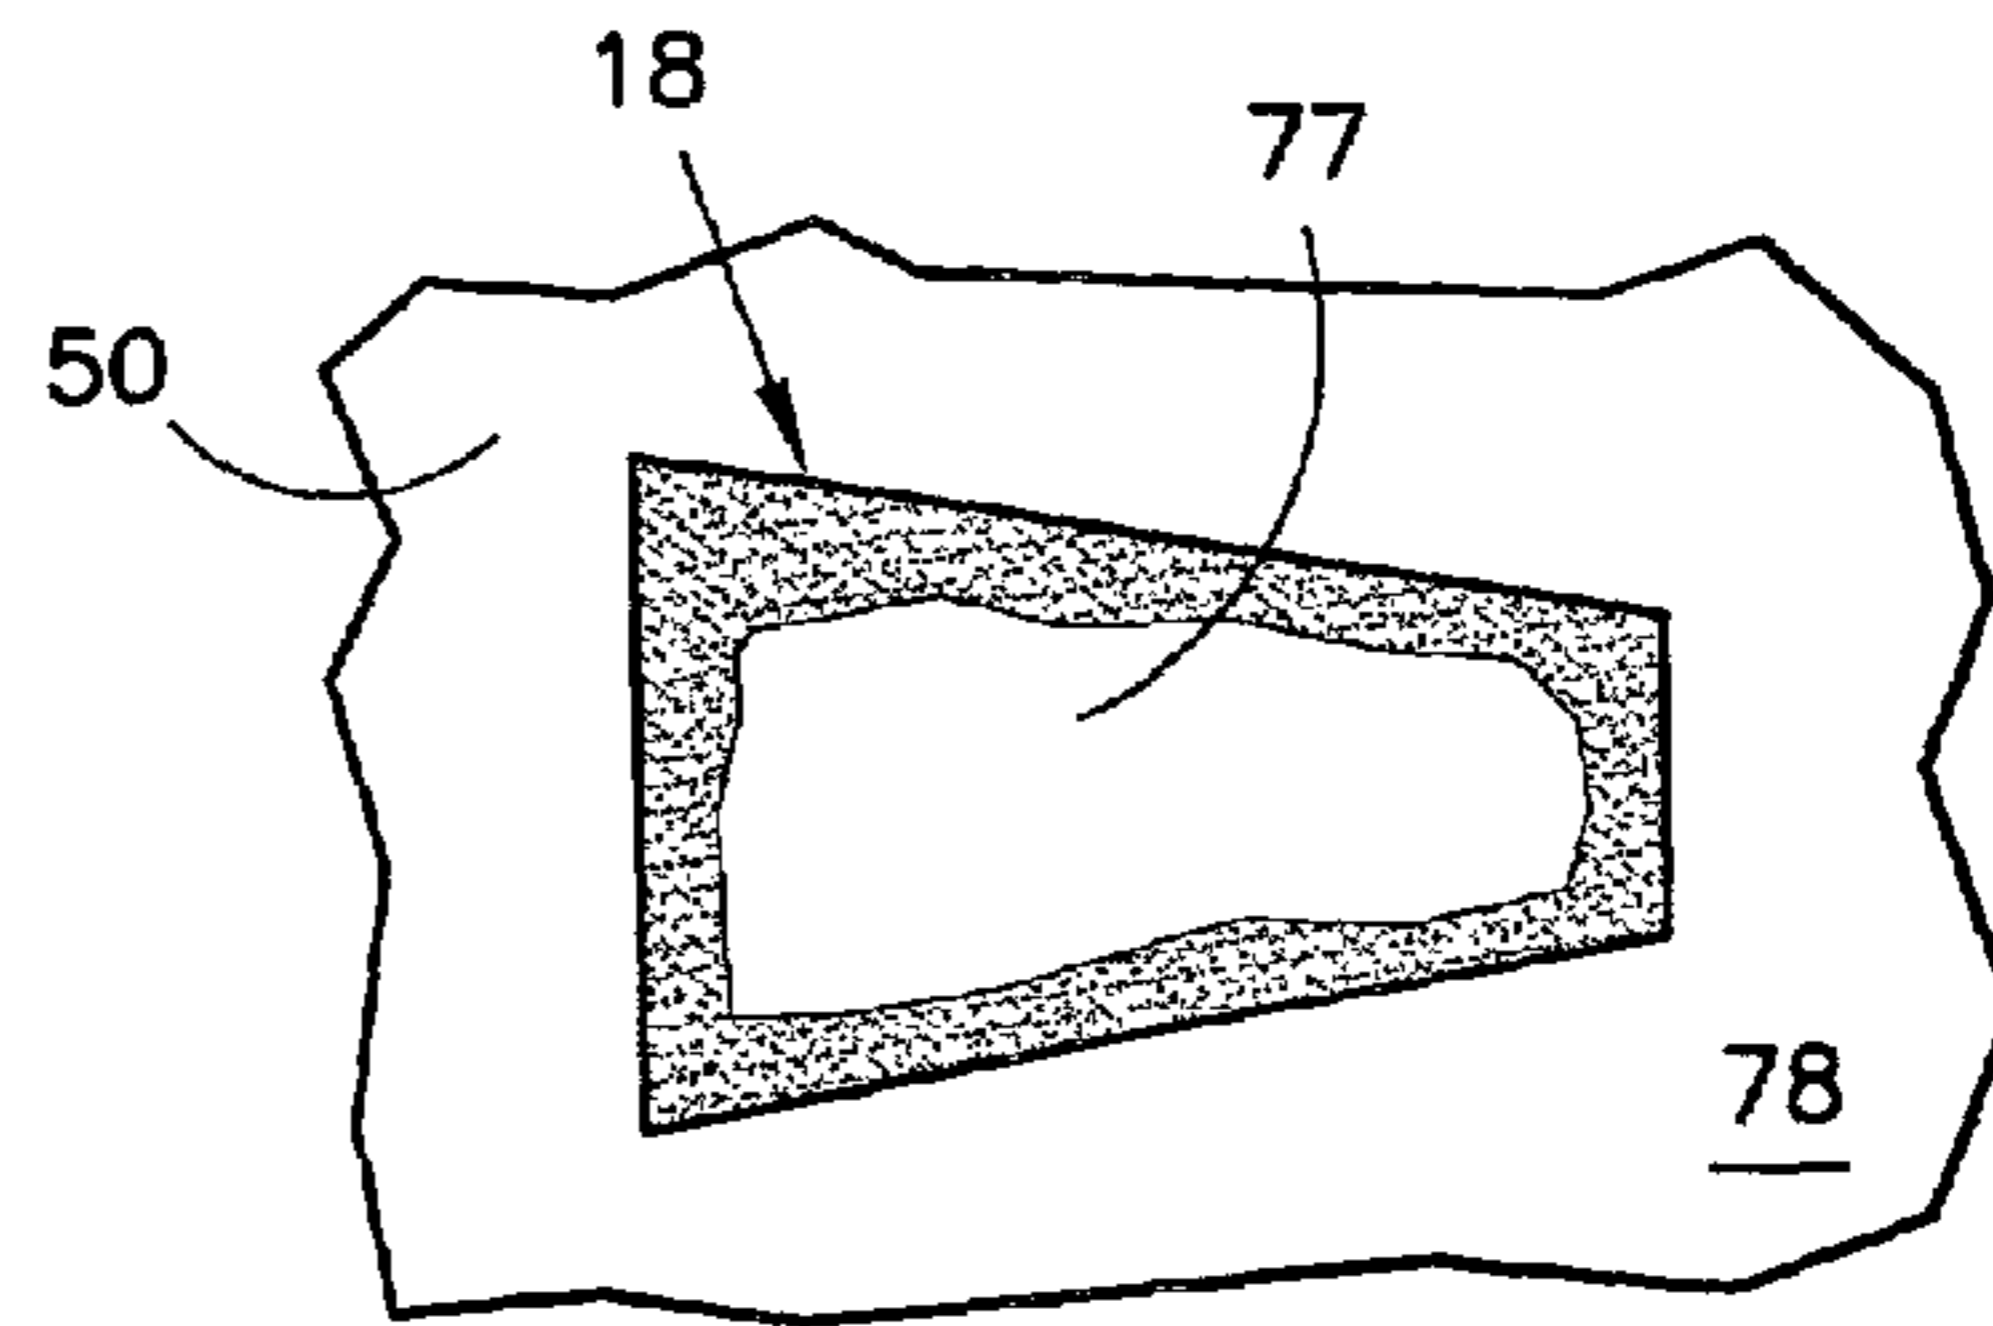
[0028] FIG. 5 is a view taken essentially in the direction 5-5 of FIG. 4 showing the diffusion hole prior to the repair of the present invention;

[0055] Referring now to FIGS. **1**, **4** and **5**, diffusion holes **18** located in region **50** may require reworking. The application of the nonoriginal metallic bond coat **46** to the entire surface **78** of the vane **10** may result in a quantity of excess bond coating accumulating in the diffusion passage **52** of the diffusion holes **18** thus reducing the area through which the cooling air passes. Since this "coatdown" phenomena, as shown in FIGS. **4** and **5**, affects most, if not all of the

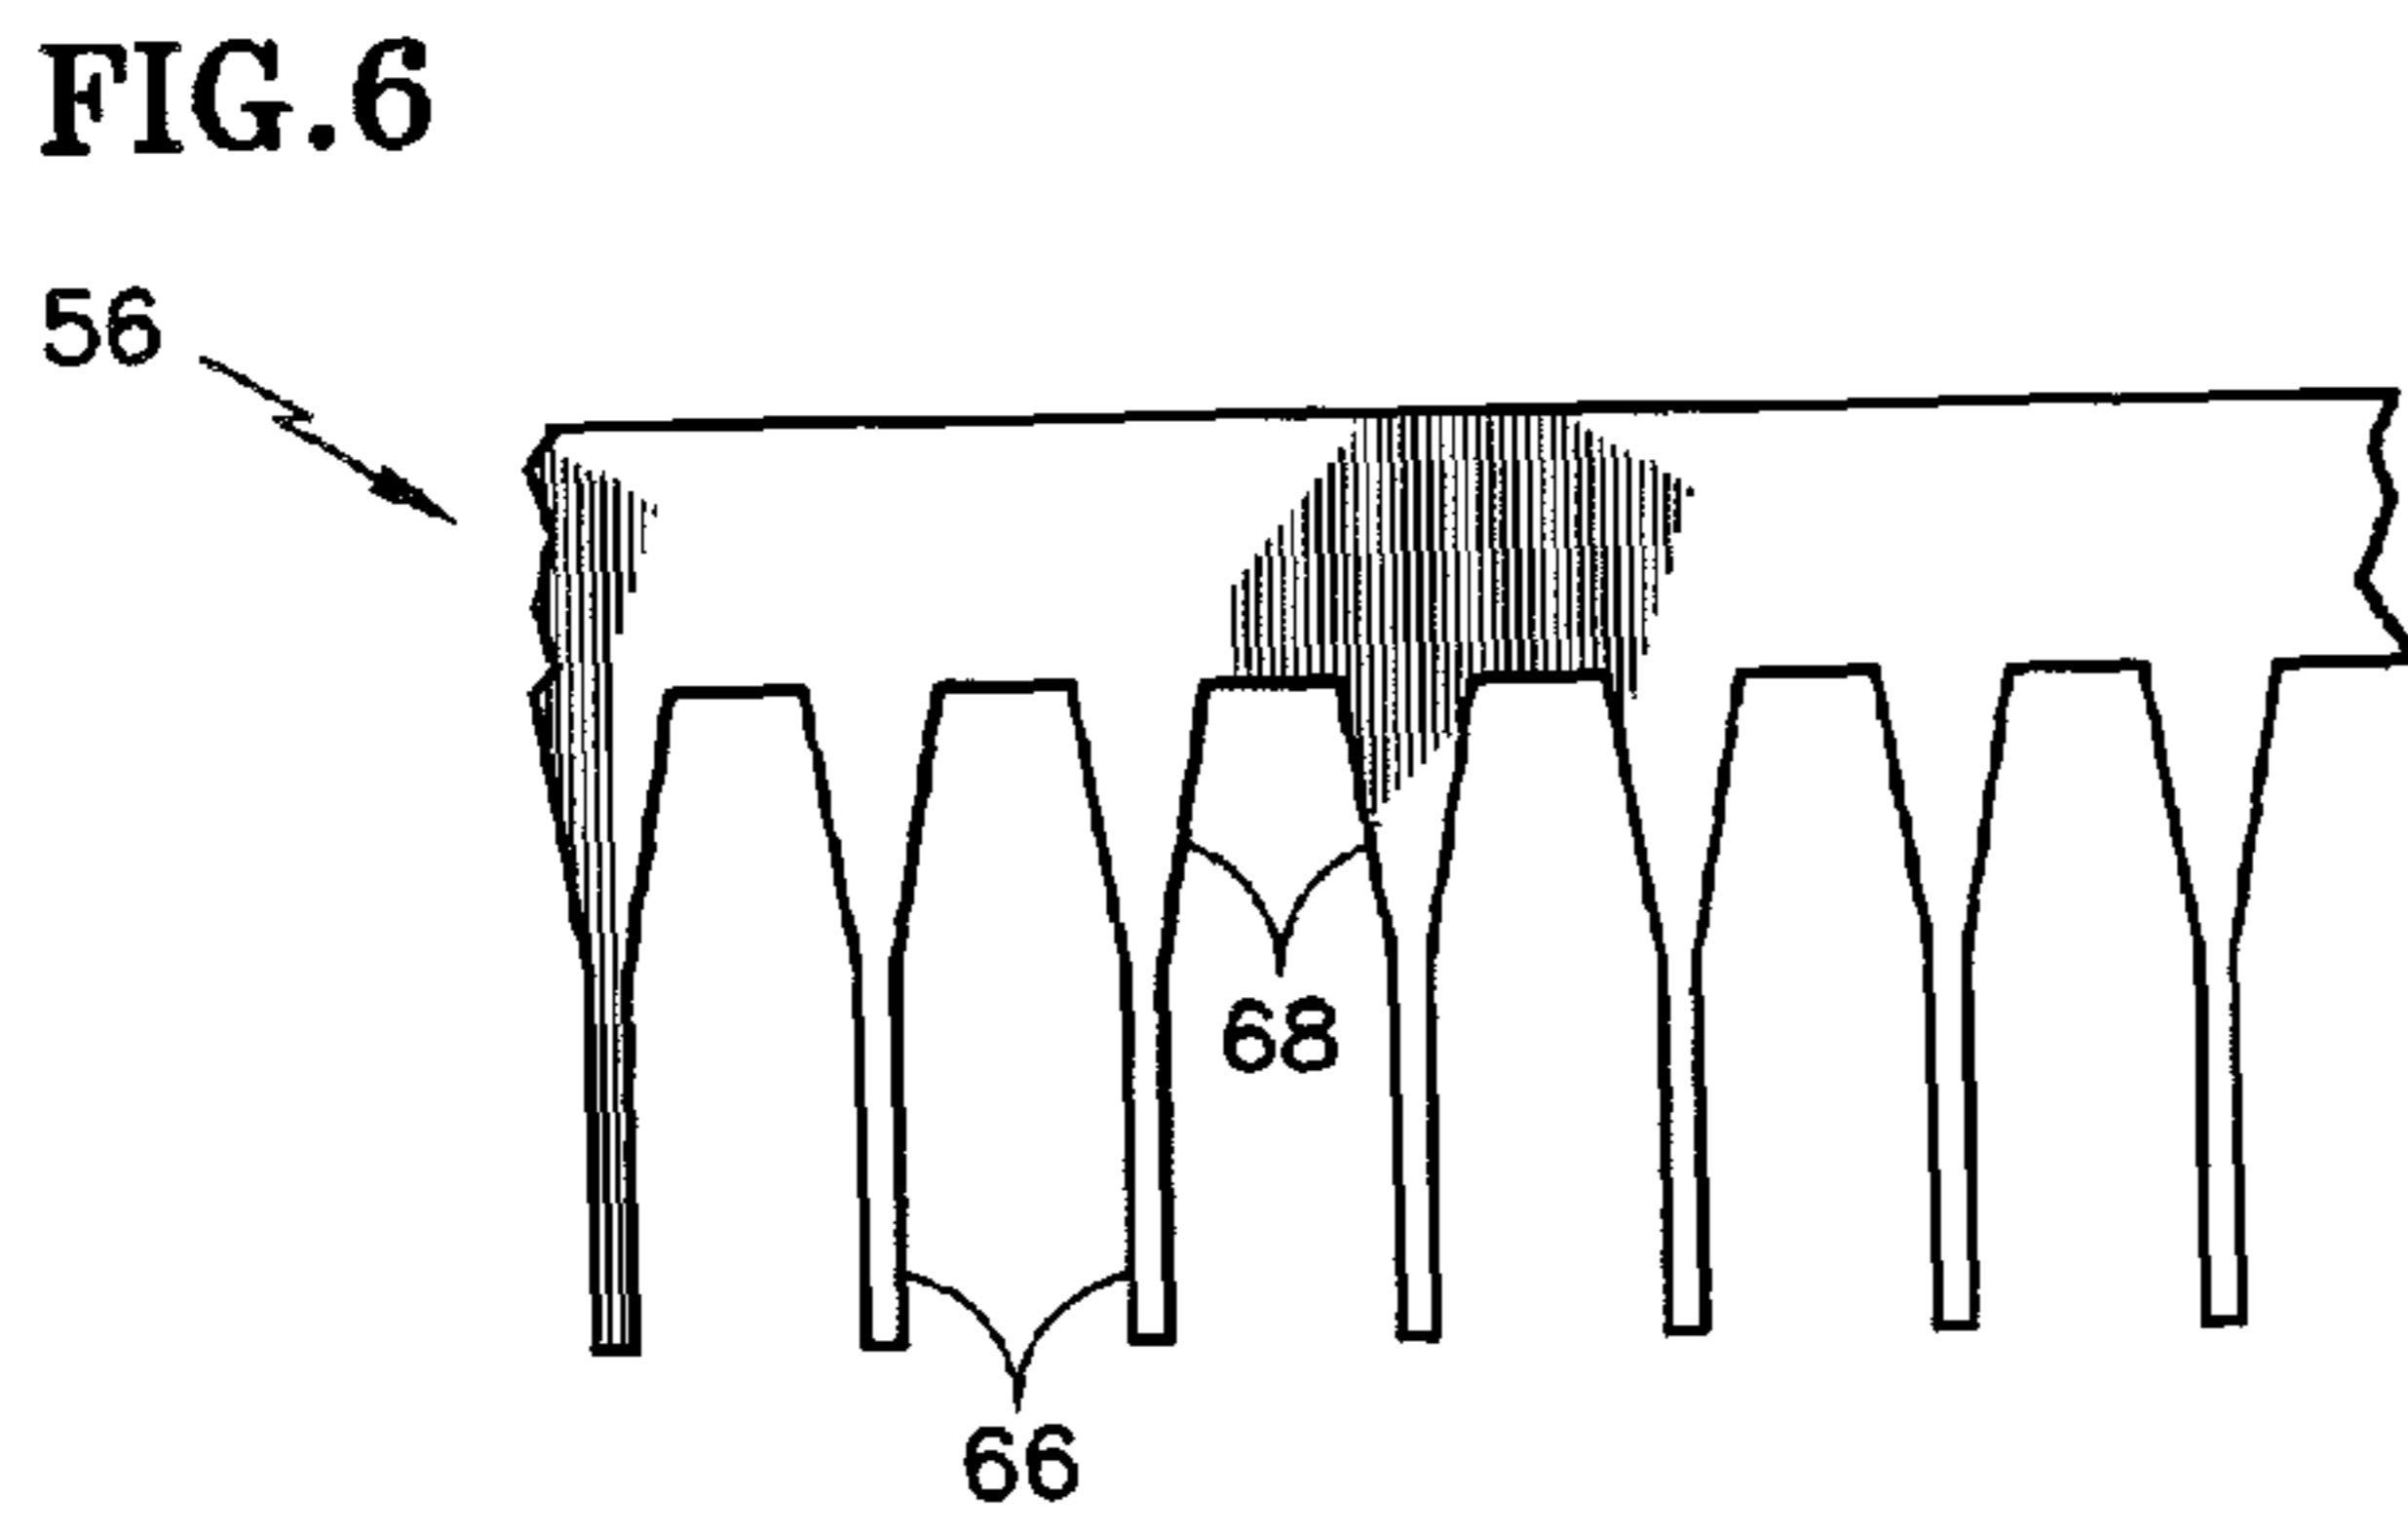
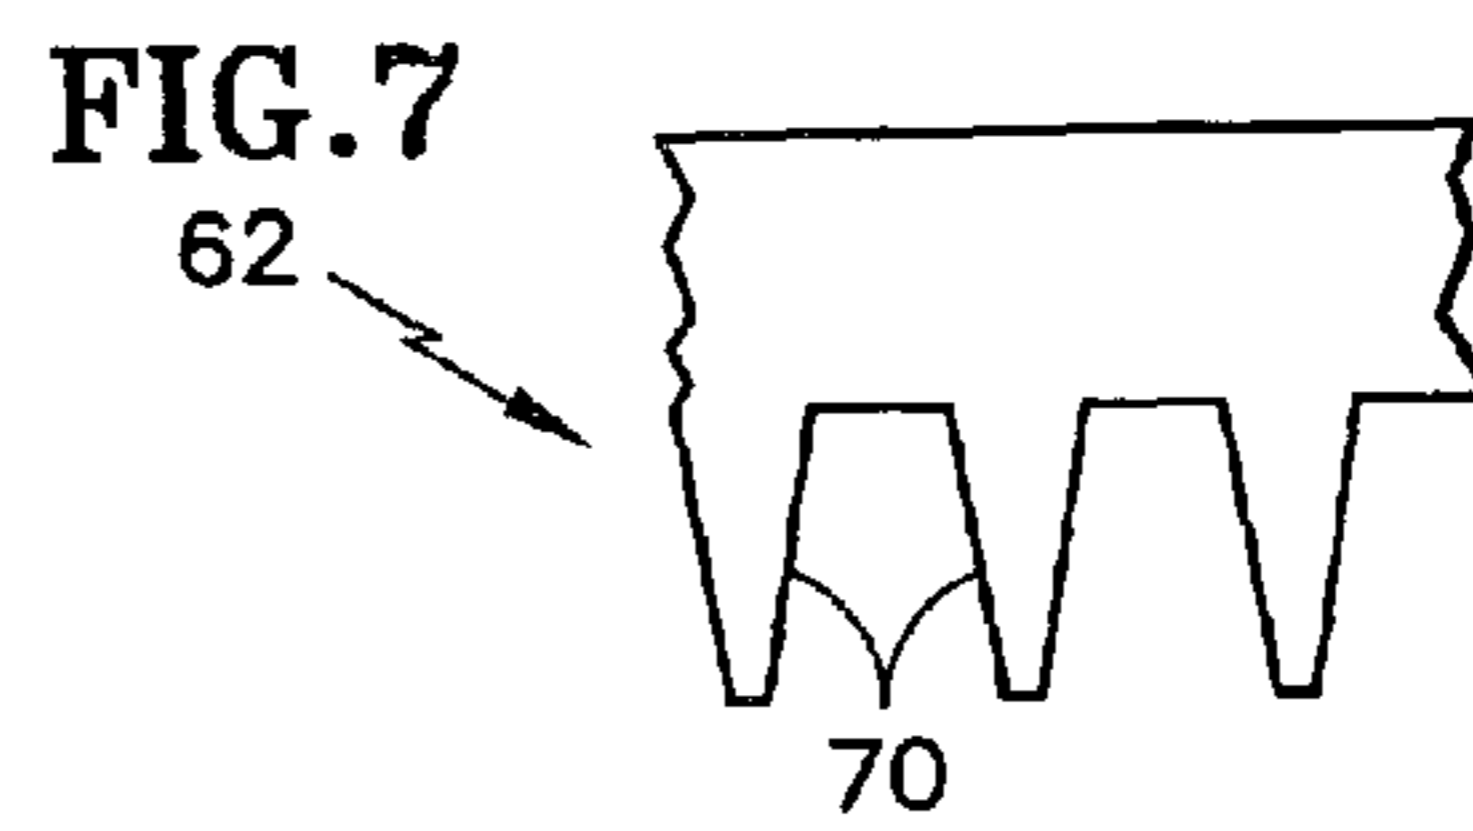
[0029] FIG. 6 is a side view of an electrode suitable for use with the repair method of the present invention; and

[0030] FIG. 7 is a side view of an electrode suitable for use with the repair method of the present invention.

[0058] Referring to FIGS. **5**, **6** and **7**, electrodes **56**, **62** suitable for insertion into an electric discharge machining device are shown. Referring to FIGS. **1**, **4** and **6**, the remanufacture and repair of the diffusion holes **18** in local regions **48**, **50** of vane **10** using electrodes **56**, **62**, respectively, will now be described.

[0059] The electrode **56** includes a metering portion **66** and a diffuser portion **68**. The electrode **62** includes a diffuser portion **70**. It is noted that the geometry of the individual electrodes **56**, **62**, specifically the respective portions **66**, **68**, **70**, are preselected to correspond to the required shape of the corresponding diffusion hole **18** to which it is used. In particular, the electrode **56** is chosen to restore the inner diffuser portion **80** and inner metering portion **82** of the respective diffusion hole **18** being repaired in region **48**. Similarly, the electrode **62** is chosen to restore the inner diffuser portion **80** of the respective diffusion hole **18** being repaired in region **50**. This ensures that after the repair is done, the predetermined air flow requirements of the respective diffusion holes **18** are met.
