US 20050098728A1

(10) **Pub. No.: US 2005/0098728 A1**

(54) **SYSTEMS AND METHODS FOR  
NON-DESTRUCTIVELY DETECTING  
MATERIAL ABNORMALITIES BENEATH A  
COATED SURFACE**

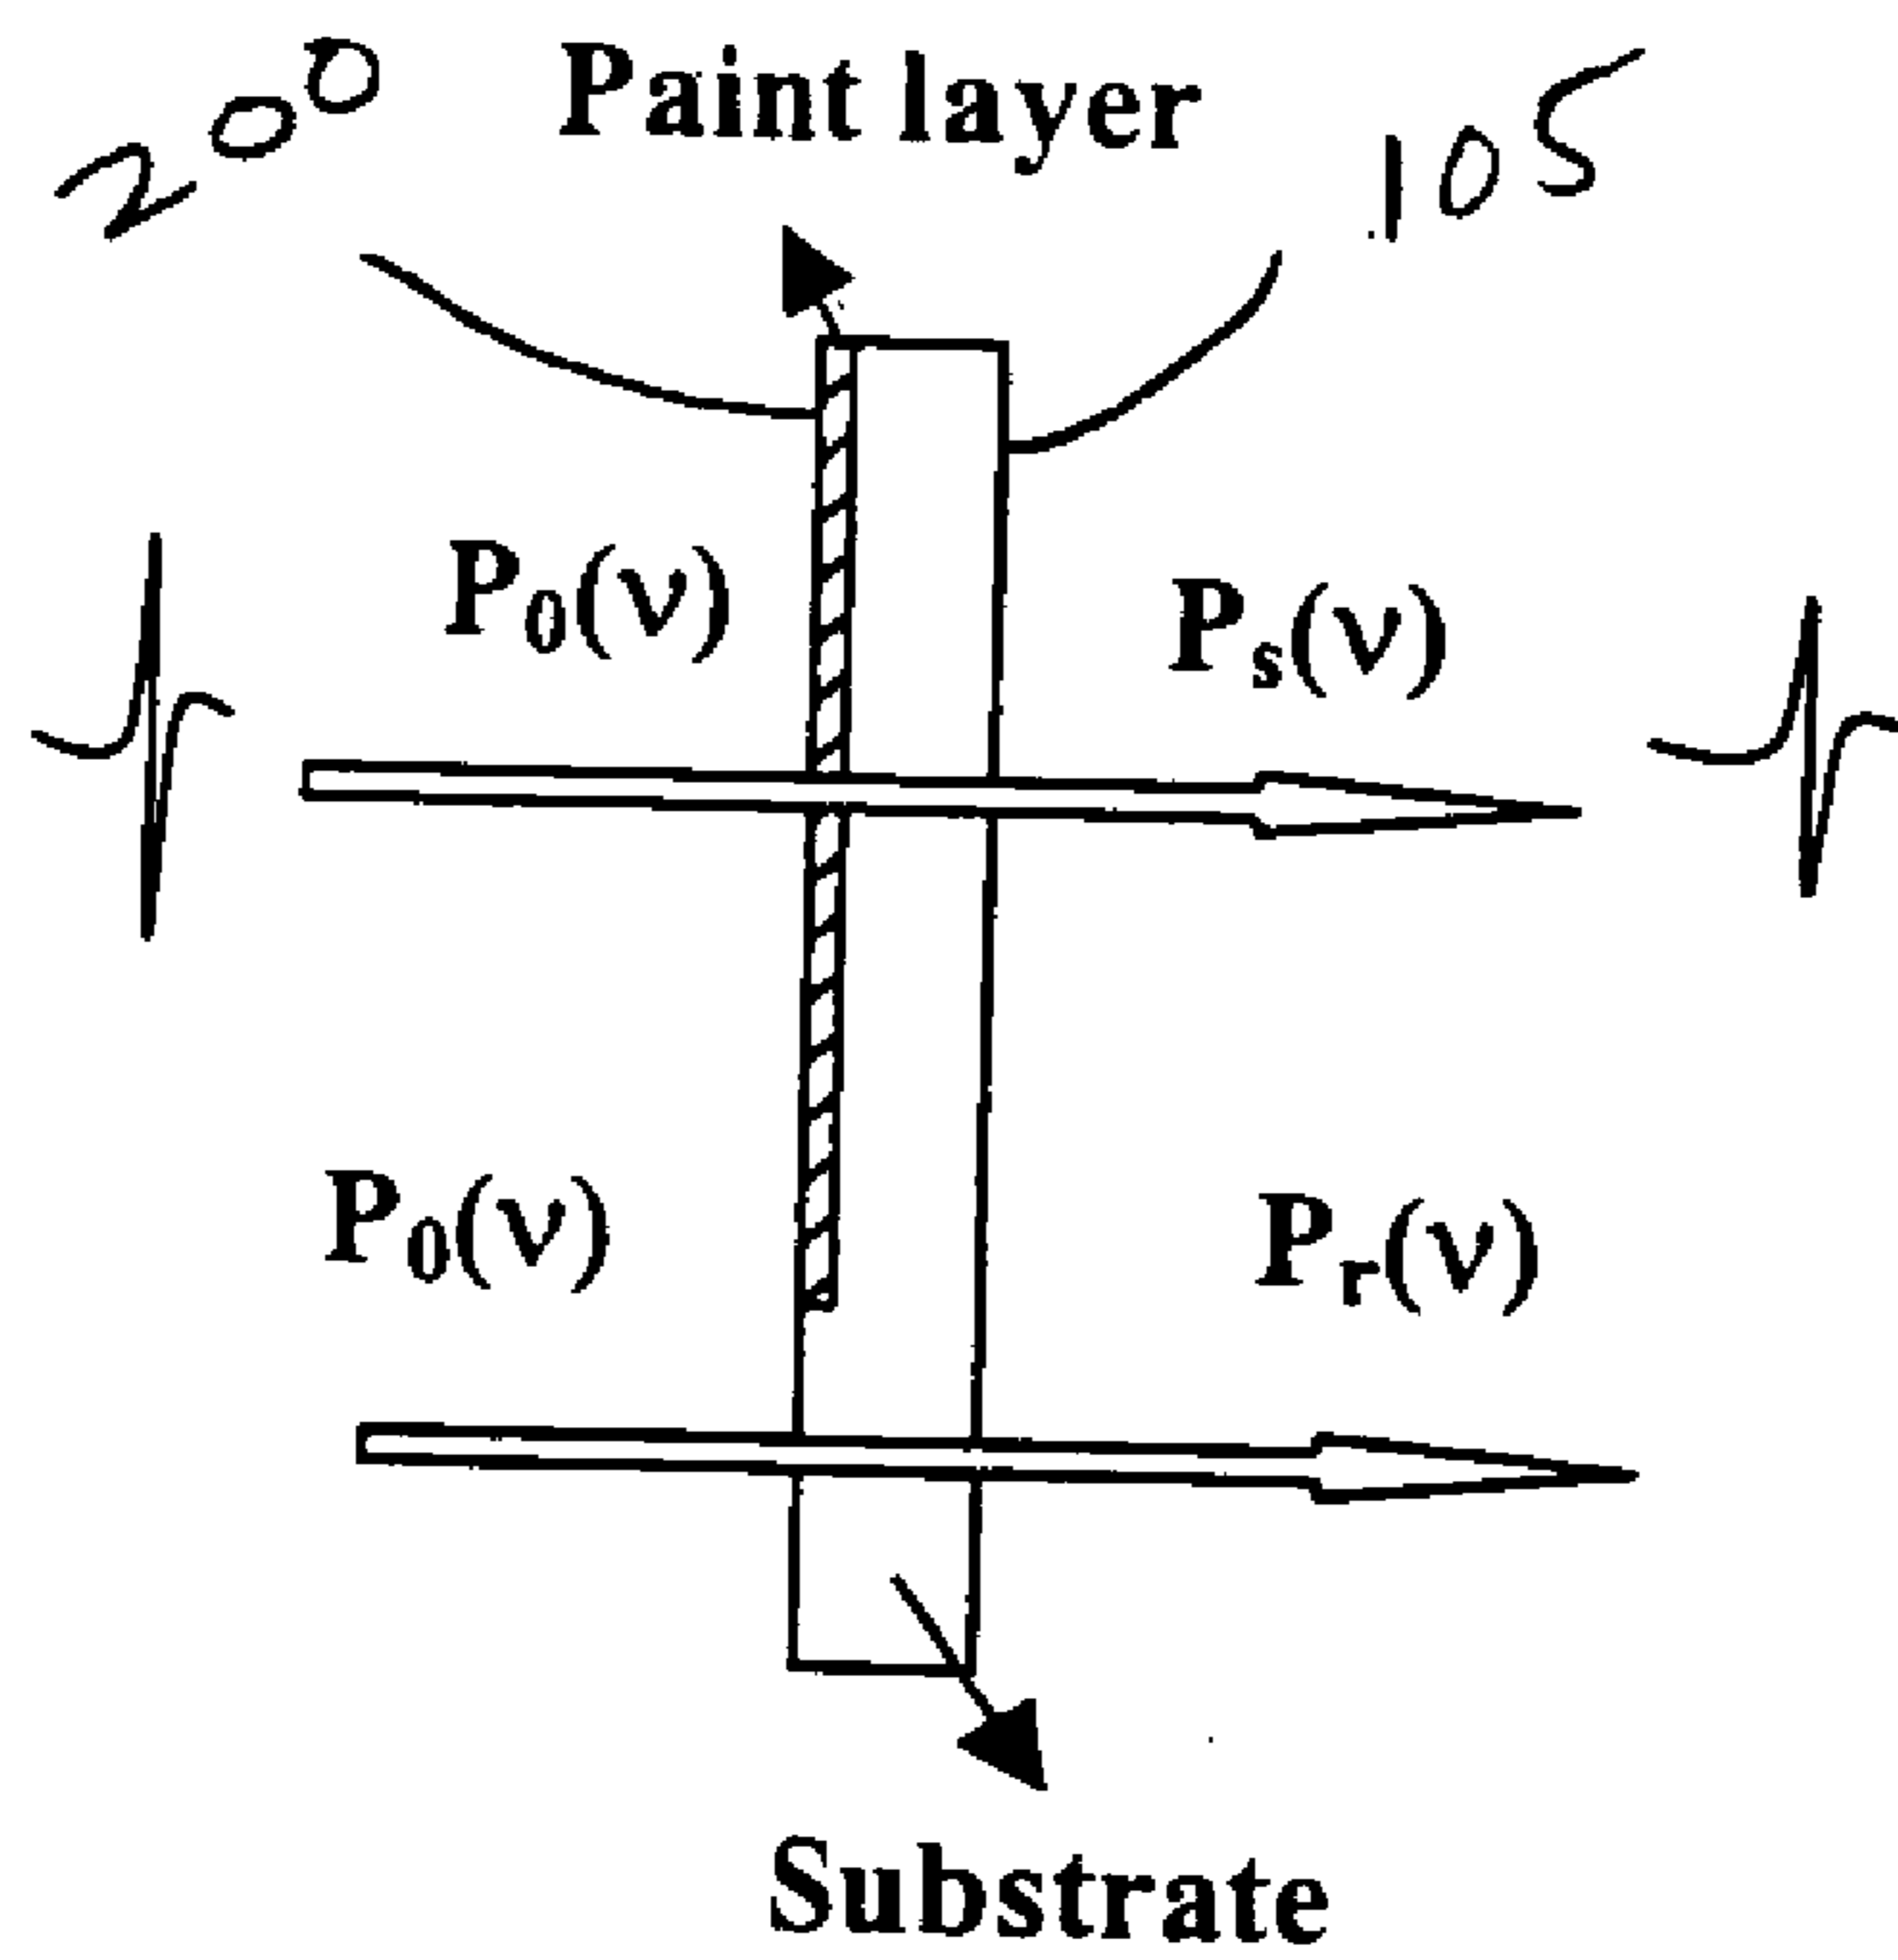
**FIG. 2**

[0025] FIG. 2 is a cross-sectional view of a sample deposited on a polyethylene substrate to measure an optical transmission of a paint system according to the first embodiment of the present invention;

[0049] FIG. 2 is a cross-sectional view of a sample deposited on a polyethylene substrate to measure an optical

transmission of a paint according to the first embodiment of the present invention. The sample **105** includes a paint layer **200** deposited on the polyethylene substrate to measure the optical transmission of the paint against frequency (wavelength). Assuming the non-absorbing substrate has a refractive index of  $n_s=1.52\pm 0.01$  at 300 K, the transmittance of the paint at different frequencies  $T(\nu)$  can be calculated from Equation (1).

$$T(\nu) = \frac{4n_p^2(1+n_s)^2}{(1+n_p)^2(n_p+n_s)^2} \cdot \frac{P_s(\nu)}{P_r(\nu)} \quad (1)$$

[0050] In Equation (1),  $P_s(\nu)$  and  $P_r(\nu)$  are the transmitted powers of the THz light through the paint layer **200** and a reference, i.e., the non-covered portion of the substrate, respectively.  $n_p$  is the group refractive index of paint. Preferably, the thickness of the polyethylene substrate is approximately 4.0 mm to avoid interference peaks in the THz profile in the studied time zone arising from multiple reflections from the two surfaces of the polyethylene substrate.

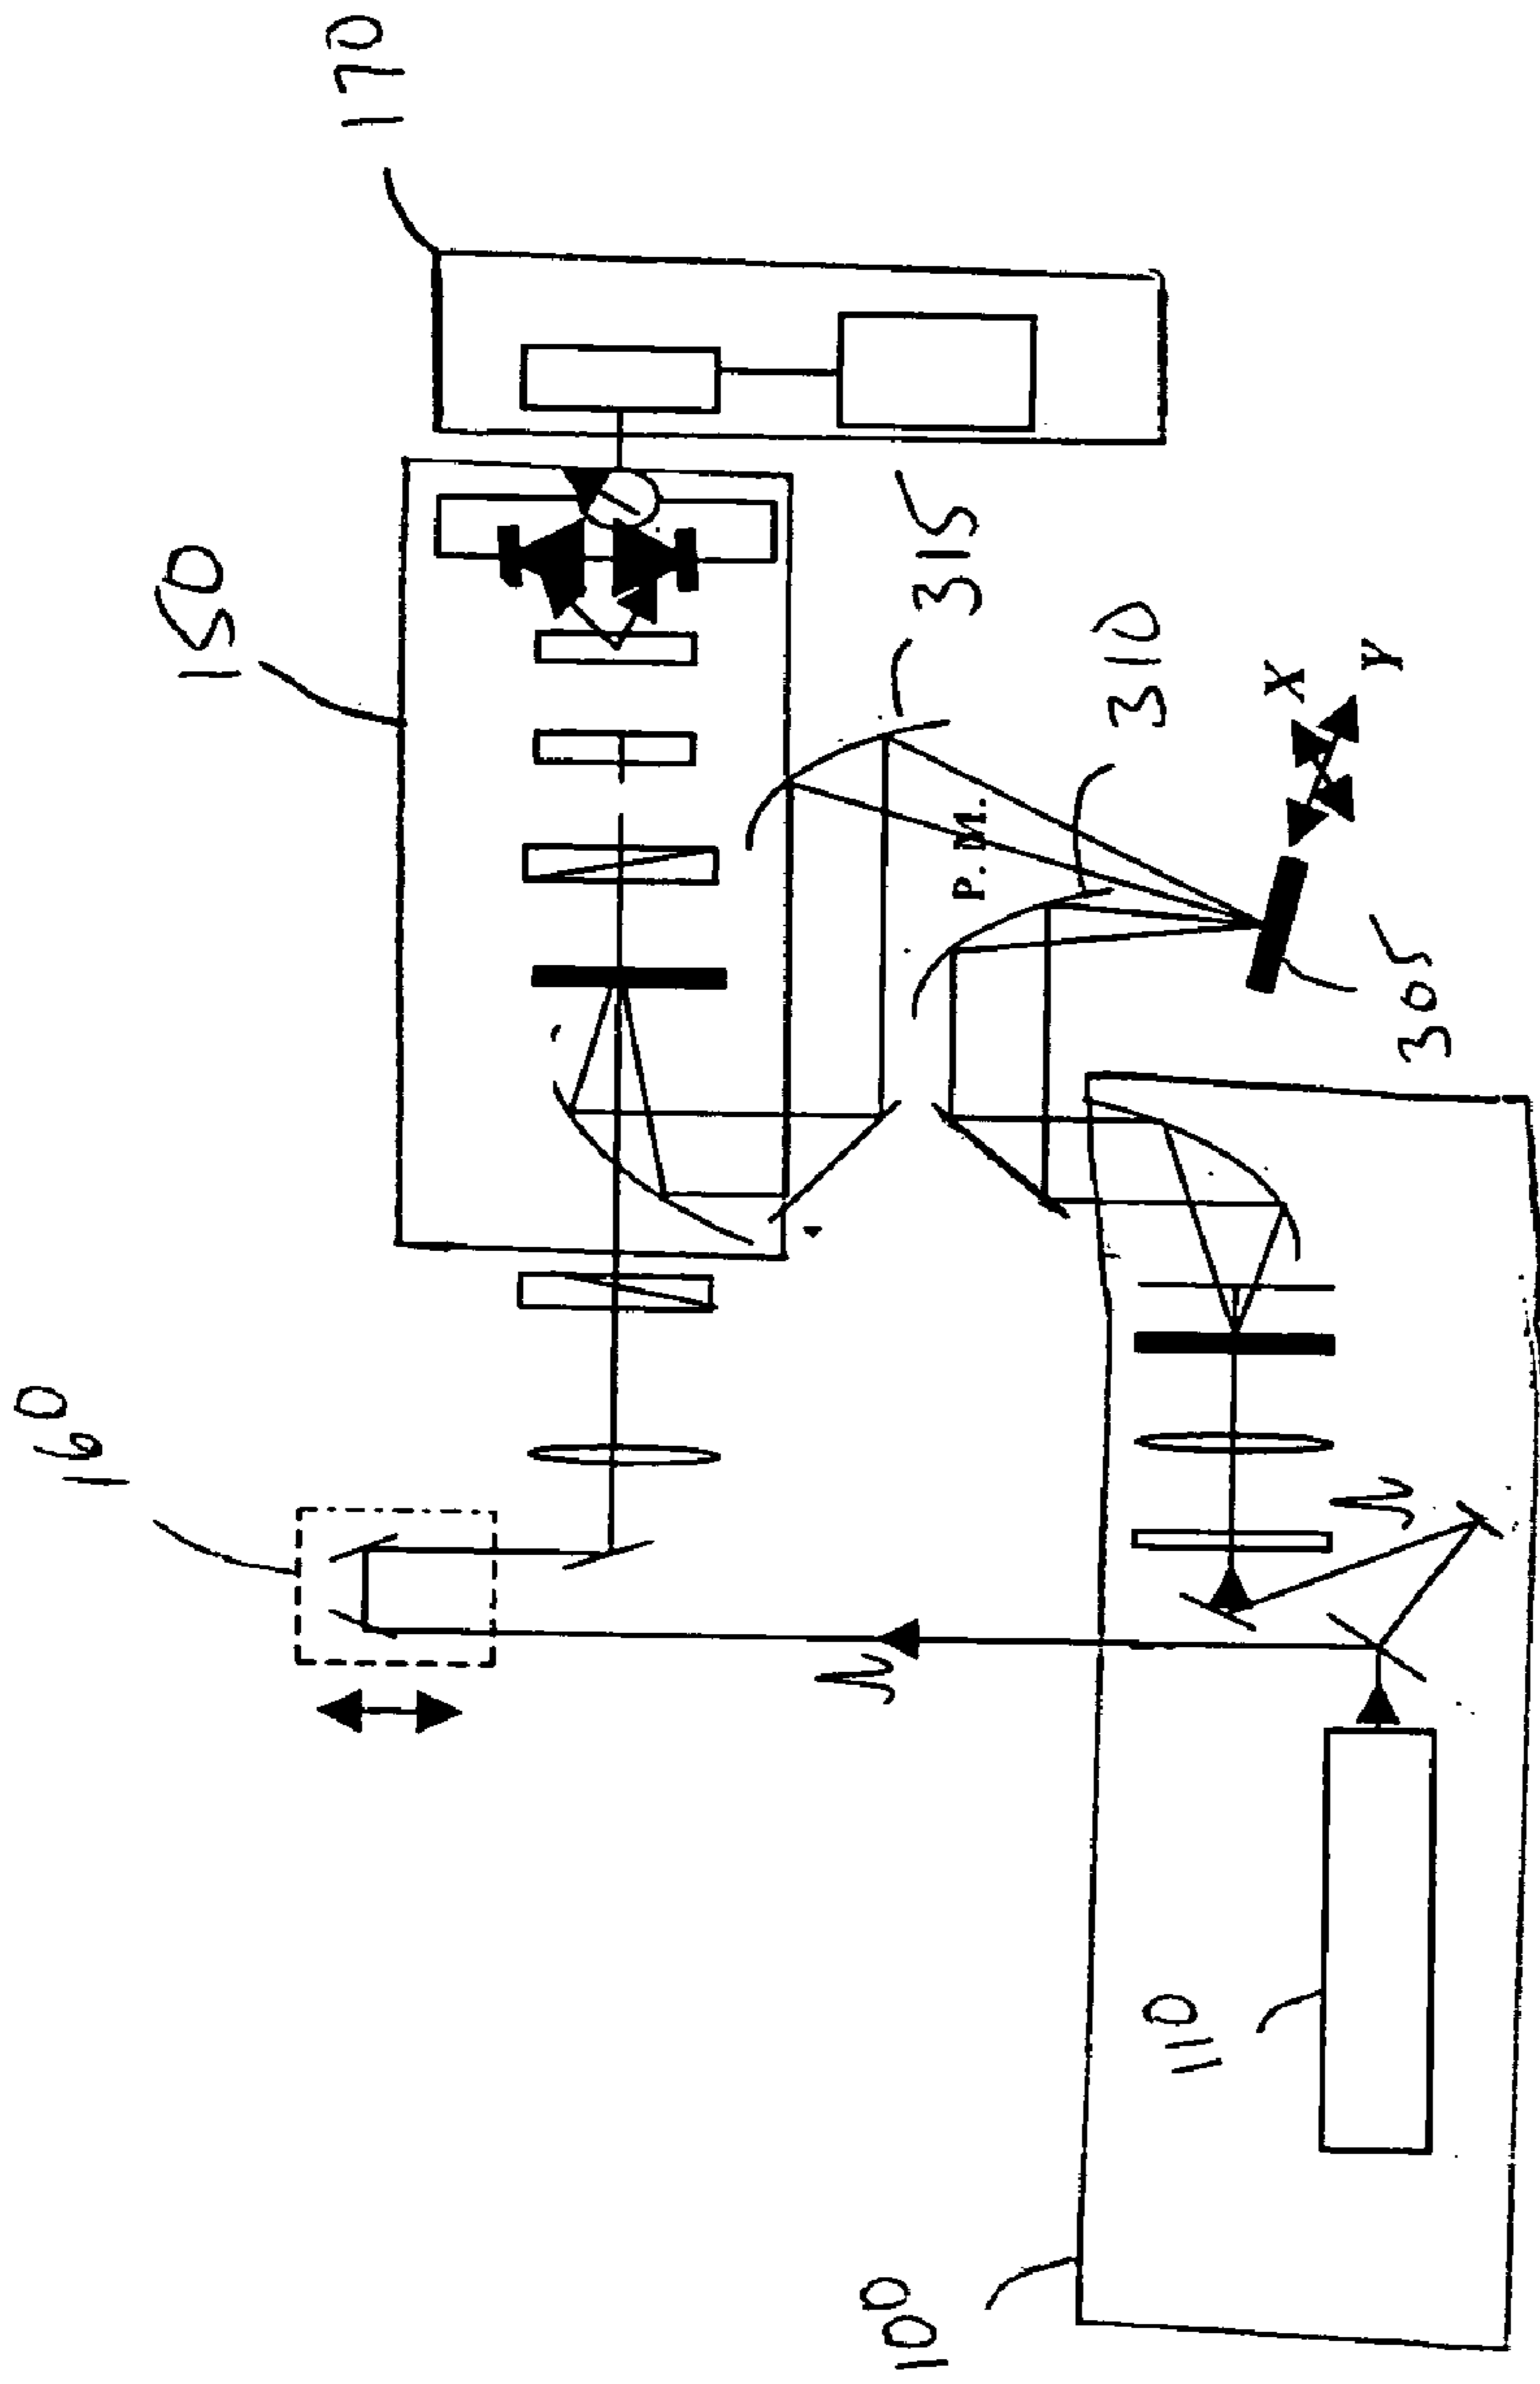
[0026] FIG. 3 is a diagram illustrating a detection system according to a second preferred embodiment of the present invention;

[0052] **FIG. 3** is a diagram illustrating a detection system according to a second preferred embodiment of the present invention. More specifically, **FIG. 3** illustrates a setup for detecting and imaging material abnormalities such as corrosion and/or cracks beneath the thick paint layer or zinc rich primer (up to 200  $\mu\text{m}$  thick) using a THz scanning reflection imaging technique by scanning the beam on a moveable sample. As described above, the previously used NIR and MIR radiations do not pass through this type of paint.

[0053] Referring to **FIG. 3**, the detection system includes a THz illumination unit **100**, a detection unit **150**, a time delay **160**, and a processing unit **170**. Additionally, because these structures are substantially identical to those described in **FIG. 1**, a detailed description thereof will not be given again.

[0054] In **FIG. 3**, however, because the sample **305** is not placed between the THz illumination unit **100** and the detection unit **150**, as in **FIG. 1**, the THz illumination unit **100** and the detection unit **150** illustrated in **FIG. 3** also included parabolic mirrors **310** and **315**, respectively. Parabolic mirror **310** is used to focus the THz light onto a specific point of the sample **305**, and the parabolic mirror **315** is used capture and direct the reflected THz light from the sample into the detection unit **150**. Accordingly, back reflection geometry is used to image the subsurface structure of the corroded samples coated with paint or primer by scanning the beams.

[0055] Additionally, in **FIG. 3**, the lock-in amplifier **171** processes signals received from the detection unit **150**, and the computer **172** digitizes and stores the processed signals to produce a 2-D image of the scanned area. The 2-D image of the scanned area can then be stored in a memory of the computer and/or displayed on a display, such as monitor.

[0056] In order to increase the imaging area of the system illustrated in **FIG. 3**, the system may also includes an X-Y

scanning system, which may comprise sliding stages, to move the THz illumination unit **100** and the detection unit **150** relative to the sample **305**.

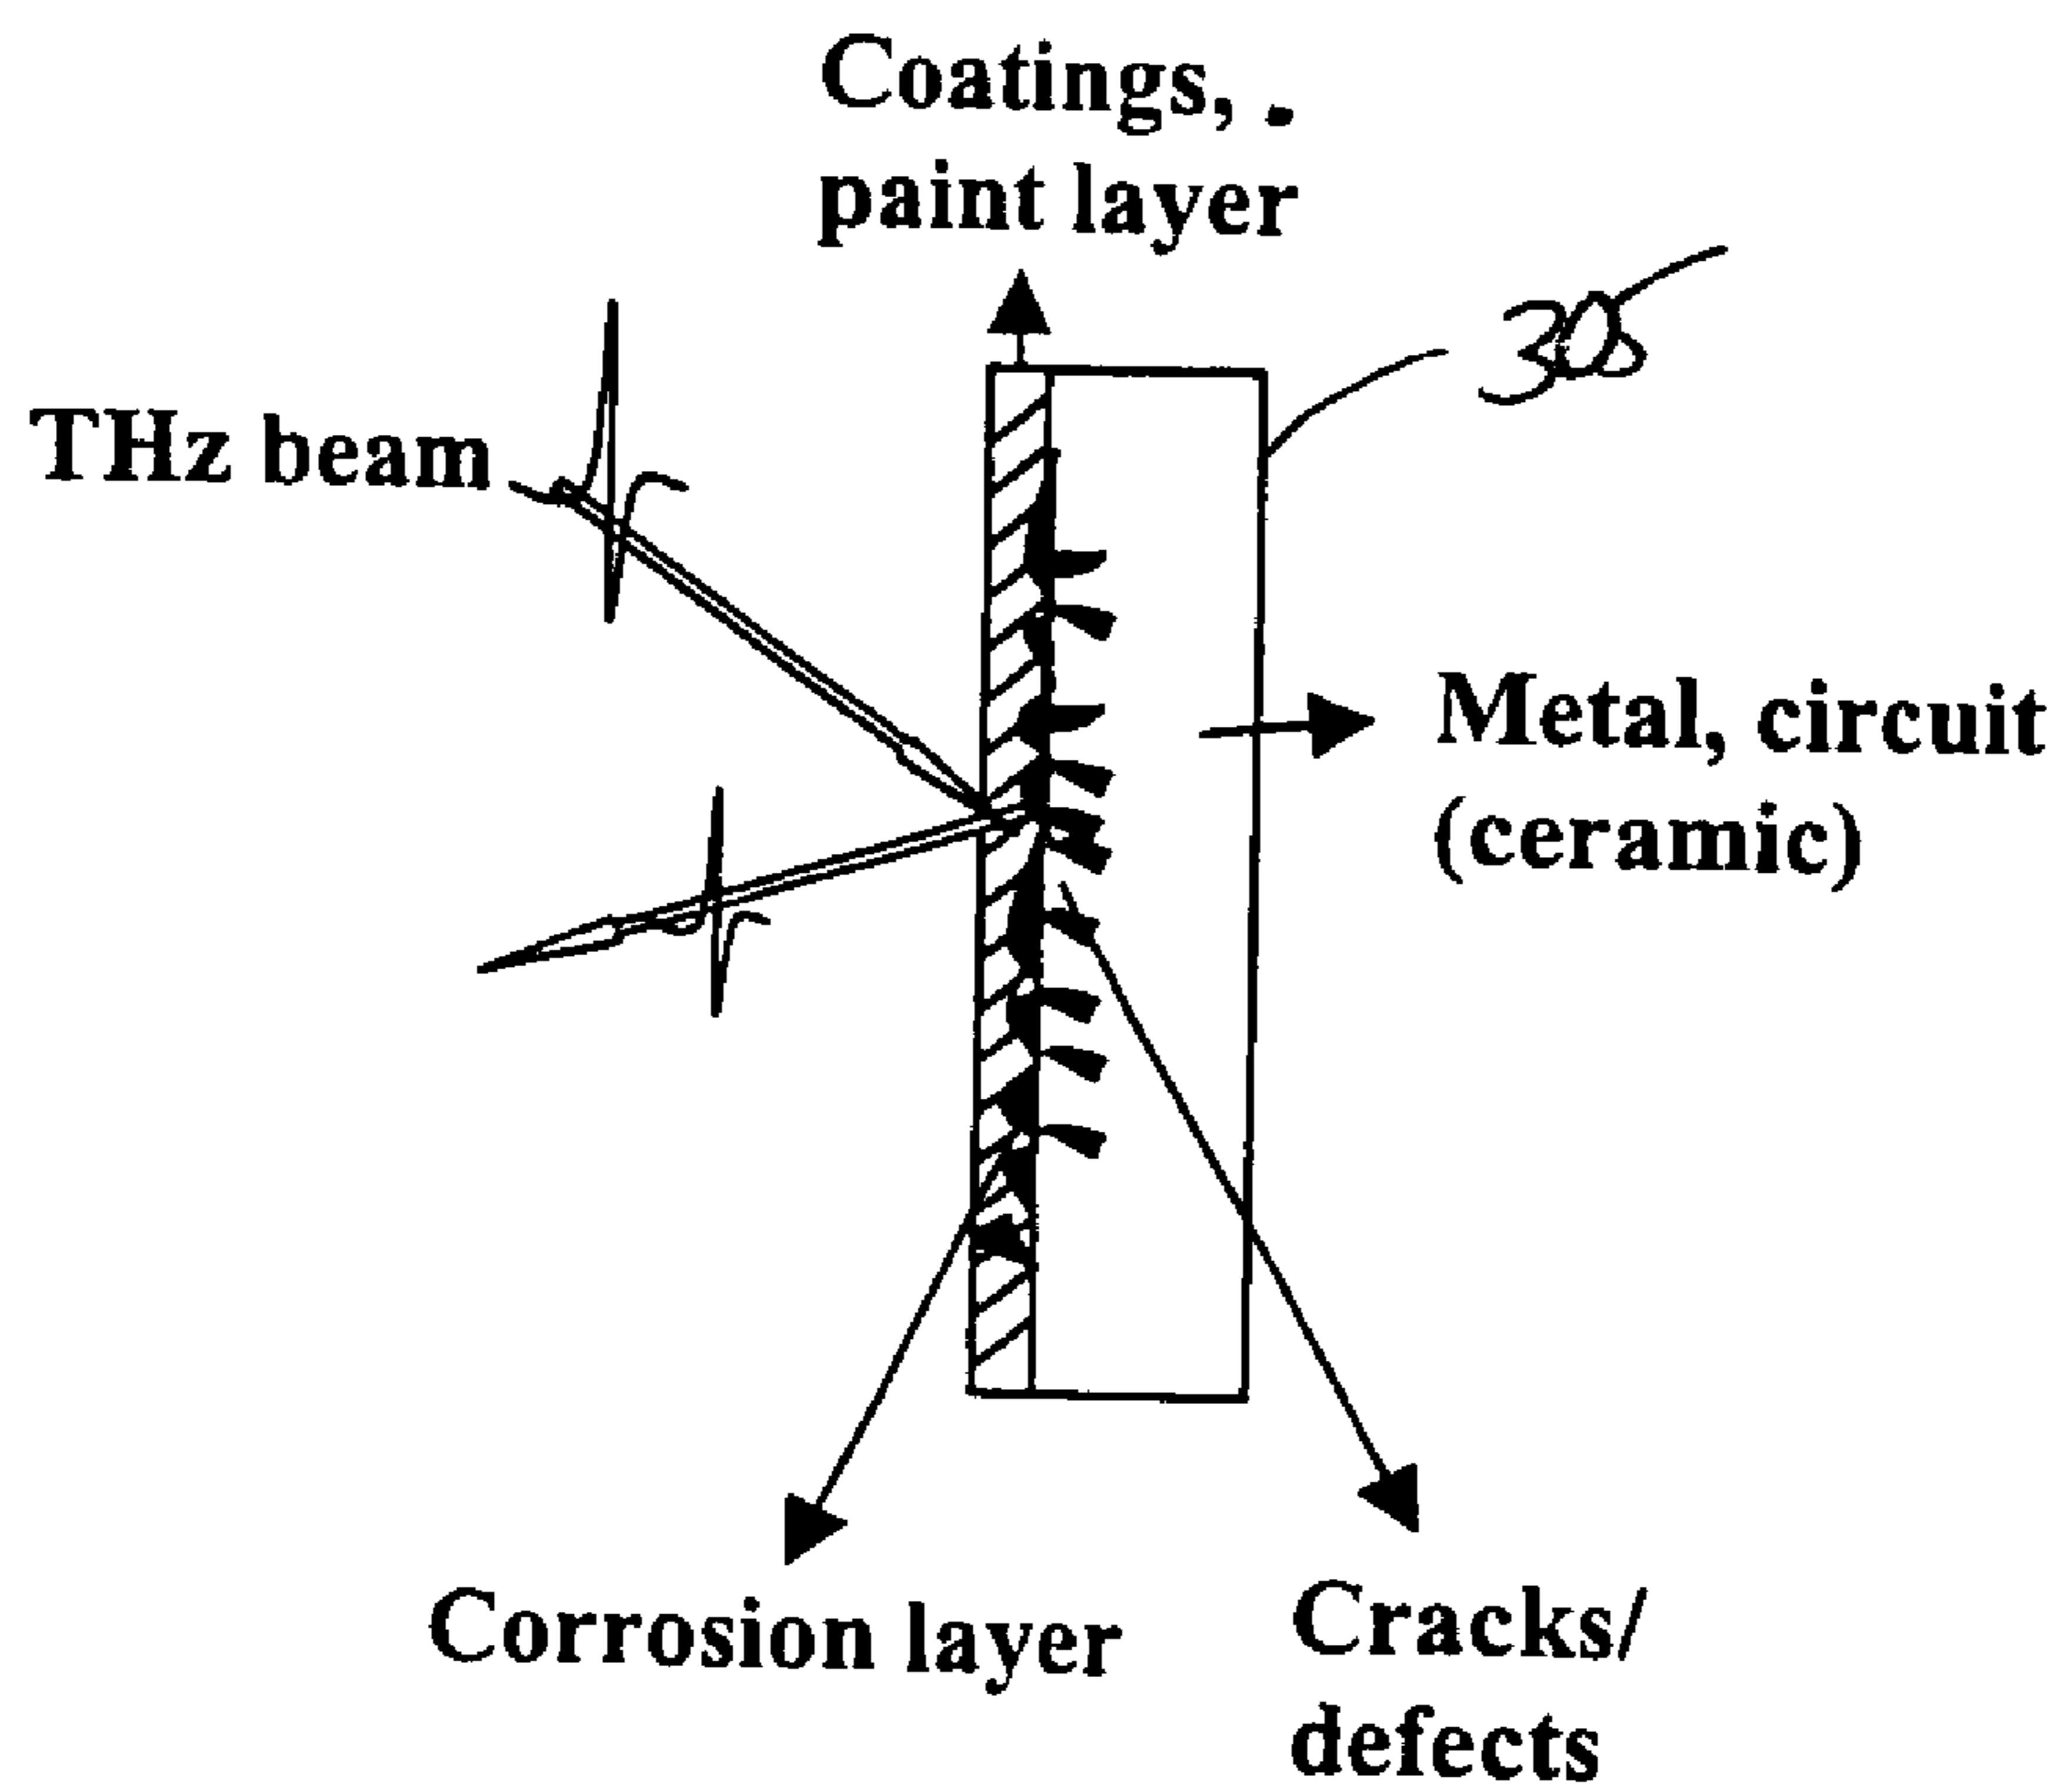
[0027] FIG. 4 is a cross-sectional view of a sample deposited on a polyethylene substrate to measure an optical transmission of a paint system according to the second embodiment of the present invention;

[0057] **FIG. 4** is a cross-sectional view of a sample deposited on a polyethylene substrate to measure an optical transmission of a paint system according to the second embodiment of the present invention. Referring to **FIG. 4**, the THz light focused to a diffraction-limited spot on the sample **305**, and the reflected THz waveforms are acquired and processed in real time at each point of the sample. Preferably, the sample is scanned in x and y directions at a rate of approximately 10-20 pixels/s to form an image in the computer **172**. By analyzing the temporal waveform reflected from the sample **305** at every pixel of the object in real time, information on the surface of the sample **305** can be inferred in many cases. Information under coatings of circuit boards, computer chips, bridges, boats, etc., about defects can be obtained using THz-TDS.

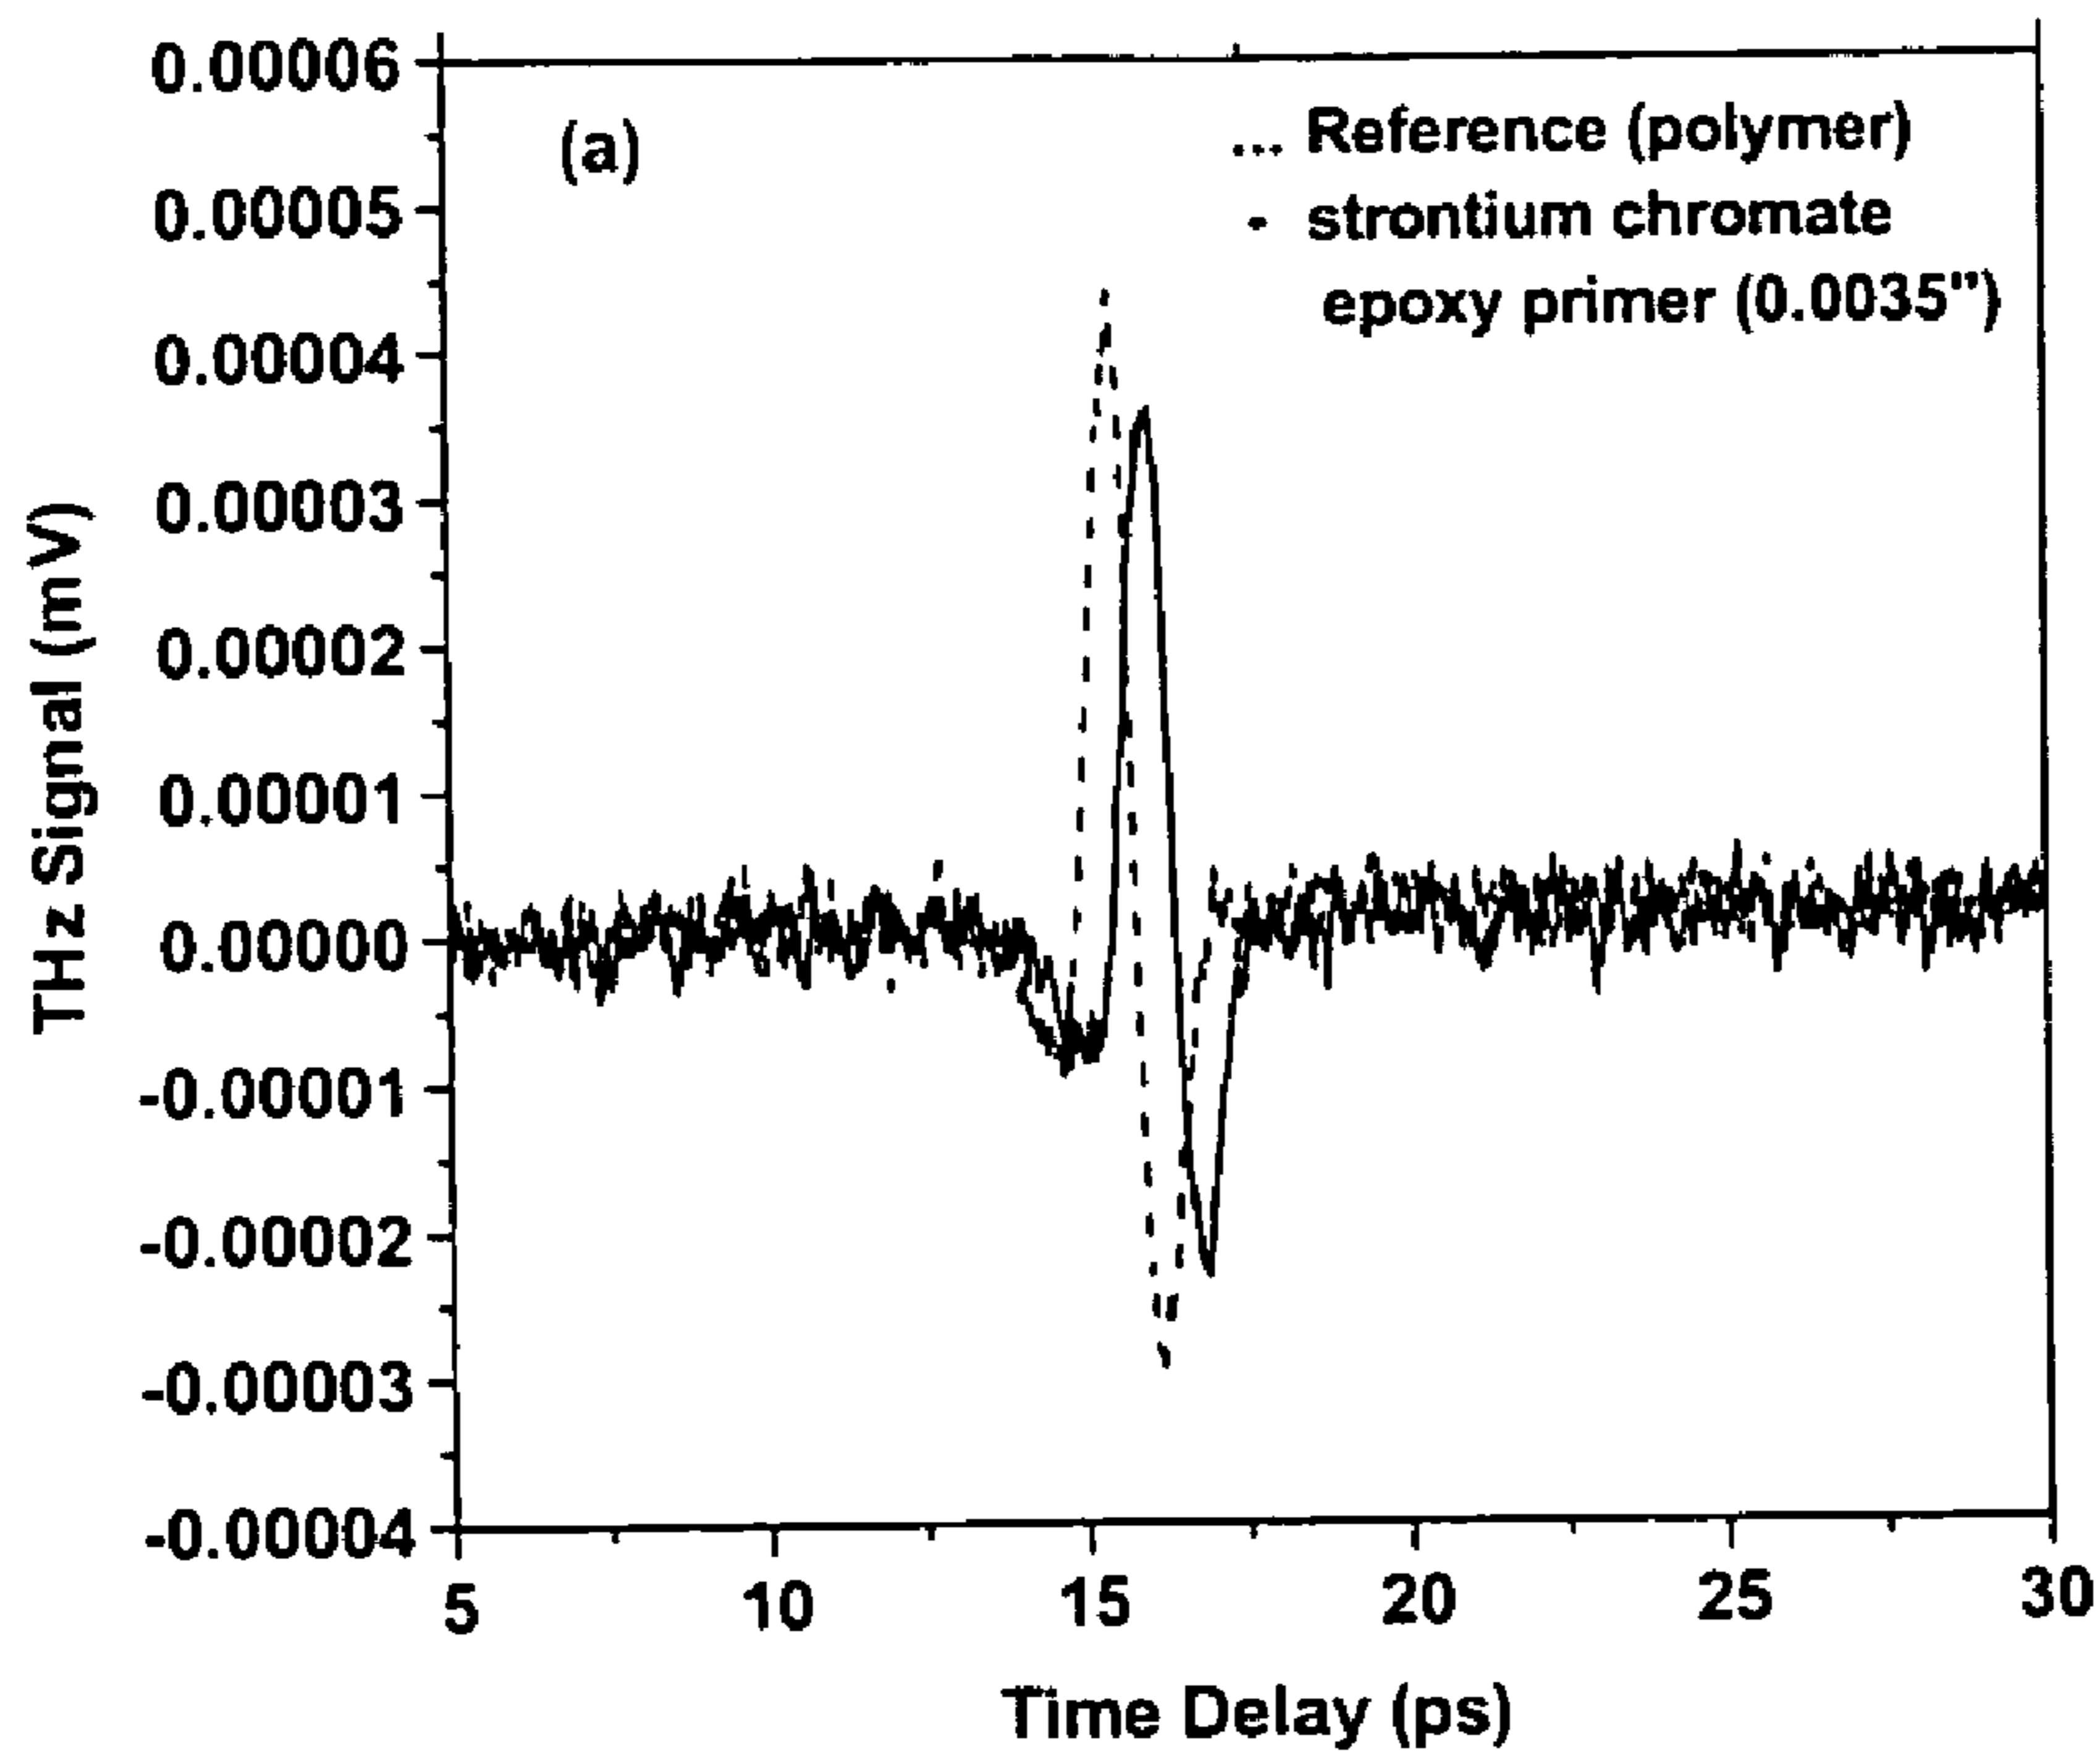
[0028] FIG. 5 is a graph illustrating THz temporal profiles of strontium chromate epoxy primer (Mil-P-23377) after passing through a pure polymer polyethylene substrate as reference;

[0059] **FIG. 5** is a graph illustrating the THz temporal profiles of strontium chromate epoxy primer (Mil-P-23377) after passing through a pure polymer polyethylene substrate as reference.

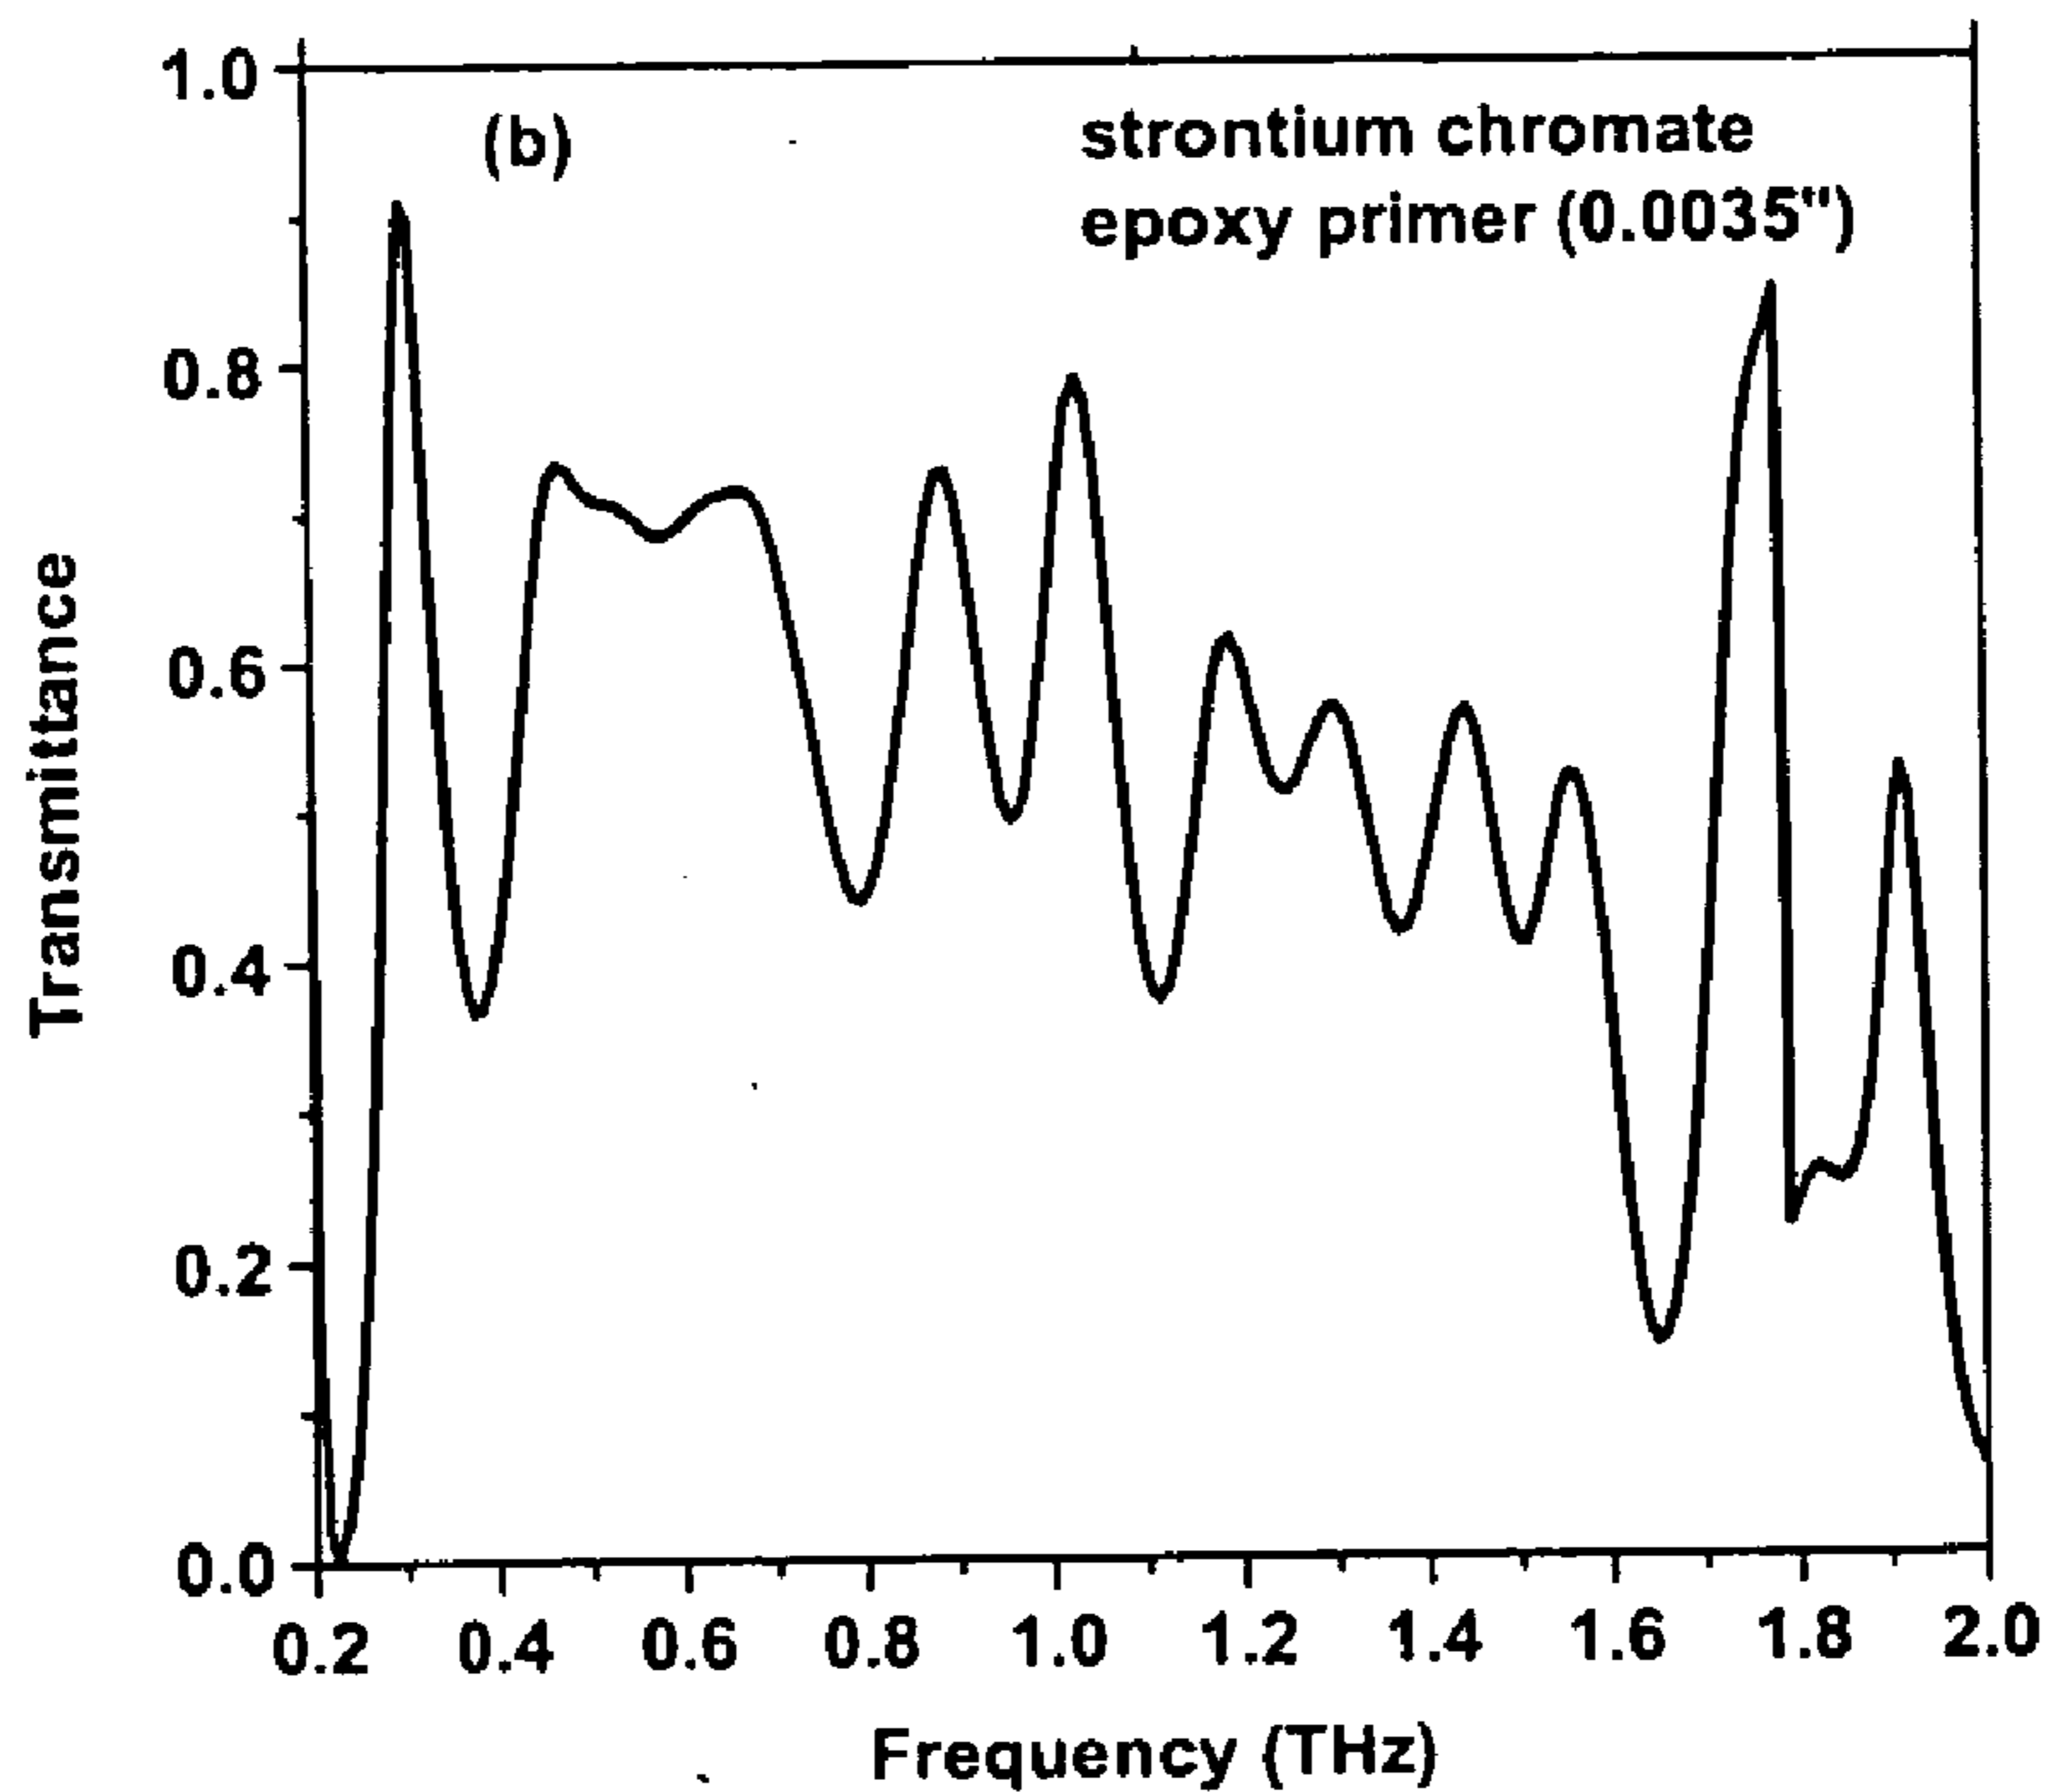
[0029] FIG. 6 is a graph illustrating THz transmitted profiles through a primer;

[0060] **FIG. 6** is a graph illustrating the THz transmitted profiles through primer layer. The transmission through the paint is more than 40%.
