US 20050098728A1

(10) **Pub. No.: US 2005/0098728 A1**

(54) **SYSTEMS AND METHODS FOR  
NON-DESTRUCTIVELY DETECTING  
MATERIAL ABNORMALITIES BENEATH A  
COATED SURFACE**

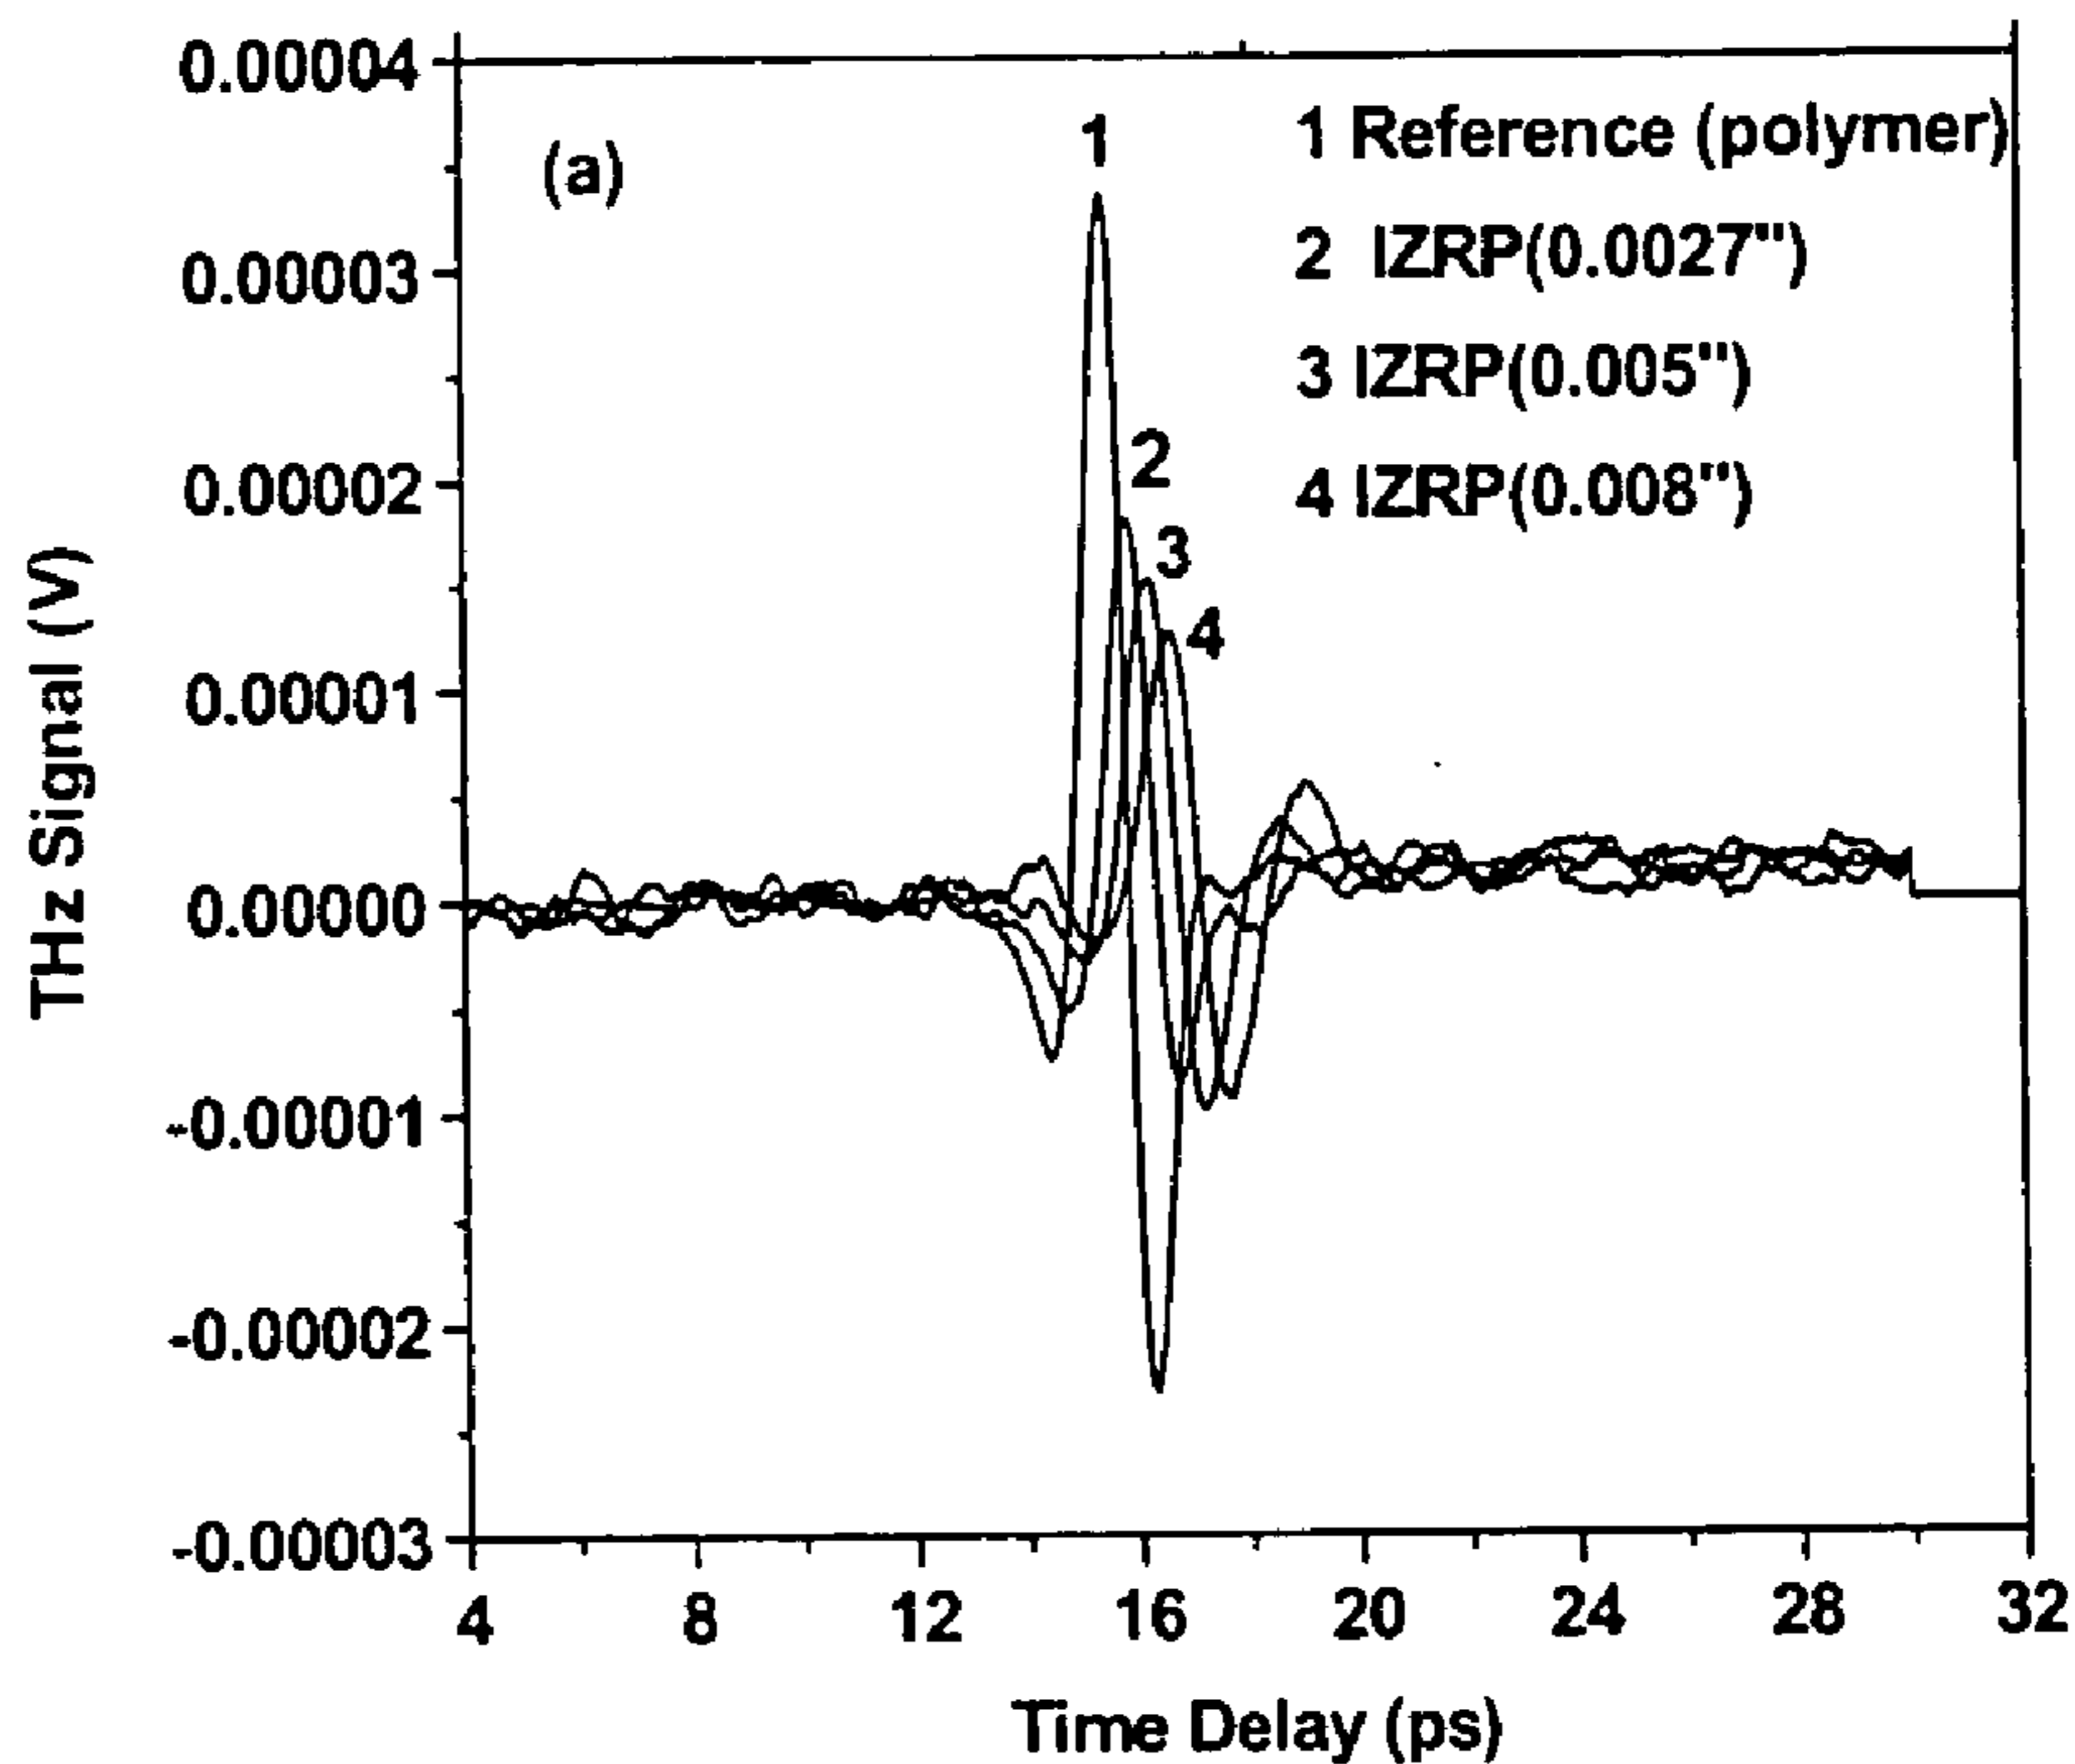
[0030] FIG. 7 is a graph illustrating THz temporal profiles of inorganic zinc rich primer (Dimetcote D9 HS) after passing through a pure polymer polyethylene substrate as reference;

[0061] **FIG. 7** is a graph illustrating the THz temporal profiles of inorganic zinc rich primer (Dimetcote D9 HS) after passing through a pure polymer polyethylene substrate as reference. The thickness of the primers are 0.0027", 0.005" and 0.008", respectively.

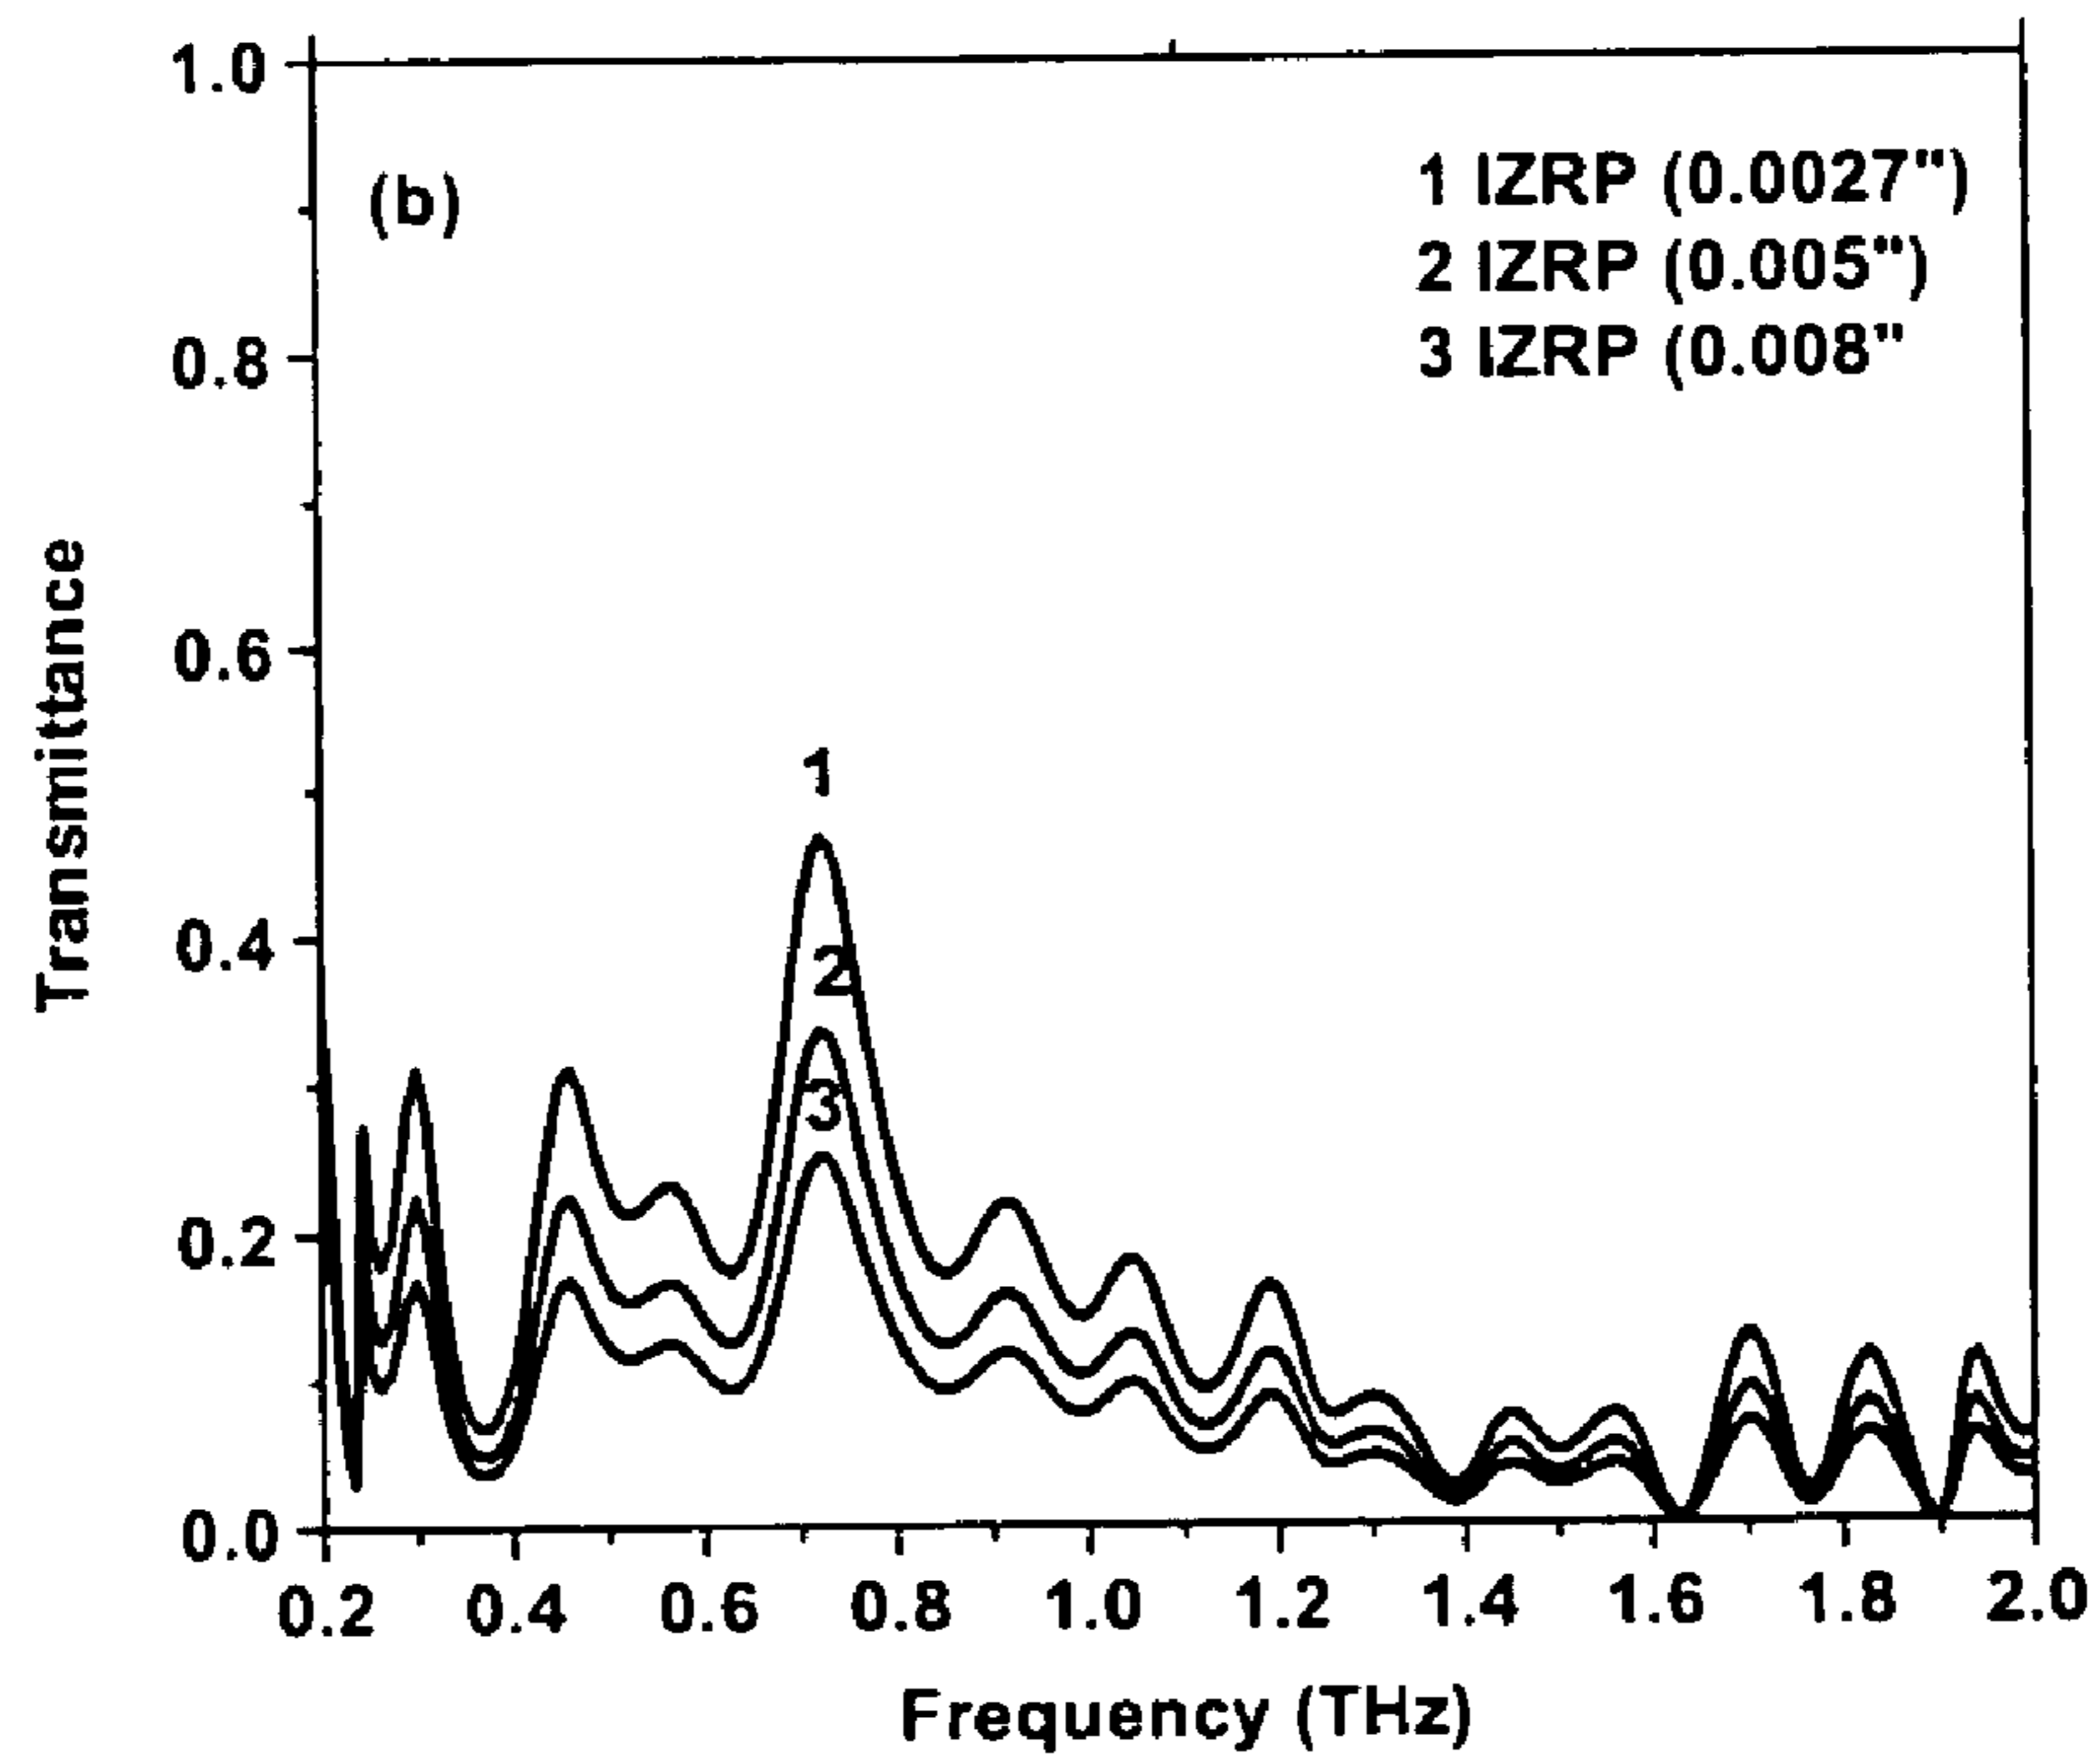
[0031] FIG. 8 is a graph illustrating THz transmitted profiles through primer films with different thickness in the frequency range 0.2 to 2.0 THz;

[0062] **FIG. 8** is a graph illustrating the THz transmitted profiles through primer films with different thickness in the frequency range 0.2 to 2.0 THz. At 0.7 THz, the transmission is more than 20%.

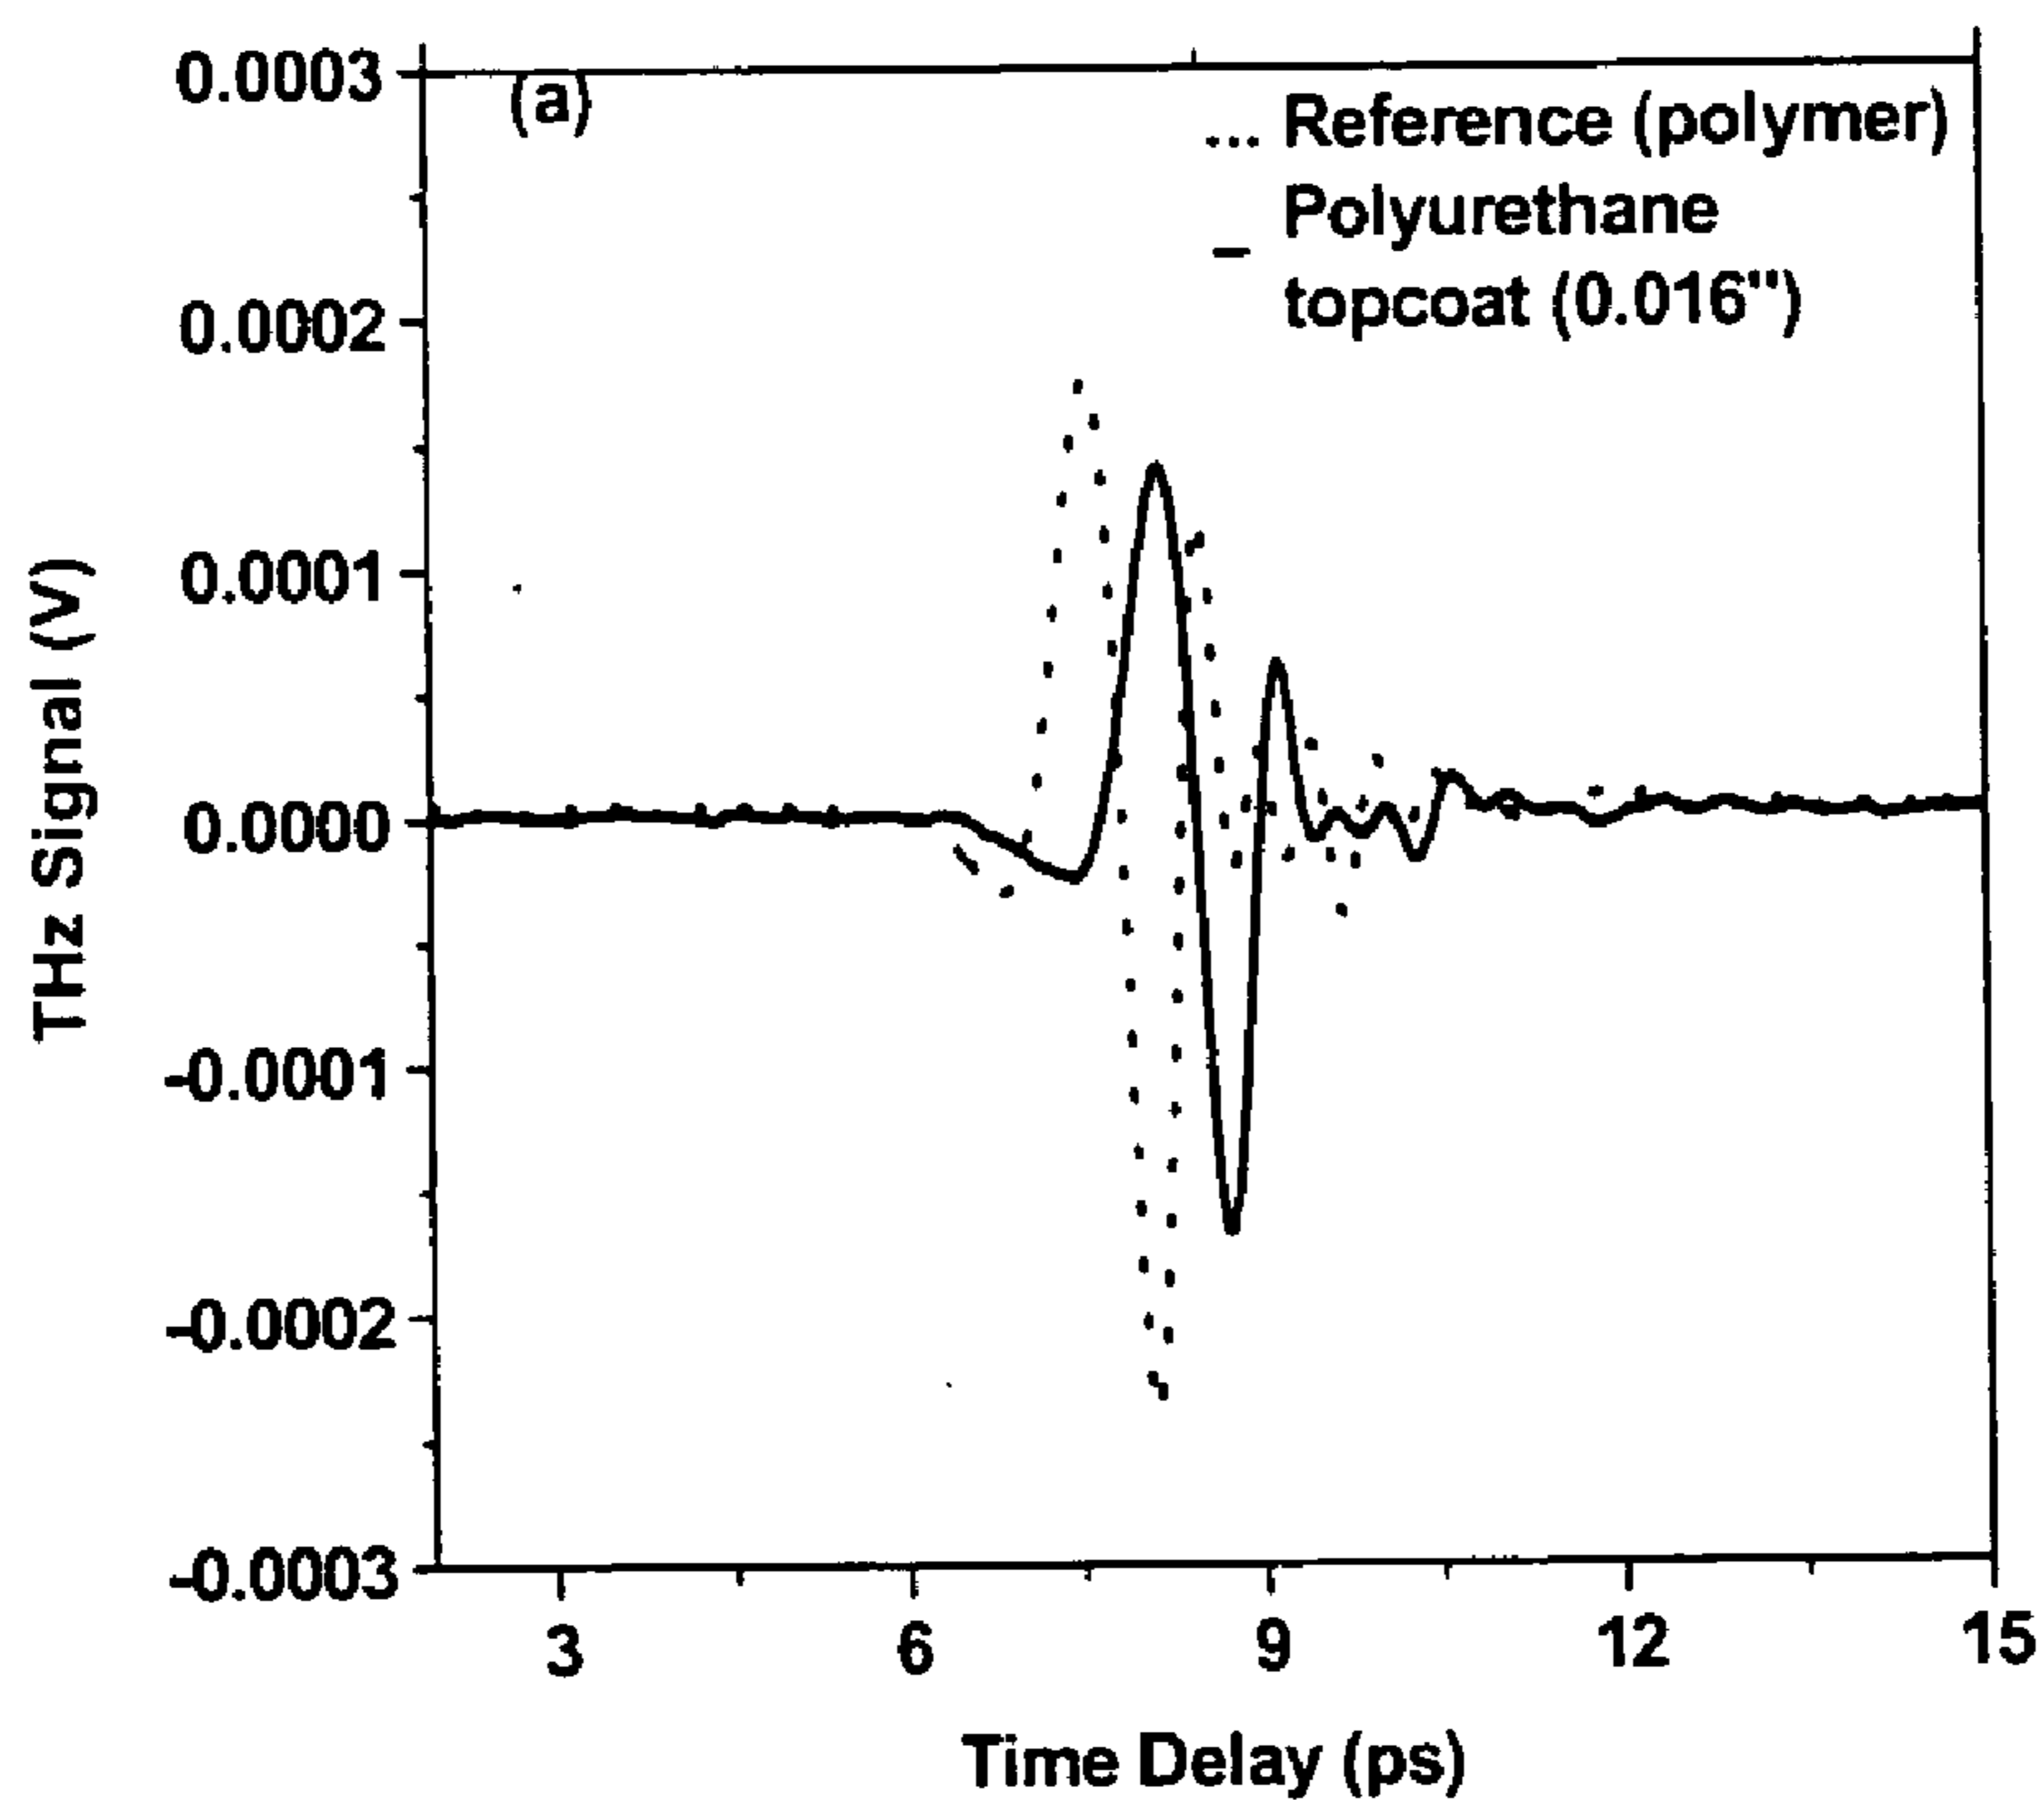
[0032] FIG. 9 is a graph illustrating THz temporal profiles for polymer polyurethane topcoat (Mil-PRF-85285, type I color 35237 blue) (0.016") (#31);

[0063] **FIG. 9** is a graph illustrating the THz temporal profiles for polymer polyurethane topcoat (Mil-PRF-85285, type I color 35237 blue) (0.016") (#31).

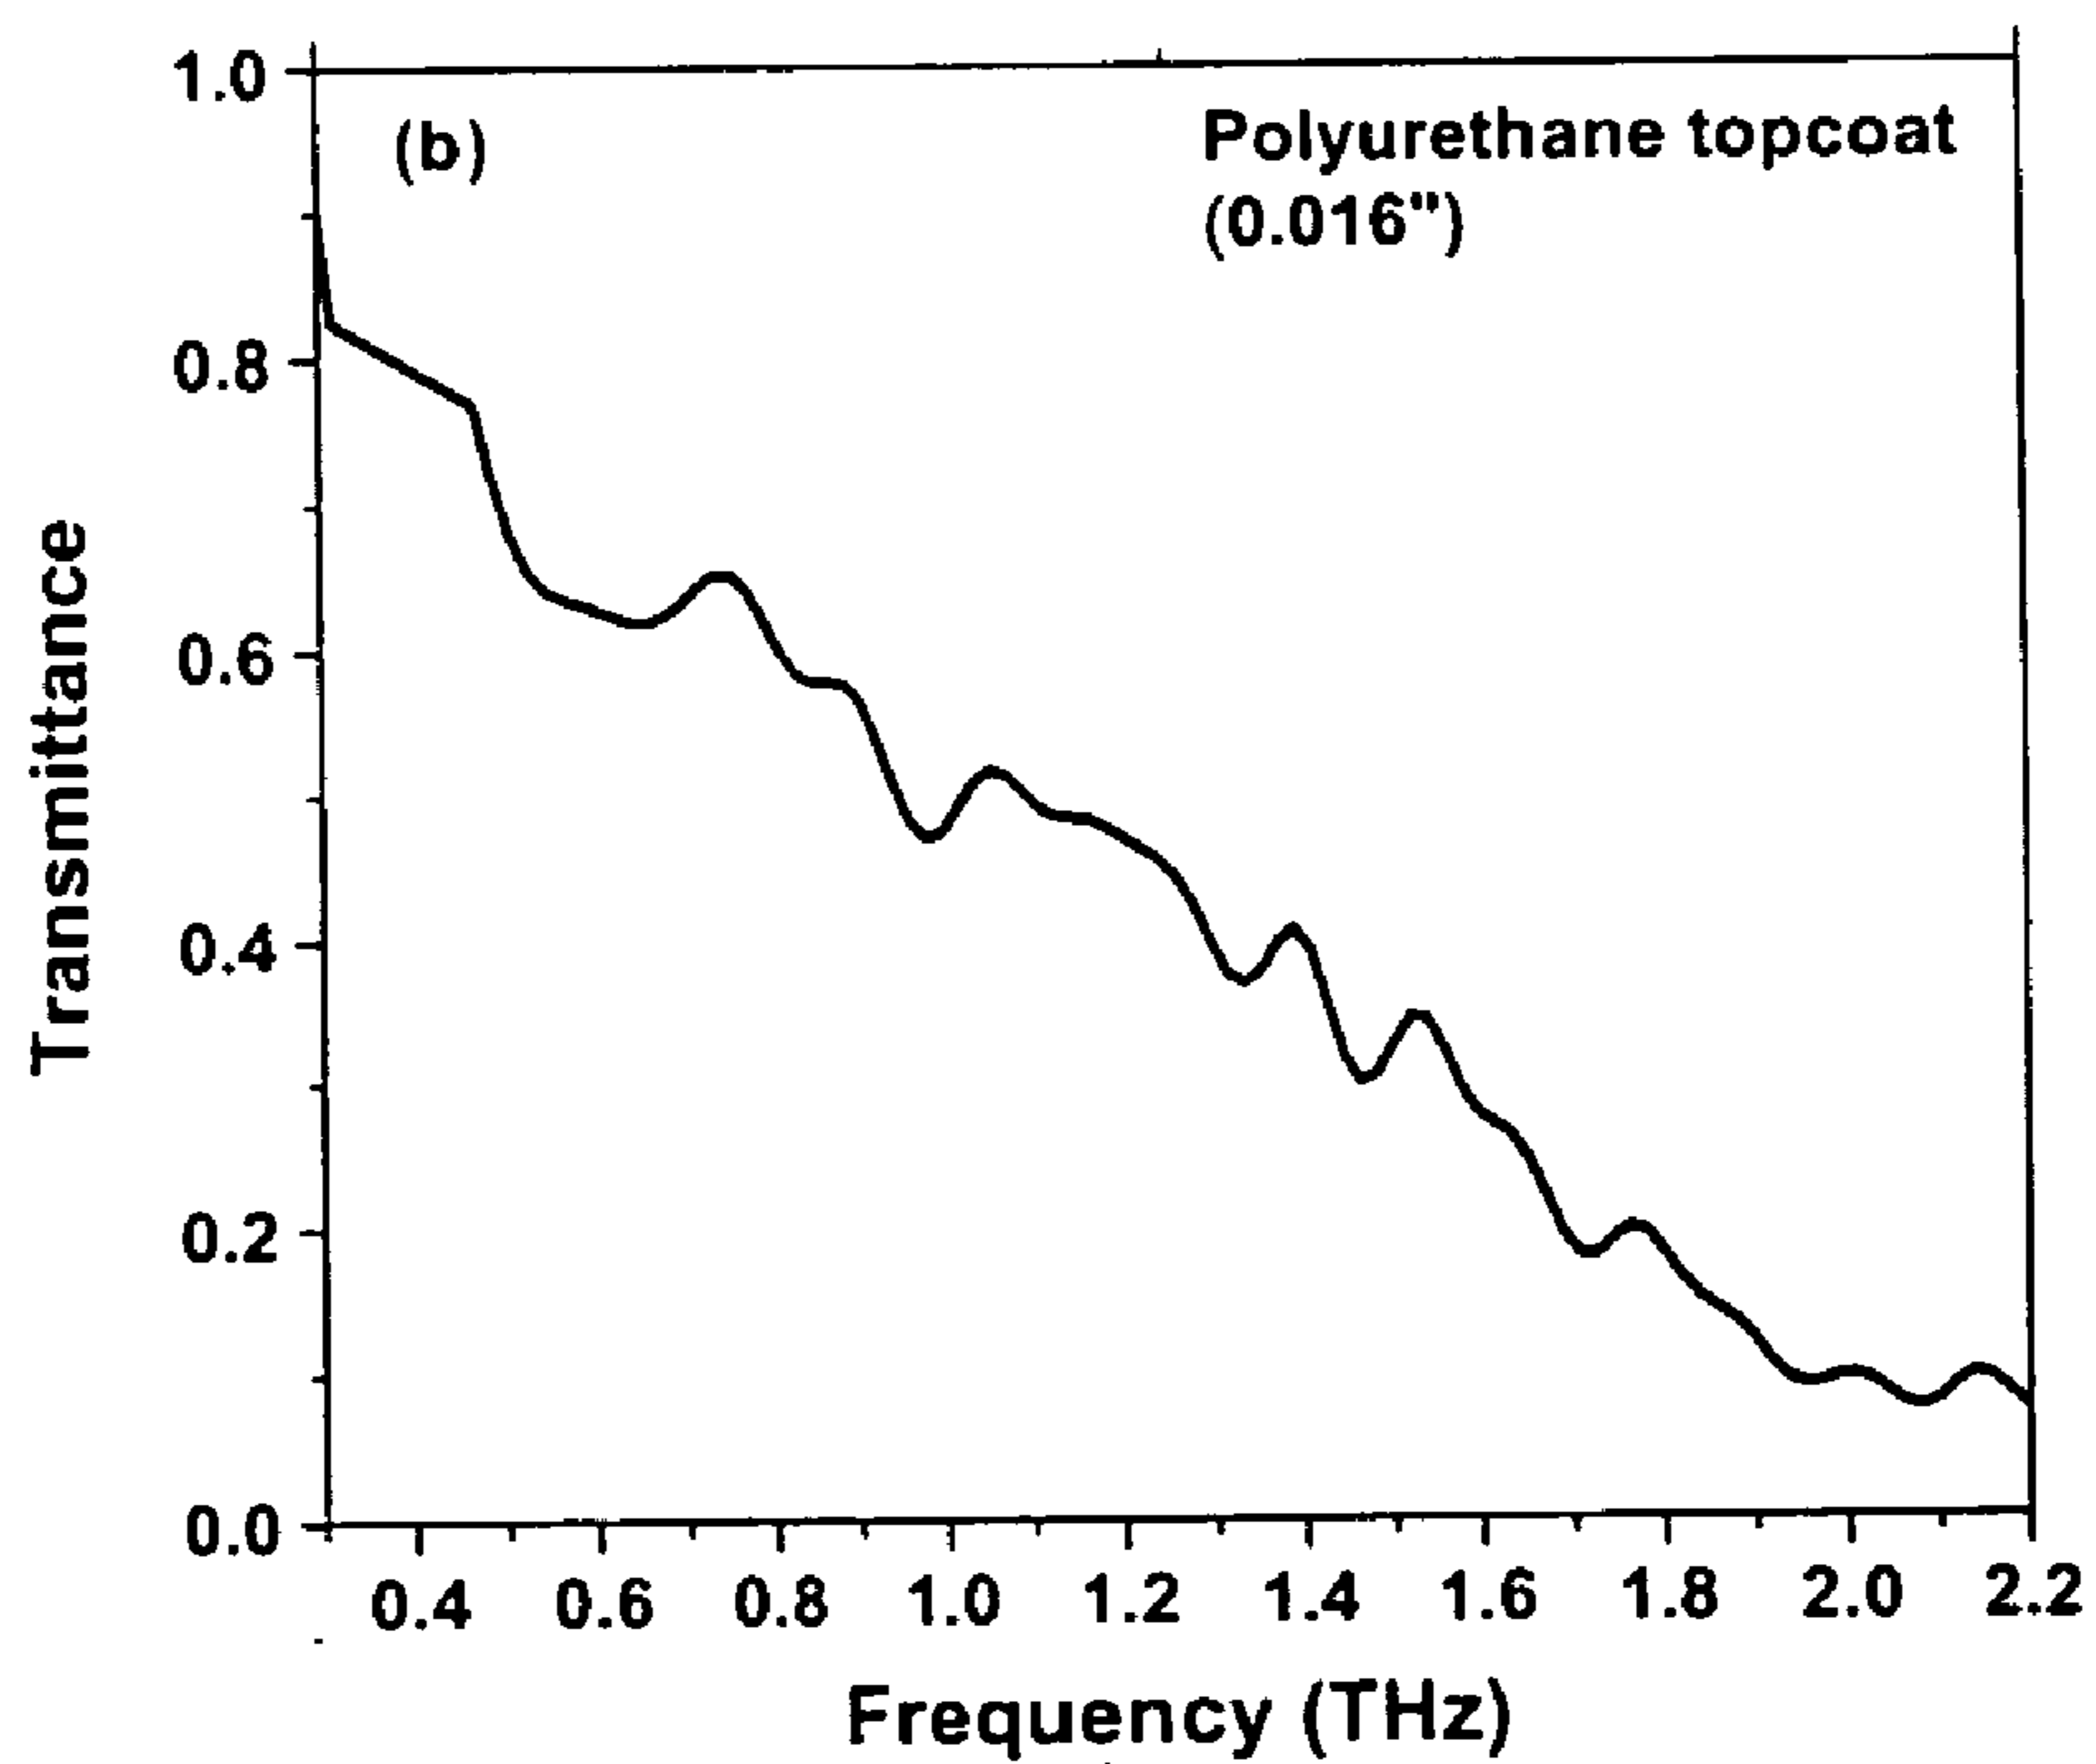
[0033] FIG. 10 is a graph illustrating a transmittance curve of a polyurethane topcoat (Mil-PRF-85285, type I color 35237 blue) in the frequency range 0.2-2.3 THz.

[0064] **FIG. 10** is a graph illustrating the transmittance curve of polyurethane topcoat (Mil-PRF-85285, type I color 35237 blue) in the frequency range 0.2-2.3 THz. The transmission through the coating is from 20% to 80%.
