[54] **METHOD AND MEANS FOR DETECTING AN OUTGOING FAILURE IN A BIDIRECTIONAL COMMUNICATIONS SPAN AND LOOPING THE SAME IN RESPONSE THERETO**

[73] Assignee: Lynch Communication Systems, Reno, Nev.

[57] **ABSTRACT**

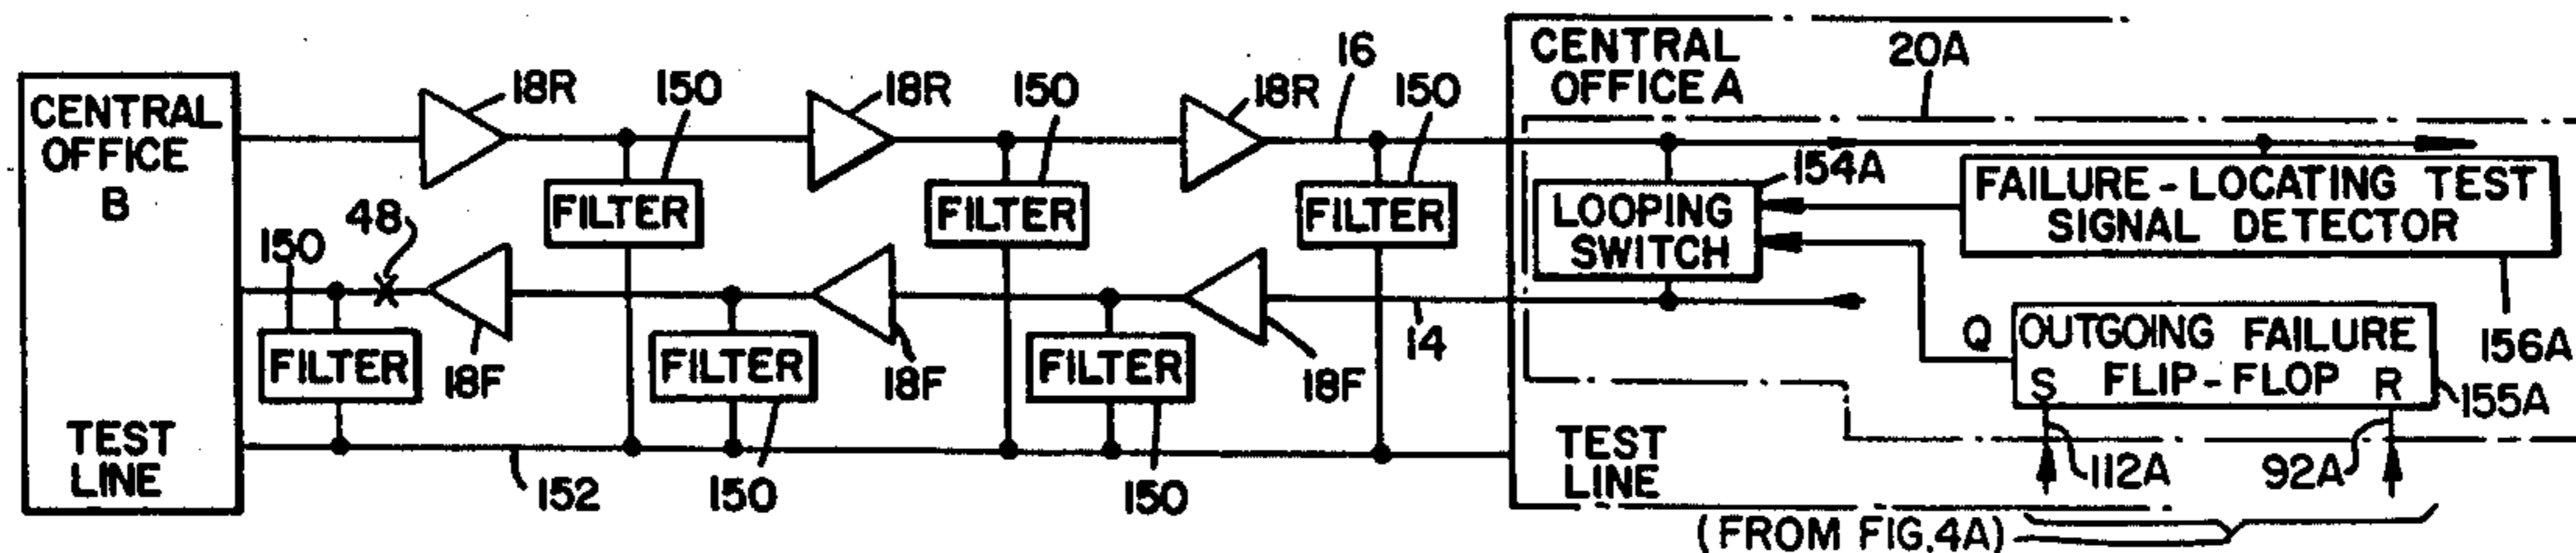
An automatic span line switch for PCM communication lines is disclosed which isolates alarm conditions to an actual span line failure, as distinguished from failures in the terminal equipment. In addition, the switch uses a specific code transmission to provide fast switching and to permit identification of the direction of failure. Although the circuit is capable of switching span segments individually and independently, it can transmit an alarm to a distant central office and automatically establish an appropriate test loop in the presence of test transmissions when needed to permit single-end troubleshooting. The switch further tests the dead line continuously and stringently for error-free data transmission, and automatically resets without disturbing traffic when the trouble has been corrected. An extremely flexible priority system for selected channels is also provided, and the circuitry on both ends of all channels (including the protective channel) is identical to minimize parts inventory costs.

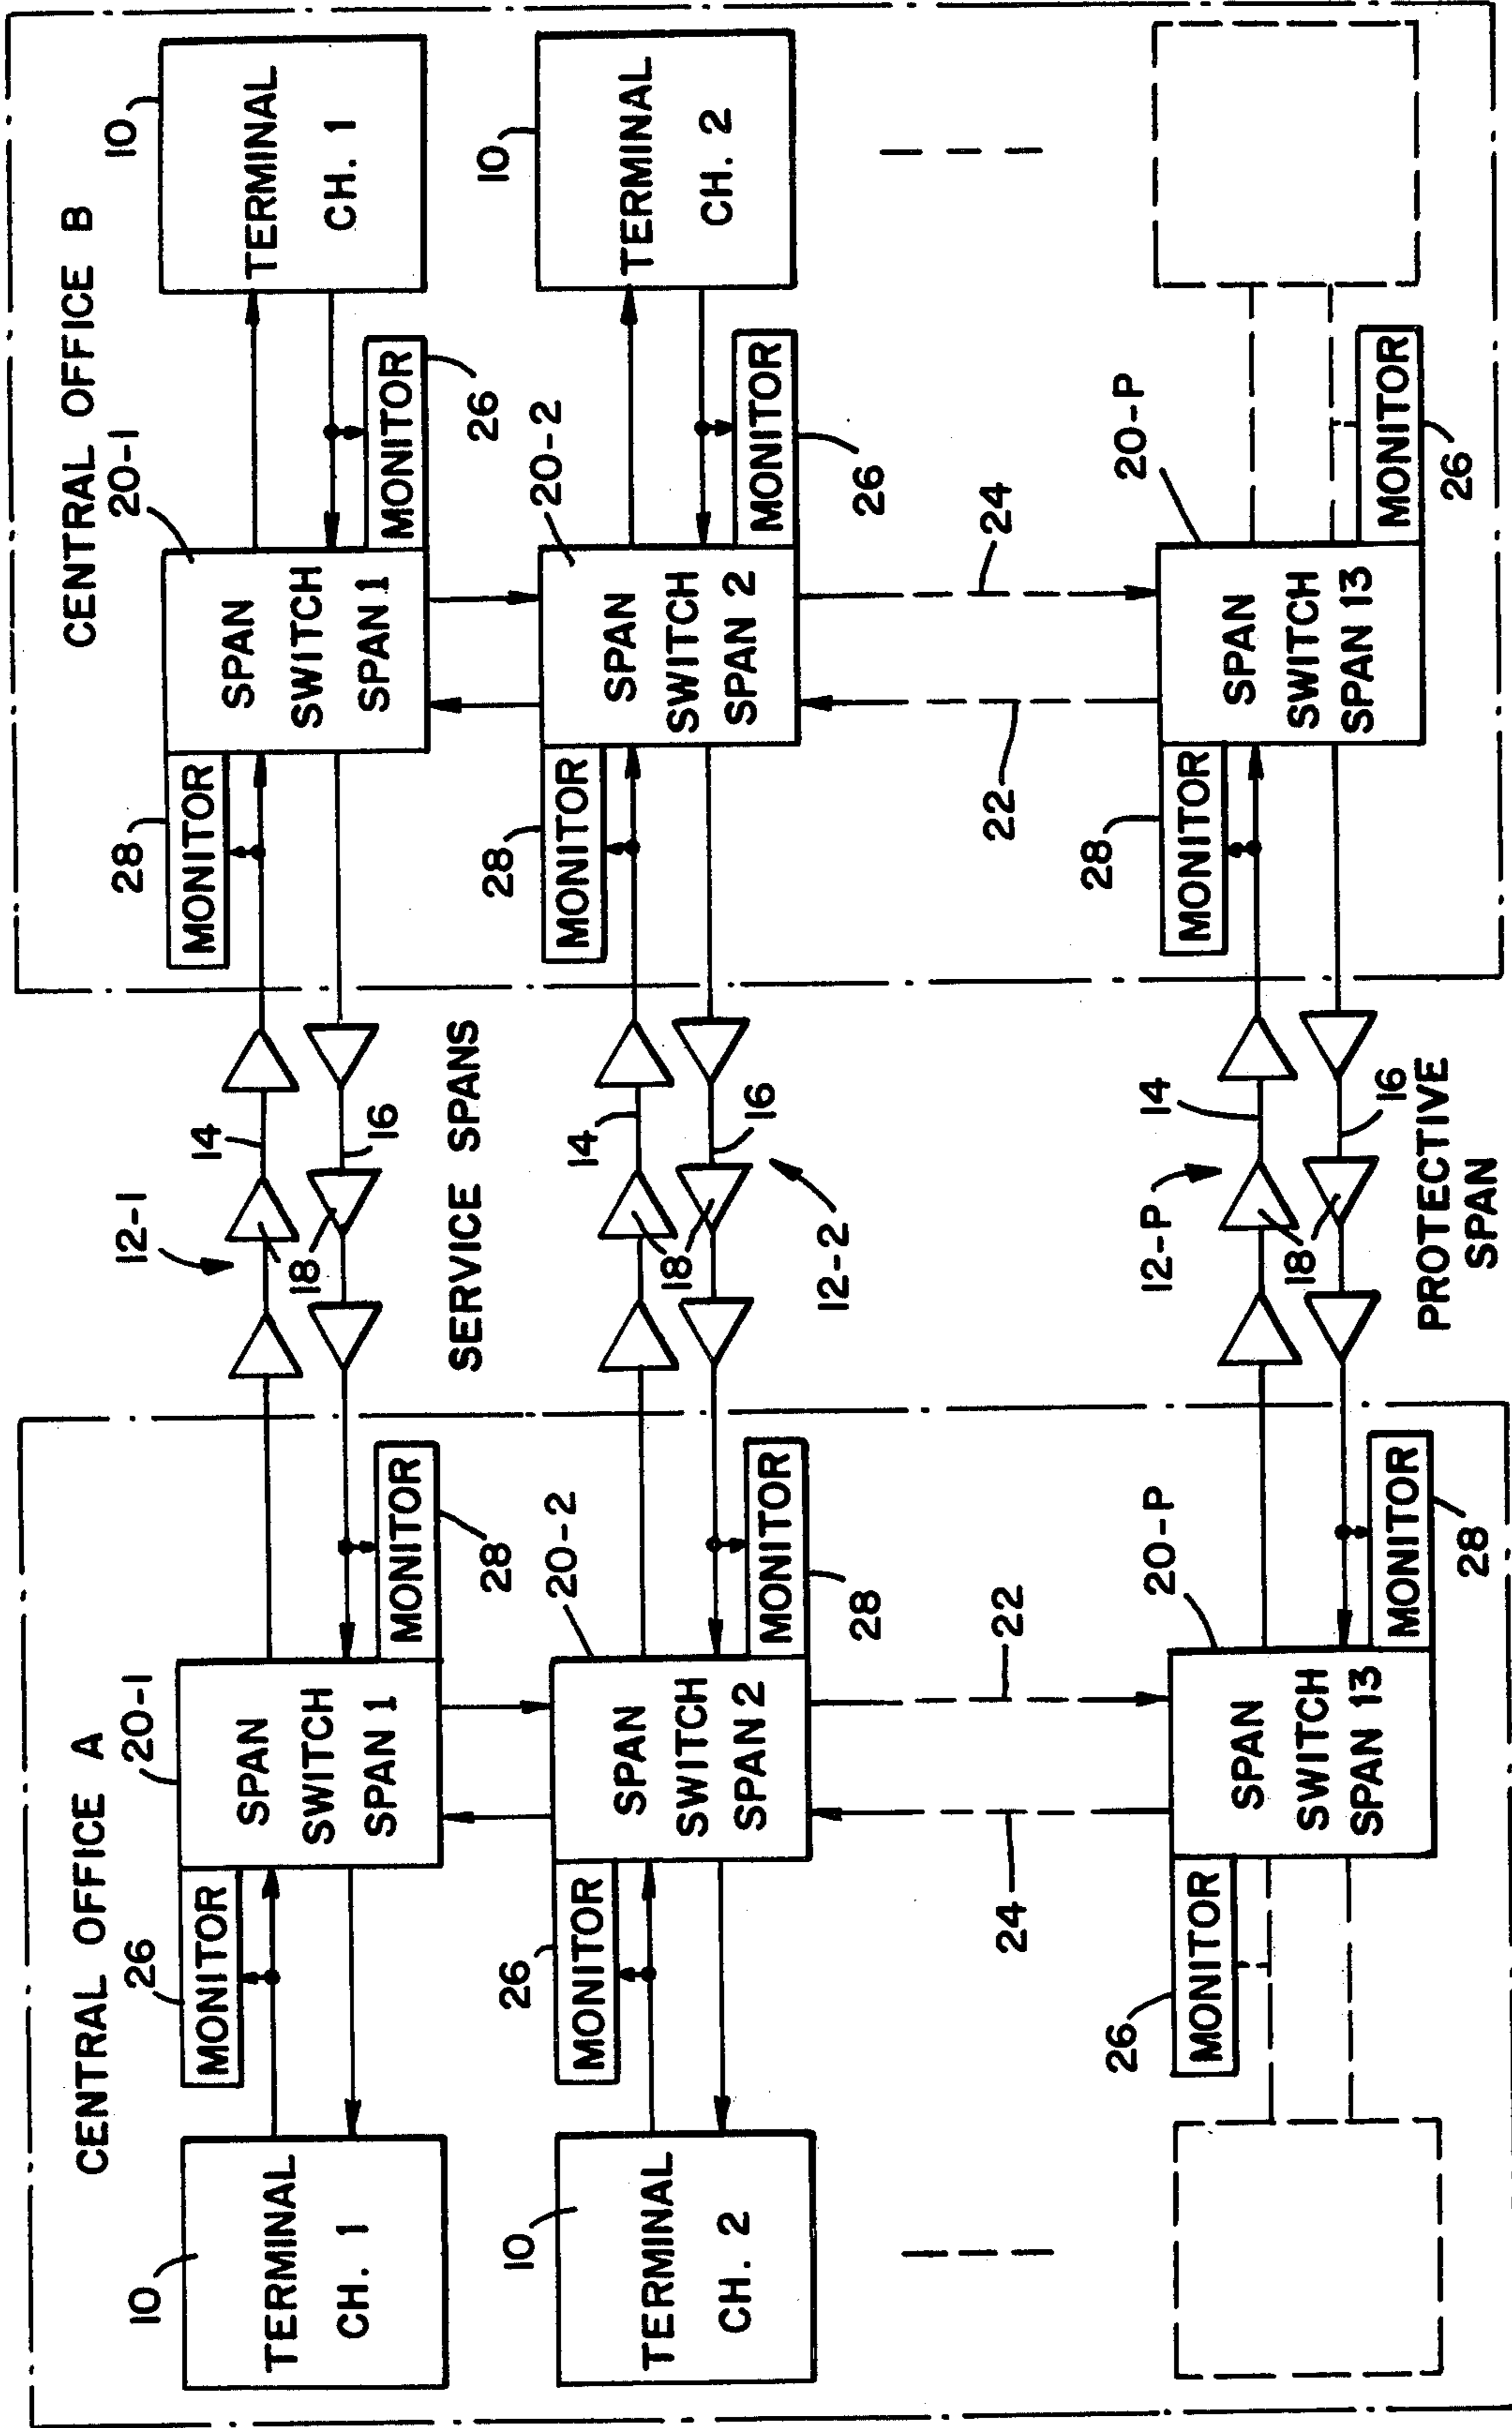
FIG - 1

FIG. 1 is a schematic representation illustrating the environment in which the device of the invention is used;

FIG. 1 shows the environment in which the device of this invention is used. A pair of central offices A and B each have a plurality of terminals 10 containing channel equipment of an appropriate type, the exact nature of which is not material to this invention. Suffice it to say that the channel equipment transmits and receives a PCM signal representative of customer traffic, the PCM signal being commonly in bipolar format and having a pulse rate of 1.544 MHz. The channel equipment typically goes into a local alarm mode if it fails to receive an intelligible PCM signal with proper framing pulses for 350 milliseconds.

The central offices are connected by repeatered service spans 12-1, 12-2, etc. one for each channel. Customarily, there are 24 voice channels to a terminal and the invention described operates with from 1 to 24 such terminals. With a single shelf, as described herein, the invention protects up to 12 such terminals. Each span 12 is made up of a forward line 14 (forward, for the purposes of this specification, being defined as the direction from A to B) and a return line 16 (the signal path from B to A), both being equipped with repeaters 18.

For the purposes of the invention, a thirteenth span, the protective span 12-P, is added between the central offices A and B, and in each central office, span switches 20-1, 20-2, etc. are interposed, respectively, between each terminal 10 and the span associated therewith. The span switch 20-P associated with the protective span 12-P is not normally connected to any terminal 10, although there is no technical reason why the protective span could not also be used as a service span for an extra low-priority channel (dotted-line equipment in FIG. 1) when it is not being used for protection of a service span. The span switches 20 at each central office are interconnected by a forward transfer bus 22 and a return transfer bus 24.

As will be described more in detail hereinafter, each span switch 20 has, as an integral part thereof, a pair of monitoring units 26 and 28. The monitoring units 26 monitor the incoming signal from the channel equipment in terminals 10 and inject a steady stream of 1

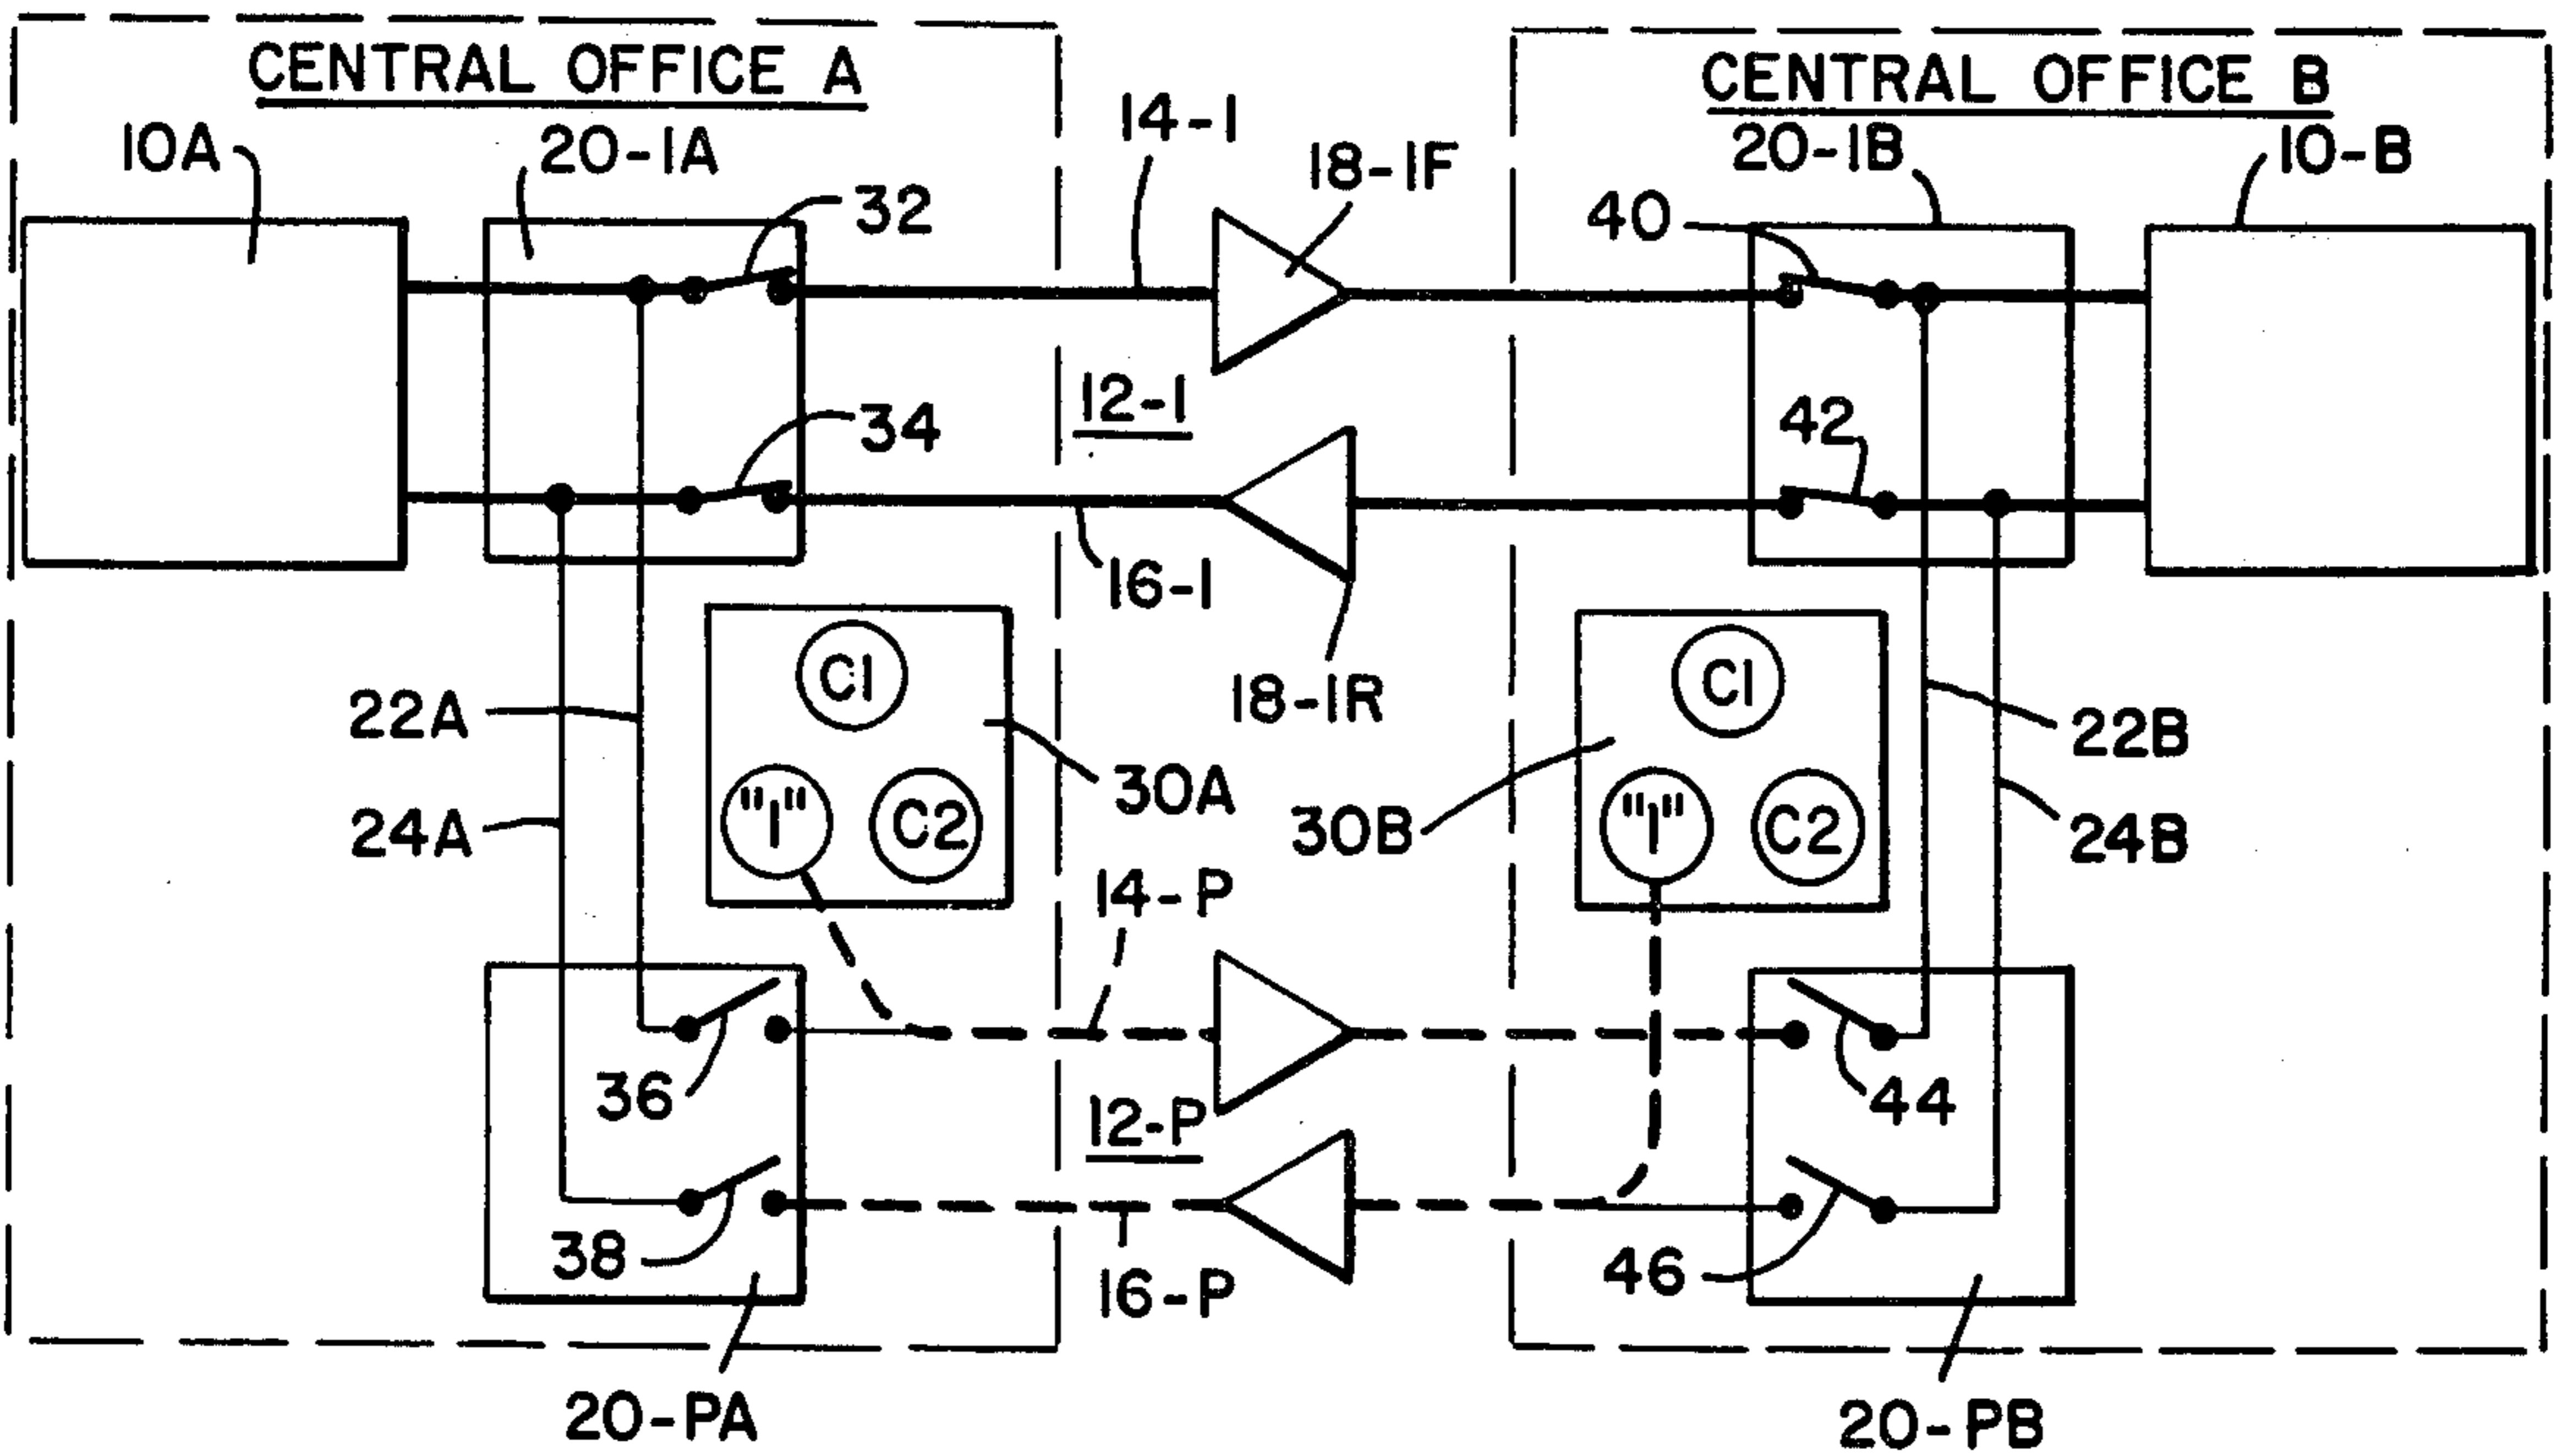
FIG_ 2a

FIG. 2a shows the normal situation with all spans operational. The forward PCM signal from terminal 10A goes through span switch unit 20-1A including closed electronic switch 32, forward span line 14-1 of service span 12-1 including repeater 18-1F, and span switch unit 20-1B including closed electronic switch 40 to terminal 10B. Likewise, the return PCM signal from terminal 10B proceeds to terminal 10A over the return line 16-1 of service span 12-1 and repeater 18-1R by virtue of the closure of electronic switches 34 and 42. At the same time, the code generators 30A and 30B keep the protective span 12-P alive by transmitting a train of 1 pulses from generator 30A over forward line 14-P to the open electronic switch 44, and from generator 30B over return line 16-P to the open electronic switch 38, respectively.

FIG. 2a through FIG. 2f are schematic representations illustrating the sequence of events as the device of the invention copes with a span line failure;

Turning first to FIGS. 2a through 2f, it will be seen that the heart of the inventive device's novel operation is the use of code sequences for transmitting failure, restoration, and switching information between central offices over the failed span itself to provide information not only of the span status but also of the direction in which the failure occurred, for purposes hereinafter explained.

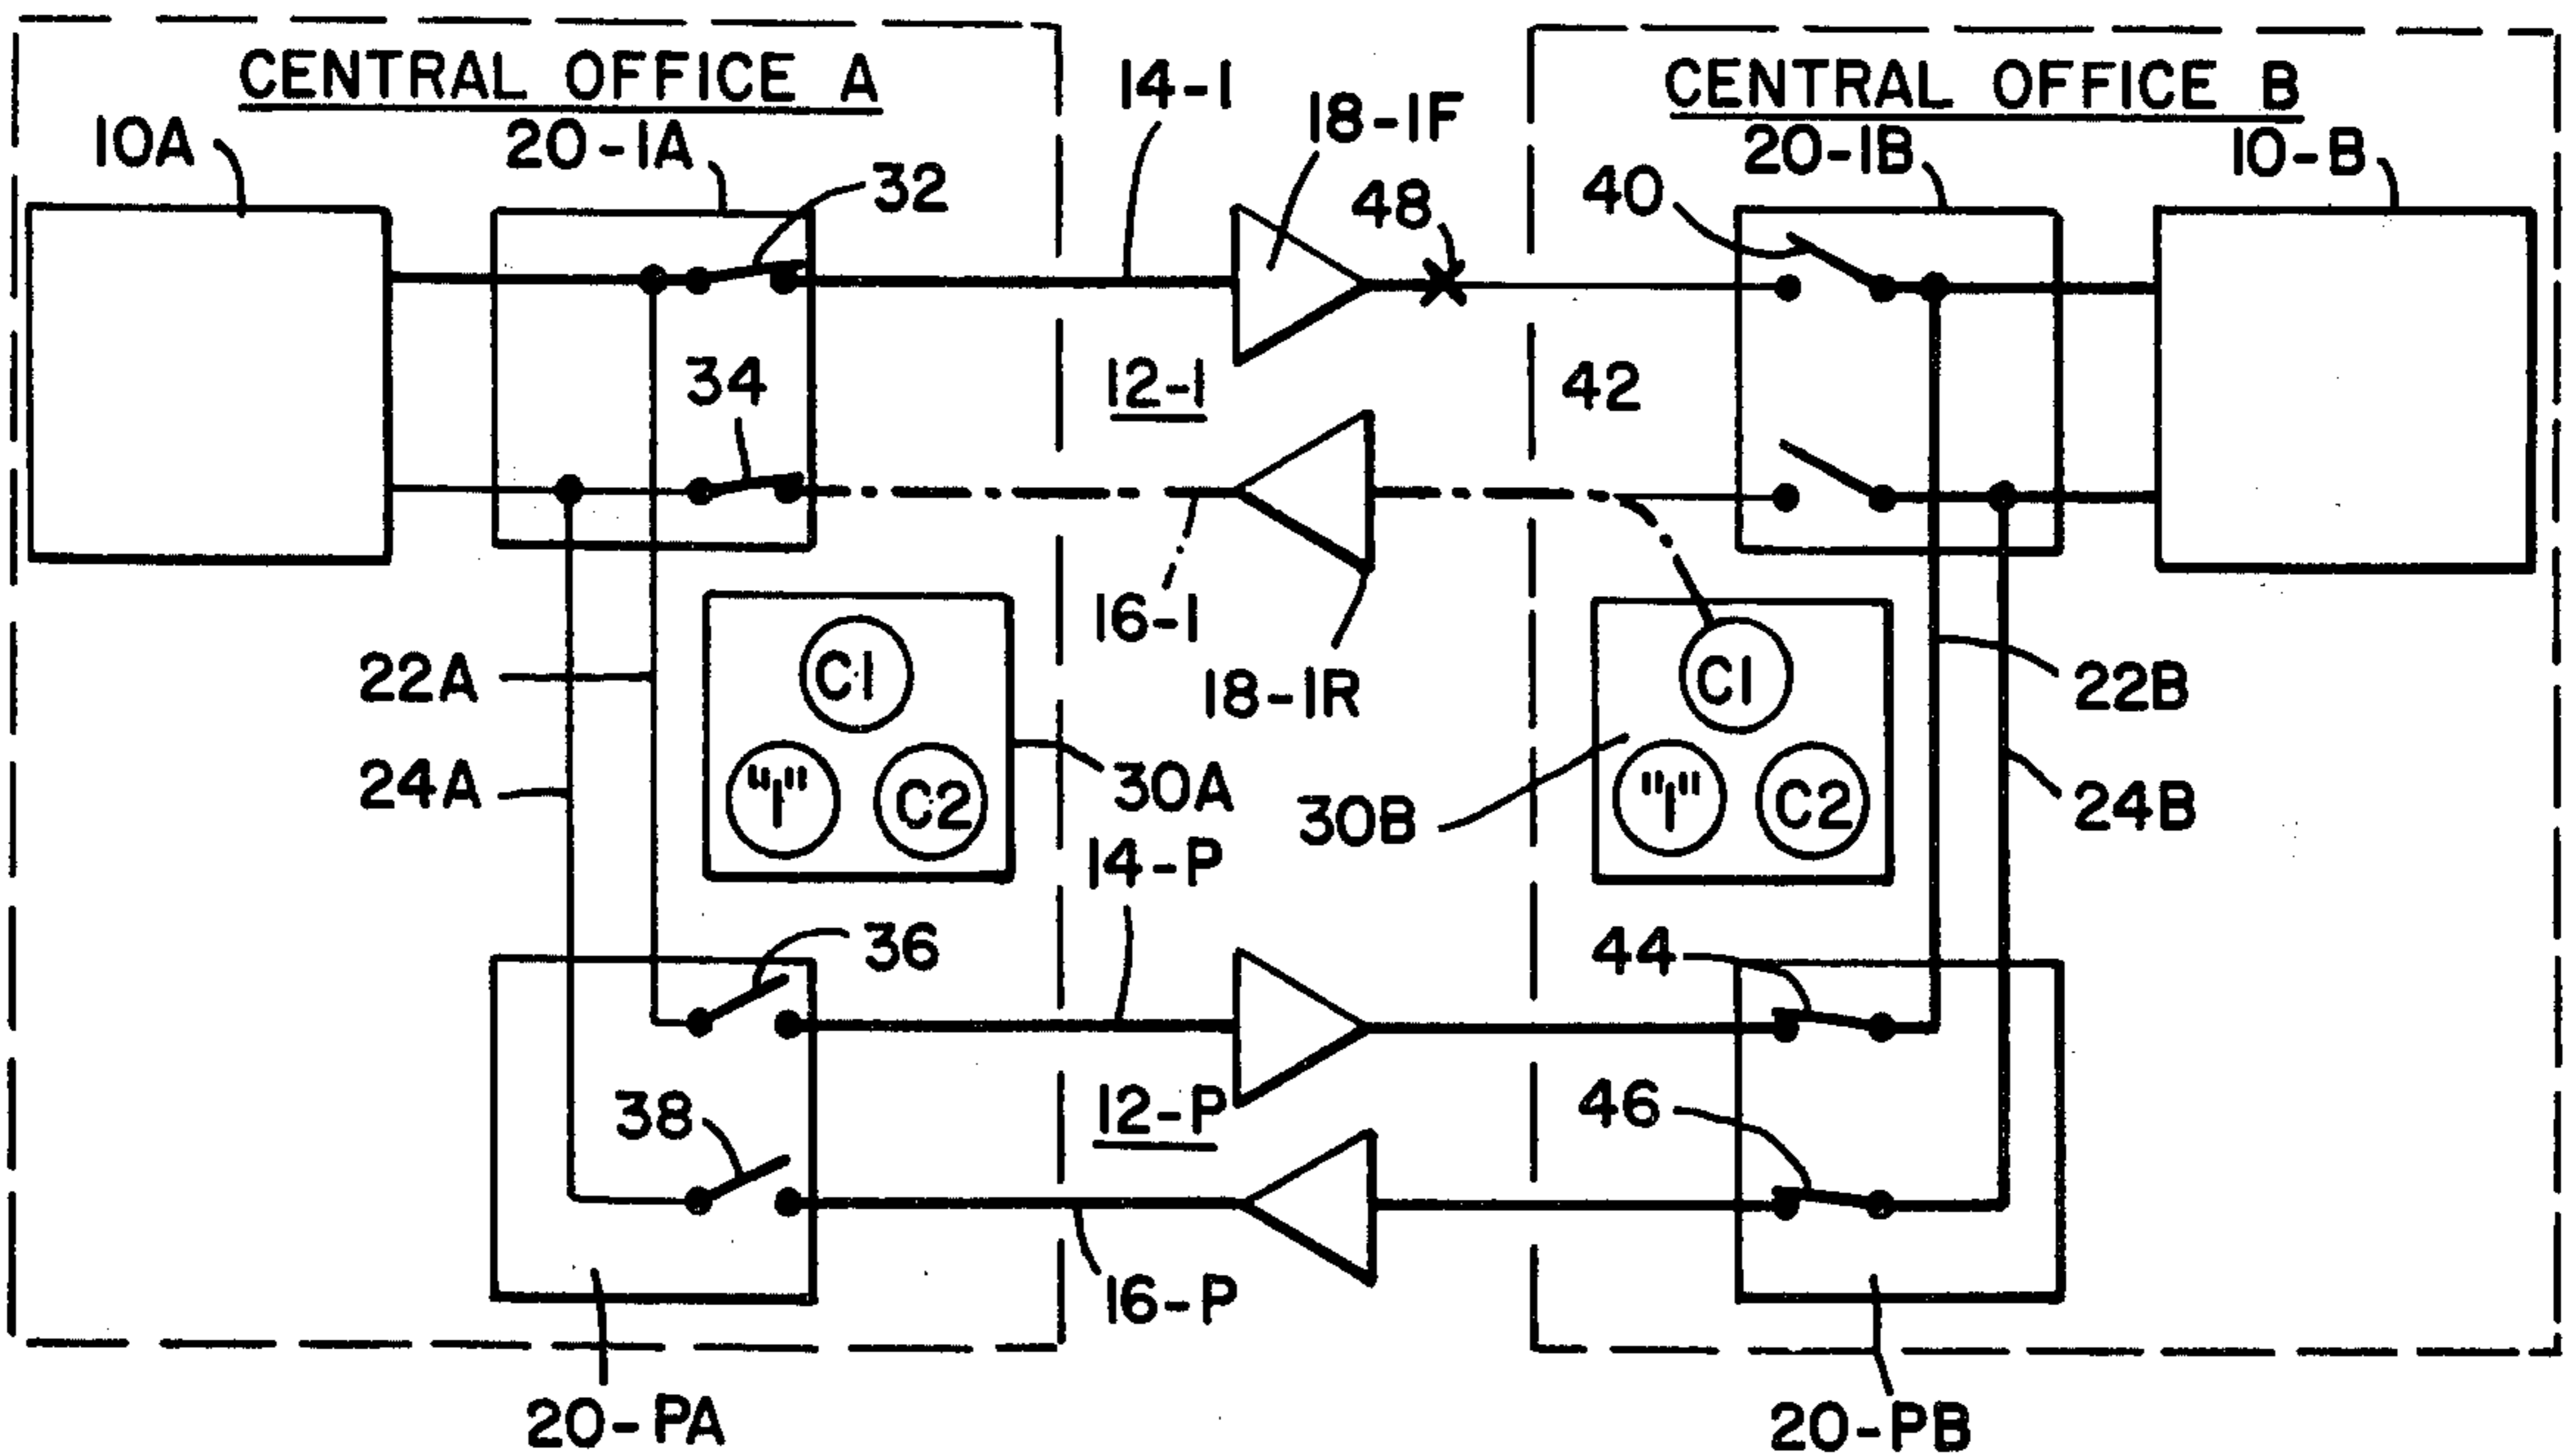
FIG_ 2b

If a fault now occurs at point 48 in forward line 14-1 (e.g., a failure of repeater 18-1F), the detection of the fault by the monitor 28 (in FIG. 1) of span switch unit 20-1B causes a transfer at central office B. The transfer at B opens electronic switches 40, 42 and closes switches 44, 46 in span switch unit 20-PB. However, switches 36, 38 in switch unit 20-PA are still open, and terminals 10A and 10B are momentarily disconnected from each other. Simultaneously with the transfer at B, code generator 30B injects code C1 into the return line 16-1, which is still operational even though span 12-1 is unusable for customer purposes.

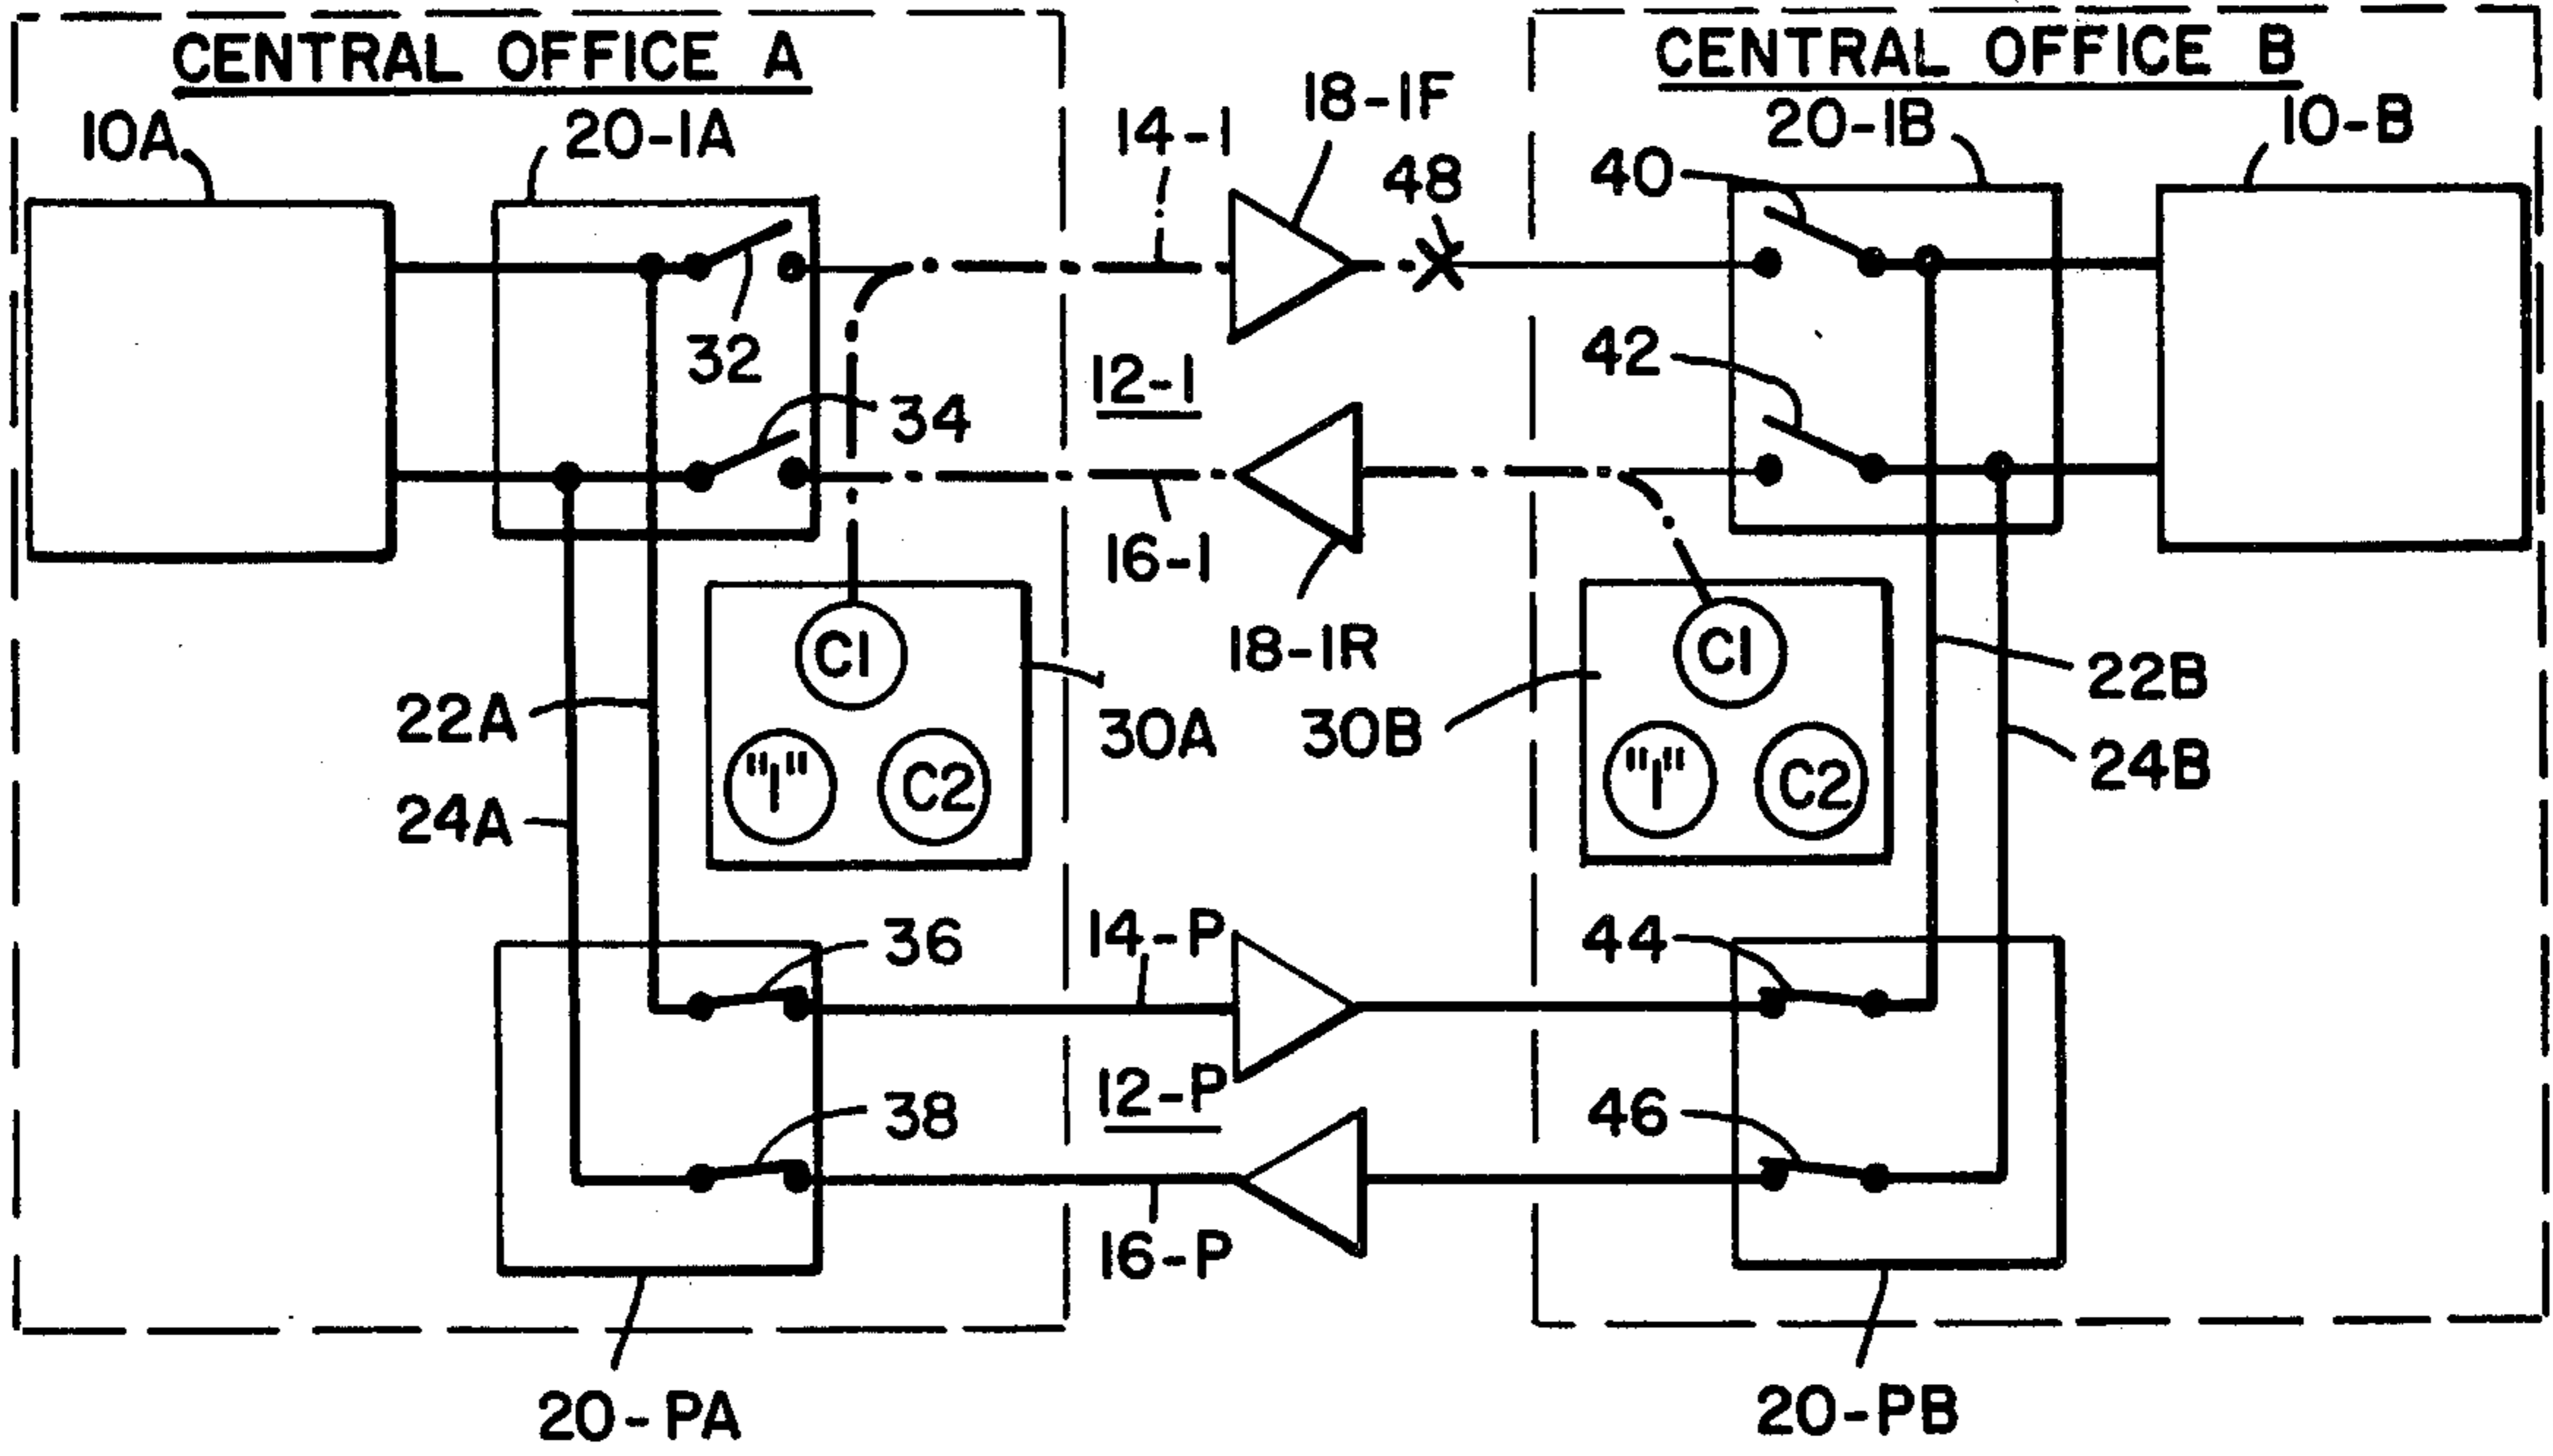
FIG_2c

Receipt of code C1 by span switch unit 20-1A for 30 microseconds or more causes a transfer to occur at central office A. As shown in FIG. 2c, the customer communication path between terminals 10A and 10B is now re-established in the forward direction through bus 22A, switch 36, line 14-P, switch 44, and bus 22B; and in the return direction, through bus 24B, switch 46, line 16-P, switch 38, and bus 24A. Simultaneously, code generator 30A injects code C1 into the failed line 14-1.

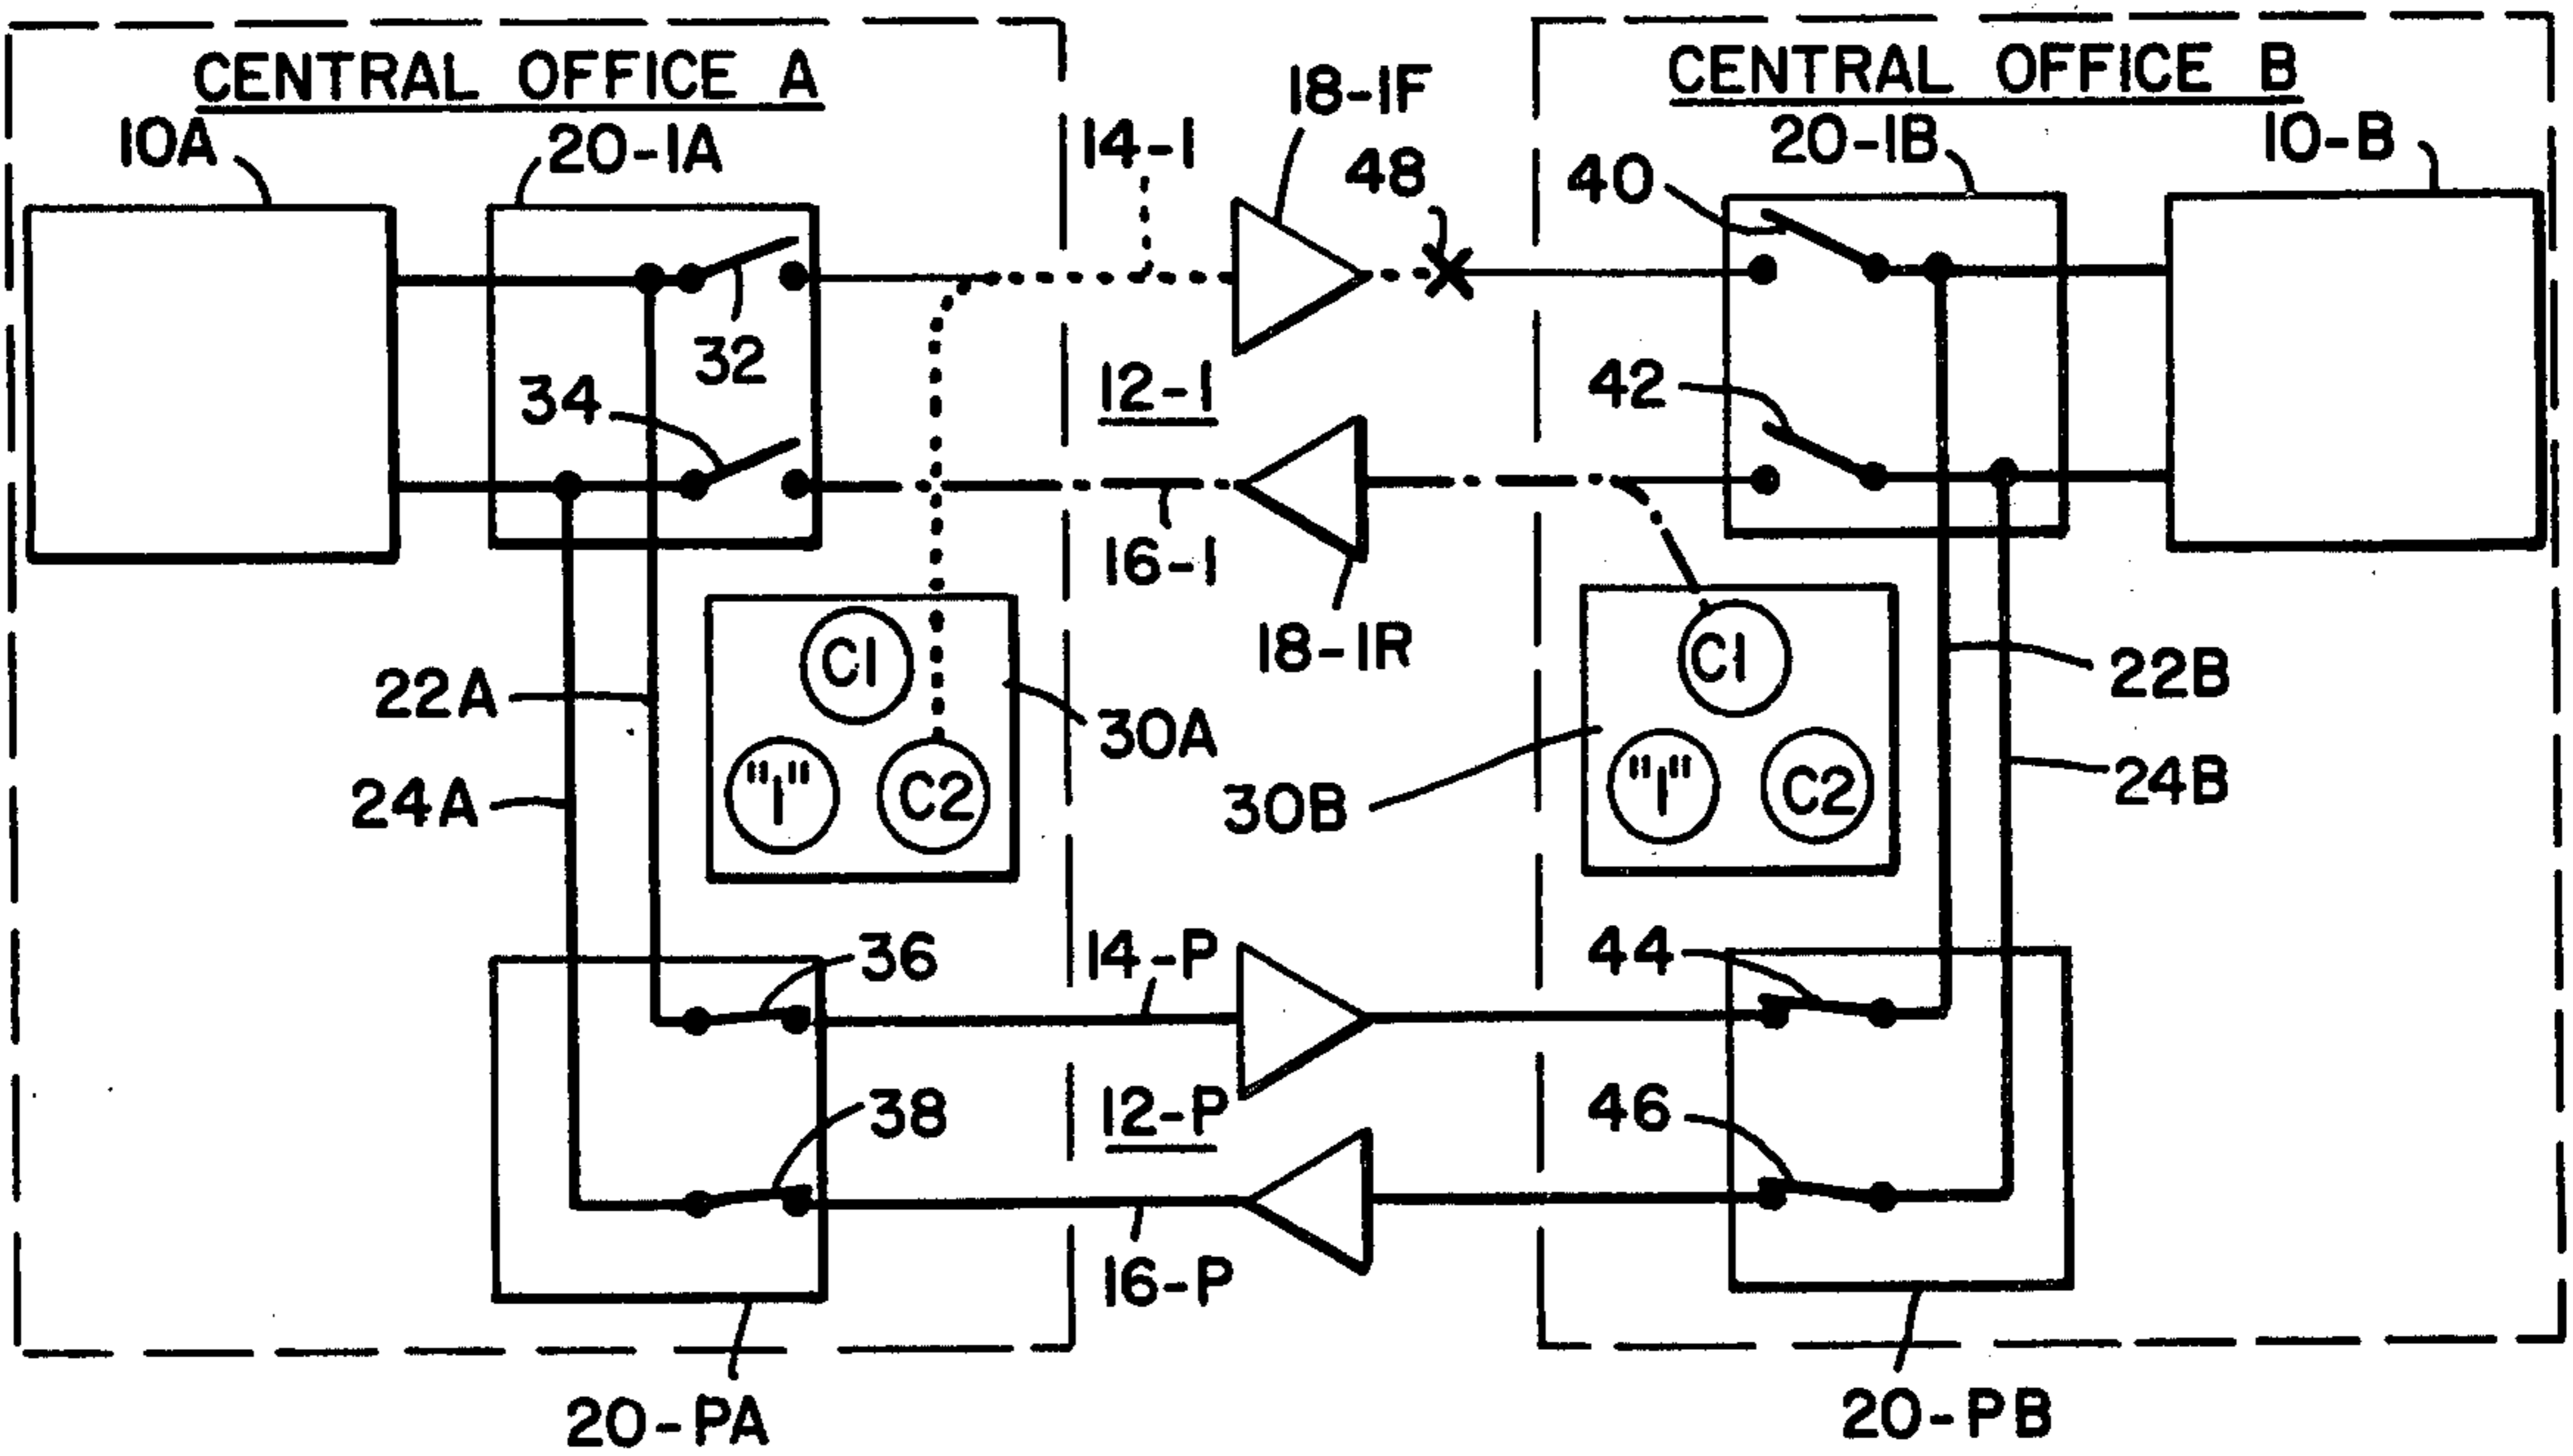
FIG_2d

Whenever a span switch unit 20 receives twenty-one seconds of fault-free signal from its span while operating in a transferred mode, its code generator switches from code C1 to code C2. Consequently, and inasmuch as return line 16-1 is still operational, the conditions of FIG. 2c are replaced, after a twenty-one second interval, by the conditions of FIG. 2d. Inasmuch as the fault 48 is still present, the C2 signal from code generator 30A does not reach span switch unit 20-1B. The circuit now remains in the condition of FIG. 2d until the fault 48 is cleared either by clearance of the fault-causing condition or by the intervention of maintenance personnel.
