[54] **METHOD AND MEANS FOR DETECTING AN OUTGOING FAILURE IN A BIDIRECTIONAL COMMUNICATIONS SPAN AND LOOPING THE SAME IN RESPONSE THERETO**

[73] Assignee: Lynch Communication Systems, Reno, Nev.

[57] **ABSTRACT**

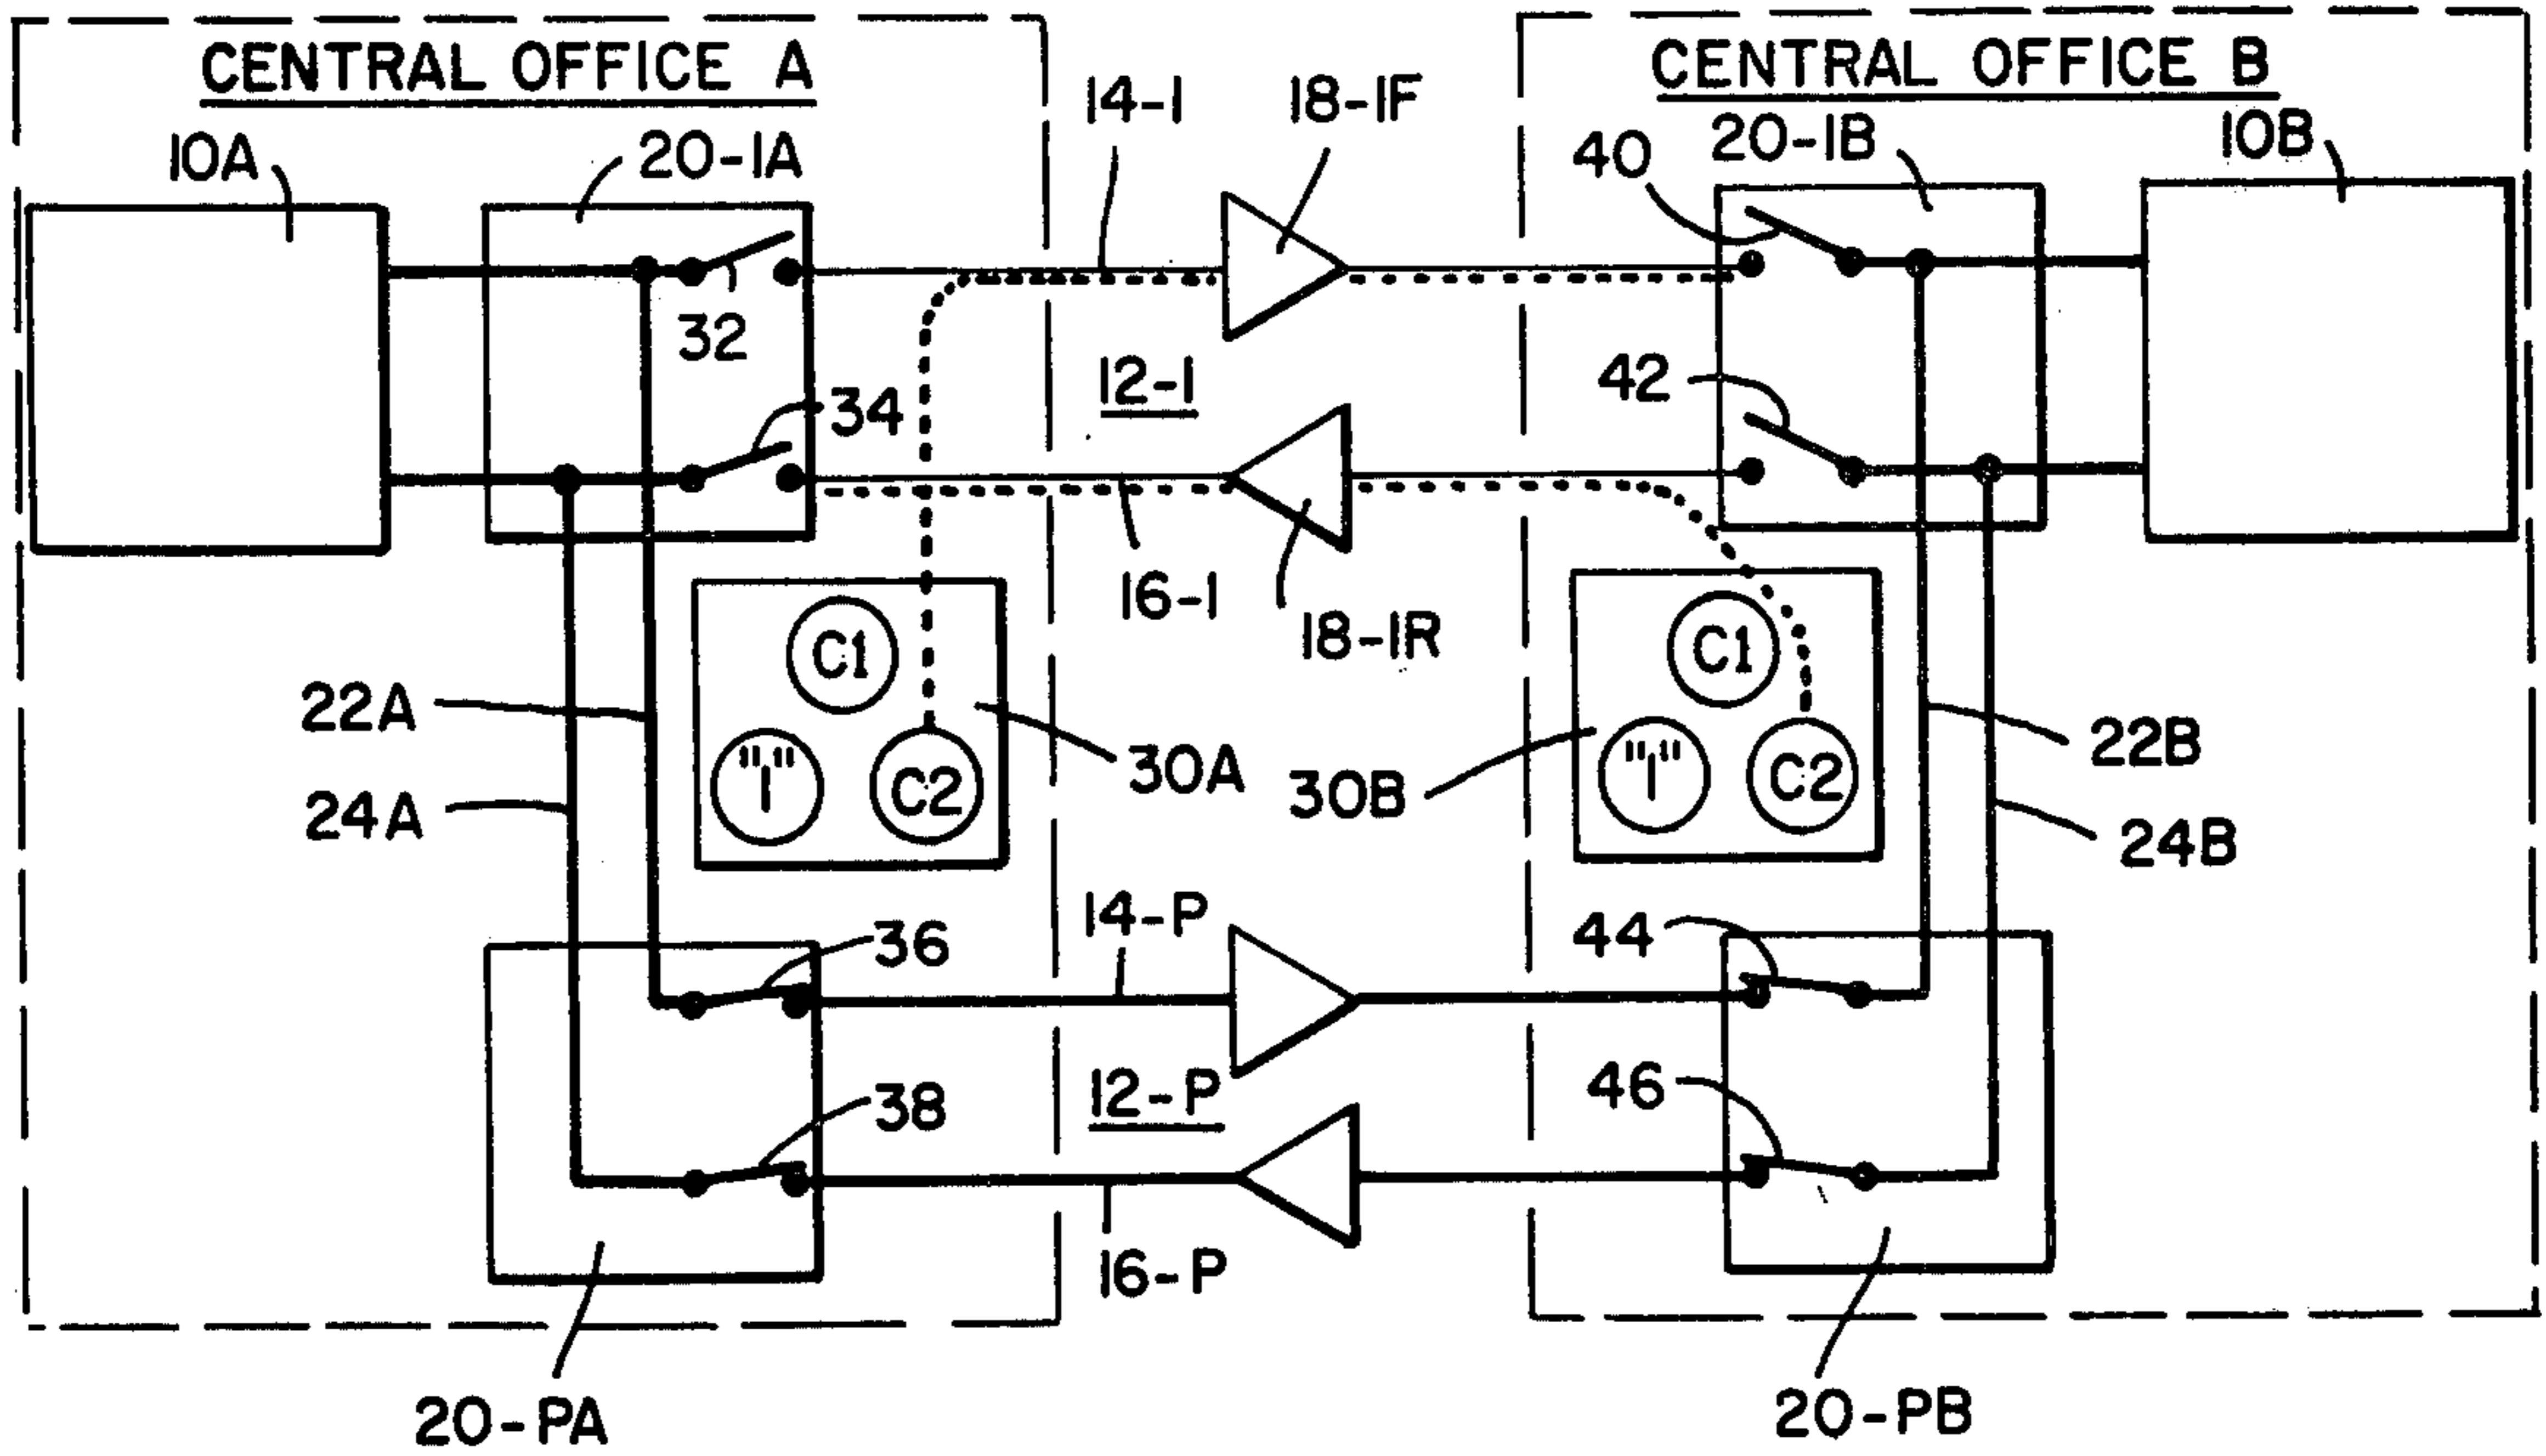
FIG_2 e

As soon as the fault 48 is cleared, C2 code (which is a valid signal as far as the monitoring units are concerned) starts to reach span switch unit 20-1B. Twenty-one seconds later, code generator 30B also starts transmitting code C2 (FIG. 2e). Thirty microseconds after a span switch unit 20 both receives and sends code C2, it resets (FIG. 2f). Consequently, (disregarding any transmission delays in the span) central offices A and B reset simultaneously, thereby preventing any line clicks or loss of customer data during the resetting operation.

FIG. 2a through FIG. 2f are schematic representations illustrating the sequence of events as the device of the invention copes with a span line failure;

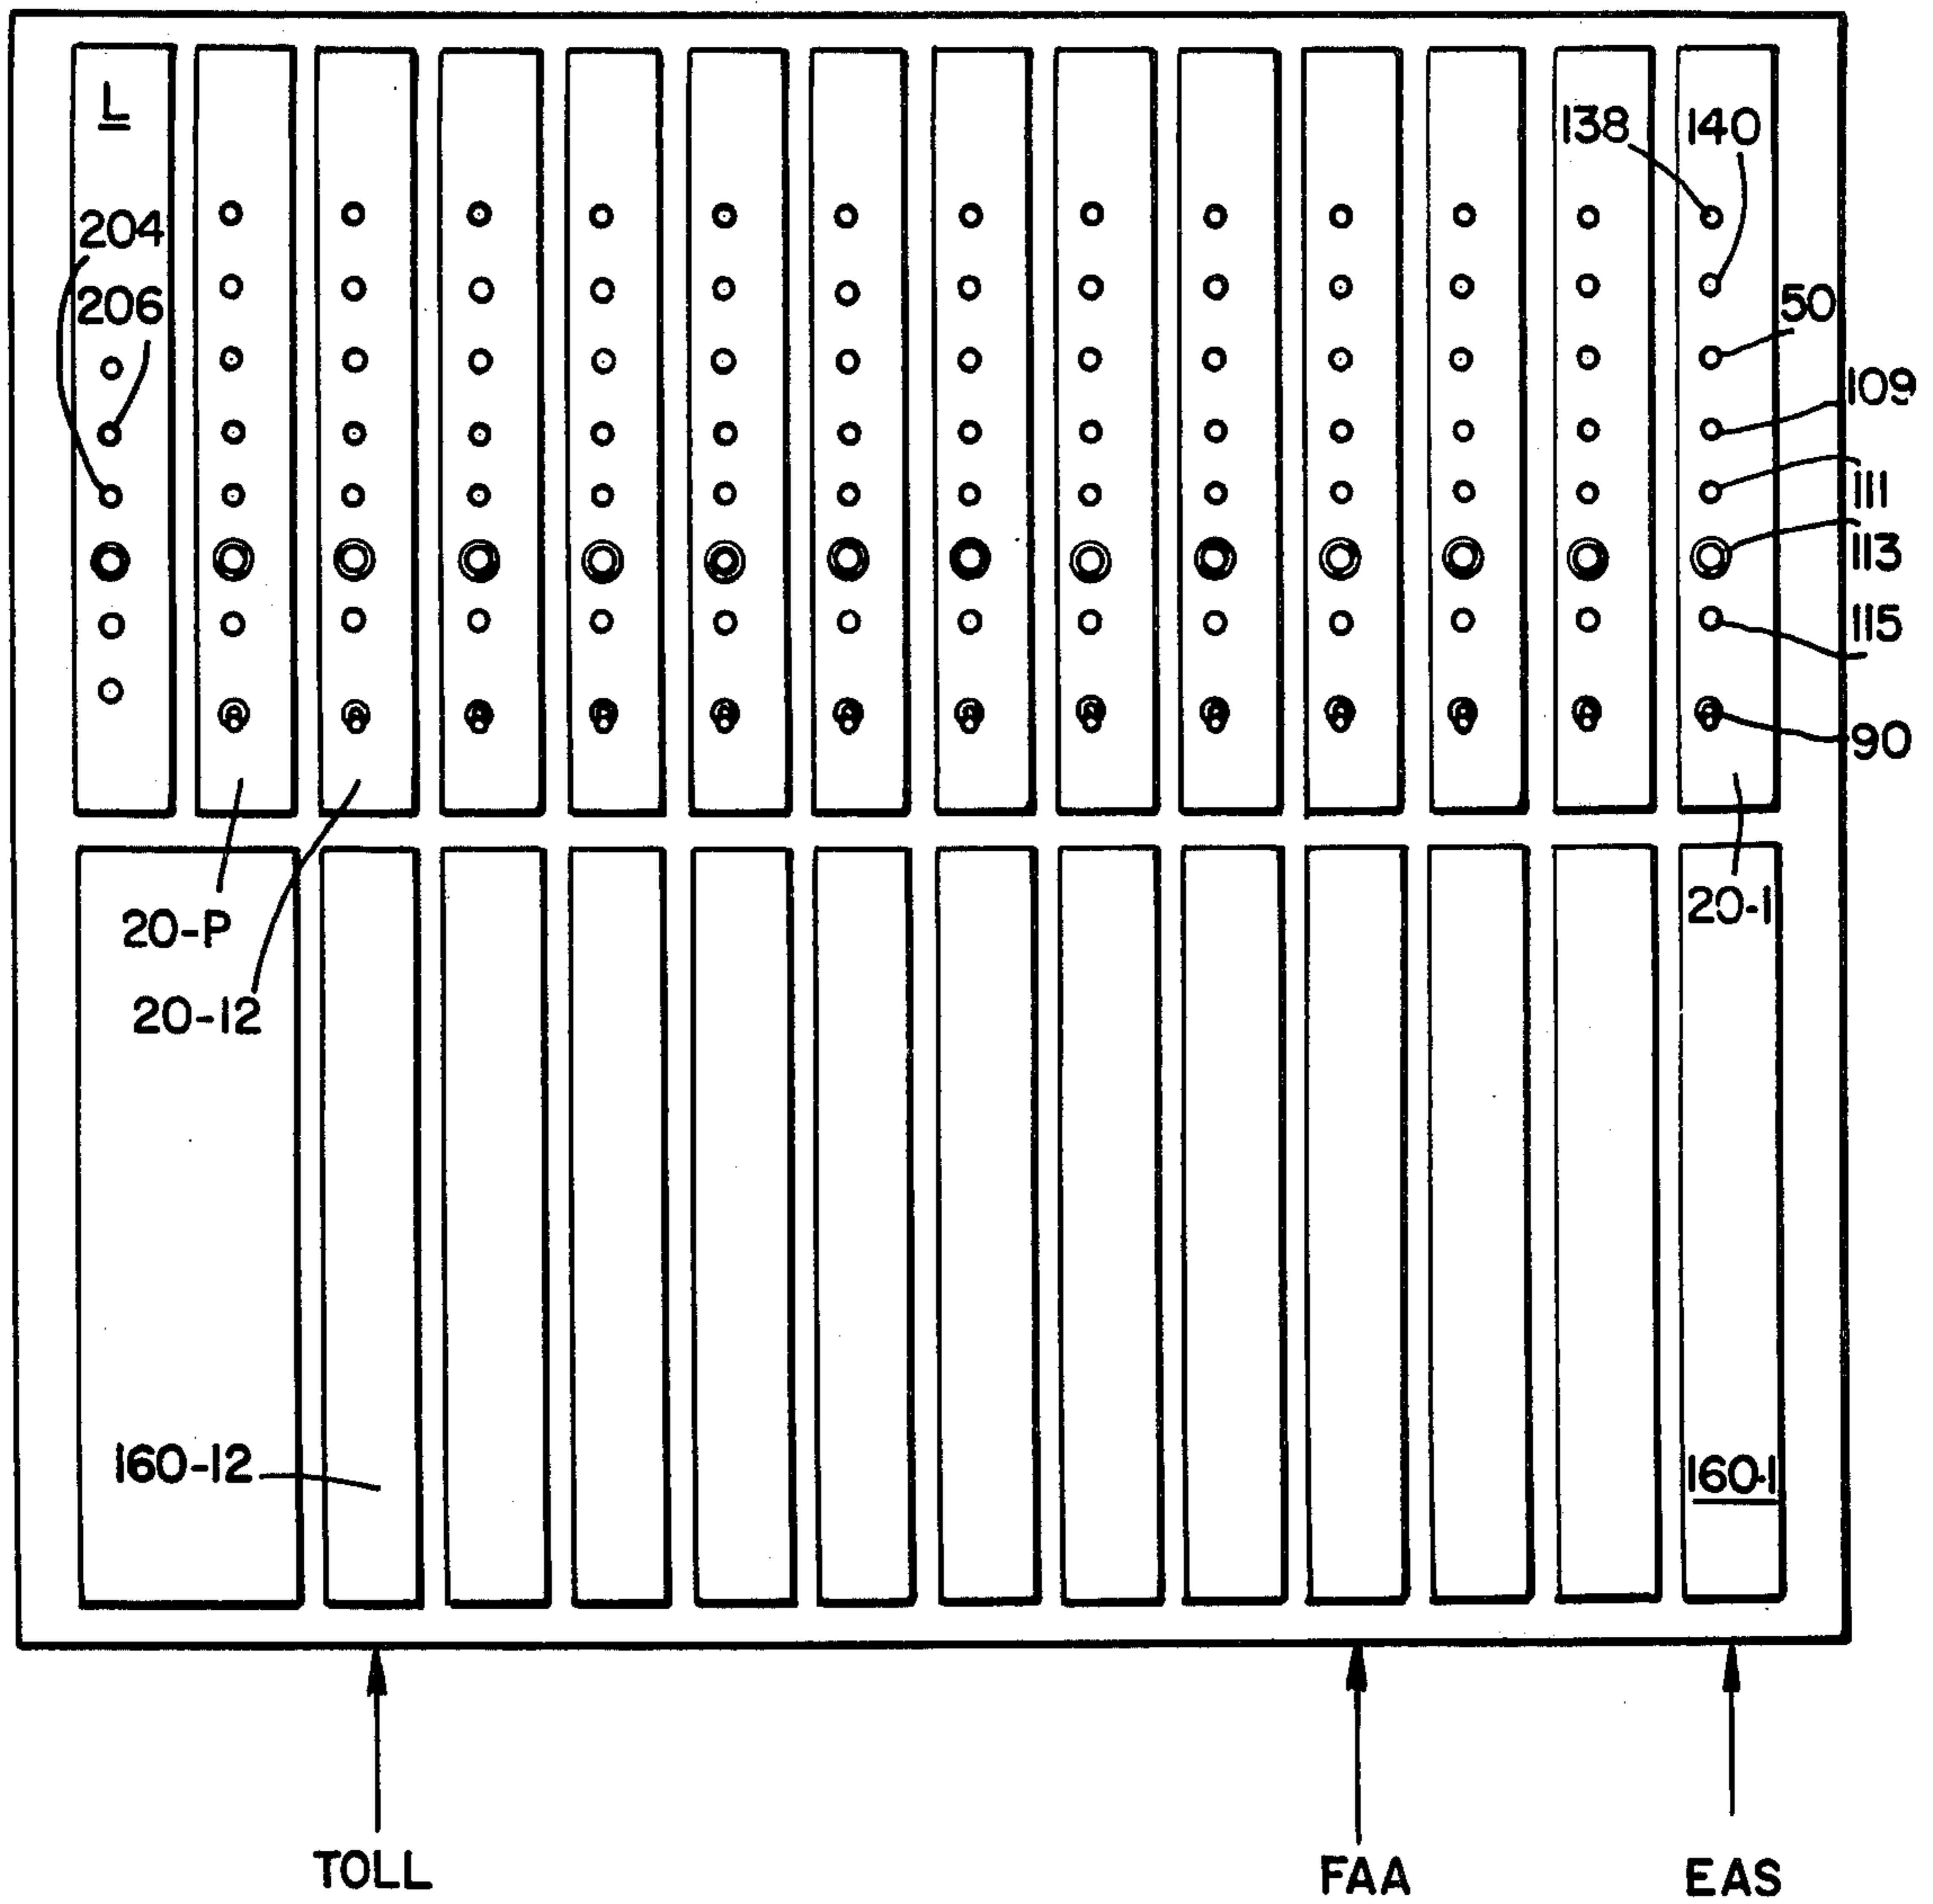
FIG_8

FIG. 8 is an elevational view of an equipment rack containing a channel bank and a corresponding span line switch set in accordance with the invention;

The bipolar violation threshold detector 52 is shown in more detail in FIG. 6. The positive and negative rails of a two-rail bipolar PCM input from the span are combined in a combining logic 132 to put out pulses on line 134 when a positive pulse is always followed by a negative pulse and vice versa, and on line 136 when two pulses of the same polarity follow one another. Lines 134 and 136 carry, respectively, the signals applied to the pulses light 138 and the errors light 140 (FIG. 8).

Consequently, the inventive device has redundancy in its clock generating capability, with an automatic switchover to another oscillator if the oscillator in use fails. An oscillator failure is therefore not a traffic-interrupting malfunction, and the output signal on line 202 to the minor alarm indicator 204 (FIG. 8) when either output sensor 196 or 198 produces a lost output signal.

Major alarms are traffic-interrupting conditions such as an unsuccessful transfer attempt (as indicated by the output of a gate 94 in FIG. 4) or a blown fuse are also provided to light the major alarm light 206 (FIG. 8) and to summon maintenance personnel by conventional means.

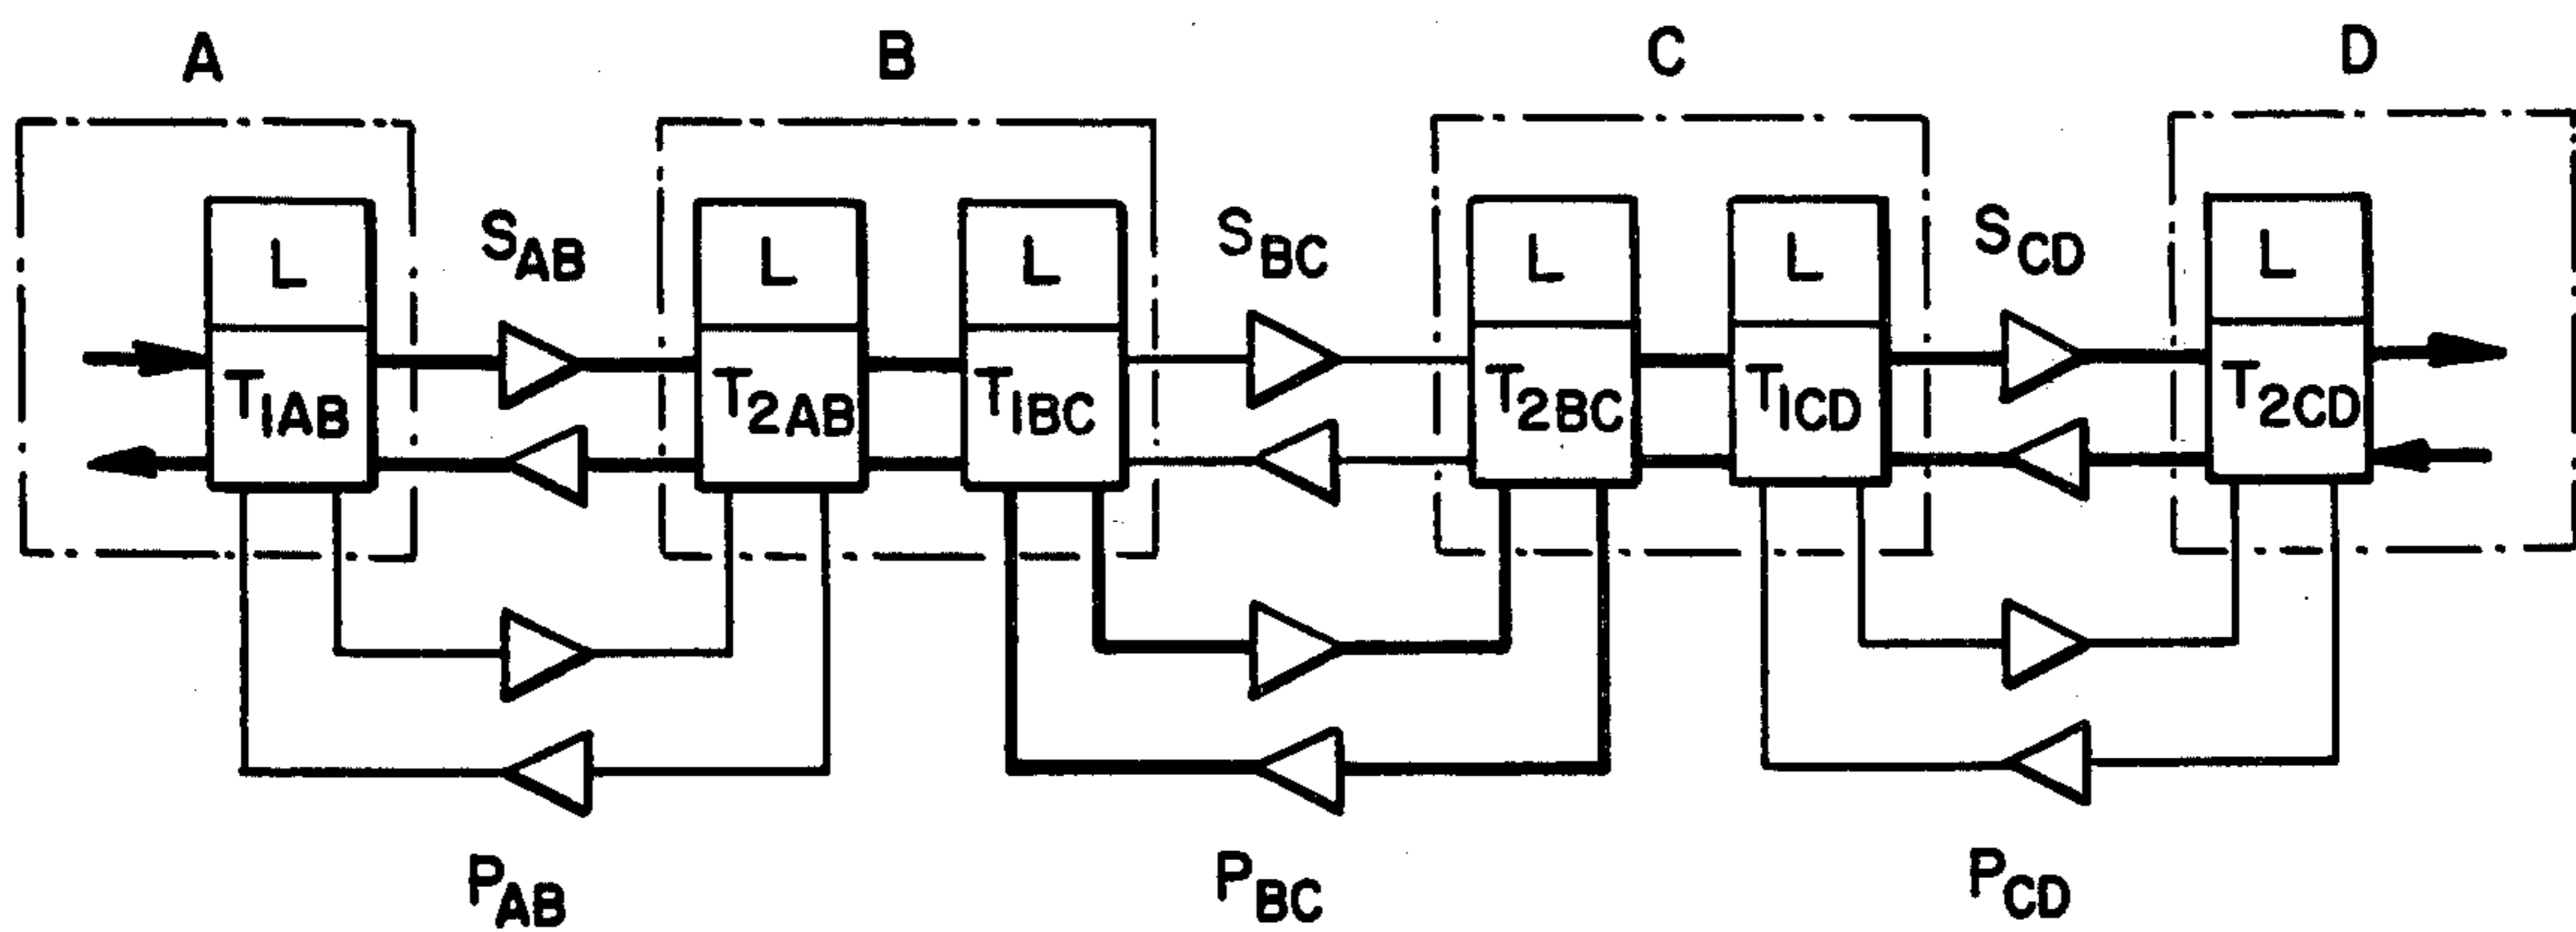
FIG_3

FIG. 3 is a schematic representation illustrating the isolation of a span transfer to a single section of a channel extending between a plurality of central offices;

FIG. 3 shows how an alarm condition at any point of a line extending through several central offices can be transmitted to a distant central office without causing unaffected spans to switch. FIG. 3 shows four central offices A, B, C, and D each connected to the next by a service span S and a protective span P. Each set of spans is equipped with a pair of span switches T, one at each end. Each span switch T contains an alarm board L. The physical appearance of the alarm board L is shown in FIG. 8, and it will be noted that each board has a "line fail" light 50. The circuitry of the span line switches T is so arranged and timed, as hereinafter described, that whenever a span line switch T receives or sends code C1 for 10 microseconds, the "line fail" light comes on. It will be recalled that the transfer to the protective span does not occur until the C1 code has persisted for 30 microseconds.

Let us now suppose that a break occurs in service span S_{BC} as indicated by that span. Upon the occurrence of the break 48, span line switch T_{2BC} immediately starts to transmit code C1 toward the left over the as-yet functional return line of service span S_{BC} . This C1 code is propagated through T_{1BC} , T_{2AB} and service span S_{AB} to span line switch T_{1AB} . When the C1 code transmitted by switch T_{2BC} has persisted for 10 microseconds, the "line fail" lights in switches T_{1BC} and T_{1AB} (switches T_{2BC} and T_{2AB} , being on the sending end of their respective spans, do not see C1 at their code receivers) come on. At the same time that it transmits code C1 to the left, span line switch T_{2BC} also transmits code C1 for only 20 microseconds to the right through switch T_{1CD} and the forward line of span S_{CD} to span line switch T_{2CD} . After 10

When any span line switch such as T_{1BC} has received code C1 for 20 microseconds, the span line switch circuit blocks further propagation of the C1 signal through the switch and therefore prevents any further C1 code from reaching switches T_{2AB} and T_{1AB} . Consequently, at the expiration of the 30 microsecond period from the first appearance of the C1 code, switches T_{1AB} and T_{2AB} no longer see any C1 code and therefore do not transfer. Likewise, switches T_{1CD} and T_{2CD} no longer see any C1 code and therefore also do not transfer. T_{1BC} and T_{2BC} , however, continue to see code C1, and at the expiration of 30 microseconds these two span line switches switch the service span S_{BC} onto the protective span P_{BC} . From this point on, the spans extending between central offices B and C continue to function in the failure mode until service is restored as hereinabove described, while the spans extending between central offices A and B and between C and D continue functioning normally as if no break had occurred. However, the "line fail" lights, which are equipped with a lock-in circuit, remain lit in all four central offices, and if any one of these offices is manned, a failure indication will promptly be conveyed to maintenance personnel.

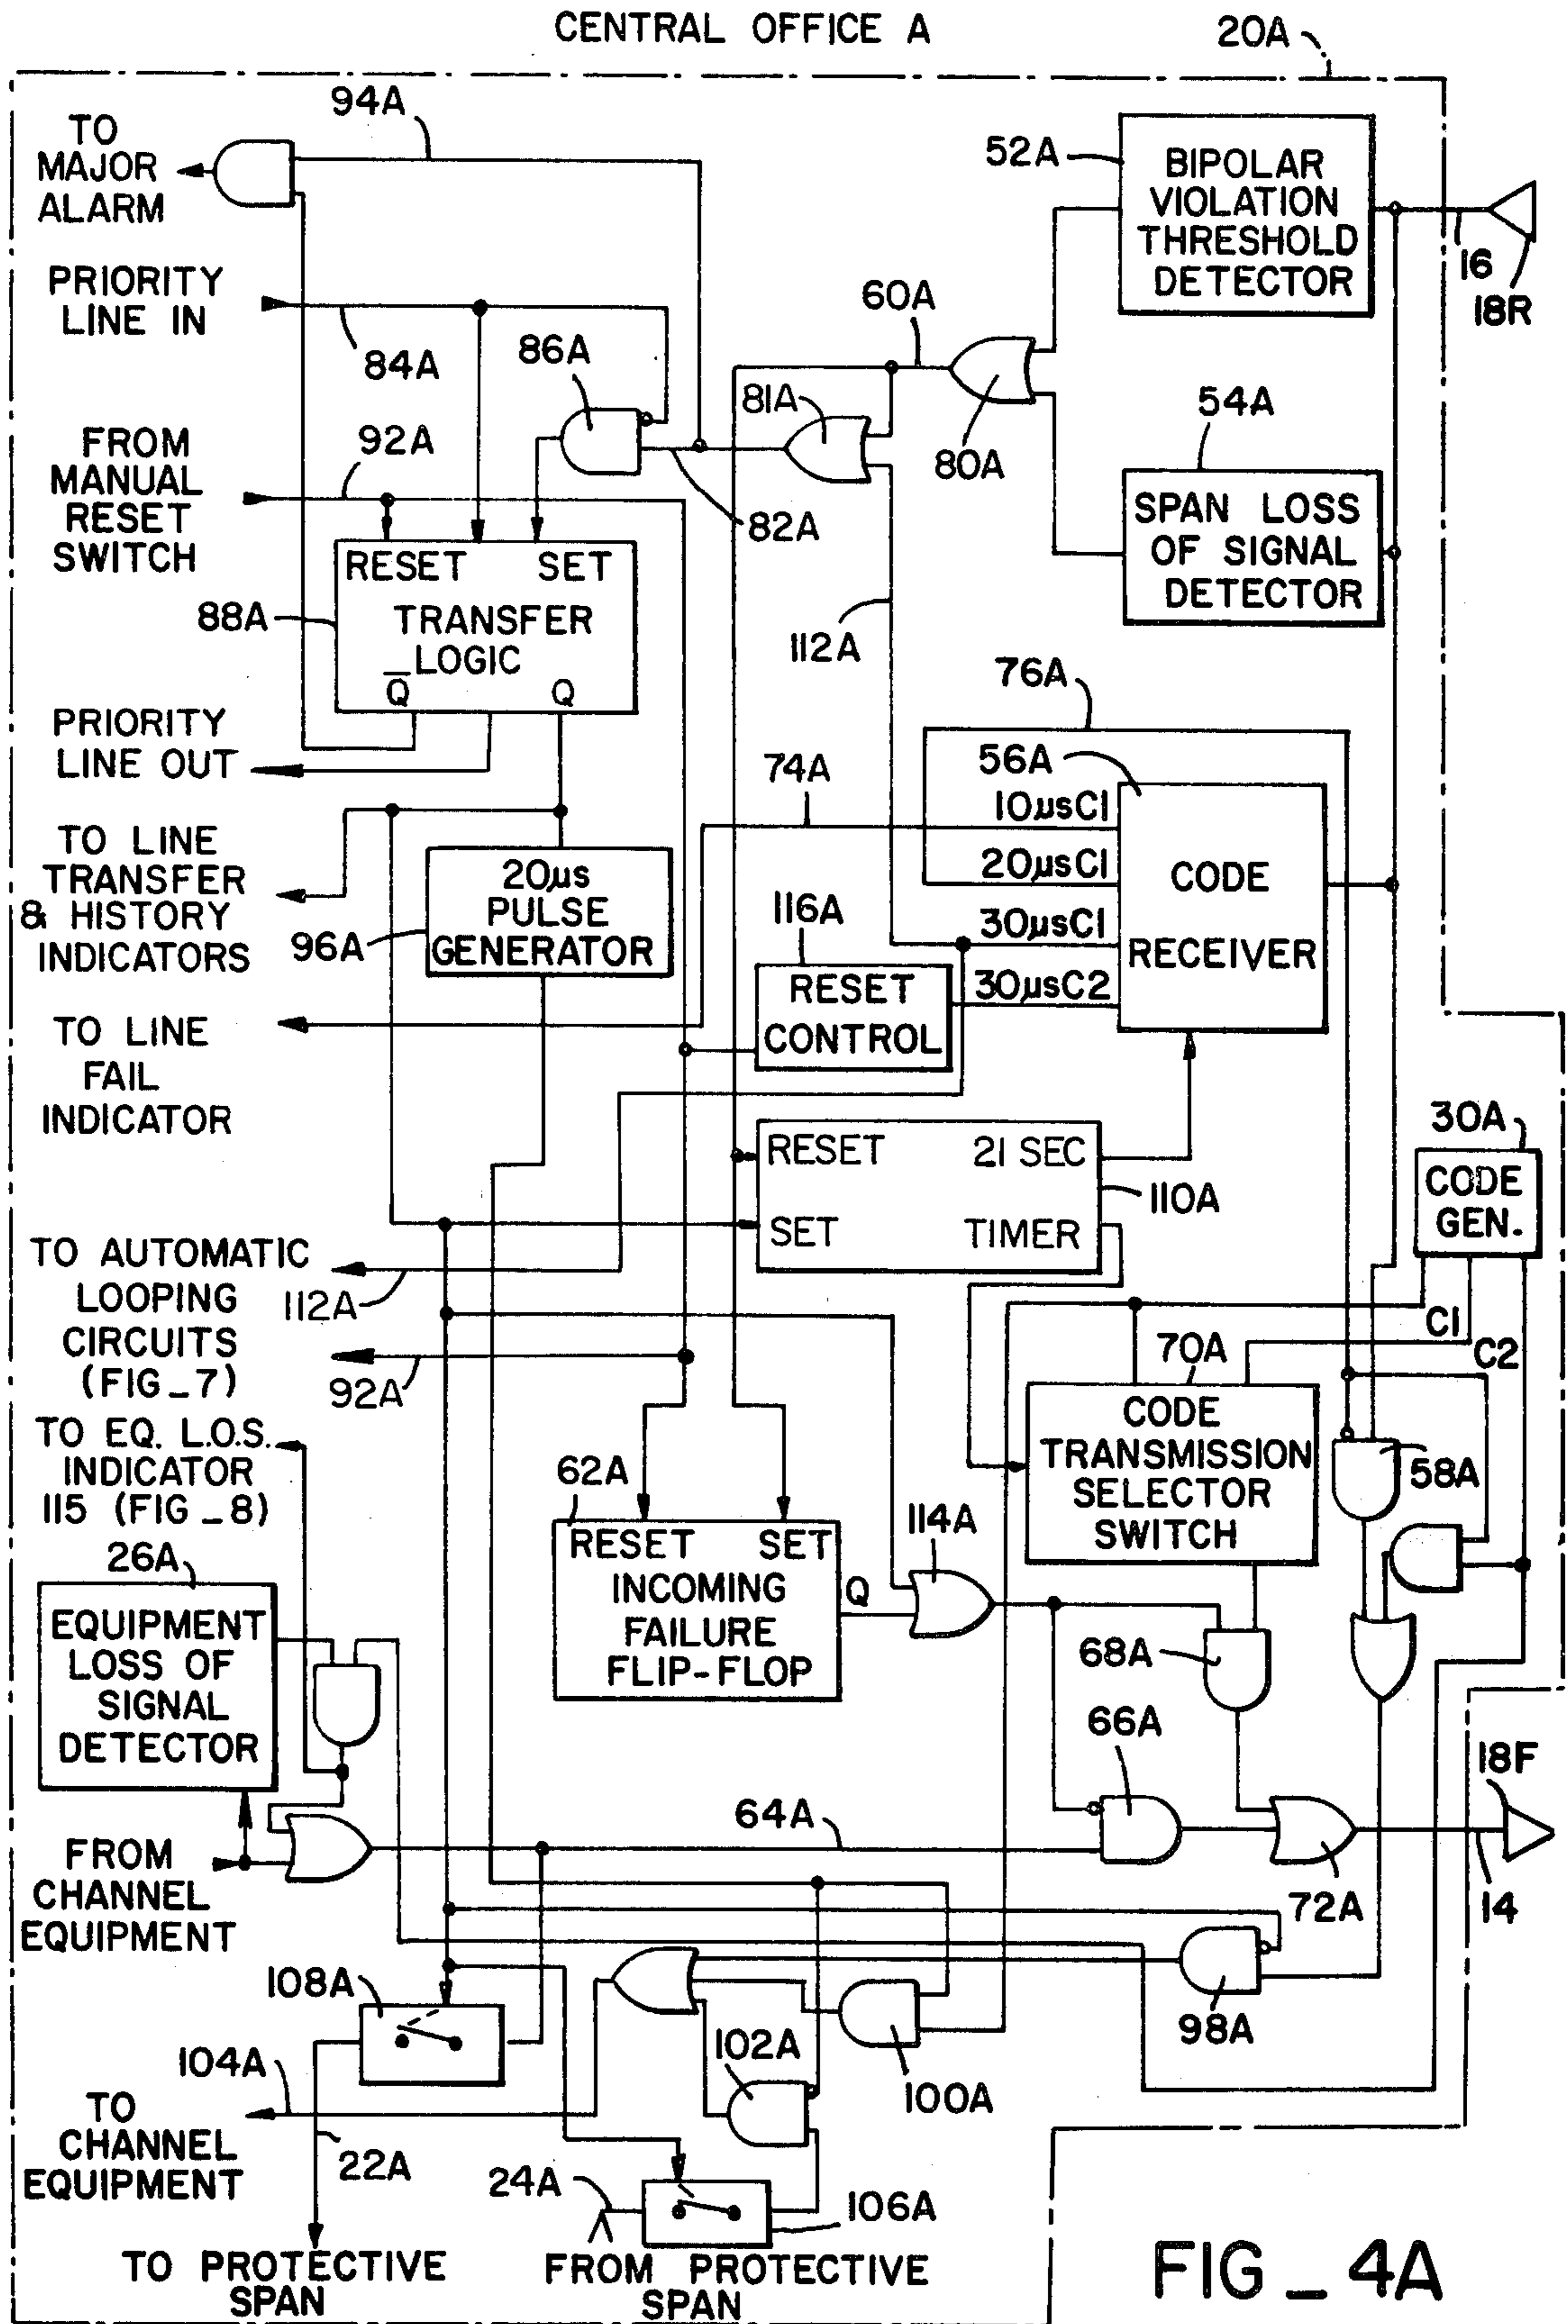
FIG. 4a and 4b together constitute a block diagram showing those portions of the inventive device on each end of a span which are involved in the transfer and reset process;

For a description of how the functions of FIGS. 2a through 2f and 3 are performed, we now turn to FIG. 4. FIG. 4A shows the transfer-and-reset equipment of a span switch unit 20A at central office A, while FIG. 4B shows the identical equipment in the corresponding span switch unit 20B at central office B. Under normal circumstances, a PCM data signal enters span switch unit 20B from repeater 18F over forward span line 14. The incoming signal is applied to bipolar violation threshold detector 52B (described in more detail in FIG. 6), loss-of-signal detector 54B, code receiver 56B (described in more detail in FIG. 5) and AND gate 58B. The detectors 52B and 54B together constitute the monitoring unit 28 of a span switch 20 in FIG. 1.

If forward line 14 fails, either or both detectors 52B; 54B produce an output. The outputs of detectors 52B and 54B are OR'd together to produce an "incoming failure" signal on line 60B. This signal sets incoming failure flip-flop 62B and causes the substitution of code C1 for the PCM signal from line 64B (i.e., traffic or, in its absence, clock) on return span line 16. The substitution is accomplished from the output of OR gate 114B by cutting line 64B off at AND gate 66B and enabling AND gate 68B to feed C1 into line 16, from code generator 30B (which generates its codes continuously) through code transmission selector switch 70B (which is normally set to select C1) and OR gate 72B.

The C1 code transmitted from central office B over return span line 16 is picked up by code receiver 56A at central office A. The code receivers 56 are normally set to listen only for code C1 (which may be, for example, 100100 repeated indefinitely) and to ignore C2 (which may be, for example, 110110 repeated indefinitely). When code receiver 56A has received code C1 steadily for ten microseconds, it send out a pulse on line 74A which lights and locks in the "line fail" light 50 (FIG. 8) for the span involved. It will be noted that code C1 at this time propagates all the way through central office A and therefore also lights the "line fail" light in all upstream receiving span switch units 20 along the affected channel.

The incoming failure signal on line 60B causes OR gate 81B to produce a transfer order signal on line 82B. If the priority line 84B into the span switch unit under consideration is a logic 0 (see the discussion of the priority system hereinbelow), the transfer is permitted, and gate 86B transmits a transfer command to the "set" terminal of the flip-flop portion of transfer logic 88B. If desired, a transfer can be manually prevented by energizing the "reset" terminal of transfer logic 88B from manual reset switch 90 (FIG. 8) over line 92B. If a transfer order appears on line 82B but the transfer logic 88B fails to transfer for any reason (e.g., when a higher-priority span has already seized the protective span), traffic is lost on the affected channel, and AND gate 94B triggers a major alarm (FIG. 10) to summon maintenance personnel.

The transfer logic 88B, it will be noted, sets immediately upon detection of an incoming failure. Its setting blocks gate 98B and energizes a pulse generator 96B which produces a single 20 microsecond pulse. This pulse is applied to gates 100B and 102B as shown and feeds code C1 directly from the code generator 30B into the channel equipment of central office B in a forward direction over line 104B for 20 microseconds. This burst of C1 replaces the failed traffic signal from forward line 14 and lights the downstream "line fail" lights but is too short to transfer any downstream spans of the affected channel. There is no problem of downstream propagation of the failure parameters themselves because proper bipolarity is inherently restored by the central office equipment before transmission of the PCM signal into the next span, and because loss of signal simply causes the equipment-loss-of-signal detector (i.e., monitoring unit) 26 of the next span to substitute keep-alive clock pulses, as explained above in the description of FIG. 1, for the missing traffic signals before any span-loss-of-signal detector 54 has time to react to any loss of signal.

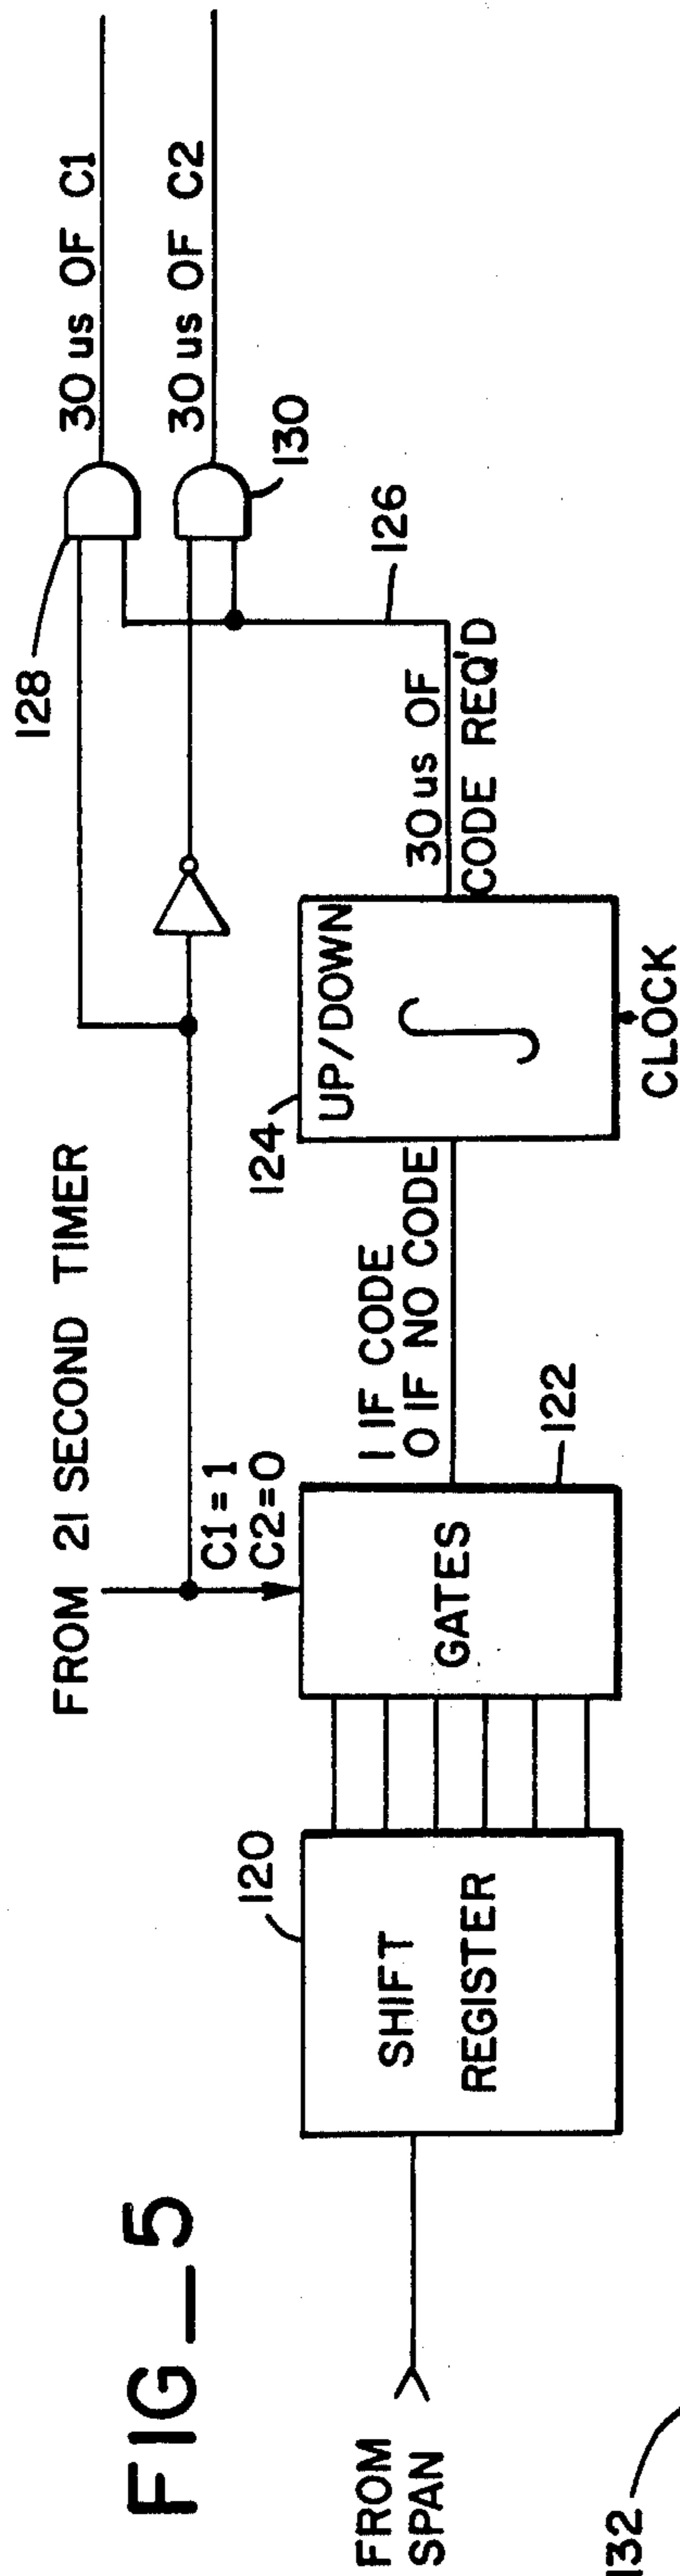
FIG-5

FIG. 5 is a detail block diagram showing the structure of the code receiver of FIG. 4;

The functioning of code receivers 56 is shown in more detail in FIG. 5. The incoming PCM signal from the span is applied to a shift register 120 whose parallel outputs are applied to logic gates 122. The output of timer 110 (FIG. 4) is normally 1, and it goes to 0 at the end of its 21-second timing interval. The gates of the logic 122 are so designed, in accordance with conventional practices, that the output of logic 122 is 1 when the shift register 120 contains the code indicated by the timer 110, and 0 when it does not.

In an uncoded pulse train, logic 122 will put out no more 1 pulses, on the average, than it does 0 pulses. Consequently, by applying the 1 output of logic 122 as

an up-count to an integrating counter 124 and the 0 as a downcount, the integrating counter 124 will produce an overflow output on line 126 only when the desired code is consistently received for a predetermined length of time. The output 126 can be used, after gating through code selection gates 128, 130, as the 30 microsecond outputs of the code receiver 56. Similar circuitry is, of course, provided for the 10 microsecond and 20 microsecond outputs of code receiver 56.

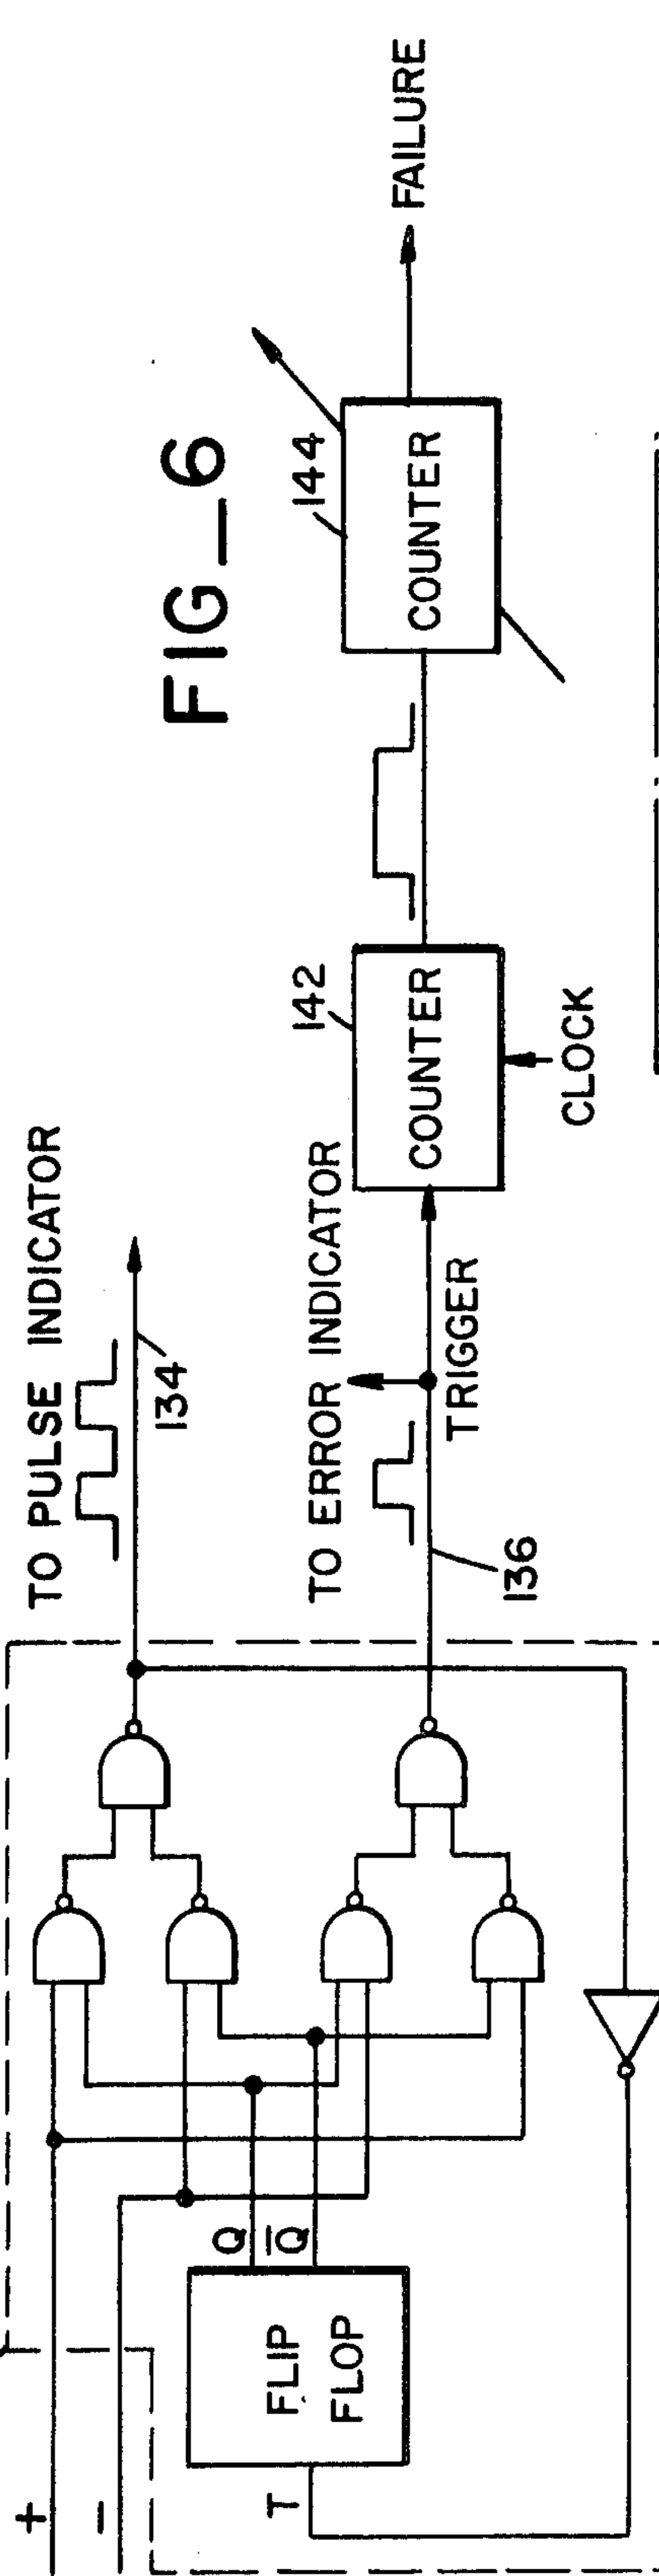
FIG-6

FIG. 6 is a detail block diagram showing the structure of the bipolar violation detector of FIG. 4;

Error pulses appearing on line 136 are applied to the counter 142. The counter 142 is arranged to be triggered by an error pulse to put out a logic 1 for a period of 512 clock pulses (about 300 microseconds). During this time the counter 142 is insensitive to further triggering. As a result, a short burst of a few hundred consecutive error pulses (typical of a transient malfunction) will put out only one pulse from counter 142.

The output of counter 142 is fed to counter 144, which responds to the count of sixteen 300-microsecond pulses in a given length of time. This length of time is adjustable so that the error rate constituting a failure indication can be varied at will. In practice, the shortest time used is on the order of 5 milliseconds, corresponding to an error rate of about 10^{-4} . The output of counter 144 is the output, in FIG. 4, of bipolar violation threshold detector 52. To provide a switching hysteresis, the error rate for resetting timer 110 is to be one order of magnitude lower than the rate set for triggering a failure indication.

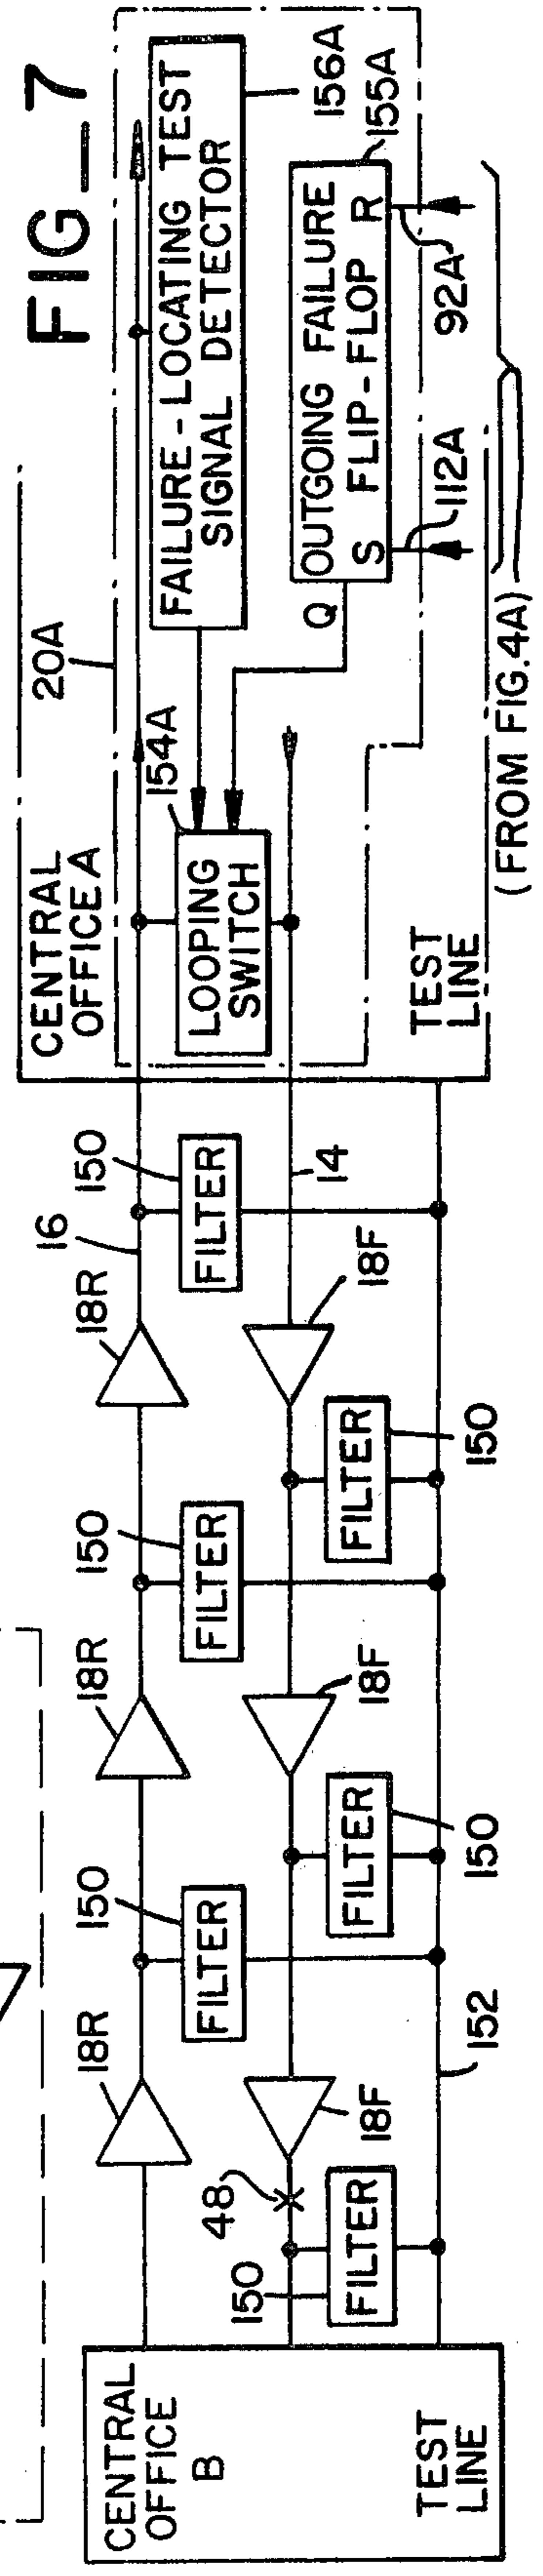
FIG-7

FIG. 7 is a schematic representation illustrating the automatic looping feature of the inventive device;

Referring to FIG. 7, a PCM span is conventionally tested by injecting into the line (e.g., line 16) of test tone consisting of a pulse train containing bipolar violations at regular intervals, (commonly every 4th to 11th pulse). These bipolar violations are inserted in the positive direction for a given period of time (say 500 microseconds), then in the negative direction for an equal period of time. Integration of this pulse train produces an audio tone whose frequency is determined by this

Throughout the span, the output of each repeater 18F or 18R is connected through an integrator-filter 150 to a test line 152. By monitoring the test line 152 while varying the frequency of the audio tone to accommodate, one by one, the various filters 150, the location of the failure 48 can be identified. In the past, this procedure had to be carried out separately from central office A for repeaters 18F and then from central office B for repeaters 18R, or the line had to be looped manually at the proper end.

In accordance with the invention, the testing can be carried out from either central office without assistance at the other. For this purpose, the span switch unit 20A (shown, for clarity only, in central office A in FIG. 7, although an identical unit, not shown is also provided in central office B) is equipped with an electronic looping switch 154A which bridges the forward line 14 and the return line 16 when it is enabled both by signal from the Q output of outgoing failure flip-flop 155A (set from line 112A and reset from line 92A in FIG. 4A) indicating a failure 48 in the forward line 14, and by the test tone sensor 156A.

The test tone sensor 156A is of conventional construction and does two things: (1) it continuously tests the pulse train for bipolar violation rates greater than one violation for each fifty pulses; and (2) it continuously tests the pulse train for the occurrence of bipolar violations alternating in polarity at an audio frequency. If both conditions are met, an enabling signal is transmitted to the looping switch 154A.
