[54] **METHOD AND MEANS FOR DETECTING AN OUTGOING FAILURE IN A BIDIRECTIONAL COMMUNICATIONS SPAN AND LOOPING THE SAME IN RESPONSE THERETO**

[73] Assignee: Lynch Communication Systems, Reno, Nev.

[57] **ABSTRACT**

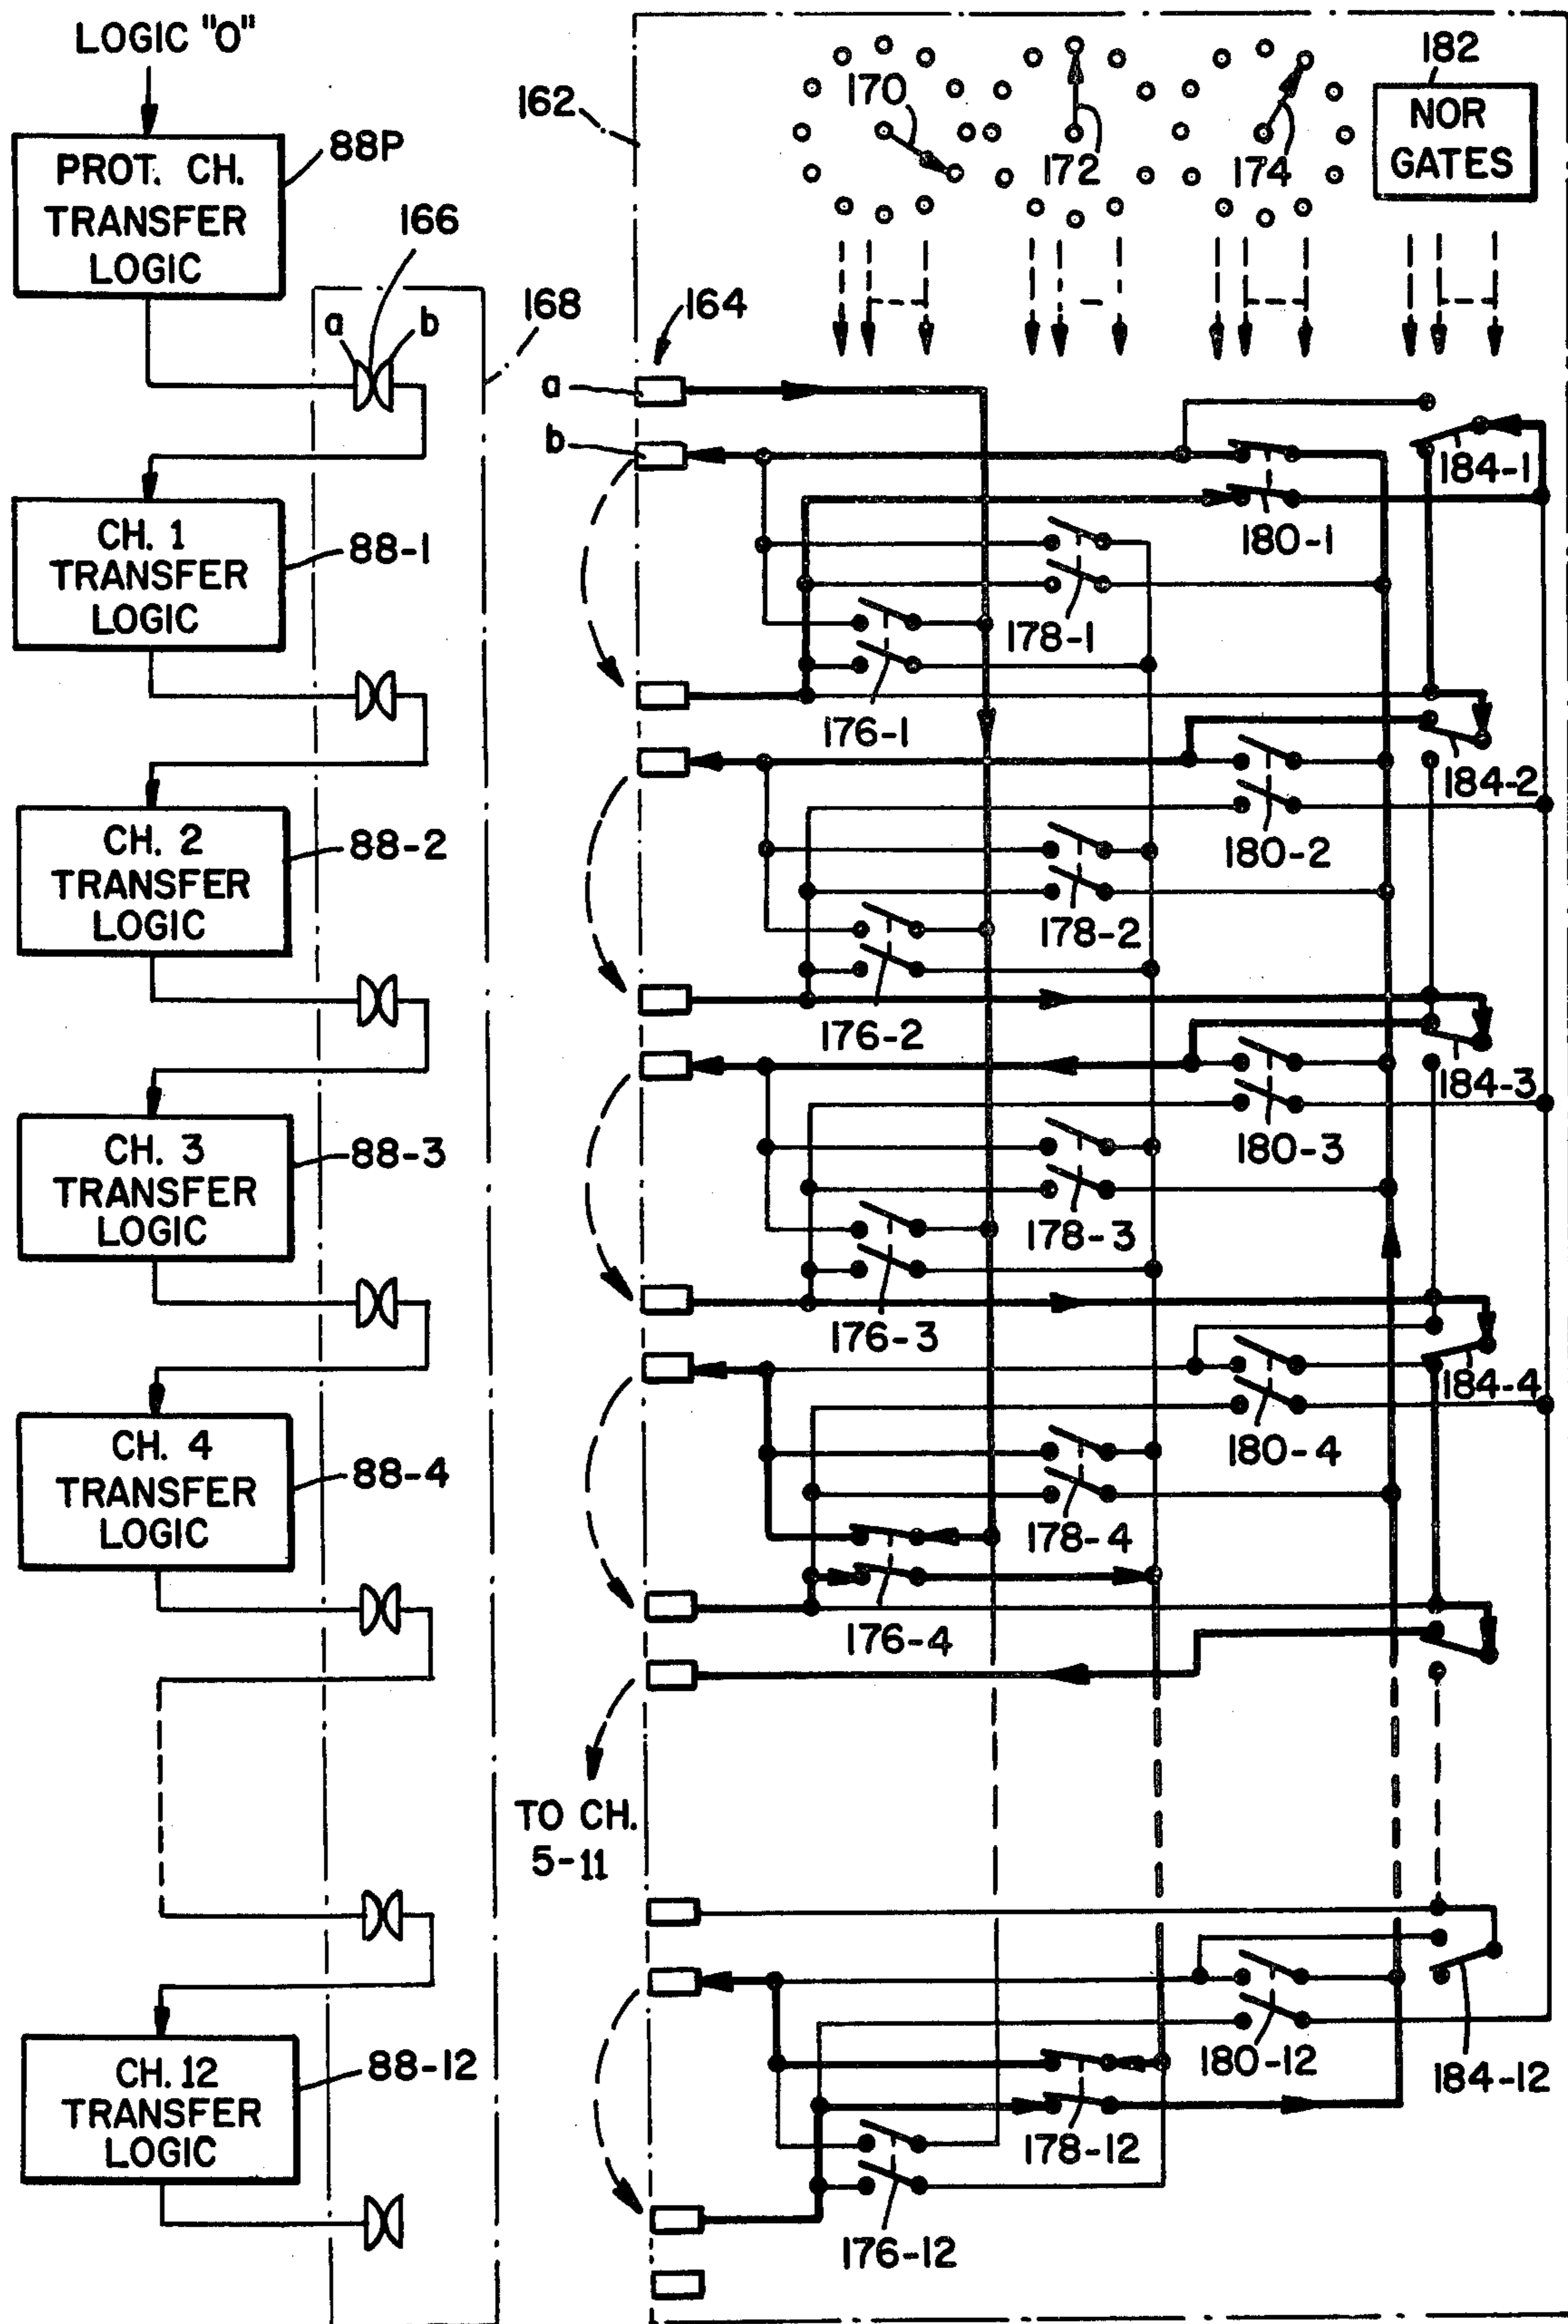
FIG. 9 is a schematized circuit diagram showing the priority selector of this invention; and

It at some future time it becomes necessary, for example, to temporarily allocate channel 3 to a top-priority military circuit, the priorities can be simply changed by removing card 162 from the rack (during which time the built-in priority takes over without any service disruption), moving the priority selectors 170, 172 and 174 to positions 3, 4 and 13 respectively, and reinserting the card 162 into the rack. It will be noted, incidentally, that in doing so the EAS line (channel 1) retains its priority over the local circuits because it is the highest of the non-selected channels.

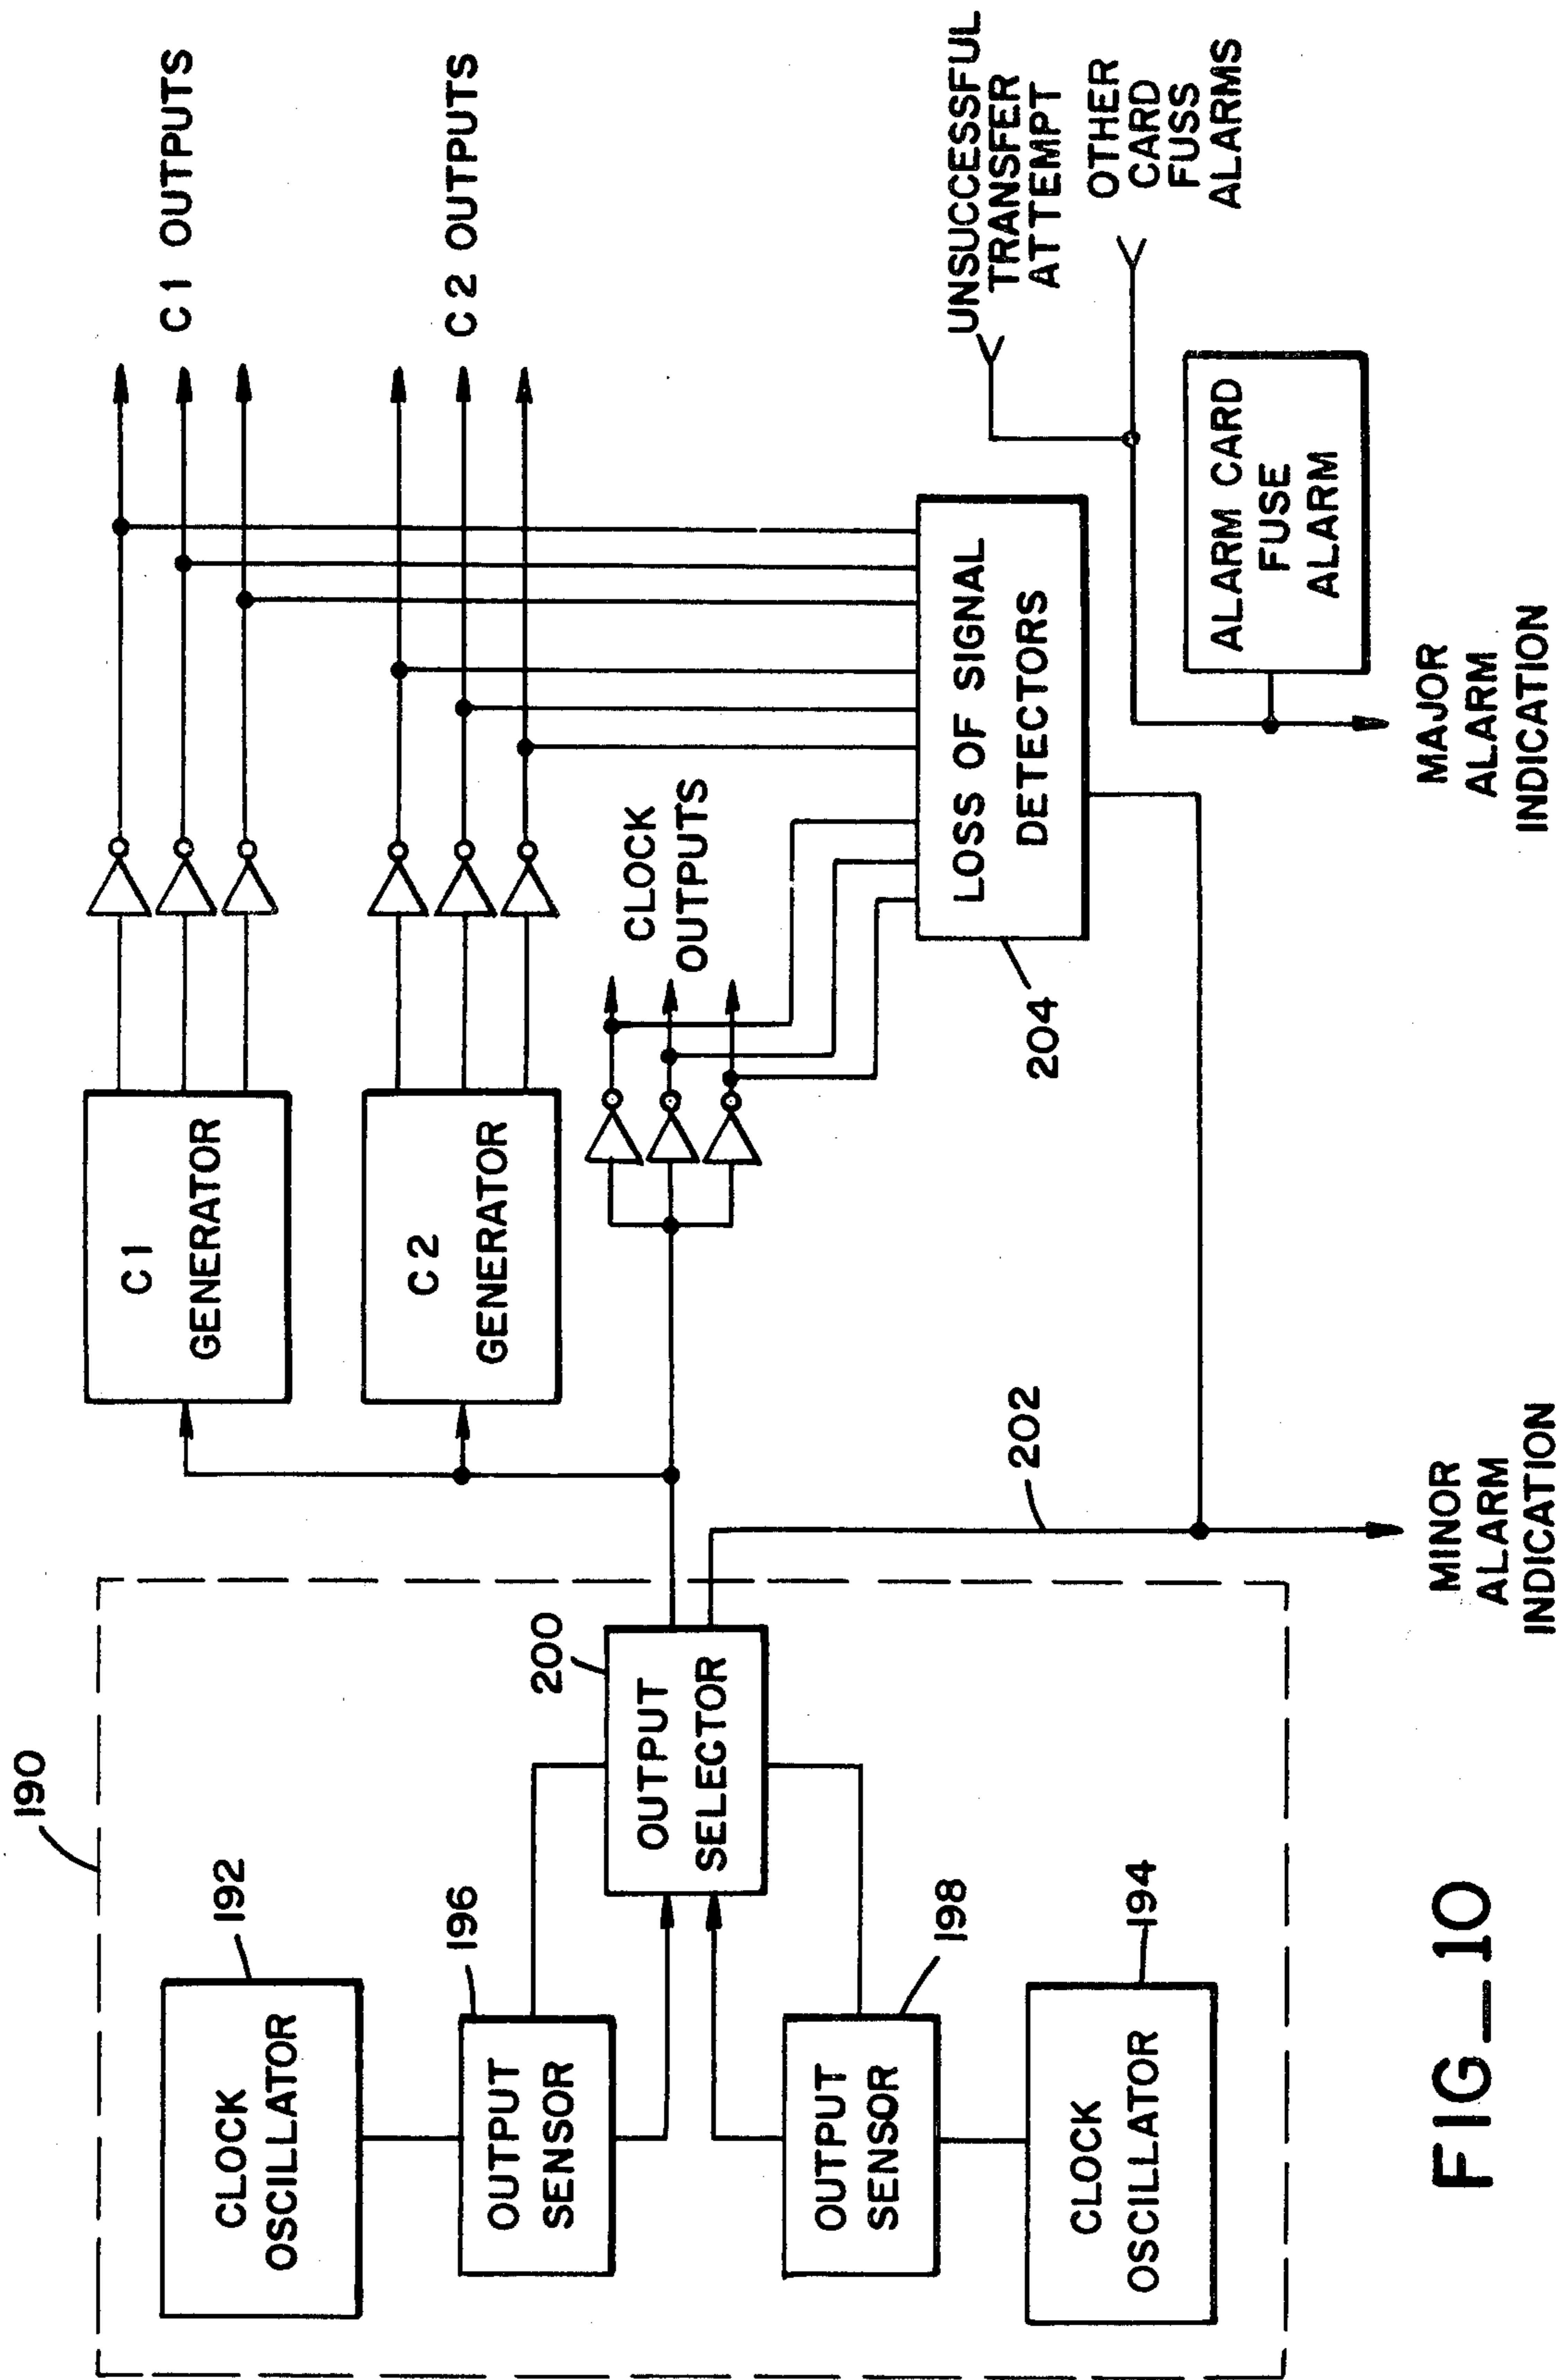
FIG. 10 is a block diagram of the common equipment of the span switch set of FIG. 8.

Consequently, the inventive device has redundancy in its clock generating capability, with an automatic switchover to another oscillator if the oscillator in use fails. An oscillator failure is therefore not a traffic-interrupting malfunction, and the output signal on line 202 to the minor alarm indicator 204 (FIG. 8) when either output sensor 196 or 198 produces a lost output signal.
