[54] METHOD AND APPARATUS FOR REPAIRING PROTECTIVELY LINED REACTOR VESSELS

[73] Assignee: R. Gelb & Sons, Inc., Union, N.J.

[21] Appl. No.: 663,113

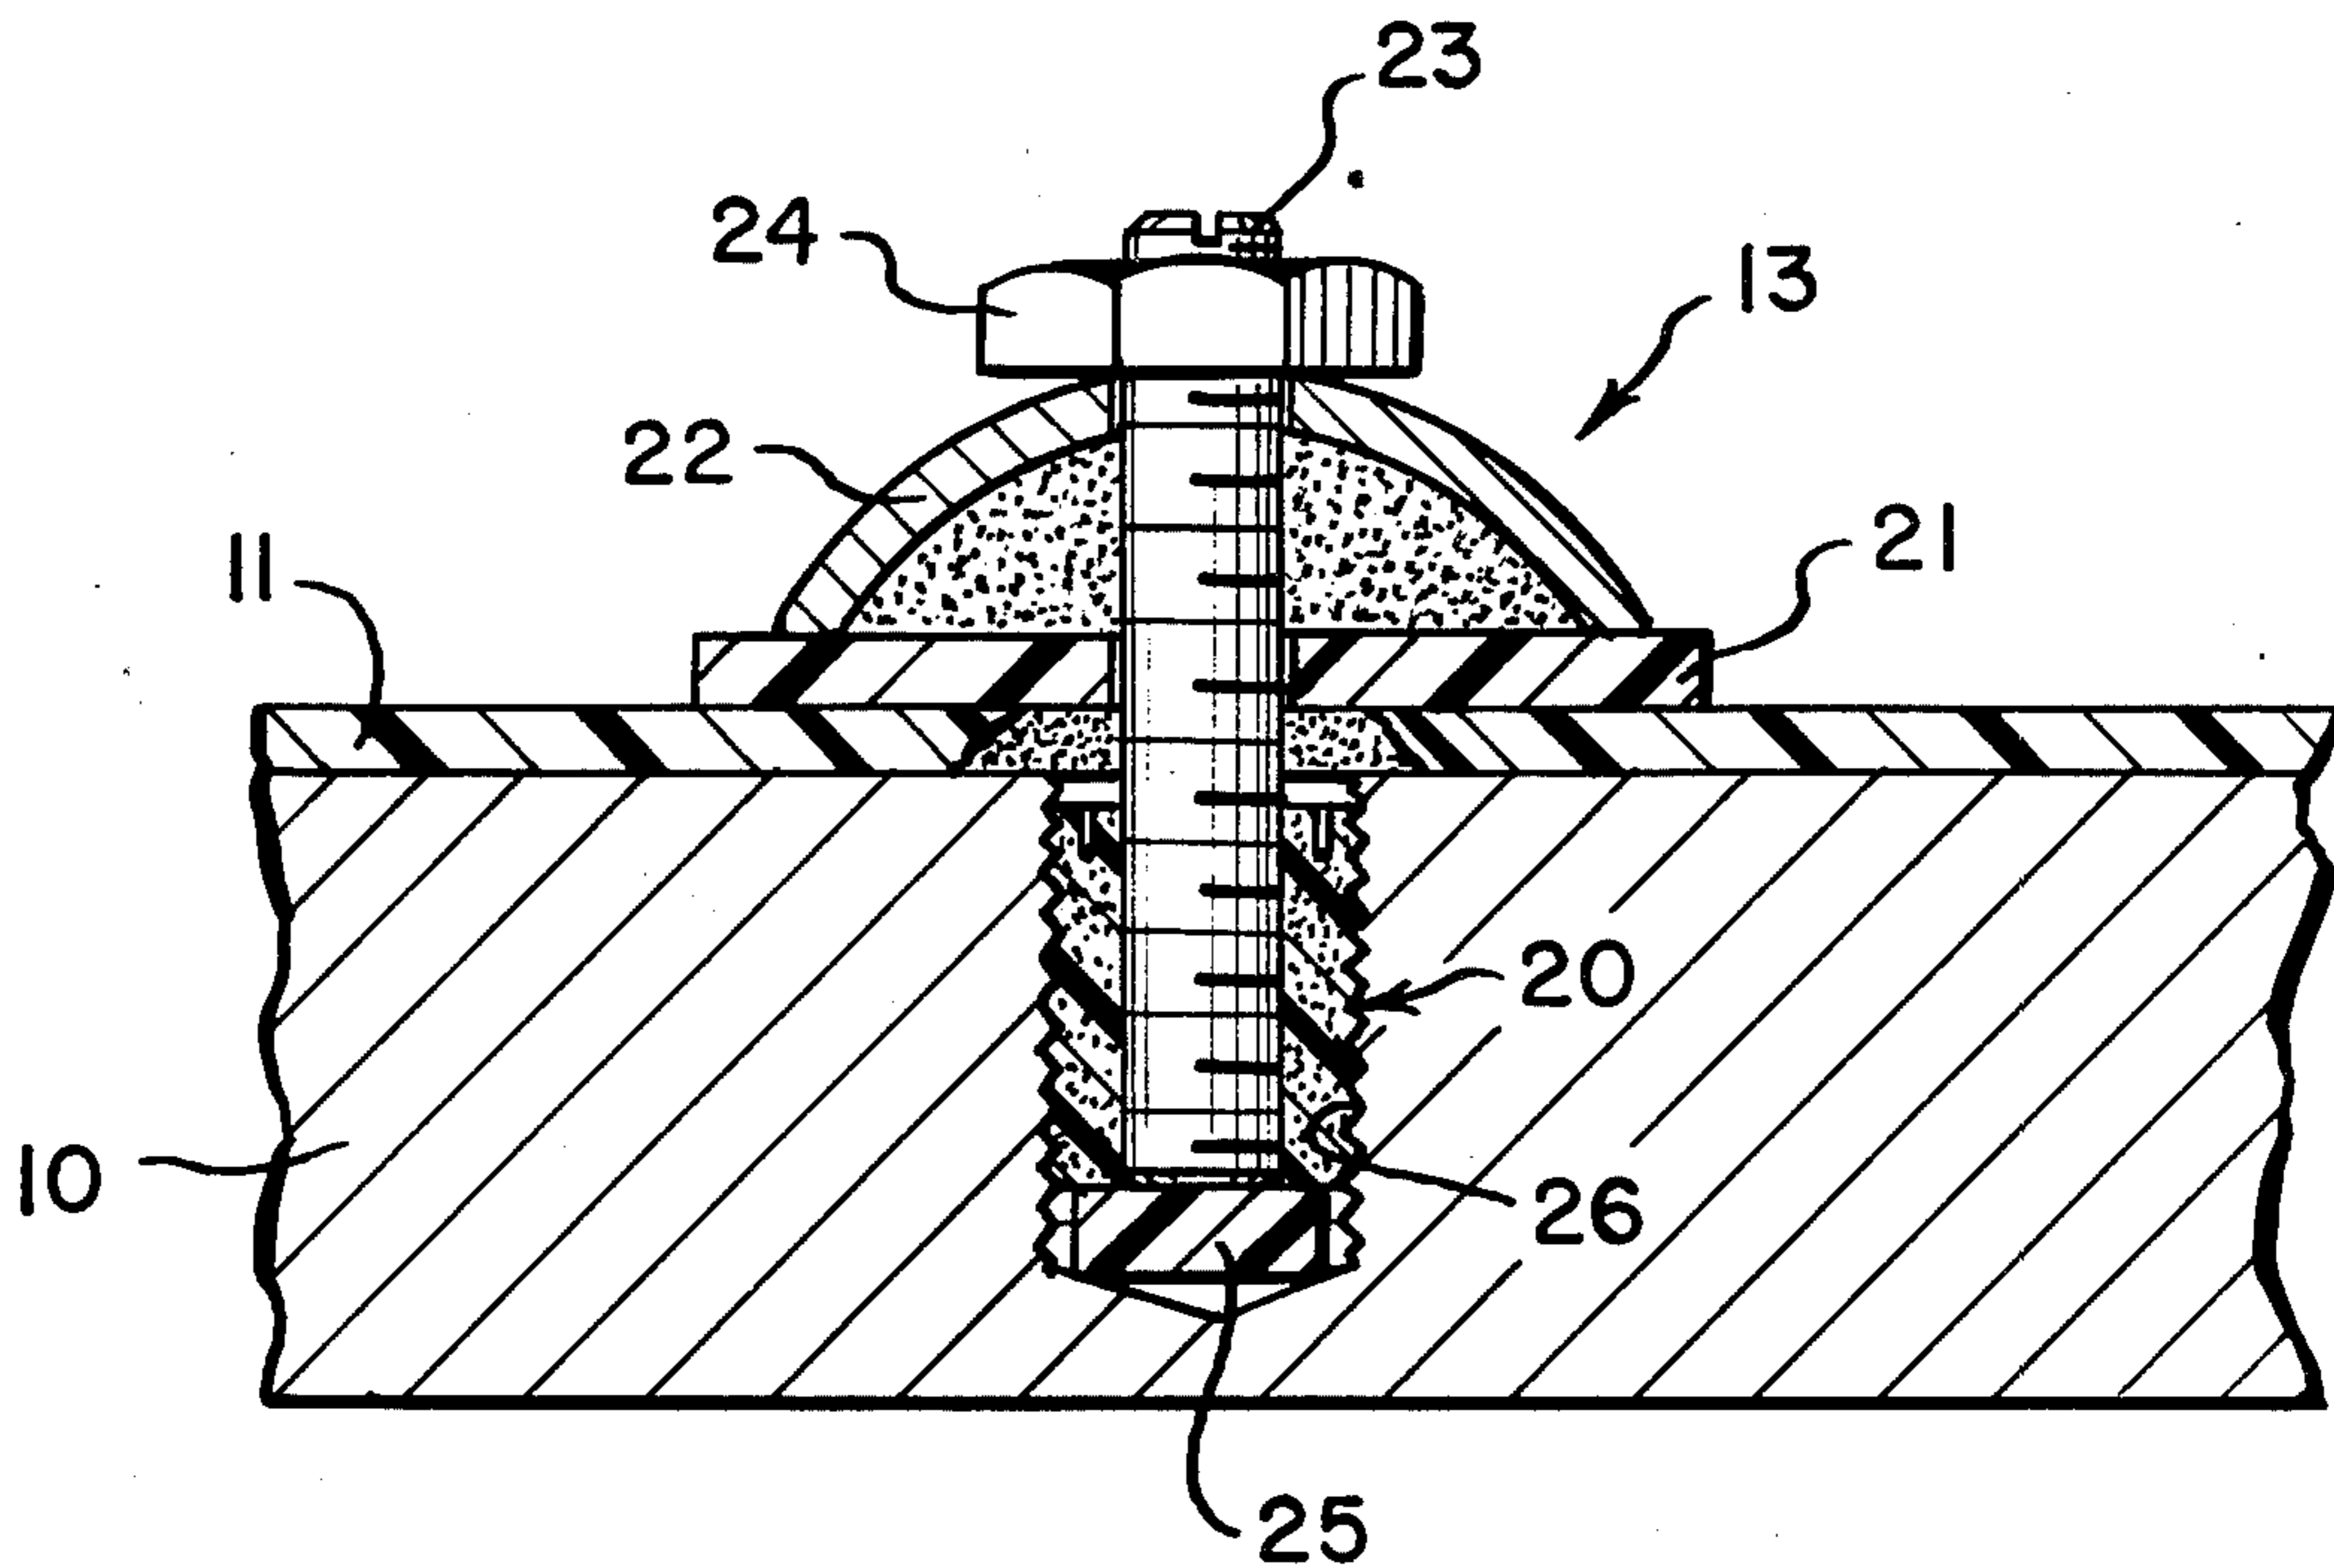
FIG. 1 is a schematic cross-sectional view of a typical protectively lined reactor vessel which has been repaired in accordance with the method and apparatus of the invention;

Referring to the drawing, FIG. 1 illustrates a typical protectively lined reactor vessel comprising a conductive metal support wall 10, typically made of steel, and an insulating protective inner lining 11, such as glass, enamel, plastic, rubber, or the like. The vessel is shown partially filled with a corrosive electrolytic reaction medium 12, such as an aqueous solution of an acid, base or salt. The vessel is shown with a break or fault in the protective lining repaired by repair plug 13 in accordance with the invention and with a second subsequently developed break 14.

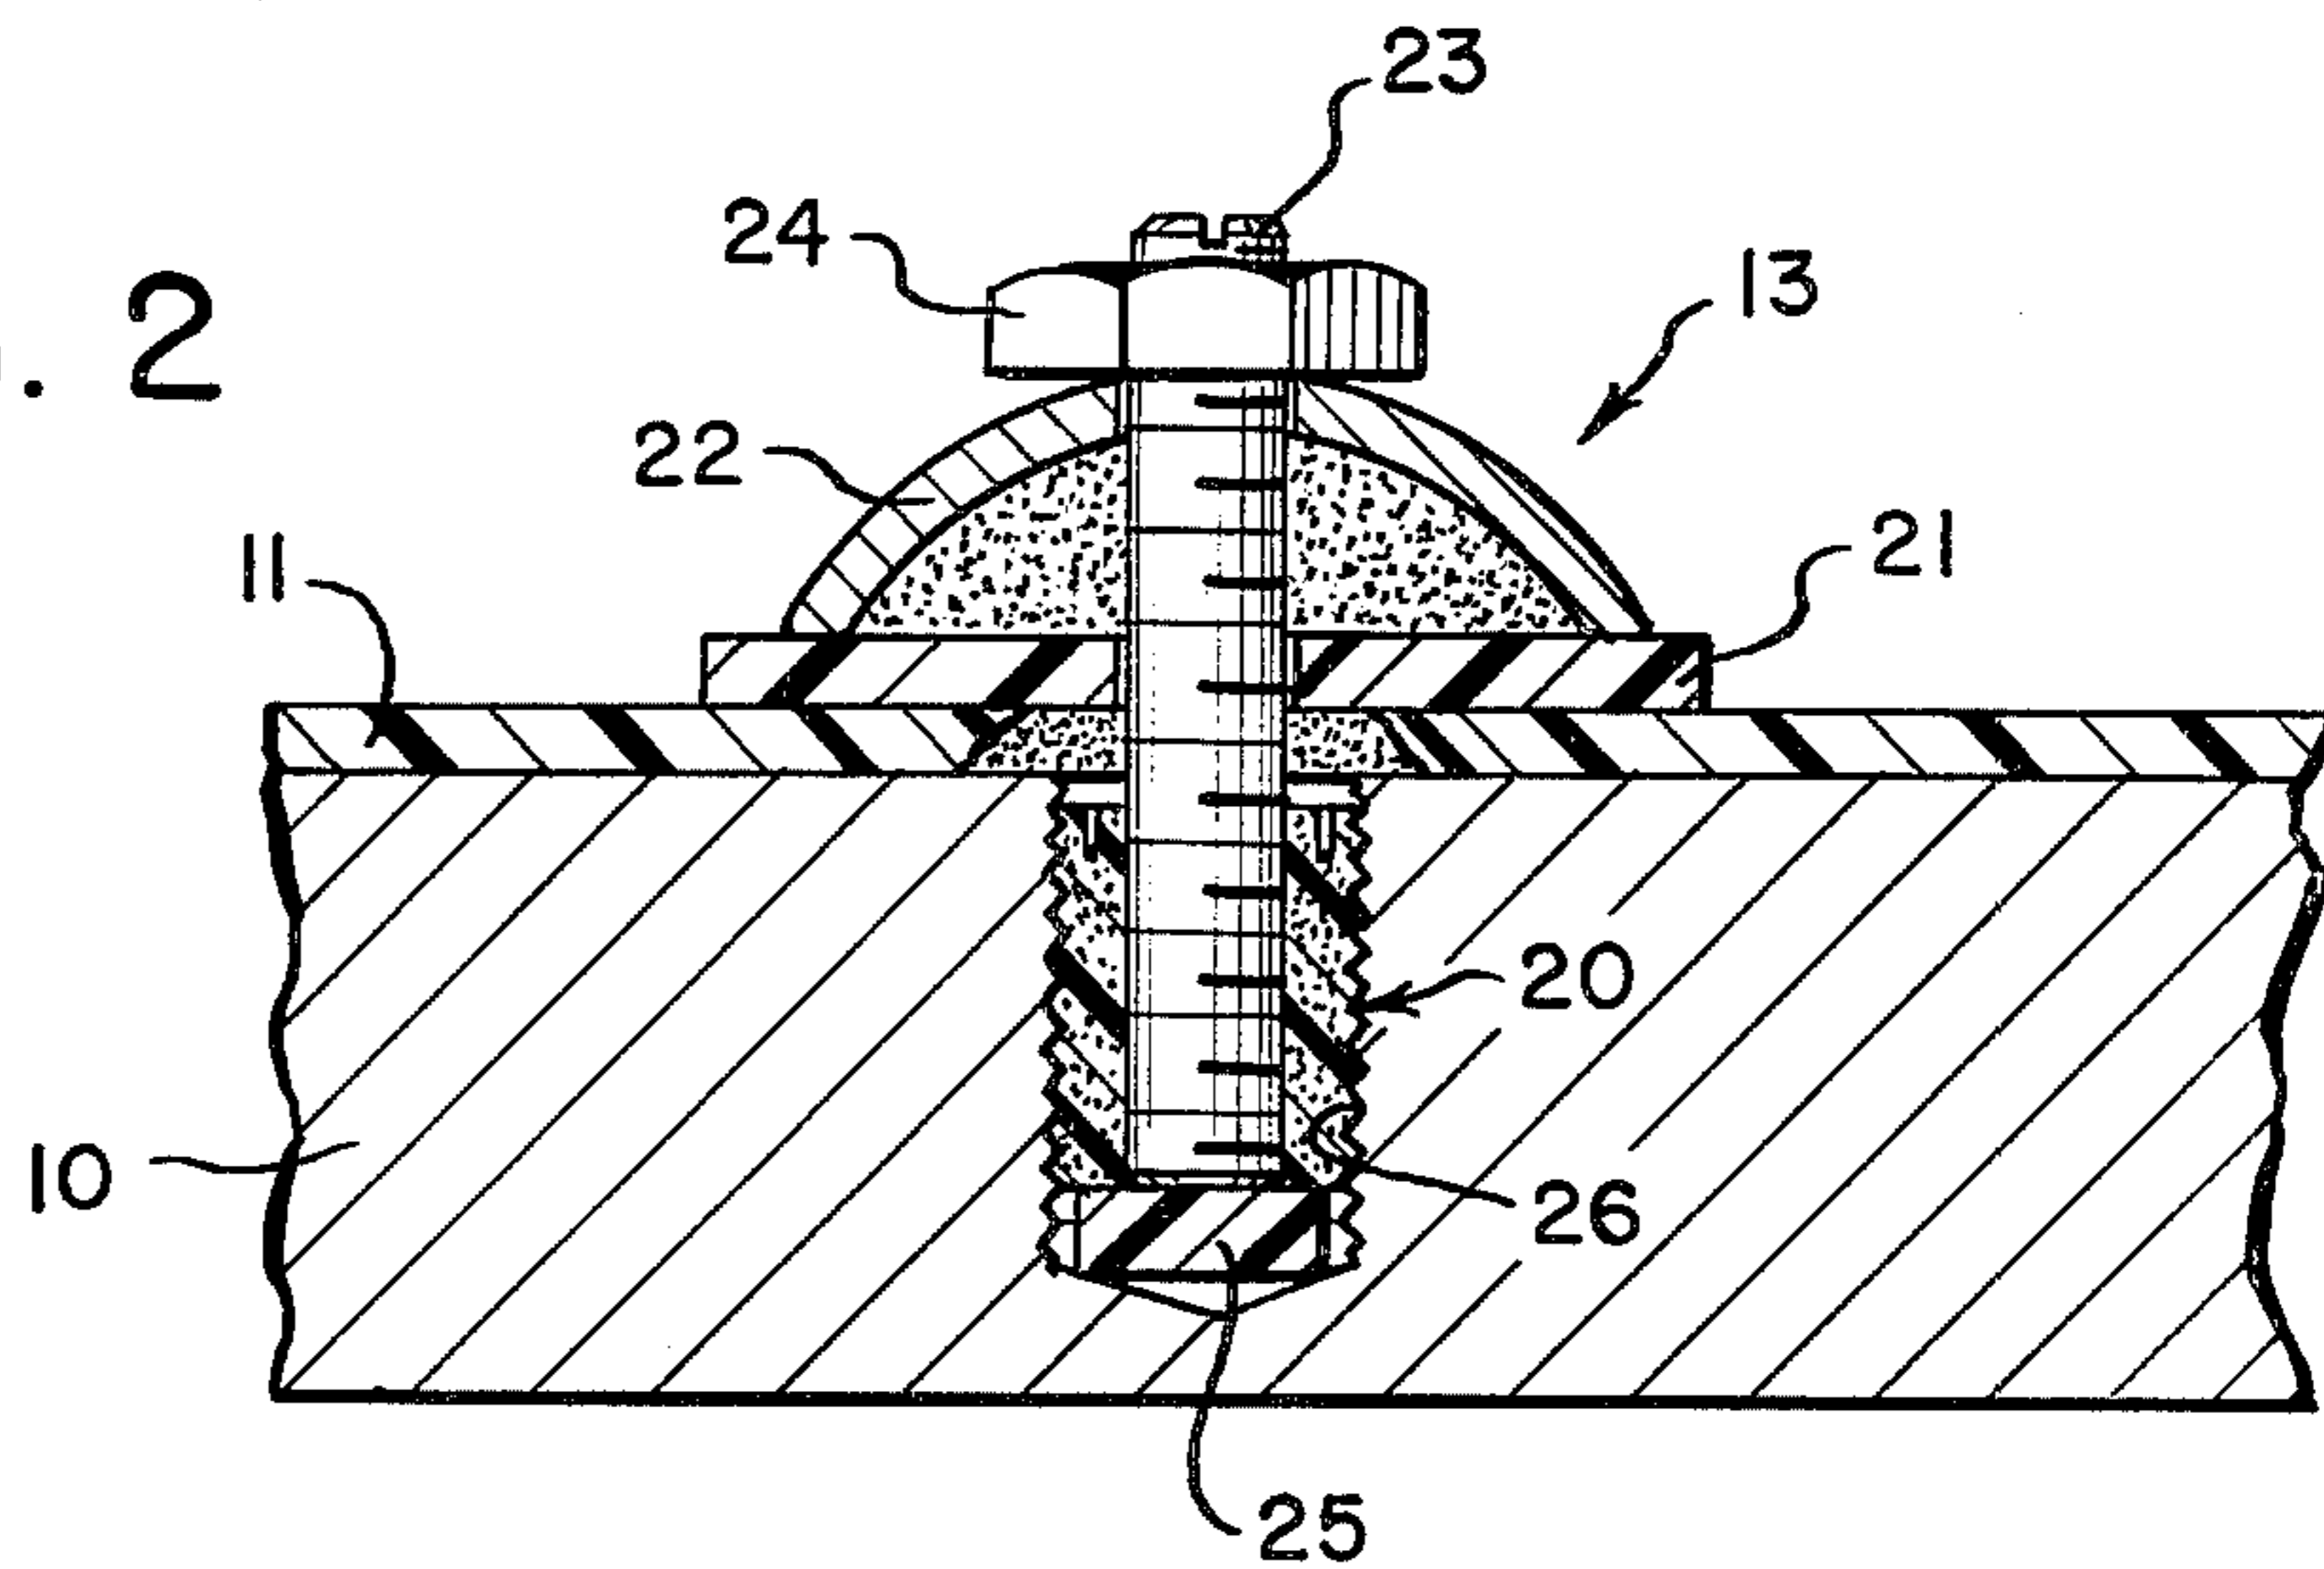
FIG. 2 is a schematic cross-sectional view of a portion of a reactor vessel wall which has been repaired,

illustrating a preferred embodiment of a repair plug in accordance with the invention;

The repair plug 13 is shown in greater detail in FIG. 2. Specifically, this preferred embodiment of a repair plug comprises an insulated anchor stud 20 anchored into the portion of the metal support wall 10 underlying a break in the protective lining 11. In this specific embodiment, the stud 20 is a ceramic stud in the form of a threaded cylinder, and it is anchored by threading into a correspondingly threaded cylindrical aperture in wall 10. The ceramic can be any high strength, non-conducting ceramic such as, for example, an alumina, aluminum silicate, or magnesium silicate.

A sealing gasket 21 is disposed on the portion of the protective lining 11 surrounding the break. Preferably, the sealing gasket 21 is made of a corrosion-resistant, insulating plastic material such as a fluorocarbon, e.g., polytetrafluoroethylene. It may conveniently be in the form of an annular ring.

A clamping arrangement comprising washer 22, metallic stud 23, and nut 24 is provided for clamping gasket 21 onto protective lining 11 throughout a path surrounding the break. Preferably, washer 22 is a dish-shaped washer of tantalum or other corrosion-resistant metal with a concave surface facing the gasket so that pressure exerted on the washer is applied to the gasket around a path surrounding the break.

Metallic stud 23, which is preferably tantalum or other corrosion-resistant metal, is attached to anchor stud 20, preferably by threaded engagement. To this end, stud 23 is preferably a cylindrical threaded stud.

Anchor stud 20 is provided with a correspondingly threaded aperture and an insulating element 25 such as a polytetrafluoroethylene disc or a ceramic cup is provided to insulate the inner end portion of metallic stud 23 from wall 10. Metal stud 23 extends through gasket 21 and washer 22.

The clamping arrangement is completed by nut 24, preferably tantalum. When nut 24 is threaded onto stud 23 and tightened down onto washer 22, pressure from the nut is transmitted to the gasket 21 along a path of contact surrounding the break in lining 11, thus sealing the underlying wall from corrosive electrolyte 12.

Advantageously, the space between the concave washer 22, the gasket 21, and the metal stud 23 is filled with a nonconducting, corrosion-resistant cement, such as a furan resin or a silicate cement. Similarly, the spaces between the gasket 21, the support wall 10, and the metallic stud 23 are filled with cement.

The method whereby a protectively lined reactor vessel is repaired in accordance with the invention can be illustrated in relation to the plug components shown in FIG. 2.

After the break is detected and after the preliminary step of removing corrosive liquid from the vessel, the first step in its repair involves producing an anchoring aperture 26 in the portion of the support wall 10 underlying the break. This aperture is expeditiously produced by drilling a sufficiently large diameter hole into but not through wall 10 to remove any corroded metal under the break and then preferably threading the drilled aperture.

The second step involves anchoring an insulating stud into the anchoring aperture just produced. In the preferred embodiment, this is accomplished by the preliminary step of placing insulating disc 25 into the aperture and then threading insulating stud 20 into the wall.

The third step involves disposing sealing gasket 21 on the portion of the protective lining 11 surrounding the break. As previously discussed, the gasket is preferably a corrosion resistant, insulating plastic material such as a fluorocarbon.

The fourth step involves applying a washer 22 outside the sealing gasket 21. Preferably, the washer is concave with respect to the gasket.

The fifth step involves applying between the washer 21 and the anchored stud 20 a clamping pressure for clamping the gasket 21 onto the protective lining 11 throughout a periphery surrounding the break, thereby sealing the break. This clamping pressure is applied in the preferred embodiment by passing metal stud 23 through washer 22 and gasket 21 and threading it into anchor stud 20. Nut 24 is then threaded onto the stud 23, exerting a clamping pressure onto washer 22 which, in turn, clamps gasket 21 onto the lining 11 around the break. As a step preliminary to the insertion of metal stud 23, the space between the gasket 21 and the concave washer 22 and the space between the gasket 21 and support wall 10 can be filled with uncured insulating cement in order to produce a unitary insulating structure upon curing.

Alternatively, the metal stud 23 could be threaded into anchoring stud 20 prior to application of gasket 21 and washer 22. This approach, however, would make introduction of the insulating cement somewhat more difficult.

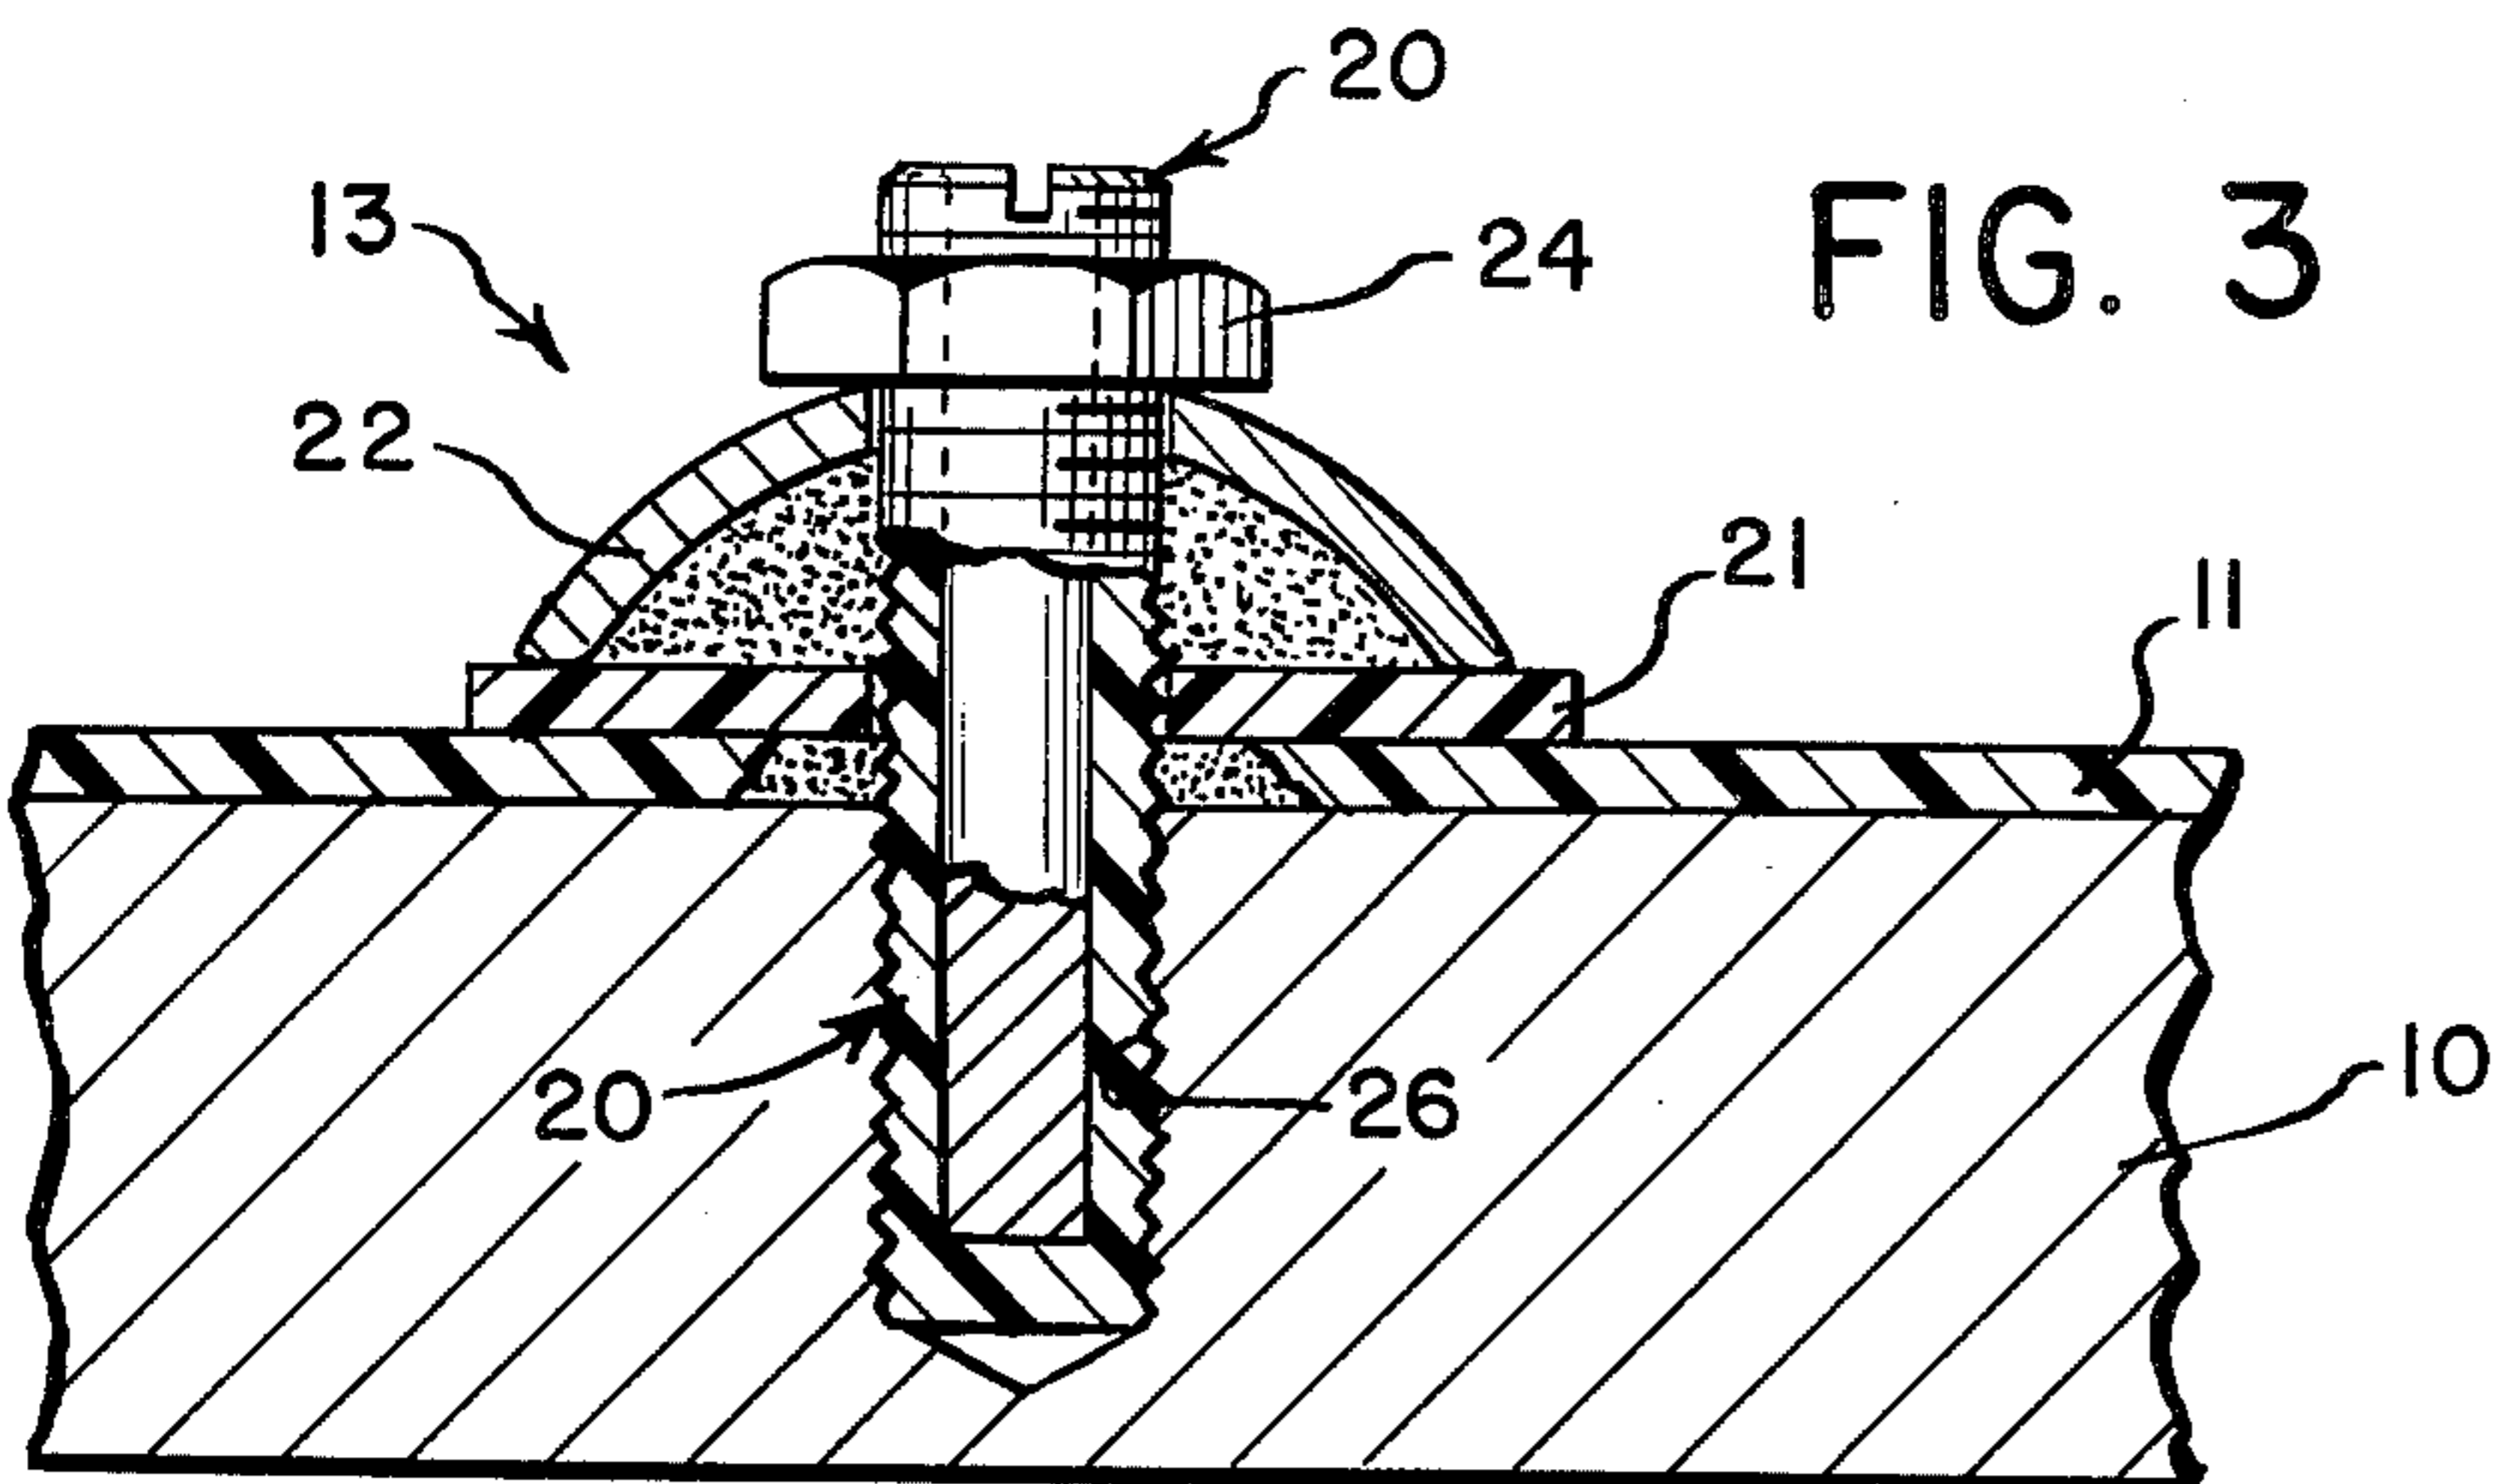
FIG. 3 illustrates a second embodiment of a repair plug in accordance with the invention;

FIG. 3 illustrates an alternative embodiment of a repair plug in accordance with the invention. This embodiment is similar to that shown in FIG. 2, except that

insulating anchor stud 20 is elongated in comparison to that of FIG. 2, rendering unnecessary metal stud 23 and disc 25. In the preferred form, anchor stud 20 in this embodiment has a metal core to give it the necessary strength and an insulating outer layer of a strong insulating material such as a ceramic. In practice, this embodiment is particularly useful in repairing small breaks where little of the underlying wall has been corroded, and the embodiment of FIG. 2 is more useful in repairing breaks where the corrosion has spread to a greater extent.

The method for repairing a reactor vessel using the plug components shown in FIG. 3 is similar to the method using the plug components of FIG. 2 except that clamping is effected by threading nut 24 directly onto anchor stud 20.

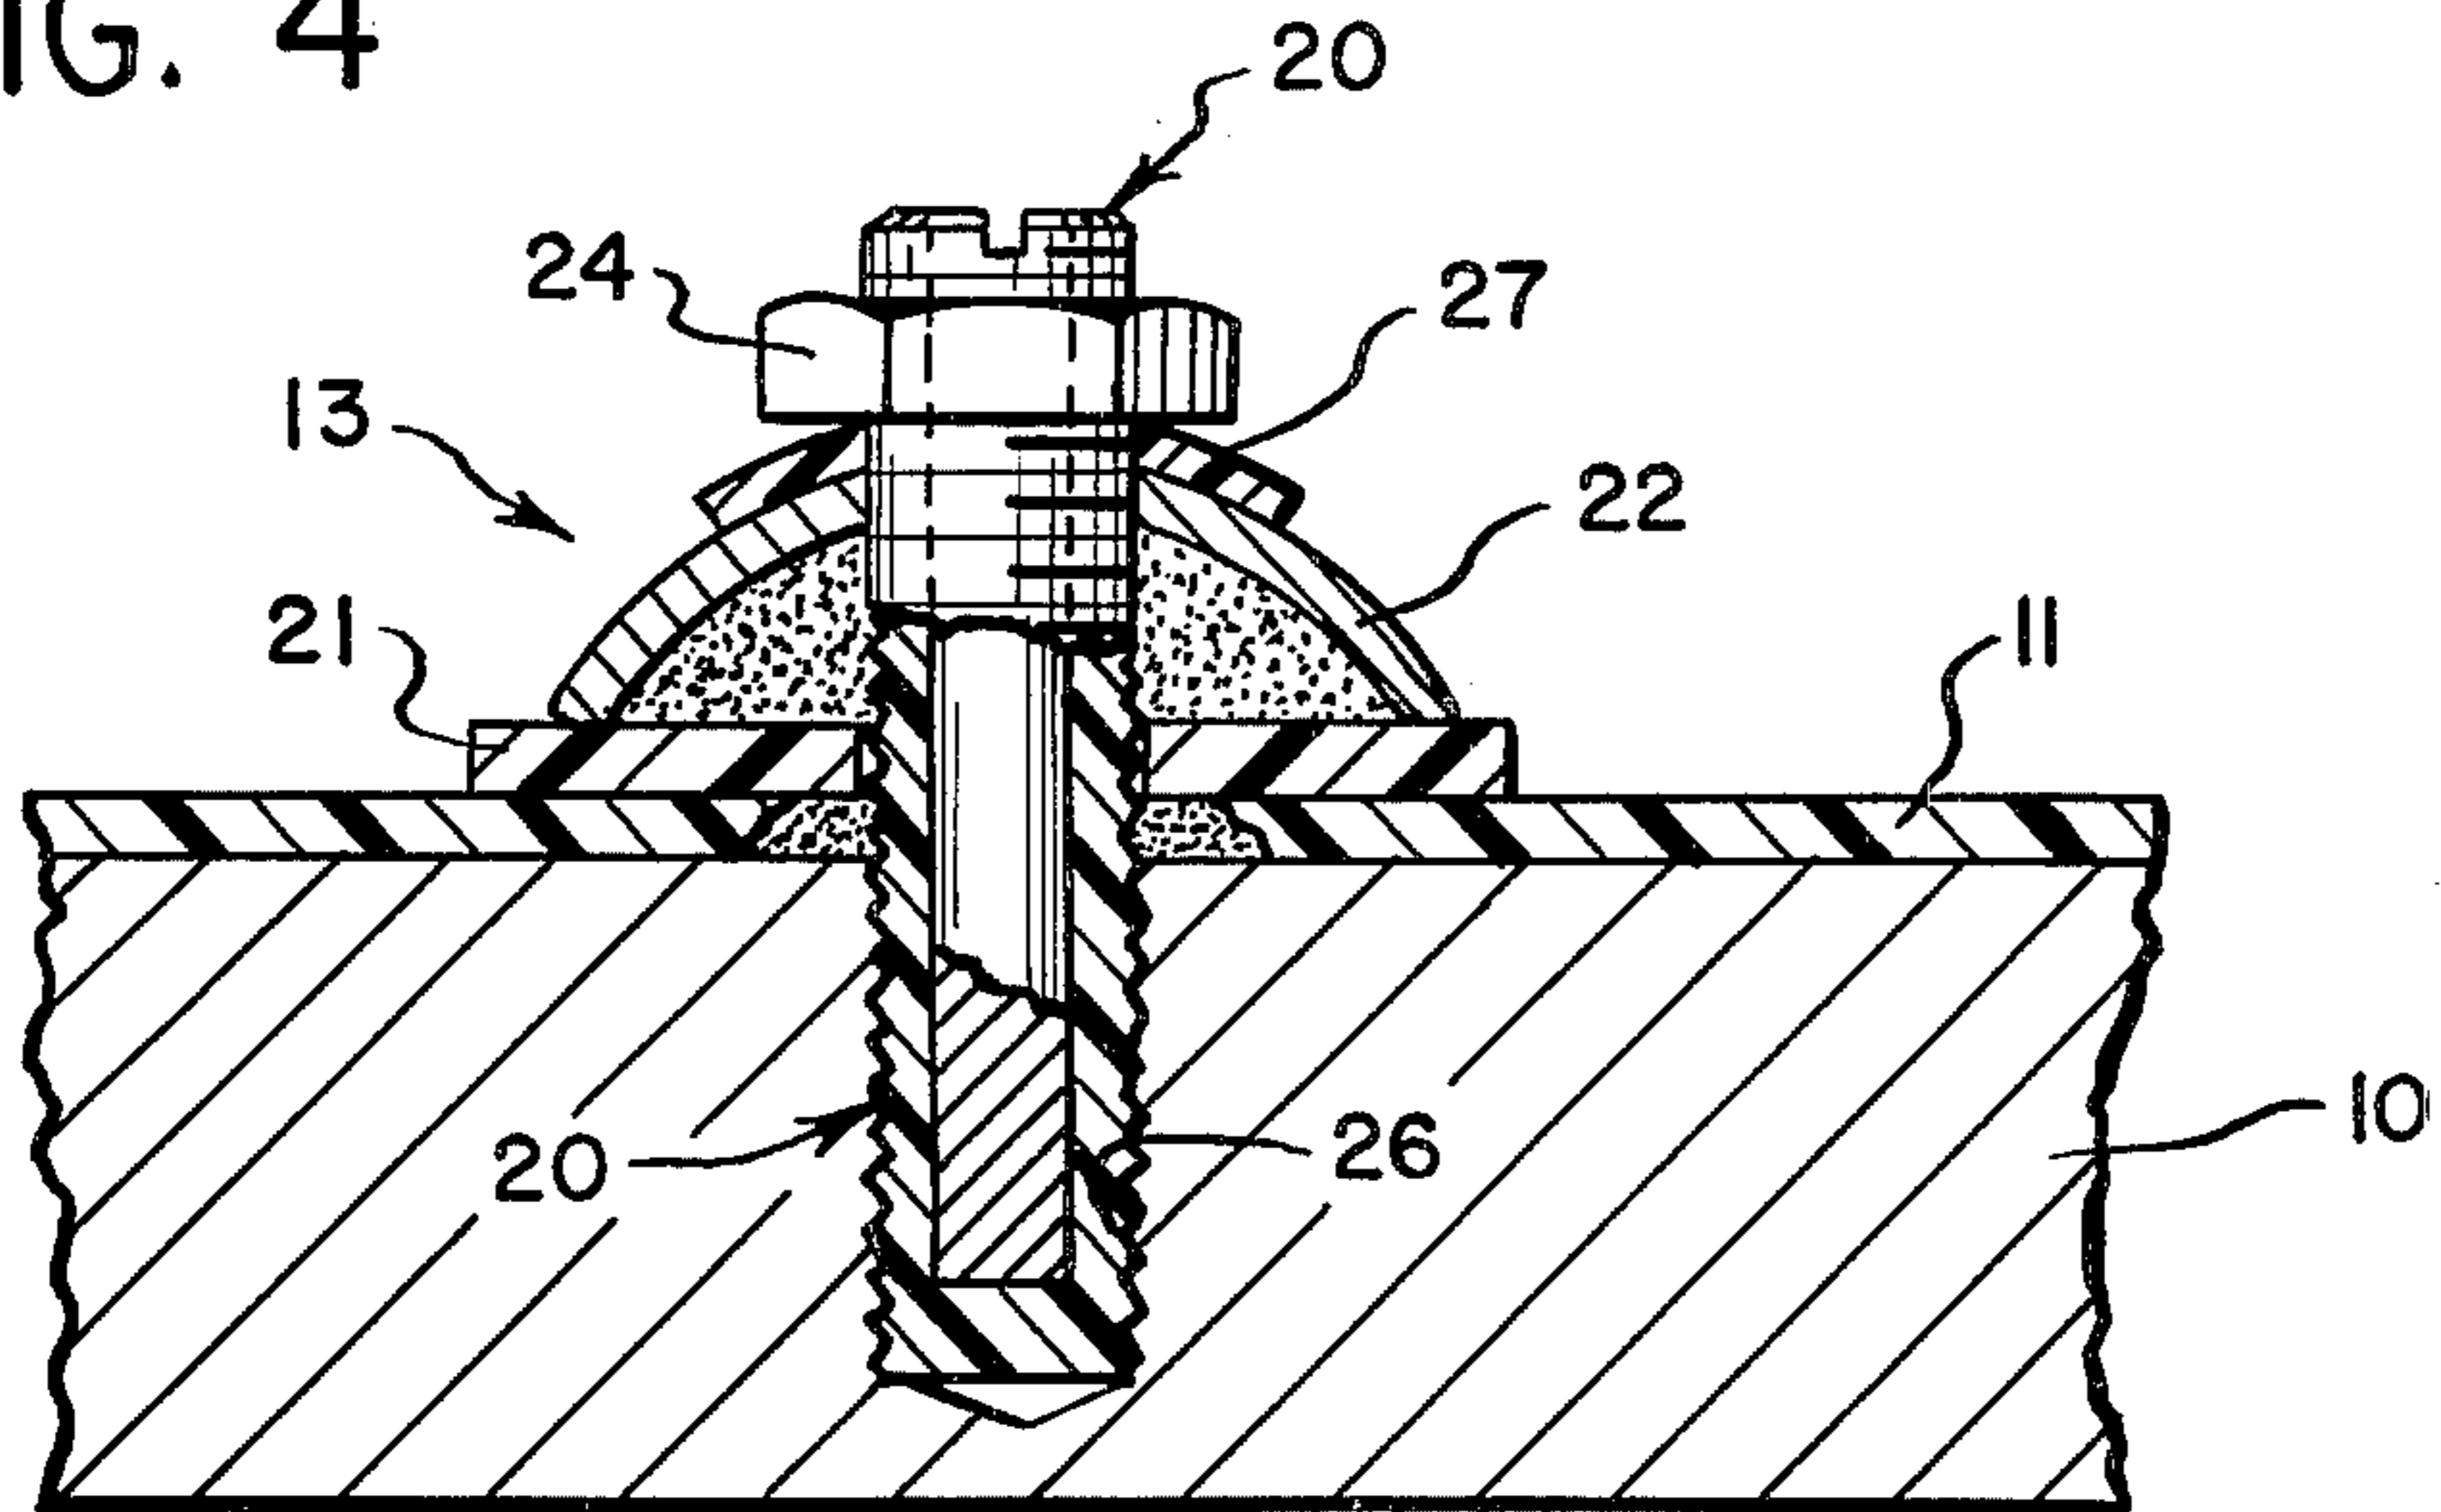
FIG. 4 illustrates a third embodiment of such a repair plug;

FIG. 4 illustrates a second alternative embodiment of a repair plug in accordance with the invention. This embodiment is similar to that shown in FIG. 3, except that a secondary insulating gasket 27 is disposed between nut 24 and washer 22. Such a gasket provides yet a further level of insulation and sealing between the interior of the vessel and the metal wall.

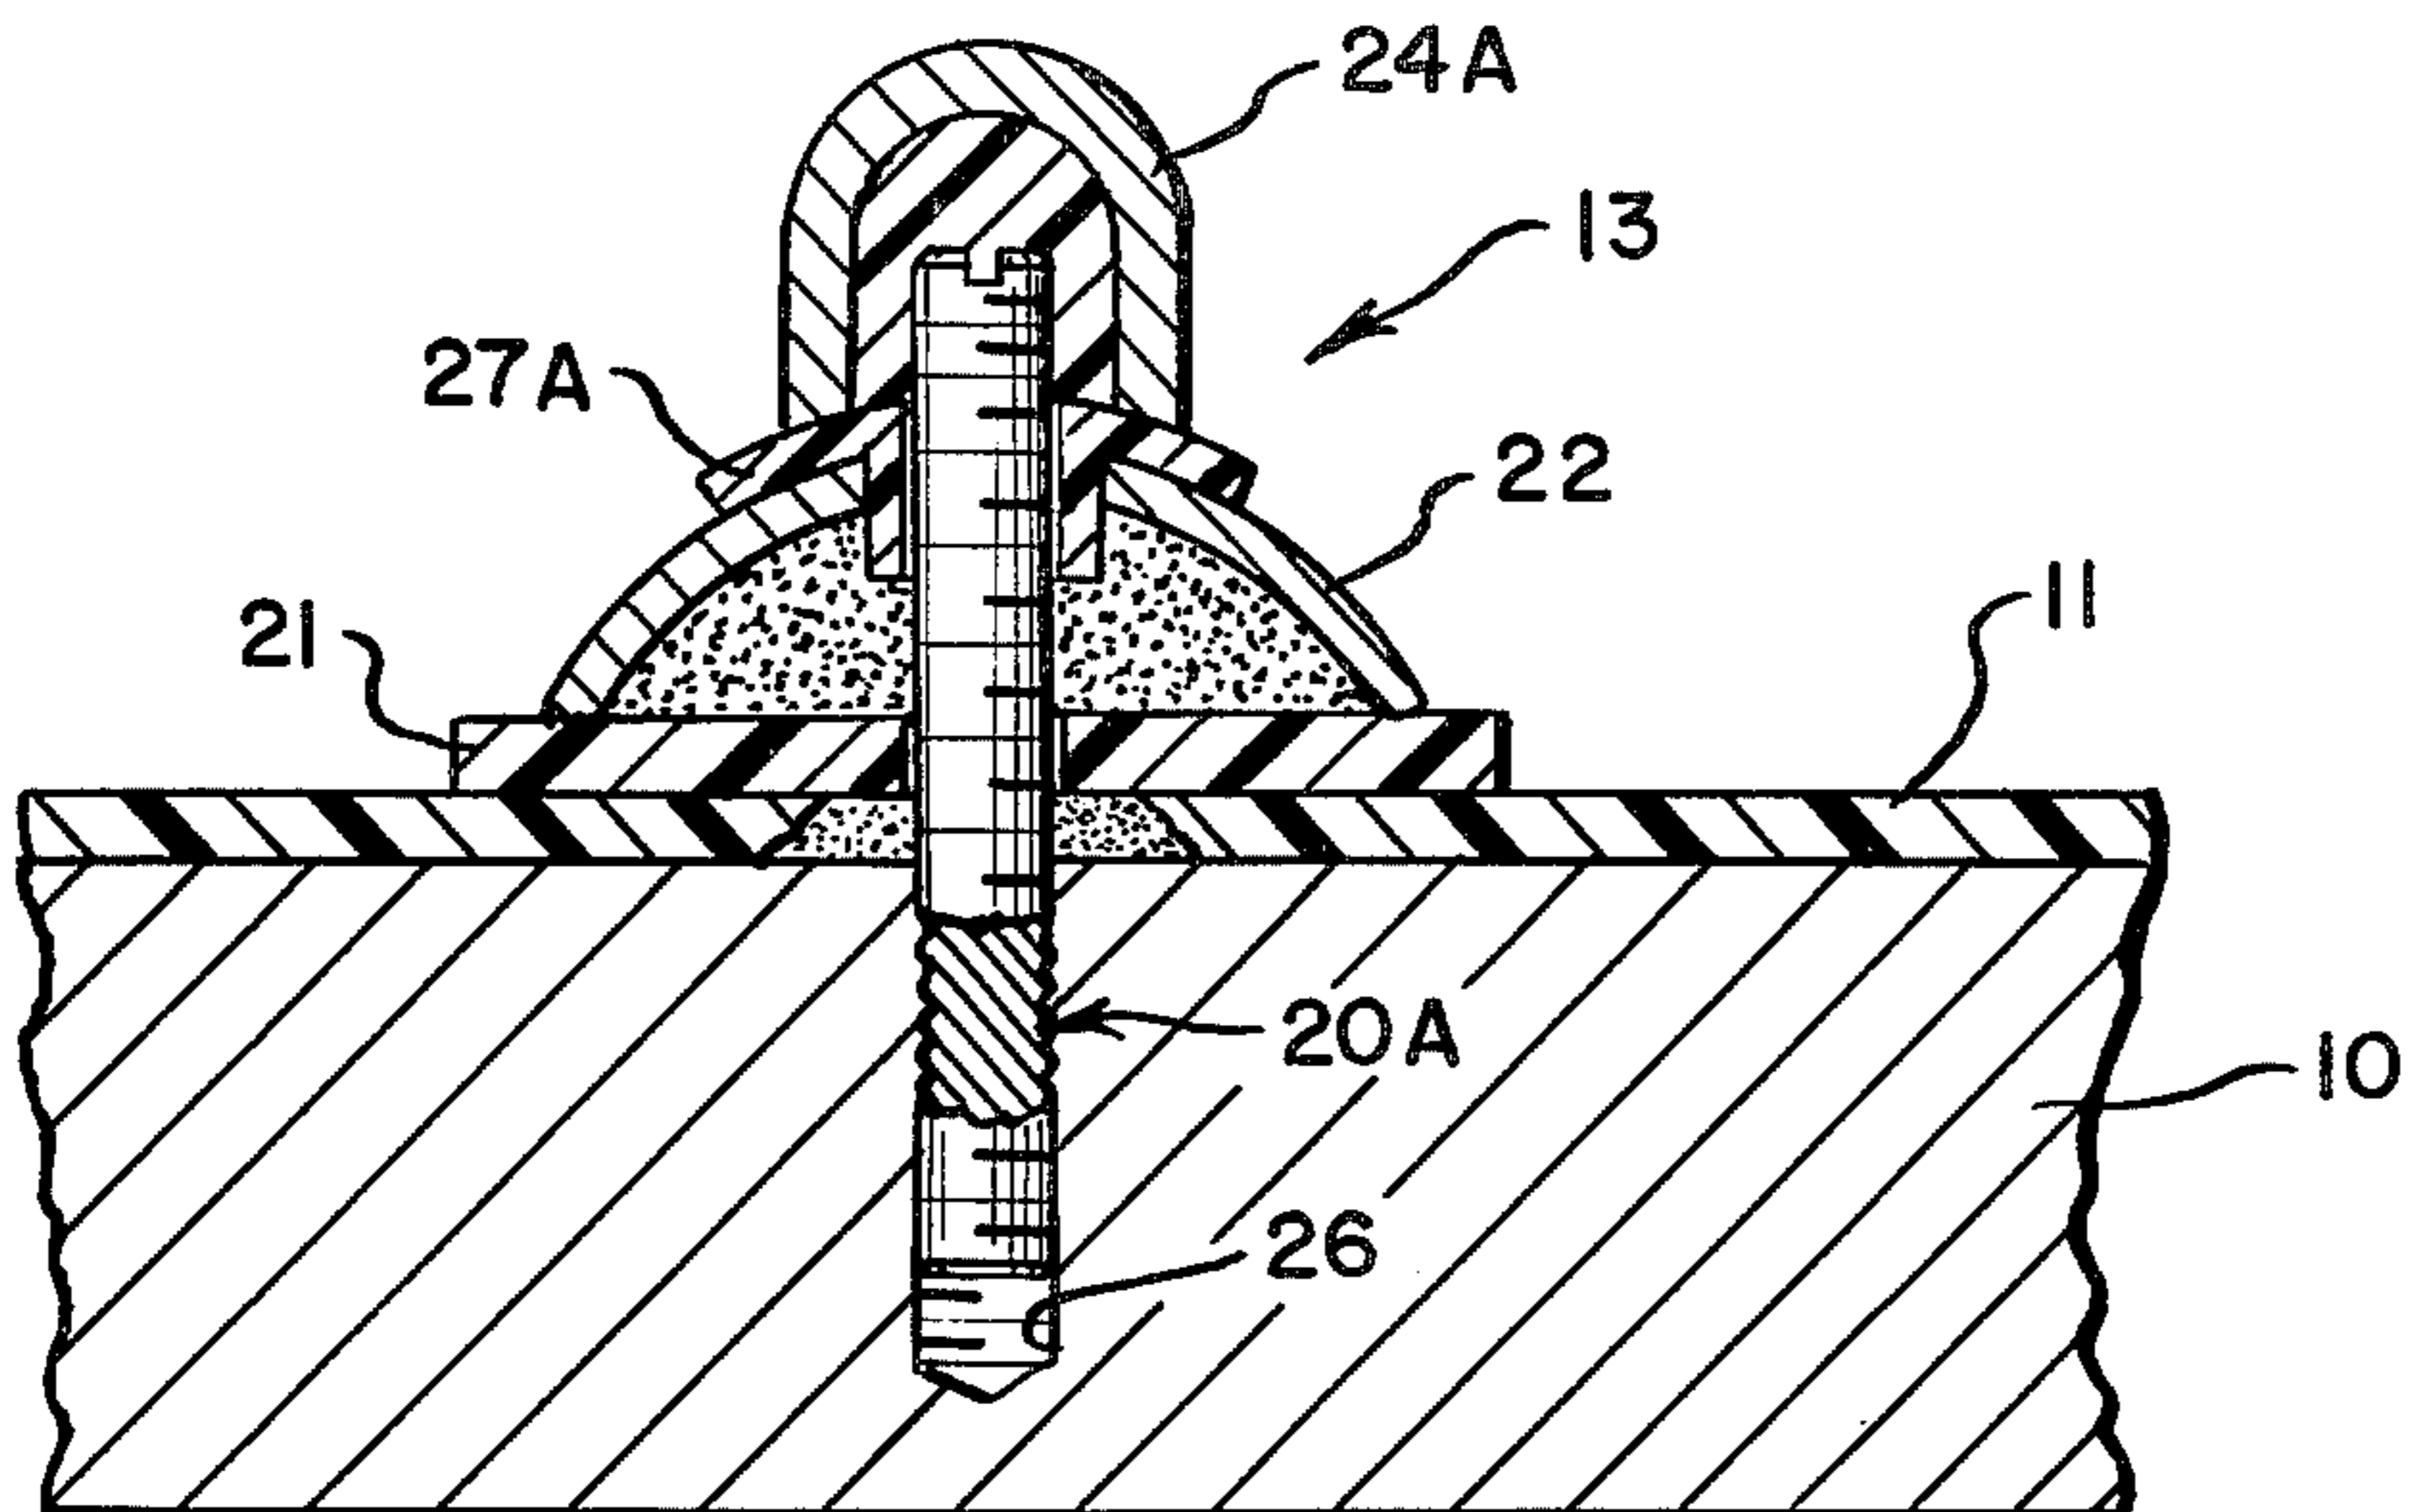
FIG. 5 illustrates a fourth embodiment of such a repair plug; and

FIG. 5 illustrates a repair plug in accordance with a second aspect of the invention wherein the anchor stud 20A is conductive rather than insulating, but is electrically insulated from the electrolyte by an insulating cap nut 24A in cooperation with a second insulating gasket 27A. Preferably, the anchor stud 20A is tantalum or other corrosion-resistant metal, the second gasket 27A is flanged for facilitating seal between the cap nut and the washer 22. The cap nut 24A is preferably a composite structure having a metal outer shell and an insulating inner section. This embodiment is useful for repairing breaks having a very small amount of corrosion as compared to the breaks where the embodiments of FIGS. 2 and 3 are particularly useful.
