[54] METHOD AND APPARATUS FOR REPAIRING PROTECTIVELY LINED REACTOR VESSELS

[73] Assignee: R. Gelb & Sons, Inc., Union, N.J.

[21] Appl. No.: 663,113

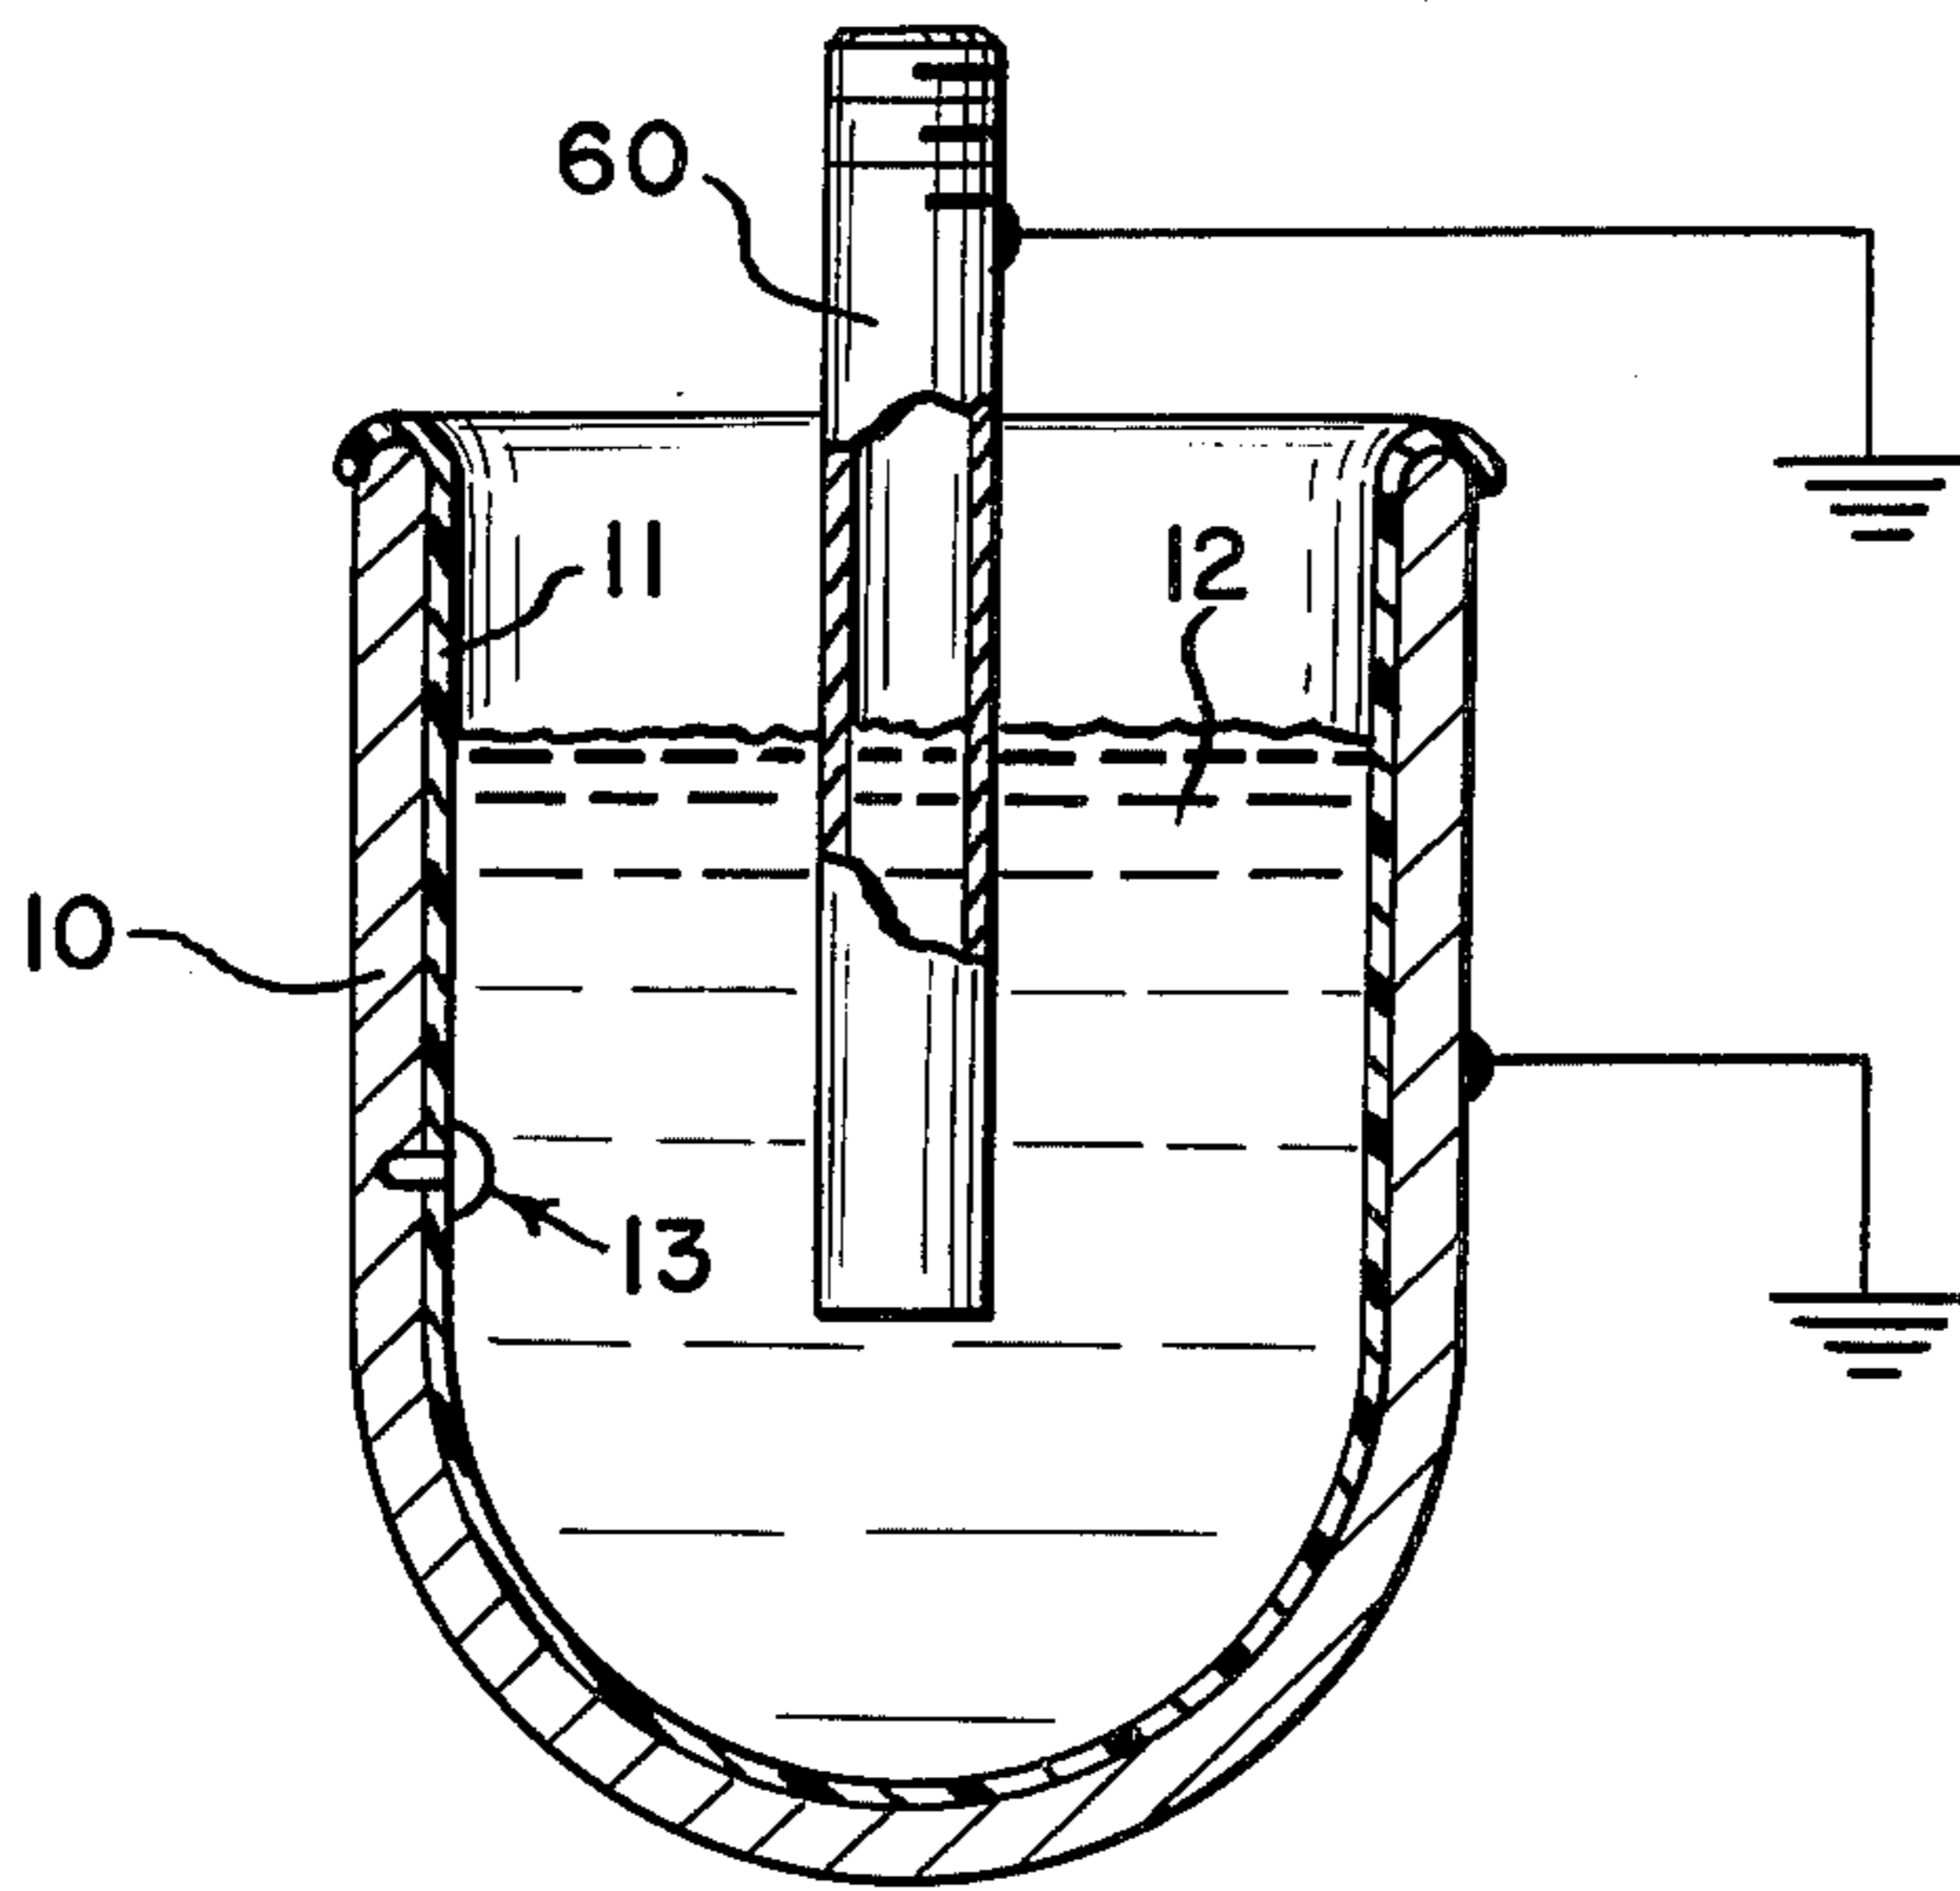
FIG. 6 is a schematic cross-sectional view of a protectively lined reactor including a repair plug in accordance with the invention and a dip tube of dissimilar metal.

FIG. 6 illustrates the combination of a protectively lined reactor vessel repaired in accordance with the invention and a dip tube 60 made of a metal different from the metal of the repair plug 13. Conveniently, the dip tube is a hollow cylindrical tube of a corrosion-resistant metal other than tantalum such as Hastelloy, a nickel-base alloy marketed by the Haynes Stellite Company. The repair plug 13 can be any one of the embodiments illustrated and described in connection with FIGS. 2-5, inclusive.

Since, in this combination, the reactor vessel has been repaired without introducing unwanted electrical paths through the lining, there is no substantial galvanic interaction between the repair plug and the dissimilar metal dip tube and hence no accelerated deterioration of either.
