[54] METHOD FOR REPAIRING WHEEL HUBS
FOR VEHICLES

[57] ABSTRACT

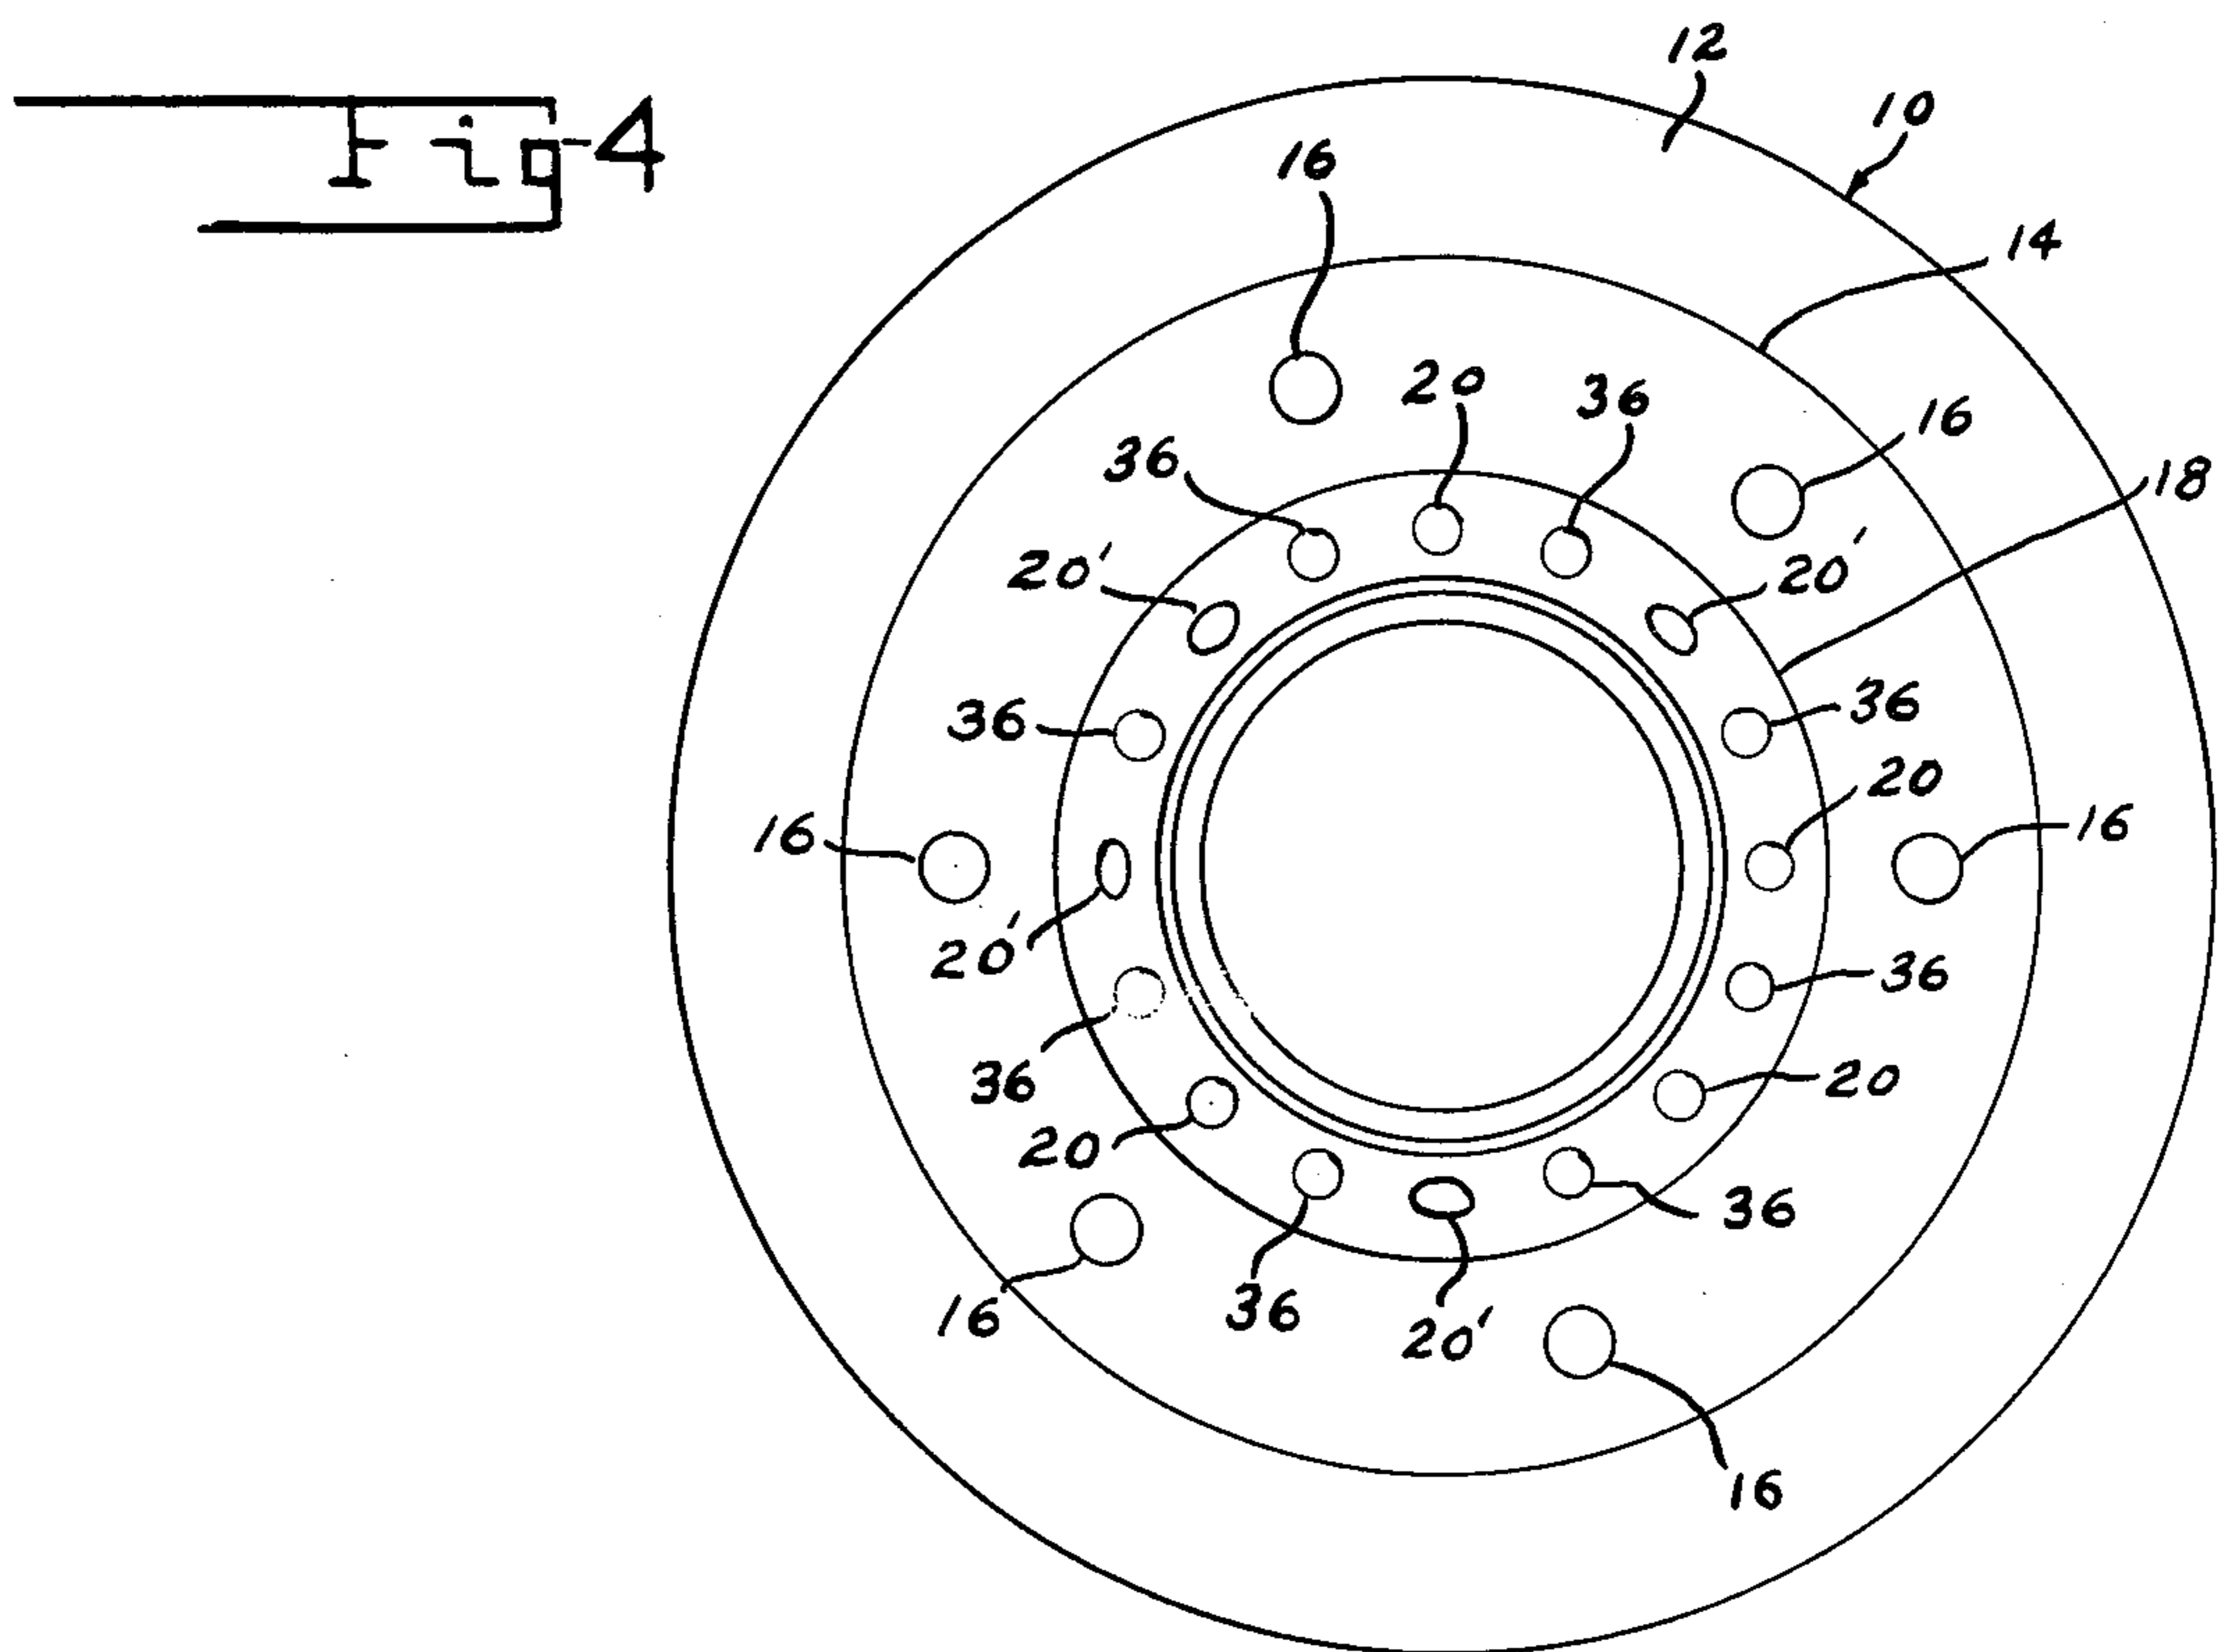
FIG. 4 shows the hub of FIG. 1 after new holes are drilled in the axle engaging flange.

With the template as a guide, new holes are then drilled in the flange 18 at the position of each of the holes 28. The new holes are drilled to the same size as holes 20. The template is then removed and the new holes 36, as shown in FIG. 4, are tapped and new studs 38 are inserted in each of the tapped holes as shown in FIG. 5. The hub is then ready for assembly in the conventional manner.

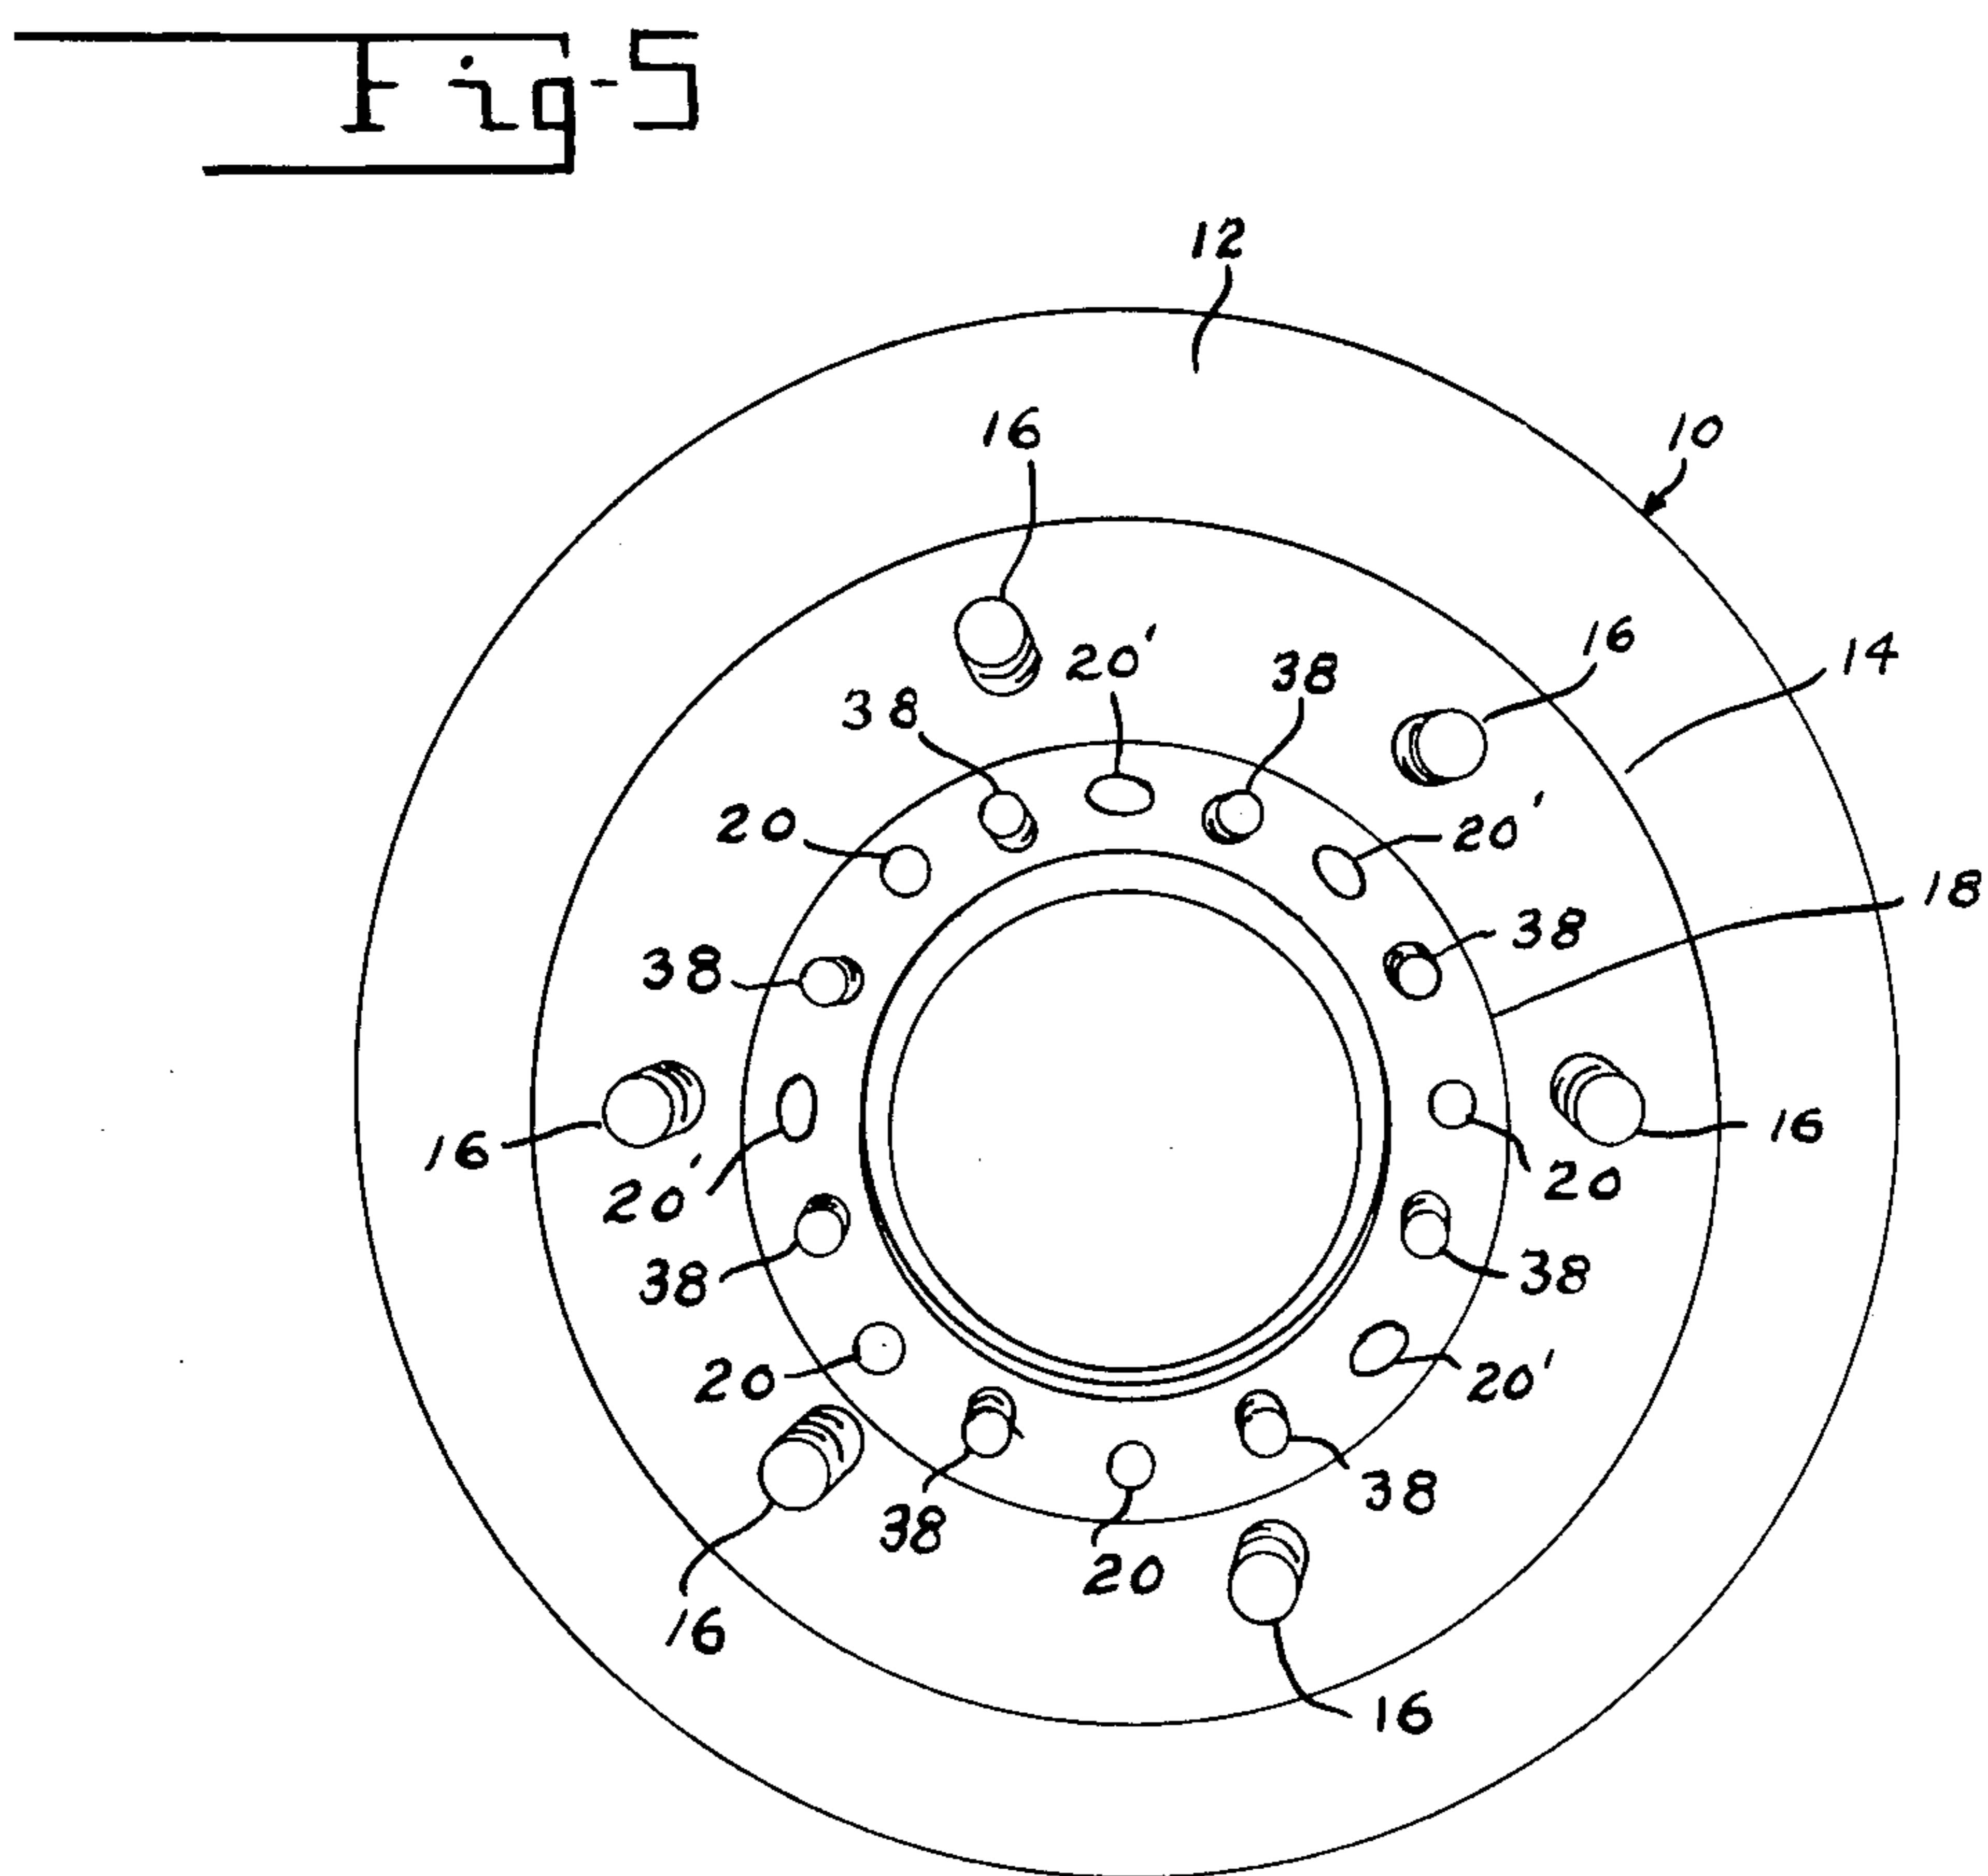
FIG. 5 is an isometric view showing the hub of FIG. 4 with the new studs in place.
