- [54] **SUPERALLOY ARTICLE CLEANING AND REPAIR METHOD**
- [75] Inventors: **Donald L. Keller, Cincinnati; David L. Resor, Mount Orab, both of Ohio**
- [73] Assignee: **General Electric Company, Cincinnati, Ohio**
- [21] Appl. No.: **778,493**
- [22] Filed: **Mar. 17, 1977**
- [51] Int. Cl.<sup>2</sup> ..... **B23K 31/00**
- [52] U.S. Cl. .... **228/119; 29/402; 164/92; 228/193; 228/220; 228/221; 228/248**
- [58] Field of Search ..... **228/119, 206, 219, 220, 228/221, 248, 193, 195; 29/402; 164/92**

## SUPERALLOY ARTICLE CLEANING AND REPAIR METHOD

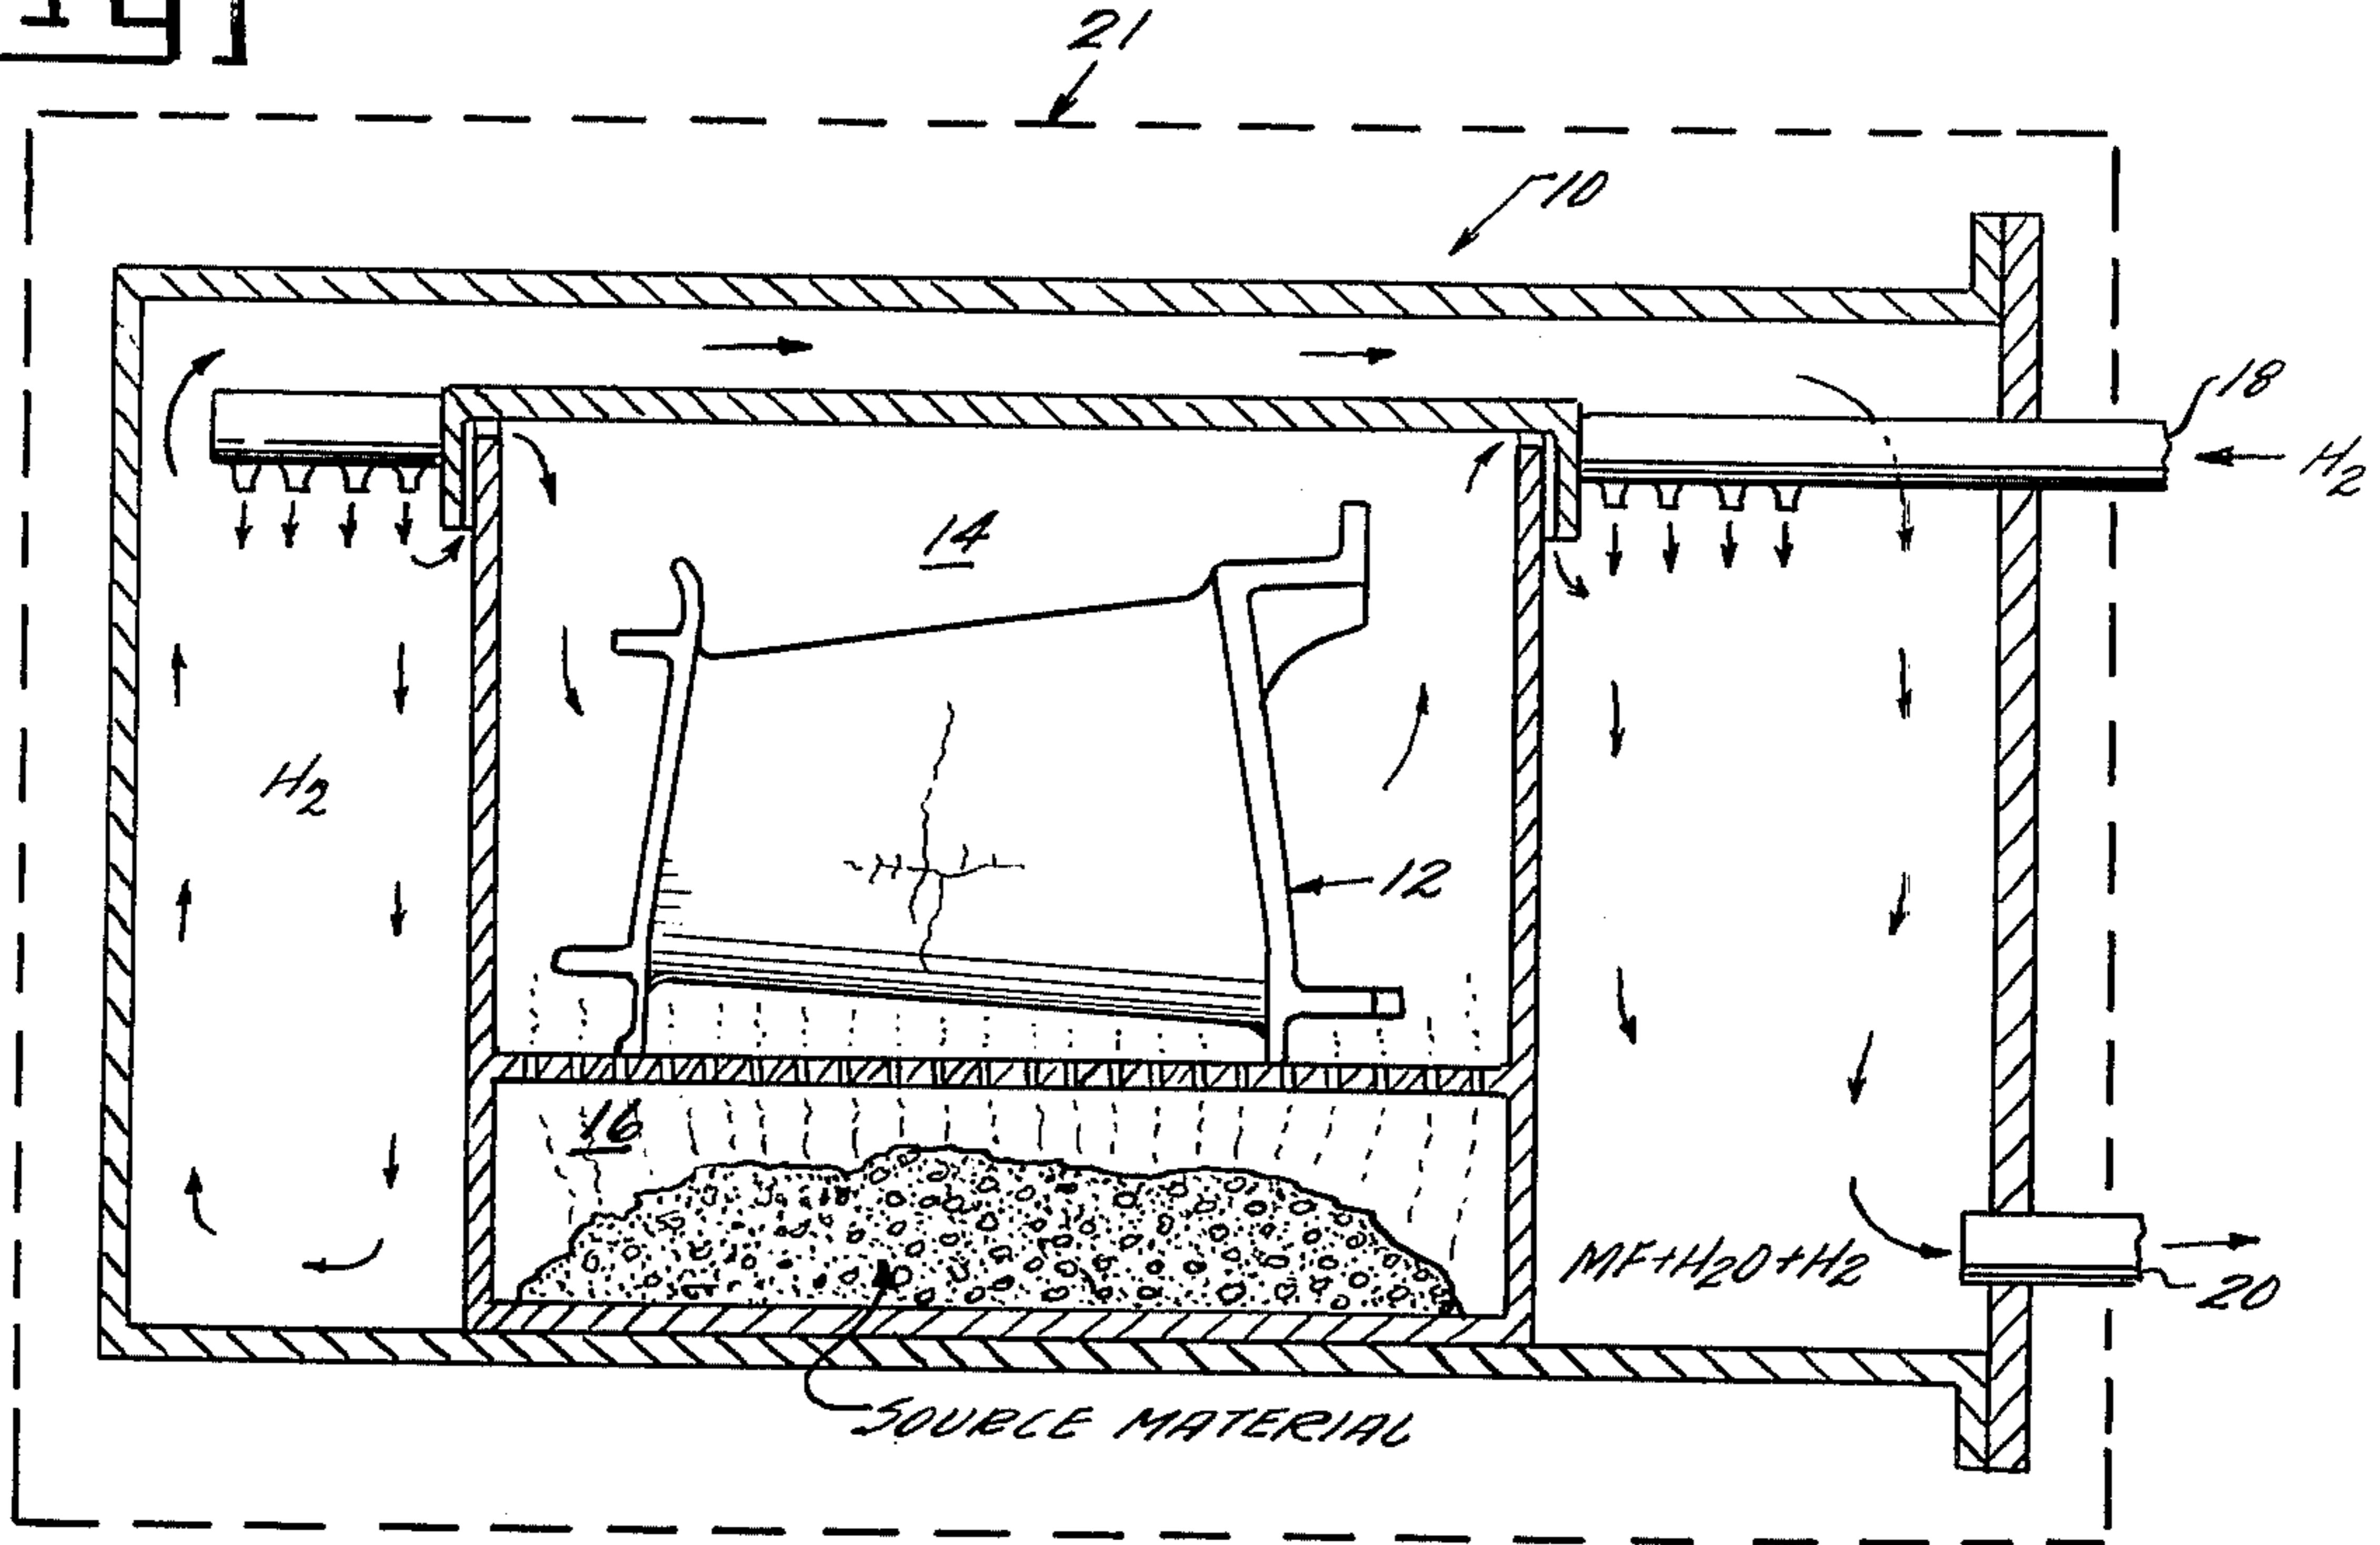
Fig 1

FIG. 1 is a diagrammatic view of a retort useful in practicing a form of the present invention;

The method of the present invention can be practiced using relatively simple heat-treatment equipment such as a hydrogen atmosphere retort in an air furnace. Such an apparatus is shown in the diagrammatic presentation of FIG. 1 wherein the retort is shown generally at 10. An article such as turbine vane 12 is placed in a processing chamber 14 of the retort. Communicating with such processing chamber is a fluoride ion source material chamber 16 which provides for flow of gaseous active fluoride ions into processing chamber 14. Although this particular embodiment is shown in FIG. 1, it will be readily recognized by those skilled in the art that any means can be used to provide gaseous fluoride ions to processing chamber 14 into contact with vane 12. A reducing atmosphere, in this case hydrogen gas, is provided about chambers 14 and 16, enabling hydrogen gas to flow, according to the arrows shown in FIG. 1, through chambers 14 and 16. For example, H<sub>2</sub> gas is introduced into inlet 18 which cooperates with gas outlet 20 to provide for a flow of H<sub>2</sub> into the retort and the flow of such gas and the products of reaction from the retort through outlet 20. When placed in a furnace, represented by broken line 21, heat is applied through walls of the retort into chambers 14 and 16.

In a typical example using the apparatus shown in FIG. 1, a turbine vane of a nickel-base superalloy commercially available as Rene' 80 alloy and described in U.S. Pat. No. 3,615,376 — Ross, the disclosure of which is incorporated herein by reference, was placed within the retort for the removal of complex oxides which had formed in a crack in the airfoil. Included in the composition of such an alloy are, nominally by weight, 3% Al and

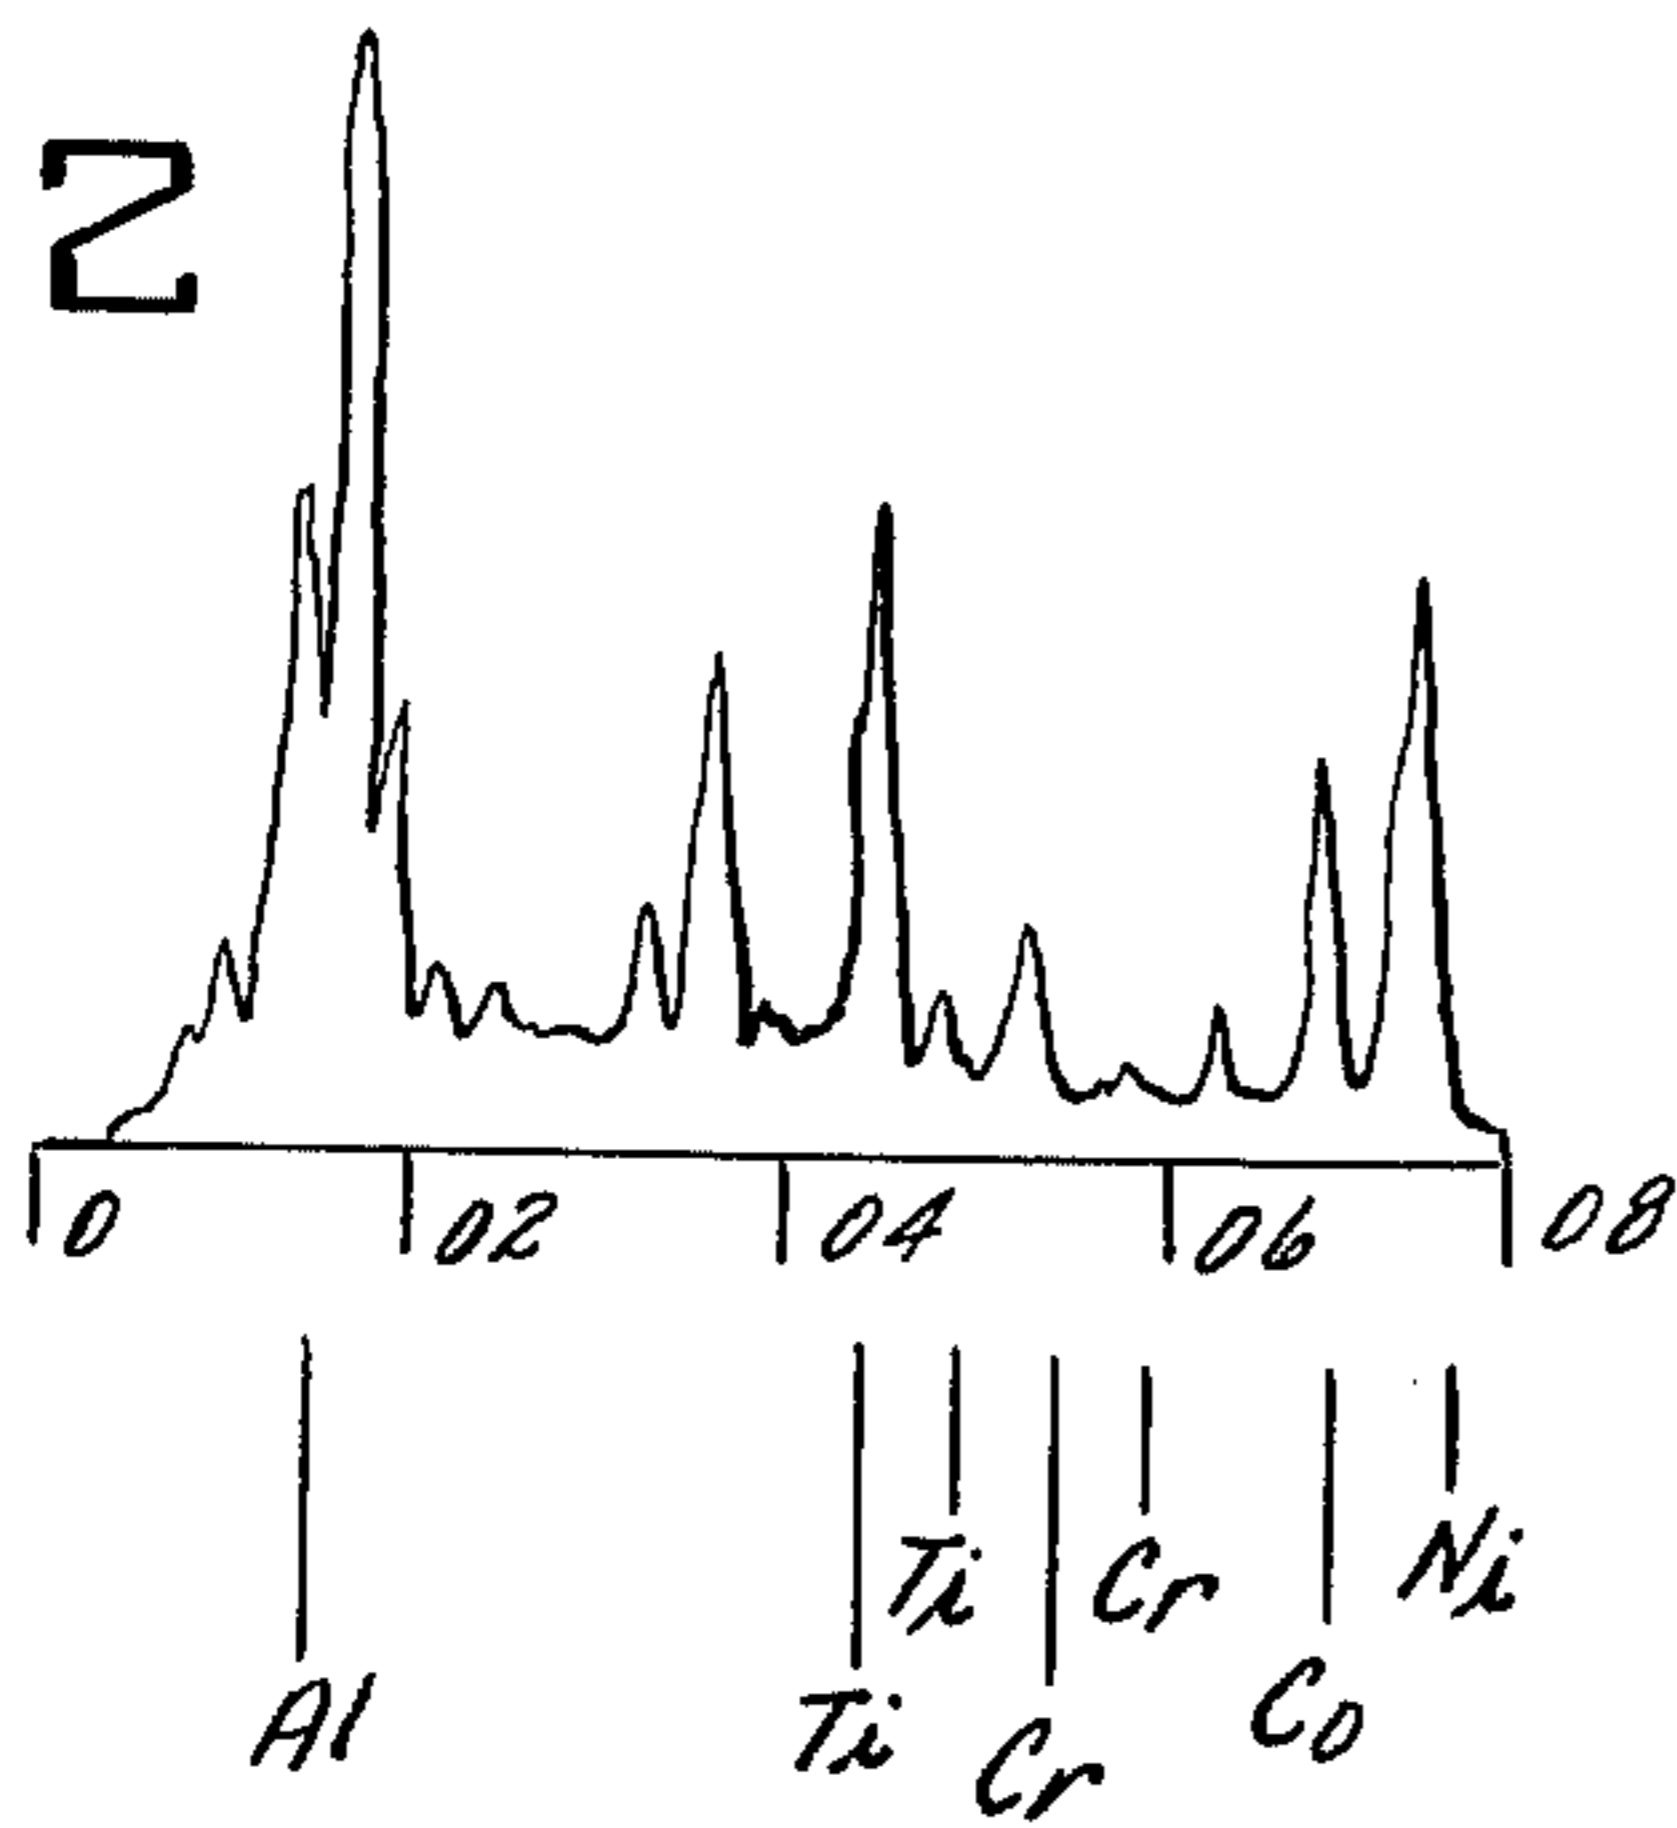
Fig 2

FIG. 2 is a graphical view of a Scanning Electron Microscope (SEM) scan of a typical crack surface before cleaning;

Examination of the cracked surfaces before and after cleaning was conducted on the SEM apparatus. Typical crack appearances and chemical compositions, as evaluated on the SEM, are shown in the graphical presentations of FIGS. 2 and 3. FIG. 2 is an SEM scan of a typical Rene' 80 alloy crack surface before cleaning, showing the relatively high Al and Ti content resulting from the presence of complex oxides including those elements. For comparison purposes, FIG. 3 presents a graphical view of an SEM scan of a typical Rene' 80 alloy crack surface after fluoride ion cleaning according to the present invention. It will be noted that the relatively large amounts of Al and Ti have been removed from the surface. Narrow cracks with openings as small as 0.001 inch at the surface and having walls tapering to a point a distance of at least about 0.050 inch within the surface have been cleaned of oxides through practice of the method of the present invention. Thus, the present invention includes a practical method for removing complex oxides from surfaces within narrow cracks in superalloys of the nickel-base type currently in use in the turbine section of many gas turbine engines.

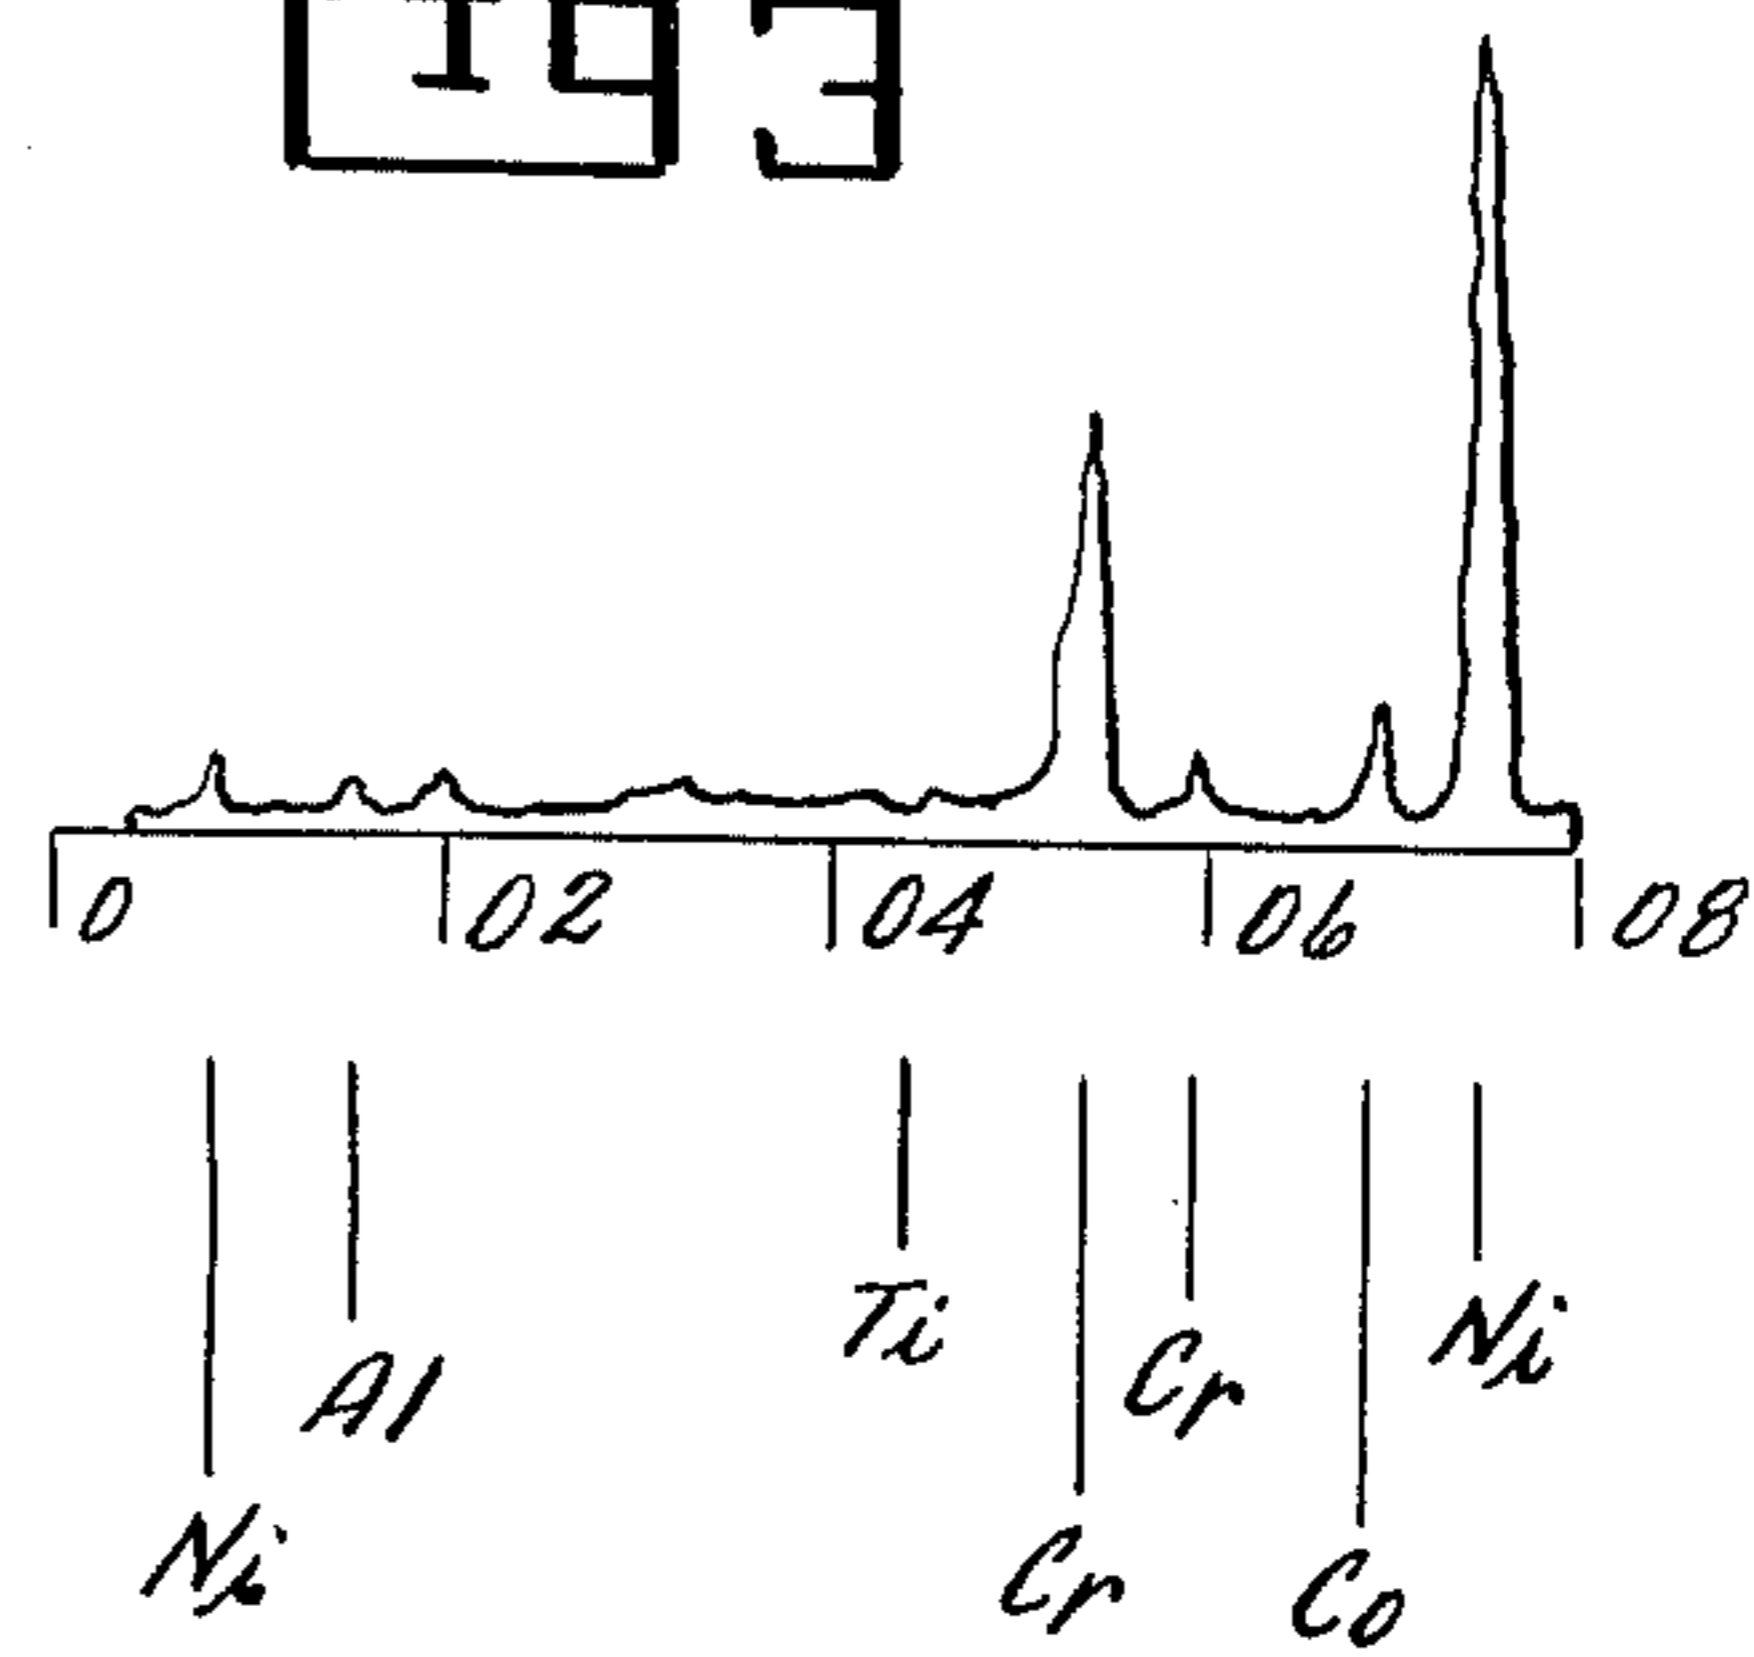
Fig 3

FIG. 3 is a graphical view of an SEM scan of a typical crack surface after gaseous active fluoride ion cleaning according to the present invention; and

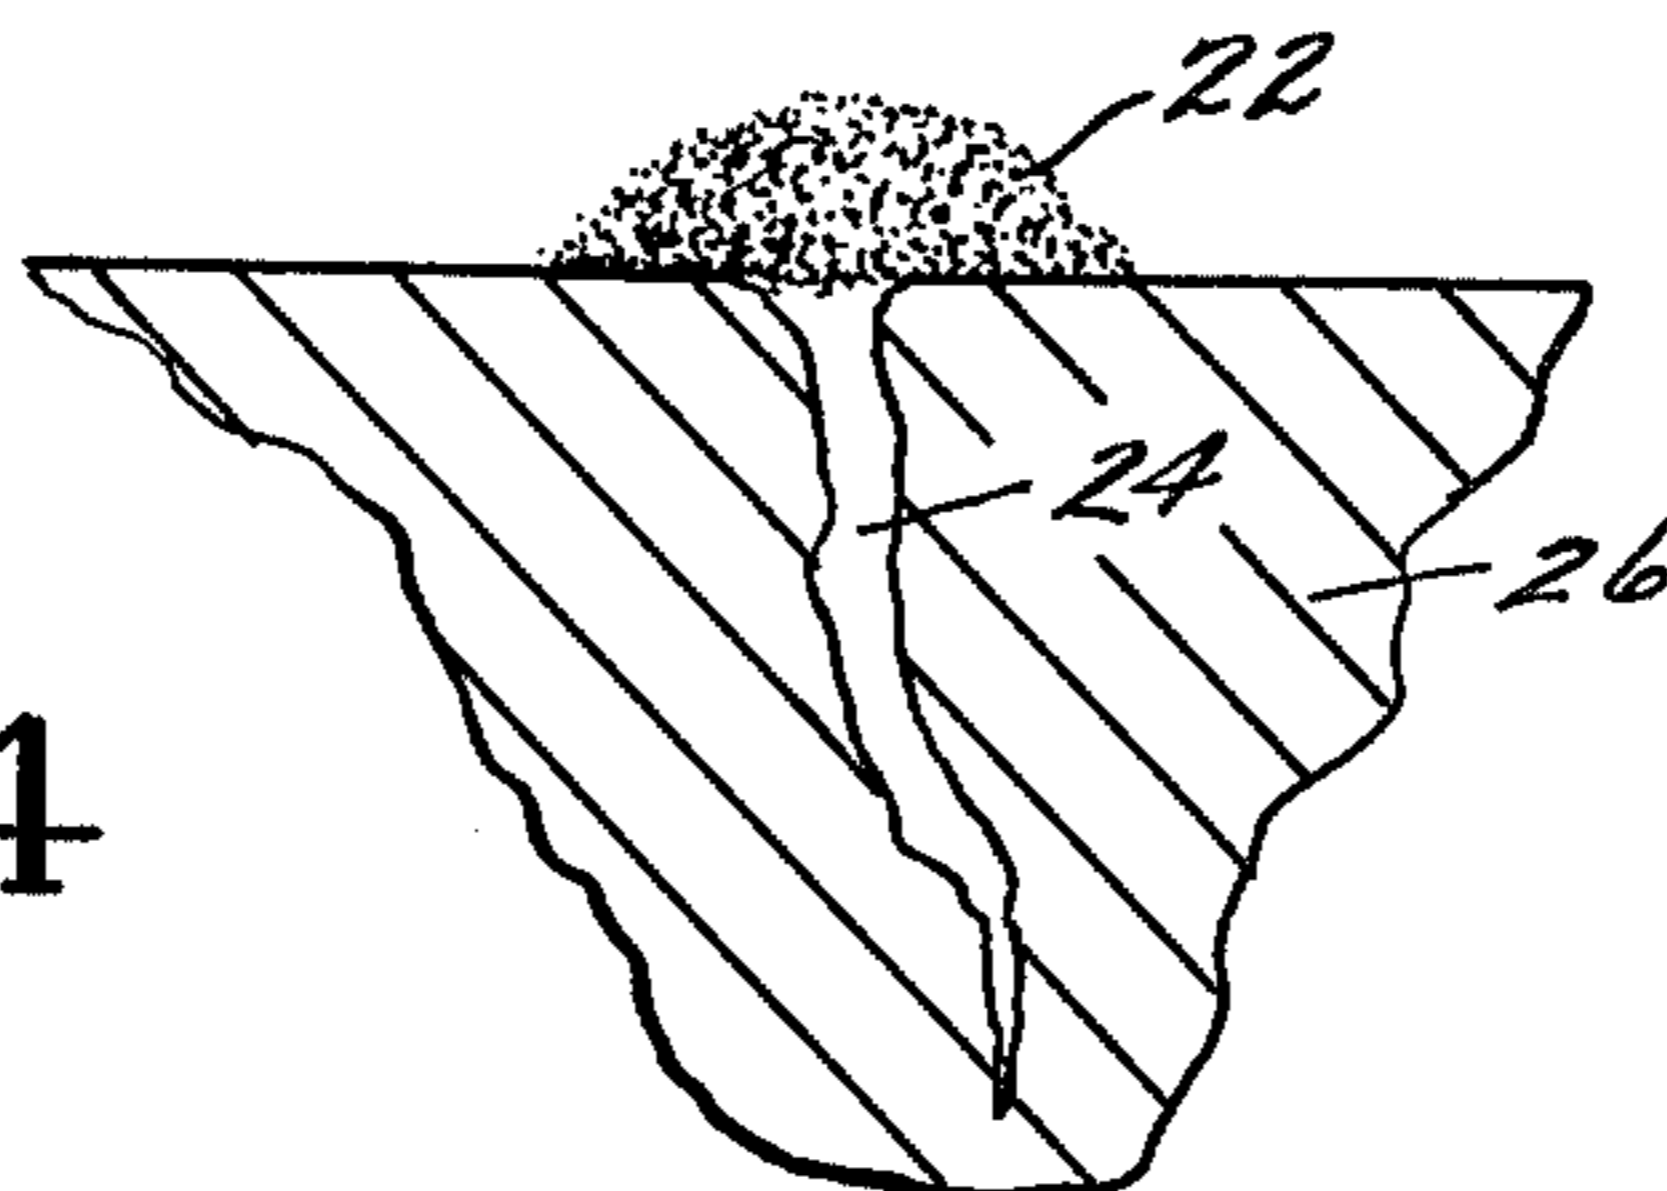
Fig 4

FIG. 4 is a fragmentary, diagrammatic sectional view of a crack in a superalloy surface over which has been placed a repair alloy.

Another aspect of the present invention is the repair of a crack in a superalloy article after cleaning as described above. One repair procedure which has been evaluated in connection with the present invention involves placement of a healing alloy over the crack after cleaning. Such an arrangement is shown in the fragmentary diagrammatic view of FIG. 4 wherein a powdered healing alloy 22 is placed over cleaned crevice 24 in substrate alloy 26. For example, in one evaluation, a crevice 24 in Rene' 80 nickel-base superalloy 26 was repaired using a powdered healing alloy 22 sometimes referred to as D-15 alloy and described in U.S. Pat. No. 3,759,692 — Zelahy, the disclosure of which is incorporated herein by reference. Nominally, the alloy consisted essentially of, by weight, 15% Cr, 10% Co, 3% Al, 3% Ta, 2.5% B with the balance Ni. In this example, the article including the crevice shown in FIG. 4, with the powdered healing alloy placed over the crevice opening, was placed in a vacuum furnace. It was first subjected to a high vacuum, for example of about 10<sup>-5</sup> Torr, during which time any atmosphere, such as air, was removed from crevice 24 as well as from other portions of the vacuum chamber. Then the article and healing alloy powder were subjected to a temperature sufficiently high to melt healing alloy 22 in FIG. 4, to allow it, under the vacuum conditions, to wet walls and

flow into crevice 24 thereby sealing it, and to diffuse it with substrate 26. In this way, diffusion healing of the cleaned crack was accomplished. In this example using D-15 alloy with a Rene 80 alloy substrate, a temperature of about 2200° F, a temperature below the incipient melting point of the alloy being repaired, was used successfully. Examination of the microstructure within and adjacent to the crack area after processing in this manner showed complete wetting and filling of the crack by the healing alloy. Engine testing of turbine vanes repaired as described above has shown that such repair provides vanes with additional useful life.
