[54] INSTRUMENT PANEL FOR A VEHICLE

[73] Assignee: Nissan Motor Company, Ltd., Japan

[57] ABSTRACT

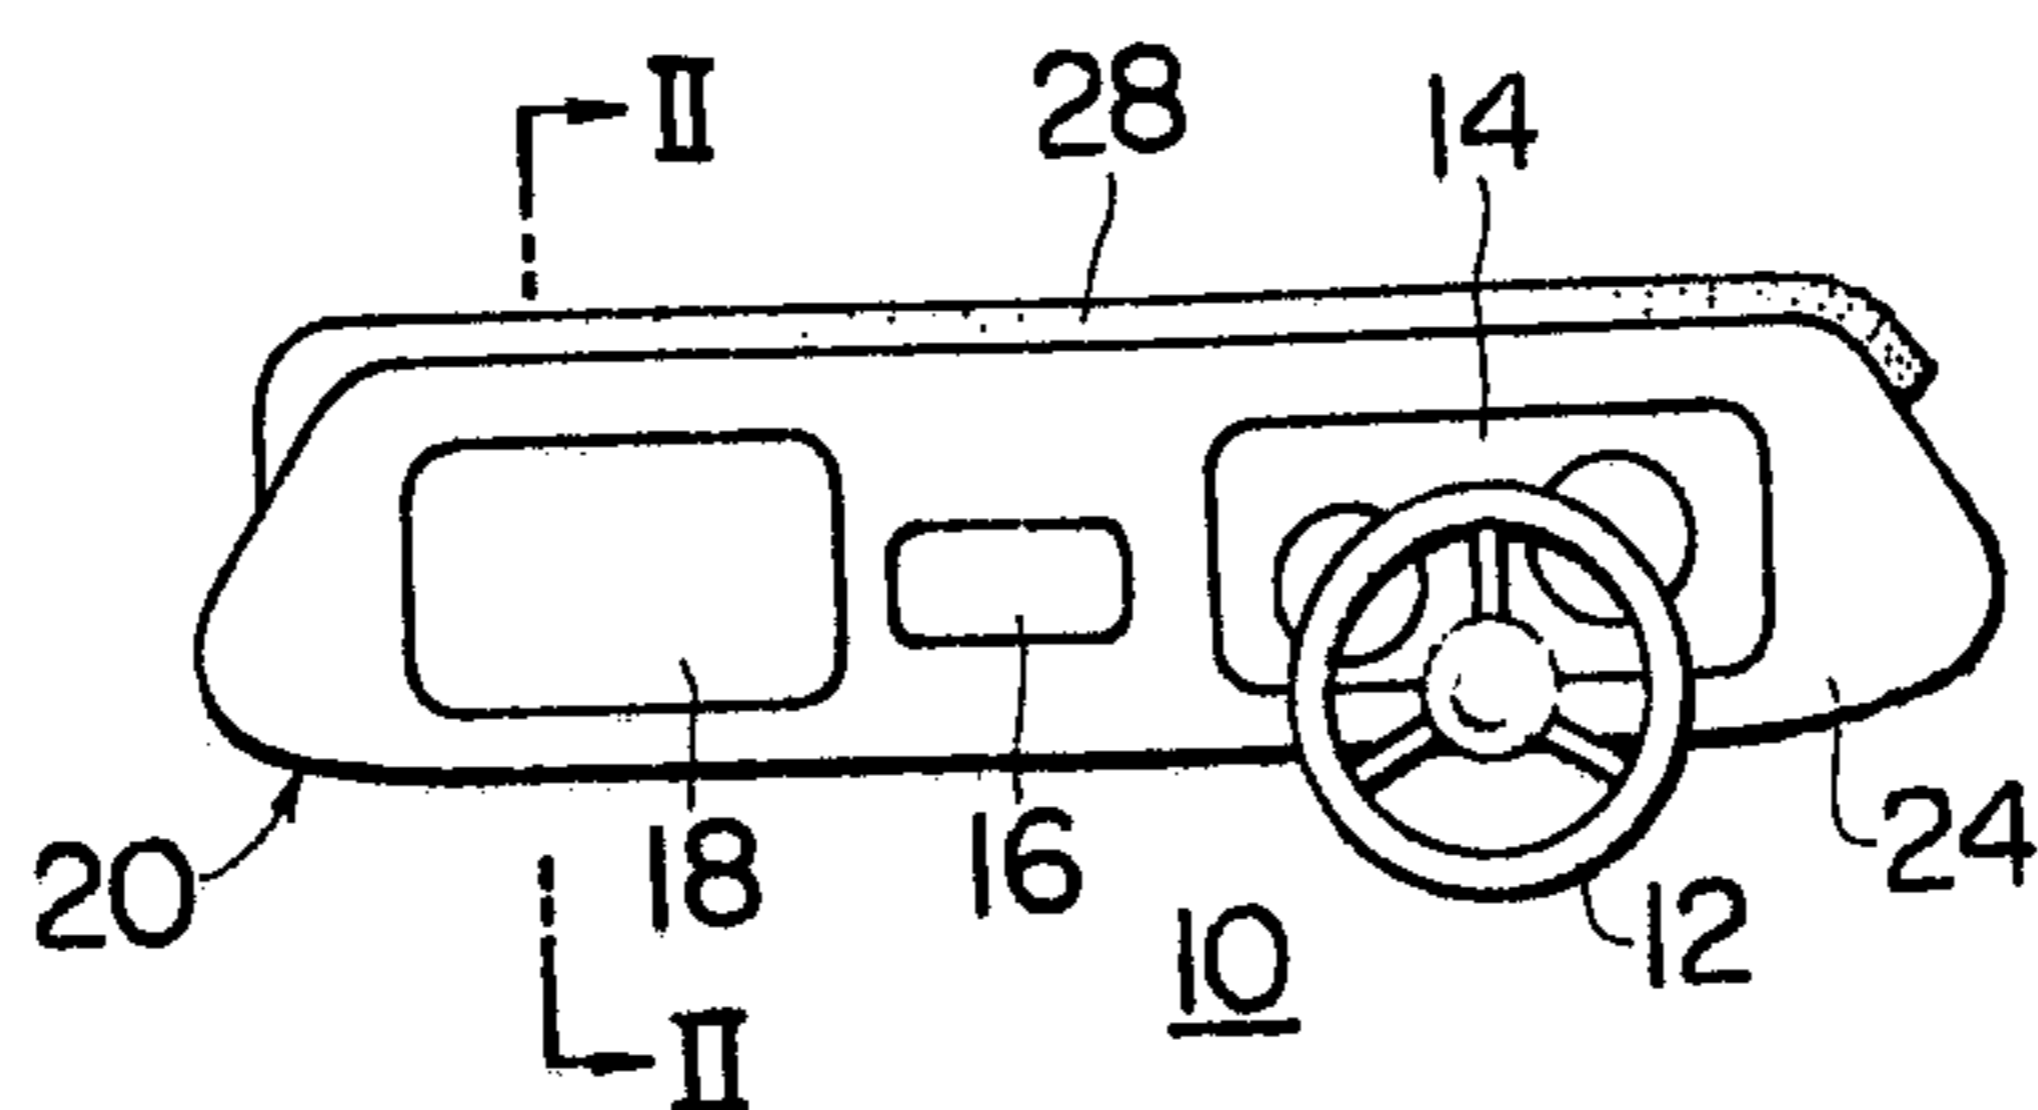
FIG. 1 is a sketch of an instrument panel in accordance with the present invention, the panel being shown combined with some parts stylized such as a steering wheel and a meter panel;

Referring now to FIG. 1 of the drawings, there is shown a safety instrument panel 10, according to the invention, which is equipped or combined with a steering wheel 12, a meter panel 14, a radio box 16 and a globe box 18. The safety instrument panel 10 comprises a stylized length of a sheet member 20 having a top surface 22 (FIG. 2) and a front surface 24 facing the passenger's compartment (not shown). The sheet mem-

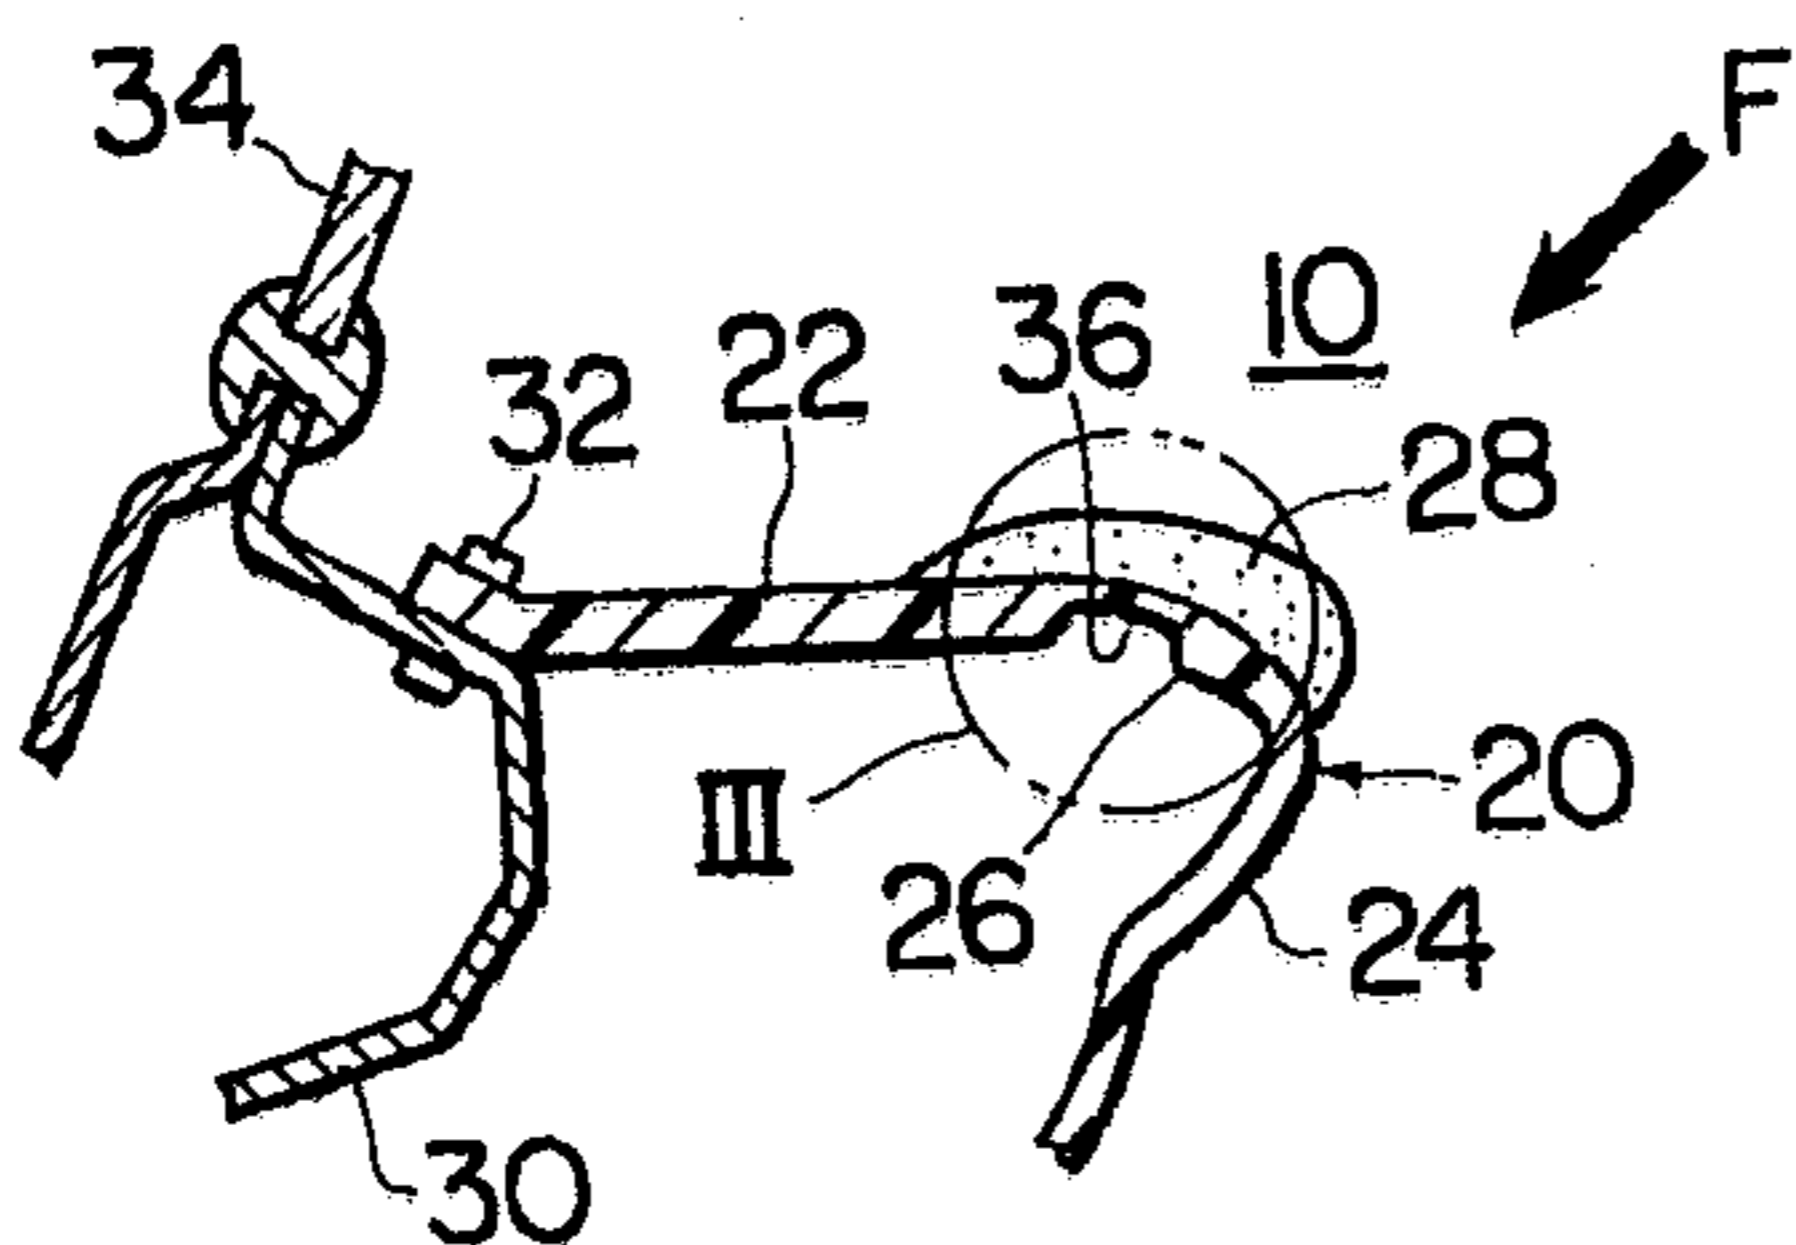
FIG. 2 is a sectional view taken along the line II—II of FIG. 1;

As well shown in FIG. 2, a portion 26 near the intersection of the top surface 22 and the front surface 24 is covered with a padding 28 made of foam material or the like. It is said that the portion 26 is most likely impacted by the passenger's head in a vehicle collision. The sheet member 20 is firmly fixed at its forward end to a laterally extending frame member 30 by suitable fastener such as a bolt 32. As shown, the frame member 30 is continued forward to the bottom edge of a windscreen 34.

In the inner side area of the above-mentioned portion 26, there is formed with a plurality of spaced parallel depressions 36 which extend through the longitudinal length of the sheet member 20. The depressions 36 are oriented substantially perpendicularly to the longitudinal axis of the sheet member 24. These depressions 36 provide for a weakening of resistance to deformation of the sheet member 20 over selected area of the instrument panel 10 without impairing the structural rigidity of the entire instrument panel 10. The shape of each of the depressions may be oval and/or square as shown in FIGS. 4A and 4B. Furthermore, depressions may be formed in the upper side area of the portion 26 for the same reason as mentioned. Furthermore, as shown in FIG. 3, a small groove 38 may be arranged around each of the depressions 36 so that the resistance of the sheet member 20 is more weakened. Now, it should be noted that if the member 20 is made of a metal plate, the depression formation is made by means of stamping and/or notching work during its manufacturing.

When an impact shock is applied from the direction indicated by an arrow F by the passenger's head in an area wherein the depression 36 are formed, deformation of the padding 28 occurs at first to absorb a certain amount of impact energy. Then, deformation of the sheet member 20 takes place. The depression arrangement thus formed tends to conform to the shape of the object impacted against the instrument panel 10. For instance, an arcuate head impacting the panel 10 would cause a progressive deformation of adjoining depression-separated sections of the sheet member 20. The impact forces are thus distributed over a large area, thereby reducing impact force at any particular point.

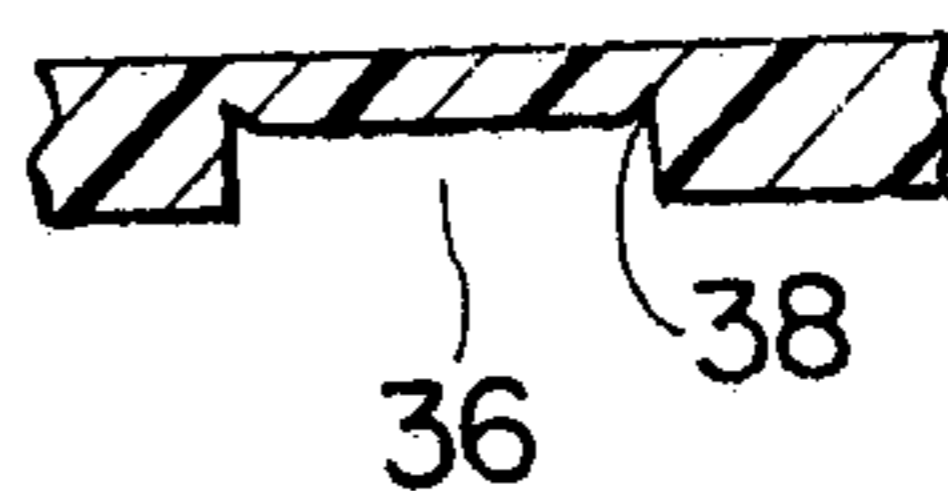
FIG. 3 is an enlarged view of a portion indicated by a mark III; and

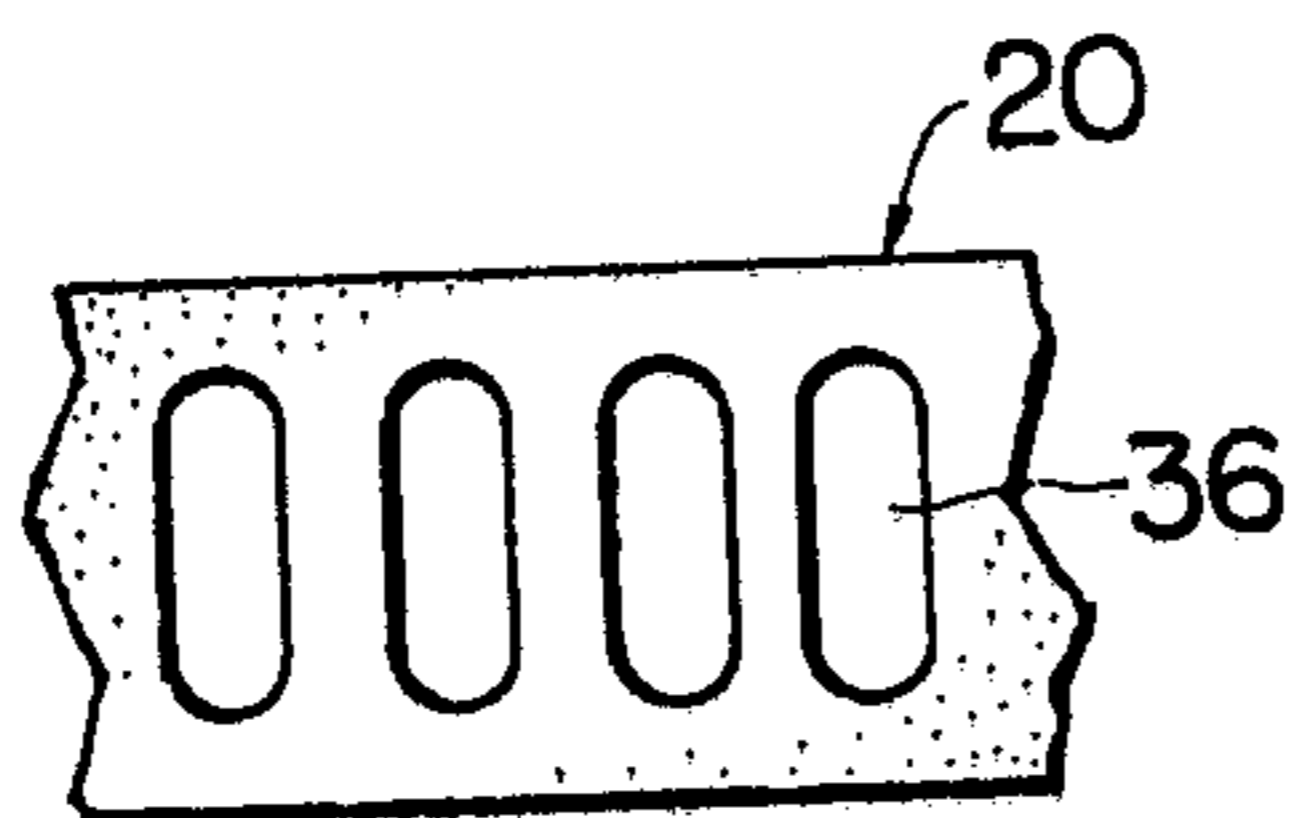
FIG. 4A

FIGS. 4A and 4B are front views of two improved sheet members for construction of the instrument panel of the invention, these sheet members being shown formed with a plurality of depressions, respectively.
