[54] METHOD OF REPAIRING A VEHICLE BODY

METHOD OF REPAIRING A VEHICLE BODY

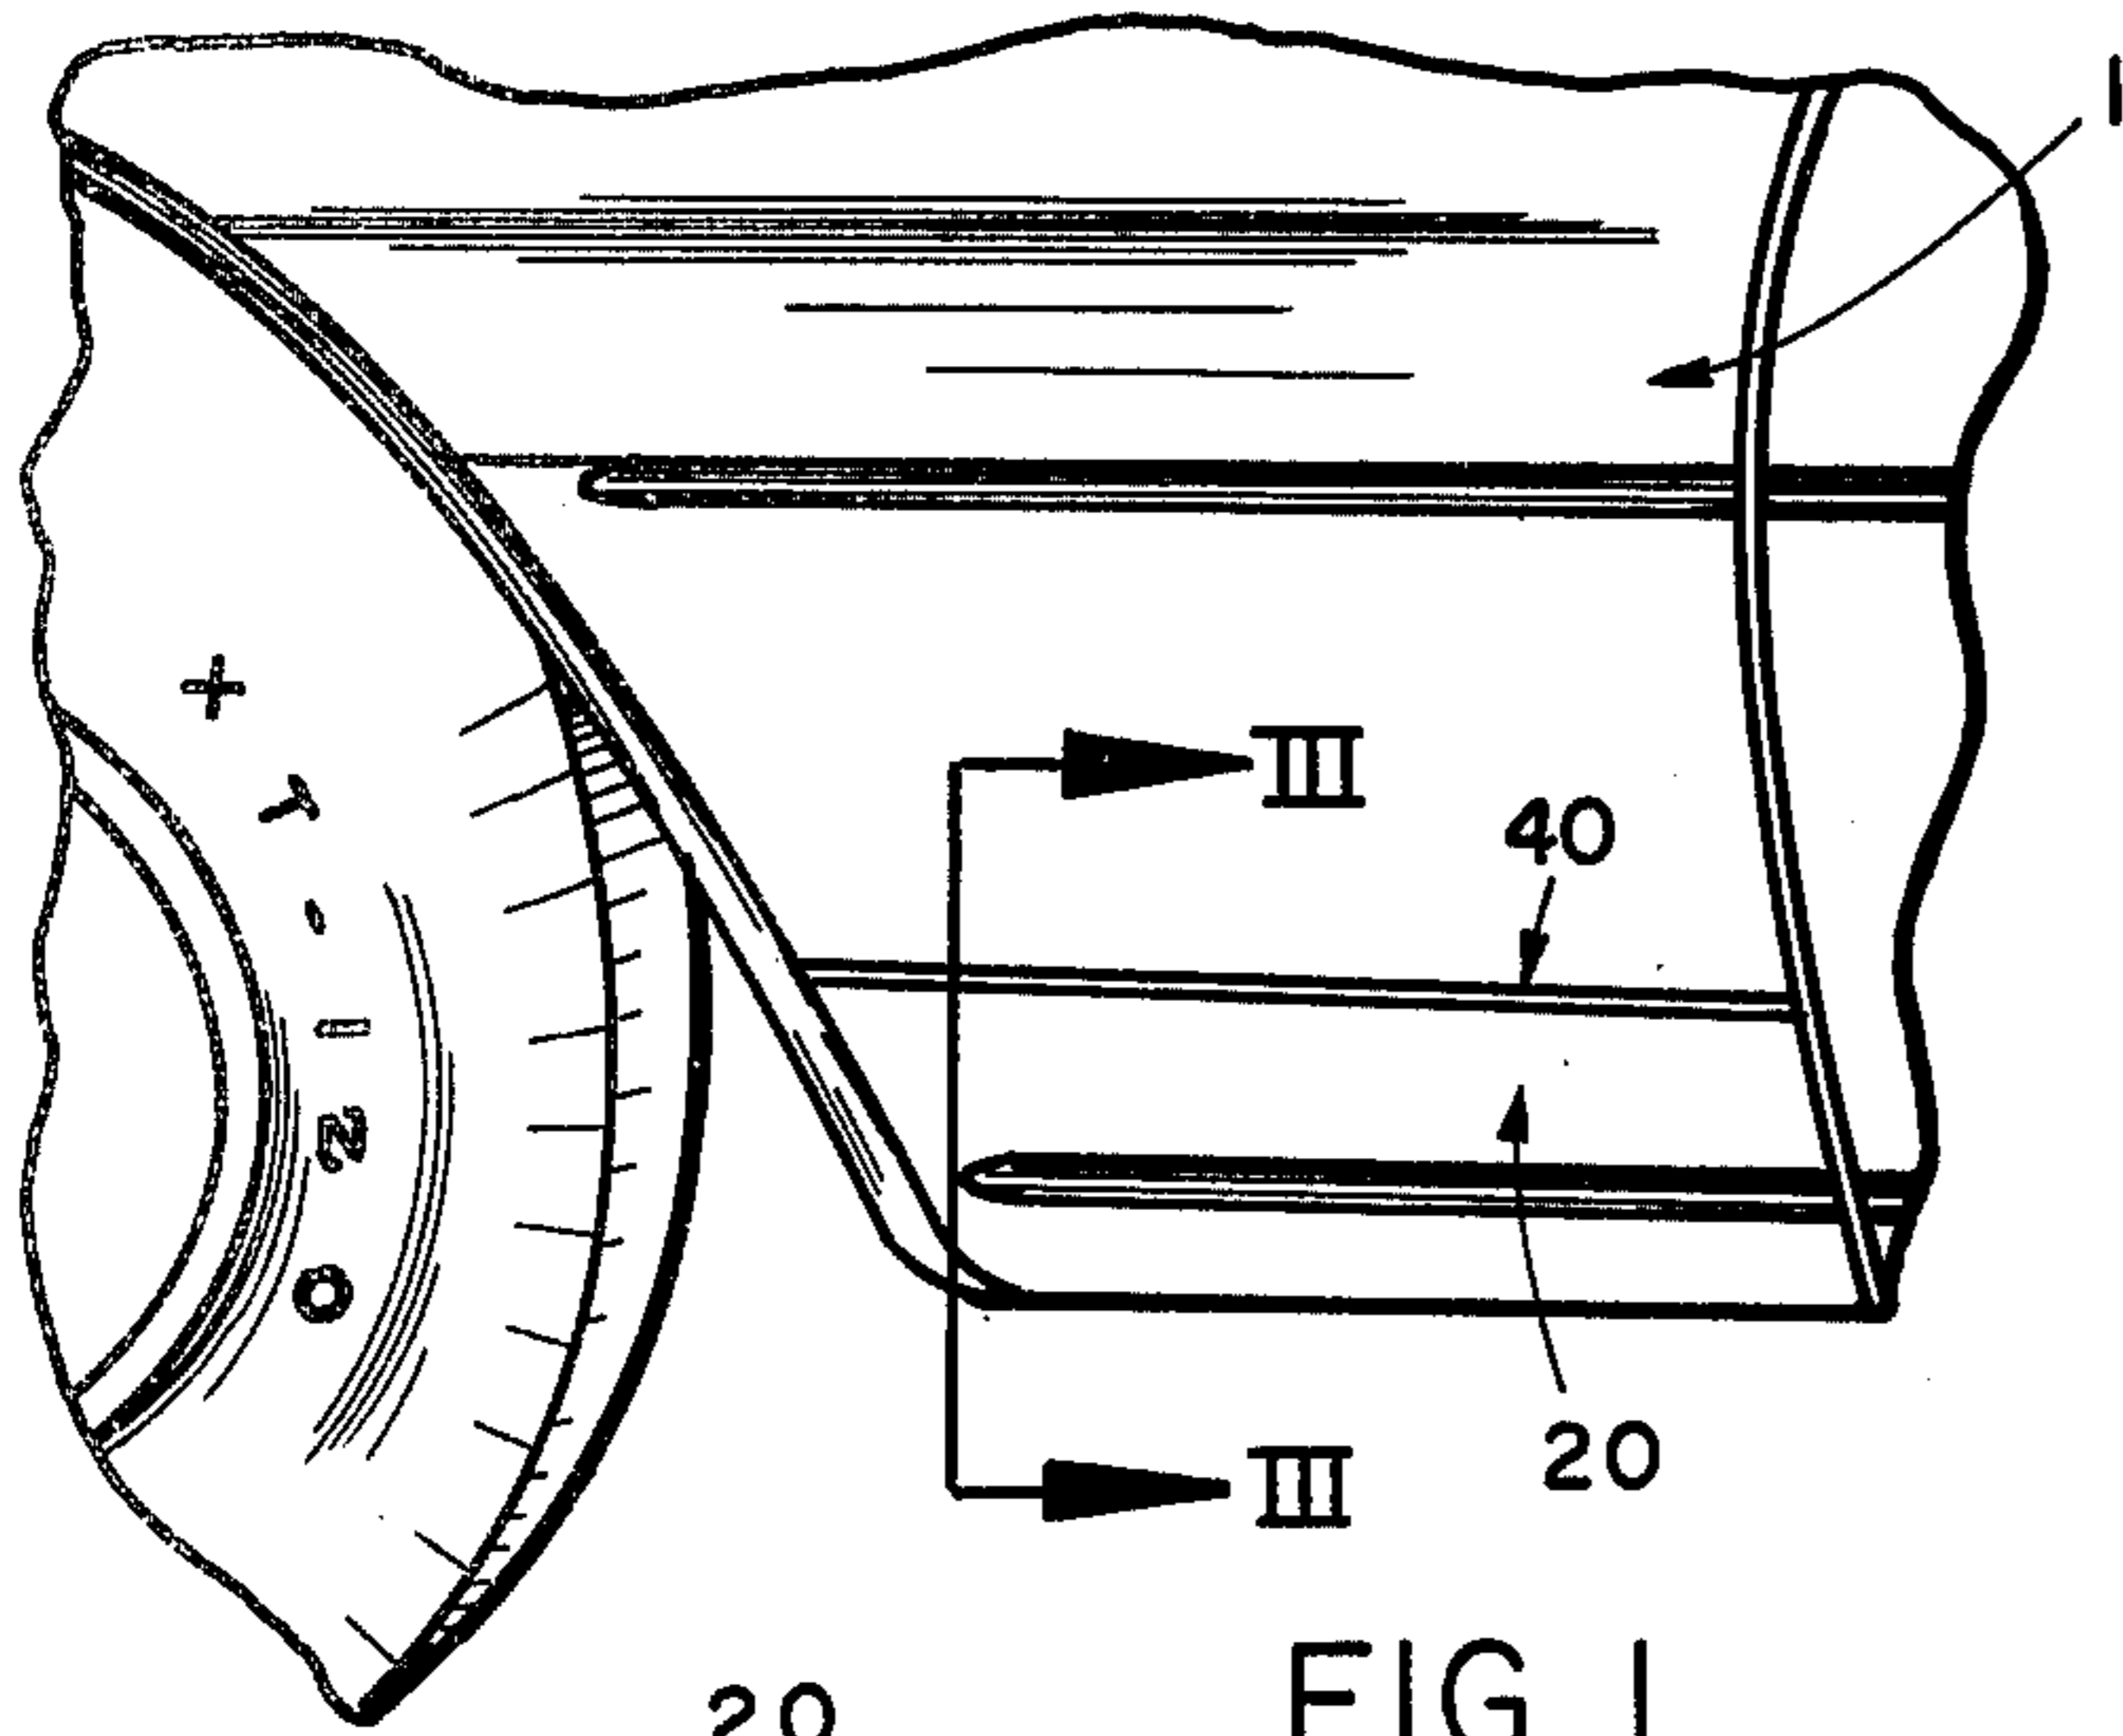
FIG 1

FIG. 1 is a fragmentary view of an automobile whose front rocker panel has been repaired in accordance with the method of the present invention;

In the preferred embodiment, the rusted area 10 (FIG. 2) of the vehicle 1 (FIG. 1) is covered with a plastic sheet 20 which is held in place by means of a contact adhesive 30 (FIG. 3). The beveled edges 21 of the plastic sheet 20 are sealed by the application of an edge sealant 40 which is feathered out from the plastic sheet onto the surface of the vehicle to create a smooth appearance. The materials necessary to practice this method can be provided in kit form as shown in FIG. 5 wherein a plastic kit container 50 contains a plastic sheet 20, a contact adhesive 30 and a sealant 40.

The thus repaired surface is painted in the usual manner. The results as can be seen from FIG. 1 is an attractive repaired surface. This is achieved with a minimum of expense in either terms of material or labor and accordingly constitutes a significant contribution to the art. Of course, it will be understood that alterations and variations can be made without departing from the spirit and broader aspects of the invention as set forth in the appended claims.

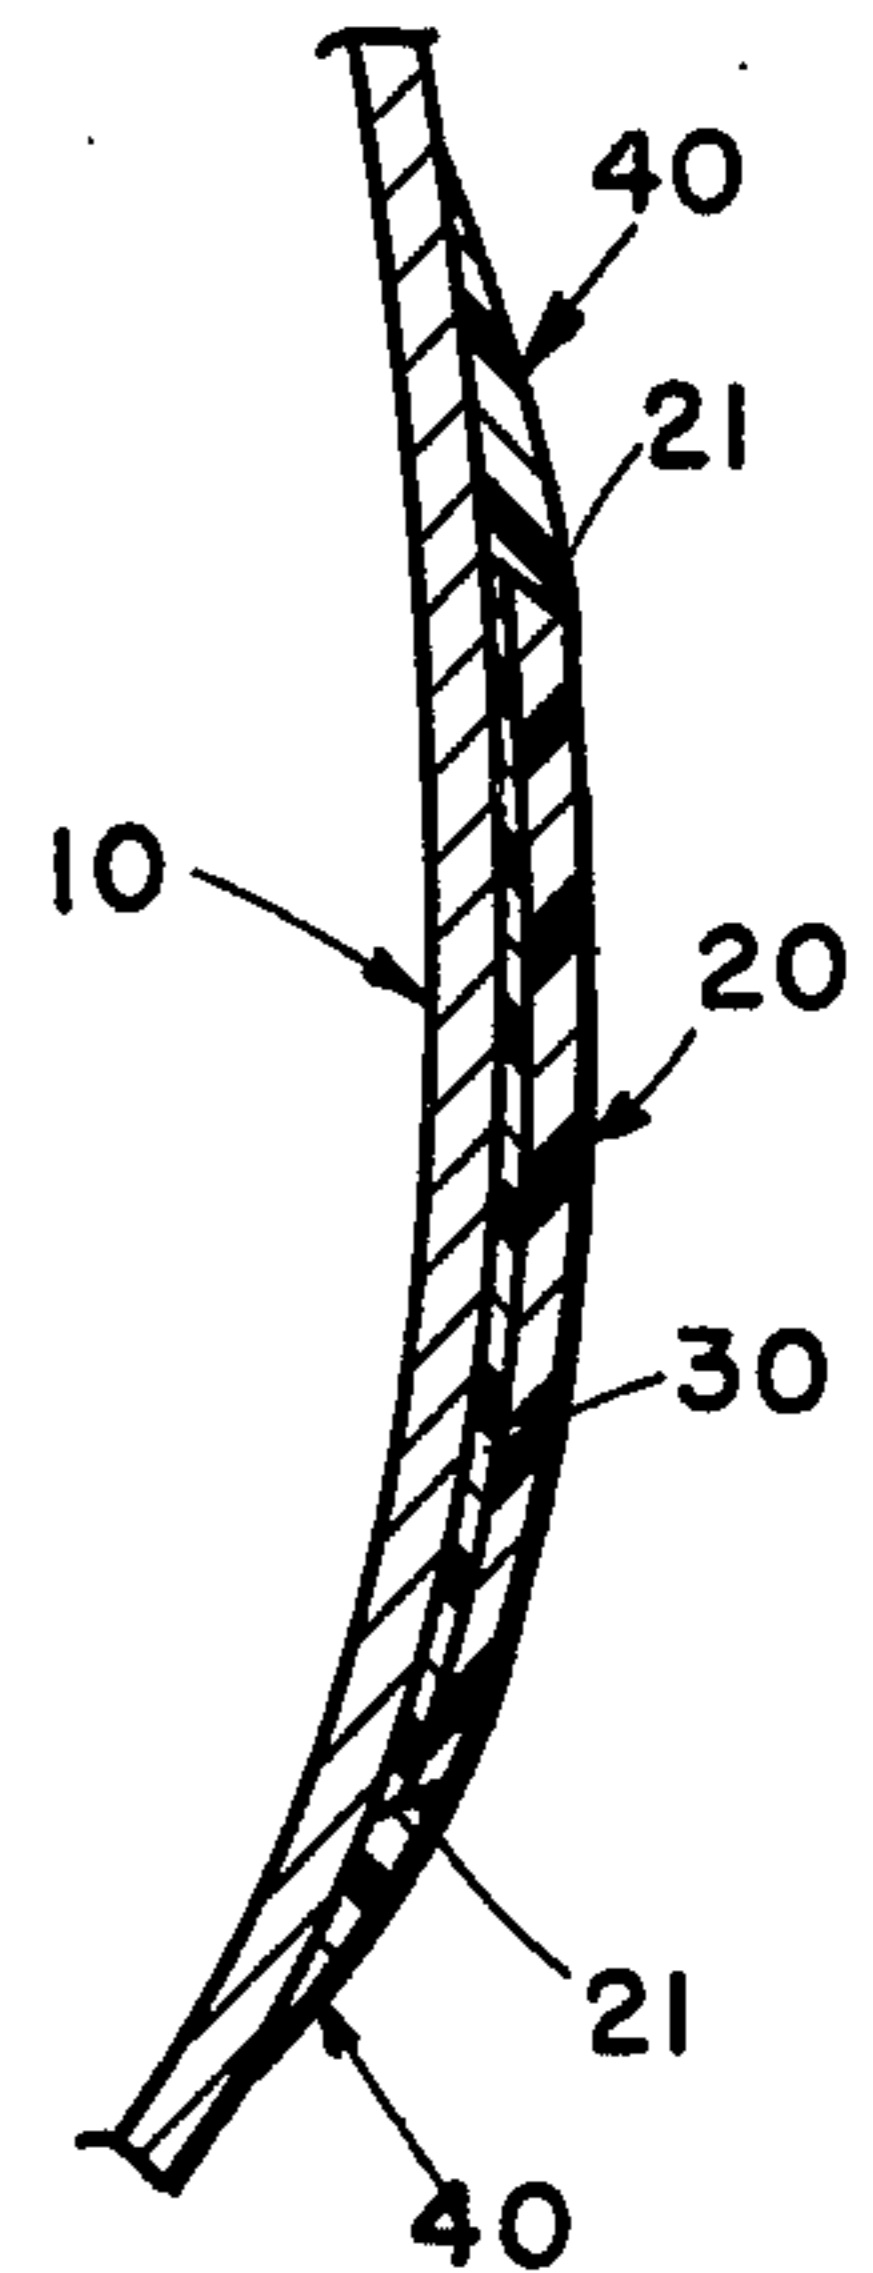
FIG 3

FIG. 3 is a cross sectional view taken along plane III—III of FIG. 1;

The edges of the plastic sheet are then beveled by the use of a razor knife or the like. This results in beveled edges 21 as shown in FIG. 3. In the alternative, the kit 50 could include plastic sheet with pre-beveled edges.

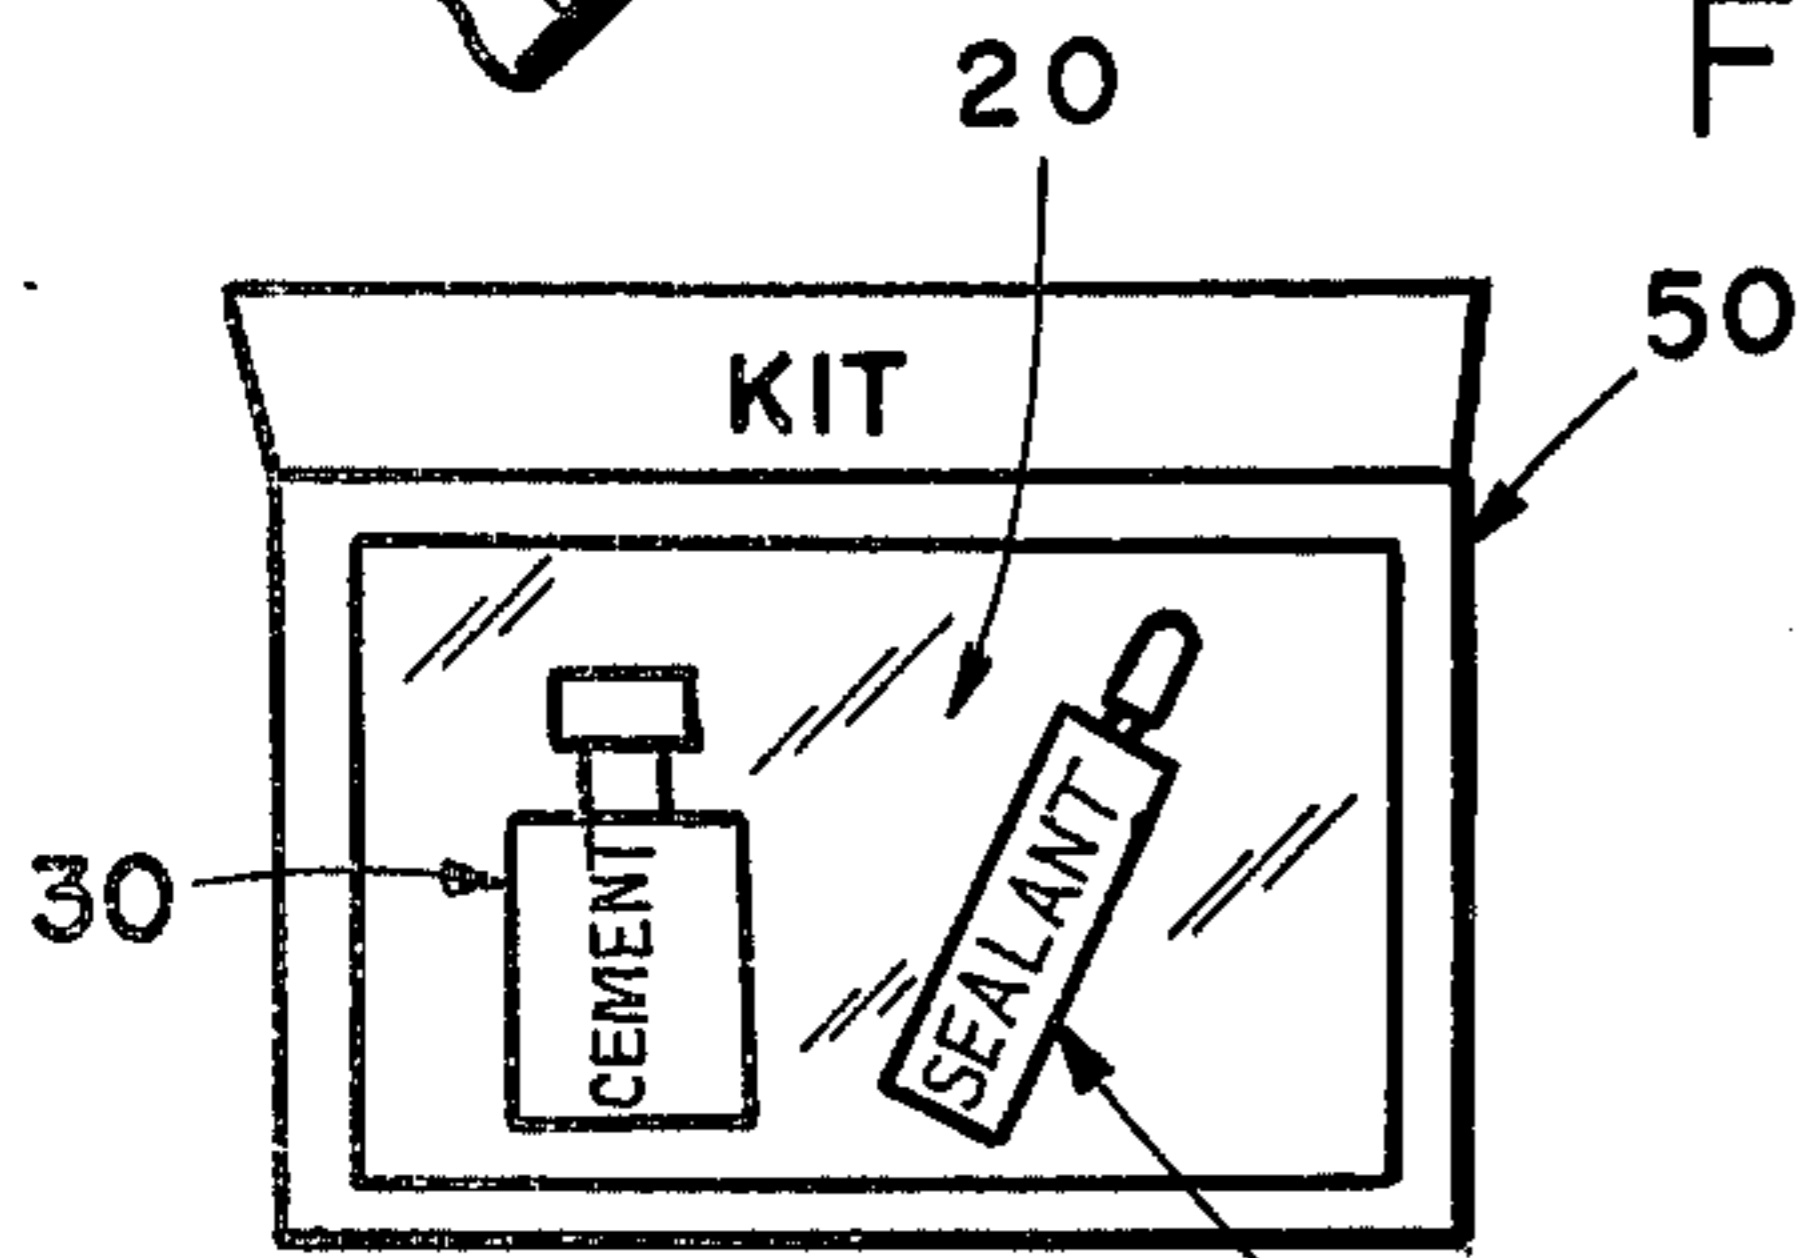
FIG 5

FIG. 5 is a front elevational view of a kit in accordance with the present invention.

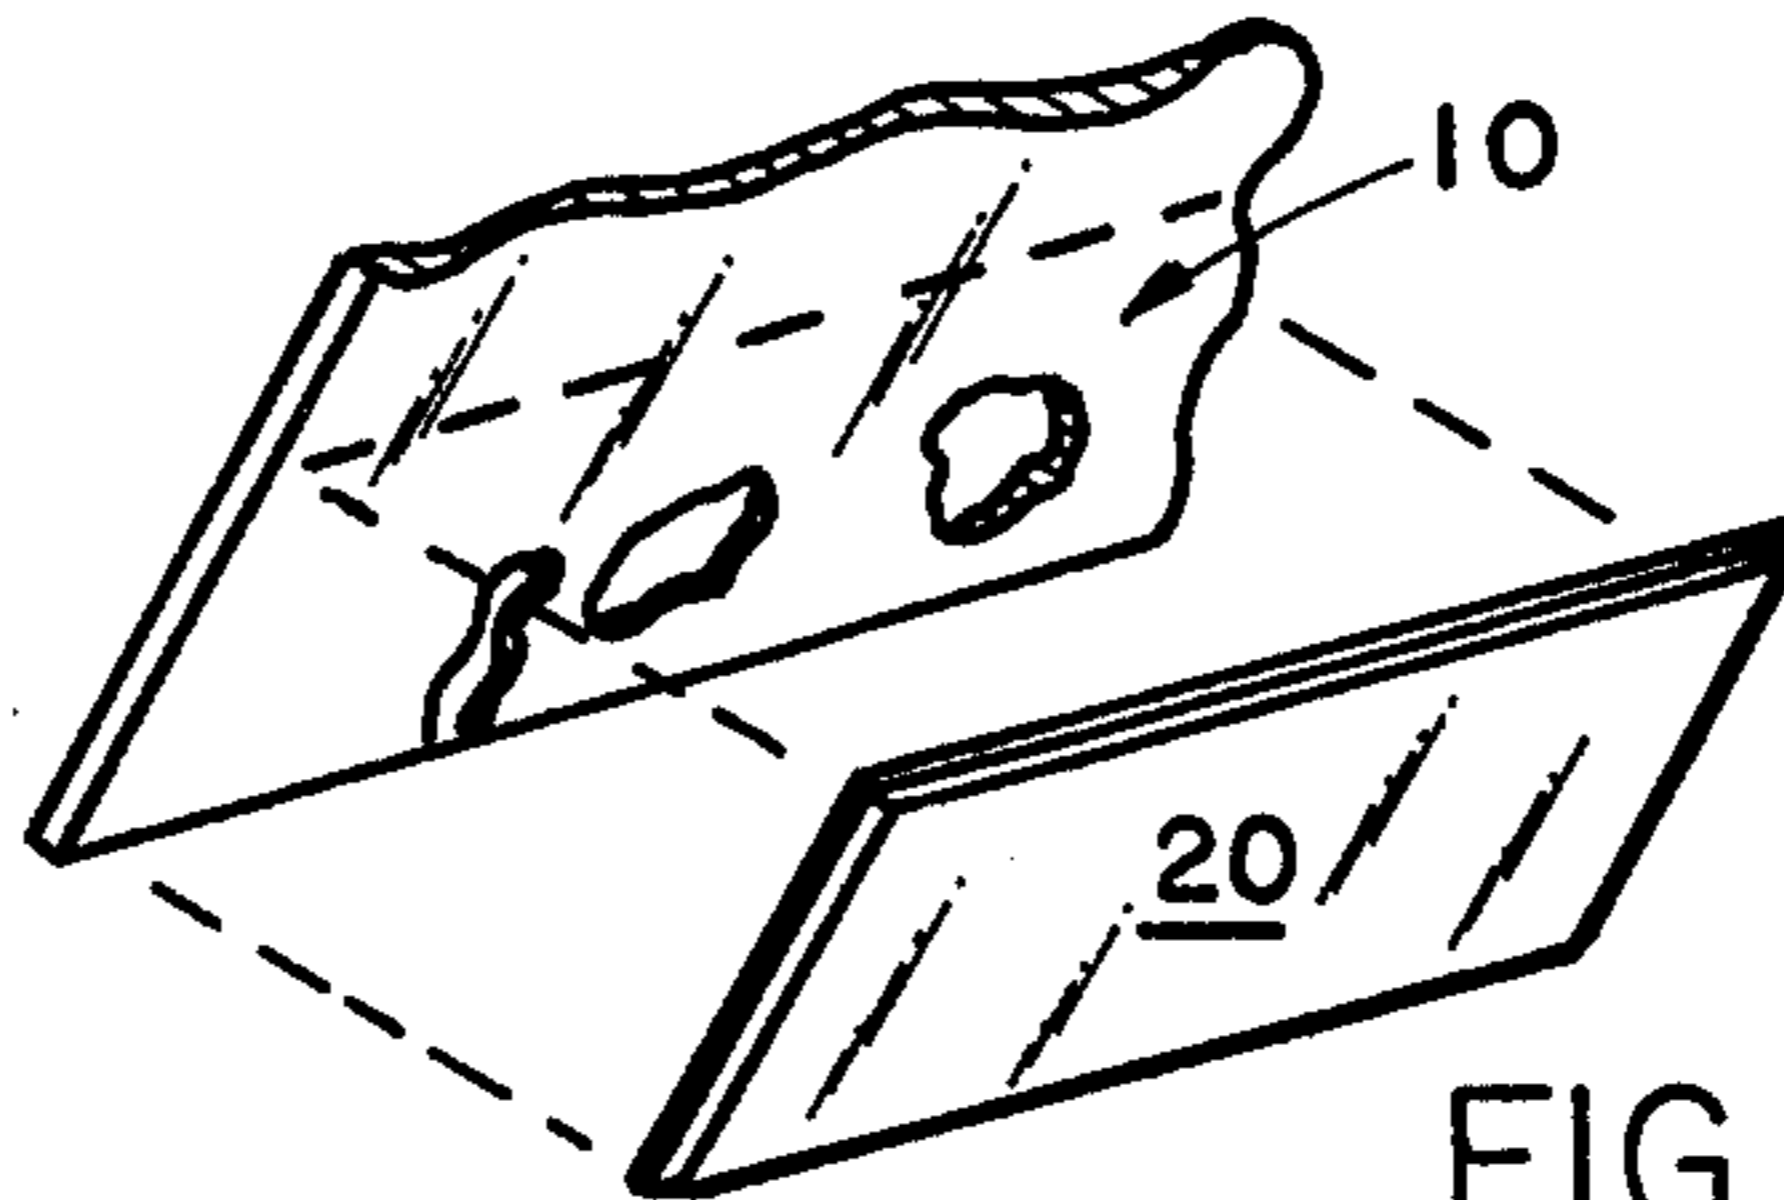
FIG 2

FIG. 2 is a fragmentary view showing a sheet of plastic in accordance with the present invention spaced from an area which has to be repaired;

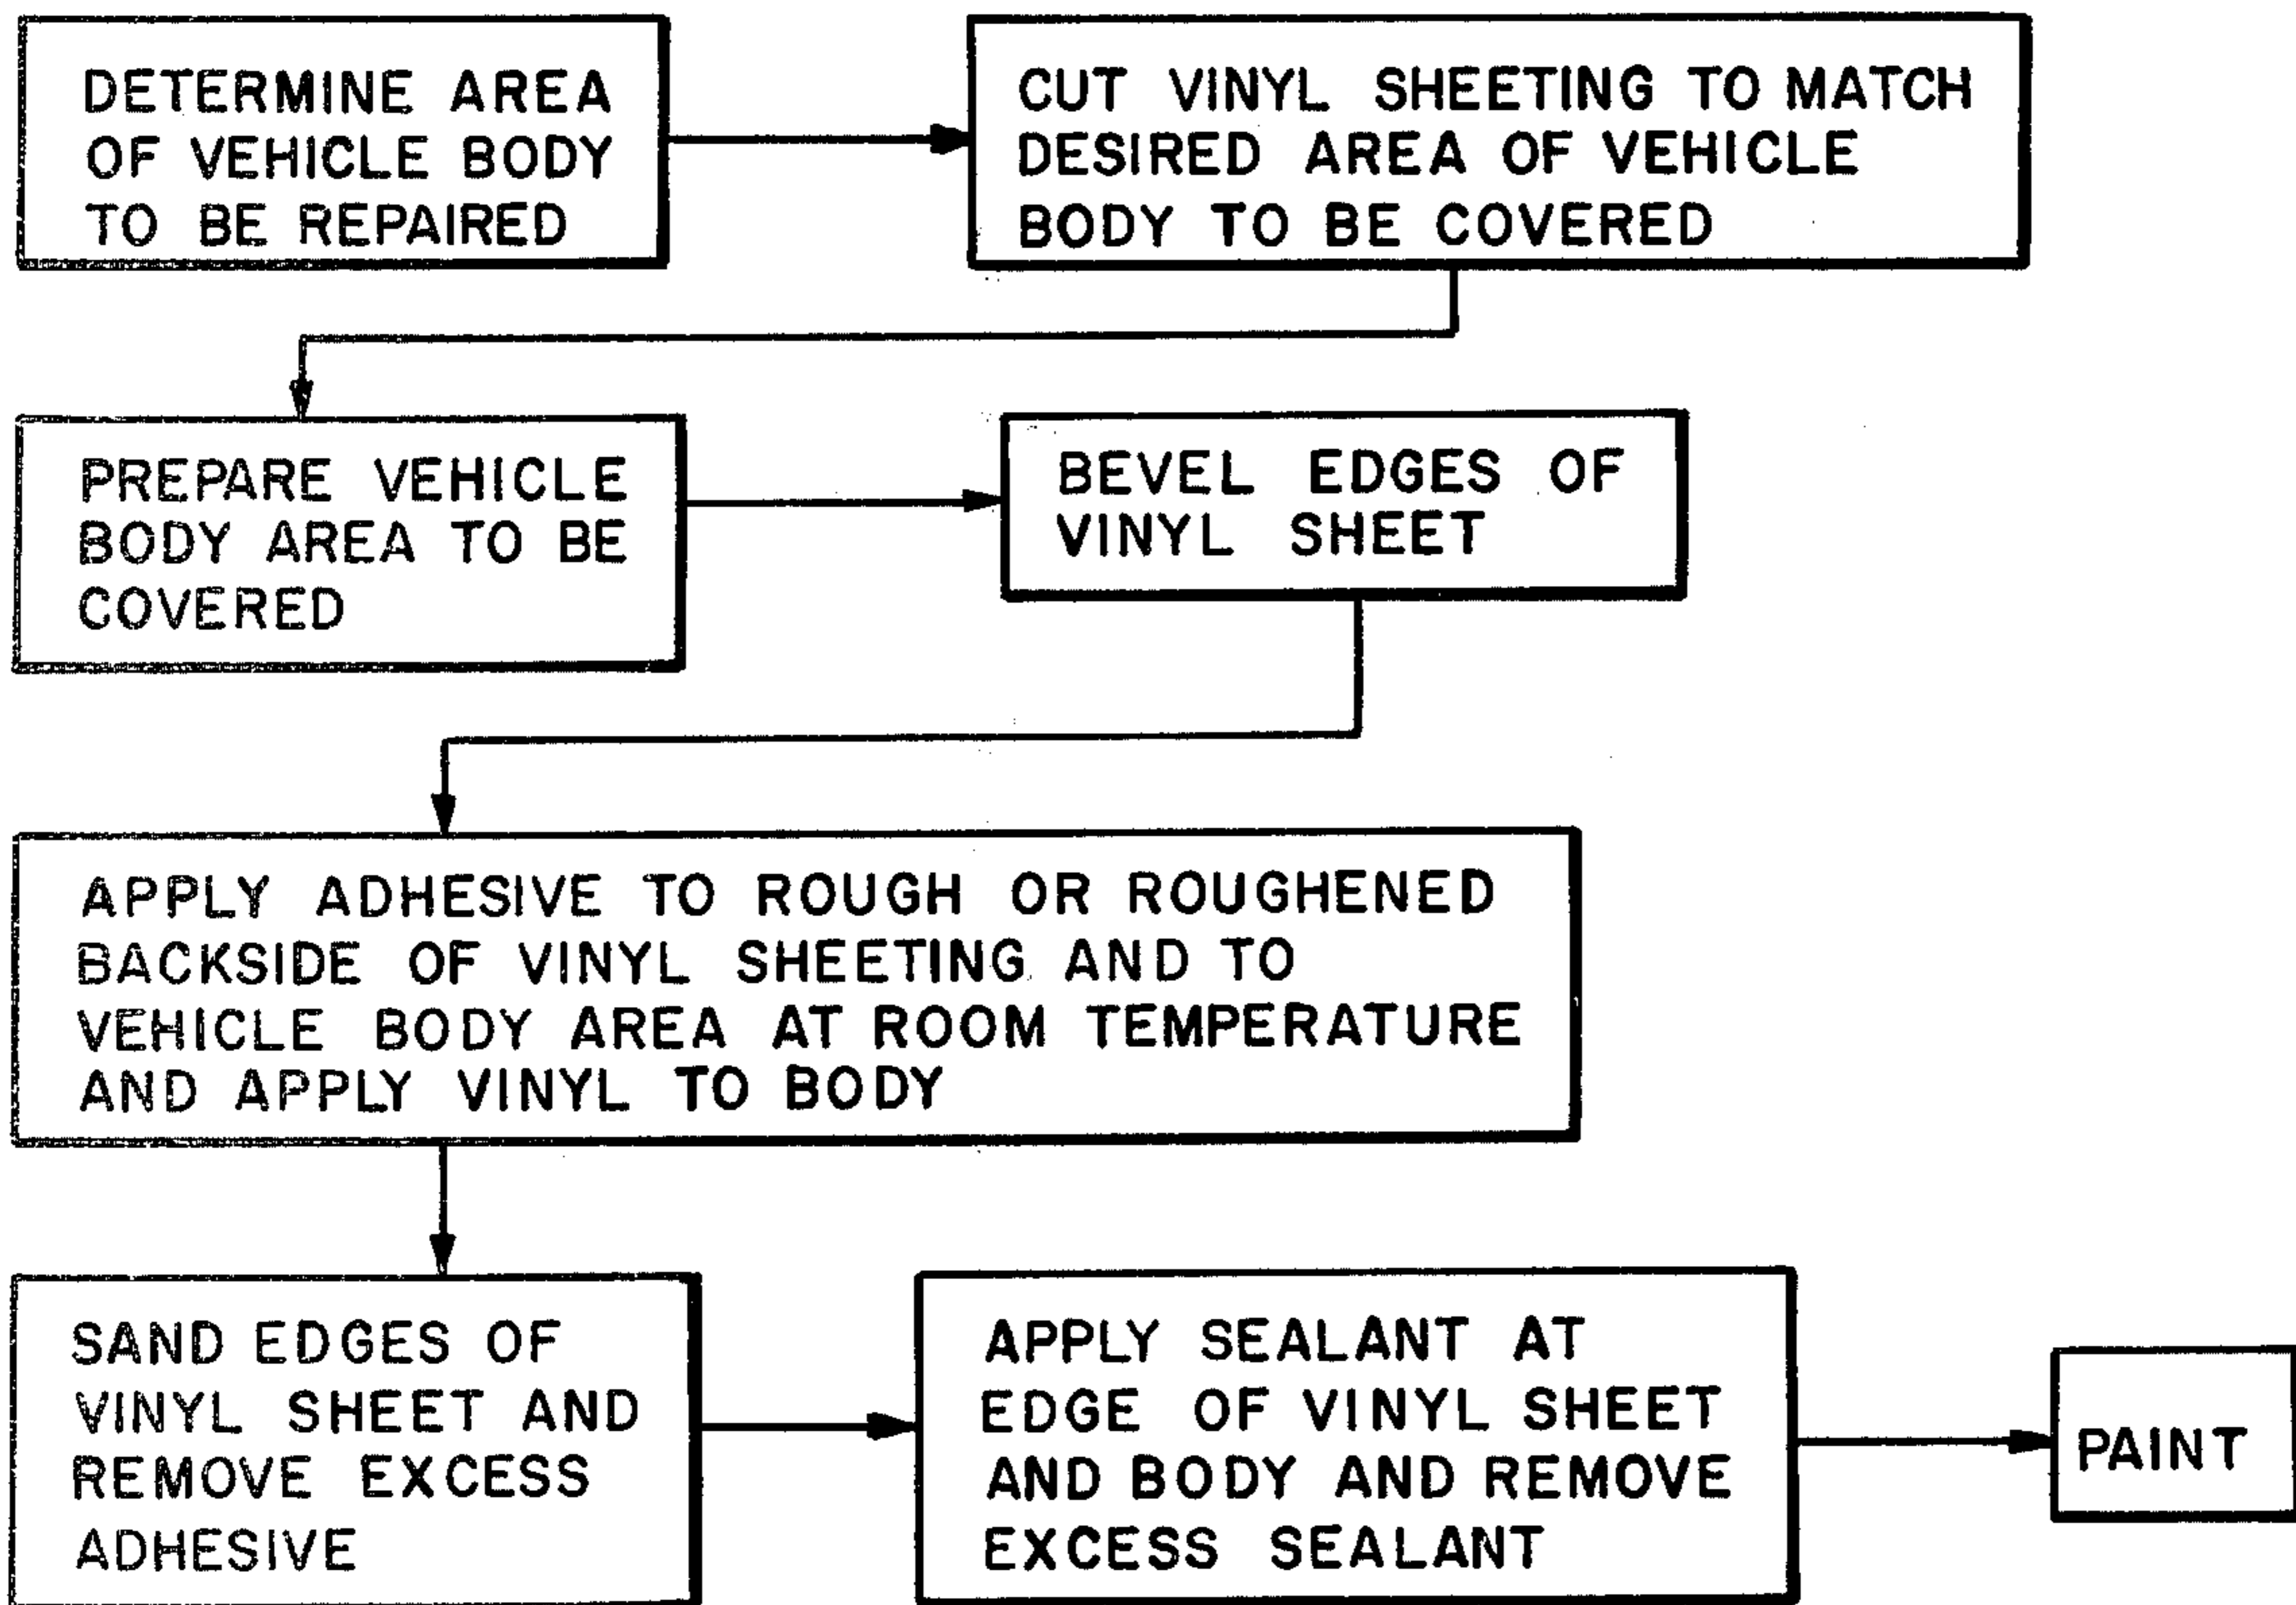
FIG 4

FIG. 4 is a flow diagram illustrating the steps employed in accordance with the method of the present invention; and

The first step in practicing the method is to determine the area of the vehicle body to be repaired (FIG. 4). One must then cut the plastic sheet 20 to match the desired area of the vehicle body to be covered. If possible, the plastic sheet 20 should be cut so that its edge comes up to a sharp bend or to a molding strip or to some other deviation in the body surface so that the edge of the plastic sheet 20 is not readily apparent in the final repair job.
