[54] METHOD AND DEVICE FOR REPAIRING DAMAGED SCREW PROPELLERS

Damaged screw propellers are repaired by use of hollow, thin-walled envelopes, each envelope having surfaces corresponding in configuration to an outer portion of a screw propeller blade. Each envelope is located on a blade, and a workable material is interposed between the damaged blade portion and the hollow interior of the envelope. The workable material and the envelope become an integral part of the blade to substantially duplicate the original configuration of the blade.

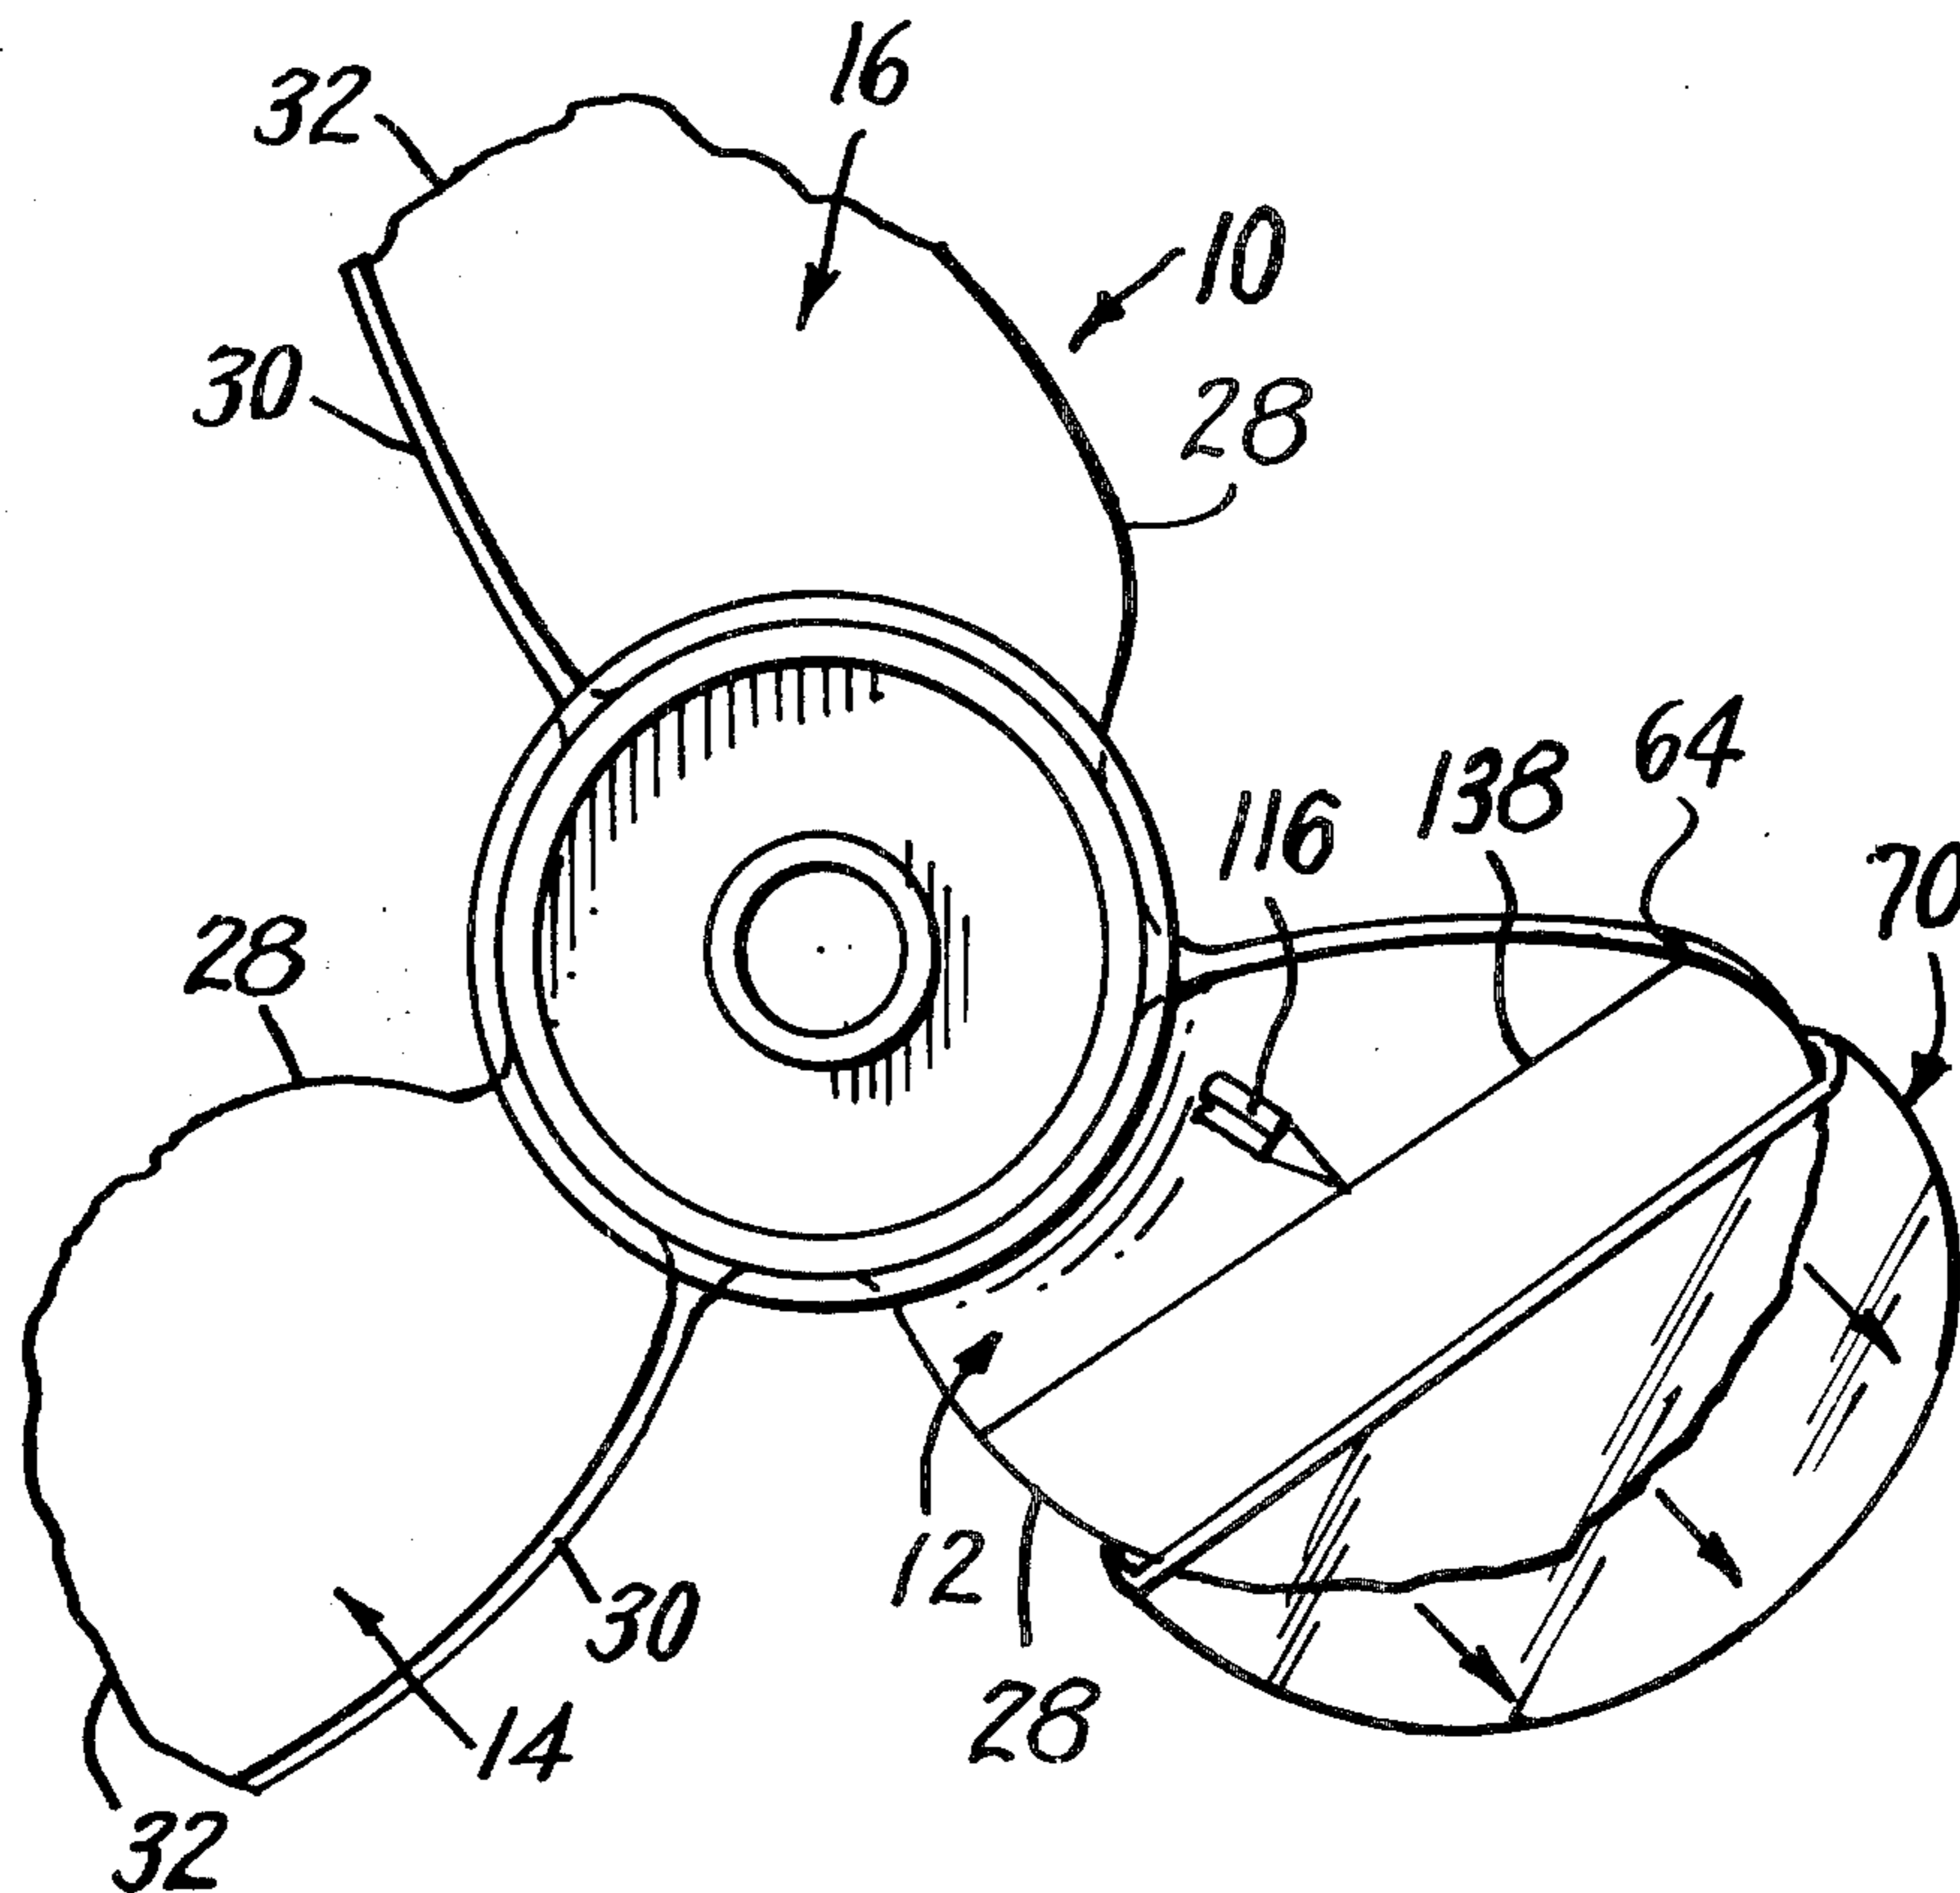
FIG. 1 is a rear elevational view of a damaged screw propeller;

Referring to FIGS. 1 and 1A, reference numeral 10 generally refers to a marine screw propeller having blades 12, 14 and 16 and a central hub 18. In FIG. 1 the rear or stern side of the propeller faces the viewer. In the particular propeller shown, the rear side includes a collar 20 by which that side of the propeller may be recognized in the other figures of the drawing. For instance, in FIG. 11 the rear or stern side 22 of propeller 10 will be recognized by collar 20 while the front or bow facing side 24 thereof will be recognized by the absence of the collar 20. It will be understood that many propellers with which the method and device of the invention will be used will not include an element such as collar 20.

FIG. 1A shows propeller 10 in the undamaged condition and FIG. 1 shows the same propeller in the damaged condition, the damage shown being typical of that produced by hitting a submerged surface or a submerged or floating object. Specifically, each blade 12, 14, 16 includes a damaged area 26 thereon. Each blade 12, 14, 16 also includes a leading edge 28 and a trailing edge 30. Since it is the leading edge 28 of each blade that advances through the water as the propeller rotates, it may readily be appreciated that each leading edge and tip receives most of the damage when rotating propeller 10 comes into contact with an object or surface in the water. Damage which occurs in this manner usually involves chips, missing pieces, curled tips from running into sand bars, creating lost portions or voids 32 in the leading edge 28 of each blade 12, 14 and 16.

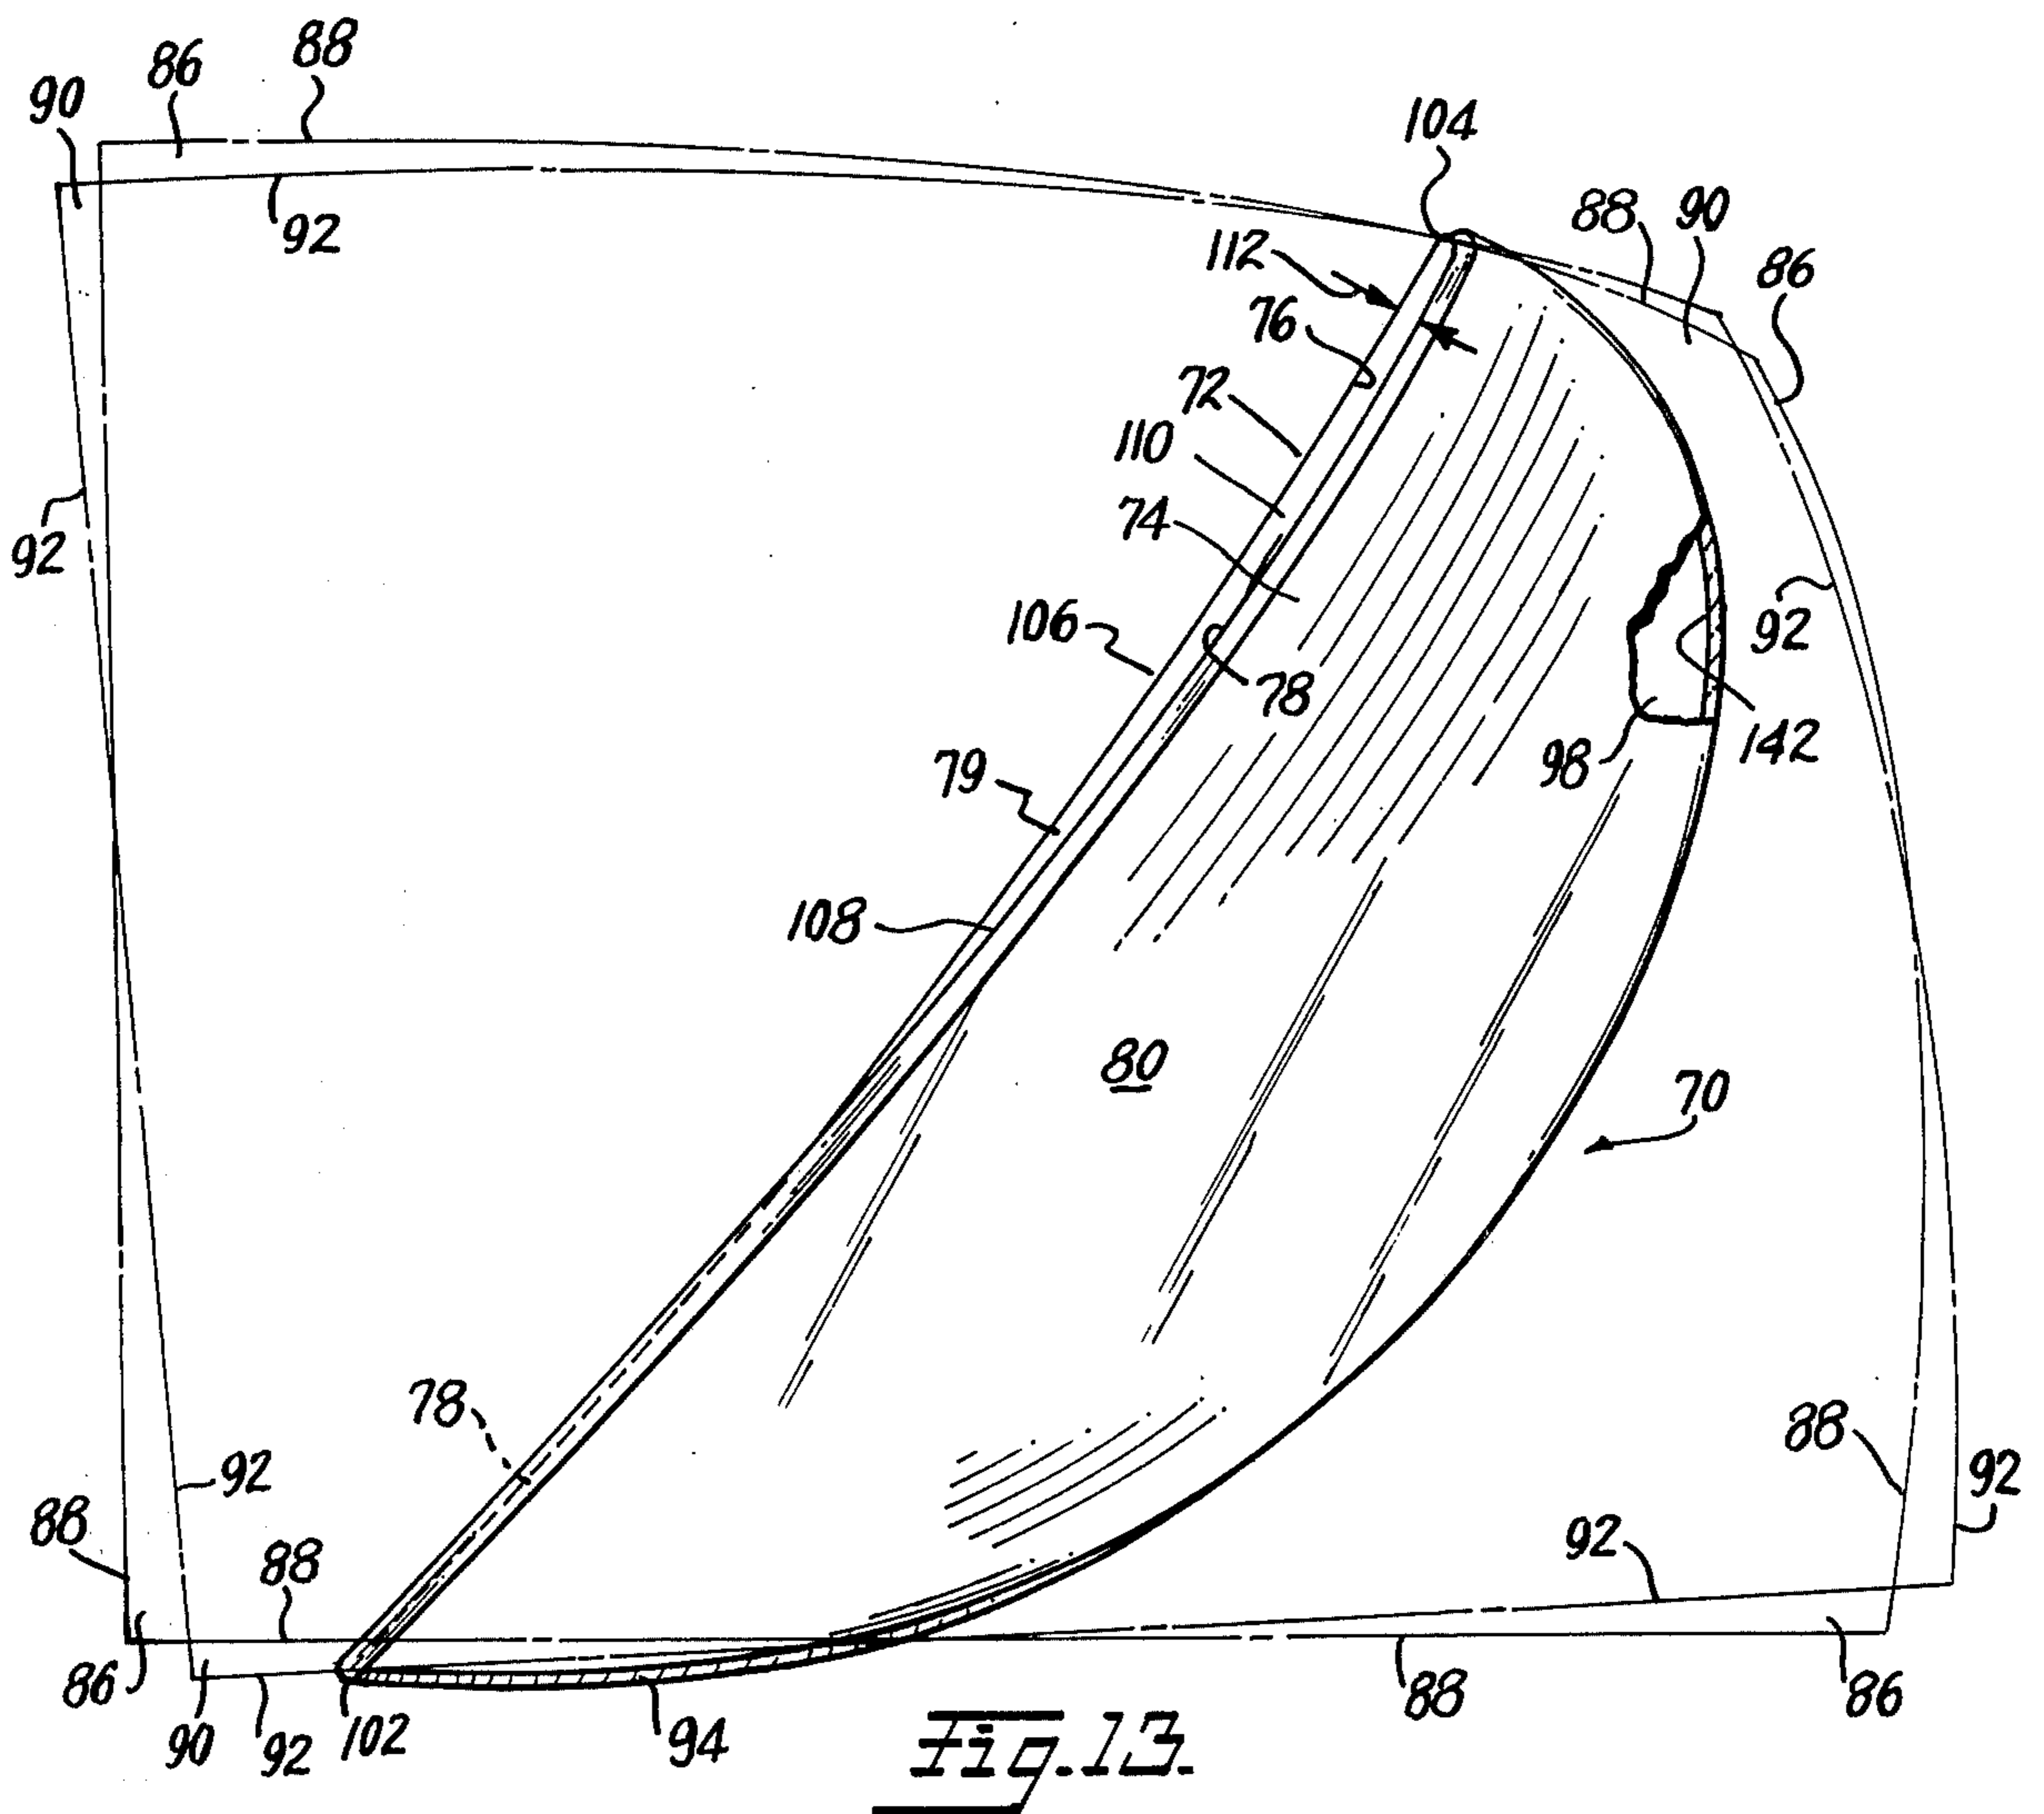
FIG. 13 is a perspective view of the hollow envelope of the invention showing, in phantom lines, extended helicoidal surfaces which correspond with the inner surfaces of the main walls of the envelope;

The construction and configuration of hollow envelope 70 is best seen by reference to FIGS. 13, 14 and 15. Envelope 70 includes a frontwardly facing main wall 72 and a rearwardly facing main wall 74. Main walls 72, 74 are disposed opposite to each other in close, side-by-side relationship. Specifically, main walls 72, 74 have corresponding configurations and are spaced apart at a substantially equal distance over their entire surfaces. The spacing between walls 72, 74 corresponds with the thickness of a propeller blade to be repaired. Main walls 72, 74 have inwardly facing surfaces 76, 78, respectively, each corresponding in configuration to a portion of one helicoidal surface of a screw propeller to be repaired. That is, inwardly facing surface 76 of main wall 72 corresponds in shape to a radially outer portion of frontwardly facing side 38 of each of the propeller blades 12, 14 and 16. Similarly, inwardly facing surface 78 corresponds in configuration to a radially outer portion of rearwardly facing side 40 of each of the blades 12, 14 and 16 of propeller 10. Main walls 72, 74 also have outwardly facing surfaces 79, 80, respectively, with the same general configuration.

When a helicoidal surface such as surface 81 is extended as in FIG. 17, it is readily apparent that the surface has a twisting configuration. Walls 72, 74 of envelope 70 and the inwardly facing surfaces 76, 78 thereof also have twisting, helicoidal configurations. Since these walls and surfaces are limited to a confined area, however, the extent of twist is rather subtle. In FIG. 13, the surface 86 defined by phantom lines 88 is an imaginary extension of the helicoidal surface of inwardly facing surface 78 of envelope 70. Similarly, the helicoidal surface 90 shown by phantom lines 92 in FIG. 13 is an imaginary extension of the inwardly facing helicoidal surface 76 of envelope 70. The extent of twist has been exaggerated slightly in FIG. 13 for purposes of illustration.
