[54] METHOD OF DETECTING DEFECTIVE PORTIONS OF METALLIC TANK HAVING THERMALLY PROTECTIVE COATING OF POLYURETHANE FOAM

[73] Assignee: Nippon Oil Company, Limited, Tokyo, Japan

[57] ABSTRACT

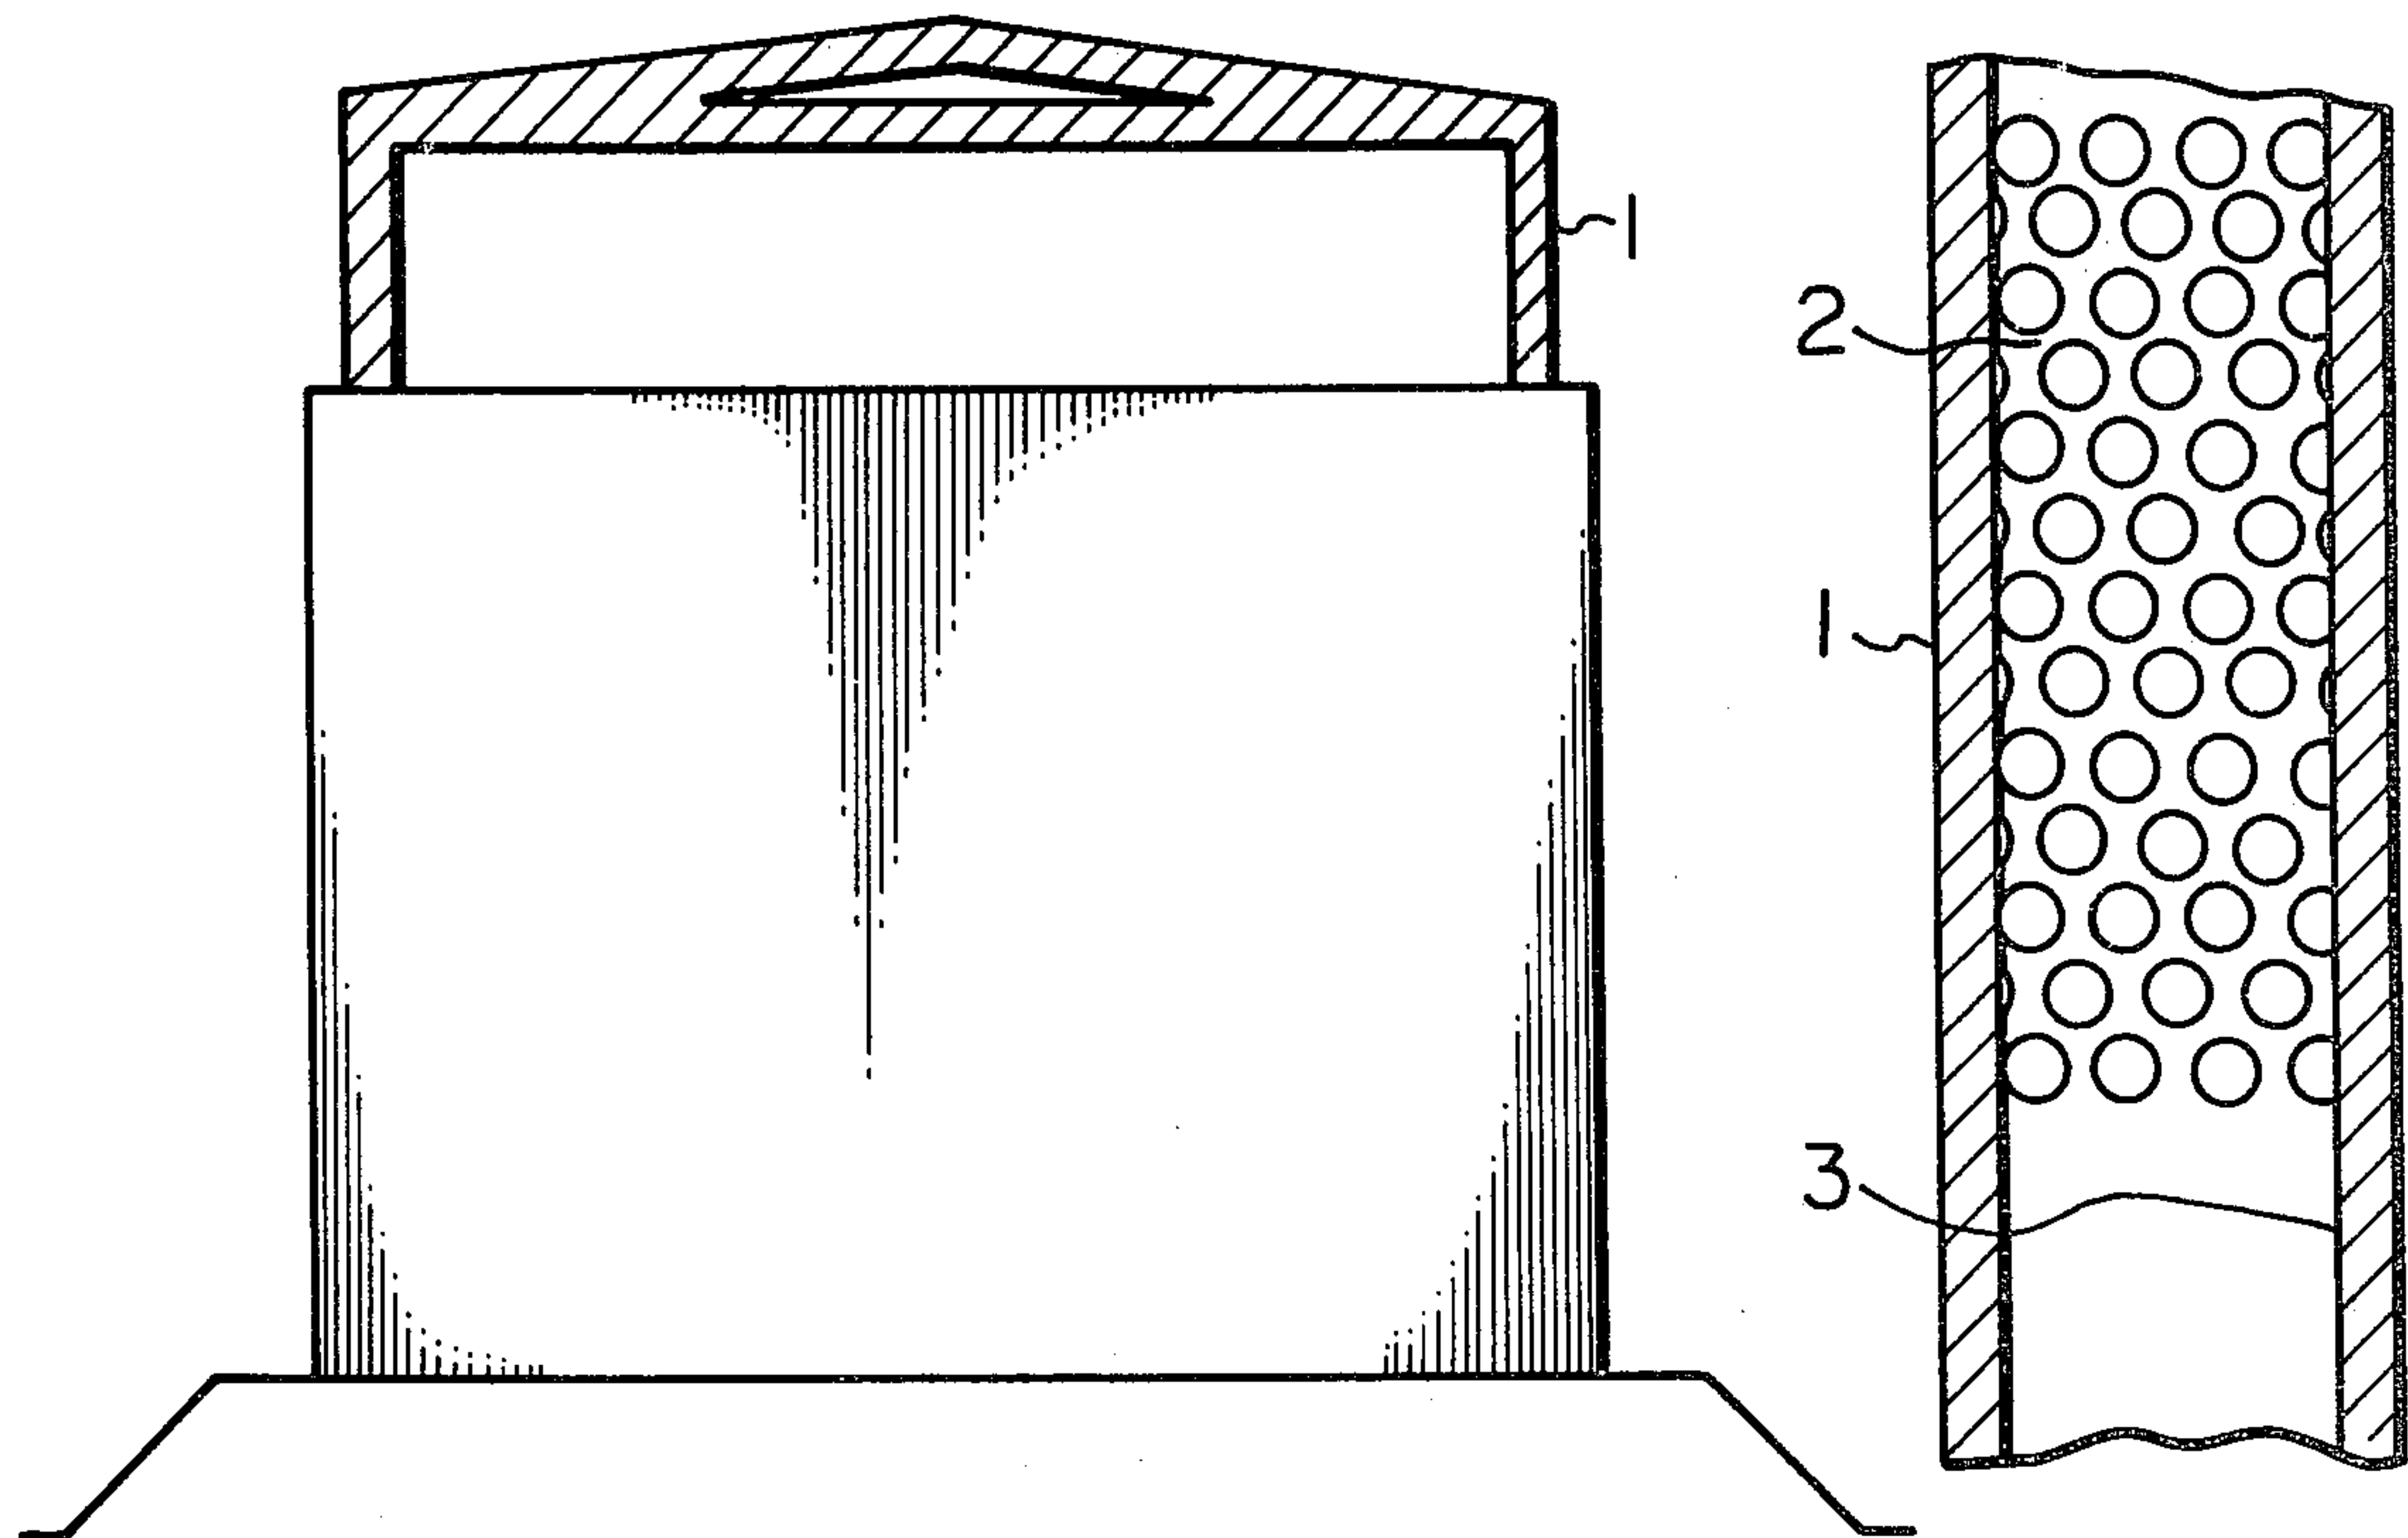
Fig. 1

FIG. 1 shows a tank in side elevation with a protective coating applied on the side walls thereof, and an enlarged detail of the applied protective coating of a polyurethane-forming composition;

Since about 1969, there has been adopted a method of construction wherein a protective coating of rigid polyurethane foam is formed in situ on the side wall of the tank by gun-spraying. This is because such a method is advantageous in various aspects. Among others, this material can be of a closed cell structure and, thus, when compared with the conventional thermally protective porous or fibrous materials, it has a reduced water regain or water uptake and exhibits an enhanced ability of keeping warmth. In addition, thereto, no covering material, such as zinc-plated steel panel is required. The cost of construction is cheap. The period of time required for construction is short. It is easy to repair, and no scaffold is required. As shown in FIG. 1, the coating of polyurethane foam may be applied to the side wall of the tank by spraying onto the outer surface of side wall 1 of the tank a rigid polyurethane-forming composition, primarily comprised of at least one polyol and at least one polyisocyanate, together with a foaming agent, such as "Freon", to form a layer of foamed polyurethane 2.

In order to impart flame retardant properties to the resulting rigid polyurethane foam, halogen- or phosphorus-containing organic compounds may be usually added to the polyurethane-forming composition, or polyurethane-forming reactants containing halogen and/or phosphorus atoms in the molecule may be employed. If desired, a fire proof coating 3 may be applied by spraying on the outer surface of the rigid polyurethane foam coating 2.

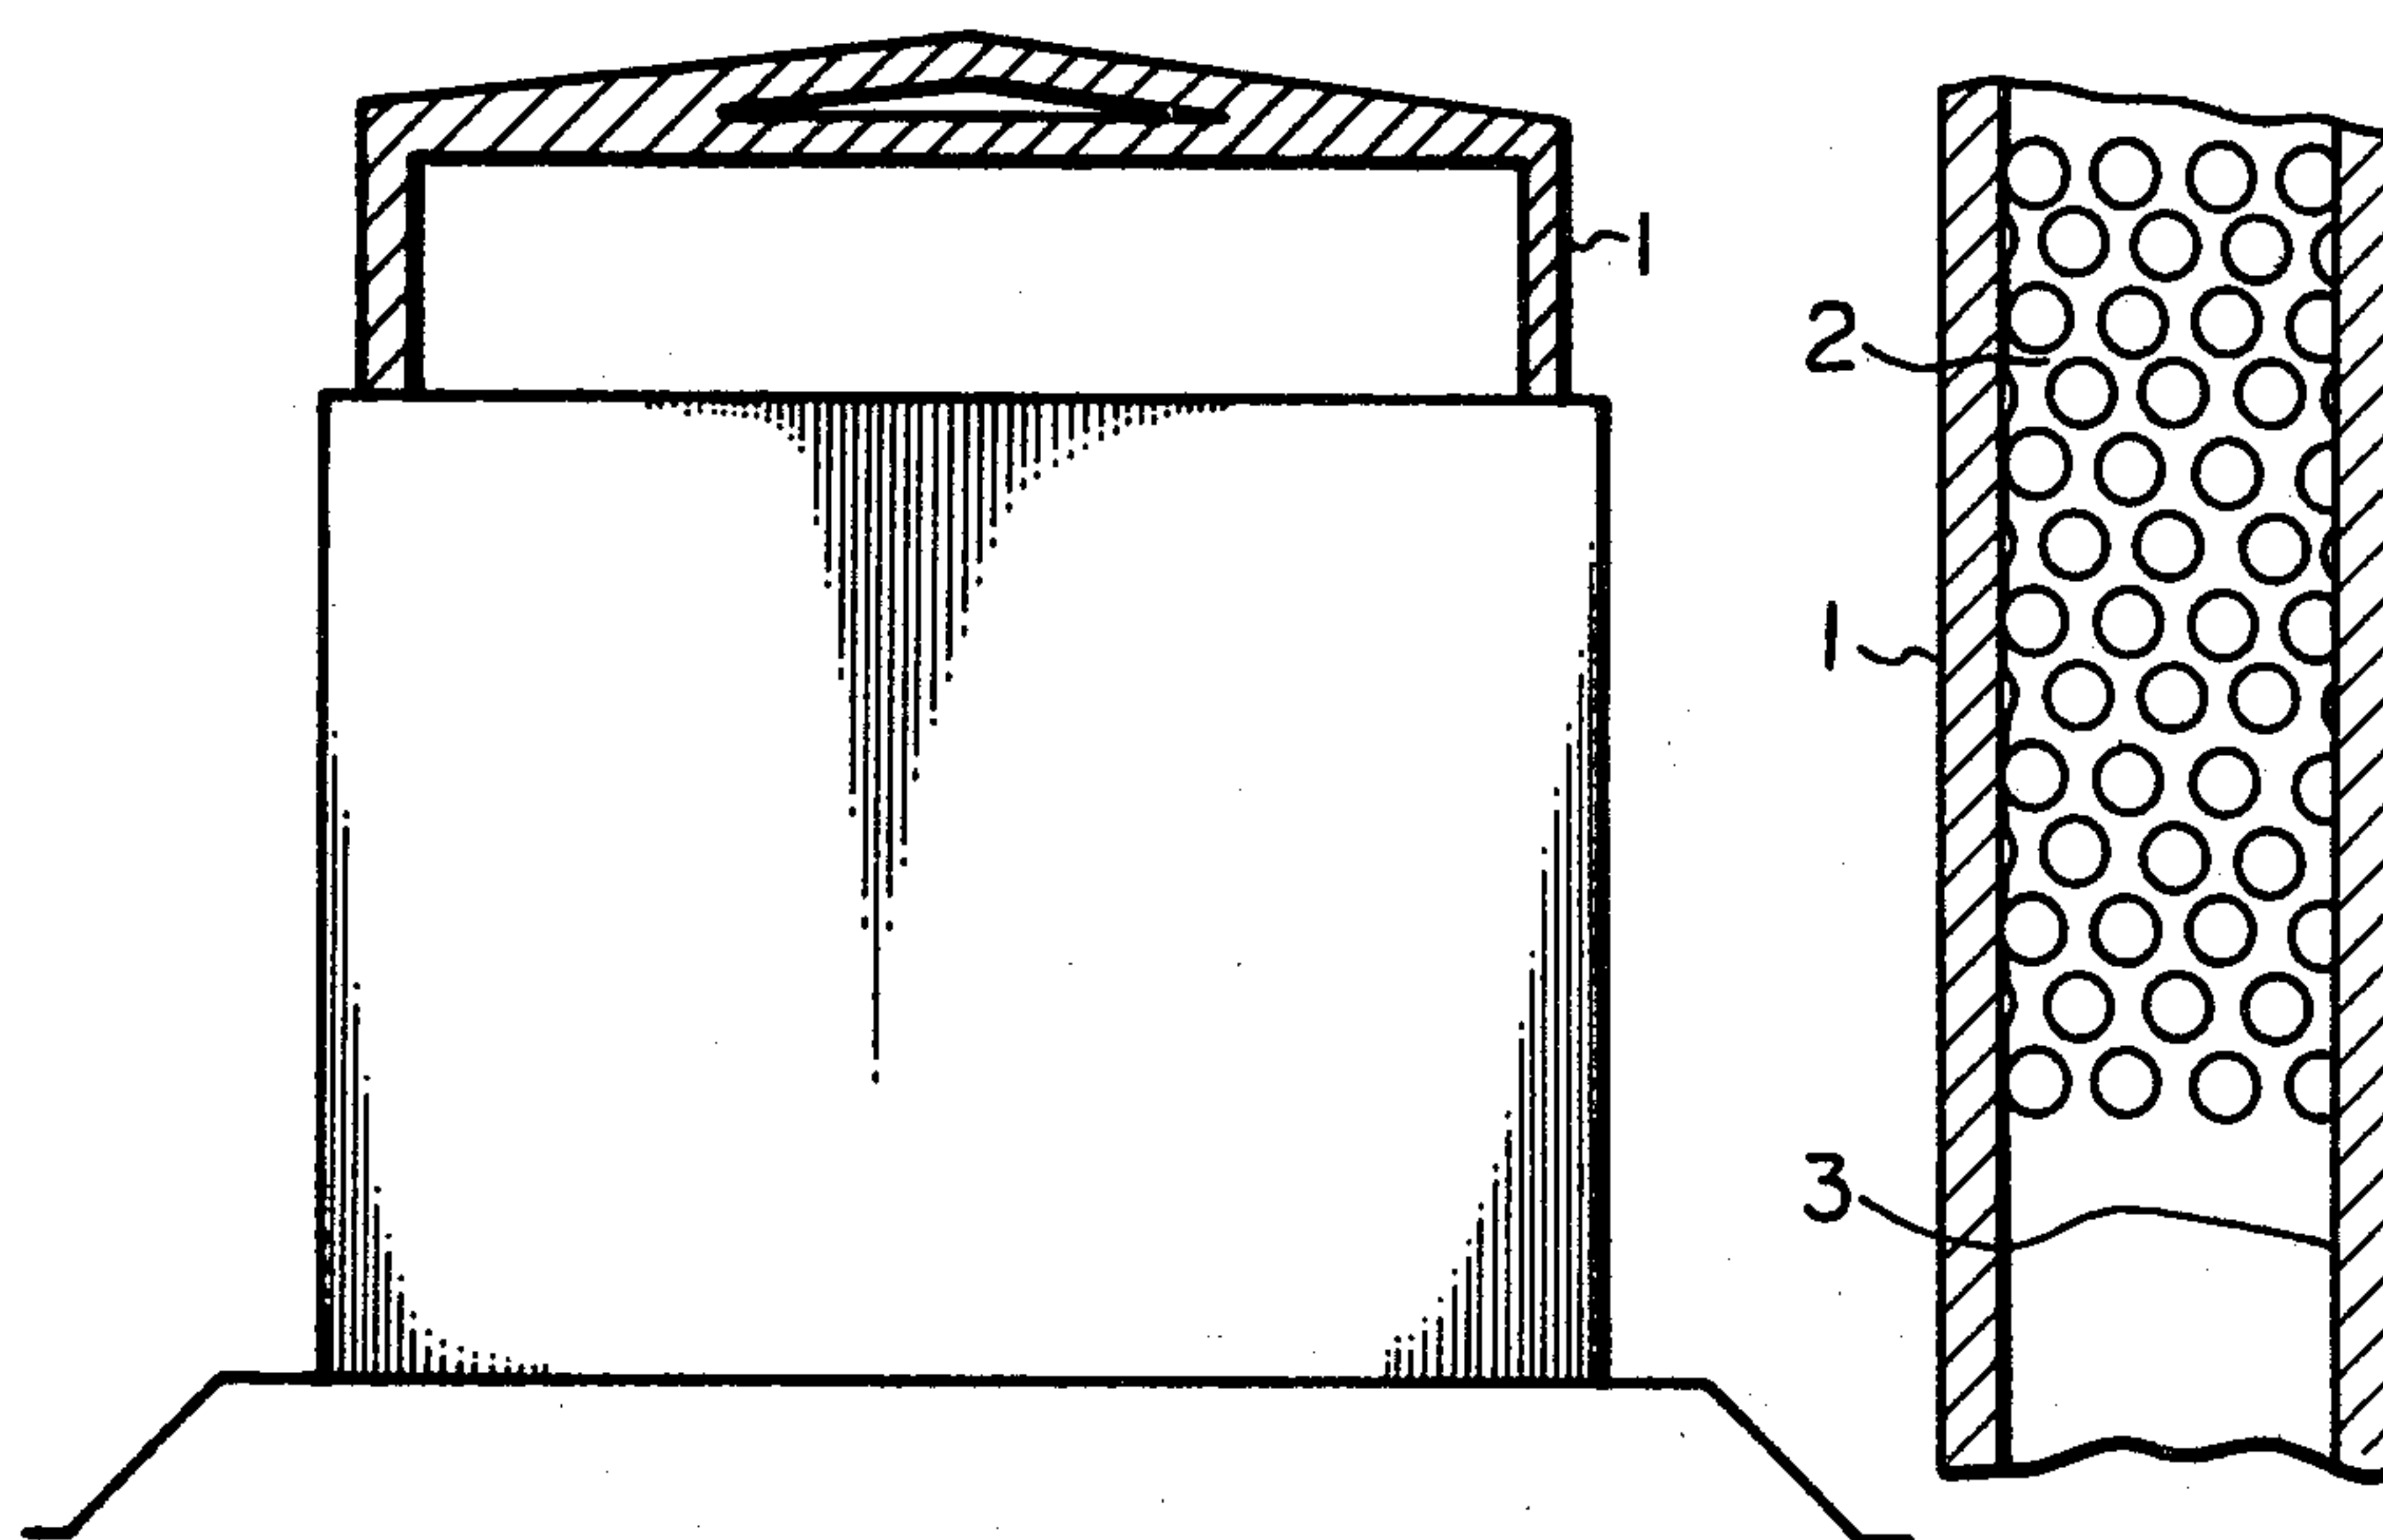
Fig. 2

FIG. 2 shows the relationship between water regain of polyurethane foam and temperature;

for prolonged period of time, it is gradually degraded and comes to absorb water. In this connection it should be noted that the water regain or uptake of a typical closed cell rigid polyurethane foam drastically increases as the temperature increases (see FIG. 2).

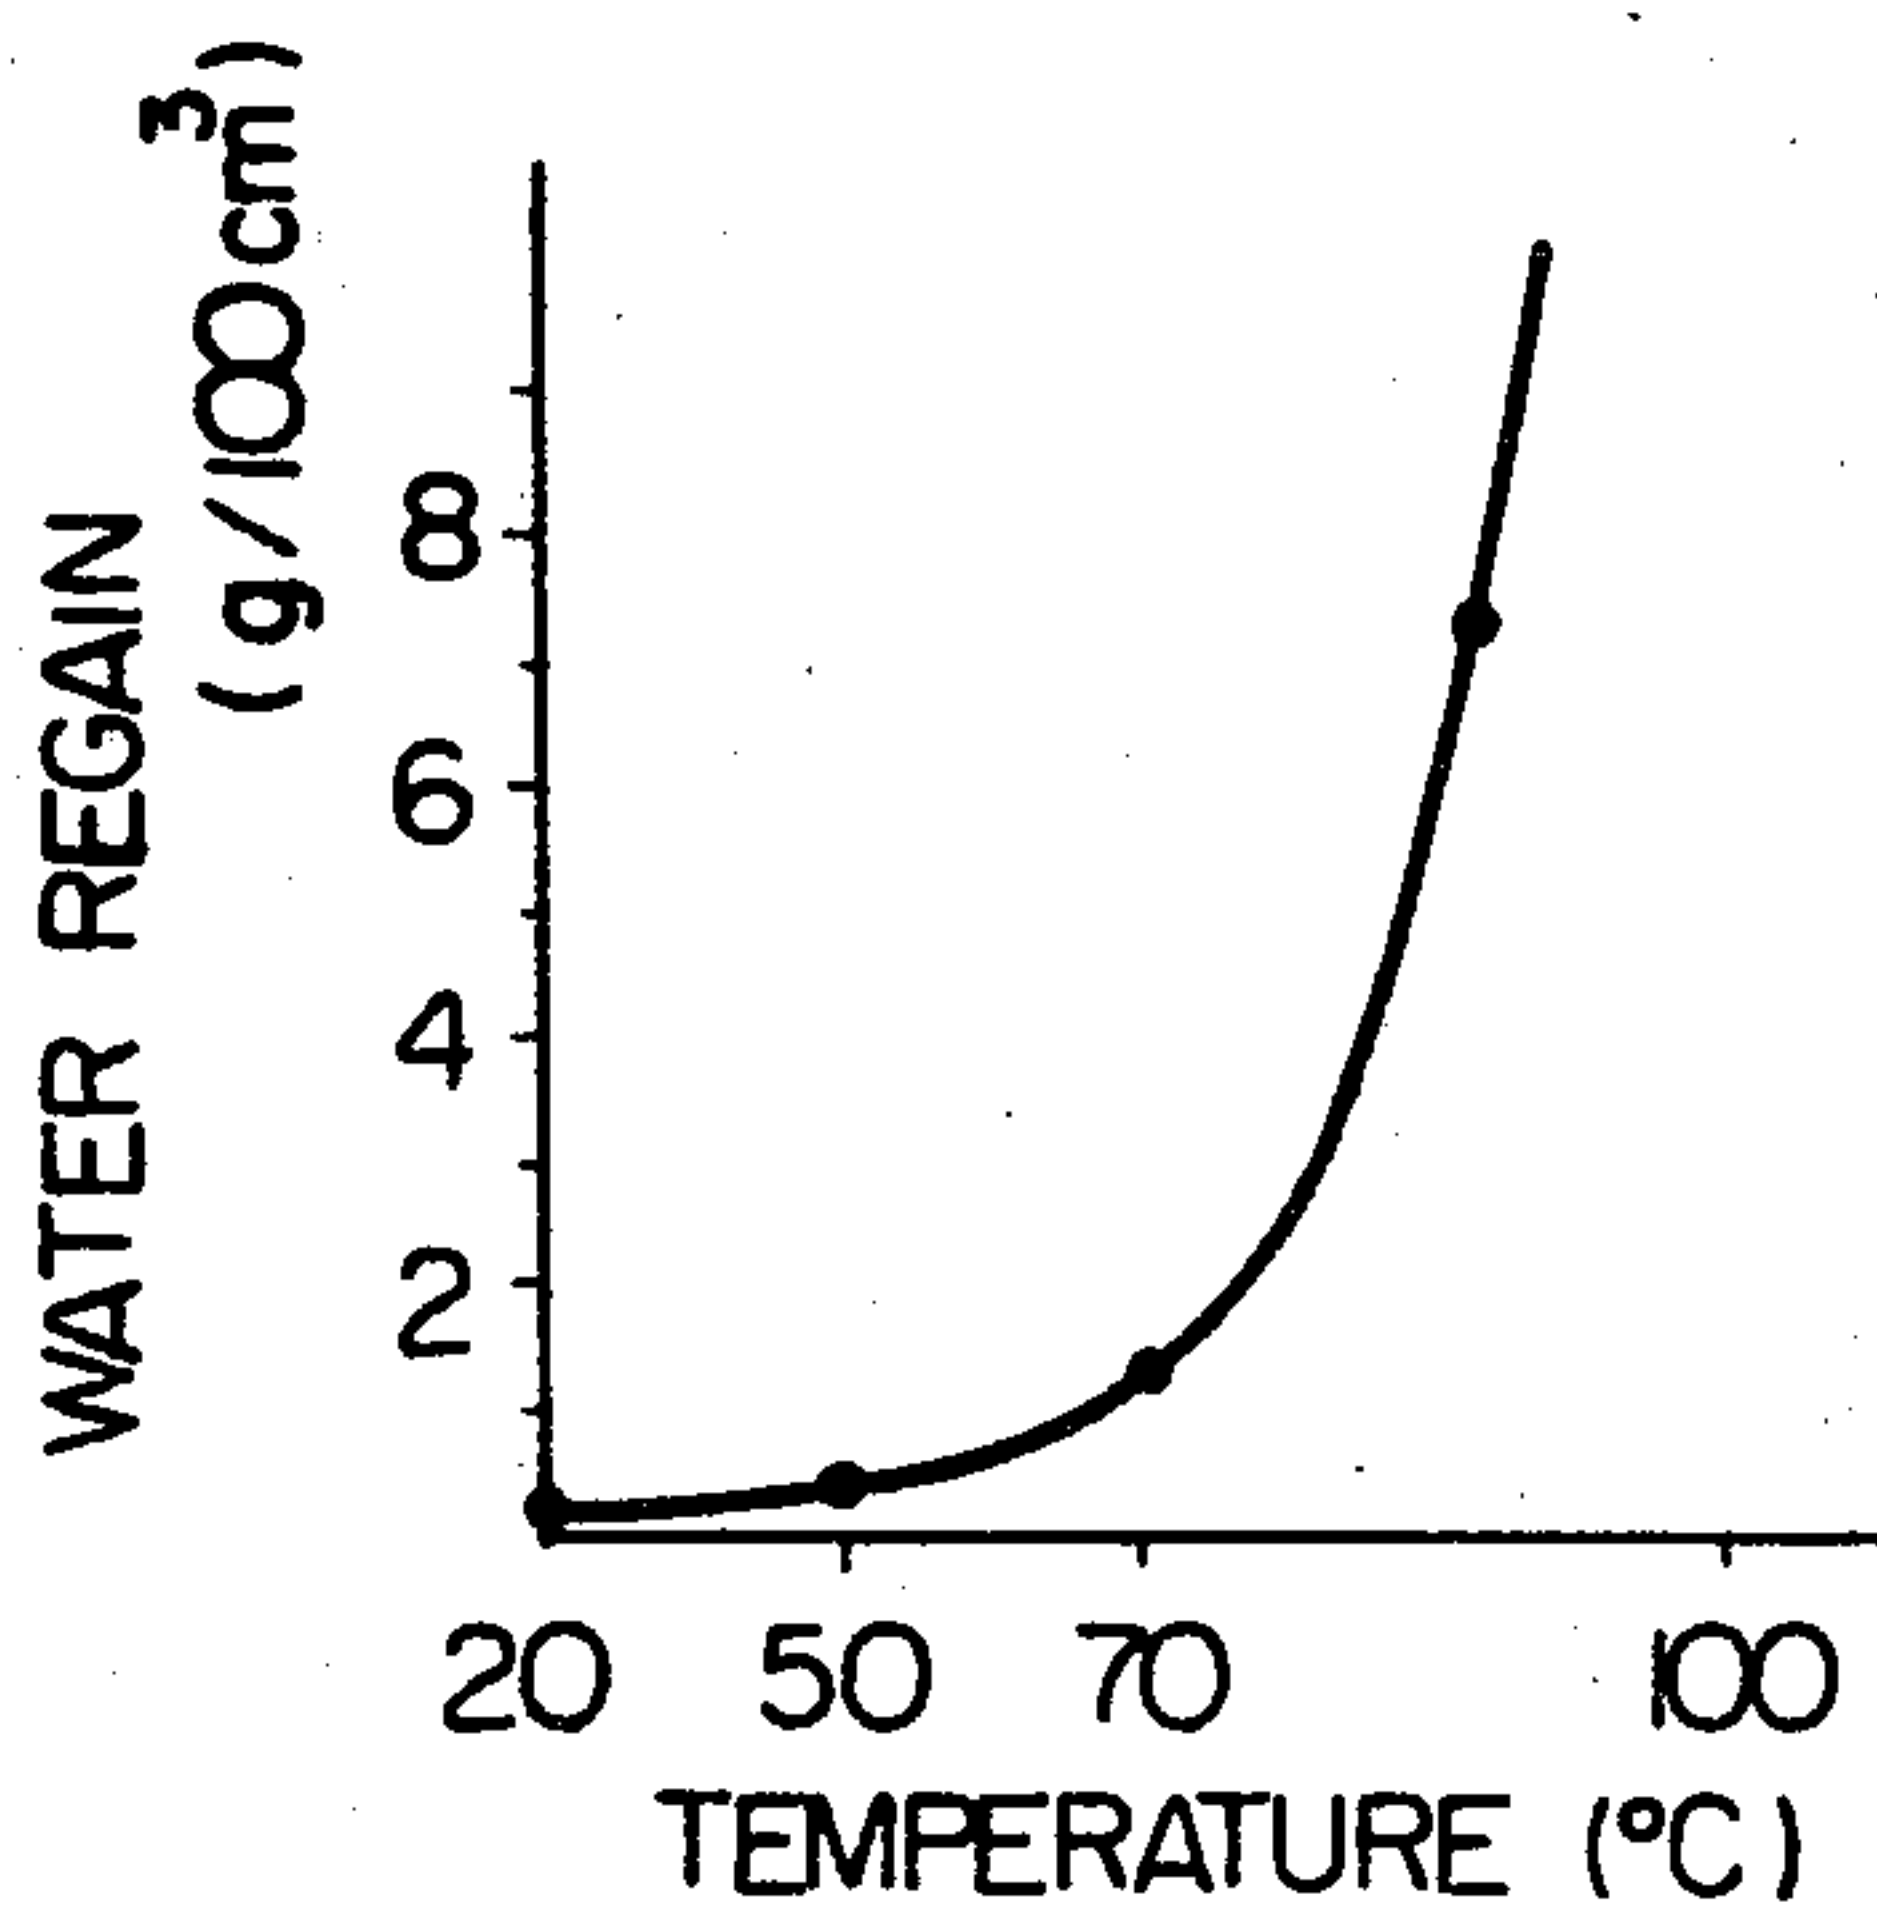
FIG. 3 shows the relationship between water content of polyurethane foam and thermal conductivity thereof;

FIG. 3 shows a relation between the water content V (in % by volume) of a sample of a typical rigid polyurethane foam and the thermal conductivity λ (in Kcal./m.hr. °C.) of the sample, wherein the plotted points represent values of λ experimentally determined by using a non-stationary thermal ray method whereas the straight line represents calculated values of λ_{th} in accordance with the following equation (1).

$$\lambda_{th} = 0.0166 = 0.494 V / 100 [\text{Kcal/mhr } ^\circ\text{C.}] \quad (1)$$

wherein V is the water content in % by volume of polyurethane foam and λ_{th} is a theoretical value of the thermal conductivity of polyurethane foam containing $V\%$ by weight of water.

As seen from FIG. 3, found values λ of the thermal conductivity of polyurethane foam are well in compliance with theoretical values λ_{th} and in good correlation to the water content V of the polyurethane foam. This fact could also be established with an actual tank having a coating of polyurethane foam by determining the thermal conductivity of the polyurethane foam coating from the surface temperature of the coating and the temperature of the oil stored in the tank, and checking the relation between the determined thermal conductivity and the water content of the coating.

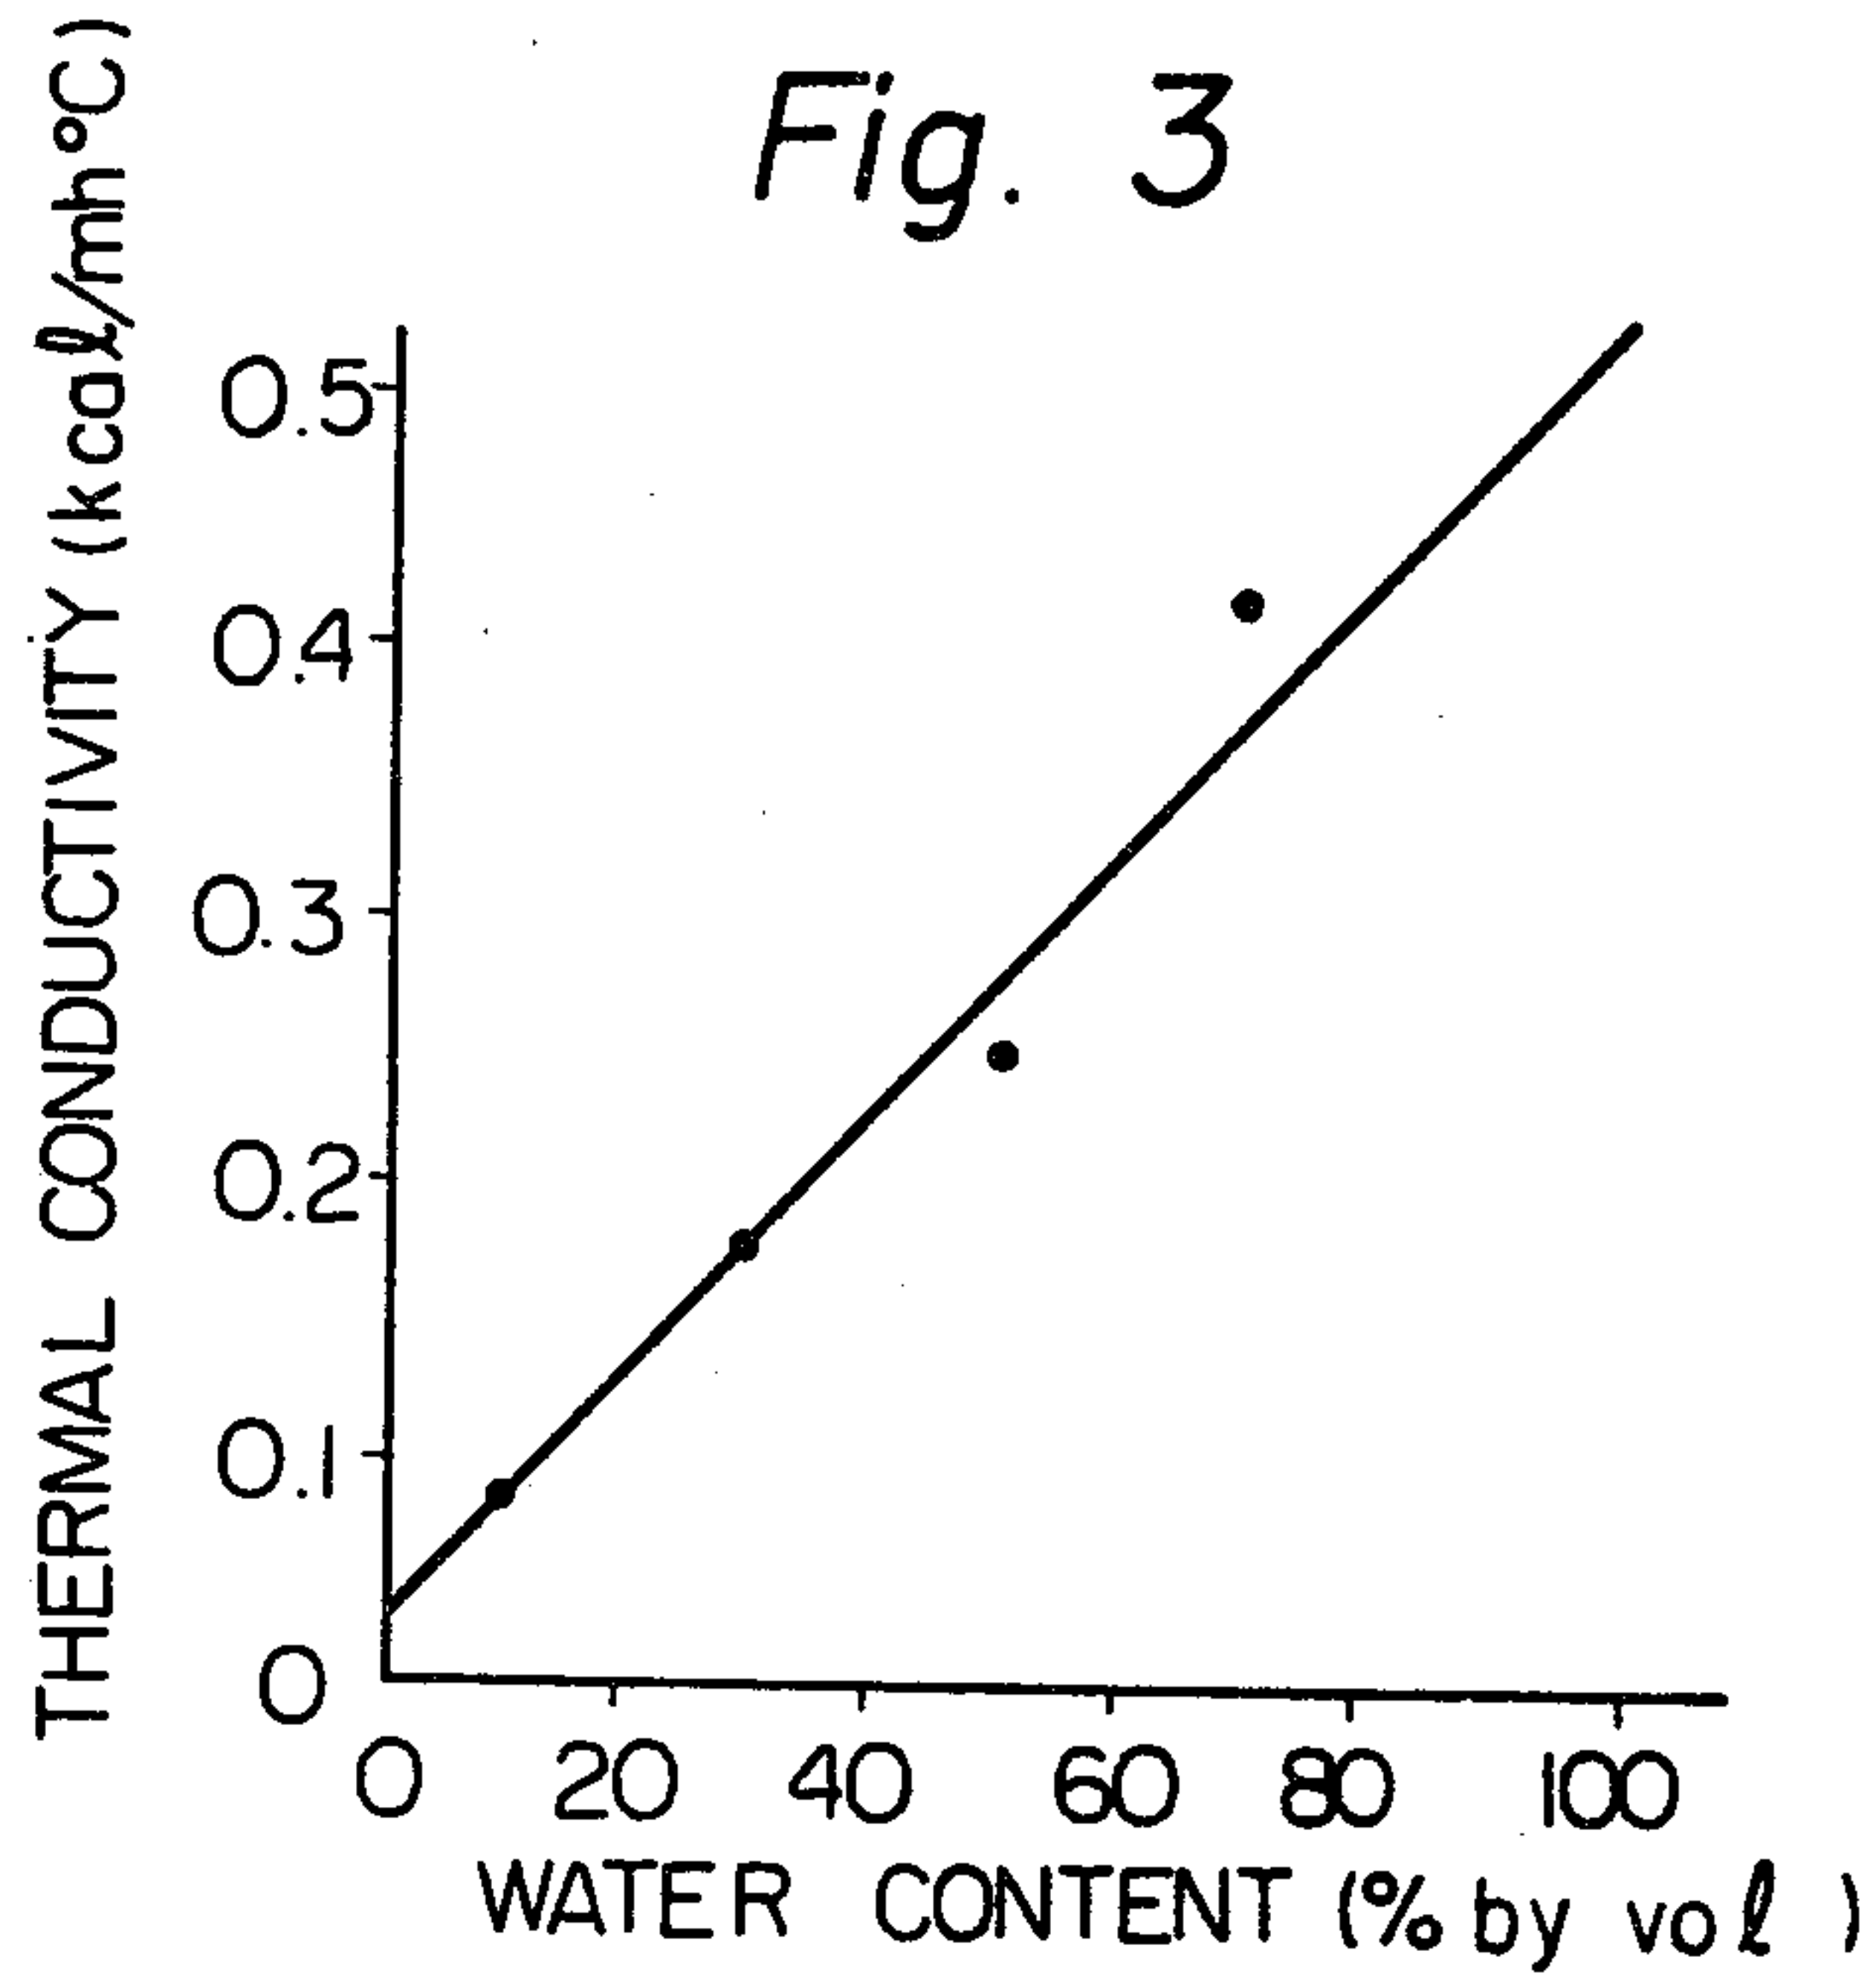
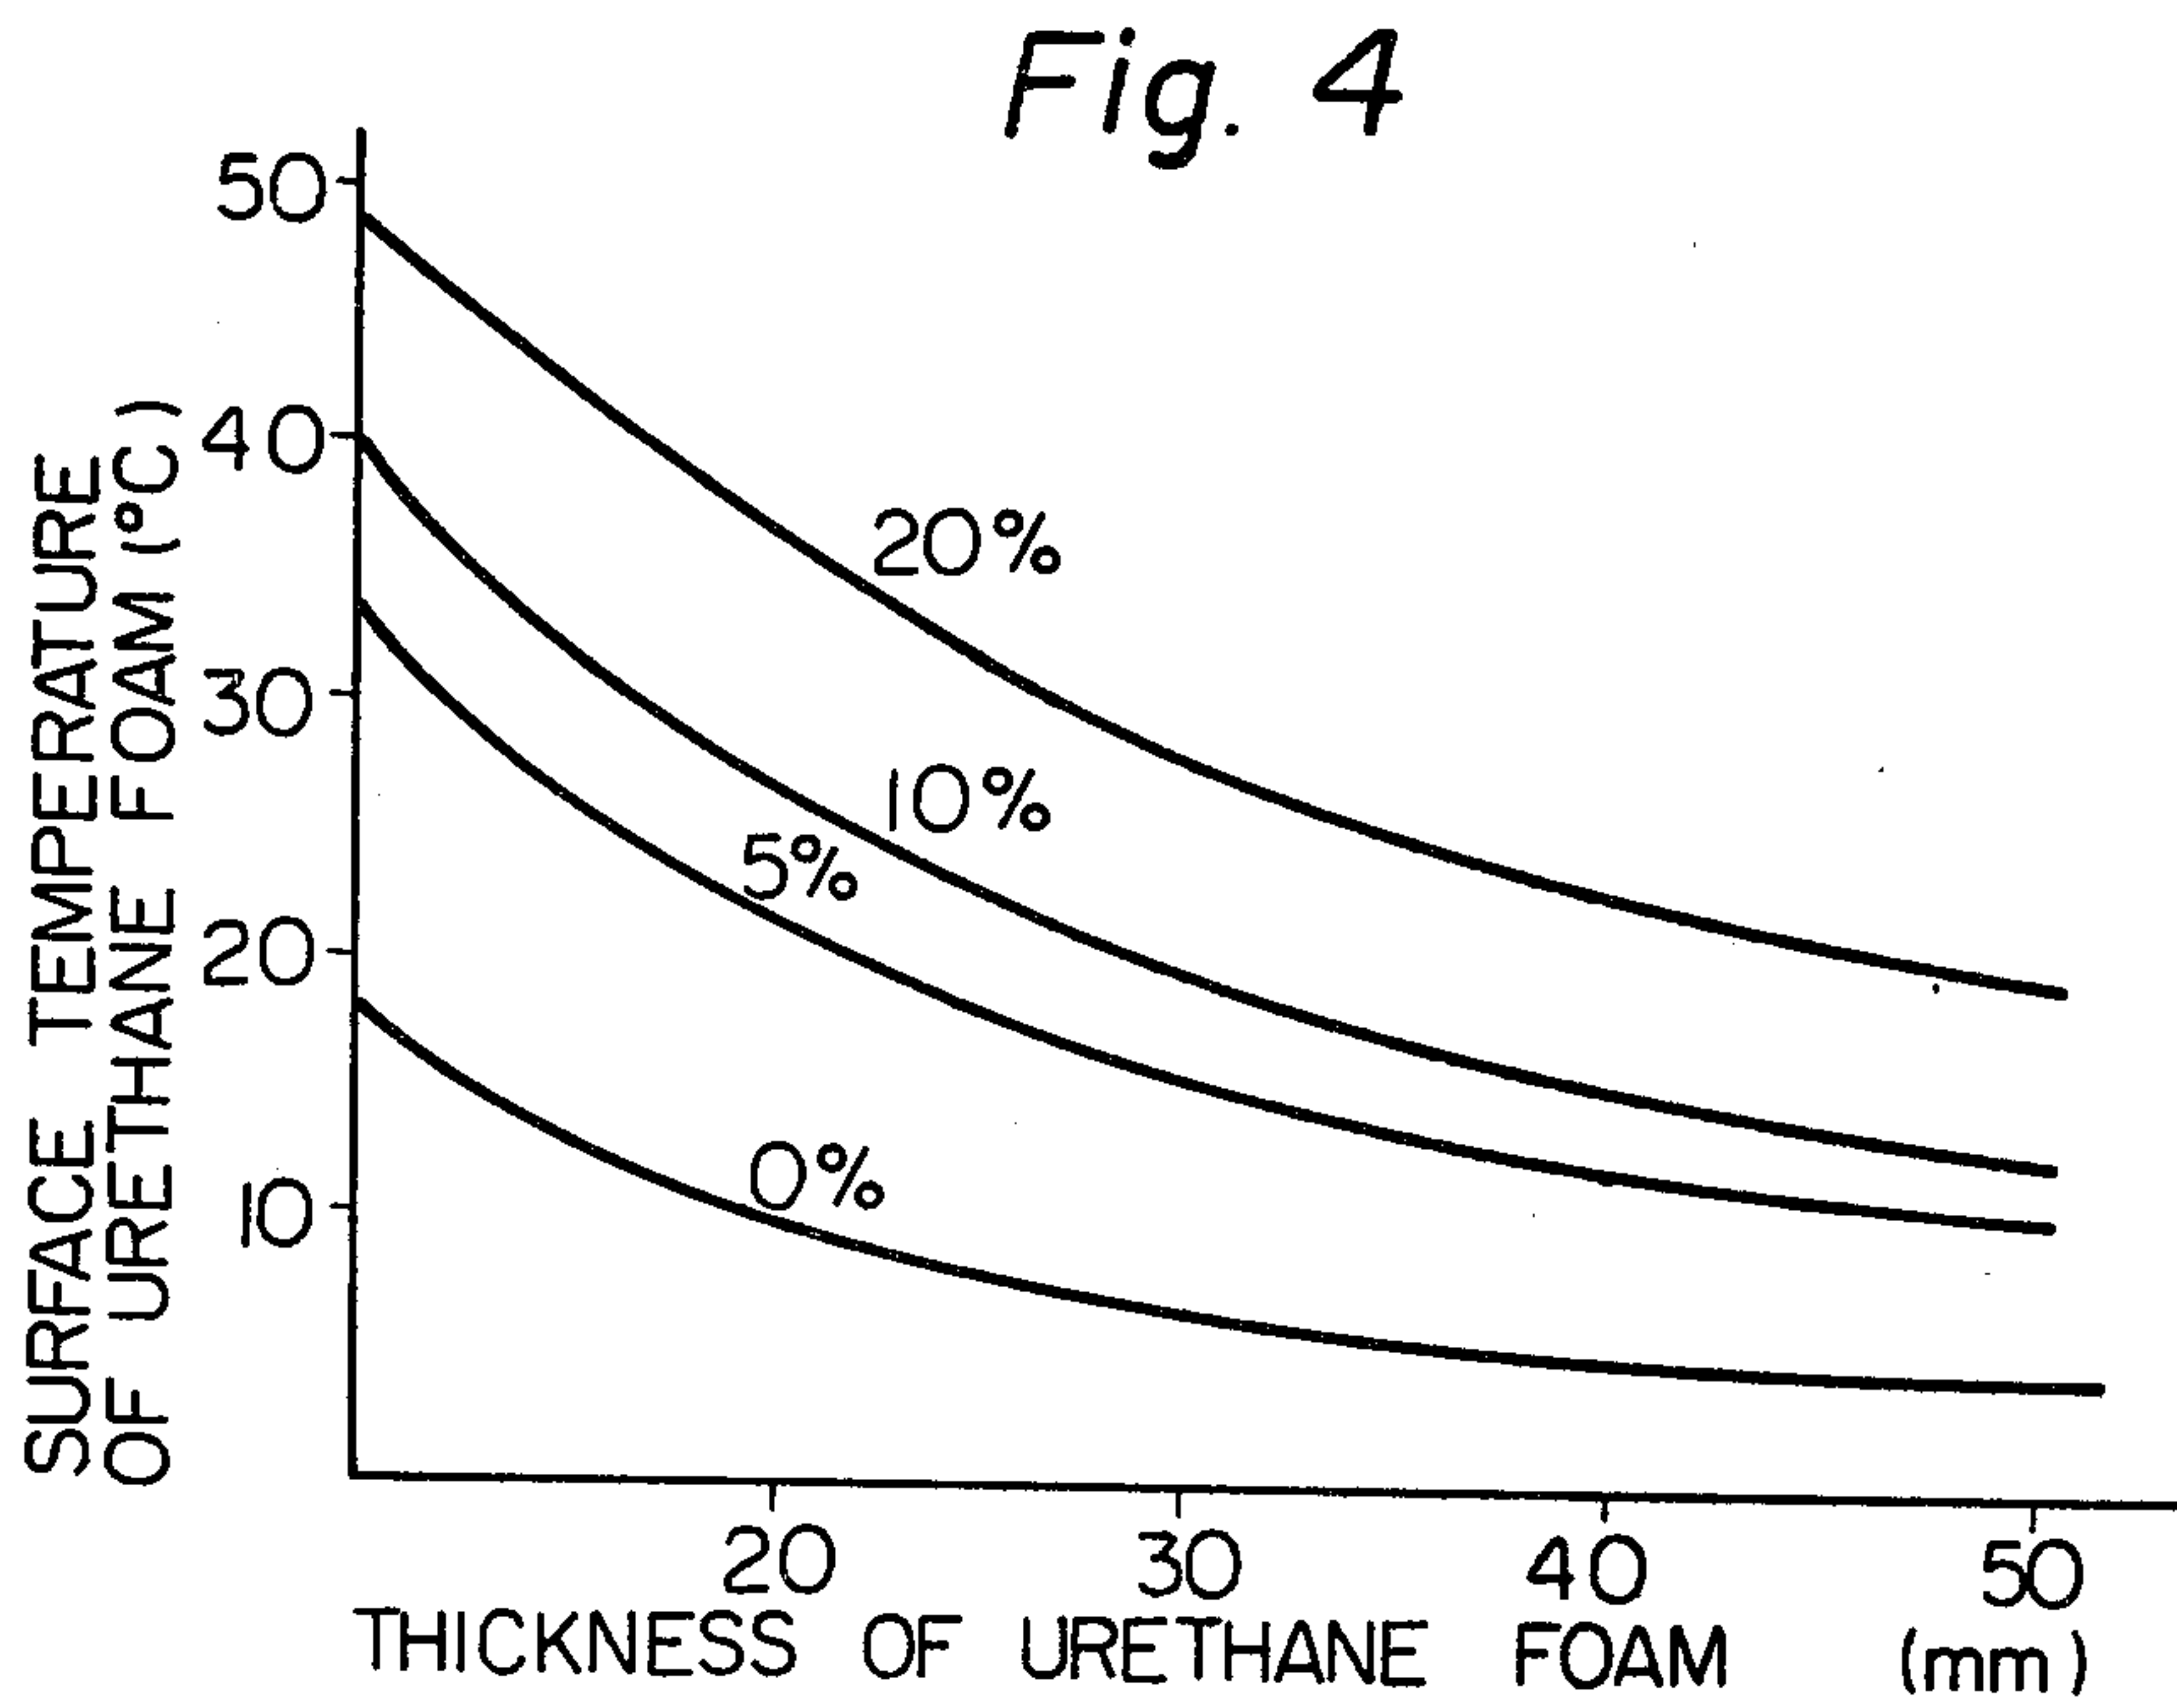
FIG. 4 shows the relationship between the surface temperature of polyurethane foam and the thickness thereof at different water contents;

It is reasonably expected that the surface temperature of the polyurethane foam will depend not only upon the water content of the foam but also upon the thickness of the foam. Therefore, we have checked the relation between the surface temperature and the thickness of the coating with respect to each of various coatings of polyurethane foam with different water contents. The results are shown in FIG. 4.

As a result, it has been found that within the practical thickness range of at least about 20 mm, the surface temperature of the coating is affected by the water content of the coating to a greater extent than by the thickness of the coating. This means that a slight variation in the thickness of the sprayed and foamed layer of polyurethane does not seriously affect the surface temperature of the resultant coating of polyurethane foam, and suggests that it is possible to determine approximate water contents of sections of the polyurethane foam coating of the tank by measuring surface temperatures of the respective sections of the coating.
