[54] METHOD OF DETECTING DEFECTIVE PORTIONS OF METALLIC TANK HAVING THERMALLY PROTECTIVE COATING OF POLYURETHANE FOAM

[73] Assignee: Nippon Oil Company, Limited, Tokyo, Japan

[57] ABSTRACT

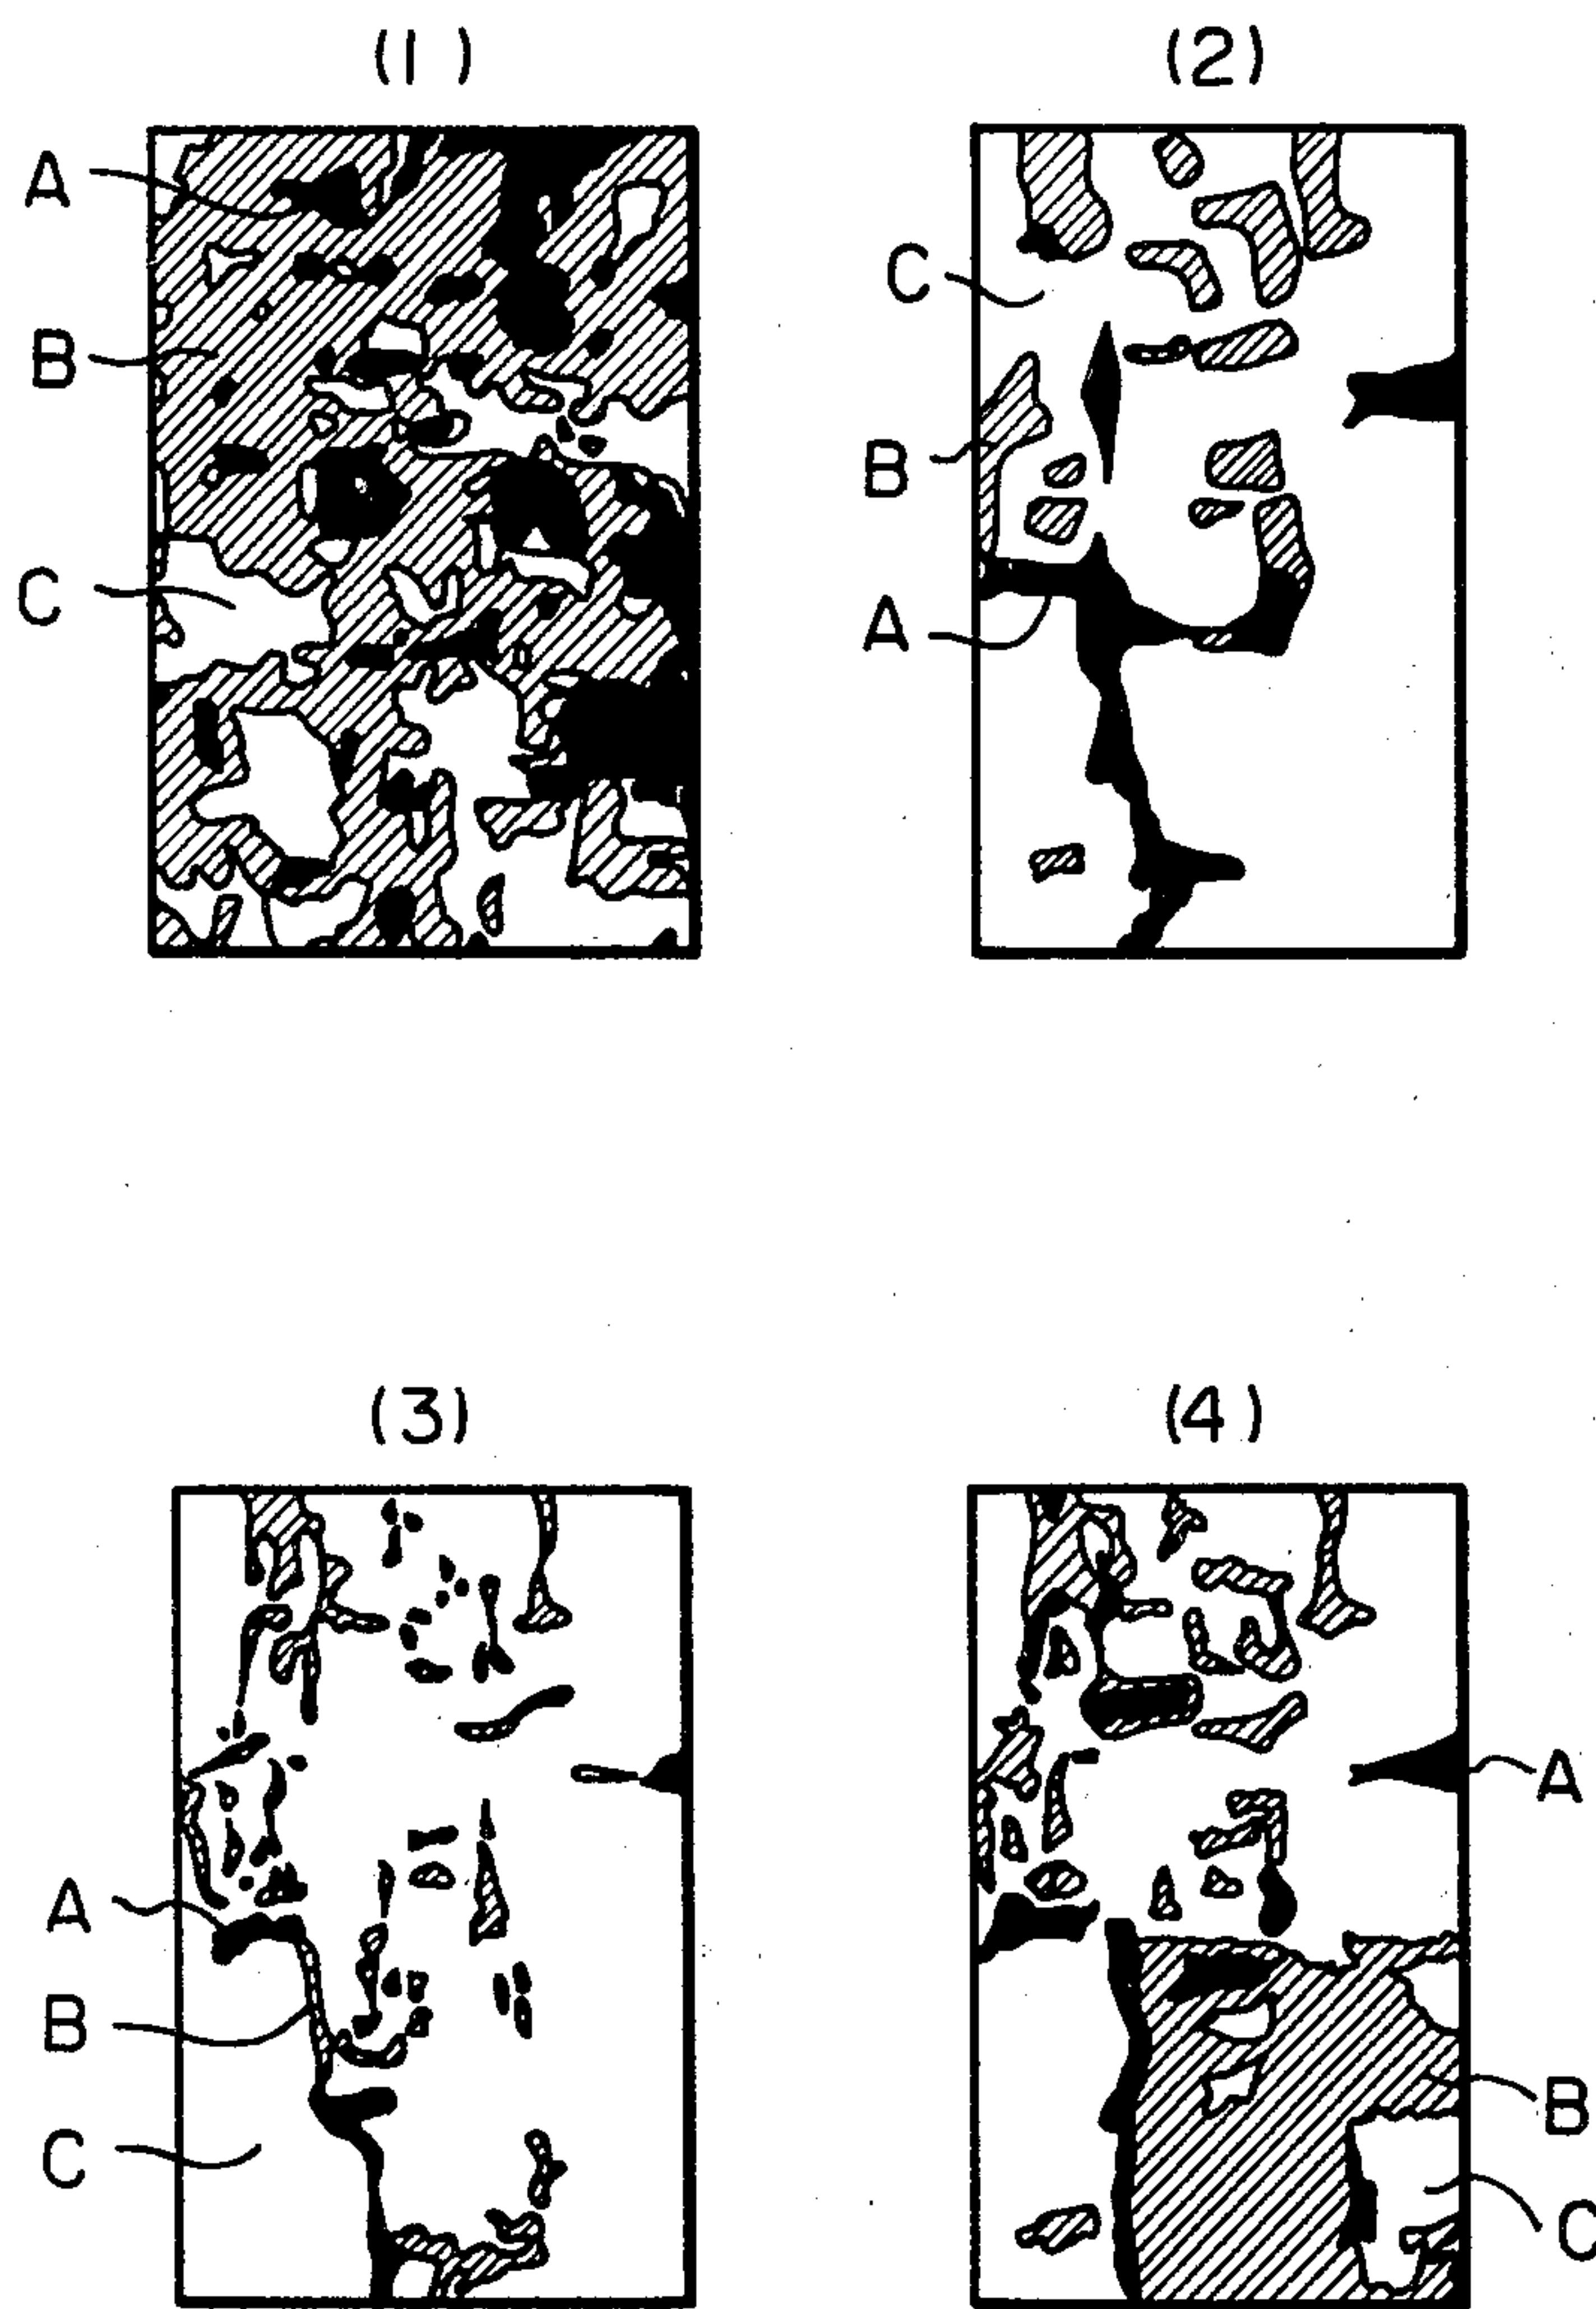
Fig. 5

FIG. 5 (1) shows a section of a coating of polyurethane foam peeled from a tank showing the distribution of the thickness of the foam;

FIG. 5 (2) shows the section of the coating of polyurethane foam peeled from the tank showing the distribution of water contents of the foam;

FIG. 5 (3) shows the distribution of corroded areas in the side wall of the tank; and

FIG. 5 (4) shows the section of the coating of the polyurethane foam peeled from the tank showing the distribution of the surface temperatures of the foam.

Using a thermography device applicable for detecting temperatures of -20°C. to 1850°C. , and having a temperature resolution ability of 0.1°C. and the number of image elements of 20,000, an infrared thermal image of a polyurethane coated tank filled with fuel oil at 75°C. was taken at night. The coating of polyurethane foam was peeled off and cut into small square sections. For each section of polyurethane foam, the thickness and water content were determined and the area of the side wall underlying the section was examined so as to find the extent of corrosion. The results are shown in FIGS. 5 (1) through (4). FIG. 5 (1) shows the distribution of thickness of the foam, in which A stands for relatively thick sections, B for sections of intermediate thickness and C for relatively thin sections. FIG. 5 (2) shows the distribution of water contents of the foam, in which A stands for sections of relatively high water uptake, B for sections of intermediate water uptake and C for relatively low water uptake. FIG. 5 (3) shows the distribution of corroded areas in the side wall of the tank, in which A stands for fairly corroded areas, B for slightly corroded areas and C for non-corroded areas. FIG. 5 (4) shows the distribution of surface temperatures of the foam, in which A stands for sections of relatively high temperatures, B for sections intermediate temperatures and C for sections of relatively low temperatures.

It can be seen from FIGS. 5 (2), (3) and (4) that the distribution of the distribution of surface temperatures of the polyurethane foam depicted in FIG. 5 (4) fairly

corresponds to the distribution of water contents of the foam shown in FIG. 5 (2) and to the distribution of corroded areas in the side wall as shown in FIG. 5 (3). Furthermore, FIG. 5 (1) reveals that the involved variation in the thickness of the foam is totally irrelevant to the distributions of the other parameters.
