[54] CAPACITANCE ELECTRONIC DISC STAMPER HAVING IMPROVED STAIN RESISTANCE AND METHOD FOR THE MANUFACTURE THEREOF

[75] Inventor: Mohamed E. Labib, Princeton, N.J.

[73] Assignee: RCA Corporation, New York, N.Y.

Nickel stampers used for the molding of capacitive electronic discs are treated prior to use in the molding process by heating the stamper in the presence of an oxygen containing gas, at a temperature from about 220° C. to about 300° C. for 2 to 5 hours until a continuous protective oxide layer approximately 10–40 angstroms thick is formed on the surface of the stamper.

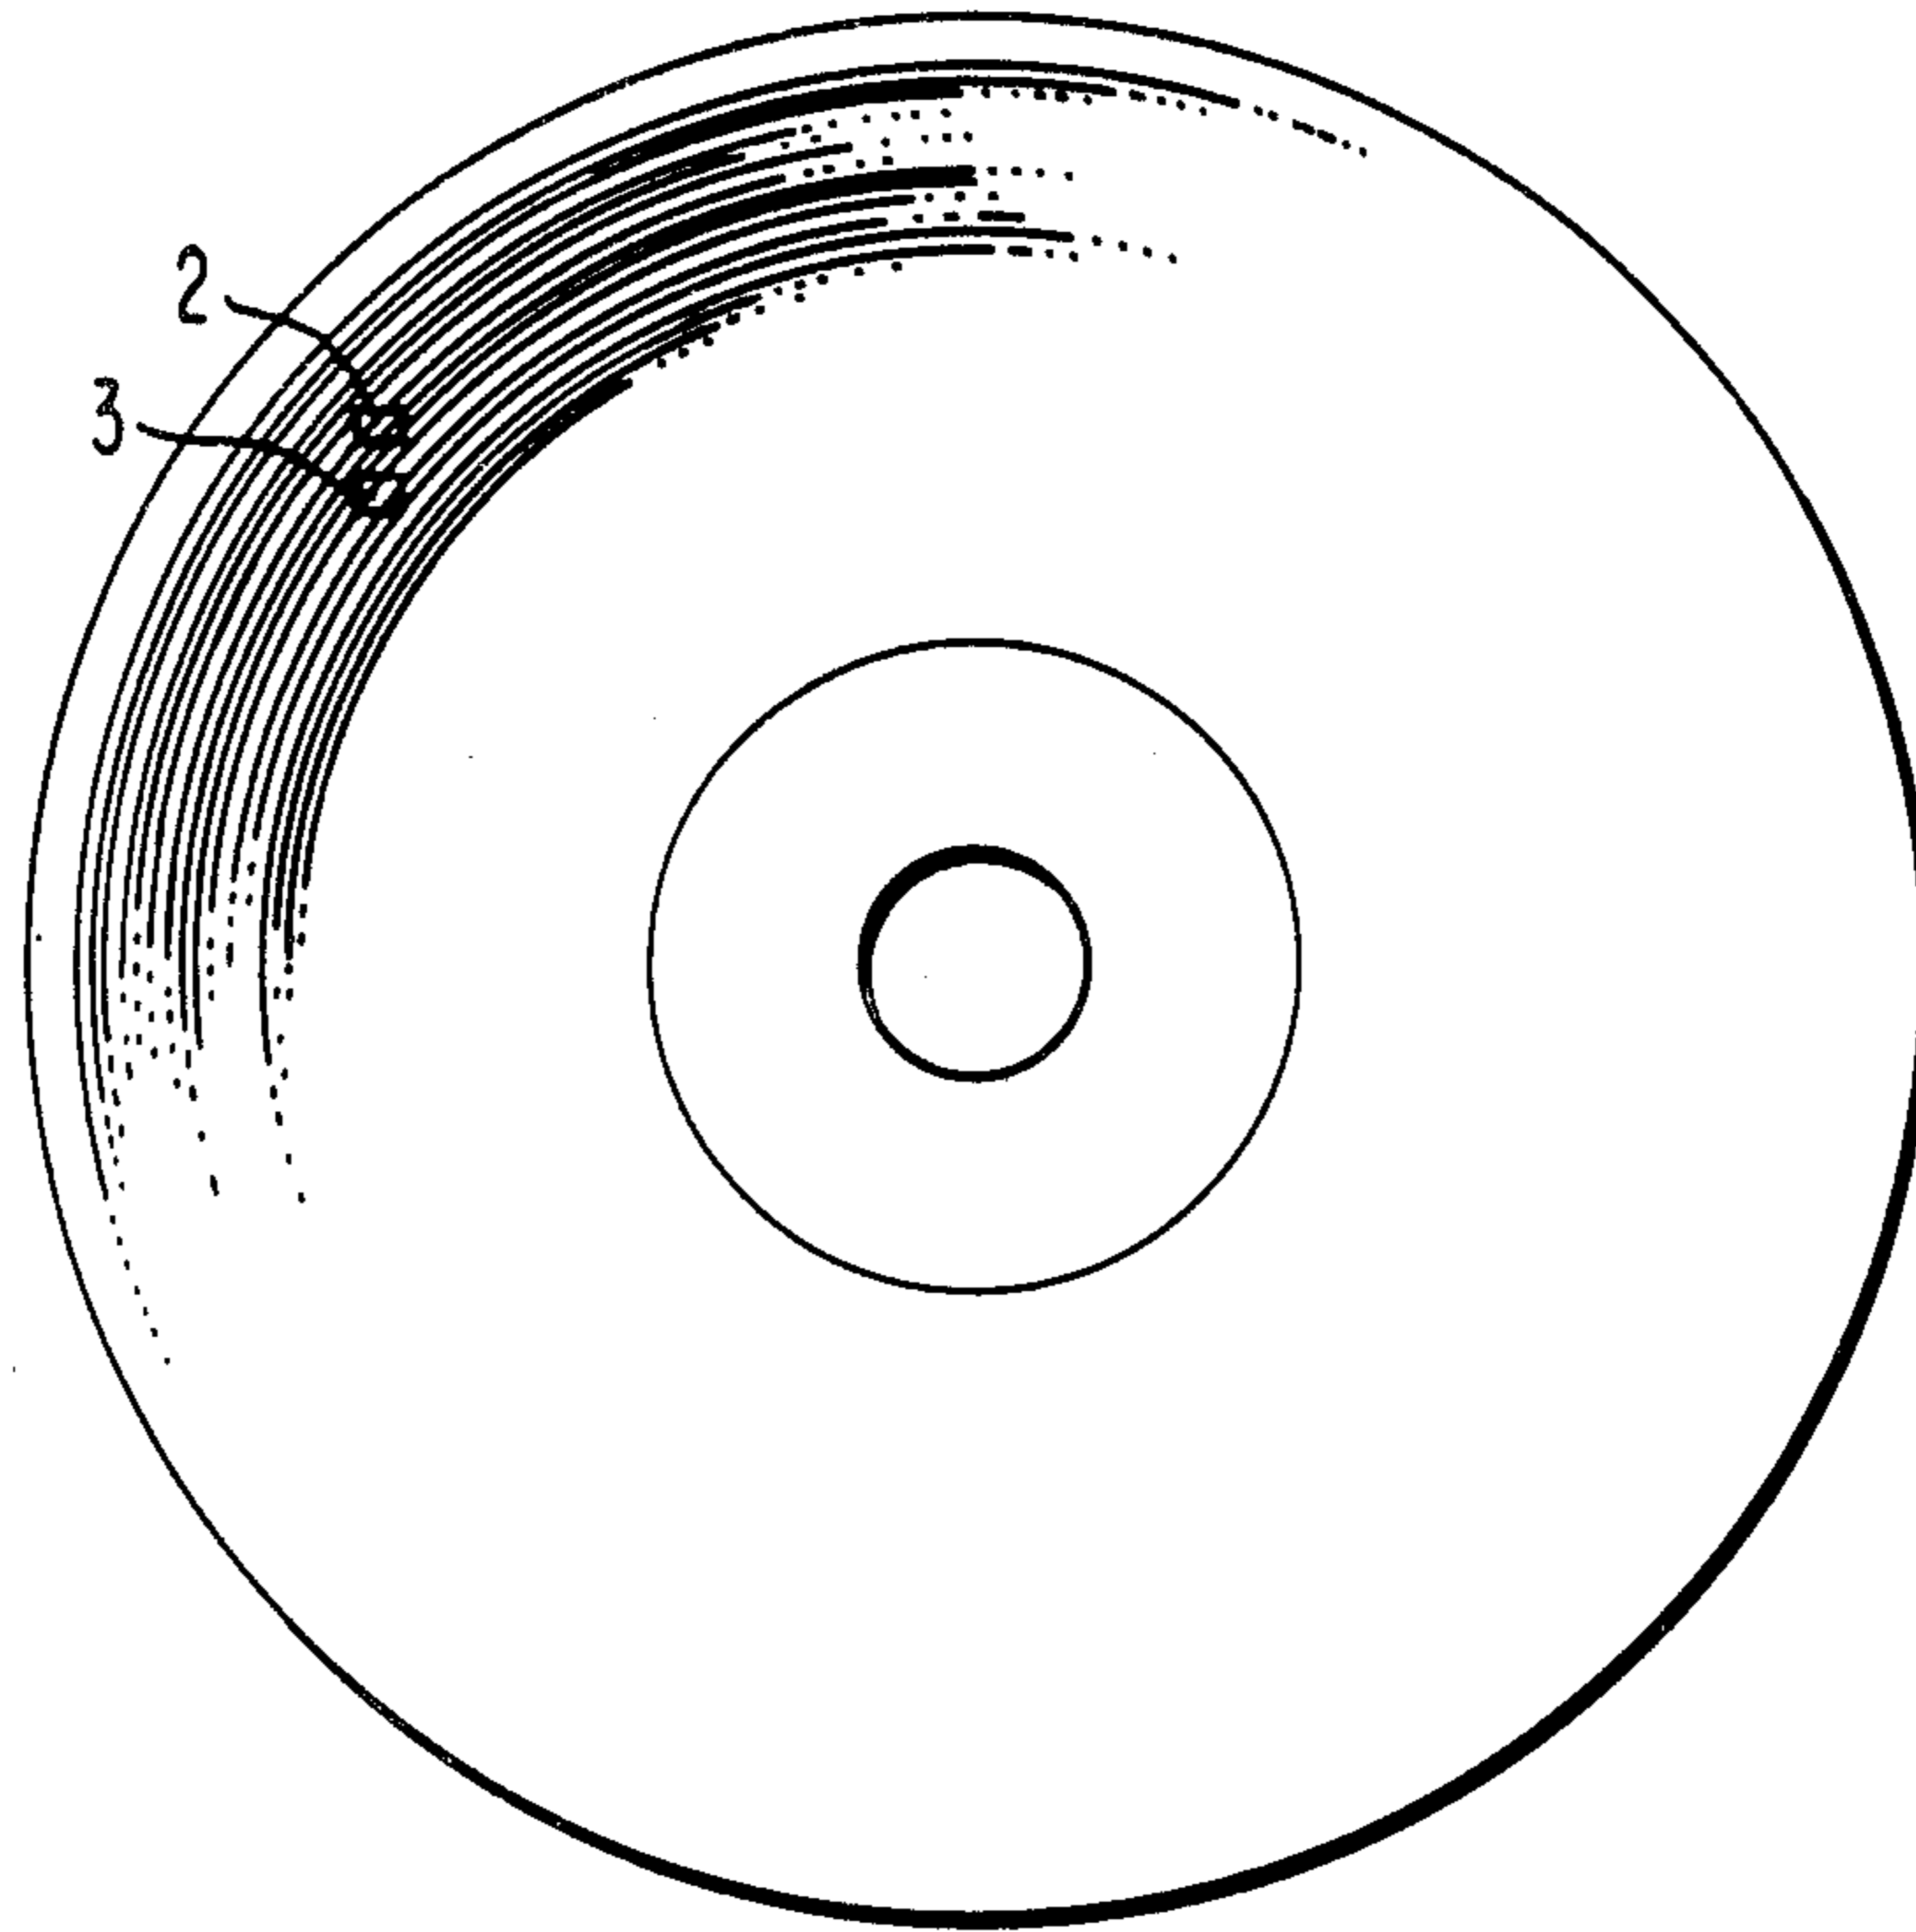
*Fig. 1*

FIG. 1 is a top plan view of a capacitive electronic disc stamper.

A number of sections were then cut from the stamper as indicated by the squares 2 and 3 on FIG. 1 for further testing and evaluation. Each section was examined and found to be virtually identical in appearance with regard to the presence of pinholes and microdefects. In FIG. 2 there is shown a 650× photomicrograph of the surface of a section as removed prior to treatment and which has been stained by silver deposition to more clearly show the presence of the pinholes and defects. The microdefects in the coating are seen as dark spots on the surface of the photomicrograph of FIG. 2.
