[54] METHOD FOR PROTECTING FORMING BUSHINGS

[73] Assignee: Owens-Corning Fiberglas Corporation, Toledo, Ohio

METHOD FOR PROTECTING FORMING BUSHINGS

This invention relates to a method for protecting forming bushings by applying a direct current bias.

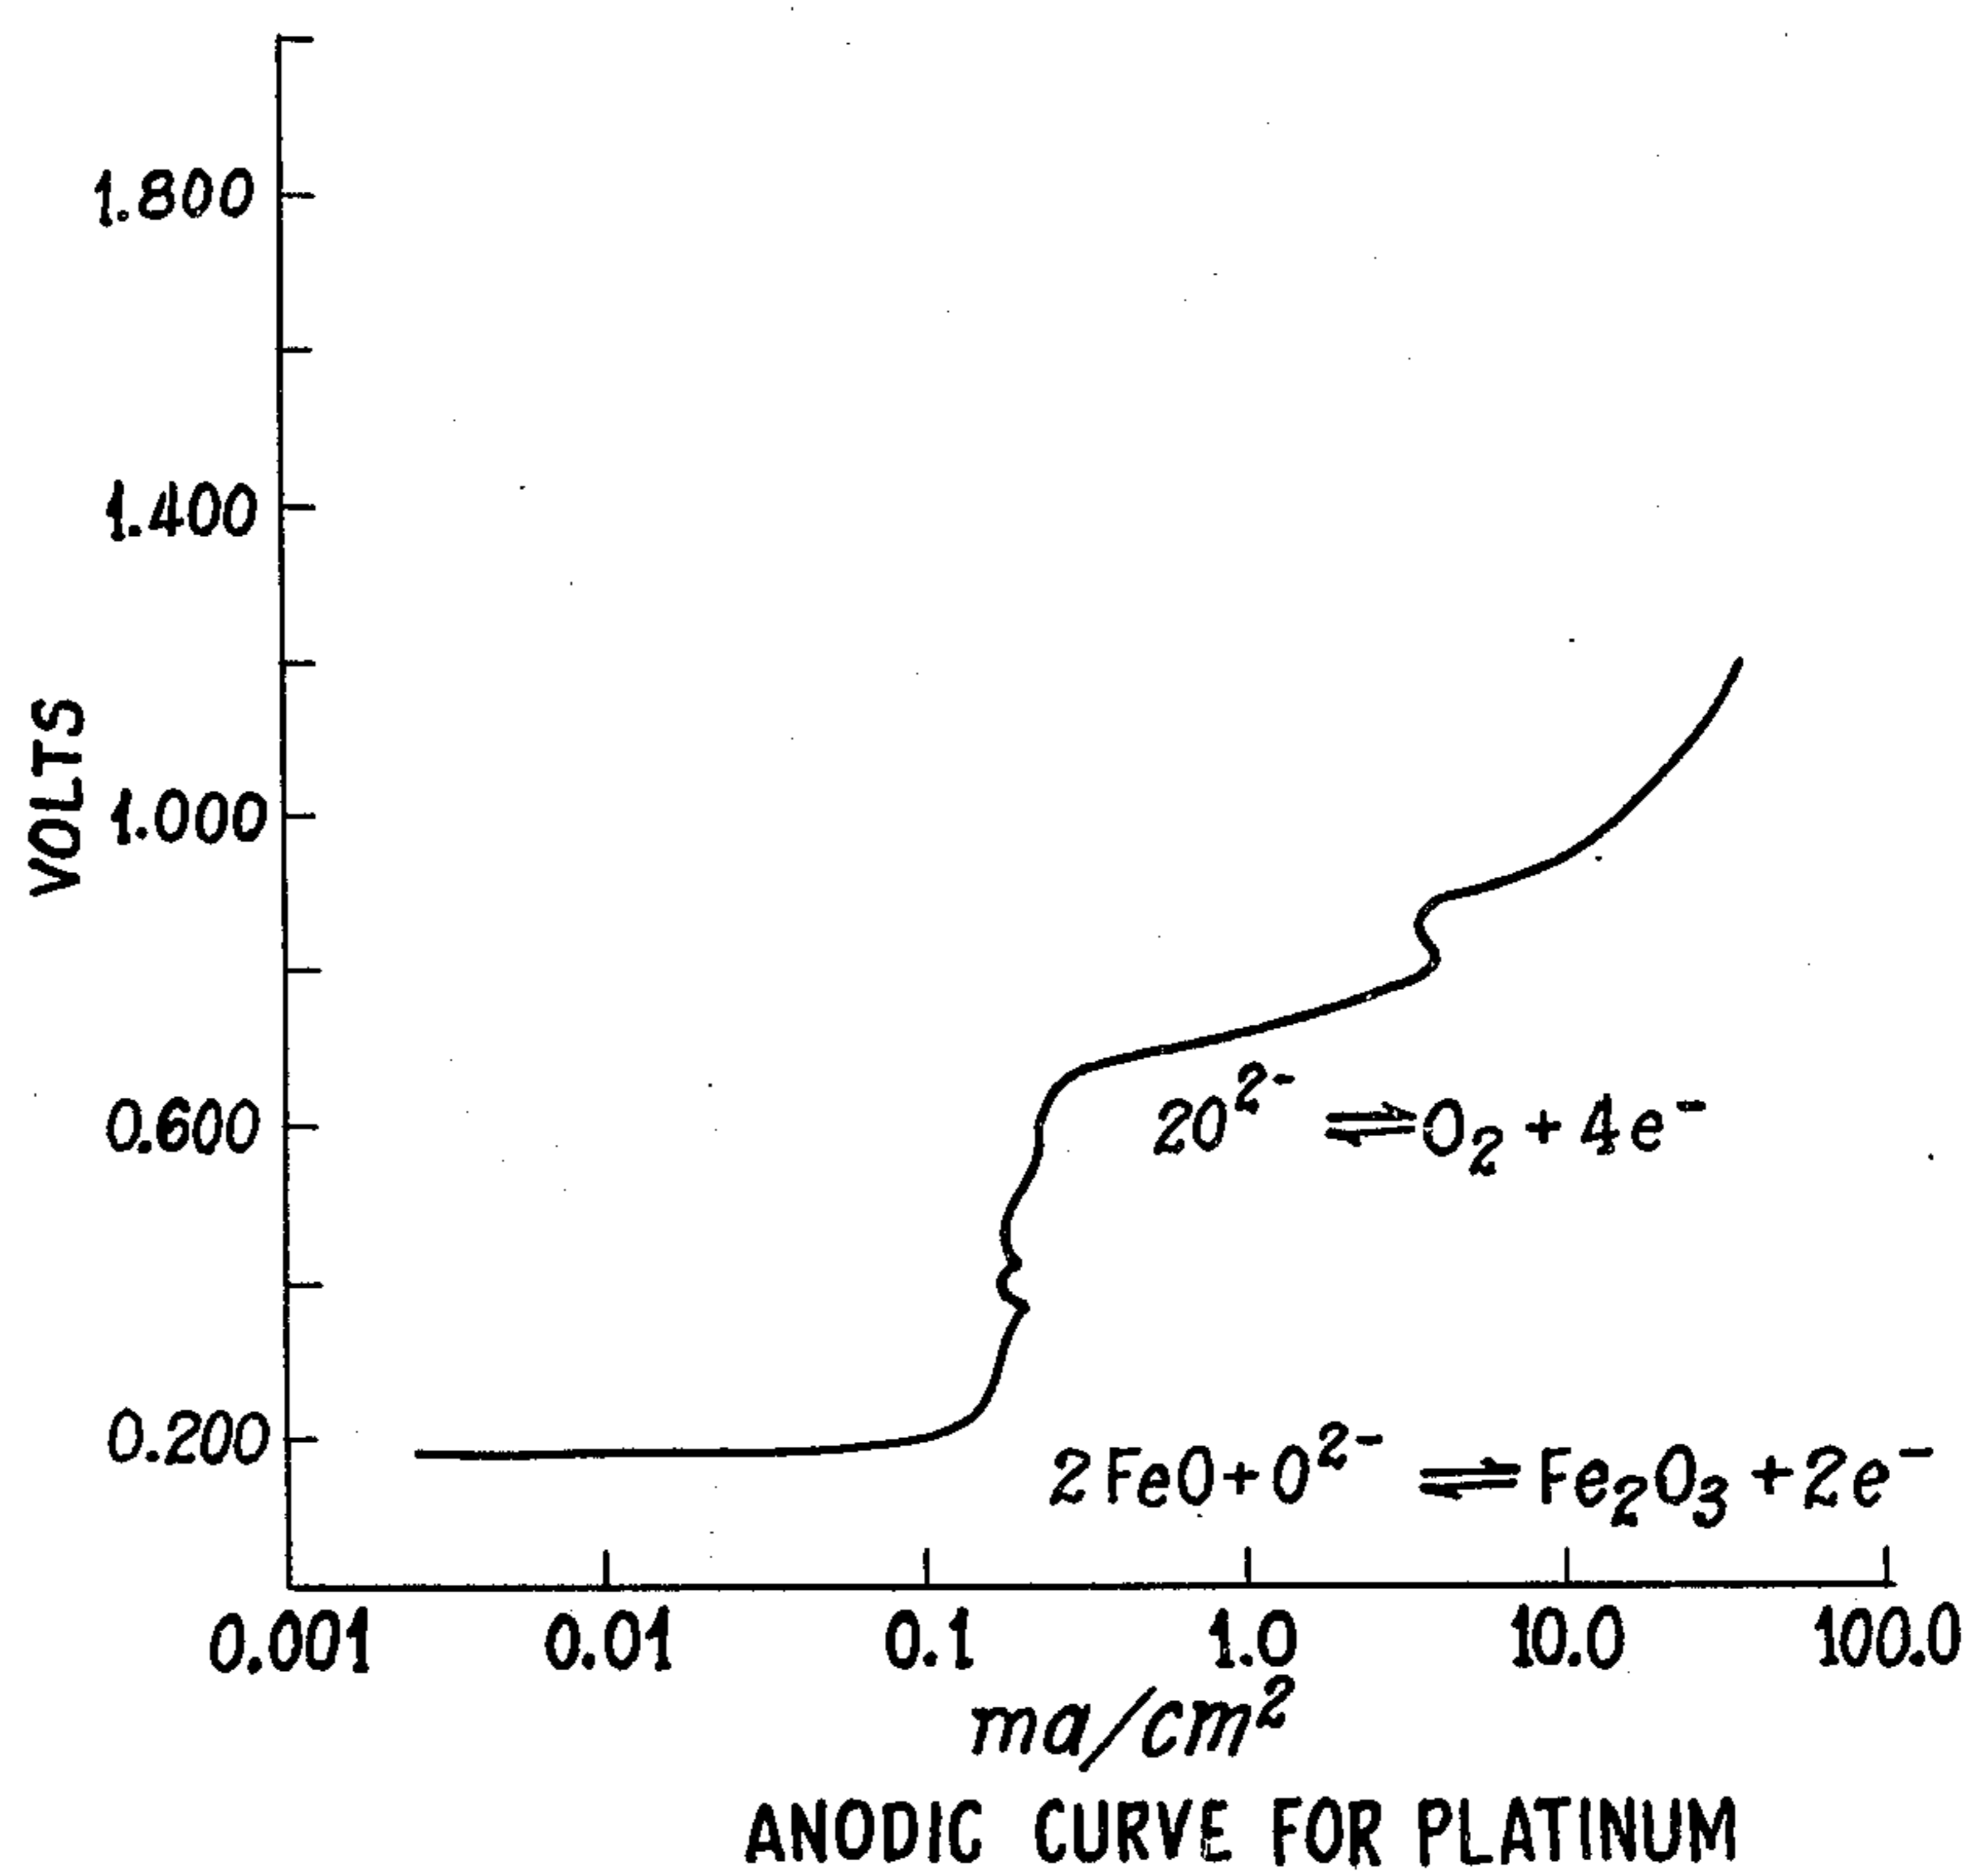
FIG. 1 is a graph of an anodic curve for platinum where voltage is plotted against current density.

FIGS. 1 and 2 show the onset of oxygen evolution at the anodic potentials and the reduction of silica at cathodic potentials. The bushing protection system was designed and operated to avoid these reactions. From the FIGURES, the optimum potential range in which platinum bushing should be maintained is from -0.6 v to $+0.2$ v versus a Pt/ O_2 reference electrode.

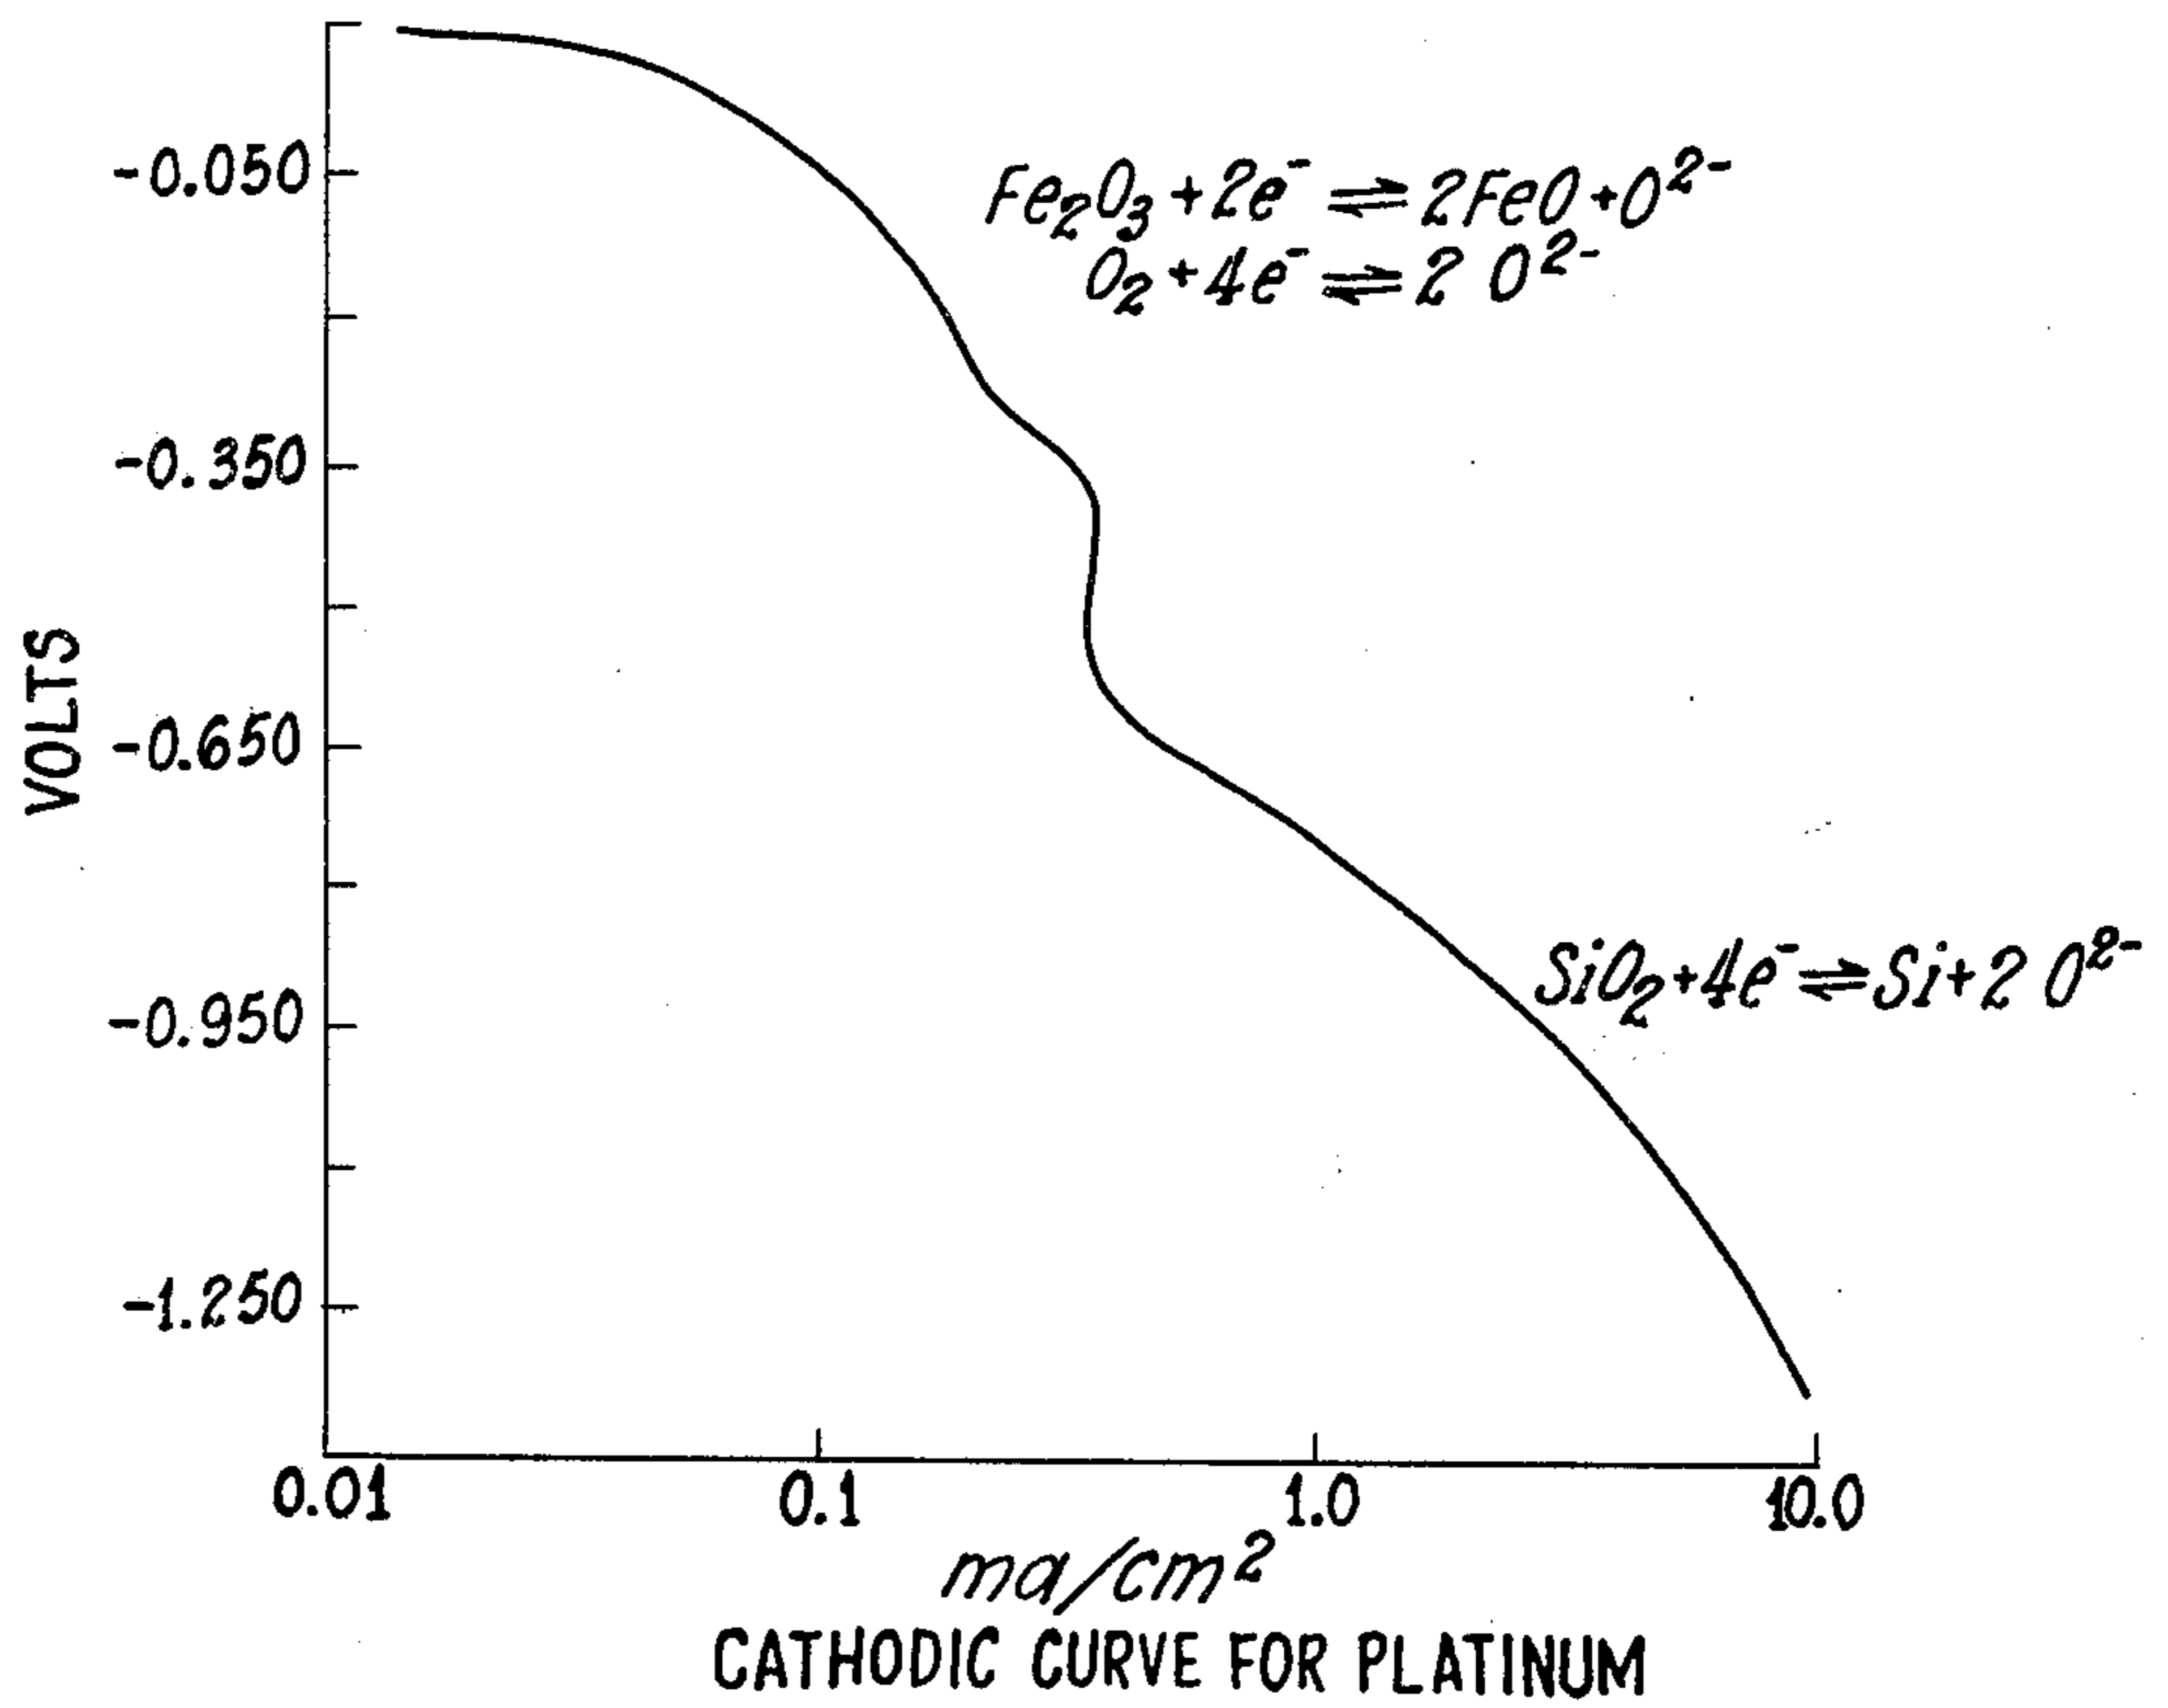
FIG. 2 is a graph of a cathodic curve for platinum where voltage is plotted against current density.

A major cause of cracking in alloy bushings is due to silicon contamination of the platinum. The silicon results from the disassociation of silica in the glass. This results when the alloy is cathodically biased as shown in FIG. 2. The disassociation of soda, if present, will proceed and cause the silica reduction. This cathodic attack can be caused by an accidental bias applied to the bushing or by a much more active metal coming in contact with the alloy.

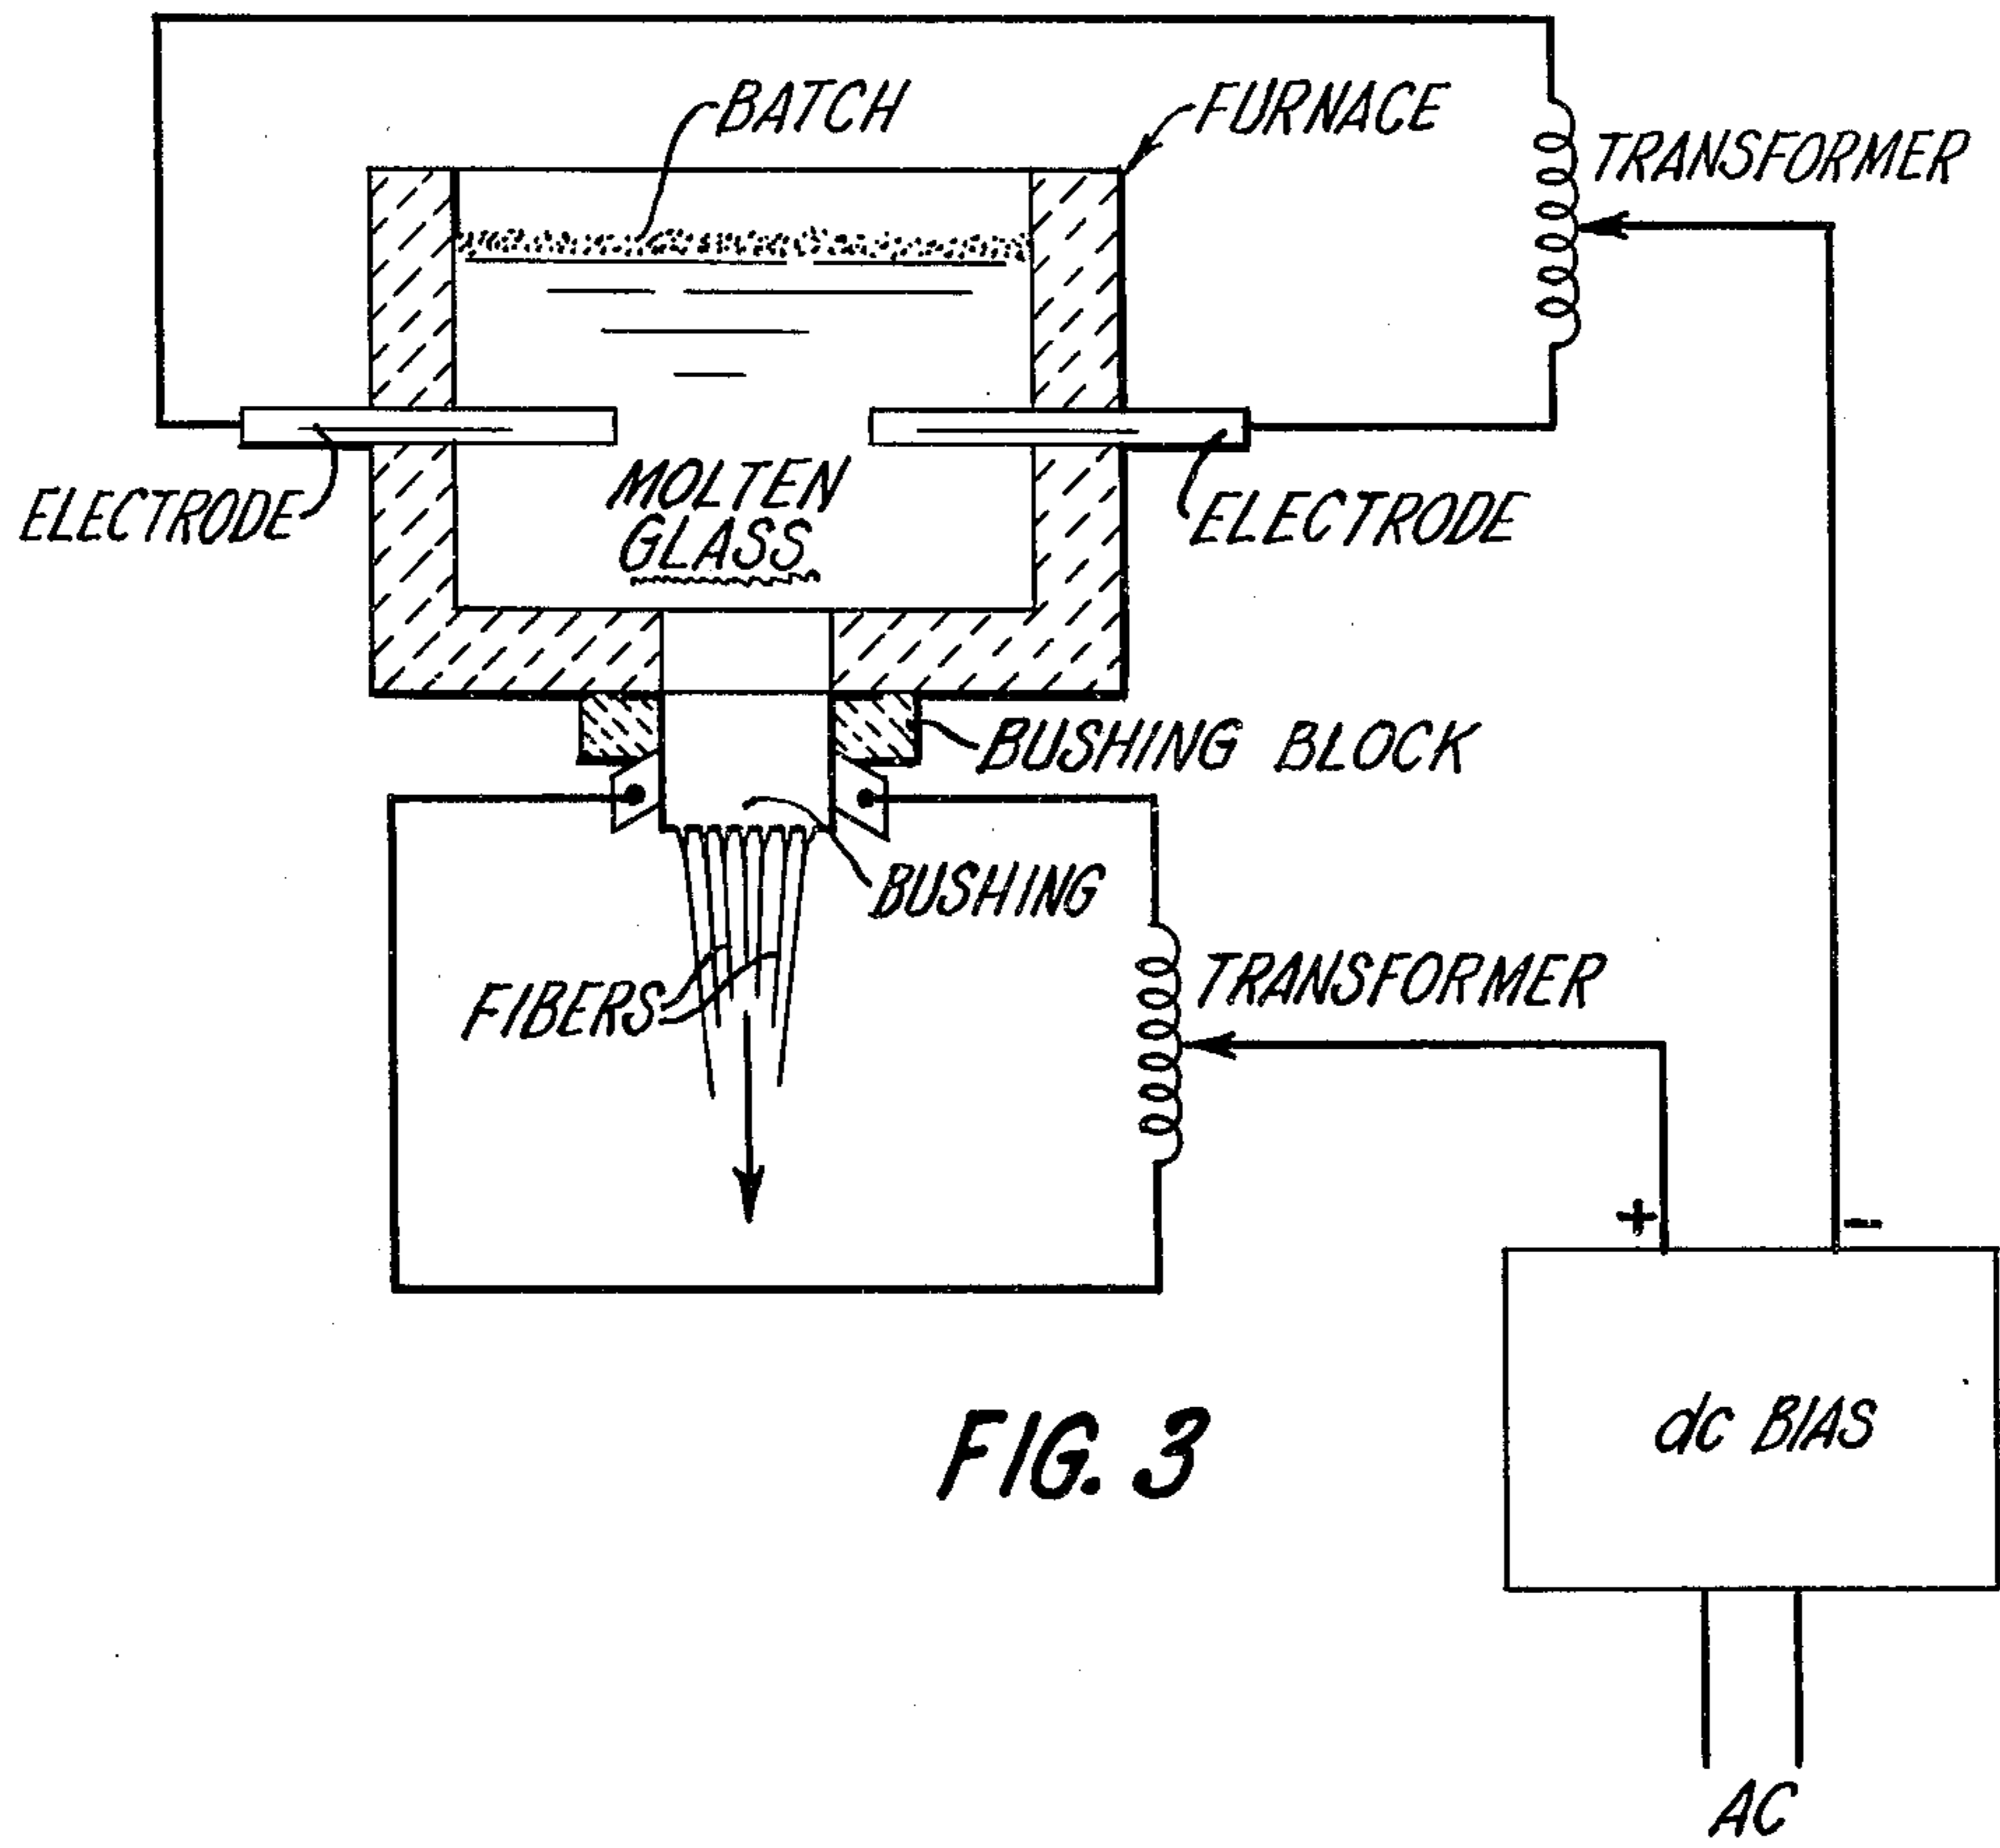
FIG. 3 shows an electric furnace with electrodes, a bushing and a schematic of the electric circuit employed in this invention.

An electric furnace in accordance with this invention was hung in position beneath a batch feed system. Four electrodes were employed in the melter. They extended through sidewalls and were arranged as pairs of opposed, parallel electrodes. The electrodes were standard molybdenum electrodes. A production platinum bushing was installed below the melter with a refractory bushing block in place. The molten material was heated by joule effect by applying electrical current to the electrodes to flow between them through the molten material. The bushing was heated by resistive heating.
