[54] **METHOD OF SEALING GLASS FURNACES TO PREVENT AIR LEAKAGE**

[75] **Inventor:** Ray S. Richards, Sylvania, Ohio

[73] **Assignee:** Owens-Illinois, Inc., Toledo, Ohio

[57] **ABSTRACT**

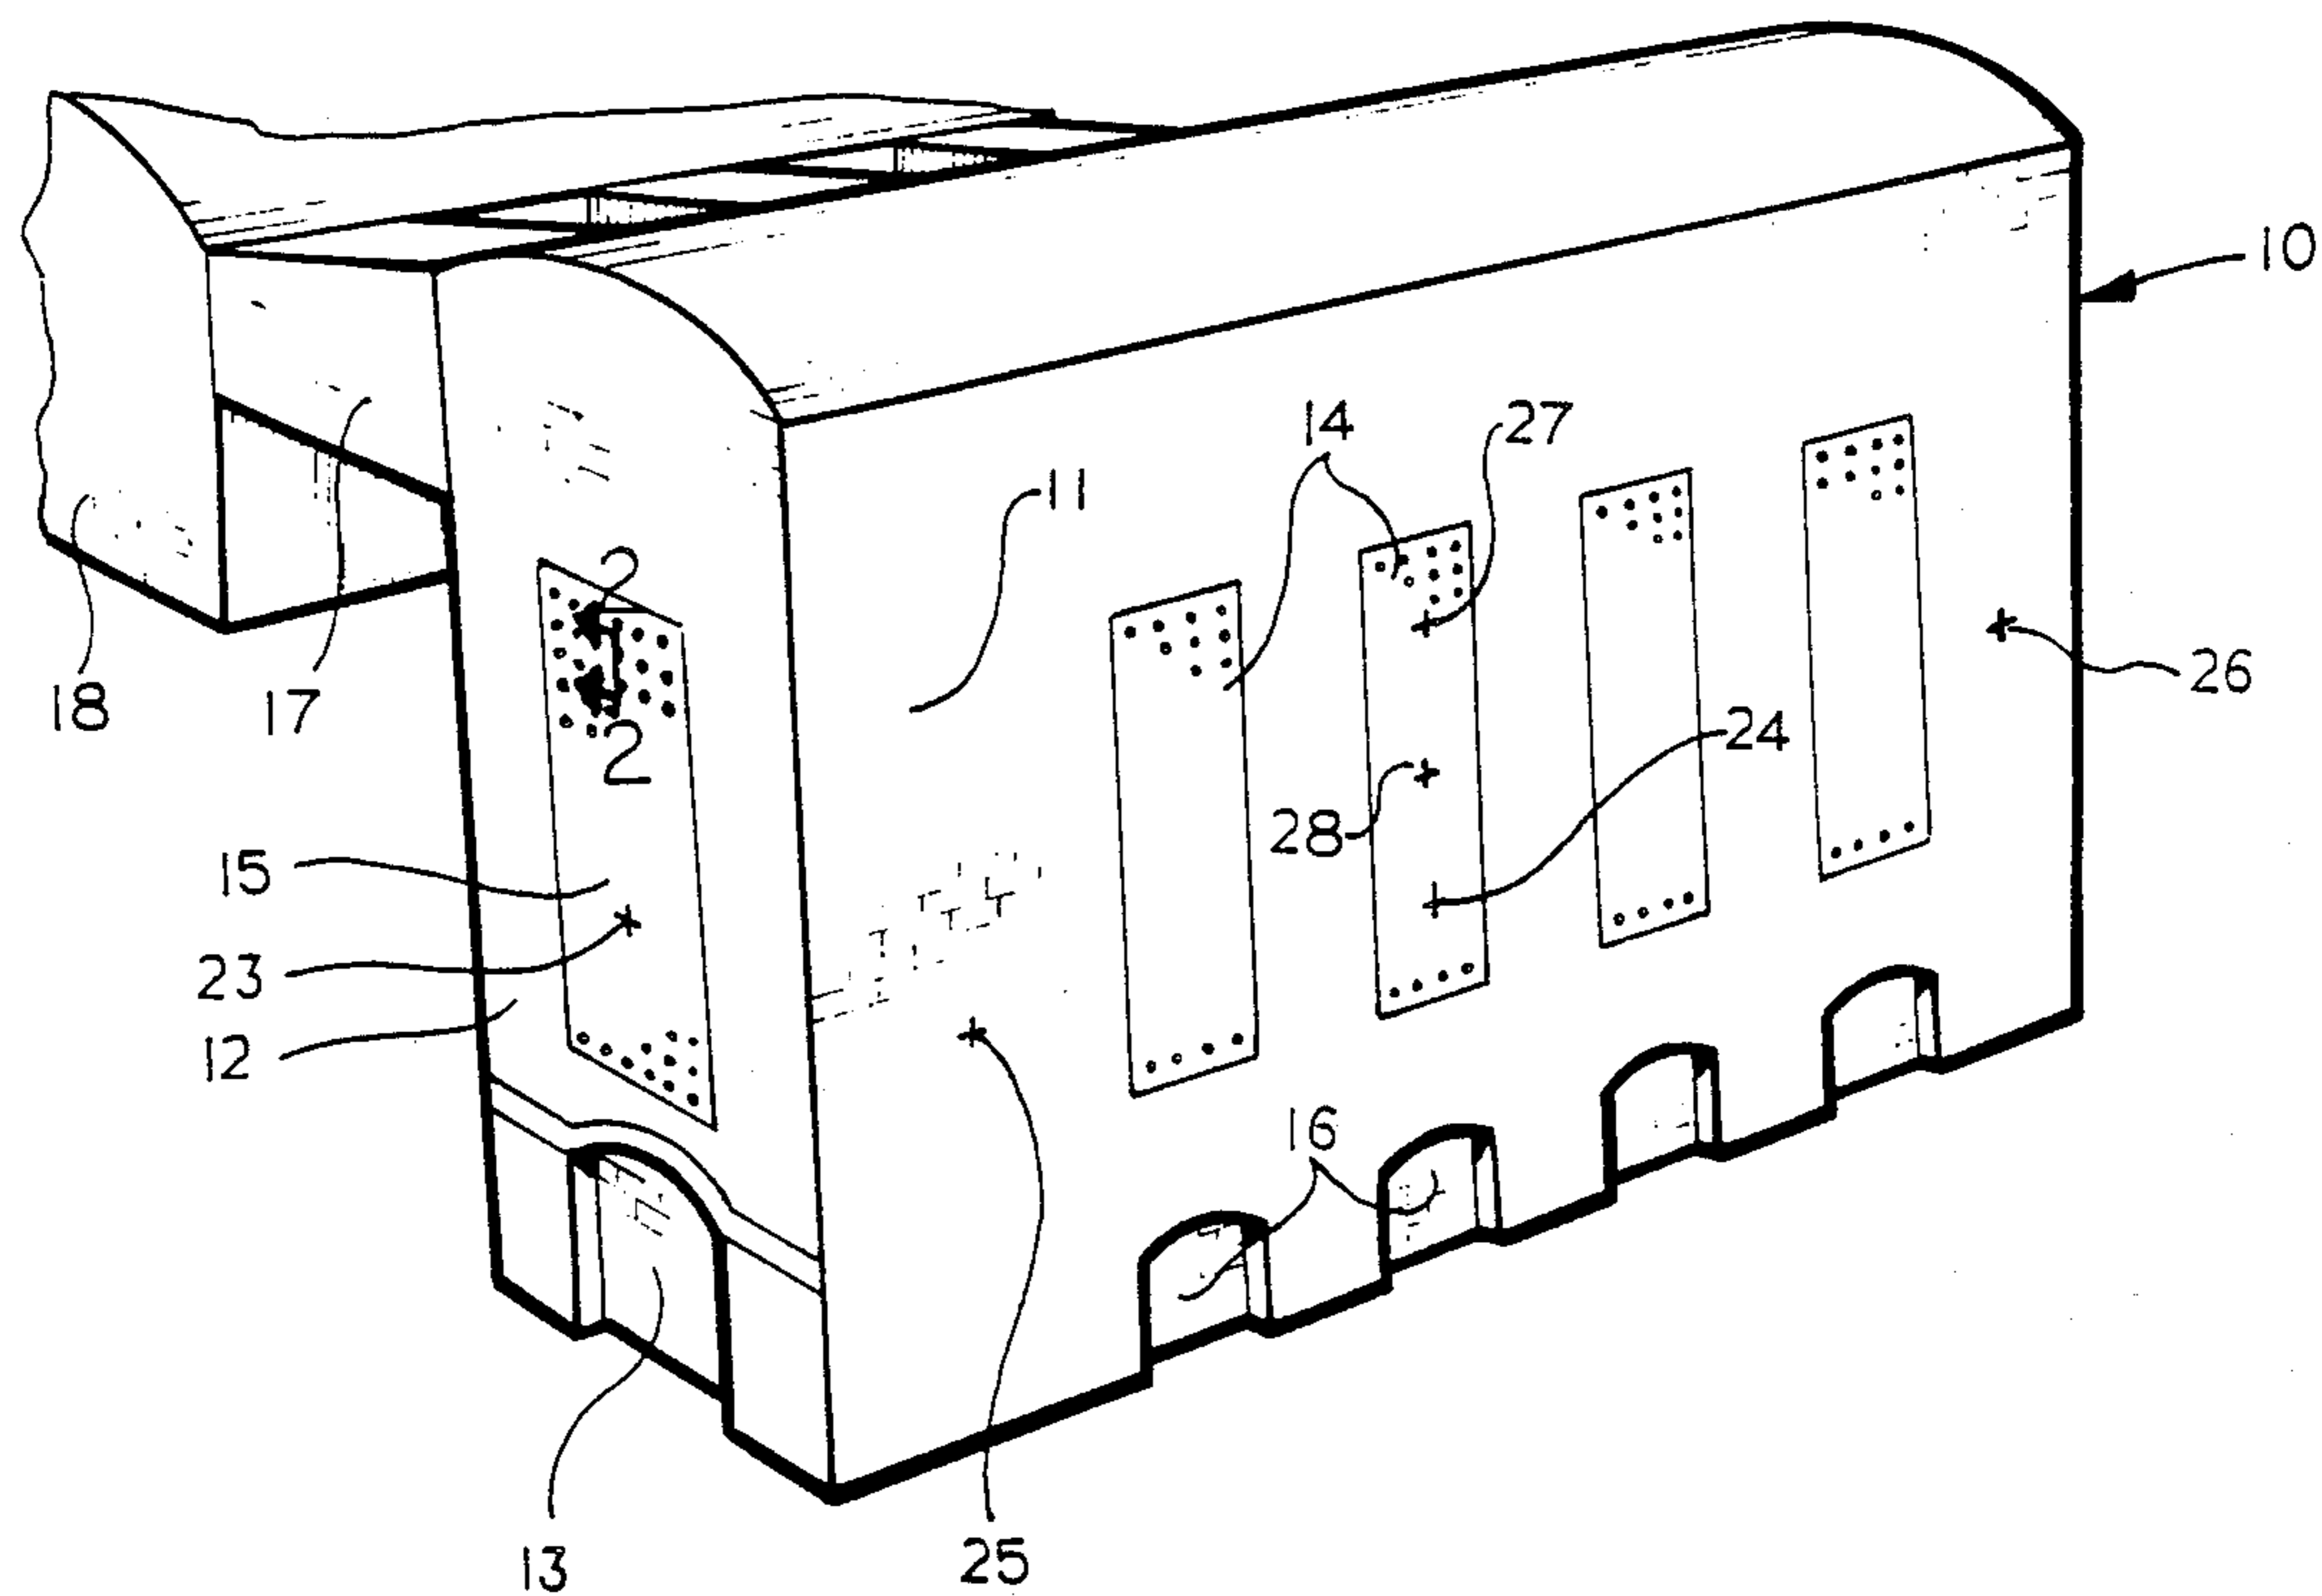
FIG. 1 is a perspective view of a typical side port regenerator of a glass melting furnace; and

As viewed in FIG. 1, the regenerator 10 is composed of a brick side wall 11 and an end wall 12. Opening into the end wall 12 is a lower canal 13, which will extend along the full length of the regenerator 10. The canal 13, or port actually, extends only beneath the area at the end of the furnace. The side wall of the regenerator, as shown in FIG. 1, is provided with a series of four cleanout panels 14. Similarly, the end wall 12 is provided with a cleanout panel 15. Beneath each of the side wall cleanout panels 14 is a comparably sized cleanout canal 16. Air from the blower (not shown) is fed upwardly from beneath through the interior of the regenerator 10, it being understood the regenerator 10 is a brick walled structure having a plurality of heat-absorbing checkerwork brick configurations internally thereof such that the air being introduced from below will pick up heat and become preheated at the time it arrives at the upper, domed area of the regenerator. In this domed area, the regenerator is formed with a plenum chamber (not shown) and the plenum chamber communicates through a plurality of ports which open through archways 17, which in turn are open to the upper interior of the glass melter 18 at spaced burner ports.

It should be understood that while a single regenerator 10 is shown in FIG. 1, an essentially identical regenerator will be positioned on the opposite side of the furnace 18, and when the incoming air is passing through the regenerator 10 and being preheated thereby, hot combustion products are exhausting through the burner ports on the opposite side of the furnace into a regenerator position on the opposite side. On the reverse cycle, the regenerator 10 will be receiving the hot exhaust gases from the melter 18 through the archways 17 into the upper end thereof and the hot exhaust then passes downward through the checkerworks contained within the regenerator and then out from the bottom thereof, through a canal which connects to a reversing valve, and the reversing valve is connected by a tunnel to a stack. Each of the cleanout panels 14 or 15, as shown in detail in FIG. 2, is in the form of an opening extending through the thickness of the regenerator wall. The inner end of the opening 19 opens into the interior 21, which in effect is the checkerwork zone within the regenerator 10. The opposite end of the opening 19 is closed by a tapered block 22. The block is sealed in the opening by mortar but the block is usually made of a permeable refractory brick and the wall section surrounding the block is also permeable. In

As an example, Applicant, on a regenerator of the type shown in FIG. 1, made measurements of air flow through the wall of the end cleanout panel at position 23, as shown in the cleanout panel 15. The flow rate at this point through the wall of the cleanout panel was found to be 415 standard cubic feet per hour (SCFH) per square foot, with an internal pressure of -0.35 inches of water. After this location 23 and the area therearound was covered with the rubber-like silicone coating of one application, it was found that the flow rate had been reduced to approximately 240 SCFH, and after a second application of the silicone coating, the flow was further reduced to approximately 115 SCFH. A third coating was applied and this reduced the flow to about 75 SCFH. At a location 24 in the panel 14, it was found that there was a flow of over 460 SCFH. After the application of a first coating of the silicone elastomer, the flow rate was reduced to about 230 SCFH. With a second coat applied, the flow rate was reduced to 110 SCFH, and after a third coat, the flow rate was about 40 SCFH. These readings were taken where the internal pressure was -0.31 inches of water. Several other locations were measured, for example, the location 25 between the first side cleanout panel and the end of the regenerator was found to be an area of high differential pressure, but there was no apparent air leakage. A similar result was found to occur at a location 26 between the last panel 14 in the side wall and the other end wall of the regenerator. The location 27 in the upper portion of the second cleanout panel experienced an extremely low differential pressure of less than 0.01 inches of water and a leakage rate of about 3 SCFH per square foot.

A location 28, intermediate the locations 24 and 26, had a measured leakage rate of 5 SCFH per square foot. After one application of silicone elastomer, there appeared to be no leakage. High leakage areas were encountered in cleanout panel areas and were accompanied by high differential pressure.

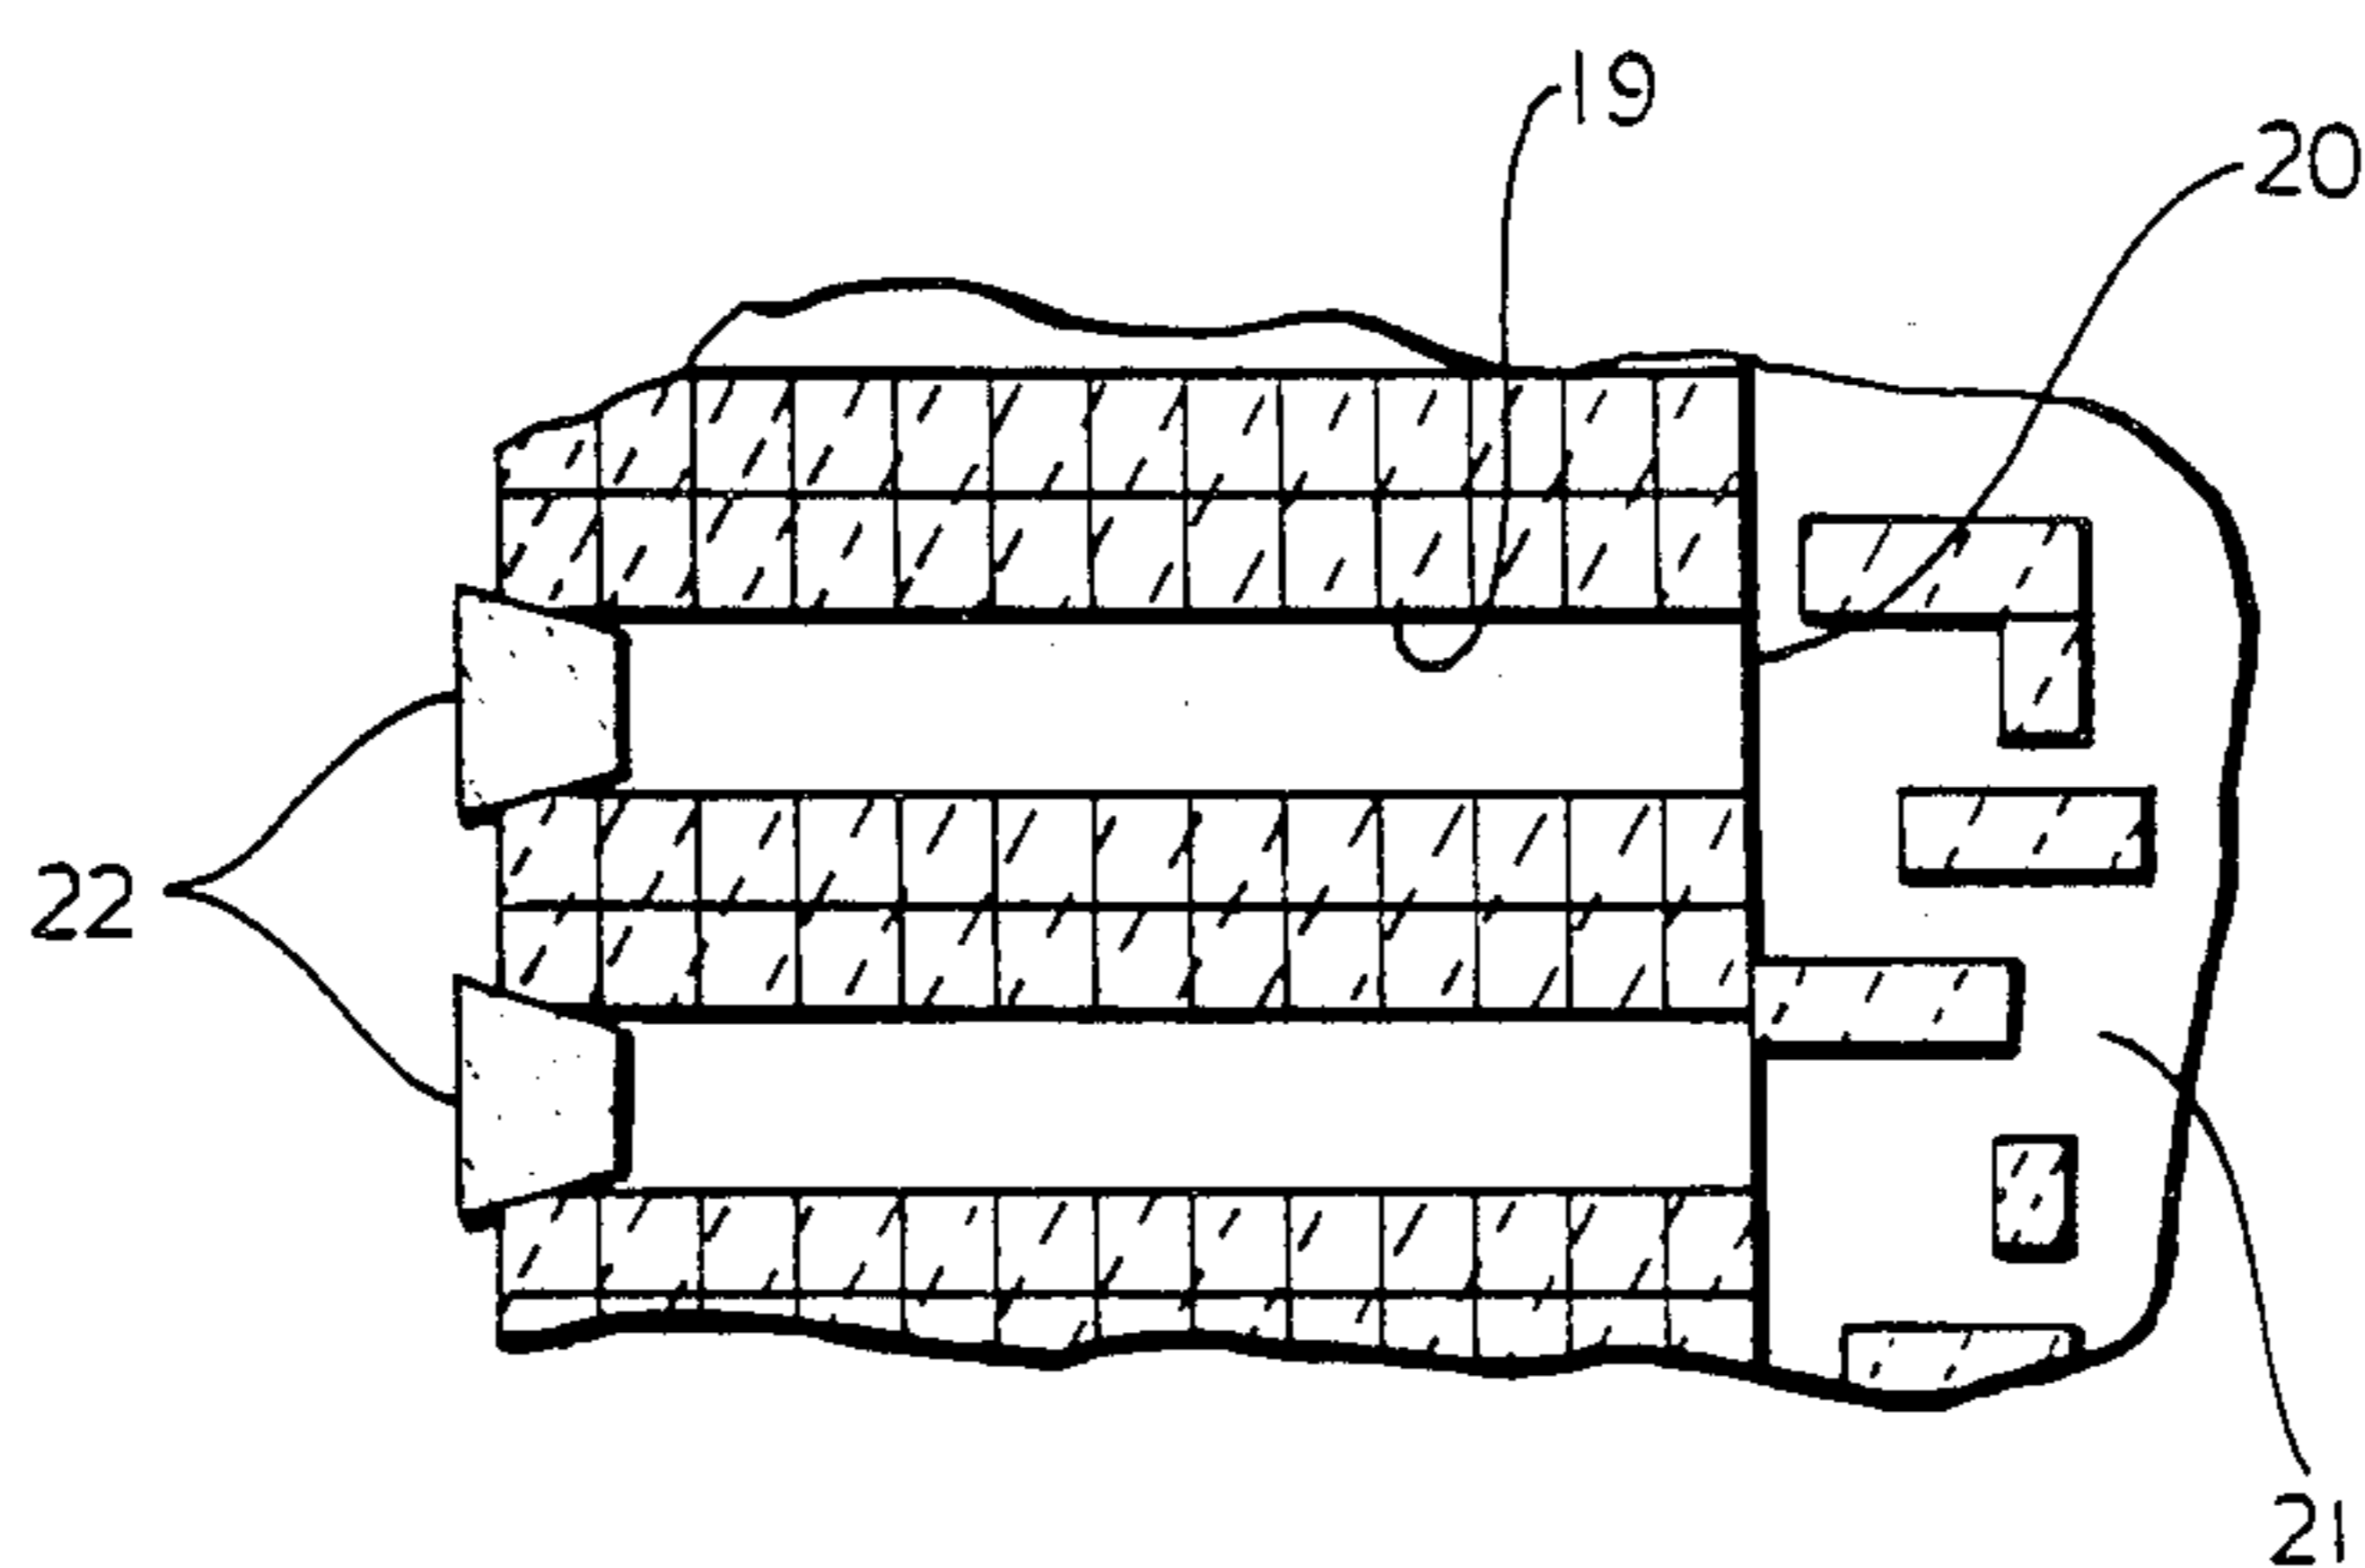
FIG. 2 is a sectional view, on an enlarged scale, taken at line 3—3 of FIG. 1.

actual practice, these blocks may be approximately 4½ inches square in the outside, cross-sectional dimension and then tapered down to a somewhat smaller inner dimension. These blocks 22 may be typically 5 inches long. Each of the openings 19 in effect constitutes a cleanout port and the tapered blocks 22 may be removed either individually or as groups, and once removed, air lances will be inserted through the ports 19 and air under pressure blown around within the interior of the checkerworks to loosen and in effect shake down the accumulated particles within the checkerworks so that they may settle down toward the bottom of the areas beneath the cleanout panels. This cleaning operation is repeated a number of times until it becomes apparent that a significant portion of the checkerworks have become clogged or filled with particles of combustion and some batch particles, at which time the regenerator will be put out of service for a major cleanout. During cleanout, the lower chambers 13 and 16 may be entered, and the accumulated debris which has been permitted to fall down into these areas will be removed. Also, the ports 19 provide viewing access to portions of the interior checkerworks so that it may be observed as to the condition of the checkers, and also it is possible to become aware of significant structural failures that might be occurring within the interior of the checkerworks. Furthermore, since the regenerator is a generally ceramic brick structure which is alternately subjected to heating and cooling cycles, typically of 20 to 30 minute reversal intervals, the walls thereof may become cracked due to the expansion and contraction created by the temperature cycling. Furthermore, as might be expected, on the exhaust cycle there will be a pressure drop created between the outside and the interior of the checkerworks, which pressure drop will set up the movement of hot gases out of the checkerwork, and consequently cold air leakage into the exhaust regenerator. This dilution of the exhaust gases by colder air lowers the temperature of the exhaust gases and thus lowers the efficiency of the regenerator. Further, on the reverse cycle, the flow of ambient air to be preheated within the checkers will not obtain as high a temperature. Further, due to the pressure differential, if there are cracks in the walls, the ambient air will infiltrate the interior of the checkerworks. This infiltration of air and movement of air through the walls of the regenerator into the checkerworks is a disrupting influence to the normal heat balance operation of the melter or furnace. In this light, Applicant has found that by providing an exterior sealing coating over the entire external surface of the regenerator, and in particular a continuous coating over those exterior surfaces of the cleanout panels, a significant reduction in the passage of air through the walls of the regenerator is effected.
