[54] MAGNETIC INSPECTION OF REINFORCING STEEL USING SENSOR ARRAY

[73] Assignee: The United States of America as represented by the Secretary of Transportation, Washington, D.C.

[57] ABSTRACT

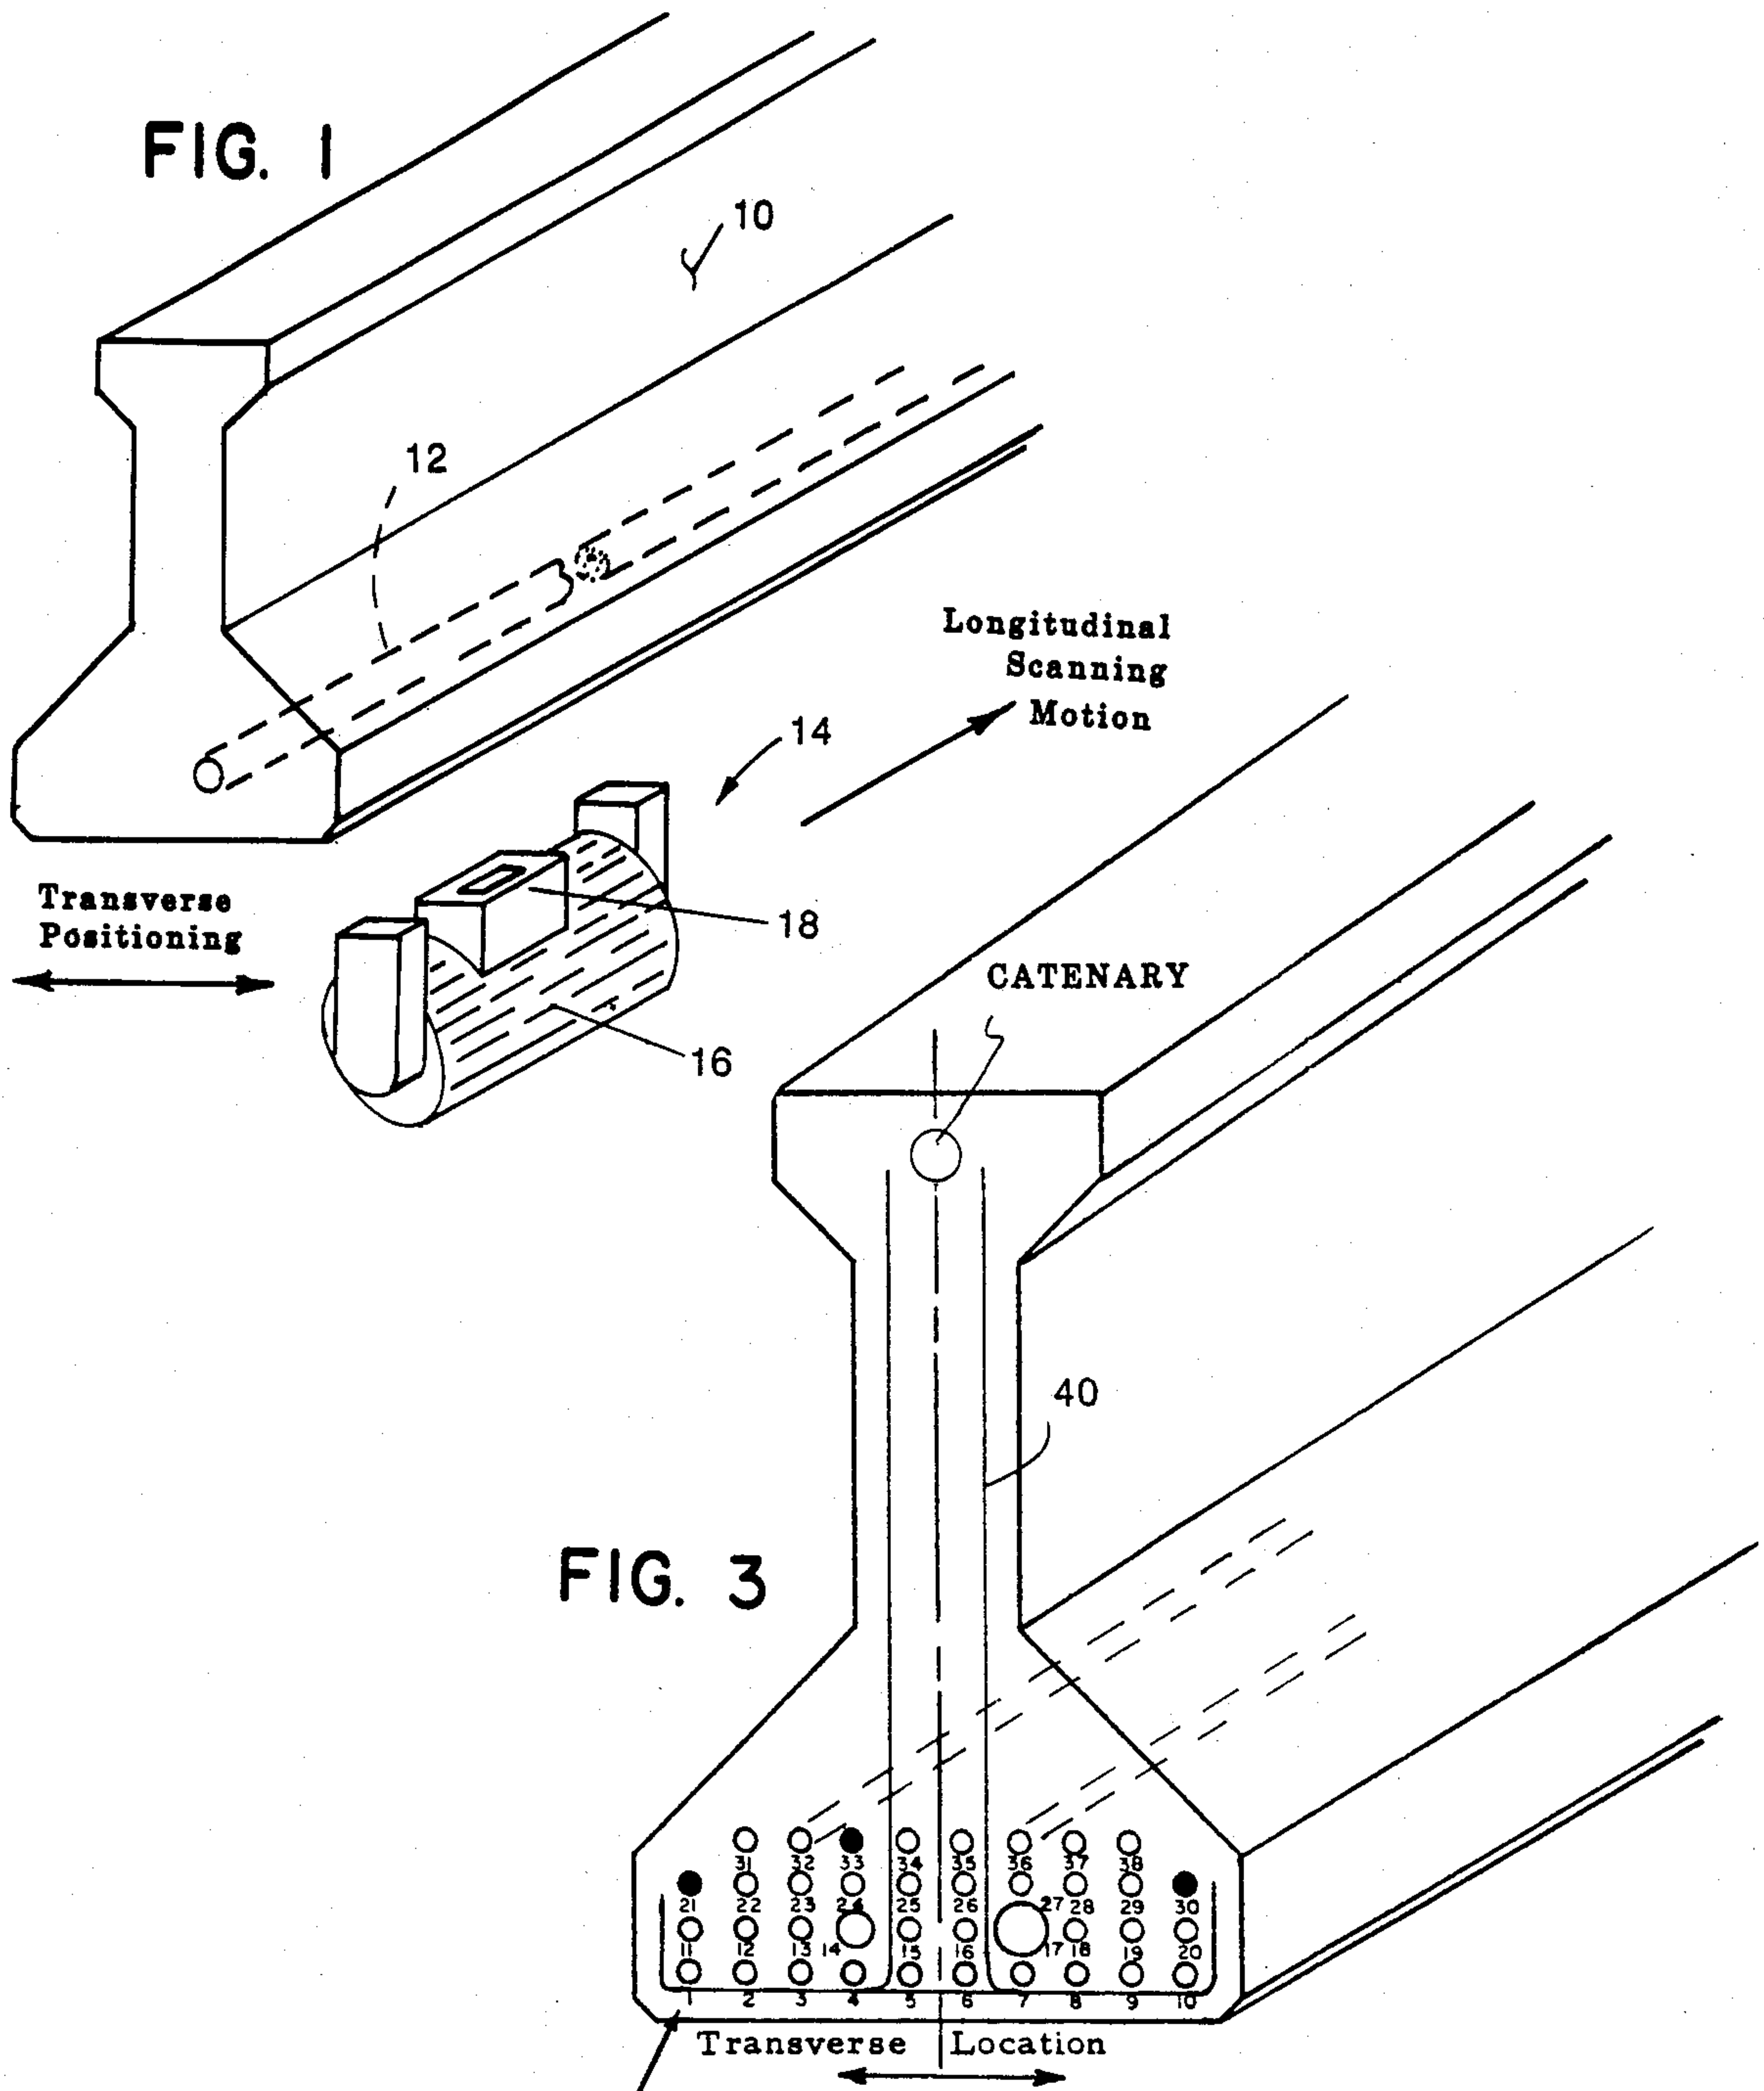
FIG. 2 shows the cart and sensor assemblies.

Cart 20 as shown in FIG. 2 comprises body 22 mounted on wheels 24 which are driven by longitudinal drive system 26. Within body 22 is magnet platform 28 which is mounted on guide rods 30; magnet platform 28 is moved transversely of body 22 on guide rods 30 by transverse drive system 32. Cart 20 must be made wide enough to allow electromagnet/sensor assembly 14 to be placed beneath the reinforcing members near the sides of the beam (members 1 and 10 in FIG. 3) in order to inspect all of the members. When the system is to be used to inspect a beam, electromagnet/sensor assembly 14 is mounted on magnet platform 28 and hooked up to the electrical system by connectors 34 and 36.

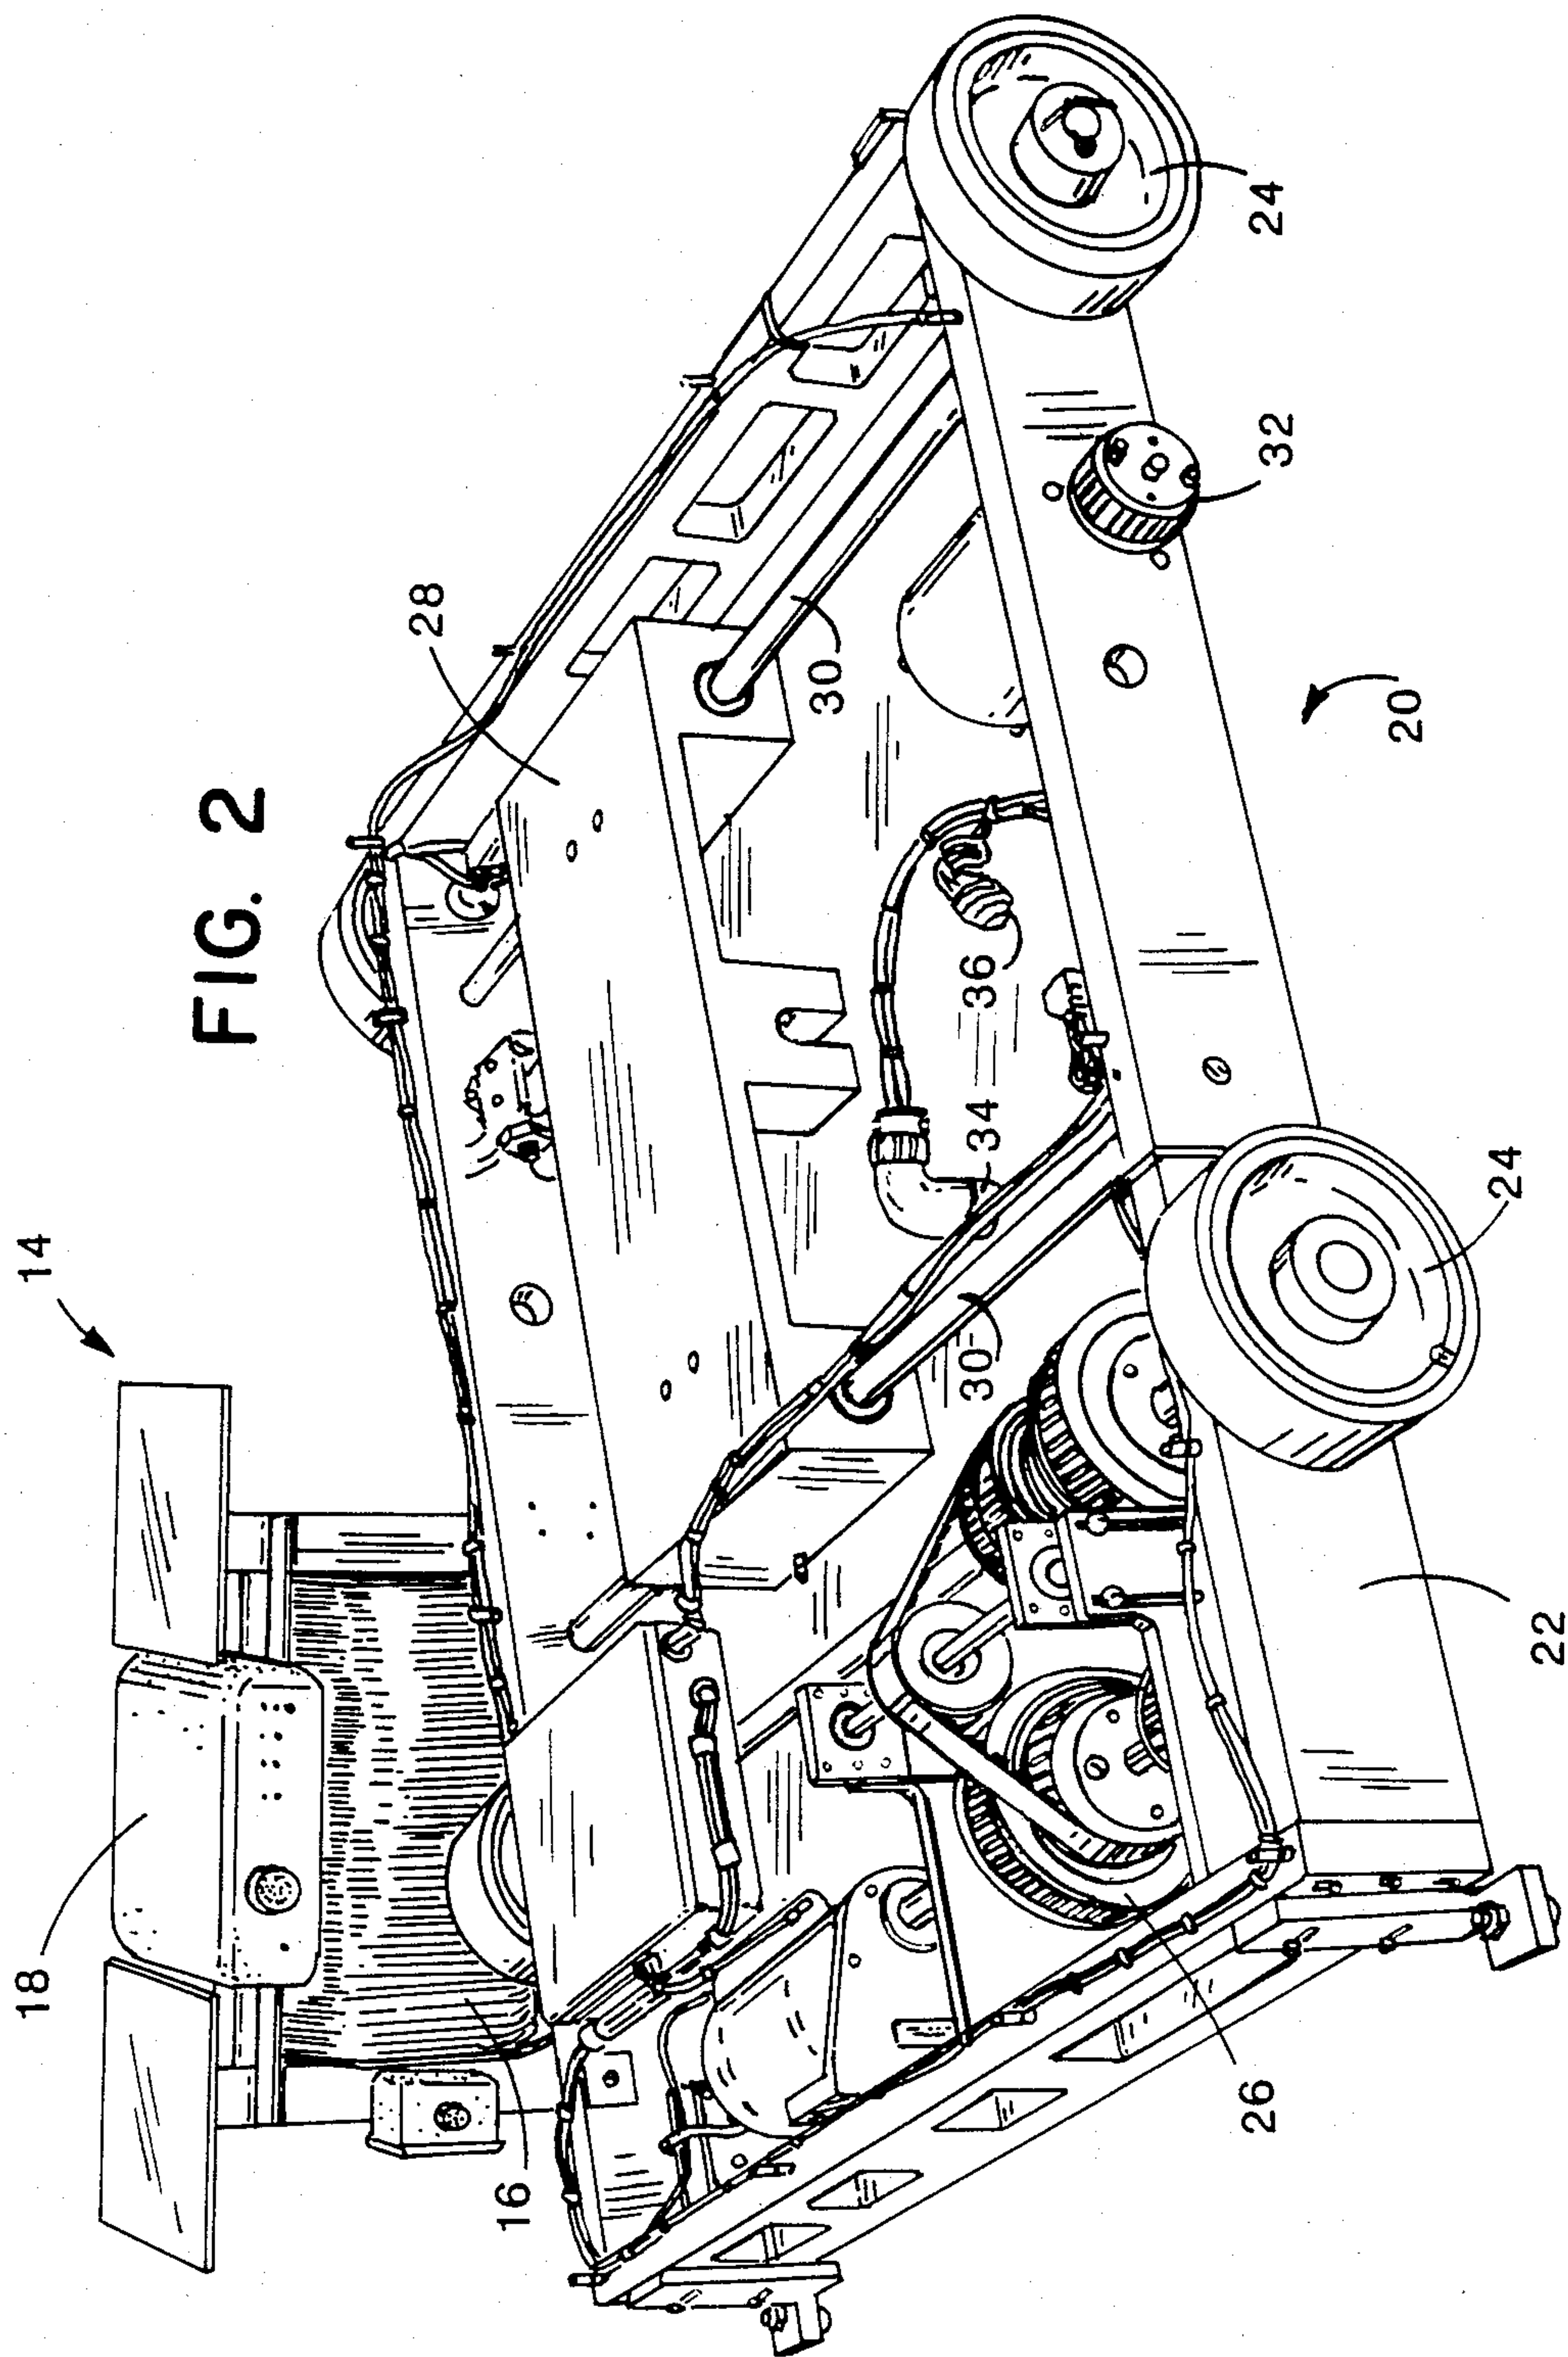
- Strand or Bar Location
- #21 and #30 pretensioned strands are permanently bonded for dead load strength
 - #33 Strand is not removable
 - #14 Duct 1-5/8 in. flexible
 - #17 Duct 2-3/8 in. rigid
 - Remainder 9/16 ID PVC Tubing
 - Catenary Duct 2 3/8 in. Rigid

FIG. 3 shows the location of the reinforcing members in the test beam.

FIG. 3 shows the distribution of reinforcing members (rods or strands) within the test beam, which is a Texas Type "C" beam. There are 38 longitudinal members as well as stirrups 40 which are used to reinforce the web of the beam; there are many such stirrups along the length of the beam, but only one is shown. Of the longitudinal members, numbers 21, 30, and 33 are permanently bonded into the beam; number 14 is a $1\frac{5}{8}$ inch diameter flexible steel duct, number 17 is a $2\frac{3}{8}$ inch diameter rigid steel duct, and the rest are $9/16$ inch inside diameter rigid PVC tubing. During testing a reinforcing member of known configuration (rod or strand, flawed or non-flawed) is put into one of these tubes or ducts and a magnetic "signature" of that member is recorded on a conventional strip chart recorder (not shown).

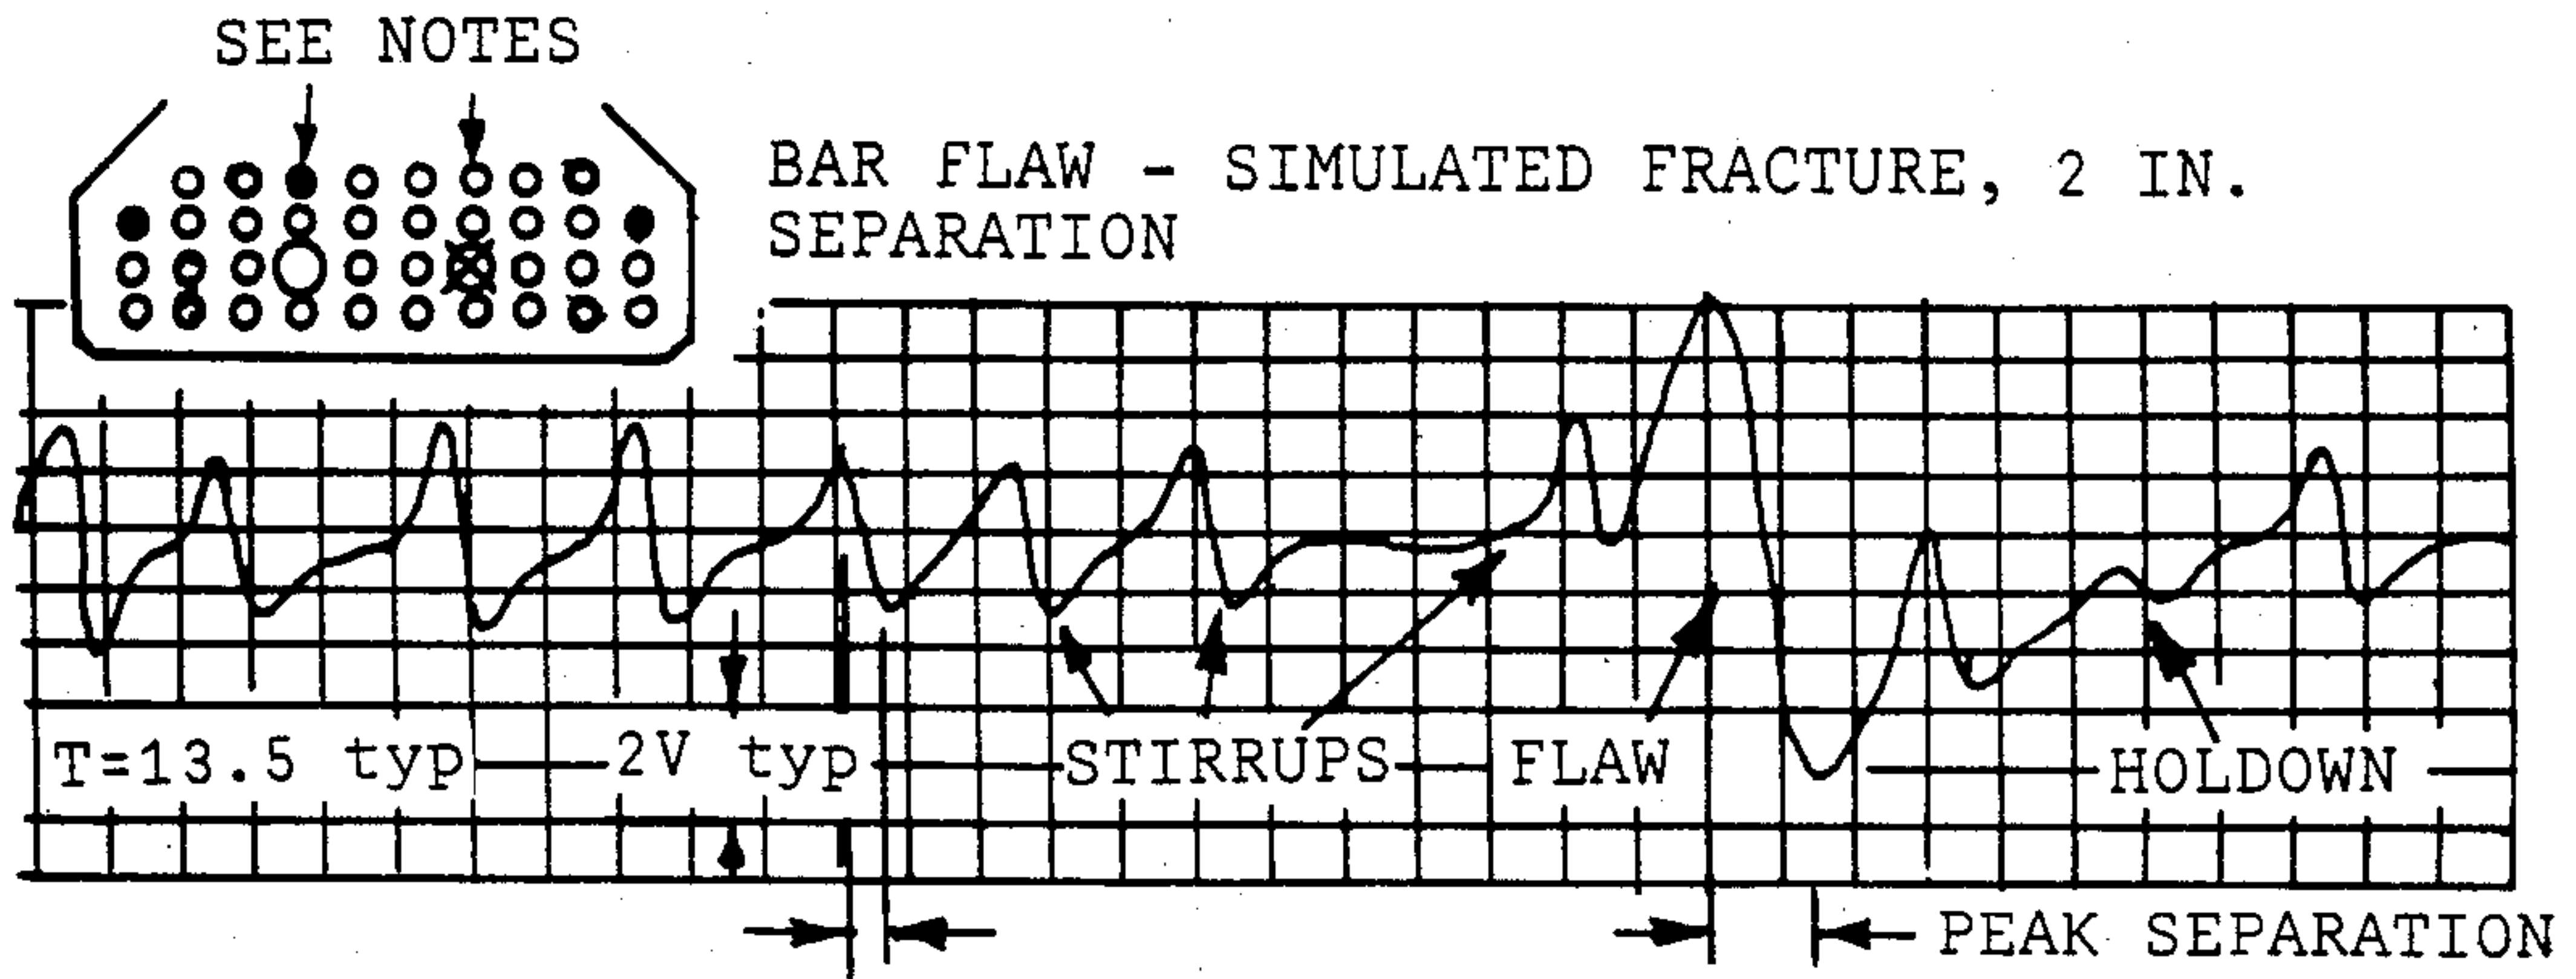
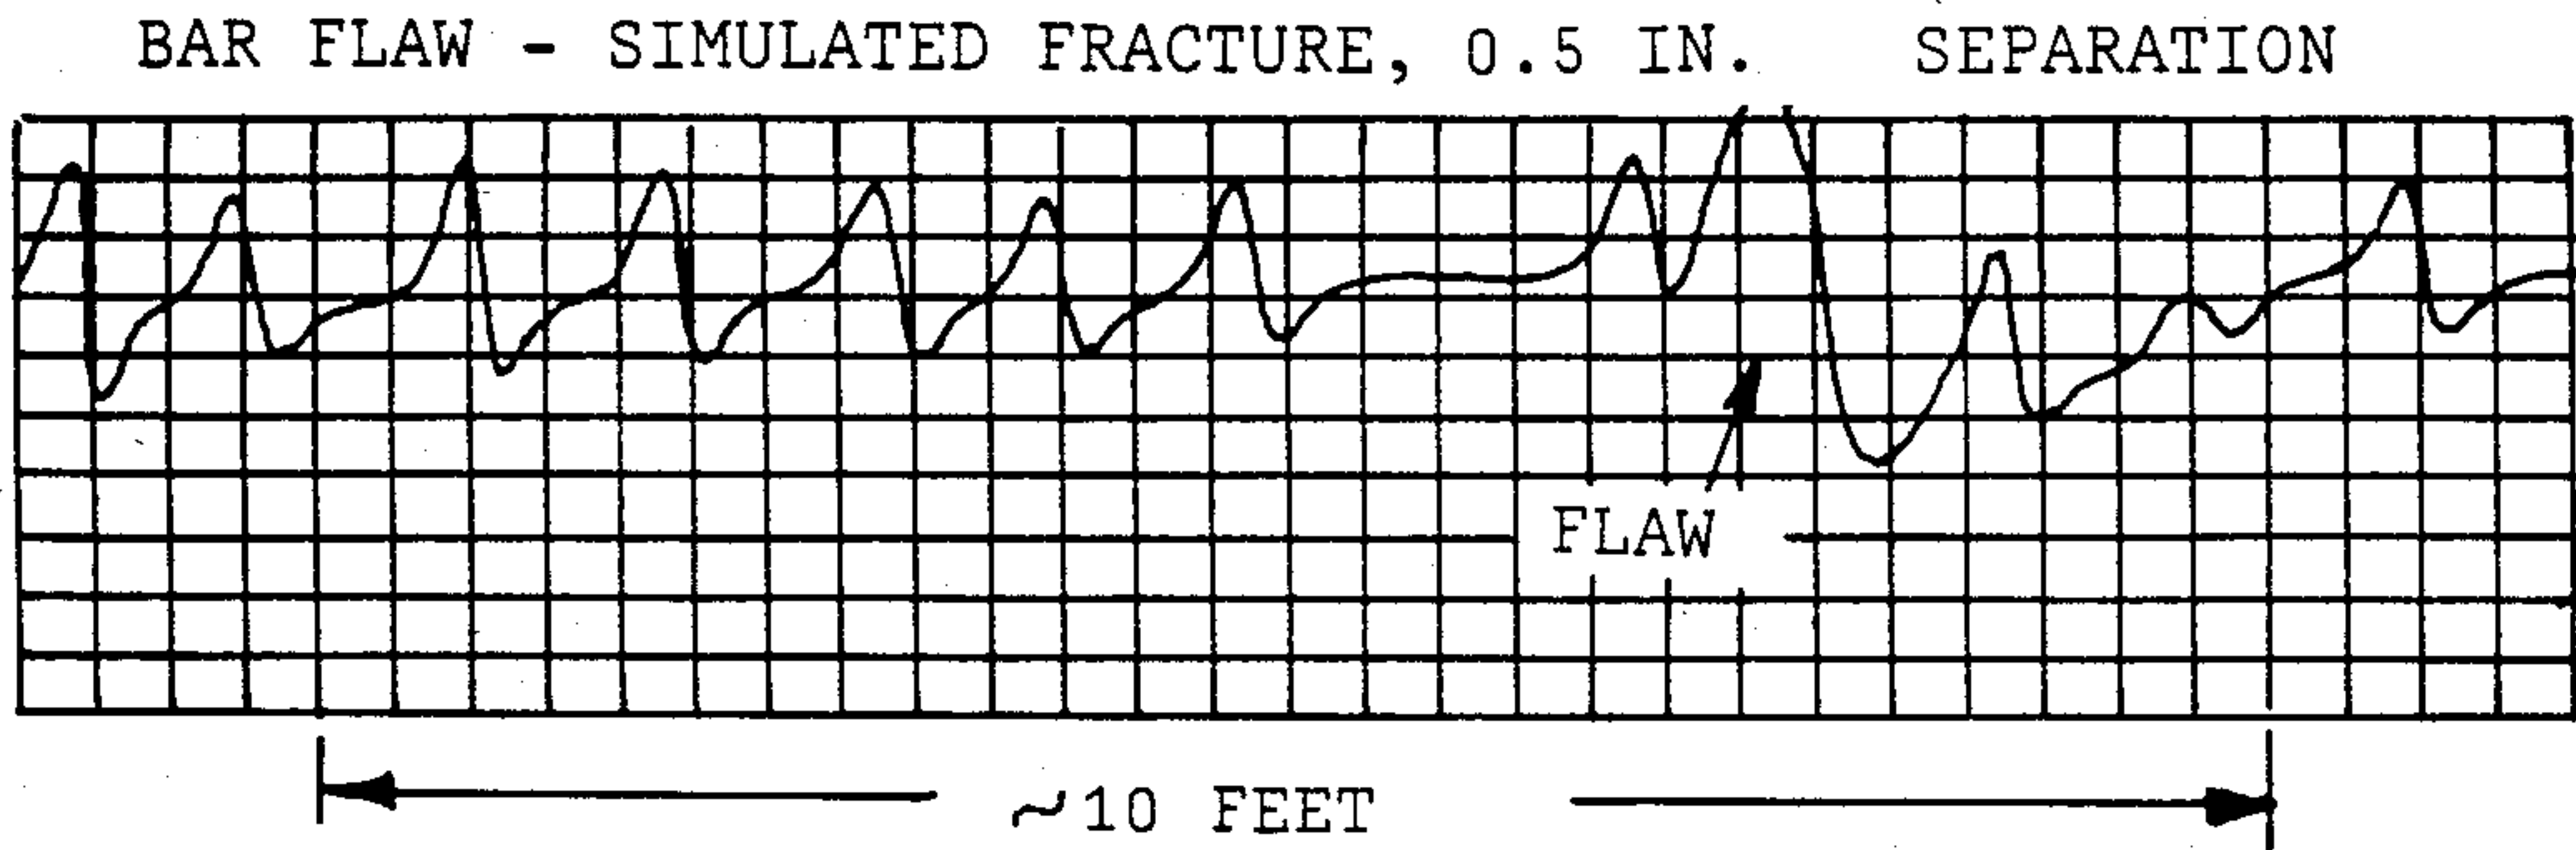
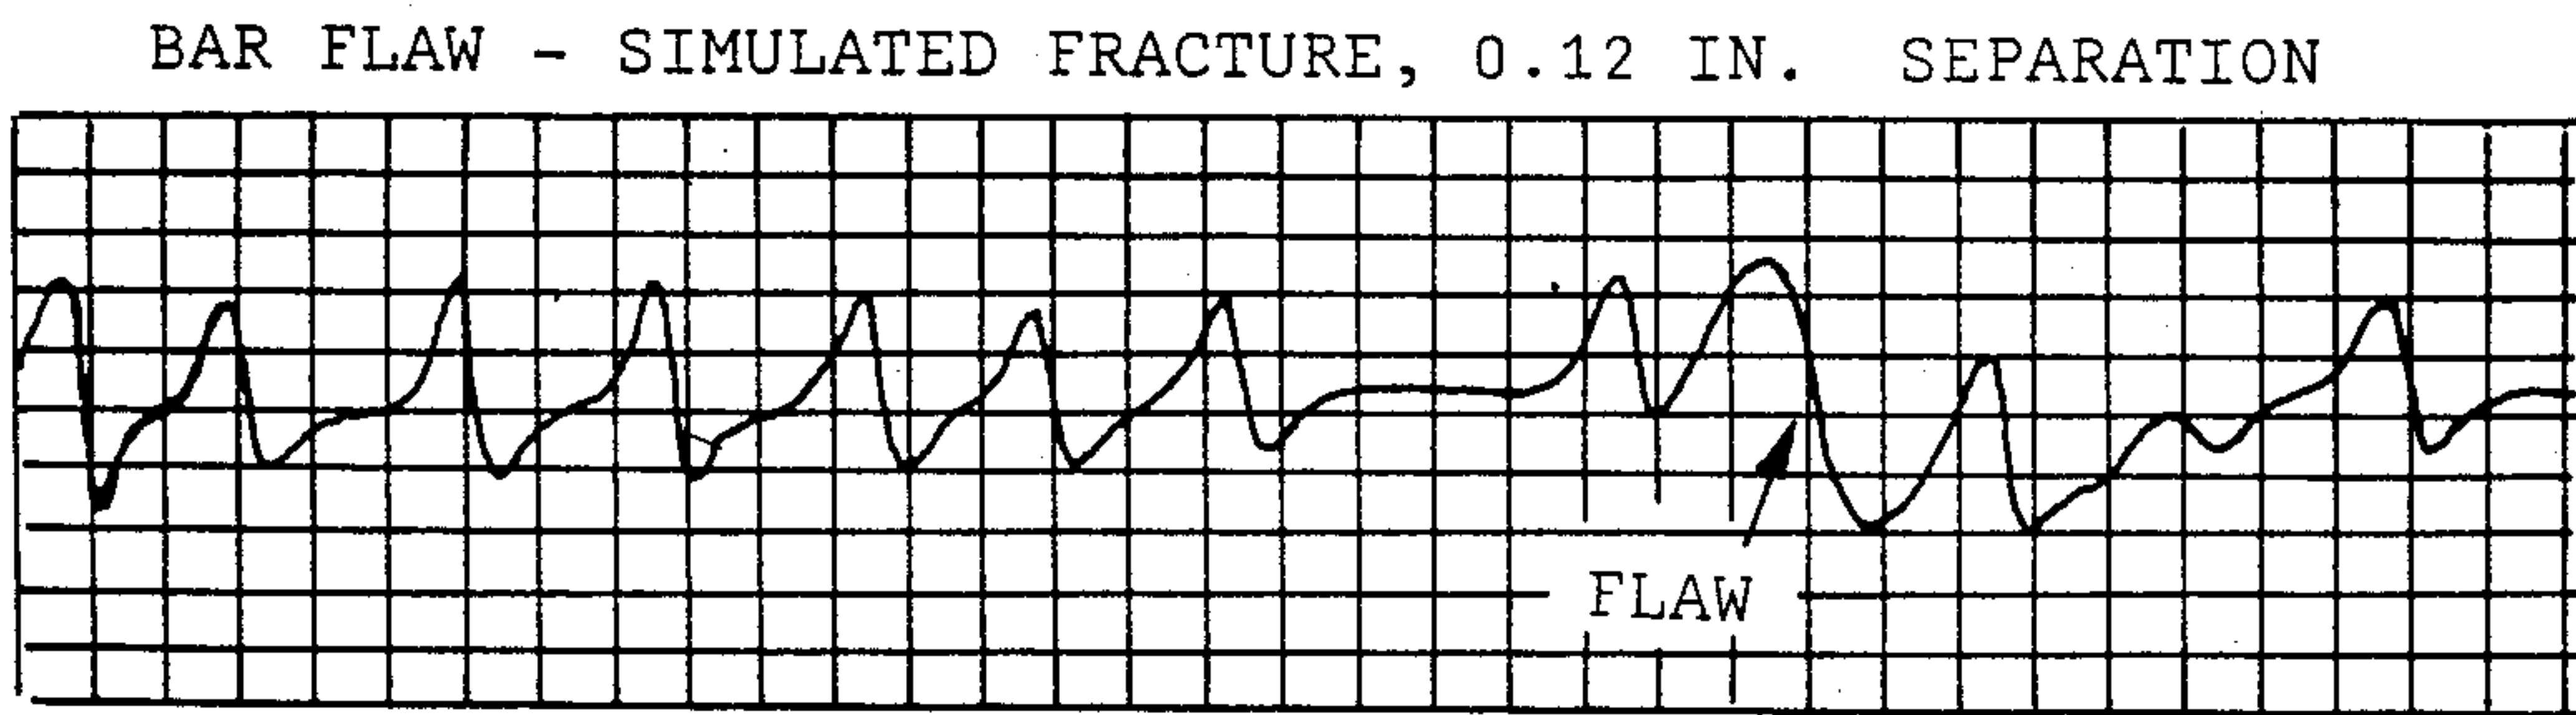
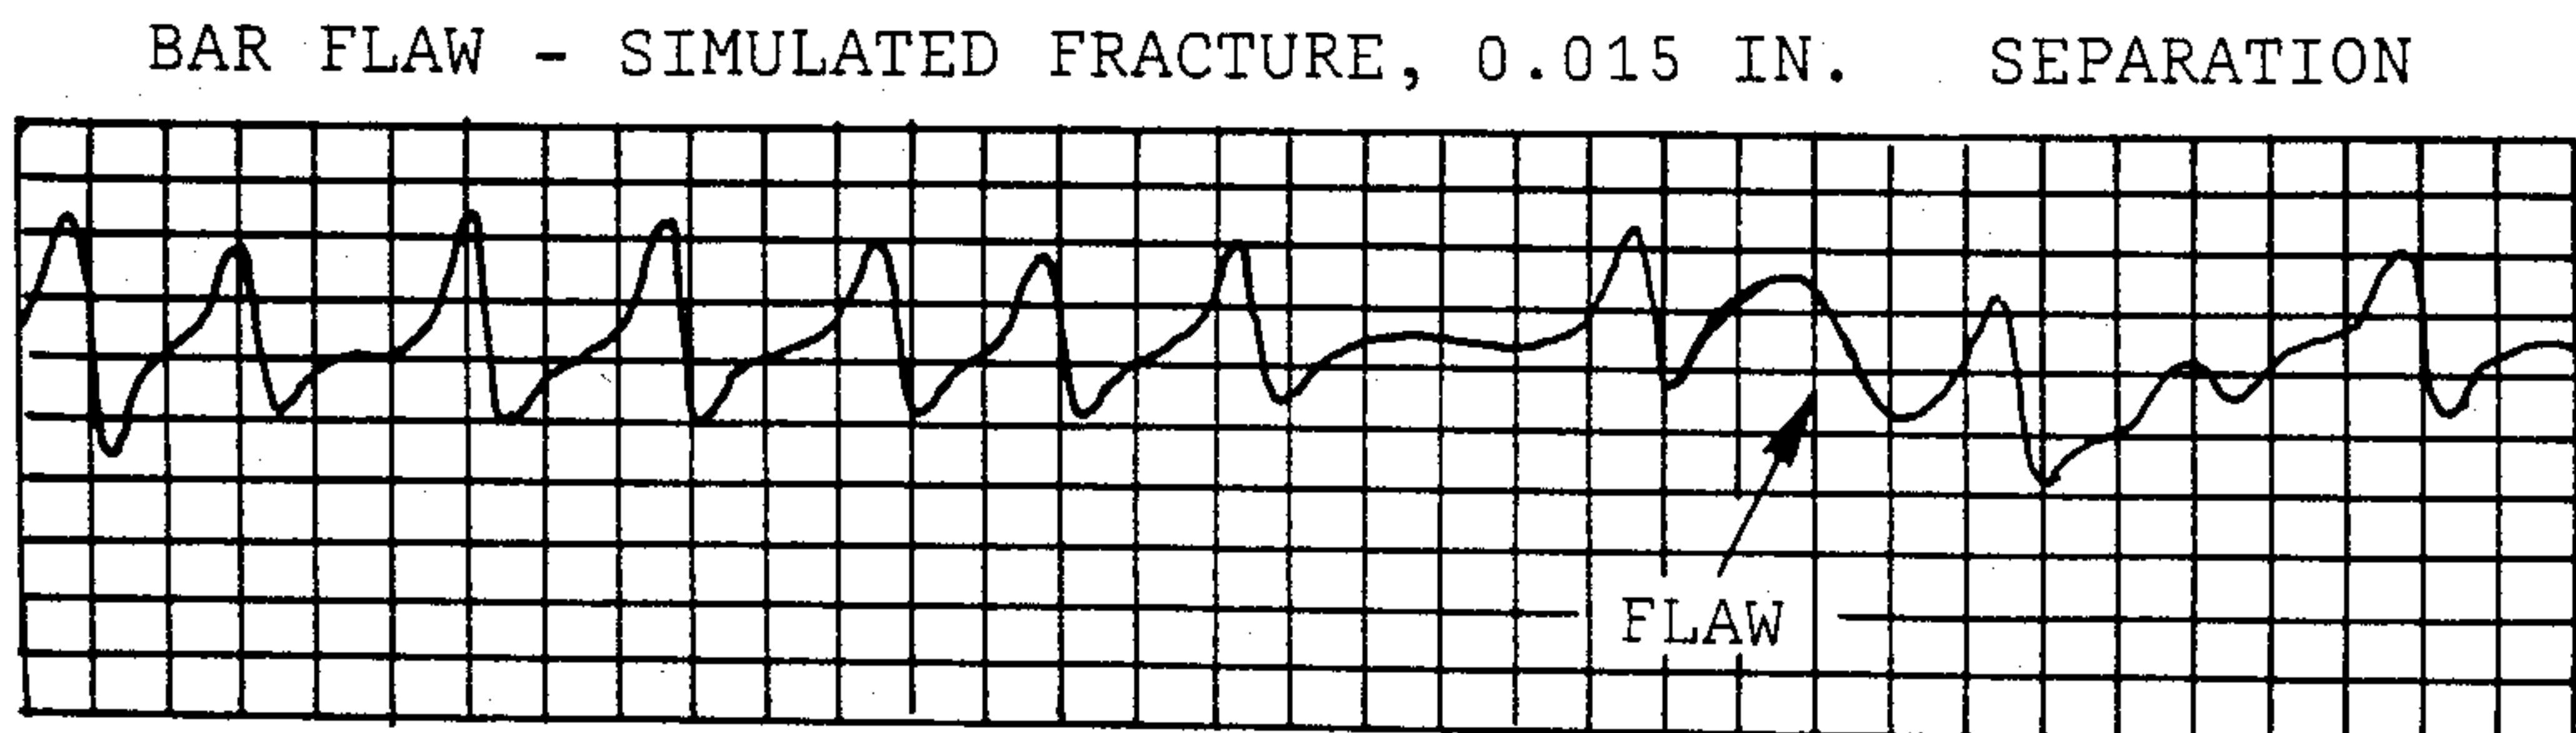
FIG.4A

FIGS. 4(a)–(d) show the effect of increasing fracture end separation in a $1\frac{1}{8}$ inch diameter bar.

FIGS. 4(a)-(d) show the signature response from a $1\frac{3}{8}$ inch diameter high-strength steel bar with a simulated fracture and varying degrees of separation between the fractured ends. The data shown in FIGS. 4(a)-(d) are for the center line of the flawed bar 3.5 inches above the bottom surface of the test beam being scanned; the clearance between the magnet pole faces (and Hall effect sensor) and the concrete surface of the beam was approximately 0.5 inch. As can be seen, the record of the magnetic field is a straight line where there are no transverse reinforcing members or fractures in the prestressed members; where these exist they produce a signature which is an anomaly in the record in the form of a voltage spike or hump. Note that the signature from the simulated fracture for 0.5 inch separation and greater can be readily distinguished from those produced by the transverse stirrups. Furthermore, for the cases in which the simulated fracture is located between stirrups, and separations as small as 0.015 inches can be discerned because of the large horizontal extent of the signature. In FIG. 4(a), the horizontal distance between the upward-going and downward-going peaks of both the stirrup and fracture signatures has been indicated. This separation between the peaks is proportional to the distance between the sensor and the flaw and/or steel configuration causing the signature, and is a parameter which can be used to identify the depth of the element causing the signature. Note that the separation of the peaks for the stirrups is approximately one-third of that for the simulated fracture; correspondingly, the lower arm of the stirrups is approximately 1.5 inches from the bottom surface of the girder while the post-tensioned bar is approximately 3.5 inches from the bottom surface. This peak separation feature of the signatures will be referred to throughout since it is a parameter which can be extremely helpful in the interpretation of inspection results. A comparison of corresponding signatures in FIGS. 4(a)-(d) shows excellent repeatability even though the bars were removed and replaced to set up the various flaw conditions. Also, it is pointed out that stirrup signatures could be monitored to assess possible deterioration in the stirrup regions and to detect missing stirrups.
