[54] MAGNETIC INSPECTION OF REINFORCING STEEL USING SENSOR ARRAY

[73] Assignee: The United States of America as represented by the Secretary of Transportation, Washington, D.C.

[57] ABSTRACT

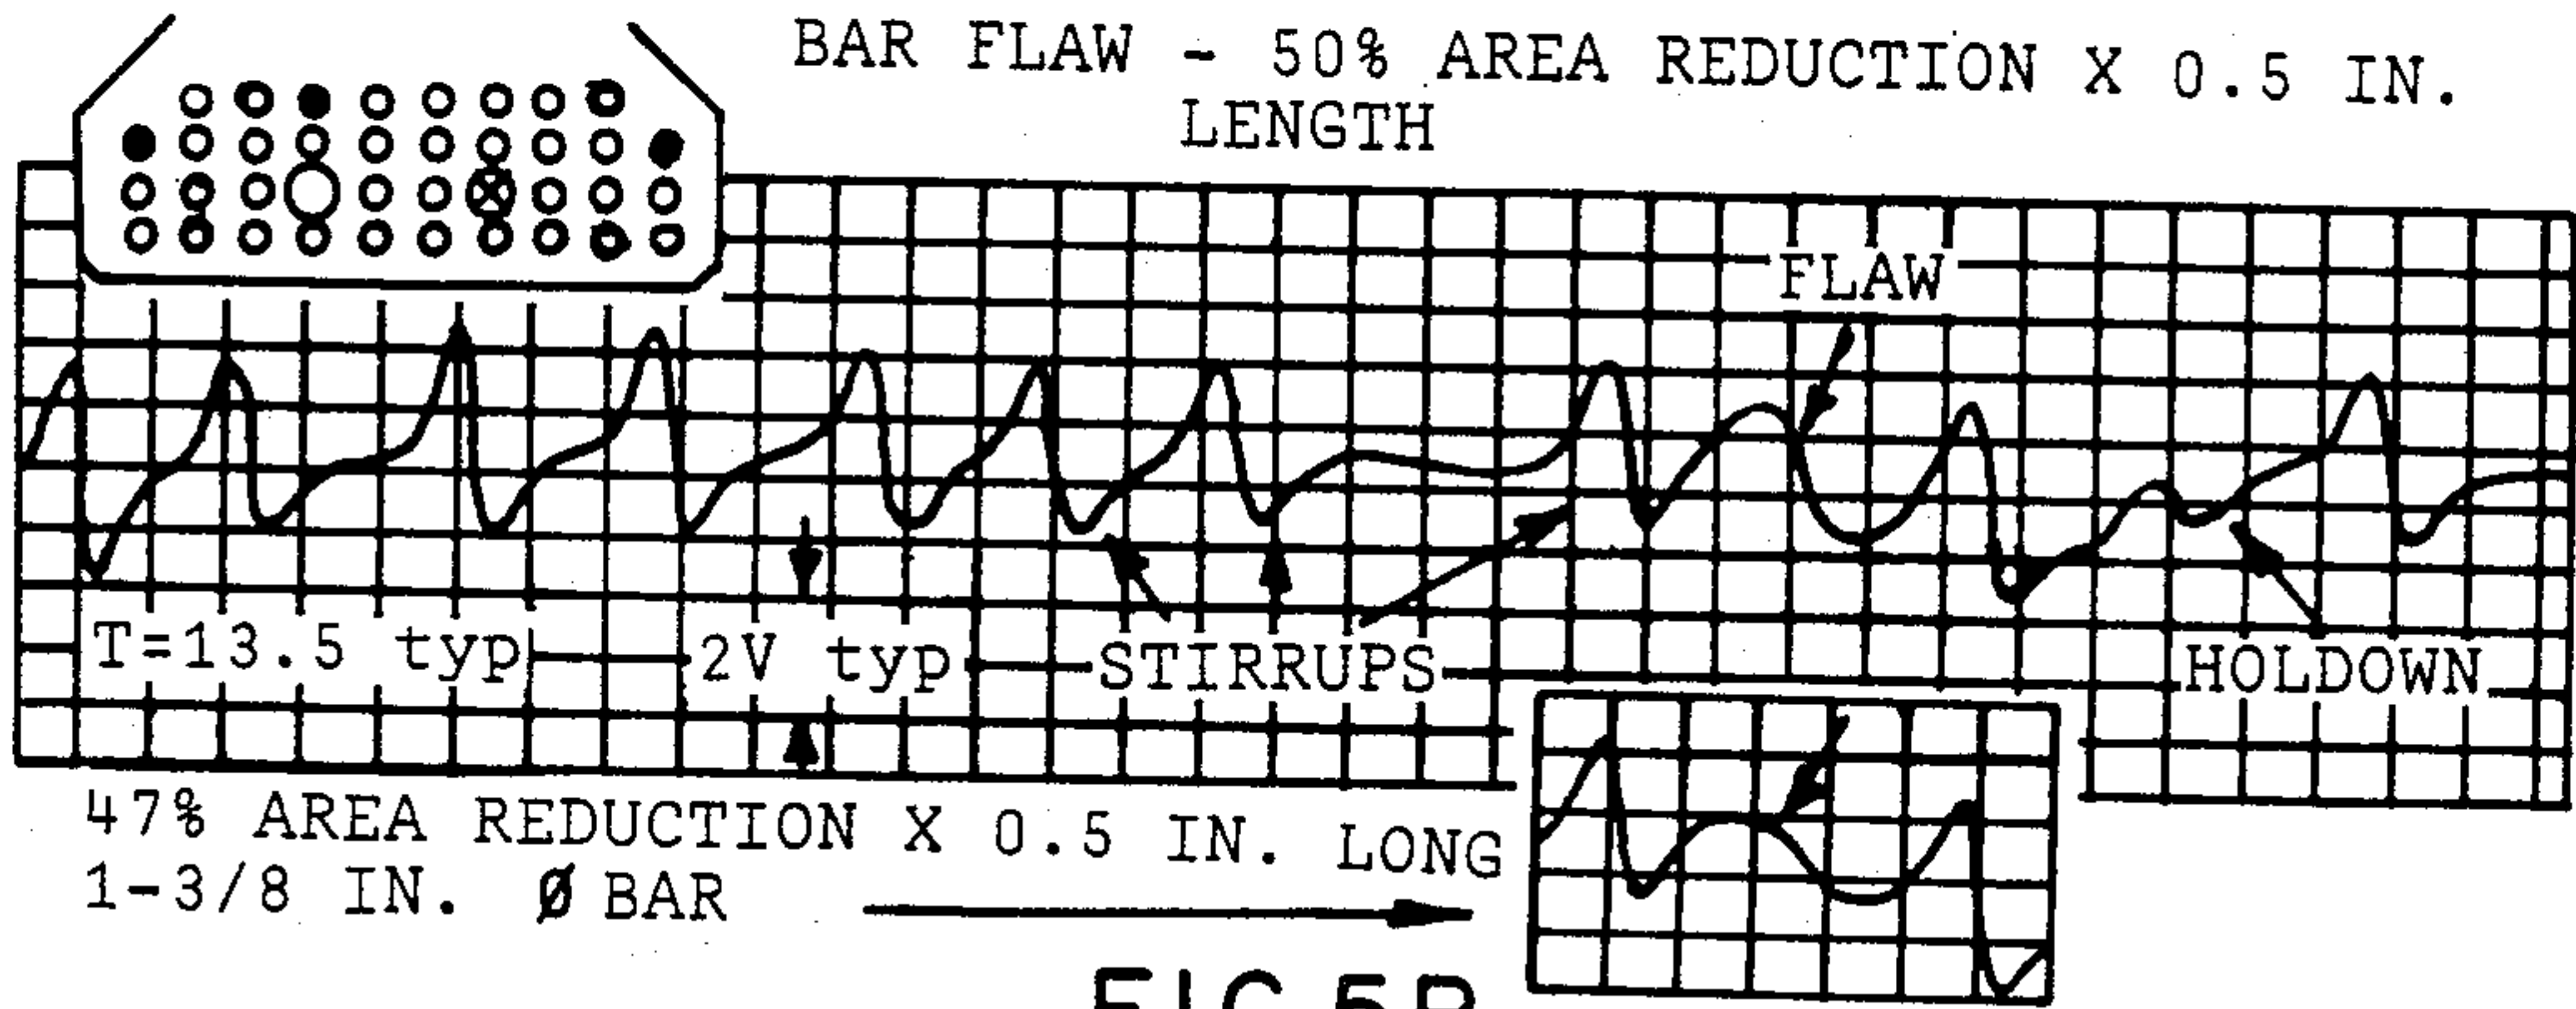
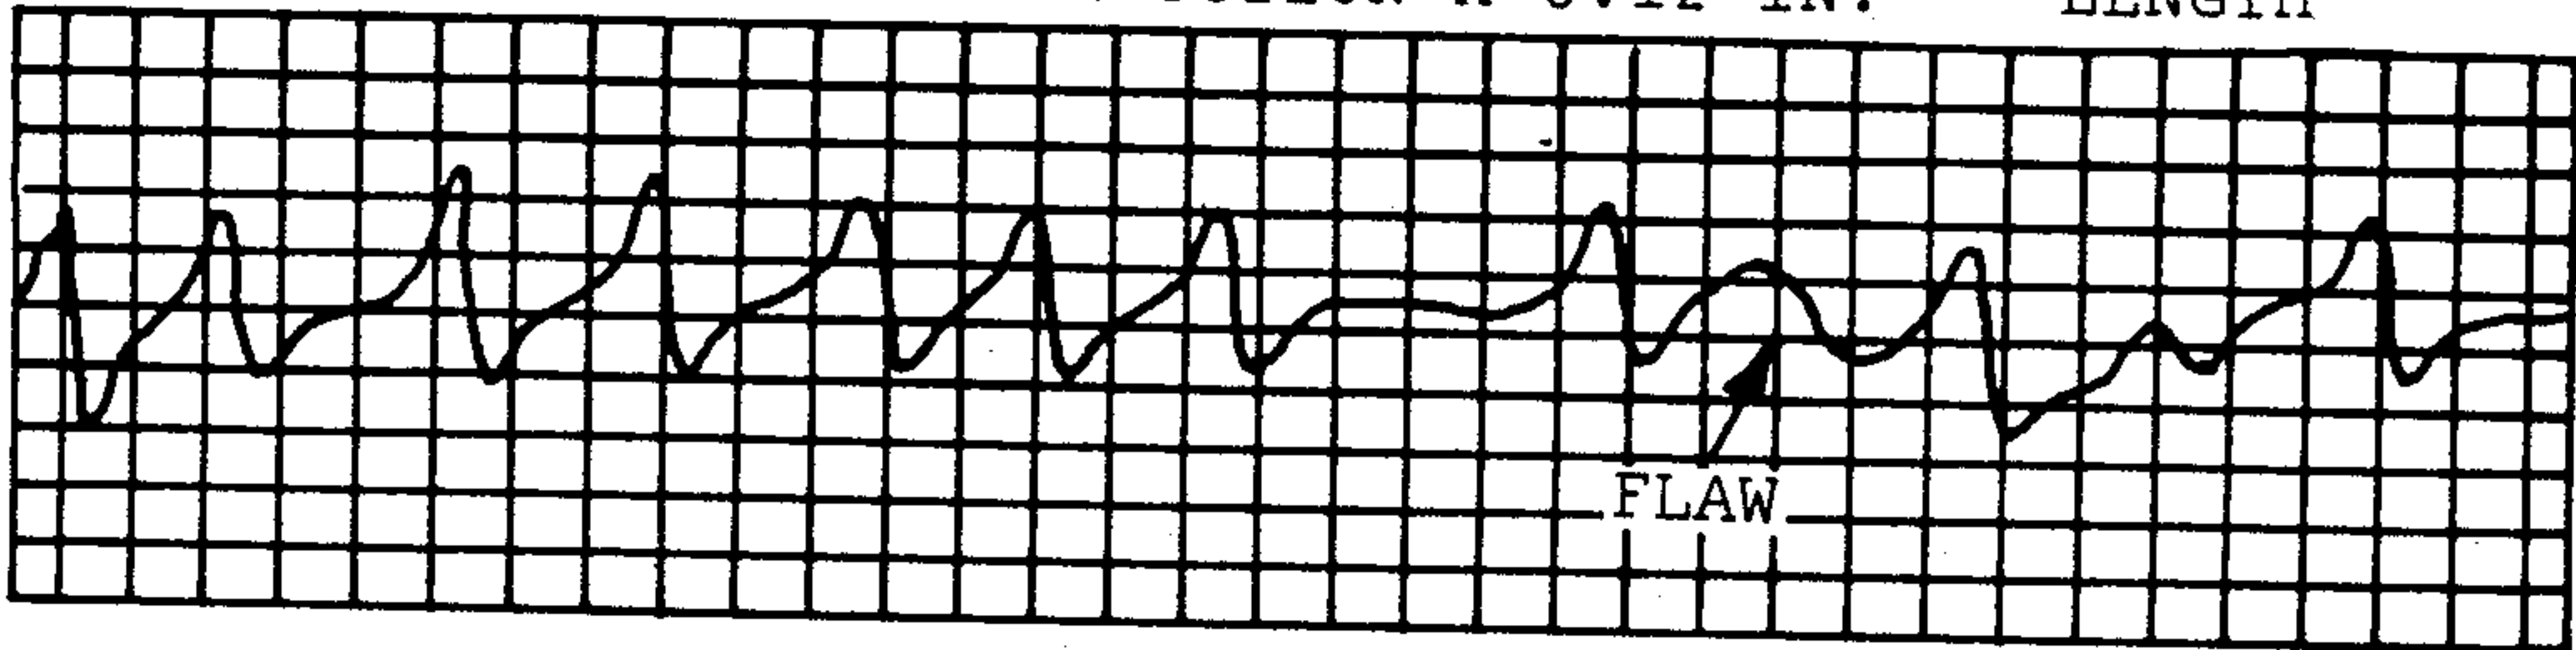
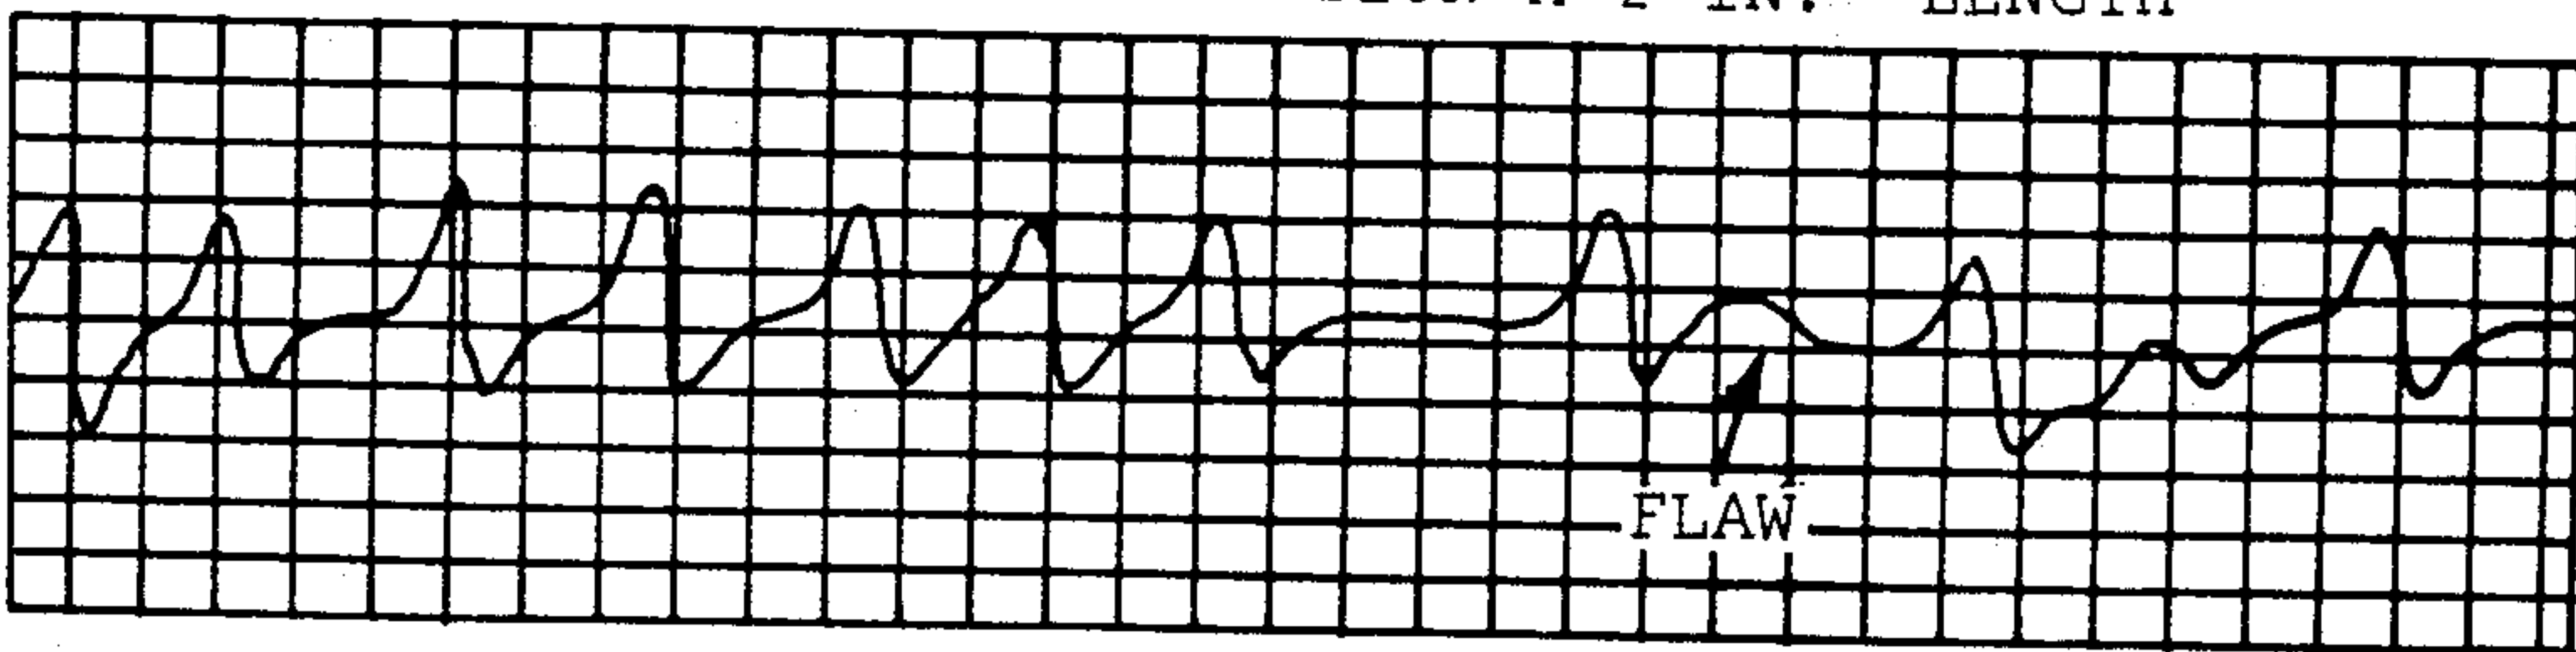
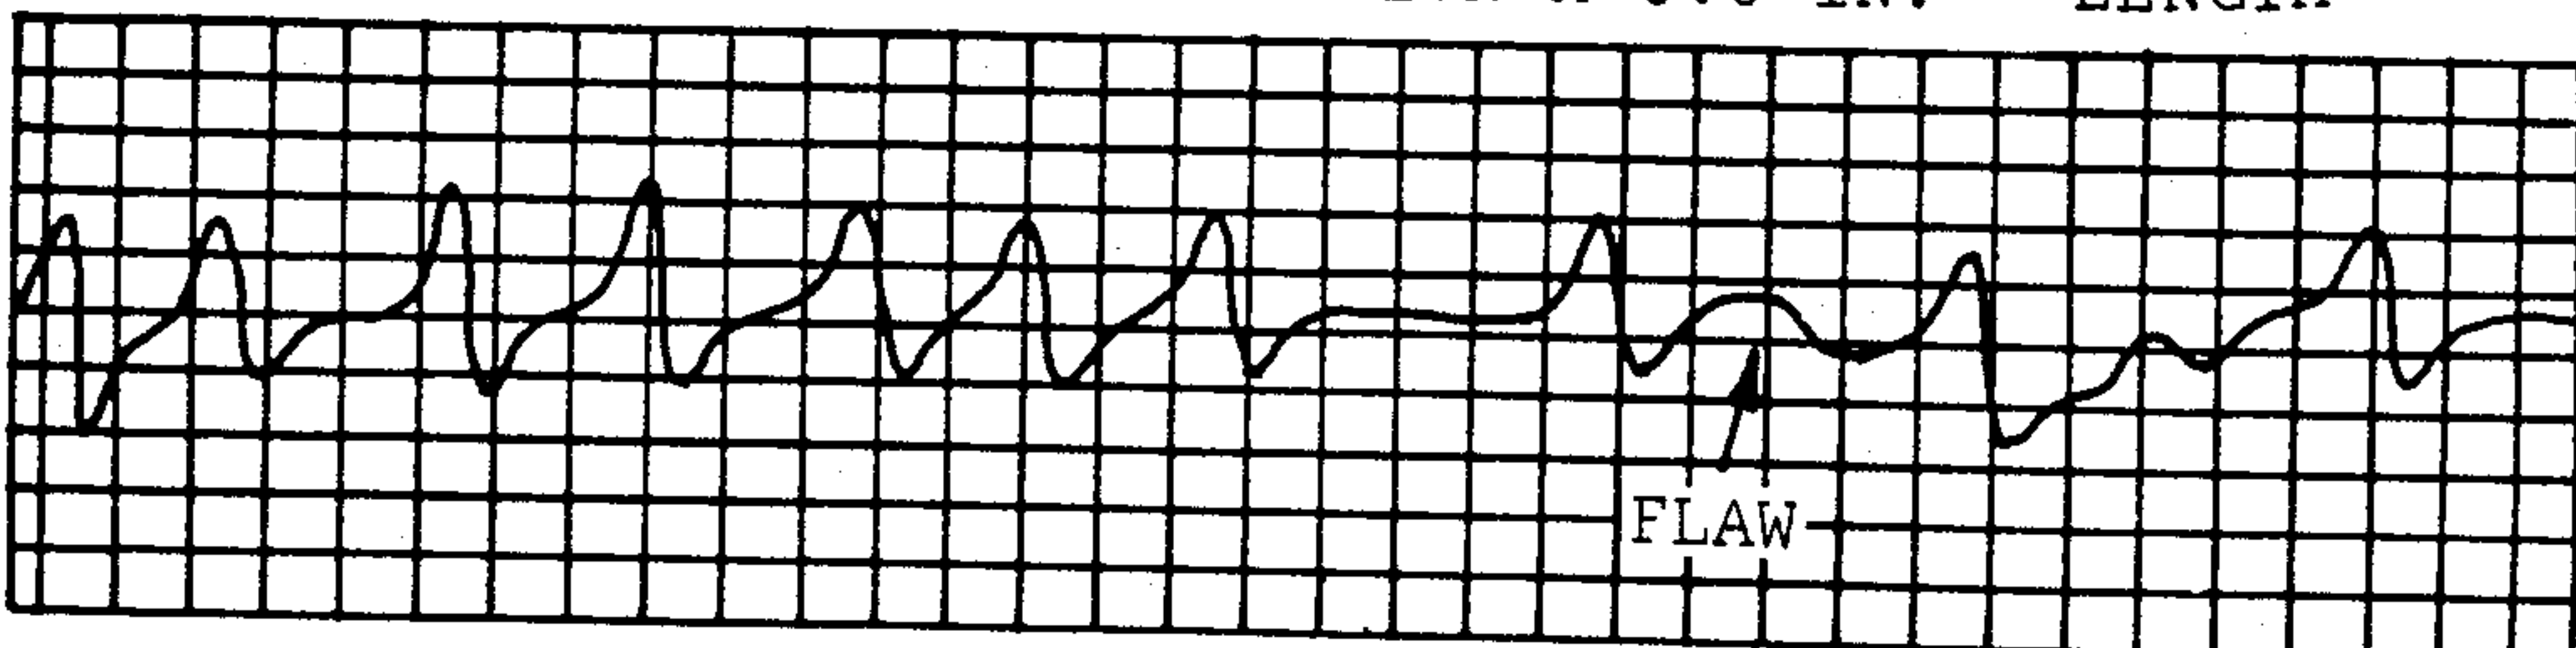
FIG.5A

BAR FLAW = 50% AREA REDUCTION X 0.12 IN. LENGTH

BAR FLAW = 20% AREA REDUCTION X 2 IN. LENGTH

BAR FLAW = 20% AREA REDUCTION X 0.5 IN. LENGTH

FIGS. 5(a)–(d) show the effect of different flaw sizes in a 1 inch diameter bar.

Signature responses from varying degrees of reduction in cross-sectional area (simulation of loss of section

due to corrosion) for a 1 inch diameter high-strength steel bar are shown in FIGS. 5(a)-(d). FIG. 5(a) shows the response from a 50-percent reduction in area over a $\frac{1}{2}$ inch length in a 1 inch diameter bar; the insert shows a similar response from a slightly lower percentage reduction in area for a $1\frac{3}{8}$ inch diameter bar. In FIGS. 5(a)-(d), the bar centerline is approximately 3.5 inches from the bottom surface of the concrete beam. Evaluation of the signatures for the 20-percent area reduction for this concrete coverage condition indicates a good probability for the detection of a 10-percent reduction in area provided adequate stirrup signature discrimination could be developed. Discrimination between configurational steel artifact signatures and simulated flaw signatures is discussed later.

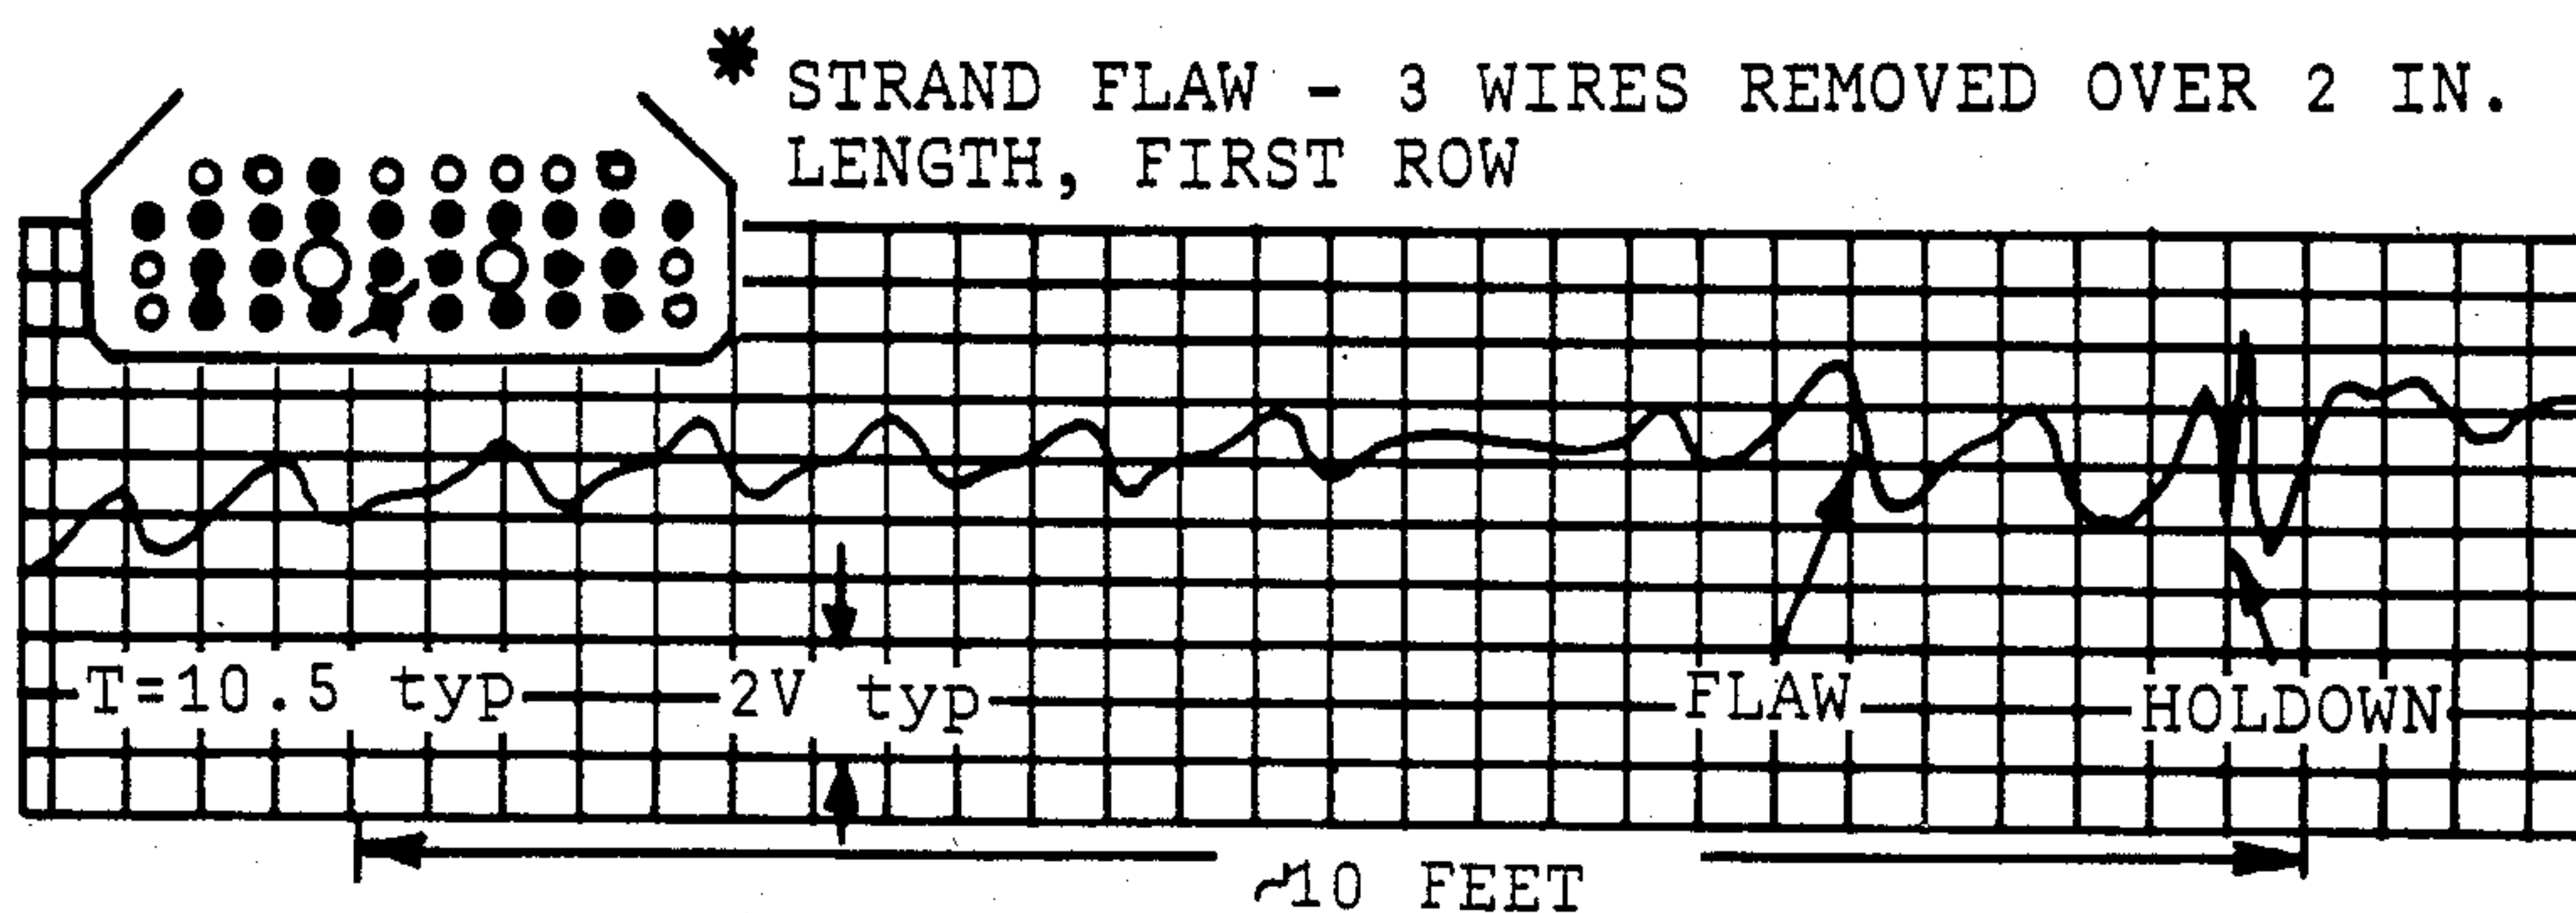
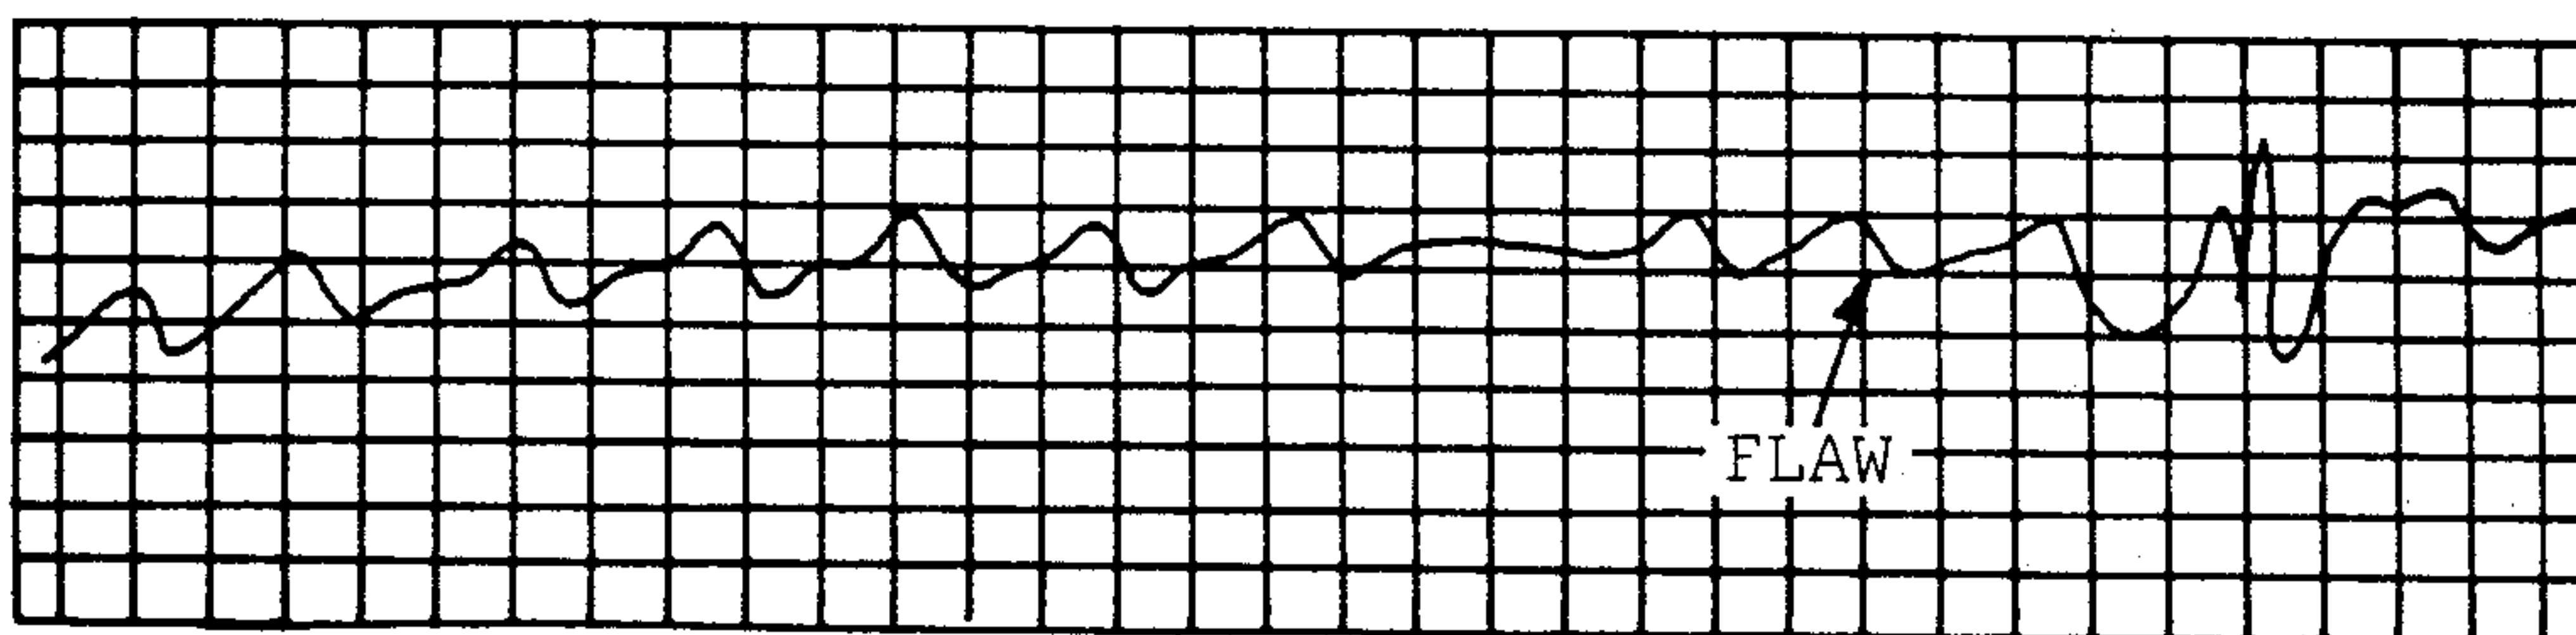
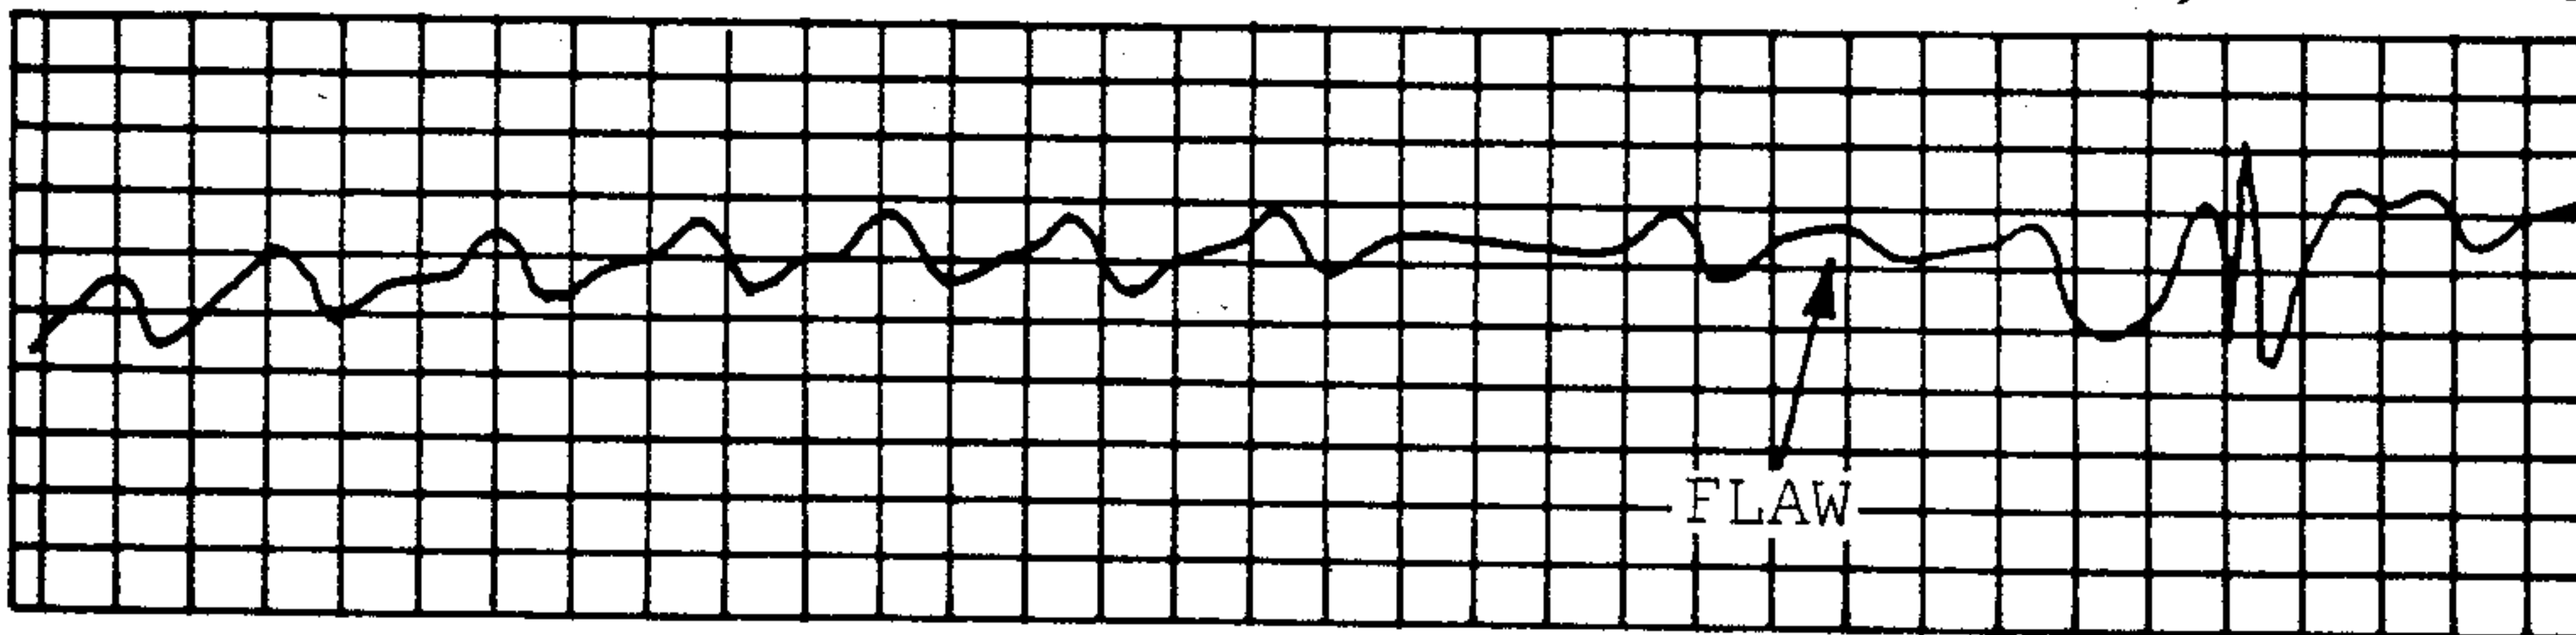
FIG.6A

*STRAND FLAW = 1 WIRE REMOVED OVER 2 IN. LENGTH, FIRST ROW

*STRAND FLAW = 1 WIRE REMOVED OVER 0.12 IN. LENGTH, FIRST ROW

FIGS. 6(a)–(c) show the effect of different flaw sizes in a $\frac{1}{2}$ inch diameter 7 wire strand.

FIGS. 6(a)-(c) and 7(a)-(d) present results from simulated flaws in a $\frac{1}{2}$ inch diameter \times 7-wire strand arranged in a typical 2 inch by 2 inch matrix. FIGS. 6(a)-(c) results for varying degrees of strand deterioration with the flawed strand in the first row of the matrix (see partial cross-sectional view of the girder at the upper left corner). Inspection of FIGS. 6(b) and (c) indicates that detection of a 14 percent reduction in cross-sectional area would probably be marginal. The records in FIGS. 7(a)-(d) show a rapid decrease in signature amplitude from the same size flaw for increasing depths of the flawed strand in the matrix. FIGS. 7(b), (c) and (d) present flaw signature data from an 86 percent reduction in area over a 2 inch length (removal of six wires from the 7-wire strand over a 2 inch length) with this flawed strand 2 inches, 4 inches, and 6 inches, respectively, above the bottom surface; unflawed strands adjacent to the flawed strand are present in all cases as indicated by the cross-section at the upper left in each record. The results in FIGS. 7(a)-(d) indicate that detection of an 86 percent \times 2 inch loss of section deeper than the first row of the matrix would probably be marginal.

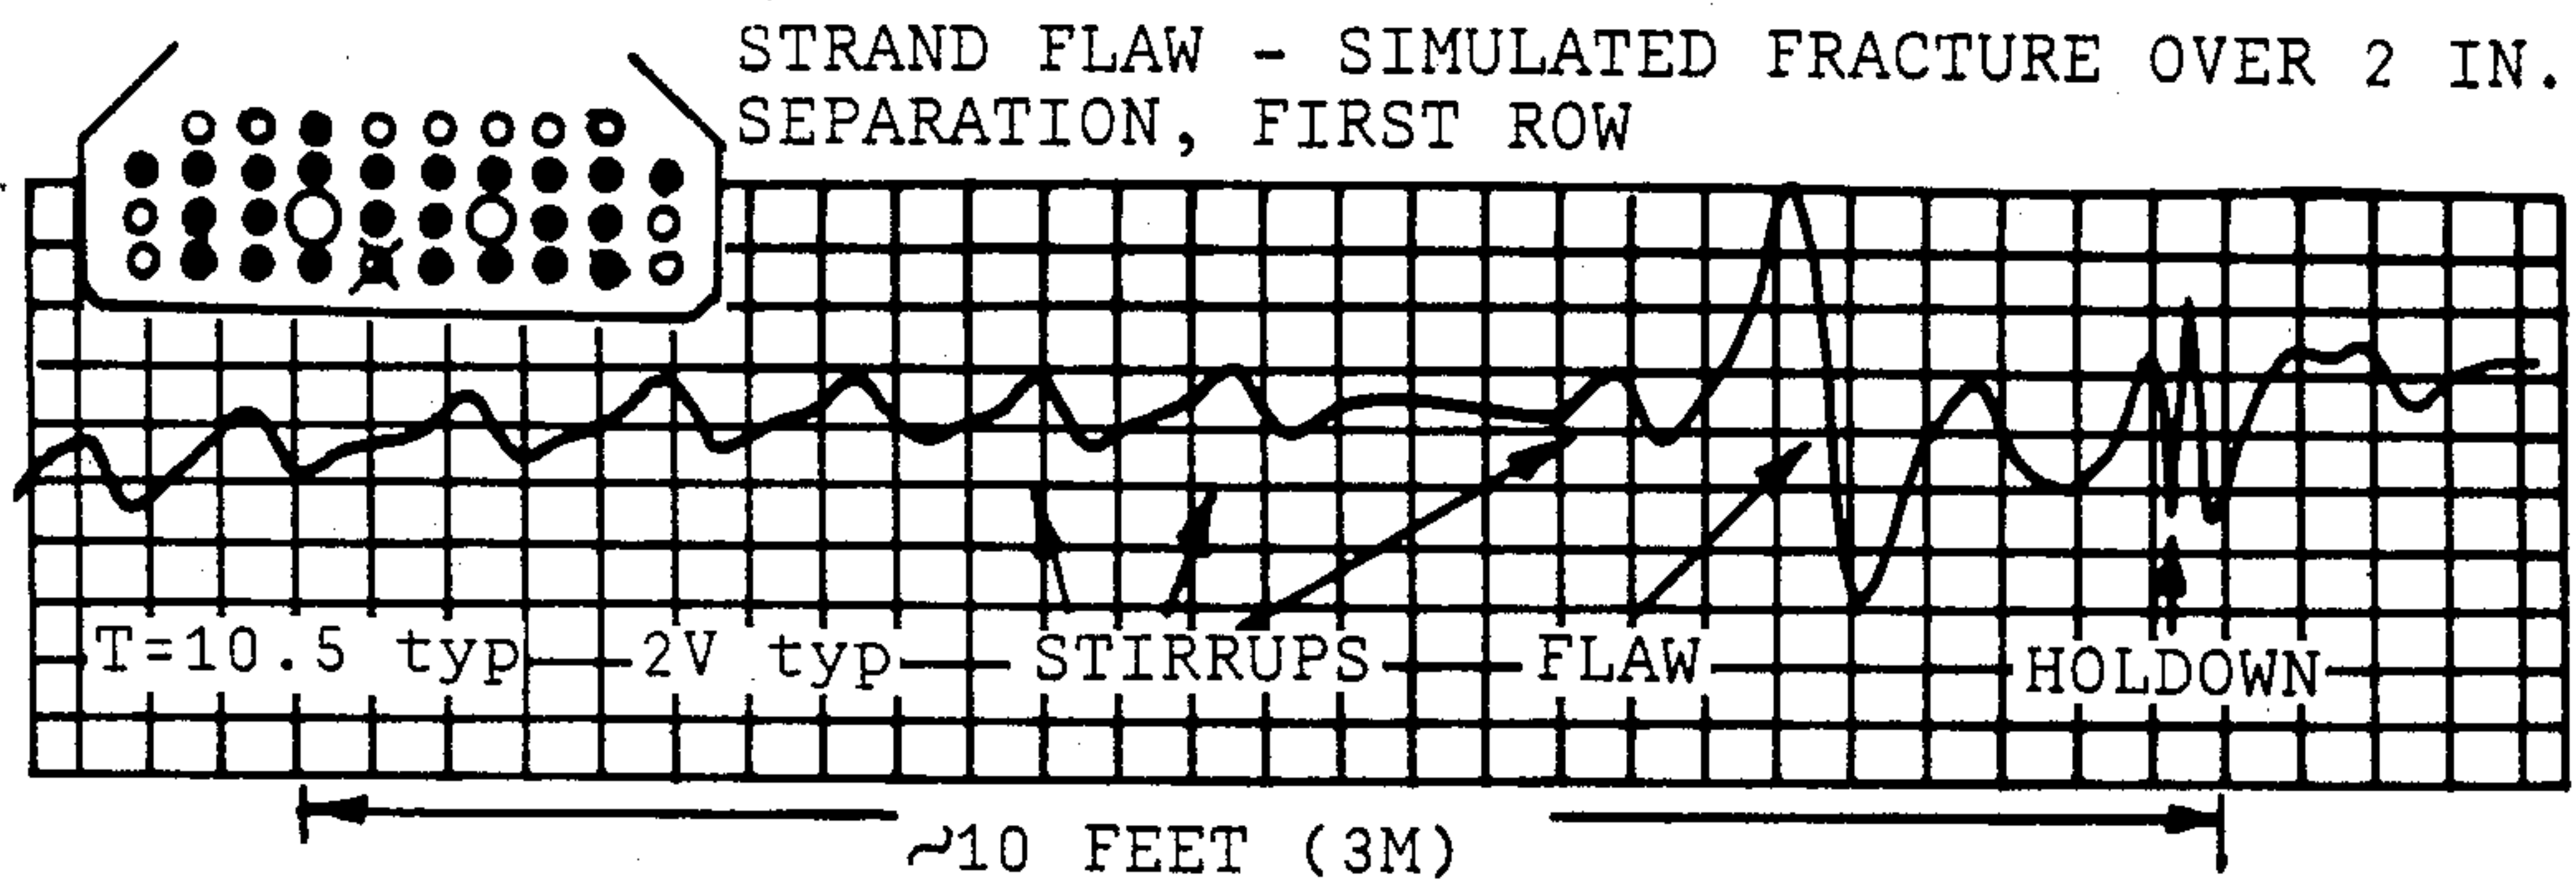
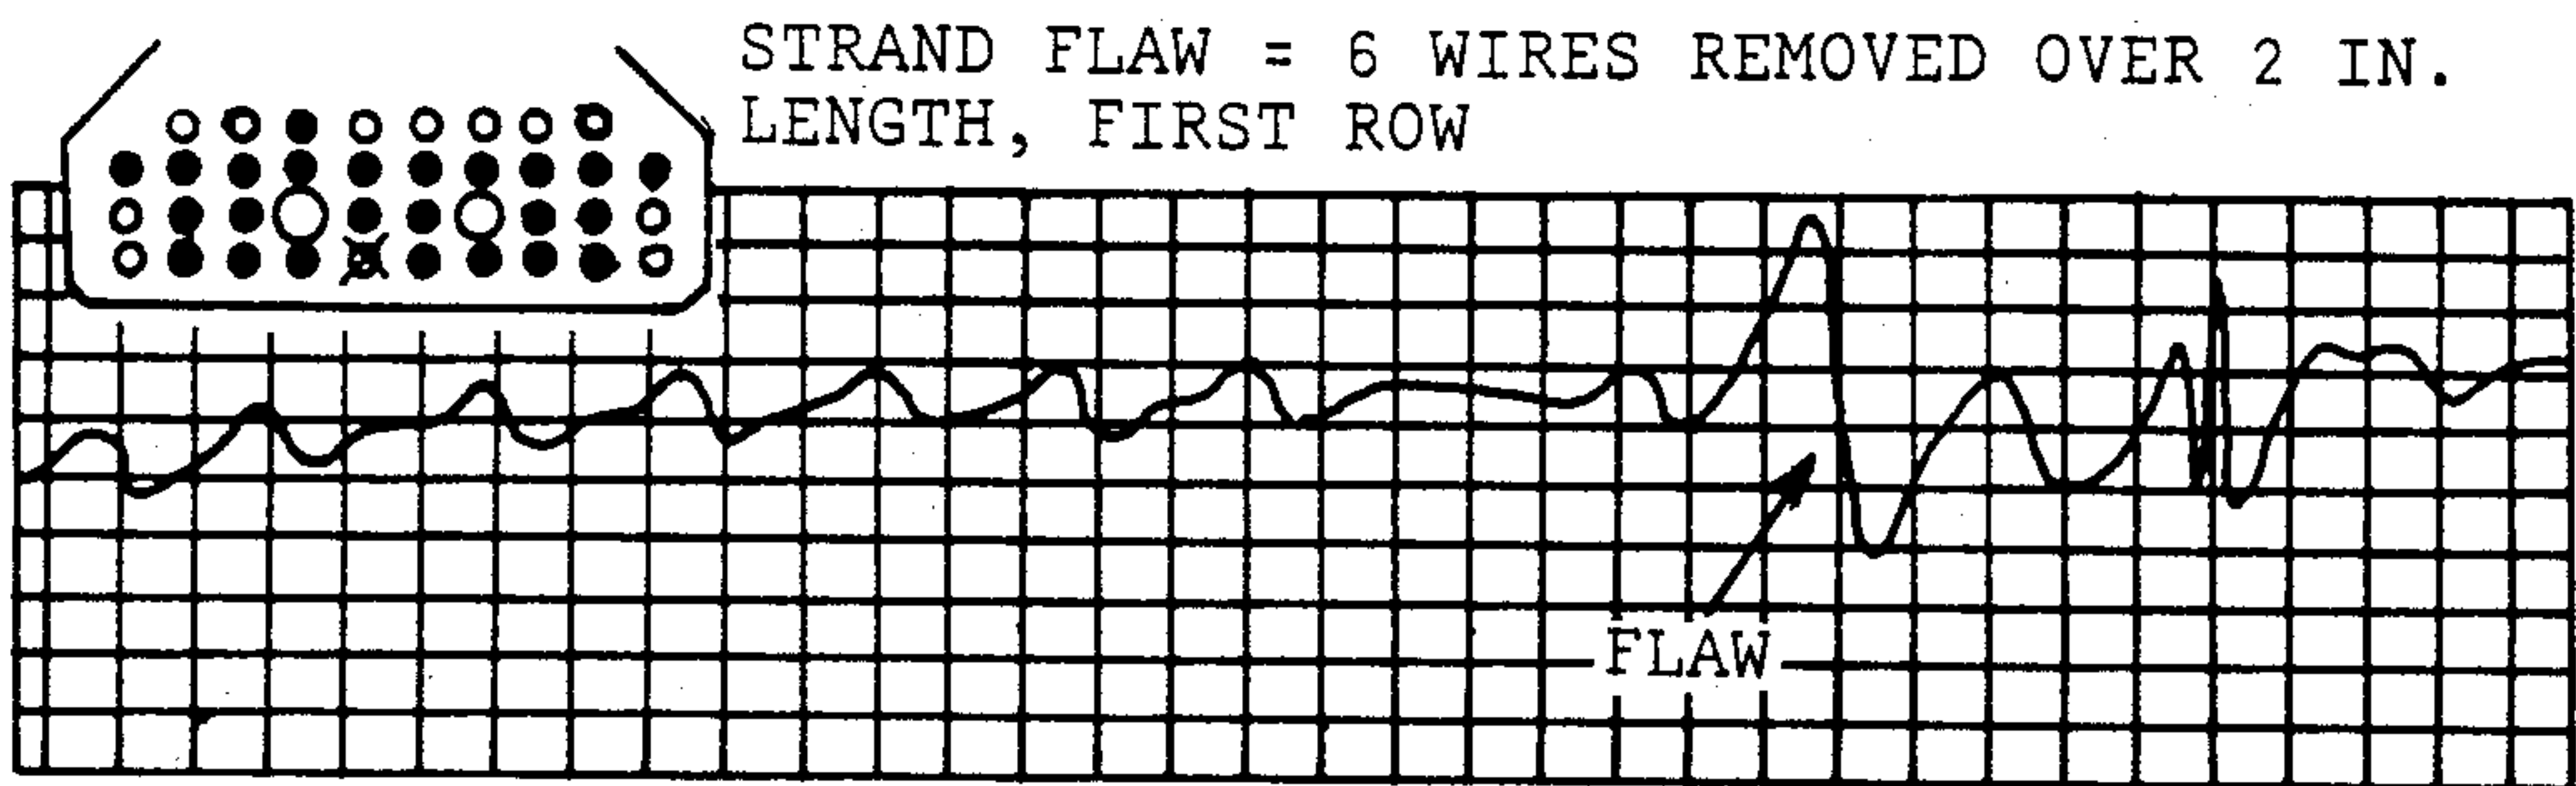
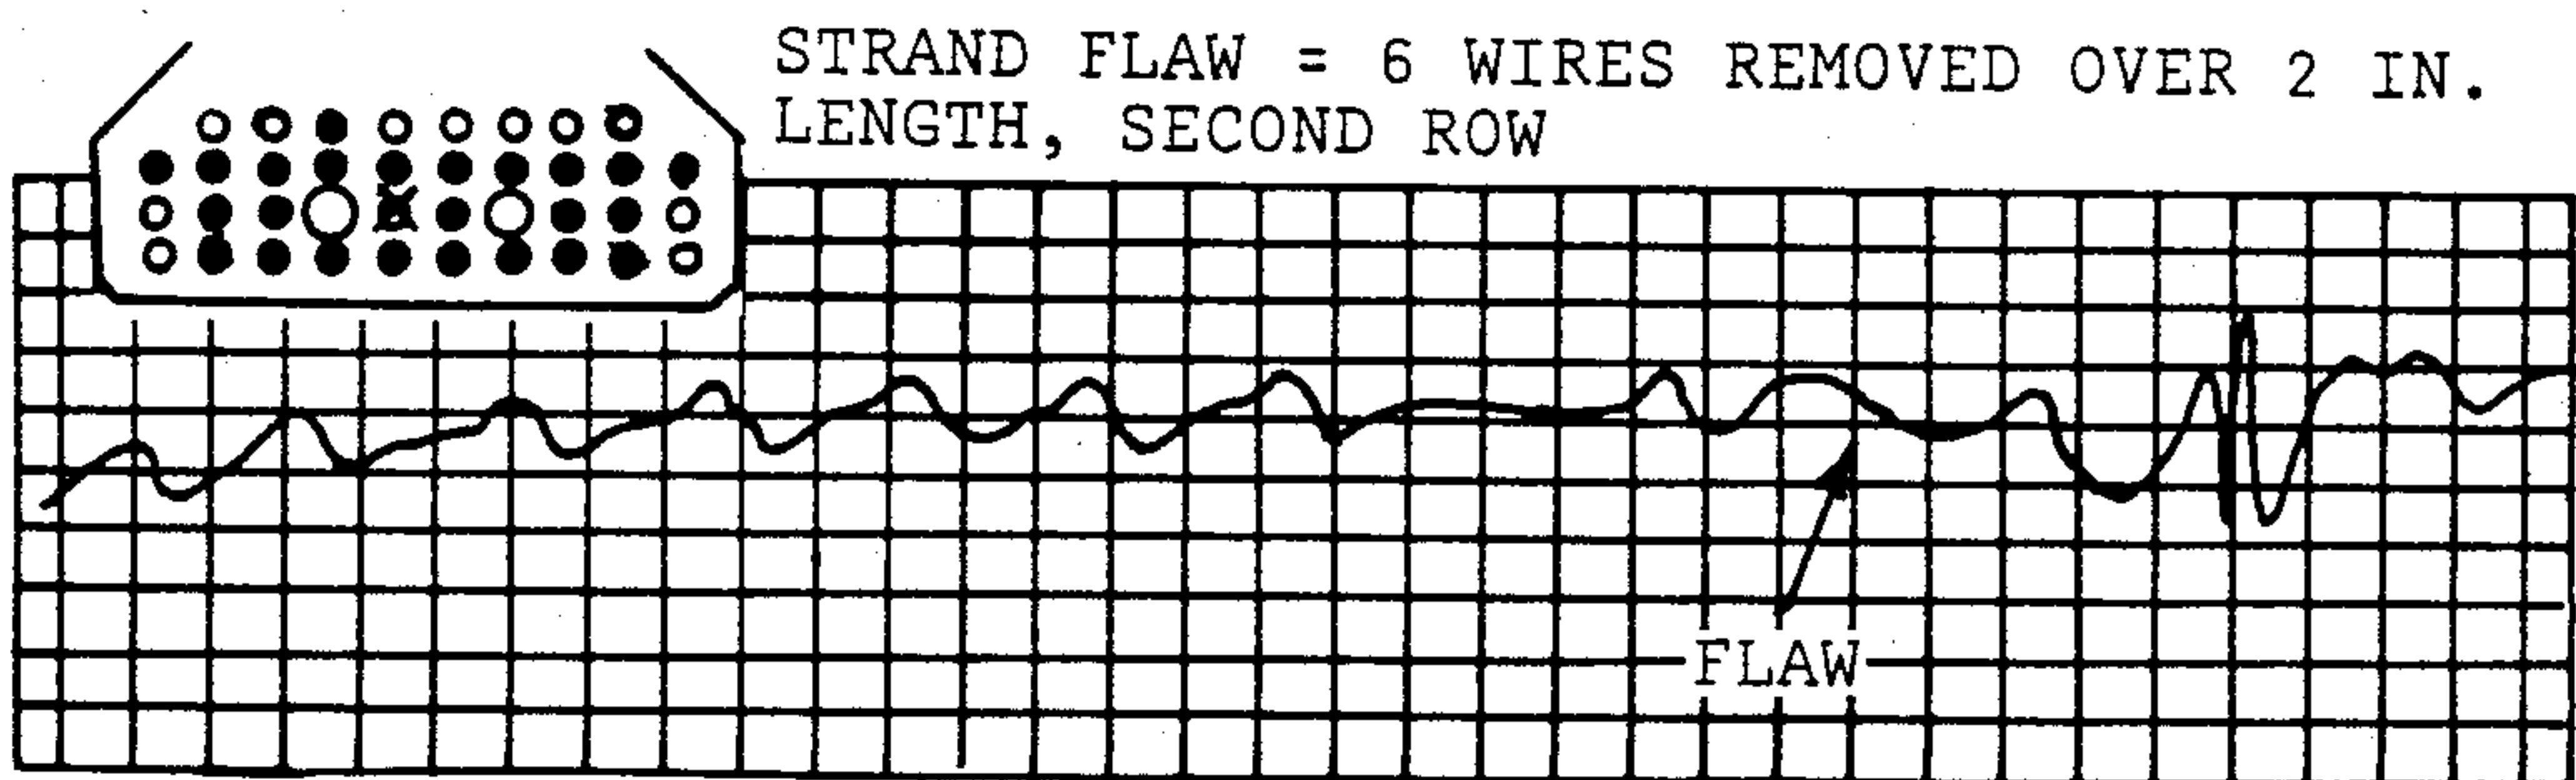
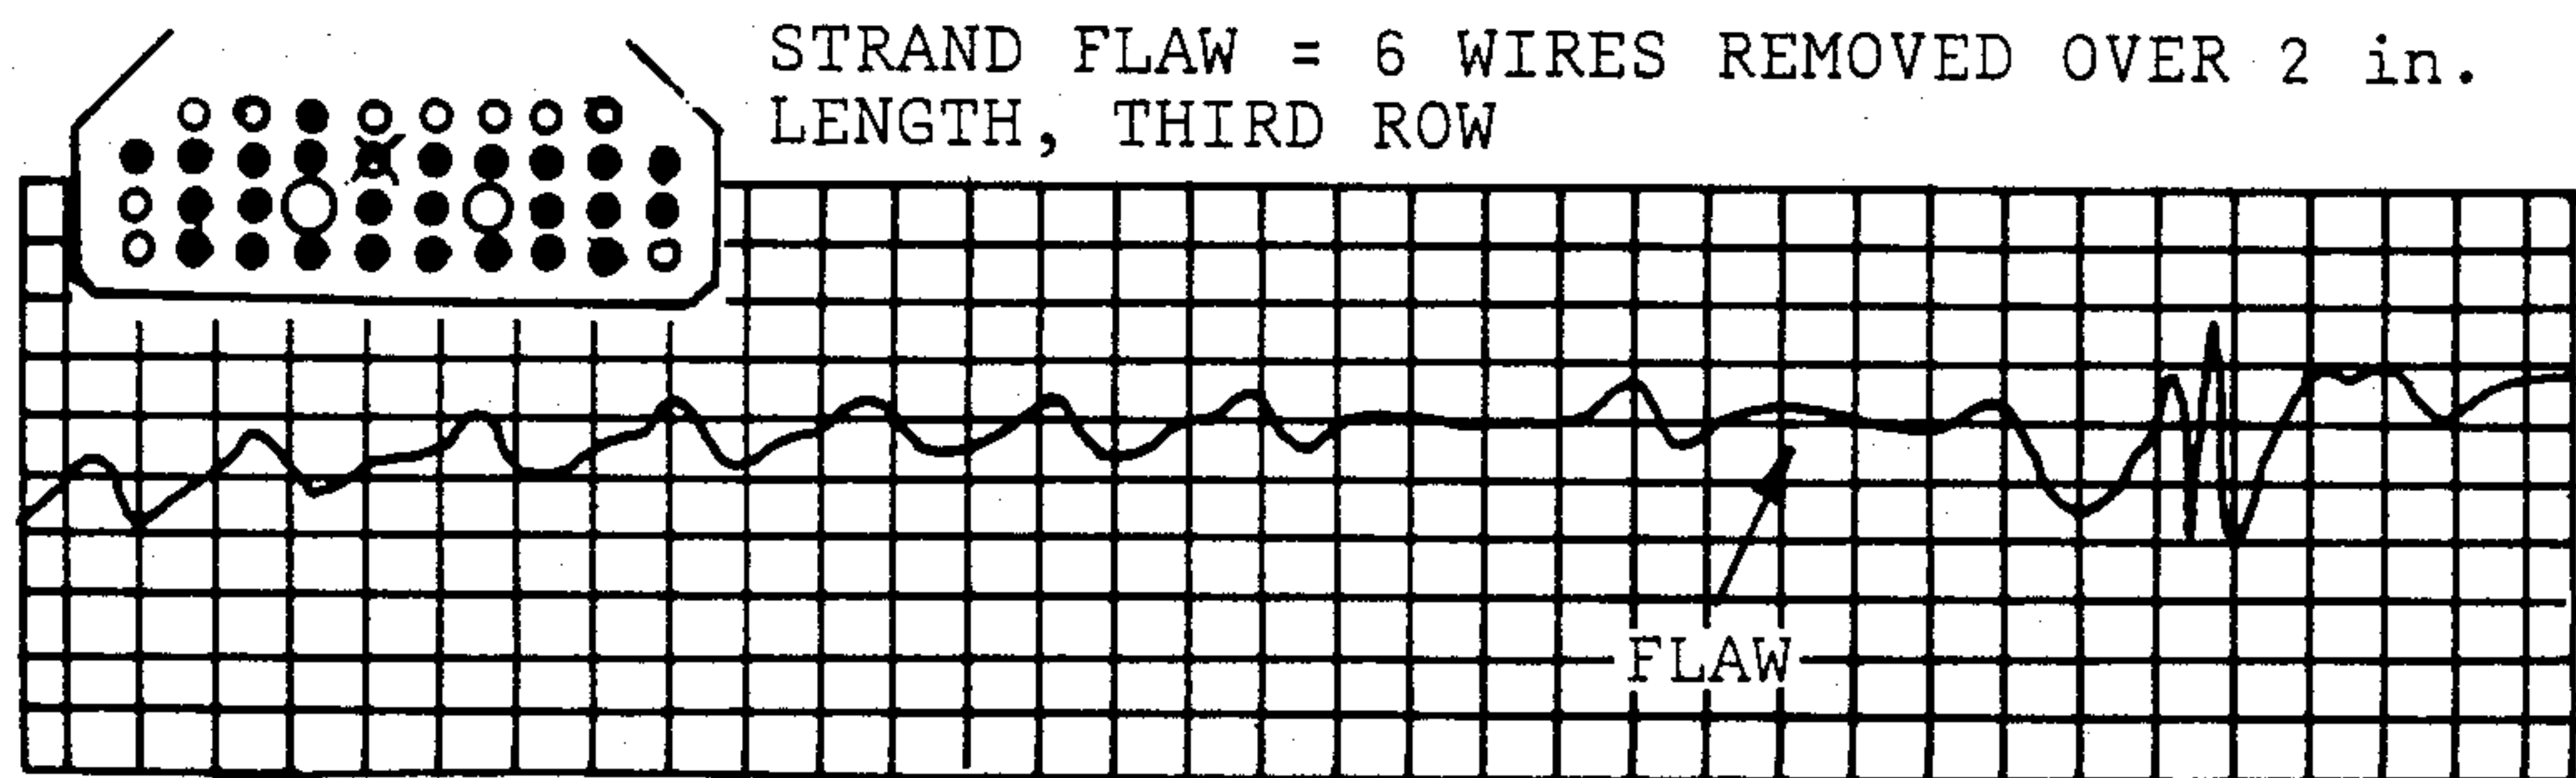
FIG.7A

FIGS. 7(a)–(d) show the effect of position within the strand matrix.
