[54] MAGNETIC INSPECTION OF REINFORCING STEEL USING SENSOR ARRAY

[73] Assignee: The United States of America as represented by the Secretary of Transportation, Washington, D.C.

[57] ABSTRACT

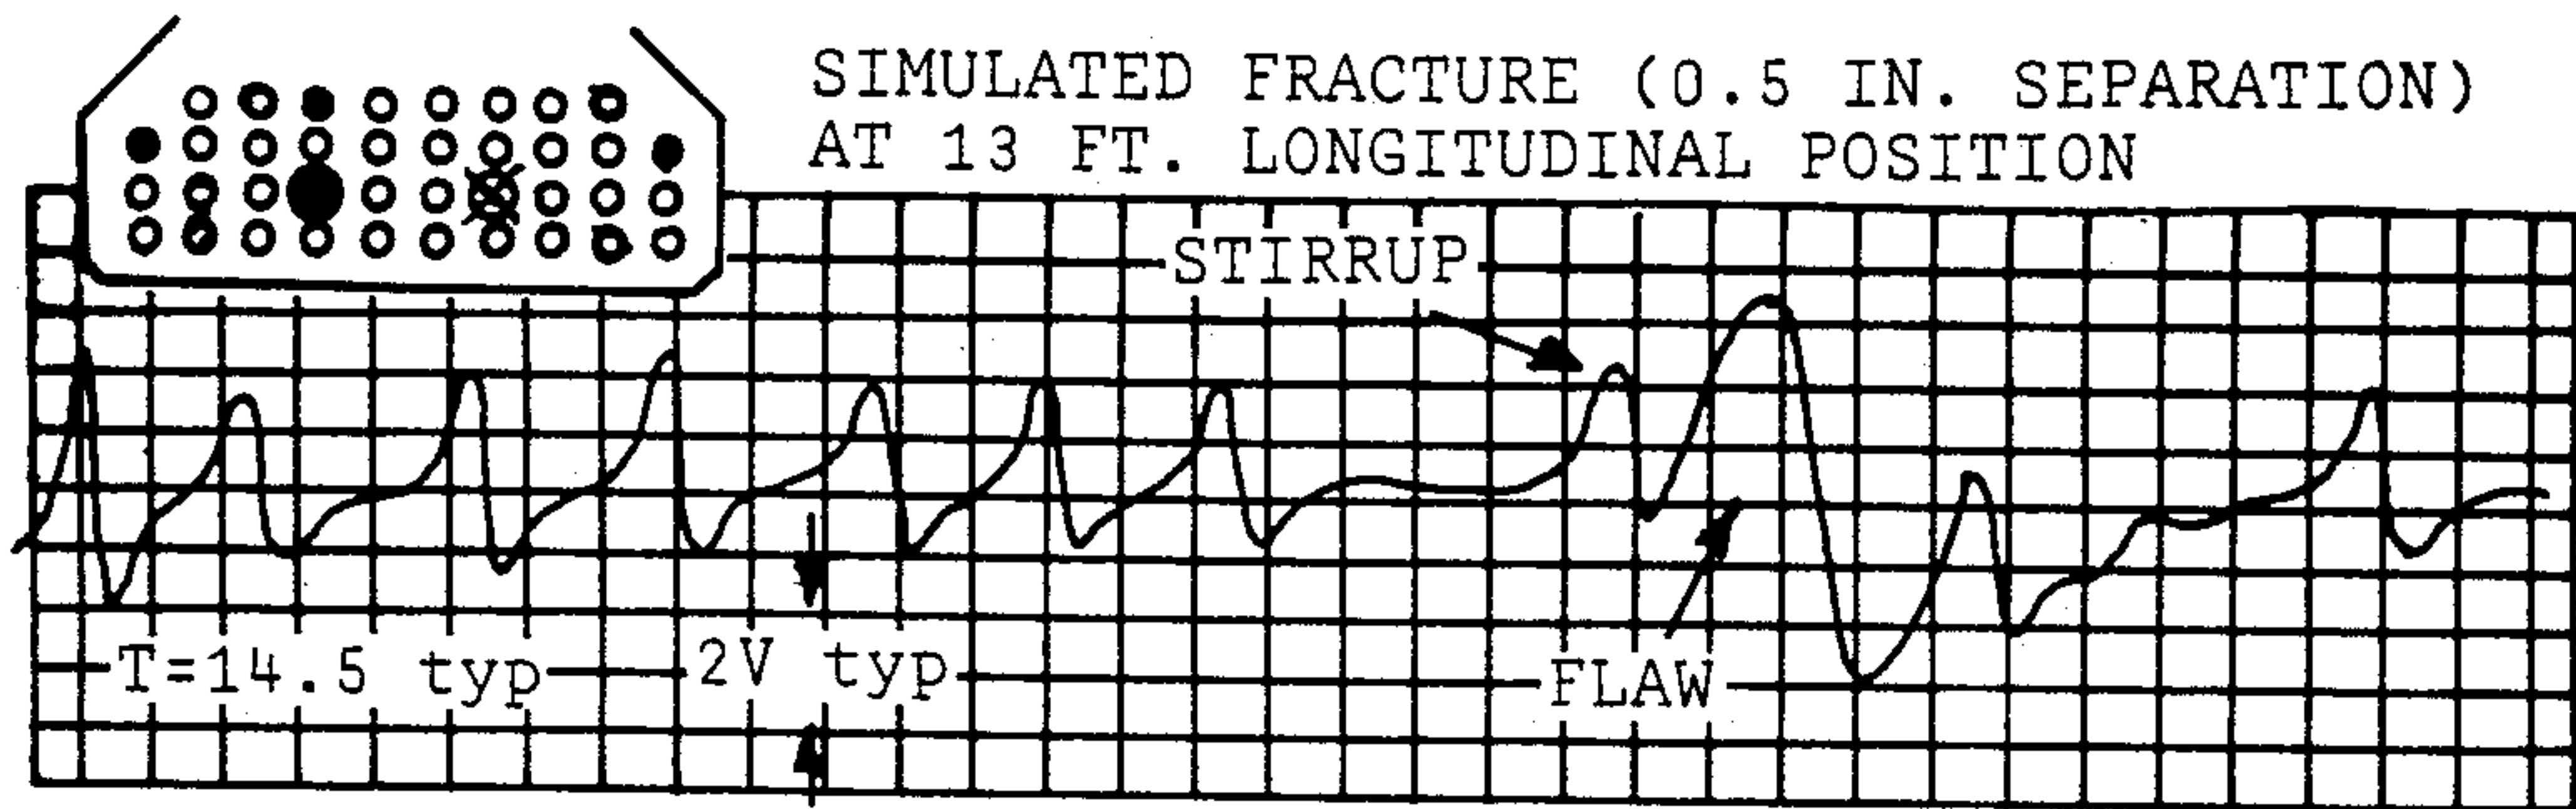
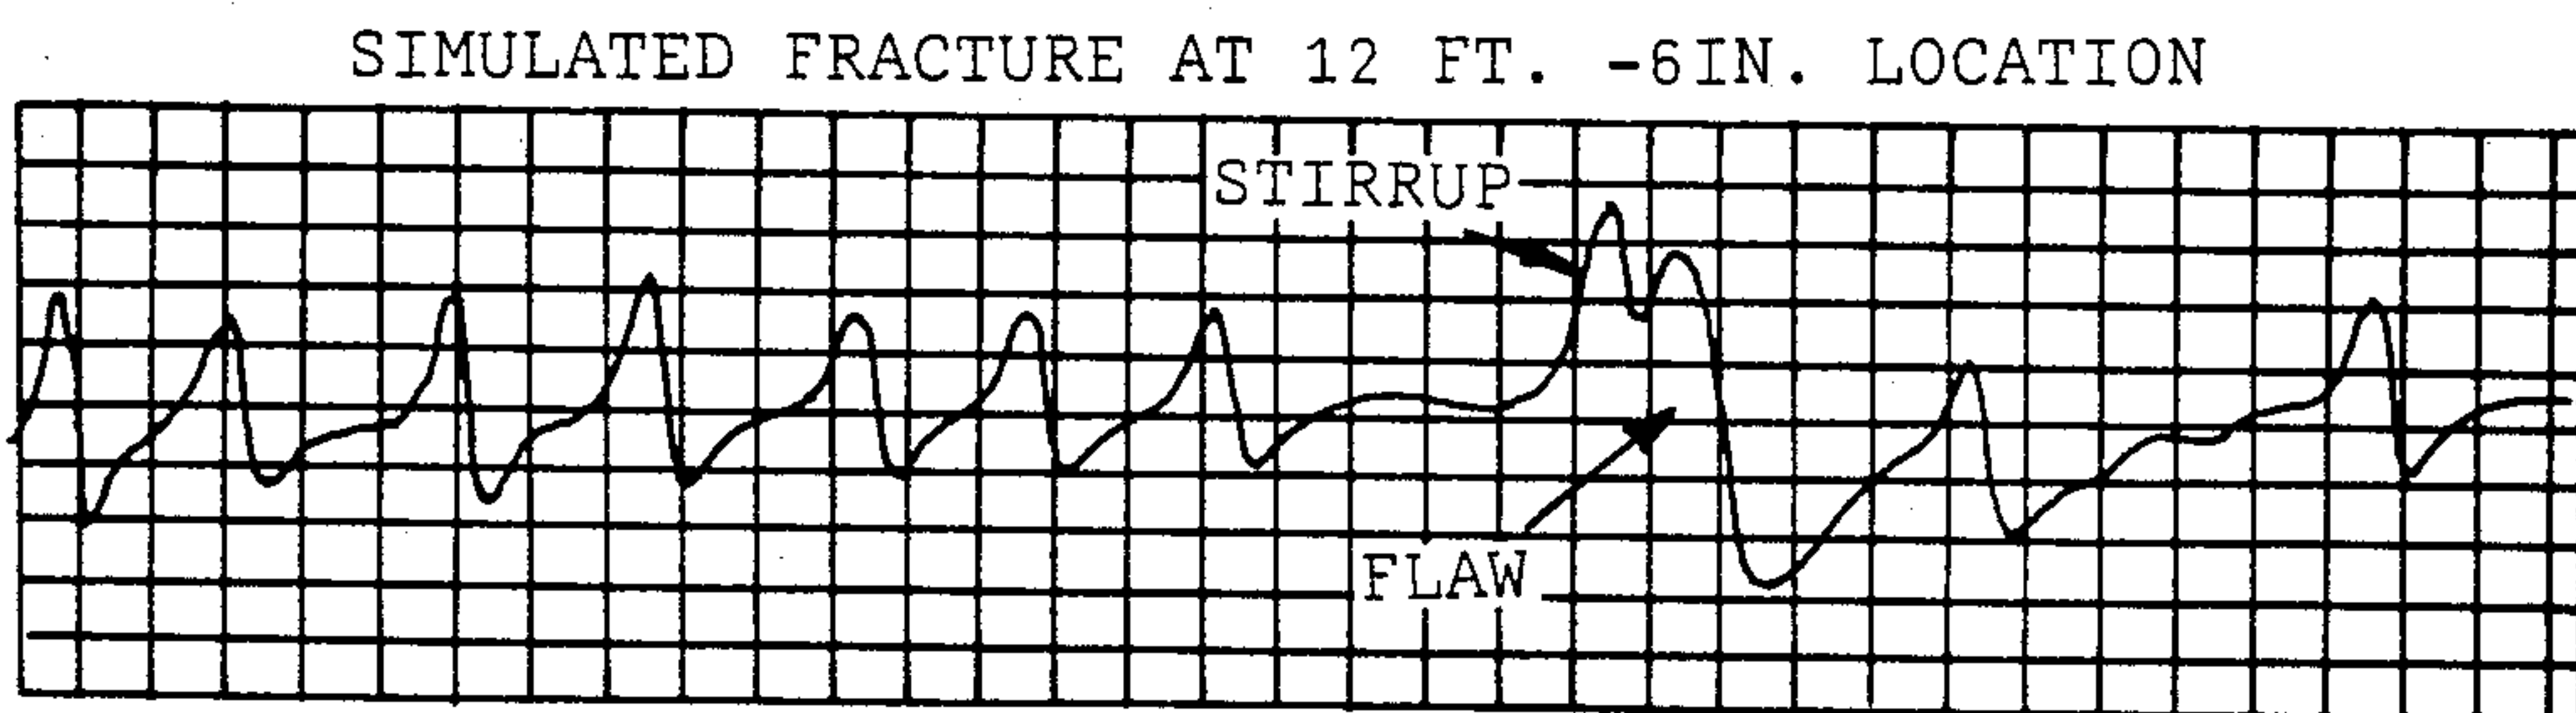
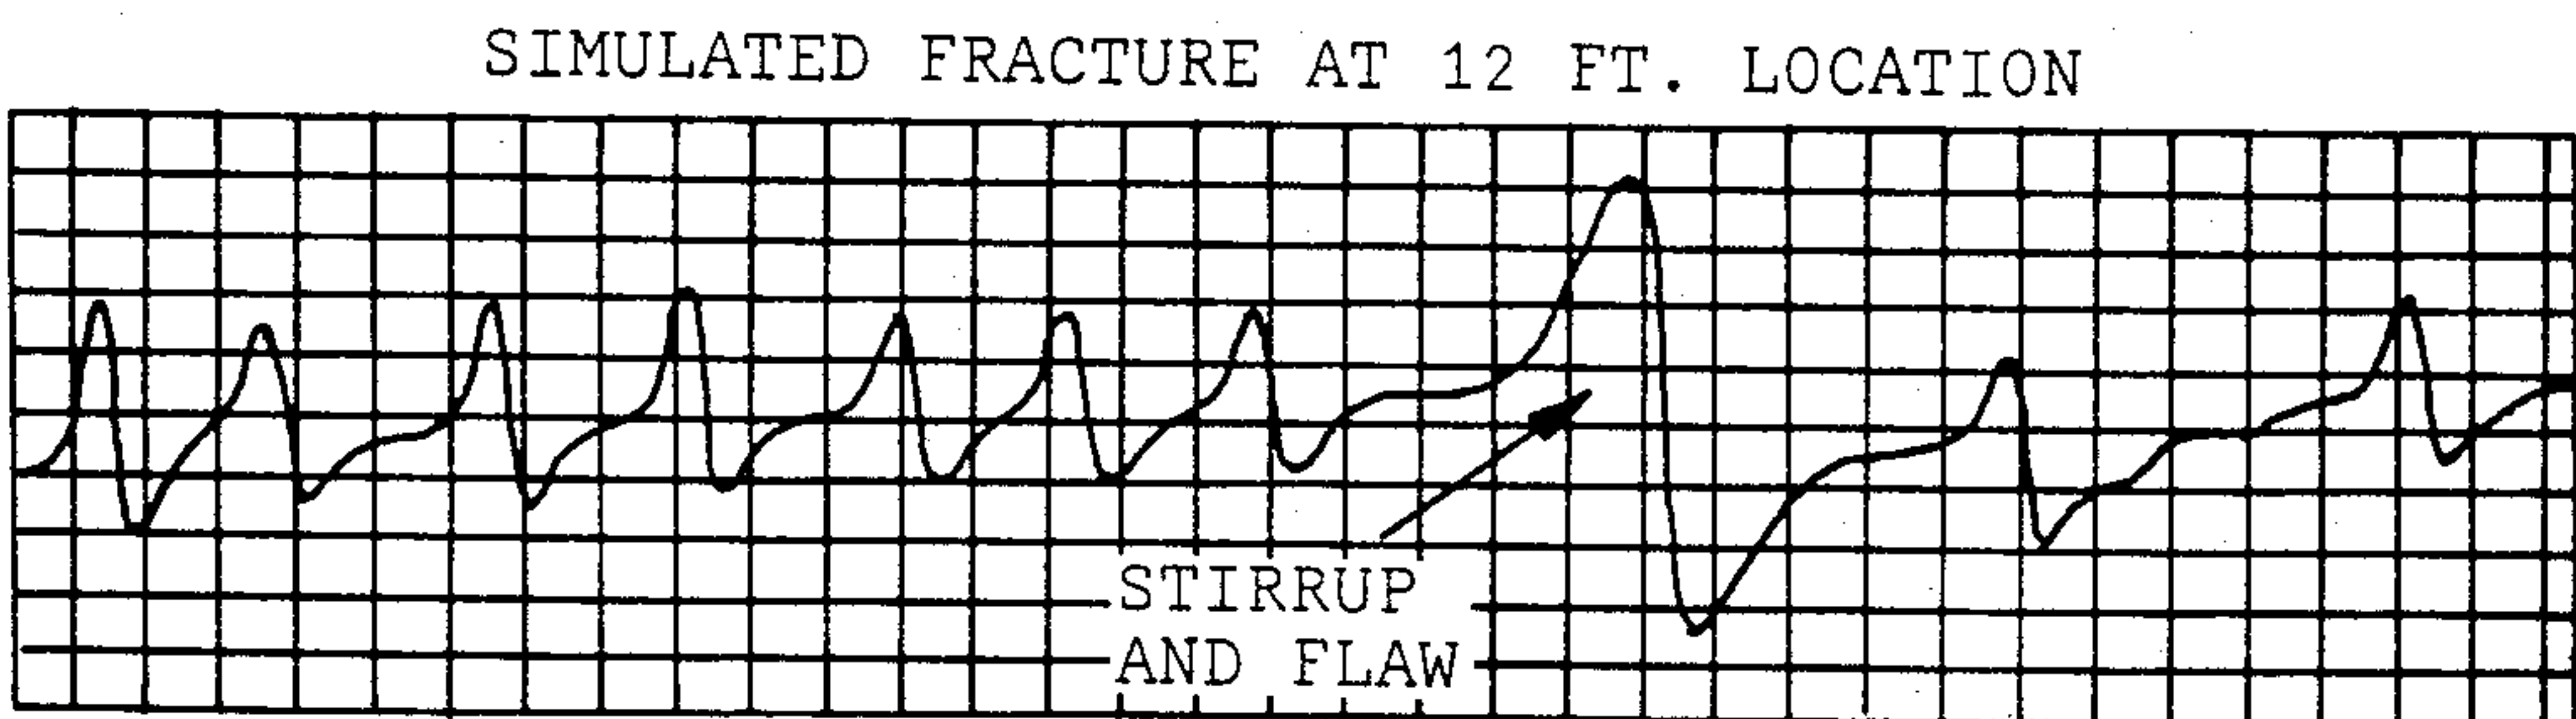
FIG.8A

FIGS. 8(a)–(c) show the effect of a transverse reinforcing member at varying distances from a flaw.

The influence of signatures from reinforcement steel details, such as stirrups, holdowns, etc., on flaw signature recognition is illustrated in FIGS. 8(a)-(c). FIGS. 8(b) and (c) indicate that the field anomalies from the combined steel and flaw configurations are essentially cumulative. The combined effects can significantly modify the amplitude and shape of the resulting signal; for example, note the greater amplitude and significantly reduced horizontal separation between the upward-going and downward-going peaks (peak separation) of the combined stirrup and flaw signature in FIG. 8(c) as compared with that for the flaw signature only in FIG. 8(a). Importantly, the outstanding signature from the simulated fracture (0.5-inch separation) illustrated in FIGS. 8(a)-(c) for a concrete coverage of approximately 3.5 inches indicates that such a condition should be readily detectable. However, the presence of other types of steel details as well as other complicating factors can significantly influence the interpretation of inspection data.

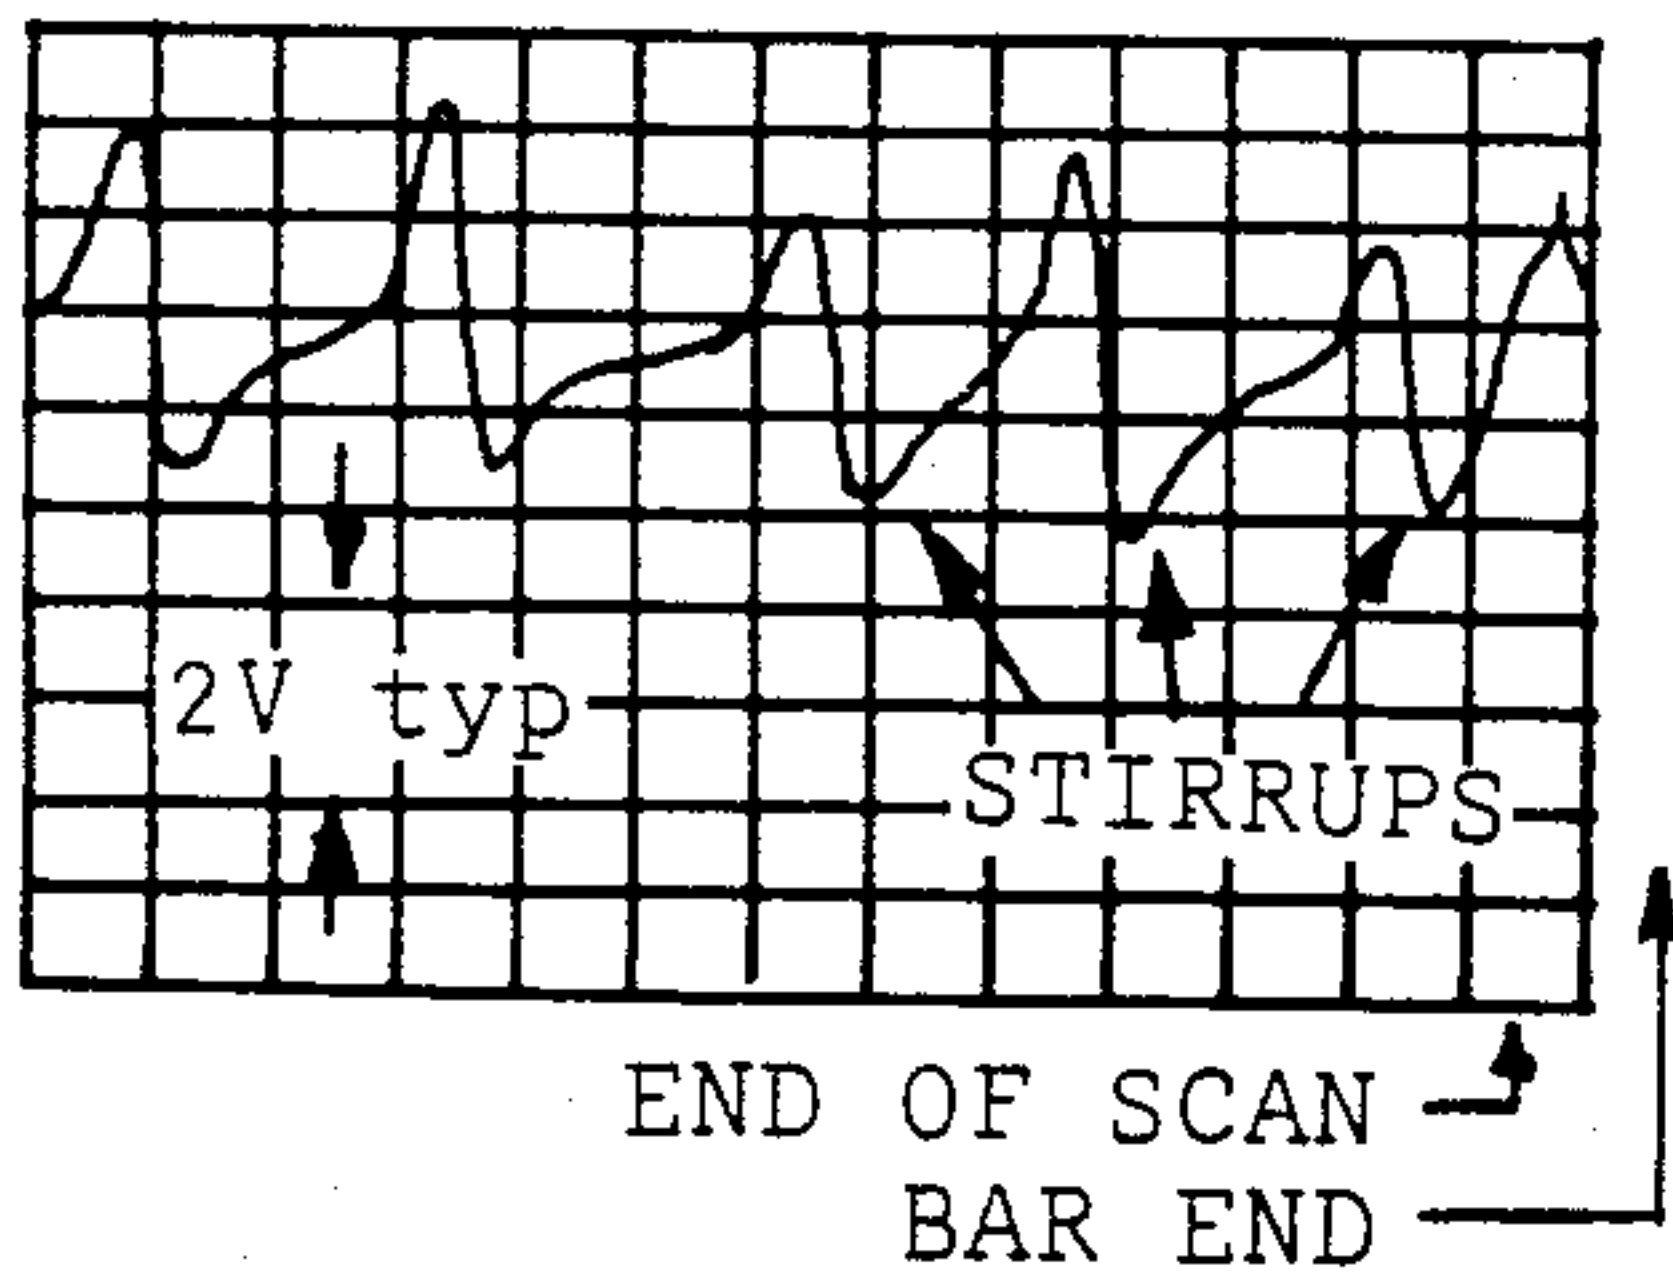
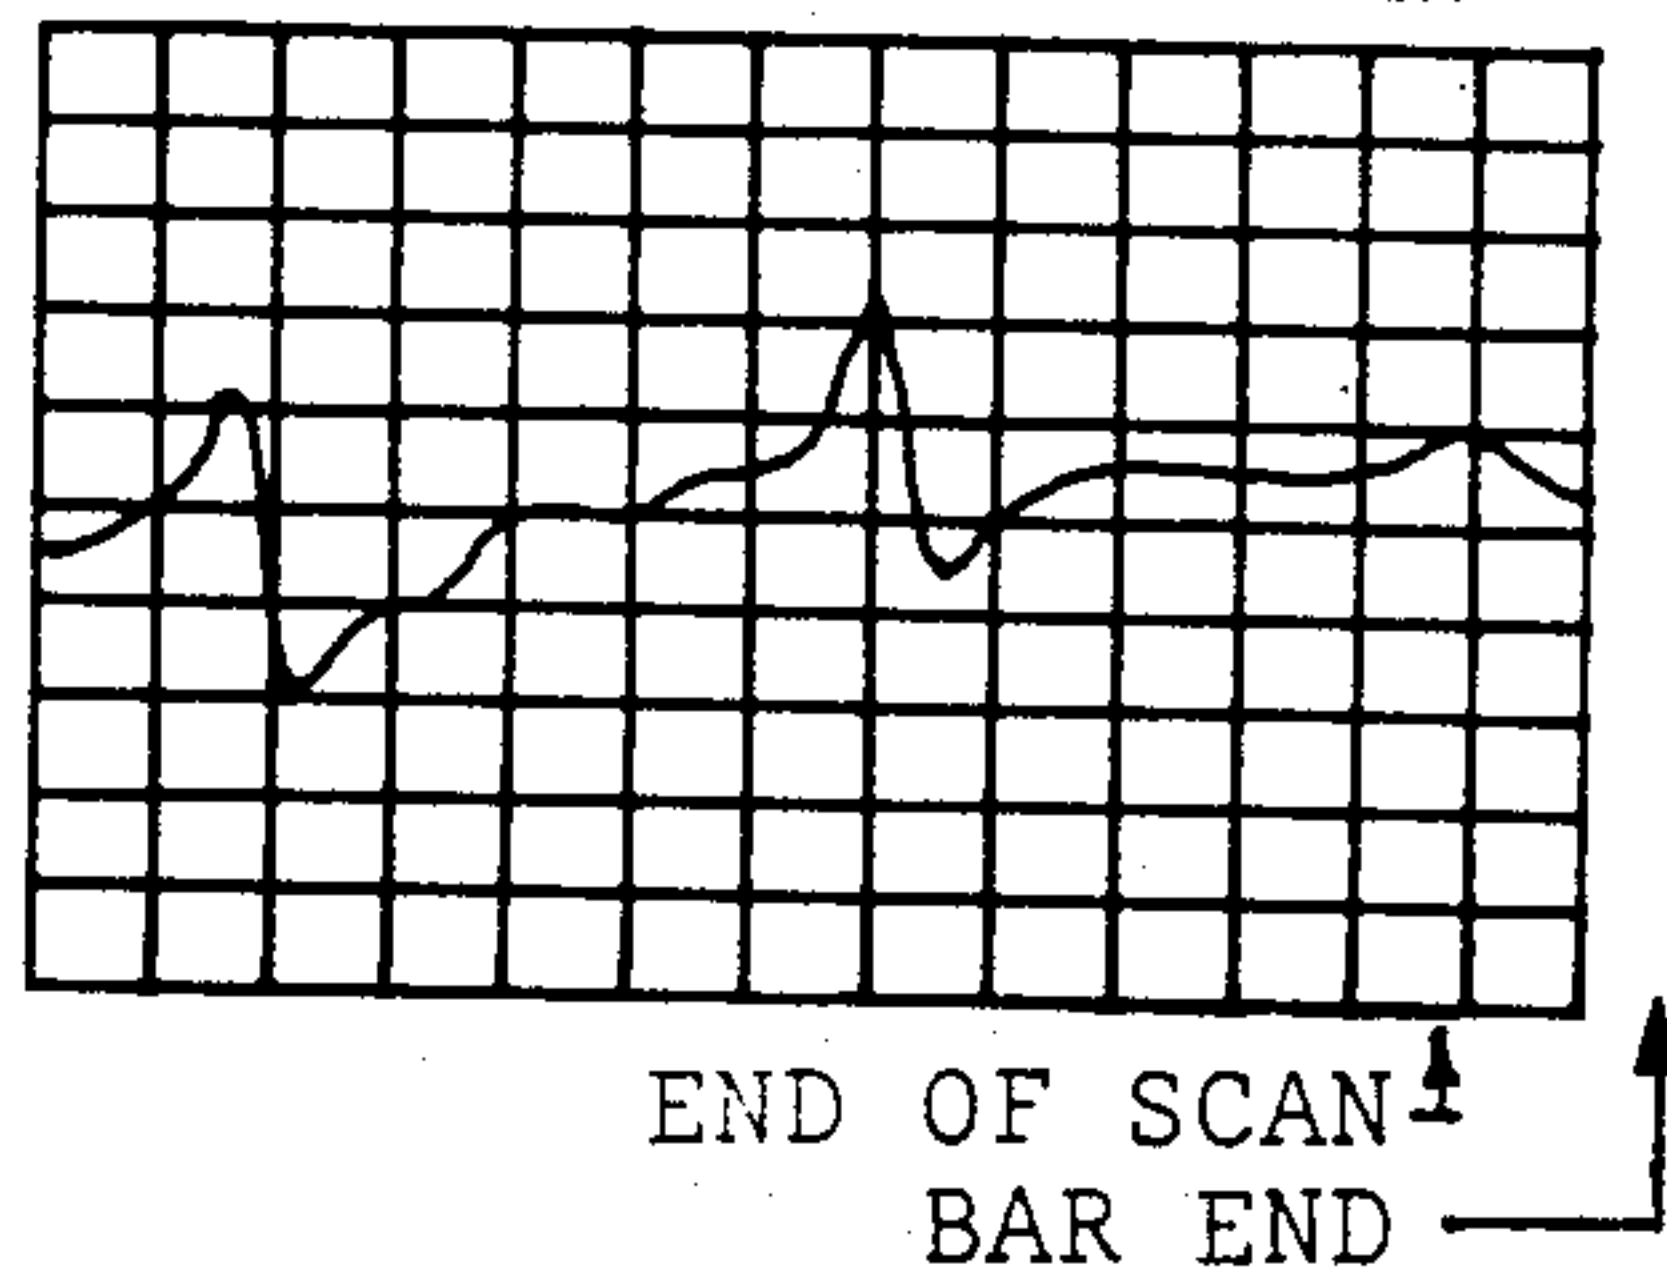
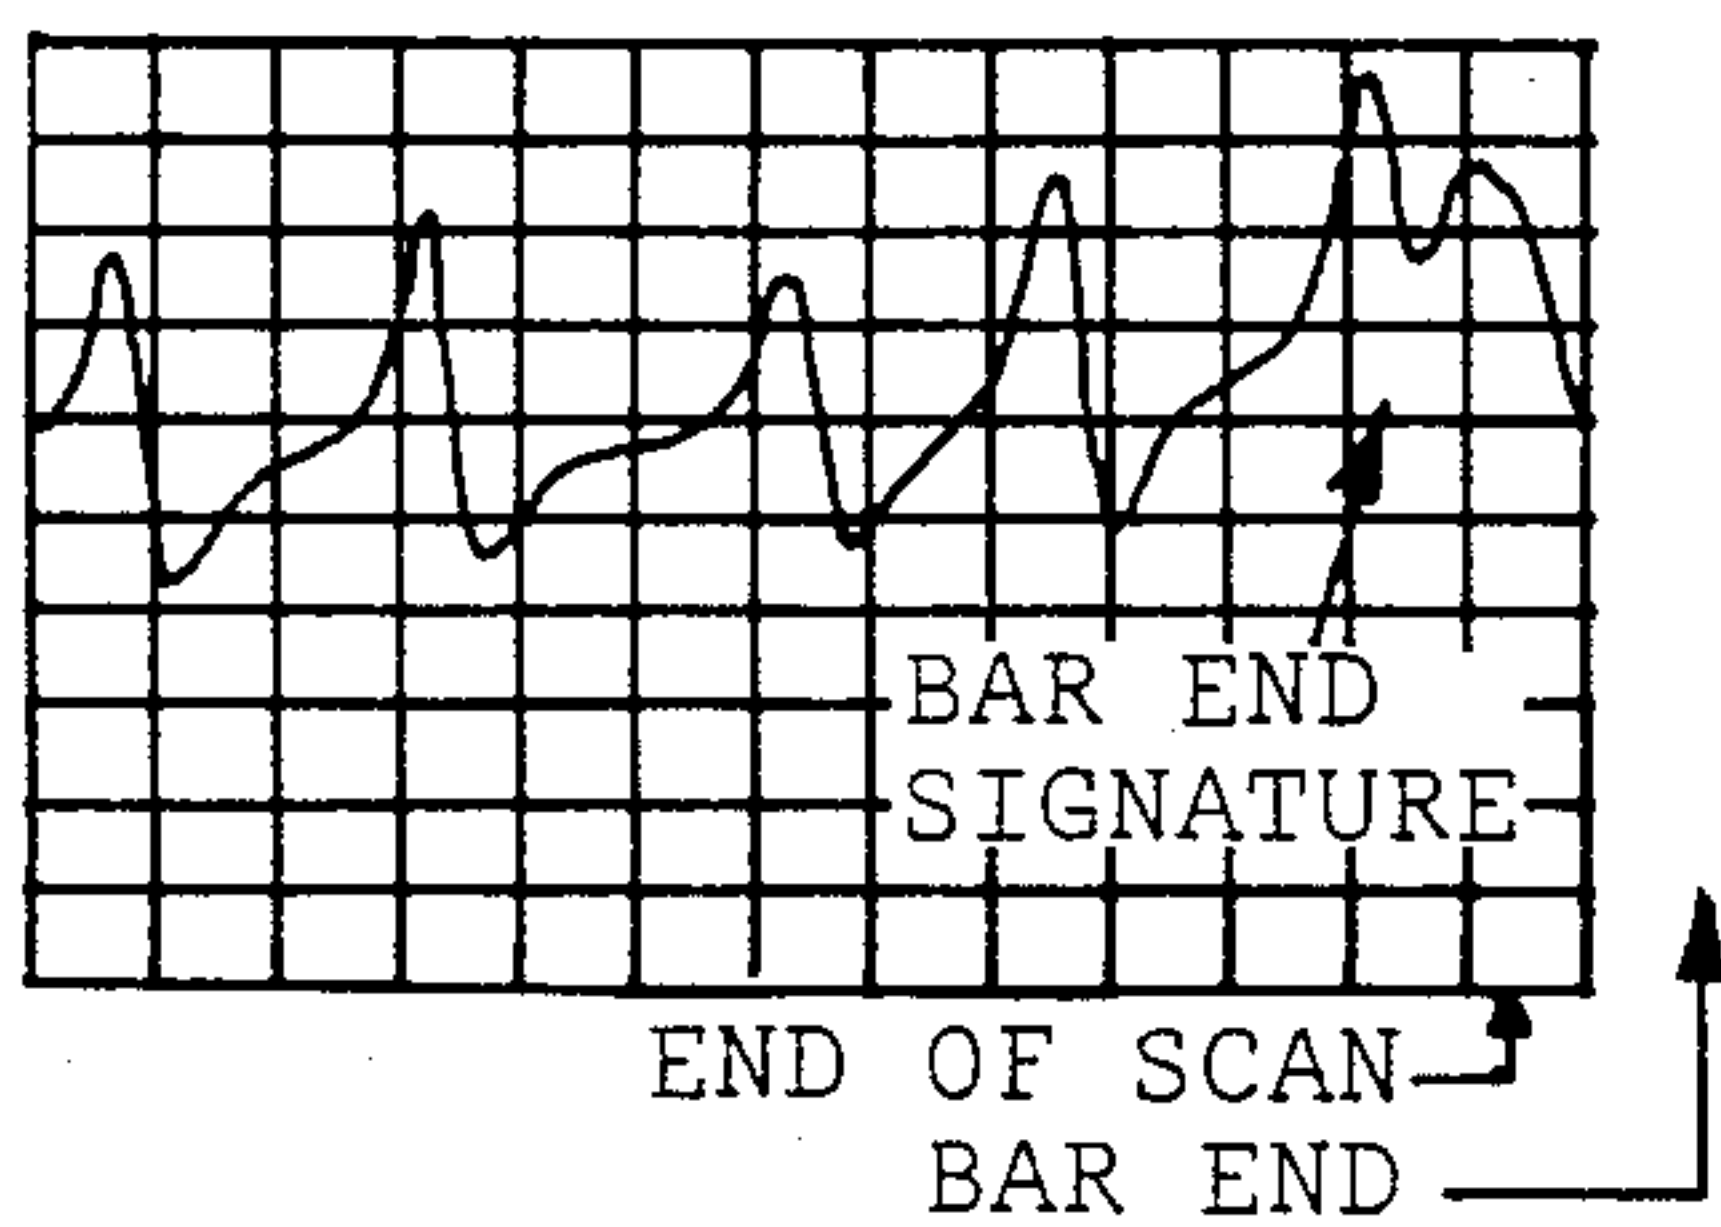
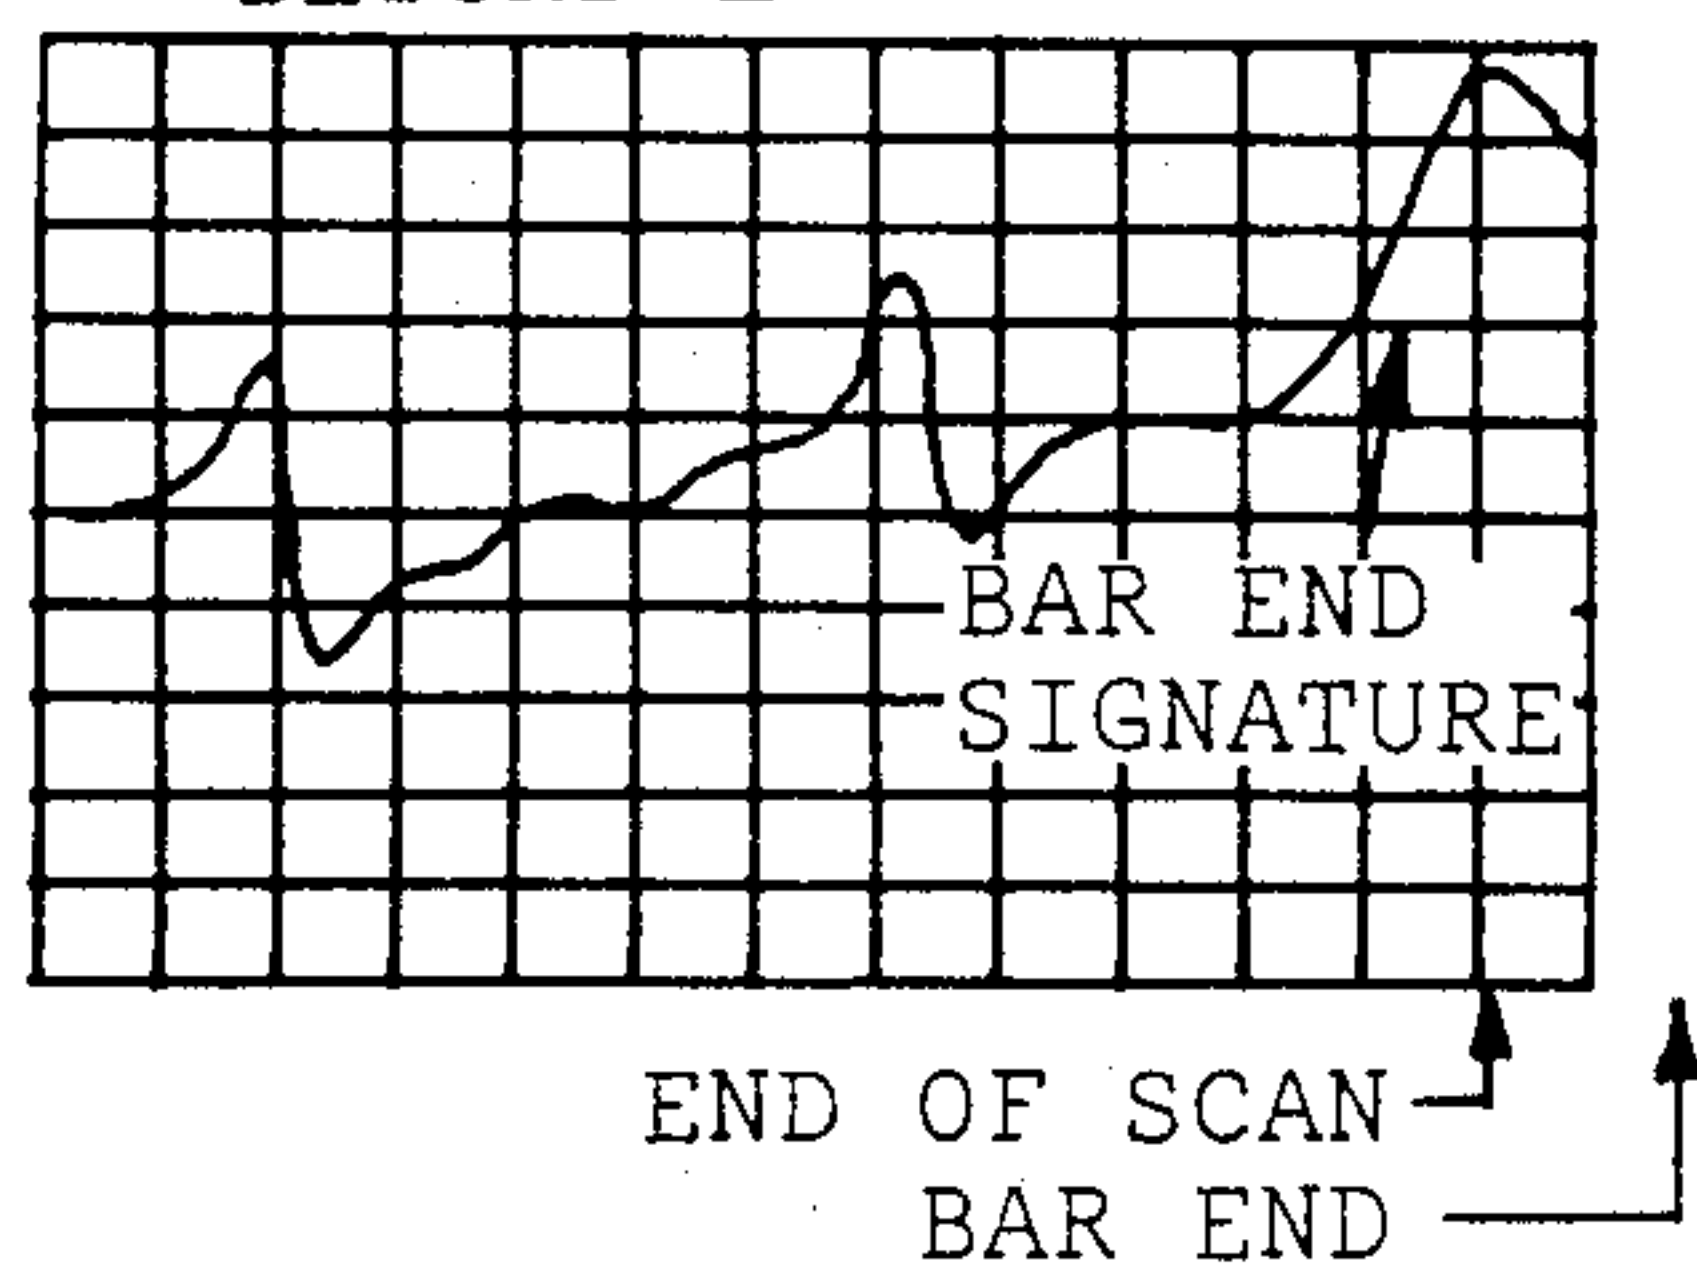
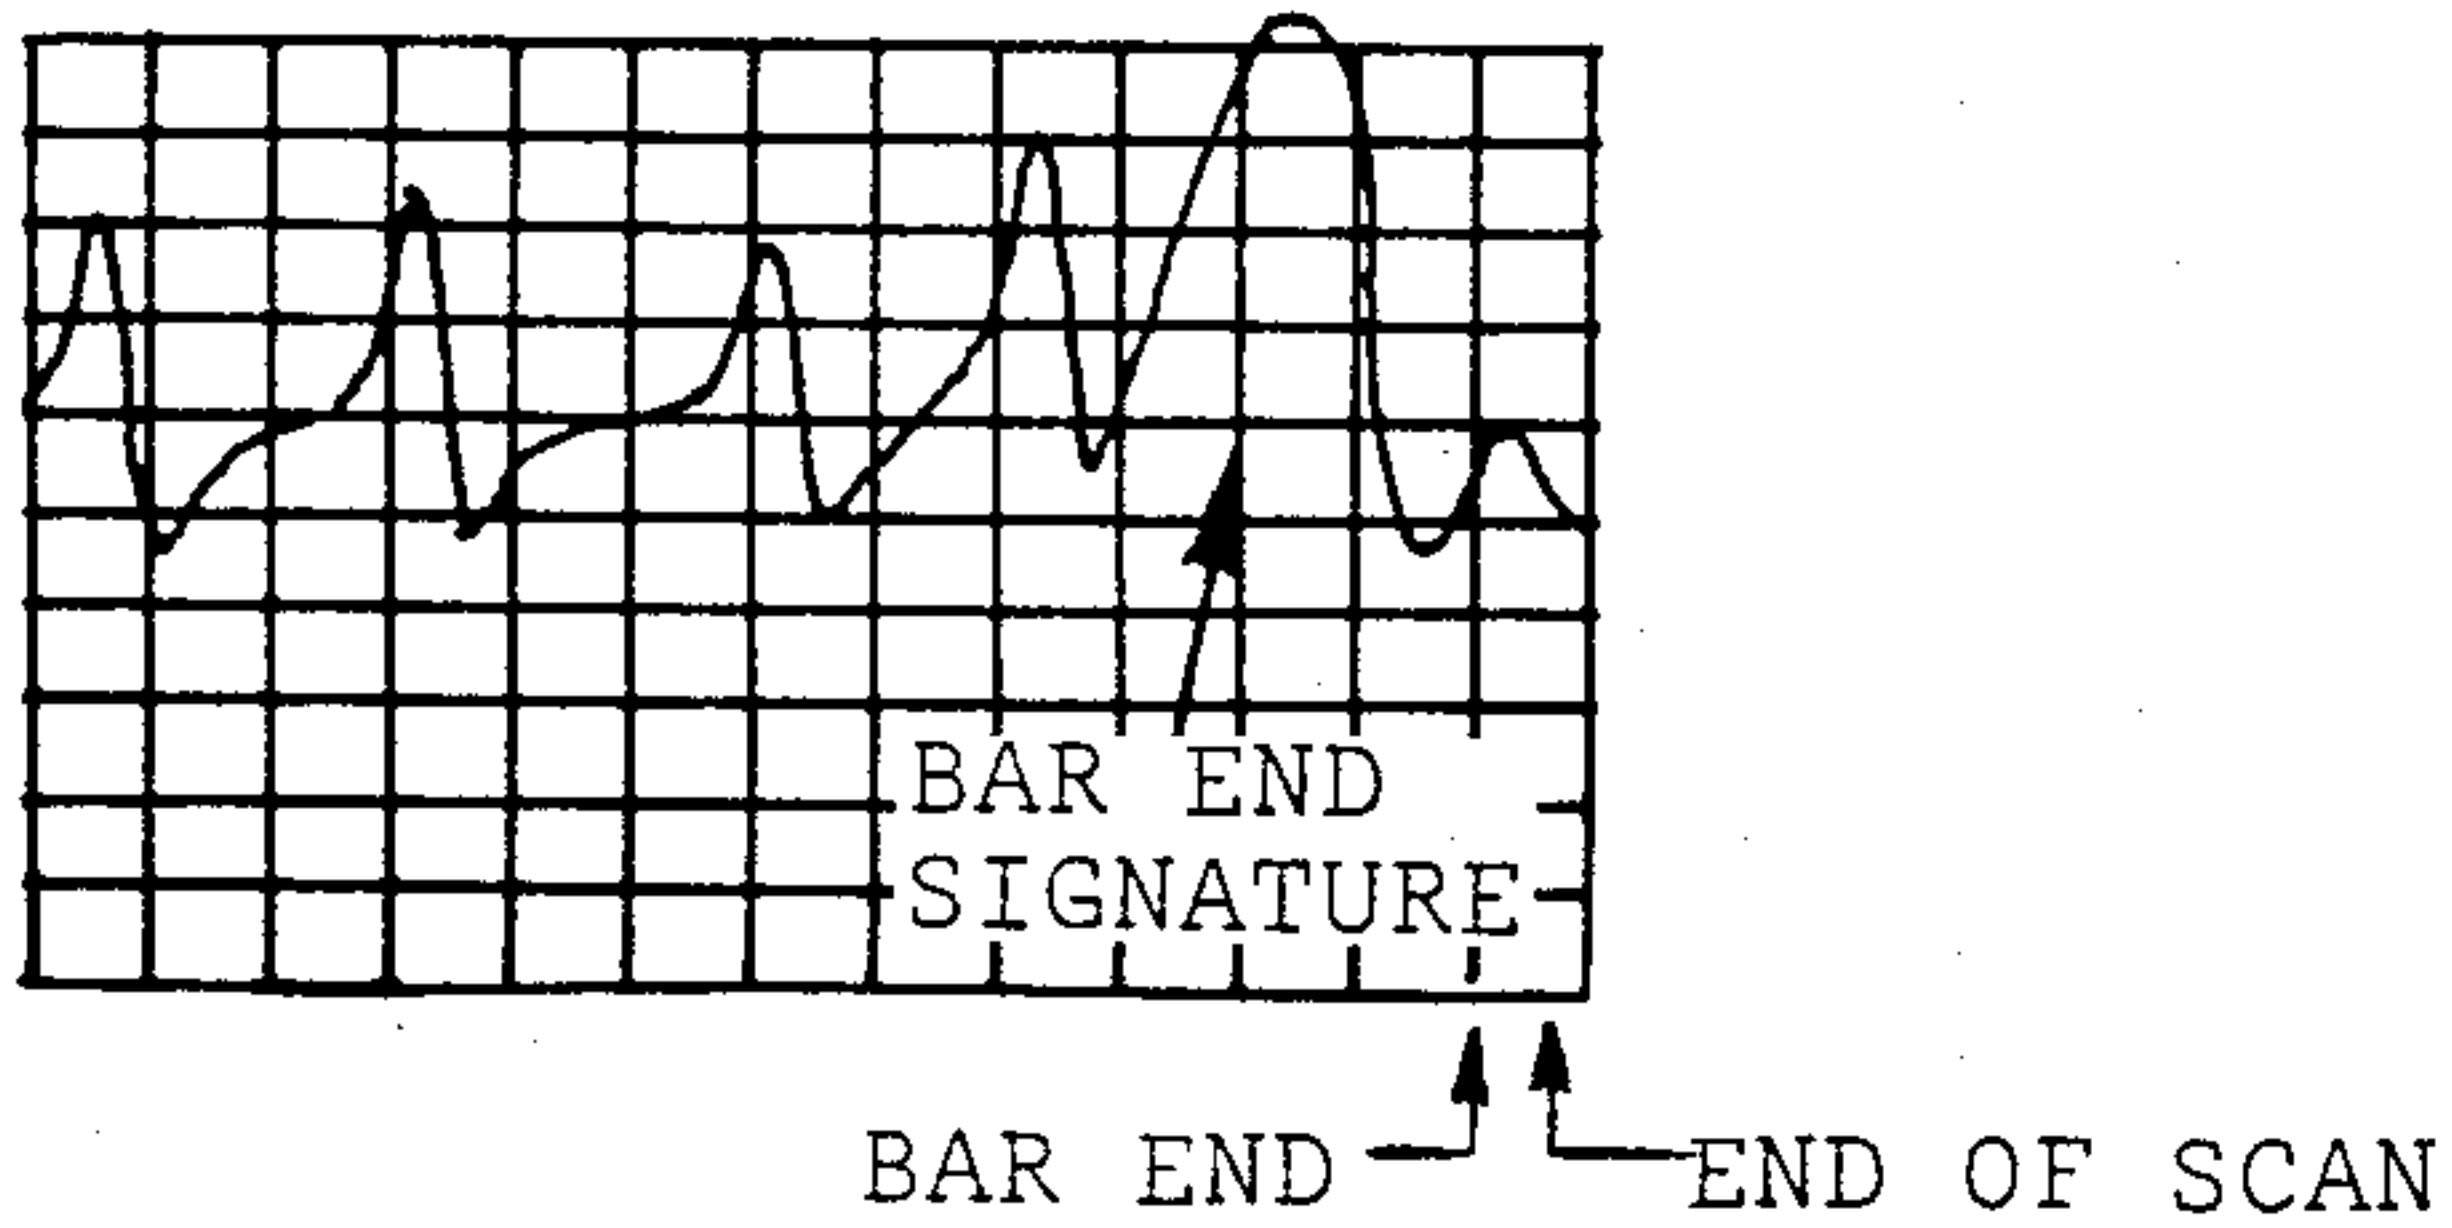
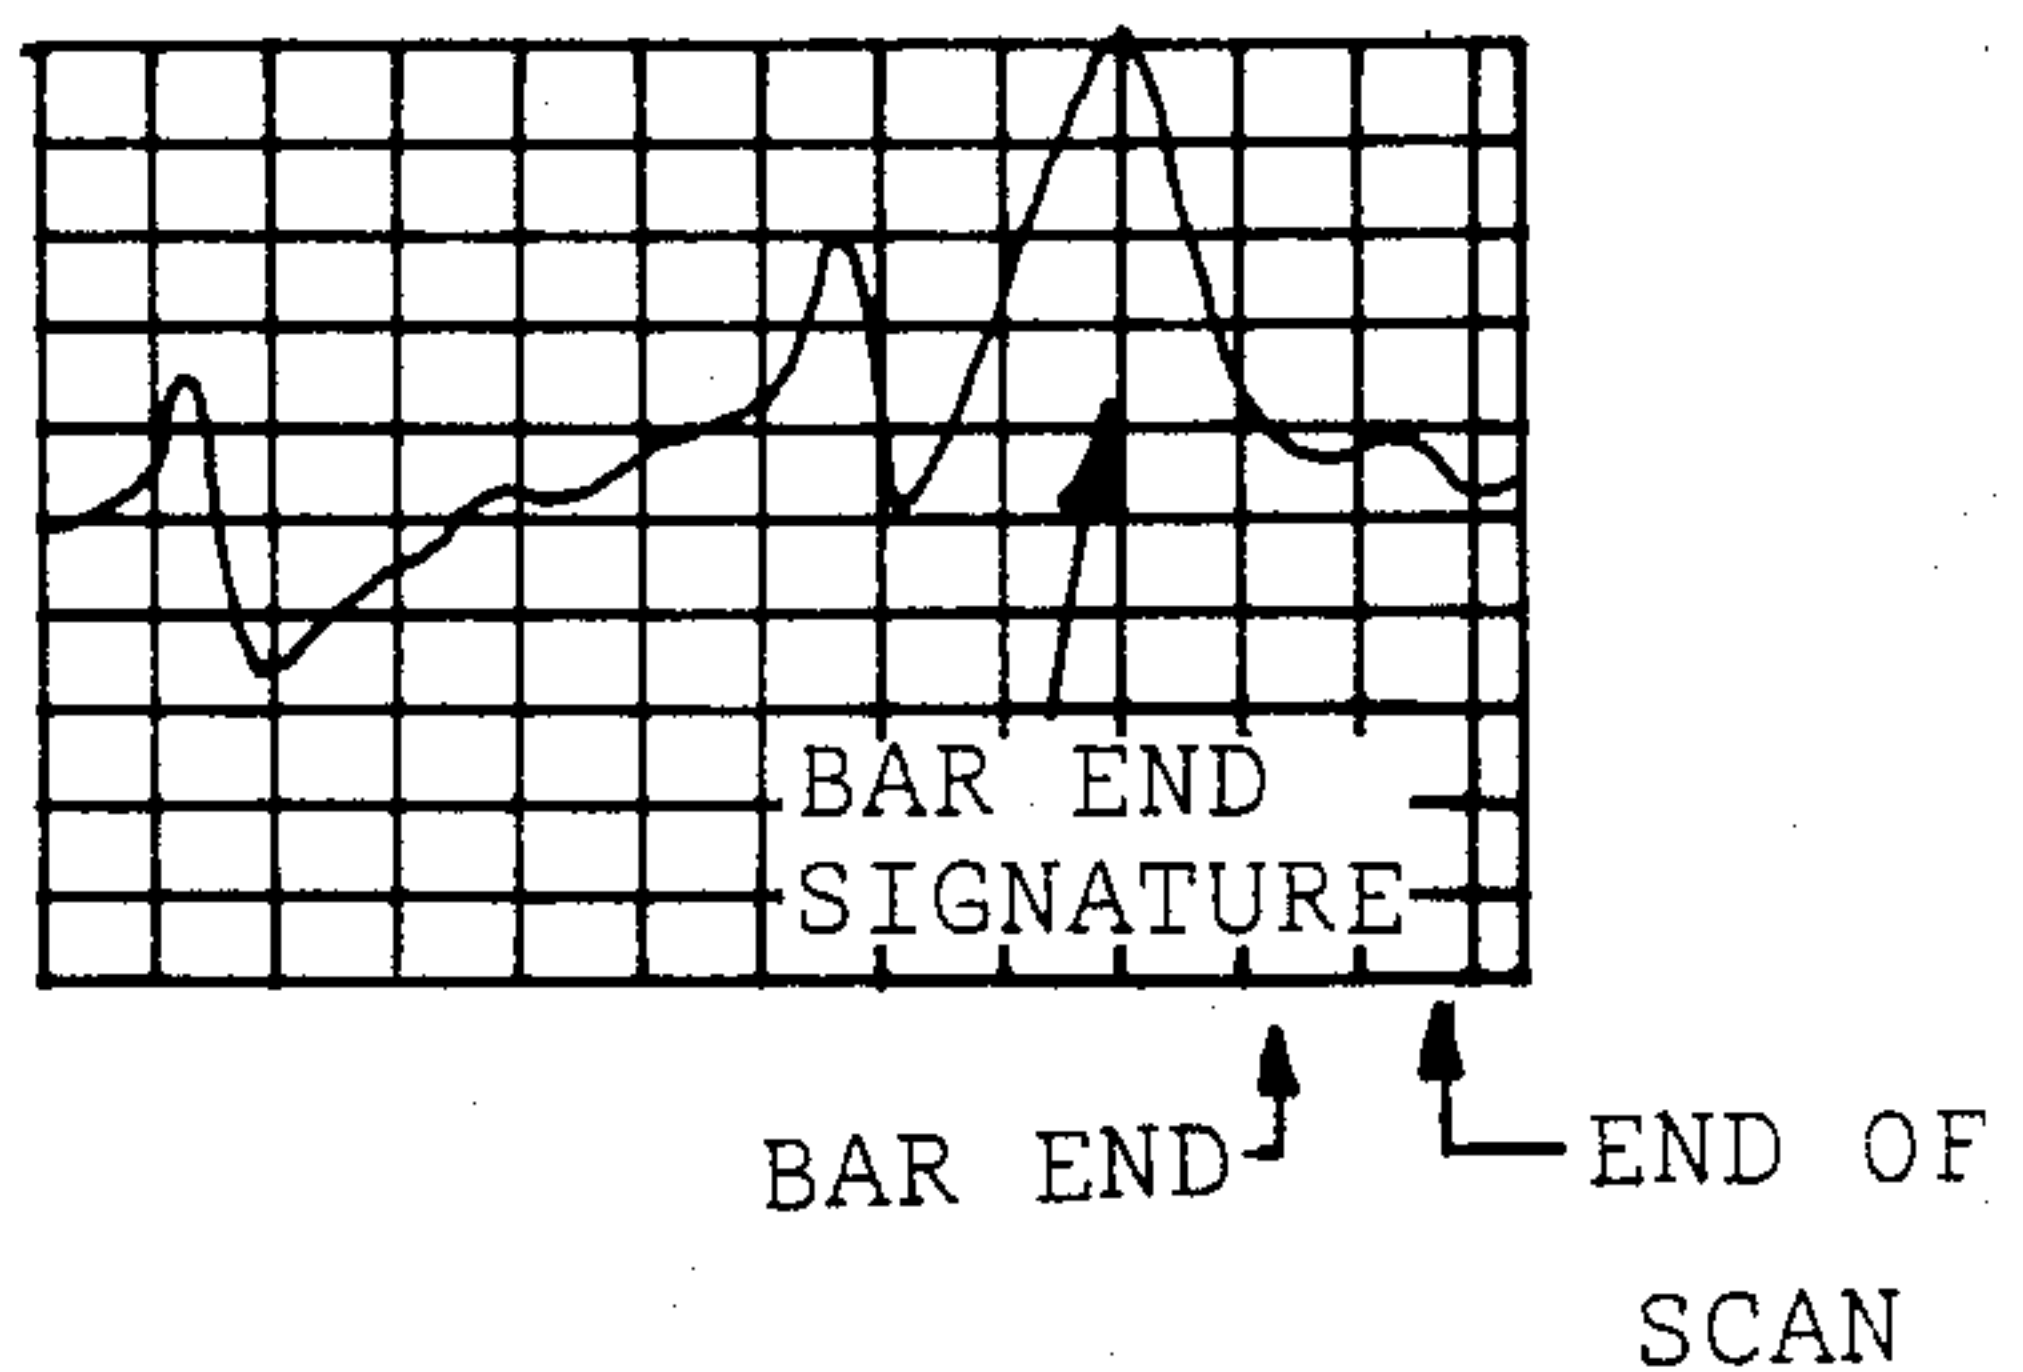
FIG.9A

BEAM END (END A)

BAR END ~ 10 IN.
BEYOND END OF SCAN

BEAM MID-SPAN (END B)

BAR END ~ 18 IN.
BEYOND END OF SCAN

BAR END ~ 4 IN.
BEYOND END OF SCAN

BAR END ~ 6 IN.
BEYOND END OF SCAN

BAR END ~ 2 IN.
BEFORE END OF SCAN

BAR END ~ 6 IN.
BEFORE END OF SCAN

FIGS. 9(a)–(f) show the signatures obtained at the end of a beam or scan.

FIGS. 9(a)-(f) show records illustrating detection of deterioration (flaw condition) near the end of a beam which is resting on a bent such that an inspection scan to the end of the beam is not possible. The test beam was made so that the reinforcing steel configuration in end A was that of the end of the beam and end B was that of the middle of the beam; thus the results for end B simulate the results for the middle of a real beam. This was done because the catenary duct is much closer to the bottom of the beam at the middle than at the two ends

and may have a greater effect on the magnetic field at the middle of the beam than at the two ends. The results in FIGS. 9(a)-(f) indicate that the presence of a significant flaw (such as a bar fracture with 0.5 inch separation) can be detected even though the sensor cannot be placed directly beneath the flaw. Based on these results, it is estimated that a significant flaw can be detected when it is approximately 6 inches beyond the end of travel of the cart.
