[54] MAGNETIC INSPECTION OF REINFORCING STEEL USING SENSOR ARRAY

[73] Assignee: The United States of America as represented by the Secretary of Transportation, Washington, D.C.

[57] ABSTRACT

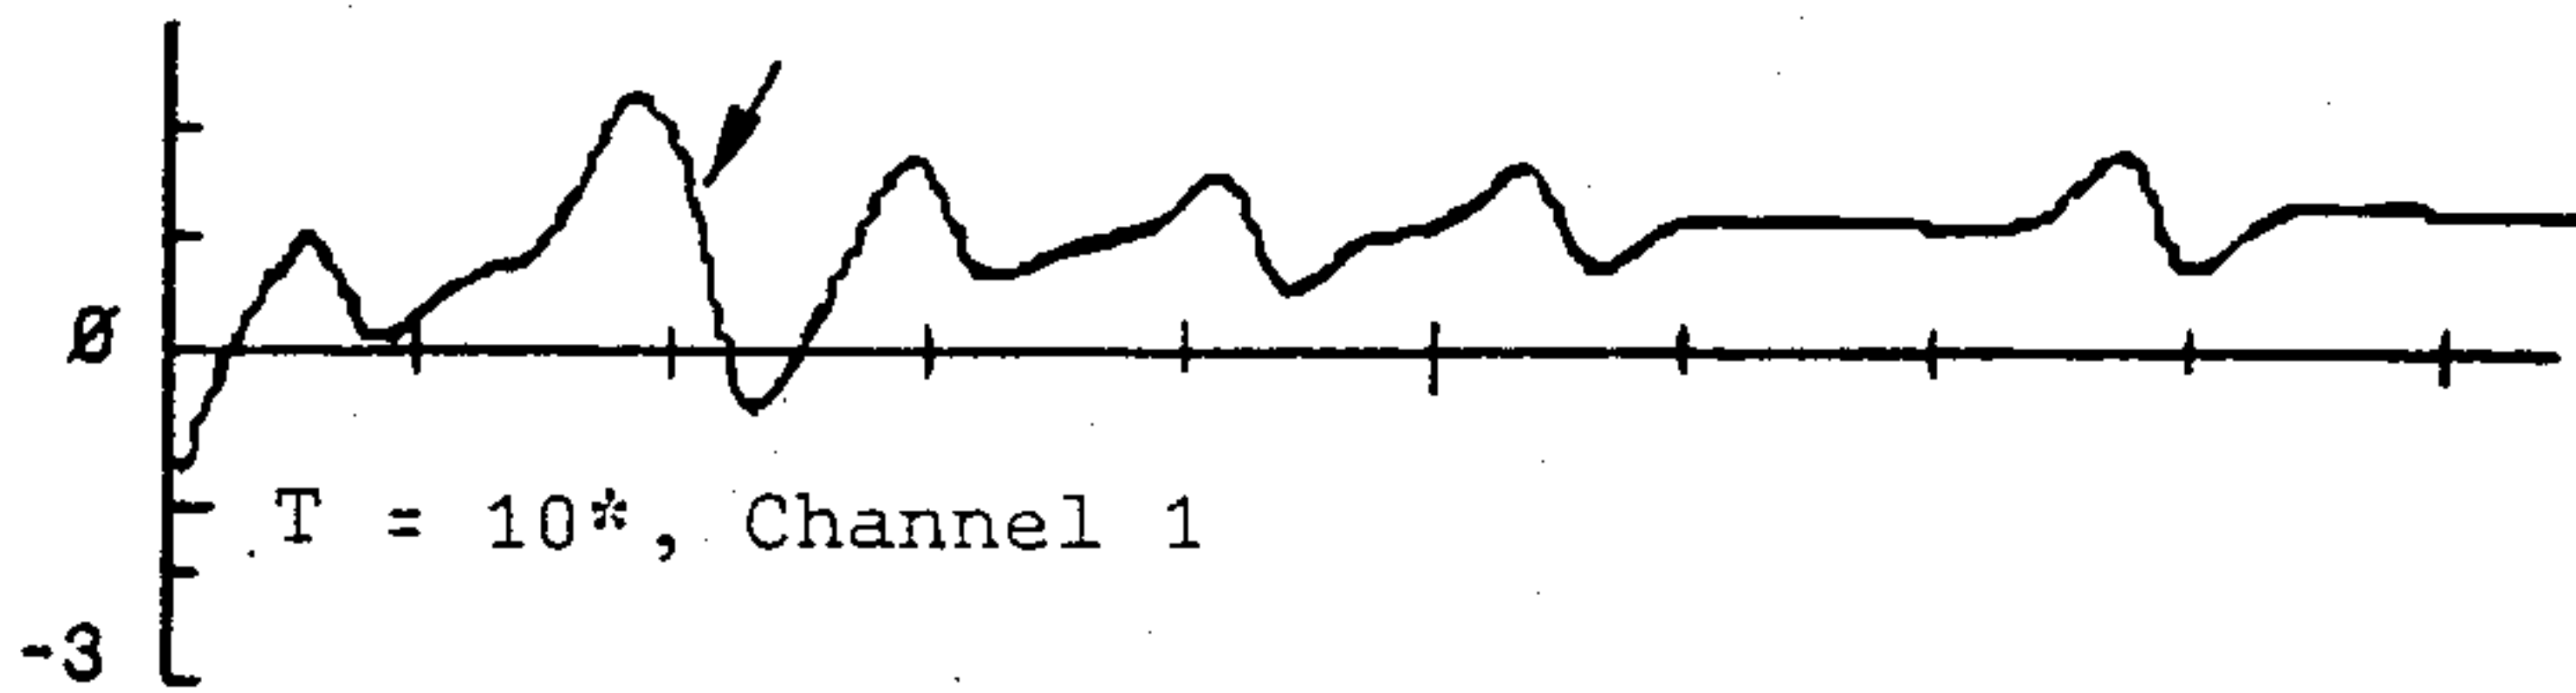
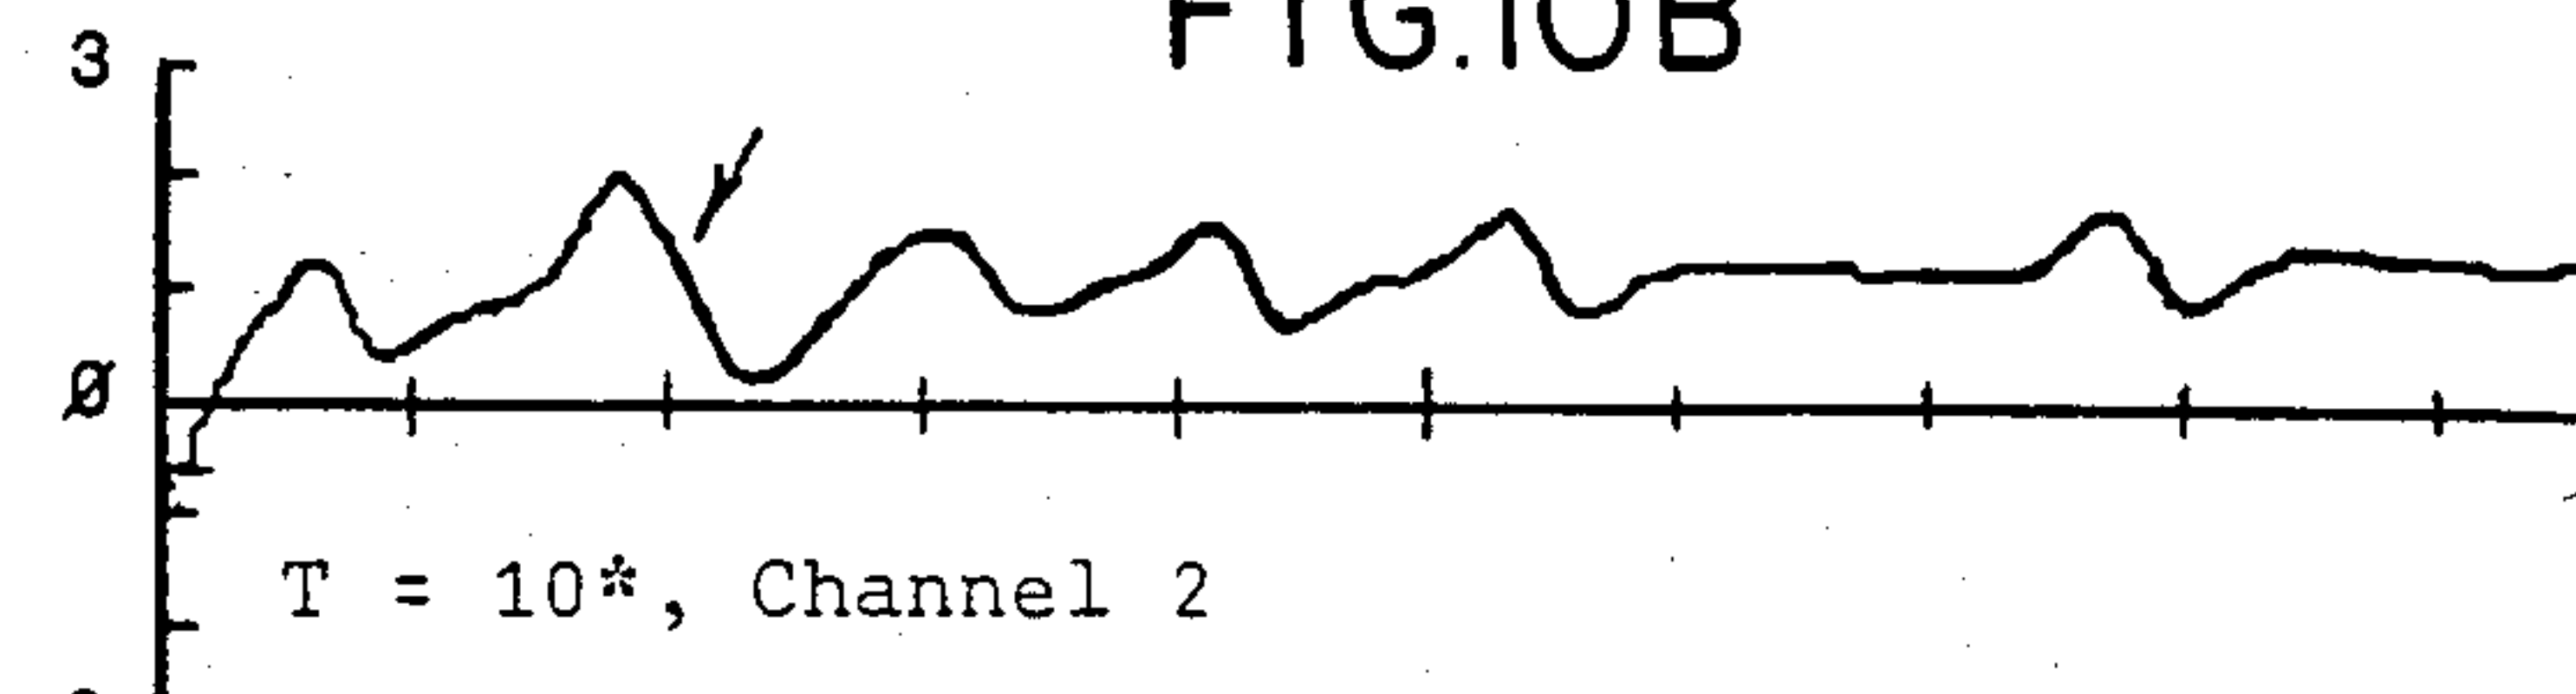
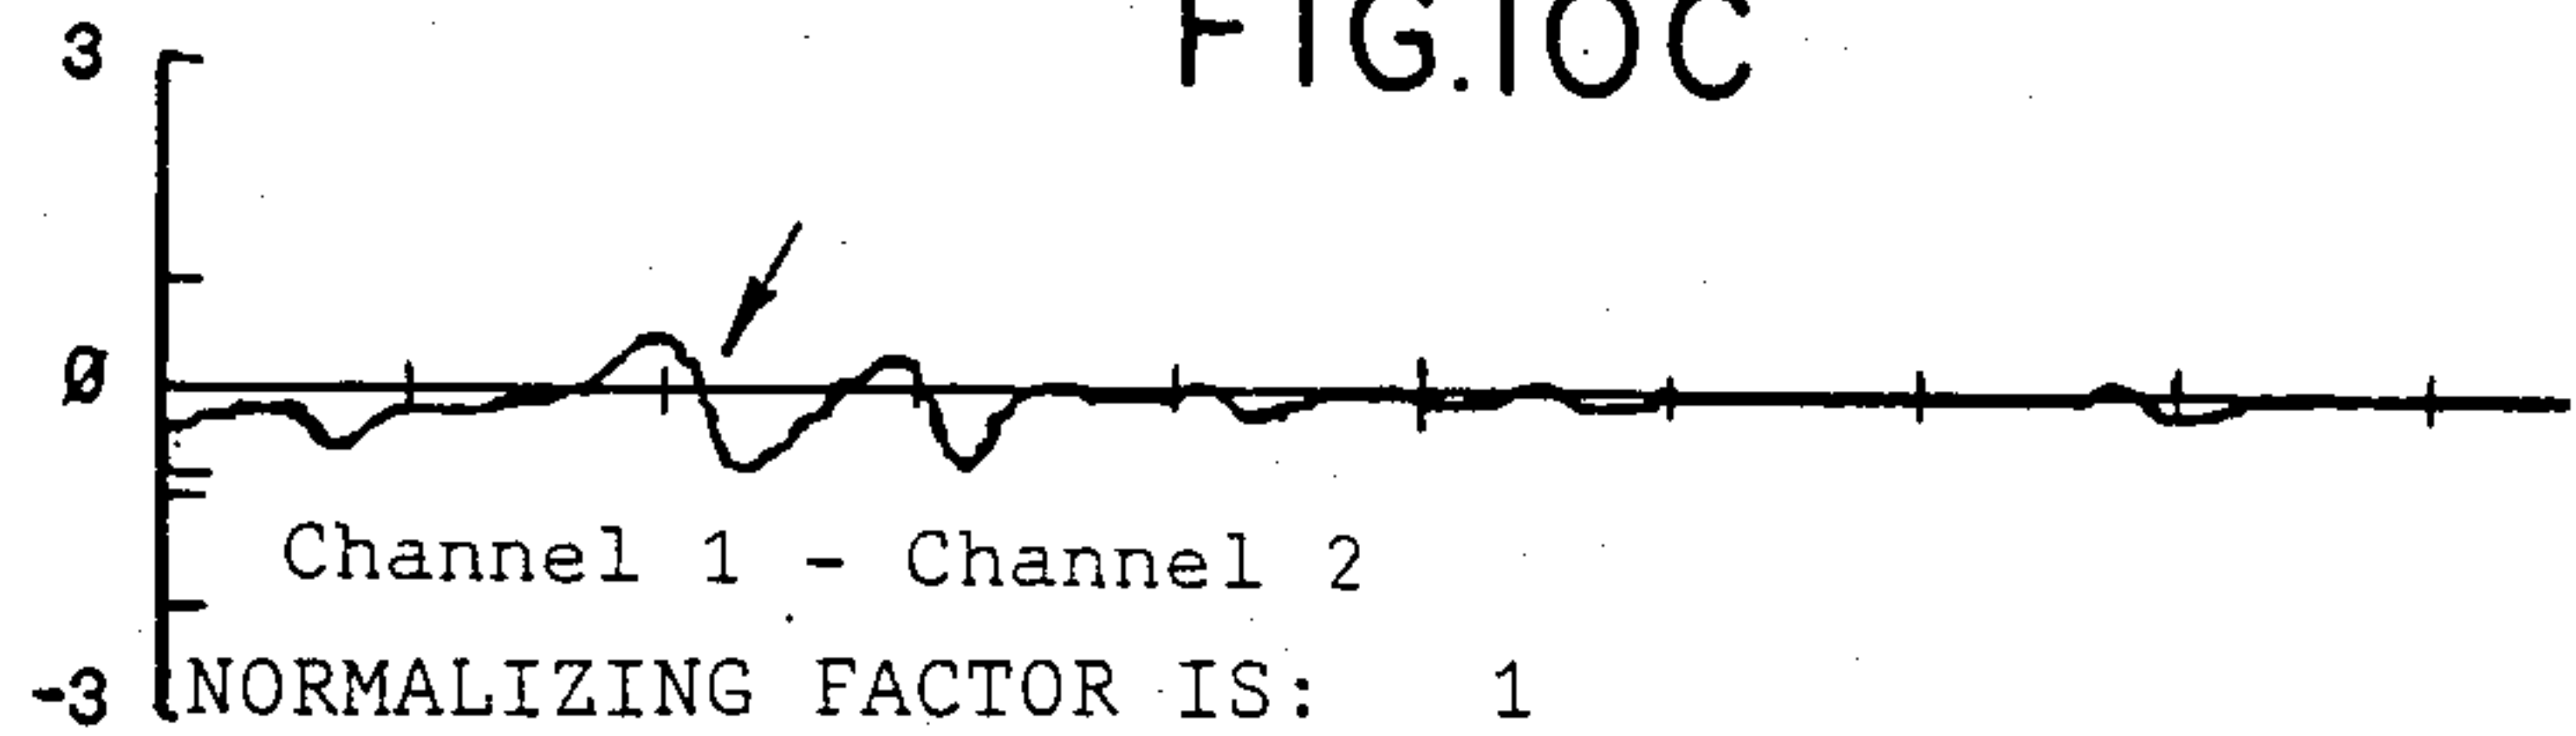
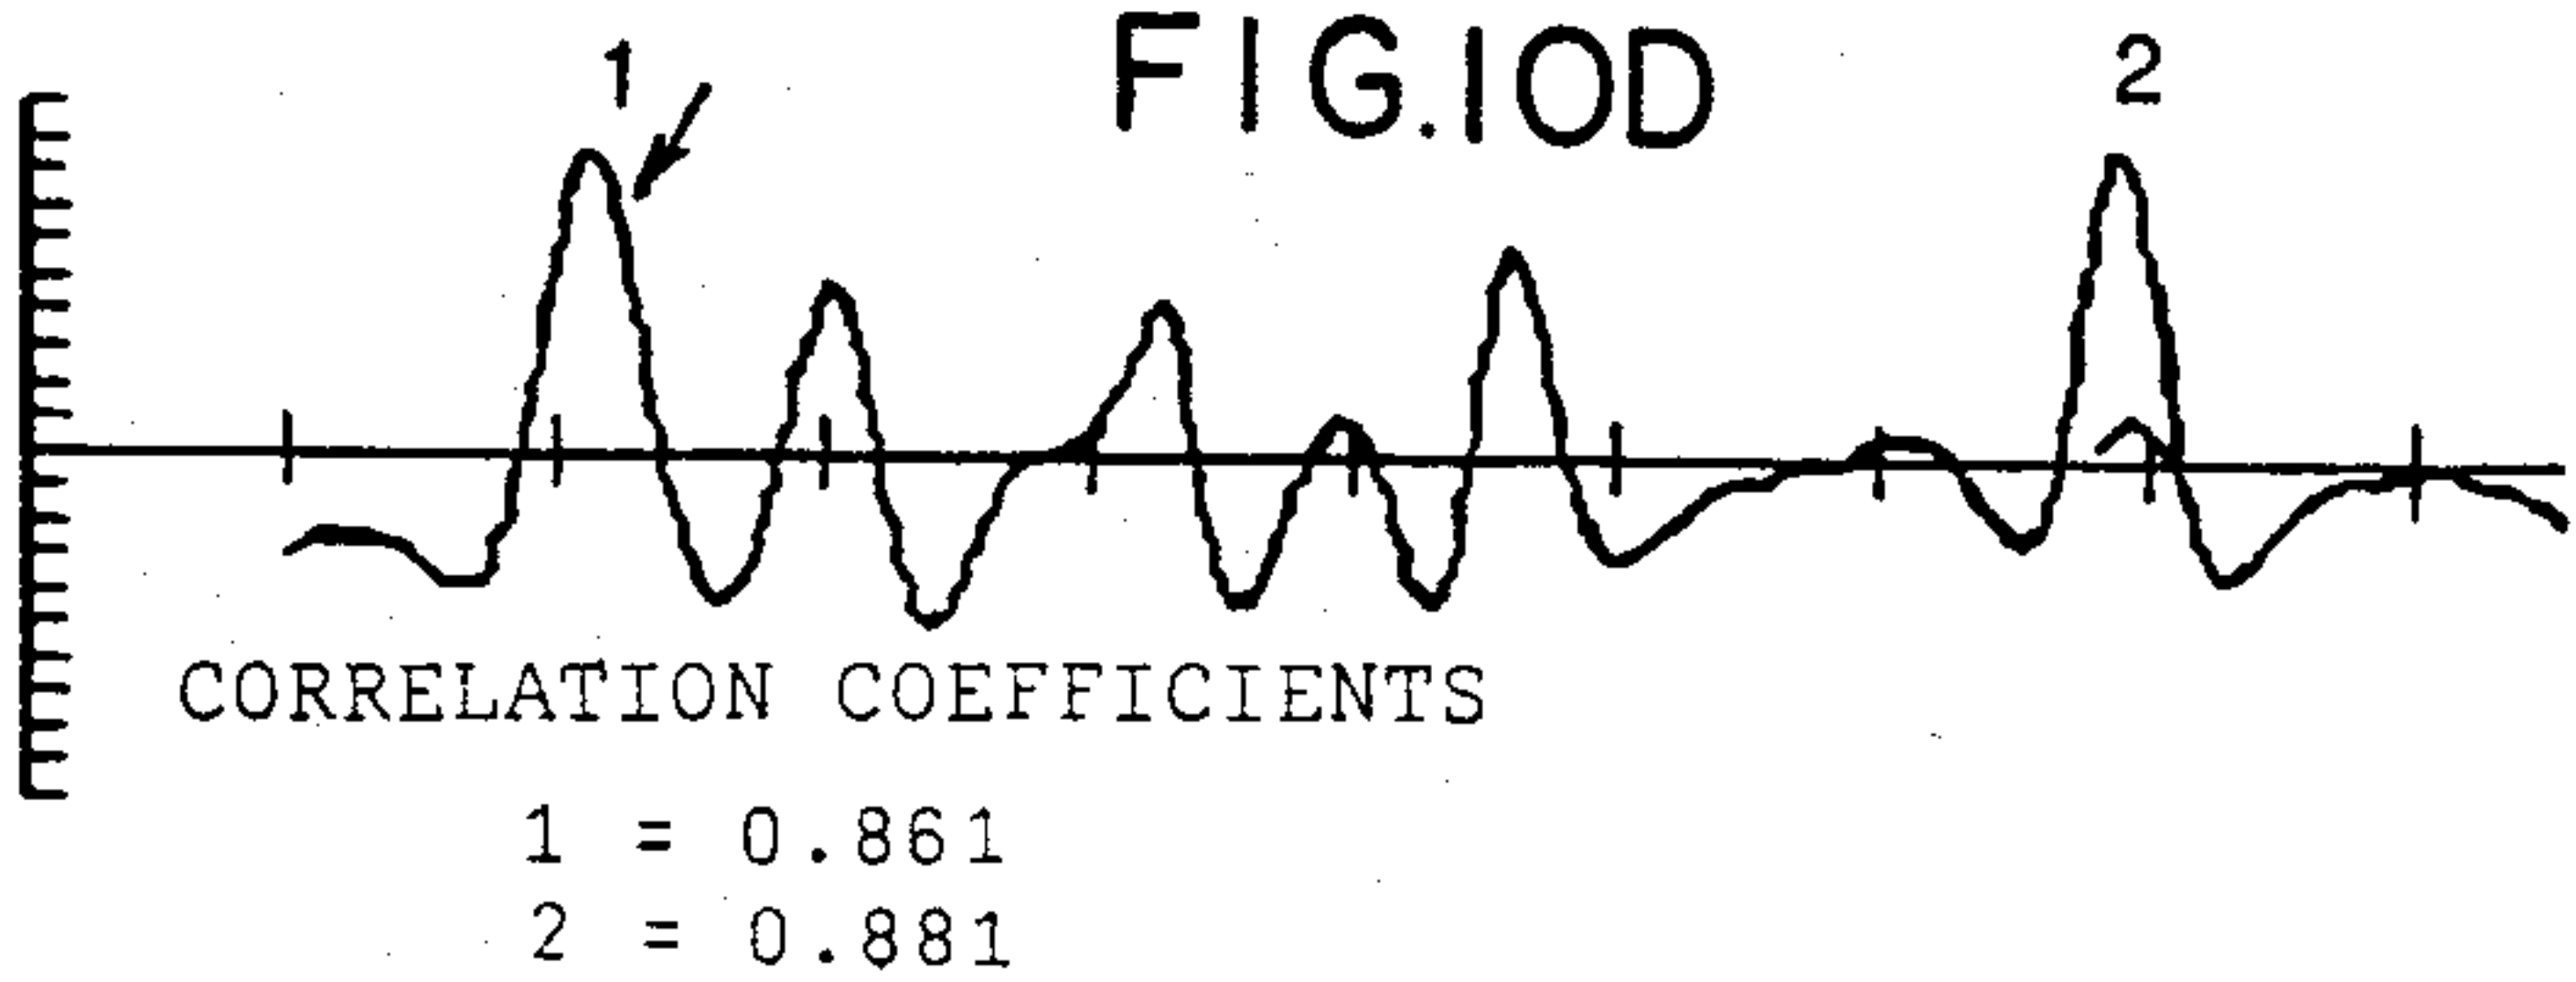
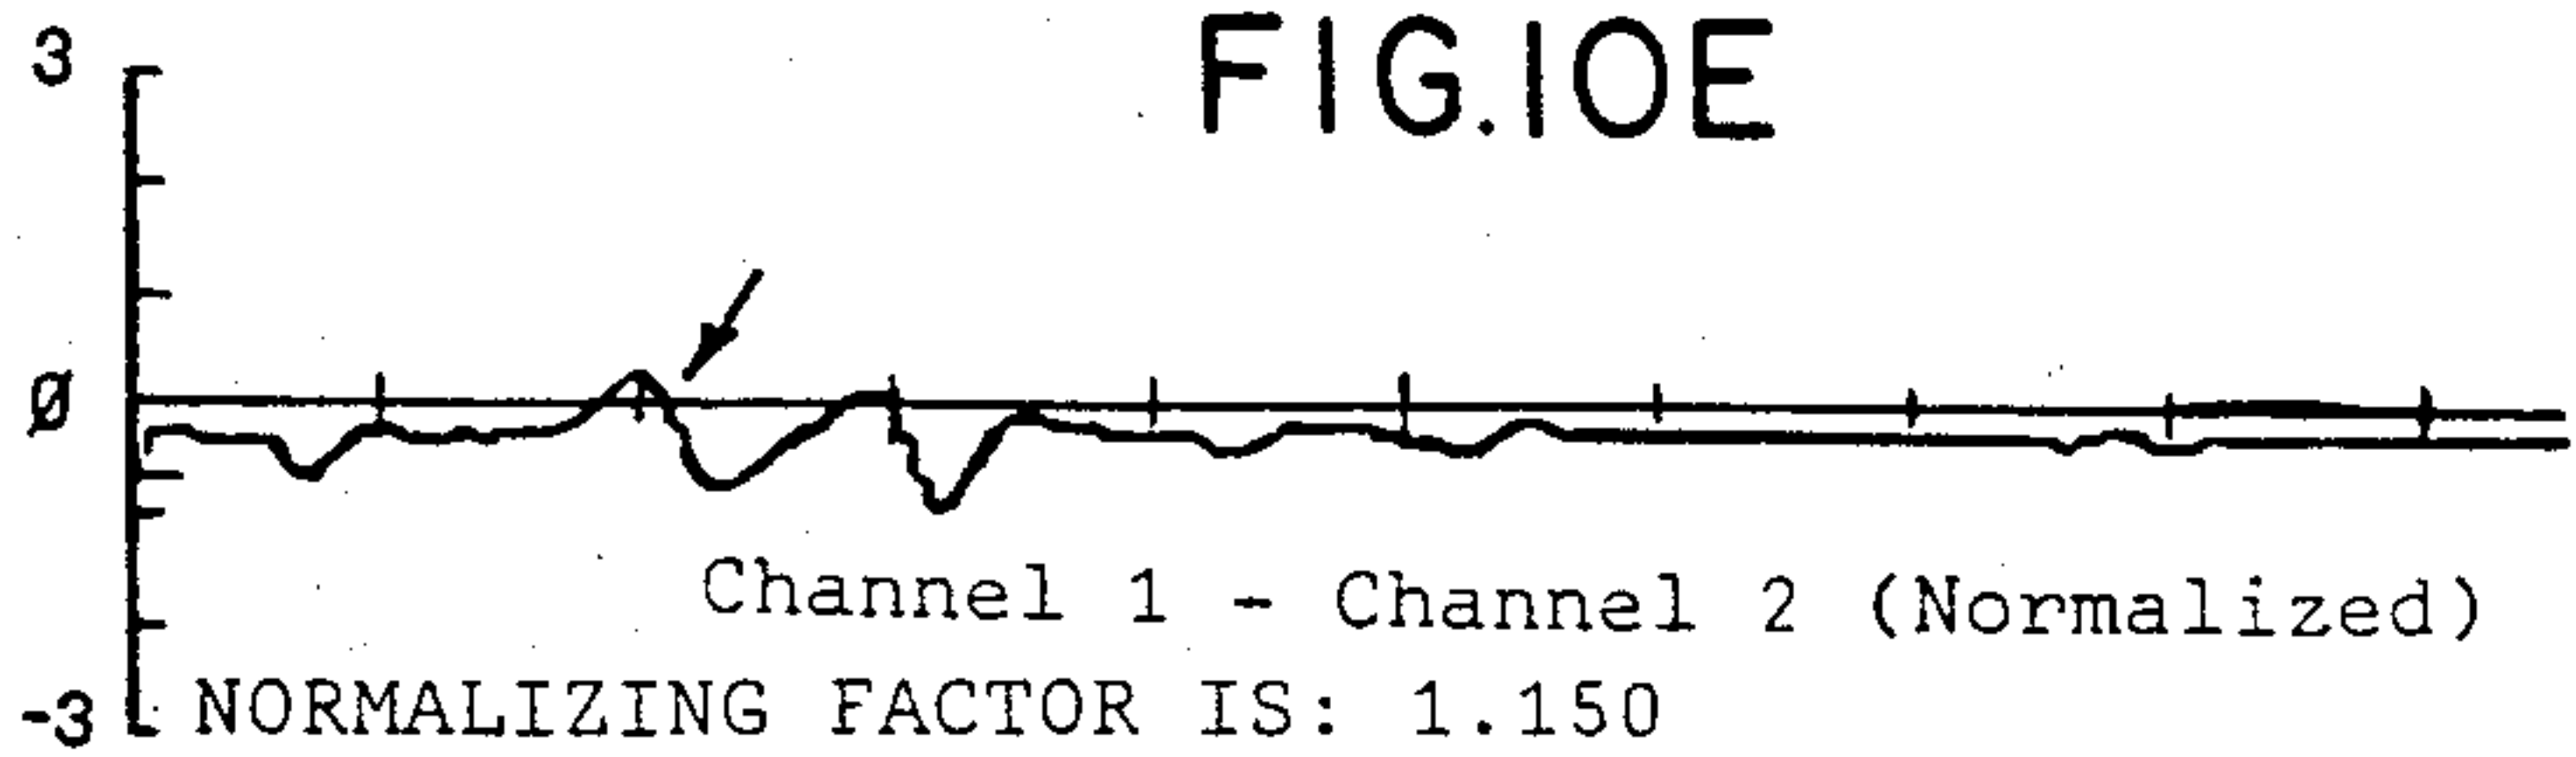
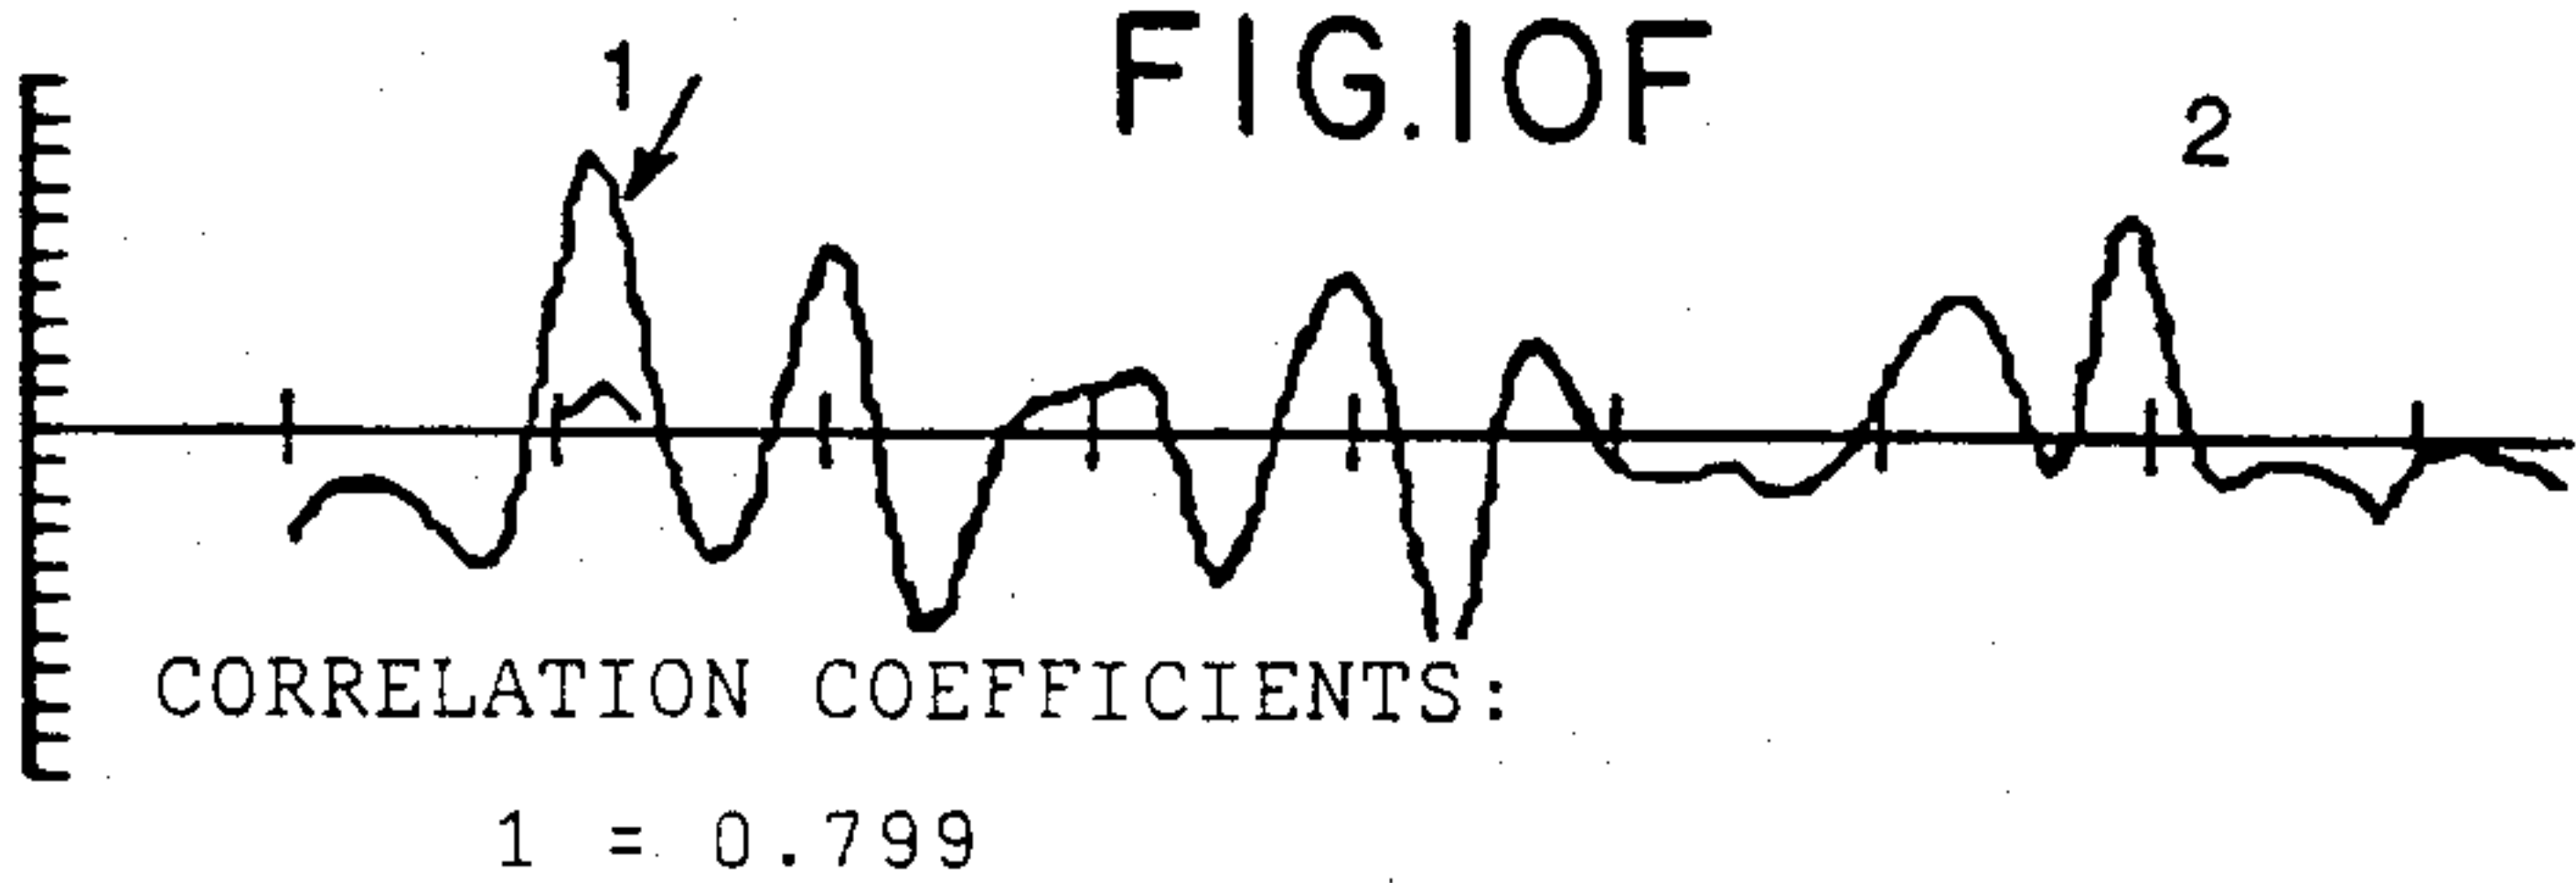
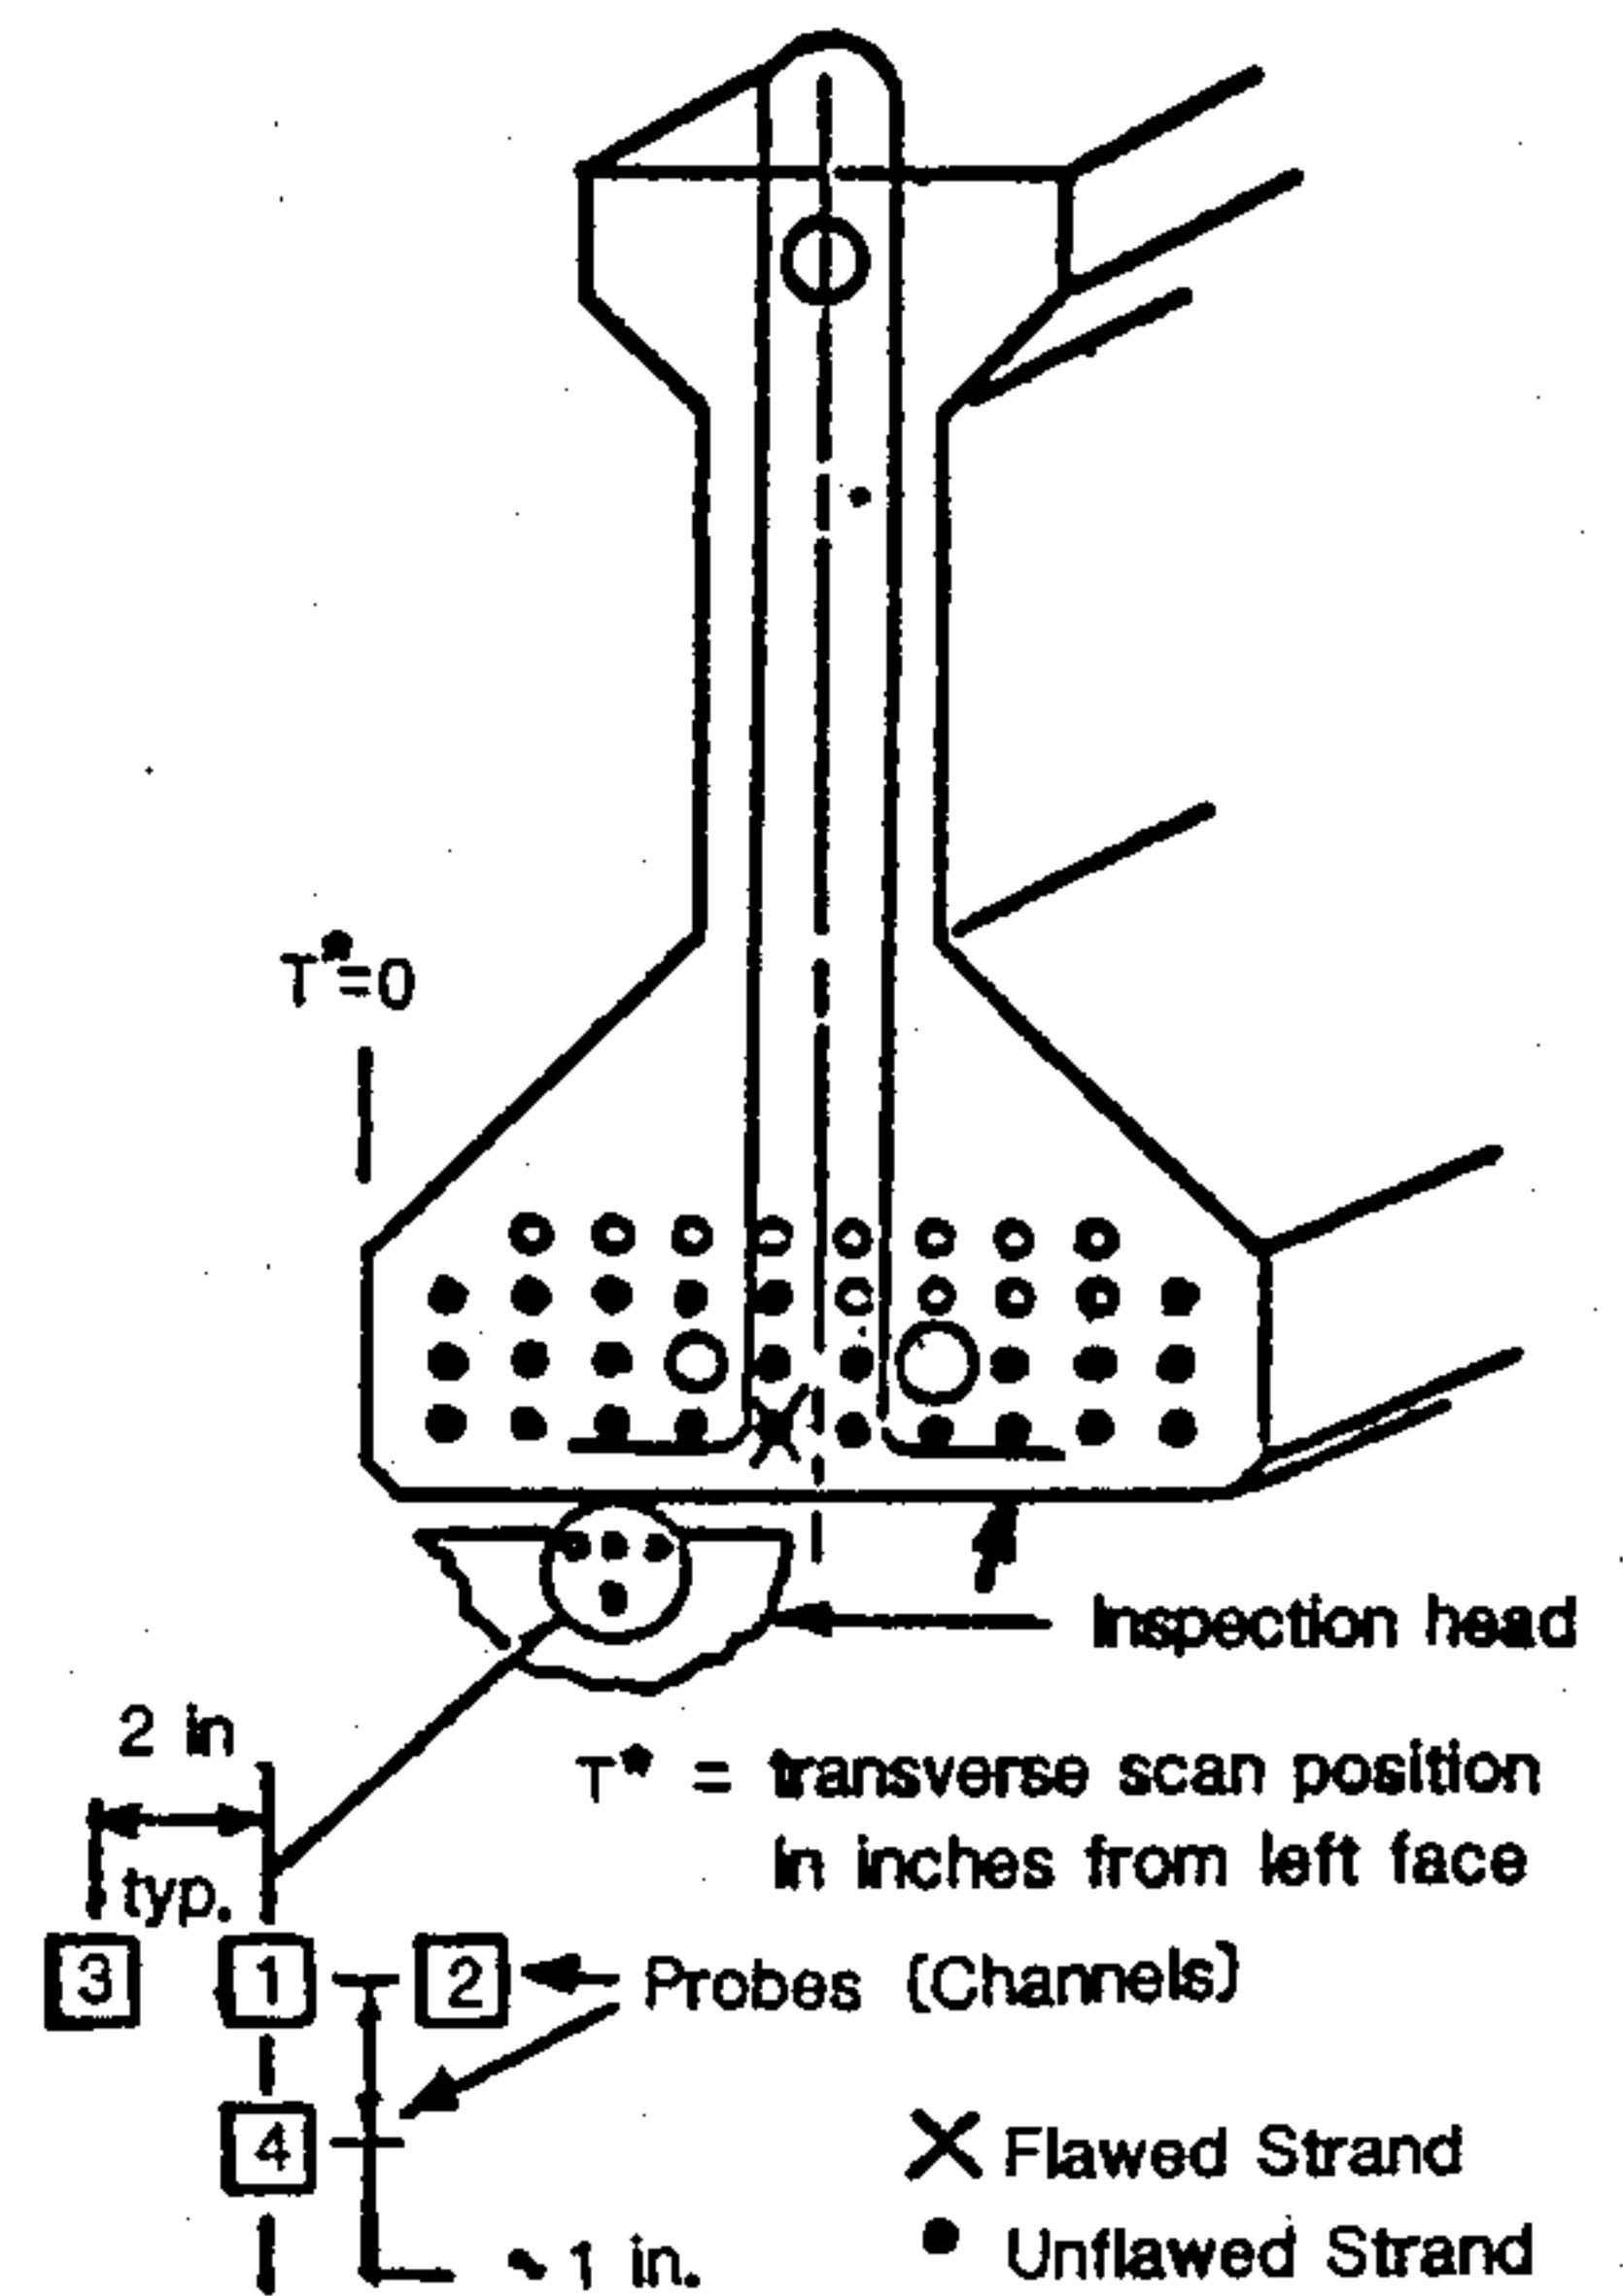
FIG.10A

Note: FLAW = 1/4 in. GAP IN 6 WIRES OF 7-WIRE STRAND

FIGS. 10 and 10(a)–(f) show the results of data enhancement by the subtraction process.

After a series of tests with multiple sensors arranged in transverse and vertical arrays it was found that the optimum configuration was an array of four sensors in two rows, with the first row comprising three sensors nearest the reinforcing members and the second row comprising one sensor below the middle sensor in the first row (see FIG. 10).

As explained above, differencing consists of the point-by-point digital subtraction of signatures from different channels and/or scan tracks. The object of this process is to enhance a flaw signatures more than stirrup and/or artifact signatures through a priori knowledge of the steel configuration and/or symmetry. FIGS. 10(a) and (b) show data acquired from Channels 1 and 2 by scanning a strand with a medium sized flaw, a $\frac{1}{4}$ inch gap in 6 wires of a 7-wire strand, for a strand position near the center of the beam (see FIG. 10 for strand location). The location of the flaw is indicated by the arrows in each signature. FIG. 10(c) shows the results of point-by-point subtraction of Channel 2 from Channel 1. Note, by comparison with the upper two signatures, that after differencing the stirrup signals are almost eliminated and the flaw signal is more recognizable. It is pointed out that in this differencing process, no adjustment of the signature amplitude for either channel was made; accordingly, the normalizing factor is equal to one.

FIG. 10(e) shows the result of subtracting Channel 2 from Channel 1 after multiplying Channel 2 by the normalization factor shown (FIGS. 10(d) and (f) will be reviewed after a brief discussion of the correlation process). The normalization factor was obtained from dividing the peak-to-peak amplitude of the fourth stirrup (reference stirrup) signal from the left in the Channel 1 record by the amplitude of the same stirrup signal in the Channel 2 signature. Note that the results of this normalization process are very similar to those obtained from an unnormalized, direct differencing of the two channels (previously shown by FIG. 10(c)).

An example of a correlation coefficient plot is shown by FIG. 10(d); this is based on FIG. 10(c), which is

channel 1 minus channel 2. The greater the correlation coefficient value, the better the match between the flaw signal being used to interrogate the scan track and that segment of the scan signature which corresponds to the location of the correlation coefficient peak, and the higher the confidence that a flaw exists. The maximum correlation coefficient value in a correlation plot is indicated by the cursor (an inverted V) near the baseline pointing out the peak, such as that associated with peak 2 in FIG. 10(d). The present processing program prints out the value of only those peaks greater than 0.700; however, any other value could be used.

In the case of FIG. 10(d), notice that the value of the correlation coefficient peak corresponding to the flaw location, 0.861, is slightly less than that of the maximum peak 2, 0.881, which corresponds to a stirrup. This would result in a stirrup being identified as a flaw, or would at best result in the identification of two possible flaws. To attempt to overcome this the normalizing factor was increased from 1.000 to 1.150 and the correlation coefficients were again calculated as shown in FIG. 10(f). The correlation coefficient peak associated with the flaw is the highest shown in the plot, but the value of peak 2 is sufficiently close to it to raise doubts.
