[54] MAGNETIC INSPECTION OF REINFORCING STEEL USING SENSOR ARRAY

[73] Assignee: The United States of America as represented by the Secretary of Transportation, Washington, D.C.

[57] ABSTRACT

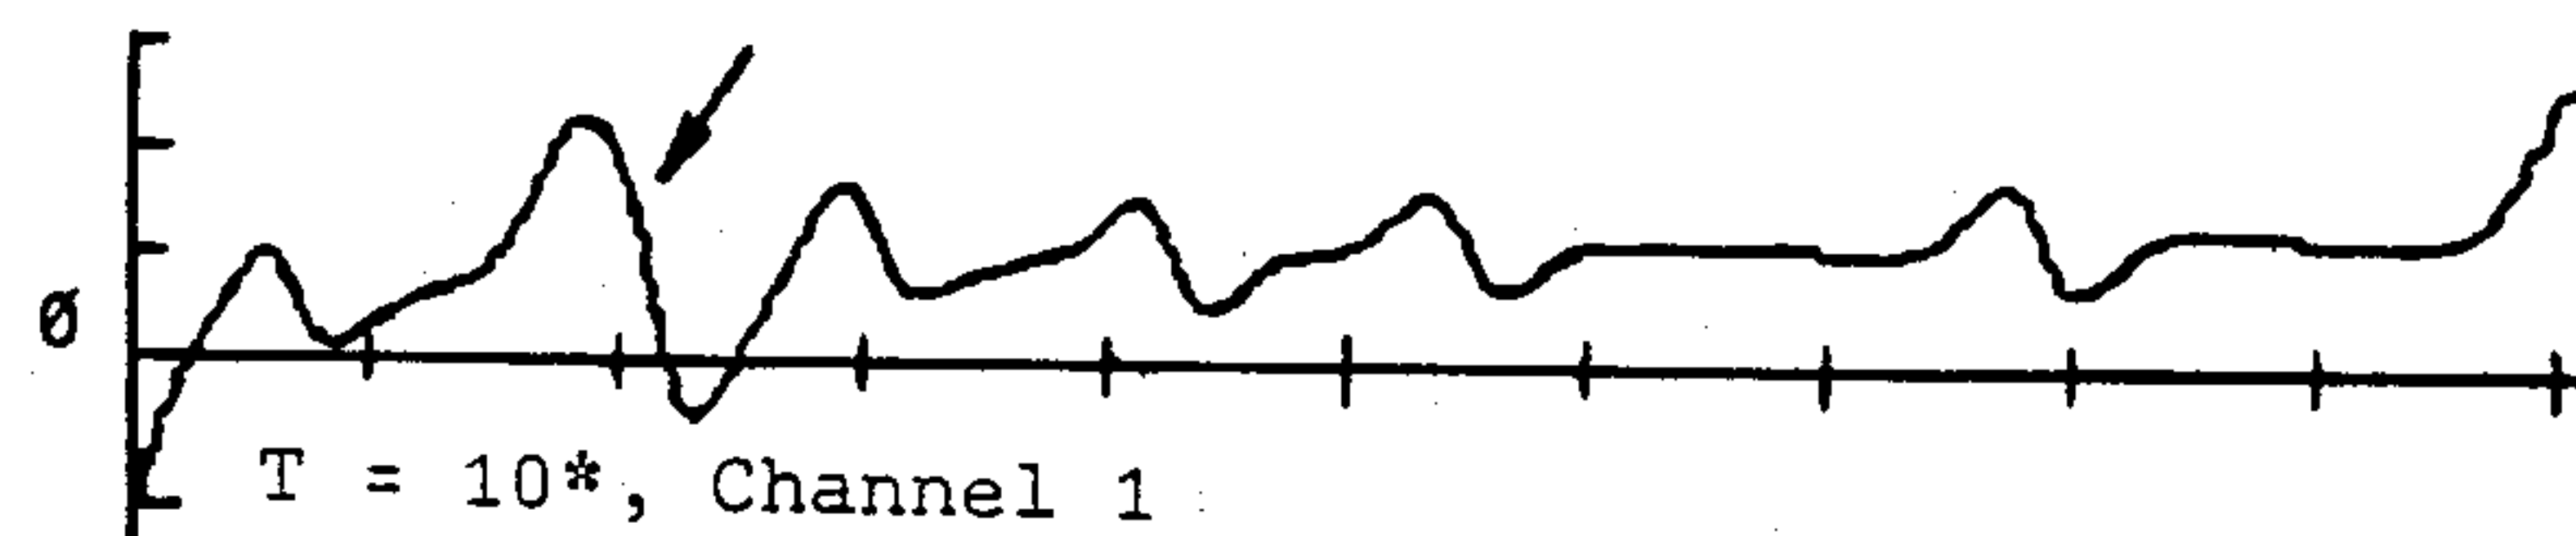
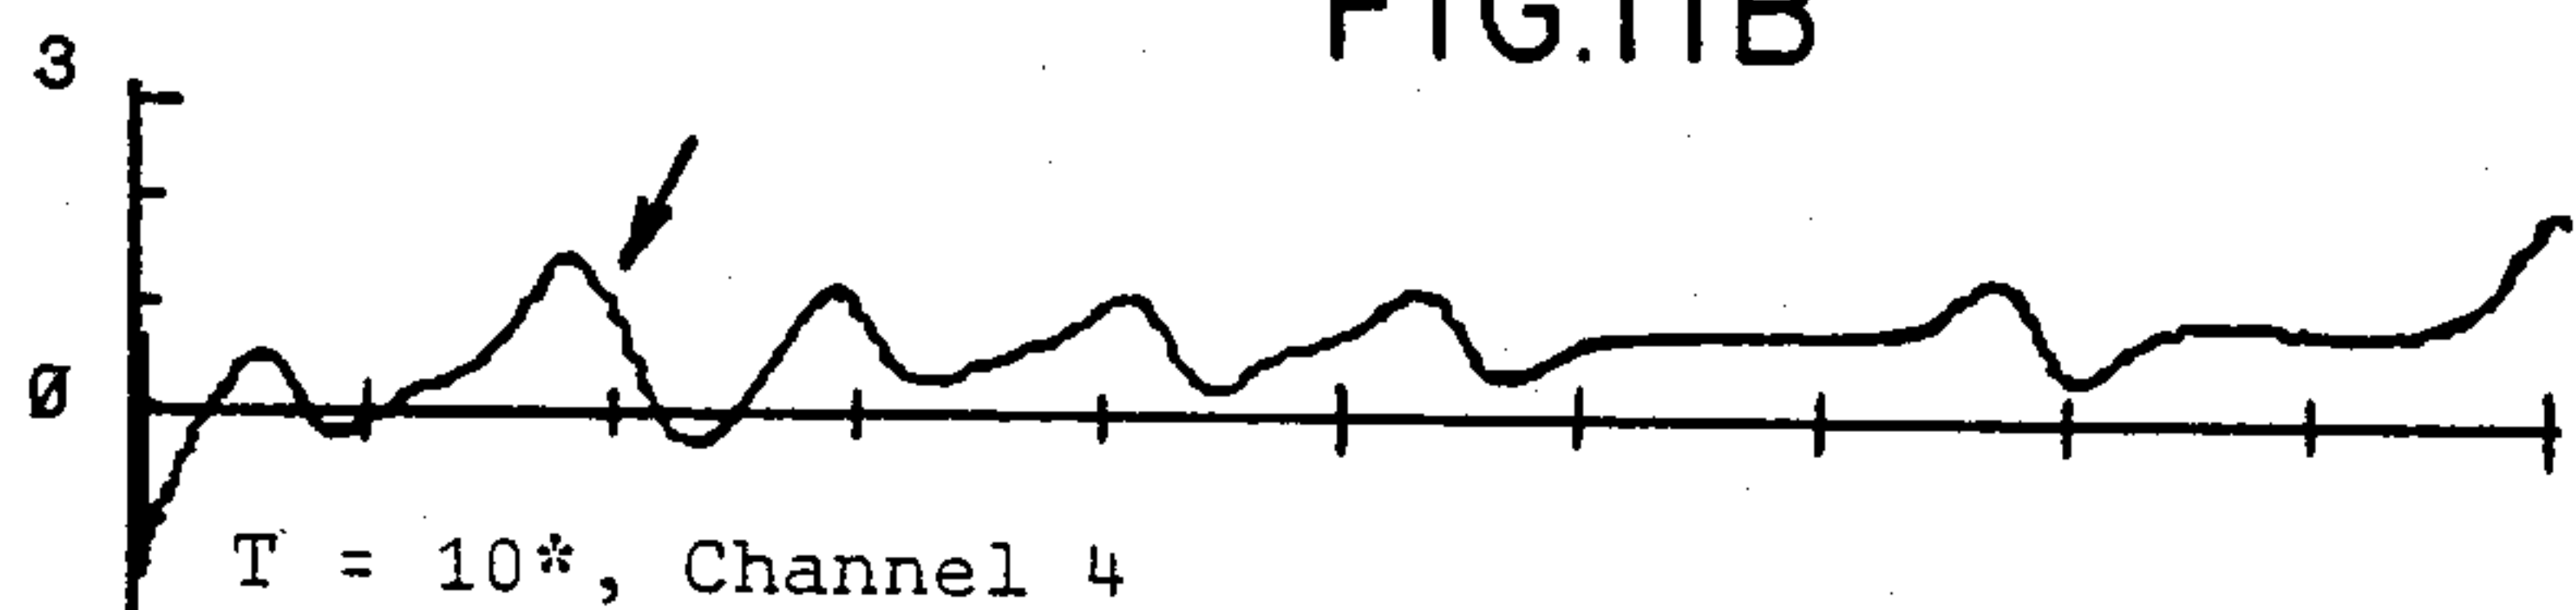
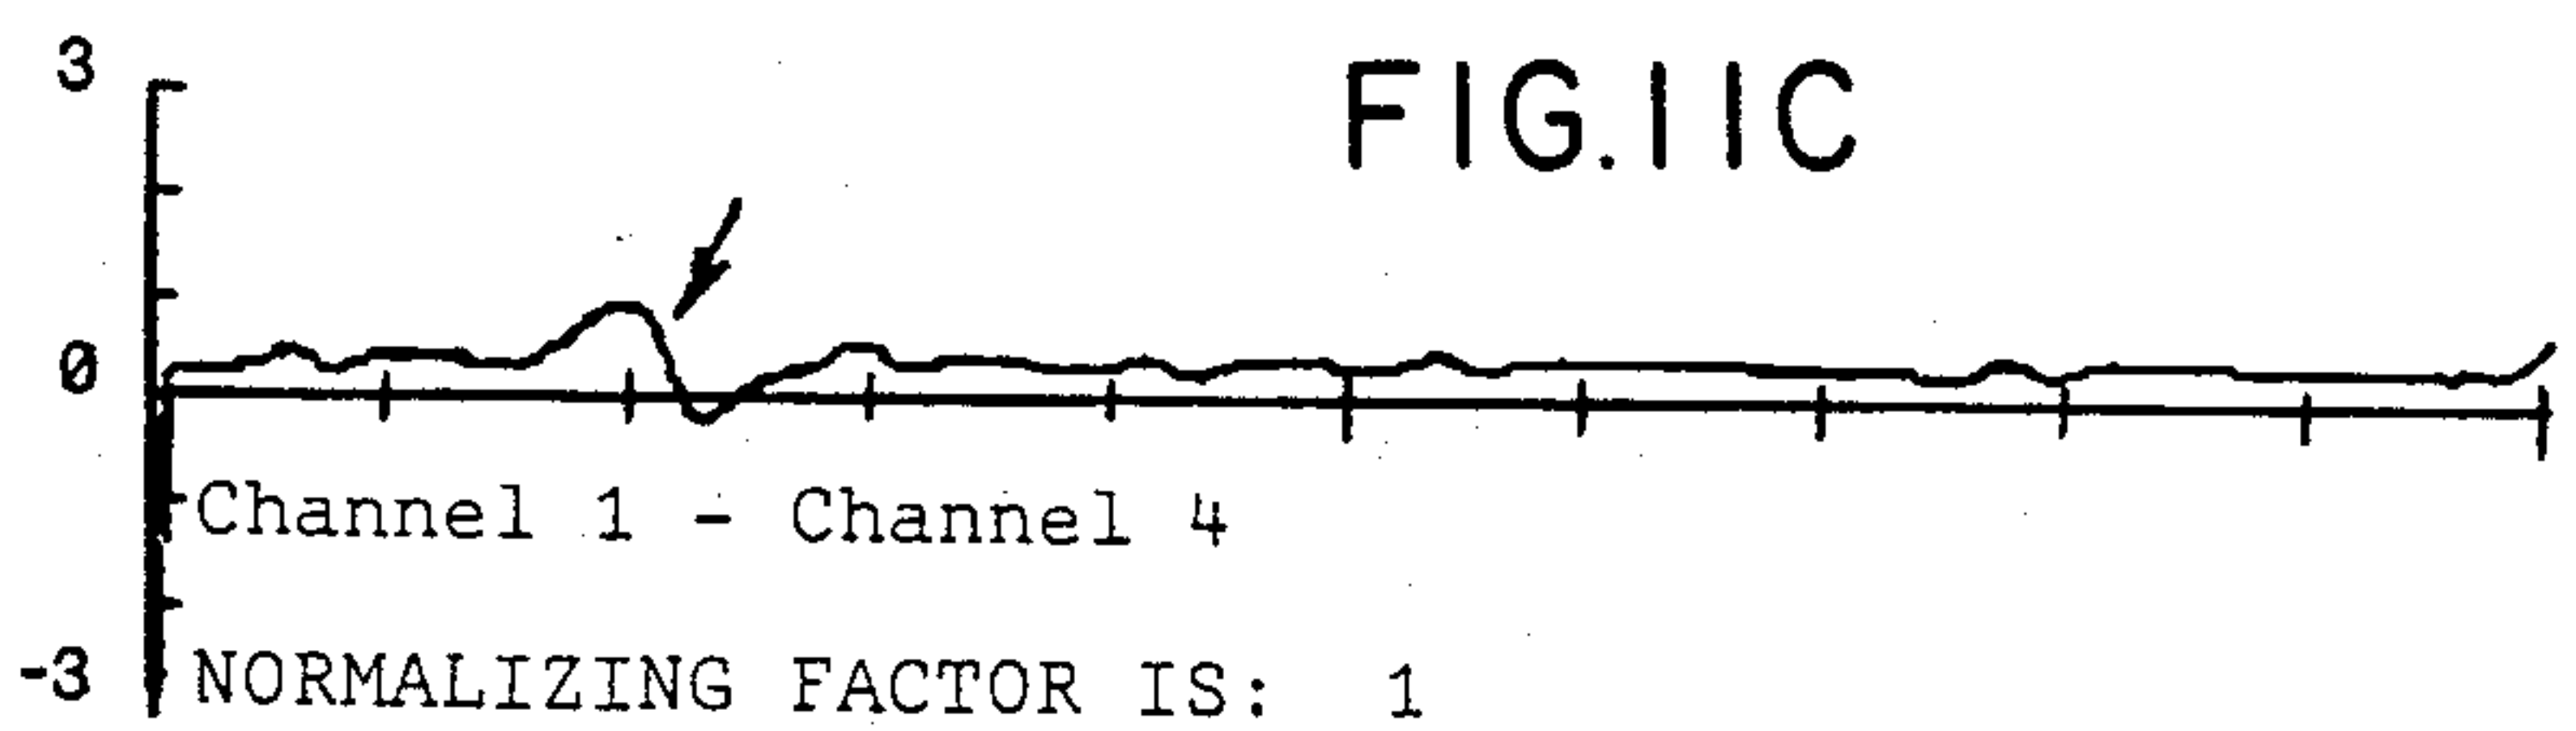
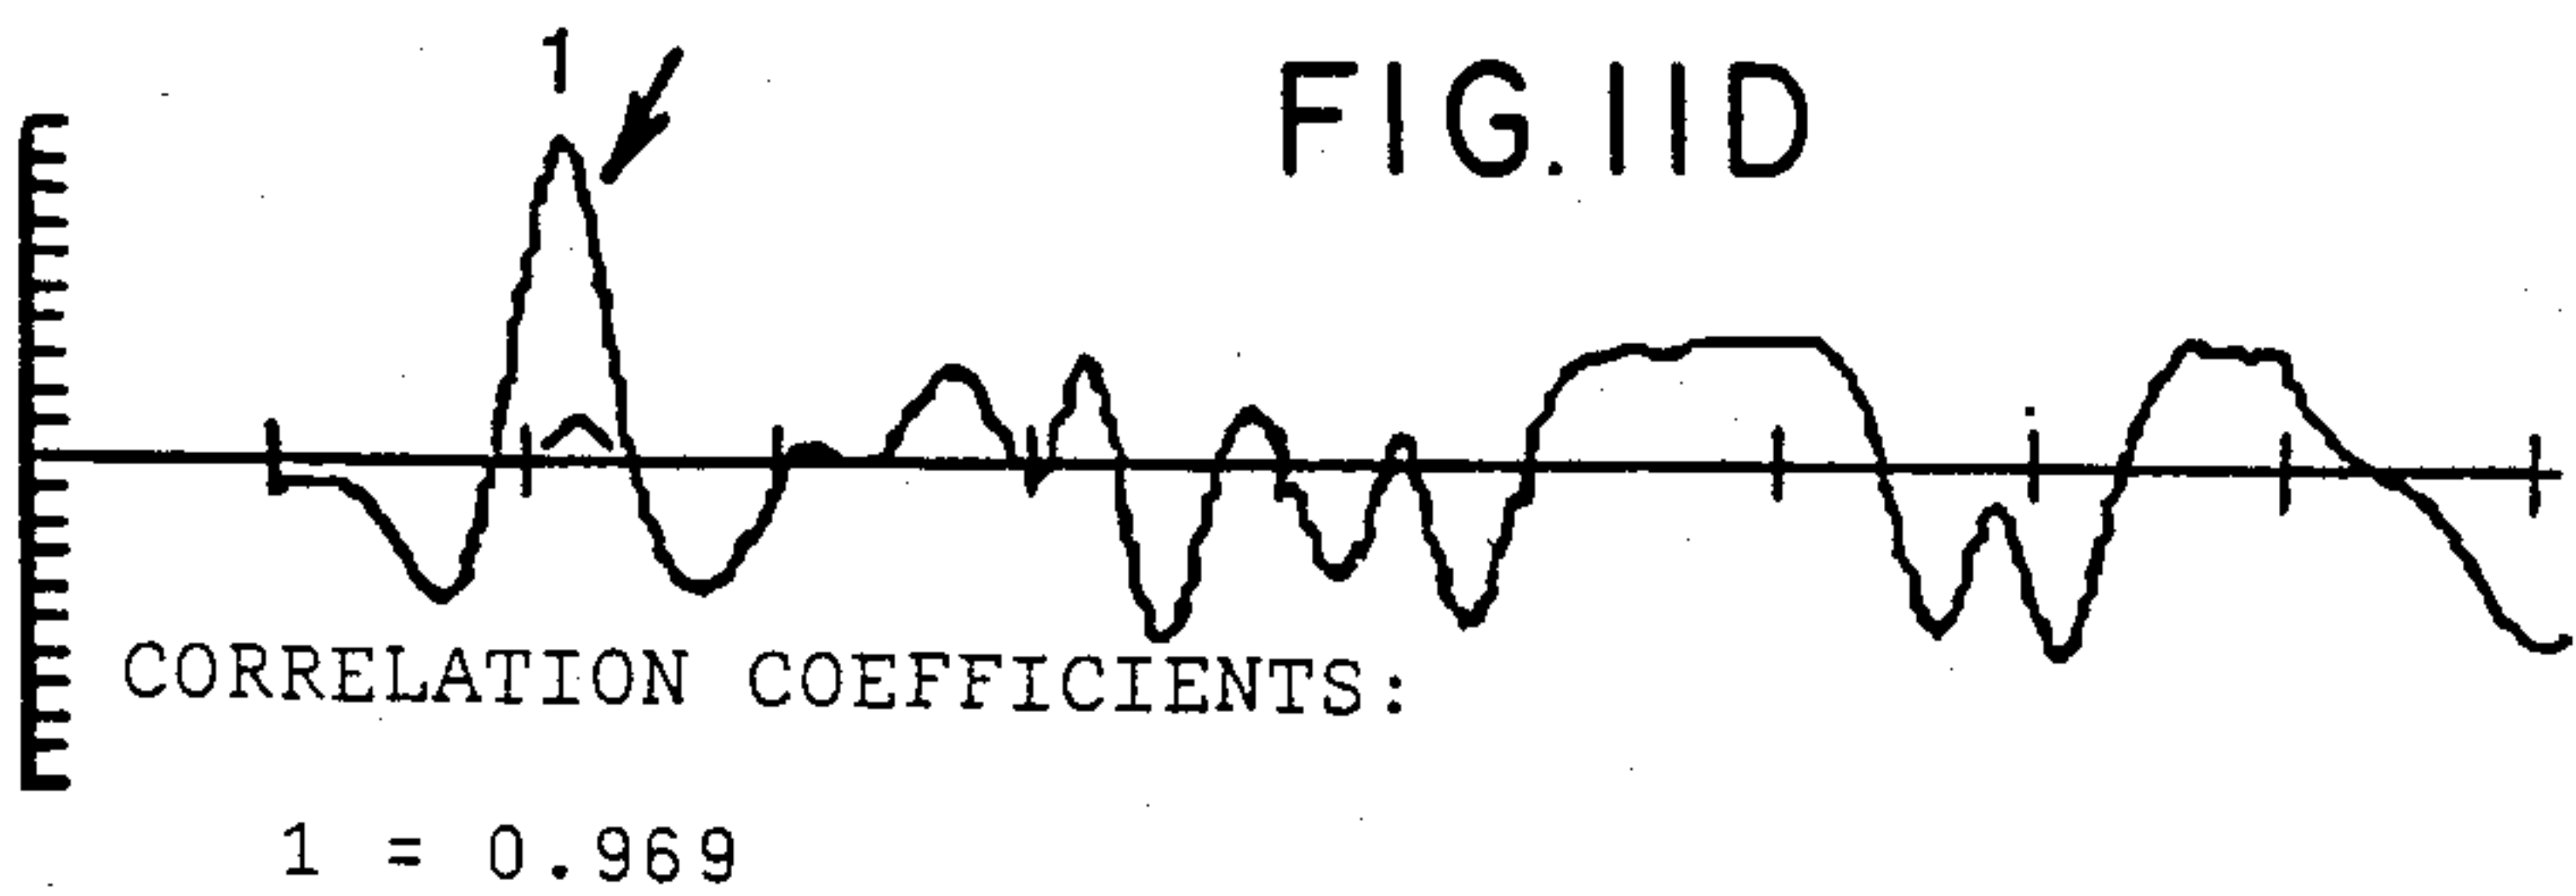
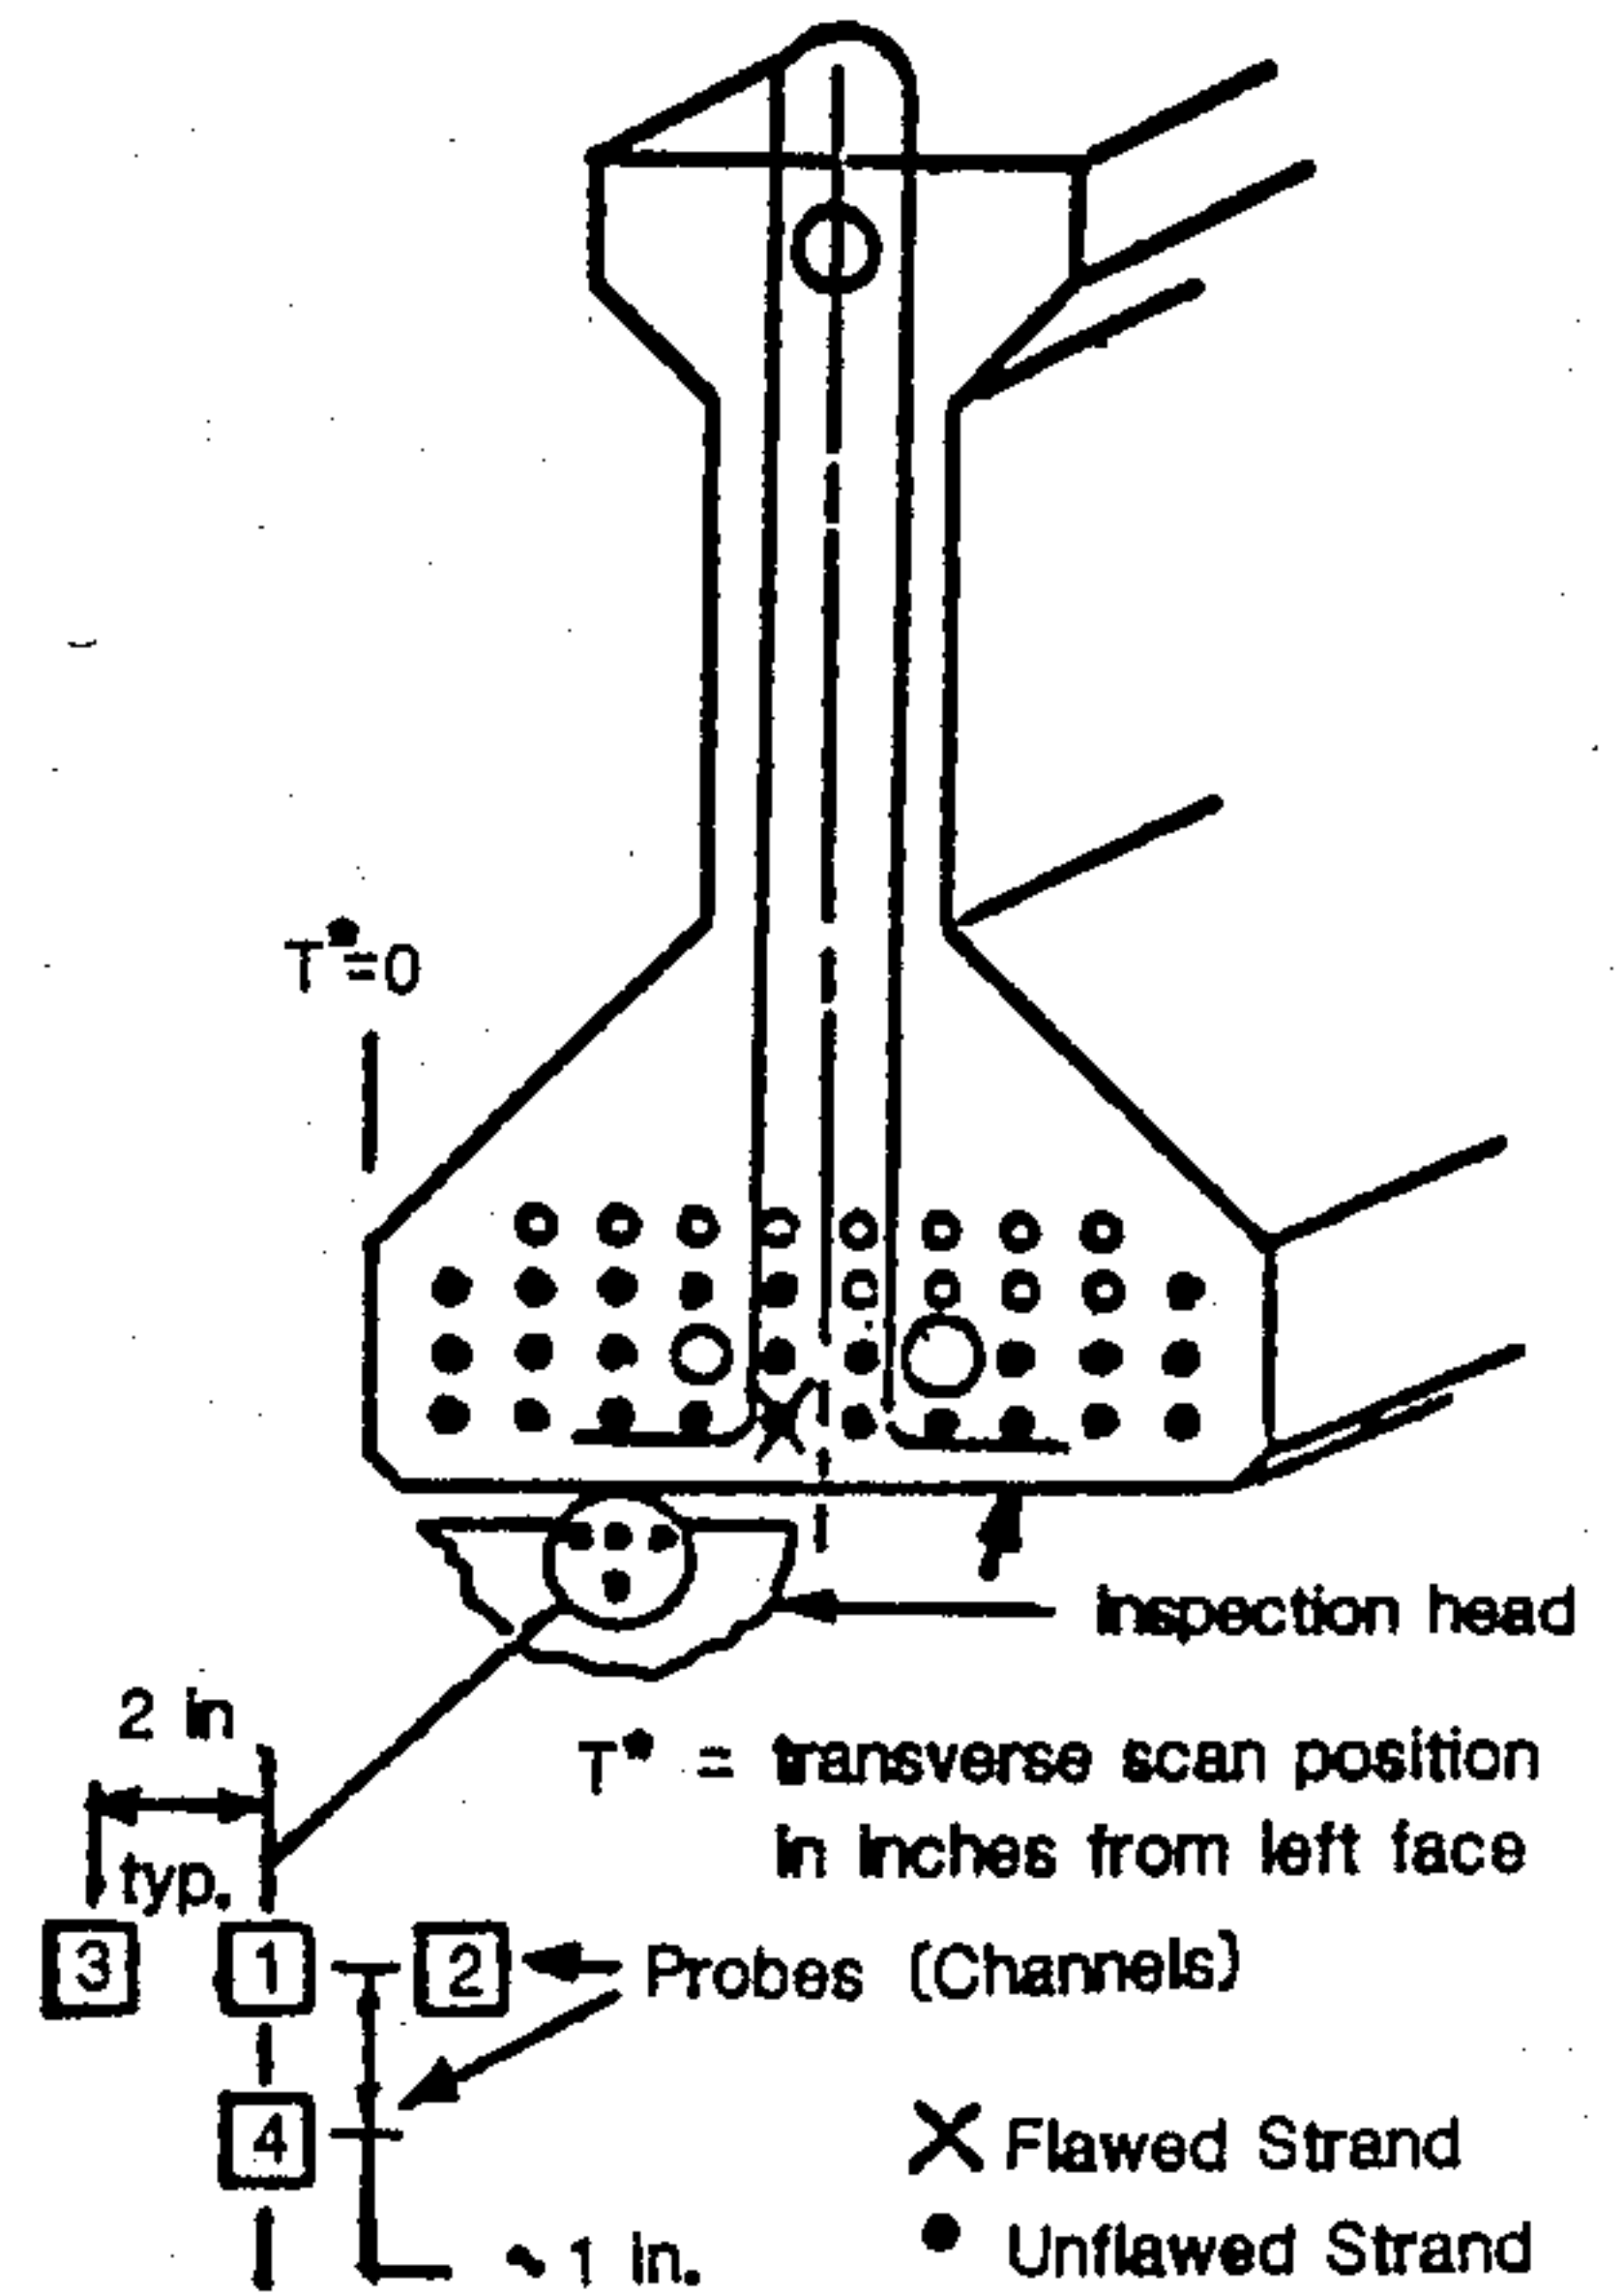
FIG.IIA

Note: FLAW = 1/4 in. GAP IN 6 WIRES OF 7-WIRE STRAND

FIGS. 11 and 11(a)–(d) show the results of data enhancement by the subtraction and correlation process.

Another example of the differencing process for the same strand location and flaw, previously presented in FIGS. 10(a)-(f), is shown in FIGS. 11(a)-(f). FIGS. 11(a) and (b) were obtained from Channel 1 and Channel 4, respectively, for a scan directly beneath the

flawed strand. In this case, the Channel 4 sensor element was located directly beneath the Channel 1 sensor element but 1 inch further beneath the beam. Accordingly, the signature should appear to be similar but somewhat reduced in amplitude. FIG. 11(c) presents the results of point-by-point subtraction of Channel 4 from Channel 1. In this case, note how much more outstanding the flaw signal is with respect to those from the stirrups.

As a final step the correlation coefficients were calculated for channel 1 minus channel 4, shown in FIGS. 11(a)-(d). Record D clearly and unambiguously shows the flaw, with no other peaks as high as 0.700. Thus it is clear that the best flaw detection method is to use two sensors lined up directly beneath the member being inspected, subtract the output of the farther one from the output of the nearer one, and then calculate the correlation coefficients as shown.

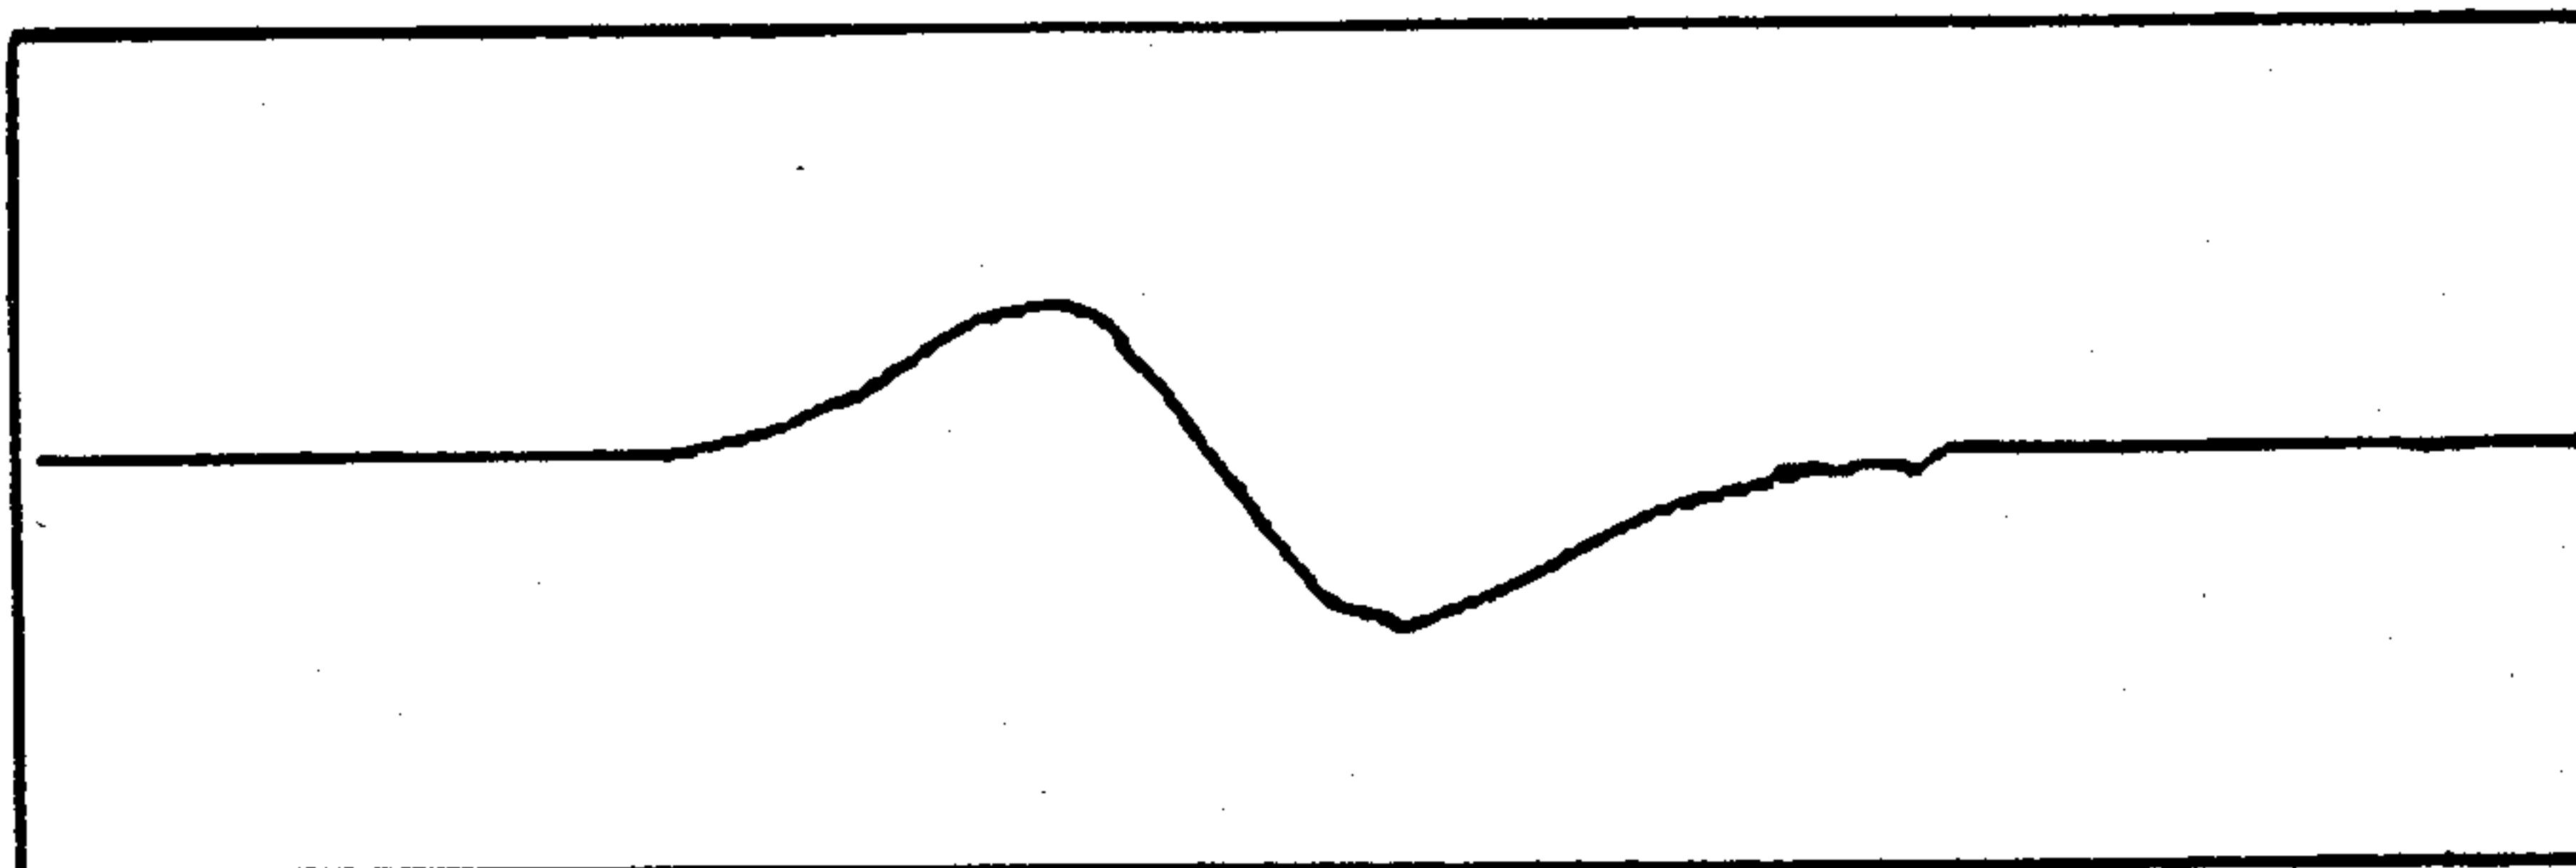
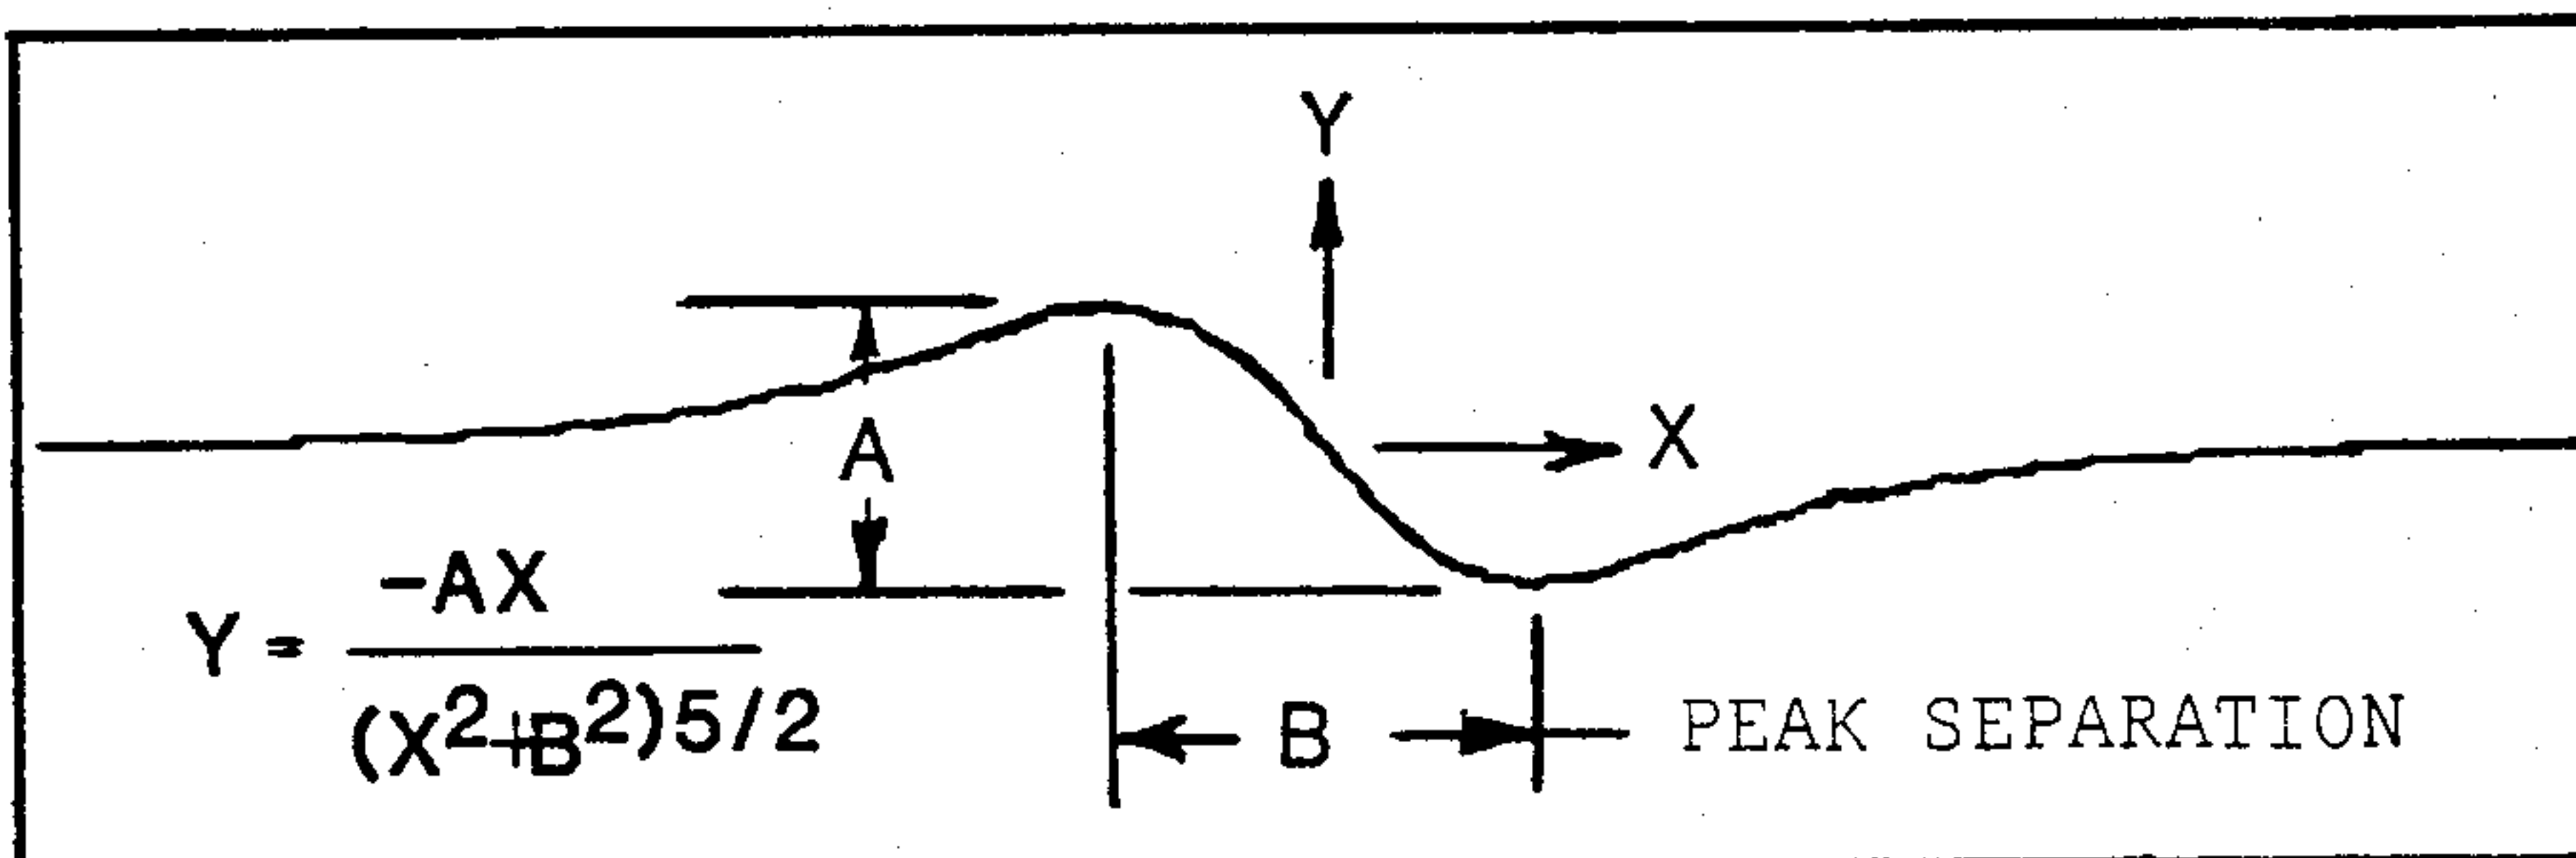
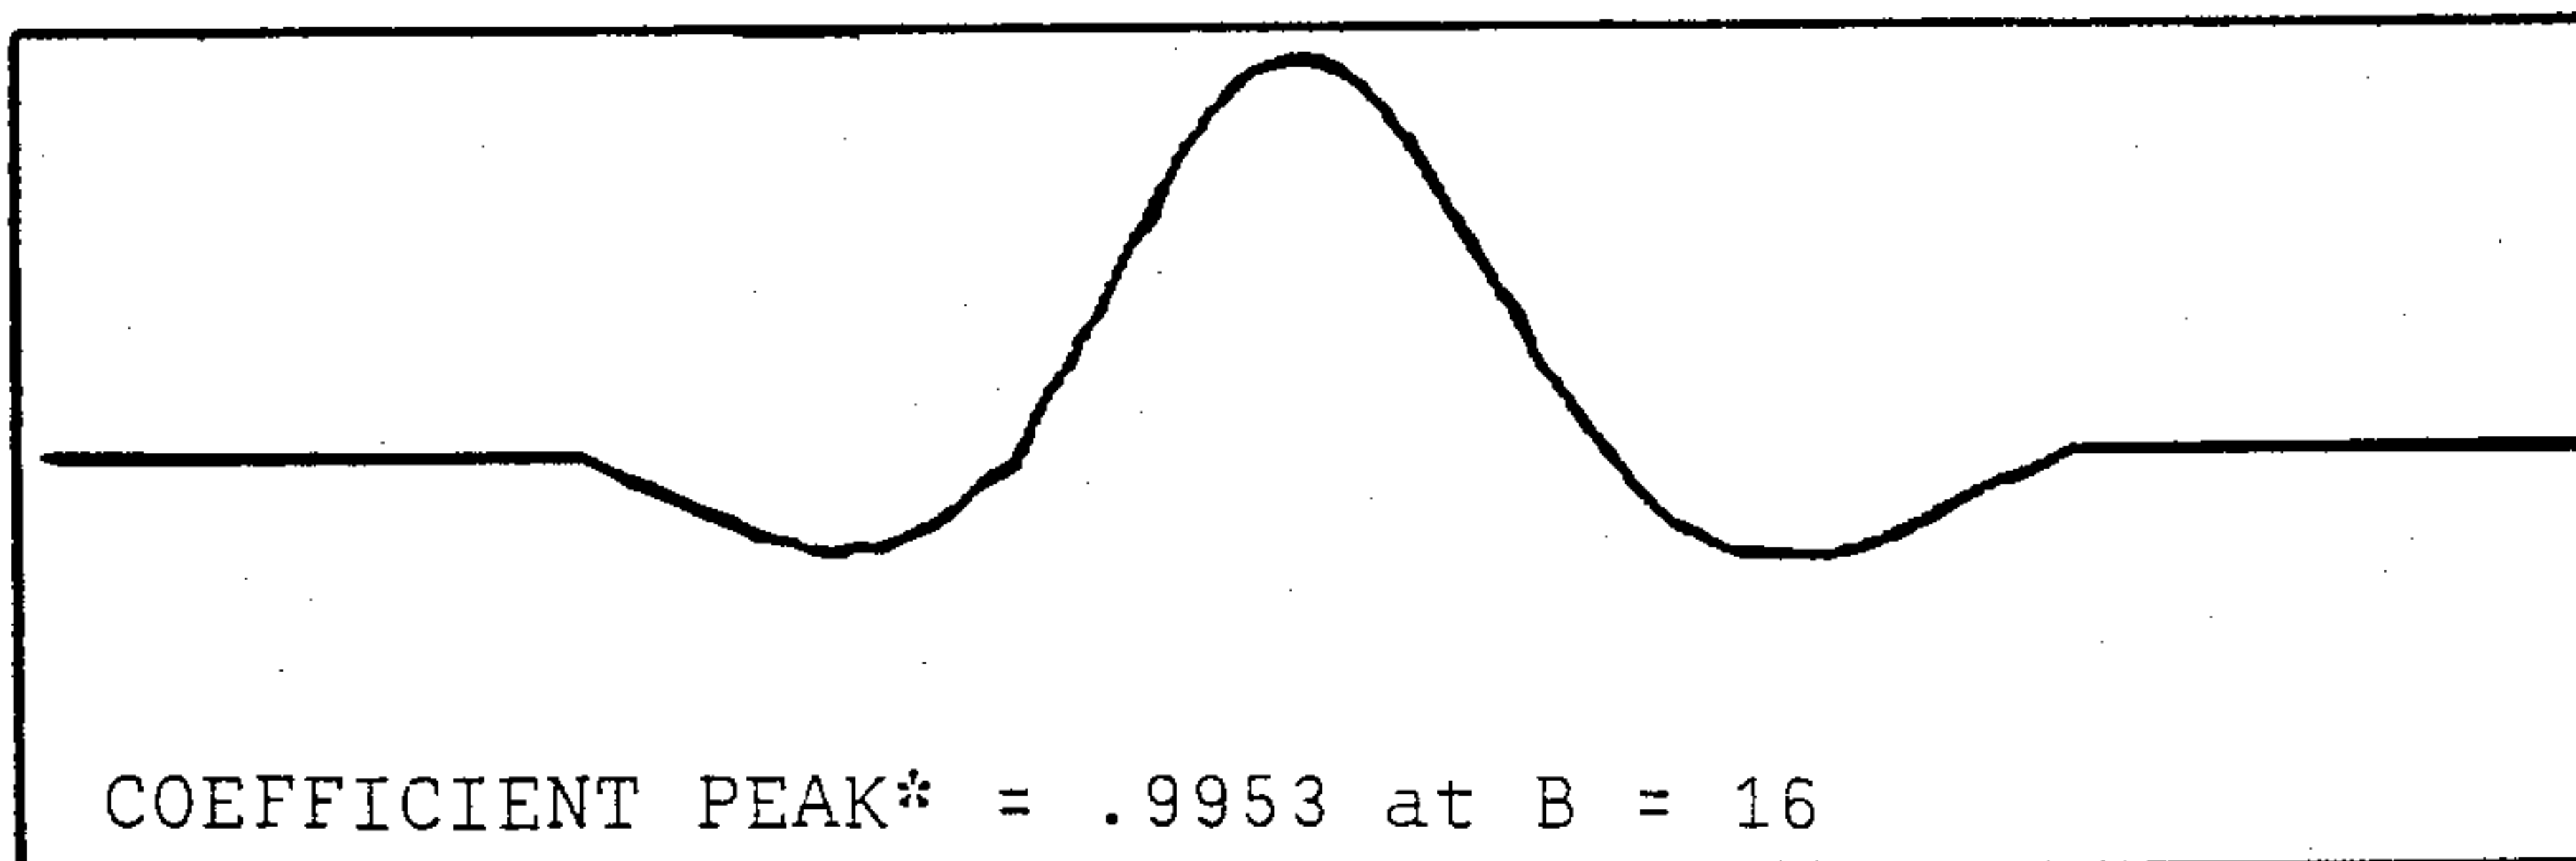
FIG.12A

TYPICAL FLAW SIGNATURE FOR STRAND

GRAPH OF ALGORITHM

COEFFICIENT PEAK* = .9953 at B = 16

CORRELATION OF ALGORITHM AND STRAND FLAW

FIGS. 12(a)–(c) show a typical flaw signature, a flaw algorithm, and a correlation between the two.

Up to this point, a typical flaw signature has been considered for use as the interrogating correlation function. It is possible, however, to use an algorithm to represent the flaw signature and such a procedure facilitates modification of the flaw signal shape which can be shown to be related to certain flaw properties and to the depth of the flaw within the beam. FIGS. 12(a)-(c) present graphs of a typical signature, an algorithm (and its equation), and a plot of the correlation coefficient for the two signatures. The similarity between a graphical presentation of the algorithm equation and that of a typical flaw signature (from a ¼-inch gap in 6 wires of 7-wire strand) is obvious.

The mathematical relationship for the algorithm in FIG. 12(b) was based on a theoretical model for the magnetic field perturbation from a sphere of permeability μ_0 buried in an infinite volume of different permeability material, μ . The two constants in the algorithm equation are A, which is related to amplitude, and B, which is a shape factor, usually referred to as peak separation. Peak separation is a parameter that is associated with the distance between the sensor and the flaw; the greater the sensor-flaw distance, the greater the value of B. The value of B may also be influenced by the length of the flaw if the distance over which the flaw extends is significant compared to the sensor-flaw spacing (e.g. extends over a distance equal to or greater than the sensor-to-flaw spacing). The goodness of fit between the algorithm and a typical flaw signature is confirmed in the fact that a maximum correlation value of 0.995 is obtained for a peak separation of $B=16$. All correlation results presented were obtained using the algorithm of FIG. 12(b); the value of B is indicated in each case. The graphs of correlation value as a function of B in FIGS. 13(a)-(b) for typical flaws in a strand and in a bar were
