[54] MAGNETIC INSPECTION OF REINFORCING STEEL USING SENSOR ARRAY

[73] Assignee: The United States of America as represented by the Secretary of Transportation, Washington, D.C.

[57] ABSTRACT

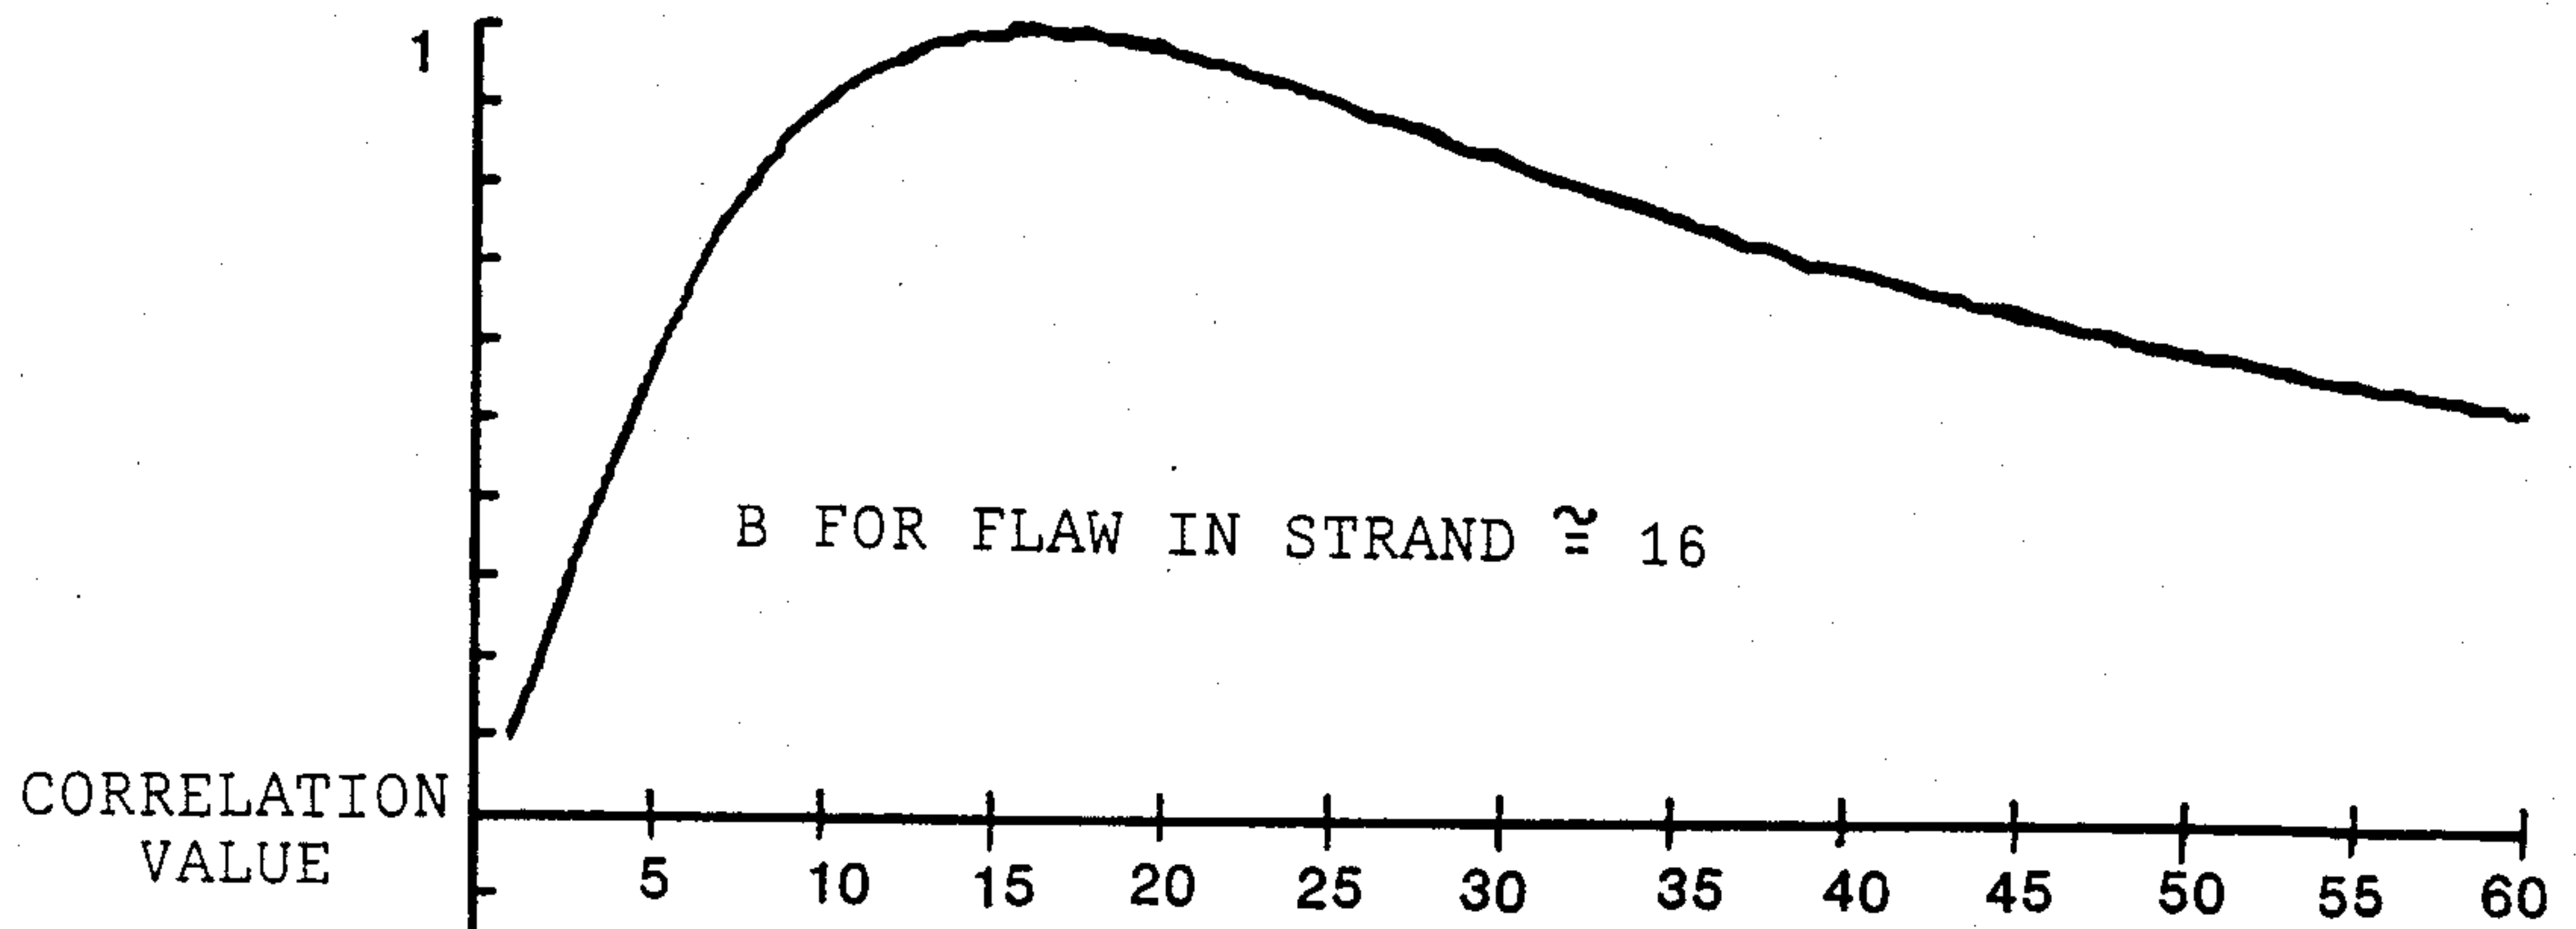
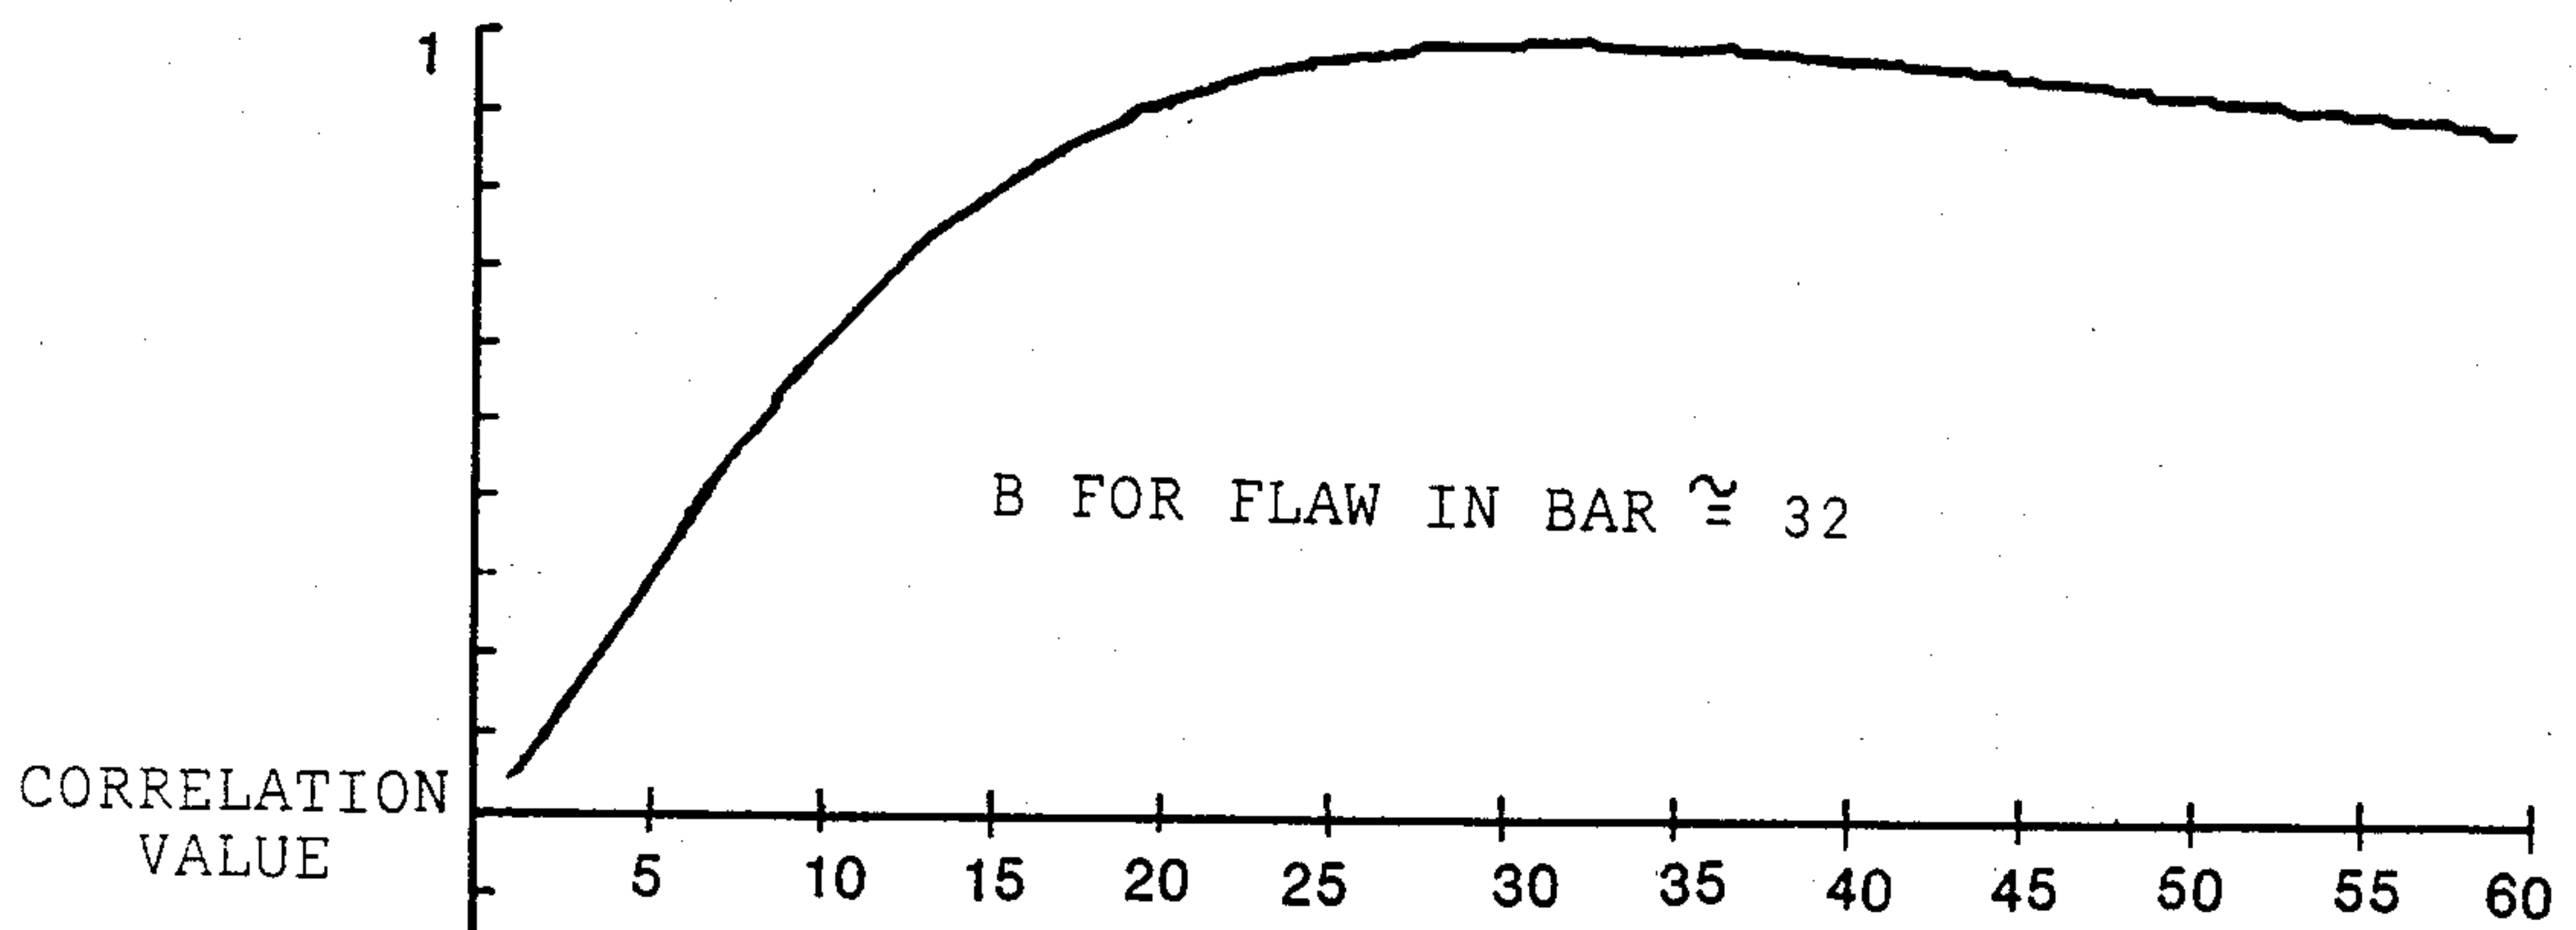
FIG.13A B(STRAND FLAW)

B(BAR FLAW)

FIGS. 13(a)–(b) show correlation coefficients as a function of B.

The mathematical relationship for the algorithm in FIG. 12(b) was based on a theoretical model for the magnetic field perturbation from a sphere of permeability μ_0 buried in an infinite volume of different permeability material, μ . The two constants in the algorithm equation are A, which is related to amplitude, and B, which is a shape factor, usually referred to as peak separation. Peak separation is a parameter that is associated with the distance between the sensor and the flaw; the greater the sensor-flaw distance, the greater the value of B. The value of B may also be influenced by the length of the flaw if the distance over which the flaw extends is significant compared to the sensor-flaw spacing (e.g. extends over a distance equal to or greater than the sensor-to-flaw spacing). The goodness of fit between the algorithm and a typical flaw signature is confirmed in the fact that a maximum correlation value of 0.995 is obtained for a peak separation of $B=16$. All correlation results presented were obtained using the algorithm of FIG. 12(b); the value of B is indicated in each case. The graphs of correlation value as a function of B in FIGS. 13(a)-(b) for typical flaws in a strand and in a bar were

obtained by varying the B value of the algorithm when correlated against a flaw signal having a peak separation of $B=16$ for the strand flaw and $B=32$ for the bar flaw.

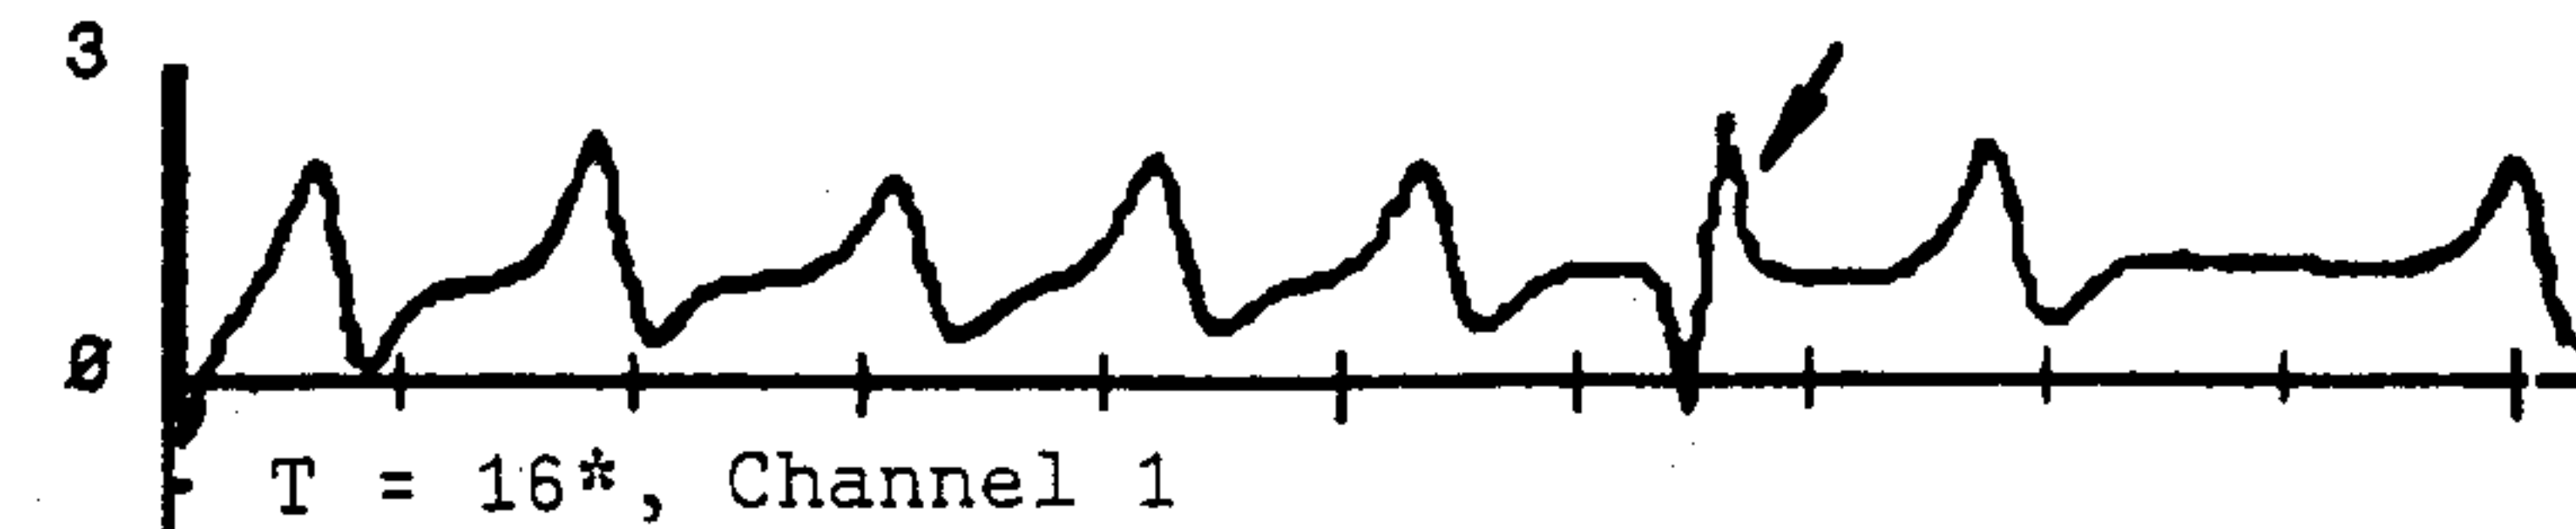
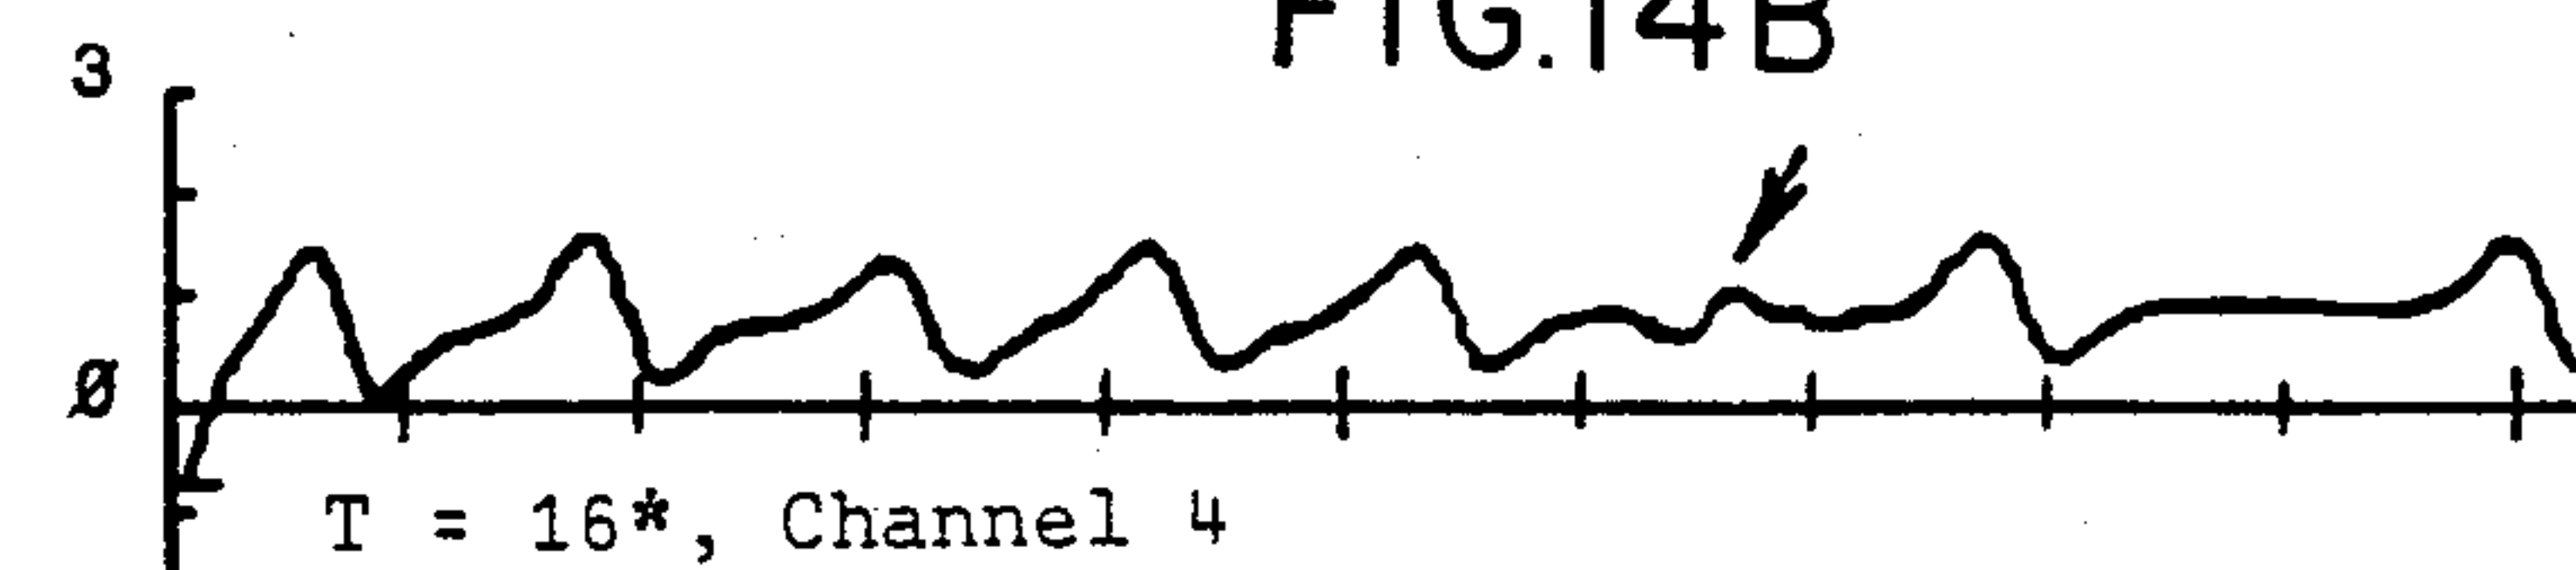
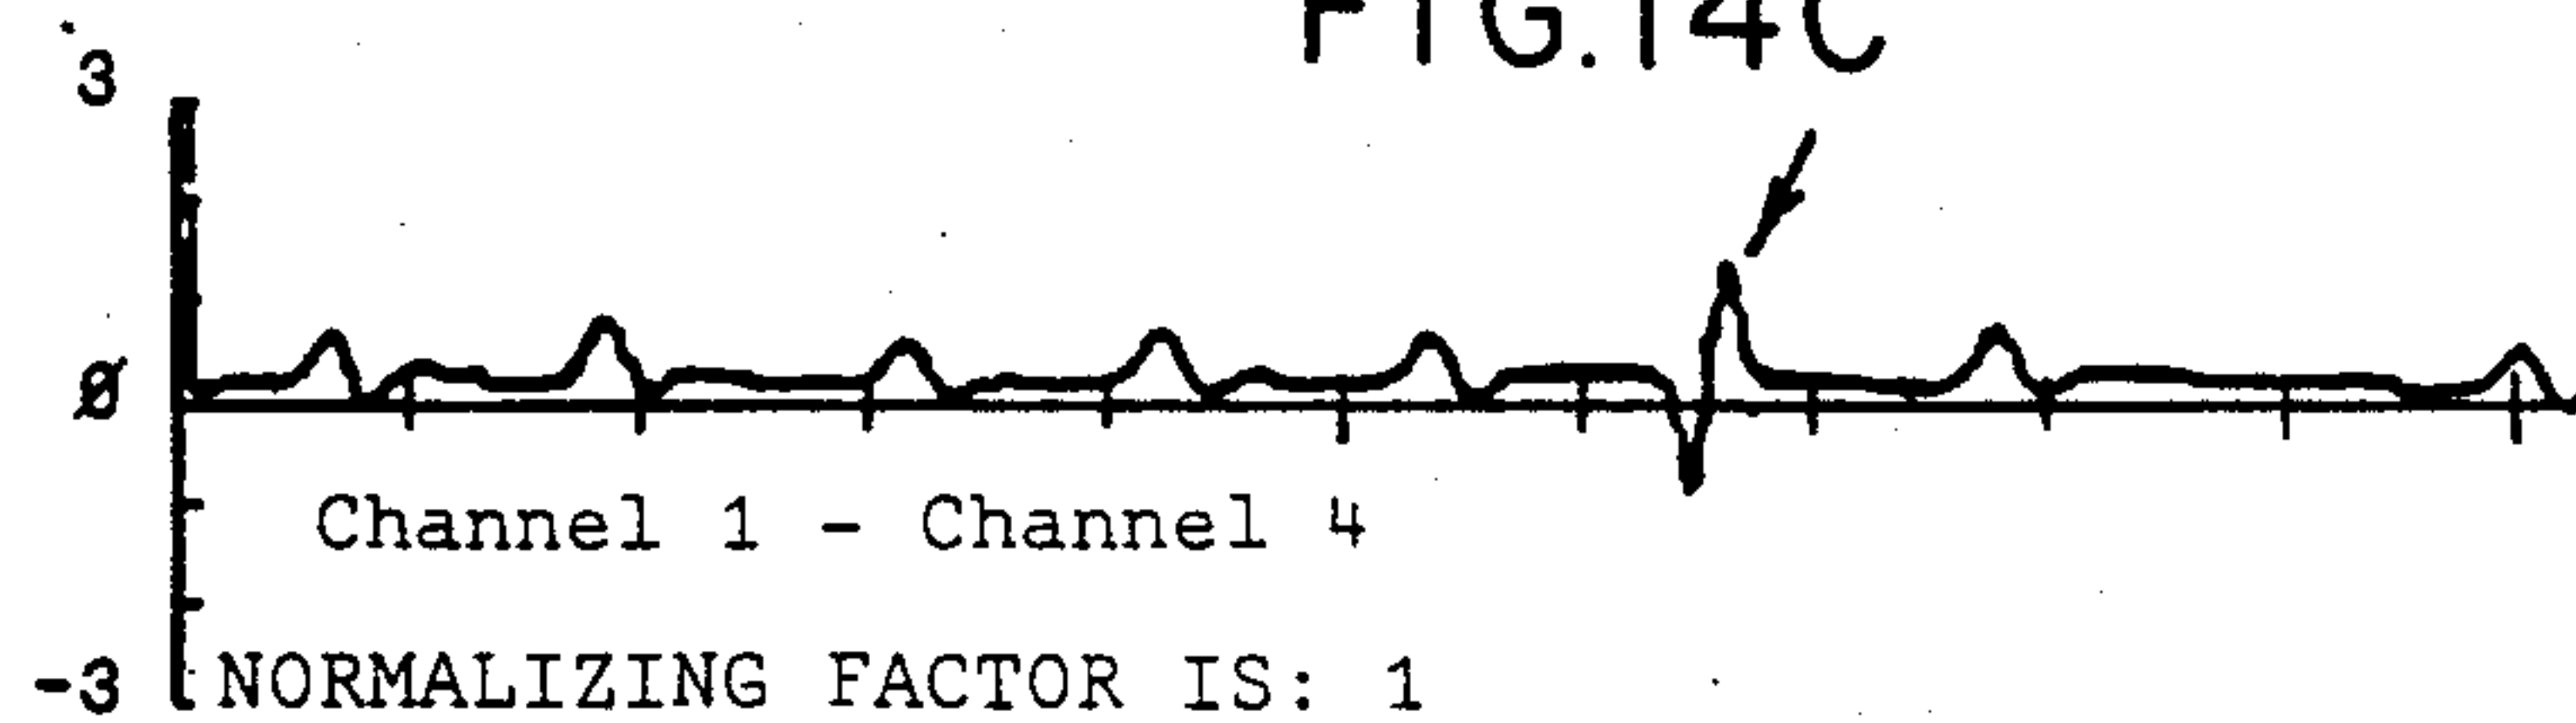
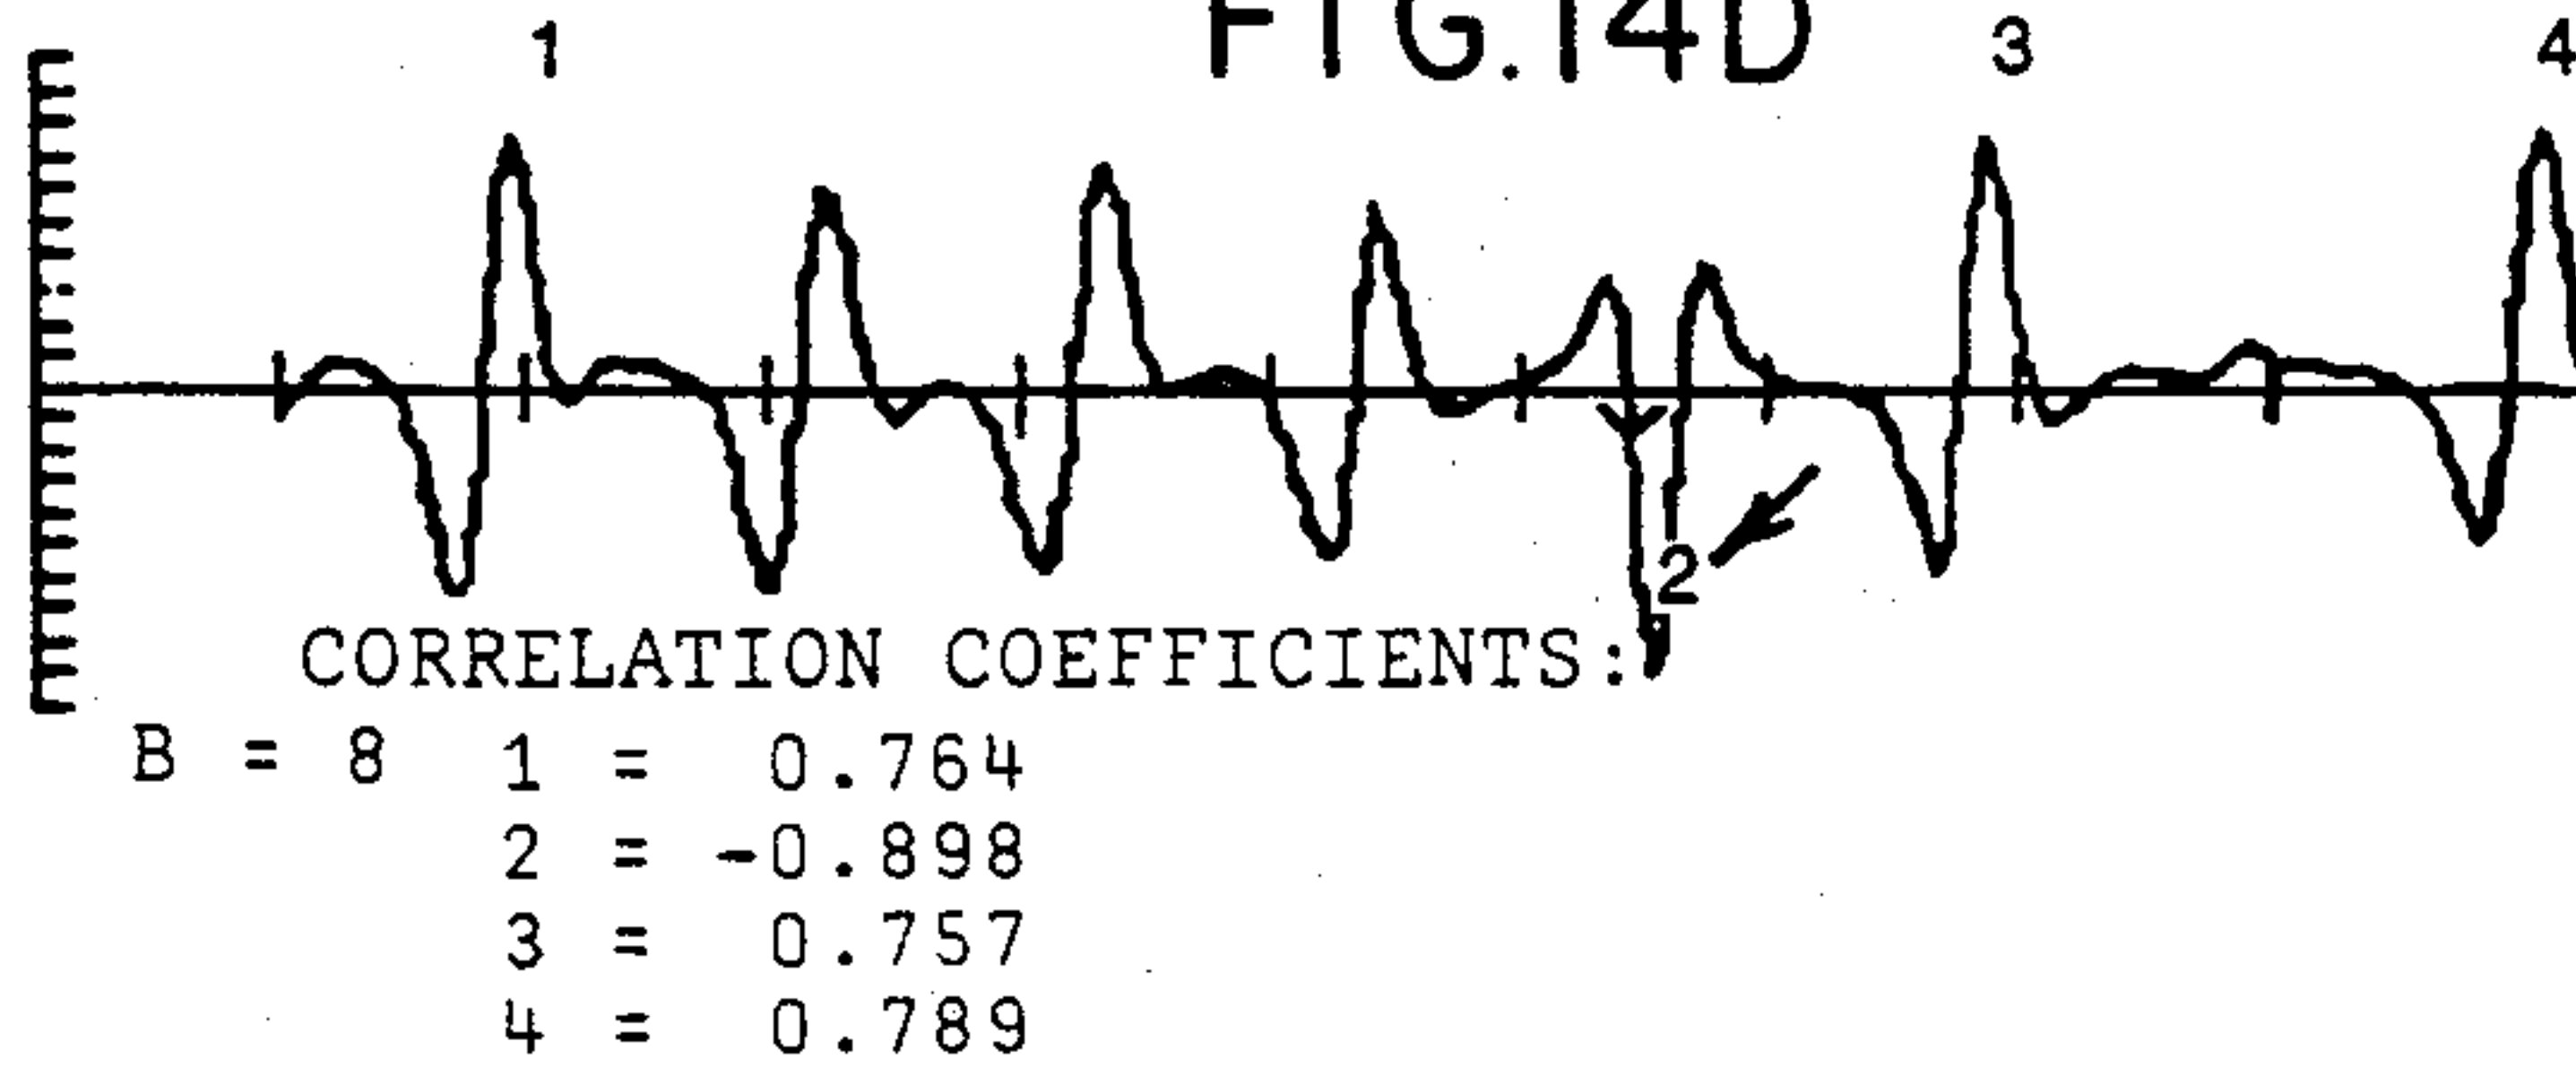
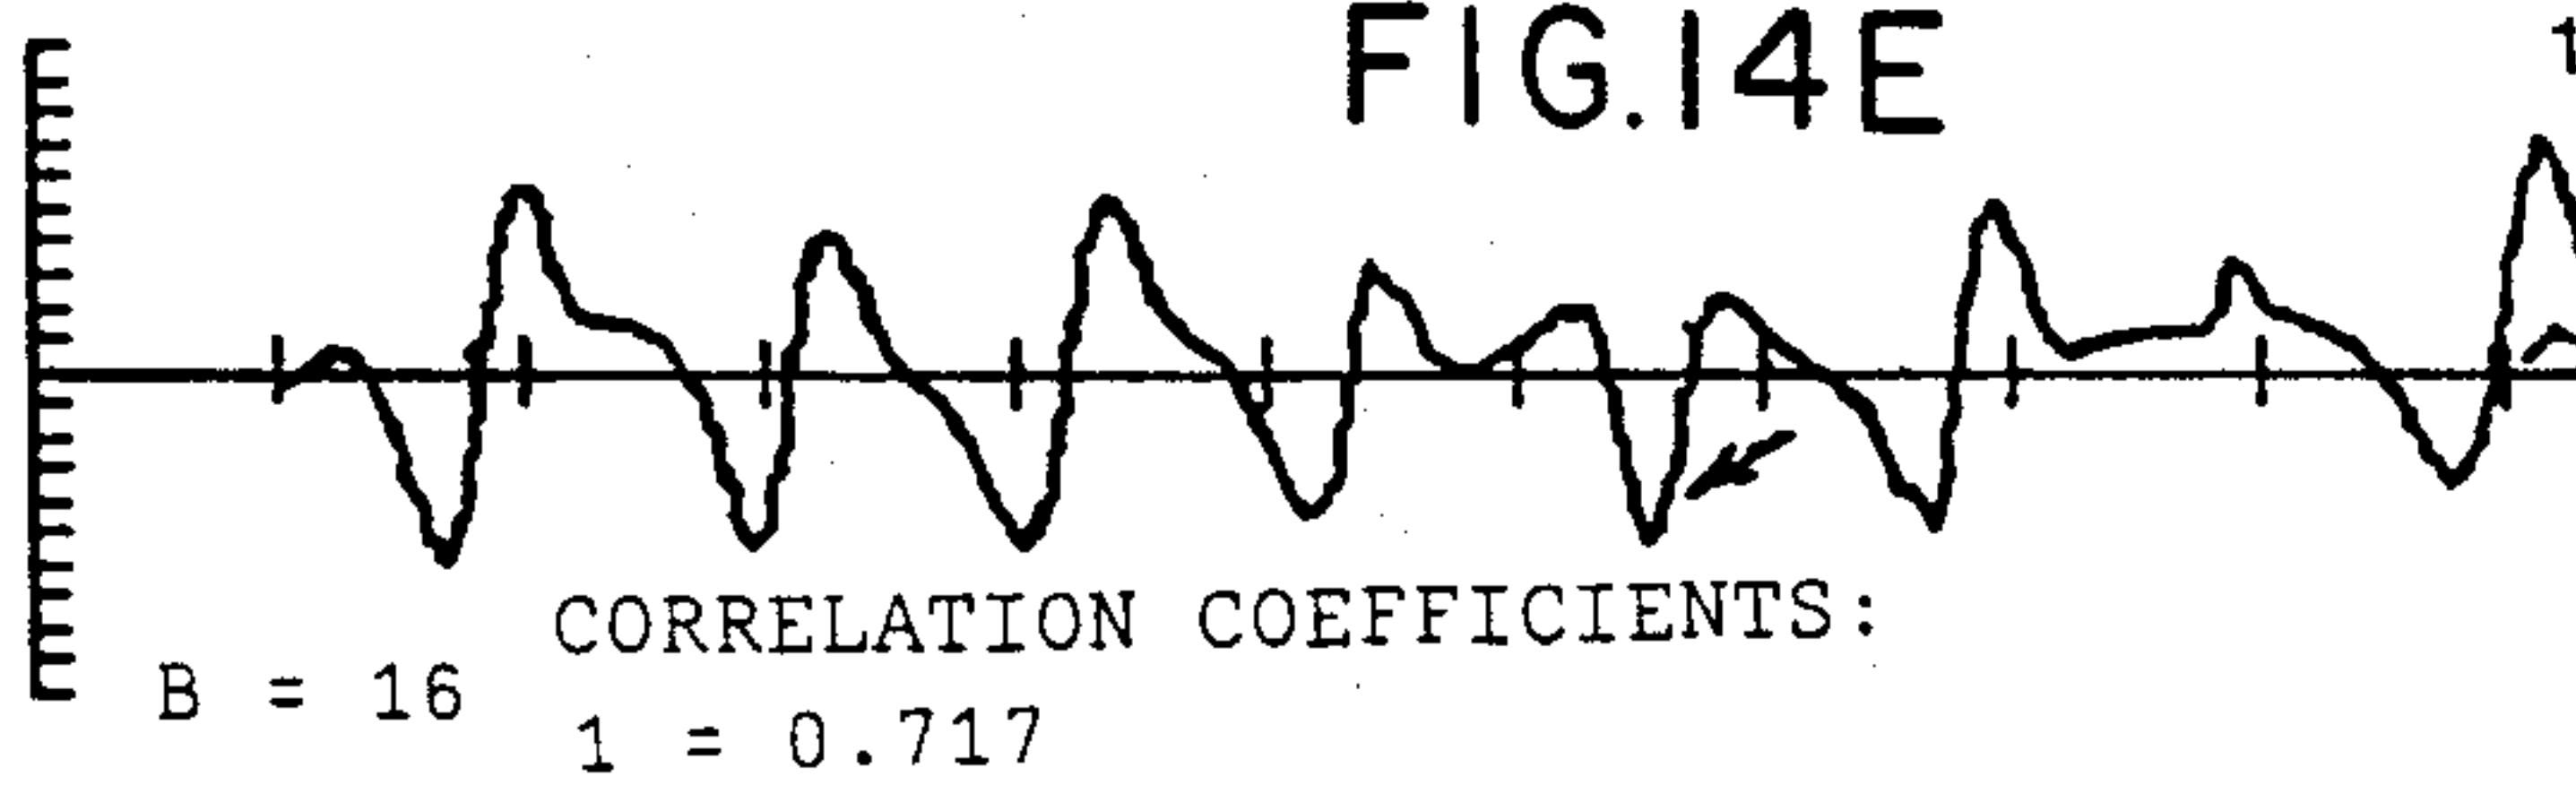
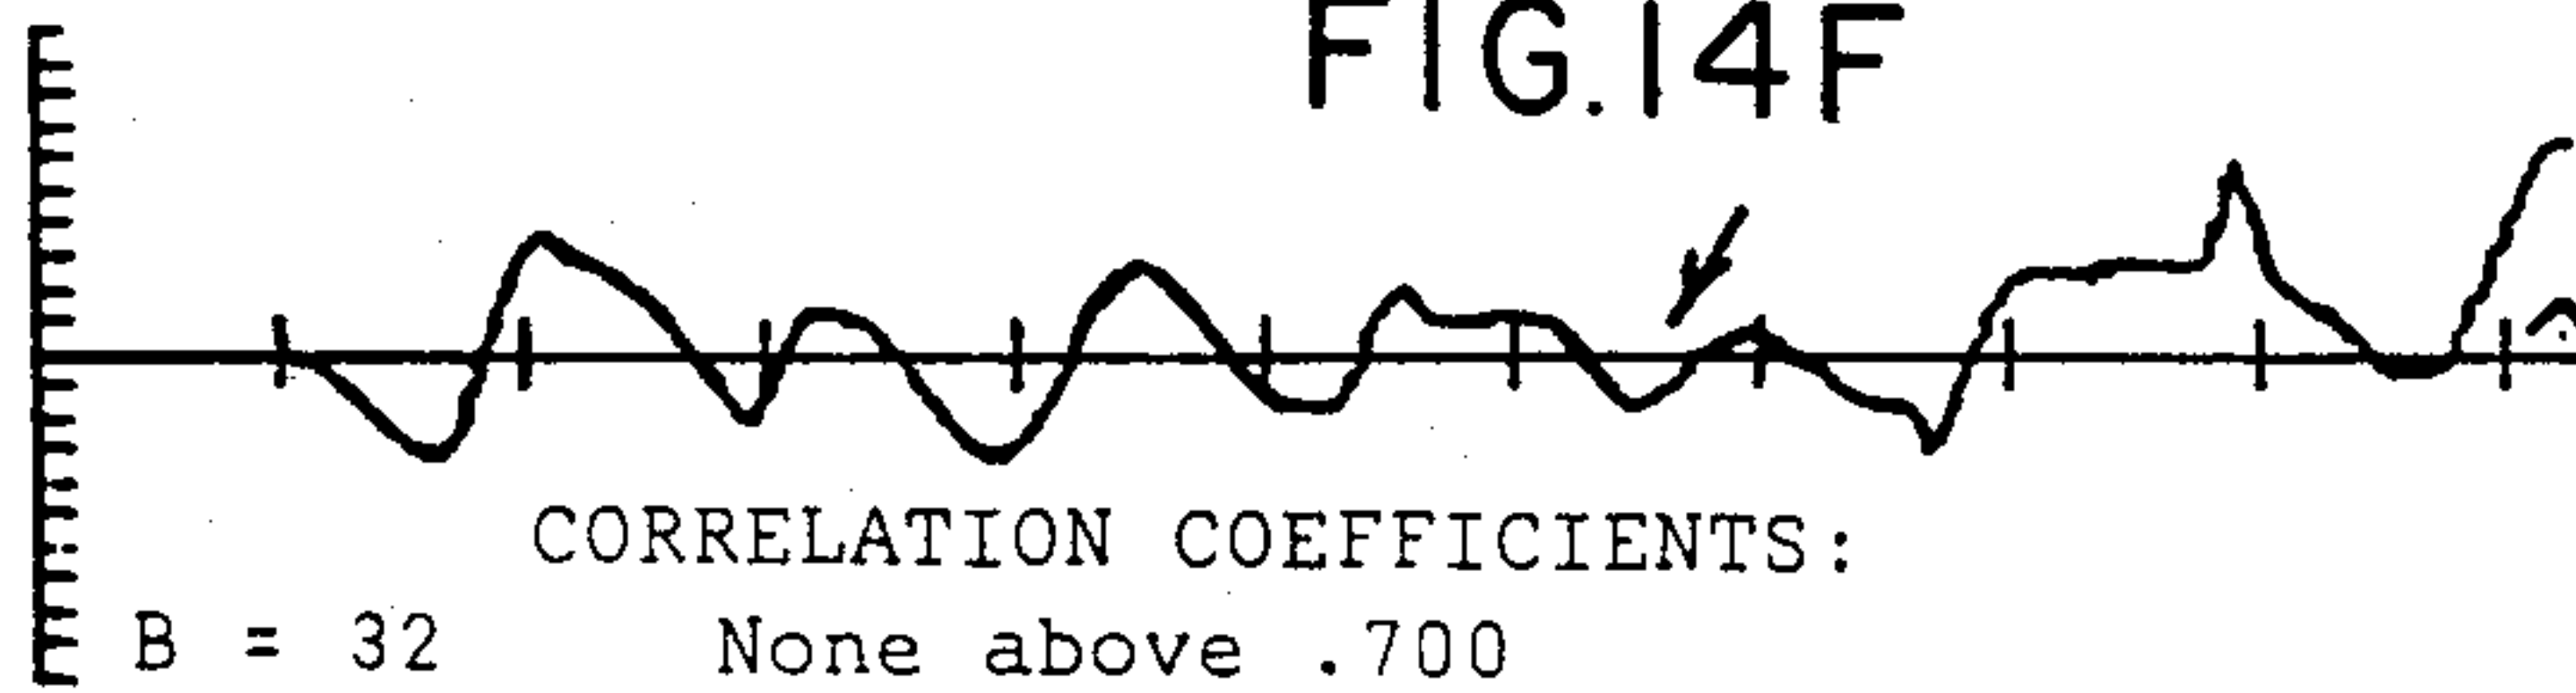
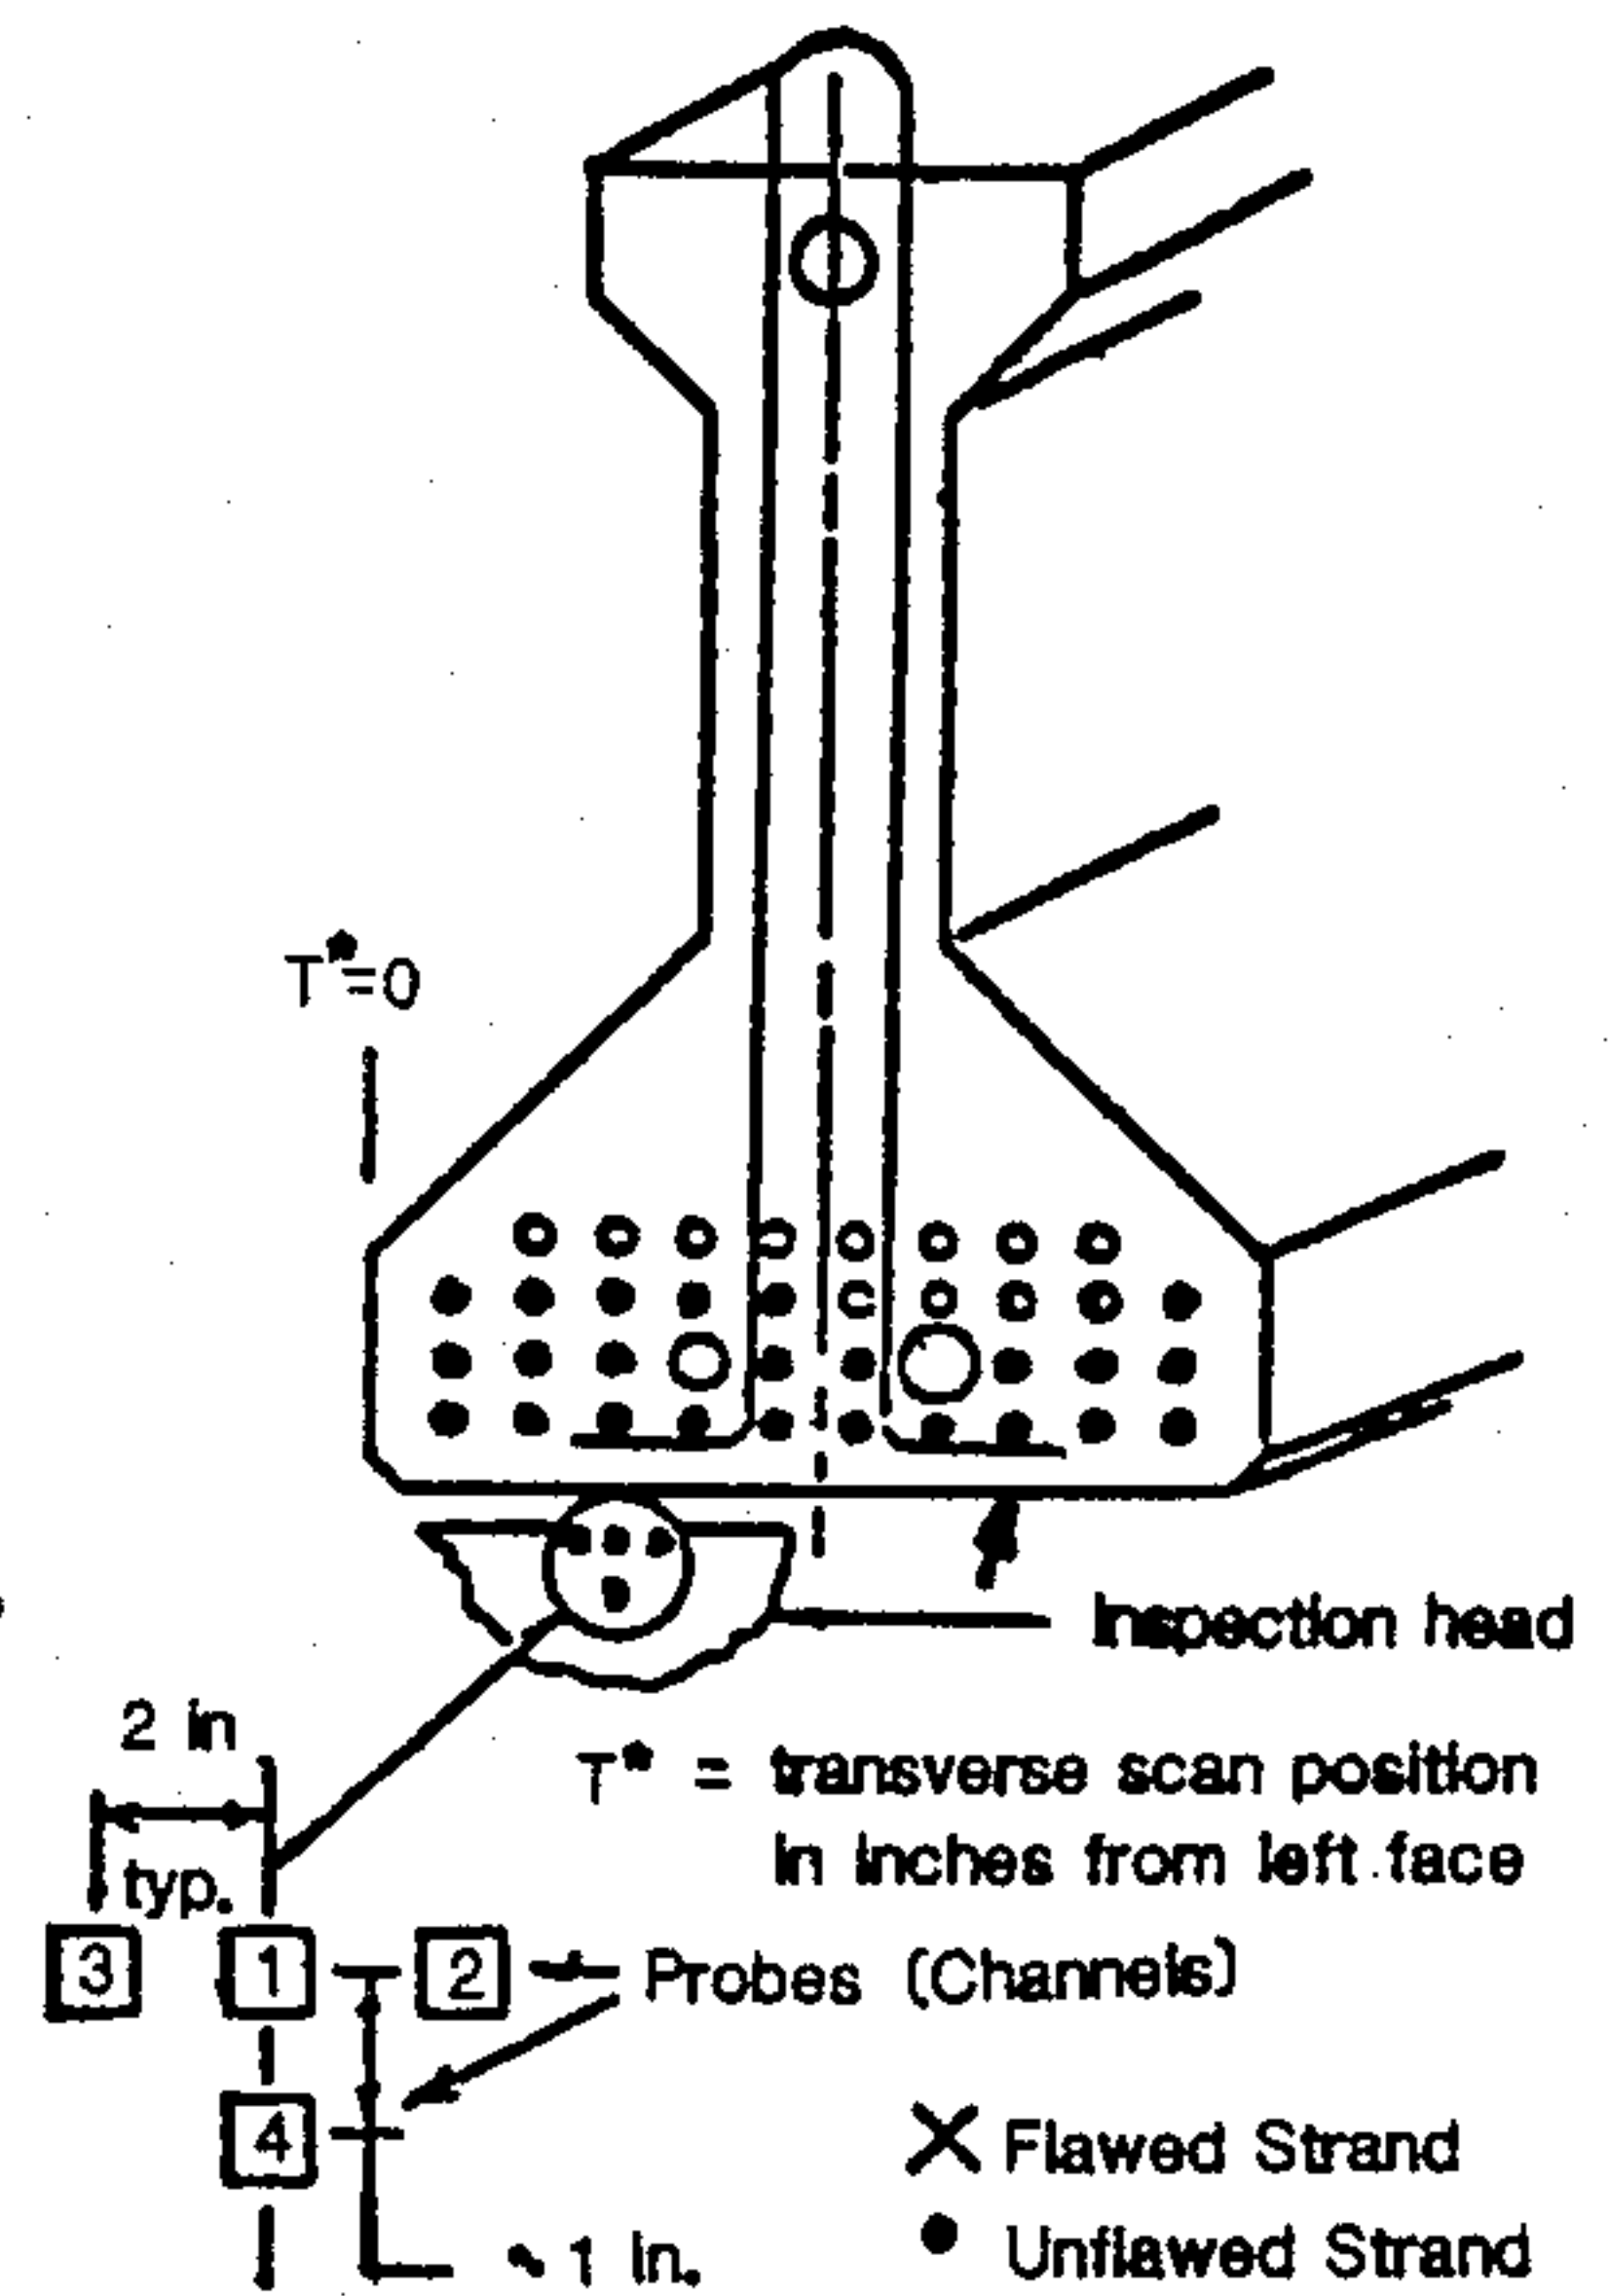
FIG. 14A

Note: SURFACE ARTIFACT = 1 PIECE 16 ga. IRON WIRE, ~ 1-1/2 in. LONG PARALLEL TO BEAM AXIS.

FIGS. 14 and 14(a)–(f) show the signature of a piece of wire scrap near the bottom of the beam.

An important property of the correlation function, i.e. that inversion of polarity between the interrogating or flaw signal and a signal in the scan signature will result in a negative value of the correlation coefficient, makes it possible to eliminate the influence of disturbing elements such as wire scrap near the lower surface of the beam from further consideration. For example, FIGS. 14(a) and (b) show the influence of a 1½ inch long piece of 16 ga. iron "tie" wire on the magnetic signature from Channels 1 and 4 when scanned directly beneath the wire scrap. Because of the greater proximity of the wire scrap to the sensor of Channel 1 than to the sensor of Channel 4, the signal amplitude is greatly reduced on Channel 4 (see arrows in FIGS. 14(a)-(f)). In addition, notice that the signal from the wire scrap is inverted in polarity; that is, the wire signal is first downward-going then upward-going as viewed from left to right while the signal from a then upward-going as viewed from left to right while the signal from a stirrup is upward-going and then downward-going. Flaw signals have the same polarity as stirrup signals, upward-going then downward-going as viewed from left to right (see FIGS. 4-7 where the flaw signal is pointed out by the arrow). FIG. 14(c) shows the result of differencing Channel 1 and Channel 4—a prominent "opposite polarity" signal is obtained from the piece of wire mounted on the lower surface of the beam. FIG. 14(d) is a plot of the correlation coefficient for the differenced signature; note that the maximum coefficient (without regard for sign) corresponds to peak 2, from the wire scrap, but is negative in sign. It should be noted that this wire scrap correlation was obtained for $B=8$, indicating it is very near the lower surface of the beam. FIGS. 14(e) and (f) show a progressively smaller value for the corresponding correlation peak (pointed out by the arrows) for values of $B=16$ and $B=32$. Accordingly, it is possible to discriminate between surface and near surface artifacts and flaws and those deeper within the beam; this can be done by merely varying the value of B in the correlation coefficient calculations to see which gives the greatest coefficient, the corresponding value of B providing the indication of depth (i.e. depth is proportional to the value of B).
