[54] MAGNETIC INSPECTION OF REINFORCING STEEL USING SENSOR ARRAY

[73] Assignee: The United States of America as represented by the Secretary of Transportation, Washington, D.C.

[57] ABSTRACT

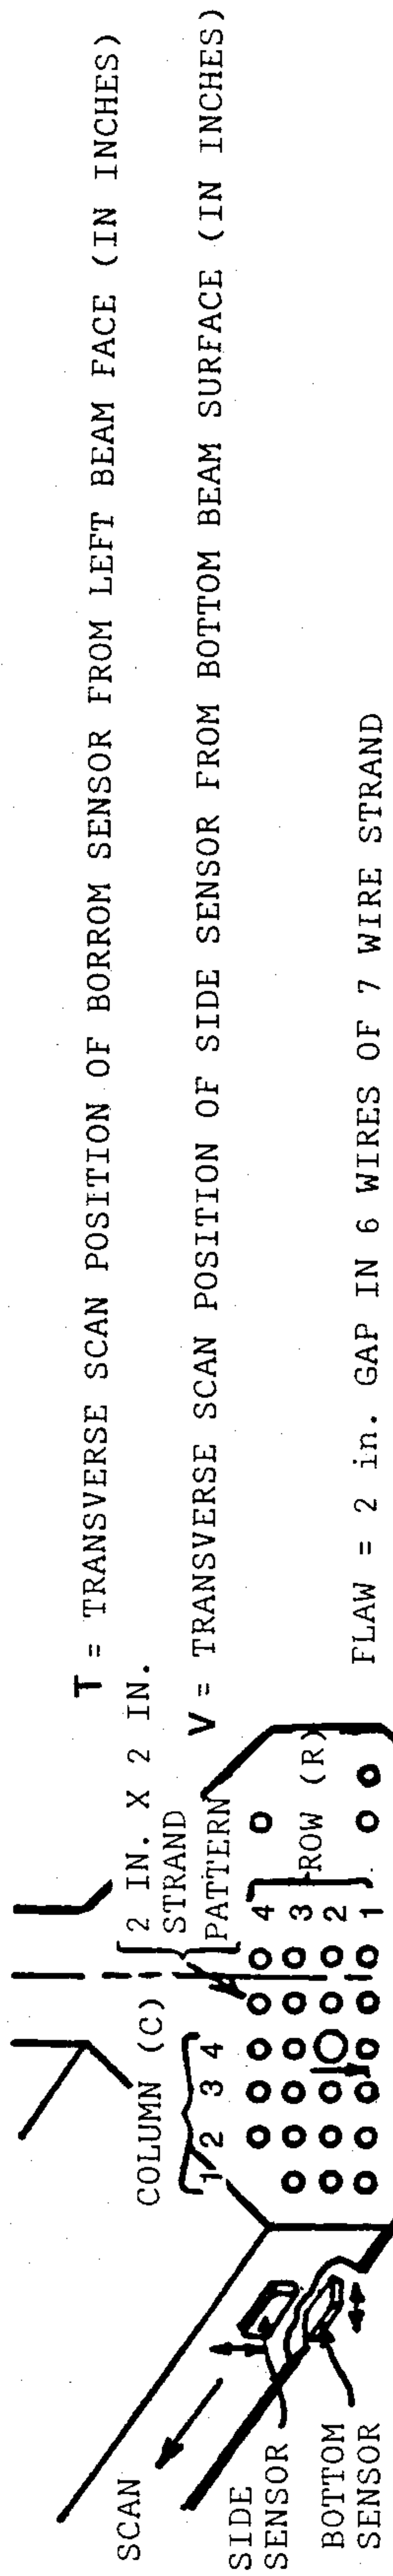
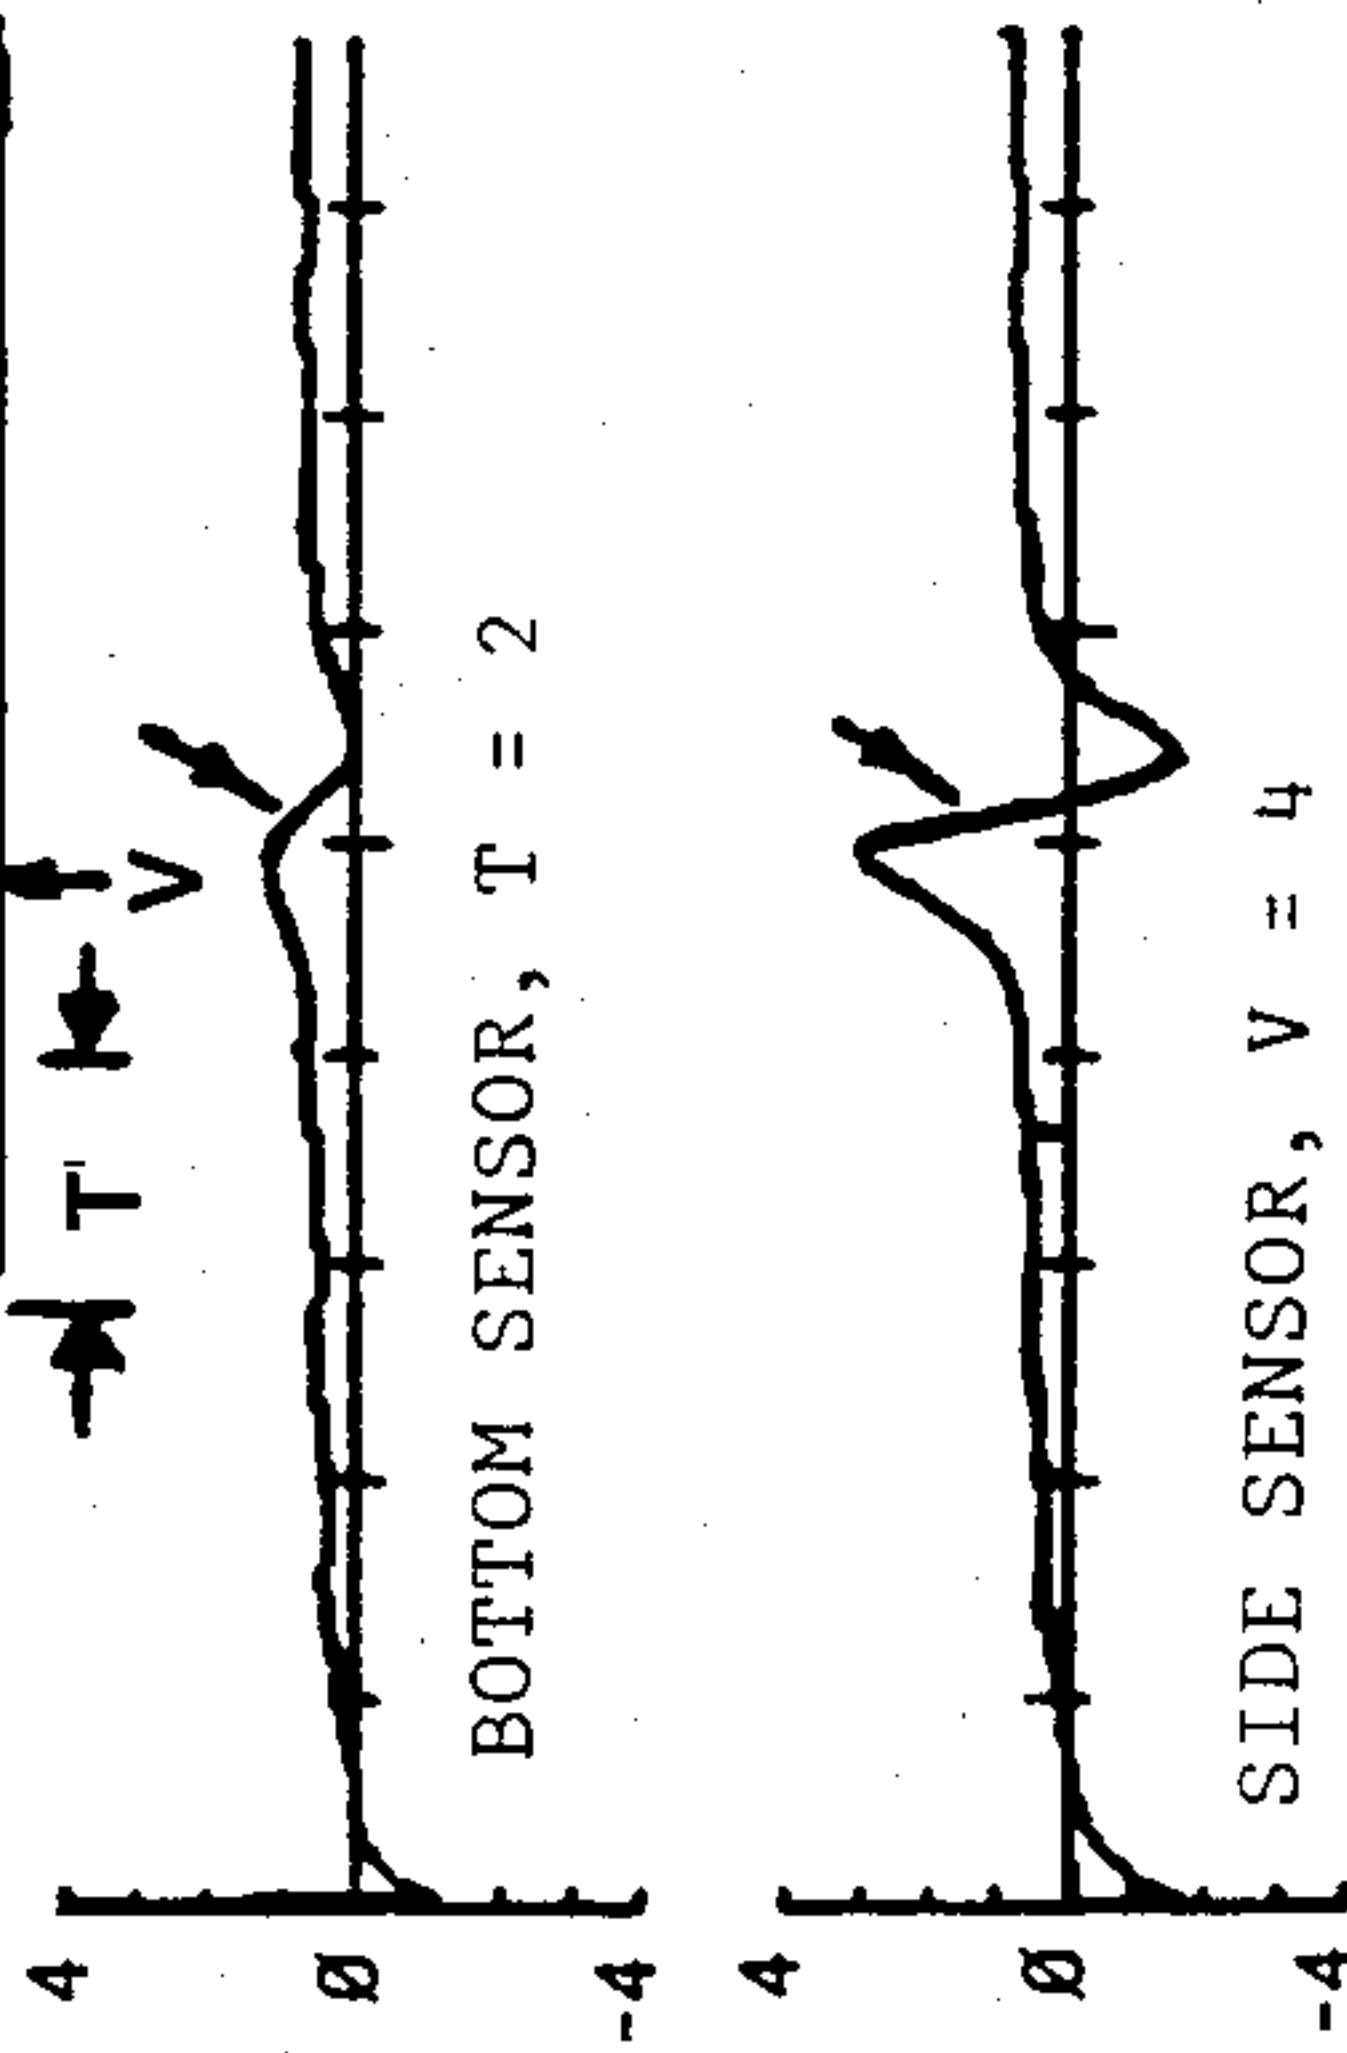
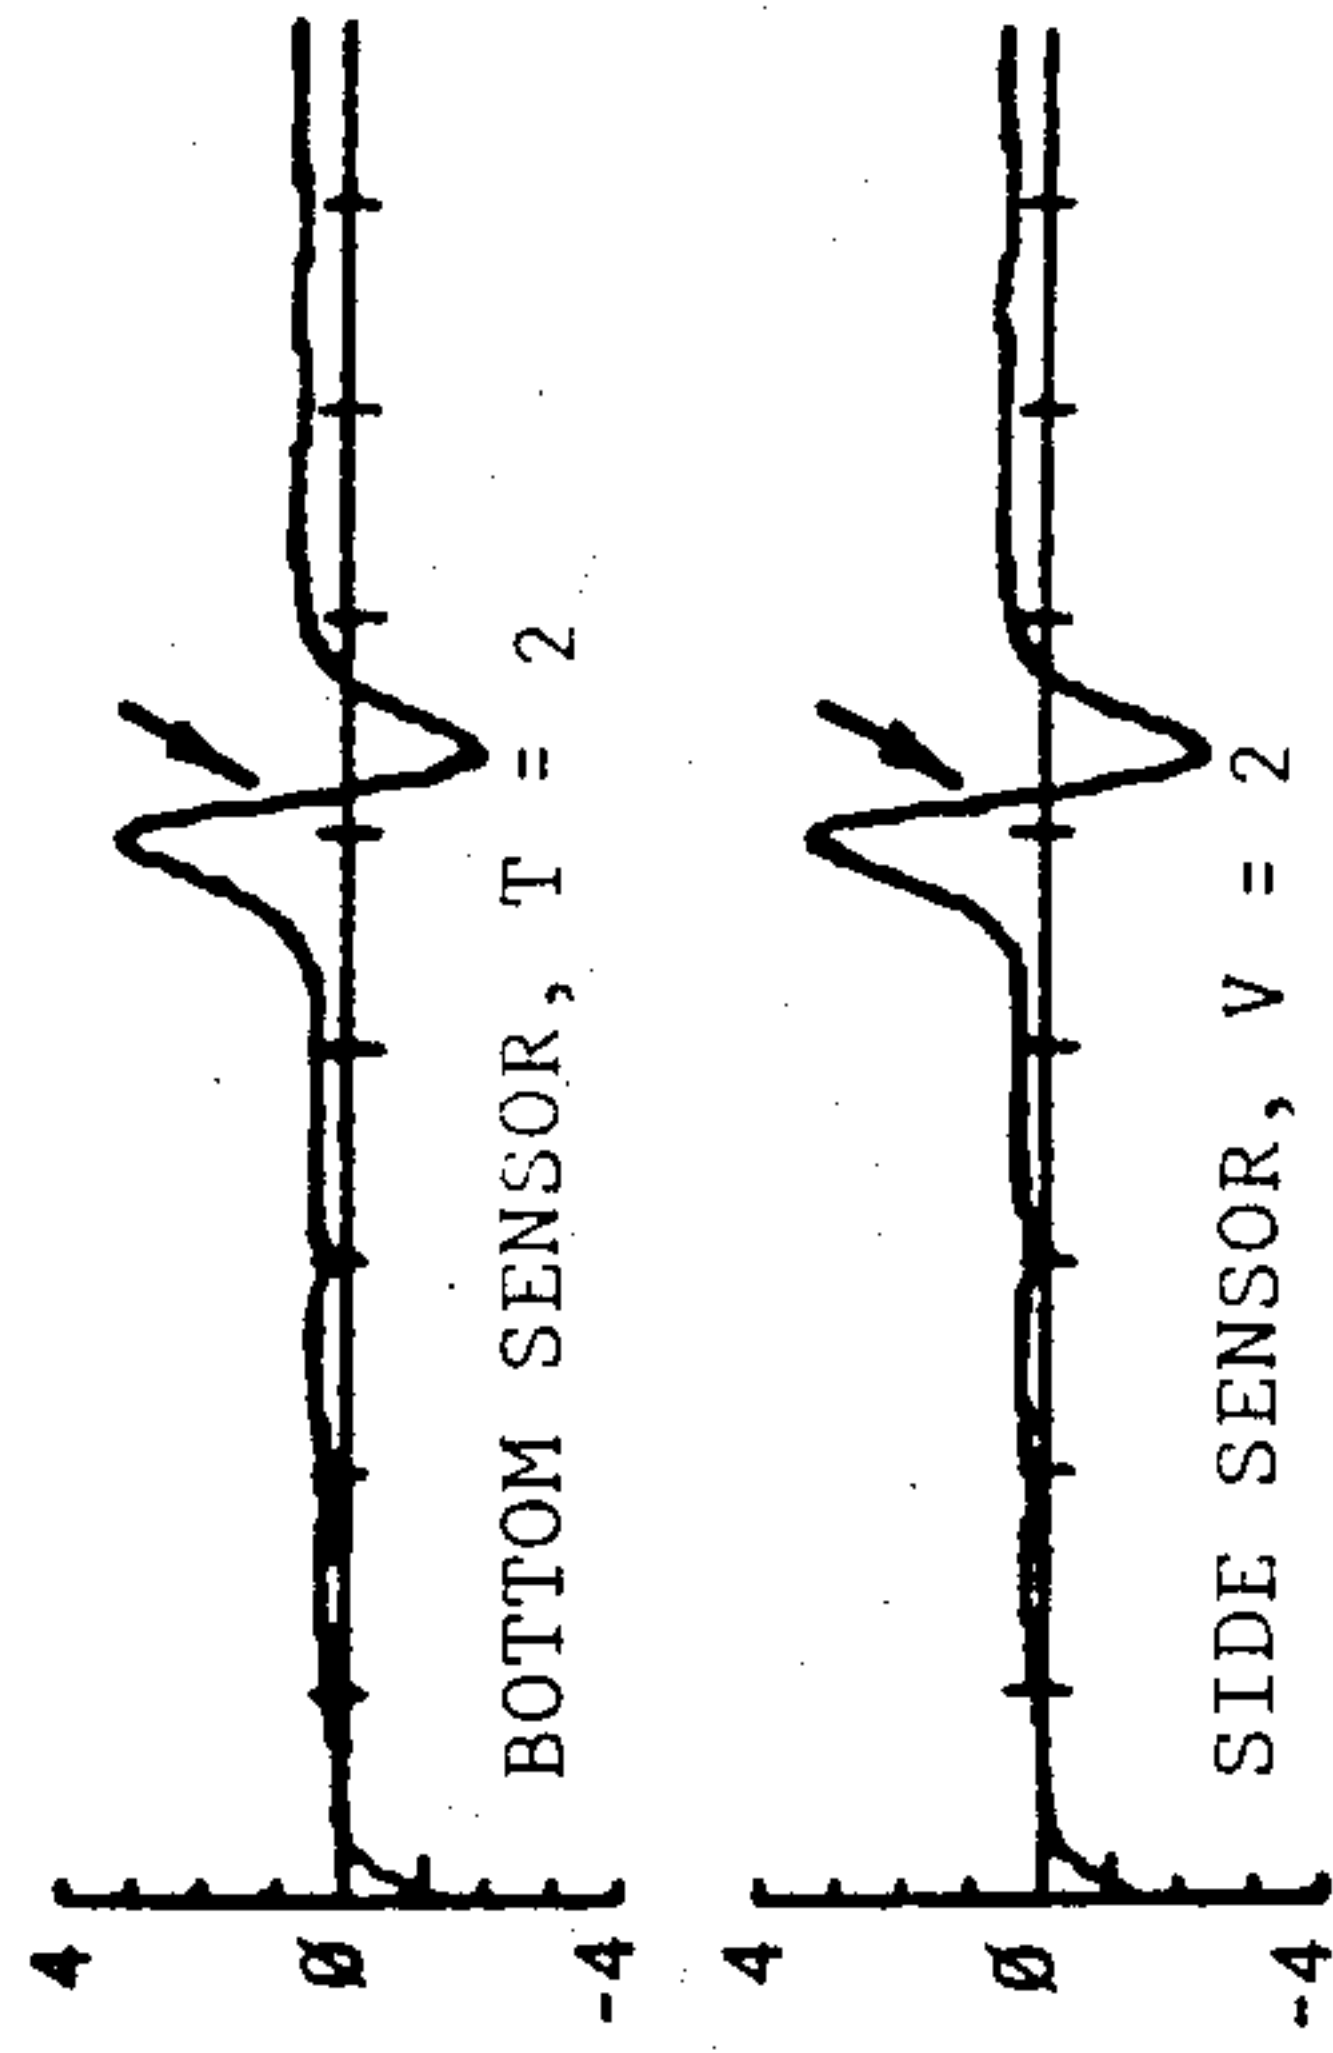
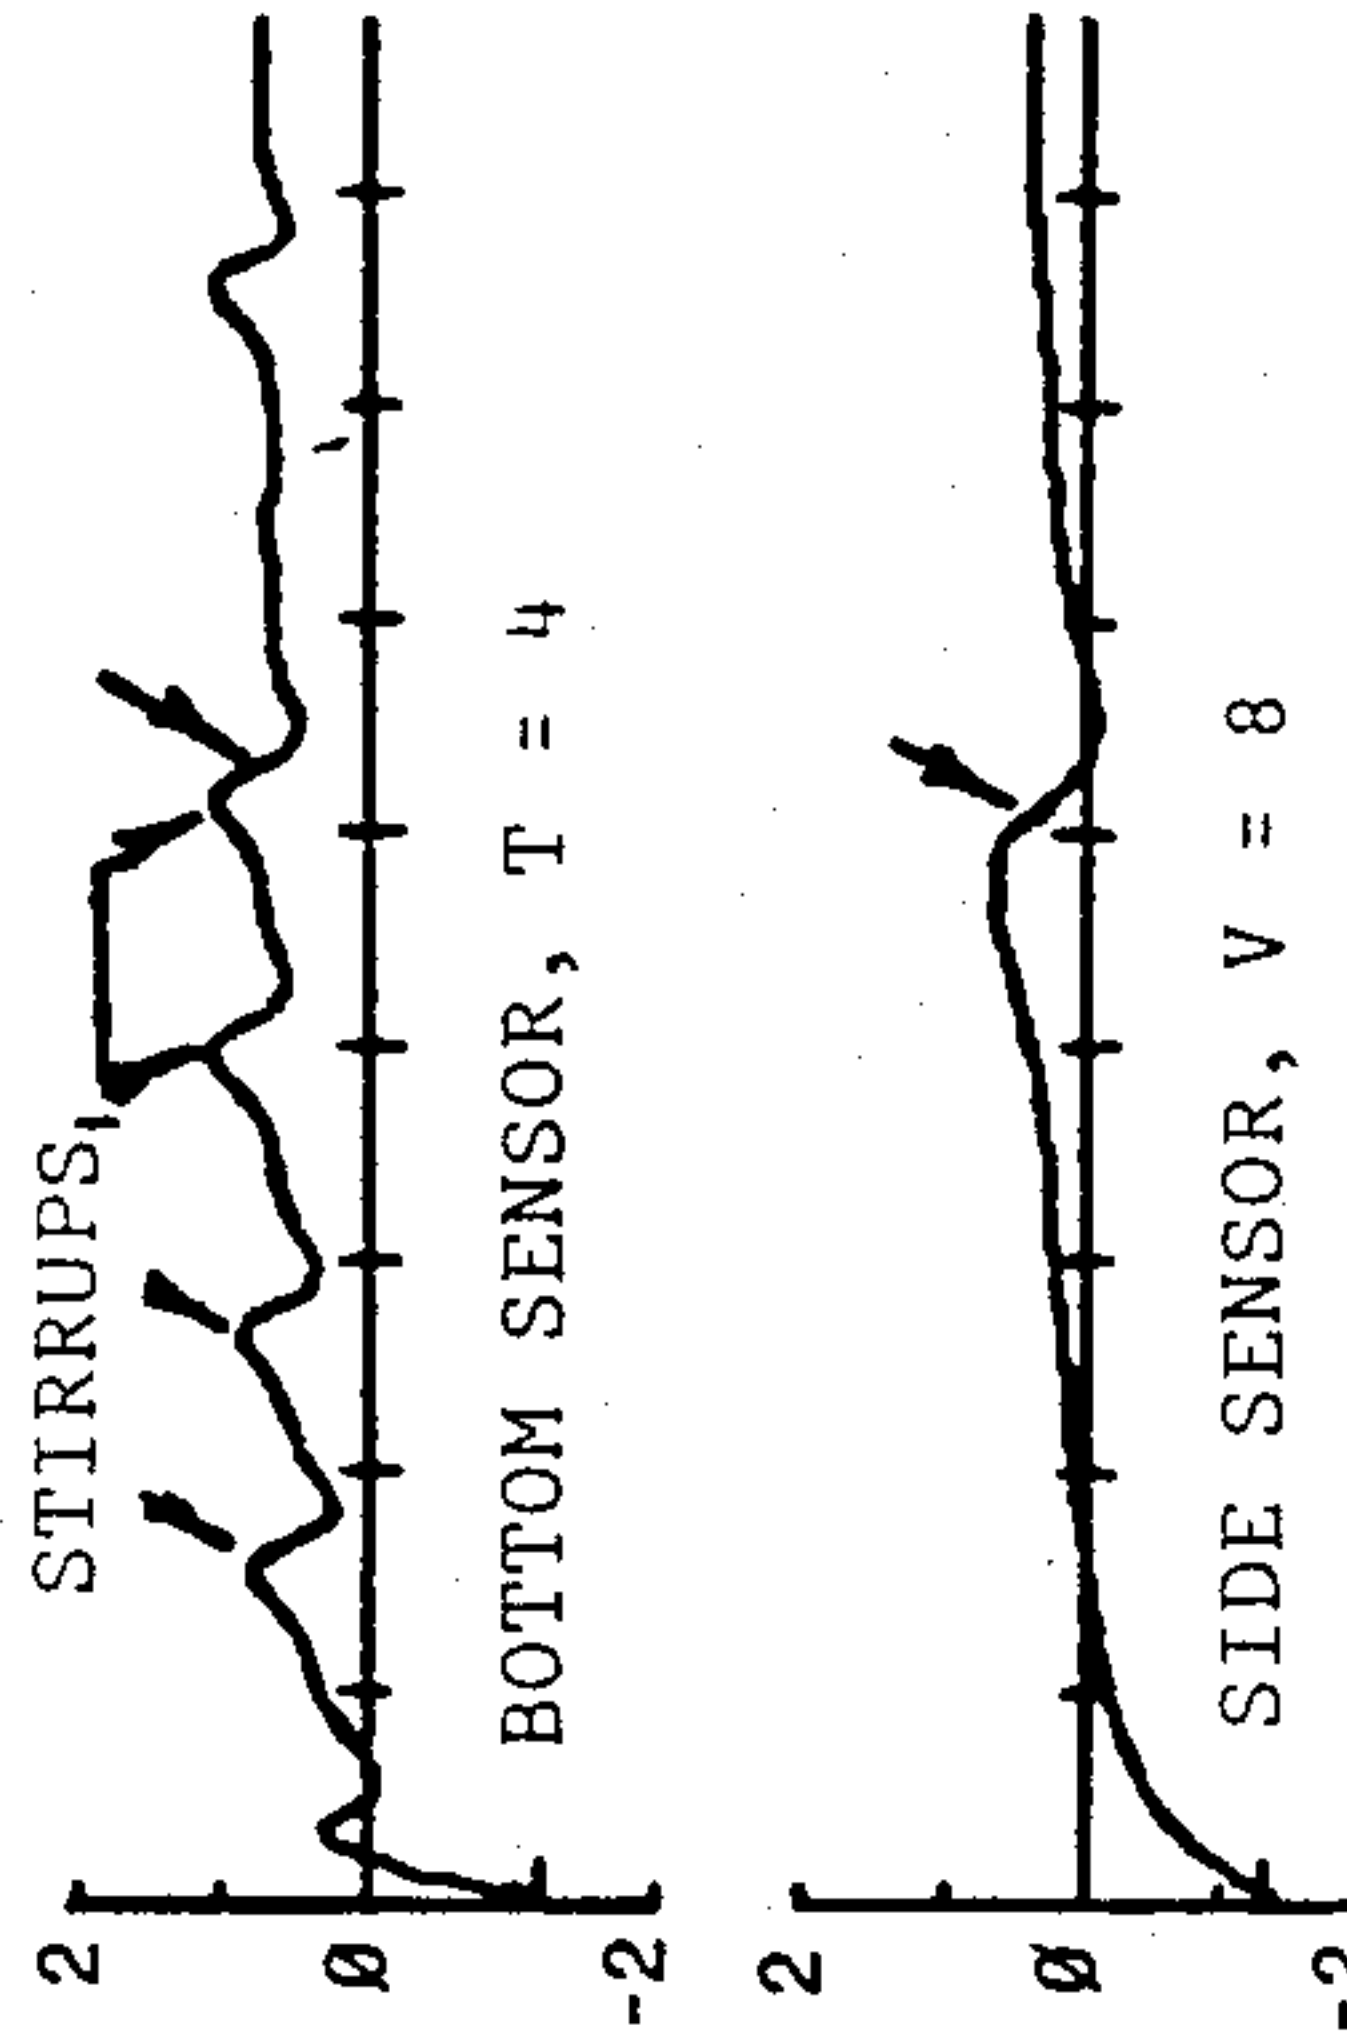
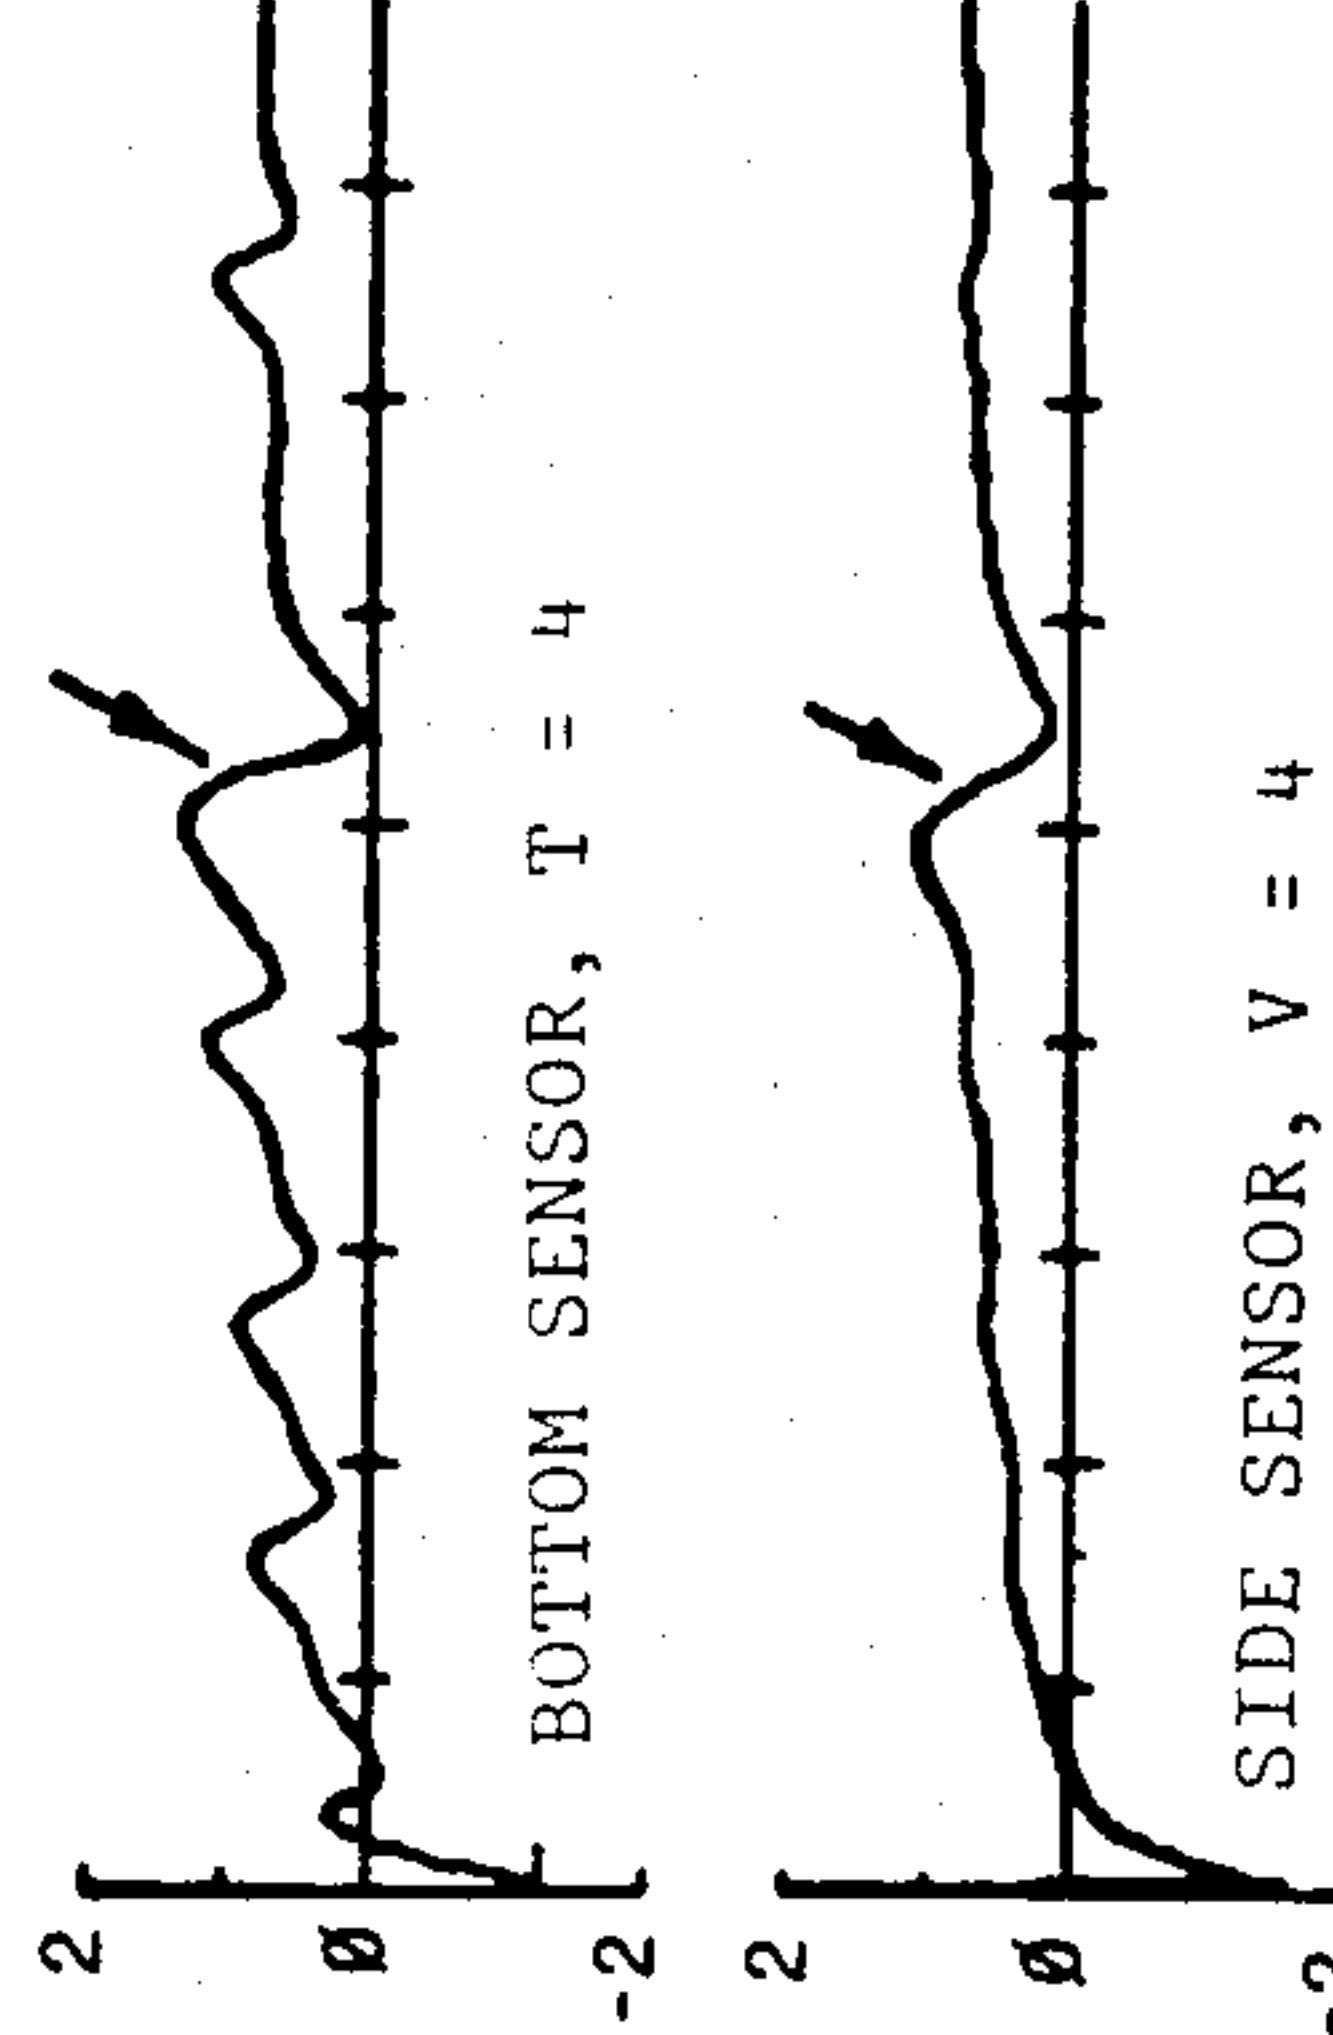
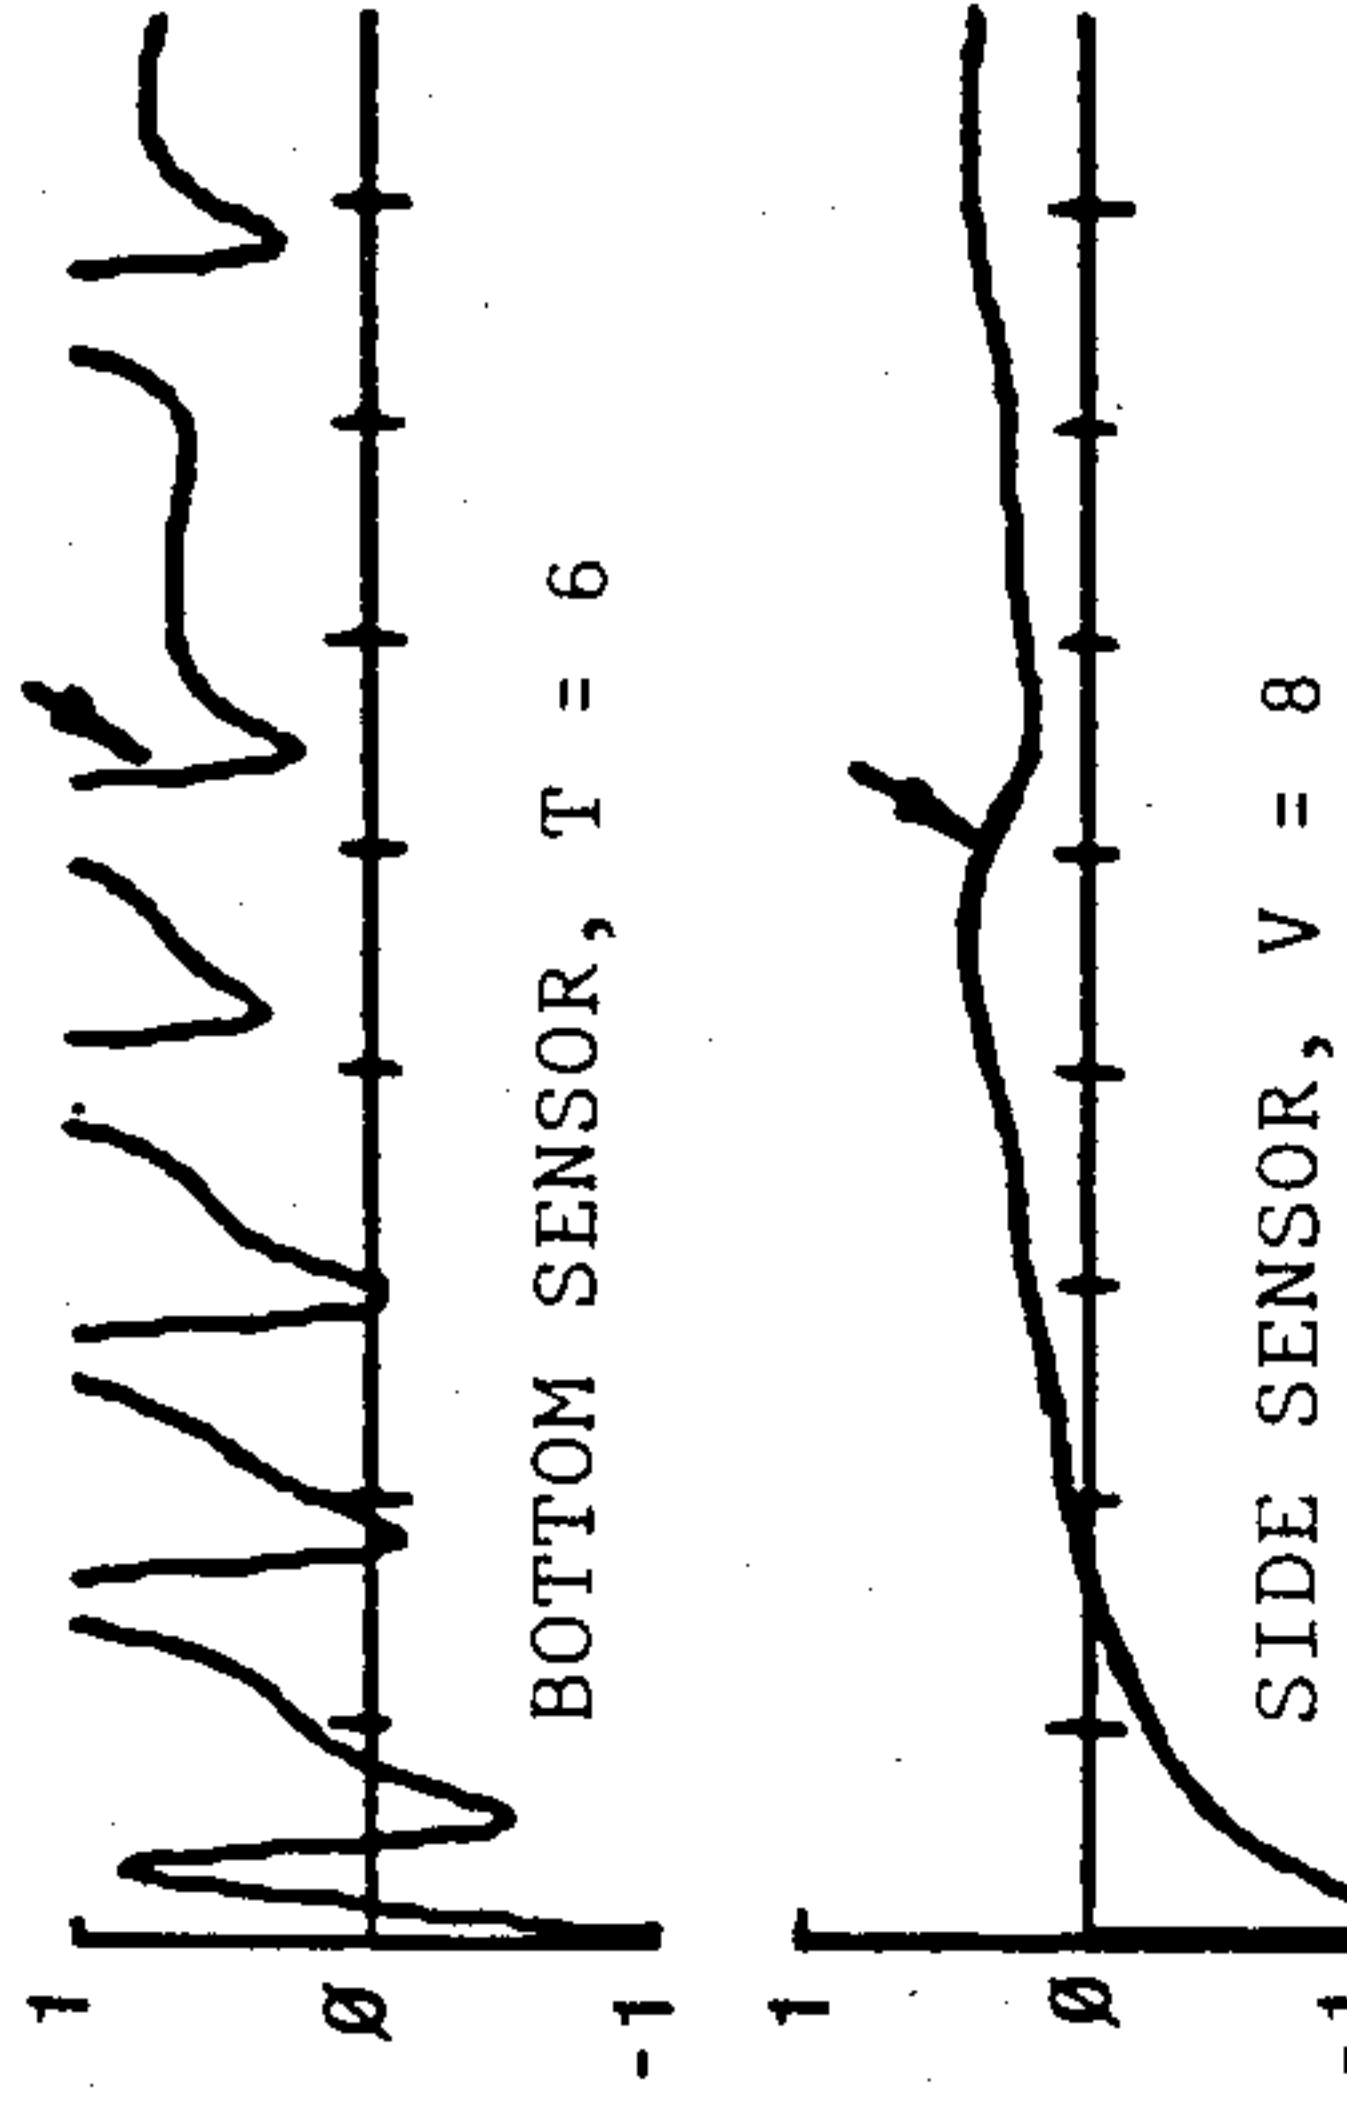
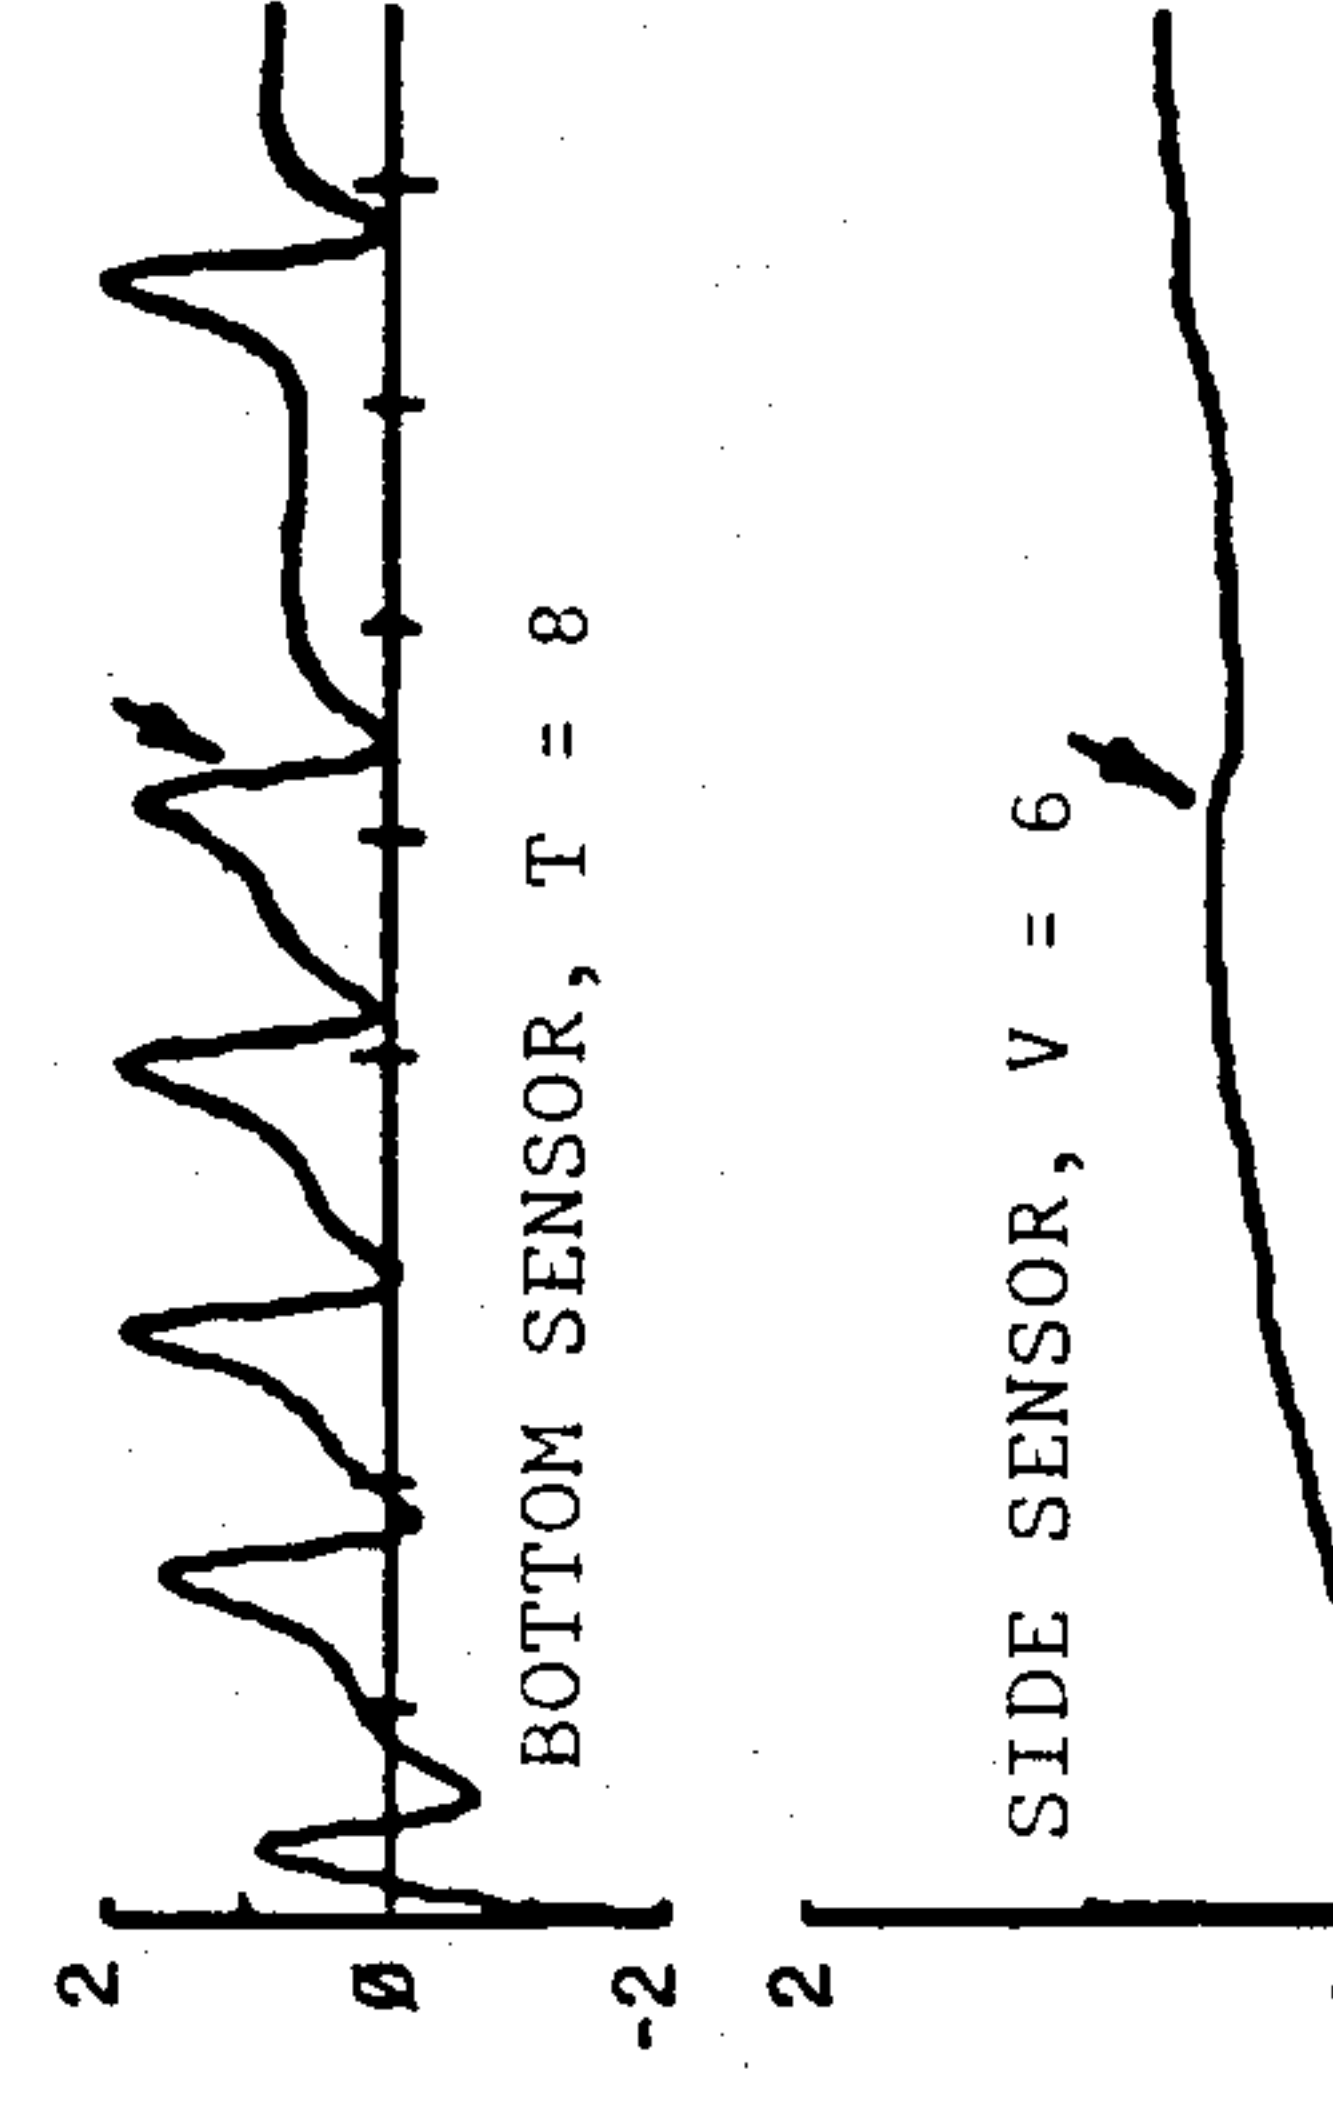
FIG. 15A

FLAW = 2 in. GAP IN 6 WIRES OF 7 WIRE STRAND

FLAW IN ROW 2, COLUMN 1 POSITION

FLAW IN ROW 1, COLUMN 1 POSITION

FLAW IN ROW 4, COLUMN 2 POSITION

FLAW IN ROW 2, COLUMN 2 POSITION

FLAW IN ROW 4, COLUMN 3 POSITION

FLAW IN ROW 3, COLUMN 4 POSITION

FIGS. 15 and 15(a)–(f) show a comparison between side mounted sensors and bottom mounted sensors.

A configuration wherein the sensor is placed against the side of the beam was also tried. FIGS. 15(a)-(f) show the results of this placement compared to those from placement against the bottom of the beam. In this comparison test, the magnet and sensor are aligned up directly below the column which contains the flawed strand, or the sensor is on the left side of the beam on the centerline of the row which contains the flawed strand and the magnet remains below the column which contains the flawed strand. When the flawed strand, is in the first row and first column as in records A the signals are approximately equal. When the flawed strand is moved to the column 1 row 2 position FIG. 15(b), the side sensor produces a much clearer indication of the flaw since it is closer to the flawed strand than the bottom sensor. When the flawed strand is moved into the second, third, or fourth row (see FIGS. 15(e)-(f)) the bottom sensor picks up the presence of the stirrups; the side sensor does not, since the stirrup is not between the sensor and the strand.

Note that FIGS. 15(a)-(f) are raw data; that is, they have not been differenced as in previous Figures nor

have correlation coefficients been calculated for them. It is obvious that the use of two side sensors in the same horizontal plane, with the data manipulated as before, would produce equally clear results. In applications where there are substantial numbers of stirrups or other transverse reinforcing members, the use of side sensors may be preferable to the use of bottom sensors.
