United States Patent [19] 4,673,122 Patent Number: [11]Jun. 16, 1987 Date of Patent: Dubey [45] 3,519,023 METHOD AND APPARATUS FOR 54 3,590,206 REPAIRING COPPER PIPES 3,633,266 Thomas W. Dubey, 2601 Lower 76 Inventor: Roswell Rd., Marietta, Ga. 30062 4,089,453 4,205,221 Appl. No.: 865,847 [21] 4,413,765 11/1983 Tracy 228/119 4,465,309 Filed: May 22, 1986 FOREIGN PATENT DOCUMENTS 285/15 0056192 4/1982 Japan 228/119 Primary Examiner—Nicholas P. Godici 432/184, 183, 224, 226; 138/97; 285/15, 41; Assistant Examiner—Karen Skillman 29/402.9, 402.16 Attorney, Agent, or Firm—Thomas & Kennedy [56] References Cited [57] **ABSTRACT** U.S. PATENT DOCUMENTS Breached copper pipes are repaired by wrapping a sol-der coated strip of copper about the pipe, mounting a 2,721,823 10/1955 Hopkins et al. 138/97 multiple section heat jacket about the pipe over the strip, and heating the heat jacket with a torch or an electrical heating element inserted into a channel 3,074,704 1/1963 Ronay 432/225 formed in the jacket. 3,464,617 9/1969 Raynes et al. 228/253 5 Claims, 3 Drawing Figures

METHOD AND APPARATUS FOR REPAIRING COPPER PIPES

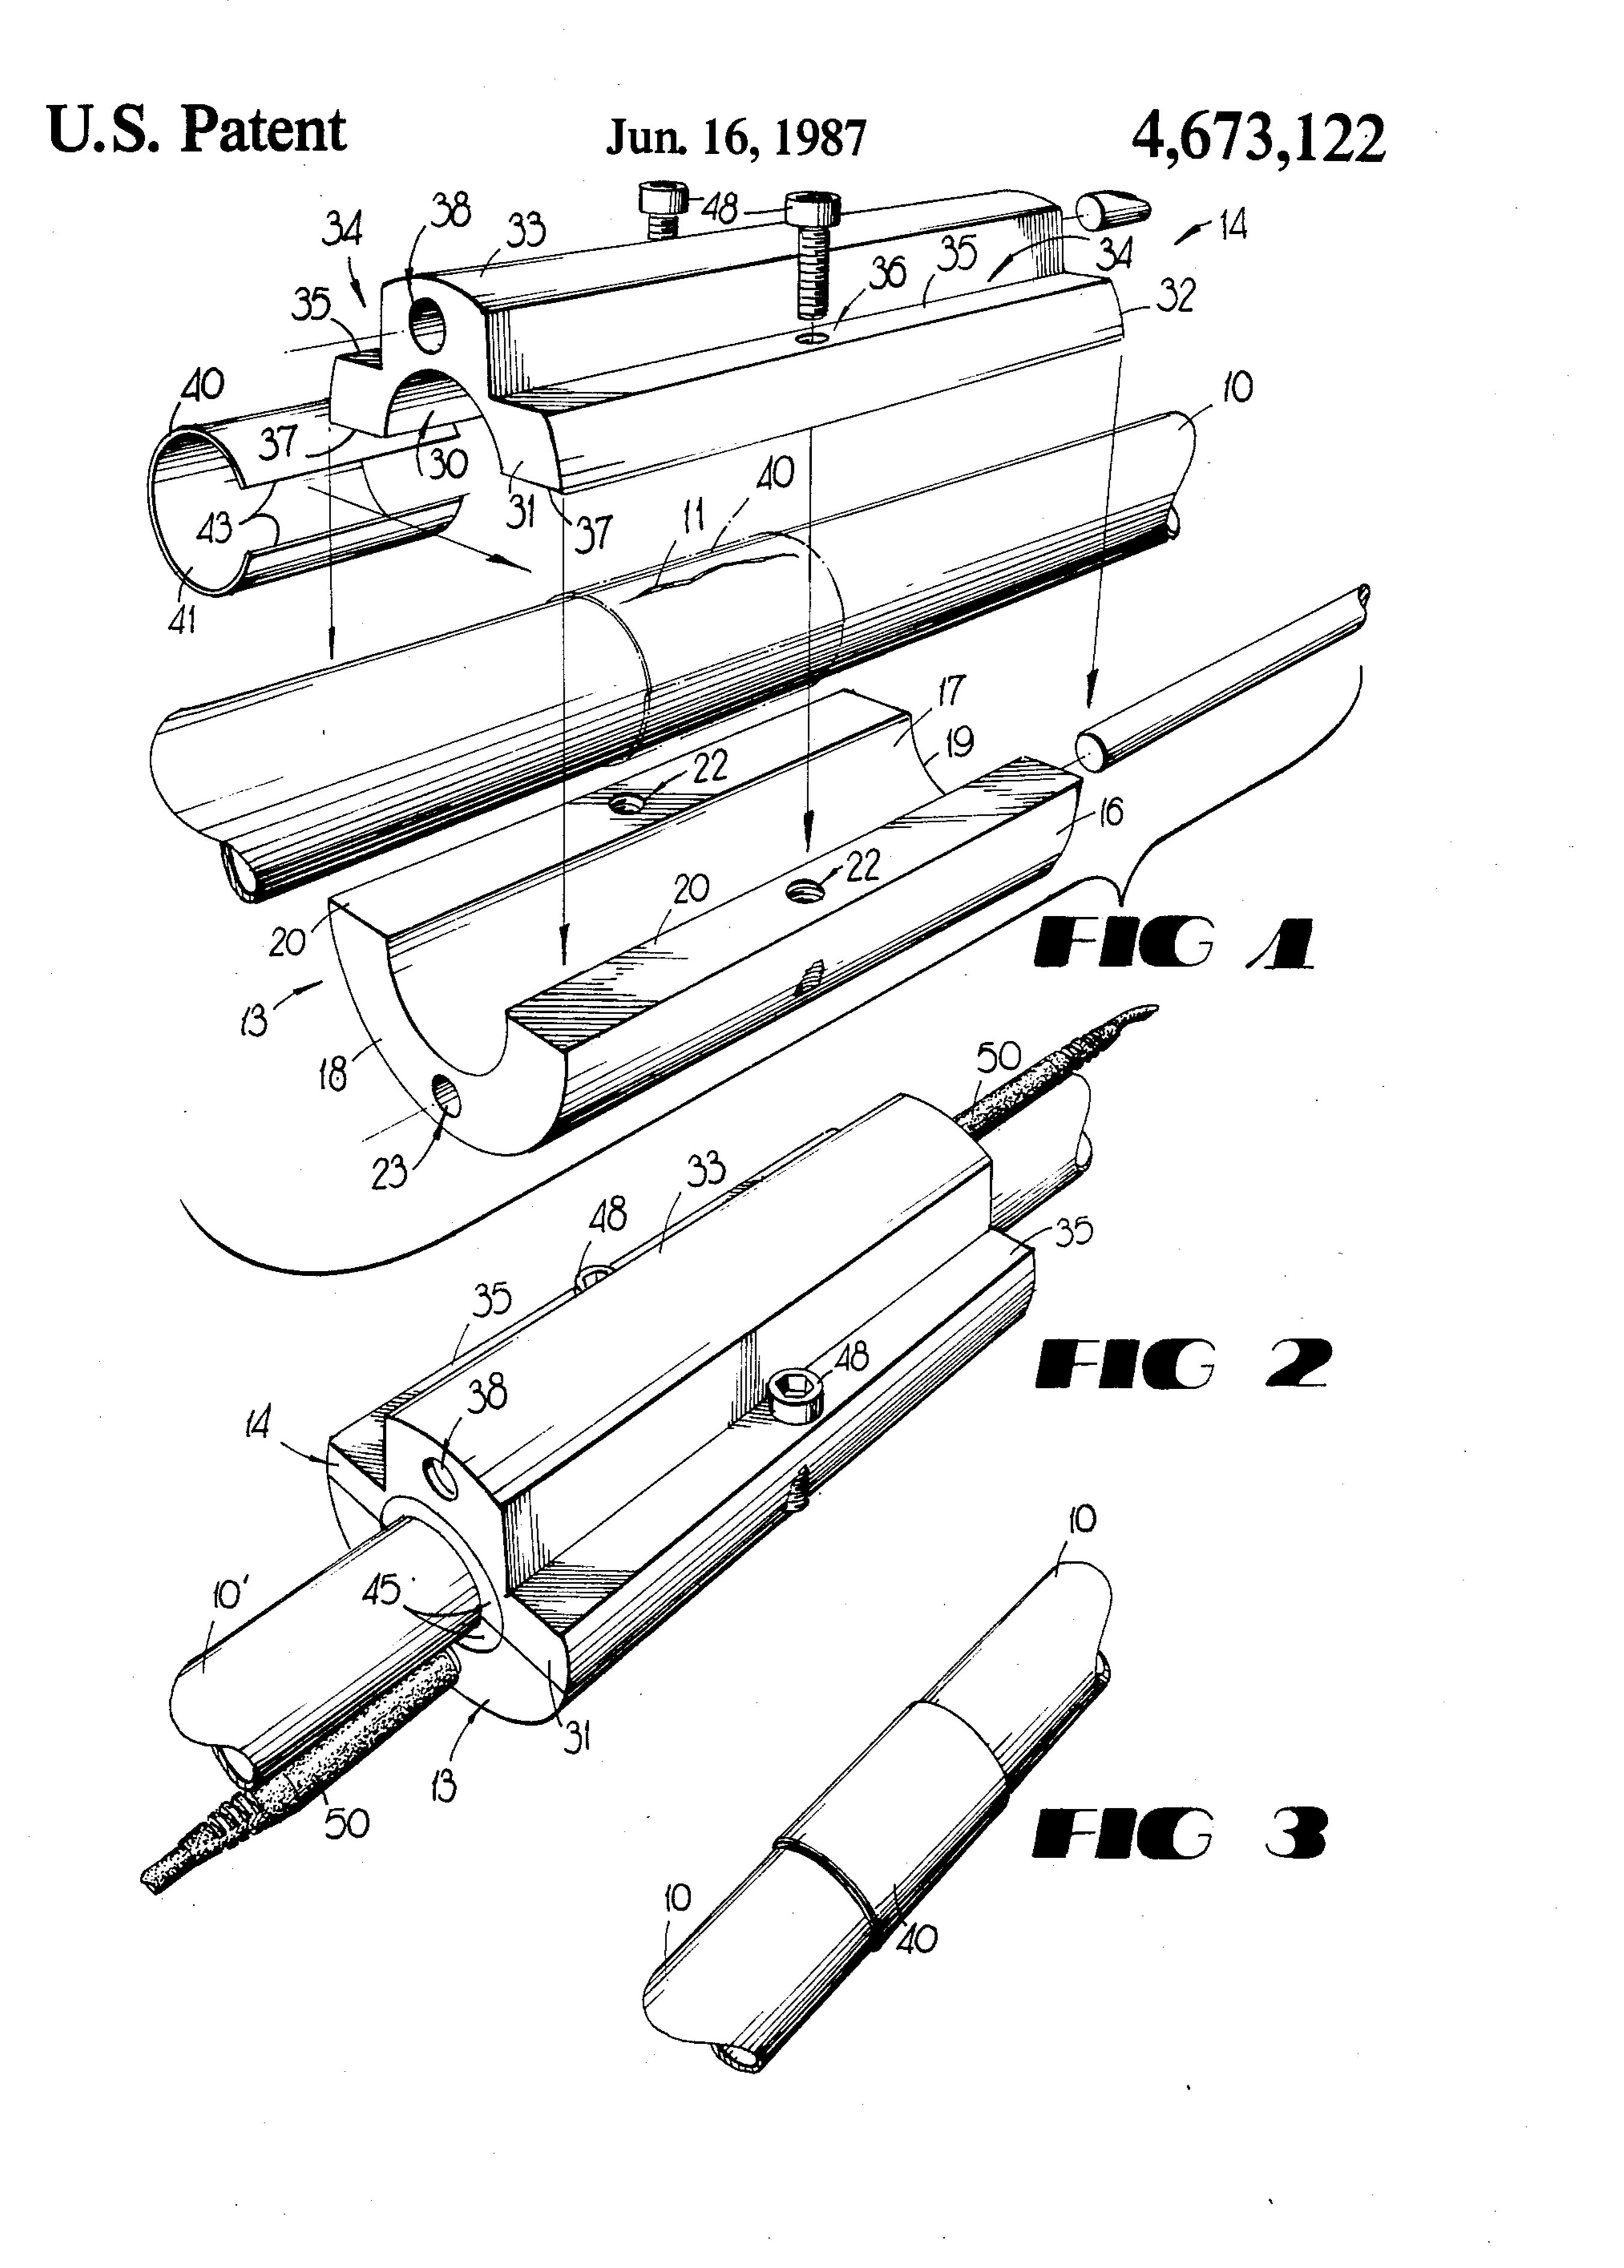
FIG. 1 is an exploded view of apparatus embodying principles of the present invention shown positioned about a breached portion of a copper pipe in preparation for repairing the pipe in accordance with a method of the invention.

FIG. 2 is a perspective view of the apparatus illustrated in FIG. 1 shown mounted to a pipe and with heating elements inserted into opposite sides thereof and with shims placed about the pipe within the apparatus.

FIG. 3 is a perspective view of the section of the pipe shown in FIG. 1 after having been repaired in accordance with principles of the invention.

With reference next to the drawing, there is shown a copper pipe 10 such as a type M copper pipe commonly used for water conduits in residences and commercial building. The two most prevalent sizes in use today is that of a $\frac{7}{8}$ inch outside diameter and $\frac{3}{4}$ inch inside diameter pipe and that of a $\frac{5}{8}$ inch outside diameter and $\frac{1}{2}$ inch inside diameter pipe. The pipe 10 is of the larger size and is seen to be breached at a fracture or rupture 11 and thus in need of repair. The apparatus for repairing

the breached pipe comprises an aluminum heat jacket having a first section indicated generally at 13 and a second section indicated generally at 14. The first heat jacket section 13 is of a semi-annular elongated shape having a semi-cylindrical exterior 16 and a semi-cylindrical interior bore defining wall 17. The section has two semi-annular, flat end walls 18 and 19, and two coplanar flat side faces 20. The jacket section 13 is also provided with two parallel threaded holes 22 that are formed in the side faces 20. The section further has a cylindrical channel 23 that extends completely from one end wall 18 to the other end wall 19 so that both ends of the channel open to ambience.

The second heat jacket section 14 is also of a generally semi-annular elongated shape having a semi-cylindrical bore defining interior wall 30, two semi-annular flat end walls 31 and 32, and an exterior wall 33 formed with two steps indicated generally at 34. The steps have coplanar flat side faces 35 in which two parallel bolt receiving holes 36 extend to two coplanar flat side faces 37. The section 14 also has a cylindrical channel 38 that extends from one end wall 31 to the other end wall 32 so as to be open at each section end to ambience. The diameter of the bore of the combined jacket section here approximately matches the O.D. size of the larger of the two most popular copper pipes.

The apparatus further includes a thin flexible strip or tape of copper 40 having a coating of solder 41 formed all over one surface thereof. The copper strip here is 20 30 mils thick while the solder coating here measures 6 mils thick. The solder preferably consists of 50% tin and 50% lead, by weight. The tape or strip is formed by cleaning and fluxing, as with zinc chloride or ammonium chloride, one side of copper shimstock and then 35 coating the flexed side only with melted solder. The length of the strip is sufficient to be wrapped completely about the pipe to be repaired so that its edges 43 touch or come close to touching one another. A pair of semi-cylindrical aluminum shims 45 is provided, as 40 shown in FIG. 2, whereby the same heat jacket sections 13 and 14 may be used for repairing a smaller size pipe 10'. Two bolts 48 are also provided of a size to be passed through the holes 36 in jacket section 14 and threaded into the threaded holes 22 in jacket section 13 as with 45 the use of an Allen head wrench. Finally, the apparatus includes an elongated electric heating element 50 that may be inserted into either end of either of the channels 23 and 38. Although two such elements are shown in FIG. 2, normally a single element will suffice.

To repair the pipe 10 or 10', shown breached at fracture 11 in FIG. 1, the pipe is drained of water and the area of the breach smoothed, as with a file or sandpaper, and fluxed. The strip of solder coated copper is then wrapped snuggly about the breached portion and cov- 55 ered with the two heat jacket sections. Bolts 48 are then passed through the holes 36 in the jacket section 14 and threaded into the threaded holes 22 in the jacket section 13 thereby fastening the two sections tightly about the breached portion of the pipe with the strip of solder 60 coated copper sandwiched between the jacket and pipe. Since the size of the jacket bore is substantially the same as that of the pipe, a snug fit is assured before confronting side faces of the two sections contact each other in view of the presence of the strip of copper. In the event 65 the pipe is of the smaller size, shims 45 are inserted over the pipe prior to or in conjunction with the mounting of the heat jacket and strip as shown in FIG. 2.

Next the jacket is heated by either the use of a propane torch or with the use of one of the electrical heating elements 50. Where the heating element is used it is inserted into the more accessible of the two channels and into the more accessible end of that particular channel. The electrical heating element is then energized whereupon the heat jacket, pipe section and solder coated strip of copper become heated. With the use of a electric Chromlax heating element made by Applebee Corp. of Atlanta, Ga., the strip of copper has been found to become well bonded to the pipe in approximately $6\frac{1}{2}$ minutes. Where an open flame torch is used the time for good bonding has been found to be 8 minutes. Surprisingly, residual water in the area of the breach does not present the problem that it does with sweat joint procedures.
