- [54] **STRESS RELIEF OF SINGLE CRYSTAL SUPERALLOY ARTICLES**
- [75] **Inventors:** Robert J. Henricks, Farmington; John J. Marcin, Hartford; Jacqueline B. Wahl, Willington, all of Conn.
- [73] **Assignee:** United Technologies Corporation, Hartford, Conn.
- [21] **Appl. No.:** 880,603
- [22] **Filed:** Jun. 30, 1986
- [51] **Int. Cl.⁴** C22F 1/10
- [52] **U.S. Cl.** 148/13; 148/20.3; 148/404
- [58] **Field of Search** 148/13, 20.3, 404

STRESS RELIEF OF SINGLE CRYSTAL SUPERALLOY ARTICLES

This invention relates to refurbishing gas turbine engine components, and more particularly, to a method of reducing residual tensile strains in single crystal superalloy airfoil blades and vanes.

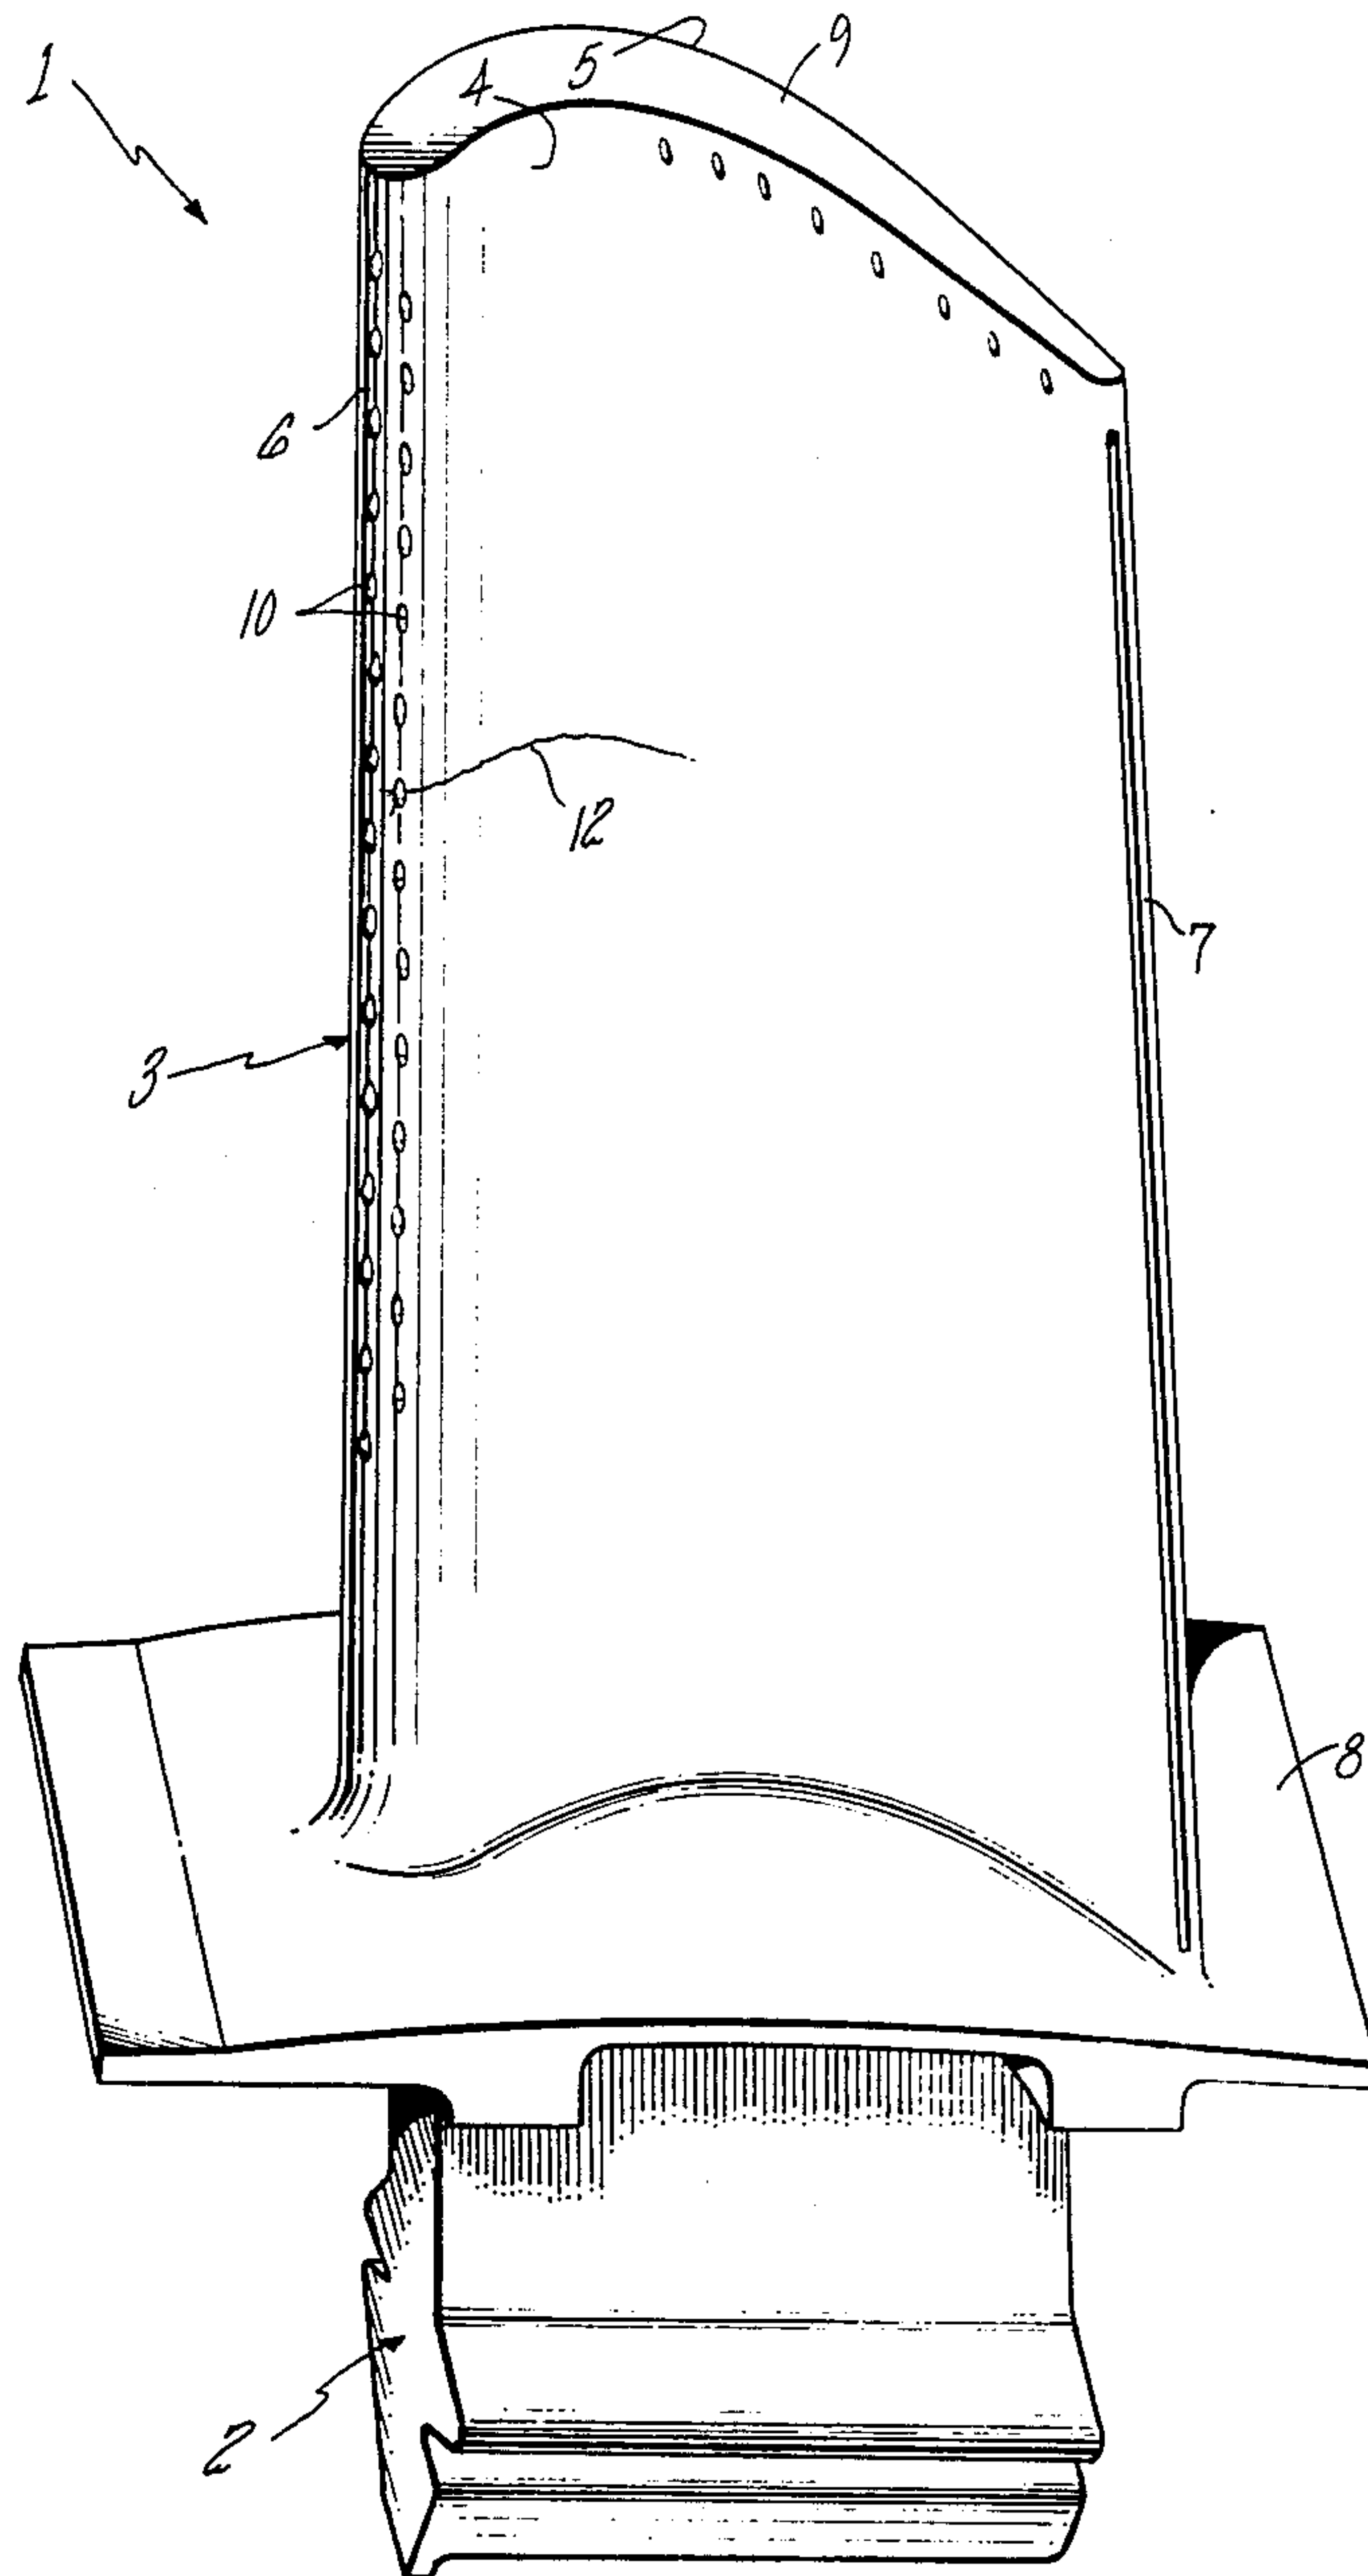
FIG. 1 is a prospective view of a used single crystal airfoil blade, illustrating a typical chordwise crack which developed during exposure of the airfoil blade to a corrosive environment.

Referring to FIG. 1, a used single crystal airfoil blade 1 is shown. The blade 1 includes a root 2 and an airfoil 3 having a concave surface 4, a convex surface 5, a leading edge 6, a trailing edge 7, a platform 8, and a tip 9. The blade 1 also includes internal cooling passages 10 which direct relatively cool air through the blade to allow operation at high temperatures. The blade 1 also previously included a surface coating 11 (not shown) on both the inner and outer surfaces which was removed. The coating may have been either a diffusion or overlay coating such as those described in U.S. Pat. Nos. 3,928,026, 3,544,348 and 4,132,816, or a combination thereof, as described in U.S. Pat. No. 4,005,989, all hereby incorporated by reference. The blade 1, as well as those other blades and vanes to which the present invention applies, are of the type used in the turbine section of a gas turbine engine, and are composed of single crystal nickel base superalloys, such as that disclosed in U.S. Pat. No. 4,209,348 to Duhl et al.

In particular, coated nickel base superalloy single crystal turbine airfoil blades, which are subject to gas turbine engine operation for 2000 to 10,000 hours, can crack from a stress corrosion mechanism when exposed to certain corrosive media. Bulk spanwise residual tensile strains of 1,000 to 1,500 microinches per inch were sufficient to create chordwise cracks at airfoil locations in 26 of 53 parts exposed to boiling hydrochloric acid. Spanwise strains are developed as the airfoil is subject to centripetal forces during engine operation. These strains within the superalloy are measured from the root platform 8 to the blade tip 9 by positioning a number of strain gauges about the article, slicing through a portion and measuring the strain relaxation. Referring to FIG. 1, a typical chordwise crack 12 is shown on a nickel base single crystal superalloy airfoil blade, the crack being perpendicular to the spanwise strain.
