[54] **STEAM TURBINE BLADE ANTI-EROSION SHIELD AND METHOD OF TURBINE BLADE REPAIR**

STEAM TURBINE BLADE ANTI-EROSION SHIELD AND METHOD OF TURBINE BLADE REPAIR

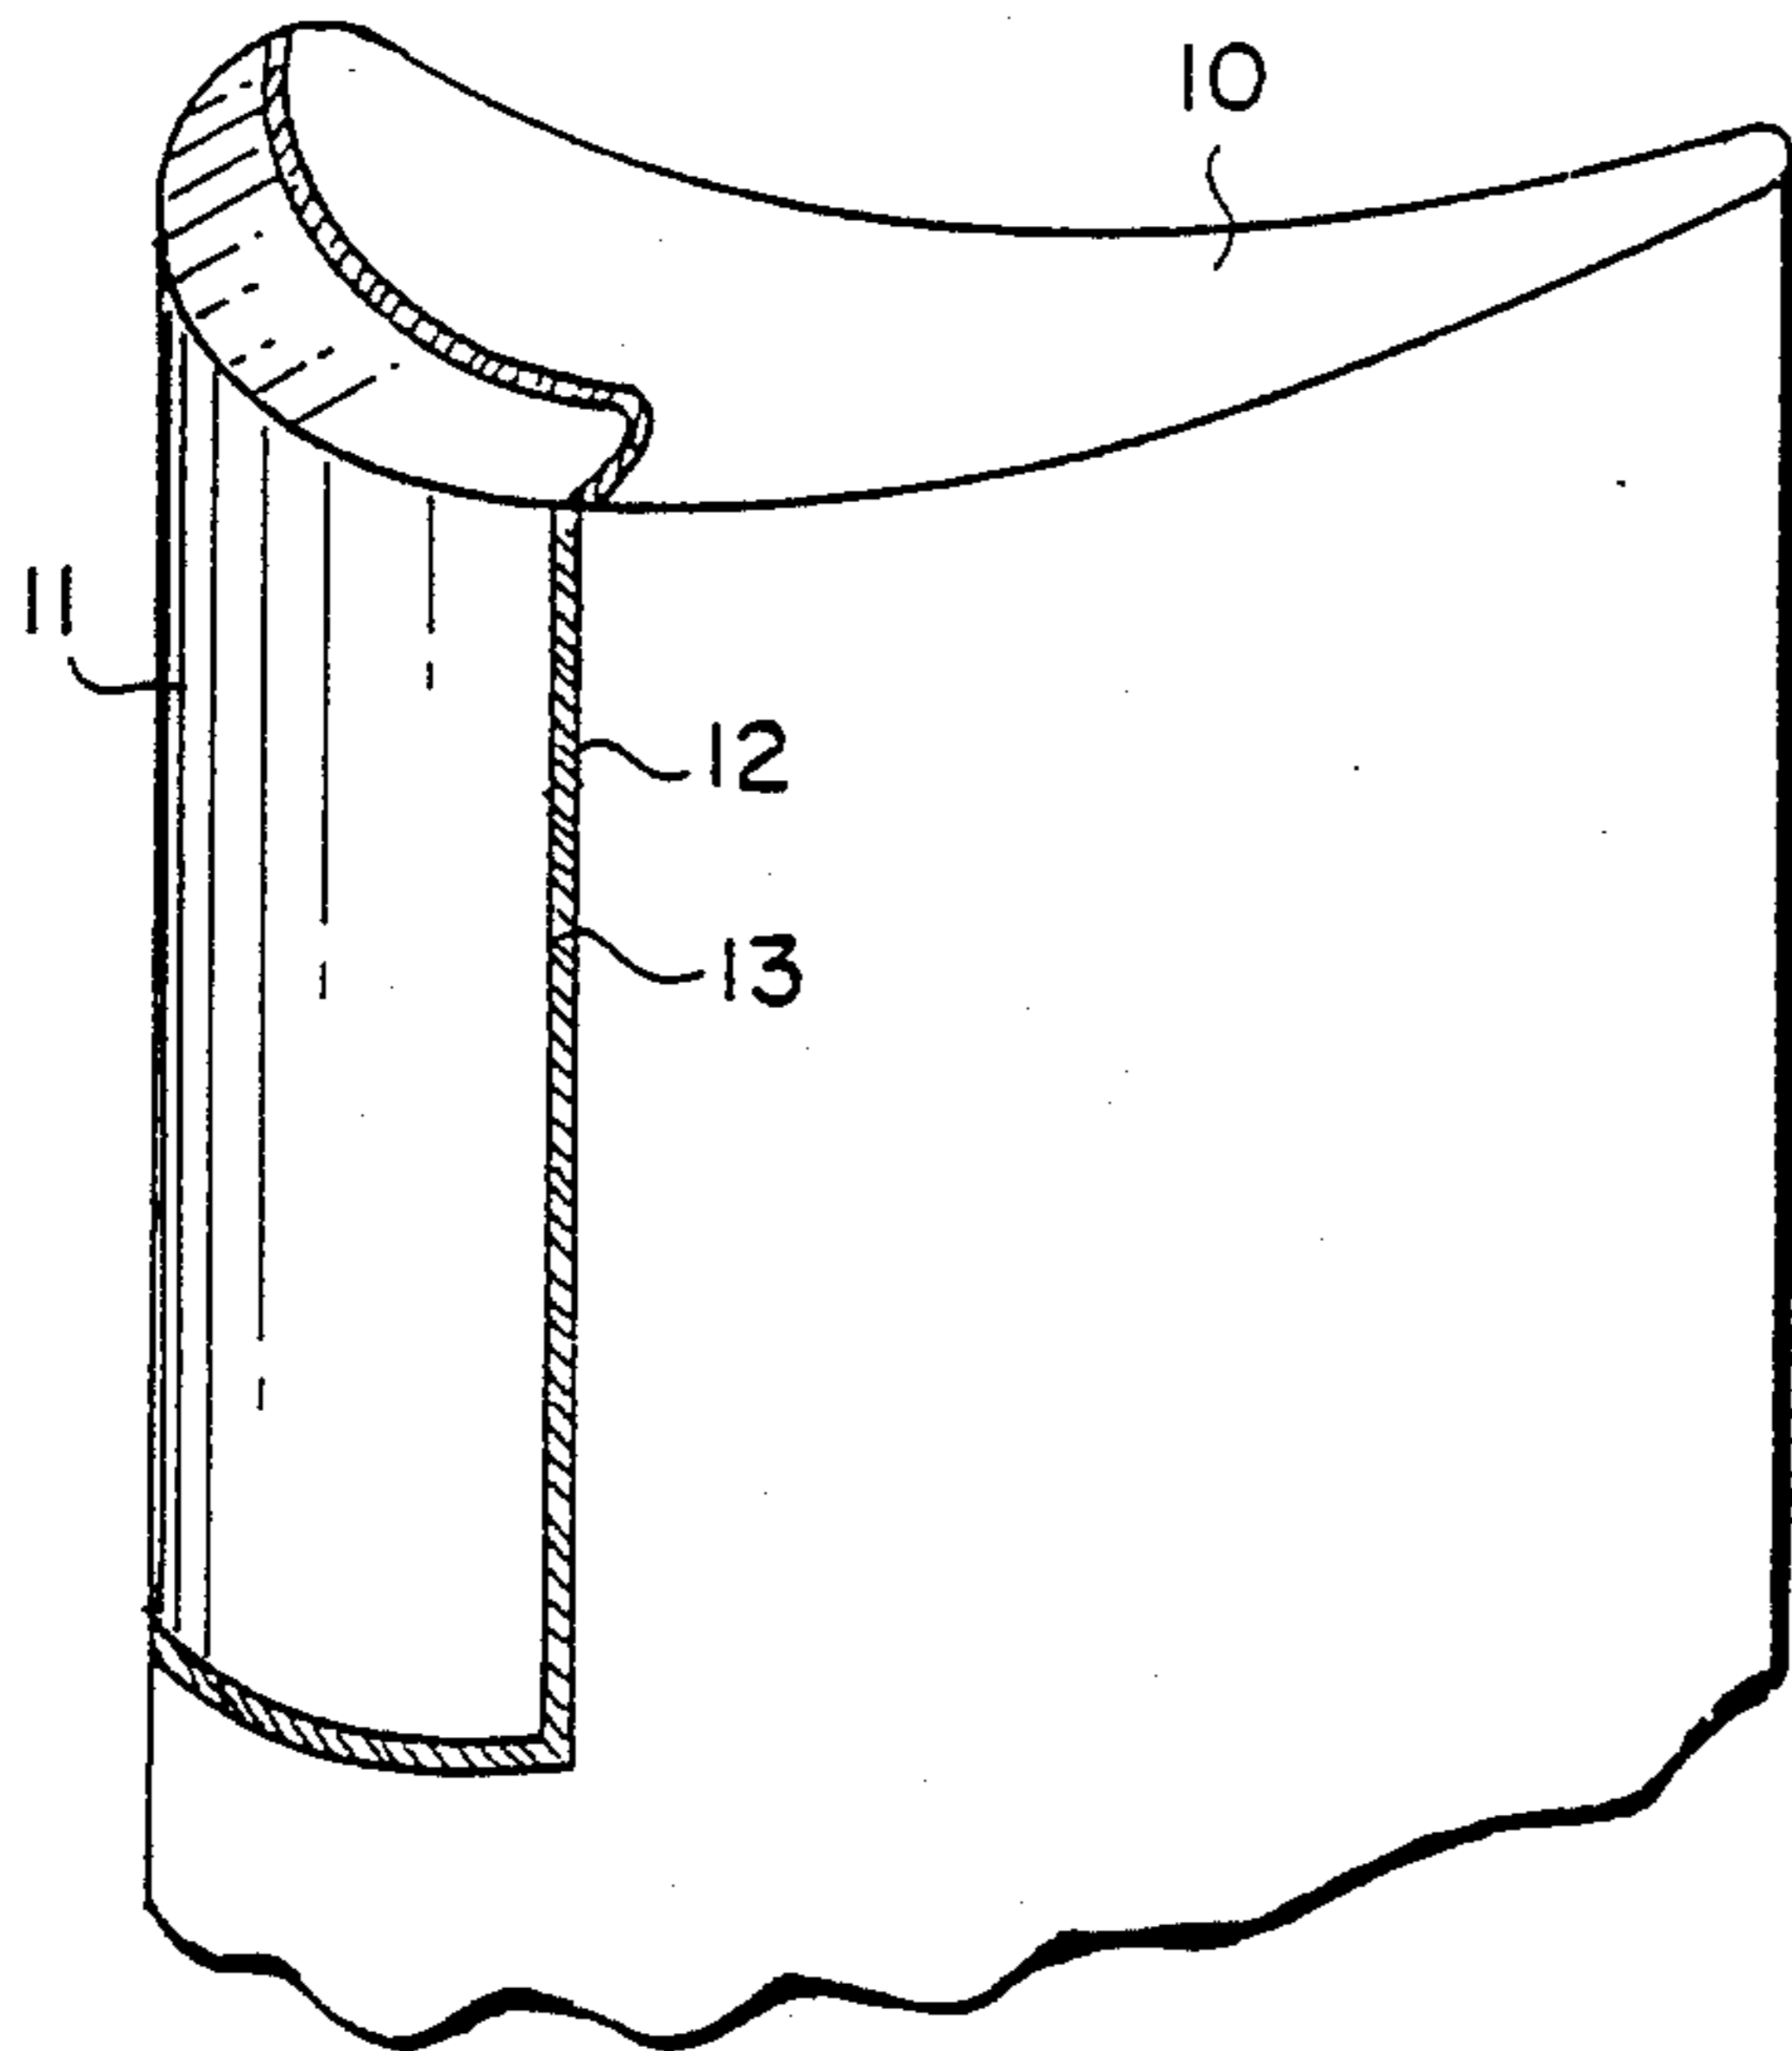
FIG. 2 is a perspective view of a prior art anti-erosion shield construction typical of General Electric Company steam turbine blades;

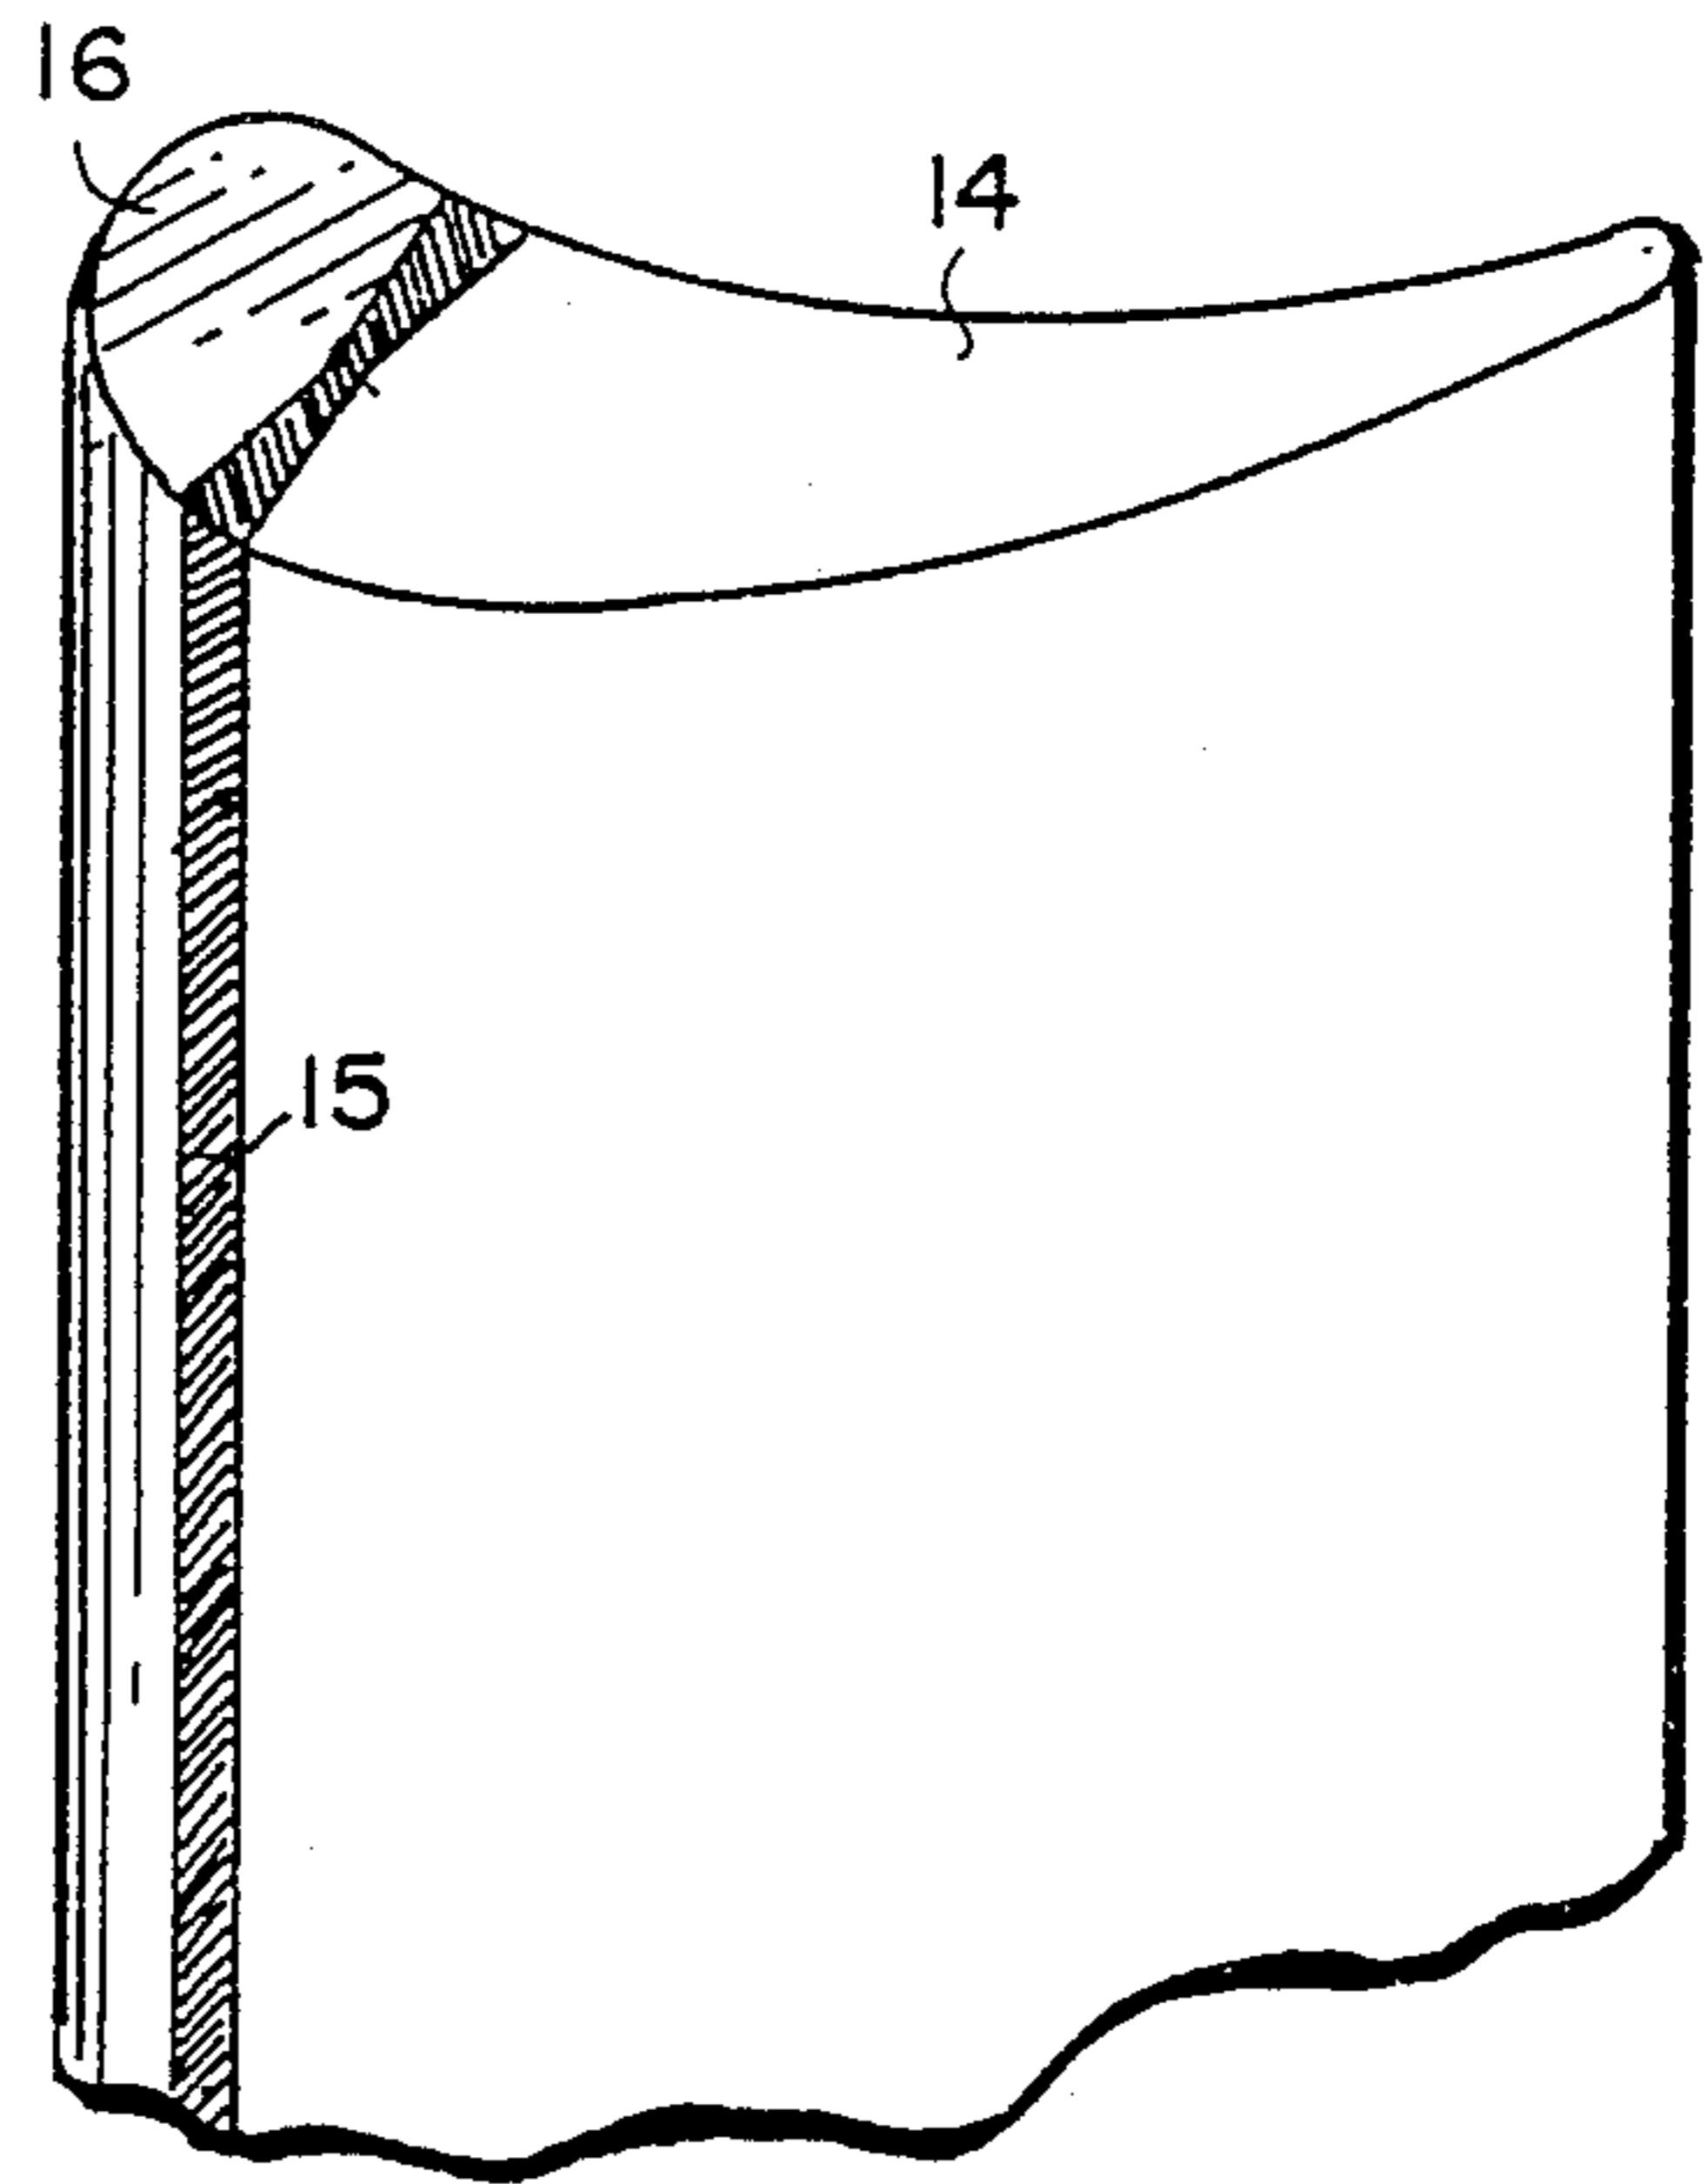
FIG. 3 is a cross-sectional view of the anti-erosion shield and turbine blade of the type of FIG. 1 in which the shield is partially eroded;

FIG. 3 shows a cross sectional view of the leading edge of a Westinghouse type turbine blade 20 having an anti-erosion shield 22 eroded from the original contour 22a. Original shield 22 was brazed in recess 25 by brazing material 24. The method of repair of blade 20 will be described with reference to FIGS. 4 through 7.

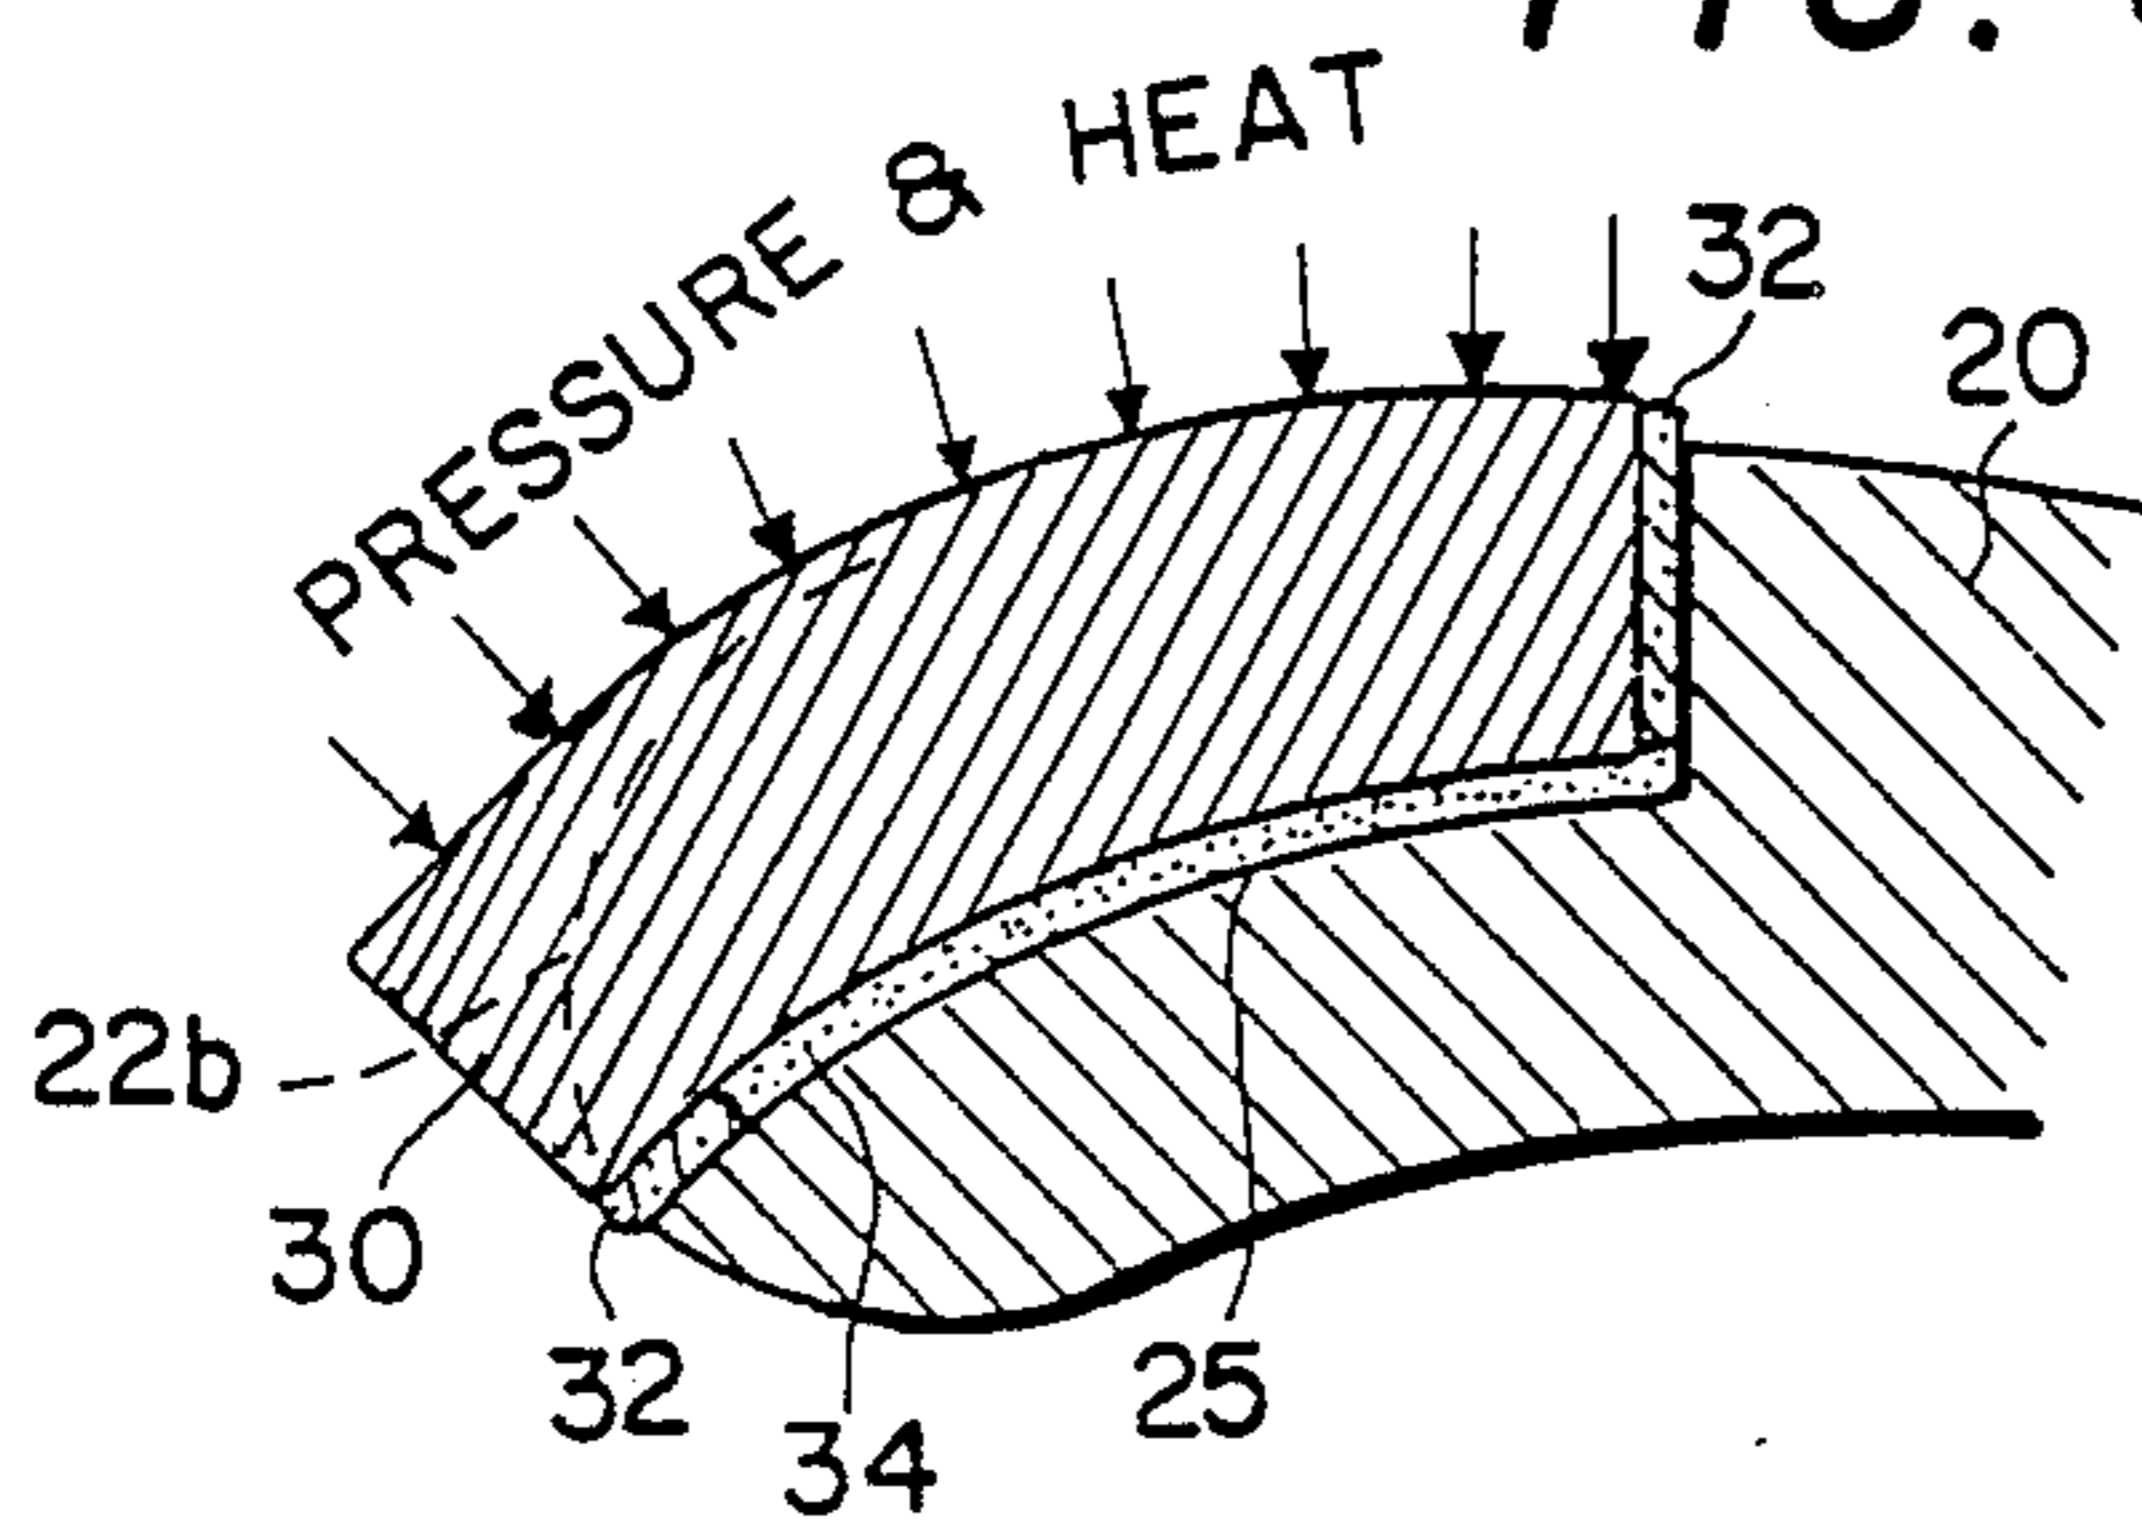
FIG. 6 shows the blade of FIG. 5 in which the film adhesive and gaskets of the repair anti-erosion shield have been cured and the repair shield ground to the proper contour;

Various techniques for applying the required pressure and heat to shield 30 will be apparent to those of skill in the art. After curing of adhesive 34, shield 30 is ground to contour 30a as shown in FIG. 6, completing the repair.

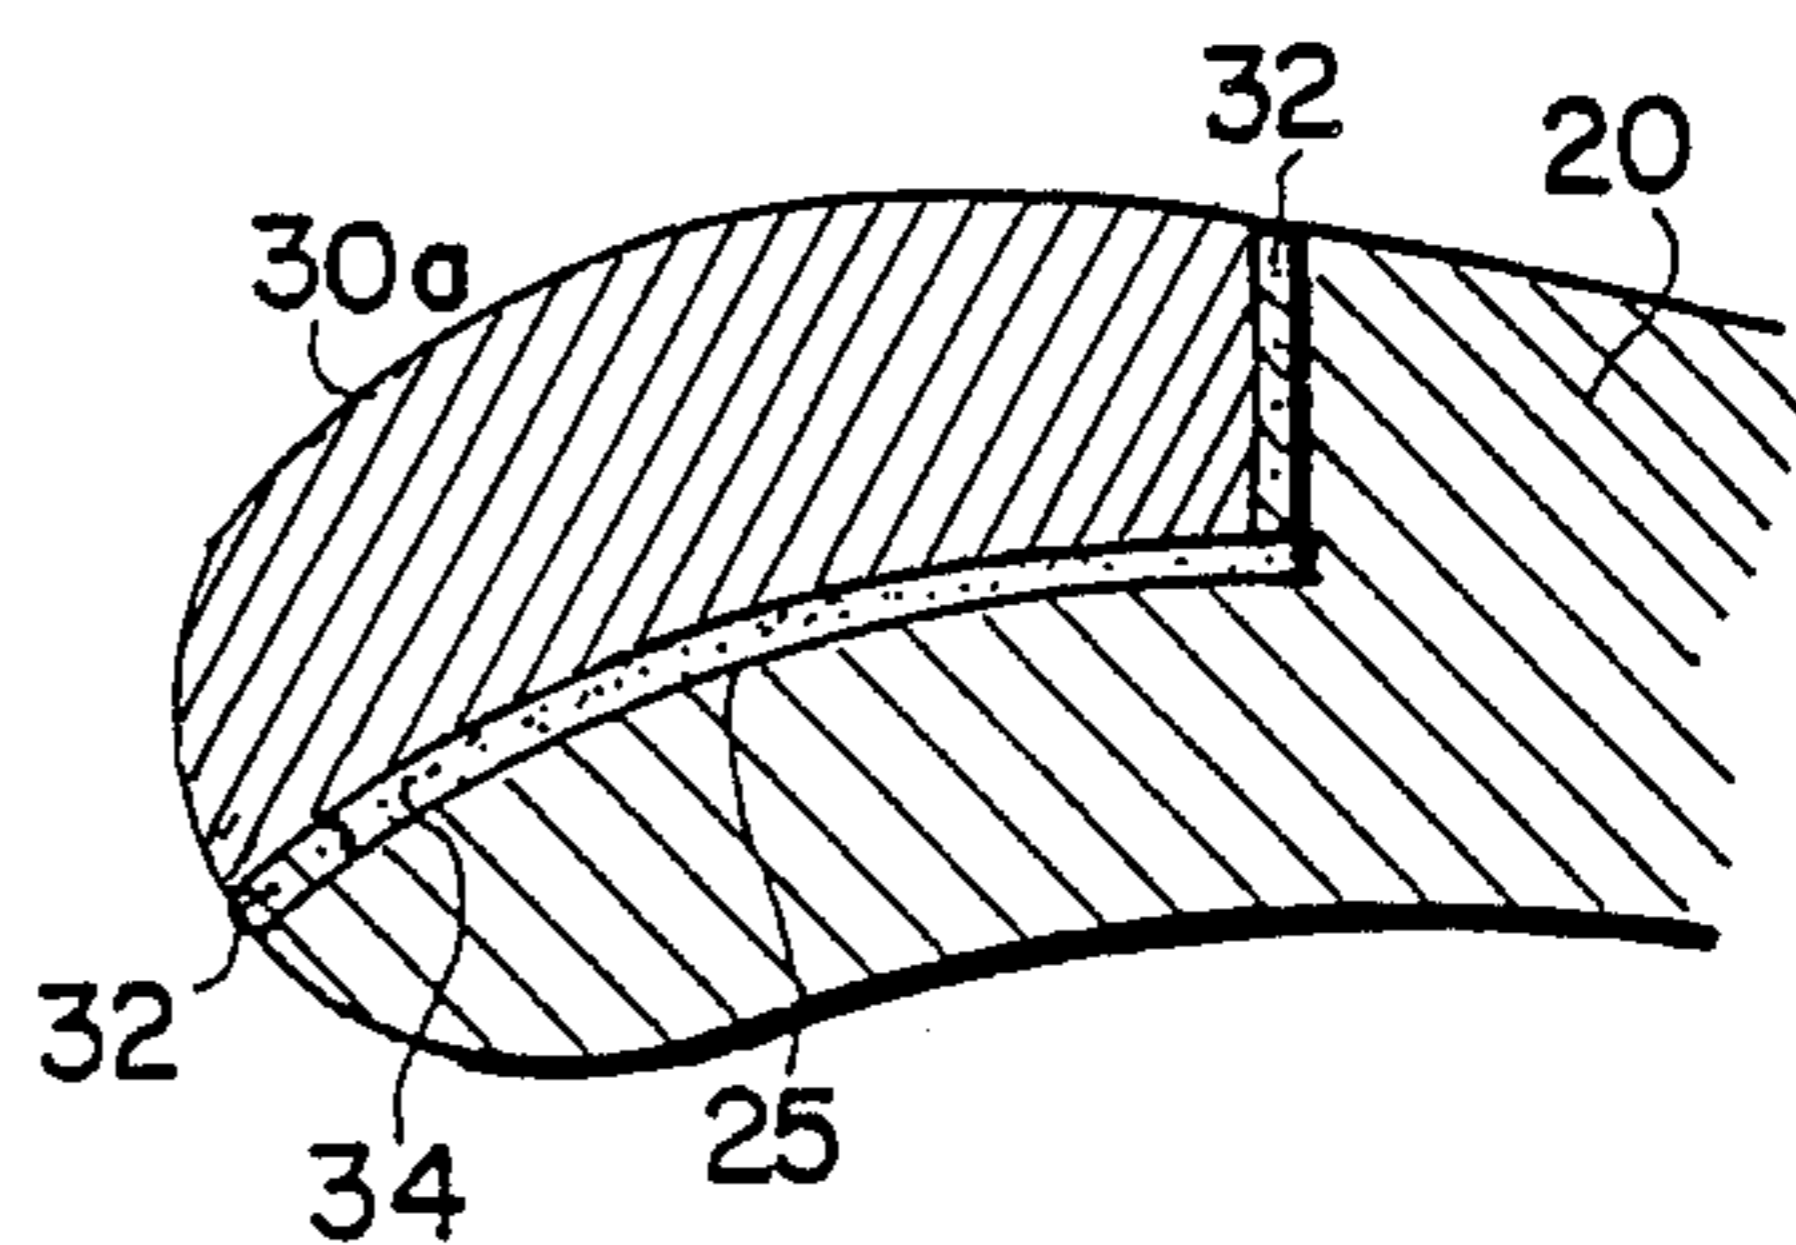
FIG. 7 is a perspective view of a typical repair anti-erosion shield of the invention prior to installation;

FIG. 7 is a perspective view of a repair anti-erosion shield 30 formed from Stellite® or similar hardened material. A preferred type of Stellite® may have the composition of 33% chromium, 55% cobalt and 6% tungsten. The shape and size of shield 30 is selected with a length and curvature to fit recess 25 of the turbine blade to be repaired. The thickness and width are selected to be slightly greater than the contour 22b to permit trimming after installation although the shield may have the exact size to eliminate trimming. A structural adhesive film 34 is used to adhere the shield 30 to blade 20 in recess 25. Thermosetting adhesive films of the modified epoxy type are available from the 3M Company or American Cyanamide Company as mentioned above. Such epoxy phenolics, as previously defined, are available in film form with a glass-cloth scrim support and as one-part pastes. These materials cure at low temperatures in the range of 300° F. to 400° F. and have sufficient strength to withstand the forces on the turbine blades.

In FIG. 7, a sheet of adhesive film 34 has had the film stripped from one surface thereof and has been applied to the inner contour of shield 30. To protect the adhesive 34 after curing, gasketing along the edges is necessary. Gaskets 32 may be formed from a fluoroelastomer material such as Fluorel® FT-235 discussed above or other fluoropolymer materials. To repair blade 20 of FIG. 3, the eroded shield 22 and welding material 24 must be removed. Brazing material 24 may be dissolved using nitric acid with recess 25 thereafter sand blasted and thoroughly cleaned. In FIG. 5, shield 7 has had the protective film removed from the exposed surface of adhesive 34 and installed in recess 25. After completion of the repair, gaskets 32 will be exposed to the steam, protecting adhesive 34. As indicated in FIG. 5, it is necessary to apply pressure and heat to cure adhesive 34. The required pressure, temperature and curing time will be determined by the specific film adhesive used. Typical pressures are 150 psi and typical temperatures used are in the range of 300° F. to 400° F.
