[54] STEAM TURBINE BLADE ANTI-EROSION SHIELD AND METHOD OF TURBINE BLADE REPAIR

STEAM TURBINE BLADE ANTI-EROSION SHIELD AND METHOD OF TURBINE BLADE REPAIR

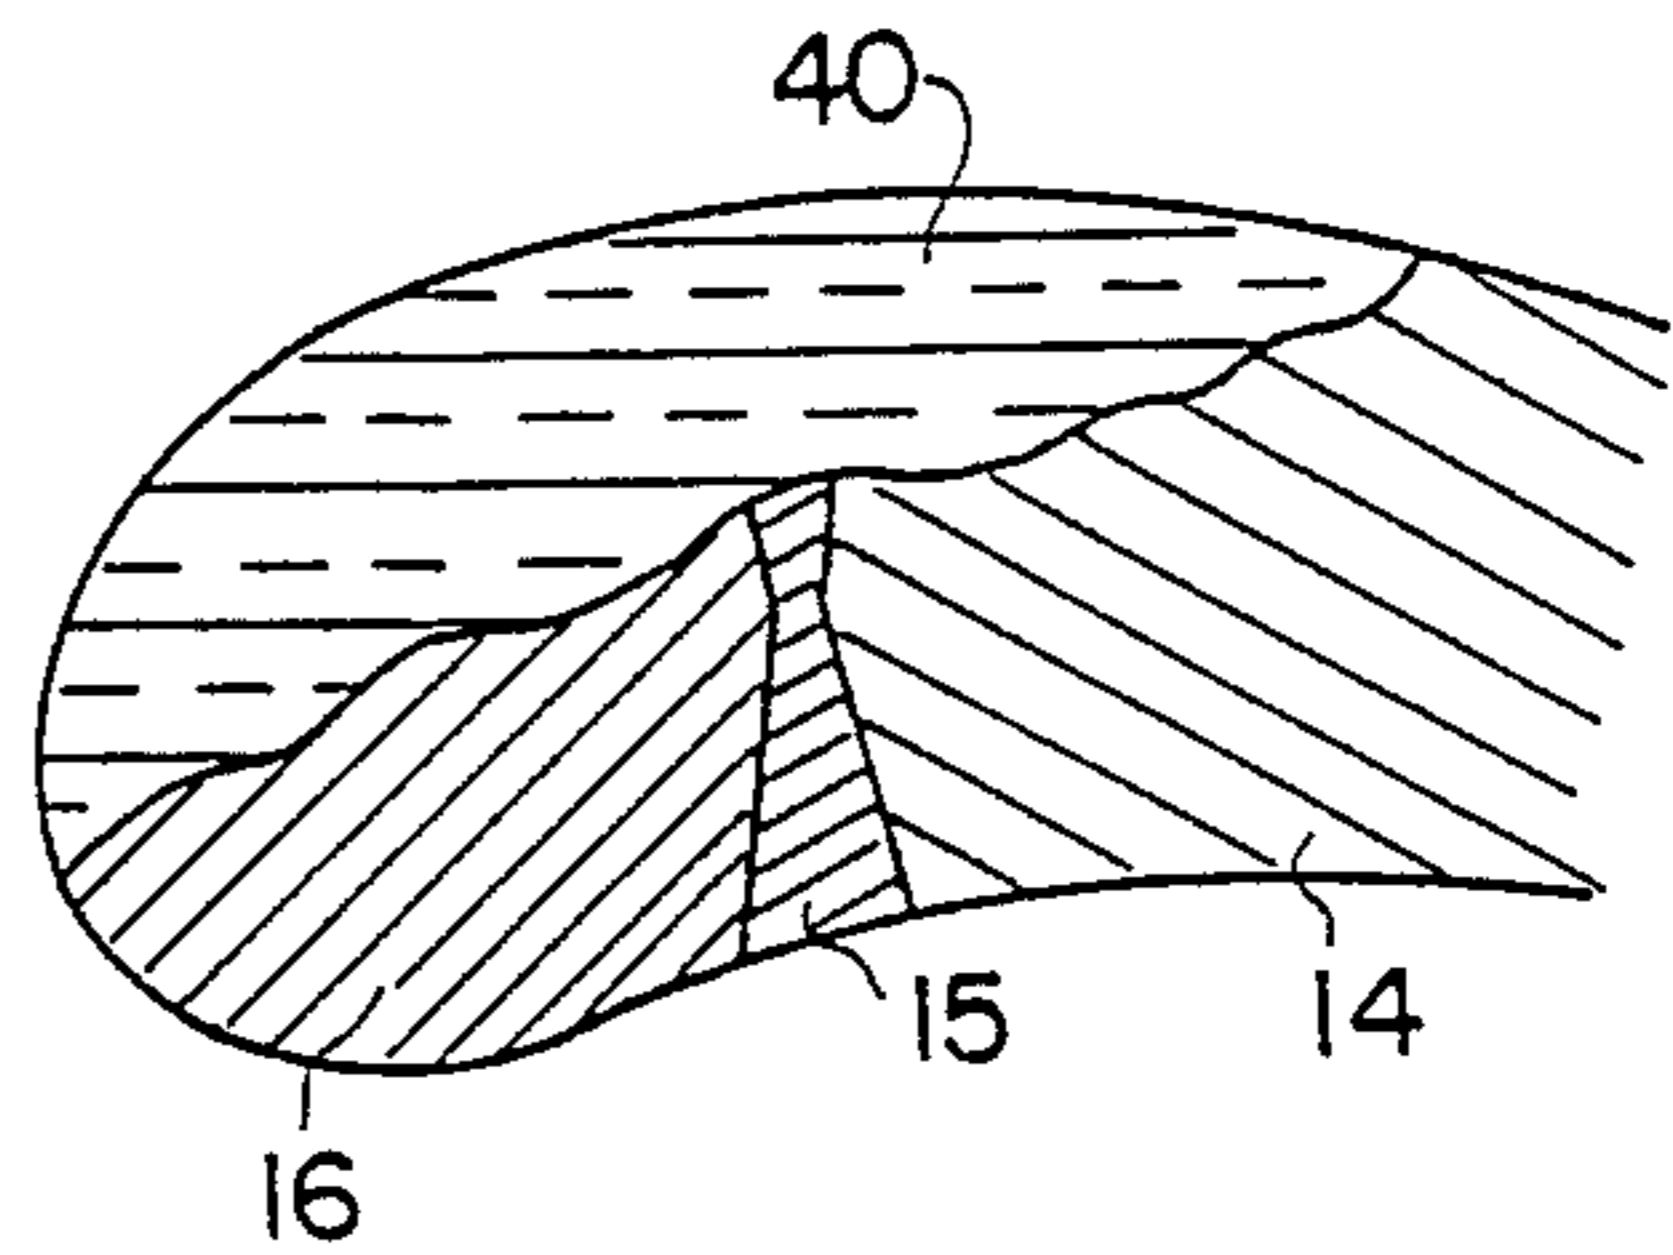
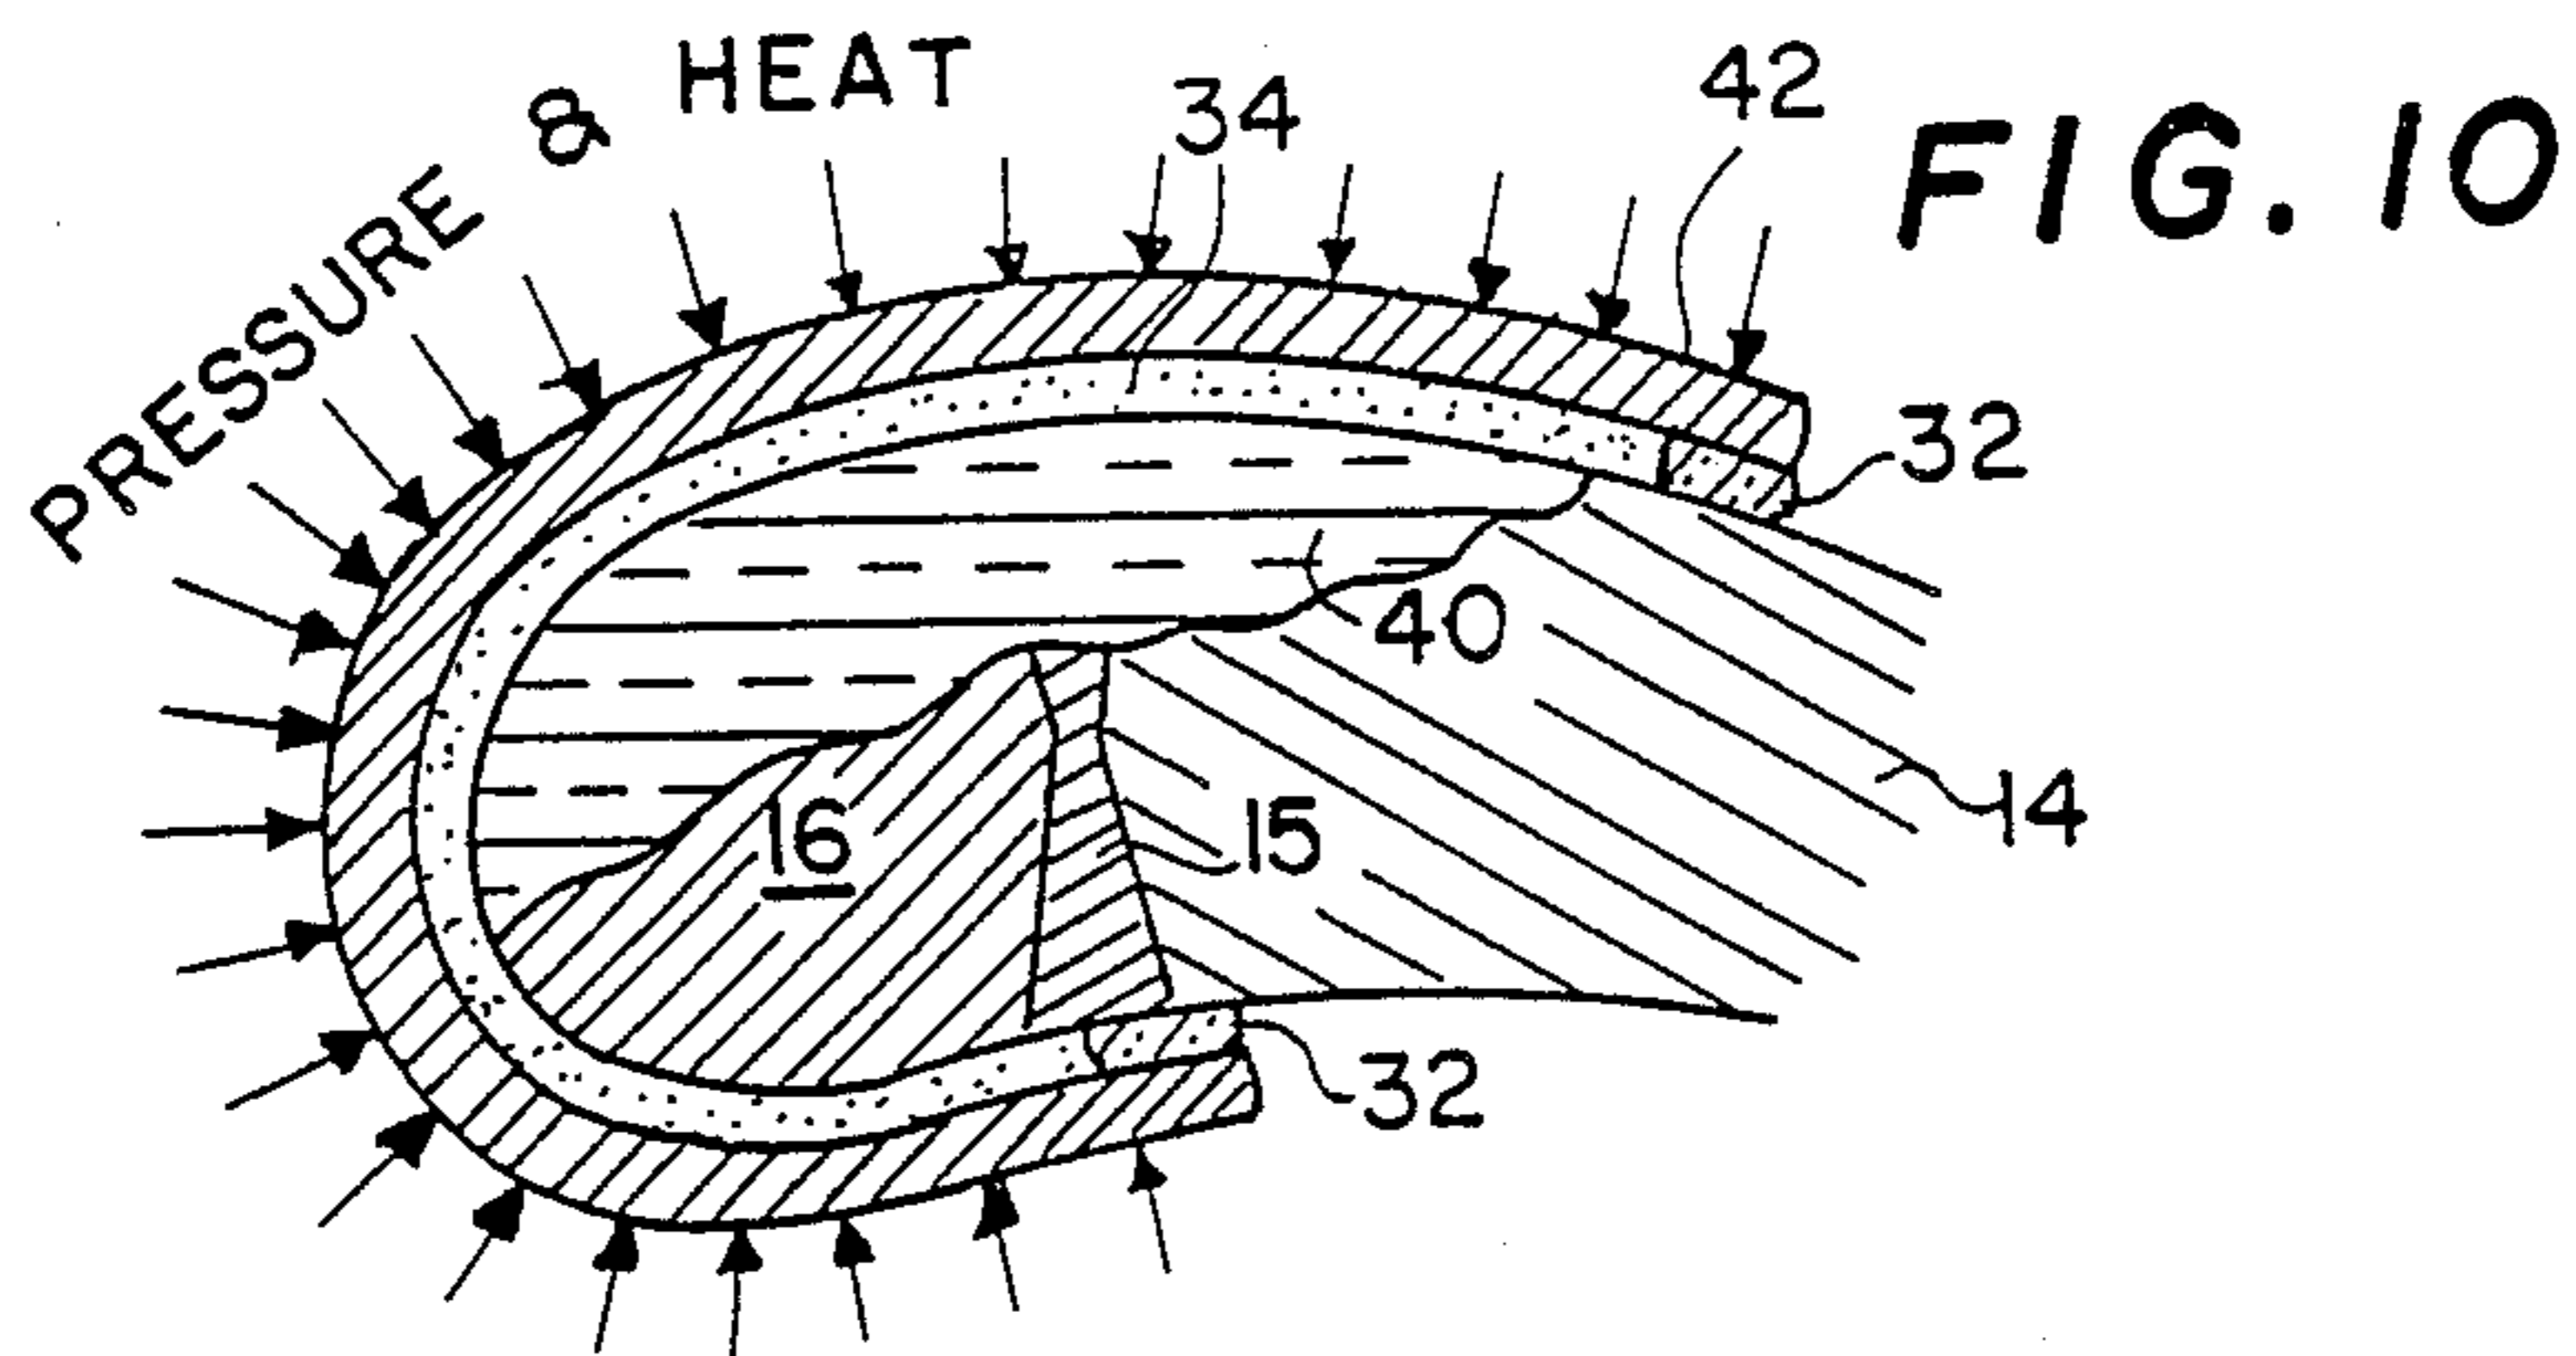
FIG. 10 shows the blade of FIG. 9 in which a wrap around type repair anti-erosion shield in accordance with the invention has been installed, and which illustrates the curing method.

FIGS. 8-10 illustrate repair of a General Electric type turbine blade. In some instances, the leading edge of a blade 14 will erode as indicated in FIG. 8 with portions of Stellite® anti-erosion shield 16, weld material 15, and blade 14 eroded away. FIG. 9 illustrates the initial step of building up the missing material utilizing an epoxy 40 which is contoured to match the original blade. To protect the epoxy from the low temperature steam, a wrap-around shield 42 is fabricated having an inside contour which will extend over epoxy 40 and around the blade 14 as shown in cross section in FIG. 10. Film supported adhesive 34 and gaskets 32 as previously described are used as shown. Pressure and heat are provided to cure adhesive 34 and to seal gaskets 32. When this type of repair is made on one turbine blade, it will also be necessary to repair the blade 180° away such that dynamic balance will be maintained.
