[54] REPAIR LAMINATE

[73] Assignee: Isovolta Osterreichische Isolierstoffwerke Aktiengesellschaft, Wiener Neudorf, Austria

A repair laminate for the quick repair of lightweight panels used particularly in aircraft construction comprised of a lightweight core 2, e.g., in the form of a possibly pressed honeycomb structure, and two outer laminates 3, 4, which repair laminate is comprised of a solid cured or thermoplastic layer of synthetic material 13 bonded on one side to a hot-melt adhesive 15 and optionally on the other side to a decorative liner-layer. The synthetic material layer 13 may advantageously be a glass-fabric reinforced phenol aldehyde resin and the liner-laminate may be a dyed polyvinyl fluoride film.

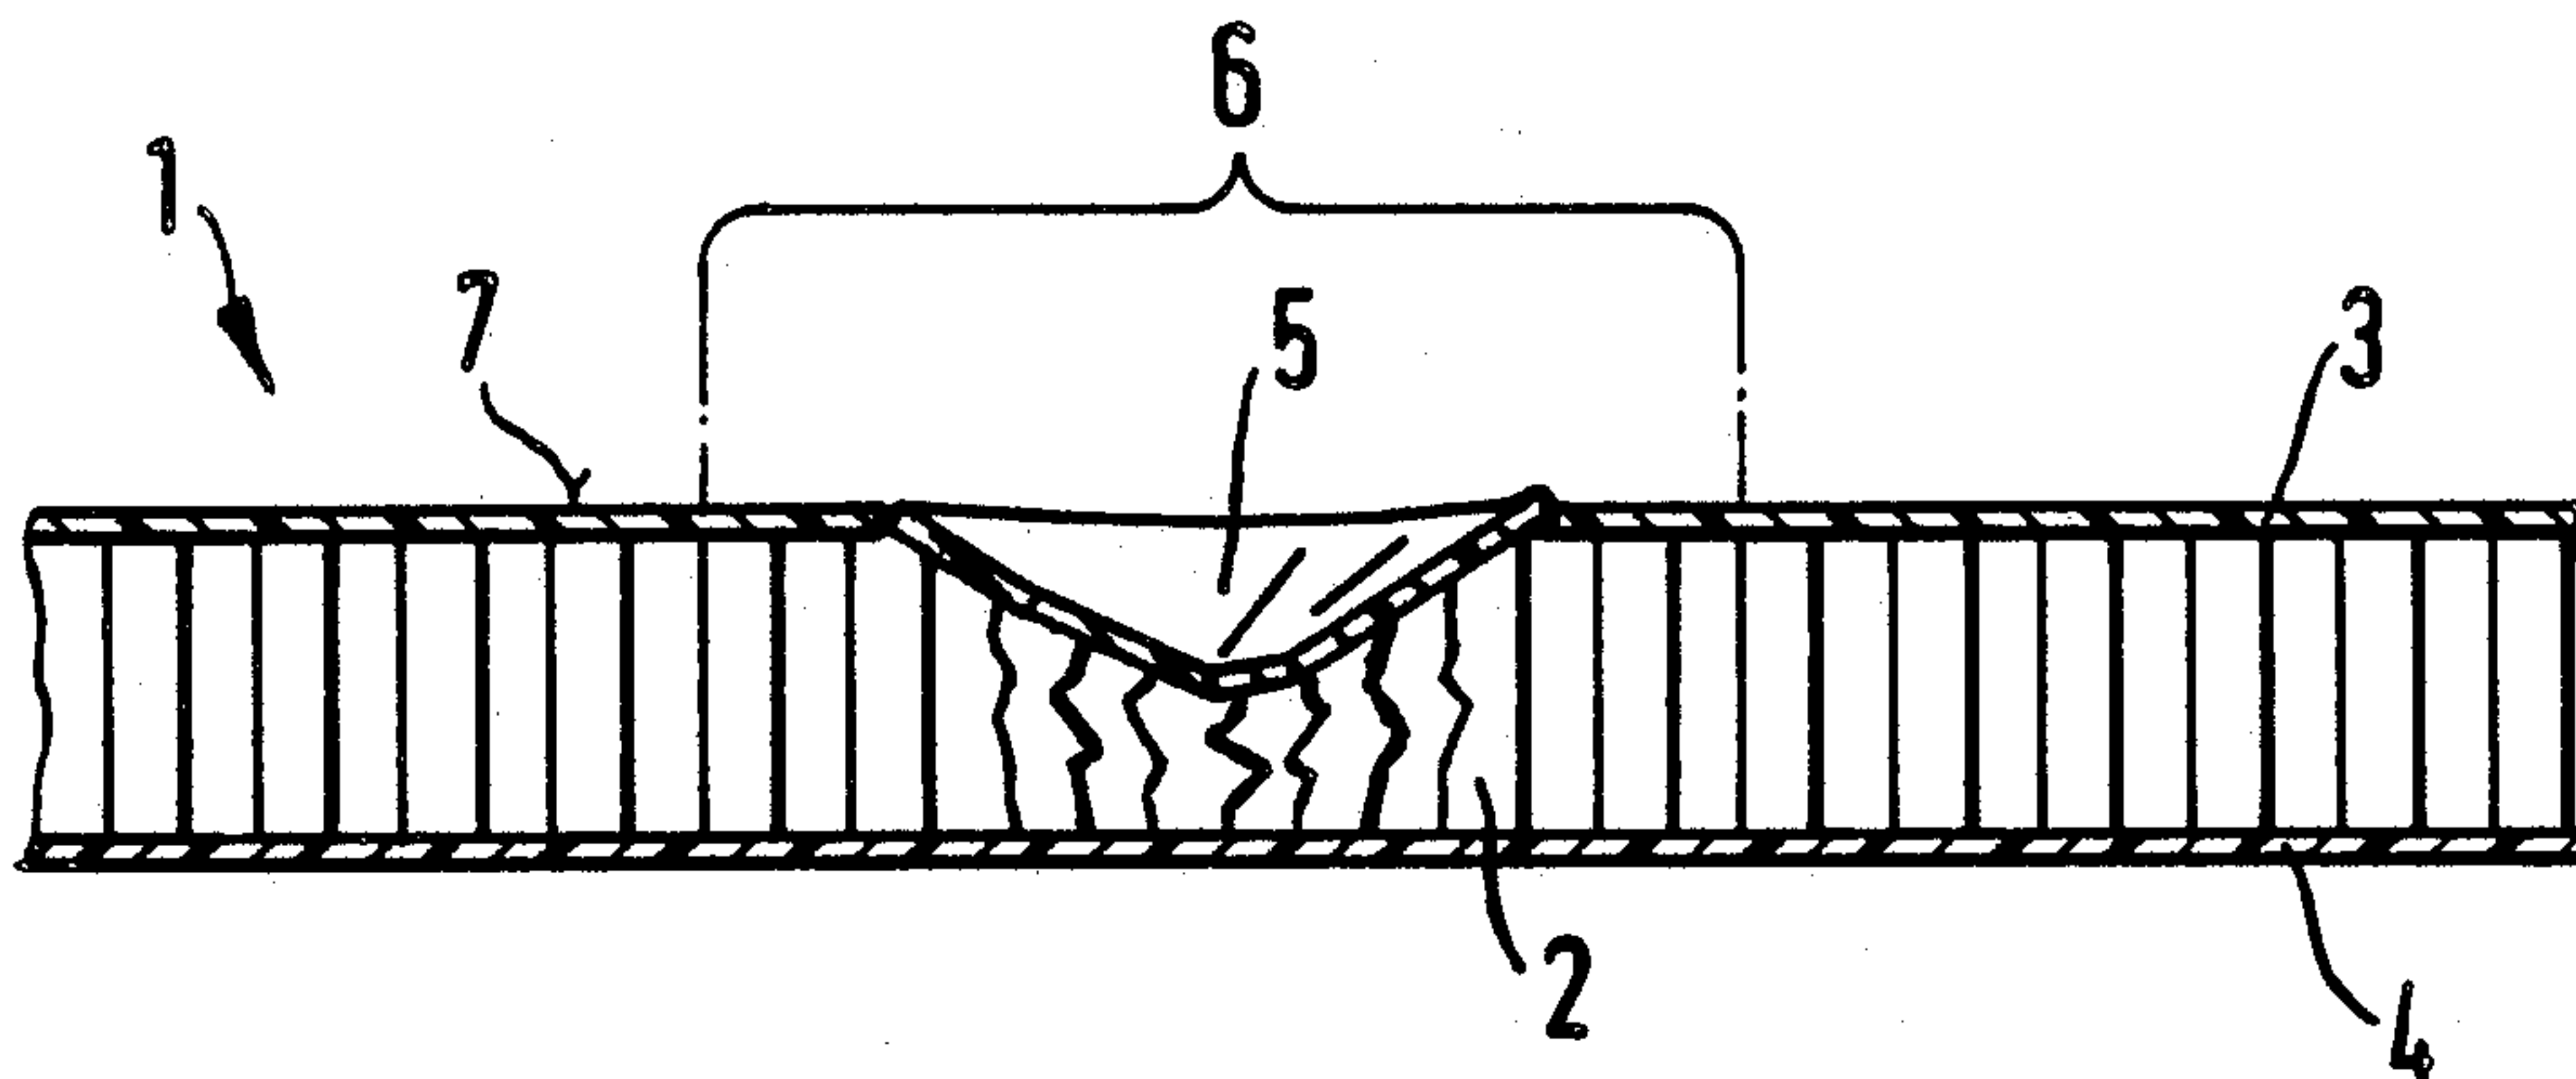
Fig. 1

FIG. 1 is a cross-sectional view of a damaged cargo lightweight panel and

In FIG. 1, "cargo panel" 1 which is used in aircraft construction and has a total thickness of approximately 7 mm is comprised of a honeycomb structure made of a polyamide fiber paper which is known, e.g., under the trade name "Nomex." On the two outer surfaces of the honeycomb core 2, lining laminates 3 and 4 have been laminated in thickness of about 0.2 mm which lining laminates each have at the core side a thin layer of glass fabric impregnated with phenol formaldehyde resin which at the panel surface is bonded to a white-dyed polyvinylfluoride film (e.g., available under the trade name "Tedlar"). Instead of the described honeycomb core 2, the core may also consist of a pressed honeycomb structure as known in aircraft panels.

The panel 1 has been damaged, e.g., by a corner of a piece of cargo hitting the section marked 5 in FIG. 1 and the repair of this damaged section 5 is effected in the following manner. Above an area marked 6 which at the panel's front side 7 displays, for example, the form of a square with rounded edges and which comprises the damaged section 5, the lining laminate 3 and the core material below it are stripped away, e.g., by cutting.

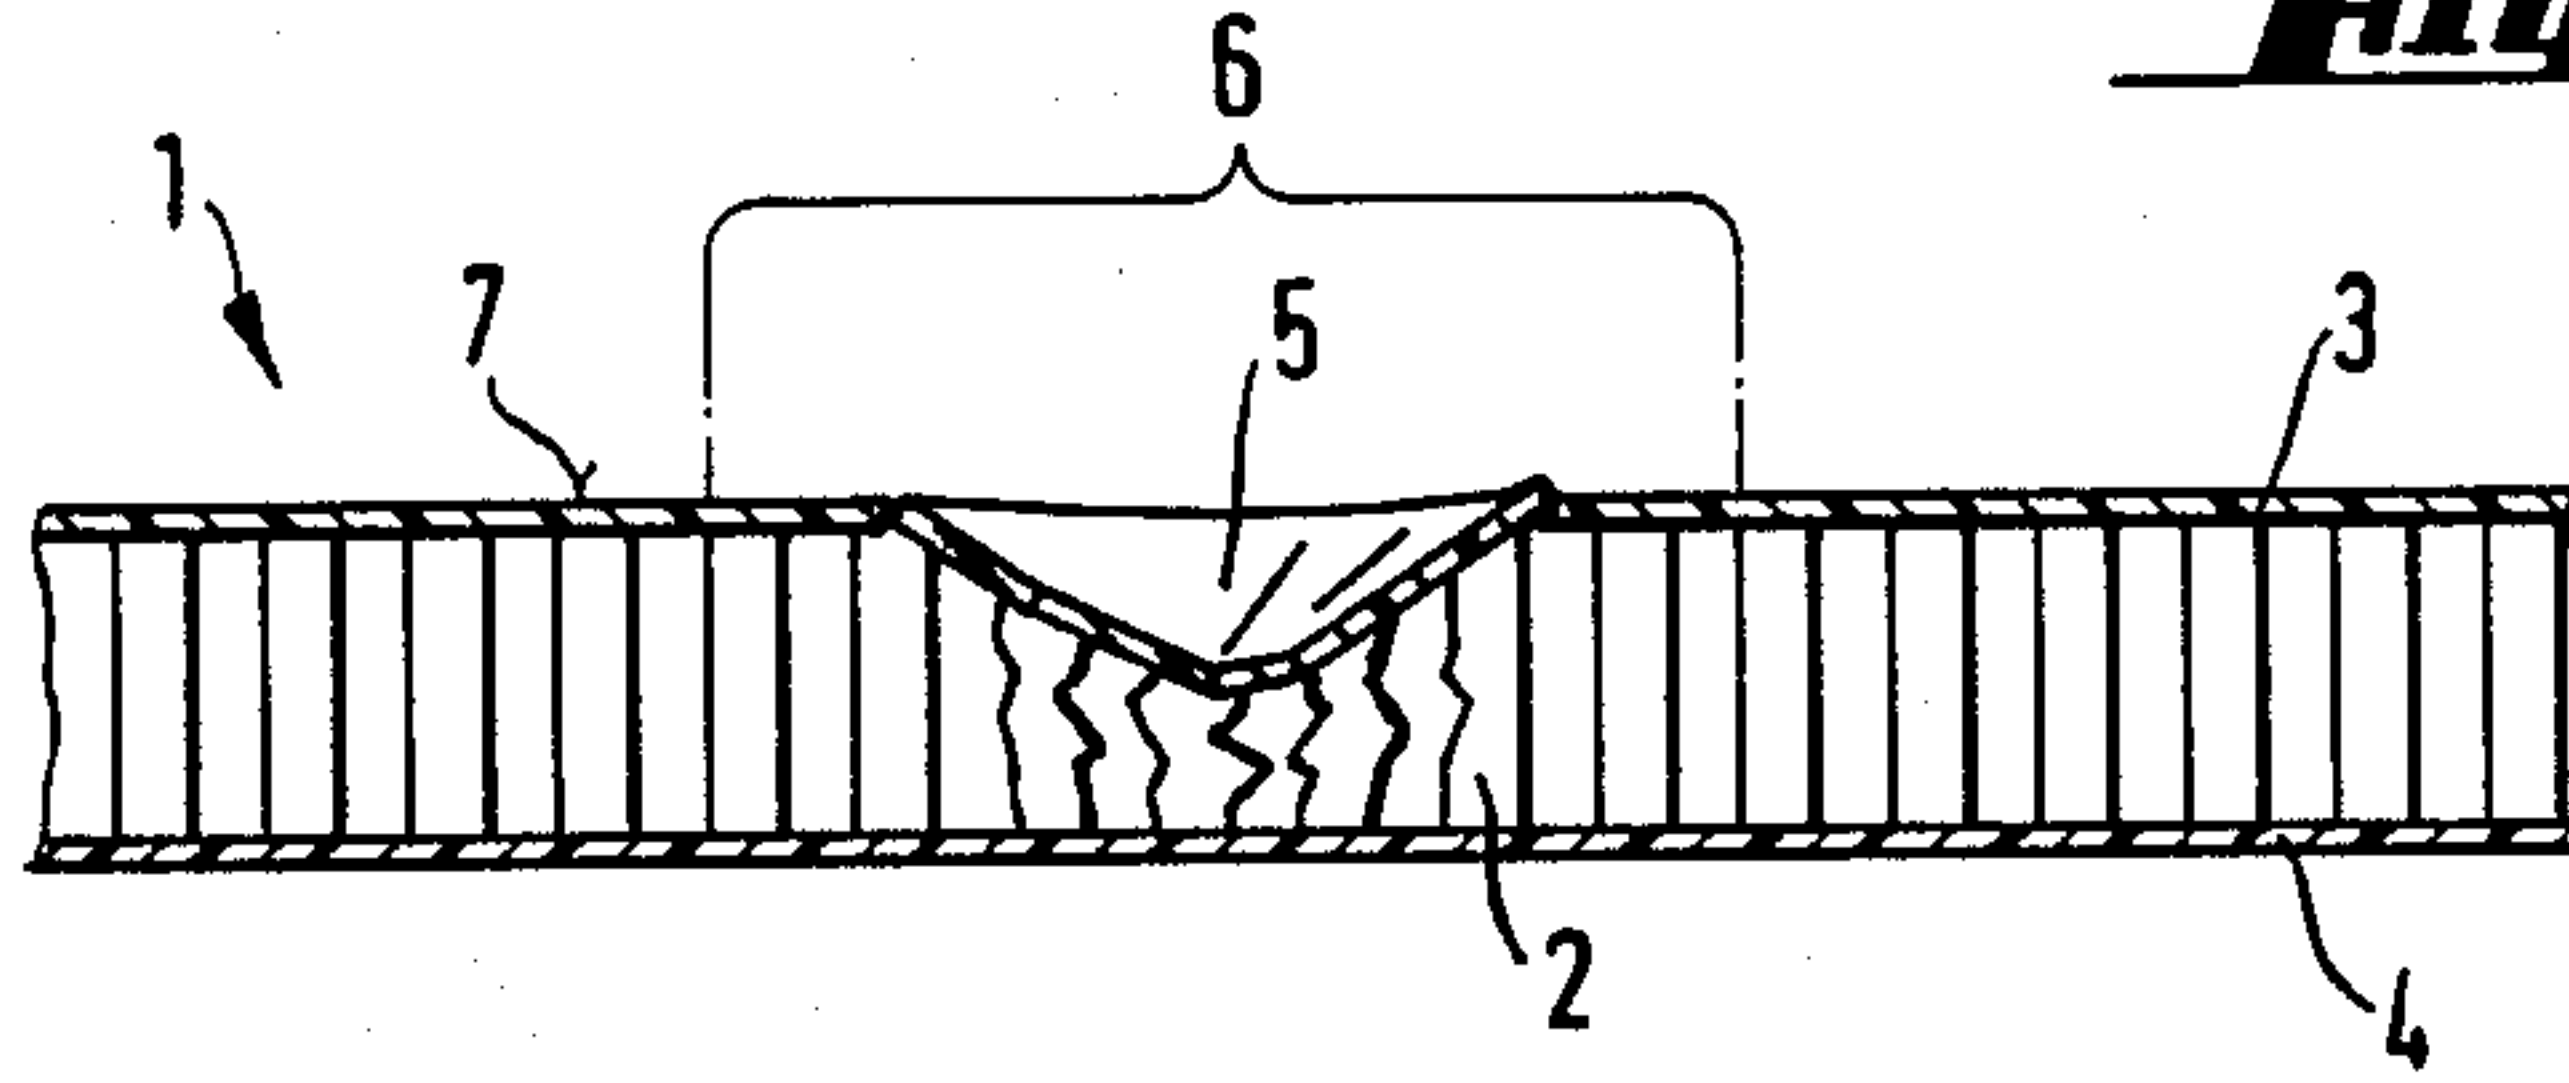
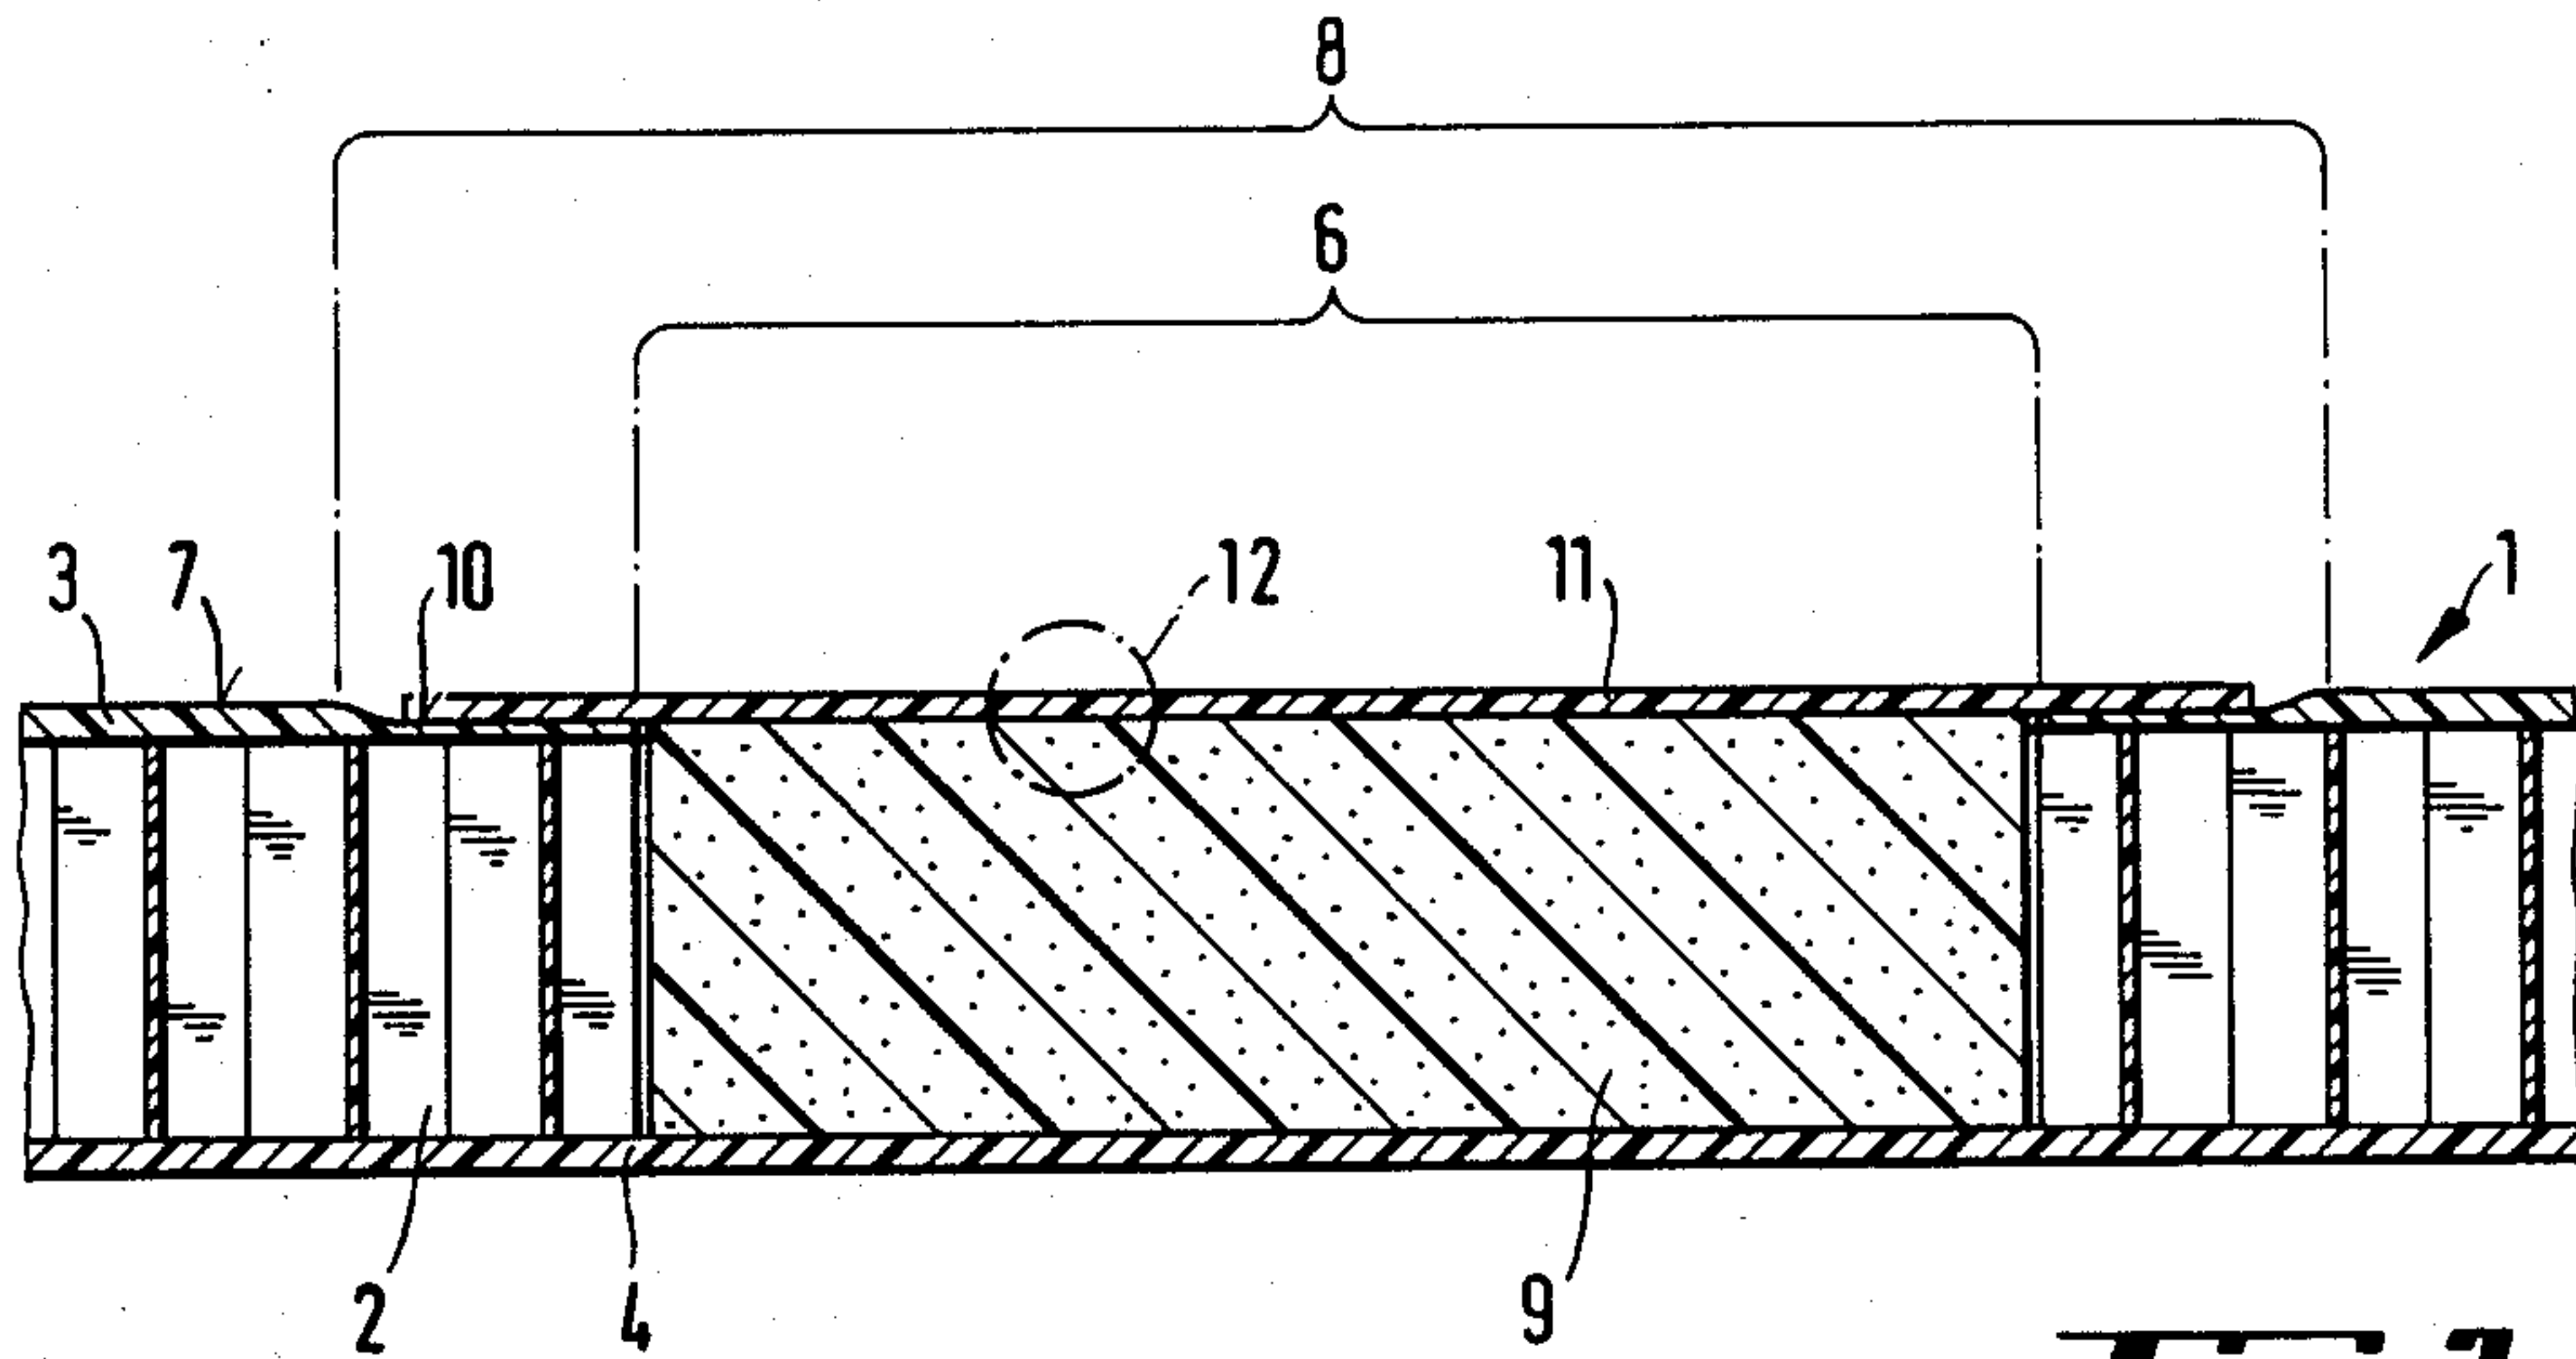
Fig. 2

FIG. 2 is a cross-sectional view of the repaired panel.

The further steps of the process are described below with the aid of FIG. 2 which shows the panel 1 on a scale that is enlarged in relation to FIG. 1. Into the space above area 6 from which the lining laminate 3 and the core material, respectively, have been removed, a replacement core material 9 which may consist of a curing synthetic adhesive is at first inserted. Then, the panel front side 7 is ground over an area 8 that laterally overlaps the area 6 so that the polyvinyl fluoride liner-film of the lining laminate 3 is removed there and a roughened surface 10 will remain at the replacement core material 9 and the lining laminate 3.

To replace the stripped off lining laminate 3, a repair laminate is used that is in the form of a synthetic material layer reinforced by two layers of glass fabric produced by impregnating the glass fabric layers with a phenol formaldehyde resin of the resol type with a glass content of 100 g/m² and a phenol resin content of 100 g/m² (solid material) and subsequent curing. A layer of a hot-melt polyester based adhesive is applied to one side of the synthetic material layer with an application quantity of about 125 g/m², while the other side of the synthetic material layer is bonded to a liner-film, e.g., about 0.025 mm thick consisting of polyvinyl fluoride that is colored white, for example. A blank 11 (FIG. 2) of a repair laminate, in the form of a square with rounded corners is then pressed with the hot-melt adhesive layer against the rough-ground surface 10 of the

panel surface 7 through use of a pressing iron-type tool, and thereby heated to a temperature of about 105° C. at which the hot-melt adhesive becomes activated and enters into a good bond with the rough-ground surface 10.

If the damage to the panel is such that not only the lining laminate and the core are dented, the panel 1 is punctured through its entire thickness, one proceeds so that a window-shaped break-out is cut out of the panel at the damaged spot. Then, the panel is ground at the surface of one of the lining laminates (e.g., the lining laminate 4) over the area 8 and then, similarly as described in FIG. 2, a first repair laminate blank 11 is applied to it by "ironing." Next, the insertion of the replacement core material 9, the grinding of the panel surface 7 and application of a repair laminate blank (the second one) to the panel surface 7 exactly as described with FIG. 2, are carried through in sequence.

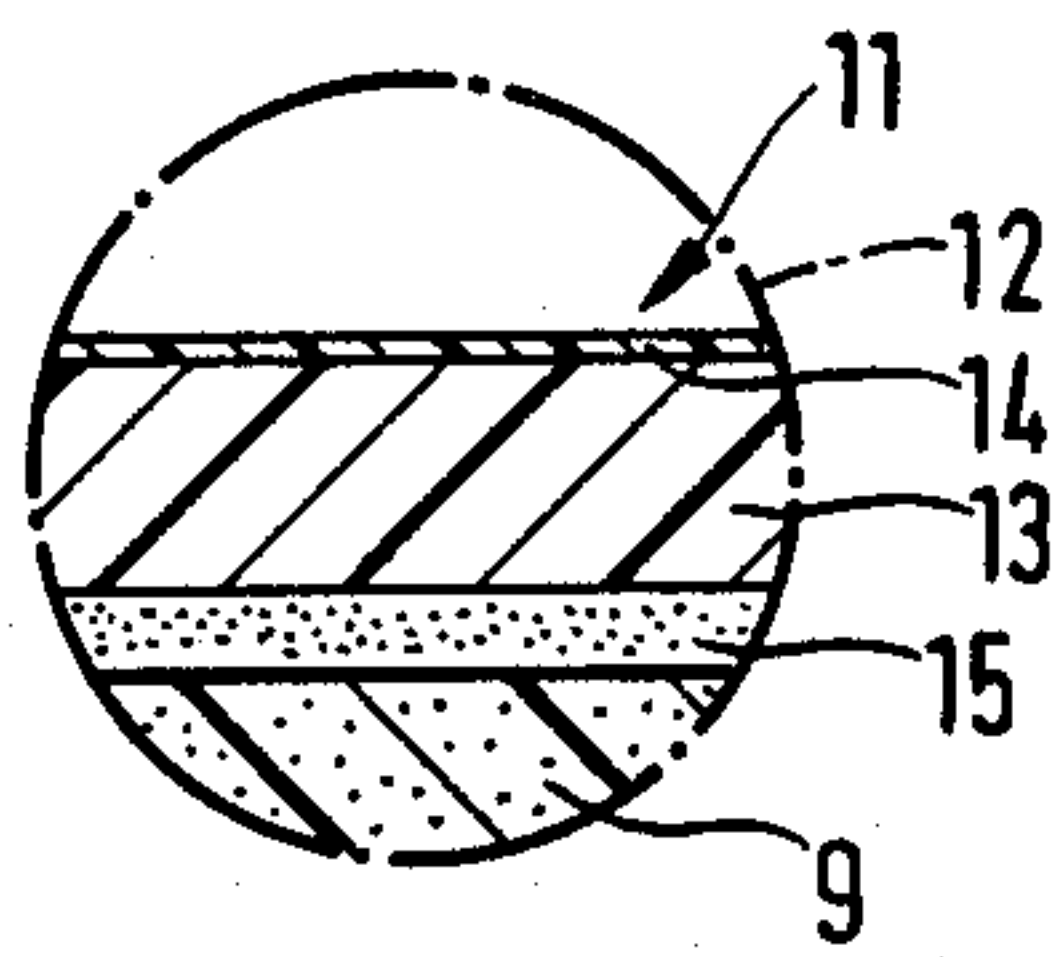
Fig. 3

FIG. 3 is a partial cross-section of a repair laminate of the invention.

FIG. 3 shows in the circle 12 of FIG. 2 the structure of the repair laminate with the synthetic material layer 13 reinforced with glass fabric, the liner-film 14, as well as the hot-melt adhesive layer 15.
