[54] REPAIR LAMINATE

[75] Inventors: Johann Ondrejas, Vienna; Friedrich Zitz, Friedberg, both of Austria

[73] Assignee: Isovolta Osterreichische Isolierstoffwerke Aktiengesellschaft, Wiener Neudorf, Austria

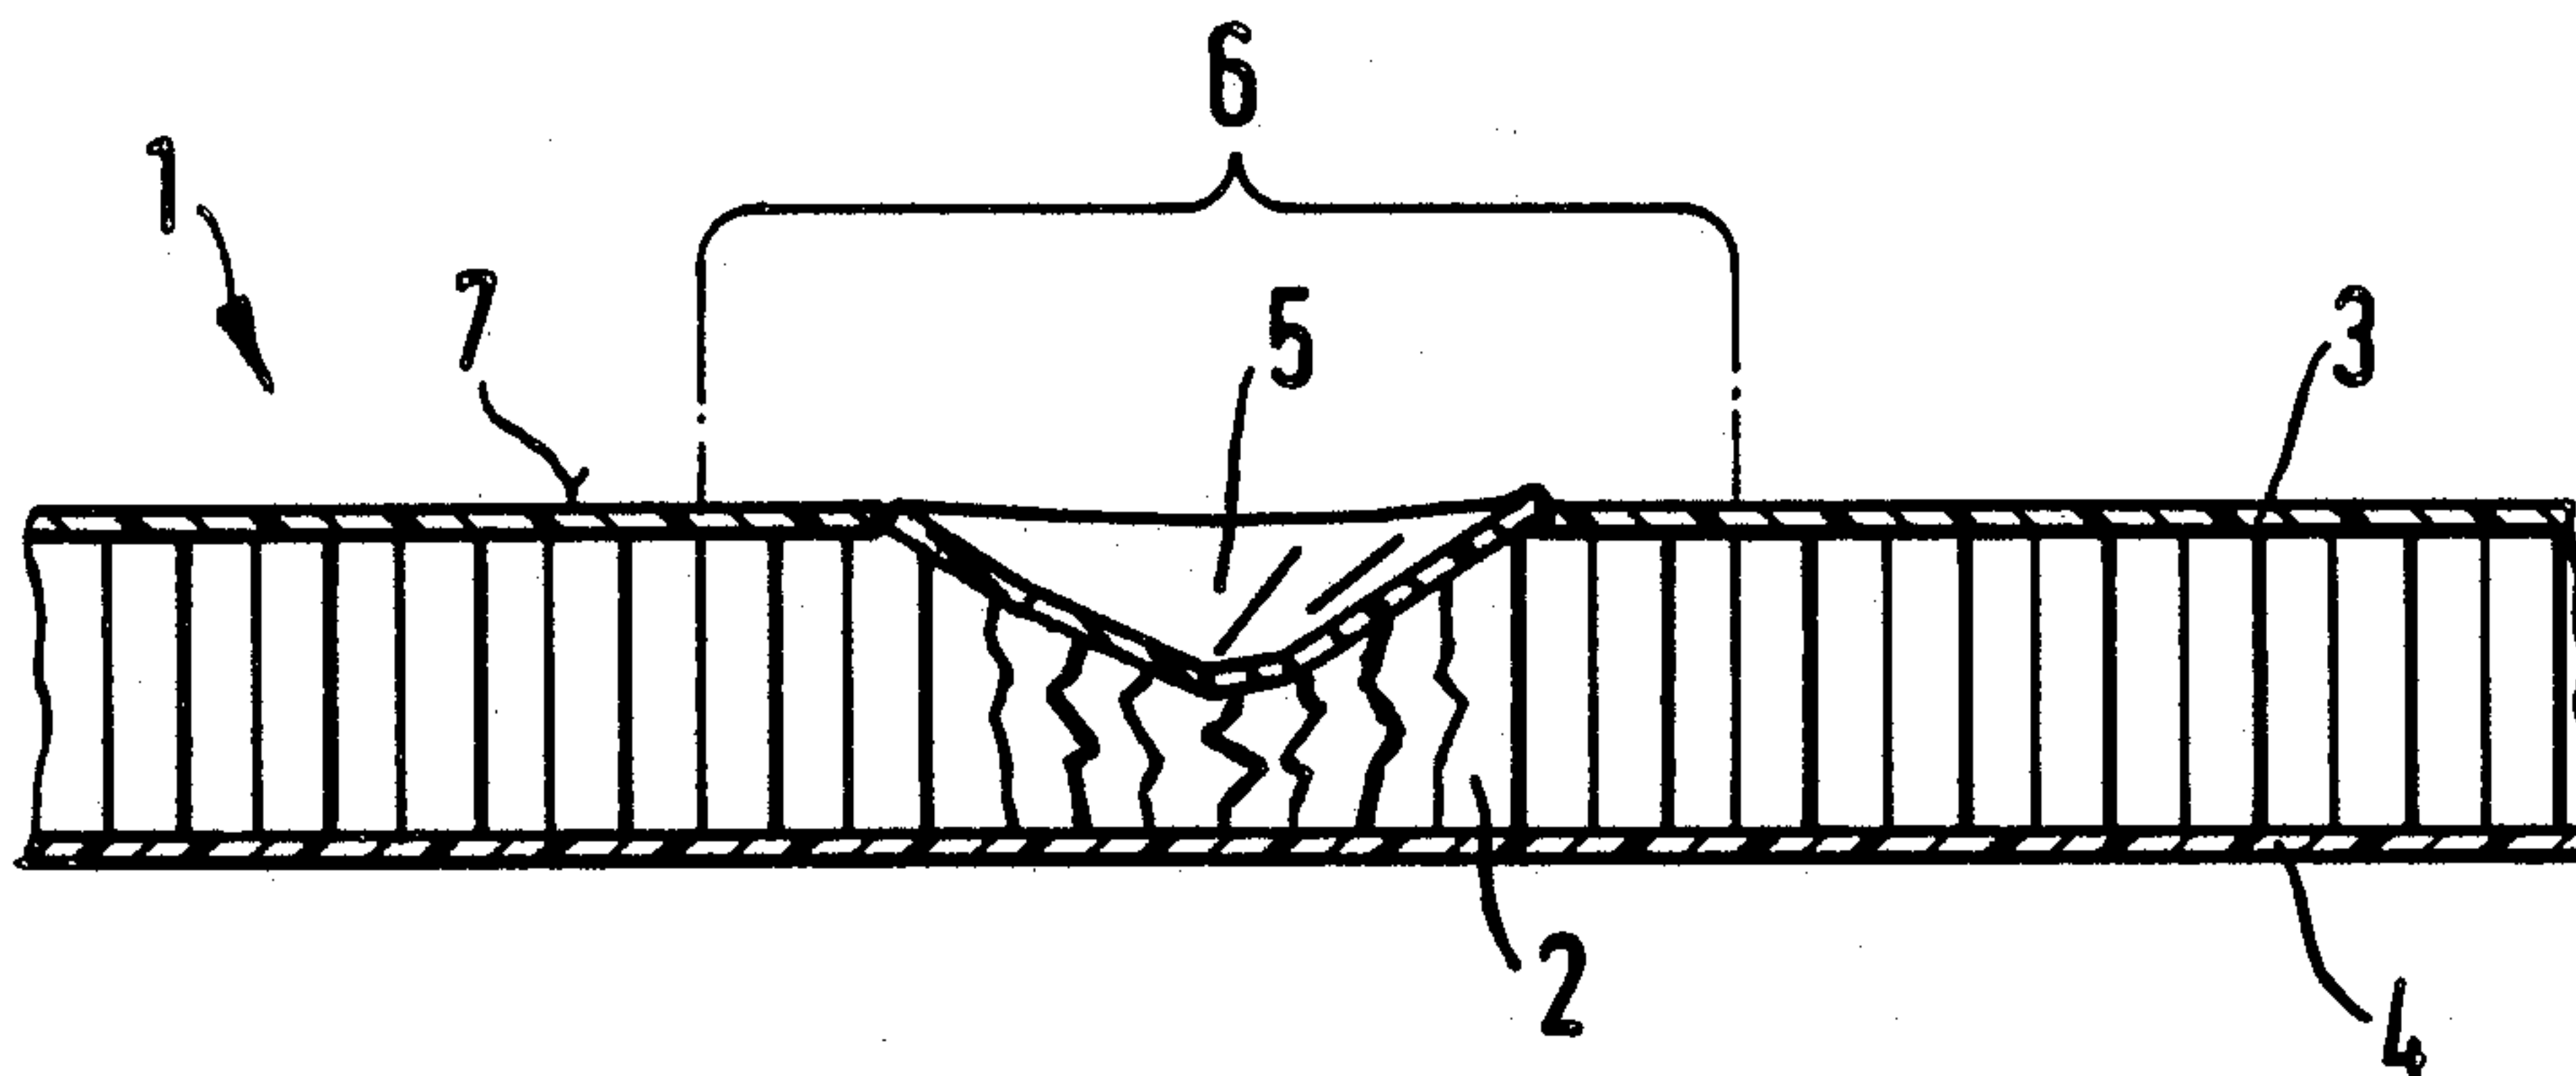
Fig. 1

FIG. 1 is a cross-sectional view of a damaged cargo lightweight panel and

In FIG. 1, "cargo panel" 1 which is used in aircraft construction and has a total thickness of approximately 7 mm is comprised of a honeycomb structure made of a polyamide fiber paper which is known, e.g., under the trade name "Nomex." On the two outer surfaces of the honeycomb core 2, lining laminates 3 and 4 have been laminated in thickness of about 0.2 mm which lining laminates each have at the core side a thin layer of glass fabric impregnated with phenol formaldehyde resin which at the panel surface is bonded to a white-dyed polyvinylfluoride film (e.g., available under the trade name "Tedlar"). Instead of the described honeycomb core 2, the core may also consist of a pressed honeycomb structure as known in aircraft panels.

The panel 1 has been damaged, e.g., by a corner of a piece of cargo hitting the section marked 5 in FIG. 1 and the repair of this damaged section 5 is effected in the following manner. Above an area marked 6 which at the panel's front side 7 displays, for example, the form of a square with rounded edges and which comprises the damaged section 5, the lining laminate 3 and the core material below it are stripped away, e.g., by cutting.
