[54] HIGHLY EROSIIVE AND ABRASIVE WEAR RESISTANT COMPOSITE COATING SYSTEM

[73] Assignee: Air Products and Chemicals, Inc., Allentown, Pa.

[57] ABSTRACT

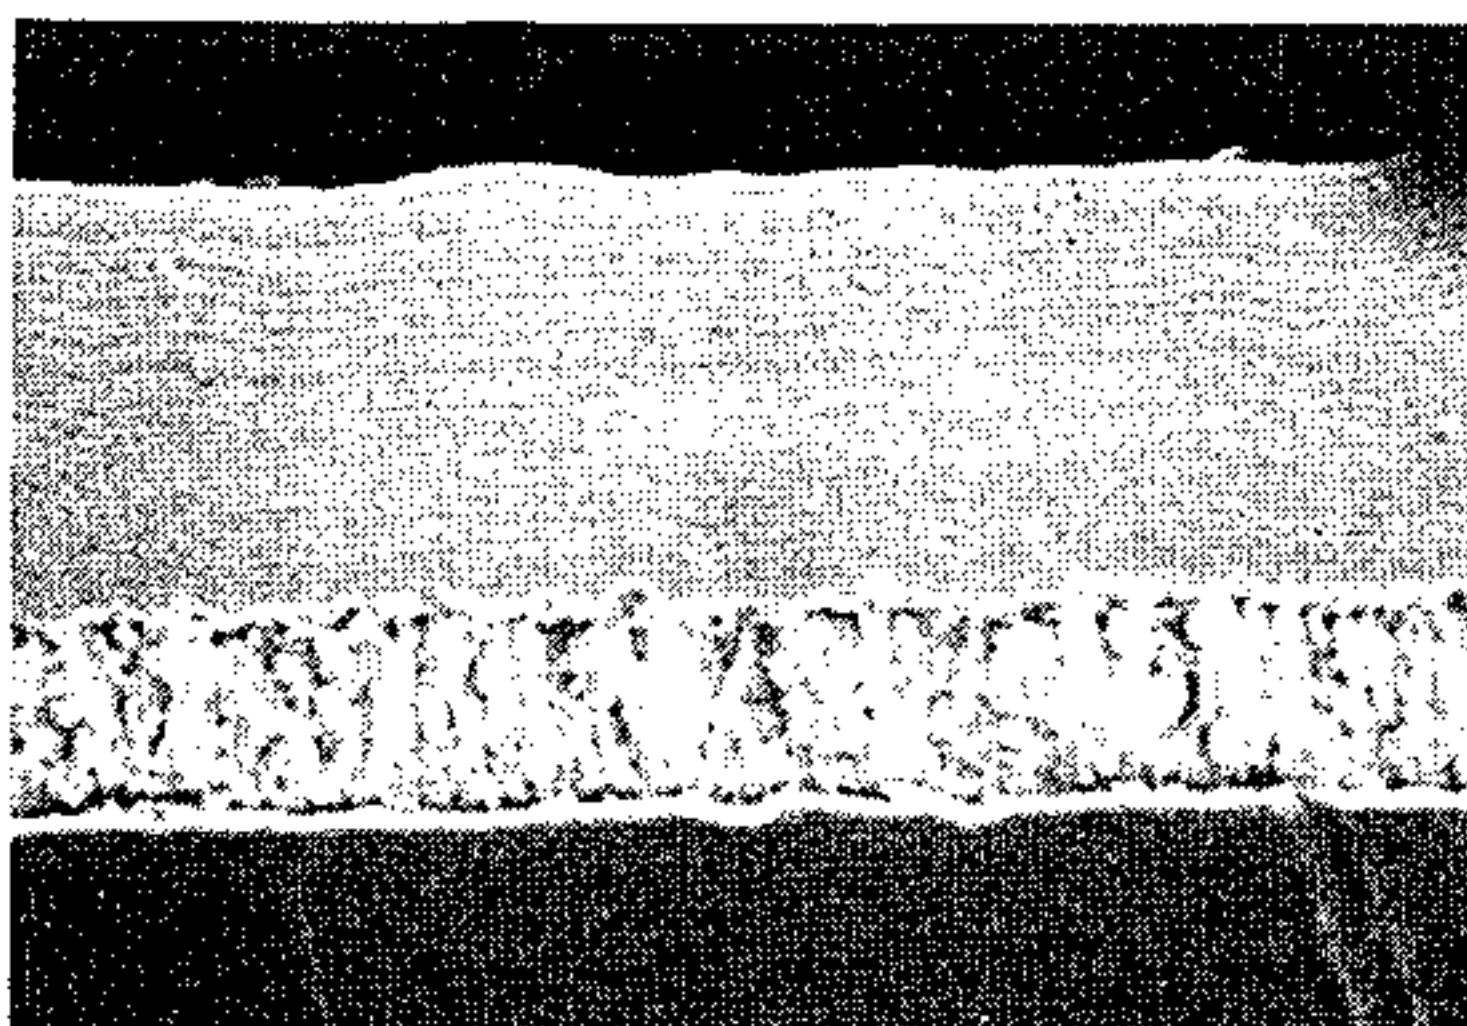
FIG. 1 is the photomicrograph at 1,000 magnification of the tungsten coating on AM-350 stainless steel showing a rough surface finish but the absence of cracks.

The specimens were found to be coated with a dull, adherent, coherent, and uniform coating. The coating thickness on stainless steel specimens was \sim 12 μm on each side (see Table 2). The coating had a rough surface finish and was free of cracks, as shown in the FIG. 1. The coating consisted of columnar growth structure, as shown in the FIG. 2. X-ray diffraction analysis showed the presence of only tungsten in the coating. It had a hardness of 455 Vickers, as shown in Table 3. The coating showed very poor erosion performance; time required to penetrate the coating was only 3 seconds, resulting in an erosion rate of 6 seconds/mil. This, therefore, indicated that CVD tungsten could not be used to provide erosion protection.

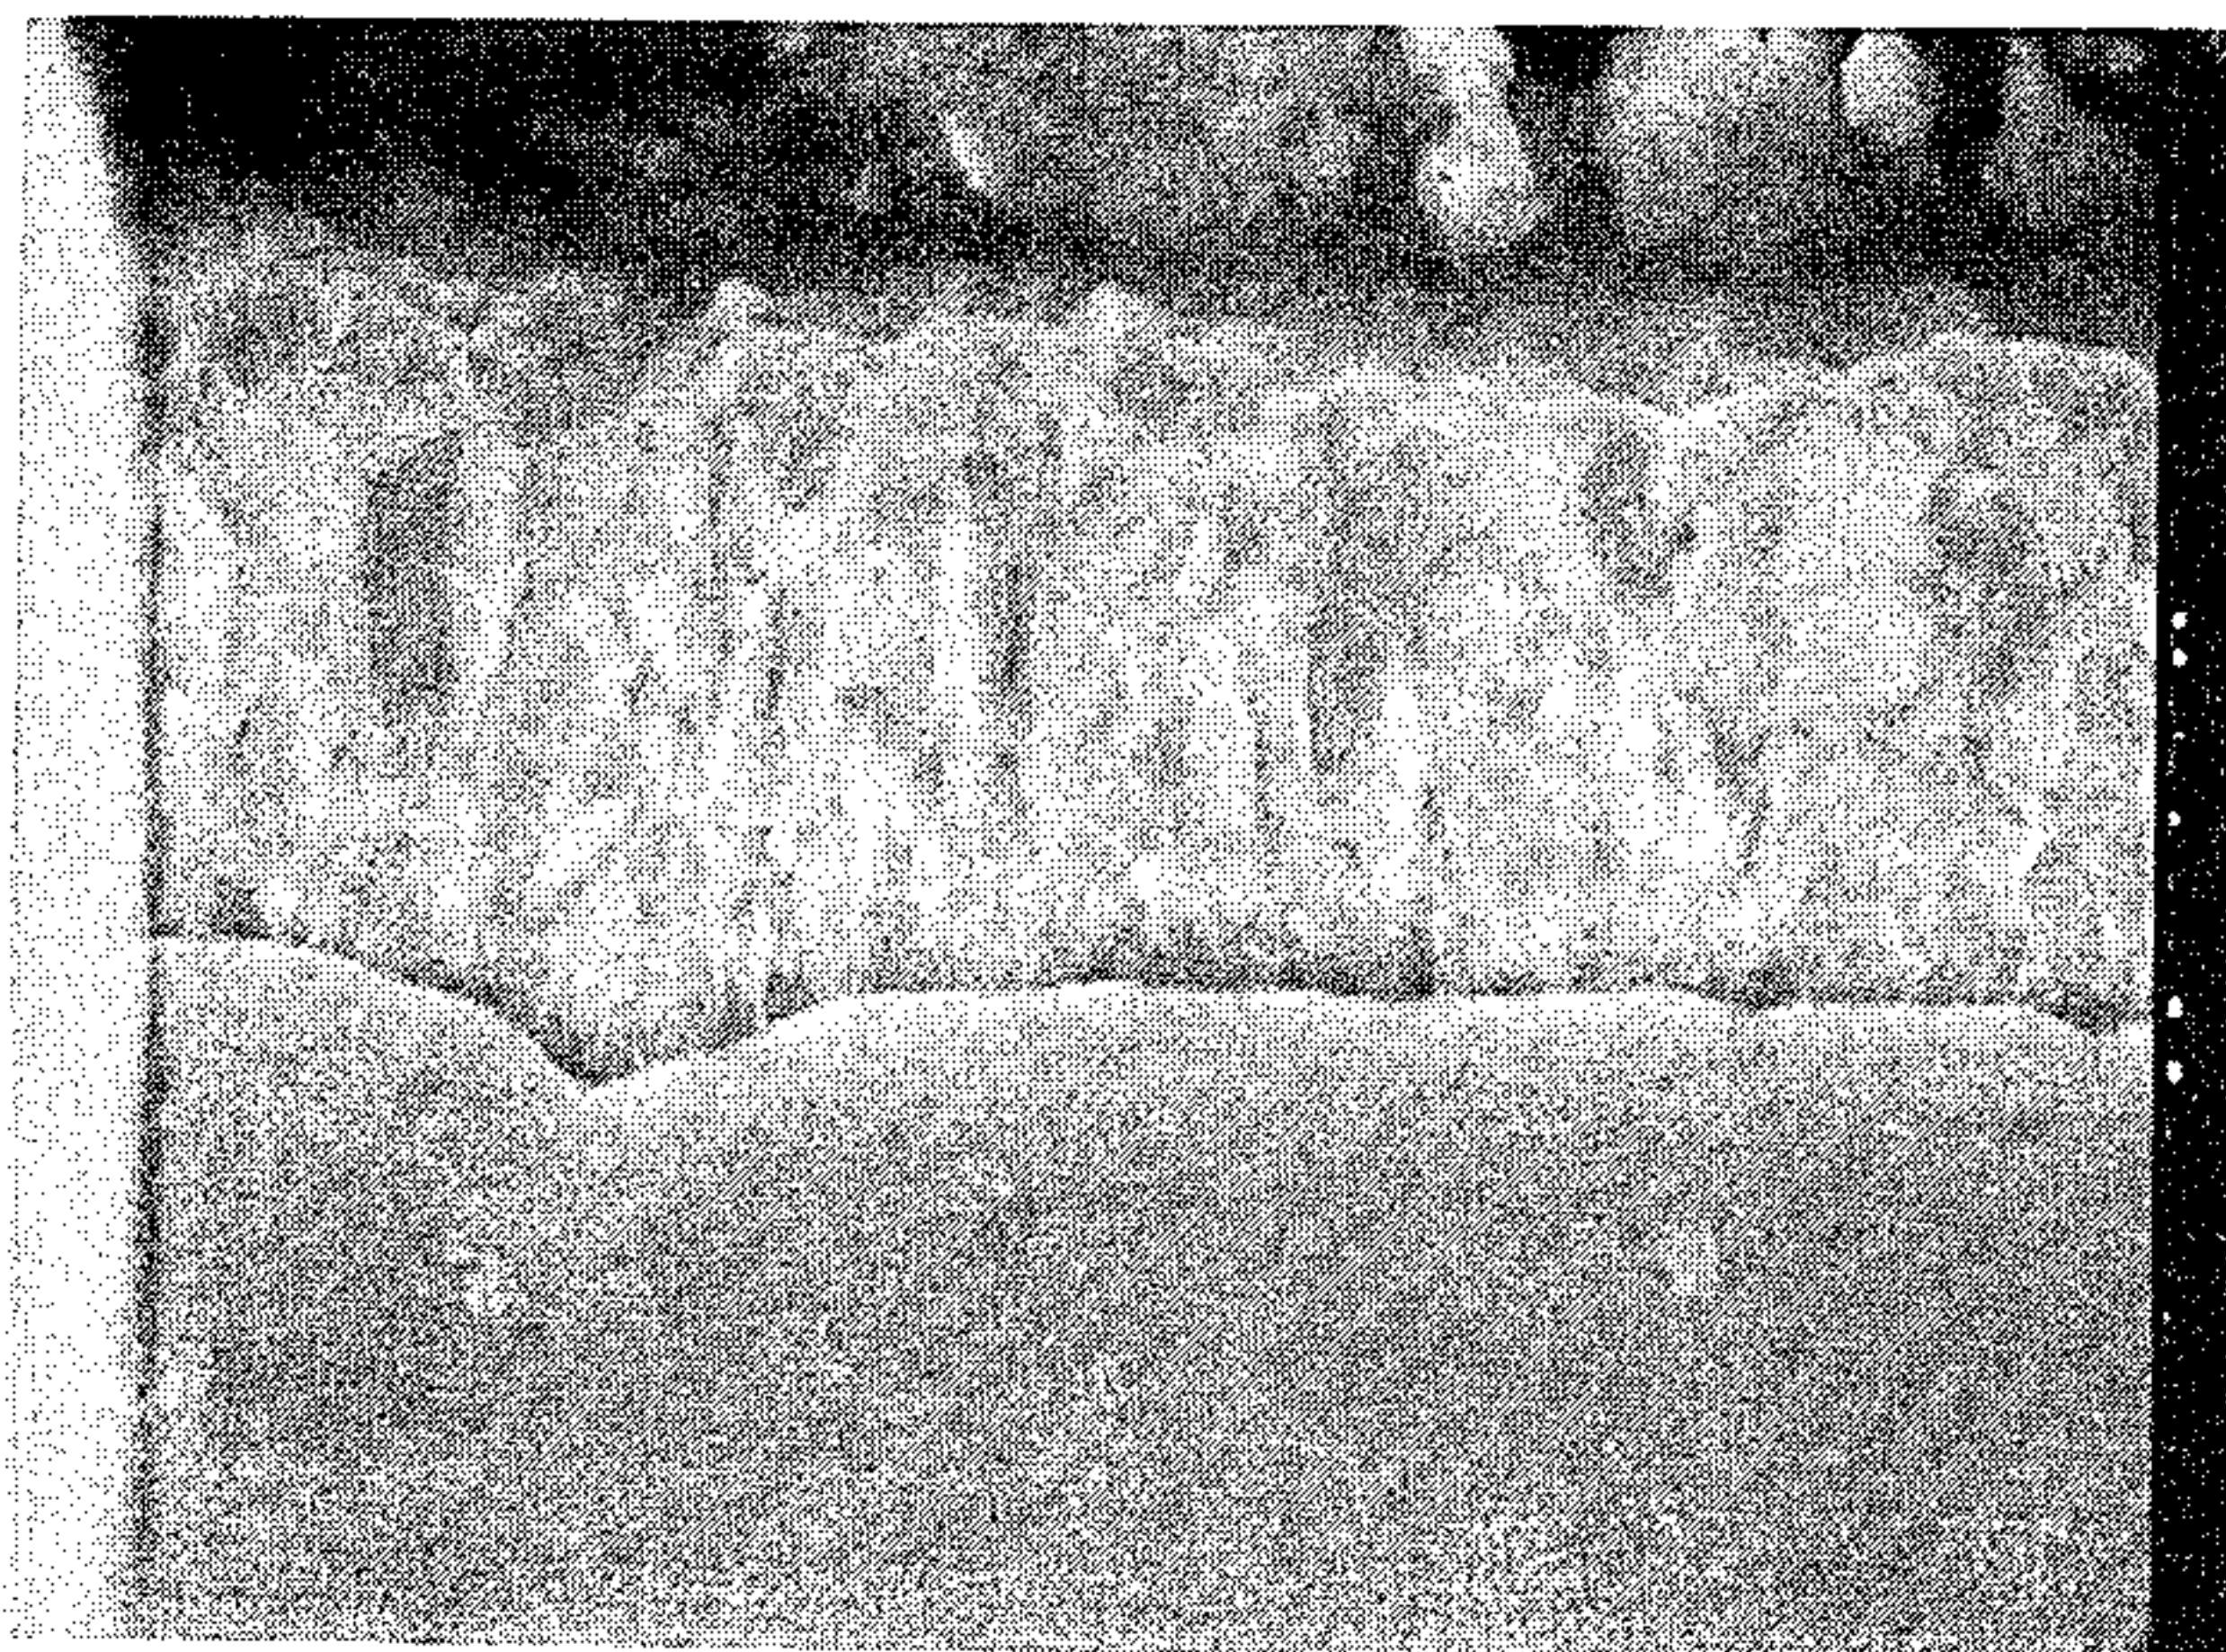
—
TUNGSTEN

—
NICKEL

—
AM-350
STAINLESS STEEL

FIG. 2 is the cross-sectional view at 3,000 magnification of the tungsten coating on AM-350 stainless steel showing columnar growth structure.

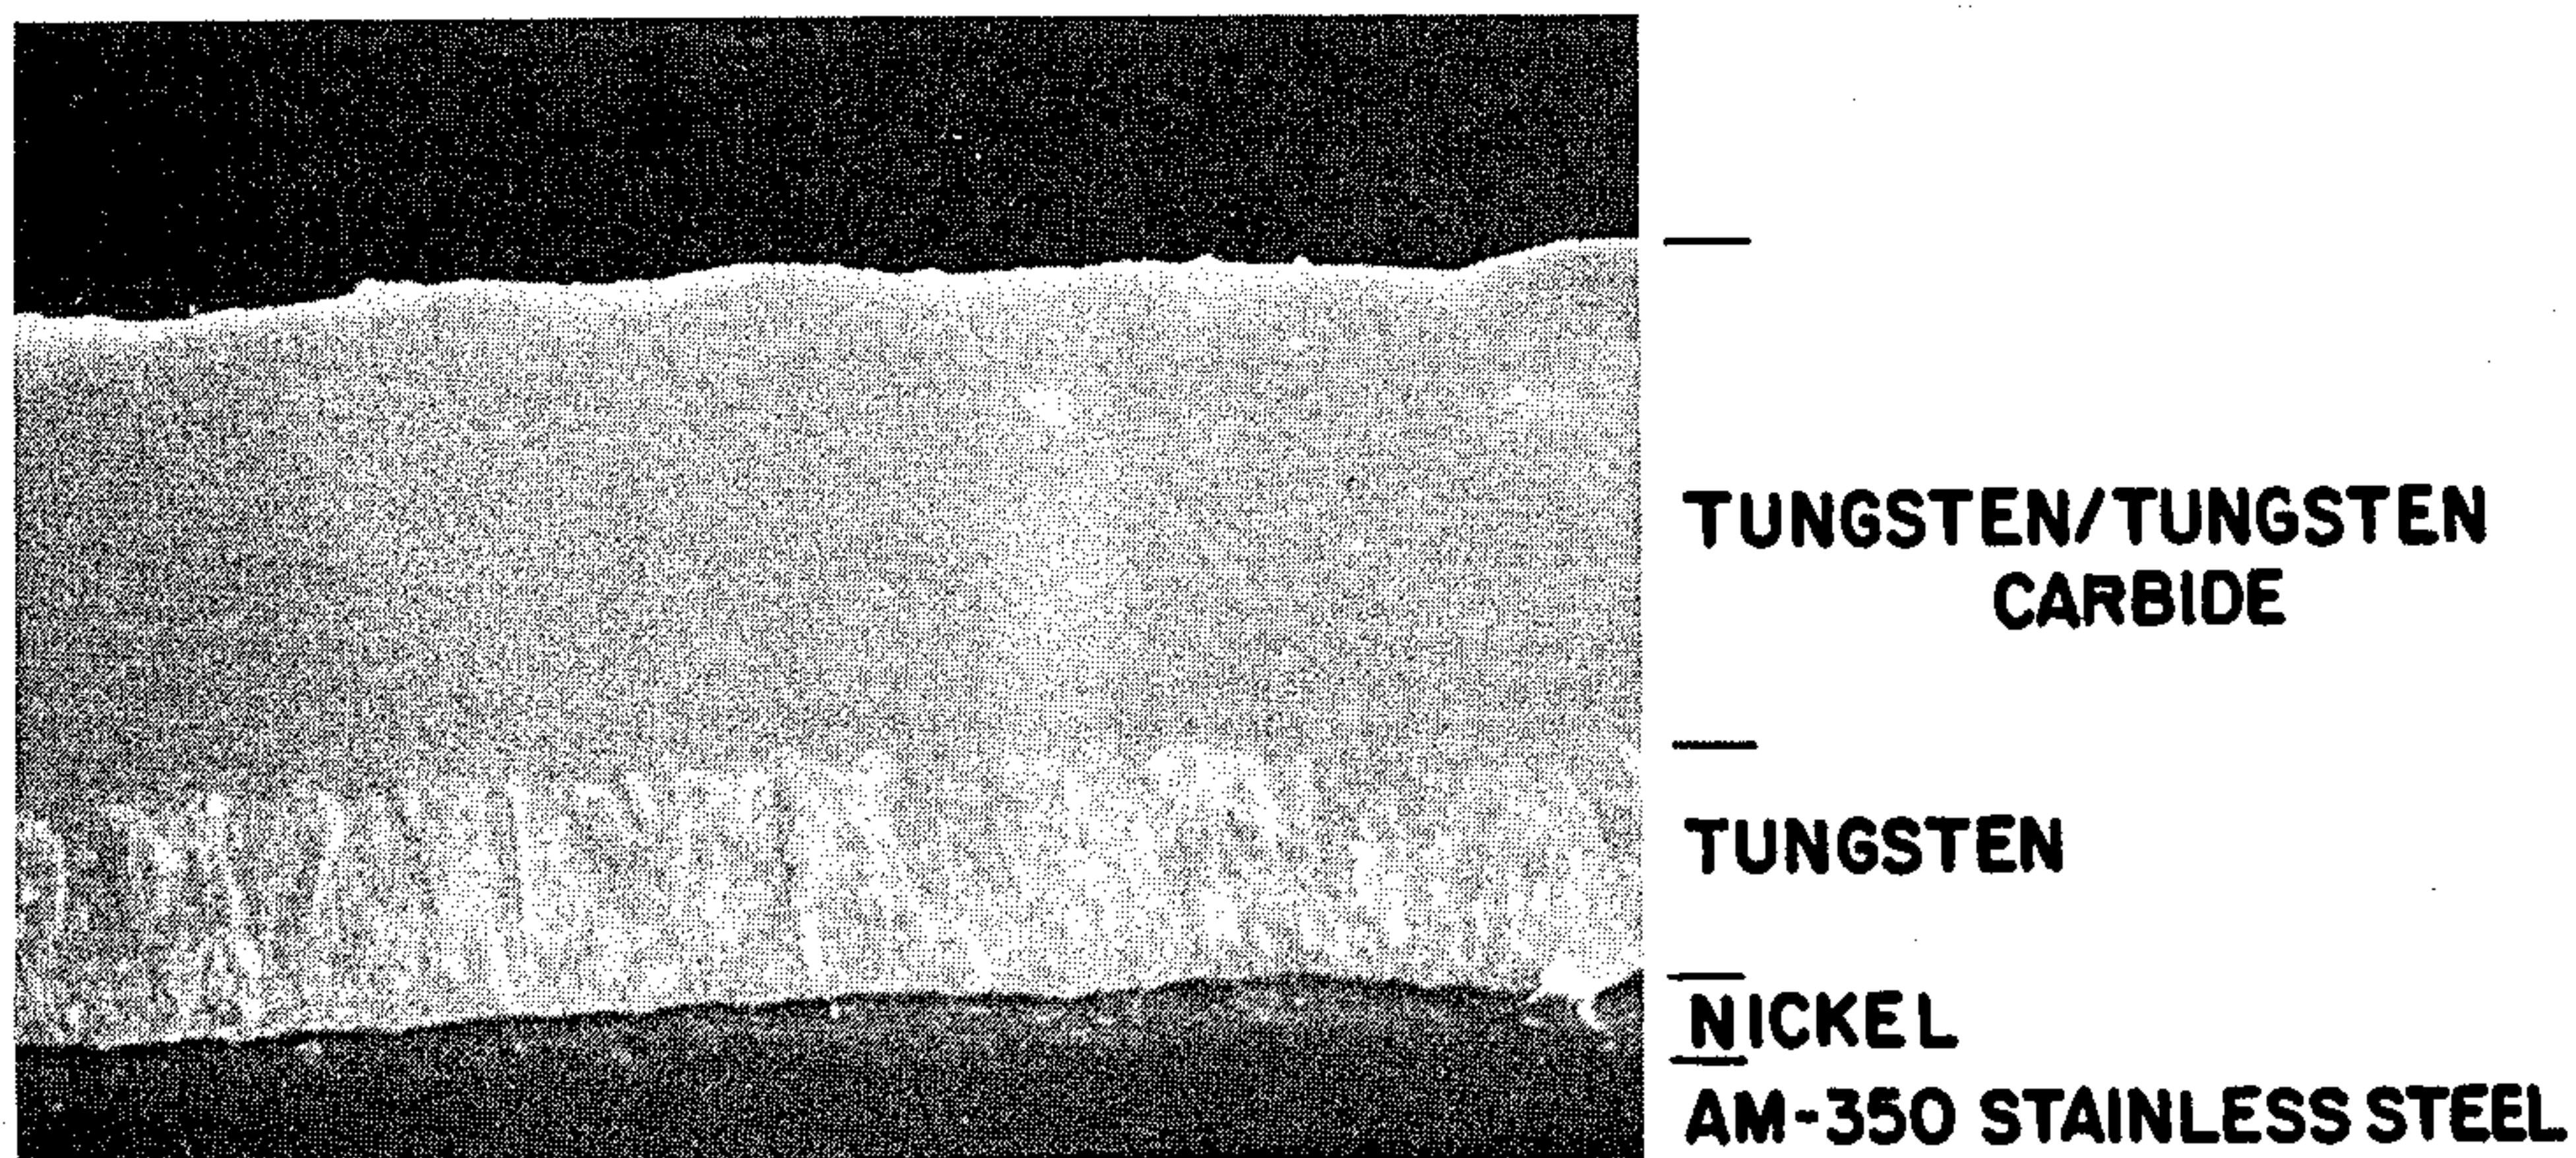
FIG. 3 is the schematic of the unetched cross-sectional view at 2,000 magnification of the composite coating system on AM-350 stainless steel substrate constructed in accordance with the invention.

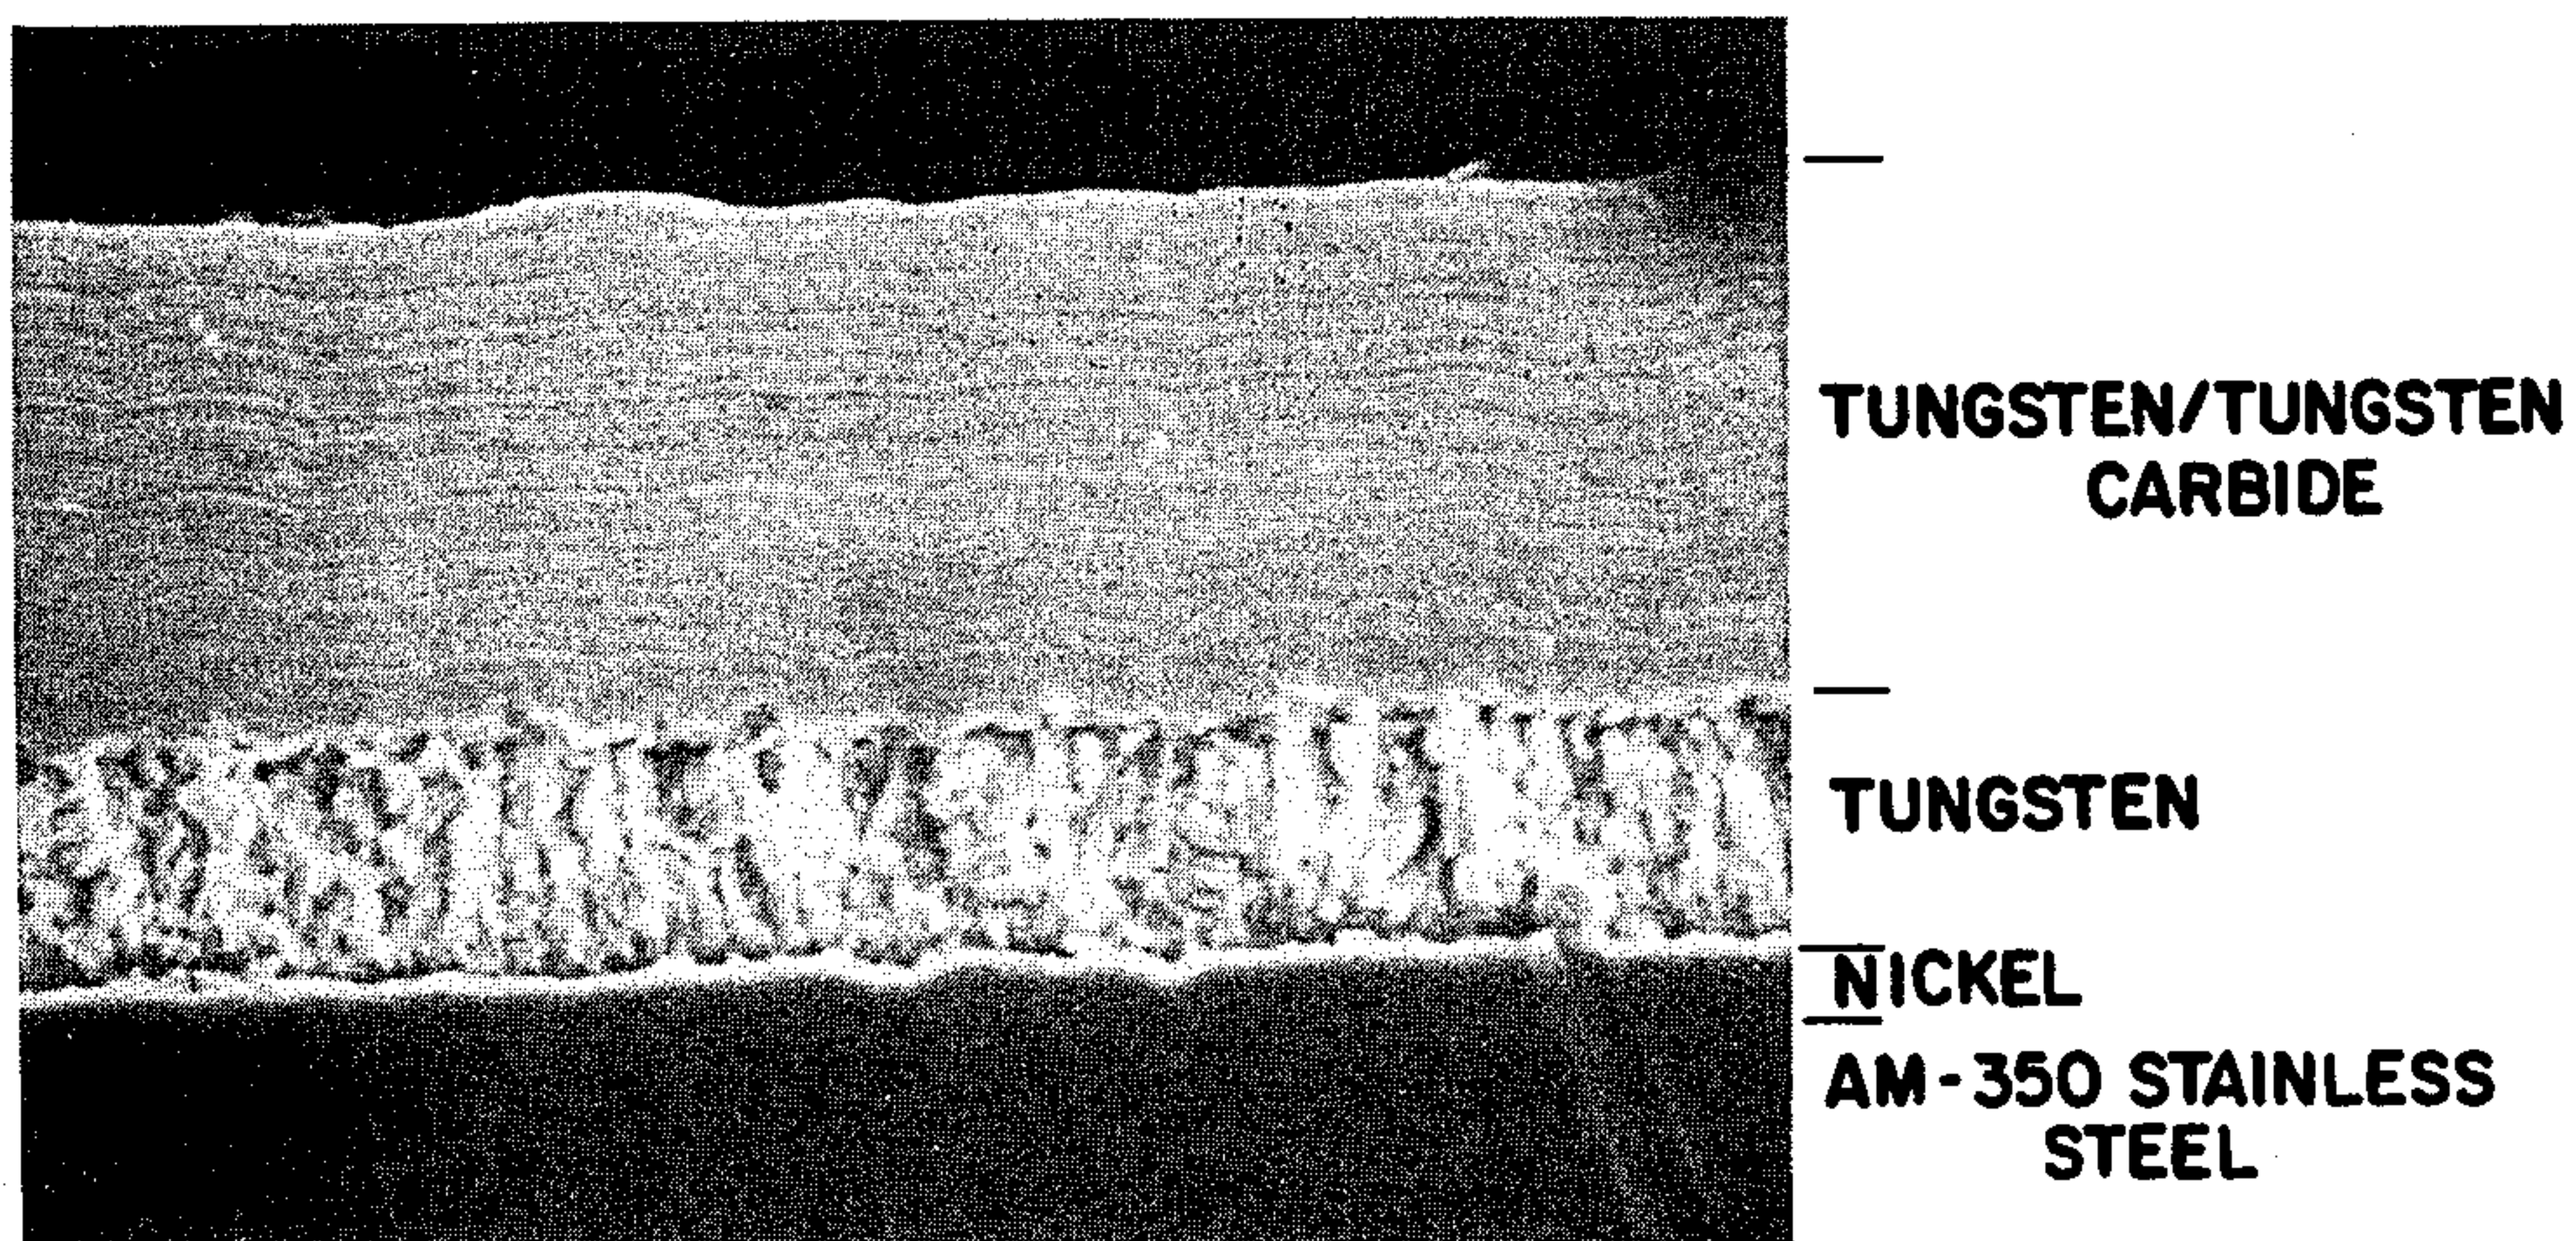
FIG. 4 is the schematic of the cross-sectional view at 2,000 magnification of the composite coating system on AM-350 stainless steel etched with the murakami solution constructed in accordance with the invention.

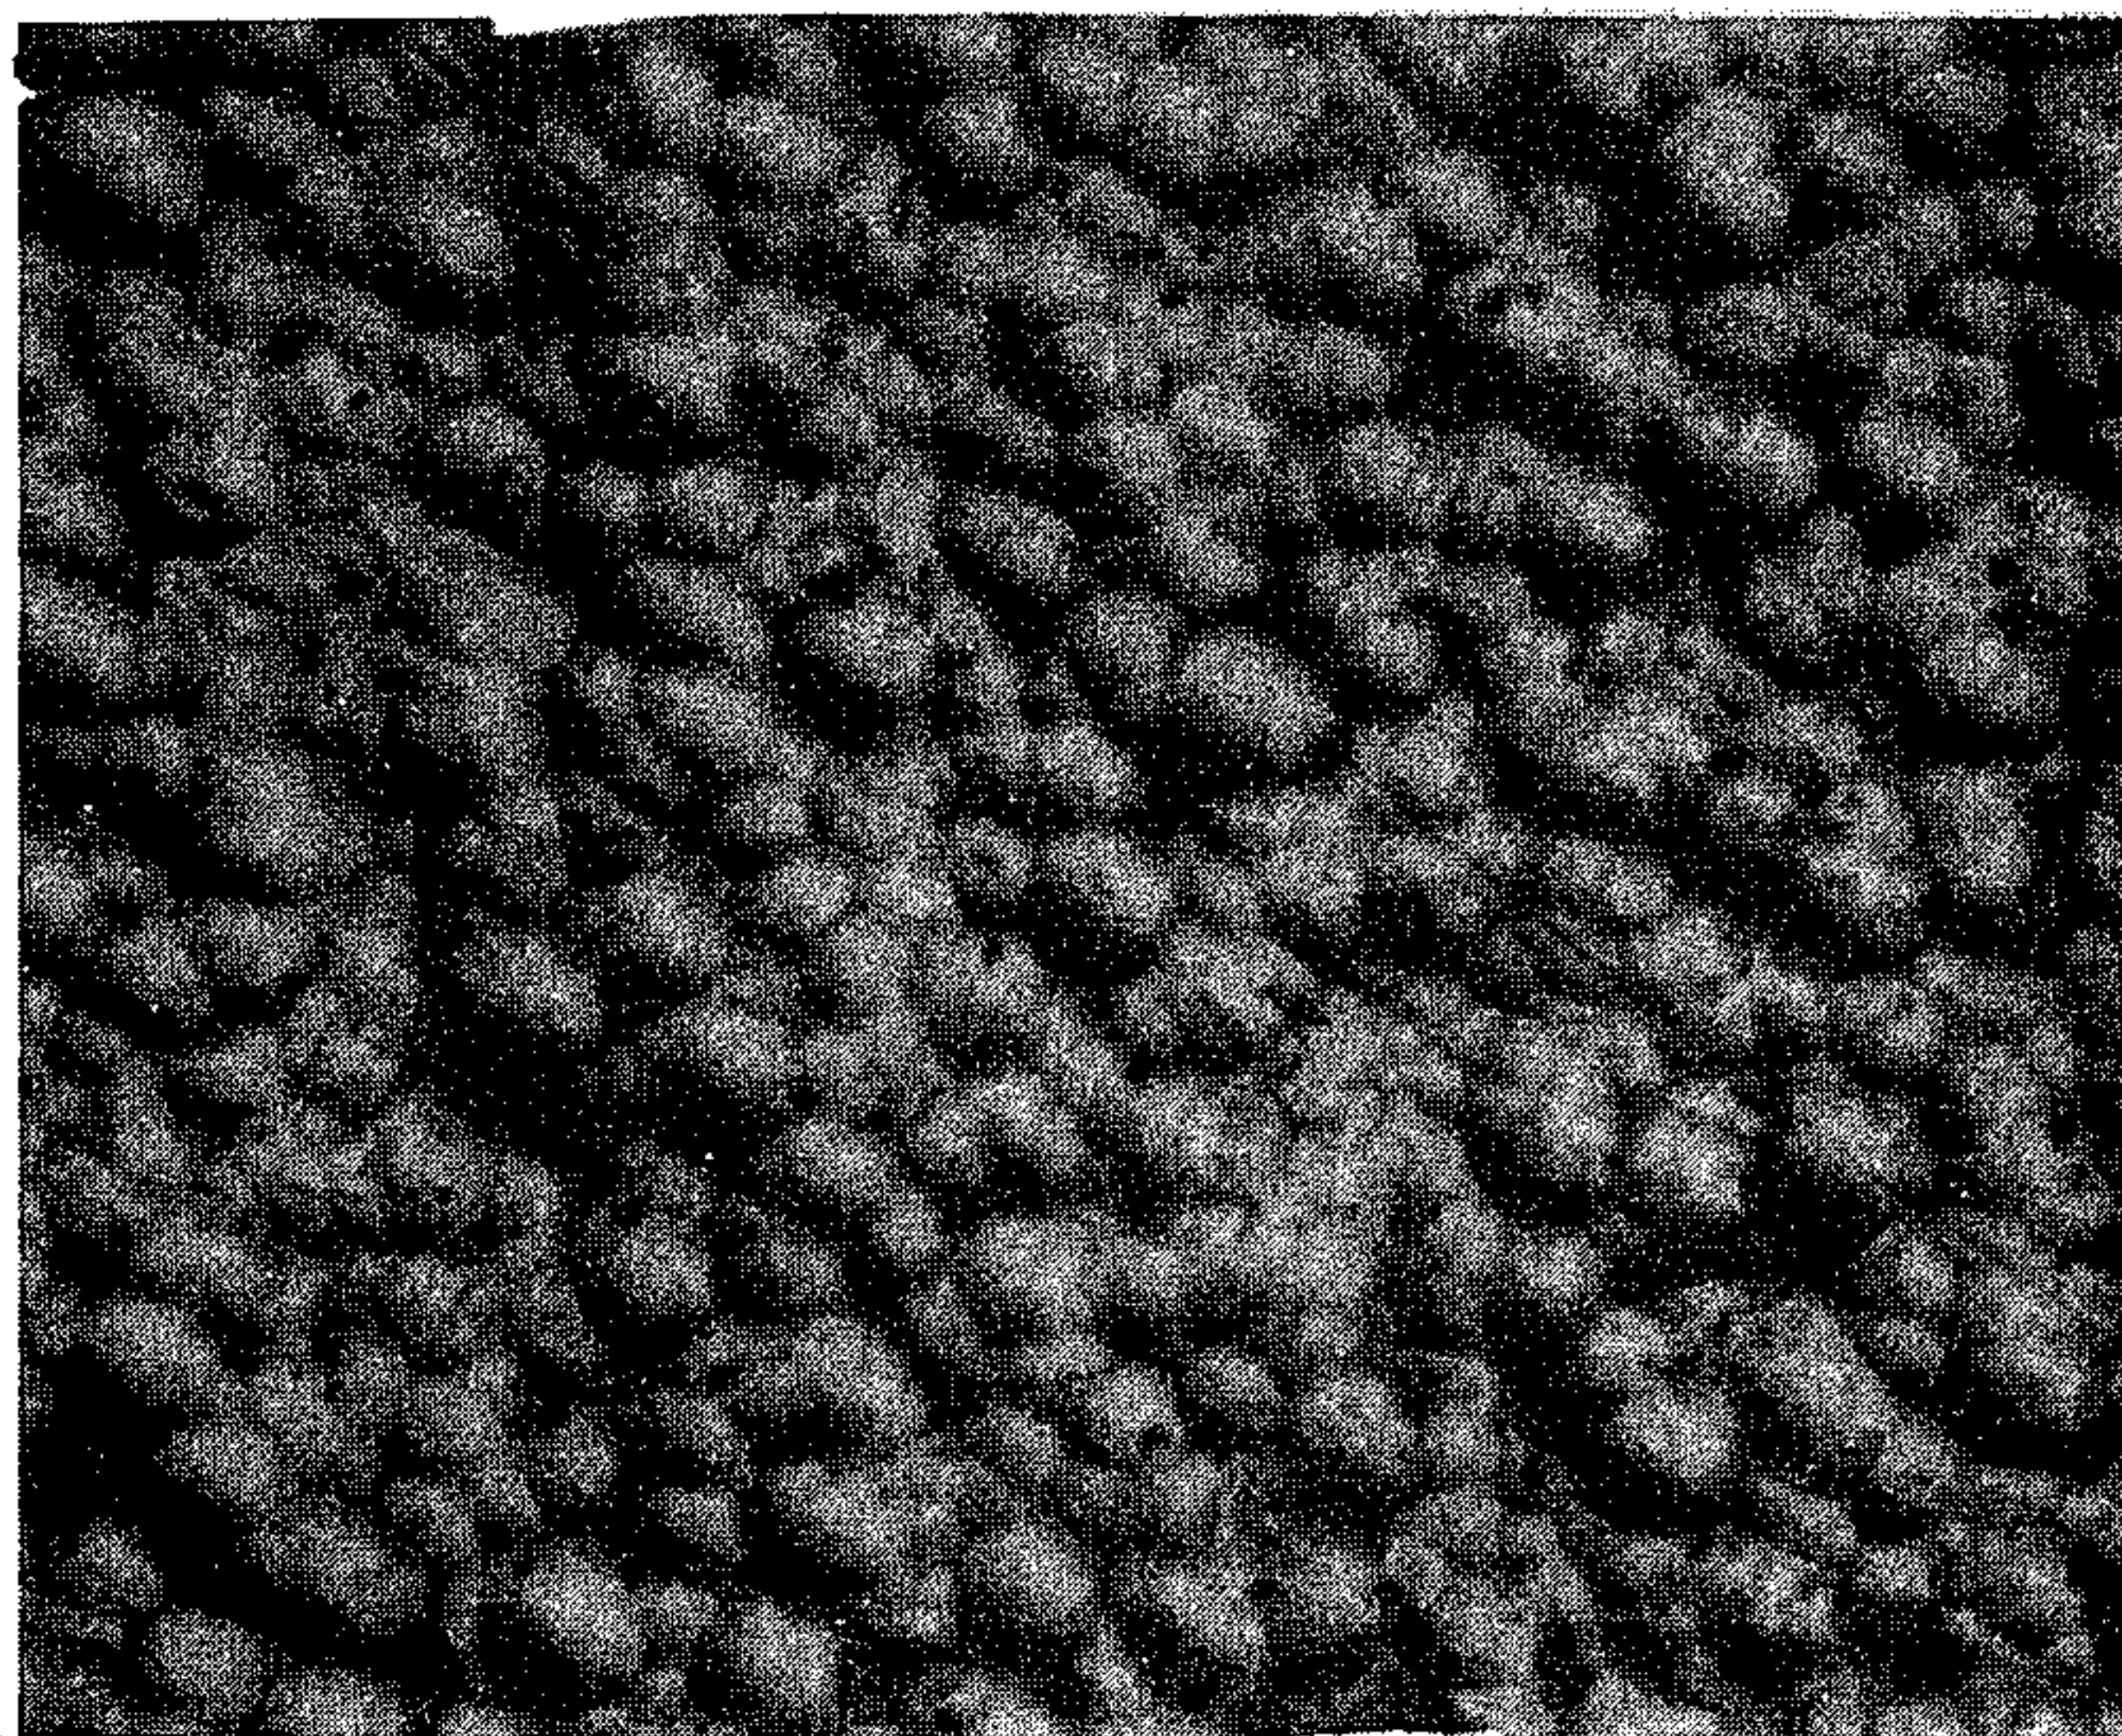
FIG. 6 is the photomicrograph of the $W+W_3C$ coating with the tungsten interlayer at 1,000 magnification on AM-350 stainless steel showing a few interconnected cracks.

The composite coating showed the presence of only a few fine cracks (see FIG. 6). Etched cross section of the coating clearly showed columnar tungsten interlayer followed by non-columnar W + W₃C coating. The composite coating demonstrated superior erosion performance as shown in Table 3.

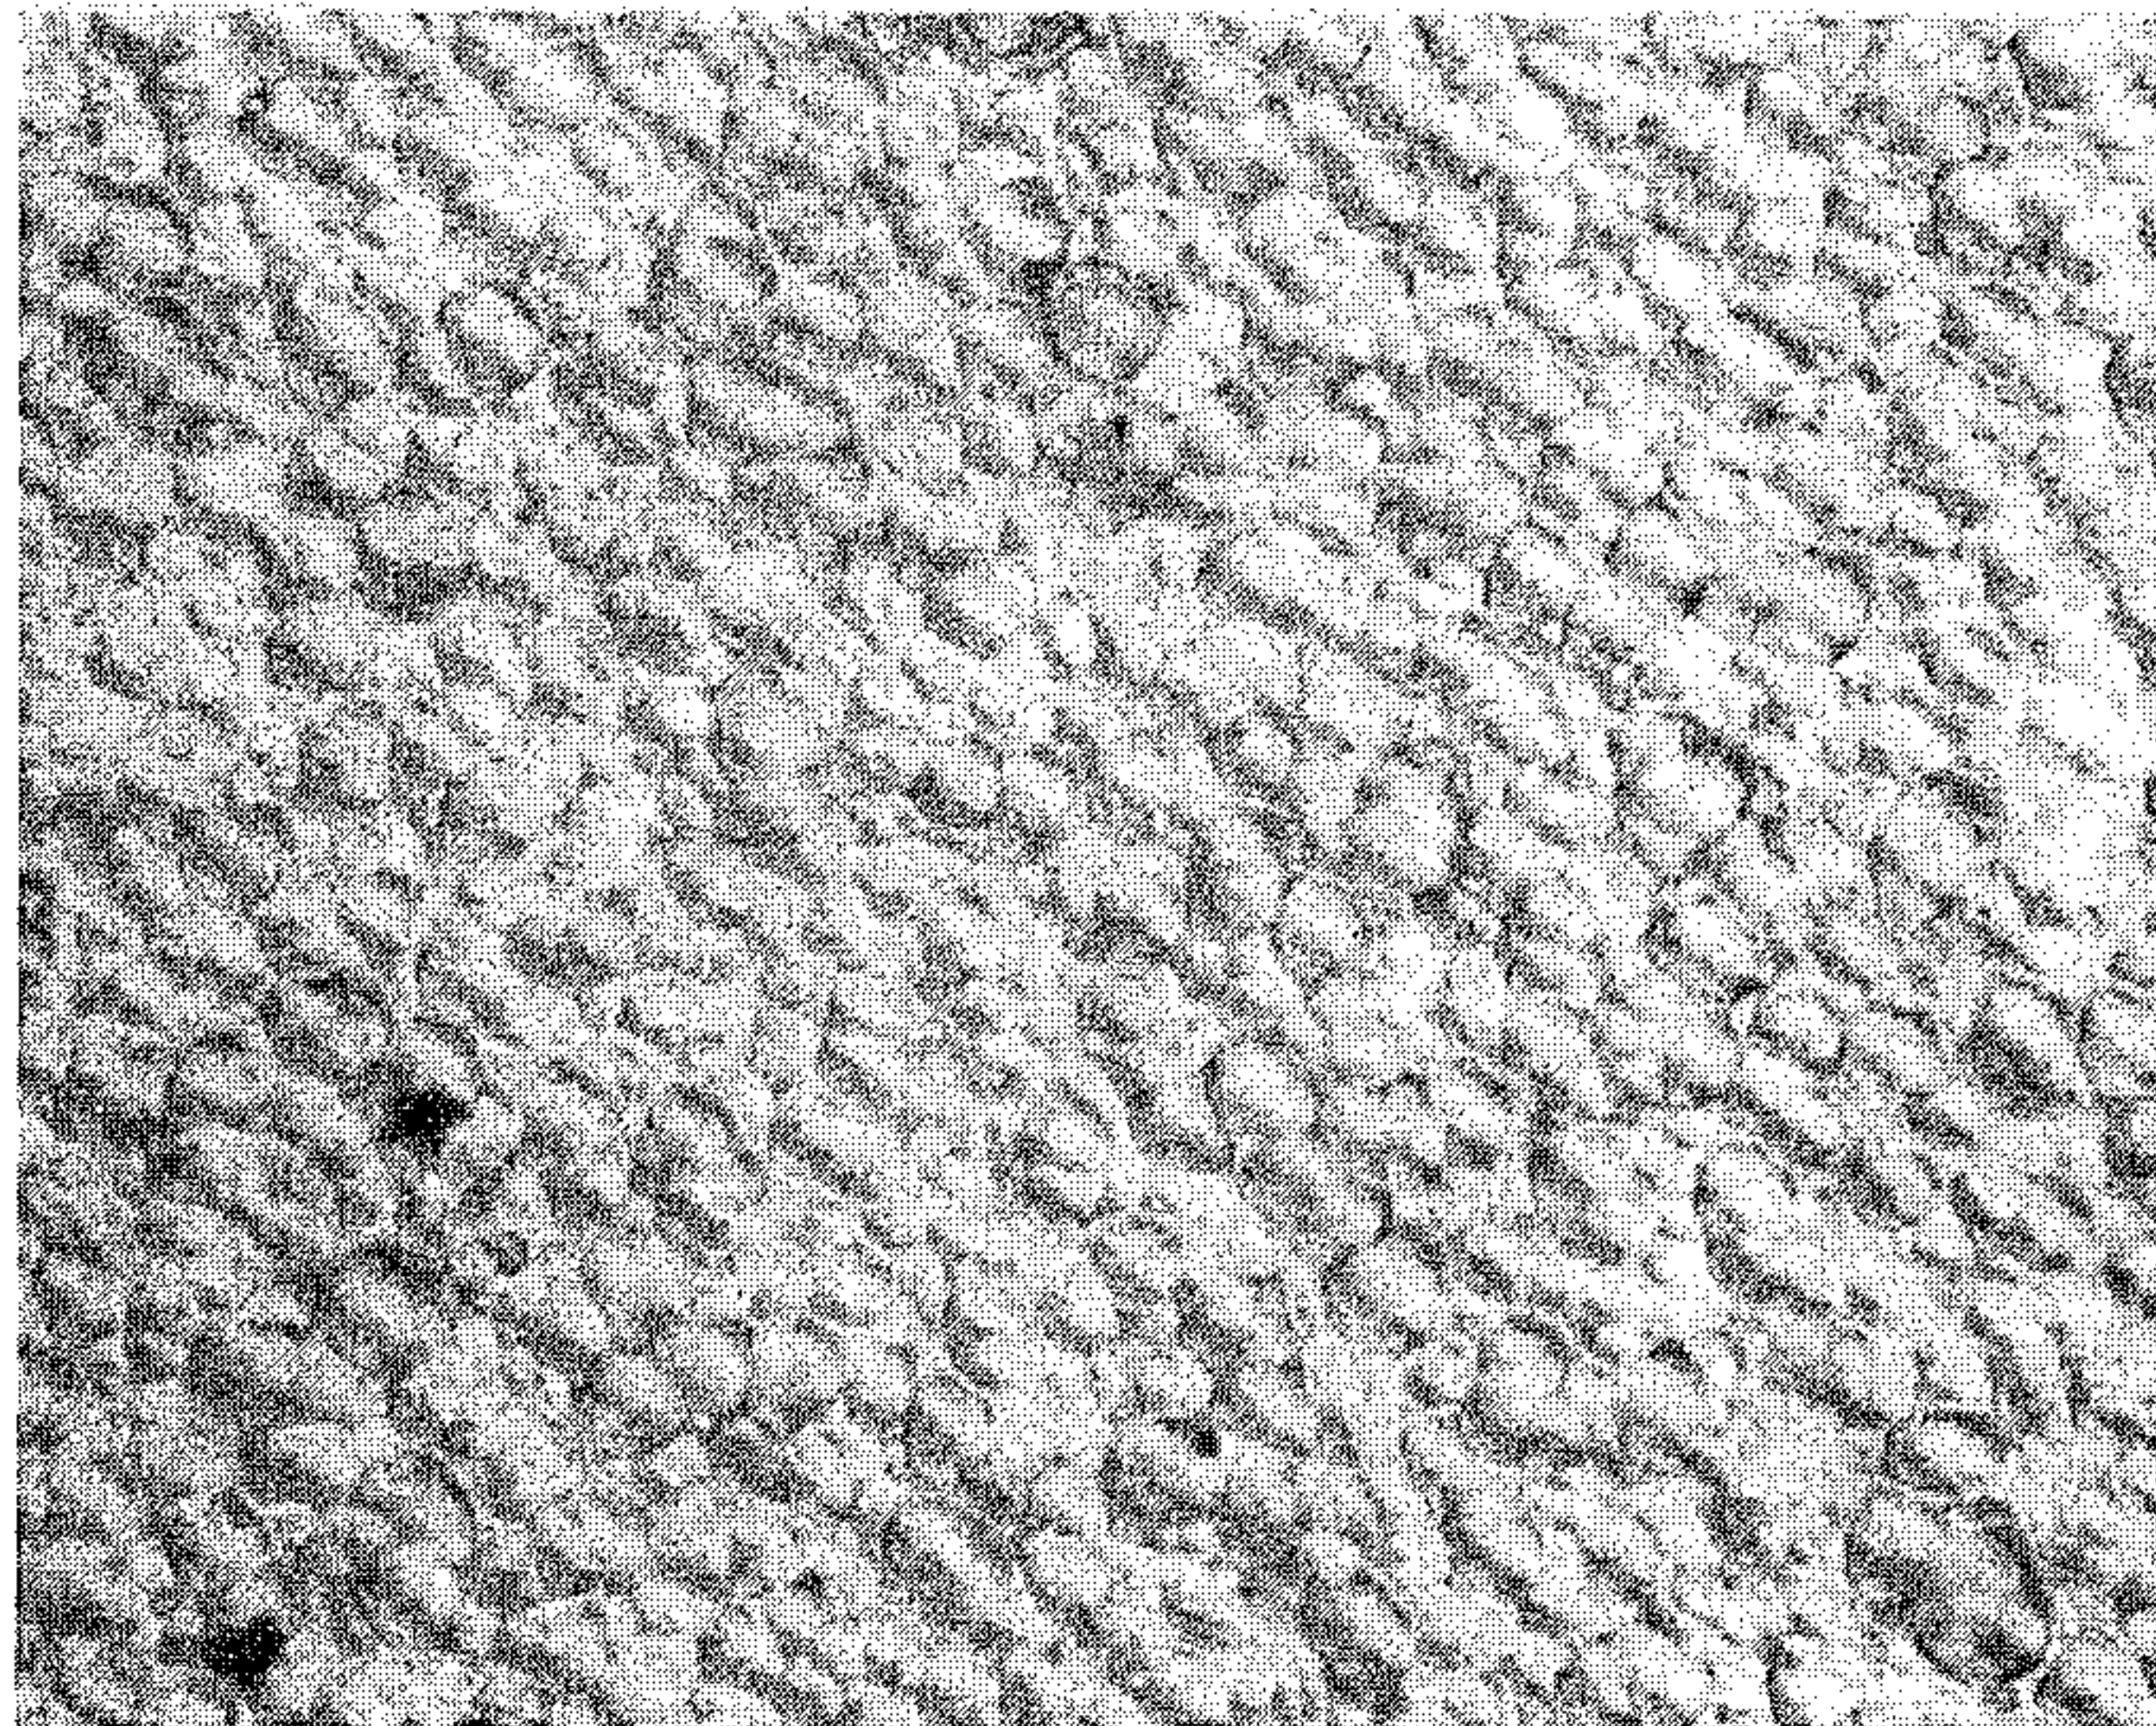
FIG. 7 is the photomicrograph of the $W+W_3C$ coating with the tungsten interlayer at 1,000 magnification on AM-350 stainless steel showing the absence of cracks.

The coating, unexpectedly, was found to be absolutely crack free, as shown in the FIG. 7. The erosion resistance of the coating was comparable to the data noted earlier. Weight loss during erosion test was also comparable to the data noted earlier.
