[54] HIGHLY EROSIIVE AND ABRASIVE WEAR RESISTANT COMPOSITE COATING SYSTEM

[73] Assignee: Air Products and Chemicals, Inc., Allentown, Pa.

[57] ABSTRACT

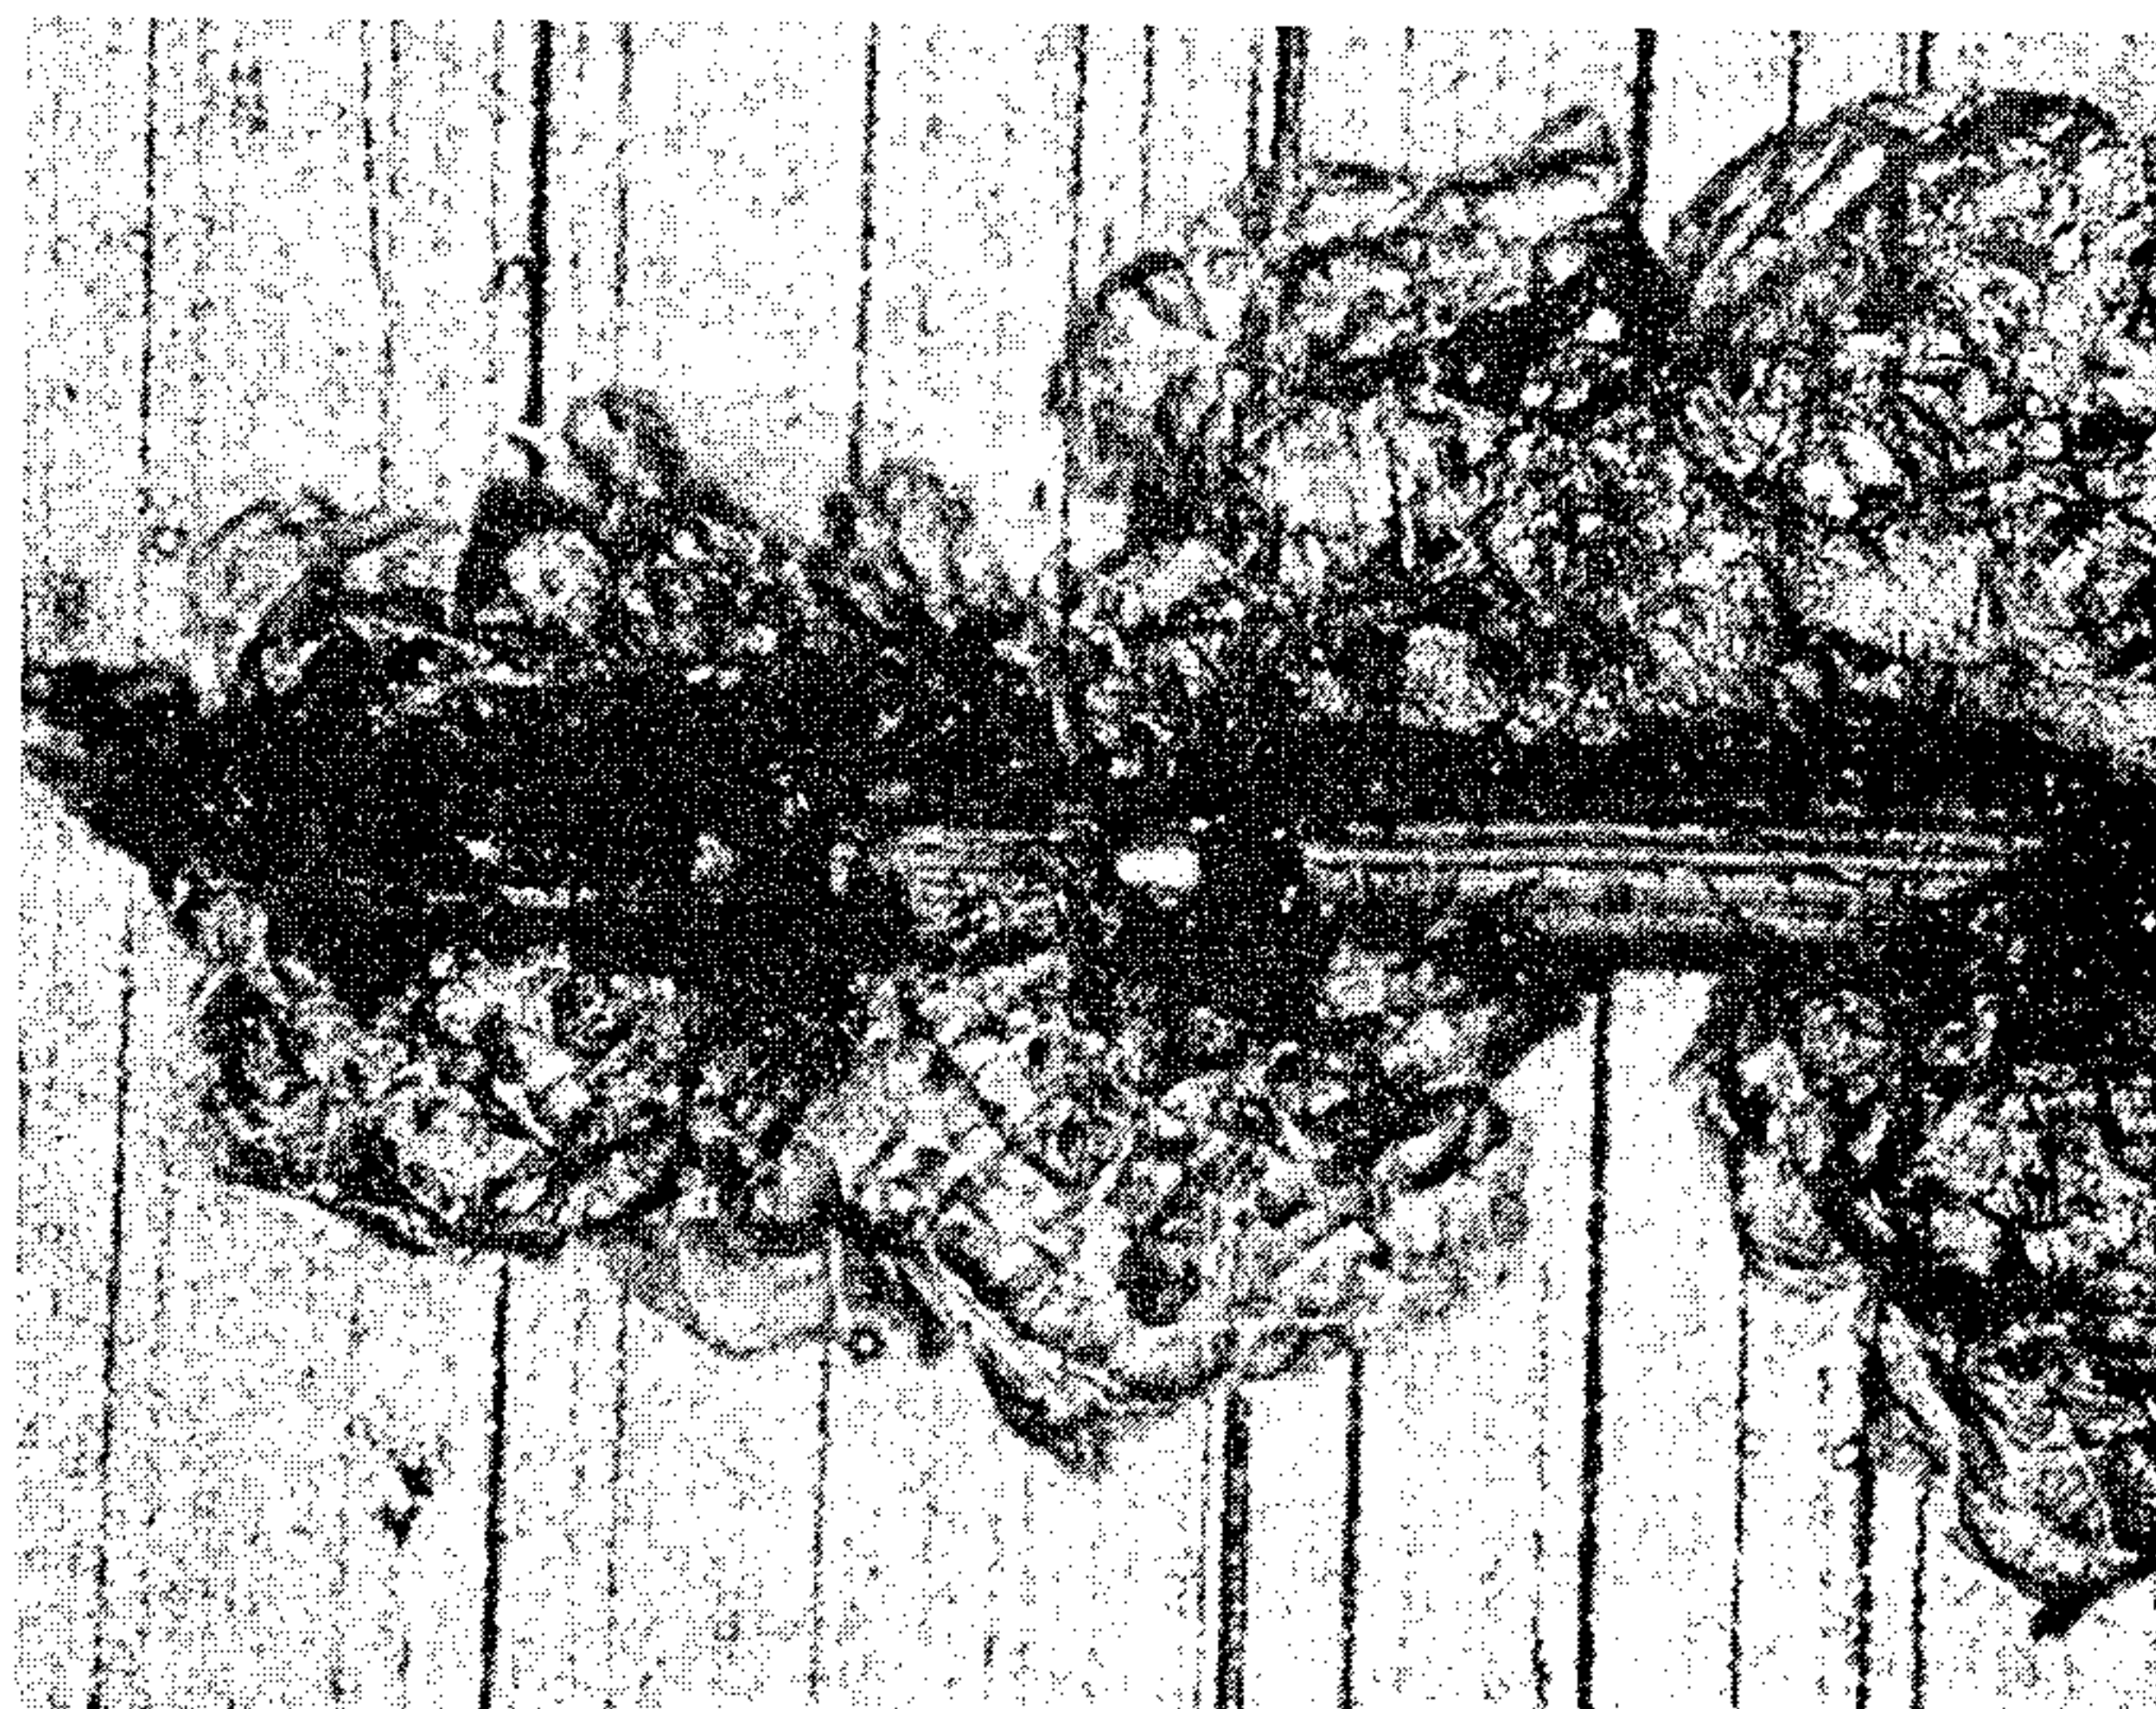
→ INCREASING LOAD

FIG. 8 is the photomicrograph of the surface of W+W₃C coating without the tungsten interlayer on AM-350 stainless steel at 100 magnification, scratched with a diamond stylus and showing significant loss of the coating in the 30-40 Newton load range.

The tungsten interlayer also effects the performance of the tungsten/tungsten carbide coating in a scratch test. In this test, a diamond stylus is dragged across the surface of the sample at a constantly increasing load. The load at which coating loss begins to occur and the extent of coating loss can generally be correlated to the performance of a coating in the erosive and abrasive wear applications. The tungsten/tungsten carbide coating with no tungsten interlayer as described in Example 3 showed extensive coating loss in the 30-40 Newton load range in the scratch test, as shown in the FIG. 8. When a tungsten interlayer is present as described in Example 4E, the loss of the coating in the same load range is significantly reduced, as demonstrated in the

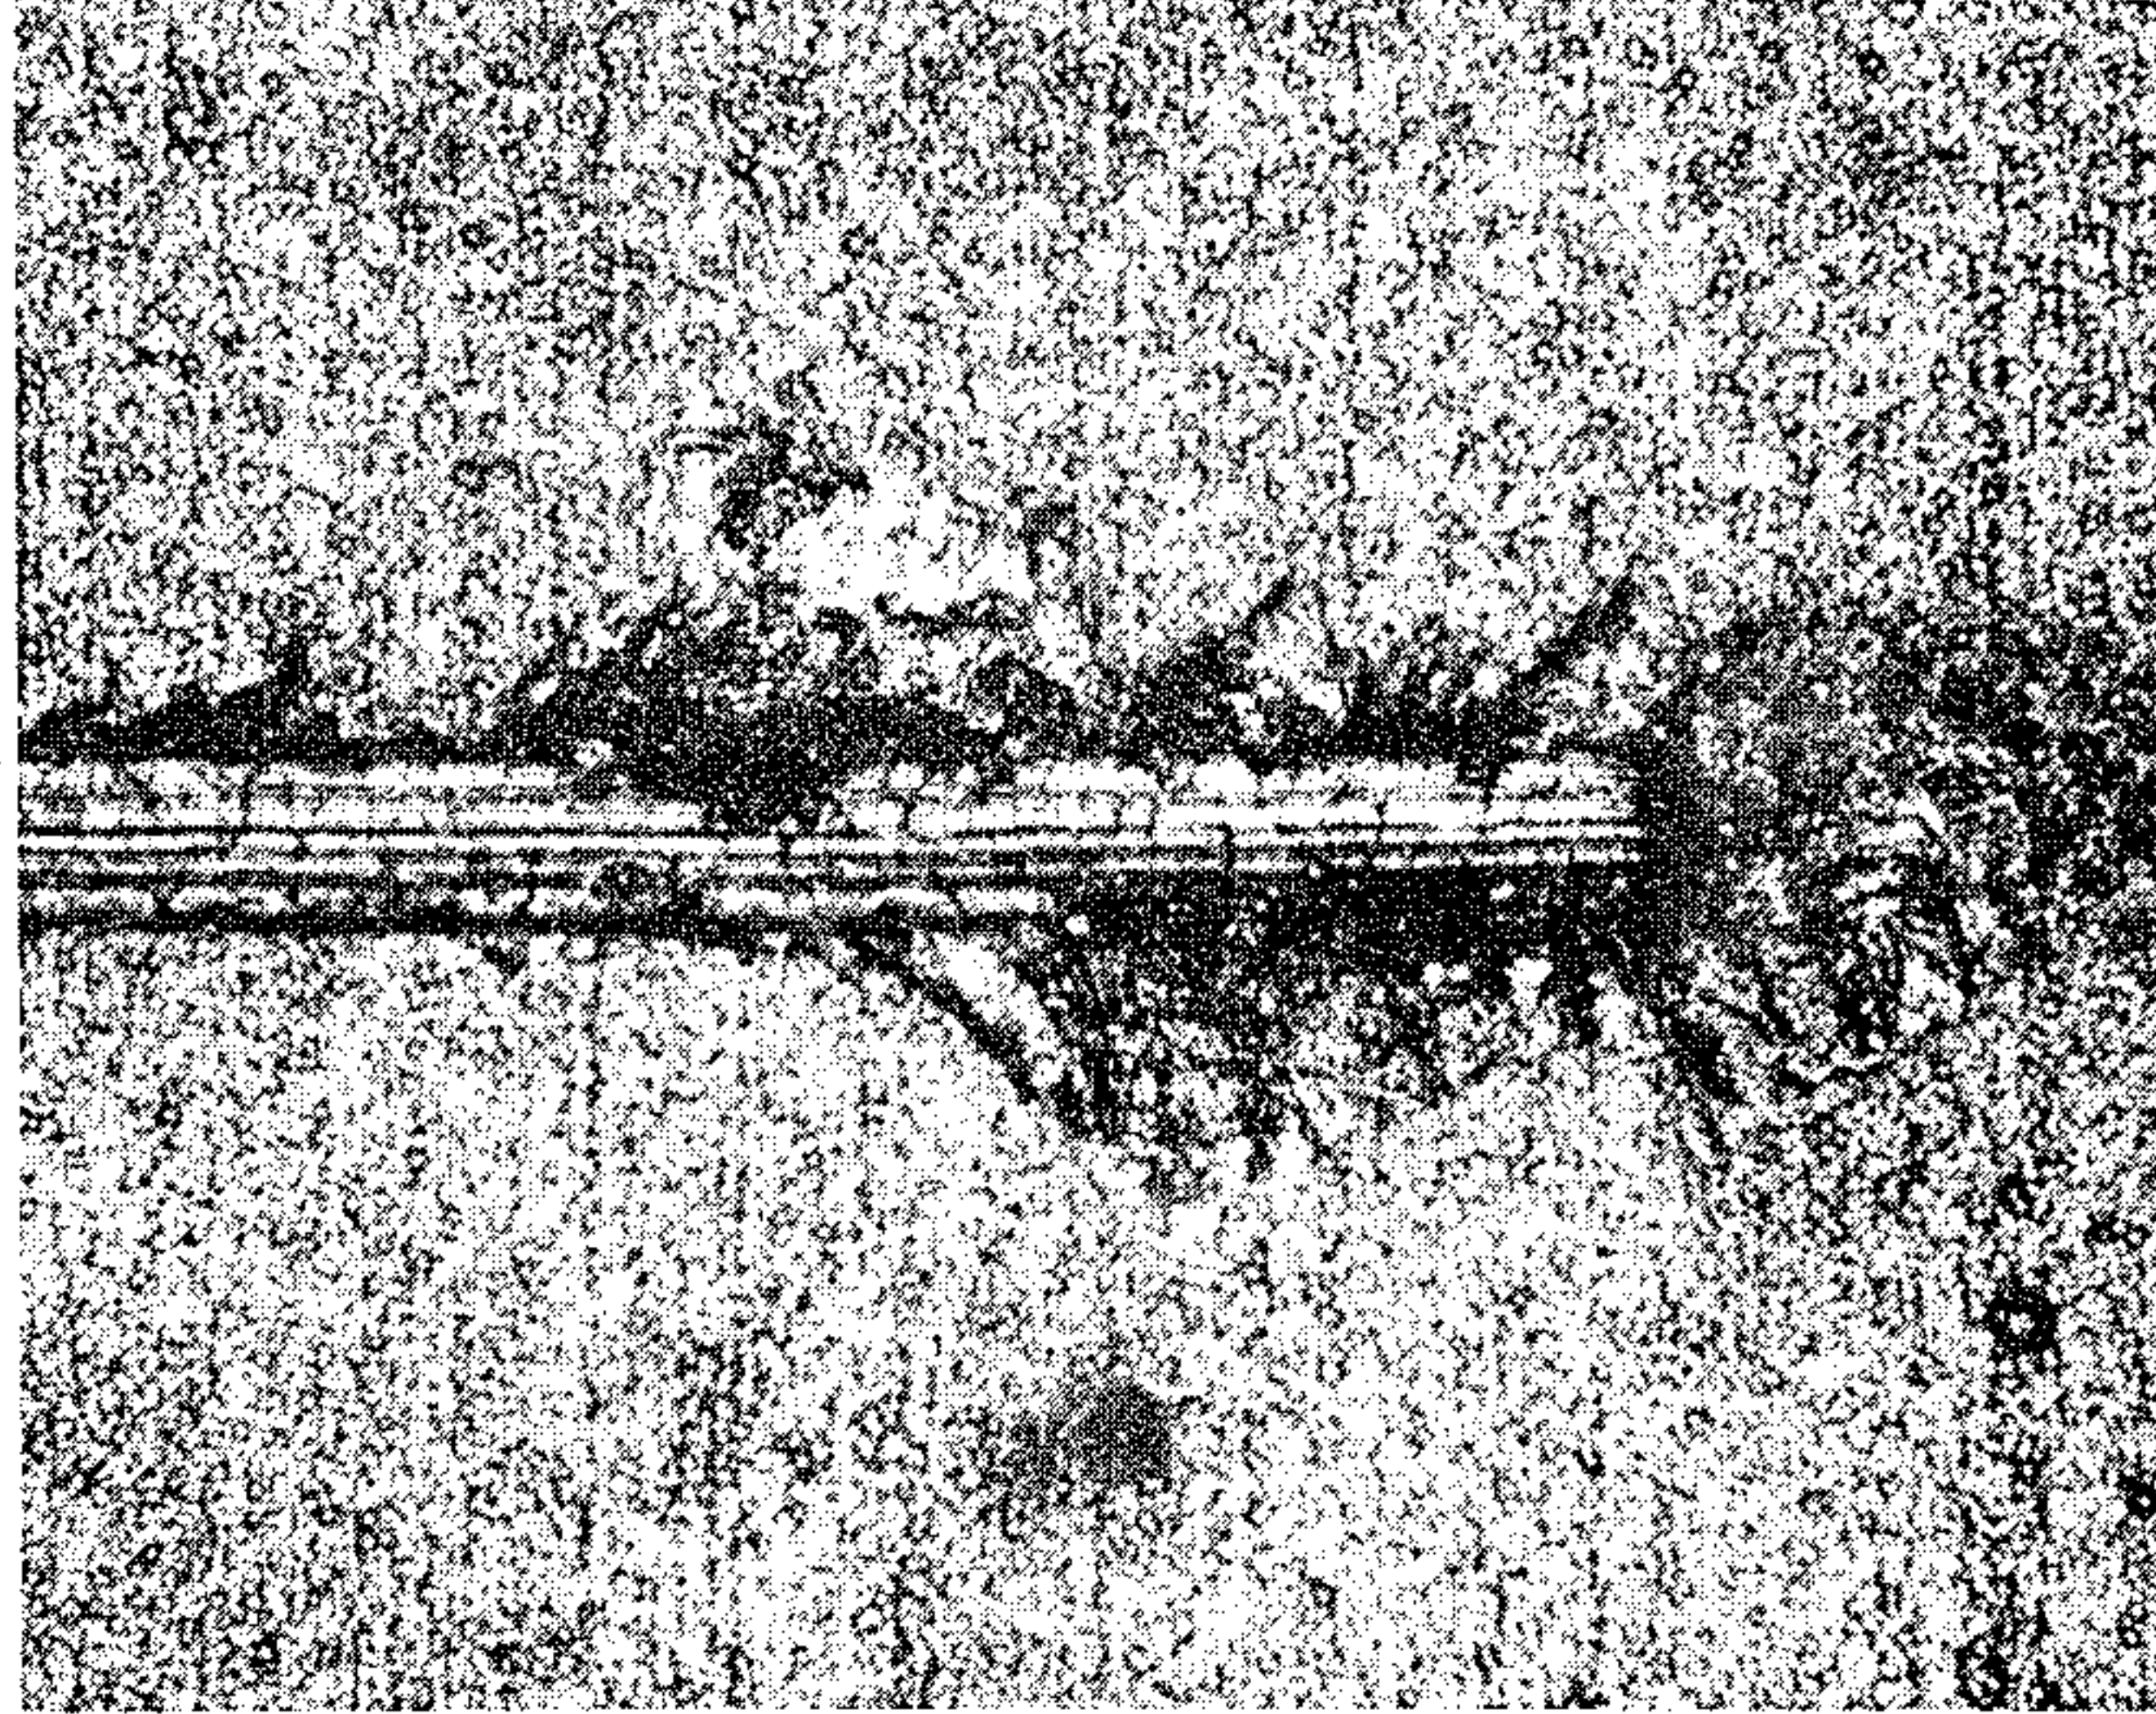
→ INCREASING LOAD

FIG. 9 is the photomicrograph of the surface of W+W₃C coating with the tungsten interlayer on AM-350 stainless steel at 100 magnification, scratched with a diamond stylus and showing significantly reduced loss of the coating in the 30-40 Newton load range.

FIG. 9; consequently, the presence of a tungsten interlayer is important for erosive and abrasive wear applications.

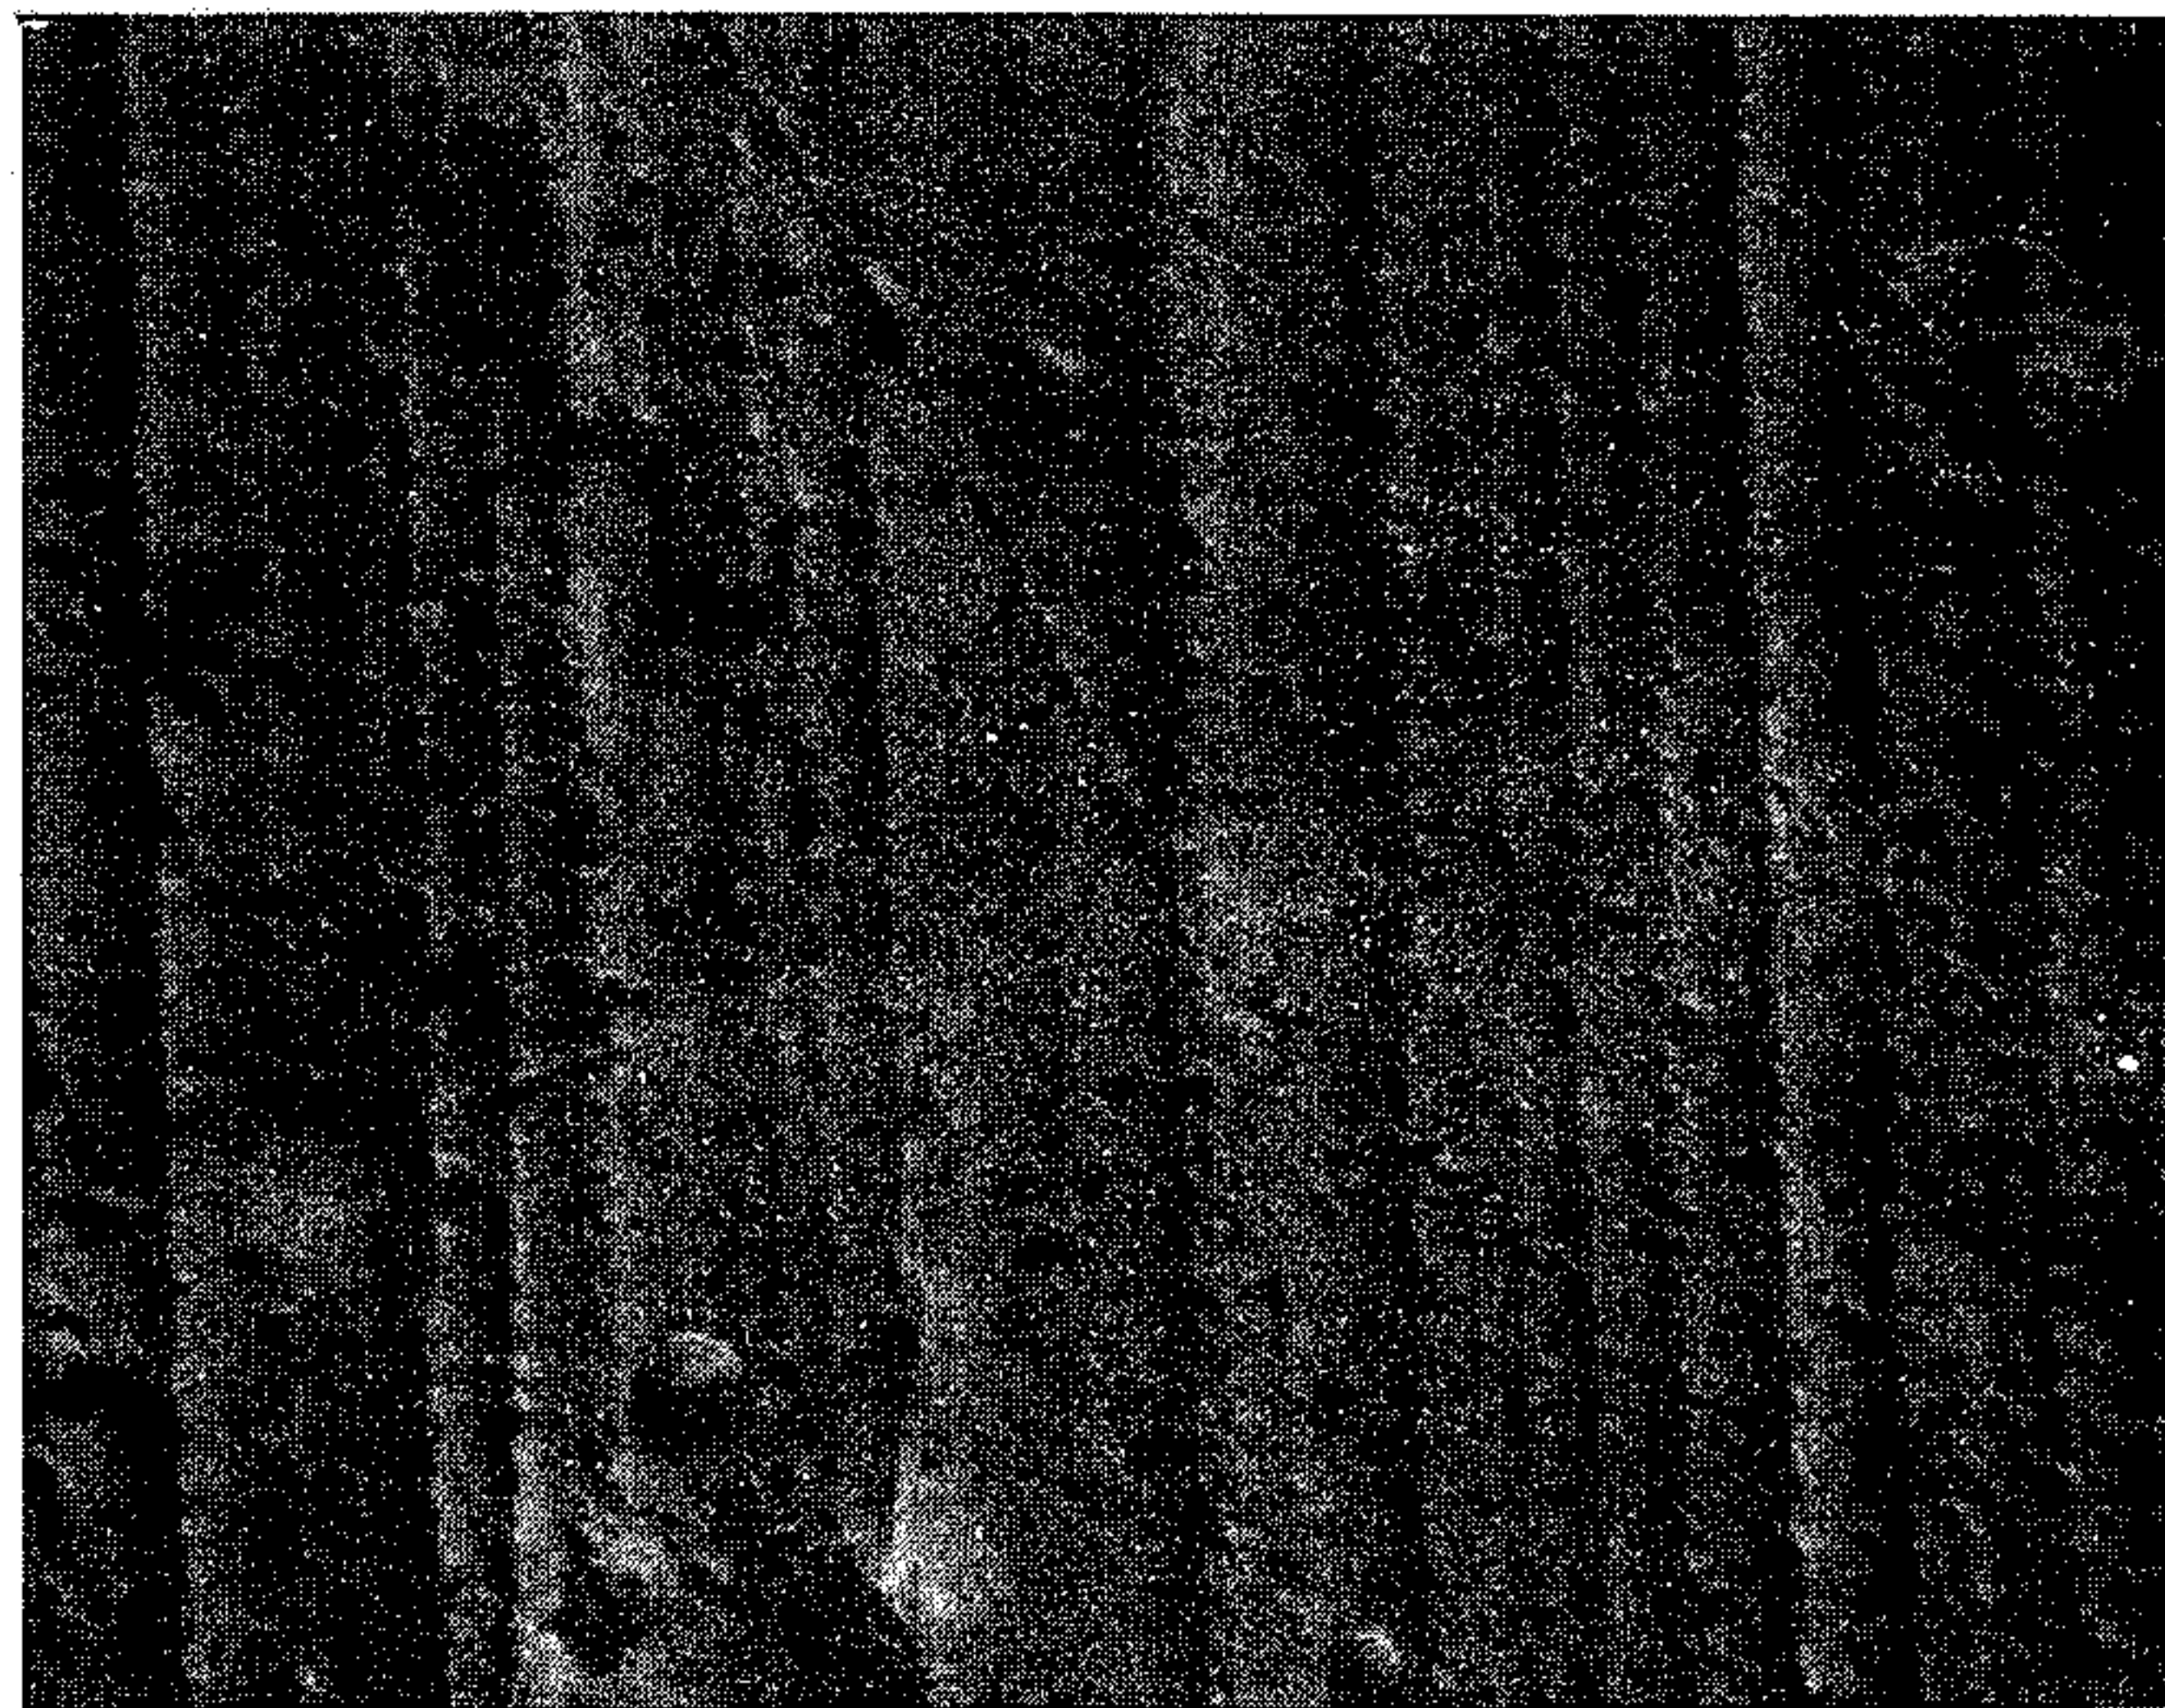
FIG. 10 is the photomicrograph of the W+W₂C+W₃C coating without the tungsten interlayer on AM-350 stainless steel at 1,000 magnification showing a network of cracks.

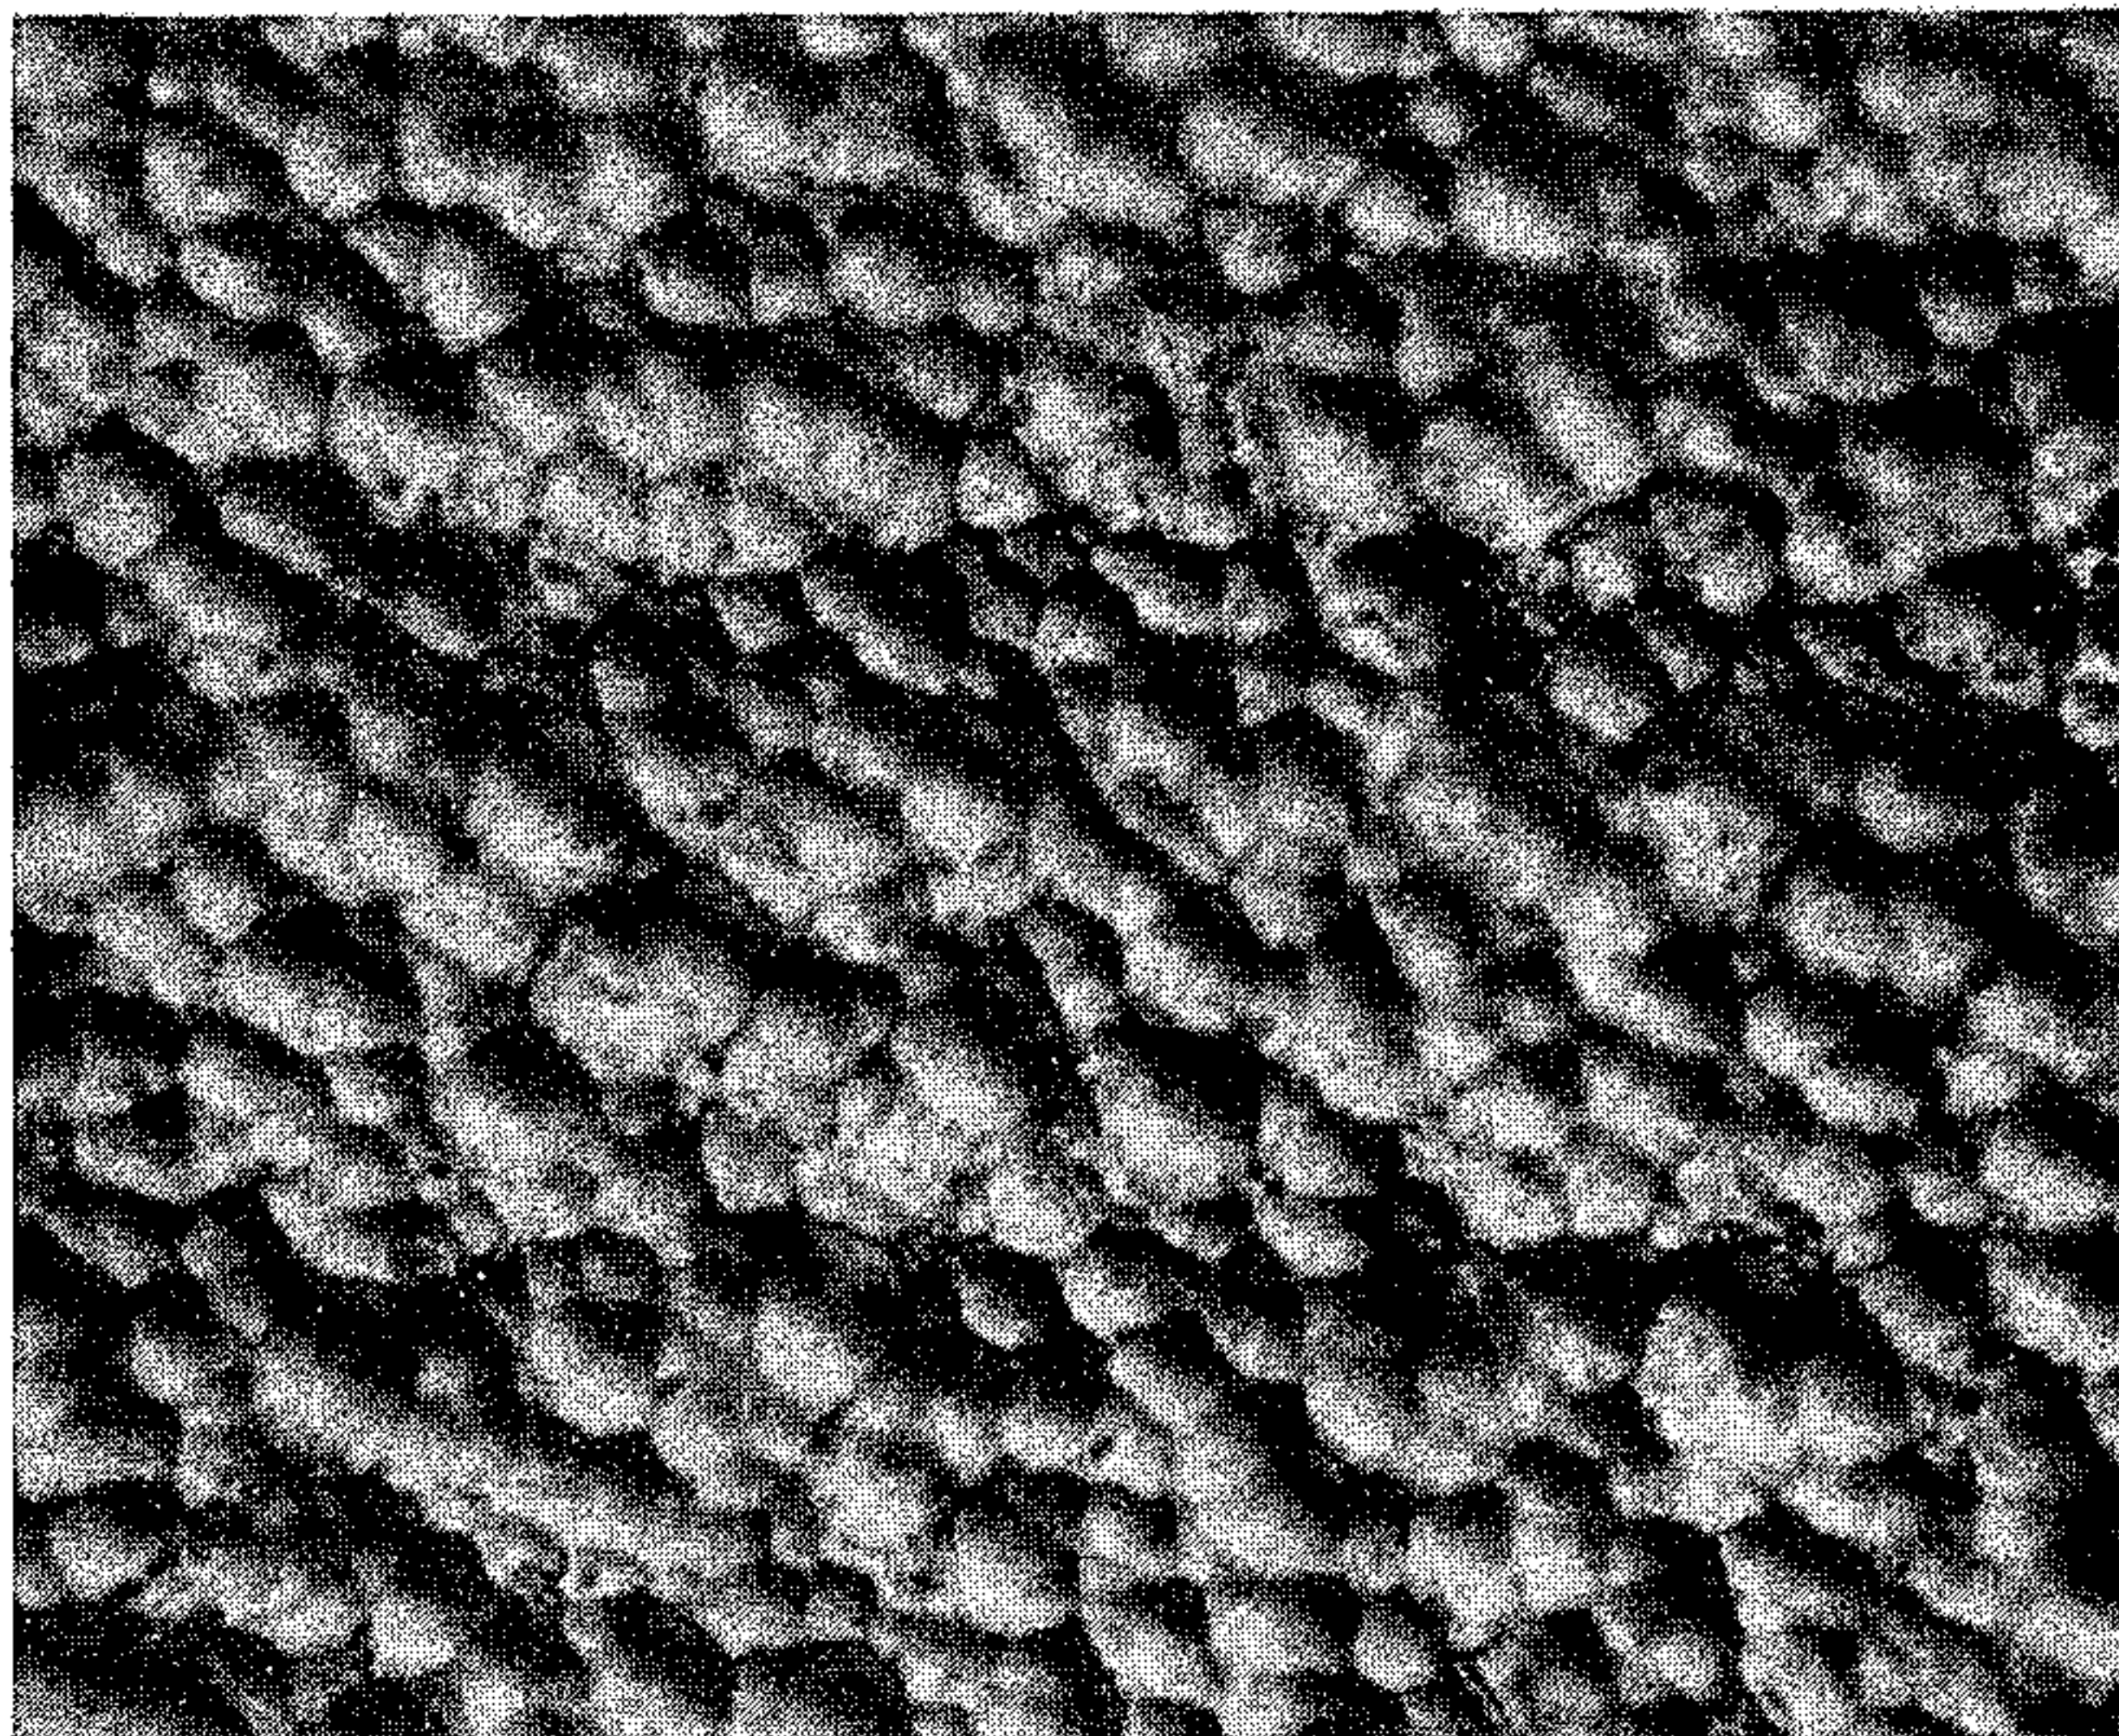
FIG. 11 is the photomicrograph of the W+W₂C+W₃C coating with the tungsten interlayer on AM-350 stainless steel at 1,000 magnification showing the absence of cracks.

Surprisingly, coatings obtained in these examples were crack-free; a photomicrograph of the crack-free coating obtained in Example 6H is shown in the FIG. 11. These examples exhibited columnar structure of W layer and non-columnar structure of tungsten/tungsten carbide layer. The weight loss during the erosion test of coating in Example 6I was very similar to that noted in Example 6A, but it was considerably lower than noted in Examples 5A and 5B. These examples indicated that a crack-free coating could be obtained by limiting the thickness of the tungsten/tungsten carbide layer to

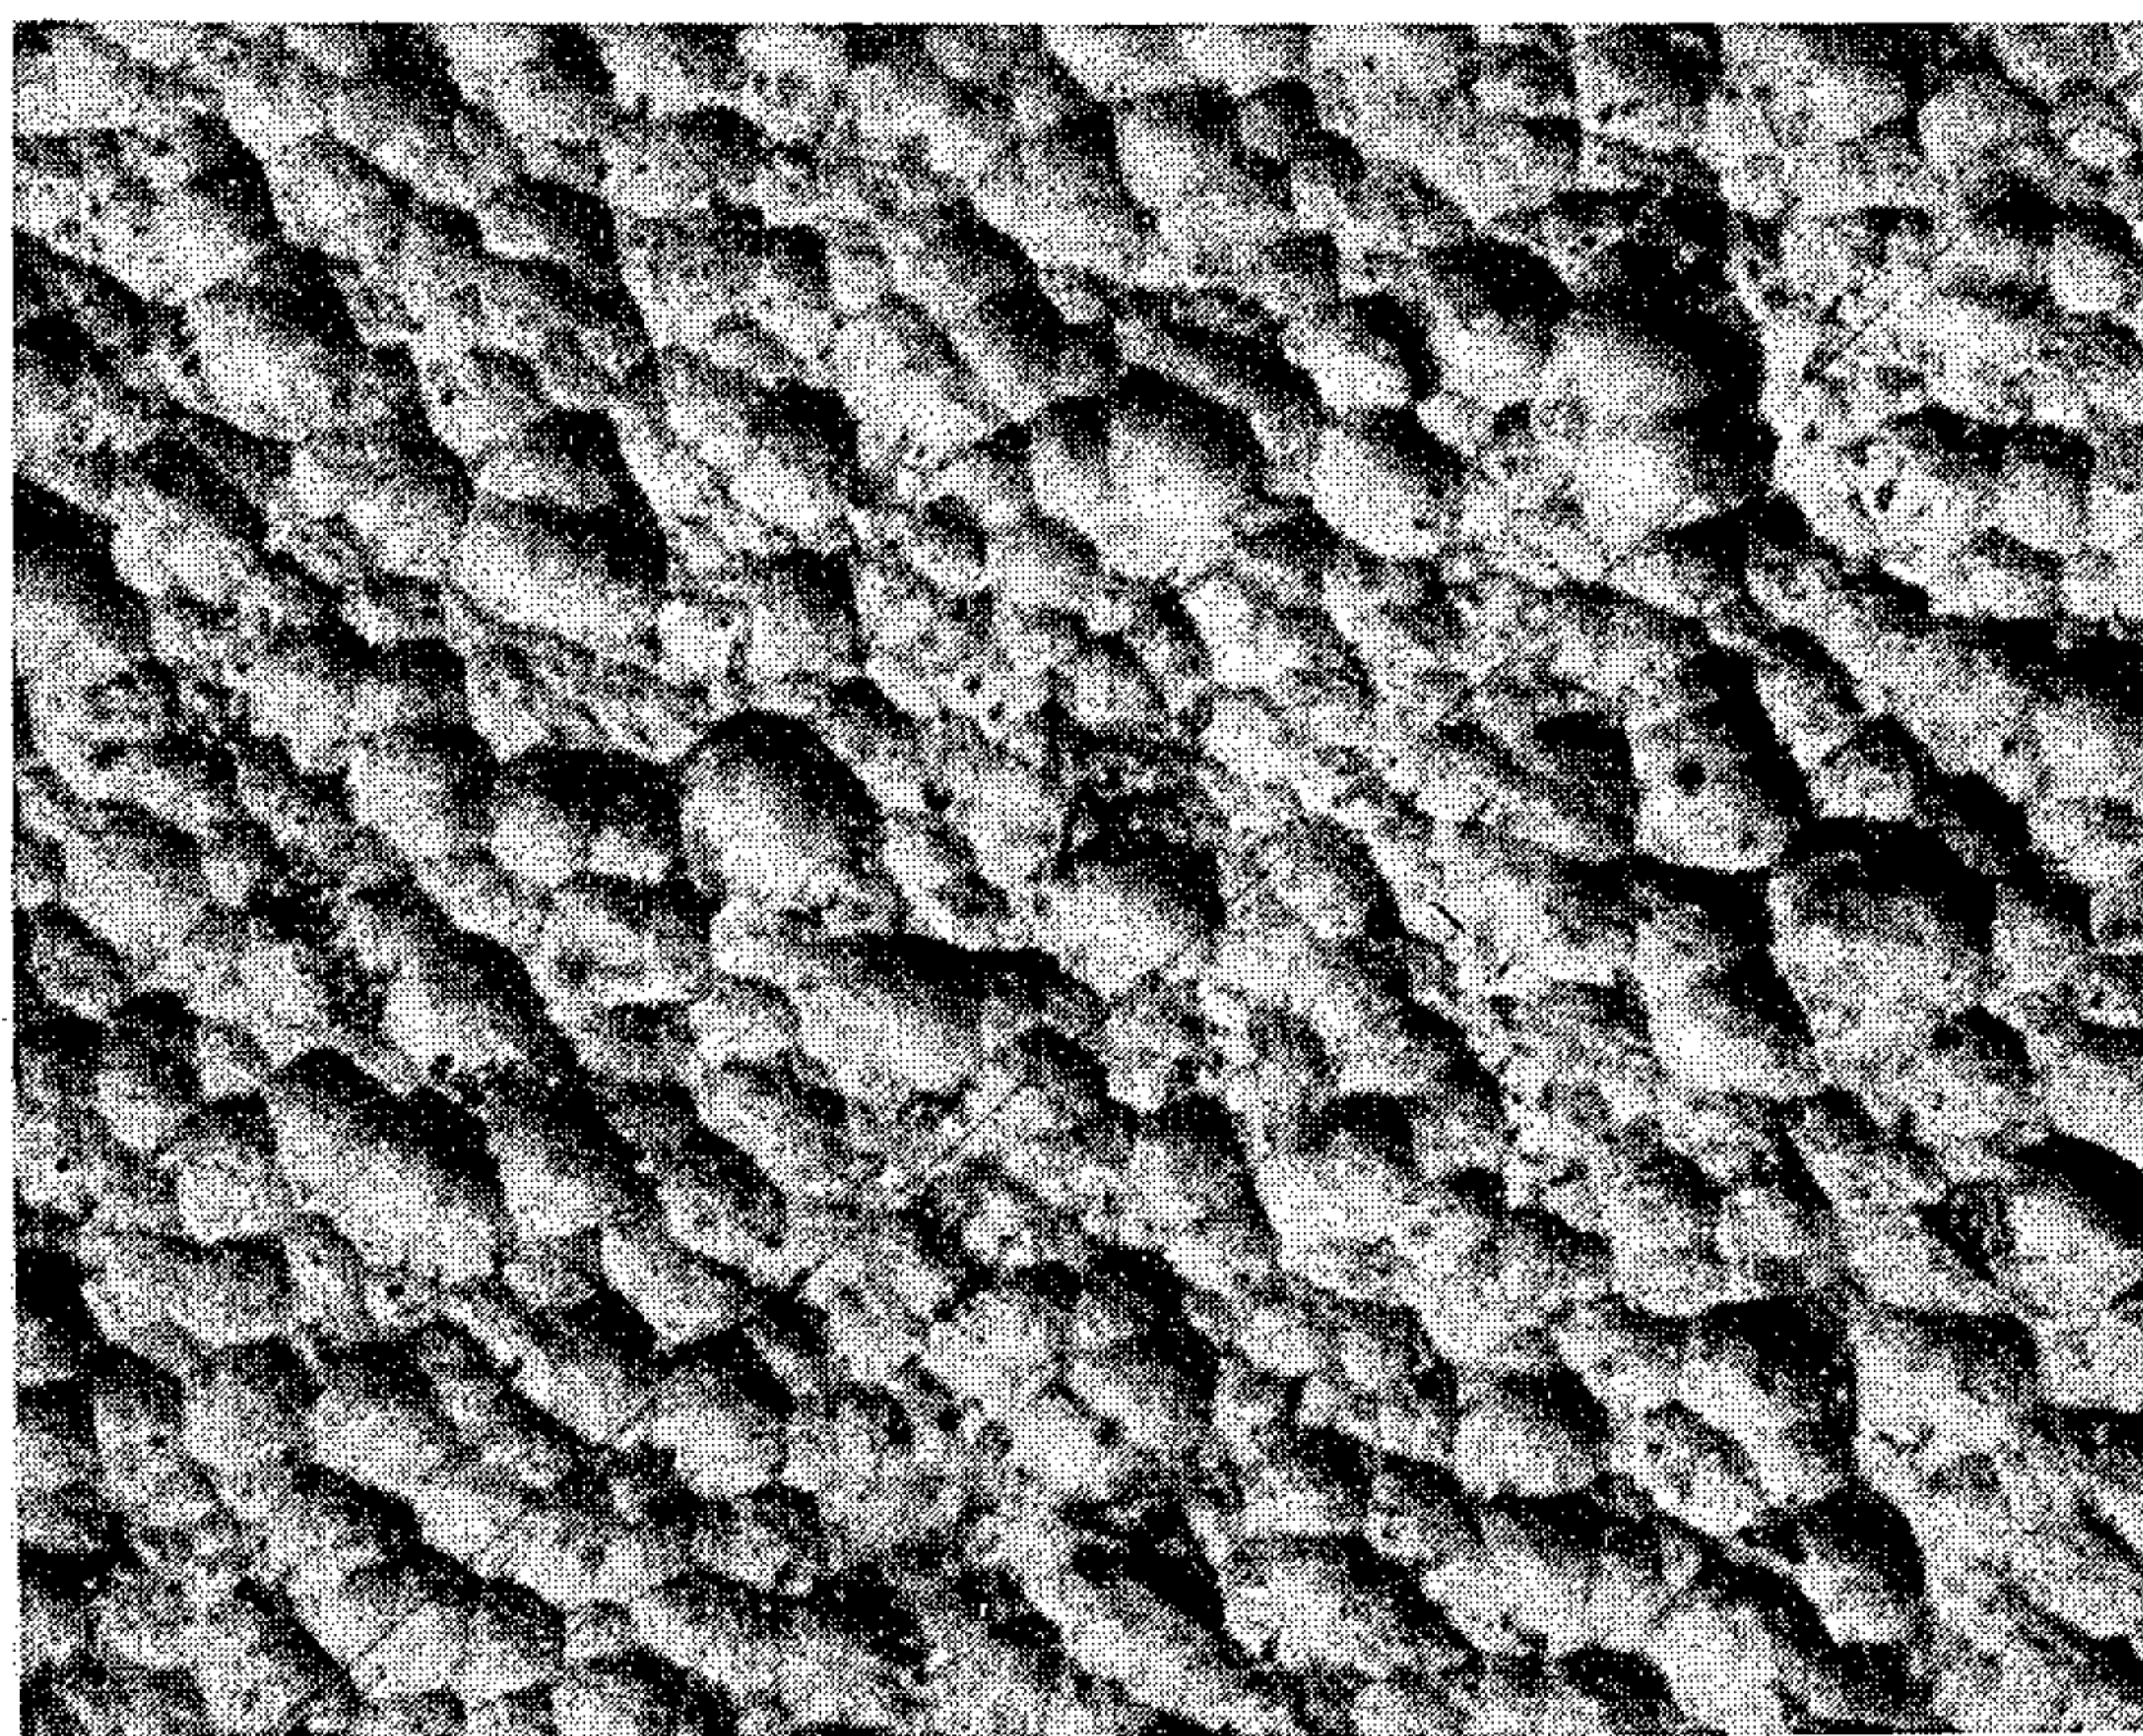
FIG. 12 is the photomicrograph of the W+W₂C coating with the tungsten interlayer on AM-350 stainless steel at 1,000 magnification showing the presence of a fine crack.

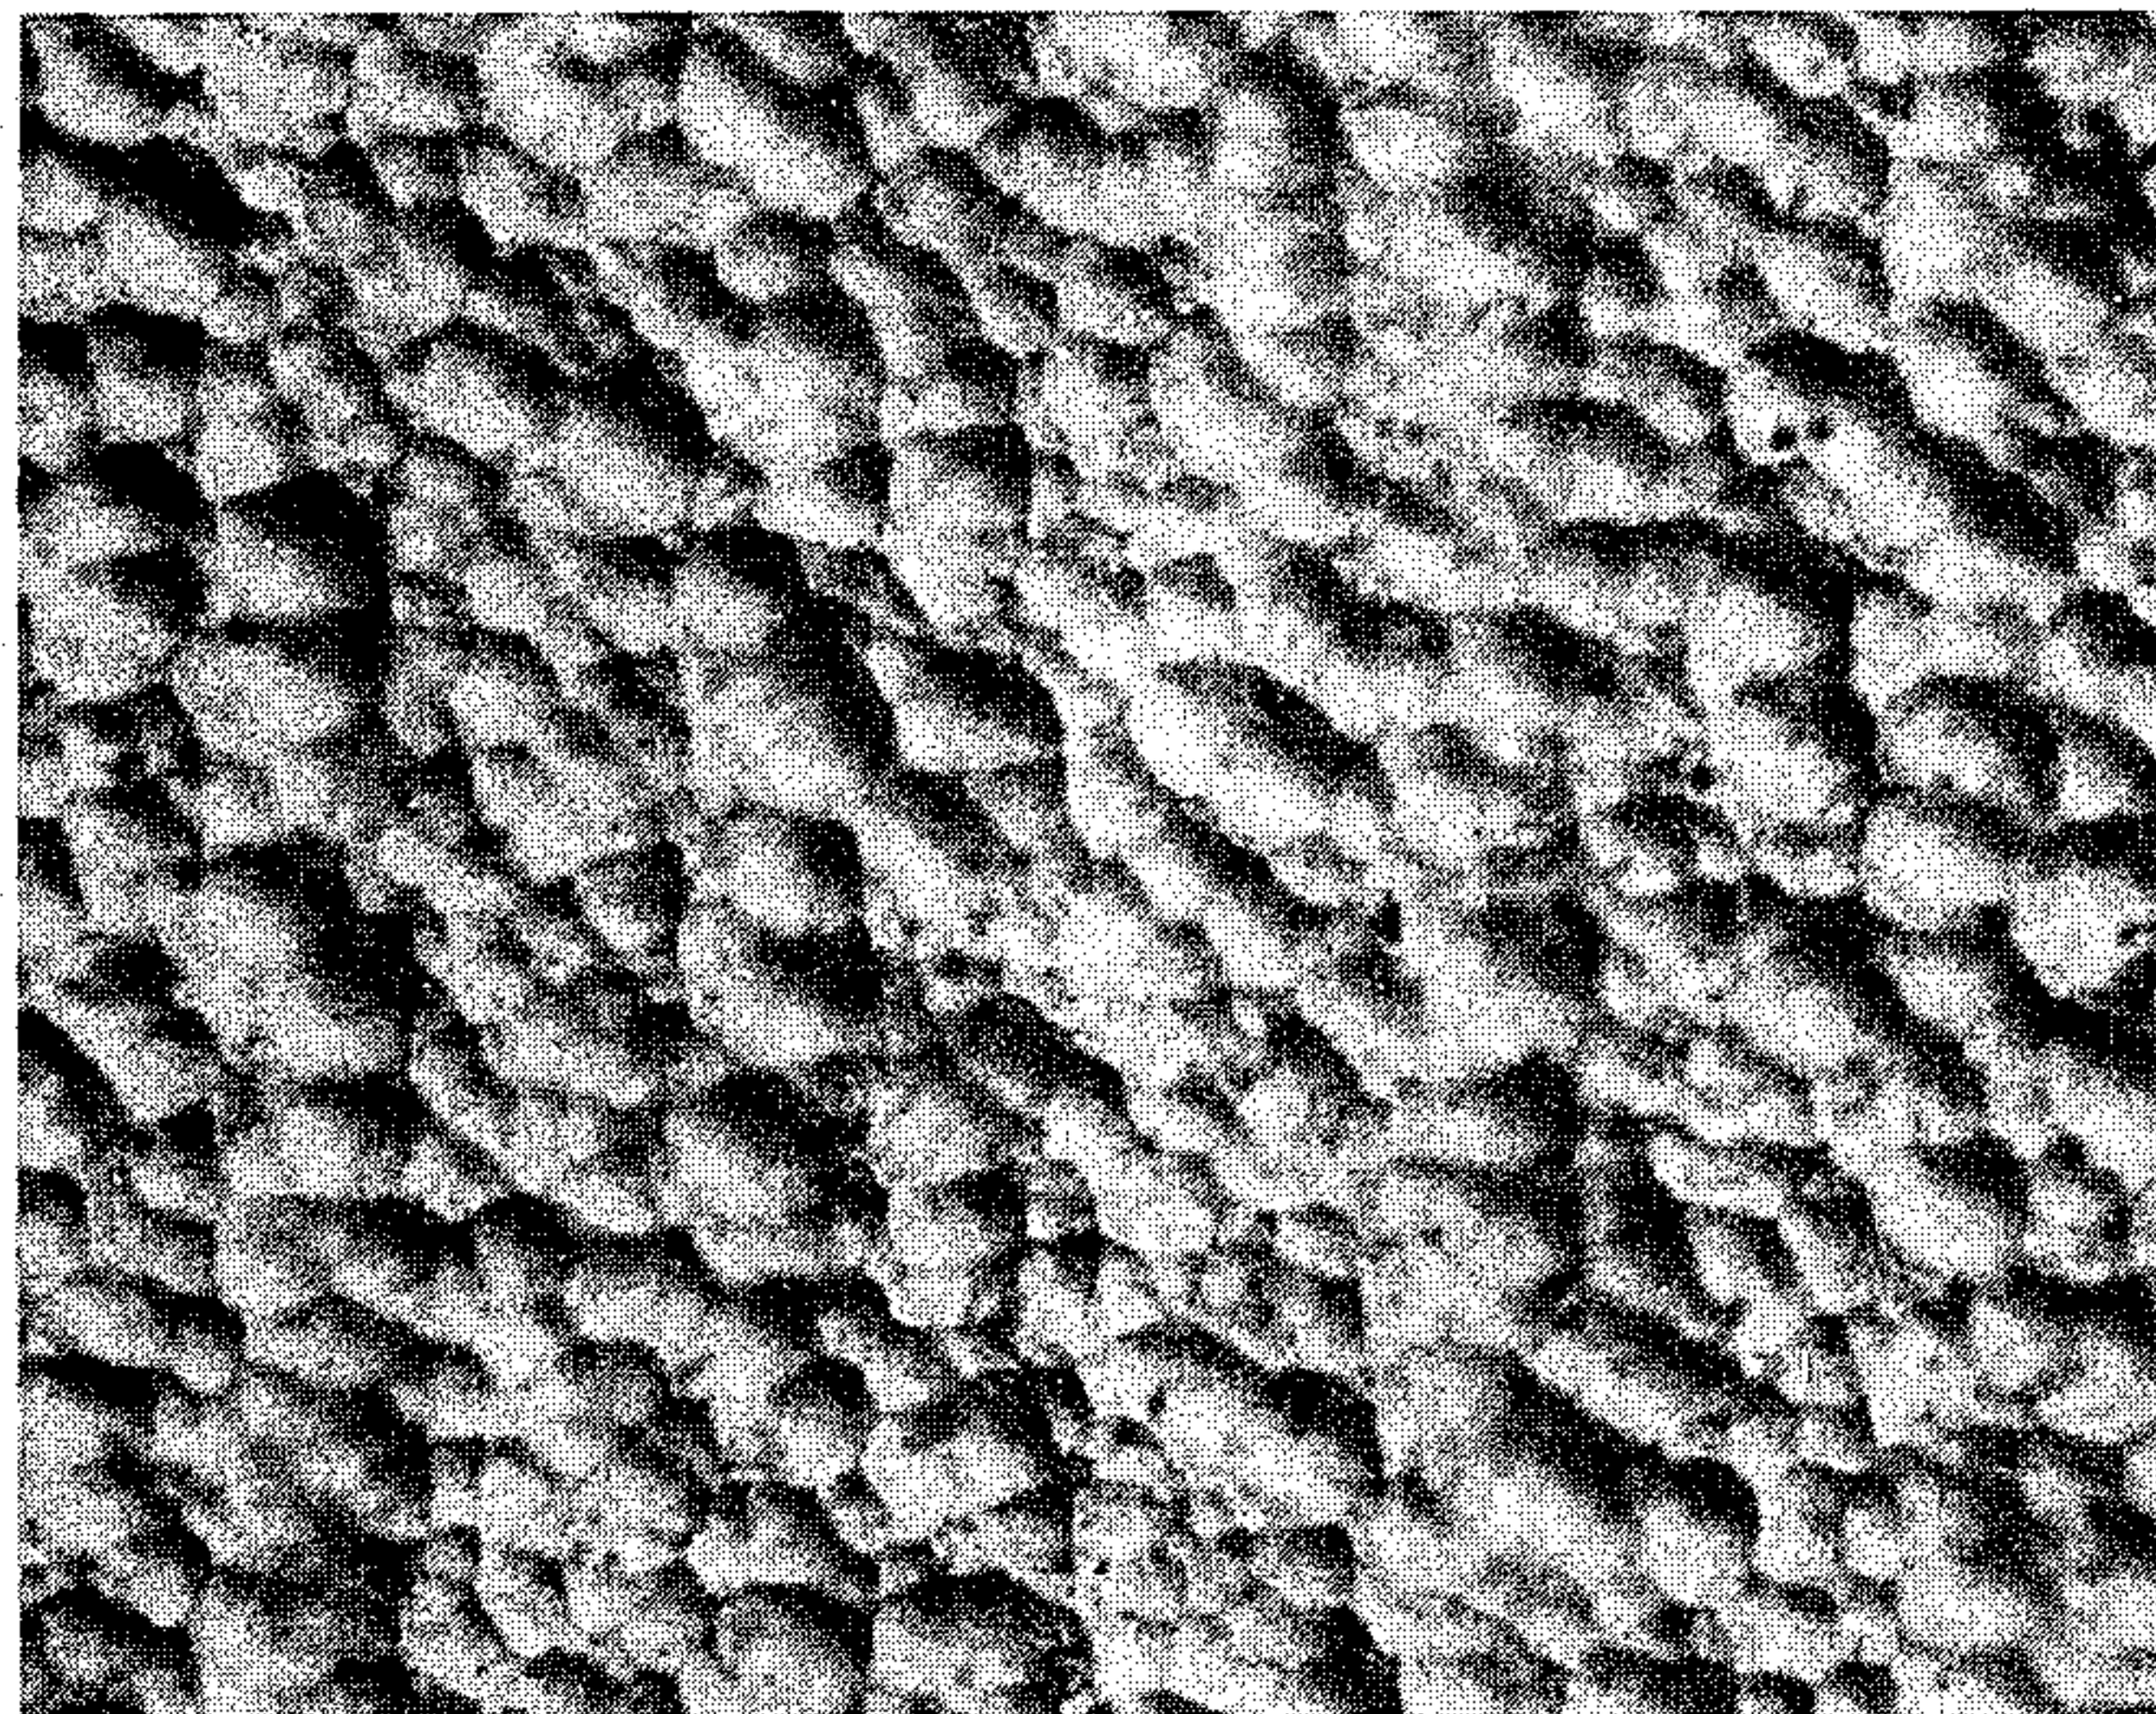
FIG. 13 is the photomicrograph of the W+W₂C coating with the tungsten interlayer on AM-350 stainless steel at 1,000 magnification showing the absence of cracks.
