[54] HIGHLY EROSIIVE AND ABRASIVE WEAR RESISTANT COMPOSITE COATING SYSTEM

[73] Assignee: Air Products and Chemicals, Inc., Allentown, Pa.

[57] ABSTRACT

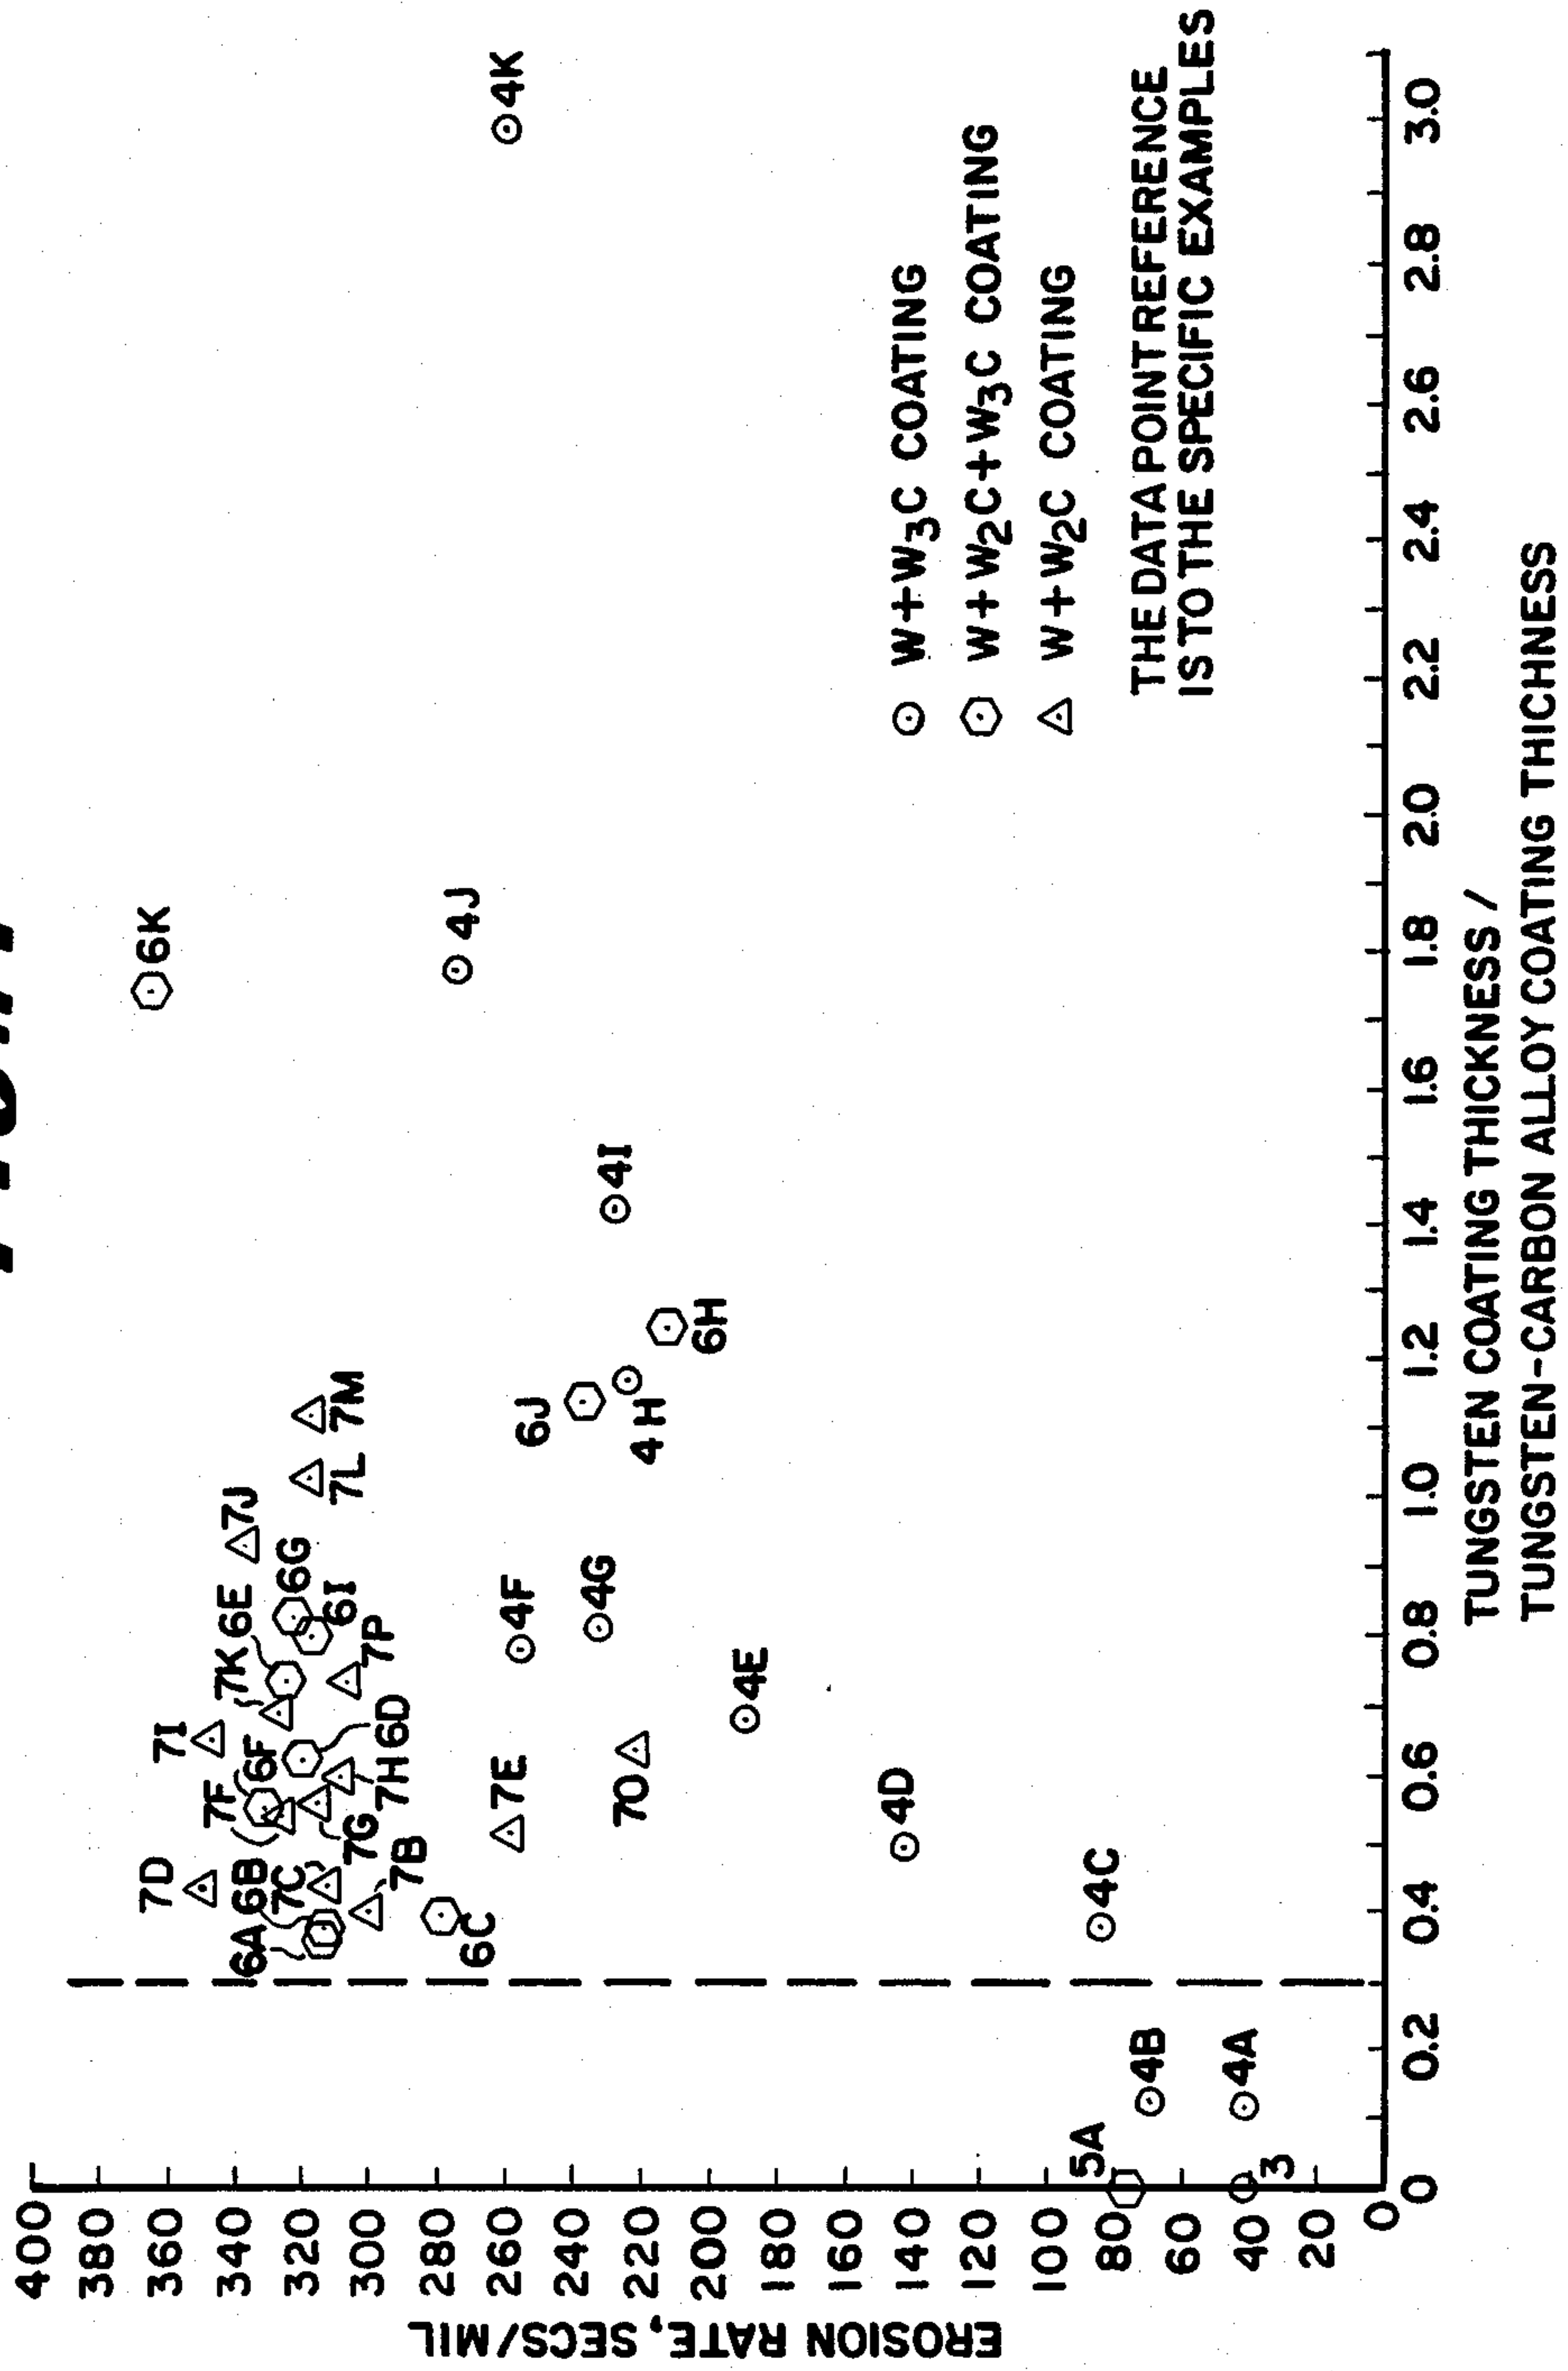
FIG. 14 is the graph illustrating the relationship between the erosion rate and the ratio of the tungsten to the tungsten/carbon alloy coating thicknesses on AM-350 stainless steel, and

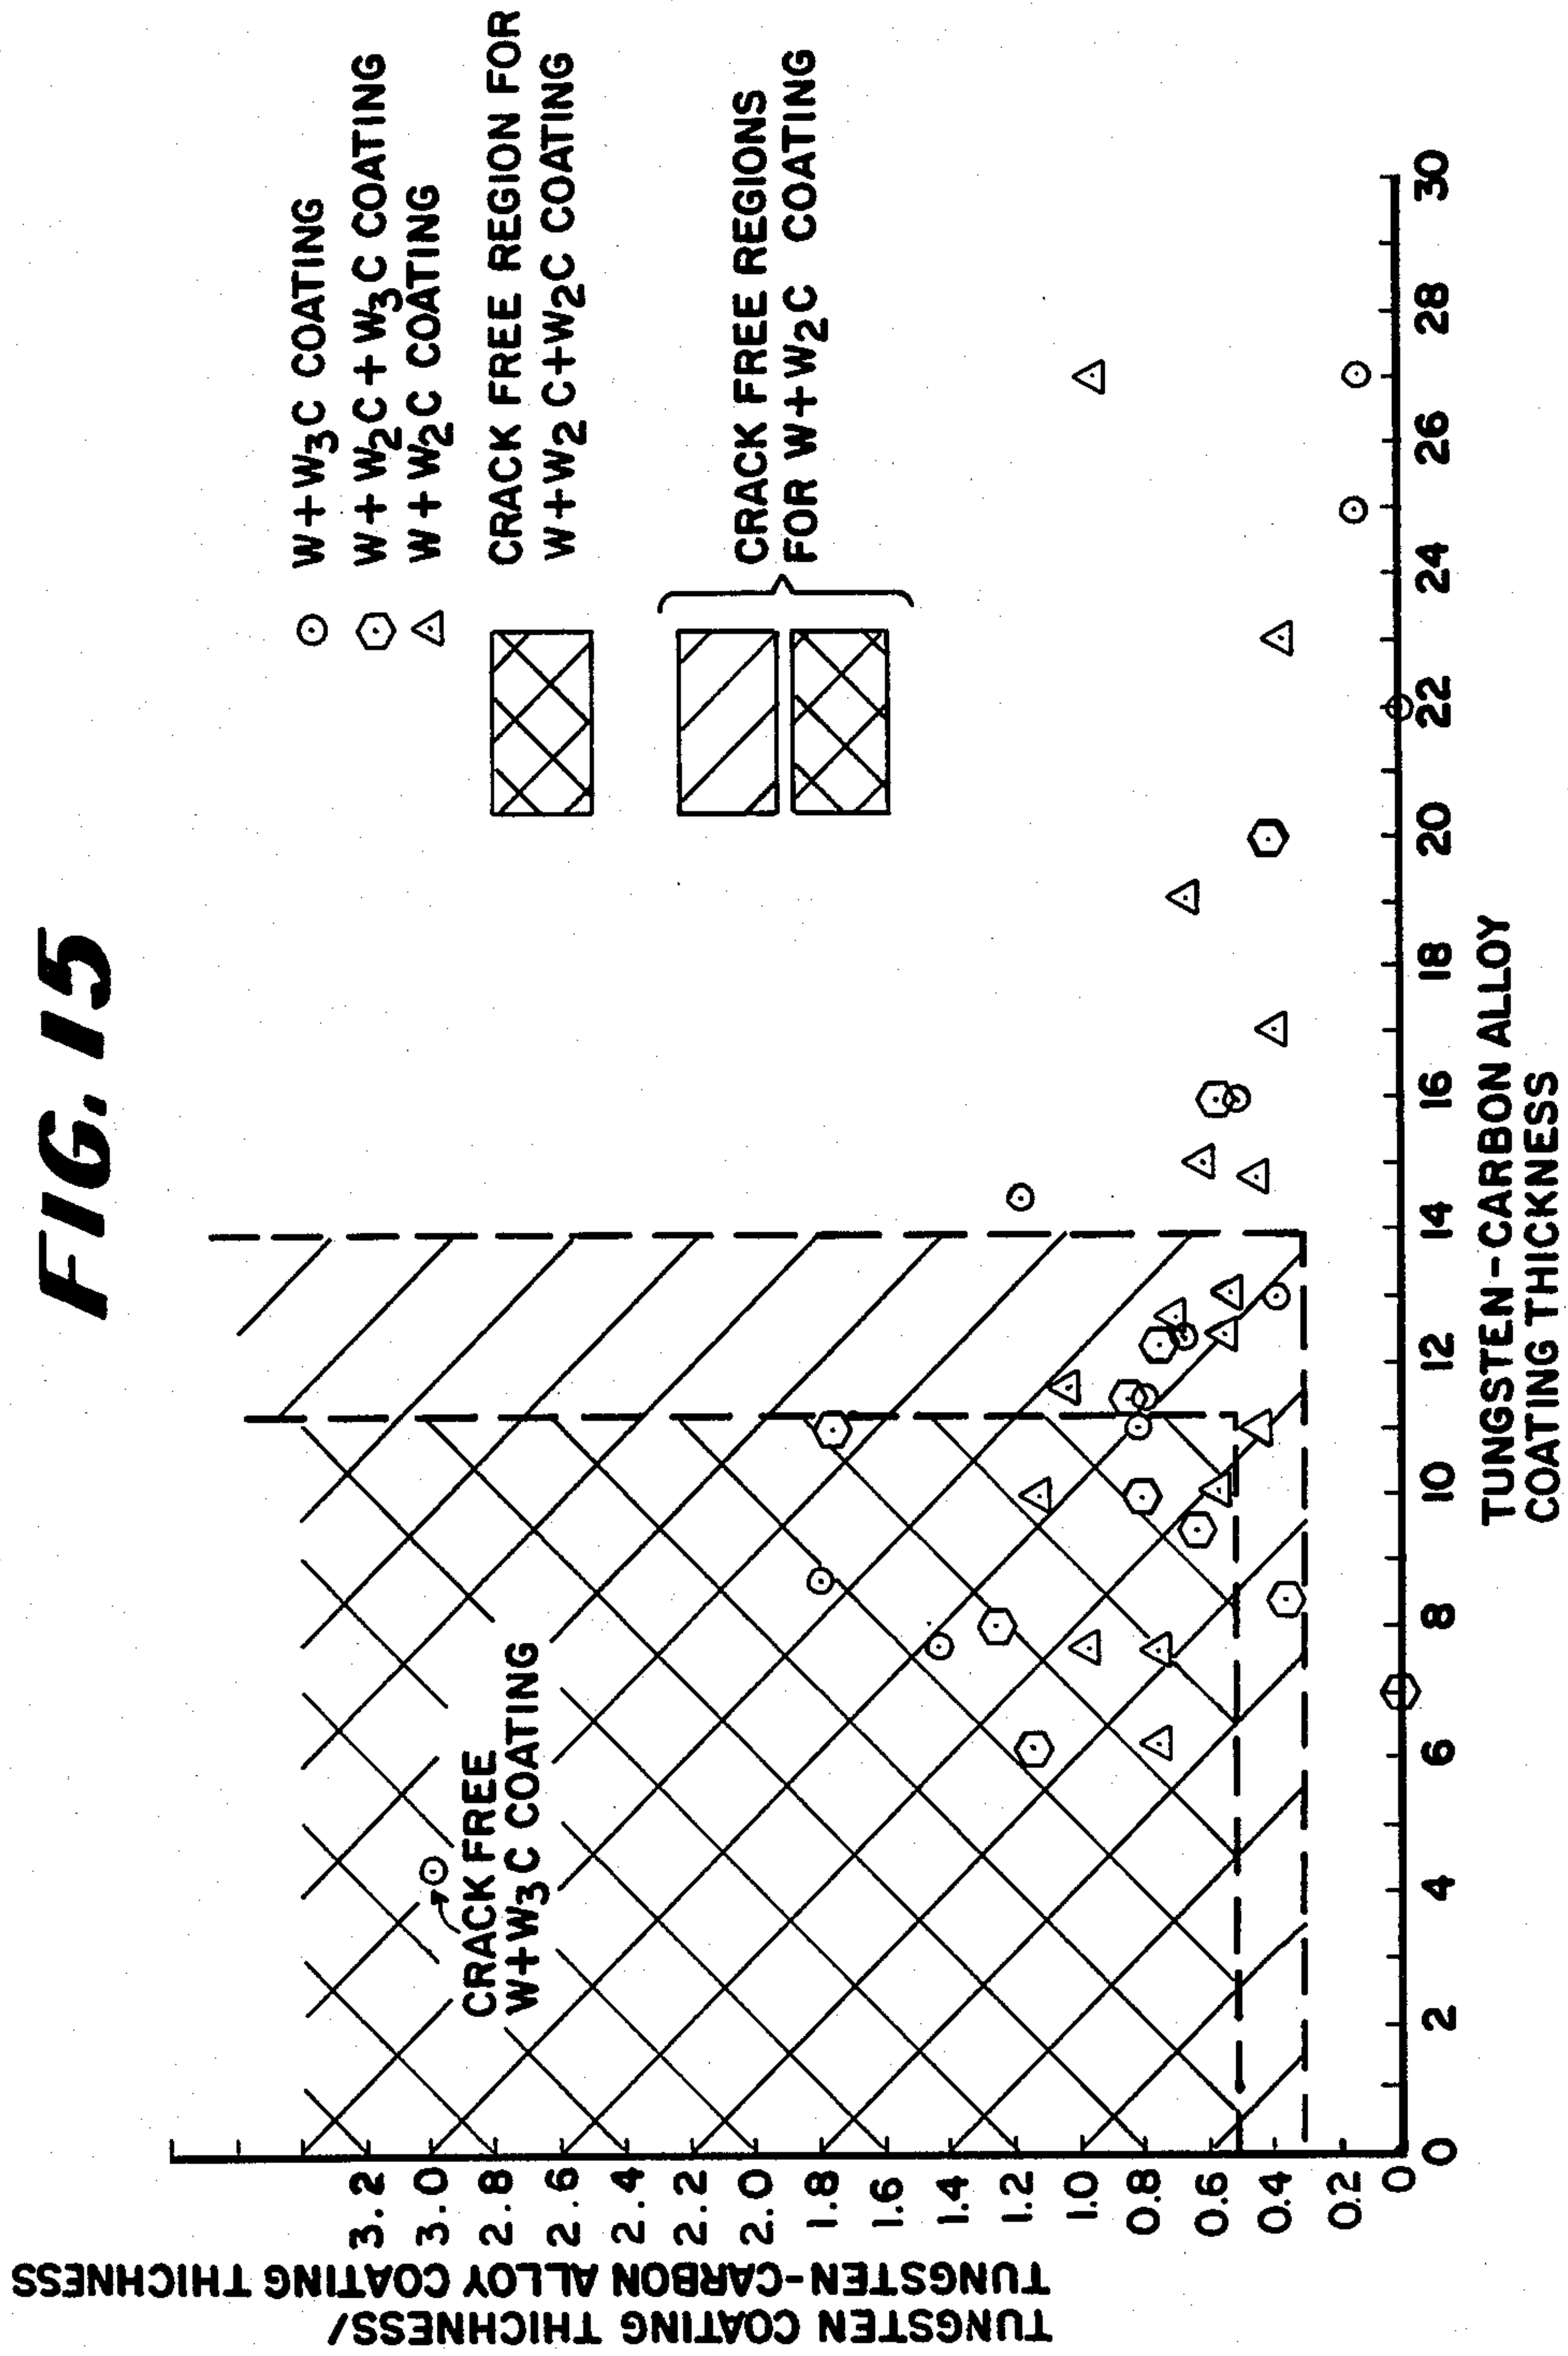
FIG. 15 is the graph illustrating the relationship between the tungsten/carbon alloy coating thickness and the ratio of the thicknesses of the tungsten layer to the tungsten/carbon alloy layer on AM-350 stainless steel.
