[54] METHOD OF REPAIRING TURBINE
BLADES

[73] Assignee: Refurbished Turbine Components
Limited, Hereford and Worcester,
England

METHOD OF REPAIRING TURBINE BLADES

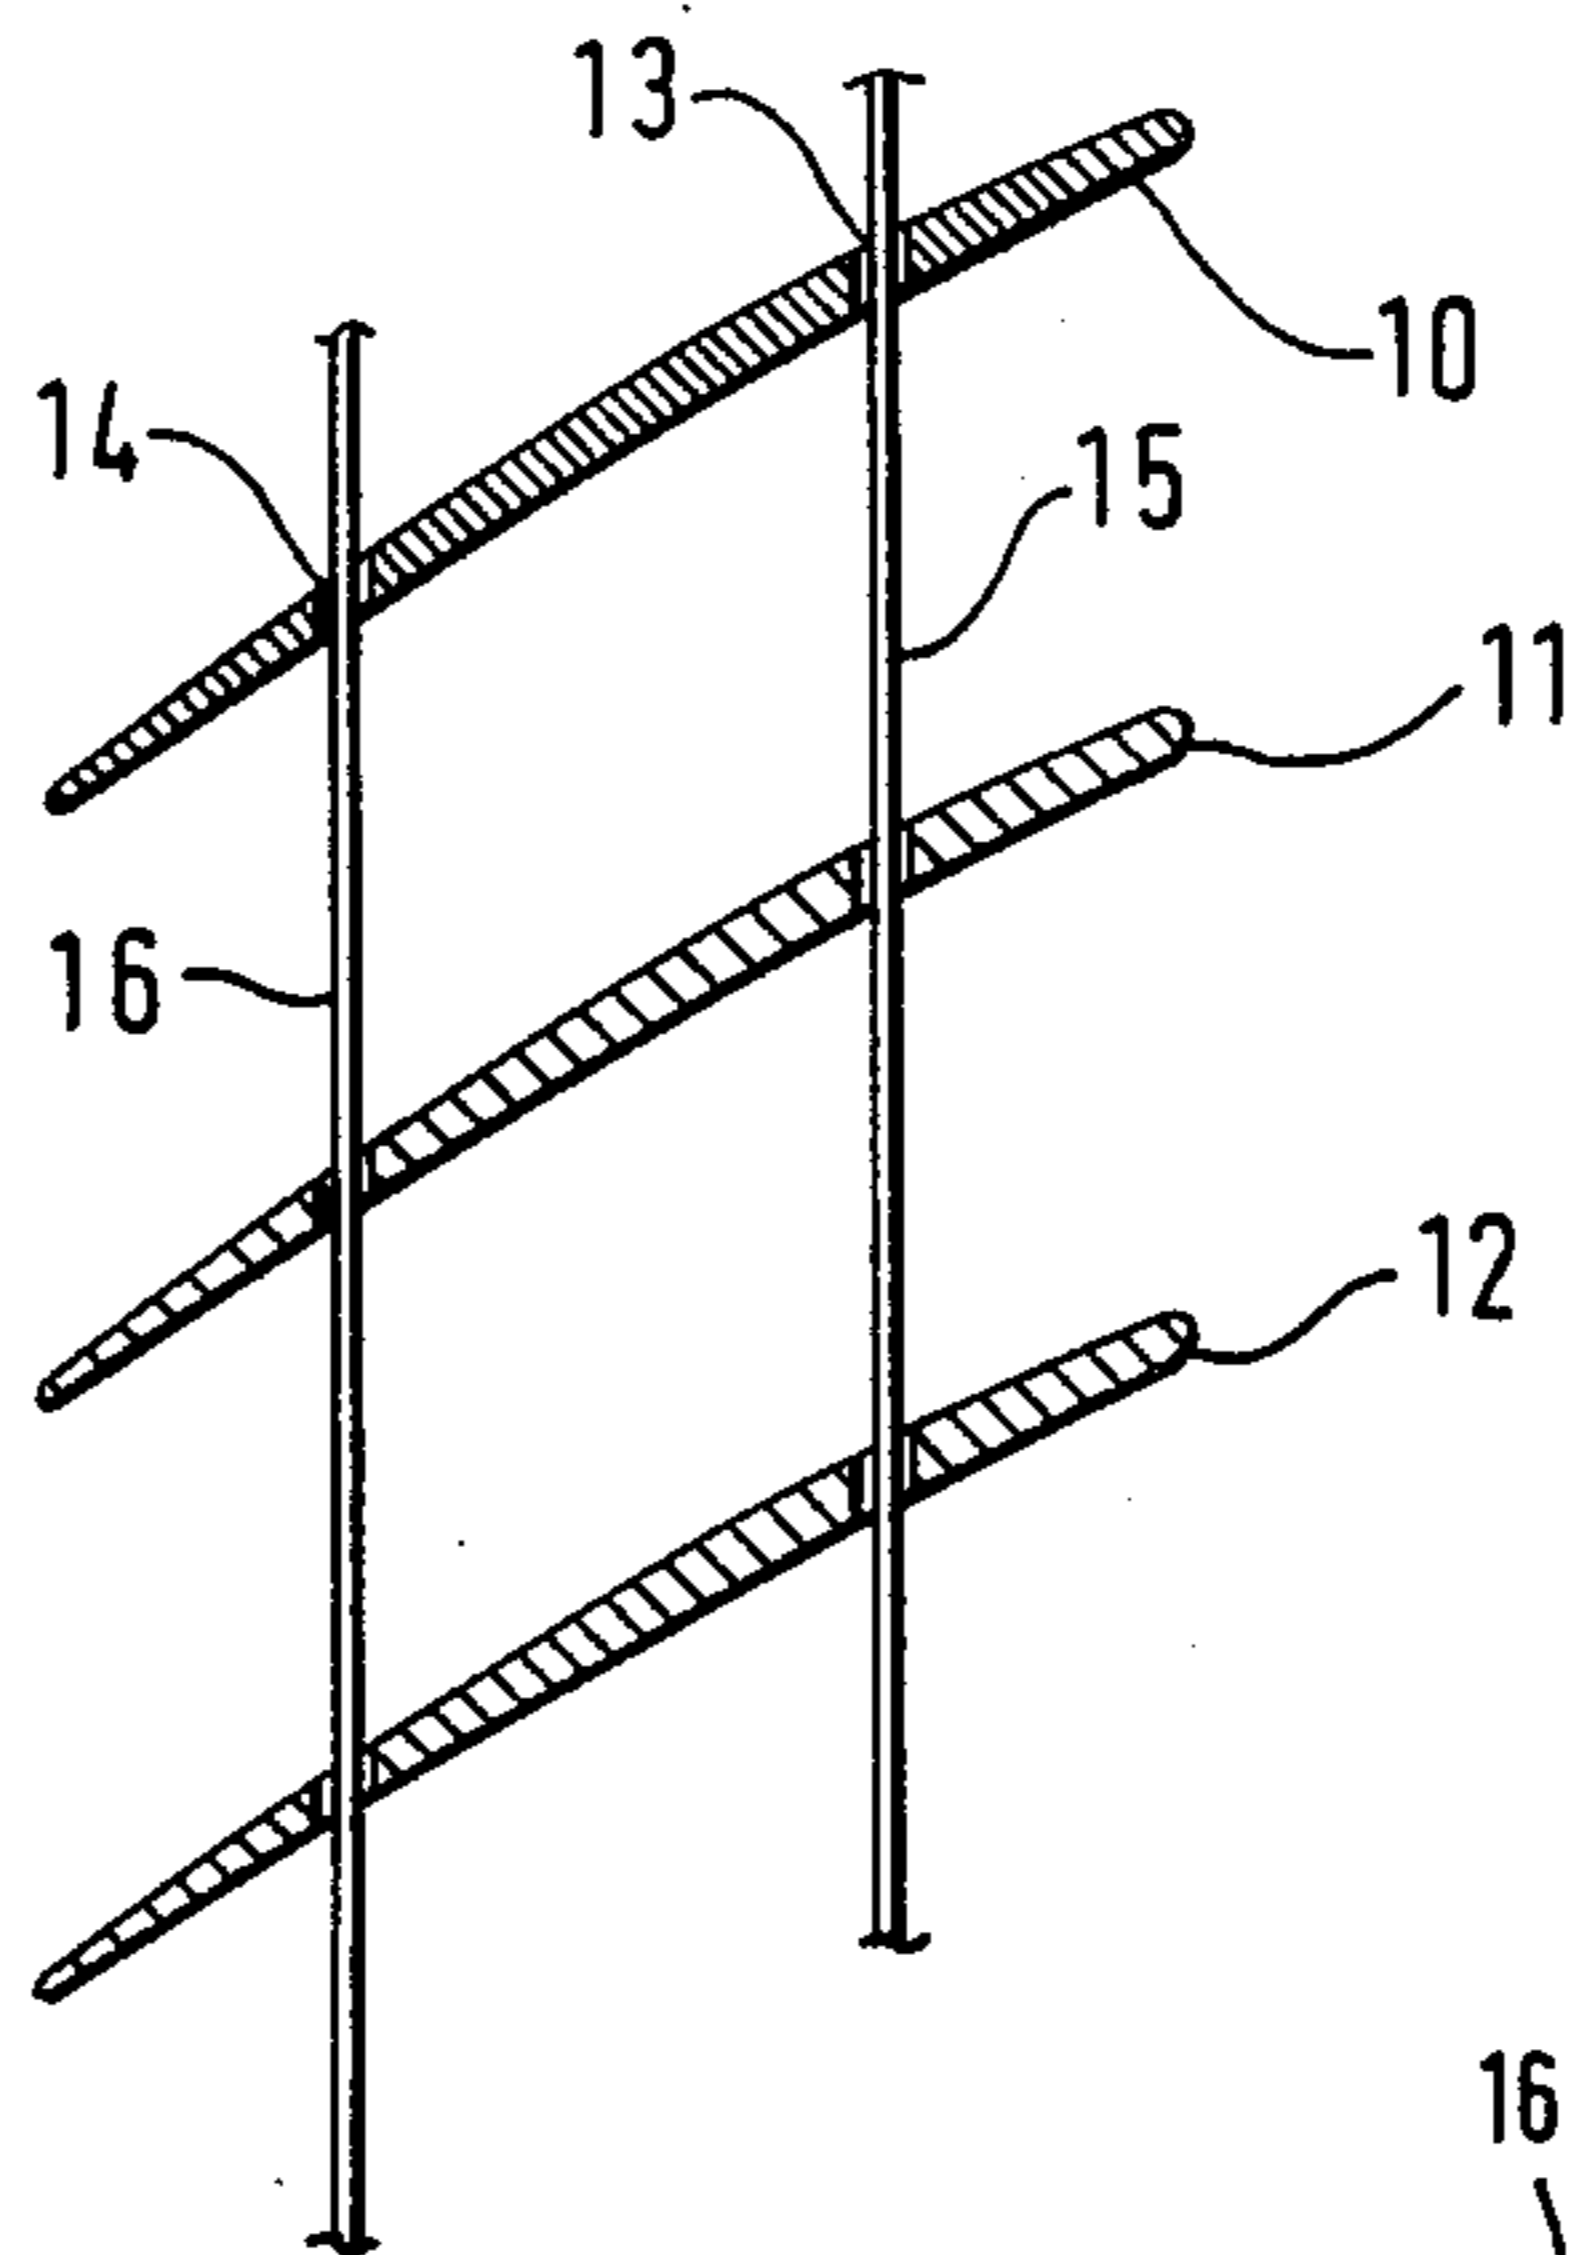
FIG 1

FIG. 1 is a cross-sectional view looking radially inwardly of three turbine blades interconnected by lacing wires;

Referring first to FIGS. 1 and 1A, three turbine blades are shown 10, 11 and 12, each turbine blade having through bores 13 and 14 through which pass respective lacing wires 15 and 16.

The lacing wires 15 and 16 can pass either with clearance through their respective through bores 13 and 14 in the turbine blades, or may be joined to each turbine blade by welding for example.

contact between the lacing wires and the turbine blades, such pressure contact being sufficient to provide the required restriction of relative movement between adjacent turbine blades.

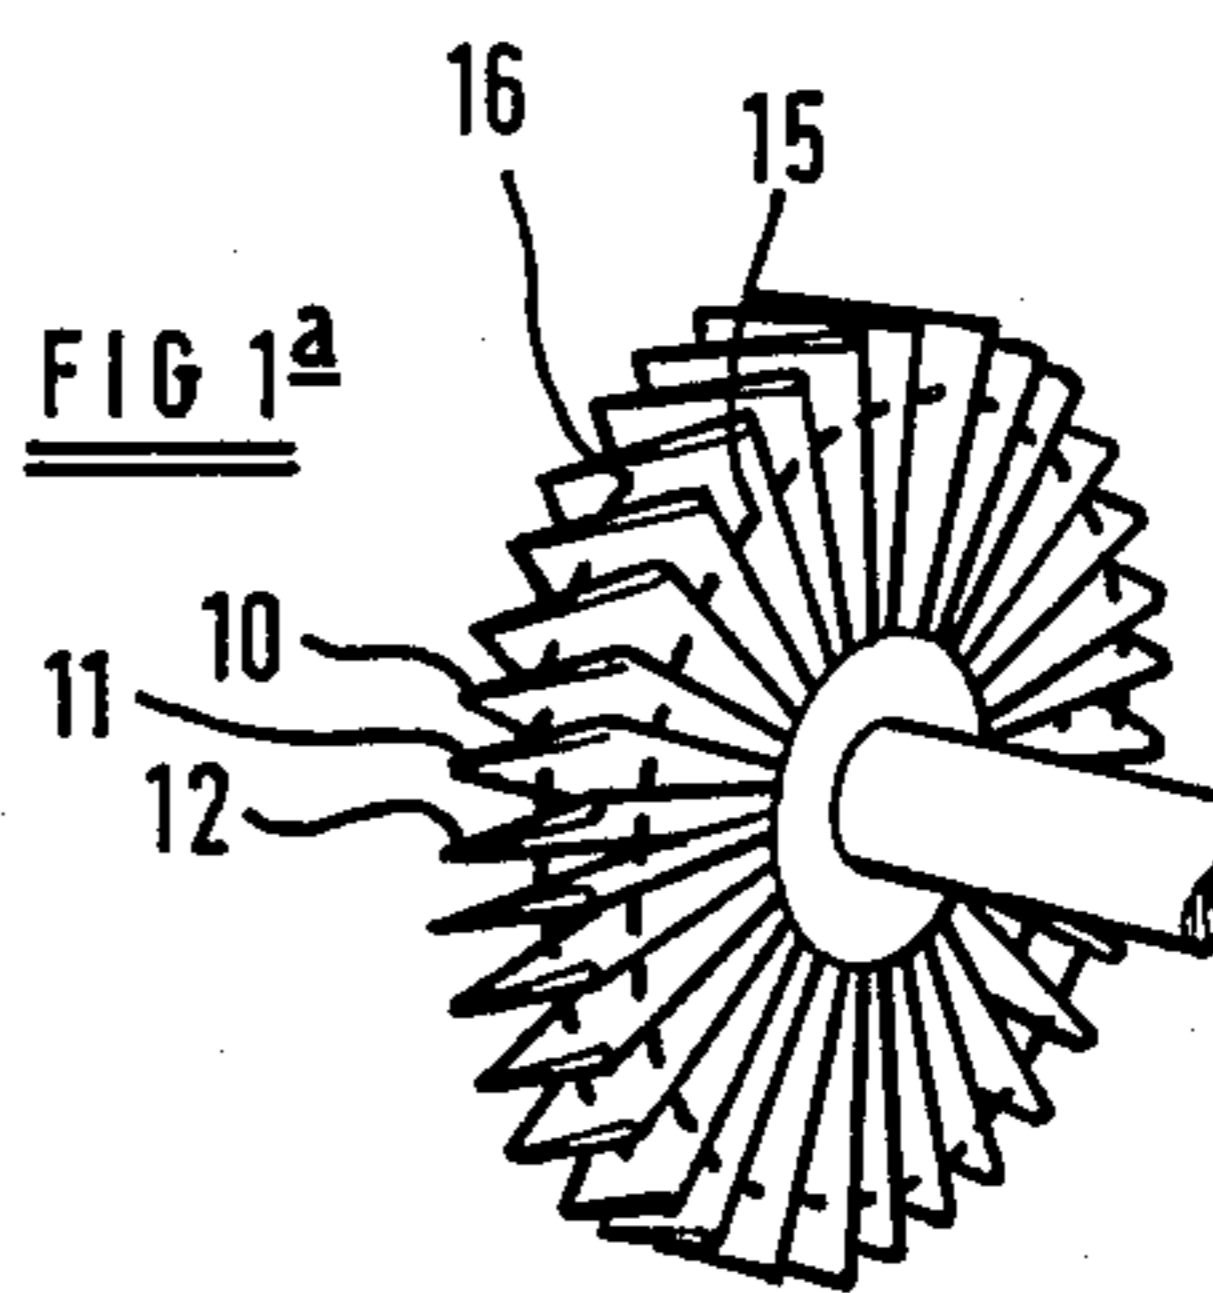
FIG 1a

FIG. 1A is a perspective view of a complete turbine rotor;

FIG. 1A illustrates an example of a rotor from a turbine, the three turbine blades 10, 11 and 12 shown in FIG. 1 being three of a considerable number of blades forming the complete array in the rotor.

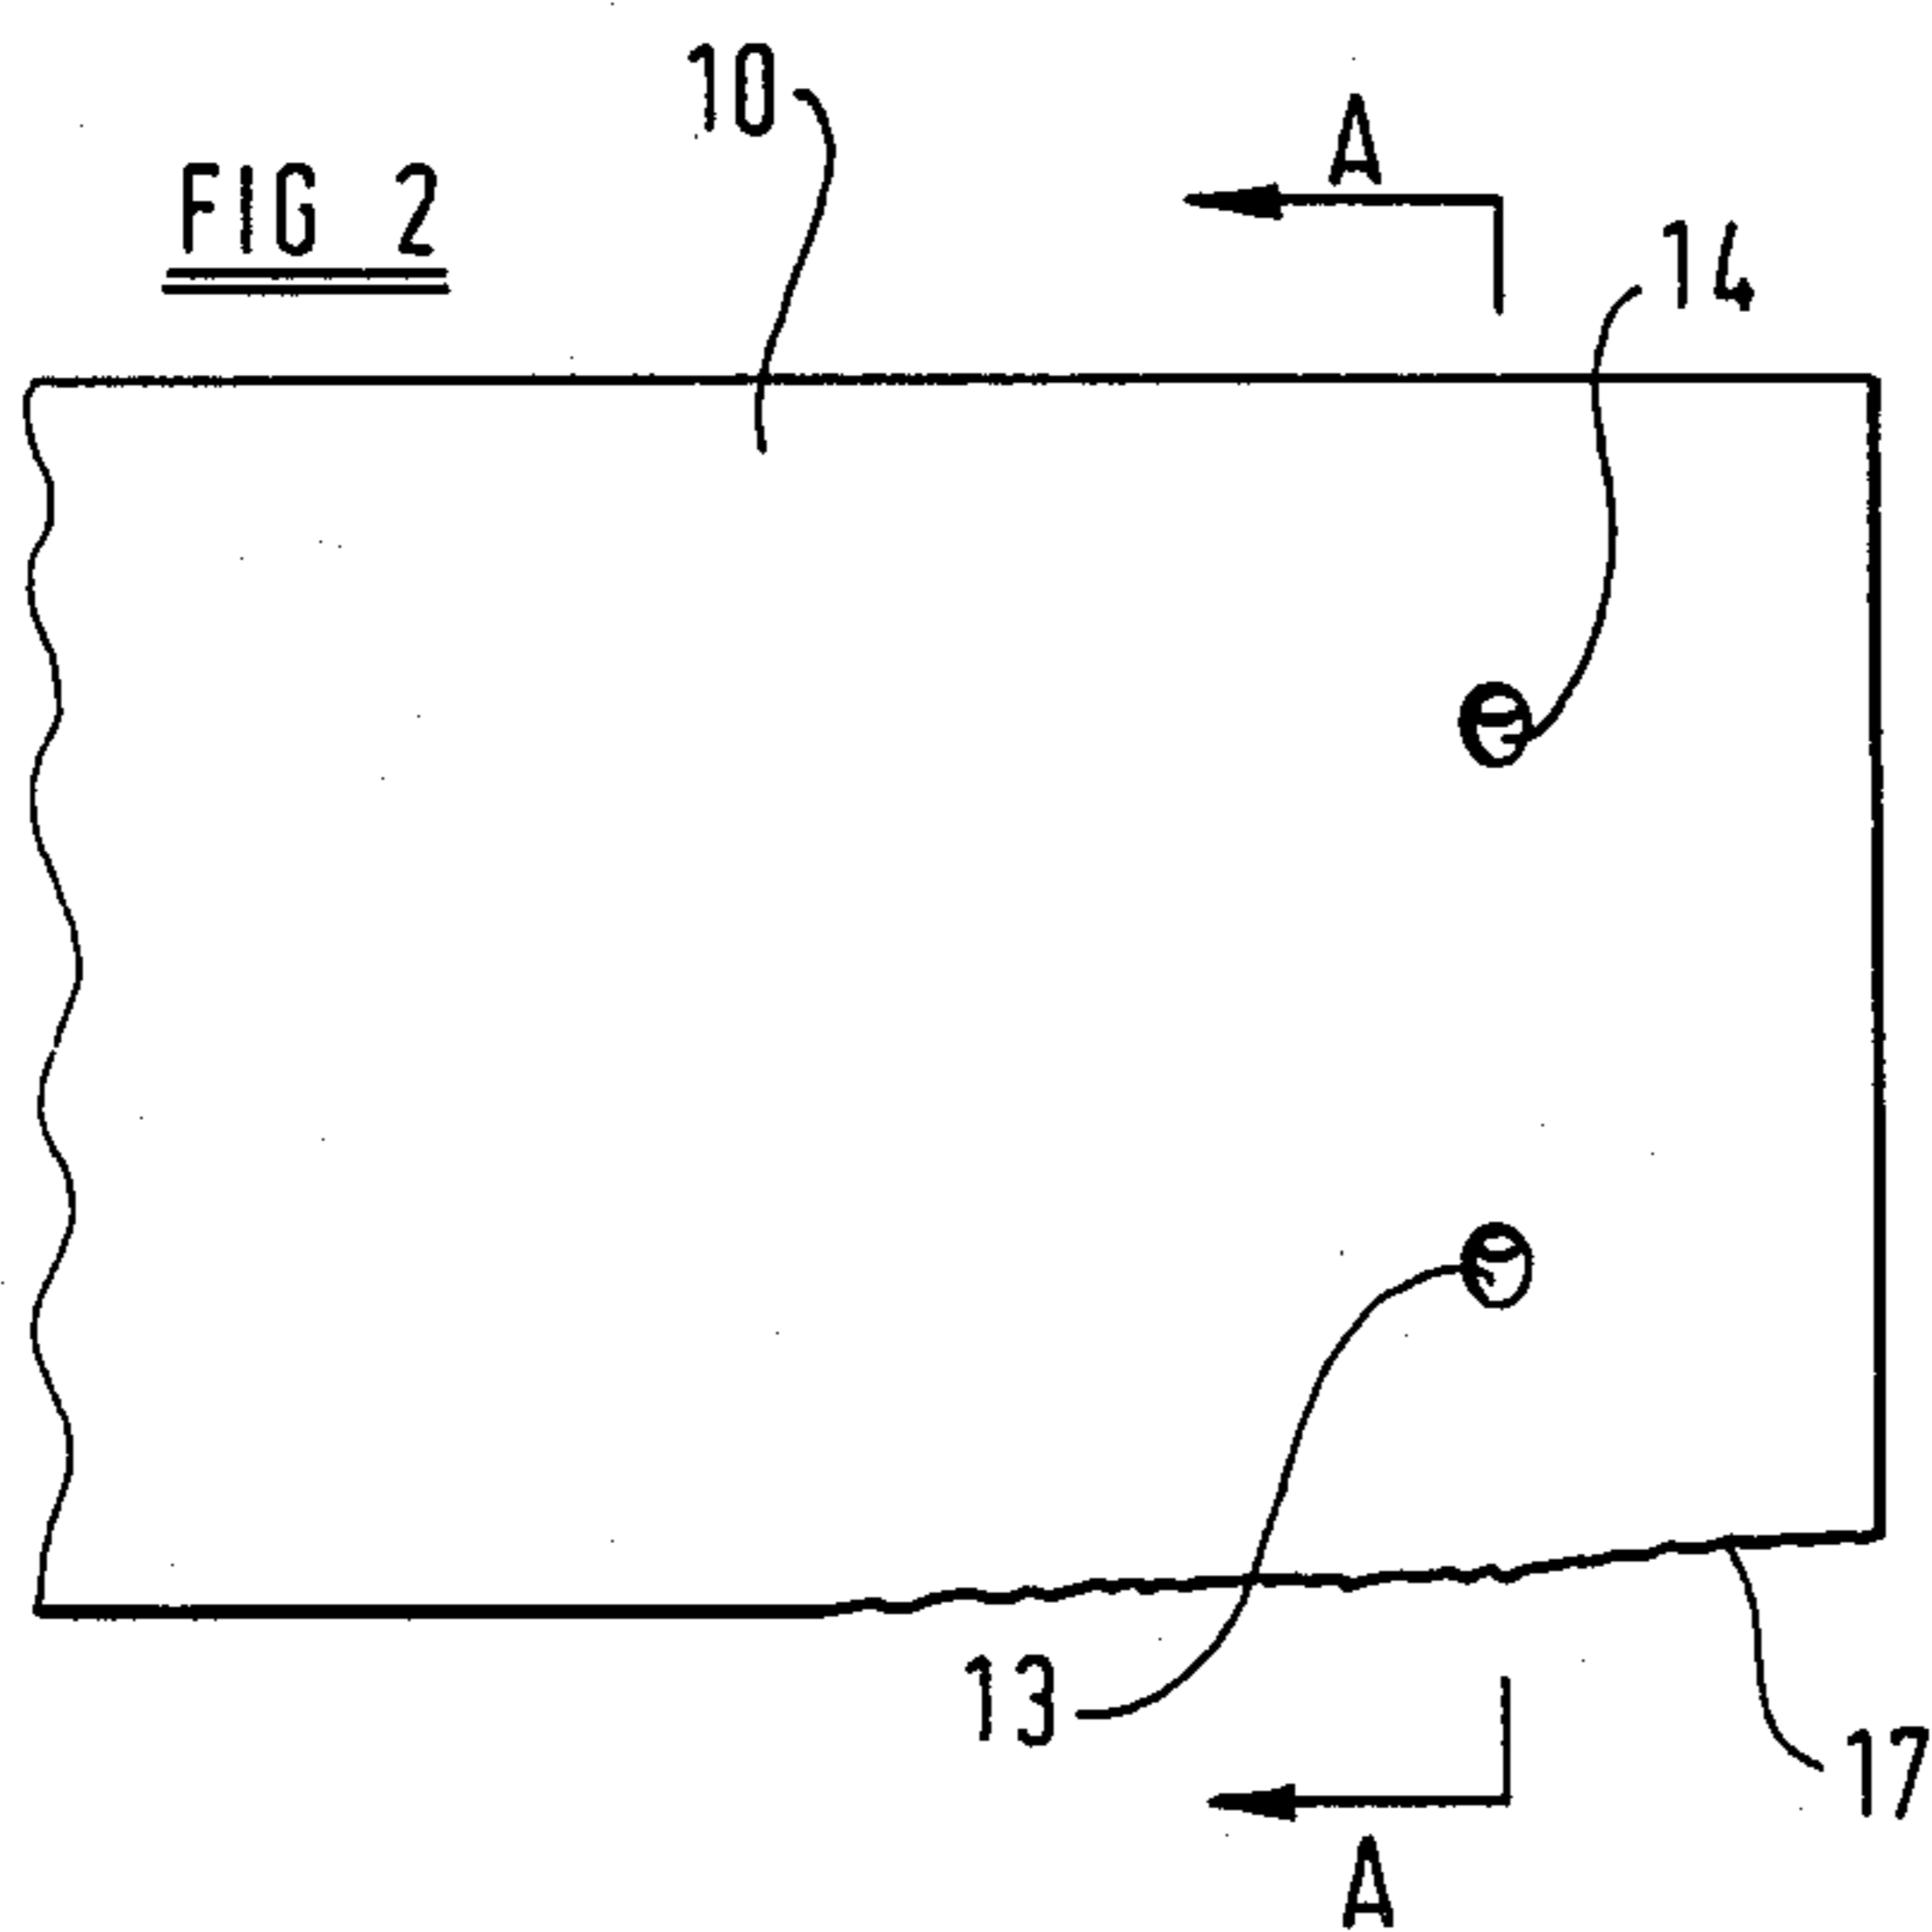
FIG 2

FIG. 2 is a view of an end of an end region of the turbine blade illustrating the area where erosion is most common;

Referring now to FIG. 2, the area of the turbine blade which is most prone to erosion is illustrated, this being the leading edge 17 of the outer end of the turbine blade since it is this part of the blade which "collides" with the steam or particles carried thereby during use of the turbine, and which also has the greatest linear speed being the radially outermost point from the axis of rotation. The leading edge 17 is the edge which is nearest the steam inlet end of the turbine.

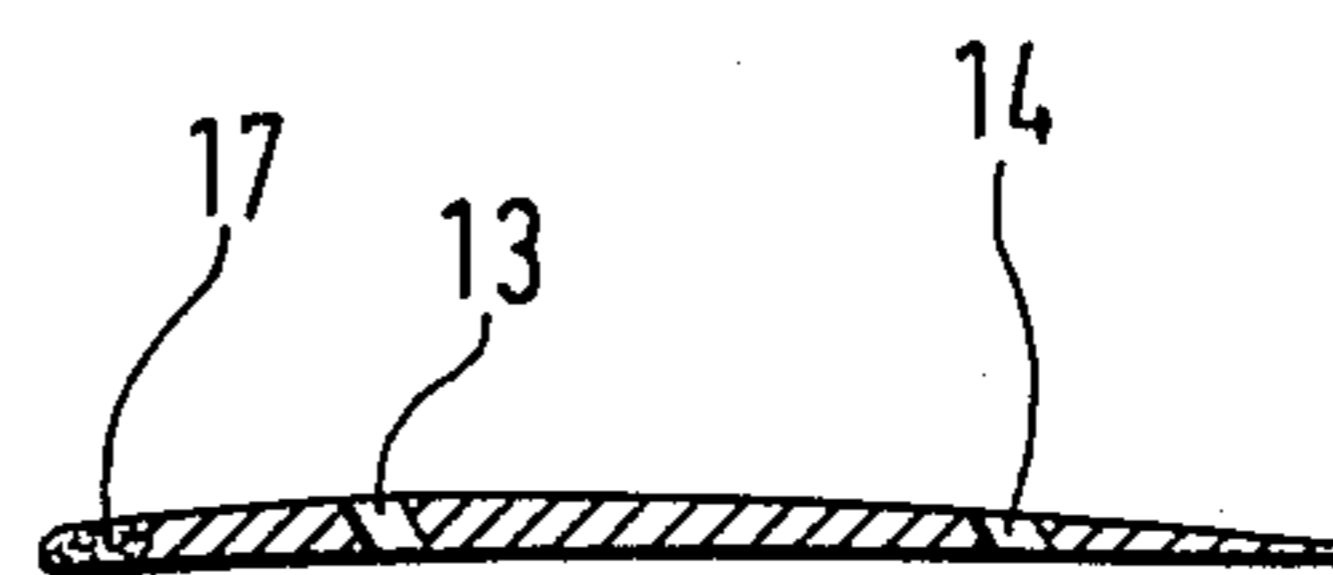
FIG 3

FIG. 3 is a cross-section of the turbine blade taken along the line A—A shown in FIG. 2;

FIG. 3 illustrates the area where erosion is most likely to occur on the leading edge 17 of the turbine blade 10, and which erosion even though it may be severe, is not normally so extensive as to reach as far as the nearest lacing hole 13.

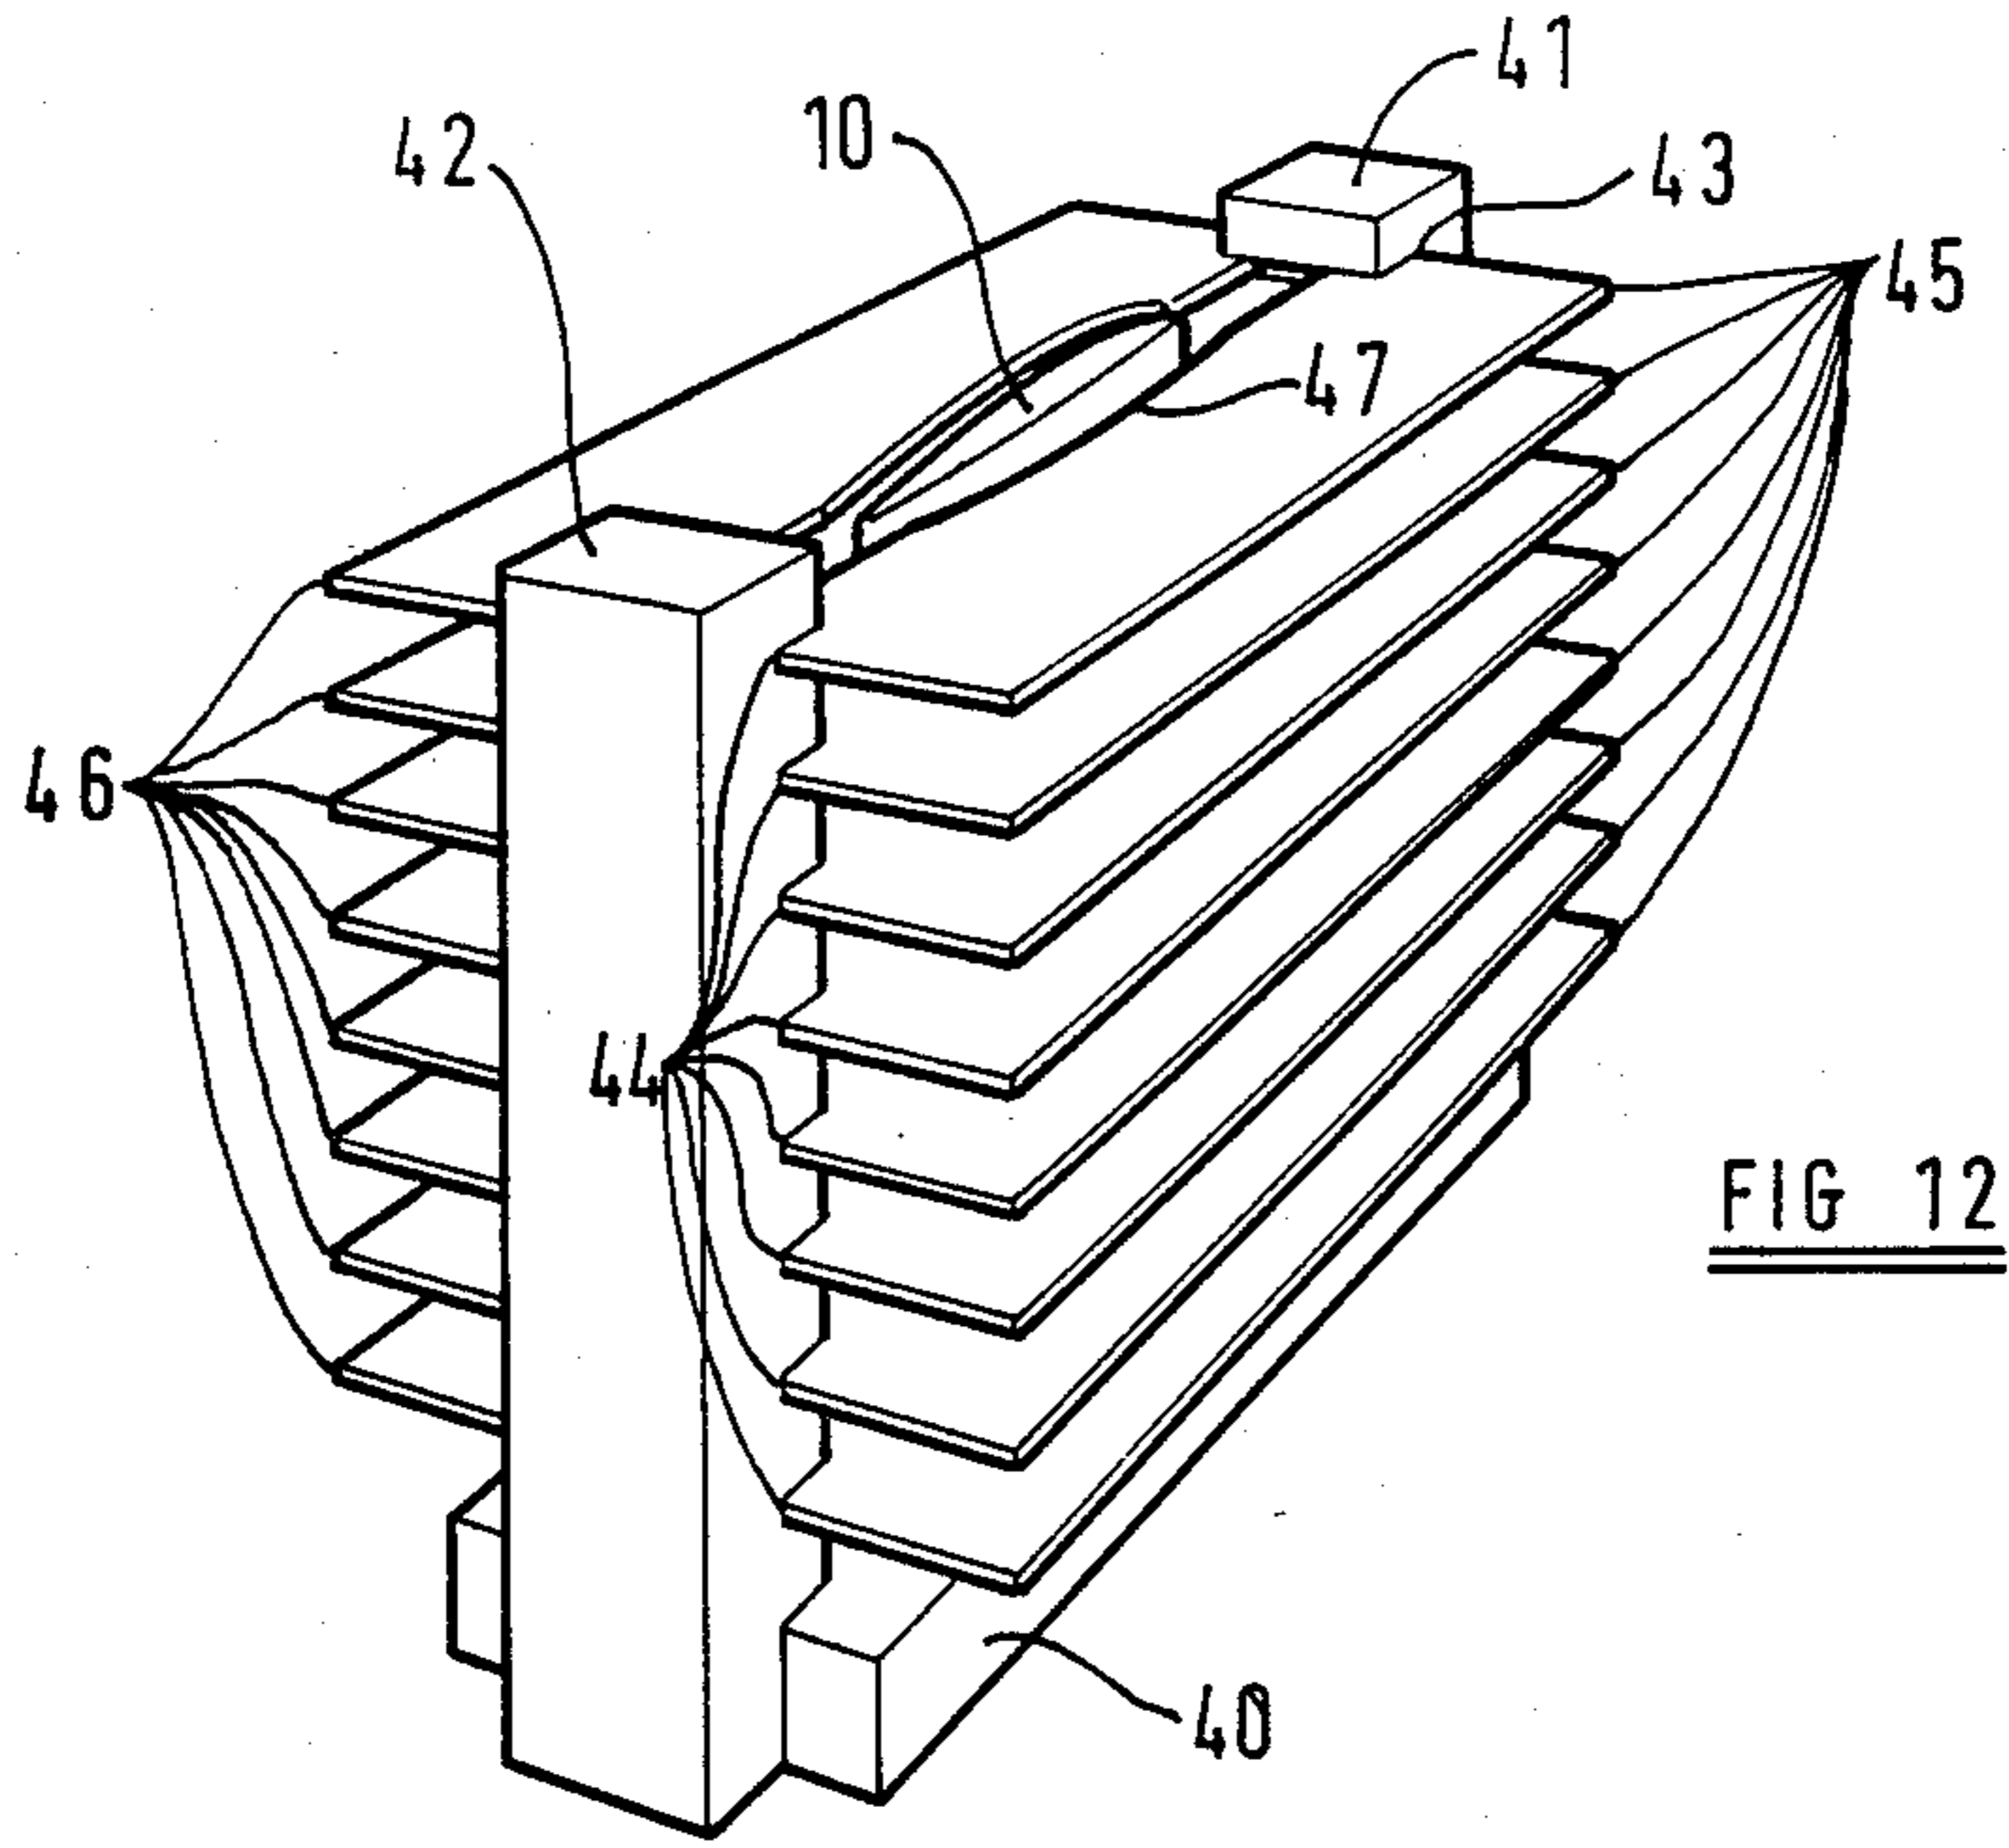
FIG 12

FIG. 12 is a perspective view of a gauge apparatus;

The gauge shown in FIGS. 12 and 13 comprises a base member 40 having a pair of upwardly extending support members 41 and 42, each of the members 41 and 42 being provided with horizontally aligned slots 43 and 44 respectively.

Extending between and located in each pair of horizontally opposed slots 43 and 44 are a pair of gauge members 45 and 46. Each of the gauge members 45 and 46 which comprise metal plates have a cut-out 47 and 48 respectively which corresponds to half the desired cross-sectional profile of the turbine blade 10 at a distance from the base member 40 determined by the distance from the base of the respective horizontally opposed channels 42 and 43.

In order to check if the turbine blade 10 is of the correct form and shape, it is carefully positioned on the base member 40 and the gauge plates 45 and 46 inserted into their respective channels 42 and 43 and moved into contact with the turbine blade 10. If the gauge plates 45 and 46 do not fit around the turbine blade perfectly, i.e. there is a gap at any position between a gauge plate and the turbine blade, either the form or shape of the blade requires some correction, the form being corrected by imparting a twisting force to the blade as afore-described, and the shape being corrected by the addition or removal of material by welding or grinding respectively for example.

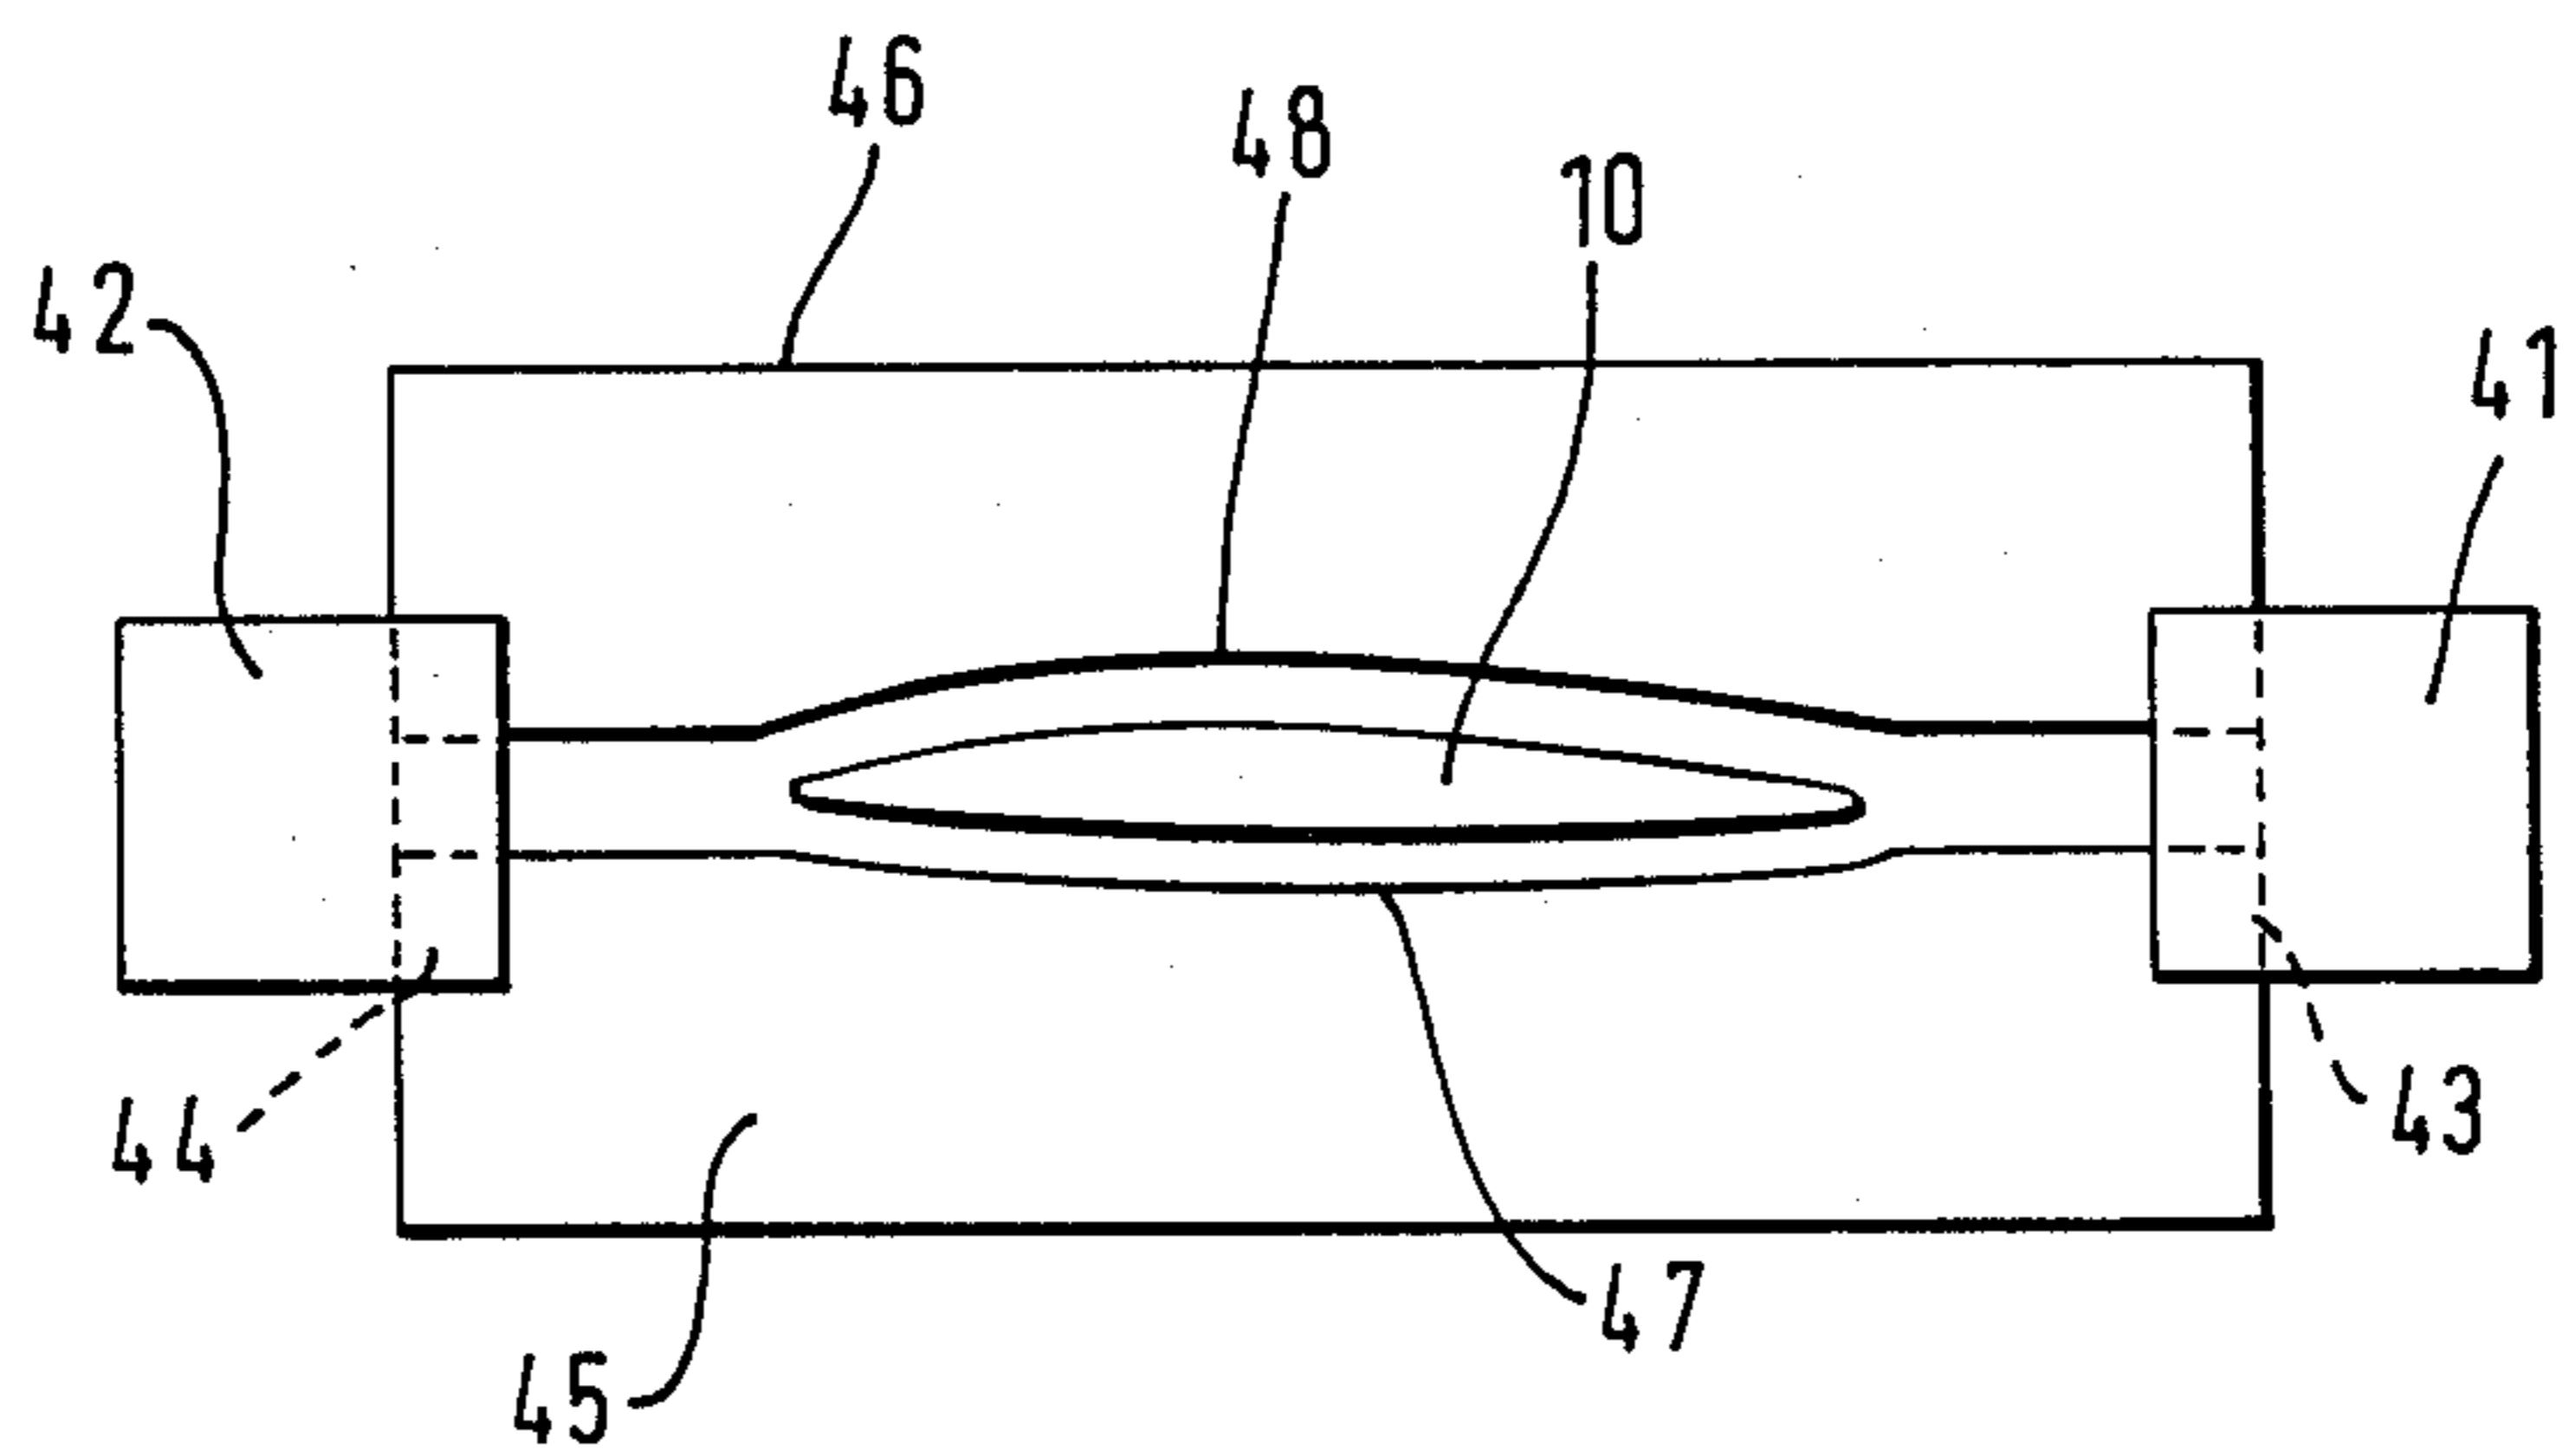
FIG 13

FIG. 13 is a plan view of the gauge apparatus shown in FIG. 12.
