[11] Patent Number: 4,866,828

[54] METHOD OF REPAIRING TURBINE
BLADES

[73] Assignee: Refurbished Turbine Components
Limited, Hereford and Worcester,
England

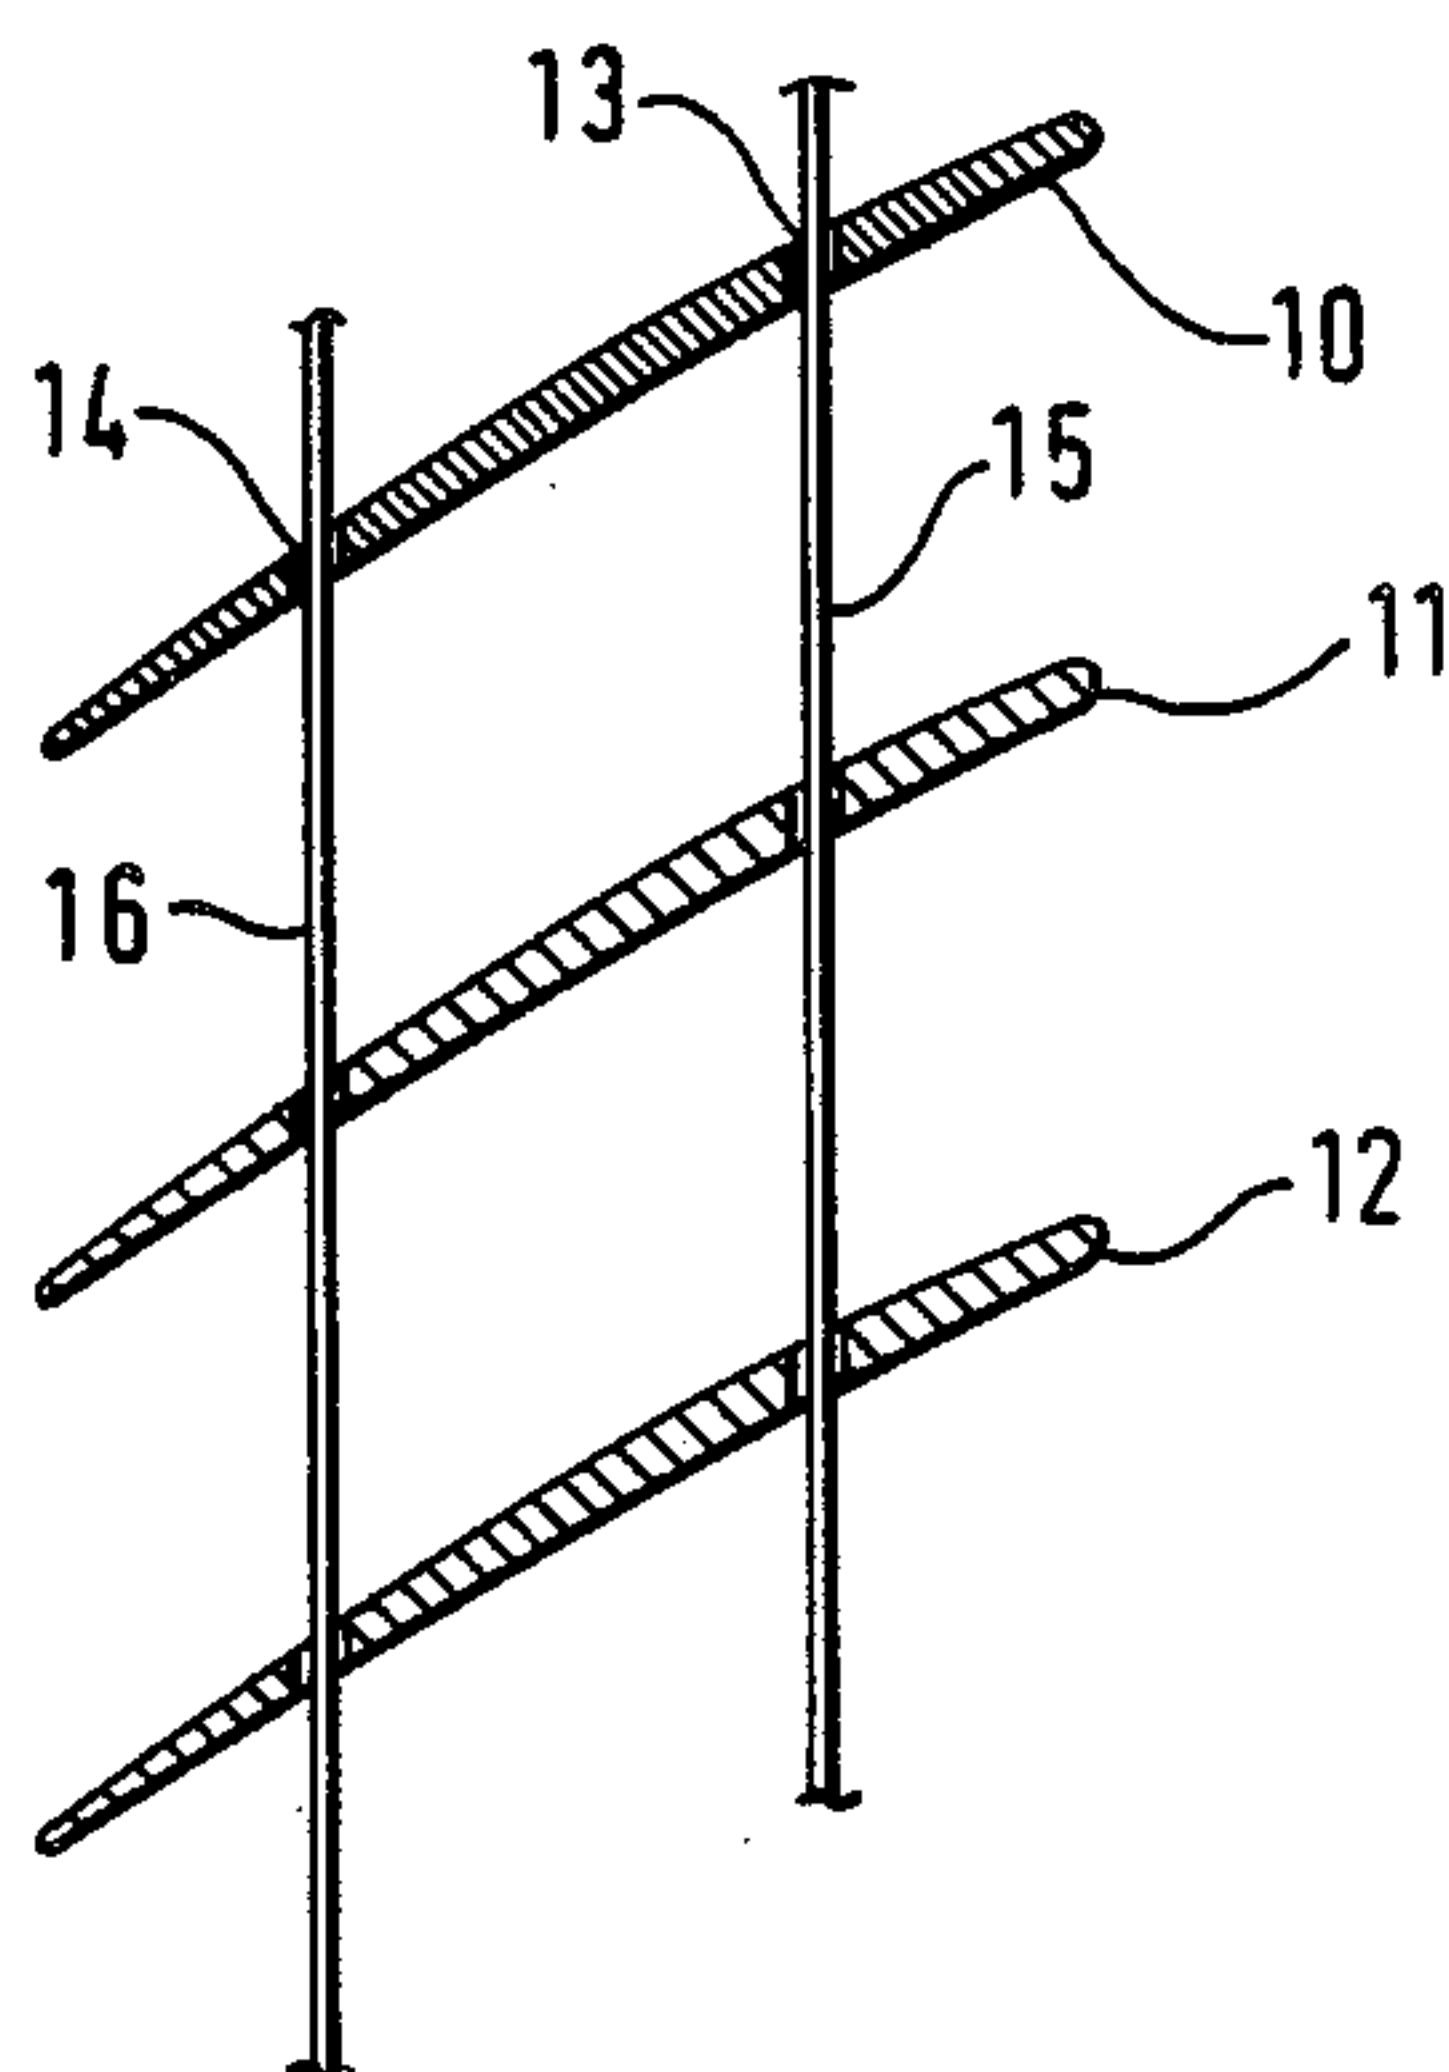
FIG. 1 is a cross-sectional view looking radially inwardly of three turbine blades interconnected by lacing wires;

Referring first to FIGS. 1 and 1A, three turbine blades are shown 10, 11 and 12, each turbine blade having through bores 13 and 14 through which pass respective lacing wires 15 and 16.

The lacing wires 15 and 16 can pass either with clearance through their respective through bores 13 and 14 in the turbine blades, or may be joined to each turbine blade by welding for example.

If the lacing wires pass freely through the through bores 13 and 14 in use of the turbine, the radially outwardly directed centrifugal force on the lacing wires between adjacent turbine blades will cause pressure

contact between the lacing wires and the turbine blades, such pressure contact being sufficient to provide the required restriction of relative movement between adjacent turbine blades.

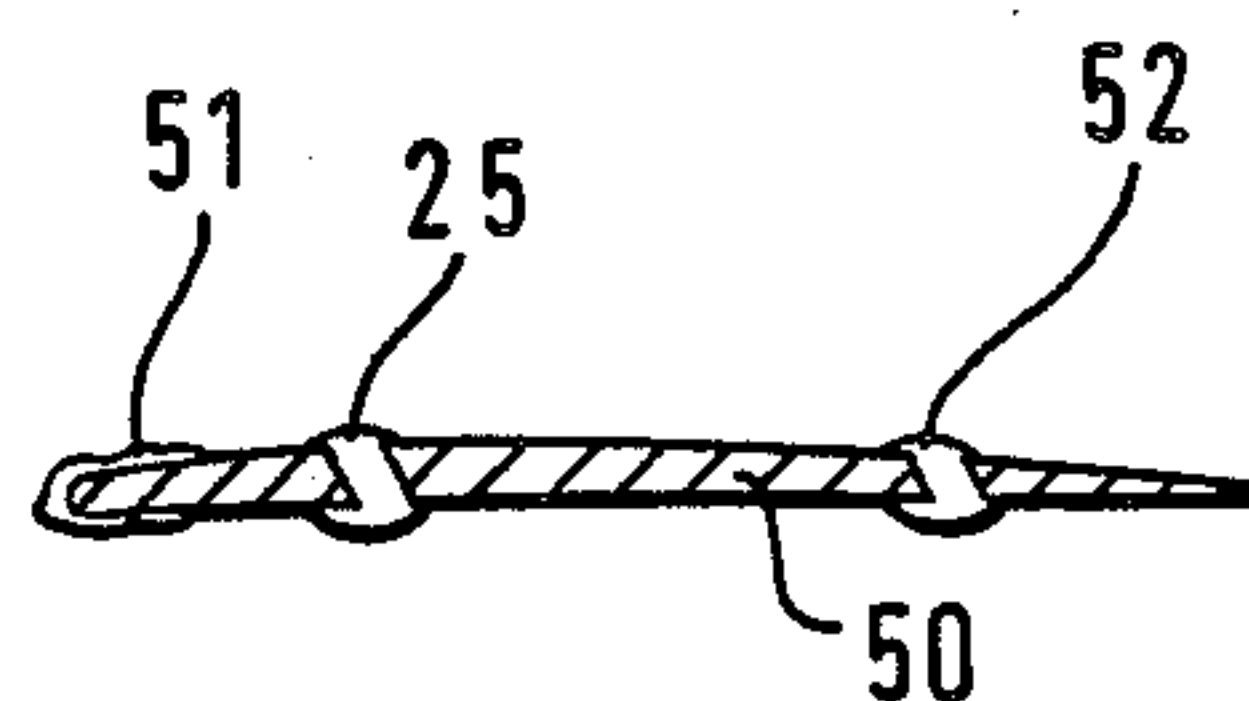
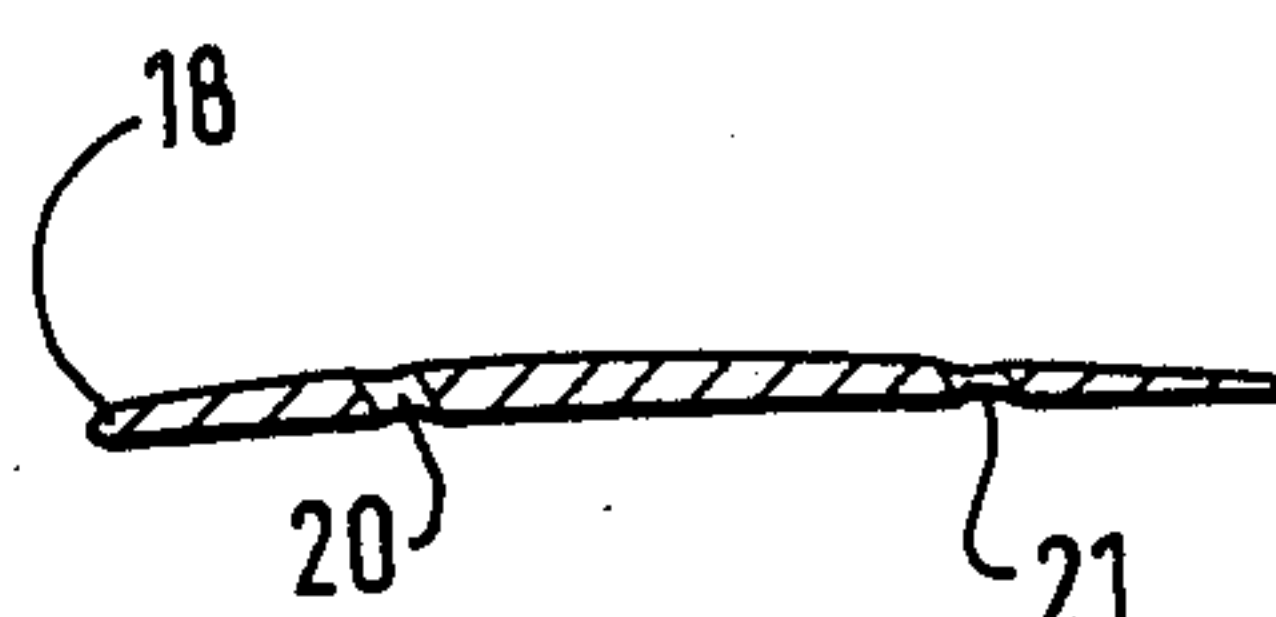
FIG. 2 is a view of an end of an end region of the turbine blade illustrating the area where erosion is most common;

FIG. 3 is a cross-section of the turbine blade taken along the line A—A shown in FIG. 2;

Referring now to FIG. 2, the area of the turbine blade which is most prone to erosion is illustrated, this being the leading edge 17 of the outer end of the turbine blade since it is this part of the blade which "collides" with the steam or particles carried thereby during use of the turbine, and which also has the greatest linear speed being the radially outermost point from the axis of rotation. The leading edge 17 is the edge which is nearest the steam inlet end of the turbine.

FIG. 3 illustrates the area where erosion is most likely to occur on the leading edge 17 of the turbine blade 10, and which erosion even though it may be severe, is not normally so extensive as to reach as far as the nearest lacing hole 13.

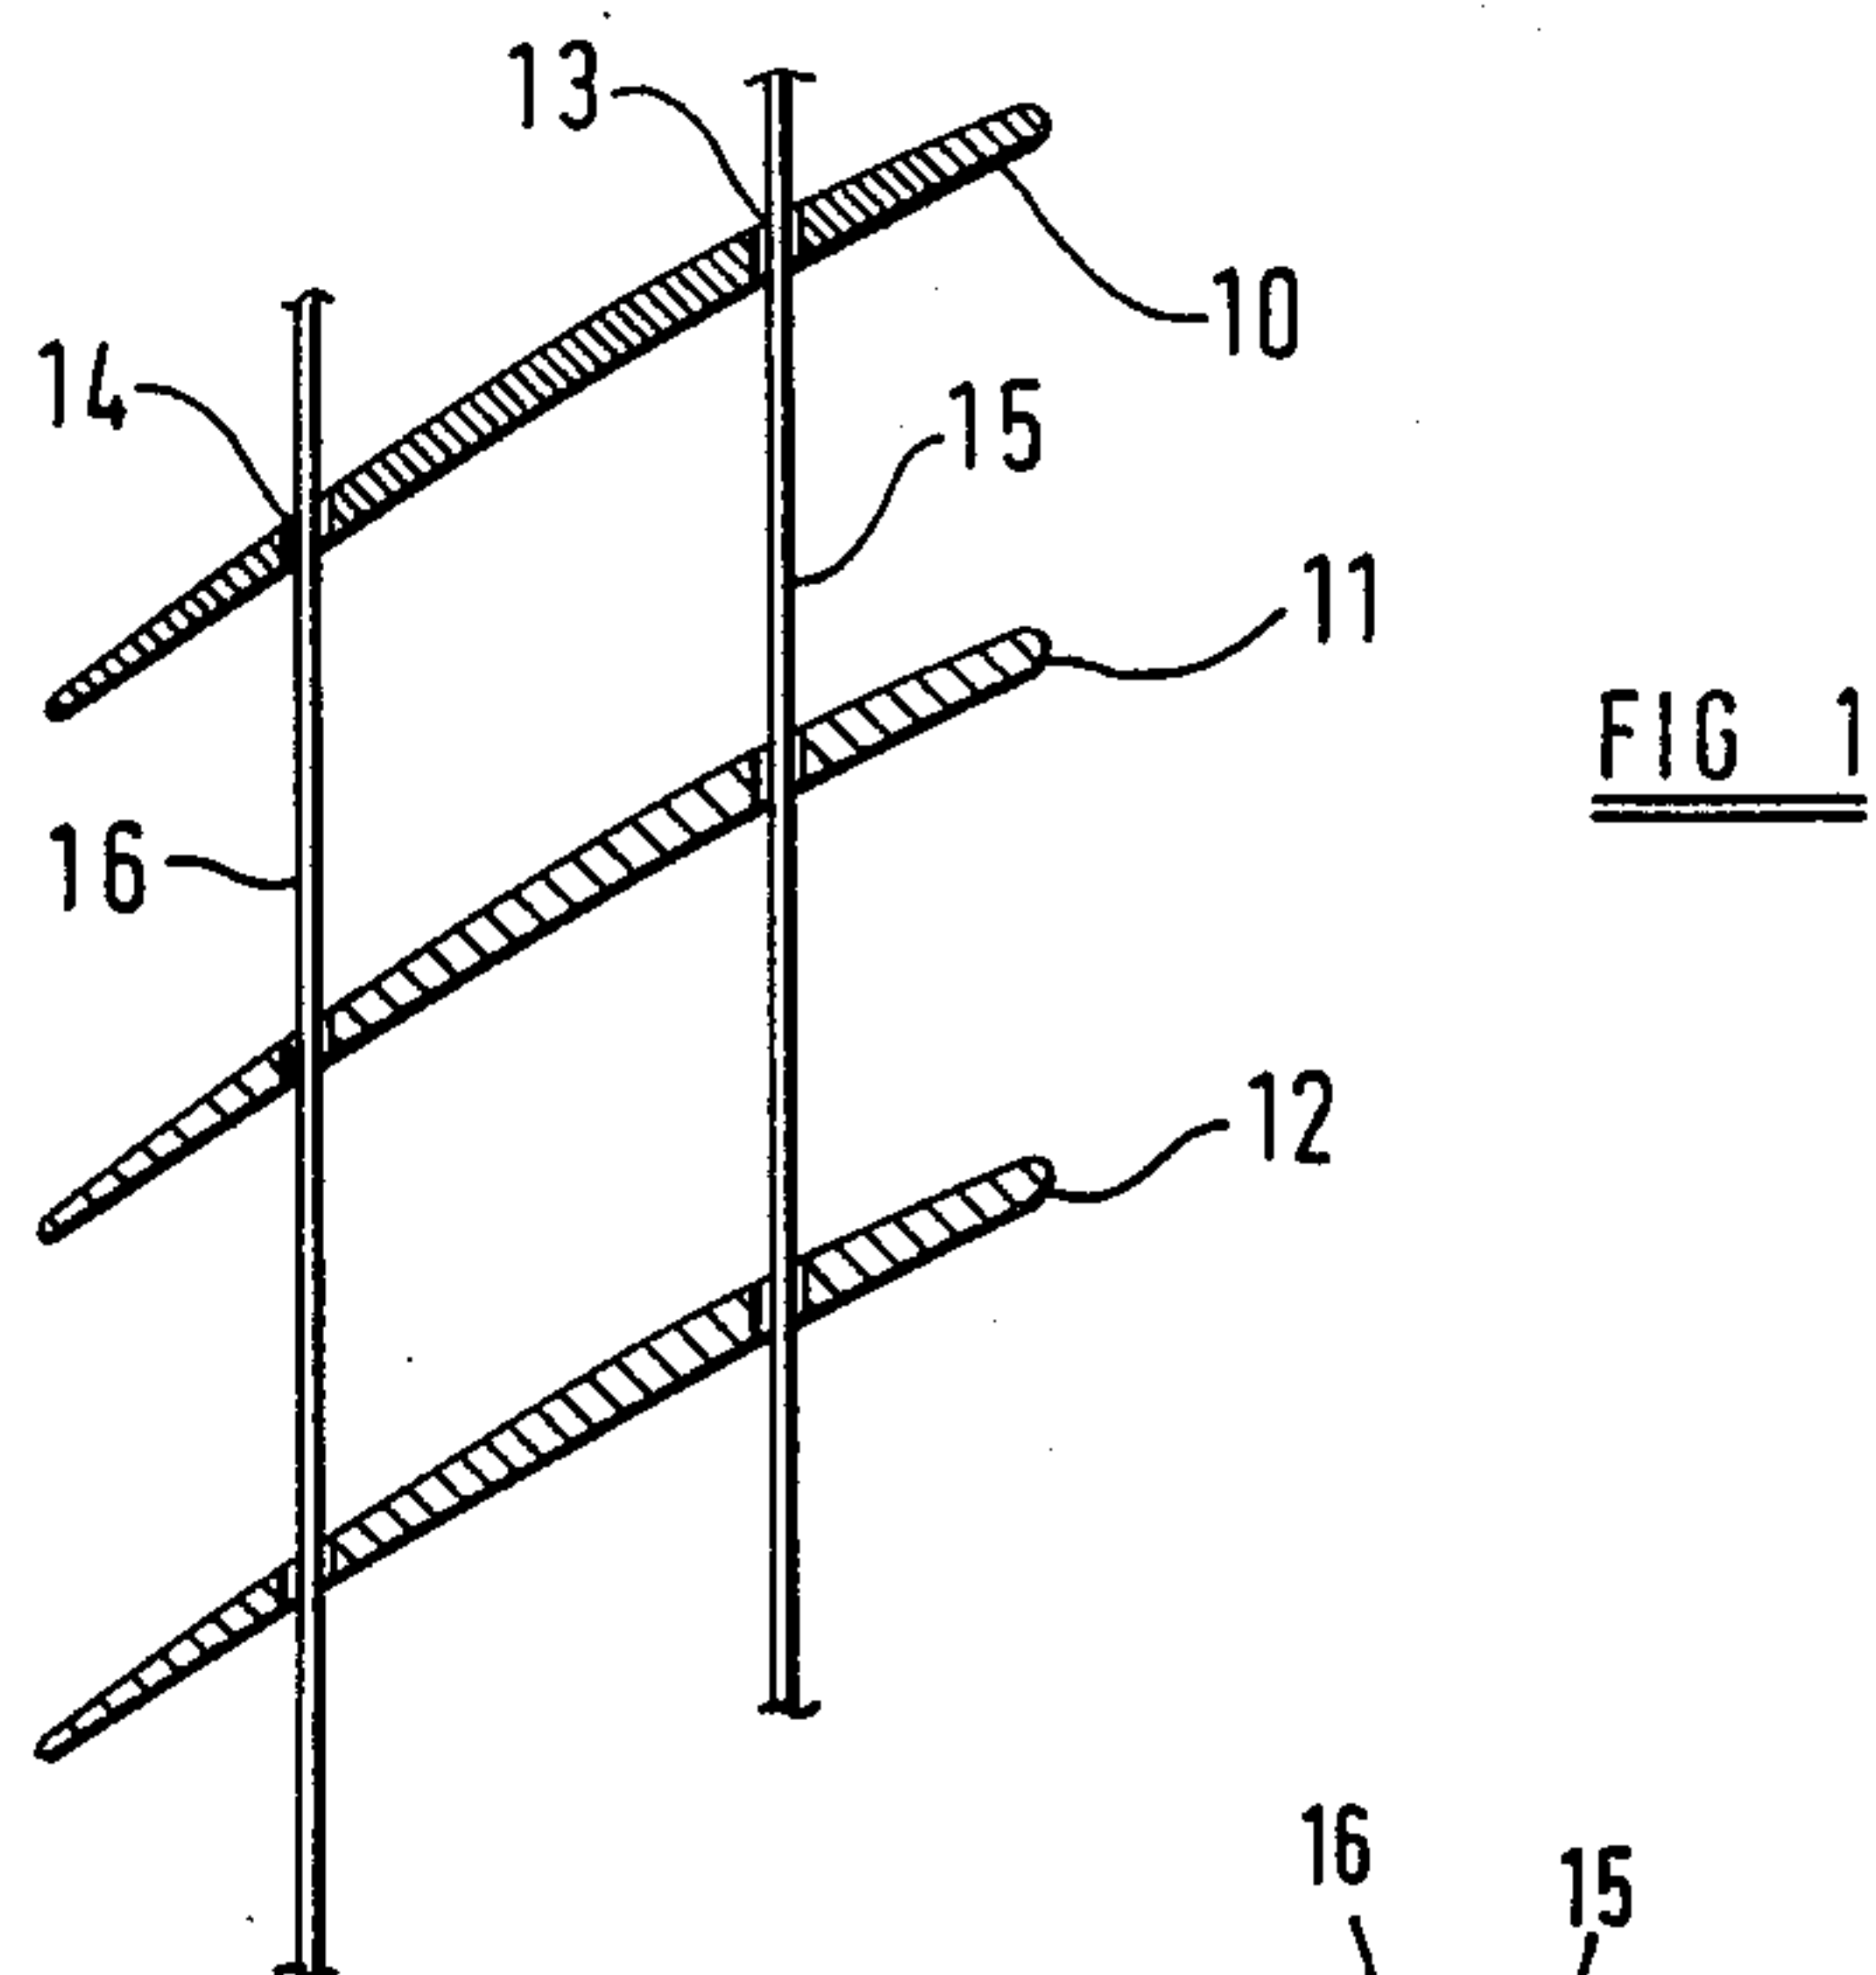
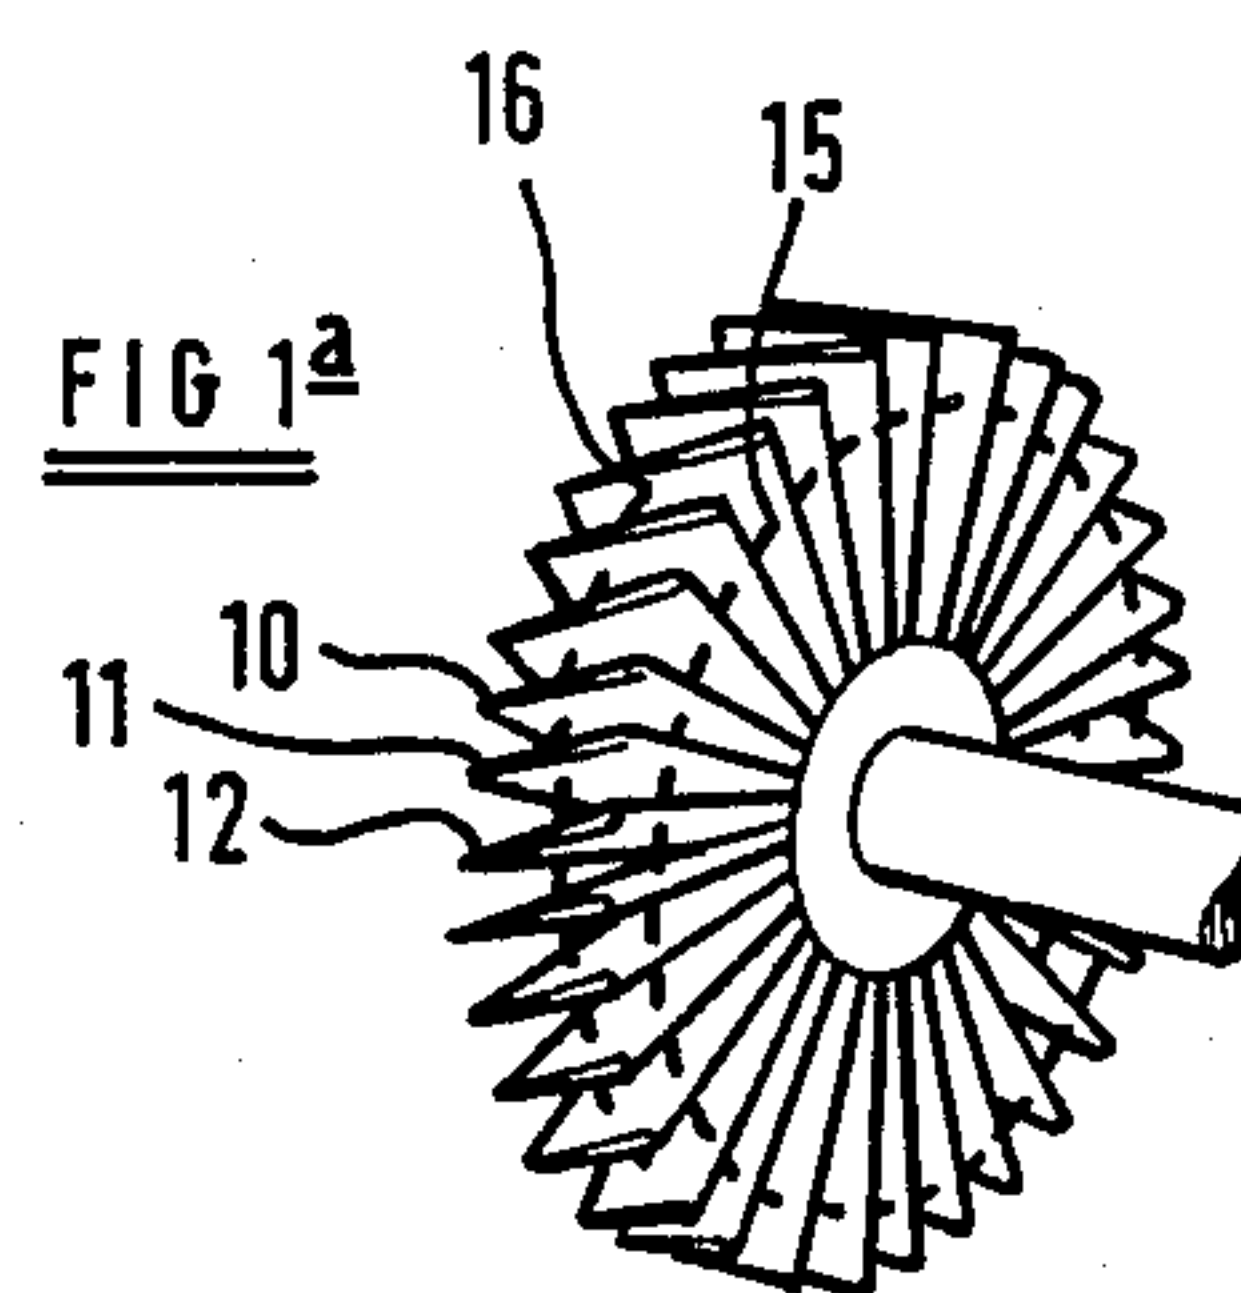
FIG. 4 illustrates a welding process being used to repair a turbine blade;

FIG. 5 is a cross-section along the line B—B shown in FIG. 4;

A piece of material is cut out from the margin bordering leading edge 17 and a new piece 18 of hard material, such as Stellite, is welded to the remainder of the turbine blade 10. The material used for welding is one compatible with the material from which the blade is made, for example, chrome steel and the material, i.e. Stellite, which is to be welded to the turbine blade 10.

The lacing wire holes 13 and 14 are filled by welding in plugs 20 and 21 which may well be of the same material from which the turbine blade is made, and once again a compatible welding metal will be used.

It is quite common that following removal of part of the blade as shown in FIGS. 4 and welding in of the

new piece 18 of hard material such as Stellite, the form of the blade can be altered by distortion, which form must be connected prior to heat treatment.

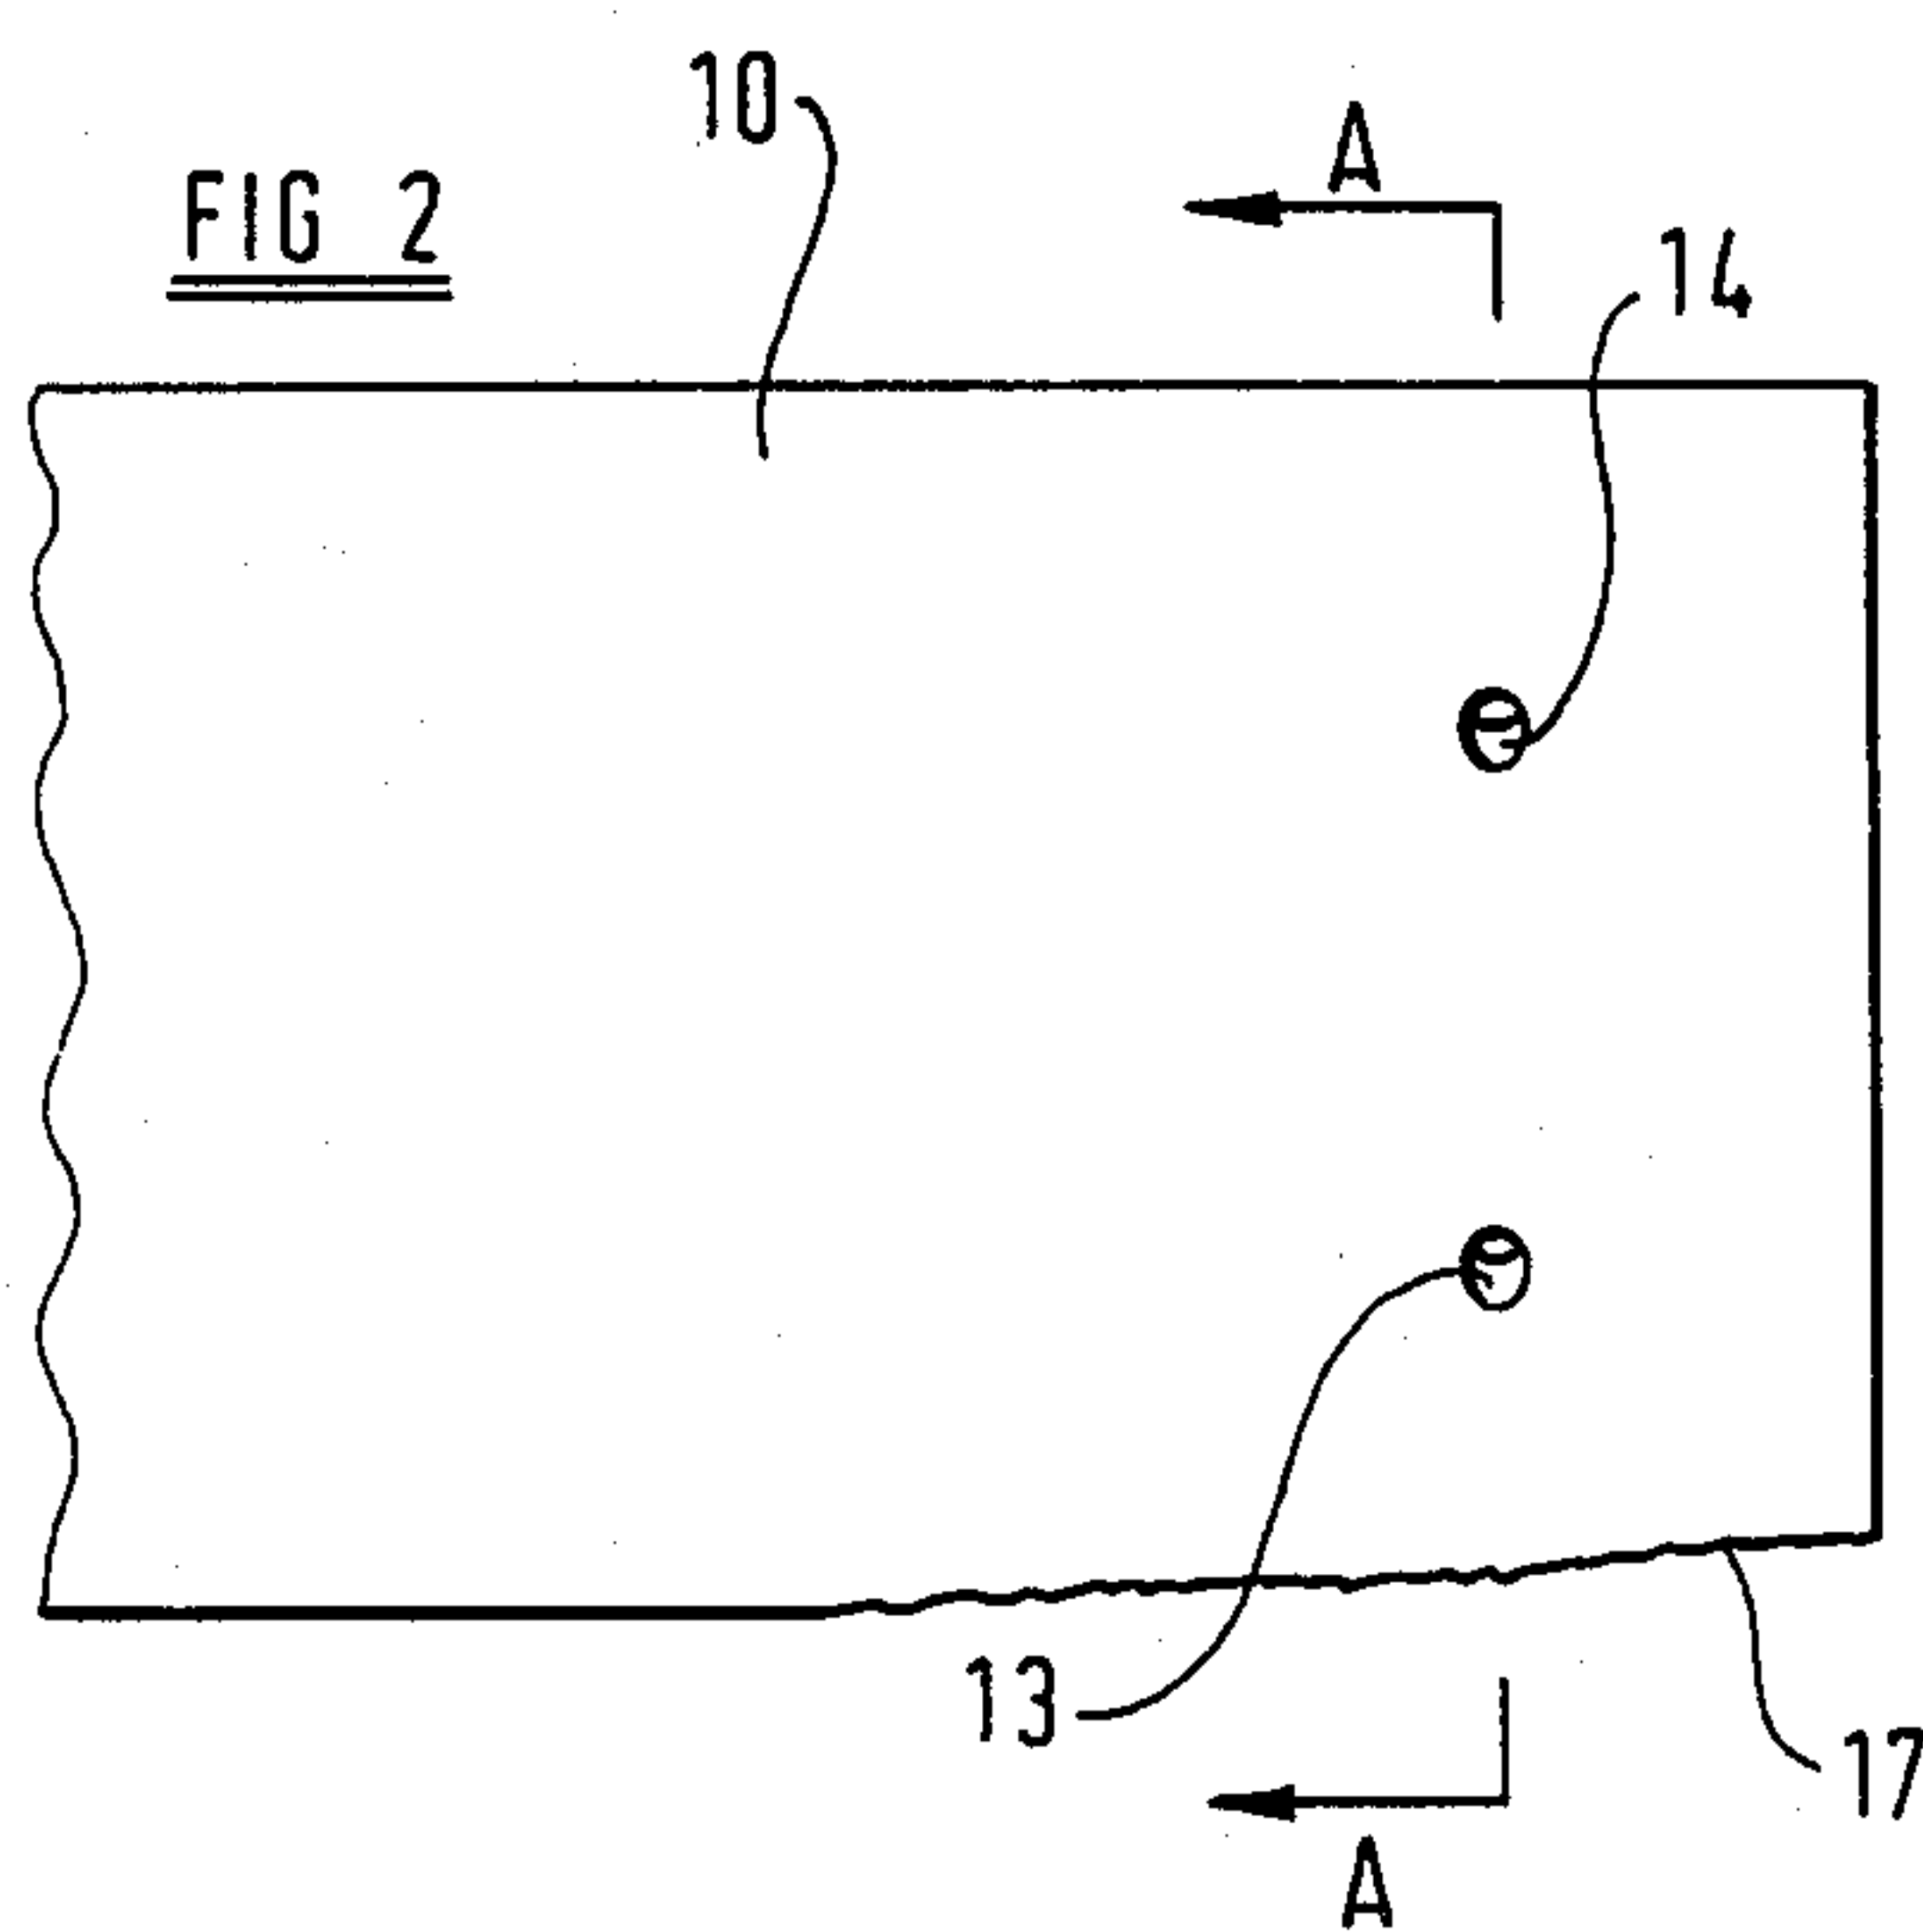
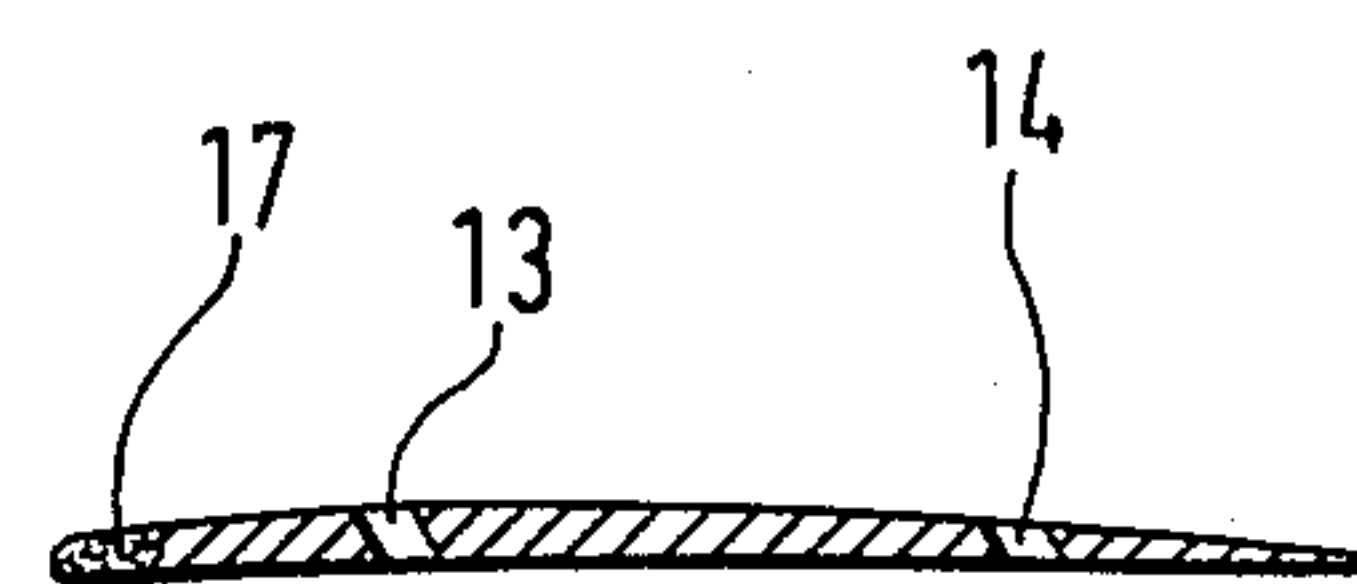
FIG. 6 illustrates an alternative repair involving by a welding process;

FIG. 7 is a cross-section along the line C—C shown in FIG. 6;

In FIGS. 6 and 7 an alternative repair is shown in which the turbine blade 50 has the leading outer edge region 57 repaired by the addition of fused metal by a welding process. The lacing wire holes 52 and 53 are likewise filled with fused metal. The method of repair then continues in an identical manner as that described for the blade 10 shown in FIGS. 4 and 5.
